Roof Safety Report

**Whitsunday Plaza,
QLD 4802**

Prepared By: Safemaster Safety Products
Date: 09 Aug 2017

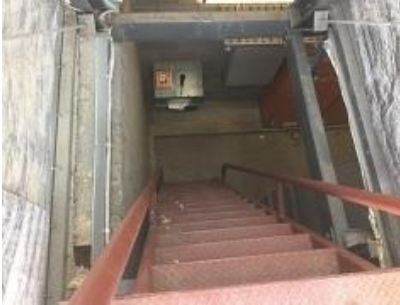
Ladder slope is greater than required maximum	Trips, Slips and Falls	Awareness induction	Med	Existing ladder can't be removed. Warning signage to be installed	Low	Client advised	Outstanding	OH&S REGULATIONS 3.7 & 3.11 AS/NZS 1657-2013 7.2.1
02	Building: BIG W Location Reference: L01 Task: Access to the roof

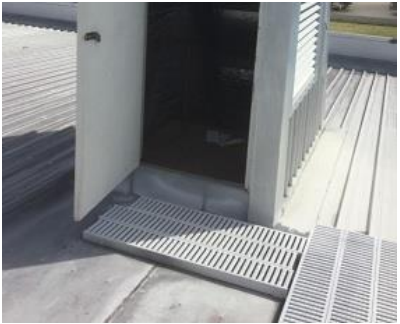
Landing is less than required minimum	Trips, Slips and Falls	Awareness induction	Med	Additional walkway section to be installed	Low	Client advised	Outstanding	OH&S REGULATIONS 3.7 AS/NZS 1657-2013 7.3.6

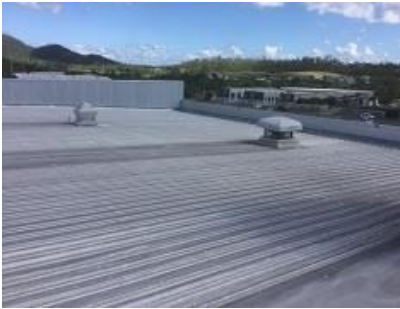
No safe access to the A/c units	Trips, Slips and Falls	N/A	Low	Supply walkway to the A/c units	Low	Client advised	Outstanding	-
04	Building: BIG W Location Reference: L03 Task: Access to the roof

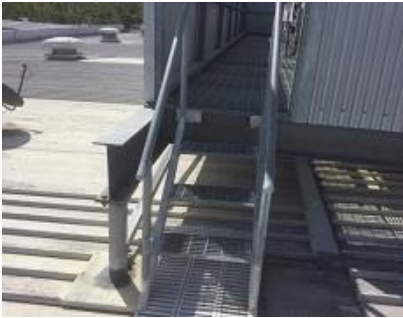
Stair width is less than required minimum	Trips, Slips and Falls	Awareness induction	Med	Access ladder including handrails to be installed	Low	Client advised	Outstanding	OH&S REGULATIONS 3.7 AS/NZS 1657-2013 7.2.1
06	Building: BIG W Location Reference: L03 Task: Access to the plant deck

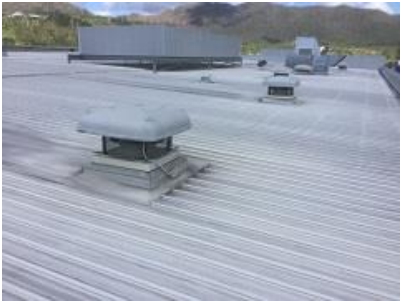
No safe access to the A/c units	Trips, Slips and Falls	N/A	Low	Supply walkway to the A/c units	Low	Client advised	Outstanding	-
08	Building: BIG W Location Reference: L05 Task: Restrict access to the roof

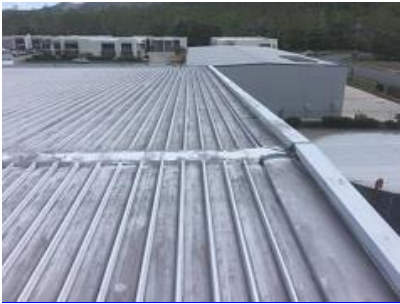
No height safety system installed	Trips, Slips and Falls	Awareness induction	High	Fall arrest anchors to be installed	Low	Client advised	Outstanding	OH&S REGULATIONS 3.55
10	Building: BIG W Location Reference: L07 & L08 Task: Restrict access to the roof

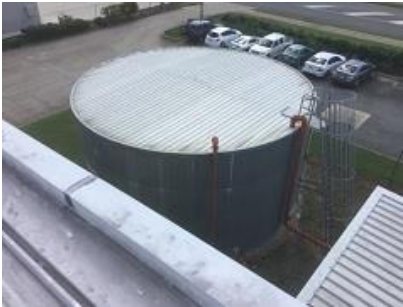
Rungs are slippery, gate is missing at top & bottom and no height safety system installed	Trips, Slips and Falls	Awareness induction	High	Non-slip rung caps, self-closing gate, cage gate and anchor point to be installed	Low	Client advised	Outstanding	OH&S REGULATIONS 3.7 & 3.55 AS/NZS 1657-2013 7.4.3.1
12	Building: General Stores Location Reference: L10 Task: Access to the roof

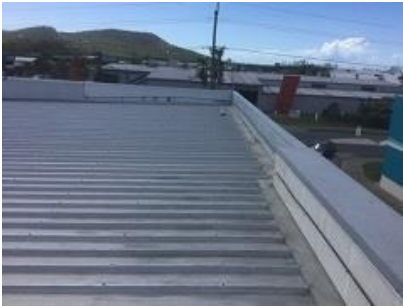
No height safety system installed	Trips, Slips and Falls	Awareness induction	High	Fall arrest anchors to be installed	Low	Client advised	Outstanding	OH&S REGULATIONS 3.55

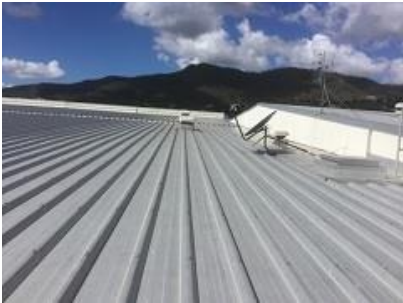
No safe access to the A/c units	Trips, Slips and Falls	N/A	Low	Supply walkway to the A/c unit	Low	Client advised	Outstanding	-
14	Building: General Stores Location Reference: L12 Task: Access to the A/c units

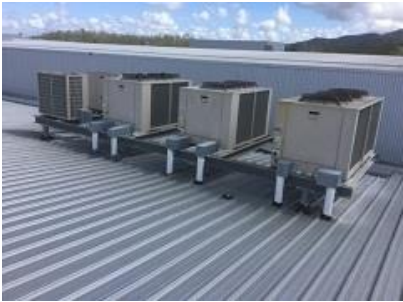
No safe access to the A/c units	Trips, Slips and Falls	N/A	Low	Supply walkway to the A/c unit	Low	Client advised	Outstanding	-
16	Building: General Stores Location Reference: L14 Task: Access to the roof

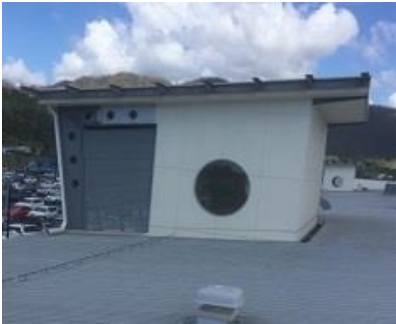
No height safety system installed	Trips, Slips and Falls	Awareness induction	High	Fall arrest anchors and ladder access bracket to be installed	Low	Client advised	Outstanding	OH&S REGULATIONS 3.55

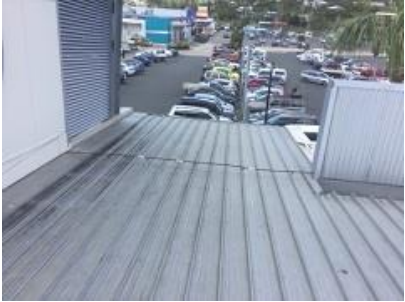
No height safety system installed	Trips, Slips and Falls	Awareness induction	High	Fall arrest anchors to be installed	Low	Client advised	Outstanding	OH&S REGULATIONS 3.55
18	Building: General Stores Location Reference: L16 Task: Access to the A/c units

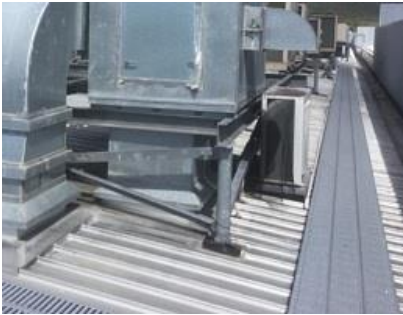
No safe access to the A/c units	Trips, Slips and Falls	N/A	Low	Supply walkway to the A/c units	Low	Client advised	Outstanding	-
20	Building: General Stores Location Reference: L17 Task: Access to the A/c unit

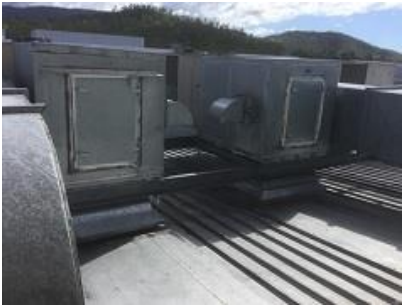
No safe access to the A/c units	Trips, Slips and Falls	N/A	Low	Supply walkway to the A/c units	Low	Client advised	Outstanding	-
22	Building: General Stores Location Reference: L19 Task: Access to the A/c units

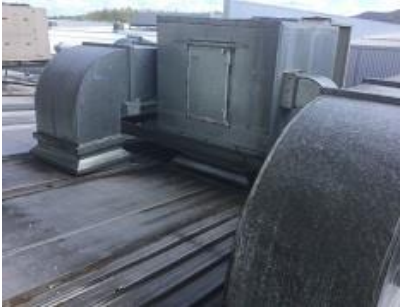
No safe access to the switches	Trips, Slips and Falls	N/A	Low	Supply walkway to the switches	Low	Client advised	Outstanding	-
24	Building: General Stores Location Reference: L20 Task: Access to the roof

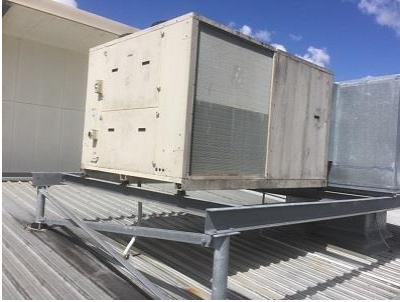
No safe access to the A/c unit	Trips, Slips and Falls	N/A	Low	Supply walkway to the A/c unit	Low	Client advised	Outstanding	-
26	Building: General Stores Location Reference: L21 Task: Access to the plant deck

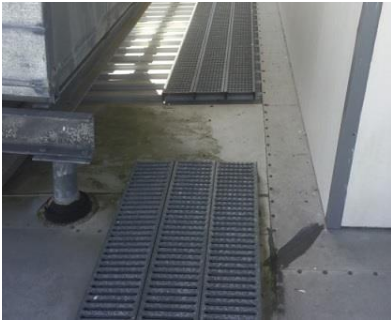
No safe access to the A/c units	Trips, Slips and Falls	N/A	Low	Supply walkway to the A/c units	Low	Client advised	Outstanding	-
28	Building: General Stores Location Reference: L23 Task: Access to the A/c units

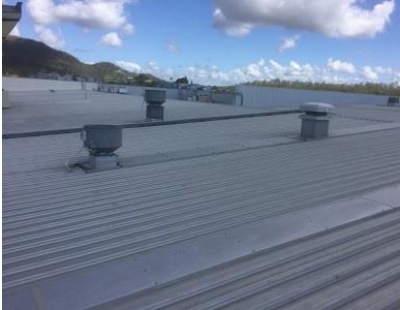
No safe access to the A/c units	Trips, Slips and Falls	N/A	Low	Supply walkway to the A/c units	Low	Client advised	Outstanding	-
30	Building: General Stores Location Reference: L25 Task: Access to the A/c units

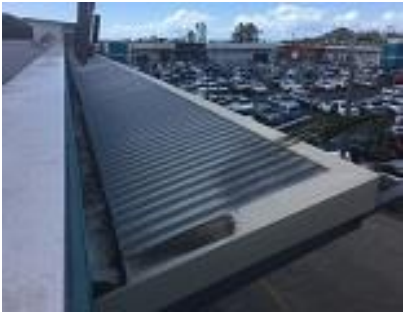
No height safety system installed	Trips, Slips and Falls	Restrict Access	High	"EWP Access Only" signs to be installed	Low	Client advised	Outstanding	OH&S REGULATIONS 3.55 & 3.11
32	Building: General Stores Location Reference: L27 Task: Access to the roof

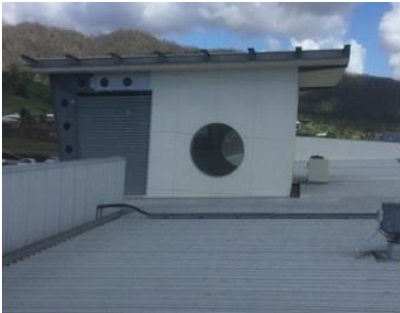
No height safety system installed	Trips, Slips and Falls	Awareness induction	High	Fall arrest anchor, Anchor strop and Ladder access bracket to be installed	Low	Client advised	Outstanding	OH&S REGULATIONS 3.55
34	Building: General Stores Location Reference: L29 Task: Restrict access to the roof

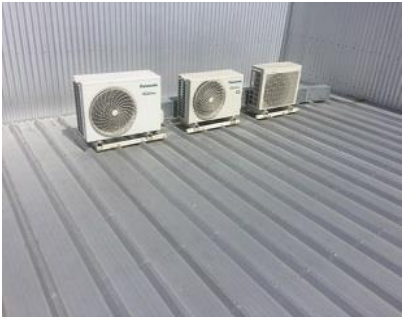
No safe access to the A/c units	Trips, Slips and Falls	N/A	Low	Supply walkway to the A/c units	Low	Client advised	Outstanding	-
36	Building: Harvey Norman Location Reference: L31 Task: Access to the A/c units

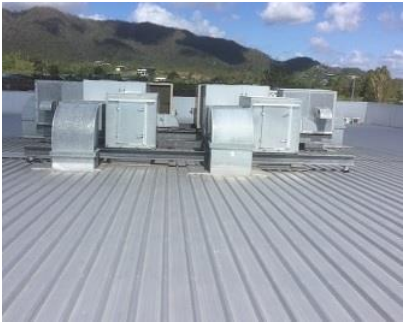
No safe access to the plant deck and switches	Trips, Slips and Falls	Awareness induction	Med	Access step, Walkway mesh and handrails to plant deck and roof walkway to be installed	Low	Client advised	Outstanding	OH&S REGULATIONS 3.7 AS/NZS 1657-2013 3.1.4 & 4.4

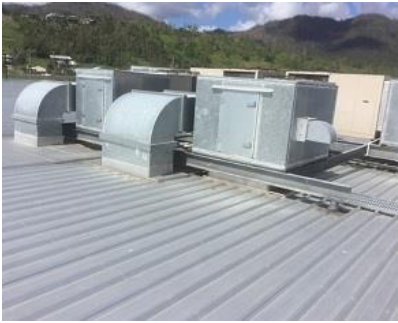
No safe access to the plant deck and switches	Trips, Slips and Falls	Awareness induction	Med	Access step, Walkway mesh and handrails to plant deck and roof walkway to be installed	Low	Client advised	Outstanding	OH&S REGULATIONS 3.7 AS/NZS 1657-2013 3.1.4 & 4.4
38	Building: Harvey Norman Location Reference: L33 Task: Access to the roof

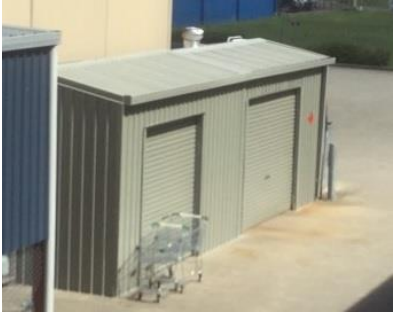
No height safety system installed	Trips, Slips and Falls	Restrict Access	High	"EWP Access Only" sign to be installed	Low	Client advised	Outstanding	OH&S REGULATIONS 3.55 & 3.11
40	Building: Harvey Norman Location Reference: L35 Task: Access to the roof

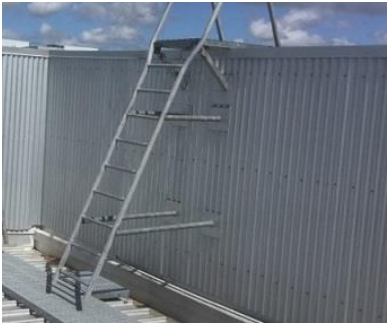
Top rung not levelled with landing, bottom rung height is less than required minimum and no slip resistance on ladder rungs	Trips, Slips and Falls	Awareness induction	Med	Existing ladder to be removed and new ladder to be installed	Low	Client advised	Outstanding	OH&S REGULATIONS 3.7 AS/NZS 1657-2013 7.4.3.3, 7.4.3.4 & 7.4.3.1
42	Building: Harvey Norman Location Reference: L37 Task: Access to the roof

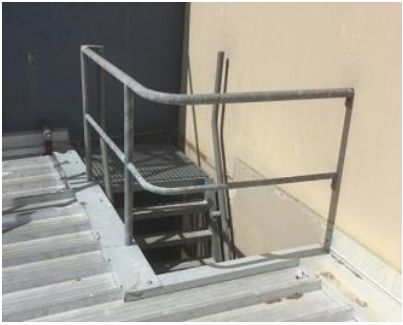
Toe board is missing at landing	Head Injury	Awareness induction	High	Toe board to be installed	Low	Client advised	Outstanding	OH&S REGULATIONS 3.7 AS/NZS 1657-2013 4.6
44	Building: Harvey Norman Location Reference: L38 Task: Access to the roof

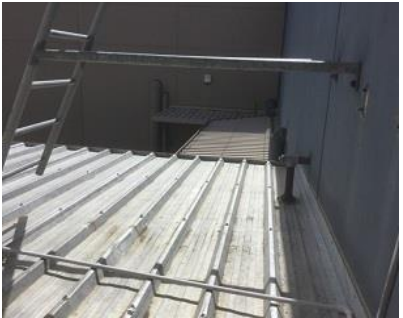
No height safety system installed	Trips, Slips and Falls	Awareness induction	High	Fall arrest anchors to be installed	Low	Client advised	Outstanding	OH&S REGULATIONS 3.55

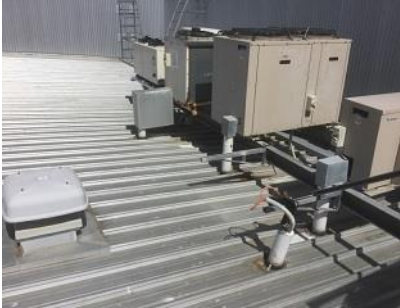
No safe access to the A/c units	Trips, Slips and Falls	N/A	Low	Supply walkway to the A/c units	Low	Client advised	Outstanding	-
46	Building: Harvey Norman Location Reference: L40 Task: Access to the A/c units

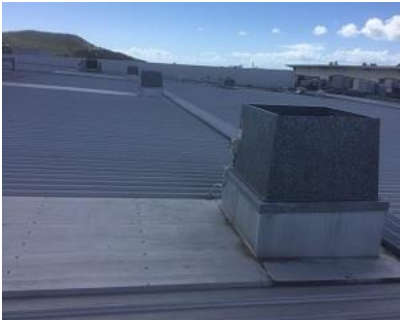
No safe access to the A/c units	Trips, Slips and Falls	N/A	Low	Supply walkway to the A/c units	Low	Client advised	Outstanding	-

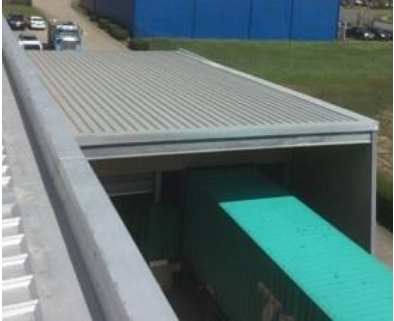
No height safety system installed	Trips, Slips and Falls	Restrict Access	High	"EWP Access Only" sign to be installed	Low	Client advised	Outstanding	OH&S REGULATIONS 3.55 & 3.11
48	Building: Woolworths Location Reference: L42 Task: Access to the A/c units

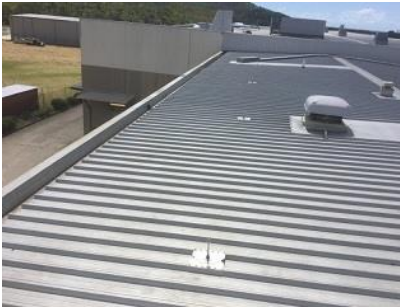
Not enough anchors installed for safe access	Trips, Slips and Falls	Awareness induction	High	Fall arrest anchors to be installed	Low	Client advised	Outstanding	OH&S REGULATIONS 3.55
50	Building: Woolworths Location Reference: L44 Task: Access to the plant deck

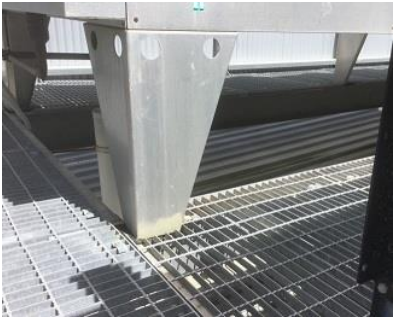
Variation in height between plant deck and unit is greater than required maximum	Trips, Slips and Falls	Awareness induction	Med	Mid rail to be installed	Low	Client advised	Outstanding	OH&S REGULATIONS 3.7 AS/NZS 1657-2013 4.4
52	Building: Woolworths Location Reference: L45 Task: Access to the A/c units

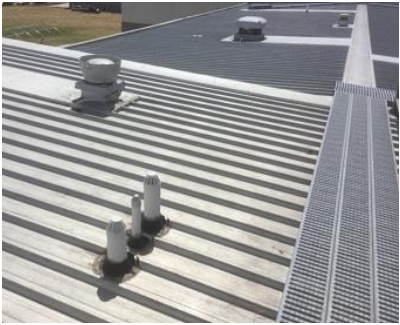
No safe access to the A/c units	Trips, Slips and Falls	N/A	Low	Supply walkway to the A/c units	Low	Client advised	Outstanding	-
54	Building: Woolworths Location Reference: L47 Task: Access to the A/c units

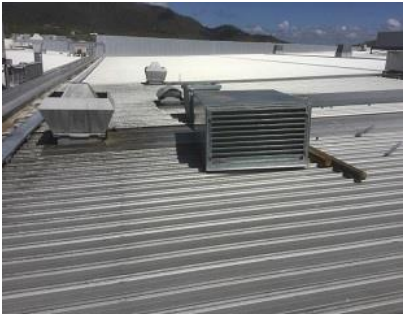
No safe access to the A/c units	Trips, Slips and Falls	N/A	Low	Supply walkway to the A/c units	Low	Client advised	Outstanding	-
56	Building: General Stores Location Reference: L49 Task: Restrict access to the roof

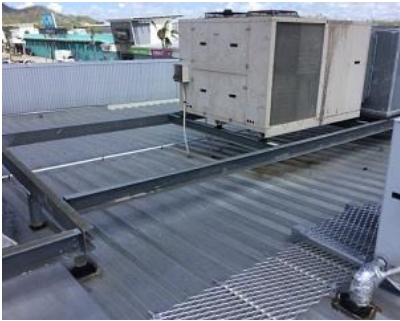
No safe access to the A/c units	Trips, Slips and Falls	Awareness induction	Med	Step bridge and walkway to be installed	Low	Client advised	Outstanding	OH&S REGULATIONS 3.7 AS/NZS 1657-2013 3.1.4
58	Building: General Stores Location Reference: L50 Task: Access to the A/c units

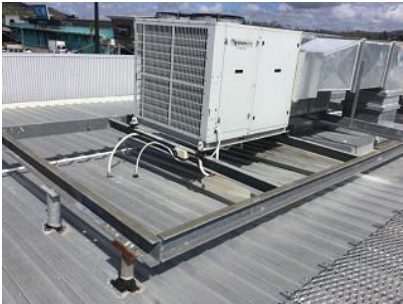
No safe access to the A/c units	Trips, Slips and Falls	Awareness induction	Med	Step bridges and walkway to be installed	Low	Client advised	Outstanding	OH&S REGULATIONS 3.7 AS/NZS 1657-2013 3.1.4
60	Building: General Stores Location Reference: L52 Task: Access to the A/c units

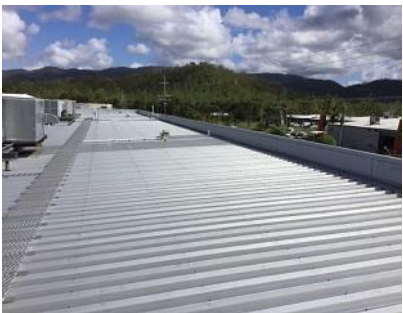
No height safety system installed	Trips, Slips and Falls	Awareness induction	High	Fall arrest anchors to be installed	Low	Client advised	Outstanding	OH&S REGULATIONS 3.55
62	Building: General Stores Location Reference: L54 Task: Restrict access to the roof

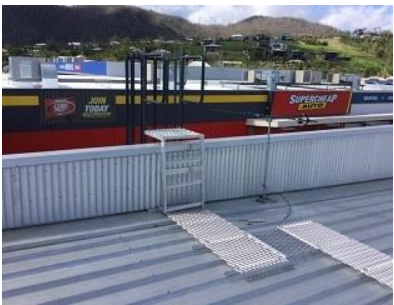
No safe access to the roof	Trips, Slips and Falls	Awareness induction	High	Fall arrest anchor and anchor stop to be installed	Low	Client advised	Outstanding	OH&S REGULATIONS 3.55
64	Building: General Stores Location Reference: L56 Task: Access to the roof

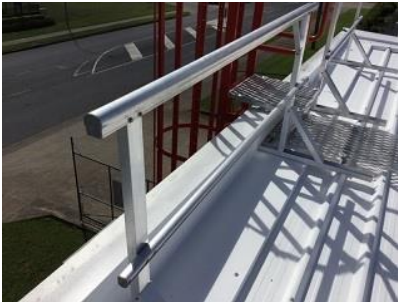
Sharp edges on handrails	Trips, Slips and Falls	Awareness induction	Med	Tek screws to be replaced with rivets	Low	Client advised	Outstanding	OH&S REGULATIONS 3.7 AS/NZS 1657-2013 5.6
66	Building: General Stores Location Reference: L57 Task: Access to the roof

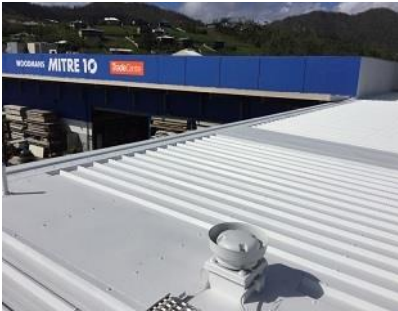
No height safety system installed	Trips, Slips and Falls	Awareness induction	High	Fall arrest anchors to be installed	Low	Client advised	Outstanding	OH&S REGULATIONS 3.55

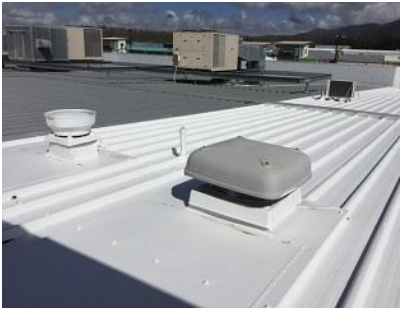
No safe access to the A/c units	Trips, Slips and Falls	N/A	Low	Supply walkway to the A/c units	Low	Client advised	Outstanding	-
68	Building: General Stores Location Reference: L59 Task: Restrict access to the roof

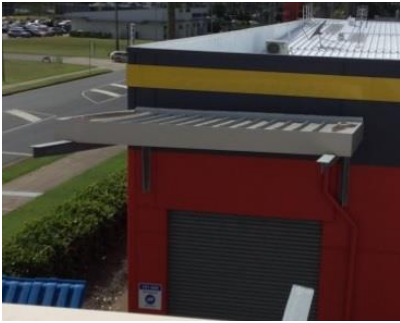
No height safety system installed	Trips, Slips and Falls	Restrict Access	High	"EWP Access Only" sign to be installed	Low	Client advised	Outstanding	OH&S REGULATIONS 3.55 & 3.11

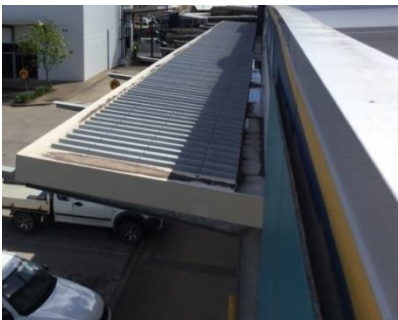
No height safety system installed	Trips, Slips and Falls	Restrict Access	High	"EWP Access Only" sign to be installed	Low	Client advised	Outstanding	OH&S REGULATIONS 3.55 & 3.11
70	Building: General Stores Location Reference: L61 Task: Access to the roof

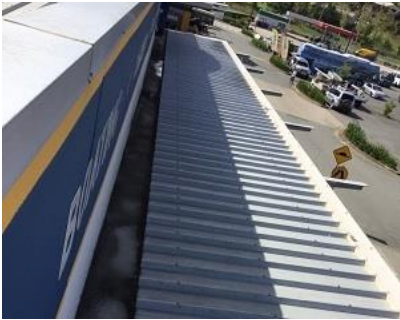
No height safety system installed	Trips, Slips and Falls	Restrict Access	High	"EWP Access Only" sign to be installed	Low	Client advised	Outstanding	OH&S REGULATIONS 3.55 & 3.11
72	Building: General Stores Location Reference: L63 Task: Restrict access to the roof

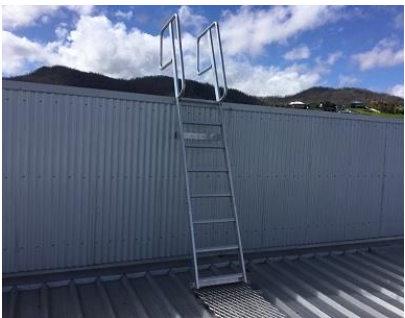
Bottom rung height is less than required minimum, top rung not levelled with landing and handrail projecting towards the user	Trips, Slips and Falls	Awareness induction	Med	Existing ladder to be removed and New ladder to be installed	Low	Client advised	Outstanding	OH&S REGULATIONS 3.7 AS/NZS 1657-2013 7.4.3.4, 7.4.3.3 & 7.4.8.5
74	Building: General Stores Location Reference: L65 Task: Access to the A/c units

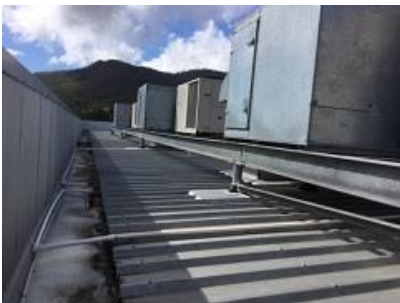
No safe access to the A/c units	Trips, Slips and Falls	N/A	Low	Supply walkway to the A/c units	Low	Client advised	Outstanding	-
76	Building: General Stores Location Reference: L67 Task: Access to the A/c unit

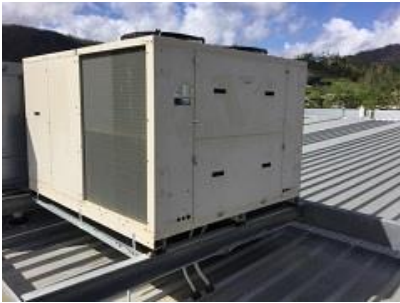
No safe access to the A/c unit	Trips, Slips and Falls	Awareness induction	Med	Step bridge and walkway to be installed	Low	Client advised	Outstanding	OH&S REGULATIONS 3.7 AS/NZS 1657-2013 3.1.4
78	Building: General Stores Location Reference: L69 Task: Access to the A/c unit

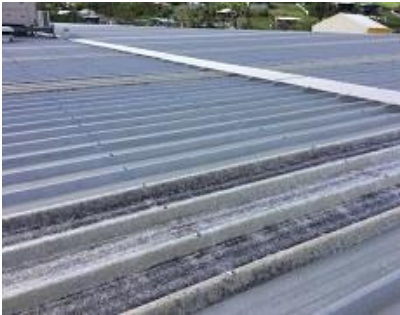
Brittle and Fragile roof	Trips, Slips and Falls	Awareness induction	High	"Keep Off - Brittle and Fragile Roof" signs to be installed	Low	Client advised	Outsta nding	OH&S REGULATIONS 3.57
80	Building: General Stores Location Reference: L71 Task: Access to the A/c units

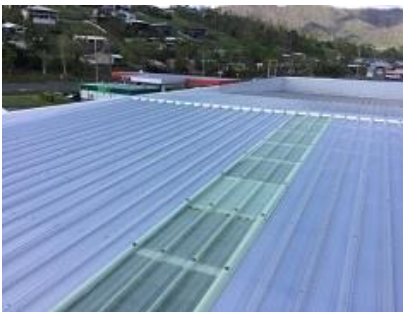
No height safety system installed	Trips, Slips and Falls	Awareness induction	High	Fall arrest anchors to be installed	Low	Client advised	Outstanding	OH&S REGULATIONS 3.55
82	Building: General Stores Location Reference: L73 Task: Restrict access to the roof

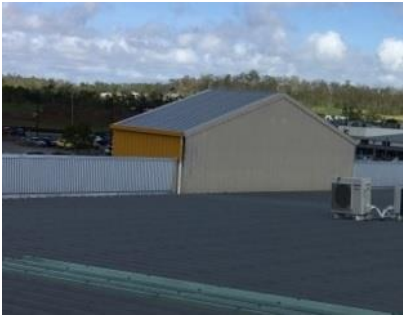
No height safety system installed	Trips, Slips and Falls	Restrict Access	High	"EWP Access Only" sign to be installed	Low	Client advised	Outstanding	OH&S REGULATIONS 3.55 & 3.11
84	Building: General Stores Location Reference: L75 Task: Access to the roof

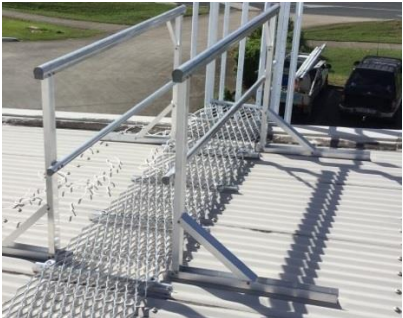
Sharp edges on handrails	Hand Injury	Awareness induction	Med	Tek screws to be replaced with rivets	Low	Client advised	Outstanding	OH&S REGULATIONS 3.7 AS/NZS 1657-2013 5.6

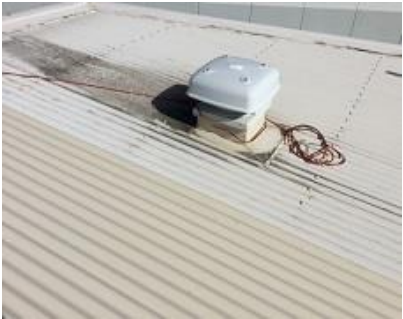
No safe access to the A/c unit	Trips, Slips and Falls	N/A	Low	Supply walkway to the A/c unit	Low	Client advised	Outstanding	-
