Roof Safety Report

Whitsunday Plaza, QLD 4802

Prepared By: Safemaster Safety Products
Date: 26-08-2020

Roof Safety Report for
Whitsunday Plaza, QLD 4802

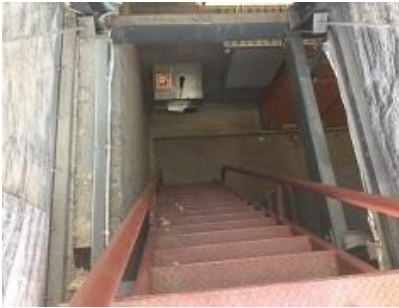
Ladder slope is greater than required maximum	Trips, Slips and Falls	Awareness induction	Med	Existing ladder can't be removed. Warning signage to be installed	Low	Client advised	Outstanding	OH&S REGULATIONS 3.7 & 3.11 AS/NZS 1657-2013 7.2.1
02	Building: BIG W Location Reference: L01 Task: Access to the roof

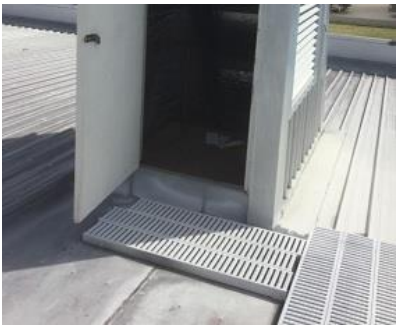
Landing is less than required minimum	Trips, Slips and Falls	Awareness induction	Med	Additional walkway section to be installed	Low	Client advised	Outstanding	OH&S REGULATIONS 3.7 AS/NZS 1657-2013 7.3.6

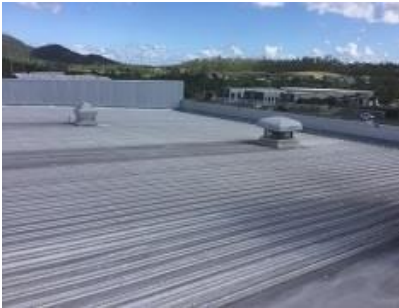
No safe access to the A/c units	Trips, Slips and Falls	N/A	Low	Supply walkway to the A/c units	Low	Client advised	Outstanding	-
04	Building: BIG W Location Reference: L03 Task: Access to the roof

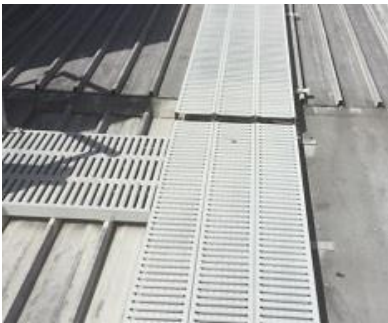
Variation in height between walkway panels are greater than required maximum	Trips, Slips and Falls	Awareness induction	Med	High visibility safety yellow nosing to be installed	Low	Client advised	Outstanding	OH&S REGULATIONS 3.7 AS/NZS 1657-2013 3.3.4

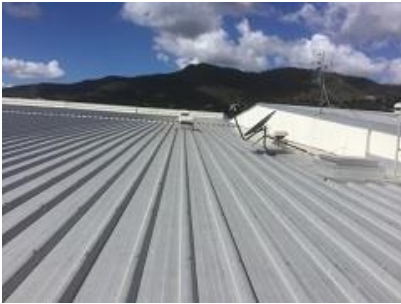
No safe access to the A/c units	Trips, Slips and Falls	N/A	Low	Supply walkway to the A/c unit	Low	Client advised	Outstanding	-
14	Building: General Stores Location Reference: L12 Task: Access to the A/c units

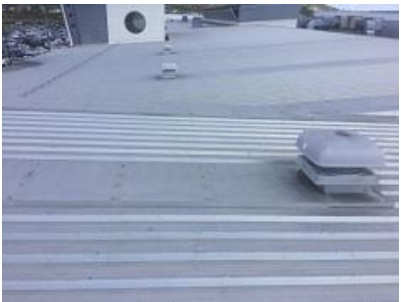
No safe access to the A/c units	Trips, Slips and Falls	N/A	Low	Supply walkway to the A/c unit	Low	Client advised	Outstanding	-

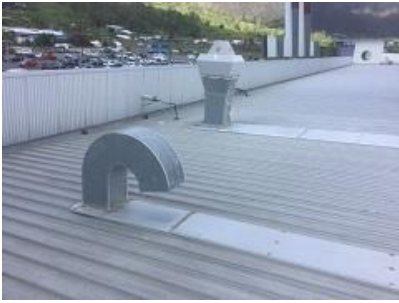
No safe access to the A/c units	Trips, Slips and Falls	N/A	Low	Supply walkway to the A/c units	Low	Client advised	Outstanding	-

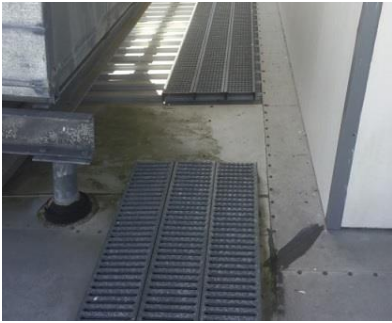
No safe access to the A/c units	Trips, Slips and Falls	N/A	Low	Supply walkway to the A/c units	Low	Client advised	Outstanding	-
28	Building: General Stores Location Reference: L23 Task: Access to the A/c units

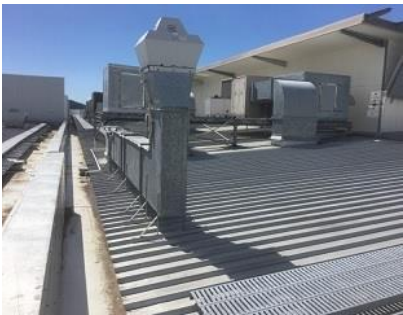
No safe access to the A/c units	Trips, Slips and Falls	N/A	Low	Supply walkway to the A/c units	Low	Client advised	Outstanding	-

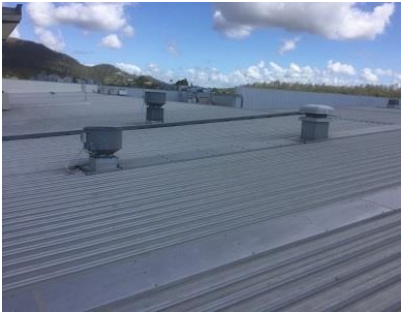
No safe access to the A/c units	Trips, Slips and Falls	N/A	Low	Supply walkway to the A/c units	Low	Client advised	Outstanding	-
30	Building: General Stores Location Reference: L25 Task: Access to the A/c units

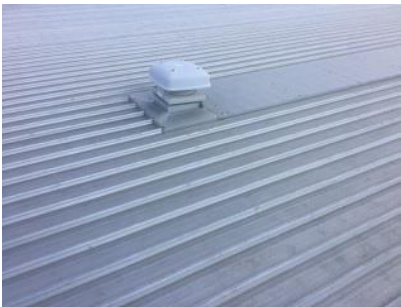
No safe access to the A/c units	Trips, Slips and Falls	N/A	Low	Supply walkway to the A/c units	Low	Client advised	Outstanding	-

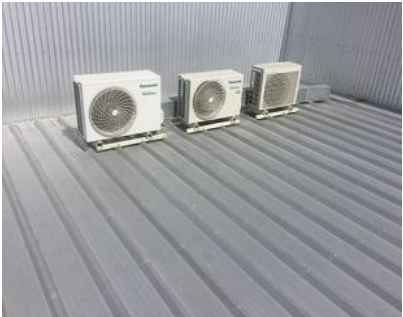
No safe access to the A/c units	Trips, Slips and Falls	N/A	Low	Supply walkway to the A/c units	Low	Client advised	Outsta nding	-

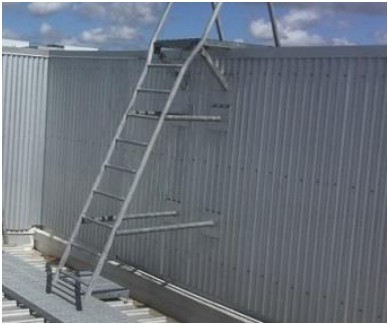
Top rung not levelled with landing, bottom rung height is less than required minimum and no slip resistance on ladder rungs	Trips, Slips and Falls	Awareness induction	Med	Existing ladder to be removed and new ladder to be installed	Low	Client advised	Outstanding	OH&S REGULATIONS 3.7 AS/NZS 1657-2013 7.4.3.3, 7.4.3.4 & 7.4.3.1
42	Building: Harvey Norman Location Reference: L37 Task: Access to the roof

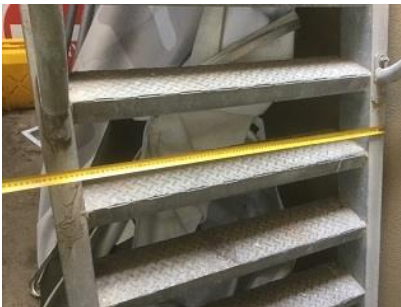
Ladder width is greater than required maximum	Trips, Slips and Falls	Awareness induction	Med	Existing ladder to be removed and New ladder to be installed	Low	Client advised	Outstanding	OH&S REGULATIONS 3.7 AS/NZS 1657-2013 7.3.1

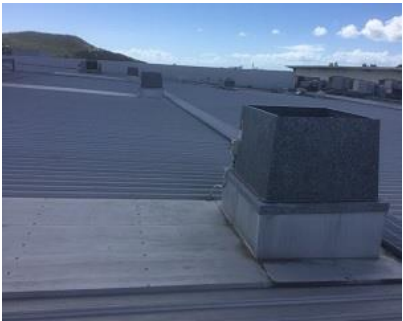
No safe access to the A/c units	Trips, Slips and Falls	N/A	Low	Supply walkway to the A/c units	Low	Client advised	Outsta nding	-

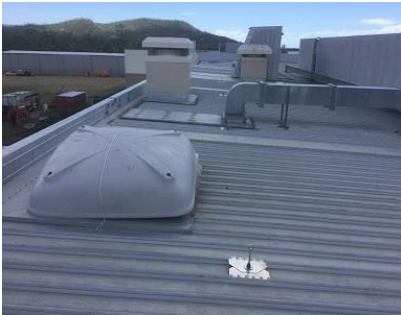
No safe access to the A/c units	Trips, Slips and Falls	N/A	Low	Supply walkway to the A/c units	Low	Client advised	Outstanding	-

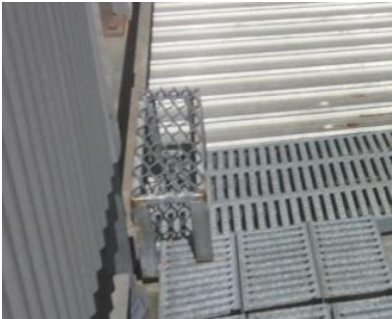
Non-compliant step	Trips, Slips and Falls	Awareness induction	Med	Existing step to be removed and new step to be installed	Low	Client advised	Outsta nding	OH&S REGULATIONS 3.7 AS/NZS 1657-2013 3.1.4

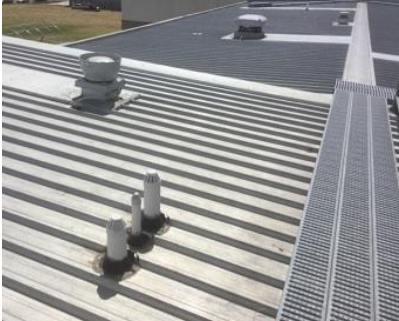
No safe access to the A/c units	Trips, Slips and Falls	N/A	Low	Supply walkway to the A/c units	Low	Client advised	Outsta nding	-

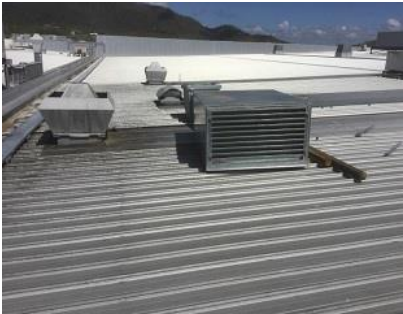
No safe access to the A/c units	Trips, Slips and Falls	N/A	Low	Supply walkway to the A/c units	Low	Client advised	Outsta nding	-

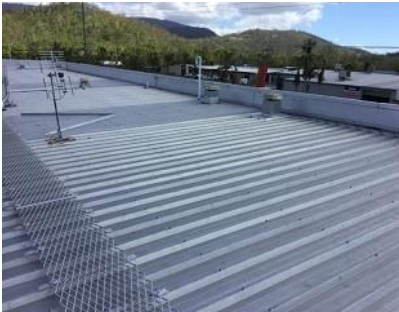
No safe access to the A/c units	Trips, Slips and Falls	N/A	Low	Supply walkway to the A/c units	Low	Client advised	Outsta nding	-

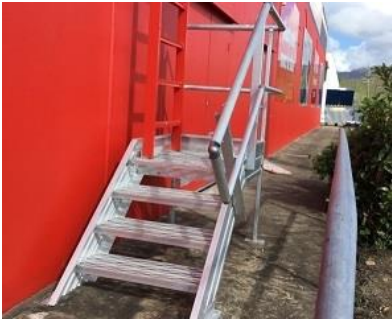
Bottom rung height is less than required minimum	Trips, Slips and Falls	Awareness induction	Med	Existing ladder to be re-install with landing platform, stiles, fittings and fixings	Low	Client advised	Outstanding	OH&S REGULATIONS 3.7 AS/NZS 1657-2013 7.4.3.4

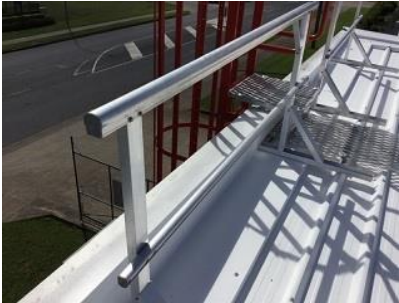
Sharp edges on handrails	Trips, Slips and Falls	Awareness induction	Med	Tek screws to be replaced with rivets	Low	Client advised	Outstanding	OH&S REGULATIONS 3.7 AS/NZS 1657-2013 5.6

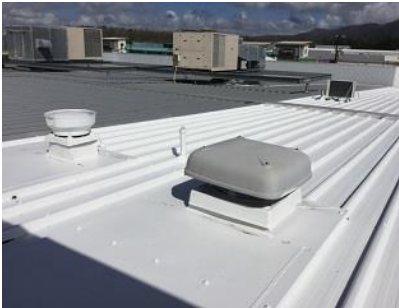
No safe access to the A/c units	Trips, Slips and Falls	N/A	Low	Supply walkway to the A/c units	Low	Client advised	Outstanding	-

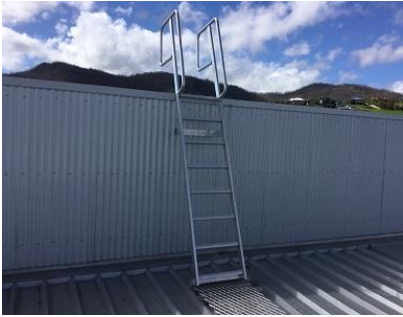
Bottom rung height is less than required minimum, top rung not levelled with landing and handrail projecting towards the user	Trips, Slips and Falls	Awareness induction	Med	Existing ladder to be removed and New ladder to be installed	Low	Client advised	Outstanding	OH&S REGULATIONS 3.7 AS/NZS 1657-2013 7.4.3.4, 7.4.3.3 & 7.4.8.5

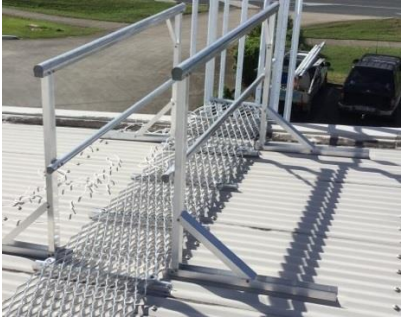
Sharp edges on handrails	Hand Injury	Awareness induction	Med	Tek screws to be replaced with rivets	Low	Client advised	Outsta nding	OH&S REGULATIONS 3.7 AS/NZS 1657-2013 5.6

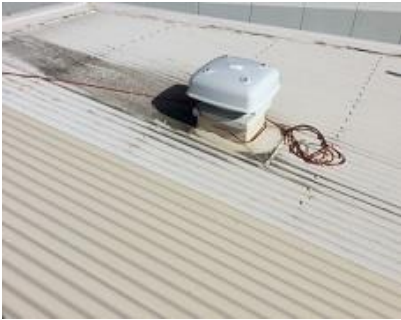
No safe access to the A/c unit	Trips, Slips and Falls	N/A	Low	Supply walkway to the A/c unit	Low	Client advised	Outstanding	-

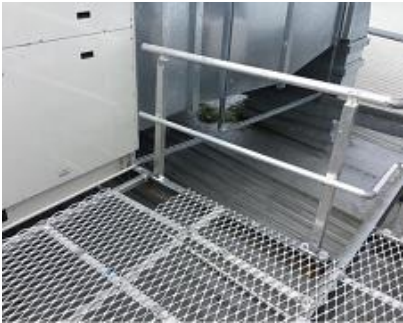
Handrail section is removed and not secured properly	Trips, Slips and Falls	Awareness induction	Med	Handrail section to be secured	Low	Client advised	Outstanding	OH&S REGULATIONS 3.7 AS/NZS 1657-2013 4.4

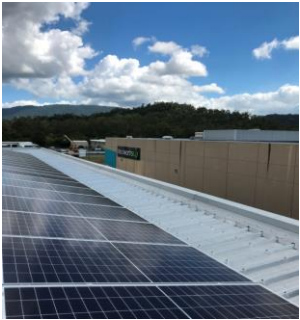
Height safety system cover by solar panels	Trips, Slips and Falls	Awareness induction	High	Install 18m handrails	Low	Client advised	Outstanding	OH&S REGULATIONS 3.7 & 3.55
97	Building: General Stores Location Reference: L70 Task: Restrict access to the roof

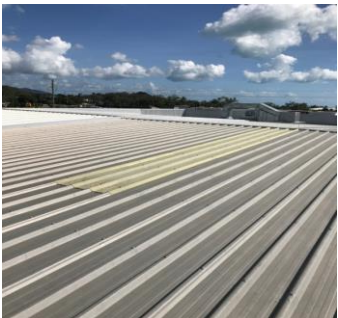
Brittle and Fragile roof sections are present	Trips, Slips and Falls	Restrict Access	High	10x "Warning-Keep Off-Brittle and Fragile Roof" sign to be installed	Low	Client advised	Outstanding	OH&S REGULATIONS 3.57
