Roof Safety Report

**381 Scarborough Beach Road,
WA 6017**

Prepared By: Safemaster Safety Products
Date: 26 April 2018

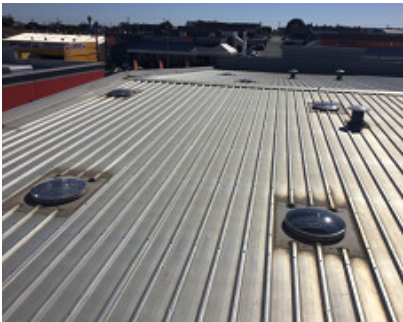
Brittle roof sections are present (Non-trafficable roof)	Trips, Slips and Falls	Restrict Access	High	"Warning-Keep Off-Brittle and Fragile Roof" signs to be installed	Low	Client advised	Outstanding	OH&S REGULATIONS 3.57
02	Building: General Stores Location Reference: L01 Task: Access to the A/c units

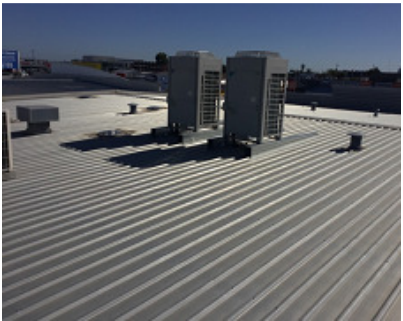
No safe access to the A/c units	Trips, Slips and Falls	N/A	Low	Supply walkway to the A/c units	Low	Client advised	Outstanding	-

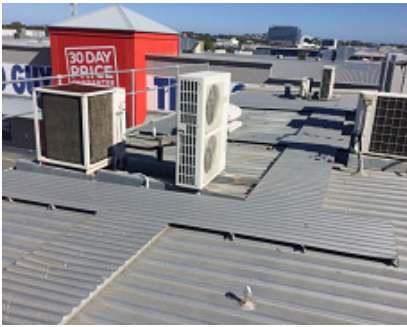
Non-complaint walkway installed (Roof sheet been used as walkway)	Trips, Slips and Falls	Awareness induction	Med	Existing walkway to be removed and new walkway to be installed	Low	Client advised	Outstanding	OH&S REGULATIONS 3.7 AS/NZS 1657-2013 3.2.3
04	Building: General Stores Location Reference: L01 Task: Access to the roof

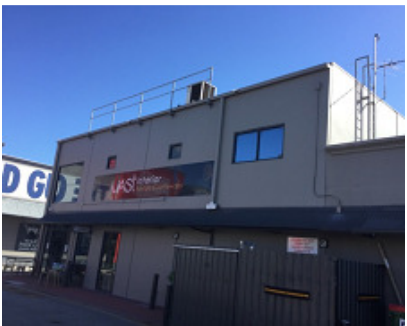
Gap between mid rail and roof is greater than required maximum and toe board is missing	Trips, Slips and Falls	Awareness induction	Med	Additional handrail including toe board to be installed	Low	Client advised	Outstanding	OH&S REGULATIONS 3.7 AS/NZS 1657-2013 6.2.1.4

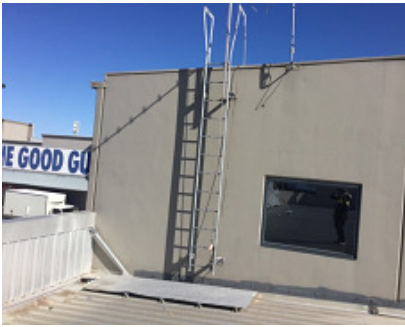
Un-even rungs are present and no slip resistance on rungs	Trips, Slips and Falls	Awareness induction	Med	Existing ladder to be removed and new ladder including anchor stop to be installed	Low	Client advised	Outstanding	OH&S REGULATIONS 3.7 AS/NZS 1657-2013 7.4.3.1 & 7.4.3.2
06	Building: General Stores Location Reference: L02 Task: Access to the roof

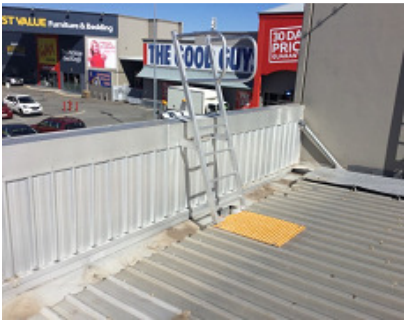
Top rung not levelled with landing, landing is less than required minimum, bottom rung height is less than required minimum and handrail projecting towards the user	Trips, Slips and Falls	Awareness induction	Med	Existing ladder to be removed and new ladder to be installed	Low	Client advised	Outstanding	OH&S REGULATIONS 3.7 AS/NZS 1657-2013 7.4.3.3, 7.3.6, 7.4.3.4 & 7.4.8.5

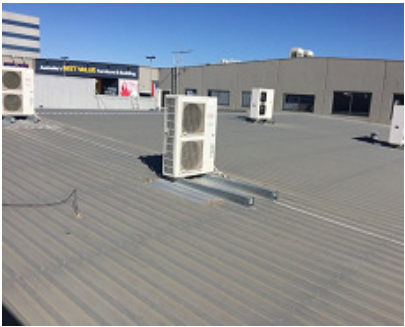
No safe access to the A/c units	Trips, Slips and Falls	N/A	Low	Supply walkway to the A/c units	Low	Client advised	Outstanding	-
08	Building: General Stores Location Reference: L03 Task: Access to the roof

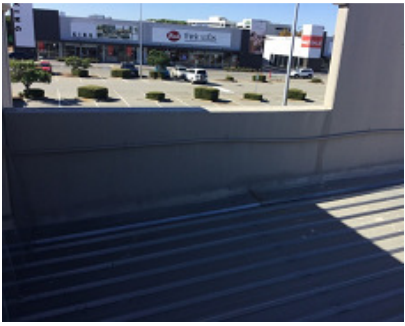
No height safety system installed	Trips, Slips and Falls	Awareness induction	High	Fall arrest anchor to be installed	Low	Client advised	Outstanding	OH&S REGULATIONS 3.55

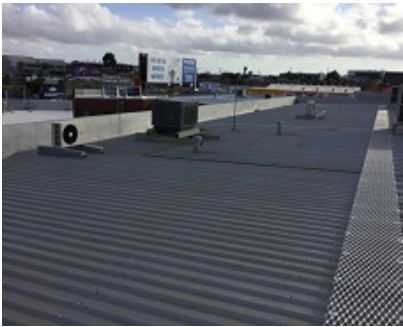
No safe access to the A/c units	Trips, Slips and Falls	N/A	Low	Supply walkway to the A/c units	Low	Client advised	Outstanding	-
10	Building: General Stores Location Reference: L04 Task: Access to the roof

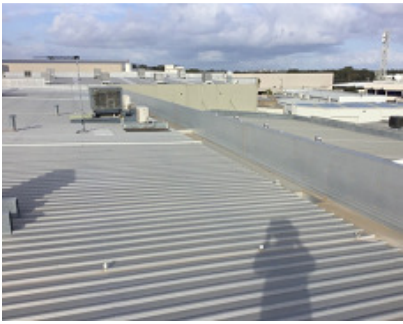
No height safety system installed	Trips, Slips and Falls	Awareness induction	High	Fall arrest anchors to be installed	Low	Client advised	Outstanding	OH&S REGULATIONS 3.55

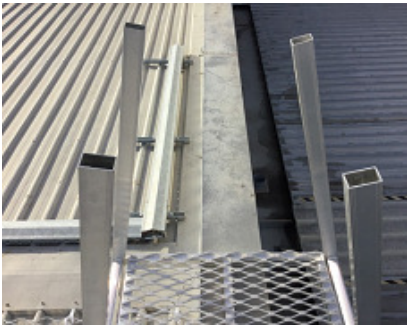
Sharp edges on ladder stiles	Trips, Slips and Falls	Awareness induction	Med	Handrail including rung caps to be installed	Low	Client advised	Outstanding	OH&S REGULATIONS 3.7 AS/NZS 1657-2013 5.6
12	Building: General Stores Location Reference: L06 Task: Access to the roof

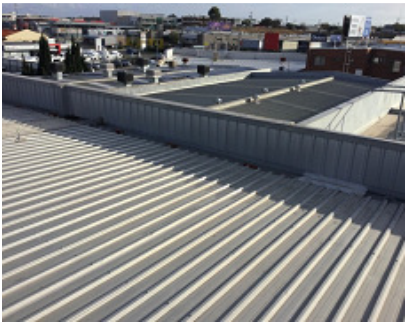
No height safety system installed	Trips, Slips and Falls	Awareness induction	High	Fall arrest anchors to be installed	Low	Client advised	Outstanding	OH&S REGULATIONS 3.55

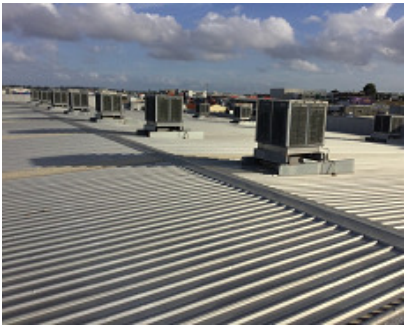
No safe access to the A/c units	Trips, Slips and Falls	N/A	Low	Supply walkway and handrail to the A/c units	Low	Client advised	Outstanding	-
14	Building: General Stores Location Reference: L07 Task: Restrict access to the roof

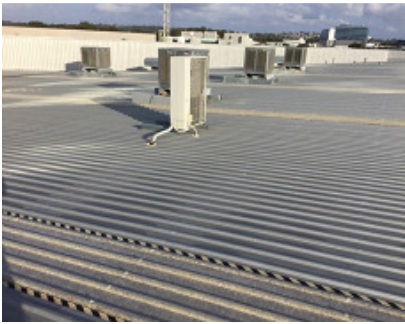
Brittle roof (Non-trafficable roof)	Trips, Slips and Falls	Restrict Access	High	"Warning-Keep Off-Brittle and Fragile Roof" signs to be installed	Low	Client advised	Outstanding	OH&S REGULATIONS 3.57

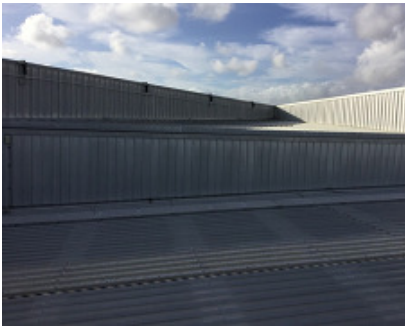
No height safety and safe access system installed	Trips, Slips and Falls	Awareness induction	High	Fall arrest anchors and access ladder to be installed	Low	Client advised	Outstanding	OH&S REGULATIONS 3.7 & 3.55 AS/NZS 1657-2013 3.1.4
16	Building: General Stores Location Reference: L10 Task: Access to the roof

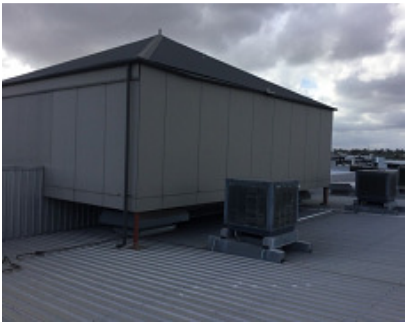
No safe access to the roof	Trips, Slips and Falls	Awareness induction	High	Ladder access bracket, anchor strop, landing platform to be installed and top anchor post to be replaced	Low	Client advised	Outstanding	OH&S REGULATIONS 3.55 AS/NZS 1657-2013 3.1.4

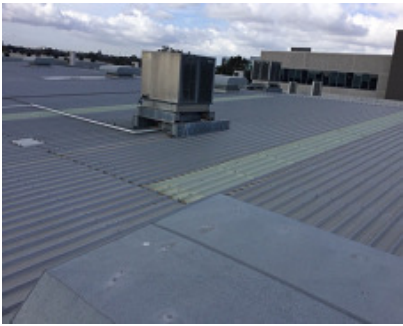
Brittle roof (Non-trafficable roof)	Trips, Slips and Falls	Restrict Access	High	"Warning-Keep Off-Brittle and Fragile Roof" signs to be installed	Low	Client advised	Outstanding	OH&S REGULATIONS 3.57
18	Building: General Stores Location Reference: L1 Task: Access to the roof

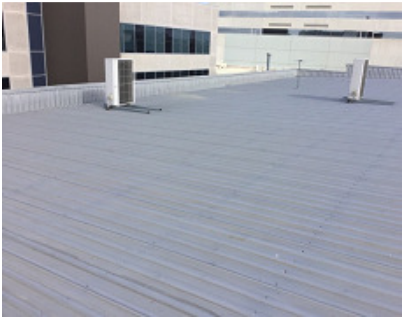
No height safety system installed	Trips, Slips and Falls	Awareness induction	High	Fall arrest anchors to be installed	Low	Client advised	Outstanding	OH&S REGULATIONS 3.55

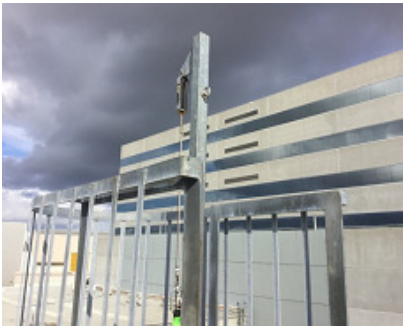
Non-complaint ladder is present	Trips, Slips and Falls	Awareness induction	Med	Existing ladder to be removed and new ladder to be installed	Low	Client advised	Outstanding	OH&S REGULATIONS 3.7 AS/NZS 1657-2013 7.4
20	Building: General Stores Location Reference: L13 Task: Access to the roof

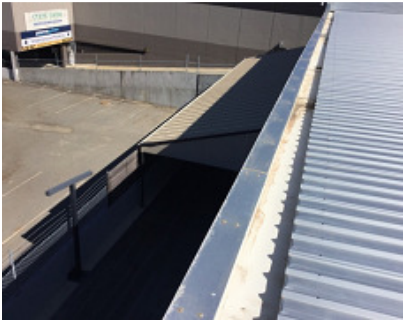
No height safety system installed	Trips, Slips and Falls	Awareness induction	High	Fall arrest anchors, anchor stop, ladder access bracket and sign to be installed	Low	Client advised	Outstanding	OH&S REGULATIONS 3.55

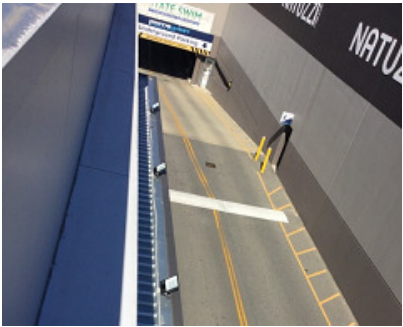
No height safety system installed	Trips, Slips and Falls	Awareness induction	High	Fall arrest static line, anchor stop, ladder access bracket and sign to be installed	Low	Client advised	Outstanding	OH&S REGULATIONS 3.55
22	Building: General Stores Location Reference: L17 Task: Access to the roof

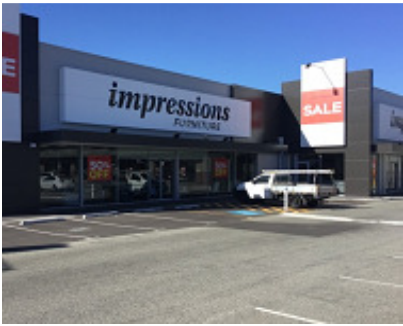
No height safety system installed	Trips, Slips and Falls	Awareness induction	High	Fall arrest static line, anchor stop, ladder access bracket and sign to be installed	Low	Client advised	Outstanding	OH&S REGULATIONS 3.55

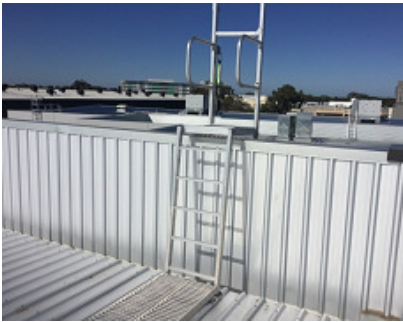
Non-compliant ladder is present	Trips, Slips and Falls	Awareness induction	Med	Existing ladder to be removed and new ladder to be installed	Low	Client advised	Outstanding	OH&S REGULATIONS 3.7 AS/NZS 1657-2013 7.4
24	Building: General Stores Location Reference: L19 Task: Access to the A/c units

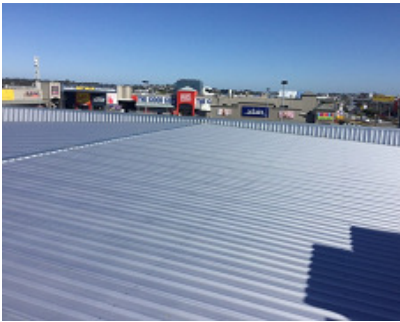
No height safety system installed	Trips, Slips and Falls	Awareness induction	High	Fall arrest anchors to be installed	Low	Client advised	Outstanding	OH&S REGULATIONS 3.55
26	Building: General Stores Location Reference: L20 Task: Access to the roof

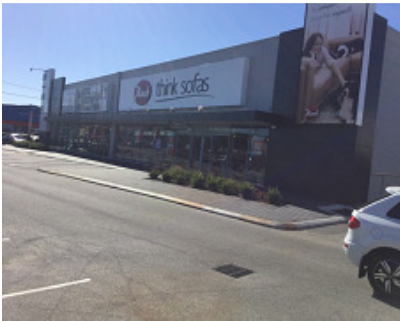
No height safety system installed	Trips, Slips and Falls	Awareness induction	High	Fall arrest static line, anchor stop, ladder access bracket and sign to be installed	Low	Client advised	Outstanding	OH&S REGULATIONS 3.55

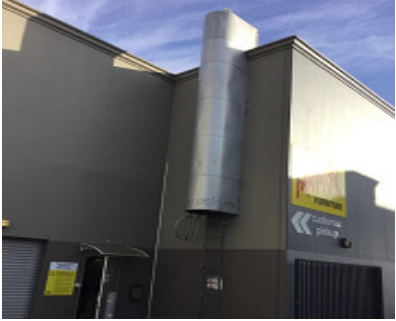
Non-complaint ladder is present	Trips, Slips and Falls	Awareness induction	Med	Existing ladder to be removed and new ladder to be installed	Low	Client advised	Outstanding	OH&S REGULATIONS 3.7 AS/NZS 1657-2013 7.4
