Roof Safety Report

**Broadmeadows Central,
VIC 3047**

Prepared By: Safemaster Safety Products
Date: 28 March 2018

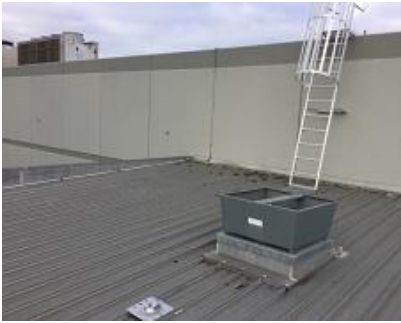
No	Photo of Hazard	Details of Hazard	Details of Risk	Existing/ Immediate Control Measure	Curre nt Risk Level	Proposed Permanent Solution	Resid ual Risk Asse sme nt	Details of Action Taken	Status	Reference
01	Building: General Stores Location Reference: L01 Task: Access to the roof

No height safety system installed	Trips, Slips and Falls	Awareness induction	High	Fall arrest anchors to be installed	Low	Client advised	Outstanding	OH&S REGULATIONS 3.55
02	Building: General Stores Location Reference: L01 Task: Access to the A/c units

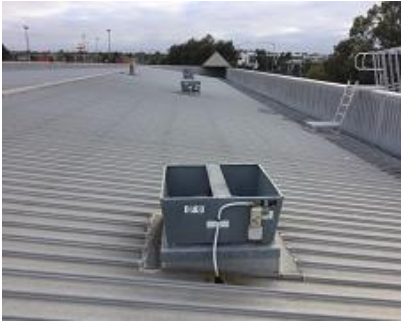
No safe access to the A/c units	Trips, Slips and Falls	N/A	Low	Supply walkway to the A/c units	Low	Client advised	Outstanding	-

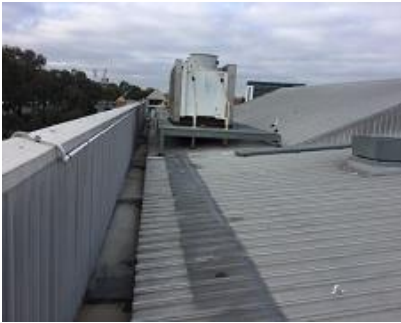
No	Photo of Hazard	Details of Hazard	Details of Risk	Existing/ Immediate Control Measure	Curre nt Risk Level	Proposed Permanent Solution	Resid ual Risk Asse sme nt	Details of Action Taken	Status	Reference
03	Building: General Stores Location Reference: L02 Task: Access to the plant deck

Variation in height between plant deck and roof is greater than required maximum	Trips, Slips and Falls	Awareness induction	Med	Guardrail to be installed	Low	Client advised	Outstanding	OH&S REGULATIONS 3.7 AS/NZS 1657-2013 4.4
04	Building: General Stores Location Reference: L02 Task: Access to the plant deck

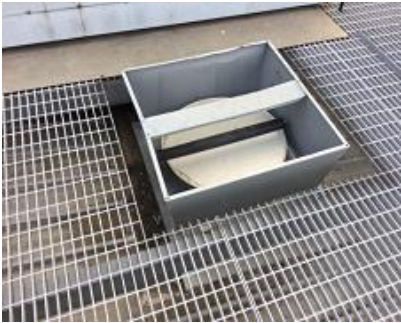
Gap between grating and unit is greater than required maximum	Trips, Slips and Falls	Awareness induction	Med	Gap to be filled	Low	Client advised	Outstanding	OH&S REGULATIONS 3.7 AS/NZS 1657-2013 3.2.3.4

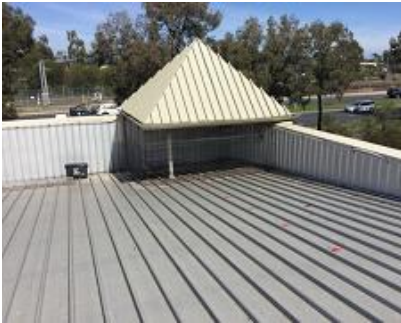
No	Photo of Hazard	Details of Hazard	Details of Risk	Existing/ Immediate Control Measure	Curre nt Risk Level	Proposed Permanent Solution	Resid ual Risk Asse sme nt	Details of Action Taken	Status	Reference
05	Building: General Stores Location Reference: L03 Task: Restrict access to the roof

No height safety system installed	Trips, Slips and Falls	Restrict Access	High	"No Access" signs to be installed	Low	Client advised	Outstanding	OH&S REGULATIONS 3.55 & 3.11
06	Building: General Stores Location Reference: L03 Task: Restrict access to the roof

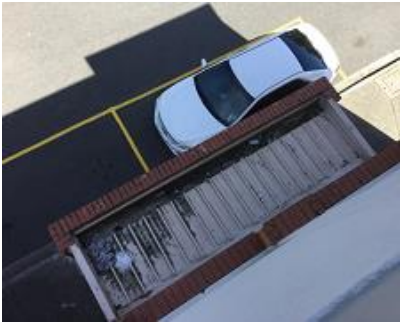
No height safety system installed	Trips, Slips and Falls	Restrict Access	High	"EWP Access Only" sign to be installed	Low	Client advised	Outstanding	OH&S REGULATIONS 3.55 & 3.11

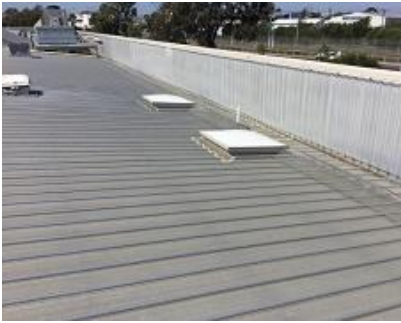
No	Photo of Hazard	Details of Hazard	Details of Risk	Existing/ Immediate Control Measure	Curre nt Risk Level	Proposed Permanent Solution	Resid ual Risk Asse sme nt	Details of Action Taken	Status	Reference
07	Building: General Stores Location Reference: L03 Task: Restrict access to the roof

Brittle roof (Non-trafficable roof)	Trips, Slips and Falls	Restrict Access	High	"Warning-Keep Off-Brittle and Fragile Roof" signs to be installed	Low	Client advised	Outstanding	OH&S REGULATIONS 3.57
08	Building: General Stores Location Reference: L03 Task: Access to the roof

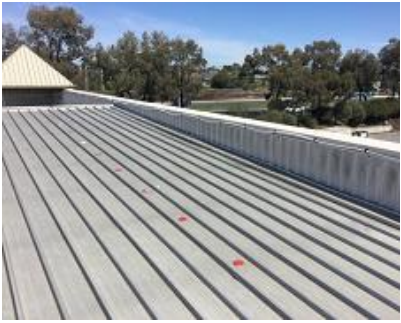
No height safety system installed	Trips, Slips and Falls	Awareness induction	High	Fall arrest anchors to be installed	Low	Client advised	Outstanding	OH&S REGULATIONS 3.55

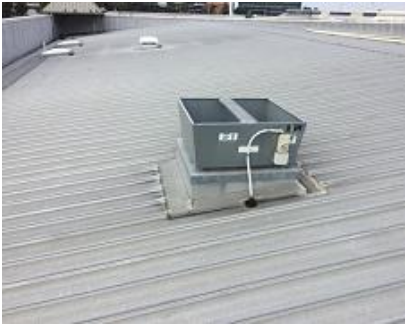
No safe access to the A/c units	Trips, Slips and Falls	N/A	Low	Supply walkway to the A/c units	Low	Client advised	Outstanding	-
10	Building: General Stores Location Reference: L04 Task: Restrict access to the roof

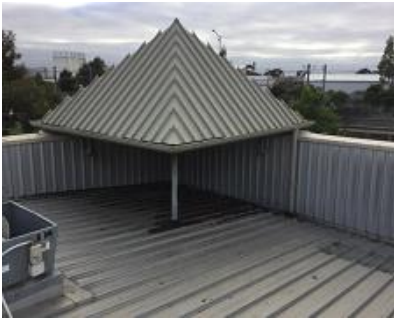
No height safety system installed	Trips, Slips and Falls	Restrict Access	High	"No Access" signs to be installed	Low	Client advised	Outstanding	OH&S REGULATIONS 3.55 & 3.11

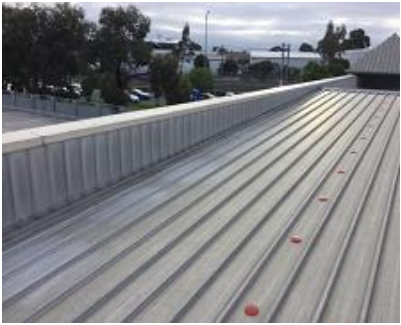
No height safety system installed	Trips, Slips and Falls	Awareness induction	High	Fall arrest anchors to be installed	Low	Client advised	Outstanding	OH&S REGULATIONS 3.55
12	Building: General Stores Location Reference: L05 Task: Access to the A/c units

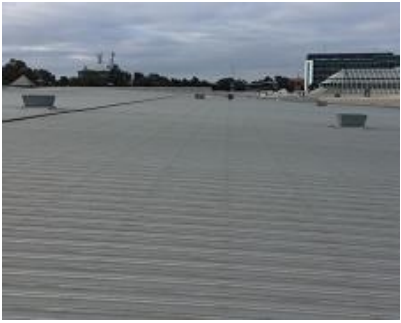
No safe access to the A/c units	Trips, Slips and Falls	N/A	Low	Supply walkway to the A/c units	Low	Client advised	Outstanding	-

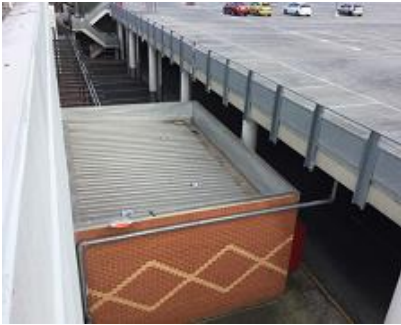
Variation in height between roofs are greater than required maximum	Trips, Slips and Falls	Awareness induction	Med	Access ladder and ladder bracket to be installed	Low	Client advised	Outstanding	OH&S REGULATIONS 3.7 AS/NZS 1657-2013 3.1.4
14	Building: General Stores Location Reference: L07 Task: Restrict access to the roof

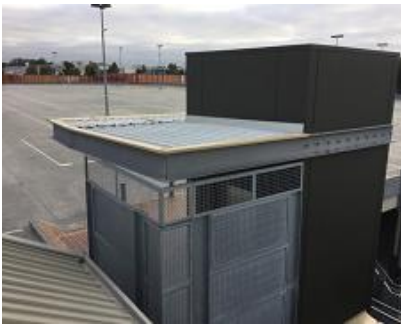
No height safety system installed	Trips, Slips and Falls	Restrict Access	High	"EWP Access Only" sign to be installed	Low	Client advised	Outstanding	OH&S REGULATIONS 3.55 & 3.11

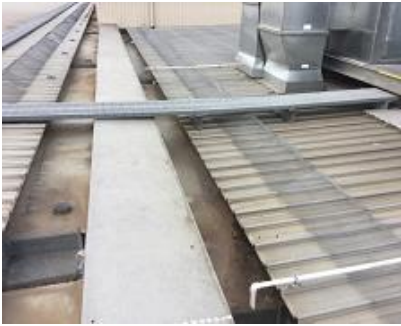
Variation in height between walkway and adjacent surface is greater than required maximum	Trips, Slips and Falls	Awareness induction	Med	Handrails to be installed	Low	Client advised	Outstanding	OH&S REGULATIONS 3.7 AS/NZS 1657-2013 4.4
16	Building: General Stores Location Reference: L08 Task: Access to the plant deck

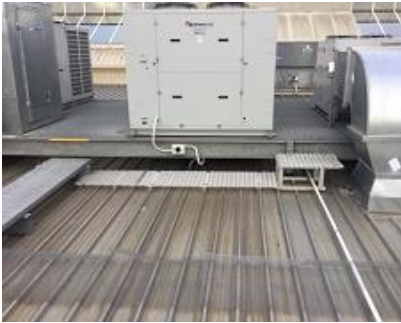
Non-complaint step is present	Trips, Slips and Falls	Awareness induction	Med	Existing step to be removed and new step to be installed	Low	Client advised	Outstanding	OH&S REGULATIONS 3.7 AS/NZS 1657-2013 3.1.4

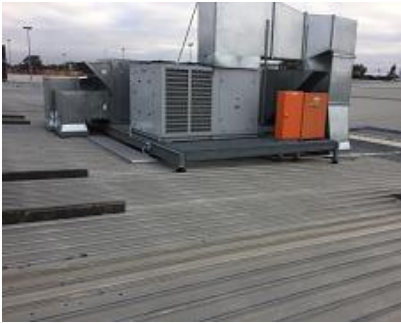
Variation in height between plant deck and roof is greater than required maximum	Trips, Slips and Falls	Awareness induction	Med	Step to be installed	Low	Client advised	Outstanding	OH&S REGULATIONS 3.7 AS/NZS 1657-2013 3.1.4

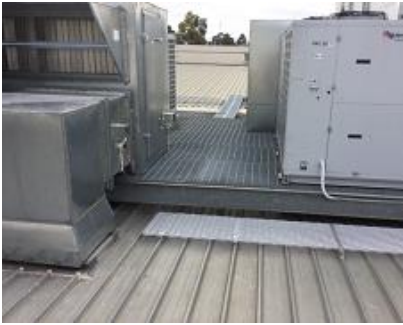
Variation in height between plant deck and roof is greater than required maximum	Trips, Slips and Falls	Awareness induction	Med	Step to be installed	Low	Client advised	Outstanding	OH&S REGULATIONS 3.7 AS/NZS 1657-2013 3.1.4
20	Building: General Stores Location Reference: L08 Task: Access to the plant deck

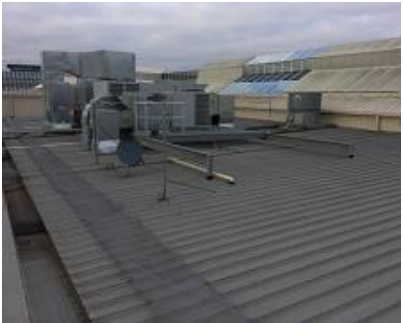
Variation in height between plant deck and roof is greater than required maximum	Trips, Slips and Falls	Awareness induction	Med	Handrails to be installed	Low	Client advised	Outstanding	OH&S REGULATIONS 3.7 AS/NZS 1657-2013 4.4

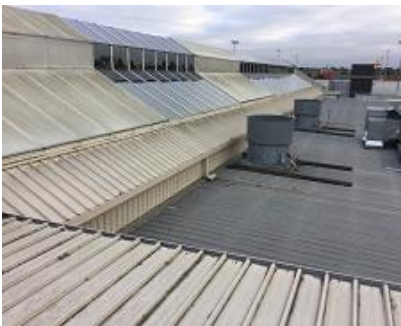
No safe access to the A/c units	Trips, Slips and Falls	N/A	Low	Supply walkway to the A/c units	Low	Client advised	Outstanding	-
22	Building: General Stores Location Reference: L09 Task: Access to the roof

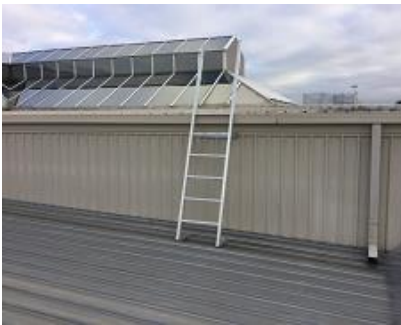
Gap between ladder and permanent structure is less than required minimum and no landing platforms	Trips, Slips and Falls	Awareness induction	Med	Existing ladder to be re-installed with landing platforms, brackets and handrails	Low	Client advised	Outstanding	OH&S REGULATIONS 3.7 AS/NZS 1657-2013 7.4.5 & 7.3.6

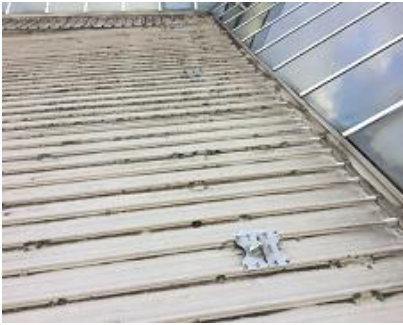
Existing non-complaint anchors are present	Trips, Slips and Falls	Awareness induction	High	Existing anchors to be removed and new anchors to be installed	Low	Client advised	Outstanding	OH&S REGULATIONS 3.55
24	Building: General Stores Location Reference: L10 Task: Access to the roof

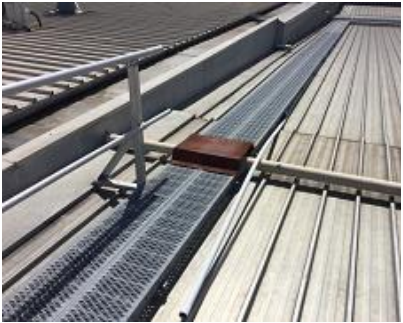
Pipes installed over the walkway path	Trips, Slips and Falls	Awareness induction	Med	Step bridge to be installed	Low	Client advised	Outstanding	OH&S REGULATIONS 3.7 AS/NZS 1657-2013 3.1.4

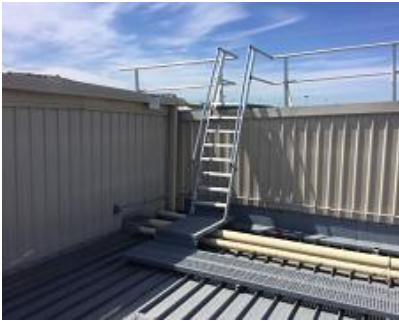
Variation in height between walkway panels are greater than required maximum	Trips, Slips and Falls	Awareness induction	Med	High visibility safety yellow nosing's to be installed	Low	Client advised	Outstanding	OH&S REGULATIONS 3.7 AS/NZS 1657-2013 3.3.4

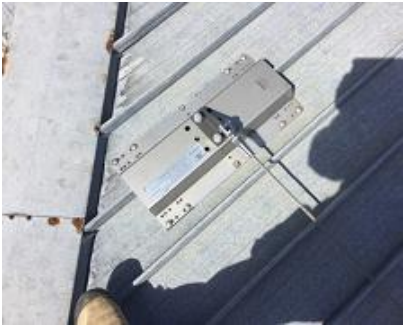
Non-complaint static line is present (Not enough fixings installed)	Trips, Slips and Falls	Awareness induction	High	Existing static line to be removed. New static line to be installed	Low	Client advised	Outstanding	OH&S REGULATIONS 3.55
28	Building: General Stores Location Reference: L1 Task: Access to the A/c units

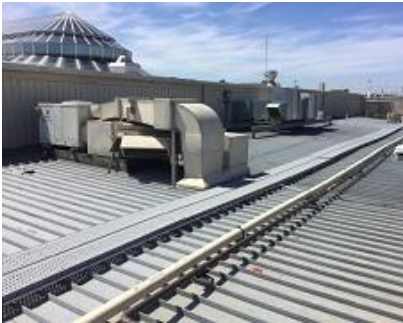
No safe access to the A/c units	Trips, Slips and Falls	N/A	Low	Supply walkway and step over to the A/c units	Low	Client advised	Outstanding	-

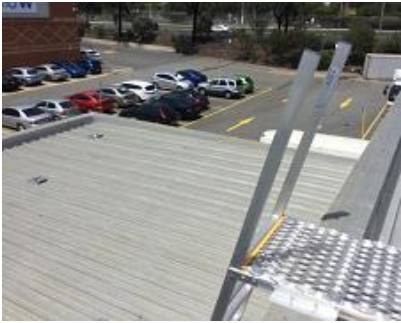
No	Photo of Hazard	Details of Hazard	Details of Risk	Existing/ Immediate Control Measure	Curre nt Risk Level	Proposed Permanent Solution	Resid ual Risk Asse sme nt	Details of Action Taken	Status	Reference
29	Building: General Stores Location Reference: L12 Task: Access to the roof

No height safety system installed	Trips, Slips and Falls	Awareness induction	High	Fall arrest anchor to be installed	Low	Client advised	Outstanding	OH&S REGULATIONS 3.55
30	Building: General Stores Location Reference: L12 Task: Access to the roof

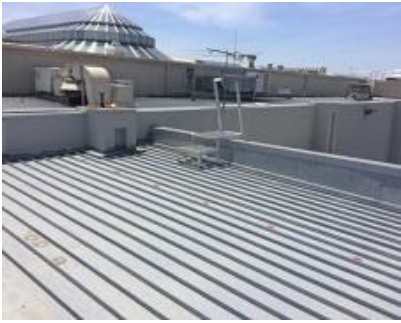
Variation in height between landing and roof is greater than required maximum	Trips, Slips and Falls	Awareness induction	Med	Handrails to be installed	Low	Client advised	Outstanding	OH&S REGULATIONS 3.7 AS/NZS 1657-2013 4.4

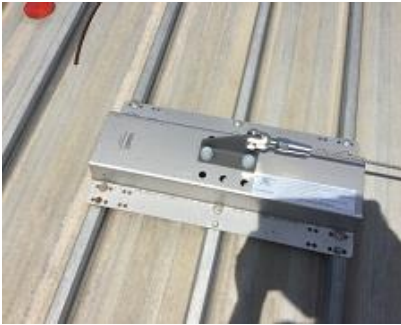
Non-complaint static line is present (Not enough fixings installed)	Trips, Slips and Falls	Awareness induction	High	Existing static line to be removed. New static line to be installed	Low	Client advised	Outstanding	OH&S REGULATIONS 3.55
32	Building: General Stores Location Reference: L13 Task: Access to the A/c units

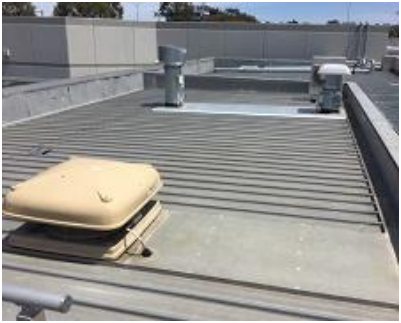
No safe access to the A/c units	Trips, Slips and Falls	N/A	Low	Supply walkway to the A/c units	Low	Client advised	Outstanding	-

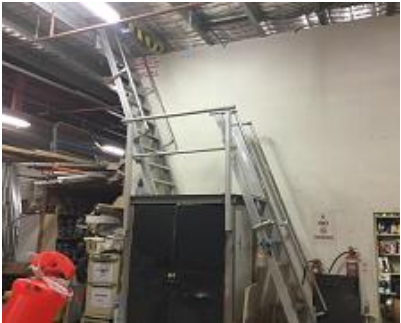
No	Photo of Hazard	Details of Hazard	Details of Risk	Existing/ Immediate Control Measure	Curre nt Risk Level	Proposed Permanent Solution	Resid ual Risk Asse sme nt	Details of Action Taken	Status	Reference
33	Building: General Stores Location Reference: L14 Task: Access to the roof

Top tread not levelled with landing and headroom is less than required minimum	Trips, Slips and Falls	Awareness induction	Med	Existing ladder to be removed. New ladder including low headroom signs to be installed	Low	Client advised	Outstanding	OH&S REGULATIONS 3.7 AS/NZS 1657-2013 7.4.3.3 & 7.3.6
34	Building: General Stores Location Reference: L15 Task: Access to the roof

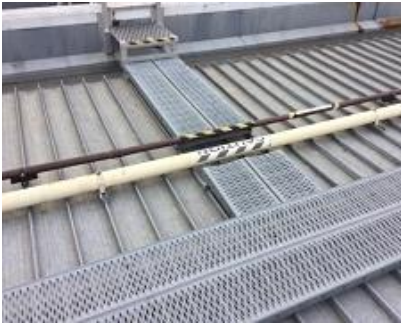
Pipes installed over the walkway path	Trips, Slips and Falls	Awareness induction	Med	Step bridge to be installed	Low	Client advised	Outstanding	OH&S REGULATIONS 3.7 AS/NZS 1657-2013 3.1.4

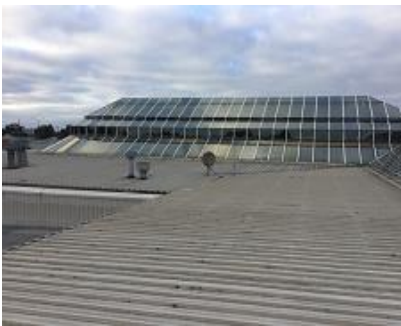
Brittle roof (Non-trafficable roof)	Trips, Slips and Falls	Restrict Access	High	"Warning-Keep Off-Brittle and Fragile Roof" signs to be installed	Low	Client advised	Outstanding	OH&S REGULATIONS 3.57
36	Building: General Stores Location Reference: L16 Task: Access to the roof

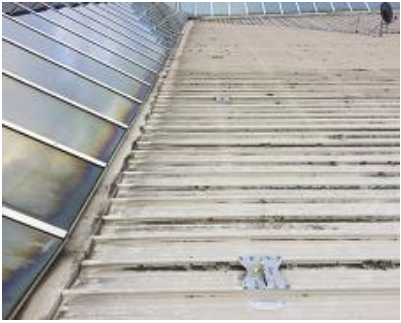
Existing non-complaint anchors are present	Trips, Slips and Falls	Awareness induction	High	Existing anchors to be removed and new anchors to be installed	Low	Client advised	Outstanding	OH&S REGULATIONS 3.55

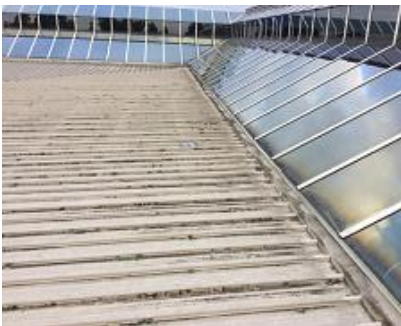
Existing non-complaint anchors are present	Trips, Slips and Falls	Awareness induction	High	Existing anchors to be removed and new anchors to be installed	Low	Client advised	Outstanding	OH&S REGULATIONS 3.55
38	Building: General Stores Location Reference: L16 Task: Access to the A/c units

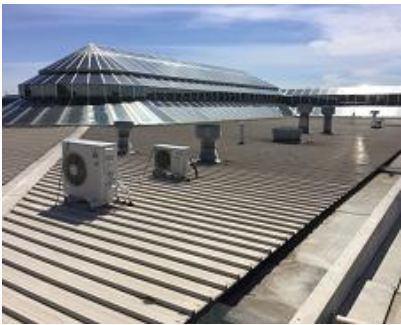
No safe access to the A/c units	Trips, Slips and Falls	N/A	Low	Supply walkway and ladder to the A/c units	Low	Client advised	Outstanding	-

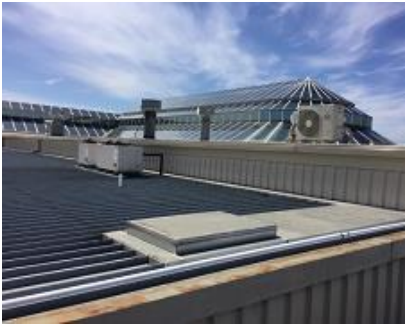
No safe access to the A/c units	Trips, Slips and Falls	N/A	Low	Supply walkway and handrail to the A/c units	Low	Client advised	Outstanding	-
40	Building: General Stores Location Reference: L17 Task: Restrict access to the roof

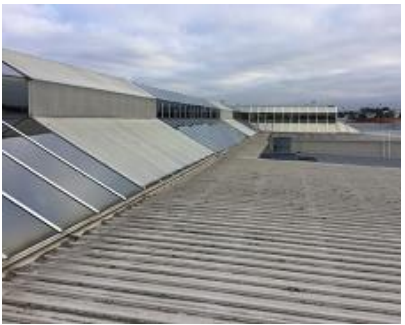
Brittle roof (Non-trafficable roof)	Trips, Slips and Falls	Restrict Access	High	“Warning-Keep Off-Brittle and Fragile Roof” signs to be installed	Low	Client advised	Outstanding	OH&S REGULATIONS 3.57

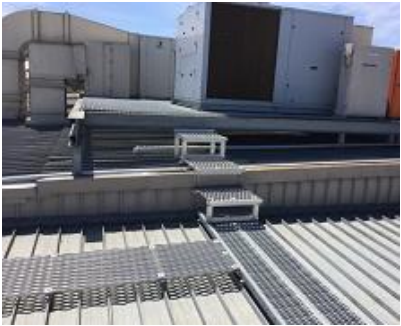
Non-complaint step is present	Trips, Slips and Falls	Awareness induction	Med	Existing step to be removed and new ladder to be installed	Low	Client advised	Outstanding	OH&S REGULATIONS 3.7 AS/NZS 1657-2013 3.1.4
42	Building: General Stores Location Reference: L18 Task: Access to the plant deck

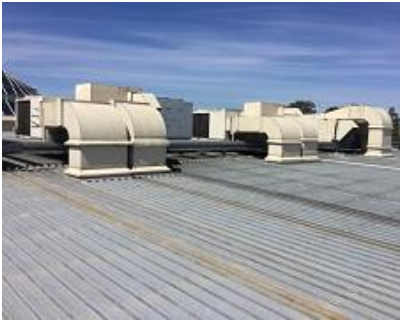
Variation in height between plant deck and roof is greater than required maximum	Trips, Slips and Falls	Awareness induction	Med	Guardrails to be installed	Low	Client advised	Outstanding	OH&S REGULATIONS 3.7 AS/NZS 1657-2013 4.4

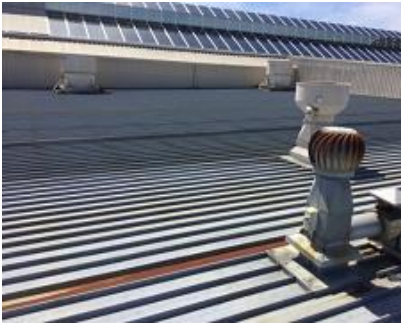
No safe access to the A/c units	Trips, Slips and Falls	N/A	Low	Supply walkway to the A/c units	Low	Client advised	Outstanding	-
44	Building: General Stores Location Reference: L19 Task: Access to the roof

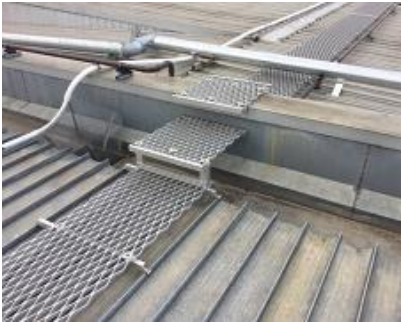
Variation in height between step and adjacent surface is greater than required maximum	Trips, Slips and Falls	Awareness induction	Med	Handrails to be installed	Low	Client advised	Outstanding	OH&S REGULATIONS 3.7 AS/NZS 1657-2013 4.4

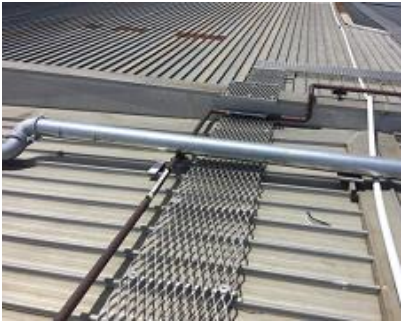
Pipes installed over the walkway path	Trips, Slips and Falls	Awareness induction	Med	Step bridge to be installed	Low	Client advised	Outstanding	OH&S REGULATIONS 3.7 AS/NZS 1657-2013 3.1.4
46	Building: General Stores Location Reference: L20 Task: Access to the roof

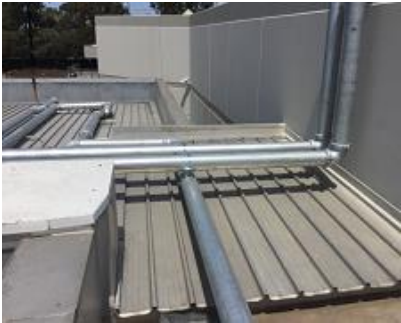
No height safety system installed	Trips, Slips and Falls	Awareness induction	High	Fall arrest anchor to be installed	Low	Client advised	Outstanding	OH&S REGULATIONS 3.55

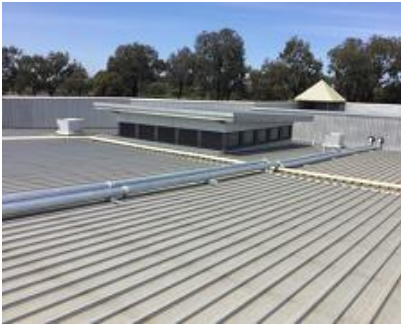
No safe access to the A/c units	Trips, Slips and Falls	N/A	Low	Supply walkway and step over to the A/c units	Low	Client advised	Outstanding	-
48	Building: General Stores Location Reference: L22 Task: Access to the roof

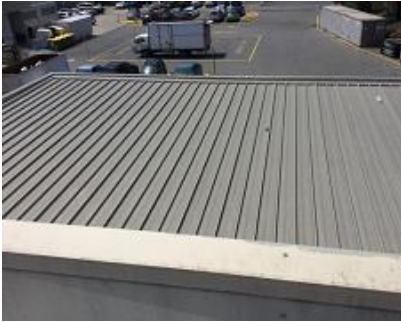
No height safety system installed	Trips, Slips and Falls	Awareness induction	High	Fall arrest anchors and access ladder to be installed	Low	Client advised	Outstanding	OH&S REGULATIONS 3.7 & 3.55 AS/NZS 1657-2013 3.1.4

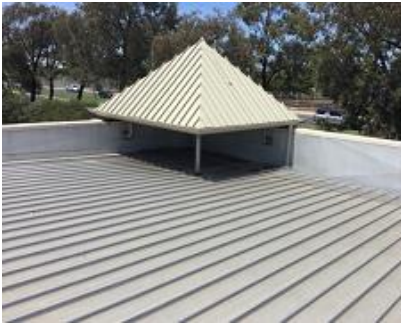
No height safety system installed	Trips, Slips and Falls	Restrict Access	High	"No Access" sign to be installed	Low	Client advised	Outstanding	OH&S REGULATIONS 3.55 & 3.11
50	Building: General Stores Location Reference: L22 Task: Access to the roof

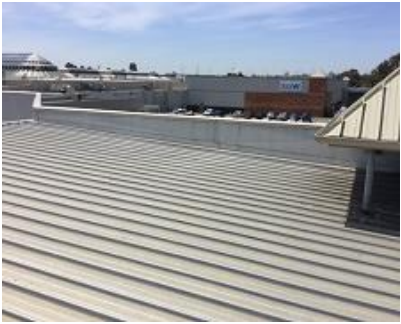
No height safety system installed	Trips, Slips and Falls	Awareness induction	High	Fall arrest anchors to be installed	Low	Client advised	Outstanding	OH&S REGULATIONS 3.55

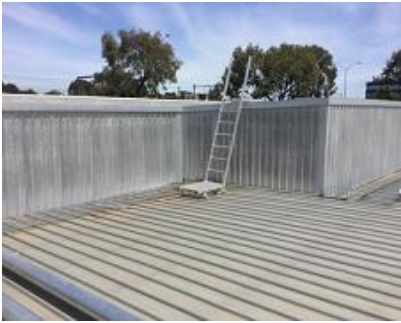
No safe access to the ladder	Trips, Slips and Falls	N/A	Low	Supply walkway to the ladder	Low	Client advised	Outstanding	-
52	Building: General Stores Location Reference: L23 Task: Access to the A/c units

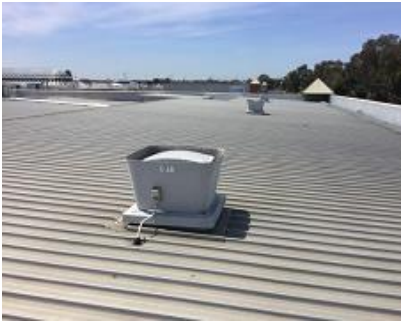
No safe access to the A/c units	Trips, Slips and Falls	N/A	Low	Supply walkway and handrail to the A/c units	Low	Client advised	Outstanding	-

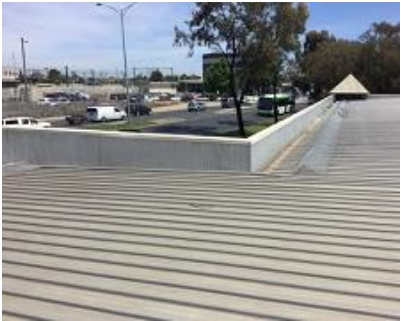
No height safety system installed	Trips, Slips and Falls	Awareness induction	High	Fall arrest anchors to be installed	Low	Client advised	Outstanding	OH&S REGULATIONS 3.55
54	Building: General Stores Location Reference: L24 Task: Restrict access to the roof

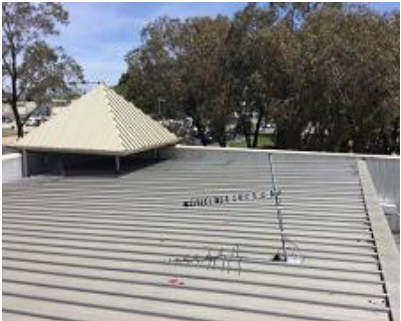
No height safety system installed	Trips, Slips and Falls	Restrict Access	High	"No Access" sign to be installed	Low	Client advised	Outstanding	OH&S REGULATIONS 3.55 & 3.11

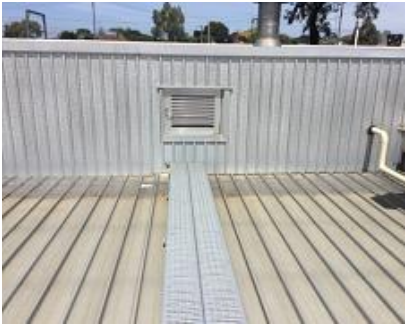
Headroom is less than required minimum	Trips, Slips and Falls	Awareness induction	High	"Caution-Low Head Room" signs to be installed	Low	Client advised	Outstanding	OH&S REGULATIONS 3.7 AS/NZS 1657-2013 3.1.5
56	Building: General Stores Location Reference: L25 Task: Access to the A/c units

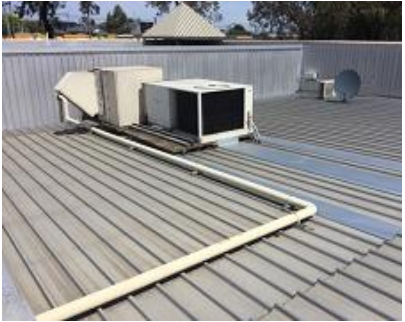
No safe access to the A/c units	Trips, Slips and Falls	N/A	Low	Supply walkway and step over to the A/c units	Low	Client advised	Outstanding	-

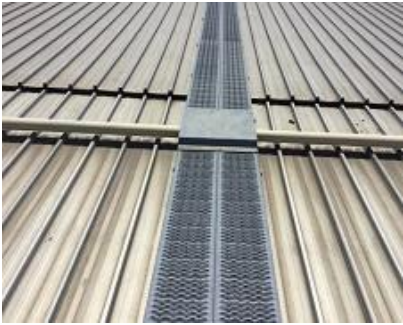
Pipes installed over the walkway path	Trips, Slips and Falls	Awareness induction	Med	Step bridge to be installed	Low	Client advised	Outstanding	OH&S REGULATIONS 3.7 AS/NZS 1657-2013 3.1.4
58	Building: General Stores Location Reference: L25 Task: Access to the A/c units

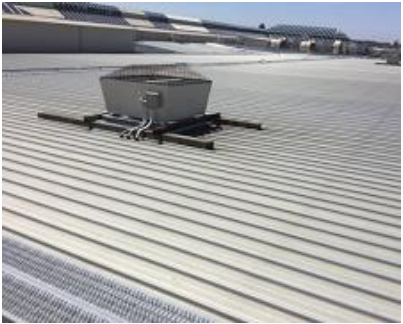
No safe access to the A/c units	Trips, Slips and Falls	N/A	Low	Supply walkway to the A/c units	Low	Client advised	Outstanding	-

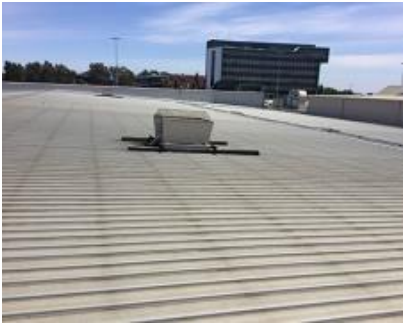
No safe access to the A/c units	Trips, Slips and Falls	N/A	Low	Supply walkway to the A/c units	Low	Client advised	Outstanding	-
60	Building: General Stores Location Reference: L25 Task: Access to the roof

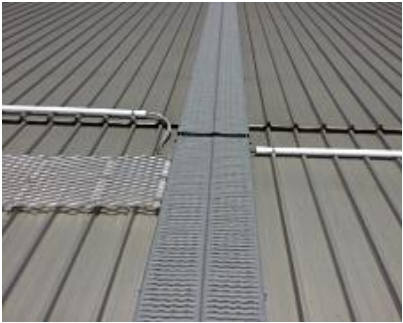
Variation in height between walkway panels are greater than required maximum	Trips, Slips and Falls	Awareness induction	Med	High visibility safety yellow nosing's to be installed	Low	Client advised	Outstanding	OH&S REGULATIONS 3.7 AS/NZS 1657-2013 3.3.4

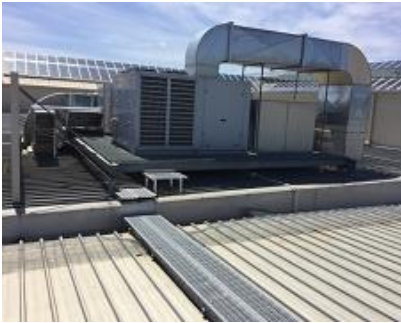
Non-complaint step is present	Trips, Slips and Falls	Awareness induction	Med	Existing step to be removed and new ladder to be installed	Low	Client advised	Outsta nding	OH&S REGULATIONS 3.7 AS/NZS 1657- 2013 3.1.4
62	Building: General Stores Location Reference: L26 Task: Access to the plant deck

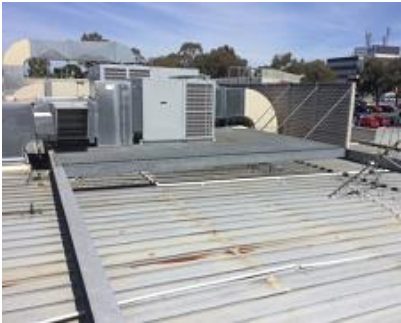
Variation in height between plant deck and roof is greater than required maximum	Trips, Slips and Falls	Awareness induction	Med	Handrails to be installed	Low	Client advised	Outsta nding	OH&S REGULATIONS 3.7 AS/NZS 1657- 2013 4.4

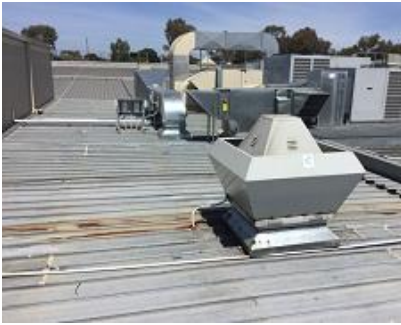
No safe access to the A/c units	Trips, Slips and Falls	N/A	Low	Supply walkway and access ladder to the A/c units	Low	Client advised	Outstanding	-
64	Building: General Stores Location Reference: L27 Task: Access to the roof

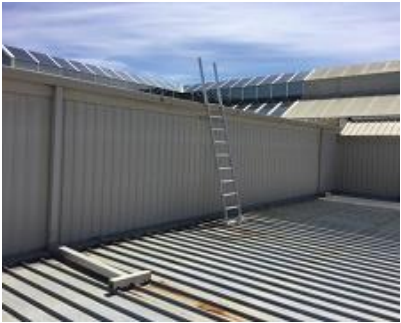
Gap between ladder and permanent structure is less than required minimum, top rung not levelled with landing and no landing platforms	Trips, Slips and Falls	Awareness induction	Med	Existing ladder to be re-installed with landing platforms, brackets and handrails	Low	Client advised	Outstanding	OH&S REGULATIONS 3.7 AS/NZS 1657-2013 7.4.5, 7.4.3.3 & 7.3.6

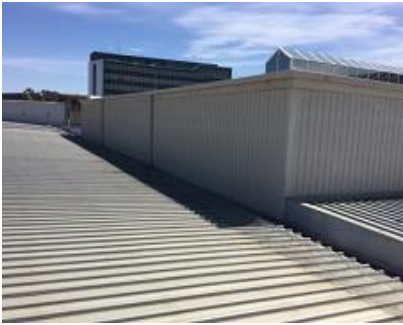
No height safety system installed	Trips, Slips and Falls	Awareness induction	High	Fall arrest anchors to be installed	Low	Client advised	Outstanding	OH&S REGULATIONS 3.55
66	Building: General Stores Location Reference: L28 Task: Access to the A/c units

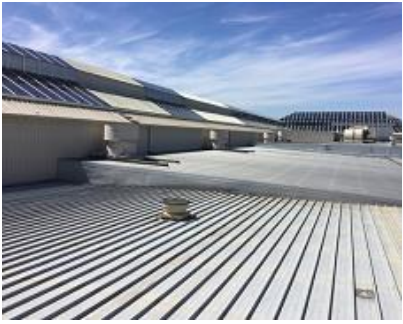
No safe access to the A/c units	Trips, Slips and Falls	N/A	Low	Supply walkway and handrail to the A/c units	Low	Client advised	Outstanding	-

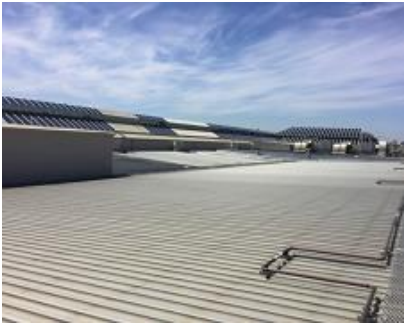
Brittle roof (Non-trafficable roof)	Trips, Slips and Falls	Restrict Access	High	"Warning-Keep Off-Brittle and Fragile Roof" signs to be installed	Low	Client advised	Outstanding	OH&S REGULATIONS 3.57
68	Building: General Stores Location Reference: L29 Task: Restrict access to the roof

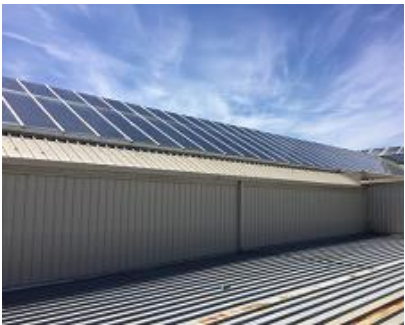
Brittle roof (Non-trafficable roof)	Trips, Slips and Falls	Restrict Access	High	"Warning-Keep Off-Brittle and Fragile Roof" signs to be installed	Low	Client advised	Outstanding	OH&S REGULATIONS 3.57

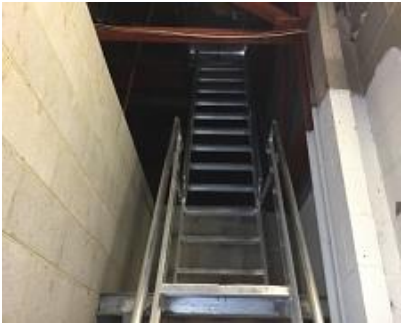
Headroom is less than required minimum and top tread not levelled with landing	Trips, Slips and Falls	Awareness induction	Med	Existing top section ladder to be removed. New ladder including "Low-Headroom" signs to be installed	Low	Client advised	Outstanding	OH&S REGULATIONS 3.7 AS/NZS 1657-2013 7.3.6 & 7.4.3.3
70	Building: General Stores Location Reference: L30 Task: Access to the A/c units

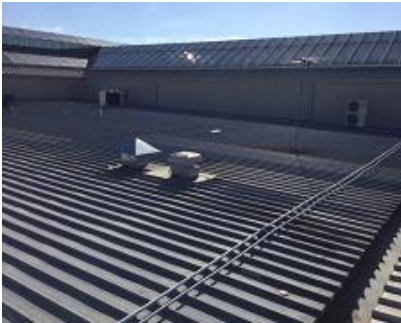
No safe access to the A/c units	Trips, Slips and Falls	N/A	Low	Supply walkway to the A/c units	Low	Client advised	Outstanding	-

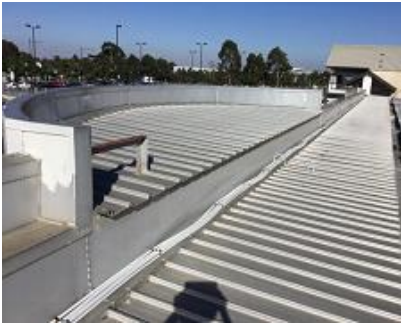
No height safety system installed	Trips, Slips and Falls	Awareness induction	High	Fall arrest anchors and access ladder to be installed	Low	Client advised	Outstanding	OH&S REGULATIONS 3.55
72	Building: General Stores Location Reference: L31 Task: Access to the A/c units

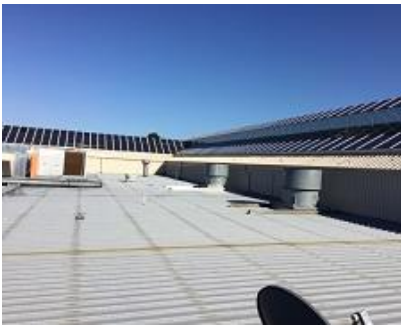
No safe access to the A/c units	Trips, Slips and Falls	N/A	Low	Supply walkway to the A/c units	Low	Client advised	Outstanding	-

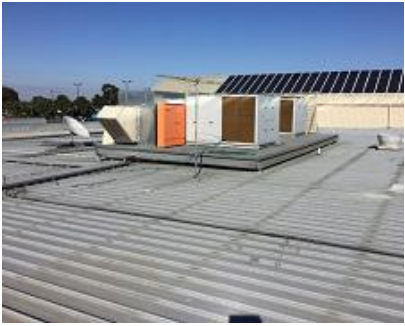
Variation in height between plant deck and roof is greater than required maximum	Trips, Slips and Falls	Awareness induction	Med	Handrails to be installed	Low	Client advised	Outstanding	OH&S REGULATIONS 3.7 AS/NZS 1657-2013 4.4
74	Building: General Stores Location Reference: L32 Task: Access to the roof

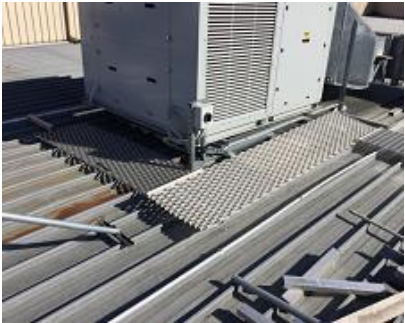
Roof walkway not fully secured	Trips, Slips and Falls	Awareness induction	Med	Existing walkway to be re-installed with additional channels	Low	Client advised	Outstanding	OH&S REGULATIONS 3.7

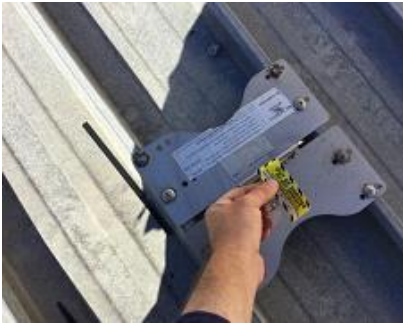
Non-complaint anchor is present	Trips, Slips and Falls	Awareness induction	High	Existing anchor to be removed and new anchor to be installed	Low	Client advised	Outstanding	OH&S REGULATIONS 3.55
76	Building: General Stores Location Reference: L32 Task: Access to the roof

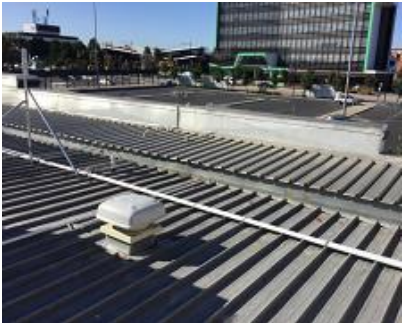
No height safety system installed	Trips, Slips and Falls	Awareness induction	High	Fall arrest anchors to be installed	Low	Client advised	Outstanding	OH&S REGULATIONS 3.55

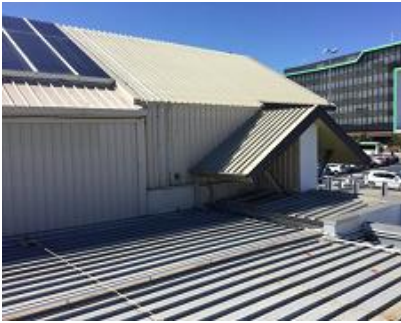
No height safety system installed	Trips, Slips and Falls	Restrict Access	High	"No Access" sign to be installed	Low	Client advised	Outstanding	OH&S REGULATIONS 3.55 & 3.11
78	Building: General Stores Location Reference: L34 Task: Access to the ladder

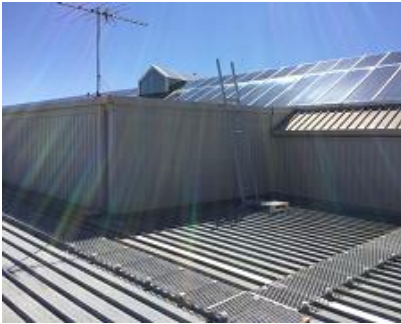
No safe access to the ladder	Trips, Slips and Falls	N/A	Low	Supply walkway to the ladder	Low	Client advised	Outstanding	-

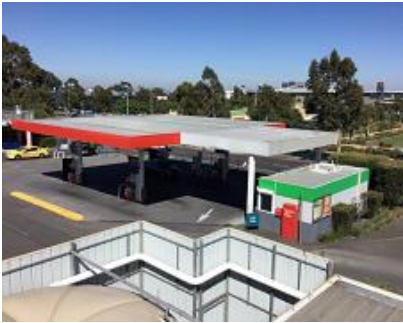
No height safety system installed	Trips, Slips and Falls	Awareness induction	High	Fall arrest anchors, anchor strops, ladder access bracket, sign and access ladder to be installed	Low	Client advised	Outstanding	OH&S REGULATIONS 3.7 & 3.55 AS/NZS 1657-2013 3.1.4
80	Building: General Stores Location Reference: L36 Task: Access to the ladder

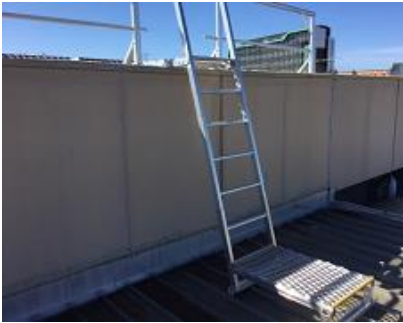
No safe access to the ladder	Trips, Slips and Falls	N/A	Low	Supply walkway to the ladder	Low	Client advised	Outstanding	-

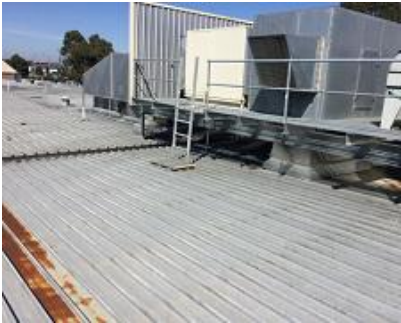
Landing is less than required minimum and gap between ladder and existing handrail is greater than required maximum	Trips, Slips and Falls	Awareness induction	Med	Existing ladder to be removed and new ladder to be installed	Low	Client advised	Outstanding	OH&S REGULATIONS 3.7 AS/NZS 1657-2013 7.3.6 & 4.4
82	Building: General Stores Location Reference: L37 Task: Access to the plant deck

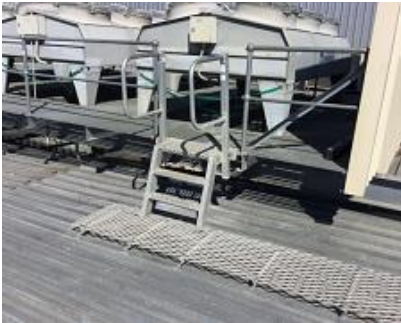
Non-complaint ladder is present	Trips, Slips and Falls	Awareness induction	Med	Existing ladder to be removed and new ladder to be installed	Low	Client advised	Outstanding	OH&S REGULATIONS 3.7 AS/NZS 1657-2013 7.3

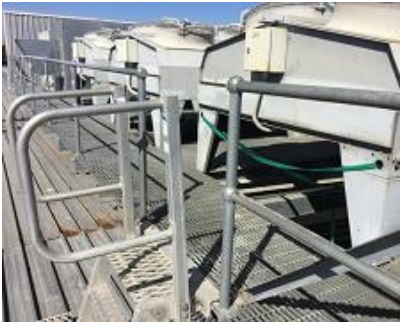
Variation in height between plant deck and unit is greater than required maximum	Trips, Slips and Falls	Awareness induction	Med	Mid rail to be installed	Low	Client advised	Outstanding	OH&S REGULATIONS 3.7 AS/NZS 1657-2013 4.4
84	Building: General Stores Location Reference: L39 Task: Access to the roof

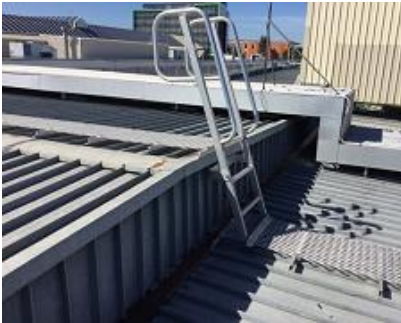
Top rung not levelled with landing, gap between ladder and permanent structure is less than required minimum and handrails projecting towards the user	Trips, Slips and Falls	Awareness induction	Med	Existing ladder to be removed and new ladder to be installed	Low	Client advised	Outstanding	OH&S REGULATIONS 3.7 AS/NZS 1657-2013 7.4.3.3, 7.4.5 & 7.4.8.5

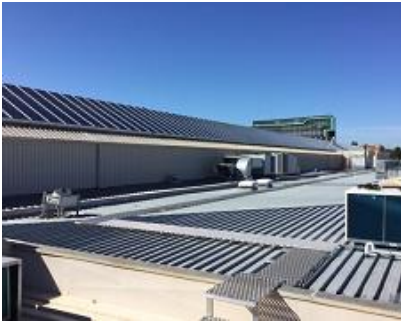
Brittle roof (Non-trafficable roof)	Trips, Slips and Falls	Restrict Access	High	"Warning-Keep Off-Brittle and Fragile Roof" signs to be installed	Low	Client advised	Outstanding	OH&S REGULATIONS 3.57
86	Building: General Stores Location Reference: L41 Task: Access to the roof

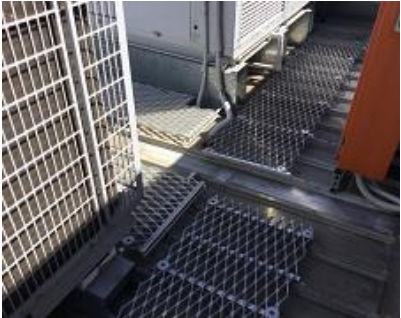
Gap between walkway panels are greater than required maximum	Trips, Slips and Falls	Awareness induction	Med	Additional walkway sections to be installed	Low	Client advised	Outstanding	OH&S REGULATIONS 3.7 AS/NZS 1657-2013 3.3.4

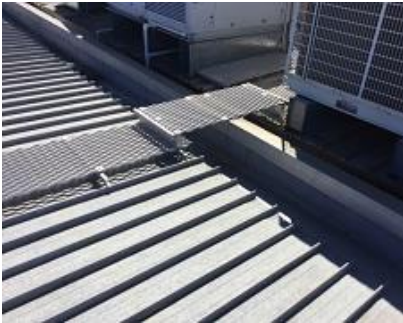
Variation in height between landing and adjacent surface is greater than required maximum	Trips, Slips and Falls	Awareness induction	Med	Handrails to be installed	Low	Client advised	Outstanding	OH&S REGULATIONS 3.7 AS/NZS 1657-2013 4.4
88	Building: General Stores Location Reference: L42 Task: Access to the A/c units

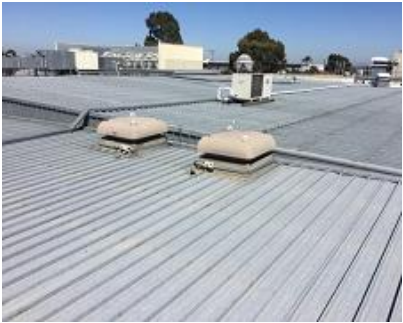
No safe access to the A/c units	Trips, Slips and Falls	N/A	Low	Supply walkway to the A/c units	Low	Client advised	Outstanding	-

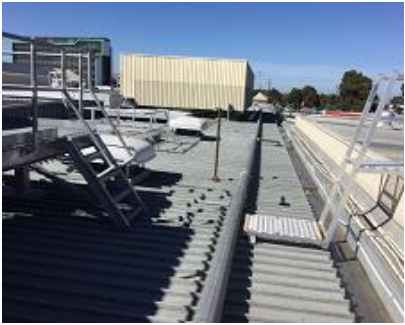
Pipe installed between ladder and stair case	Trips, Slips and Falls	Awareness induction	Med	Step over and walkway to be installed	Low	Client advised	Outstanding	OH&S REGULATIONS 3.7 AS/NZS 1657-2013 3.1.4
90	Building: General Stores Location Reference: L43 Task: Access to the A/c units

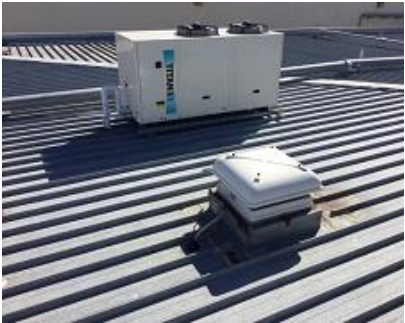
No safe access to the A/c units	Trips, Slips and Falls	N/A	Low	Supply walkway to the A/c units	Low	Client advised	Outstanding	-

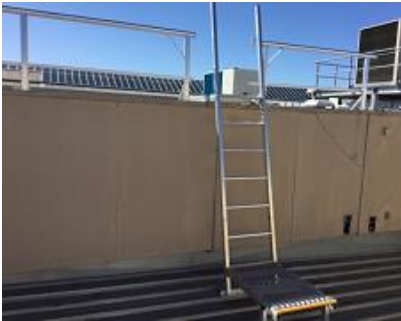
Gap between ladder and handrails is greater than required maximum	Trips, Slips and Falls	Awareness induction	Med	Handrail to existing ladder to be installed	Low	Client advised	Outstanding	OH&S REGULATIONS 3.7 AS/NZS 1657-2013 4.4
92	Building: General Stores Location Reference: L46 Task: Access to the roof

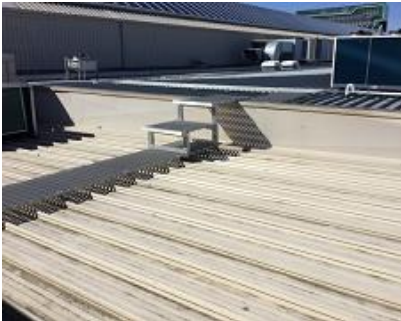
Handrail is missing for steps	Trips, Slips and Falls	Awareness induction	Med	Handrail to be installed	Low	Client advised	Outstanding	OH&S REGULATIONS 3.7 AS/NZS 1657-2013 7.2.6

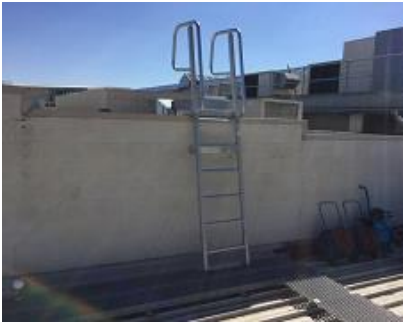
Top rung not levelled with landing, bottom rung heights are less than required minimum and handrails projecting towards the user	Trips, Slips and Falls	Awareness induction	Med	Existing ladder to be removed and new ladder to be installed	Low	Client advised	Outstanding	OH&S REGULATIONS 3.7 AS/NZS 1657-2013 7.4.3.3, 7.4.3.4 & 7.4.8.5
94	Building: General Stores Location Reference: L47 Task: Access to the roof

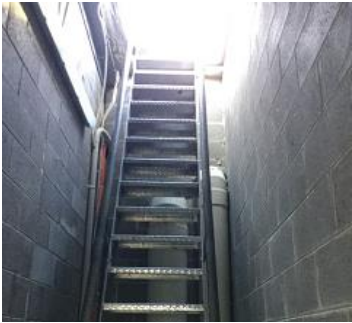
Top tread not levelled with landing and headroom is less than required minimum	Trips, Slips and Falls	Awareness induction	Med	Existing ladder to be removed and new ladder to be installed	Low	Client advised	Outstanding	OH&S REGULATIONS 3.7 AS/NZS 1657-2013 7.4.3.3 & 3.1.5

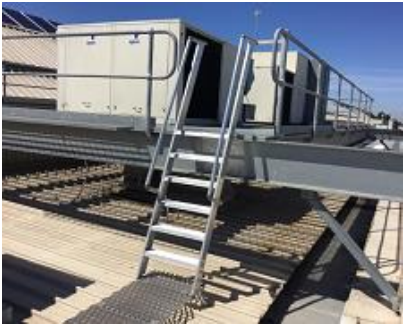
Gap between handrail and ladder is greater than required maximum	Trips, Slips and Falls	Awareness induction	Med	Handrails to be installed	Low	Client advised	Outstanding	OH&S REGULATIONS 3.7 AS/NZS 1657-2013 4.4
96	Building: General Stores Location Reference: L48 Task: Access to the A/c units

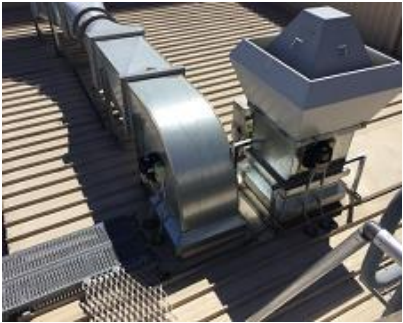
No safe access to the A/c units	Trips, Slips and Falls	N/A	Low	Supply walkway to the A/c units	Low	Client advised	Outstanding	-

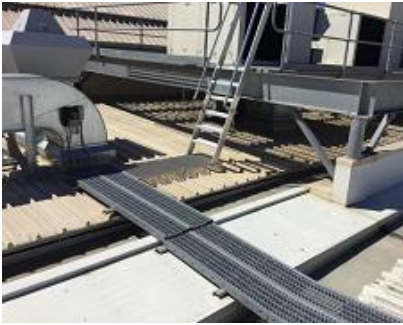
Variation in height between walkway and adjacent surface is greater than required maximum	Trips, Slips and Falls	Awareness induction	Med	Handrail to be installed	Low	Client advised	Outstanding	OH&S REGULATIONS 3.7 AS/NZS 1657-2013 4.4
98	Building: General Stores Location Reference: L48 Task: Access to the roof

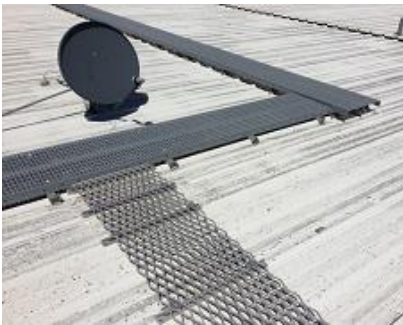
Variation in height between walkway panels are greater than required maximum	Trips, Slips and Falls	Awareness induction	Med	High visibility safety yellow nosing's to be installed	Low	Client advised	Outstanding	OH&S REGULATIONS 3.7 AS/NZS 1657-2013 3.3.4

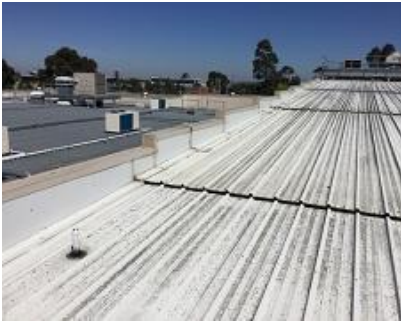
No height safety system installed	Trips, Slips and Falls	Awareness induction	High	Fall arrest anchors to be installed	Low	Client advised	Outstanding	OH&S REGULATIONS 3.55
100	Building: General Stores Location Reference: L49 Task: Access to the A/c units

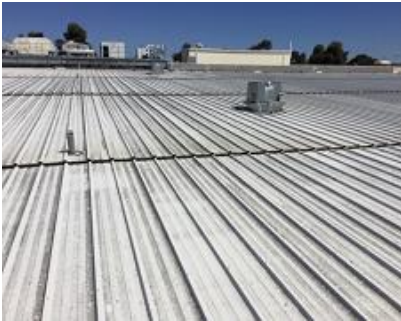
No safe access to the A/c units	Trips, Slips and Falls	N/A	Low	Supply walkway to the A/c units	Low	Client advised	Outstanding	-

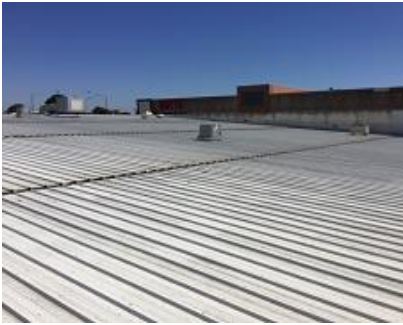
No safe access to the A/c units	Trips, Slips and Falls	N/A	Low	Supply walkway to the A/c units	Low	Client advised	Outstanding	-
102	Building: General Stores Location Reference: L51 Task: Access to the A/c units

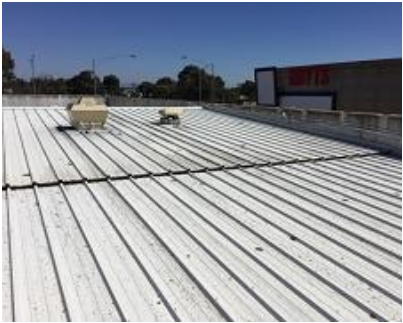
No safe access to the A/c units	Trips, Slips and Falls	N/A	Low	Supply walkway to the A/c units	Low	Client advised	Outstanding	-

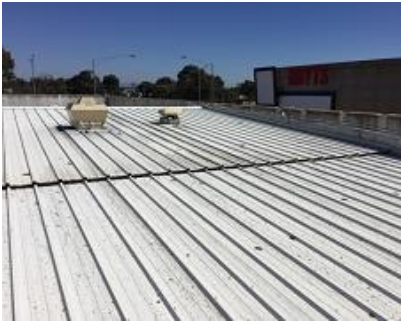
No height safety system installed	Trips, Slips and Falls	Awareness induction	High	Fall arrest anchors to be installed	Low	Client advised	Outstanding	OH&S REGULATIONS 3.55
104	Building: General Stores Location Reference: L52 Task: Access to the roof

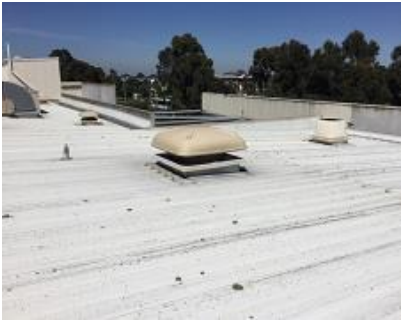
No height safety system installed	Trips, Slips and Falls	Awareness induction	High	Fall arrest anchors to be installed	Low	Client advised	Outstanding	OH&S REGULATIONS 3.55

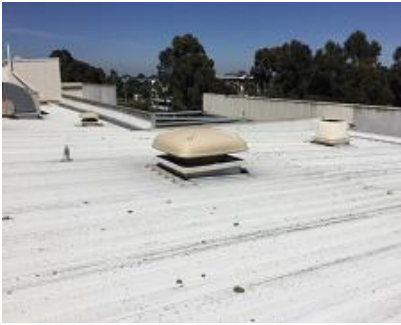
No safe access to the A/c units	Trips, Slips and Falls	N/A	Low	Supply walkway to the A/c units	Low	Client advised	Outstanding	-
106	Building: General Stores Location Reference: L53 Task: Access to the roof

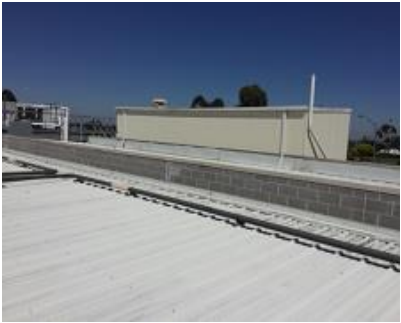
No height safety system installed	Trips, Slips and Falls	Awareness induction	High	Fall arrest anchors, anchor stop and access ladder to be installed	Low	Client advised	Outstanding	OH&S REGULATIONS 3.7 & 3.55 AS/NZS 1657-2013 3.1.4

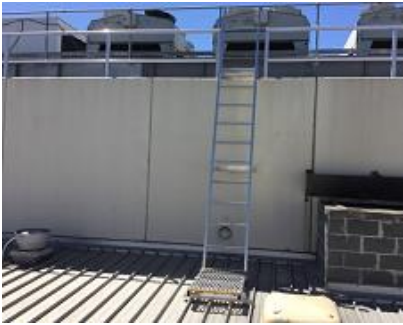
Handrail is missing for landing	Trips, Slips and Falls	Awareness induction	Med	Handrail to be installed	Low	Client advised	Outstanding	OH&S REGULATIONS 3.7 AS/NZS 1657-2013 4.4
108	Building: General Stores Location Reference: L56 Task: Access to the roof

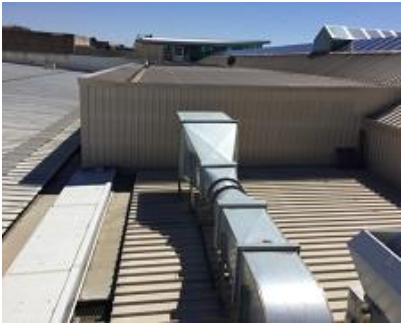
Variation in height between roofs are greater than required maximum	Trips, Slips and Falls	Awareness induction	Med	Access ladder and anchor strop to be installed	Low	Client advised	Outstanding	OH&S REGULATIONS 3.7 AS/NZS 1657-2013 3.1.4

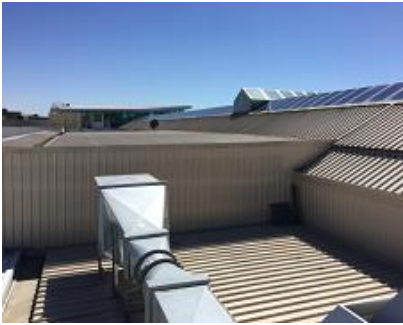
Brittle roof (Non-trafficable roof)	Trips, Slips and Falls	Restrict Access	High	"Warning-Keep Off-Brittle and Fragile Roof" signs to be installed	Low	Client advised	Outstanding	OH&S REGULATIONS 3.57
110	Building: General Stores Location Reference: L57 Task: Access to the roof

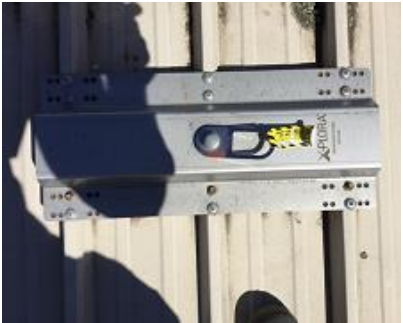
Non-complaint anchor is present	Trips, Slips and Falls	Awareness induction	High	Existing anchor to be removed and new anchor to be installed	Low	Client advised	Outstanding	OH&S REGULATIONS 3.55

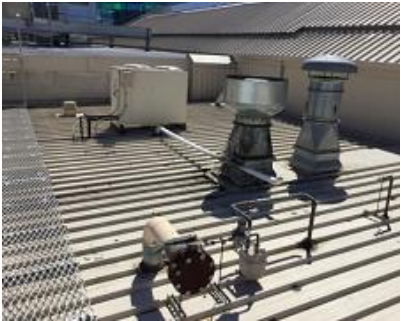
No safe access to the A/c units	Trips, Slips and Falls	N/A	Low	Supply walkway to the A/c units	Low	Client advised	Outstanding	-
112	Building: General Stores Location Reference: L57 Task: Access to the roof

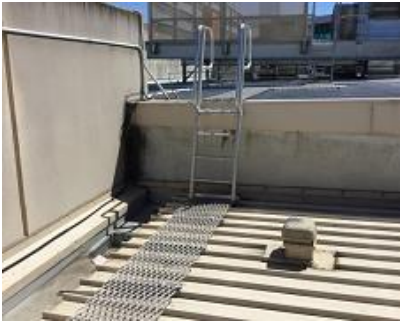
Top rung not levelled with landing, bottom rung height is less than required minimum and handrails projecting towards the user	Trips, Slips and Falls	Awareness induction	Med	Existing ladder to be removed and new ladder to be installed	Low	Client advised	Outstanding	OH&S REGULATIONS 3.7 AS/NZS 1657-2013 7.4.3.3, 7.4.3.4 & 7.4.8.5

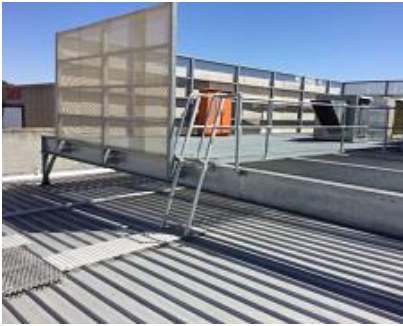
Top rung not levelled with landing, bottom rung height is less than required minimum and handrails projecting towards the user	Trips, Slips and Falls	Awareness induction	Med	Existing ladder to be removed and new ladder to be installed	Low	Client advised	Outstanding	OH&S REGULATIONS 3.7 AS/NZS 1657-2013 7.4.3.3, 7.4.3.4 & 7.4.8.5
114	Building: General Stores Location Reference: L59 Task: Access to the roof

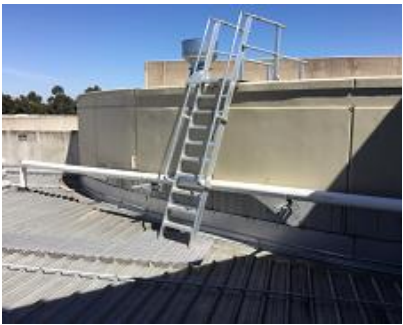
Landing is less than required minimum	Trips, Slips and Falls	Awareness induction	Med	Additional walkway section to be installed	Low	Client advised	Outstanding	OH&S REGULATIONS 3.7 AS/NZS 1657-2013 7.3.6
