Roof Safety Report

**Broadmeadows Central,
VIC 3047**

Prepared By: Safemaster Safety Products
Date: 28 March 2018

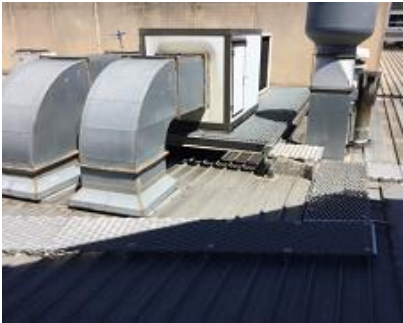
Variation in height between plant deck and roof is greater than required maximum	Trips, Slips and Falls	Awareness induction	Med	Handrails to be installed	Low	Client advised	Outstanding	OH&S REGULATIONS 3.7 AS/NZS 1657-2013 4.4
116	Building: General Stores Location Reference: L60 Task: Access to the A/c units

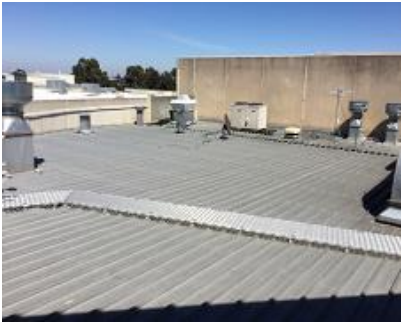
No safe access to the A/c units	Trips, Slips and Falls	N/A	Low	Supply walkway to the A/c units	Low	Client advised	Outstanding	-

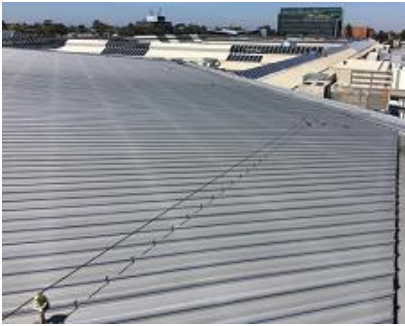
Non-complaint static line is present	Trips, Slips and Falls	Awareness induction	High	Existing static line to be removed and new static line to be installed	Low	Client advised	Outstanding	OH&S REGULATIONS 3.55
118	Building: General Stores Location Reference: L61 Task: Access to the roof

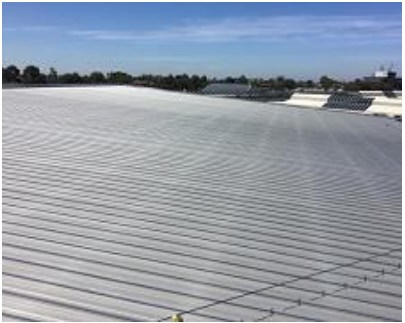
No height safety system installed	Trips, Slips and Falls	Awareness induction	High	Fall arrest anchors to be installed	Low	Client advised	Outstanding	OH&S REGULATIONS 3.55

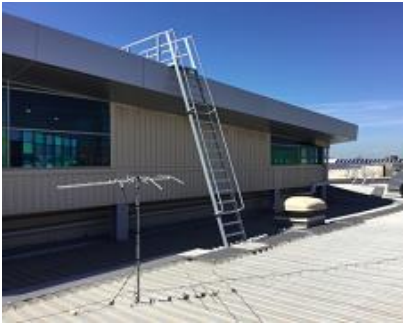
Landing is less than required minimum	Trips, Slips and Falls	Awareness induction	Med	Additional walkway section to be installed	Low	Client advised	Outstanding	OH&S REGULATIONS 3.7 AS/NZS 1657-2013 7.3.6
120	Building: General Stores Location Reference: L63 Task: Access to the plant deck

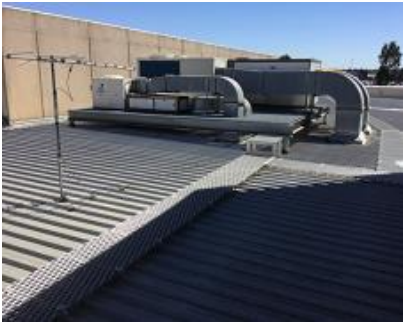
Non-complaint step is present	Trips, Slips and Falls	Awareness induction	Med	Existing step to be removed and new ladder to be installed	Low	Client advised	Outstanding	OH&S REGULATIONS 3.7 AS/NZS 1657-2013 3.1.4

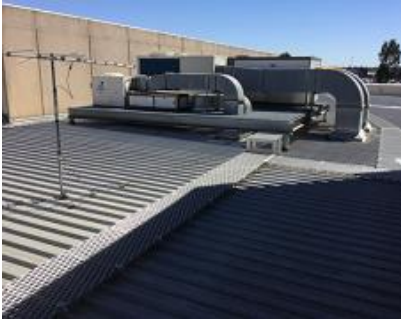
Variation in height between plant deck and roof is greater than required maximum	Trips, Slips and Falls	Awareness induction	Med	Handrails to be installed	Low	Client advised	Outstanding	OH&S REGULATIONS 3.7 AS/NZS 1657-2013 4.4
122	Building: General Stores Location Reference: L63 Task: Access to the A/c units

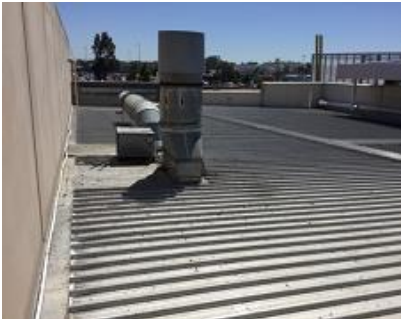
No safe access to the A/c units	Trips, Slips and Falls	N/A	Low	Supply walkway to the A/c units	Low	Client advised	Outstanding	-

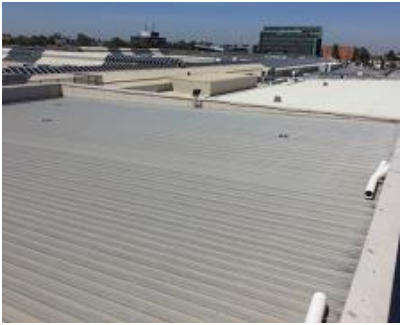
No height safety system installed	Trips, Slips and Falls	Awareness induction	High	Fall arrest anchors to be installed	Low	Client advised	Outstanding	OH&S REGULATIONS 3.55
124	Building: General Stores Location Reference: L65 Task: Access to the A/c units

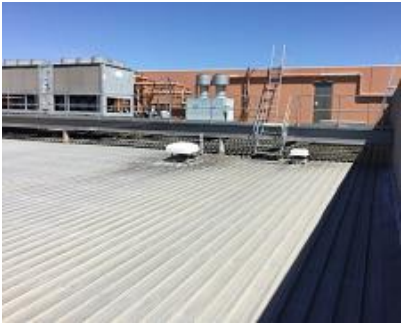
No safe access to the A/c units	Trips, Slips and Falls	N/A	Low	Supply walkway to the A/c units	Low	Client advised	Outstanding	-

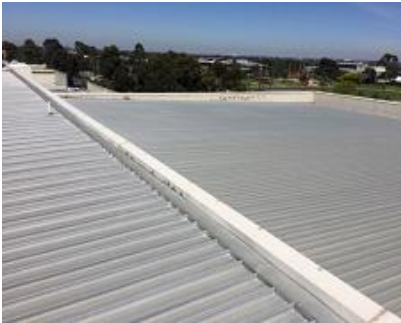
No height safety system installed	Trips, Slips and Falls	Awareness induction	High	Fall arrest anchors to be installed	Low	Client advised	Outstanding	OH&S REGULATIONS 3.55
126	Building: General Stores Location Reference: L67 Task: Access to the roof

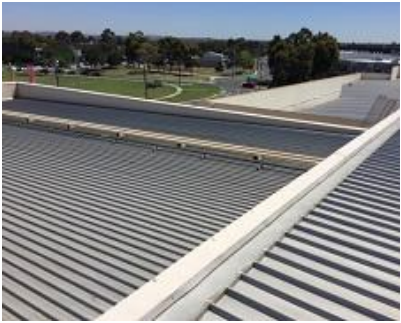
No height safety system installed	Trips, Slips and Falls	Awareness induction	High	Fall arrest anchors to be installed	Low	Client advised	Outstanding	OH&S REGULATIONS 3.55

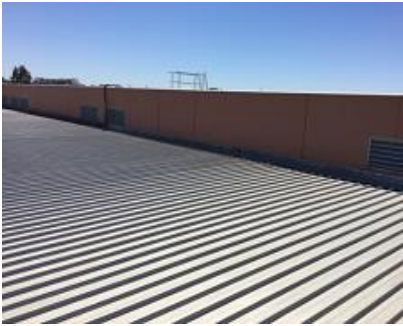
Variation in height between roofs are greater than required maximum	Trips, Slips and Falls	Awareness induction	Med	Access ladder, anchor and anchor stop to be installed	Low	Client advised	Outstanding	OH&S REGULATIONS 3.7 AS/NZS 1657-2013 3.1.4
128	Building: General Stores Location Reference: L69 Task: Access to the roof

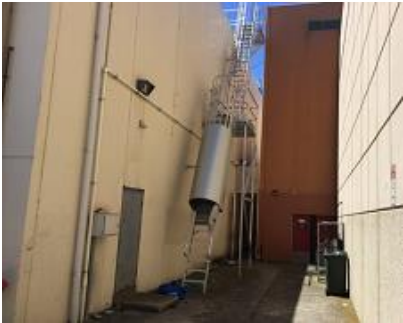
Clearance behind the tread is less than required minimum	Trips, Slips and Falls	Awareness induction	Med	Existing fabricated sheet to be removed and new security sheet to be installed	Low	Client advised	Outstanding	OH&S REGULATIONS 3.7 AS/NZS 1657-2013 7.3.5

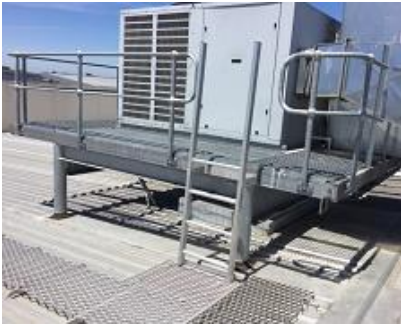
Gap between top rung and landing is greater than required maximum and bottom rung height is less than required minimum	Trips, Slips and Falls	Awareness induction	Med	Existing ladder to be re-installed with landing platforms, brackets and handrails	Low	Client advised	Outstanding	OH&S REGULATIONS 3.7 AS/NZS 1657-2013 7.4.8.4 & 7.4.3.4
130	Building: General Stores Location Reference: L70 Task: Access to the plant deck

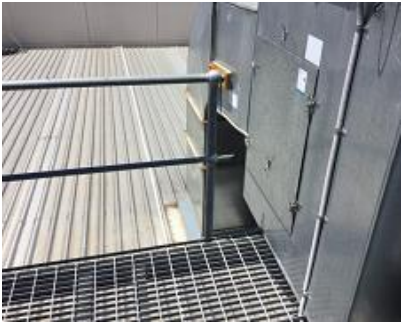
Gap between handrail post and permanent structure is greater than required maximum	Trips, Slips and Falls	Awareness induction	Med	Handrail to be installed	Low	Client advised	Outstanding	OH&S REGULATIONS 3.7 AS/NZS 1657-2013 4.4

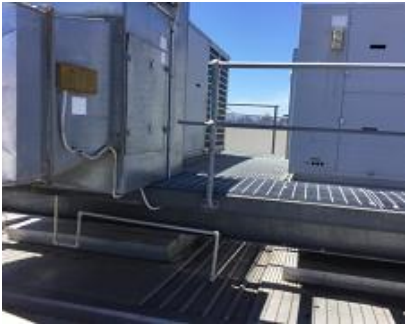
Gap between handrail post and permanent structure is greater than required maximum	Trips, Slips and Falls	Awareness induction	Med	Handrail to be installed	Low	Client advised	Outstanding	OH&S REGULATIONS 3.7 AS/NZS 1657-2013 4.4
132	Building: General Stores Location Reference: L70 Task: Access to the plant deck

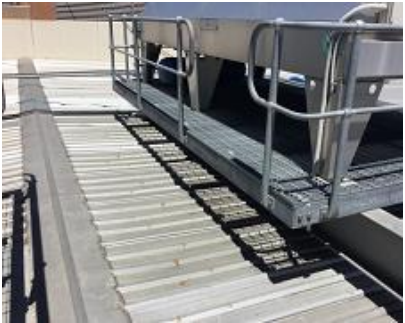
Variation in height between plant deck and roof is greater than required maximum	Trips, Slips and Falls	Awareness induction	Med	Access ladder to be installed	Low	Client advised	Outstanding	OH&S REGULATIONS 3.7 AS/NZS 1657-2013 3.1.4

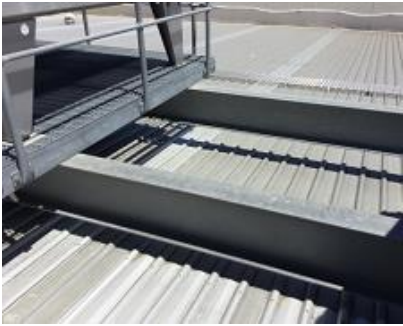
Bracings installed on the way to access plant deck	Trips, Slips and Falls	Awareness induction	Med	Access ladders and walkway to be installed	Low	Client advised	Outstanding	OH&S REGULATIONS 3.7 AS/NZS 1657-2013 3.1.4
134	Building: General Stores Location Reference: L71 Task: Access to the plant deck

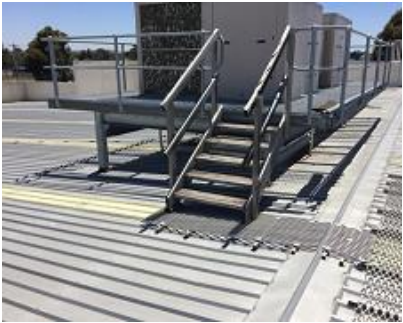
Un-even tread heights are present	Trips, Slips and Falls	Awareness induction	Med	Existing stair to be removed and new ladder to be installed	Low	Client advised	Outstanding	OH&S REGULATIONS 3.7 AS/NZS 1657-2013 7.2

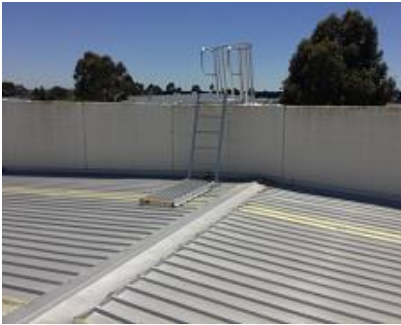
No safe access to the ladder	Trips, Slips and Falls	N/A	Low	Supply walkway to the ladder	Low	Client advised	Outstanding	-
136	Building: General Stores Location Reference: L72 Task: Access to the A/c units

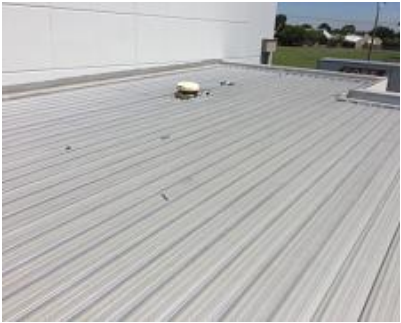
No safe access to the A/c units	Trips, Slips and Falls	N/A	Low	Supply walkway to the A/c units	Low	Client advised	Outstanding	-

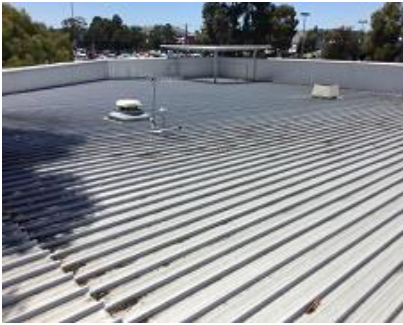
No safe access to the A/c units	Trips, Slips and Falls	N/A	Low	Supply walkway to the A/c units	Low	Client advised	Outstanding	-
138	Building: General Stores Location Reference: L73 Task: Restrict access to the roof

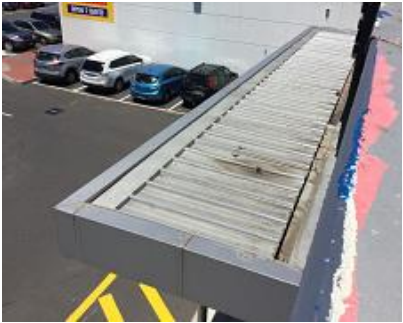
No height safety system installed	Trips, Slips and Falls	Restrict Access	High	"EWP Access Only" sign to be installed	Low	Client advised	Outstanding	OH&S REGULATIONS 3.55 & 3.11

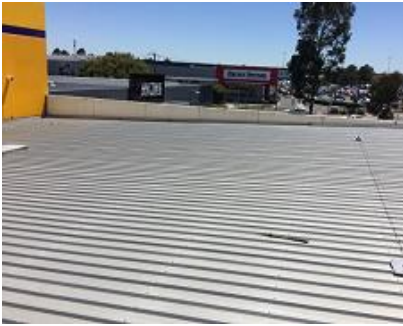
No height safety system installed	Trips, Slips and Falls	Awareness induction	High	Fall arrest anchors to be installed	Low	Client advised	Outstanding	OH&S REGULATIONS 3.55
140	Building: General Stores Location Reference: L74 Task: Access to the A/c units

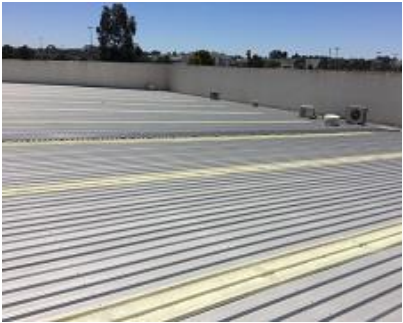
No safe access to the A/c units	Trips, Slips and Falls	N/A	Low	Supply walkway to the A/c units	Low	Client advised	Outstanding	-

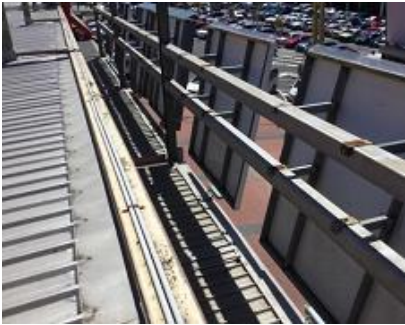
No height safety system installed	Trips, Slips and Falls	Restrict Access	High	"EWP Access Only" signs to be installed	Low	Client advised	Outstanding	OH&S REGULATIONS 3.55 & 3.11
142	Building: General Stores Location Reference: L77 Task: Access to the roof

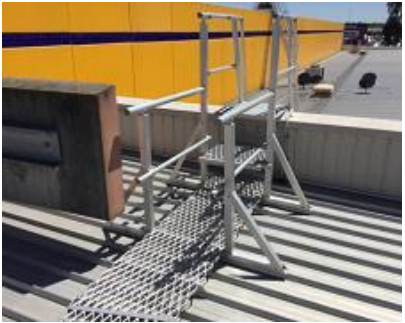
Non-complaint step is present	Trips, Slips and Falls	Awareness induction	Med	Existing step to be removed and new ladder to be installed	Low	Client advised	Outstanding	OH&S REGULATIONS 3.7 AS/NZS 1657-2013 3.1.4

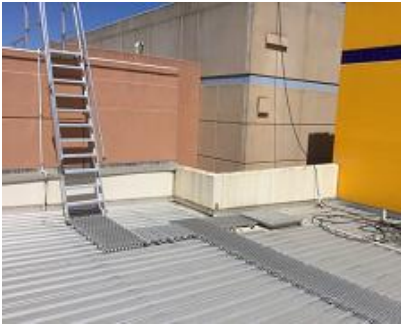
No height safety system installed	Trips, Slips and Falls	Awareness induction	High	Fall arrest anchor to be installed	Low	Client advised	Outstanding	OH&S REGULATIONS 3.55
144	Building: General Stores Location Reference: L78 Task: Access to the roof

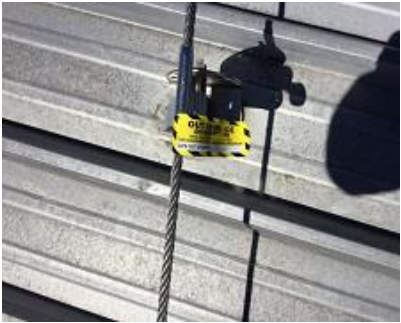
Non-complaint static line is present	Trips, Slips and Falls	Awareness induction	High	Existing static line to be removed and new static line to be installed	Low	Client advised	Outstanding	OH&S REGULATIONS 3.55

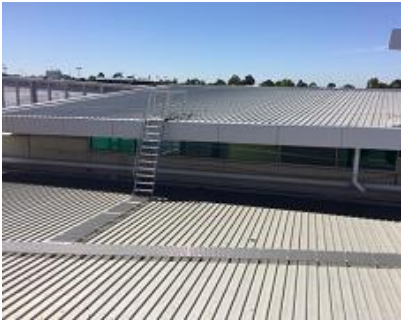
No height safety system installed	Trips, Slips and Falls	Awareness induction	High	Fall arrest anchors to be installed	Low	Client advised	Outstanding	OH&S REGULATIONS 3.55
146	Building: General Stores Location Reference: L79 Task: Restrict access to the roof

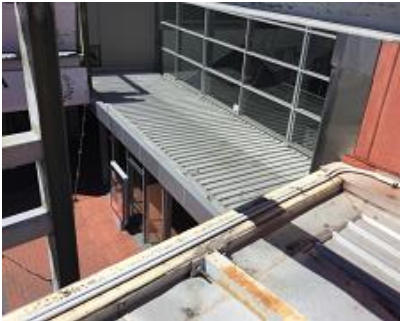
No height safety system installed	Trips, Slips and Falls	Restrict Access	High	"EWP Access Only" signs to be installed	Low	Client advised	Outstanding	OH&S REGULATIONS 3.55 & 3.11

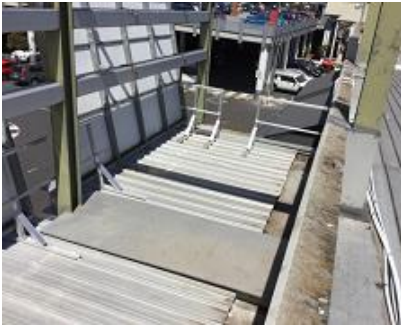
Variation in height between roofs are greater than required maximum	Trips, Slips and Falls	Awareness induction	Med	Access ladder to be installed	Low	Client advised	Outstanding	OH&S REGULATIONS 3.7 AS/NZS 1657-2013 3.1.4
148	Building: General Stores Location Reference: L81 Task: Access to the A/c units

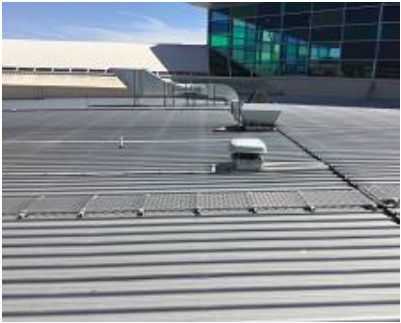
No safe access to the A/c units	Trips, Slips and Falls	N/A	Low	Supply walkway to the A/c units	Low	Client advised	Outstanding	-

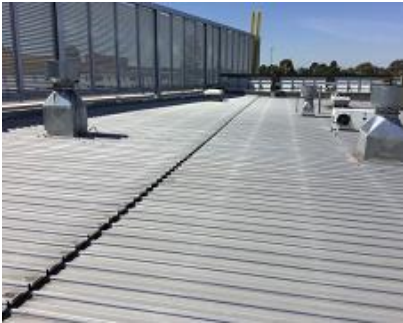
No safe access to the A/c units	Trips, Slips and Falls	N/A	Low	Supply walkway to the A/c units	Low	Client advised	Outstanding	-
150	Building: General Stores Location Reference: L81 Task: Access to the plant deck

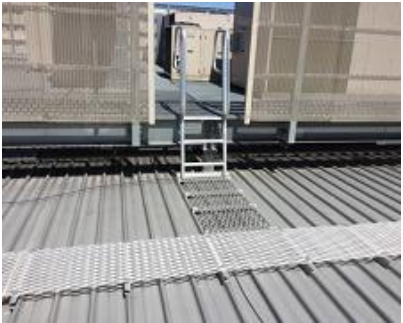
Top rung not levelled with landing, bottom rung height is less than required minimum and handrails projecting towards the user	Trips, Slips and Falls	Awareness induction	Med	Existing ladder to be removed and new ladder to be installed	Low	Client advised	Outstanding	OH&S REGULATIONS 3.7 AS/NZS 1657-2013 7.4.3.3, 7.4.3.4 & 7.4.8.5

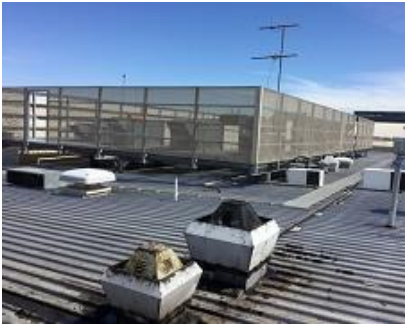
No safe access to the A/c units	Trips, Slips and Falls	N/A	Low	Supply walkway to the A/c units	Low	Client advised	Outstanding	-
152	Building: General Stores Location Reference: L81 Task: Access to the plant deck

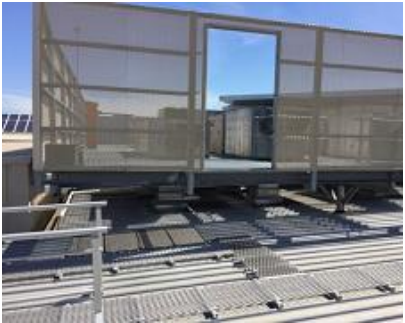
Variation in height between plant deck and roof is greater than required maximum	Trips, Slips and Falls	Awareness induction	Med	Access ladder to be installed	Low	Client advised	Outstanding	OH&S REGULATIONS 3.7 AS/NZS 1657-2013 3.1.4

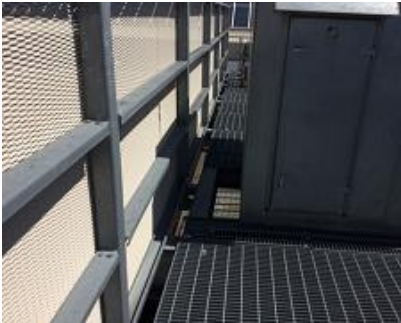
Variation in height between plant deck and roof is greater than required maximum	Trips, Slips and Falls	Awareness induction	Med	Gap to be filled	Low	Client advised	Outstanding	OH&S REGULATIONS 3.7 AS/NZS 1657-2013 4.4
154	Building: General Stores Location Reference: L82 Task: Access to the roof

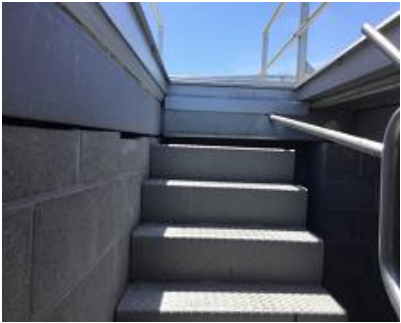
Step is missing, and headroom is less than required minimum	Trips, Slips and Falls	Awareness induction	Med	Step and "Caution-Low headroom" signs to be installed	Low	Client advised	Outstanding	OH&S REGULATIONS 3.7 AS/NZS 1657-2013 3.1.4 & 3.1.5

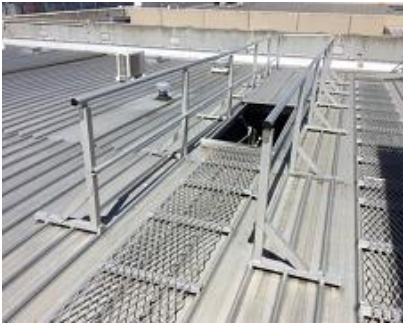
No safe access to the A/c units	Trips, Slips and Falls	N/A	Low	Supply walkway to the A/c units	Low	Client advised	Outstanding	-
156	Building: General Stores Location Reference: L83 Task: Access to the roof

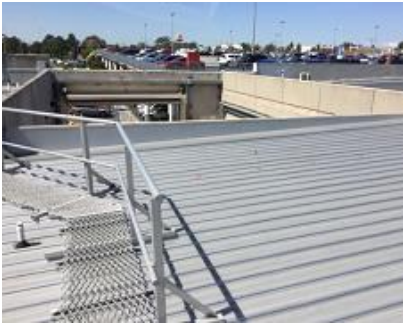
No height safety system installed	Trips, Slips and Falls	Awareness induction	High	Fall arrest anchors to be installed	Low	Client advised	Outstanding	OH&S REGULATIONS 3.55

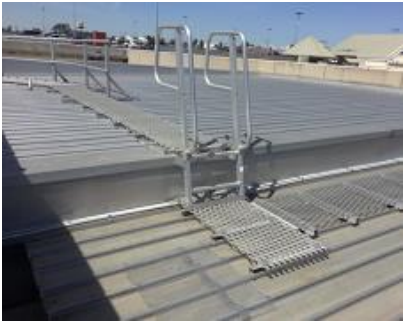
Top rung not levelled with landing, bottom rung height is less than required minimum and handrails projecting towards the user	Trips, Slips and Falls	Awareness induction	Med	Existing ladder to be removed and new ladder to be installed	Low	Client advised	Outstanding	OH&S REGULATIONS 3.7 AS/NZS 1657-2013 7.4.3.3, 7.4.3.4 & 7.4.8.5
158	Building: General Stores Location Reference: L85 Task: Access to the plant deck

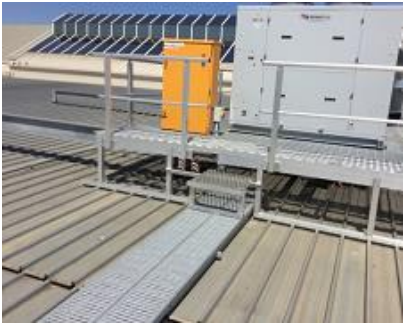
Non-complaint step is present	Trips, Slips and Falls	Awareness induction	Med	Existing step to be removed and new ladder to be installed	Low	Client advised	Outstanding	OH&S REGULATIONS 3.7 AS/NZS 1657-2013 3.1.4

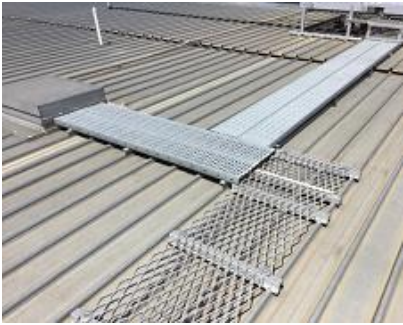
Variation in height between walkway panels are greater than required maximum	Trips, Slips and Falls	Awareness induction	Med	High visibility safety yellow nosing's to be installed	Low	Client advised	Outstanding	OH&S REGULATIONS 3.7 AS/NZS 1657-2013 3.3.4
160	Building: General Stores Location Reference: L85 Task: Access to the plant deck

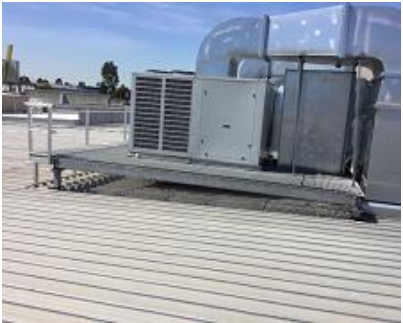
Variation in height between plant deck and roof is greater than required maximum	Trips, Slips and Falls	Awareness induction	Med	Handrails to be installed	Low	Client advised	Outstanding	OH&S REGULATIONS 3.7 AS/NZS 1657-2013 4.4

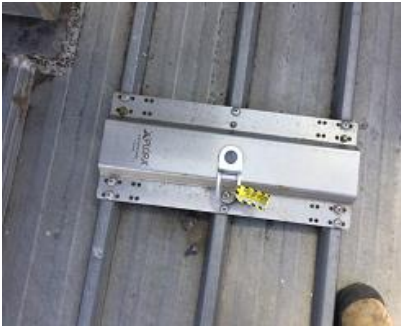
Non-complaint anchor is present	Trips, Slips and Falls	Awareness induction	High	Existing anchors to be removed and new anchors to be installed	Low	Client advised	Outstanding	OH&S REGULATIONS 3.55
162	Building: General Stores Location Reference: L86 Task: Access to the roof

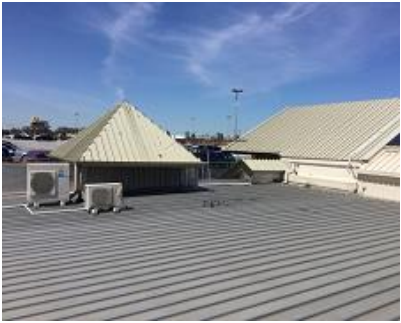
No height safety system installed	Trips, Slips and Falls	Awareness induction	High	Fall arrest anchor to be installed	Low	Client advised	Outstanding	OH&S REGULATIONS 3.55

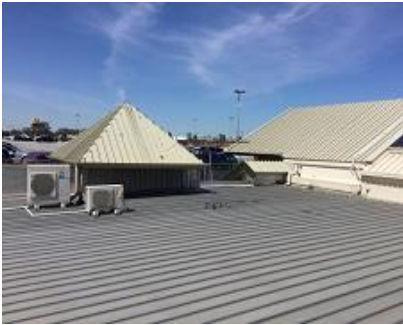
No height safety system installed	Trips, Slips and Falls	Restrict Access	High	"No Access" sign to be installed	Low	Client advised	Outstanding	OH&S REGULATIONS 3.55 & 3.11
164	Building: General Stores Location Reference: L86 Task: Access to the A/c units

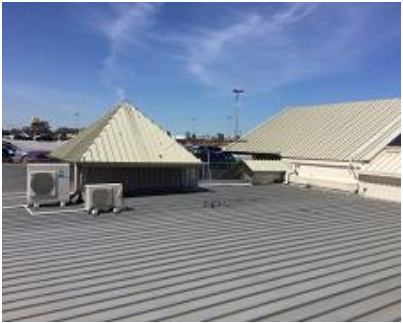
No safe access to the A/c units	Trips, Slips and Falls	N/A	Low	Supply walkway to the A/c units	Low	Client advised	Outstanding	-

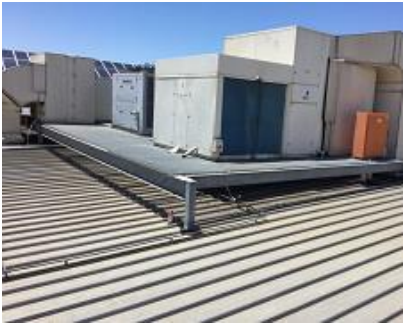
Variation in height between plant deck and roof is greater than required maximum	Trips, Slips and Falls	Awareness induction	Med	Access ladder, new walkway and handrails to be installed	Low	Client advised	Outstanding	OH&S REGULATIONS 3.7 AS/NZS 1657-2013 3.1.4 & 4.4
166	Building: General Stores Location Reference: L88 Task: Access to the roof

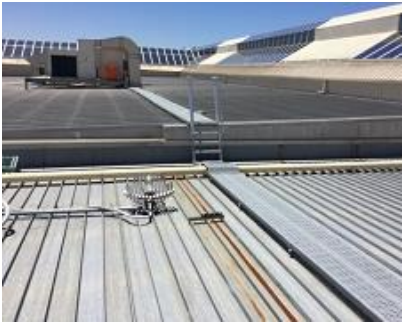
Landing is less than required minimum	Trips, Slips and Falls	Awareness induction	Med	Existing ladder to be re-installed with landing platforms and brackets	Low	Client advised	Outstanding	OH&S REGULATIONS 3.7 AS/NZS 1657-2013 7.3.6

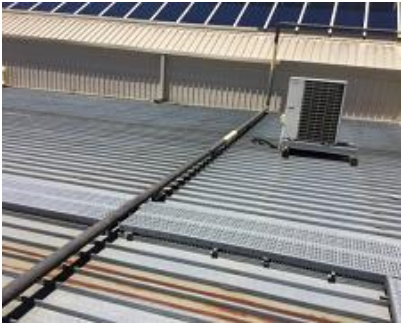
Pipe installed over the walkway path	Trips, Slips and Falls	Awareness induction	Med	Step bridge to be installed	Low	Client advised	Outstanding	OH&S REGULATIONS 3.7 AS/NZS 1657-2013 3.1.4
168	Building: General Stores Location Reference: L89 Task: Access to the A/c units

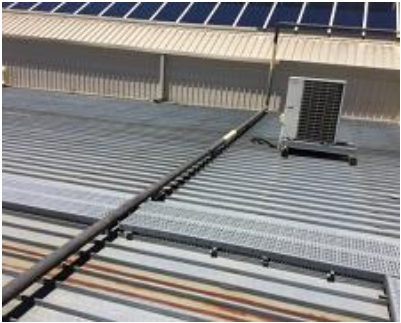
No safe access to the A/c units	Trips, Slips and Falls	N/A	Low	Supply walkway to the A/c units	Low	Client advised	Outstanding	-

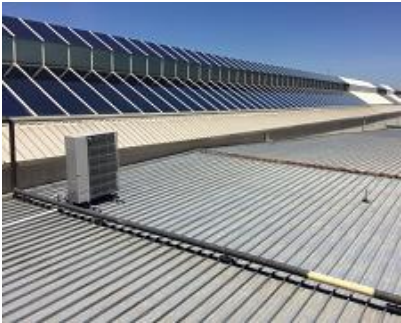
No safe access to the A/c units	Trips, Slips and Falls	N/A	Low	Supply walkway to the A/c units	Low	Client advised	Outstanding	-
170	Building: General Stores Location Reference: L90 Task: Restrict access to the roof

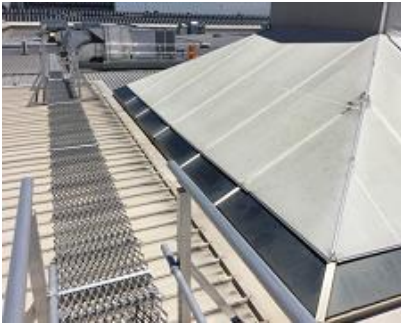
Brittle roof (Non-trafficable roof)	Trips, Slips and Falls	Restrict Access	High	"Warning-Brittle and Fragile Roof" signs to be installed	Low	Client advised	Outstanding	OH&S REGULATIONS 3.57

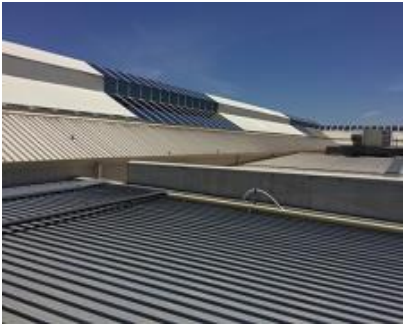
Brittle roof (Non-trafficable roof)	Trips, Slips and Falls	Restrict Access	High	"Warning-Brittle and Fragile Roof" signs to be installed	Low	Client advised	Outstanding	OH&S REGULATIONS 3.57
172	Building: General Stores Location Reference: L92 Task: Access to the roof

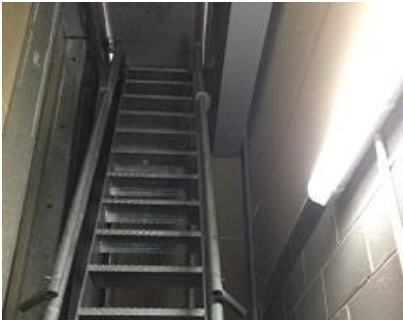
Top tread not levelled with landing	Trips, Slips and Falls	Awareness induction	Med	Existing ladder to be removed and new ladder to be installed	Low	Client advised	Outstanding	OH&S REGULATIONS 3.7 AS/NZS 1657-2013 7.4.3.3

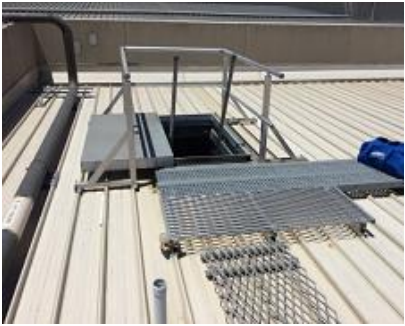
Variation in height between walkway panels are greater than required maximum	Trips, Slips and Falls	Awareness induction	Med	High visibility safety yellow nosing to be installed	Low	Client advised	Outstanding	OH&S REGULATIONS 3.7 AS/NZS 1657-2013 3.3.4
174	Building: General Stores Location Reference: L92 Task: Access to the roof

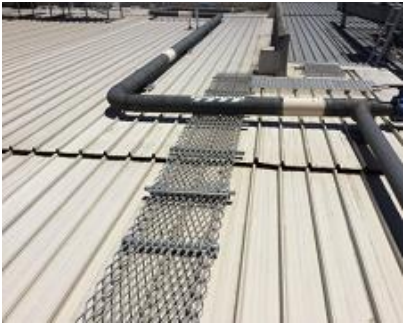
Variation in height between walkway panels are greater than required maximum	Trips, Slips and Falls	Awareness induction	Med	High visibility safety yellow nosing to be installed	Low	Client advised	Outstanding	OH&S REGULATIONS 3.7 AS/NZS 1657-2013 3.3.4

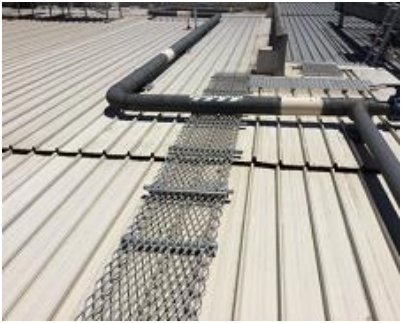
Pipe installed over the walkway path	Trips, Slips and Falls	Awareness induction	Med	Step bridge to be installed	Low	Client advised	Outstanding	OH&S REGULATIONS 3.7 AS/NZS 1657-2013 3.1.4
176	Building: General Stores Location Reference: L93 Task: Access to the plant deck

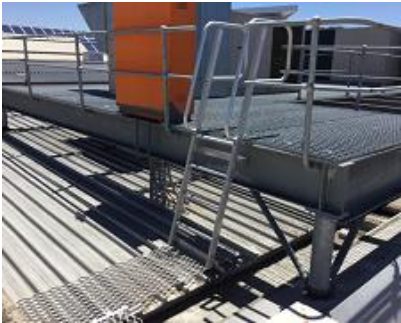
Top rung not levelled with landing, Bottom rung height is less than required minimum and handrails projecting towards the user	Trips, Slips and Falls	Awareness induction	Med	Existing handrail to be removed. Existing ladder to be re-installed with landing platforms, brackets and handrails	Low	Client advised	Outstanding	OH&S REGULATIONS 3.7 AS/NZS 1657-2013 7.4.3.3, 7.4.3.4 & 7.4.8.5

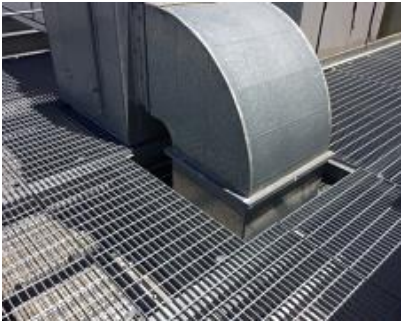
Gap between grating and unit is greater than required maximum	Trips, Slips and Falls	Awareness induction	Med	Gap to be filled	Low	Client advised	Outstanding	OH&S REGULATIONS 3.7 AS/NZS 1657-2013 3.2.3.4
178	Building: General Stores Location Reference: L93 Task: Access to the A/c units

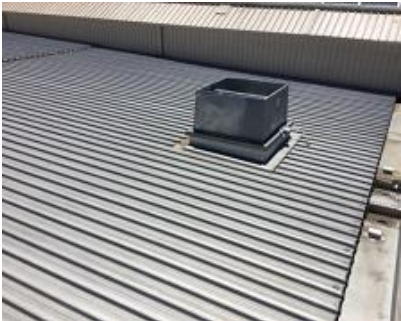
No safe access to the A/c units	Trips, Slips and Falls	N/A	Low	Supply walkway to the A/c units	Low	Client advised	Outstanding	-

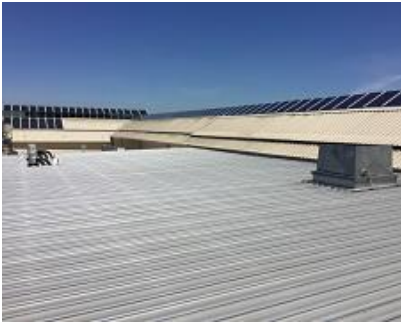
No safe access to the A/c units	Trips, Slips and Falls	N/A	Low	Supply walkway to the A/c units	Low	Client advised	Outstanding	-
180	Building: General Stores Location Reference: L94 Task: Access to the plant deck

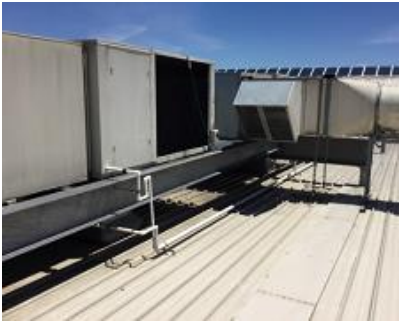
Variation in height between plant deck and roof is greater than required maximum	Trips, Slips and Falls	Awareness induction	Med	Handrail to be installed	Low	Client advised	Outstanding	OH&S REGULATIONS 3.7 AS/NZS 1657-2013 4.4

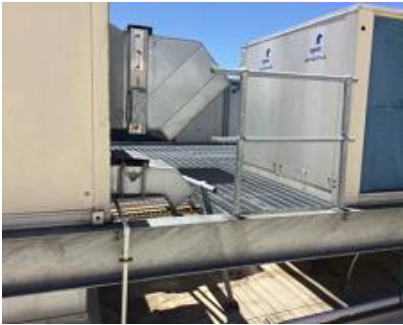
Variation in height between plant deck and roof is greater than required maximum	Trips, Slips and Falls	Awareness induction	Med	Handrail to be installed	Low	Client advised	Outstanding	OH&S REGULATIONS 3.7 AS/NZS 1657-2013 4.4
182	Building: General Stores Location Reference: L94 Task: Access to the roof

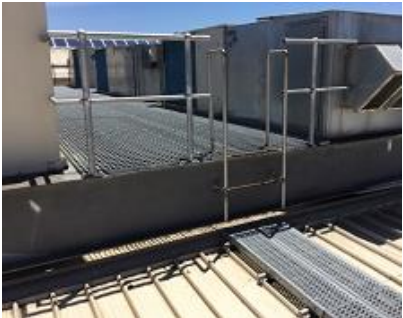
Non-complaint ladder is present	Trips, Slips and Falls	Awareness induction	Med	Existing ladder to be removed and new ladder to be installed	Low	Client advised	Outstanding	OH&S REGULATIONS 3.7 AS/NZS 1657-2013 7.4

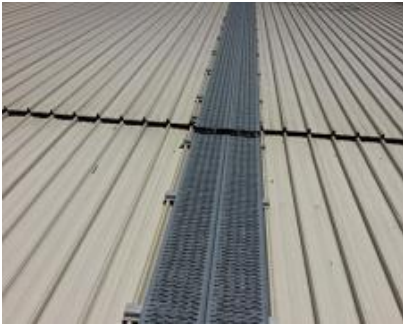
Variation in height between walkway panels are greater than required maximum	Trips, Slips and Falls	Awareness induction	Med	High visibility safety yellow nosing to be installed	Low	Client advised	Outstanding	OH&S REGULATIONS 3.7 AS/NZS 1657-2013 3.3.4
184	Building: General Stores Location Reference: L95 Task: Access to the plant deck

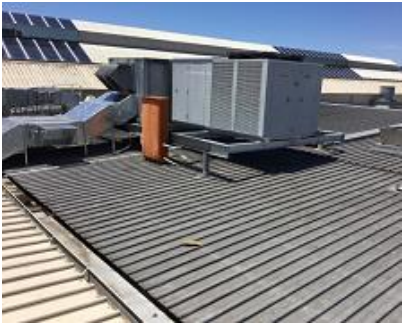
No safe access to the plant deck	Trips, Slips and Falls	Awareness induction	Med	Access ladders, grating and handrails to be installed	Low	Client advised	Outstanding	OH&S REGULATIONS 3.7 AS/NZS 1657-2013 3.1.4

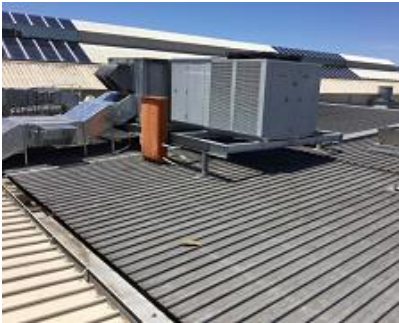
No safe access to the A/c units	Trips, Slips and Falls	N/A	Low	Supply walkway to the A/c units	Low	Client advised	Outstanding	-
186	Building: General Stores Location Reference: L95 Task: Access to the A/c units

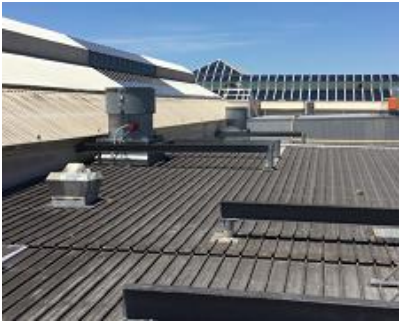
No safe access to the A/c units	Trips, Slips and Falls	N/A	Low	Supply walkway to the A/c units	Low	Client advised	Outstanding	-

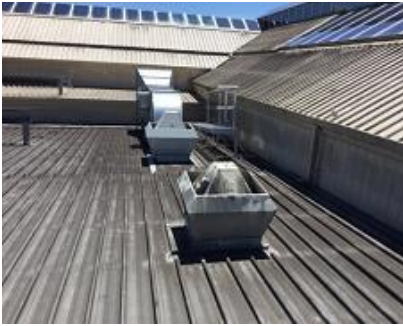
No safe access to the A/c units	Trips, Slips and Falls	N/A	Low	Supply walkway to the A/c units	Low	Client advised	Outstanding	-
188	Building: General Stores Location Reference: L95 Task: Access to the A/c units

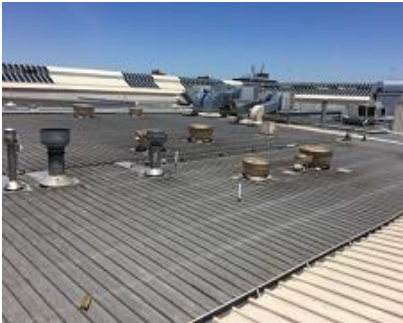
No safe access to the A/c units	Trips, Slips and Falls	N/A	Low	Supply walkway and step over to the A/c units	Low	Client advised	Outstanding	-

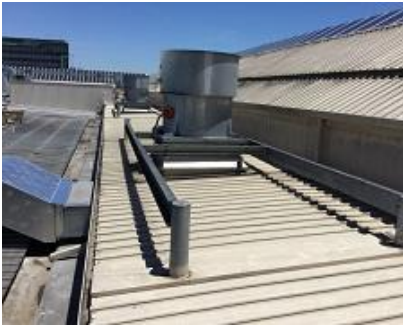
No	Photo of Hazard	Details of Hazard	Details of Risk	Existing/ Immediate Control Measure	Curre nt Risk Level	Proposed Permanent Solution	Resid ual Risk Asse ssme nt	Details of Action Taken	Status	Reference
189	Building: General Stores Location Reference: L95 Task: Access to the A/c units

No safe access to the A/c units	Trips, Slips and Falls	N/A	Low	Supply walkway, Access ladder, step and handrail to the units	Low	Client advised	Outstanding	-
190	Building: General Stores Location Reference: L95 Task: Access to the A/c units

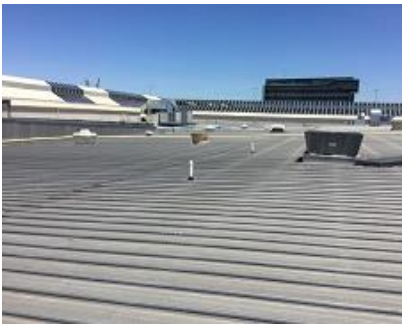
No safe access to the A/c units	Trips, Slips and Falls	N/A	Low	Supply walkway to the A/c units	Low	Client advised	Outstanding	-

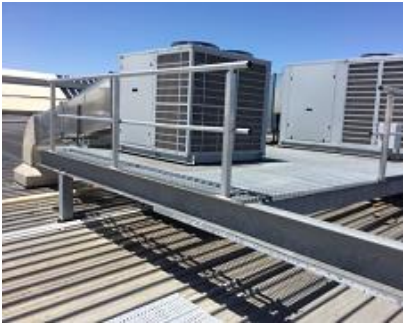
No	Photo of Hazard	Details of Hazard	Details of Risk	Existing/ Immediate Control Measure	Curre nt Risk Level	Proposed Permanent Solution	Resid ual Risk Asse sme nt	Details of Action Taken	Status	Reference
191	Building: General Stores Location Reference: L96 Task: Access to the plant deck

Variation in height between plant deck and roof is greater than required maximum	Trips, Slips and Falls	Awareness induction	Med	Handrail to be installed	Low	Client advised	Outstanding	OH&S REGULATIONS 3.7 AS/NZS 1657-2013 4.4
192	Building: General Stores Location Reference: L97 Task: Access to the plant deck

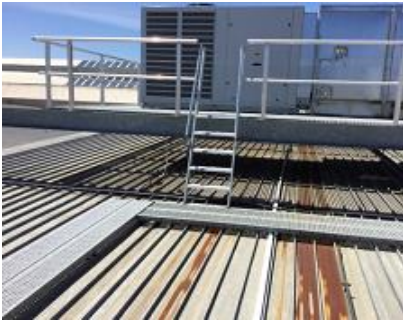
Landing is less than required minimum	Trips, Slips and Falls	Awareness induction	Med	Additional walkway section to be installed	Low	Client advised	Outstanding	OH&S REGULATIONS 3.7 AS/NZS 1657-2013 7.3.6

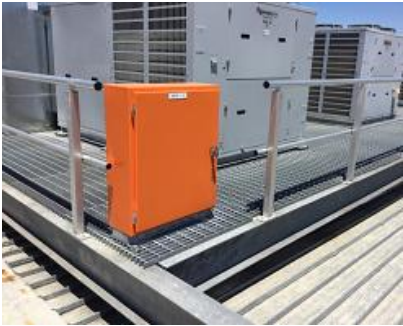
No	Photo of Hazard	Details of Hazard	Details of Risk	Existing/ Immediate Control Measure	Curre nt Risk Level	Proposed Permanent Solution	Resid ual Risk Asse sme nt	Details of Action Taken	Status	Reference
193	Building: General Stores Location Reference: L97 Task: Access to the plant deck

Variation in height between plant deck and roof is greater than required maximum	Trips, Slips and Falls	Awareness induction	Med	Handrail to be installed	Low	Client advised	Outstanding	OH&S REGULATIONS 3.7 AS/NZS 1657-2013 4.4
194	Building: General Stores Location Reference: L97 Task: Access to the roof

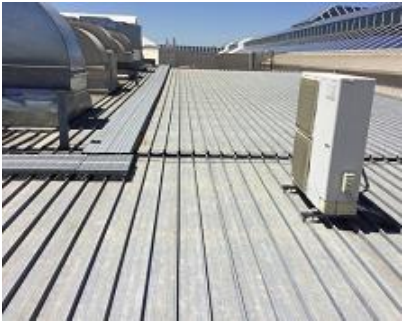
Variation in height between walkway panels are greater than required maximum	Trips, Slips and Falls	Awareness induction	Med	High visibility safety yellow nosing to be installed	Low	Client advised	Outstanding	OH&S REGULATIONS 3.7 AS/NZS 1657-2013 3.3.4

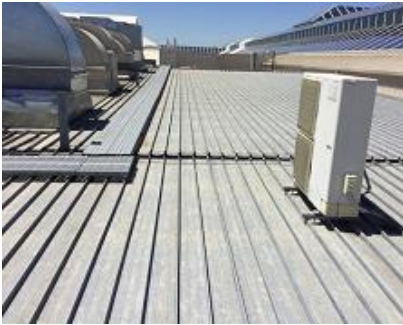
No	Photo of Hazard	Details of Hazard	Details of Risk	Existing/ Immediate Control Measure	Curre nt Risk Level	Proposed Permanent Solution	Resid ual Risk Asse sme nt	Details of Action Taken	Status	Reference
195	Building: General Stores Location Reference: L97 Task: Access to the A/c units

No safe access to the A/c units	Trips, Slips and Falls	N/A	Low	Supply walkway to the A/c units	Low	Client advised	Outstanding	-
196	Building: General Stores Location Reference: L98 Task: Access to the roof

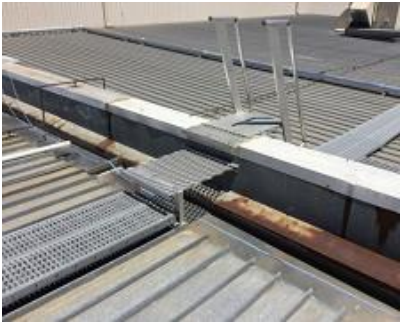
Handrail is missing for landing	Trips, Slips and Falls	Awareness induction	Med	Handrail to be installed	Low	Client advised	Outstanding	OH&S REGULATIONS 3.7 AS/NZS 1657-2013 4.4

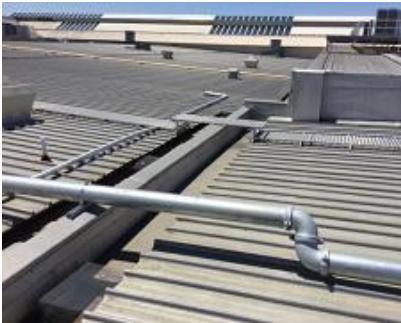
No	Photo of Hazard	Details of Hazard	Details of Risk	Existing/ Immediate Control Measure	Curre nt Risk Level	Proposed Permanent Solution	Resid ual Risk Asse sme nt	Details of Action Taken	Status	Reference
197	Building: General Stores Location Reference: L98 Task: Access to the roof

Variation in height between landing and adjacent surface is greater than required maximum	Trips, Slips and Falls	Awareness induction	Med	Handrail to be installed	Low	Client advised	Outstanding	OH&S REGULATIONS 3.7 AS/NZS 1657-2013 4.4
198	Building: General Stores Location Reference: L98 Task: Access to the roof

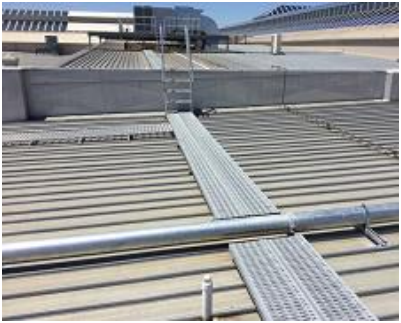
Pipe installed over the walkway path	Trips, Slips and Falls	Awareness induction	Med	Step bridge to be installed	Low	Client advised	Outstanding	OH&S REGULATIONS 3.7 AS/NZS 1657-2013 3.1.4

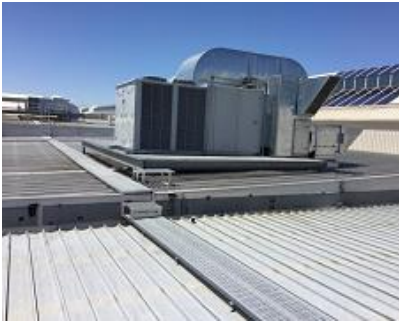
No	Photo of Hazard	Details of Hazard	Details of Risk	Existing/ Immediate Control Measure	Curre nt Risk Level	Proposed Permanent Solution	Resid ual Risk Asse sme nt	Details of Action Taken	Status	Reference
199	Building: General Stores Location Reference: L99 Task: Access to the roof

Handrail is missing for steps	Trips, Slips and Falls	Awareness induction	Med	Handrail to be installed	Low	Client advised	Outstanding	OH&S REGULATIONS 3.7 AS/NZS 1657-2013 7.2.6
200	Building: General Stores Location Reference: L99 Task: Access to the plant deck

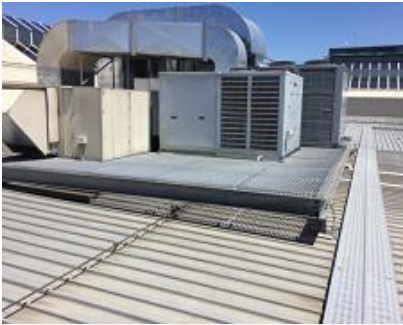
No	Photo of Hazard	Details of Hazard	Details of Risk	Existing/ Immediate Control Measure	Curre nt Risk Level	Proposed Permanent Solution	Resid ual Risk Asse sme nt	Details of Action Taken	Status	Reference
201	Building: General Stores Location Reference: L99 Task: Access to the plant deck

Variation in height between plant deck and roof is greater than required maximum	Trips, Slips and Falls	Awareness induction	Med	Handrail to be installed	Low	Client advised	Outstanding	OH&S REGULATIONS 3.7 AS/NZS 1657-2013 4.4
202	Building: General Stores Location Reference: L100 Task: Access to the A/c units

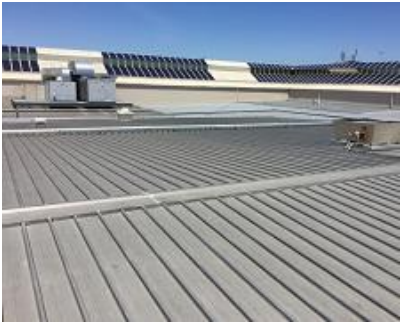
No safe access to the A/c units	Trips, Slips and Falls	N/A	Low	Supply walkway and step bridge to the A/c units	Low	Client advised	Outstanding	-

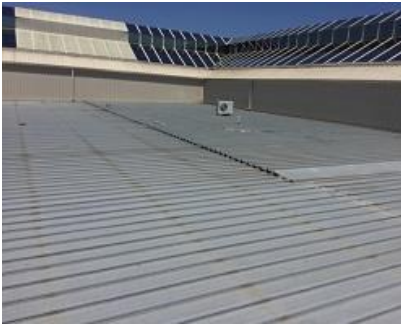
No	Photo of Hazard	Details of Hazard	Details of Risk	Existing/ Immediate Control Measure	Curre nt Risk Level	Proposed Permanent Solution	Resid ual Risk Asse sme nt	Details of Action Taken	Status	Reference
20 3	Building: General Stores Location Reference: L101 Task: Access to the A/c units

No safe access to the A/c units	Trips, Slips and Falls	N/A	Low	Supply walkway to the A/c units	Low	Client advised	Outstanding	-
20 4	Building: General Stores Location Reference: L101 Task: Access to the A/c units

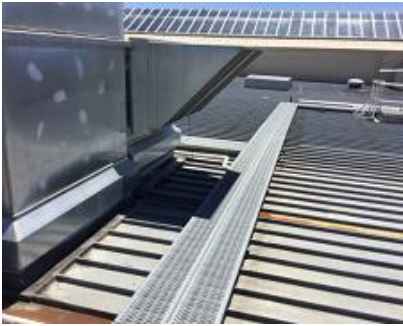
No	Photo of Hazard	Details of Hazard	Details of Risk	Existing/ Immediate Control Measure	Curre nt Risk Level	Proposed Permanent Solution	Resid ual Risk Asse sme nt	Details of Action Taken	Status	Reference
20 5	Building: General Stores Location Reference: L101 Task: Access to the A/c units

Duct protrudes over the walkway path	Trips, Slips and Falls	Awareness induction	Med	Additional walkway sections to be installed	Low	Client advised	Outstanding	OH&S REGULATIONS 3.7
20 6	Building: General Stores Location Reference: L101 Task: Access to the plant deck

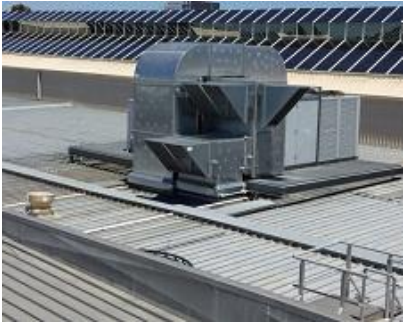
Variation in height between plant deck and roof is greater than required maximum	Trips, Slips and Falls	Awareness induction	Med	Handrail to be installed	Low	Client advised	Outstanding	OH&S REGULATIONS 3.7 AS/NZS 1657-2013 4.4

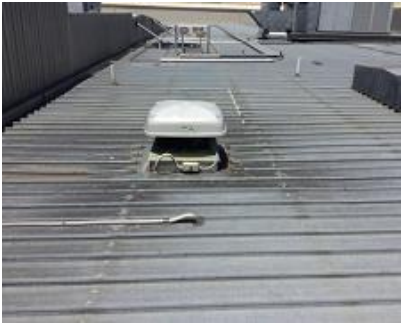
No	Photo of Hazard	Details of Hazard	Details of Risk	Existing/ Immediate Control Measure	Curre nt Risk Level	Proposed Permanent Solution	Resid ual Risk Asse sme nt	Details of Action Taken	Status	Reference
20 7	Building: General Stores Location Reference: L103 Task: Access to the A/c units

No safe access to the A/c units	Trips, Slips and Falls	N/A	Low	Supply walkway to the A/c units	Low	Client advised	Outstanding	-
20 8	Building: General Stores Location Reference: L103 Task: Access to the A/c units

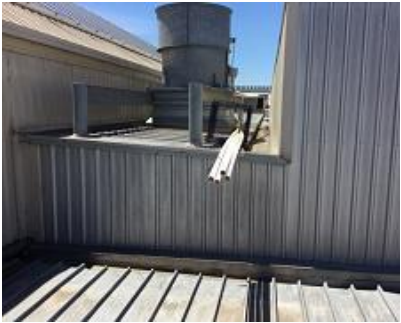
No safe access to the A/c units	Trips, Slips and Falls	N/A	Low	Supply walkway, Access ladder and handrail to the A/c units	Low	Client advised	Outstanding	-

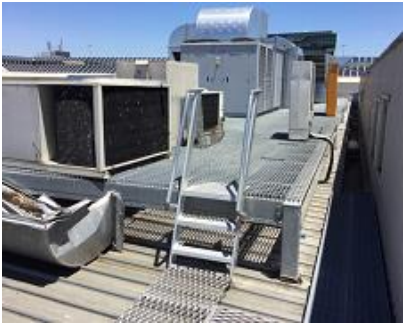
No	Photo of Hazard	Details of Hazard	Details of Risk	Existing/ Immediate Control Measure	Curre nt Risk Level	Proposed Permanent Solution	Resid ual Risk Asse sme nt	Details of Action Taken	Status	Reference
209	Building: General Stores Location Reference: L104 Task: Access to the plant deck

Bottom tread height is less than required minimum	Trips, Slips and Falls	Awareness induction	Med	Landing platform to be installed	Low	Client advised	Outstanding	OH&S REGULATIONS 3.7 AS/NZS 1657-2013 7.4.3.4
210	Building: General Stores Location Reference: L104 Task: Access to the A/c units

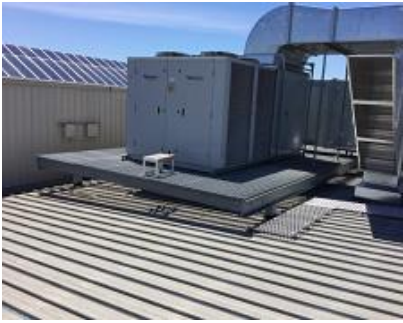
No safe access to the A/c units	Trips, Slips and Falls	N/A	Low	Supply walkway and step to the A/c units	Low	Client advised	Outstanding	-

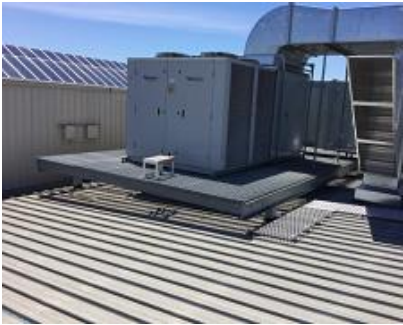
No	Photo of Hazard	Details of Hazard	Details of Risk	Existing/ Immediate Control Measure	Curre nt Risk Level	Proposed Permanent Solution	Resid ual Risk Asse sme nt	Details of Action Taken	Status	Reference
211	Building: General Stores Location Reference: L104 Task: Access to the plant deck

Variation in height between plant deck and roof is greater than required maximum	Trips, Slips and Falls	Awareness induction	Med	Handrail to be installed	Low	Client advised	Outstanding	OH&S REGULATIONS 3.7 AS/NZS 1657-2013 4.4
212	Building: General Stores Location Reference: L105 Task: Access to the A/c units

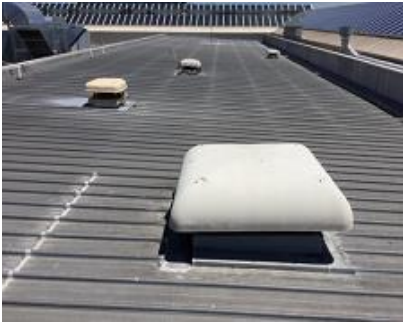
No safe access to the A/c units	Trips, Slips and Falls	N/A	Low	Supply walkway to the A/c units	Low	Client advised	Outstanding	-

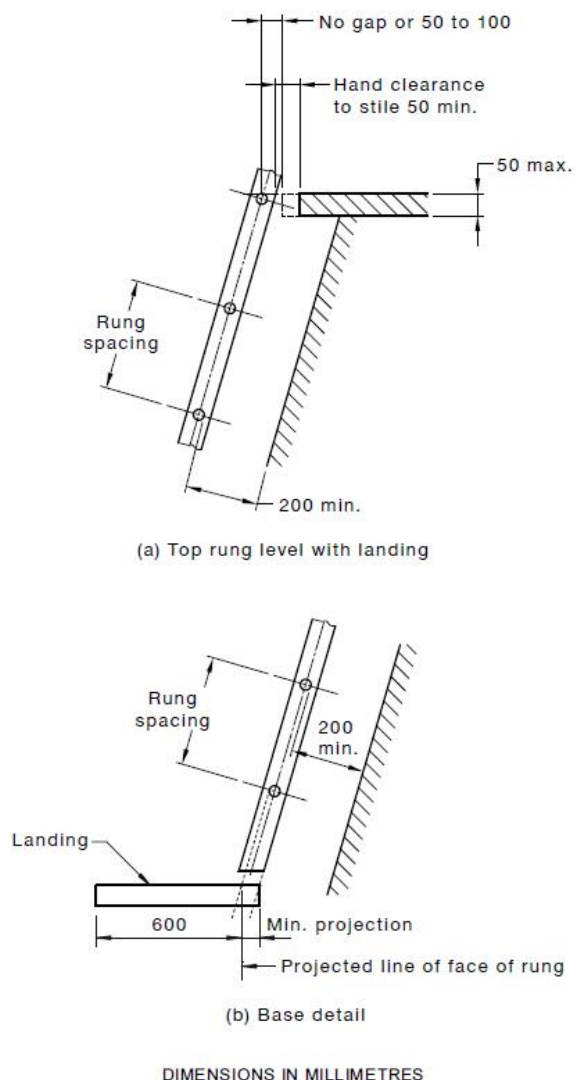
FIGURE 7.11 TYPICAL GAP BETWEEN LANDING AND LADDER

Where the ladder provides access to a landing, the landing shall be level with the top rung. The landing shall extend to the top rung, or there shall be a gap of not less than 50 mm and not greater than 100 mm between the top rung and the landing.
NOTE: See Figure 7.11(a).

Ladder landings shall extend forward to at least the projected line of the rear of the stile.
NOTE: See Figure 7.11(b).
