# Roof Safety Report

**Buranda Village, QLD 4102**

Prepared By: Safemaster Safety Products  
Date: 11 May 2018

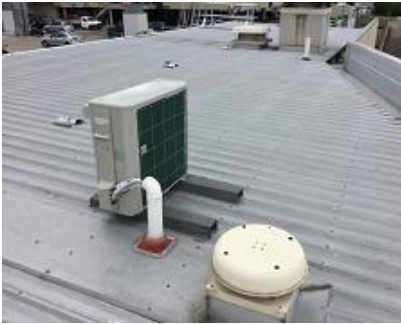
No safe access to the A/c units	Trips, Slips and Falls	N/A	Low	Supply walkway to the A/c units	Low	Client advised	Outstanding	-

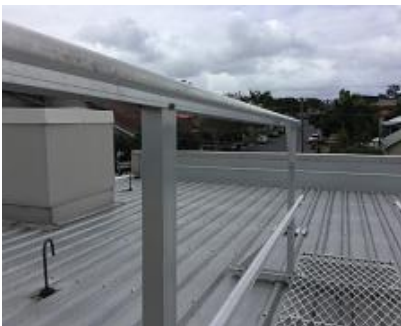
Sharp edges on handrails	Trips, Slips and Falls	Awareness induction	Med	Tek screws to be replaced with rivets	Low	Client advised	Outstanding	OH&S REGULATIONS 3.7  AS/NZS 1657-2013 5.6
06	Building: General Stores Location Reference: <a href="#">L05</a> Task: Access to the roof

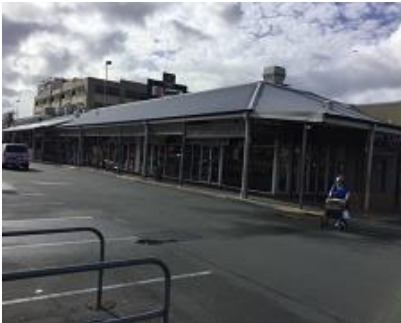
No height safety system installed	Trips, Slips and Falls	Awareness induction	High	Fall arrest anchors to be installed	Low	Client advised	Outstanding	OH&S REGULATIONS 3.55

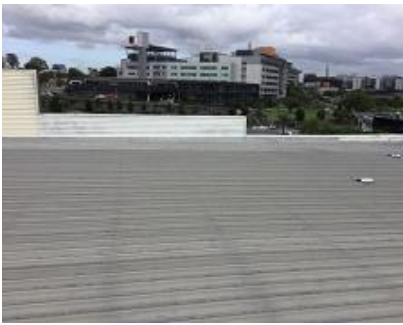
No height safety system installed	Trips, Slips and Falls	Awareness induction	High	Fall arrest anchors to be installed	Low	Client advised	Outstanding	OH&S REGULATIONS 3.55

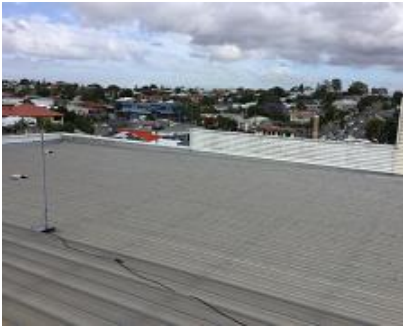
No height safety system installed	Trips, Slips and Falls	Awareness induction	High	Fall arrest anchors to be installed	Low	Client advised	Outstanding	OH&S REGULATIONS 3.55
16	Building: General Stores Location Reference: <a href="#">L12</a> Task: Access to the roof

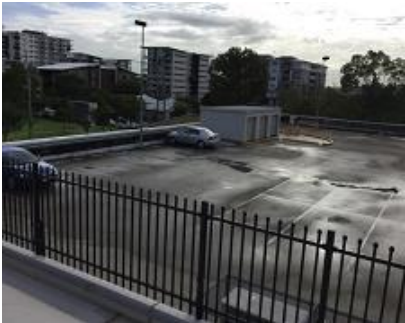
No height safety system installed	Trips, Slips and Falls	Restrict Access	High	"EWP Access Only" sign to be installed	Low	Client advised	Outstanding	OH&S REGULATIONS 3.55 & 3.11

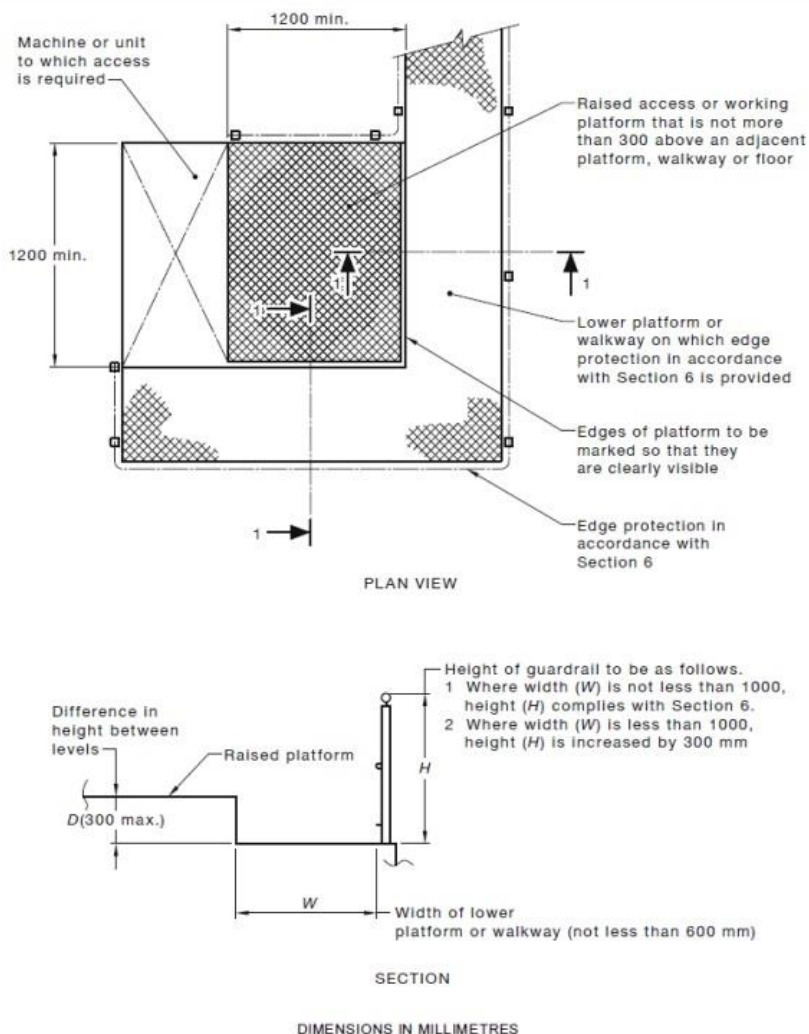
NOTE: Figure 4.1 illustrates guardrail details in relation to platform configurations

FIGURE 4.1 GUARDRAILS ON PLATFORMS

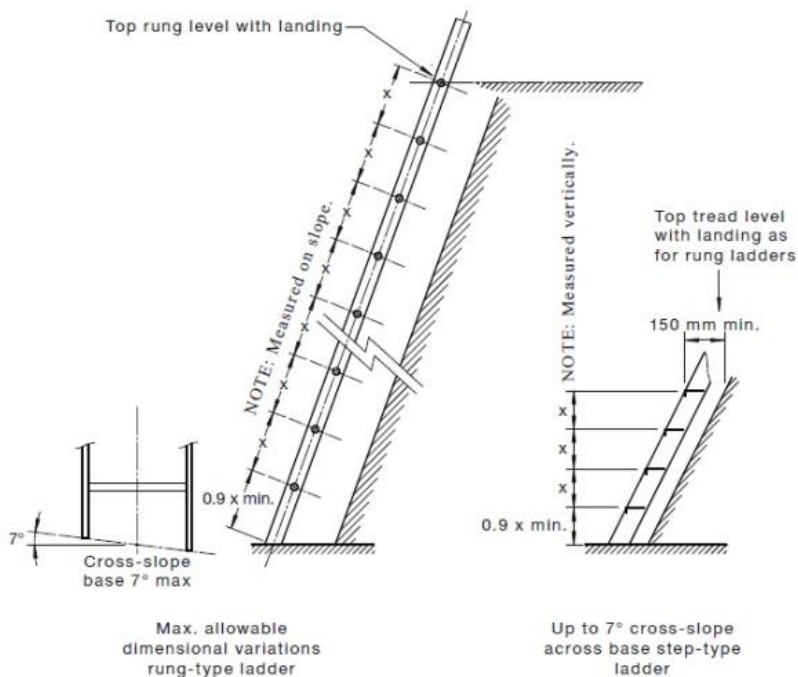
- 1 This distance should be measured at the ladder centre-line where the landing has a cross-slope (see Figure 7.5).
- 2 Where possible, the distance between the landing and the first rung/tread should be equal to the rung/tread spacing.

**FIGURE 7.5 VARIATION OF RUNG/TREAD SPACING**

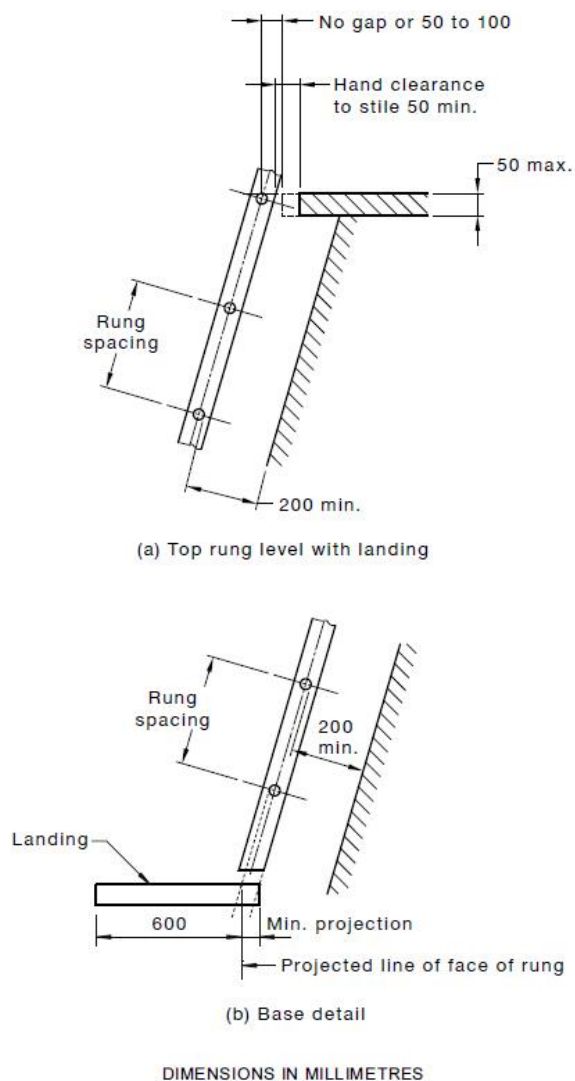
FIGURE 7.11 TYPICAL GAP BETWEEN LANDING AND LADDER
