Roof Safety Report

DFO Essendon, VIC 3041

Prepared By: Safemaster Safety Products
Date: 08 May 2018

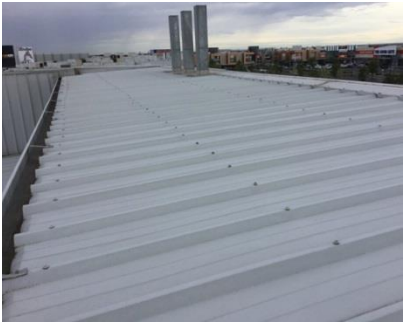
No	Photo of Hazard	Details of Hazard	Details of Risk	Existing/ Immediate Control Measure	Curre nt Risk Level	Proposed Permanent Solution	Resid ual Risk Asse sme nt	Details of Action Taken	Status	Reference
01	Building: General Stores Location Reference: L01 Task: Access to the roof

No height safety system installed	Trips, Slips and Falls	Awareness induction	High	Fall arrest anchors to be installed	Low	Client advised	Outstanding	OH&S REGULATIONS 3.55
02	Building: General Stores Location Reference: L01 Task: Access to the roof

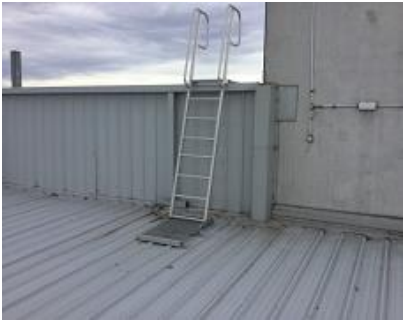
Bottom rung height is less than required minimum and handrail projecting towards the user	Trips, Slips and Falls	Awareness induction	Med	Existing handrail to be removed. Existing ladder to be re-installed with landing platforms and handrails	Low	Client advised	Outstanding	OH&S REGULATIONS 3.7 AS/NZS 1657-2013 7.4.3.4 & 7.4.8.5

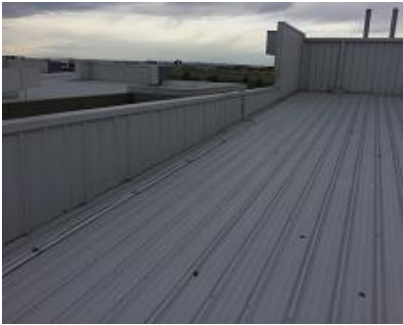
No	Photo of Hazard	Details of Hazard	Details of Risk	Existing/ Immediate Control Measure	Curre nt Risk Level	Proposed Permanent Solution	Resid ual Risk Asse sme nt	Details of Action Taken	Status	Reference
03	Building: General Stores Location Reference: L01 Task: Access to the roof

No height safety system installed	Trips, Slips and Falls	Awareness induction	High	Fall arrest anchors to be installed	Low	Client advised	Outstanding	OH&S REGULATIONS 3.55
04	Building: General Stores Location Reference: L02 Task: Access to the roof

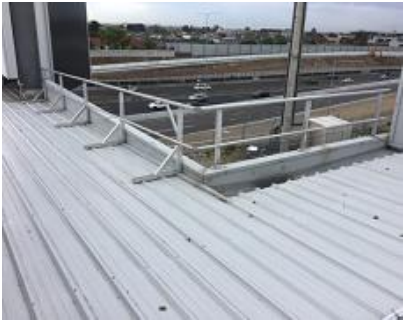
Sharp edges on handrails	Trips, Slips and Falls	Awareness induction	Med	Tek screws to be replaced with rivets	Low	Client advised	Outstanding	OH&S REGULATIONS 3.7 AS/NZS 1657-2013 5.6

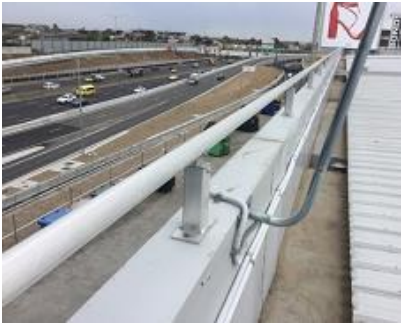
Sharp edges on handrails	Trips, Slips and Falls	Awareness induction	Med	Tek screws to be replaced with rivets	Low	Client advised	Outstanding	OH&S REGULATIONS 3.7 AS/NZS 1657-2013 5.6
06	Building: General Stores Location Reference: L04 Task: Access to the roof

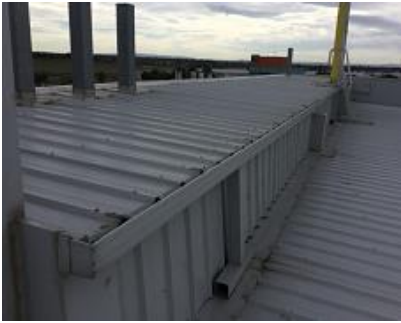
No height safety system installed	Trips, Slips and Falls	Awareness induction	High	Fall arrest anchors to be installed	Low	Client advised	Outstanding	OH&S REGULATIONS 3.55

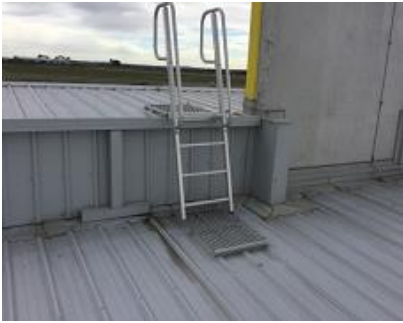
No	Photo of Hazard	Details of Hazard	Details of Risk	Existing/ Immediate Control Measure	Curre nt Risk Level	Proposed Permanent Solution	Resid ual Risk Asse sme nt	Details of Action Taken	Status	Reference
07	Building: General Stores Location Reference: L04 Task: Access to the roof

Bottom rung height is less than required minimum and handrail projecting towards the user	Trips, Slips and Falls	Awareness induction	Med	Existing handrail to be removed. Existing ladder to be re-installed with landing platforms and handrails	Low	Client advised	Outstanding	OH&S REGULATIONS 3.7 AS/NZS 1657-2013 7.4.3.4 & 7.4.8.5
08	Building: General Stores Location Reference: L04 Task: Access to the roof

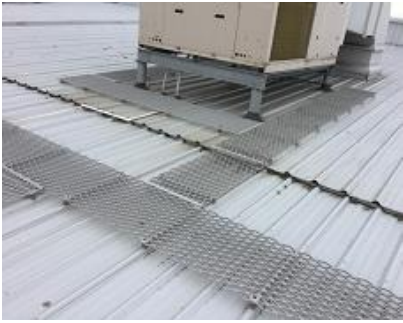
Variation in height between walkway panels are greater than required maximum	Trips, Slips and Falls	Awareness induction	Med	High visibility safety yellow nosing's to be installed	Low	Client advised	Outstanding	OH&S REGULATIONS 3.7 AS/NZS 1657-2013 3.3.4

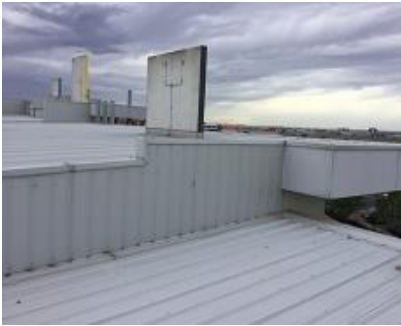
No	Photo of Hazard	Details of Hazard	Details of Risk	Existing/ Immediate Control Measure	Curre nt Risk Level	Proposed Permanent Solution	Resid ual Risk Asse sme nt	Details of Action Taken	Status	Reference
09	Building: General Stores Location Reference: L05 Task: Access to the roof

No height safety system installed	Trips, Slips and Falls	Awareness induction	High	Fall arrest anchors to be installed	Low	Client advised	Outstanding	OH&S REGULATIONS 3.55
10	Building: General Stores Location Reference: L05 Task: Access to the roof

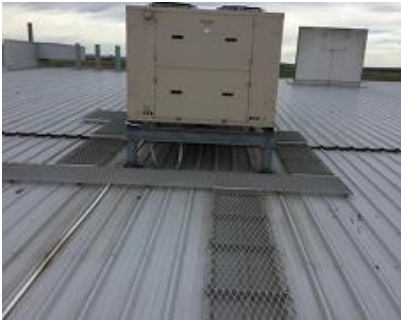
Variation in height between walkway panels are greater than required maximum	Trips, Slips and Falls	Awareness induction	Med	High visibility safety yellow nosing's to be installed	Low	Client advised	Outstanding	OH&S REGULATIONS 3.7 AS/NZS 1657-2013 3.3.4

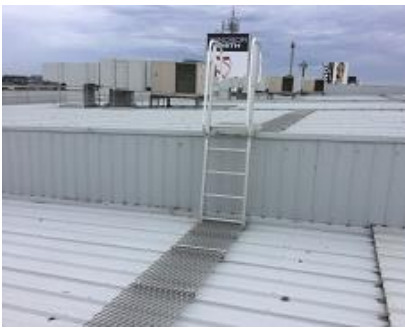
No	Photo of Hazard	Details of Hazard	Details of Risk	Existing/ Immediate Control Measure	Curre nt Risk Level	Proposed Permanent Solution	Resid ual Risk Asse sme nt	Details of Action Taken	Status	Reference
11	Building: General Stores Location Reference: L06 Task: Access to the roof

Bottom rung height is less than required minimum and handrail projecting towards the user	Trips, Slips and Falls	Awareness induction	Med	Existing handrail to be removed. Existing ladder to be re-installed with landing platforms and handrails	Low	Client advised	Outstanding	OH&S REGULATIONS 3.7 AS/NZS 1657-2013 7.4.3.4 & 7.4.8.5
12	Building: General Stores Location Reference: L07 Task: Access to the roof

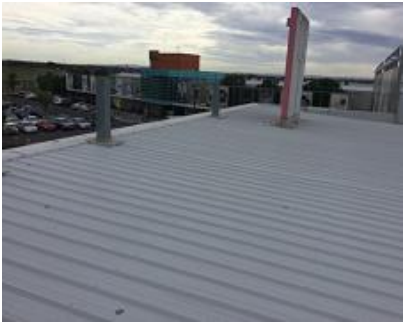
No height safety system installed	Trips, Slips and Falls	Awareness induction	High	Fall arrest anchors to be installed	Low	Client advised	Outstanding	OH&S REGULATIONS 3.55

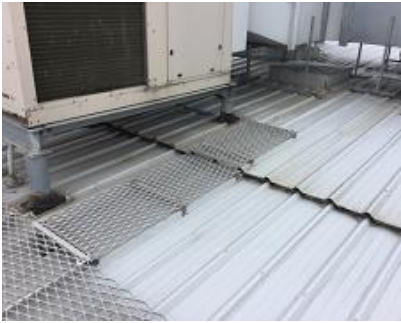
Variation in height between walkway panels are greater than required maximum	Trips, Slips and Falls	Awareness induction	Med	High visibility safety yellow nosing's to be installed	Low	Client advised	Outstanding	OH&S REGULATIONS 3.7 AS/NZS 1657-2013 3.3.4
14	Building: General Stores Location Reference: L08 Task: Access to the roof

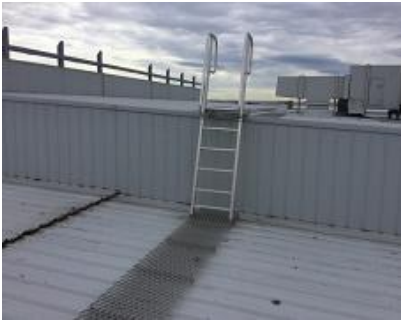
Bottom rung height is less than required minimum and handrail projecting towards the user	Trips, Slips and Falls	Awareness induction	Med	Existing handrail to be removed. Existing ladder to be re-installed with landing platforms and handrails	Low	Client advised	Outstanding	OH&S REGULATIONS 3.7 AS/NZS 1657-2013 7.4.3.4 & 7.4.8.5

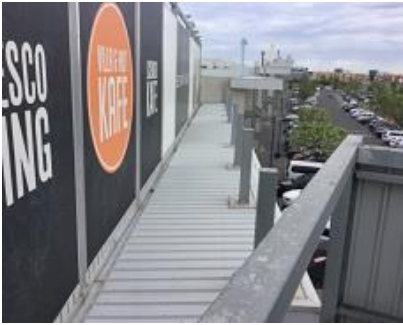
No	Photo of Hazard	Details of Hazard	Details of Risk	Existing/ Immediate Control Measure	Curre nt Risk Level	Proposed Permanent Solution	Resid ual Risk Asse sme nt	Details of Action Taken	Status	Reference
15	Building: General Stores Location Reference: L09 Task: Restrict access to the roof

No height safety system installed	Trips, Slips and Falls	Restrict Access	High	"EWP Access Only" signs to be installed	Low	Client advised	Outstanding	OH&S REGULATIONS 3.55 & 3.11
16	Building: General Stores Location Reference: L10 Task: Access to the roof

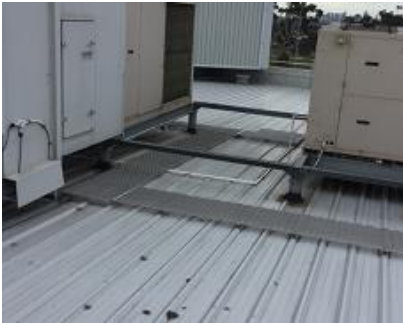
Bracings installed over the walkway path	Trips, Slips and Falls	Awareness induction	Med	Access ladders to be installed	Low	Client advised	Outstanding	OH&S REGULATIONS 3.7 AS/NZS 1657-2013 3.1.4

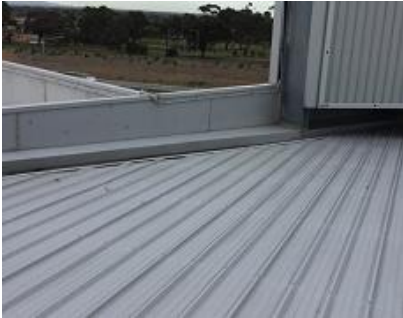
No height safety system installed	Trips, Slips and Falls	Awareness induction	High	Fall arrest anchors to be installed	Low	Client advised	Outstanding	OH&S REGULATIONS 3.55

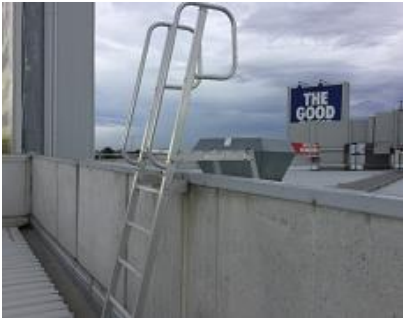
Gap between the ladder and permanent structure is less than required minimum, bottom rung height is less than required minimum and handrail projecting towards the user	Trips, Slips and Falls	Awareness induction	Med	Existing handrail and parapet platform to be removed. Existing ladder to be re-installed with parapet platform, landing platform and handrail	Low	Client advised	Outstanding	OH&S REGULATIONS 3.7 AS/NZS 1657-2013 7.4.5, 7.4.3.4 & 7.4.8.5

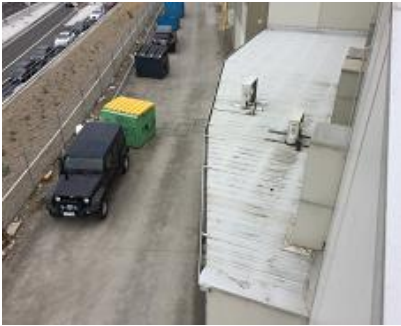
No	Photo of Hazard	Details of Hazard	Details of Risk	Existing/ Immediate Control Measure	Curre nt Risk Level	Proposed Permanent Solution	Resid ual Risk Asse sme nt	Details of Action Taken	Status	Reference
21	Building: General Stores Location Reference: L12 Task: Access to the roof

No height safety system installed	Trips, Slips and Falls	Awareness induction	High	Fall arrest anchors, anchor strop, ladder access bracket and sign to be installed	Low	Client advised	Outstanding	OH&S REGULATIONS 3.55
22	Building: General Stores Location Reference: L12 Task: Access to the roof

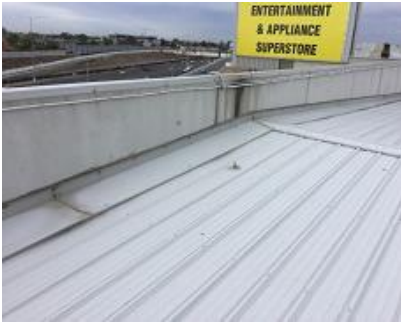
No height safety system installed	Trips, Slips and Falls	Awareness induction	High	Fall arrest anchors to be installed	Low	Client advised	Outstanding	OH&S REGULATIONS 3.55

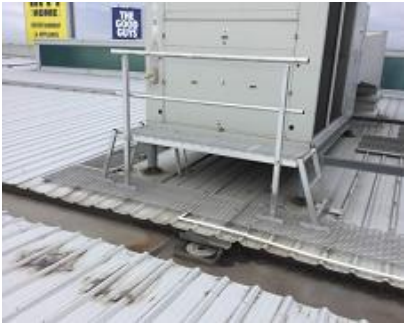
Non-complaint ladder is present	Trips, Slips and Falls	Awareness induction	Med	Existing ladder to be removed and new ladder to be installed	Low	Client advised	Outstanding	OH&S REGULATIONS 3.7 AS/NZS 1657-2013 7.4

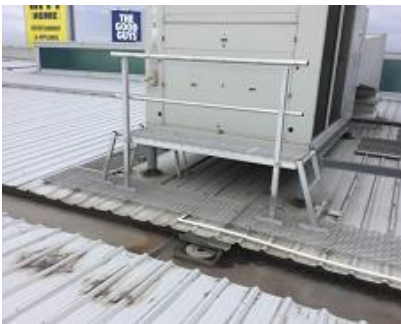
Non-complaint ladder is present	Trips, Slips and Falls	Awareness induction	Med	Existing ladder to be removed and new ladder to be installed	Low	Client advised	Outstanding	OH&S REGULATIONS 3.7 AS/NZS 1657-2013 7.4
26	Building: General Stores Location Reference: L13 Task: Access to the roof

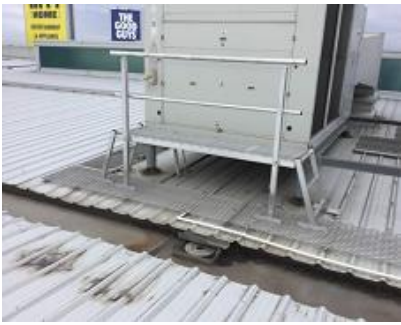
Sharp edges on handrails	Trips, Slips and Falls	Awareness induction	Med	Tek screws to be replaced with rivets	Low	Client advised	Outstanding	OH&S REGULATIONS 3.7 AS/NZS 1657-2013 5.6

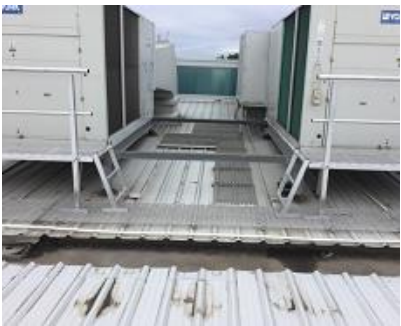
No	Photo of Hazard	Details of Hazard	Details of Risk	Existing/ Immediate Control Measure	Curre nt Risk Level	Proposed Permanent Solution	Resid ual Risk Asse sme nt	Details of Action Taken	Status	Reference
27	Building: General Stores Location Reference: L13 Task: Access to the roof

Bracings installed over the walkway path	Trips, Slips and Falls	Awareness induction	Med	Access ladders to be installed	Low	Client advised	Outstanding	OH&S REGULATIONS 3.7 AS/NZS 1657-2013 3.1.4
28	Building: General Stores Location Reference: L13 Task: Access to the roof

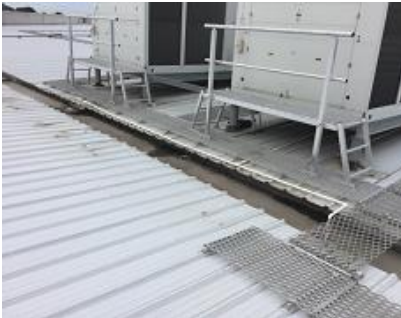
Walkway width is less than required minimum	Trips, Slips and Falls	Awareness induction	Med	Additional walkway sections to be installed	Low	Client advised	Outstanding	OH&S REGULATIONS 3.7 AS/NZS 1657-2013 5.1.3

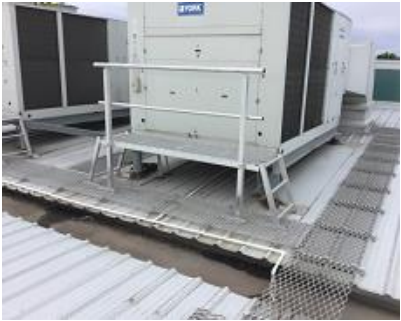
Non-complaint ladder is present	Trips, Slips and Falls	Awareness induction	Med	Existing ladder to be removed and new ladder to be installed	Low	Client advised	Outstanding	OH&S REGULATIONS 3.7 AS/NZS 1657-2013 7.4
30	Building: General Stores Location Reference: L13 Task: Access to the roof

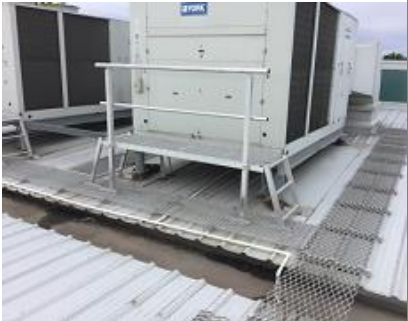
Non-complaint ladder is present	Trips, Slips and Falls	Awareness induction	Med	Existing ladder to be removed and new ladder to be installed	Low	Client advised	Outstanding	OH&S REGULATIONS 3.7 AS/NZS 1657-2013 7.4

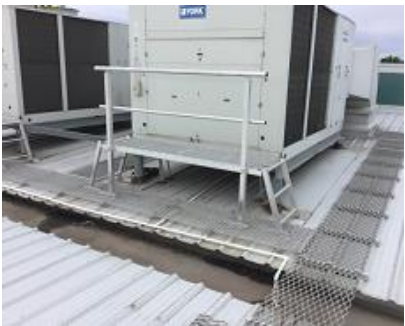
No	Photo of Hazard	Details of Hazard	Details of Risk	Existing/ Immediate Control Measure	Curre nt Risk Level	Proposed Permanent Solution	Resid ual Risk Asse sme nt	Details of Action Taken	Status	Reference
31	Building: General Stores Location Reference: L13 Task: Access to the roof

Sharp edges on handrails	Trips, Slips and Falls	Awareness induction	Med	Tek screws to be replaced with rivets	Low	Client advised	Outstanding	OH&S REGULATIONS 3.7 AS/NZS 1657-2013 5.6
32	Building: General Stores Location Reference: L14 Task: Access to the roof

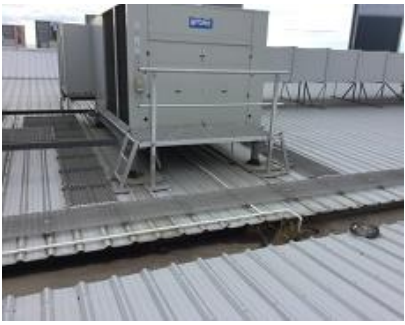
Sharp edges on handrails	Trips, Slips and Falls	Awareness induction	Med	Tek screws to be replaced with rivets	Low	Client advised	Outstanding	OH&S REGULATIONS 3.7 AS/NZS 1657-2013 5.6

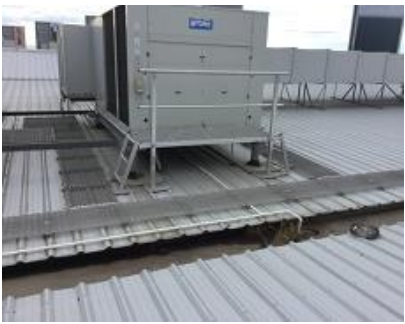
No	Photo of Hazard	Details of Hazard	Details of Risk	Existing/ Immediate Control Measure	Curre nt Risk Level	Proposed Permanent Solution	Resid ual Risk Asse sme nt	Details of Action Taken	Status	Reference
33	Building: General Stores Location Reference: L14 Task: Access to the roof

Non-complaint ladder is present	Trips, Slips and Falls	Awareness induction	Med	Existing ladder to be removed and new ladder to be installed	Low	Client advised	Outstanding	OH&S REGULATIONS 3.7 AS/NZS 1657-2013 7.4
34	Building: General Stores Location Reference: L14 Task: Access to the roof

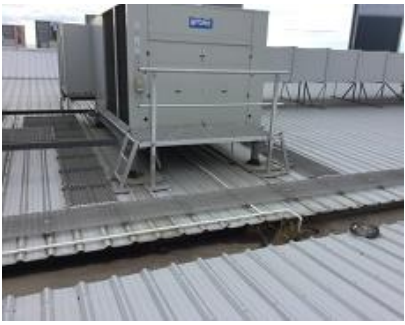
Non-complaint ladder is present	Trips, Slips and Falls	Awareness induction	Med	Existing ladder to be removed and new ladder to be installed	Low	Client advised	Outstanding	OH&S REGULATIONS 3.7 AS/NZS 1657-2013 7.4

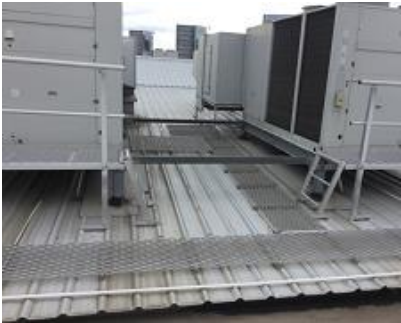
Bracings installed over the walkway path	Trips, Slips and Falls	Awareness induction	Med	Access ladders to be installed	Low	Client advised	Outstanding	OH&S REGULATIONS 3.7 AS/NZS 1657-2013 3.1.4
36	Building: General Stores Location Reference: L14 Task: Access to the roof

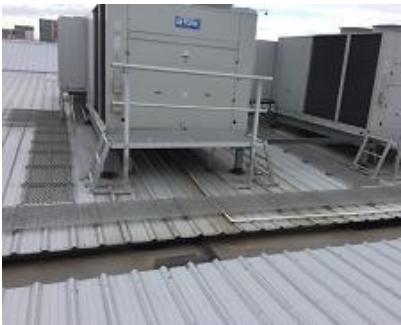
Non-complaint ladder is present	Trips, Slips and Falls	Awareness induction	Med	Existing ladder to be removed and new ladder to be installed	Low	Client advised	Outstanding	OH&S REGULATIONS 3.7 AS/NZS 1657-2013 7.4

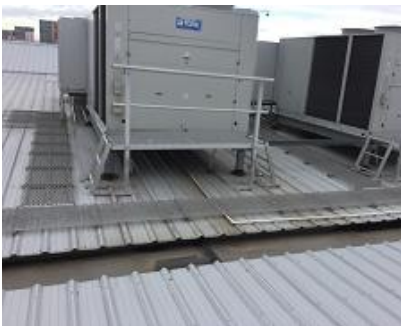
No	Photo of Hazard	Details of Hazard	Details of Risk	Existing/ Immediate Control Measure	Curre nt Risk Level	Proposed Permanent Solution	Resid ual Risk Asse sme nt	Details of Action Taken	Status	Reference
37	Building: General Stores Location Reference: L14 Task: Access to the roof

Non-complaint ladder is present	Trips, Slips and Falls	Awareness induction	Med	Existing ladder to be removed and new ladder to be installed	Low	Client advised	Outstanding	OH&S REGULATIONS 3.7 AS/NZS 1657-2013 7.4
38	Building: General Stores Location Reference: L14 Task: Access to the roof

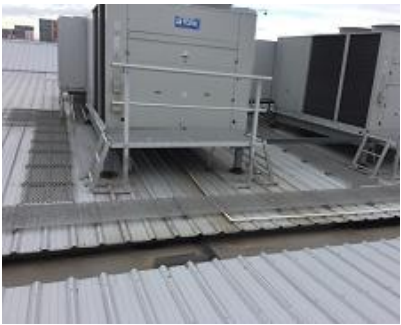
Sharp edges on handrails	Trips, Slips and Falls	Awareness induction	Med	Tek screws to be replaced with rivets	Low	Client advised	Outstanding	OH&S REGULATIONS 3.7 AS/NZS 1657-2013 5.6

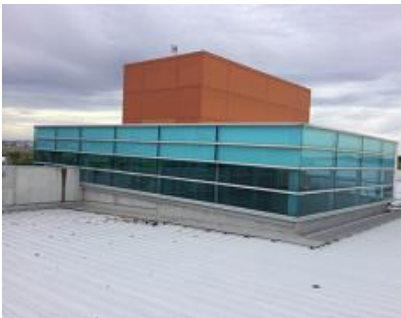
No height safety system installed	Trips, Slips and Falls	Restrict Access	High	"EWP Access Only" signs to be installed	Low	Client advised	Outstanding	OH&S REGULATIONS 3.55 & 3.11

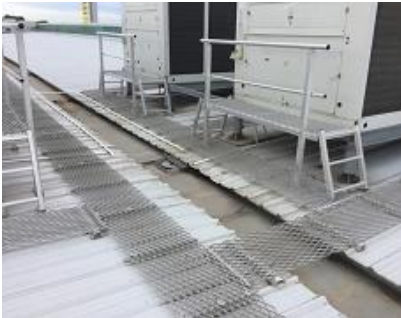
Non-complaint ladders(x8) are present	Trips, Slips and Falls	Awareness induction	Med	Existing ladders(x8) to be removed and new ladders(x8) to be installed	Low	Client advised	Outstanding	OH&S REGULATIONS 3.7 AS/NZS 1657-2013 7.4

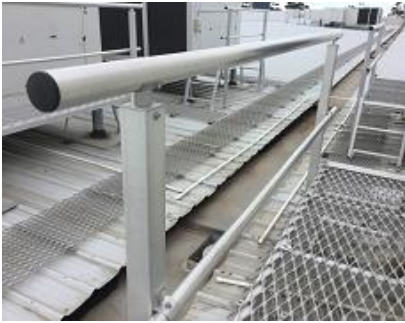
No	Photo of Hazard	Details of Hazard	Details of Risk	Existing/ Immediate Control Measure	Curre nt Risk Level	Proposed Permanent Solution	Resid ual Risk Asse sme nt	Details of Action Taken	Status	Reference
43	Building: General Stores Location Reference: L16 Task: Access to the roof

Sharp edges on handrails	Trips, Slips and Falls	Awareness induction	Med	Tek screws to be replaced with rivets for handrail (x4)	Low	Client advised	Outstanding	OH&S REGULATIONS 3.7 AS/NZS 1657-2013 5.6
44	Building: General Stores Location Reference: L16 Task: Access to the roof

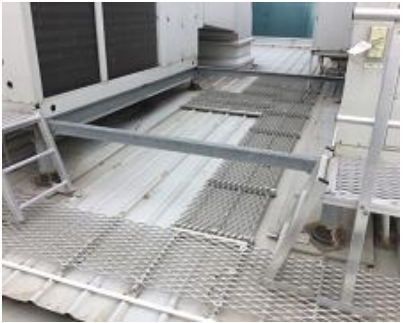
Bracings installed over the walkway path	Trips, Slips and Falls	Awareness induction	Med	Access ladders(x4) to be installed	Low	Client advised	Outstanding	OH&S REGULATIONS 3.7 AS/NZS 1657-2013 3.1.4

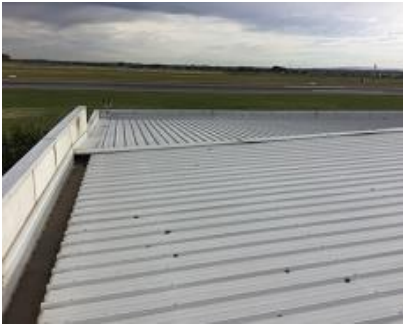
No height safety system installed	Trips, Slips and Falls	Awareness induction	High	Fall arrest anchors to be installed	Low	Client advised	Outstanding	OH&S REGULATIONS 3.55
46	Building: General Stores Location Reference: L19 Task: Access to the roof

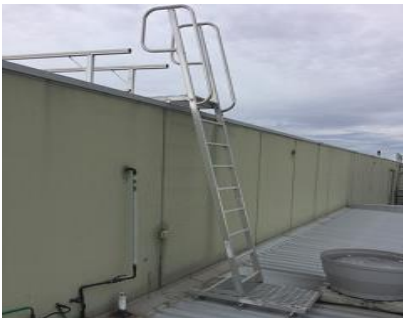
Bottom rung heights are less than required minimum, landing is less than required minimum and handrail projecting towards the user	Trips, Slips and Falls	Awareness induction	Med	Existing handrail to be removed. Existing ladder to be re-installed with landing platforms, brackets and handrails	Low	Client advised	Outstanding	OH&S REGULATIONS 3.7 AS/NZS 1657-2013 7.4.3.4, 7.3.6 & 7.4.8.5

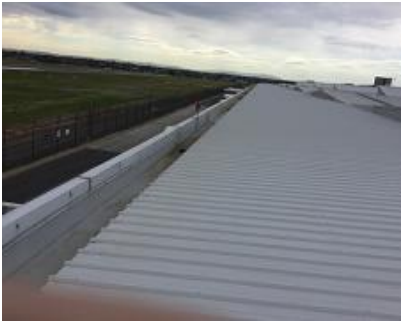
No height safety system installed	Trips, Slips and Falls	Awareness induction	High	Fall arrest anchors to be installed	Low	Client advised	Outstanding	OH&S REGULATIONS 3.55
48	Building: General Stores Location Reference: L20 Task: Access to the roof

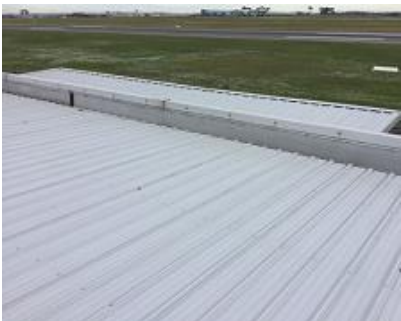
No height safety and access system installed	Trips, Slips and Falls	Awareness induction	High	Fall arrest anchors and access ladder to be installed	Low	Client advised	Outstanding	OH&S REGULATIONS 3.7 AS/NZS 1657-2013 3.1.4

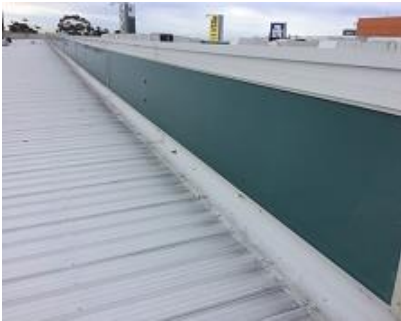
Brittle roof (Non-trafficable roof)	Trips, Slips and Falls	Restrict Access	High	"Warning-Keep Off-Brittle and Fragile Roof" signs to be installed	Low	Client advised	Outstanding	OH&S REGULATIONS 3.57
50	Building: General Stores Location Reference: L22 Task: Access to the roof

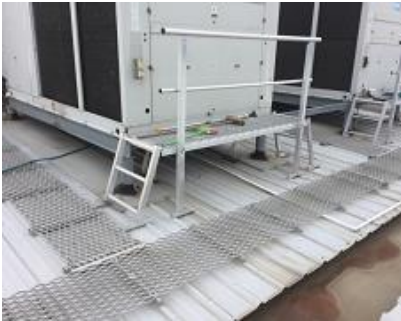
Non-complaint ladders(x4) are present	Trips, Slips and Falls	Awareness induction	Med	Existing ladders(x4) to be removed and new ladders(x4) to be installed	Low	Client advised	Outstanding	OH&S REGULATIONS 3.7 AS/NZS 1657-2013 7.4

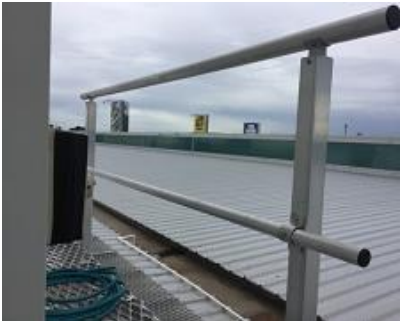
Sharp edges on handrails	Trips, Slips and Falls	Awareness induction	Med	Tek screws to be replaced with rivets for handrail (x2)	Low	Client advised	Outstanding	OH&S REGULATIONS 3.7 AS/NZS 1657-2013 5.6
52	Building: General Stores Location Reference: L22 Task: Access to the roof

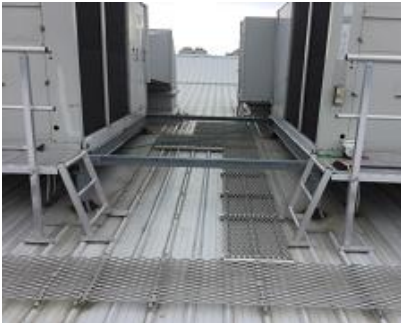
Bracings installed over the walkway path	Trips, Slips and Falls	Awareness induction	Med	Access ladders(x2) to be installed	Low	Client advised	Outstanding	OH&S REGULATIONS 3.7 AS/NZS 1657-2013 3.1.4

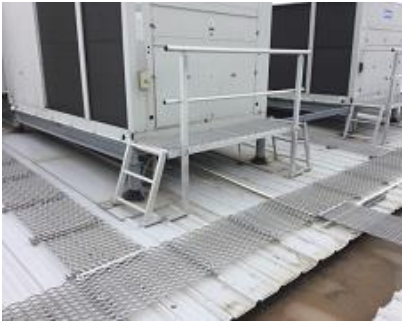
Non-complaint ladders(x4) are present	Trips, Slips and Falls	Awareness induction	Med	Existing ladders(x4) to be removed and new ladders(x4) to be installed	Low	Client advised	Outsta nding	OH&S REGULATIONS 3.7 AS/NZS 1657- 2013 7.4
54	Building: General Stores Location Reference: L23 Task: Access to the roof

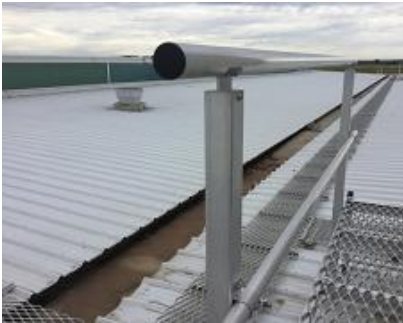
Sharp edges on handrails	Trips, Slips and Falls	Awareness induction	Med	Tek screws to be replaced with rivets for handrail (x2)	Low	Client advised	Outsta nding	OH&S REGULATIONS 3.7 AS/NZS 1657- 2013 5.6

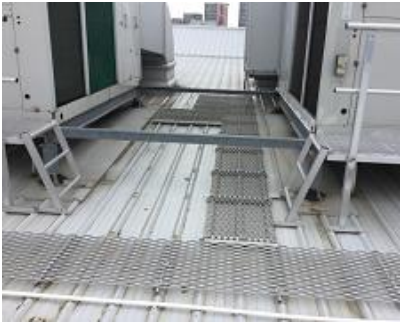
Bracings installed over the walkway path	Trips, Slips and Falls	Awareness induction	Med	Access ladders(x2) to be installed	Low	Client advised	Outstanding	OH&S REGULATIONS 3.7 AS/NZS 1657-2013 3.1.4
56	Building: General Stores Location Reference: L23 Task: Access to the A/c units

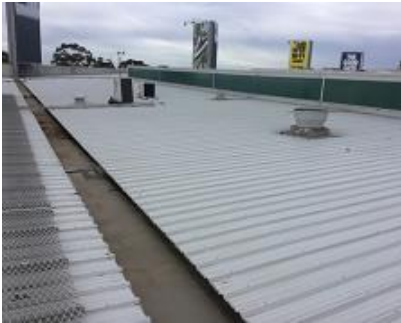
No safe access to the A/c units	Trips, Slips and Falls	N/A	Low	Supply walkway to the A/c units	Low	Client advised	Outstanding	-

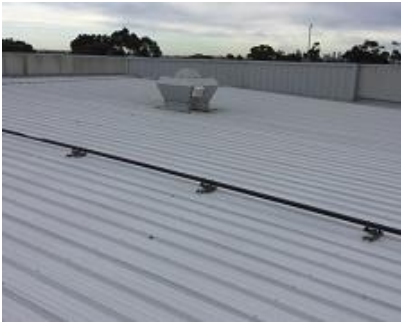
No safe access to the A/c units	Trips, Slips and Falls	N/A	Low	Supply walkway to the A/c units	Low	Client advised	Outstanding	-
58	Building: General Stores Location Reference: L24 Task: Access to the roof

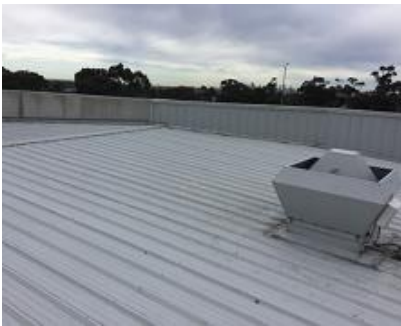
No height safety system installed	Trips, Slips and Falls	Awareness induction	High	Fall arrest anchors to be installed	Low	Client advised	Outstanding	OH&S REGULATIONS 3.55

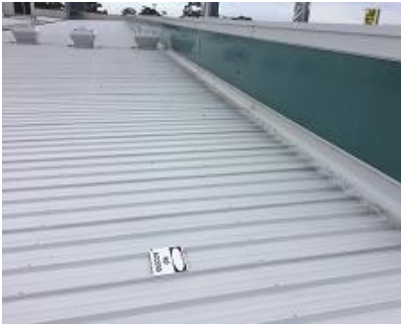
Brittle roof (Non-trafficable roof)	Trips, Slips and Falls	Restrict Access	High	"Warning-Keep Off-Brittle and Fragile Roof" signs to be installed	Low	Client advised	Outstanding	OH&S REGULATIONS 3.57
60	Building: General Stores Location Reference: L26 Task: Access to the roof

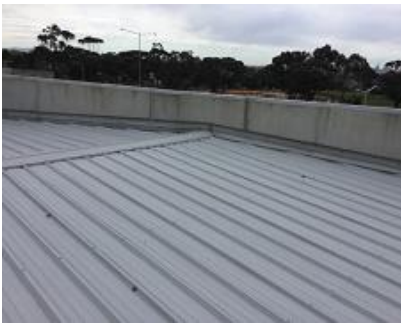
No height safety system installed	Trips, Slips and Falls	Awareness induction	High	Fall arrest anchors to be installed	Low	Client advised	Outstanding	OH&S REGULATIONS 3.55

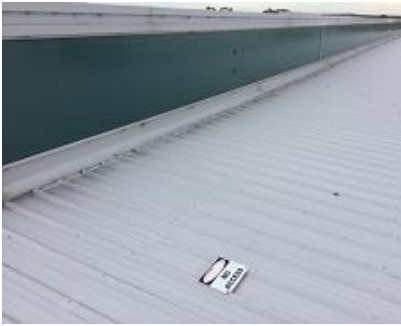
Brittle roof (Non-trafficable roof)	Trips, Slips and Falls	Restrict Access	High	"Warning-Keep Off-Brittle and Fragile Roof" signs to be installed	Low	Client advised	Outstanding	OH&S REGULATIONS 3.57
62	Building: General Stores Location Reference: L27 Task: Access to the roof

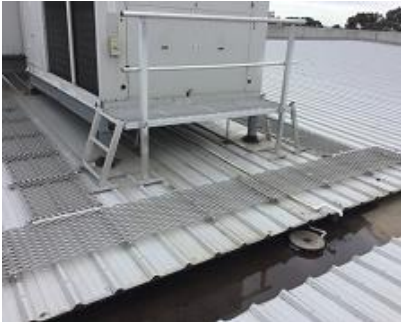
Non-complaint ladders(x2) are present	Trips, Slips and Falls	Awareness induction	Med	Existing ladders(x2) to be removed and new ladders(x2) to be installed	Low	Client advised	Outstanding	OH&S REGULATIONS 3.7 AS/NZS 1657-2013 7.4

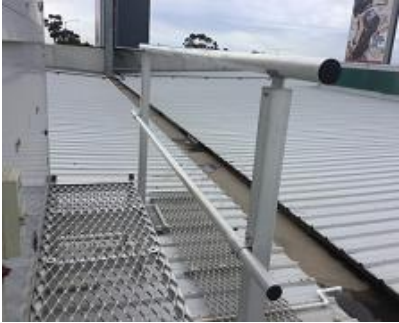
Sharp edges on handrails	Trips, Slips and Falls	Awareness induction	Med	Tek screws to be replaced with rivets for handrail (x1)	Low	Client advised	Outstanding	OH&S REGULATIONS 3.7 AS/NZS 1657-2013 5.6
64	Building: General Stores Location Reference: L28 Task: Access to the roof

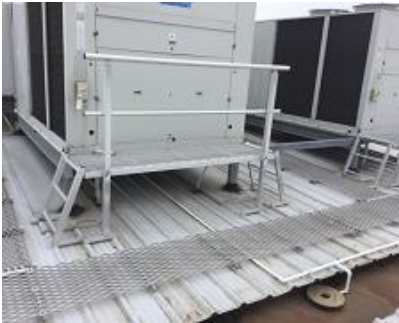
Non-complaint ladders(x4) are present	Trips, Slips and Falls	Awareness induction	Med	Existing ladders(x4) to be removed and new ladders(x4) to be installed	Low	Client advised	Outstanding	OH&S REGULATIONS 3.7 AS/NZS 1657-2013 7.4

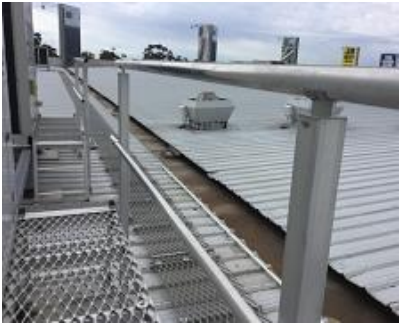
Sharp edges on handrails	Trips, Slips and Falls	Awareness induction	Med	Tek screws to be replaced with rivets for handrail (x2)	Low	Client advised	Outsta nding	OH&S REGULATIONS 3.7 AS/NZS 1657- 2013 5.6
66	Building: General Stores Location Reference: L28 Task: Access to the roof

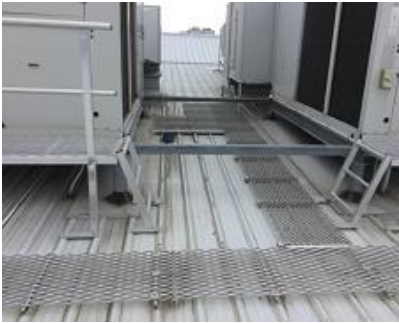
Bracings installed over the walkway path	Trips, Slips and Falls	Awareness induction	Med	Access ladders(x2) to be installed	Low	Client advised	Outsta nding	OH&S REGULATIONS 3.7 AS/NZS 1657- 2013 3.1.4

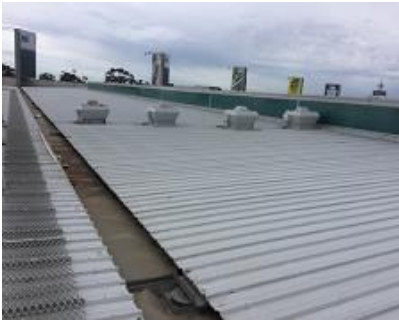
No safe access to the A/c units	Trips, Slips and Falls	N/A	Low	Supply walkway to the A/c units	Low	Client advised	Outstanding	-
68	Building: General Stores Location Reference: L29 Task: Access to the roof

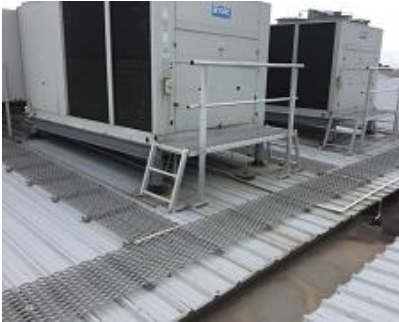
Non-complaint ladders(x4) are present	Trips, Slips and Falls	Awareness induction	Med	Existing ladders(x4) to be removed and new ladders(x4) to be installed	Low	Client advised	Outstanding	OH&S REGULATIONS 3.7 AS/NZS 1657-2013 7.4

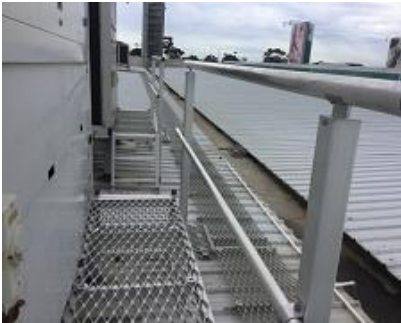
Sharp edges on handrails	Trips, Slips and Falls	Awareness induction	Med	Tek screws to be replaced with rivets for handrail (x2)	Low	Client advised	Outsta nding	OH&S REGULATIONS 3.7 AS/NZS 1657- 2013 5.6
70	Building: General Stores Location Reference: L30 Task: Access to the roof

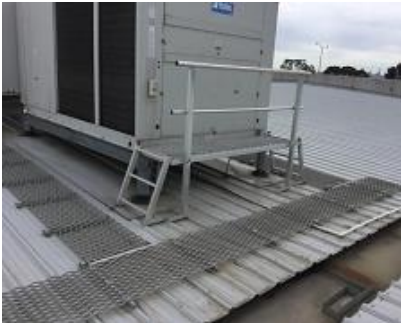
Non-complaint ladders(x2) are present	Trips, Slips and Falls	Awareness induction	Med	Existing ladders(x2) to be removed and new ladders(x2) to be installed	Low	Client advised	Outsta nding	OH&S REGULATIONS 3.7 AS/NZS 1657- 2013 7.4

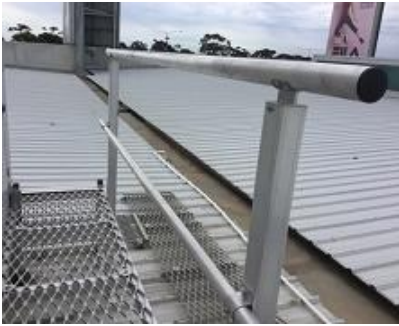
Sharp edges on handrails	Trips, Slips and Falls	Awareness induction	Med	Tek screws to be replaced with rivets for handrail (x1)	Low	Client advised	Outsta nding	OH&S REGULATIONS 3.7 AS/NZS 1657- 2013 5.6
72	Building: General Stores Location Reference: L31 Task: Access to the roof

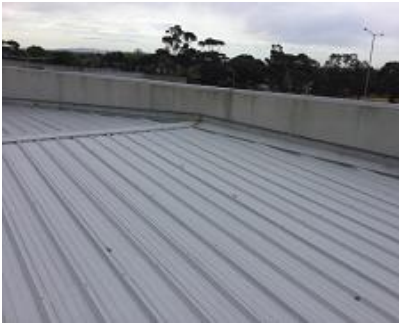
No height safety system installed	Trips, Slips and Falls	Awareness induction	High	Fall arrest anchors to be installed	Low	Client advised	Outsta nding	OH&S REGULATIONS 3.55

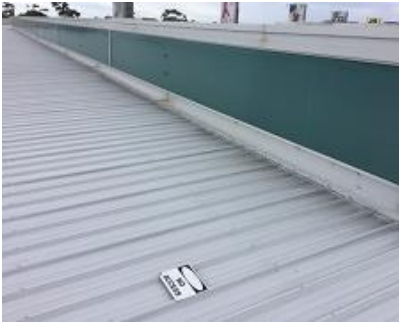
Brittle roof (Non-trafficable roof)	Trips, Slips and Falls	Restrict Access	High	"Warning-Keep Off-Brittle and Fragile Roof" signs to be installed	Low	Client advised	Outstanding	OH&S REGULATIONS 3.57
74	Building: General Stores Location Reference: L32 Task: Access to the roof

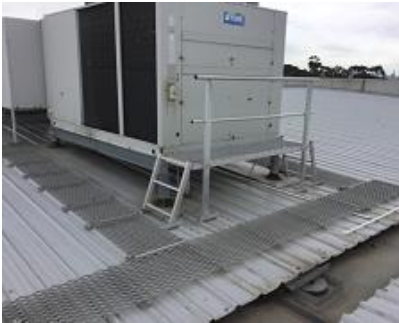
Non-complaint ladders(x2) are present	Trips, Slips and Falls	Awareness induction	Med	Existing ladders(x2) to be removed and new ladders(x2) to be installed	Low	Client advised	Outstanding	OH&S REGULATIONS 3.7 AS/NZS 1657-2013 7.4

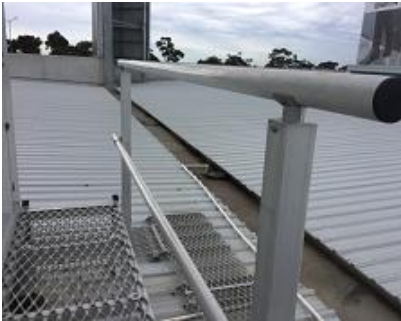
Sharp edges on handrails	Trips, Slips and Falls	Awareness induction	Med	Tek screws to be replaced with rivets for handrail (x1)	Low	Client advised	Outstanding	OH&S REGULATIONS 3.7 AS/NZS 1657-2013 5.6
76	Building: General Stores Location Reference: L33 Task: Access to the roof

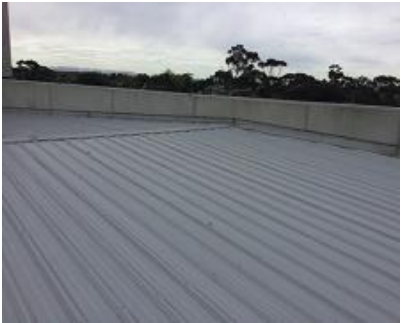
No height safety system installed	Trips, Slips and Falls	Awareness induction	High	Fall arrest anchors to be installed	Low	Client advised	Outstanding	OH&S REGULATIONS 3.55

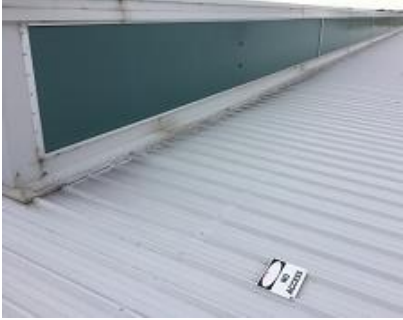
Brittle roof (Non-trafficable roof)	Trips, Slips and Falls	Restrict Access	High	"Warning-Keep Off-Brittle and Fragile Roof" signs to be installed	Low	Client advised	Outstanding	OH&S REGULATIONS 3.57
78	Building: General Stores Location Reference: L34 Task: Access to the roof

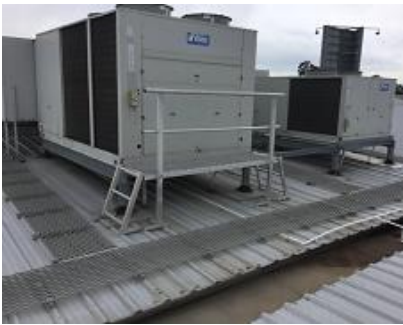
Non-complaint ladders(x2) are present	Trips, Slips and Falls	Awareness induction	Med	Existing ladders(x2) to be removed and new ladders(x2) to be installed	Low	Client advised	Outstanding	OH&S REGULATIONS 3.7 AS/NZS 1657-2013 7.4

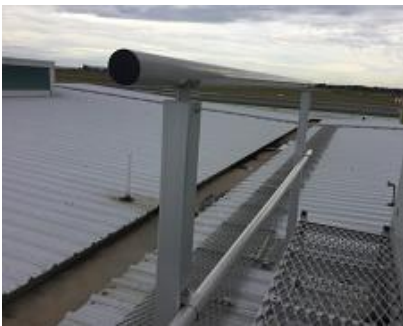
Sharp edges on handrails	Trips, Slips and Falls	Awareness induction	Med	Tek screws to be replaced with rivets for handrail (x1)	Low	Client advised	Outstanding	OH&S REGULATIONS 3.7 AS/NZS 1657-2013 5.6
80	Building: General Stores Location Reference: L34 Task: Access to the roof

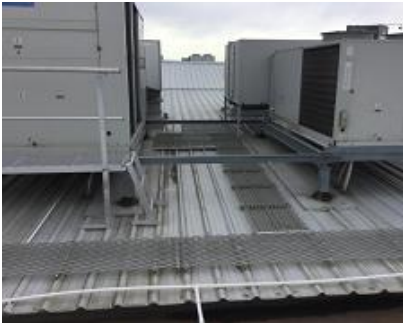
Bracings installed over the walkway path	Trips, Slips and Falls	Awareness induction	Med	Access ladders(x2) to be installed	Low	Client advised	Outstanding	OH&S REGULATIONS 3.7 AS/NZS 1657-2013 3.1.4

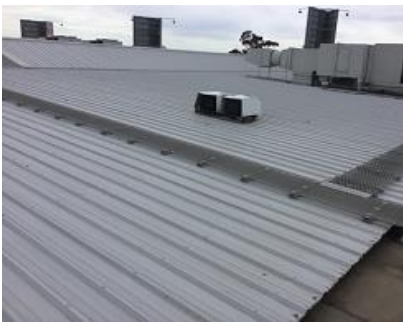
No safe access to the A/c units	Trips, Slips and Falls	N/A	Low	Supply walkway to the A/c units	Low	Client advised	Outstanding	-
82	Building: General Stores Location Reference: L35 Task: Access to the roof

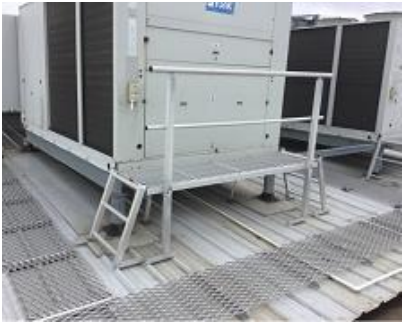
Non-complaint ladders(x4) are present	Trips, Slips and Falls	Awareness induction	Med	Existing ladders(x4) to be removed and new ladders(x4) to be installed	Low	Client advised	Outstanding	OH&S REGULATIONS 3.7 AS/NZS 1657-2013 7.4

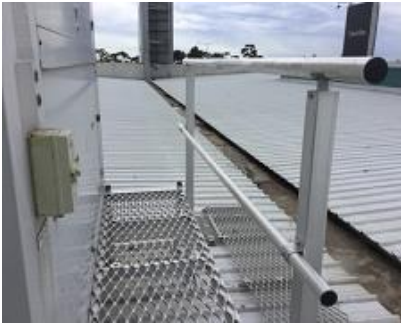
Sharp edges on handrails	Trips, Slips and Falls	Awareness induction	Med	Tek screws to be replaced with rivets for handrail (x2)	Low	Client advised	Outsta nding	OH&S REGULATIONS 3.7 AS/NZS 1657- 2013 5.6
84	Building: General Stores Location Reference: L35 Task: Access to the roof

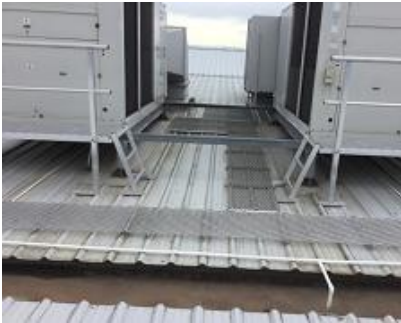
Bracings installed over the walkway path	Trips, Slips and Falls	Awareness induction	Med	Access ladders(x2) to be installed	Low	Client advised	Outsta nding	OH&S REGULATIONS 3.7 AS/NZS 1657- 2013 3.1.4

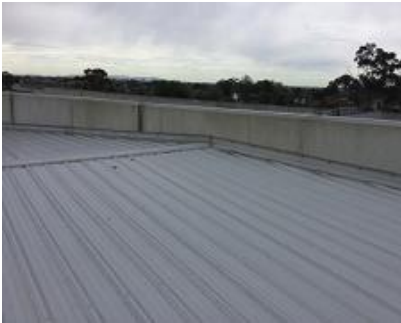
No height safety system installed	Trips, Slips and Falls	Awareness induction	High	Fall arrest anchors to be installed	Low	Client advised	Outstanding	OH&S REGULATIONS 3.55
86	Building: General Stores Location Reference: L36 Task: Restrict access to the roof

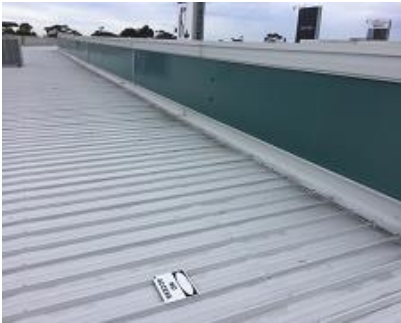
Brittle roof (Non-trafficable roof)	Trips, Slips and Falls	Restrict Access	High	"Warning-Keep Off-Brittle and Fragile Roof" signs to be installed	Low	Client advised	Outstanding	OH&S REGULATIONS 3.57

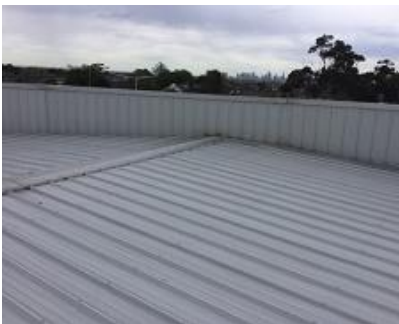
No height safety system installed	Trips, Slips and Falls	Awareness induction	High	Fall arrest anchors to be installed	Low	Client advised	Outstanding	OH&S REGULATIONS 3.55
88	Building: General Stores Location Reference: L37 Task: Access to the A/c units

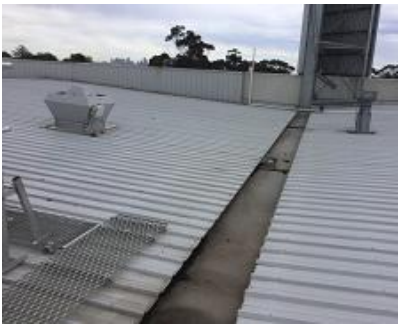
No safe access to the A/c units	Trips, Slips and Falls	N/A	Low	Supply walkway to the A/c units	Low	Client advised	Outstanding	-

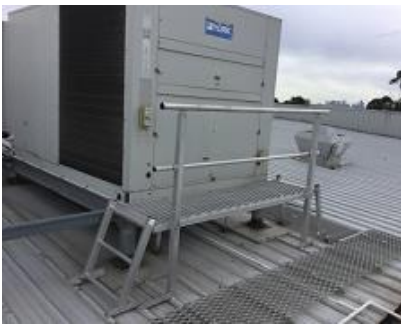
Non-compliant ladders(x2) are present	Trips, Slips and Falls	Awareness induction	Med	Existing ladders(x2) to be removed and new ladders(x2) to be installed	Low	Client advised	Outstanding	OH&S REGULATIONS 3.7 AS/NZS 1657-2013 7.4
90	Building: General Stores Location Reference: L38 Task: Access to the roof

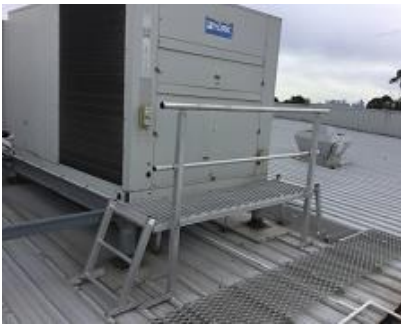
Sharp edges on handrails	Trips, Slips and Falls	Awareness induction	Med	Tek screws to be replaced with rivets for handrail (x1)	Low	Client advised	Outstanding	OH&S REGULATIONS 3.7 AS/NZS 1657-2013 5.6

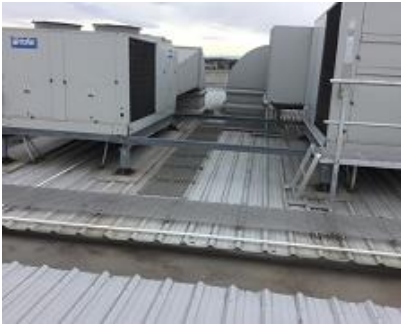
Bracings installed over the walkway path	Trips, Slips and Falls	Awareness induction	Med	Access ladders(x2) to be installed	Low	Client advised	Outstanding	OH&S REGULATIONS 3.7 AS/NZS 1657-2013 3.1.4
92	Building: General Stores Location Reference: L38 Task: Access to the A/c units

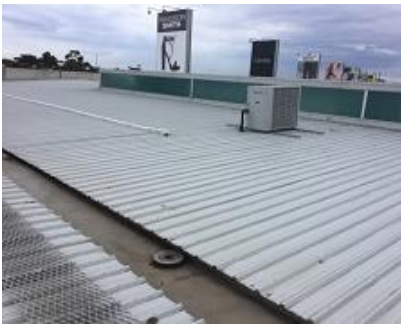
No safe access to the A/c units	Trips, Slips and Falls	N/A	Low	Supply walkway to the A/c units	Low	Client advised	Outstanding	-

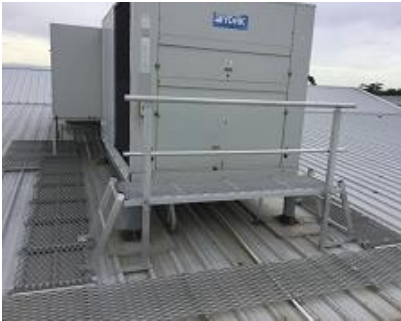
Non-complaint ladders(x2) are present	Trips, Slips and Falls	Awareness induction	Med	Existing ladders(x2) to be removed and new ladders(x2) to be installed	Low	Client advised	Outsta nding	OH&S REGULATIONS 3.7 AS/NZS 1657- 2013 7.4
94	Building: General Stores Location Reference: L39 Task: Access to the roof

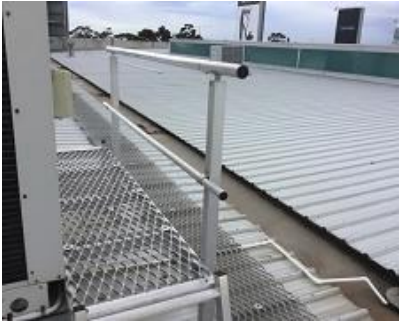
Sharp edges on handrails	Trips, Slips and Falls	Awareness induction	Med	Tek screws to be replaced with rivets for handrail (x1)	Low	Client advised	Outsta nding	OH&S REGULATIONS 3.7 AS/NZS 1657- 2013 5.6

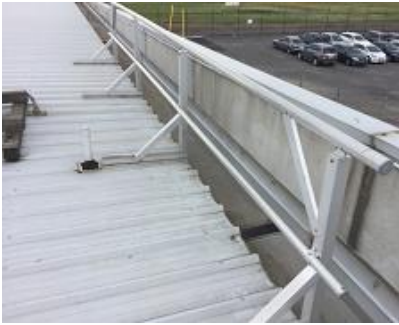
Sharp edges on handrails	Trips, Slips and Falls	Awareness induction	Med	Tek screws to be replaced with rivets	Low	Client advised	Outstanding	OH&S REGULATIONS 3.7 AS/NZS 1657-2013 5.6
96	Building: General Stores Location Reference: L40 Task: Restrict access to the roof

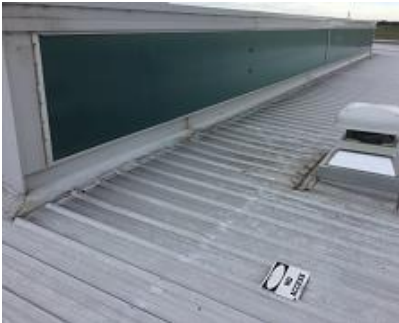
Brittle roof (Non-trafficable roof)	Trips, Slips and Falls	Restrict Access	High	"Warning-Keep Off-Brittle and Fragile Roof" signs to be installed	Low	Client advised	Outstanding	OH&S REGULATIONS 3.57

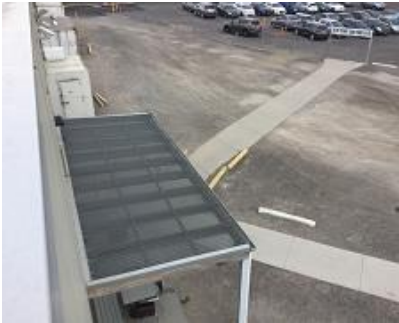
Brittle roof (Non-trafficable roof)	Trips, Slips and Falls	Restrict Access	High	"Warning-Keep Off-Brittle and Fragile Roof" signs to be installed	Low	Client advised	Outstanding	OH&S REGULATIONS 3.57
98	Building: General Stores Location Reference: L40 Task: Access to the A/c units

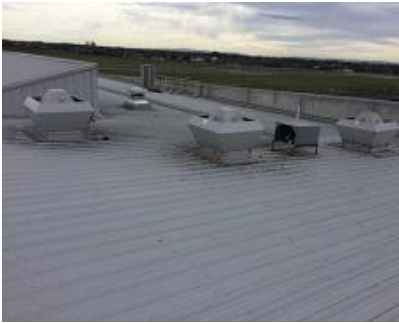
No safe access to the A/c units	Trips, Slips and Falls	N/A	Low	Supply walkway to the A/c units	Low	Client advised	Outstanding	-

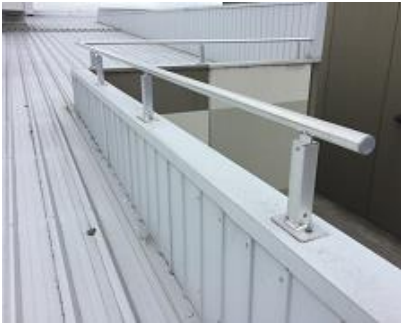
Sharp edges on handrails	Trips, Slips and Falls	Awareness induction	Med	Tek screws to be replaced with rivets	Low	Client advised	Outstanding	OH&S REGULATIONS 3.7 AS/NZS 1657-2013 5.6
100	Building: General Stores Location Reference: L41 Task: Access to the A/c units

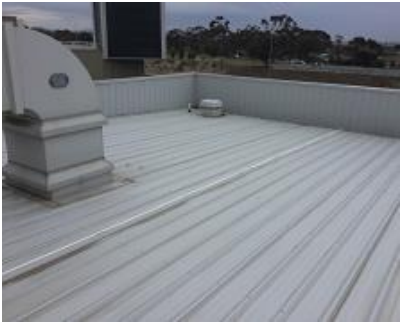
No safe access to the A/c units	Trips, Slips and Falls	N/A	Low	Supply walkway to the A/c units	Low	Client advised	Outstanding	-

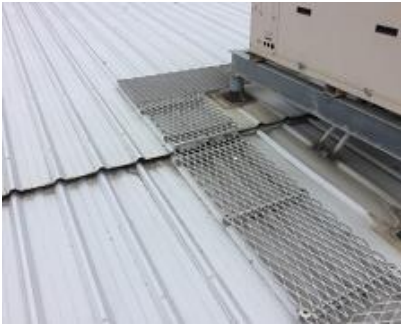
Variation in height between walkway panels are greater than required maximum	Trips, Slips and Falls	Awareness induction	Med	High visibility safety yellow nosing to be installed	Low	Client advised	Outstanding	OH&S REGULATIONS 3.7 AS/NZS 1657-2013 3.3.4
102	Building: General Stores Location Reference: L42 Task: Access to the roof

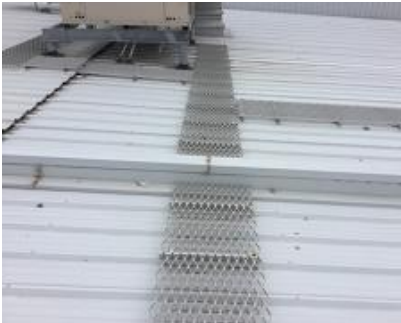
Variation in height between roofs are greater than required maximum	Trips, Slips and Falls	Awareness induction	Med	Step over including handrail to be installed	Low	Client advised	Outstanding	OH&S REGULATIONS 3.7 AS/NZS 1657-2013 3.1.4

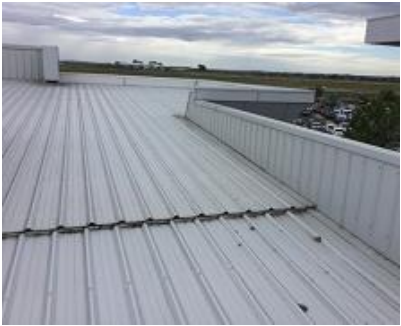
No height safety system installed	Trips, Slips and Falls	Awareness induction	High	Fall arrest anchors to be installed	Low	Client advised	Outstanding	OH&S REGULATIONS 3.55
104	Building: General Stores Location Reference: L43 Task: Access to the roof

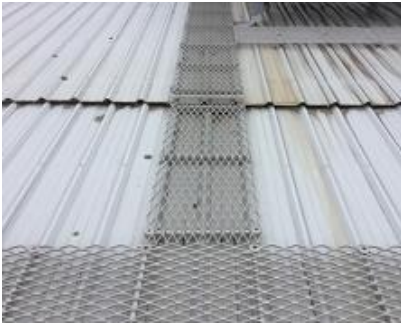
Variation in height between walkway panels are greater than required maximum	Trips, Slips and Falls	Awareness induction	Med	High visibility safety yellow nosing to be installed	Low	Client advised	Outstanding	OH&S REGULATIONS 3.7 AS/NZS 1657-2013 3.3.4

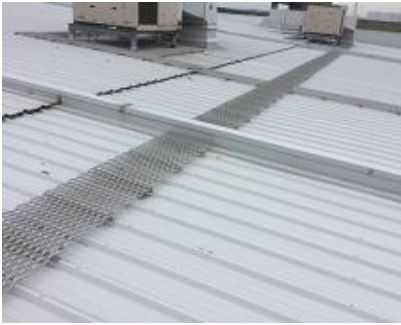
Variation in height between roofs are greater than required maximum	Trips, Slips and Falls	Awareness induction	Med	Step over including handrail to be installed	Low	Client advised	Outstanding	OH&S REGULATIONS 3.7 AS/NZS 1657-2013 3.1.4
106	Building: General Stores Location Reference: L43 Task: Access to the roof

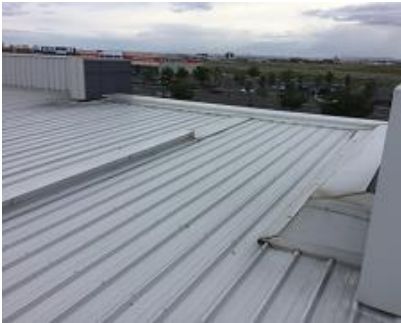
No height safety system installed	Trips, Slips and Falls	Awareness induction	High	Fall arrest anchors to be installed	Low	Client advised	Outstanding	OH&S REGULATIONS 3.55

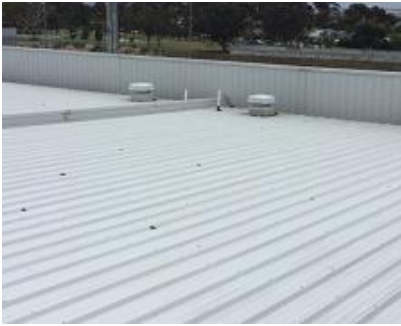
No safe access to the A/c units	Trips, Slips and Falls	N/A	Low	Supply walkway and step over including handrail to the A/c units	Low	Client advised	Outstanding	-
108	Building: General Stores Location Reference: L45 Task: Access to the roof

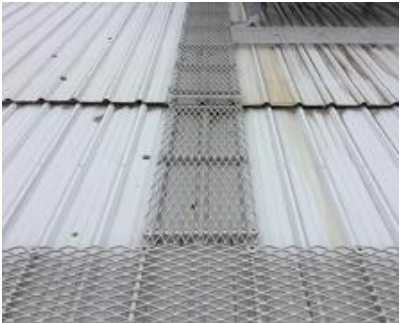
Variation in height between walkway panels are greater than required maximum	Trips, Slips and Falls	Awareness induction	Med	High visibility safety yellow nosing to be installed	Low	Client advised	Outstanding	OH&S REGULATIONS 3.7 AS/NZS 1657-2013 3.3.4

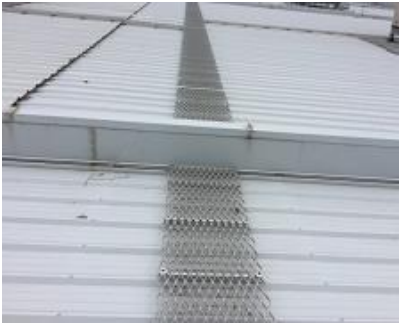
Variation in height between roofs are greater than required maximum	Trips, Slips and Falls	Awareness induction	Med	Single step including high visibility safety yellow nosing's to be installed	Low	Client advised	Outstanding	OH&S REGULATIONS 3.7 AS/NZS 1657-2013 3.1.4
110	Building: General Stores Location Reference: L45 Task: Access to the roof

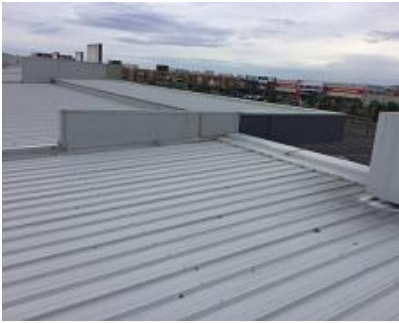
No height safety system installed	Trips, Slips and Falls	Awareness induction	High	Fall arrest anchors to be installed	Low	Client advised	Outstanding	OH&S REGULATIONS 3.55

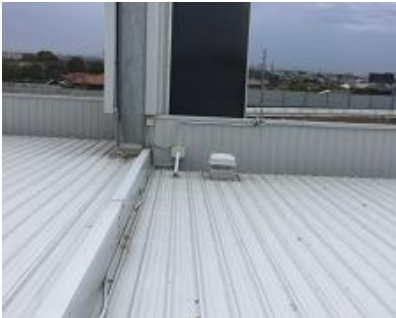
No height safety system installed	Trips, Slips and Falls	Awareness induction	High	Handrail to be installed	Low	Client advised	Outstanding	OH&S REGULATIONS 3.55
112	Building: General Stores Location Reference: L46 Task: Access to the A/c unit

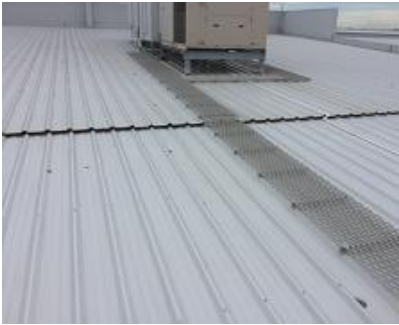
Variation in height between walkway panels are greater than required maximum	Trips, Slips and Falls	Awareness induction	Med	High visibility safety yellow nosing to be installed	Low	Client advised	Outstanding	OH&S REGULATIONS 3.7 AS/NZS 1657-2013 3.3.4
114	Building: General Stores Location Reference: L47 Task: Access to the roof

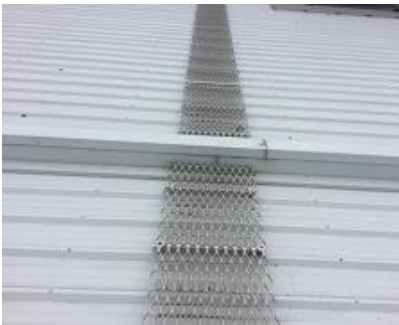
Variation in height between roofs are greater than required maximum	Trips, Slips and Falls	Awareness induction	Med	Step over including handrail to be installed	Low	Client advised	Outstanding	OH&S REGULATIONS 3.7 AS/NZS 1657-2013 3.1.4
