Roof Safety Report

DFO Essendon, VIC 3041

Prepared By: Safemaster Safety Products
Date: 08 May 2018

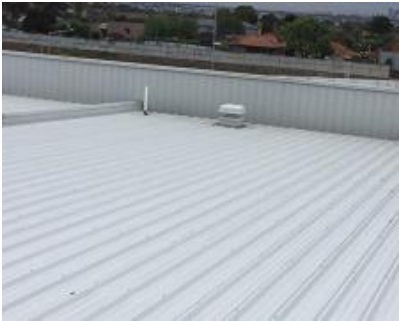
No safe access to the A/c units	Trips, Slips and Falls	N/A	Low	Supply walkway to the A/c units	Low	Client advised	Outstanding	-
116	Building: General Stores Location Reference: L48 Task: Access to the roof

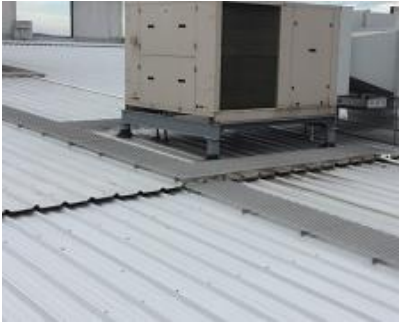
Variation in height between walkway panels are greater than required maximum	Trips, Slips and Falls	Awareness induction	Med	High visibility safety yellow nosing to be installed	Low	Client advised	Outstanding	OH&S REGULATIONS 3.7 AS/NZS 1657-2013 3.3.4

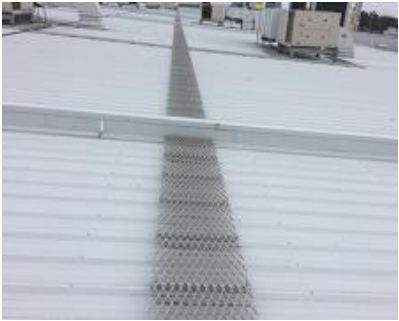
Variation in height between roofs are greater than required maximum	Trips, Slips and Falls	Awareness induction	Med	Step over including handrail to be installed	Low	Client advised	Outstanding	OH&S REGULATIONS 3.7 AS/NZS 1657-2013 3.1.4
118	Building: General Stores Location Reference: L49 Task: Access to the roof

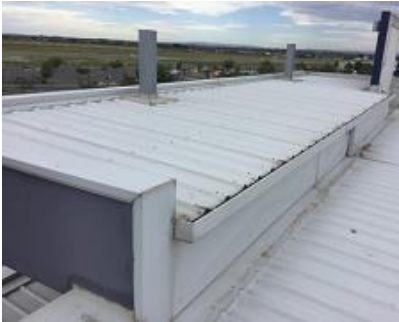
No height safety system installed	Trips, Slips and Falls	Awareness induction	High	Fall arrest anchors to be installed	Low	Client advised	Outstanding	OH&S REGULATIONS 3.55

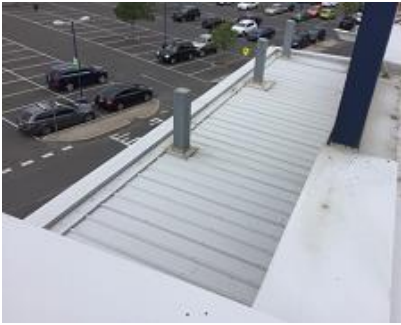
No height safety system installed	Trips, Slips and Falls	Awareness induction	High	Fall arrest anchors and access ladder to be installed	Low	Client advised	Outstanding	OH&S REGULATIONS 3.55
120	Building: General Stores Location Reference: L49 Task: Access to the roof

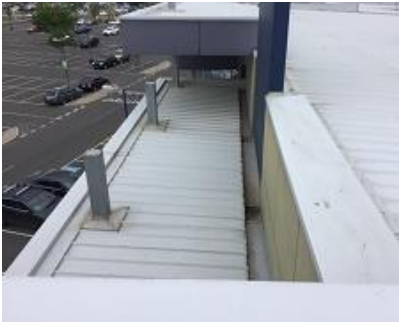
No height safety system installed	Trips, Slips and Falls	Awareness induction	High	Fall arrest anchors and access ladder to be installed	Low	Client advised	Outstanding	OH&S REGULATIONS 3.55

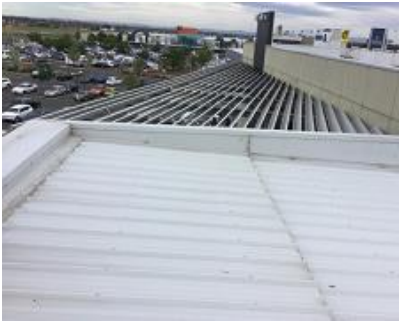
No height safety system installed	Trips, Slips and Falls	Awareness induction	High	Fall arrest anchors to be installed	Low	Client advised	Outstanding	OH&S REGULATIONS 3.55
122	Building: General Stores Location Reference: L50 Task: Access to the roof

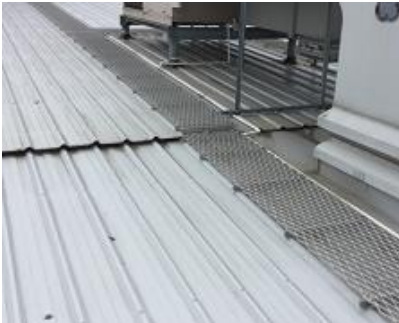
Variation in height between walkway panels are greater than required maximum	Trips, Slips and Falls	Awareness induction	Med	High visibility safety yellow nosing to be installed	Low	Client advised	Outstanding	OH&S REGULATIONS 3.7 AS/NZS 1657-2013 3.3.4

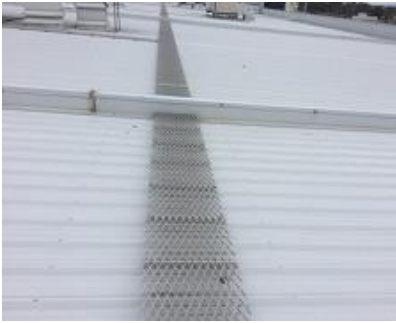
Variation in height between roofs are greater than required maximum	Trips, Slips and Falls	Awareness induction	Med	Step over including handrail to be installed	Low	Client advised	Outstanding	OH&S REGULATIONS 3.7 AS/NZS 1657-2013 3.1.4
124	Building: General Stores Location Reference: L50 Task: Access to the roof

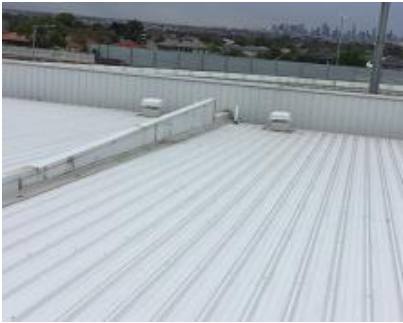
No safe access to the A/c units	Trips, Slips and Falls	N/A	Low	Supply walkway and step over including handrail to the A/c units	Low	Client advised	Outstanding	-

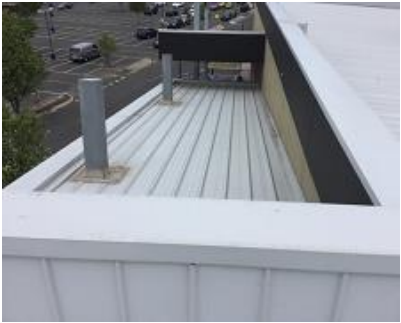
No height safety system installed	Trips, Slips and Falls	Awareness induction	High	Fall arrest anchors and access ladder to be installed	Low	Client advised	Outstanding	OH&S REGULATIONS 3.55
126	Building: General Stores Location Reference: L51 Task: Access to the roof

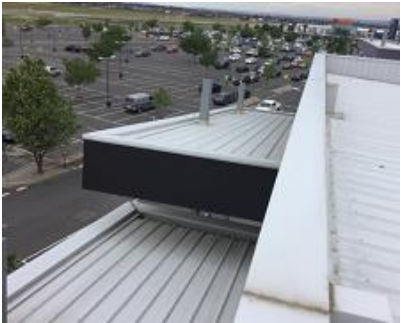
No height safety system installed	Trips, Slips and Falls	Awareness induction	High	Fall arrest anchors and access ladder to be installed	Low	Client advised	Outstanding	OH&S REGULATIONS 3.55

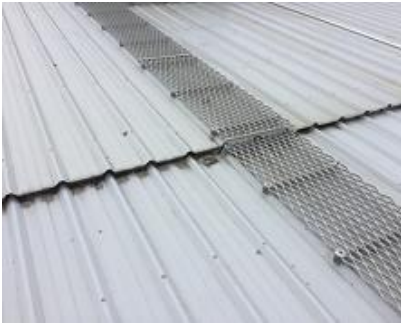
Variation in height between walkway panels are greater than required maximum	Trips, Slips and Falls	Awareness induction	Med	High visibility safety yellow nosing to be installed	Low	Client advised	Outstanding	OH&S REGULATIONS 3.7 AS/NZS 1657-2013 3.3.4
128	Building: General Stores Location Reference: L52 Task: Access to the roof

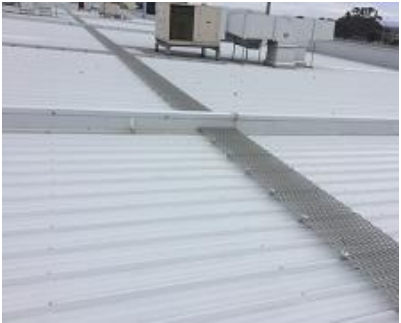
Variation in height between roofs are greater than required maximum	Trips, Slips and Falls	Awareness induction	Med	Step over including handrail to be installed	Low	Client advised	Outstanding	OH&S REGULATIONS 3.7 AS/NZS 1657-2013 3.1.4

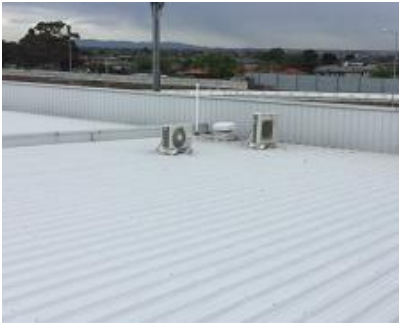
No safe access to the A/c units	Trips, Slips and Falls	N/A	Low	Supply walkway to the A/c units	Low	Client advised	Outstanding	-
130	Building: General Stores Location Reference: L53 Task: Access to the roof

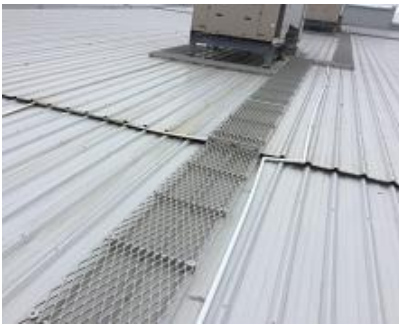
Variation in height between walkway panels are greater than required maximum	Trips, Slips and Falls	Awareness induction	Med	High visibility safety yellow nosing to be installed	Low	Client advised	Outstanding	OH&S REGULATIONS 3.7 AS/NZS 1657-2013 3.3.4

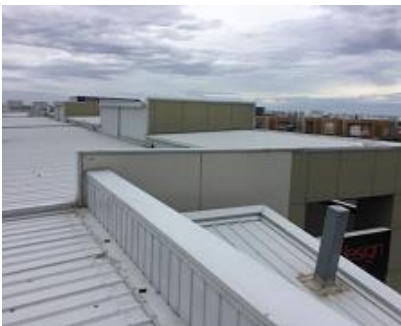
No height safety system installed	Trips, Slips and Falls	Awareness induction	High	Fall arrest anchors, anchor strops and access ladders to be installed	Low	Client advised	Outstanding	OH&S REGULATIONS 3.7 & 3.55 AS/NZS 1657-2013 3.1.4
132	Building: General Stores Location Reference: L55 Task: Access to the roof

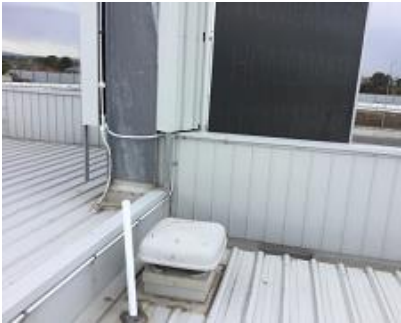
No height safety system installed	Trips, Slips and Falls	Awareness induction	High	Handrail to be installed	Low	Client advised	Outstanding	OH&S REGULATIONS 3.55

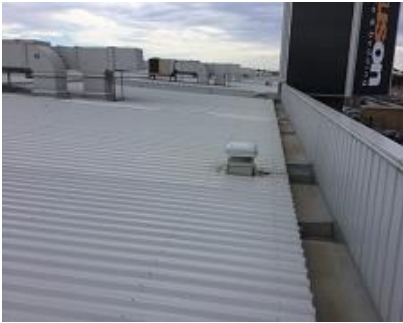
No safe access to the A/c units	Trips, Slips and Falls	N/A	Low	Supply walkway to the A/c units	Low	Client advised	Outstanding	-
134	Building: General Stores Location Reference: L55 Task: Access to the roof

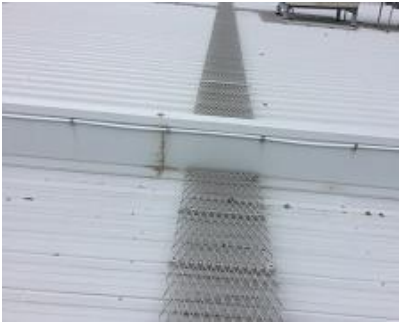
Variation in height between roofs are greater than required maximum	Trips, Slips and Falls	Awareness induction	Med	Step over including handrail to be installed	Low	Client advised	Outstanding	OH&S REGULATIONS 3.7 AS/NZS 1657-2013 3.1.4

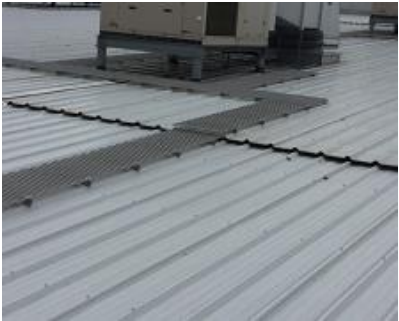
Variation in height between walkway panels are greater than required maximum	Trips, Slips and Falls	Awareness induction	Med	High visibility safety yellow nosing to be installed	Low	Client advised	Outstanding	OH&S REGULATIONS 3.7 AS/NZS 1657-2013 3.3.4
136	Building: General Stores Location Reference: L55 Task: Access to the roof

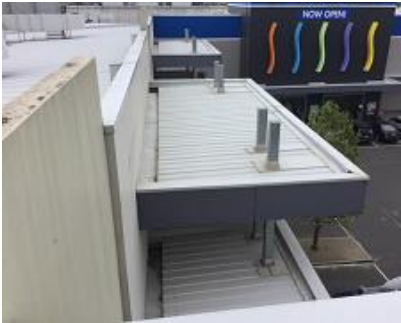
No height safety system installed	Trips, Slips and Falls	Restrict Access	High	"EWP Access Only" signs to be installed	Low	Client advised	Outstanding	OH&S REGULATIONS 3.55 & 3.11
138	Building: General Stores Location Reference: L57 Task: Access to the roof

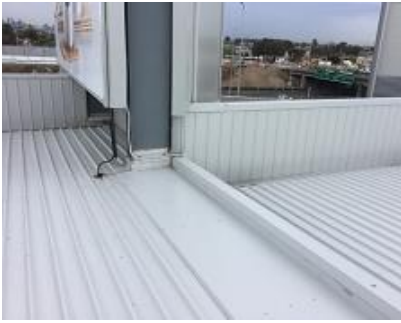
No height safety system installed	Trips, Slips and Falls	Awareness induction	High	Handrail to be installed	Low	Client advised	Outstanding	OH&S REGULATIONS 3.55

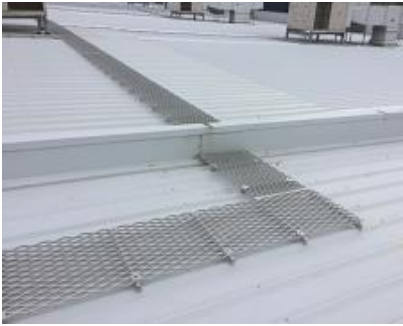
Variation in height between roofs are greater than required maximum	Trips, Slips and Falls	Awareness induction	Med	Step over including handrail to be installed	Low	Client advised	Outstanding	OH&S REGULATIONS 3.7 AS/NZS 1657-2013 3.1.4
140	Building: General Stores Location Reference: L57 Task: Access to the A/c units

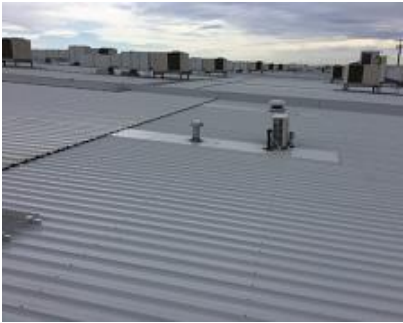
No safe access to the A/c units	Trips, Slips and Falls	N/A	Low	Supply walkway to the A/c units	Low	Client advised	Outstanding	-

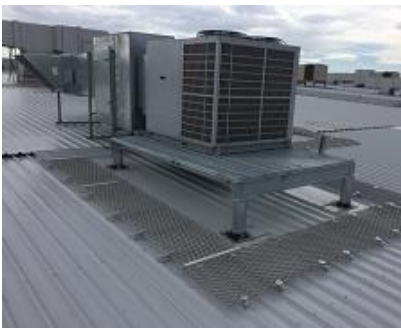
Variation in height between plant deck and roof is greater than required maximum	Trips, Slips and Falls	Awareness induction	Med	Access ladder and handrail to be installed	Low	Client advised	Outstanding	OH&S REGULATIONS 3.7 AS/NZS 1657-2013 3.1.4 & 4.4
142	Building: General Stores Location Reference: L58 Task: Access to the plant deck

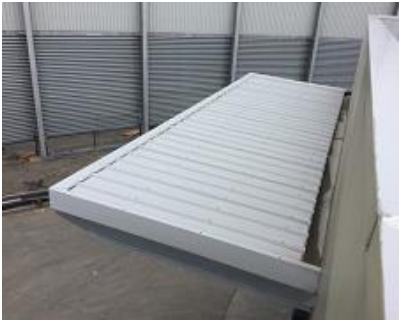
No height safety system installed	Trips, Slips and Falls	Restrict Access	High	"EWP Access Only" signs to be installed	Low	Client advised	Outstanding	OH&S REGULATIONS 3.55 & 3.11

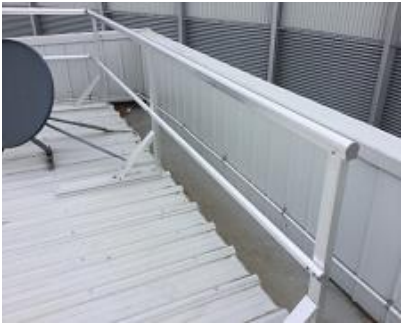
Sharp edges on handrails	Trips, Slips and Falls	Awareness induction	Med	Tek screws to be replaced with rivets	Low	Client advised	Outstanding	OH&S REGULATIONS 3.7 AS/NZS 1657-2013 5.6
144	Building: General Stores Location Reference: L59 Task: Access to the roof

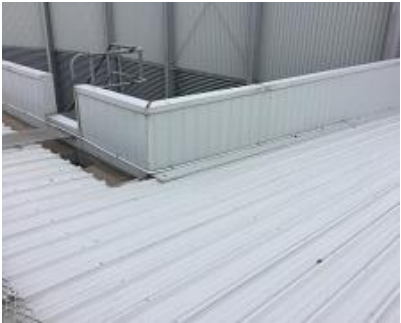
No height safety system installed	Trips, Slips and Falls	Awareness induction	High	Fall arrest anchors to be installed	Low	Client advised	Outstanding	OH&S REGULATIONS 3.55

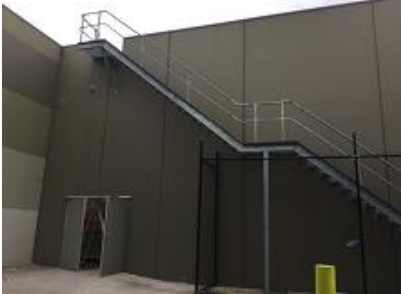
Toe board is missing for landings	Trips, Slips and Falls	Awareness induction	Med	Toe board to be installed	Low	Client advised	Outstanding	OH&S REGULATIONS 3.7 AS/NZS 1657-2013 4.6
146	Building: General Stores Location Reference: L60 Task: Access to the roof

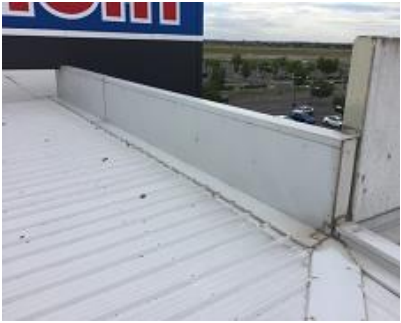
No height safety system installed	Trips, Slips and Falls	Awareness induction	High	Fall arrest anchors to be installed	Low	Client advised	Outstanding	OH&S REGULATIONS 3.55

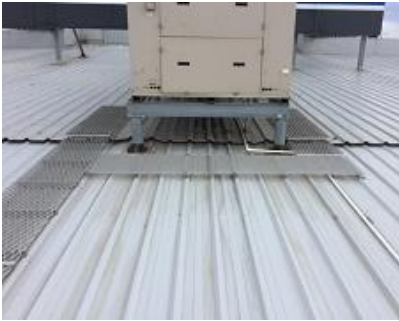
Variation in height between walkway panels are greater than required maximum	Trips, Slips and Falls	Awareness induction	Med	High visibility safety yellow nosing to be installed	Low	Client advised	Outstanding	OH&S REGULATIONS 3.7 AS/NZS 1657-2013 3.3.4
148	Building: General Stores Location Reference: L60 Task: Access to the roof

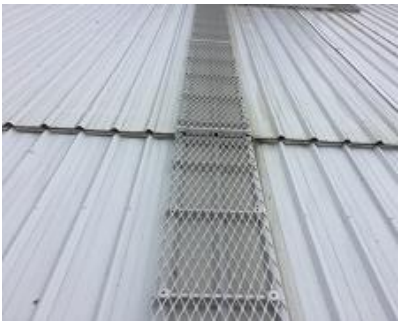
Variation in height between walkway panels are greater than required maximum	Trips, Slips and Falls	Awareness induction	Med	High visibility safety yellow nosing to be installed	Low	Client advised	Outstanding	OH&S REGULATIONS 3.7 AS/NZS 1657-2013 3.3.4

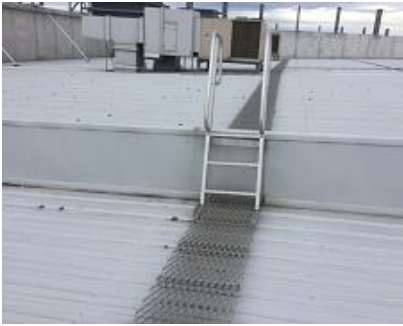
Top rung not levelled with landing, bottom rung height is less than required minimum, handrail projecting towards the user and landing is less than required minimum	Trips, Slips and Falls	Awareness induction	Med	Existing ladder to be removed and new ladder to be installed	Low	Client advised	Outstanding	OH&S REGULATIONS 3.7 AS/NZS 1657-2013 7.4.3.1, 7.4.3.4, 7.4.8.5 & 7.3.6
150	Building: General Stores Location Reference: L62 Task: Access to the roof

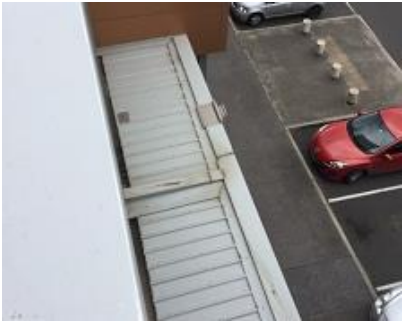
Not enough anchors installed, and anchor stop is missing for lower awning roofs	Trips, Slips and Falls	Awareness induction	High	Fall arrest anchors and stoppers to be installed	Low	Client advised	Outstanding	OH&S REGULATIONS 3.55

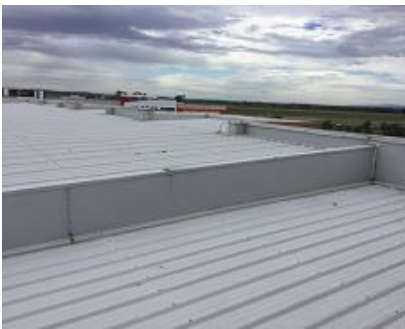
No height safety system installed	Trips, Slips and Falls	Awareness induction	High	Fall arrest anchors to be installed	Low	Client advised	Outstanding	OH&S REGULATIONS 3.55
152	Building: General Stores Location Reference: L63 Task: Access to the roof

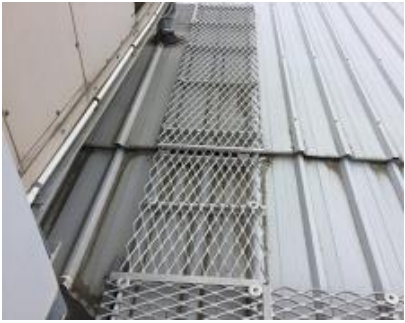
Variation in height between walkway panels are greater than required maximum	Trips, Slips and Falls	Awareness induction	Med	High visibility safety yellow nosing to be installed	Low	Client advised	Outstanding	OH&S REGULATIONS 3.7 AS/NZS 1657-2013 3.3.4

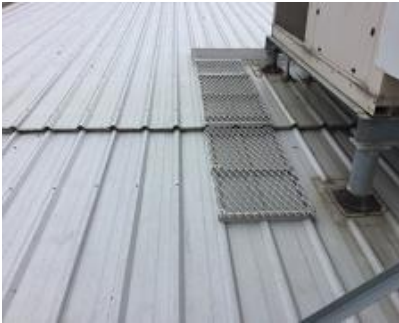
Variation in height between walkway panels are greater than required maximum	Trips, Slips and Falls	Awareness induction	Med	High visibility safety yellow nosing to be installed	Low	Client advised	Outstanding	OH&S REGULATIONS 3.7 AS/NZS 1657-2013 3.3.4
154	Building: General Stores Location Reference: L63 Task: Access to the roof

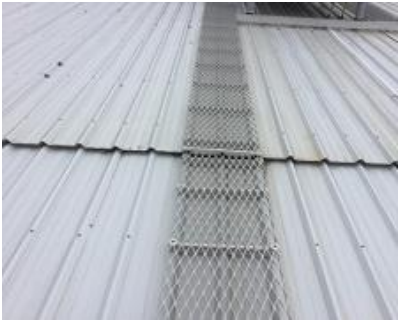
Variation in height between walkway panels are greater than required maximum	Trips, Slips and Falls	Awareness induction	Med	High visibility safety yellow nosing to be installed	Low	Client advised	Outstanding	OH&S REGULATIONS 3.7 AS/NZS 1657-2013 3.3.4

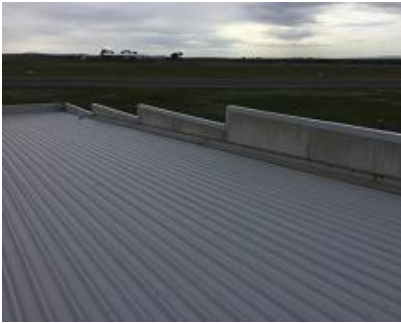
No height safety system installed	Trips, Slips and Falls	Awareness induction	High	Fall arrest anchors to be installed	Low	Client advised	Outstanding	OH&S REGULATIONS 3.55
156	Building: General Stores Location Reference: L65 Task: Access to the roof

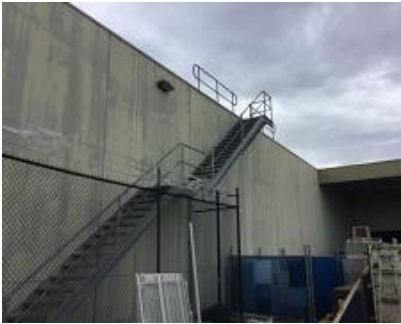
Toe board is missing for landings	Trips, Slips and Falls	Awareness induction	Med	Toe board to be installed	Low	Client advised	Outstanding	OH&S REGULATIONS 3.7 AS/NZS 1657-2013 4.6

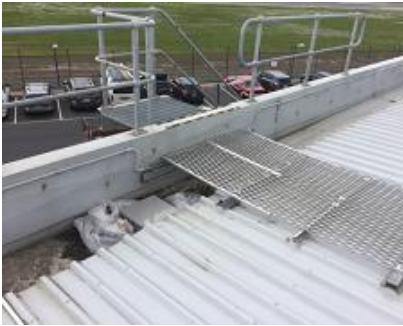
Variation in height between walkway and adjacent surface is greater than required maximum	Trips, Slips and Falls	Awareness induction	Med	Handrail to be installed	Low	Client advised	Outstanding	OH&S REGULATIONS 3.7 AS/NZS 1657-2013 4.4
158	Building: General Stores Location Reference: L66 Task: Access to the A/c units

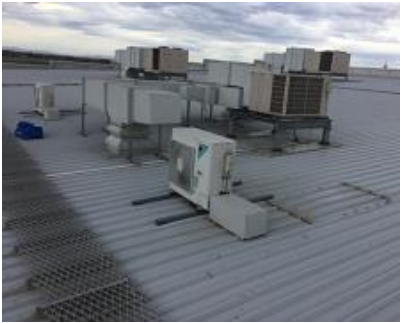
No safe access to the A/c units	Trips, Slips and Falls	N/A	Low	Supply walkway to the A/c units	Low	Client advised	Outstanding	-

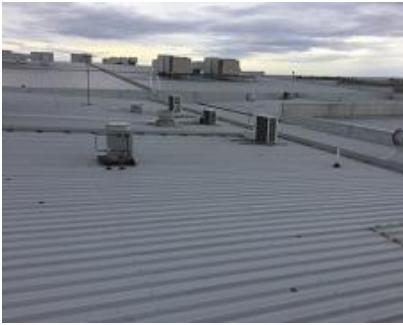
No safe access to the A/c units	Trips, Slips and Falls	N/A	Low	Supply walkway to the A/c units	Low	Client advised	Outstanding	-
160	Building: General Stores Location Reference: L67 Task: Access to the roof

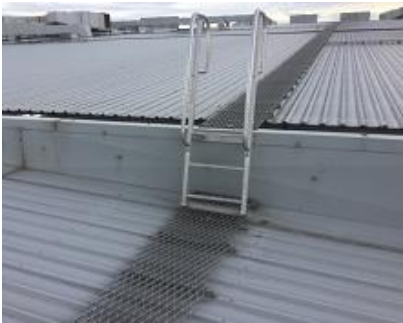
Top rung not levelled with landing, bottom rung height is less than required minimum and handrail projecting towards the user	Trips, Slips and Falls	Awareness induction	Med	Existing ladder to be removed and new ladder to be installed	Low	Client advised	Outstanding	OH&S REGULATIONS 3.7 AS/NZS 1657-2013 7.4.3.3, 7.4.3.4 & 7.4.8.5

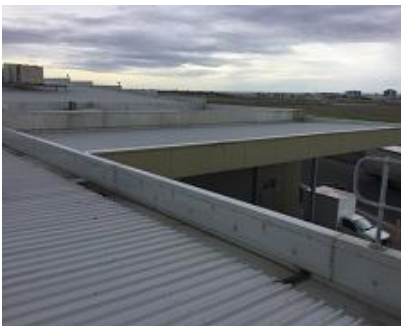
No height safety system installed	Trips, Slips and Falls	Awareness induction	High	Fall arrest anchors to be installed	Low	Client advised	Outstanding	OH&S REGULATIONS 3.55
162	Building: General Stores Location Reference: L69 Task: Access to the roof

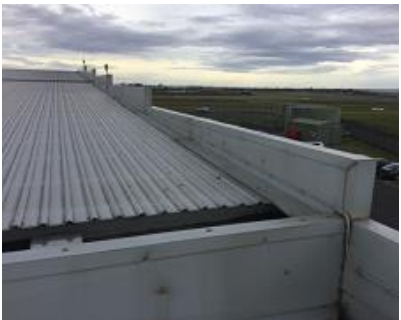
No height safety system installed	Trips, Slips and Falls	Awareness induction	High	Fall arrest anchors to be installed	Low	Client advised	Outstanding	OH&S REGULATIONS 3.55

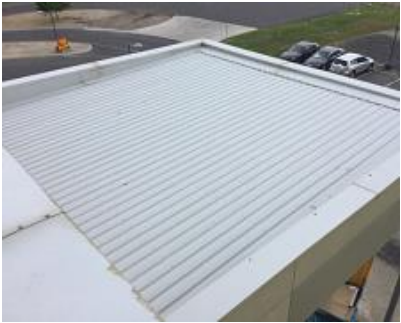
No height safety system installed	Trips, Slips and Falls	Restrict Access	High	"EWP Access Only" signs to be installed	Low	Client advised	Outstanding	OH&S REGULATIONS 3.55 & 3.11
164	Building: General Stores Location Reference: L71 Task: Access to the roof

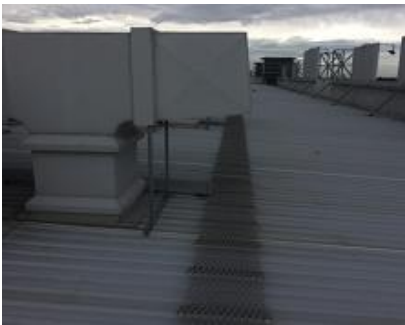
Duct protruding over the walkway path	Trips, Slips and Falls	Awareness induction	Med	Additional walkway section to be installed	Low	Client advised	Outstanding	OH&S REGULATIONS 3.7 AS/NZS 1657-2013 3.1.4

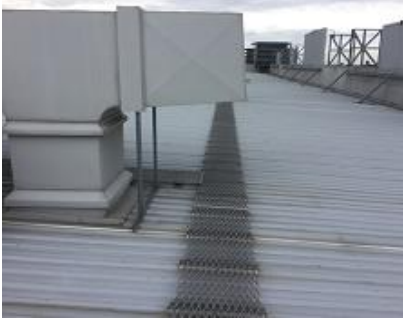
Duct protruding over the walkway path	Trips, Slips and Falls	Awareness induction	Med	Additional walkway section to be installed	Low	Client advised	Outstanding	OH&S REGULATIONS 3.7 AS/NZS 1657-2013 3.1.4
166	Building: General Stores Location Reference: L71 Task: Access to the roof

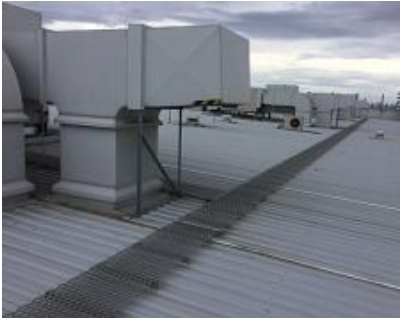
Duct protruding over the walkway path	Trips, Slips and Falls	Awareness induction	Med	Additional walkway section to be installed	Low	Client advised	Outstanding	OH&S REGULATIONS 3.7 AS/NZS 1657-2013 3.1.4

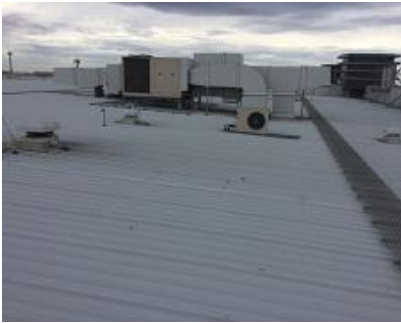
No safe access to the A/c units	Trips, Slips and Falls	N/A	Low	Supply walkway to the A/c units	Low	Client advised	Outstanding	-
168	Building: General Stores Location Reference: L71 Task: Access to the roof

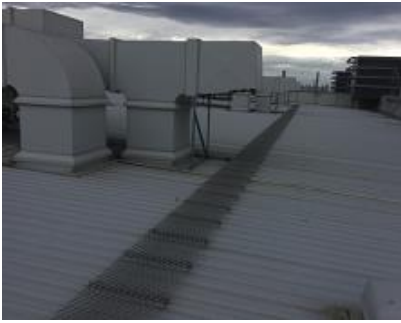
Duct protruding over the walkway path	Trips, Slips and Falls	Awareness induction	Med	Additional walkway section to be installed	Low	Client advised	Outstanding	OH&S REGULATIONS 3.7 AS/NZS 1657-2013 3.1.4

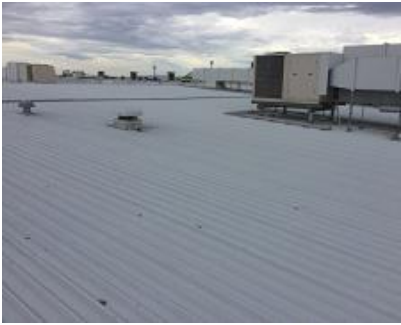
No safe access to the A/c units	Trips, Slips and Falls	N/A	Low	Supply walkway to the A/c units	Low	Client advised	Outstanding	-
170	Building: General Stores Location Reference: L71 Task: Access to the roof

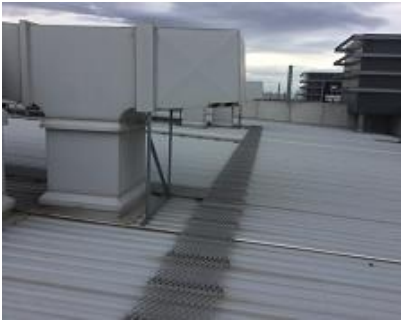
Duct protruding over the walkway path	Trips, Slips and Falls	Awareness induction	Med	Additional walkway section to be installed	Low	Client advised	Outstanding	OH&S REGULATIONS 3.7 AS/NZS 1657-2013 3.1.4

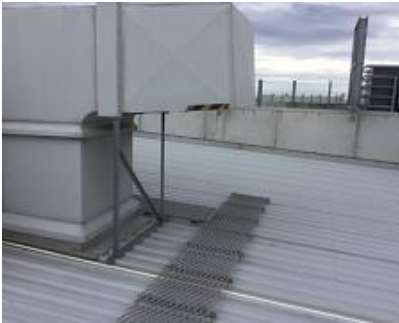
Duct protruding over the walkway path	Trips, Slips and Falls	Awareness induction	Med	Additional walkway section to be installed	Low	Client advised	Outstanding	OH&S REGULATIONS 3.7 AS/NZS 1657-2013 3.1.4
172	Building: General Stores Location Reference: L71 Task: Access to the roof

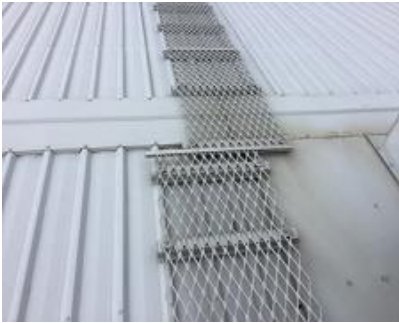
Walkway width is less than required minimum	Trips, Slips and Falls	Awareness induction	Med	Additional walkway section to be installed	Low	Client advised	Outstanding	OH&S REGULATIONS 3.7 AS/NZS 1657-2013 5.1.3

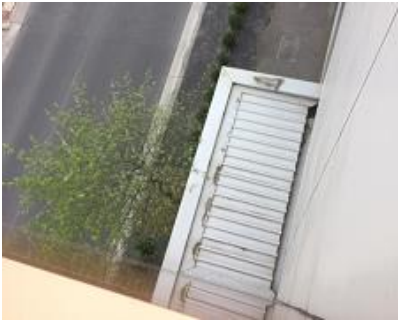
No height safety system installed for awning roofs	Trips, Slips and Falls	Awareness induction	High	Fall arrest anchors, anchor strop, ladder access bracket and sign to be installed	Low	Client advised	Outstanding	OH&S REGULATIONS 3.55
174	Building: General Stores Location Reference: L72 Task: Access to the roof

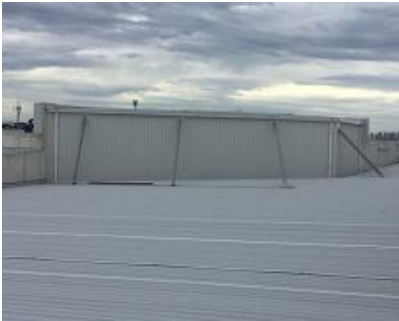
No height safety system installed for awning roofs	Trips, Slips and Falls	Awareness induction	High	Fall arrest anchors, anchor strop and access ladder to be installed	Low	Client advised	Outstanding	OH&S REGULATIONS 3.7 & 3.55 AS/NZS 1657-2013 3.1.4

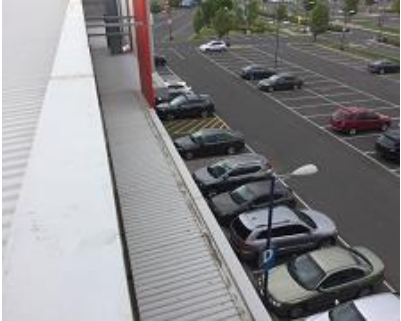
No height safety system installed	Trips, Slips and Falls	Restrict Access	High	"EWP Access Only" signs to be installed	Low	Client advised	Outstanding	OH&S REGULATIONS 3.55 & 3.11

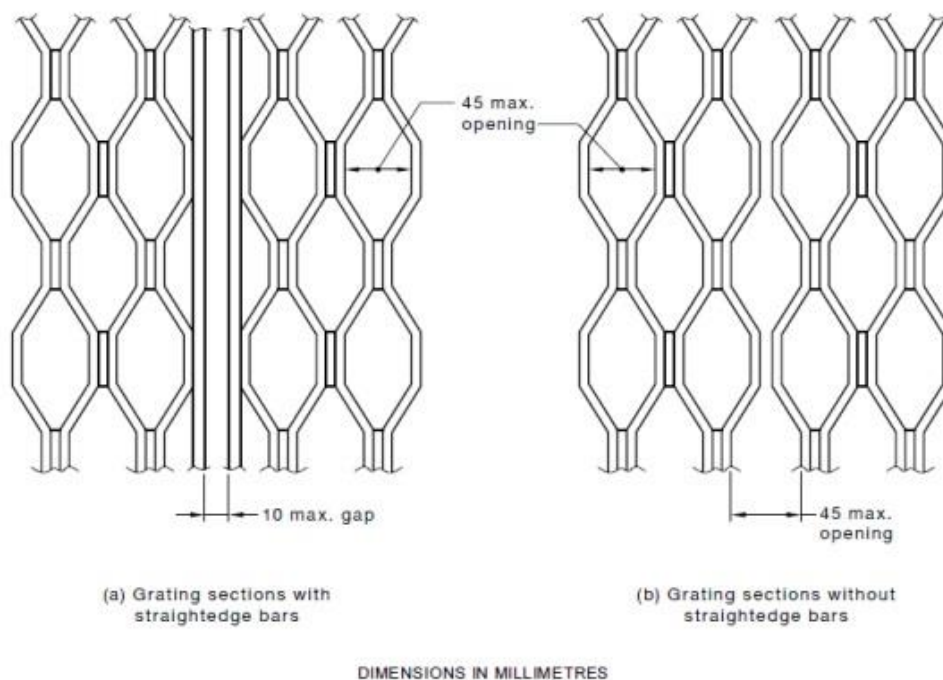
Where straightedge bars are not fitted, the size of any opening at the joint between adjacent panels shall not exceed the requirements for openings in the grating, as given in Figure 3.1.

FIGURE 3.1 CLEARANCES BETWEEN ADJOINING PANELS OF GRATING

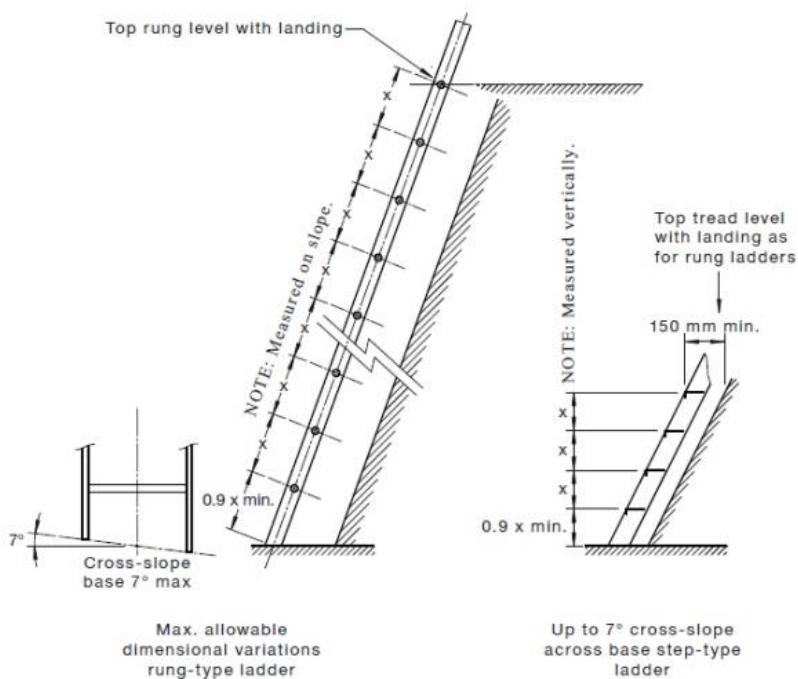
The distance between the bottom rung/tread and the bottom landing shall be not less than 90% and not greater than 100% of the rung/tread spacing (see Figure 7.5).

- 1 This distance should be measured at the ladder centre-line where the landing has a cross-slope (see Figure 7.5).
- 2 Where possible, the distance between the landing and the first rung/tread should be equal to the rung/tread spacing.

FIGURE 7.5 VARIATION OF RUNG/TREAD SPACING

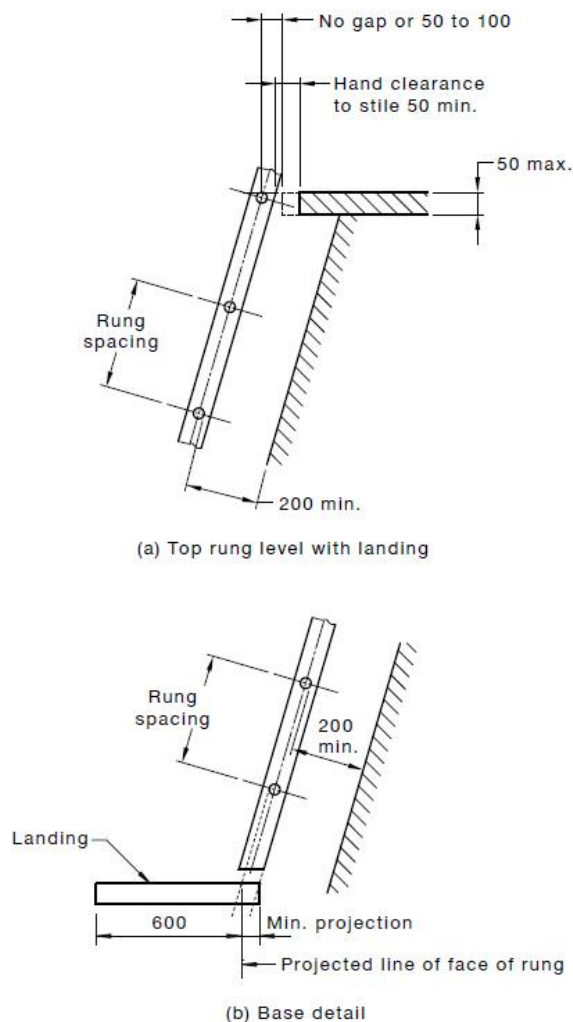
FIGURE 7.11 TYPICAL GAP BETWEEN LANDING AND LADDER

NOTE: See Figure 7.11(a).

NOTE: See Figure 7.11(b).
