Roof Safety Report

DFO Moorabbin, VIC 3194

Prepared By: Safemaster Safety Products
Date: 11 May 2018

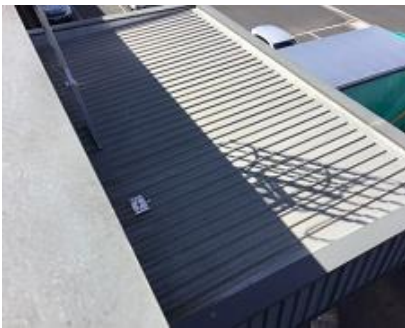
No	Photo of Hazard	Details of Hazard	Details of Risk	Existing/ Immediate Control Measure	Curre nt Risk Level	Proposed Permanent Solution	Resid ual Risk Asse sme nt	Details of Action Taken	Status	Reference
01	Building: General Stores Location Reference: L01 Task: Access to the roof

Not enough anchors installed	Trips, Slips and Falls	Awareness induction	High	Fall arrest anchors to be installed	Low	Client advised	Outstanding	OH&S REGULATIONS 3.55
02	Building: General Stores Location Reference: L01 Task: Access to the roof

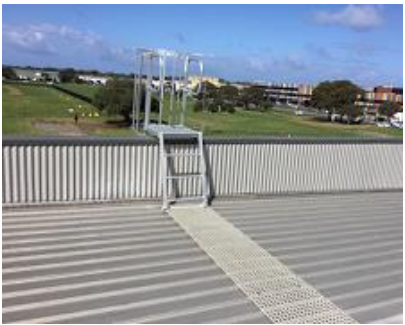
Bottom rung heights are less than required minimum and ladder not fully secured	Trips, Slips and Falls	Awareness induction	Med	Landing platforms including additional brackets to be installed	Low	Client advised	Outstanding	OH&S REGULATIONS 3.7 AS/NZS 1657-2013 7.4.3.4

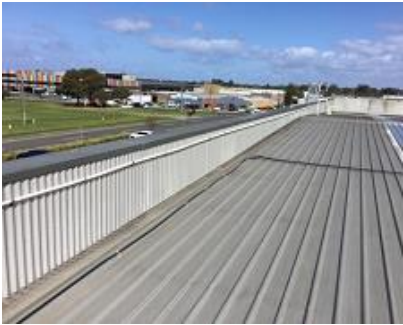
No	Photo of Hazard	Details of Hazard	Details of Risk	Existing/ Immediate Control Measure	Curre nt Risk Level	Proposed Permanent Solution	Resid ual Risk Asse sme nt	Details of Action Taken	Status	Reference
03	Building: General Stores Location Reference: L01 Task: Access to the roof

No height safety system installed	Trips, Slips and Falls	Awareness induction	High	Fall arrest anchors to be installed	Low	Client advised	Outstanding	OH&S REGULATIONS 3.55
04	Building: General Stores Location Reference: L02 Task: Access to the A/c units

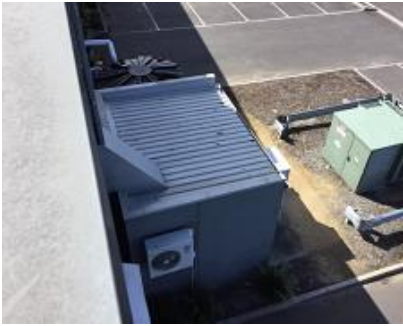
No	Photo of Hazard	Details of Hazard	Details of Risk	Existing/ Immediate Control Measure	Curre nt Risk Level	Proposed Permanent Solution	Resid ual Risk Asse sme nt	Details of Action Taken	Status	Reference
05	Building: General Stores Location Reference: L03 Task: Restrict access to the roof

No height safety system installed (No serviceable items)	Trips, Slips and Falls	Restrict Access	High	"EWP Access Only" sign to be installed	Low	Client advised	Outstanding	OH&S REGULATIONS 3.55 & 3.11
06	Building: General Stores Location Reference: L04 Task: Access to the A/c units

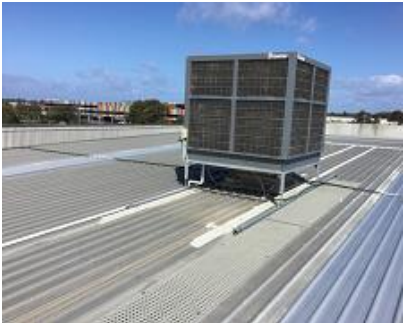
No safe access to the A/c units	Trips, Slips and Falls	N/A	Low	Supply walkway to the A/c units	Low	Client advised	Outstanding	-

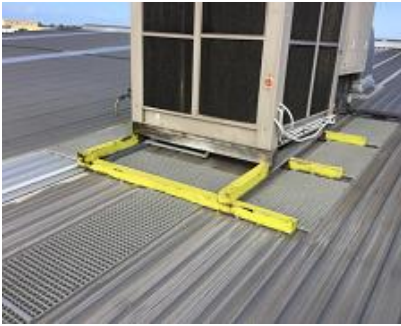
No	Photo of Hazard	Details of Hazard	Details of Risk	Existing/ Immediate Control Measure	Curre nt Risk Level	Proposed Permanent Solution	Resid ual Risk Asse sme nt	Details of Action Taken	Status	Reference
09	Building: General Stores Location Reference: L05 Task: Access to the roof

Bracings installed over the walkway path	Trips, Slips and Falls	Awareness induction	Med	Additional walkway sections and step over to be installed	Low	Client advised	Outstanding	OH&S REGULATIONS 3.7 AS/NZS 1657-2013 3.3.4
10	Building: General Stores Location Reference: L05 Task: Access to the roof

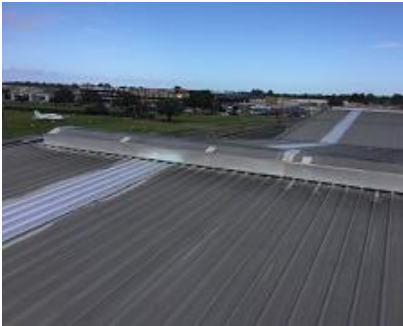
No	Photo of Hazard	Details of Hazard	Details of Risk	Existing/ Immediate Control Measure	Curre nt Risk Level	Proposed Permanent Solution	Resid ual Risk Asse sme nt	Details of Action Taken	Status	Reference
11	Building: General Stores Location Reference: L05 Task: Access to the roof

No height safety system installed	Trips, Slips and Falls	Awareness induction	High	Fall arrest anchors to be installed	Low	Client advised	Outstanding	OH&S REGULATIONS 3.55
12	Building: General Stores Location Reference: L06 Task: Access to the roof

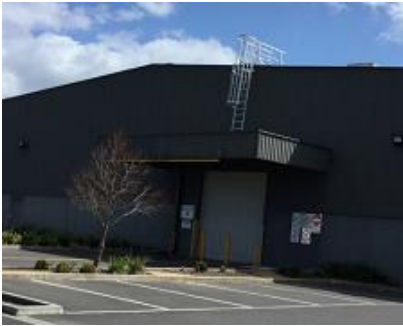
No	Photo of Hazard	Details of Hazard	Details of Risk	Existing/ Immediate Control Measure	Curre nt Risk Level	Proposed Permanent Solution	Resid ual Risk Asse sme nt	Details of Action Taken	Status	Reference
13	Building: General Stores Location Reference: L06 Task: Access to the roof

Bottom rung heights are less than required minimum and sharp edges on handrails	Trips, Slips and Falls	Awareness induction	Med	Landing platforms to be installed and tek screws to be replaced with rivets	Low	Client advised	Outstanding	OH&S REGULATIONS 3.7 AS/NZS 1657-2013 7.4.3.4 & 5.6
14	Building: General Stores Location Reference: L06 Task: Access to the roof

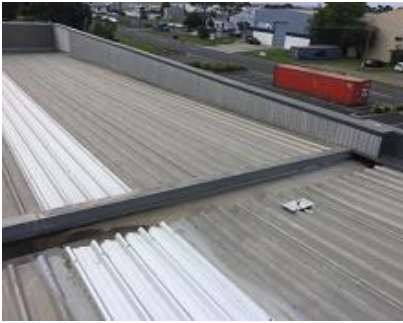
No height safety system installed	Trips, Slips and Falls	Awareness induction	High	Fall arrest anchors to be installed	Low	Client advised	Outstanding	OH&S REGULATIONS 3.55

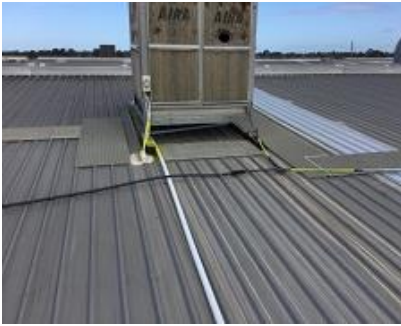
No	Photo of Hazard	Details of Hazard	Details of Risk	Existing/ Immediate Control Measure	Curre nt Risk Level	Proposed Permanent Solution	Resid ual Risk Asse sme nt	Details of Action Taken	Status	Reference
15	Building: General Stores Location Reference: L07 Task: Access to the A/c units

No safe access to the A/c units	Trips, Slips and Falls	N/A	Low	Supply walkway to the A/c units	Low	Client advised	Outstanding	-
16	Building: General Stores Location Reference: L07 Task: Access to the roof

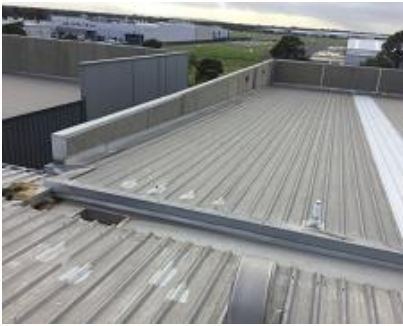
No	Photo of Hazard	Details of Hazard	Details of Risk	Existing/ Immediate Control Measure	Curre nt Risk Level	Proposed Permanent Solution	Resid ual Risk Asse sme nt	Details of Action Taken	Status	Reference
19	Building: General Stores Location Reference: L08 Task: Access to the roof

No height safety system installed	Trips, Slips and Falls	Awareness induction	High	Fall arrest anchors to be installed	Low	Client advised	Outstanding	OH&S REGULATIONS 3.55
20	Building: General Stores Location Reference: L08 Task: Access to the roof

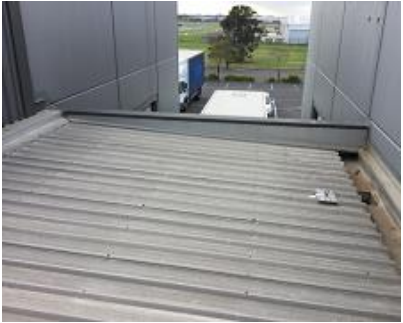
No height safety system installed	Trips, Slips and Falls	Awareness induction	High	Fall arrest anchors to be installed	Low	Client advised	Outstanding	OH&S REGULATIONS 3.55

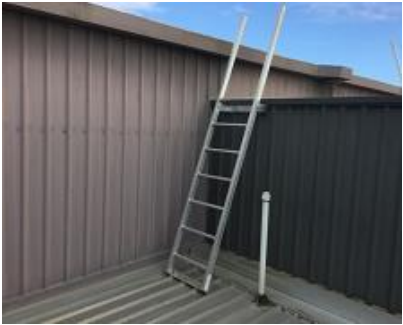
No	Photo of Hazard	Details of Hazard	Details of Risk	Existing/ Immediate Control Measure	Curre nt Risk Level	Proposed Permanent Solution	Resid ual Risk Asse ssme nt	Details of Action Taken	Status	Reference
21	Building: General Stores Location Reference: L08 Task: Access to the roof

Bottom rung height is less than required minimum, landing is less than required minimum and no return ladder	Trips, Slips and Falls	Awareness induction	Med	Existing ladder to be removed and new ladder to be installed	Low	Client advised	Outstanding	OH&S REGULATIONS 3.7 AS/NZS 1657-2013 7.4.3.4, 7.3.6 & 3.1.4
22	Building: General Stores Location Reference: L08 Task: Access to the roof

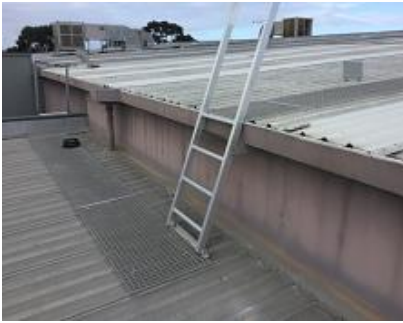
Top rung not levelled with landing, bottom rung height is less than required minimum and gap between ladder and the permanent structure is less than required minimum	Trips, Slips and Falls	Awareness induction	Med	Existing ladder to be re-installed with landing platforms and brackets	Low	Client advised	Outstanding	OH&S REGULATIONS 3.7 AS/NZS 1657-2013 7.4.3.3, 7.4.3.4 & 7.4.5

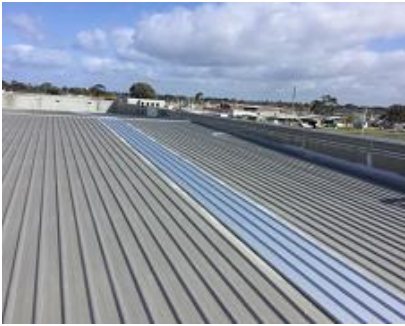
No	Photo of Hazard	Details of Hazard	Details of Risk	Existing/ Immediate Control Measure	Curre nt Risk Level	Proposed Permanent Solution	Resid ual Risk Asse sme nt	Details of Action Taken	Status	Reference
33	Building: General Stores Location Reference: L13 Task: Access to the roof

No height safety system installed	Trips, Slips and Falls	Awareness induction	High	Fall arrest anchors to be installed	Low	Client advised	Outstanding	OH&S REGULATIONS 3.55
34	Building: General Stores Location Reference: L14 Task: Access to the roof

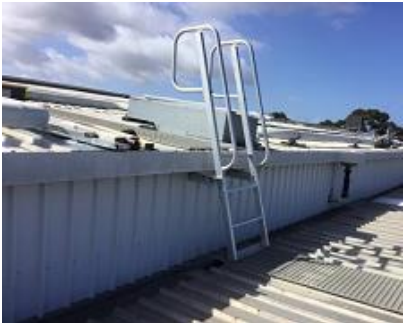
Top rung not levelled with landing and handrail projecting towards the user	Trips, Slips and Falls	Awareness induction	Med	Existing ladder to be removed and new ladder to be installed	Low	Client advised	Outstanding	OH&S REGULATIONS 3.7 AS/NZS 1657-2013 7.4.3.3 & 7.4.8.5

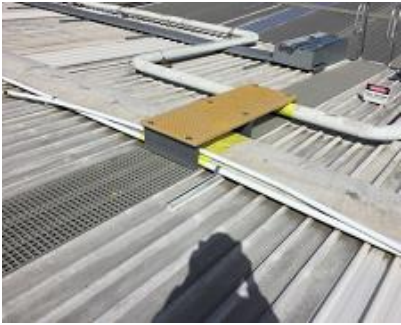
No	Photo of Hazard	Details of Hazard	Details of Risk	Existing/ Immediate Control Measure	Curre nt Risk Level	Proposed Permanent Solution	Resid ual Risk Asse sme nt	Details of Action Taken	Status	Reference
35	Building: General Stores Location Reference: L14 Task: Access to the roof

Step bridge not secured	Trips, Slips and Falls	Awareness induction	Med	Step bridge to be fully secured	Low	Client advised	Outsta nding	OH&S REGULATIONS 3.7
36	Building: General Stores Location Reference: L15 Task: Access to the roof

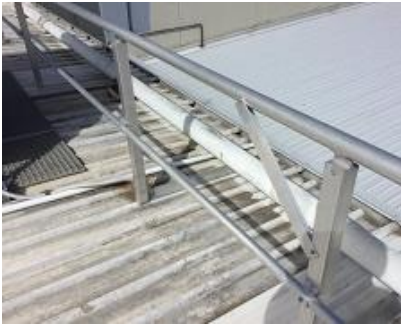
No	Photo of Hazard	Details of Hazard	Details of Risk	Existing/ Immediate Control Measure	Curre nt Risk Level	Proposed Permanent Solution	Resid ual Risk Asse sme nt	Details of Action Taken	Status	Reference
37	Building: General Stores Location Reference: L15 Task: Access to the roof

Sharp edges on handrails	Trips, Slips and Falls	Awareness induction	Med	Tek screws to be replaced with rivets	Low	Client advised	Outstanding	OH&S REGULATIONS 3.7 AS/NZS 1657-2013 5.6
38	Building: General Stores Location Reference: L15 Task: Access to the roof

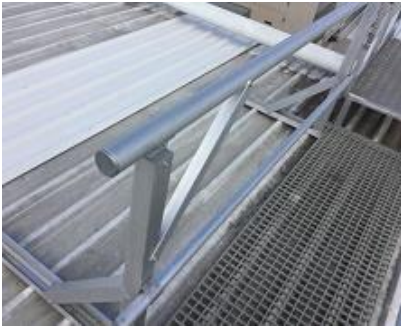
No	Photo of Hazard	Details of Hazard	Details of Risk	Existing/ Immediate Control Measure	Curre nt Risk Level	Proposed Permanent Solution	Resid ual Risk Asse sme nt	Details of Action Taken	Status	Reference
39	Building: General Stores Location Reference: L16 Task: Access to the roof

Sharp edges on handrails	Trips, Slips and Falls	Awareness induction	Med	Tek screws to be replaced with rivets	Low	Client advised	Outstanding	OH&S REGULATIONS 3.7 AS/NZS 1657-2013 5.6
40	Building: General Stores Location Reference: L16 Task: Access to the roof

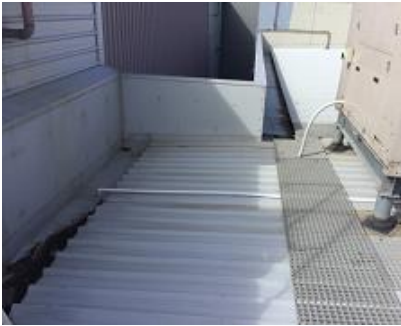
No	Photo of Hazard	Details of Hazard	Details of Risk	Existing/ Immediate Control Measure	Curre nt Risk Level	Proposed Permanent Solution	Resid ual Risk Asse sme nt	Details of Action Taken	Status	Reference
41	Building: General Stores Location Reference: L16 Task: Access to the roof

No height safety system installed	Trips, Slips and Falls	Awareness induction	High	Fall arrest anchor to be installed	Low	Client advised	Outstanding	OH&S REGULATIONS 3.55
42	Building: General Stores Location Reference: L16 Task: Access to the roof

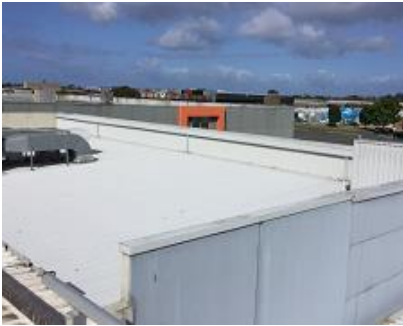
No	Photo of Hazard	Details of Hazard	Details of Risk	Existing/ Immediate Control Measure	Curre nt Risk Level	Proposed Permanent Solution	Resid ual Risk Asse sme nt	Details of Action Taken	Status	Reference
43	Building: General Stores Location Reference: L17 Task: Access to the roof

No height safety system installed	Trips, Slips and Falls	Awareness induction	High	Fall arrest anchors to be installed	Low	Client advised	Outstanding	OH&S REGULATIONS 3.55
44	Building: General Stores Location Reference: L18 Task: Access to the A/c unit

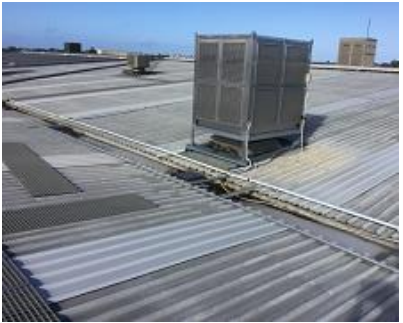
No safe access to the A/c units	Trips, Slips and Falls	N/A	Low	Supply walkway and step over to the A/c units	Low	Client advised	Outstanding	-

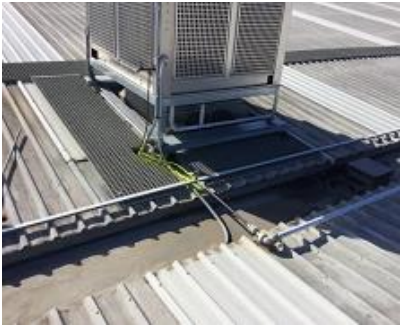
No	Photo of Hazard	Details of Hazard	Details of Risk	Existing/ Immediate Control Measure	Curre nt Risk Level	Proposed Permanent Solution	Resid ual Risk Asse sme nt	Details of Action Taken	Status	Reference
45	Building: General Stores Location Reference: L18 Task: Access to the roof

Pipe installed over the walkway path	Trips, Slips and Falls	Awareness induction	Med	Step overs to be installed	Low	Client advised	Outstanding	OH&S REGULATIONS 3.7 AS/NZS 1657-2013 3.1.4
46	Building: General Stores Location Reference: L19 Task: Access to the roof

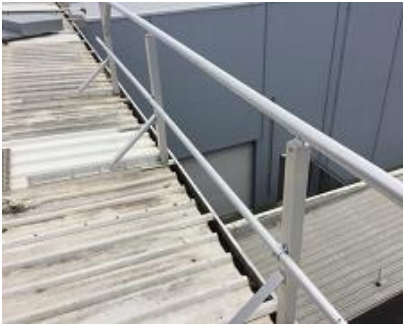
Sharp edges on handrails	Trips, Slips and Falls	Awareness induction	Med	Tek screws to be replaced with rivets	Low	Client advised	Outstanding	OH&S REGULATIONS 3.7 AS/NZS 1657-2013 5.6
50	Building: General Stores Location Reference: L19 Task: Access to the roof

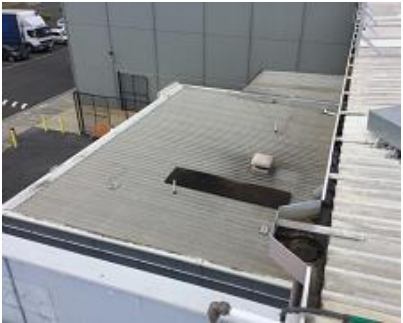
No height safety system installed	Trips, Slips and Falls	Awareness induction	High	Fall arrest anchors to be installed	Low	Client advised	Outstanding	OH&S REGULATIONS 3.55

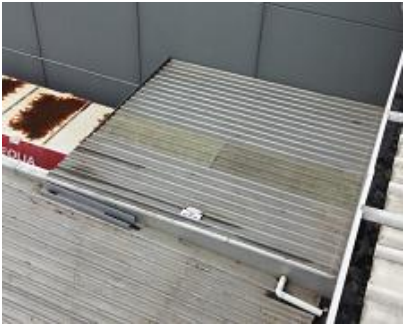
Brittle roof (Non-trafficable roof)	Trips, Slips and Falls	Restrict Access	High	"Warning-Keep Off-Brittle and Fragile Roof" signs to be installed	Low	Client advised	Outstanding	OH&S REGULATIONS 3.57
52	Building: General Stores Location Reference: L20 Task: Access to the roof

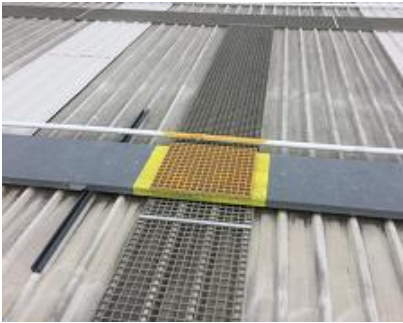
Cable tray installed over the walkway	Trips, Slips and Falls	Awareness induction	Med	Step bridge to be installed	Low	Client advised	Outstanding	OH&S REGULATIONS 3.7 AS/NZS 1657-2013 3.1.4

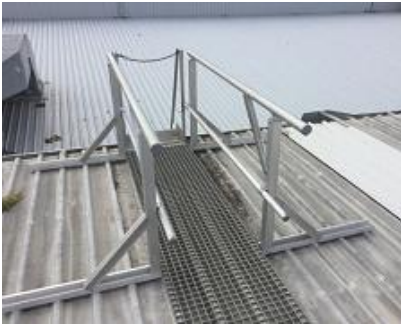
Sharp edges on handrails	Trips, Slips and Falls	Awareness induction	Med	Tek screws to be replaced with rivets	Low	Client advised	Outstanding	OH&S REGULATIONS 3.7 AS/NZS 1657-2013 5.6
54	Building: General Stores Location Reference: L20 Task: Access to the roof

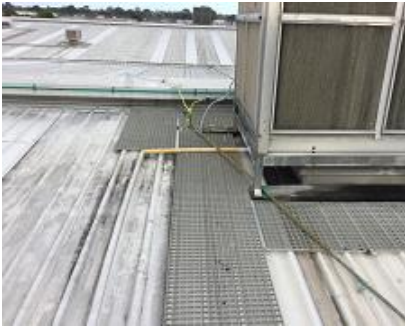
Pipes installed over the walkway path	Trips, Slips and Falls	Awareness induction	Med	Additional walkway sections and step over to be installed	Low	Client advised	Outstanding	OH&S REGULATIONS 3.7 AS/NZS 1657-2013 3.1.4
58	Building: General Stores Location Reference: L21 Task: Access to the roof

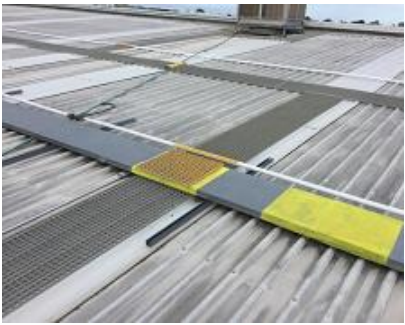
Cable tray installed over the walkway	Trips, Slips and Falls	Awareness induction	Med	Step bridge to be installed	Low	Client advised	Outstanding	OH&S REGULATIONS 3.7 AS/NZS 1657-2013 3.1.4

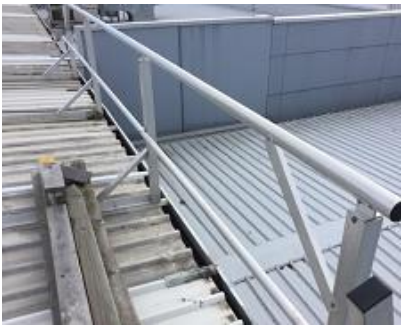
Sharp edges on handrails	Trips, Slips and Falls	Awareness induction	Med	Tek screws to be replaced with rivets	Low	Client advised	Outstanding	OH&S REGULATIONS 3.7 AS/NZS 1657-2013 5.6

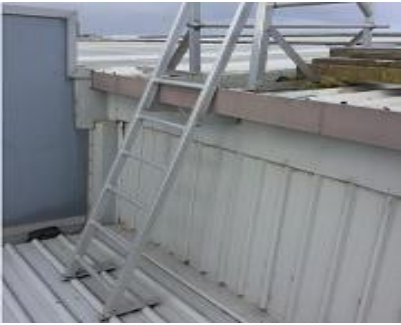
Top rung not levelled with landing, bottom rung height is less than required minimum and gap between ladder and permanent structure is less than required minimum	Trips, Slips and Falls	Awareness induction	Med	Existing ladder to be re-installed with landing platforms, brackets and handrails	Low	Client advised	Outstanding	OH&S REGULATIONS 3.7 AS/NZS 1657-2013 7.4.3.3, 7.4.3.4 & 7.4.5
62	Building: General Stores Location Reference: L21 Task: Access to the roof

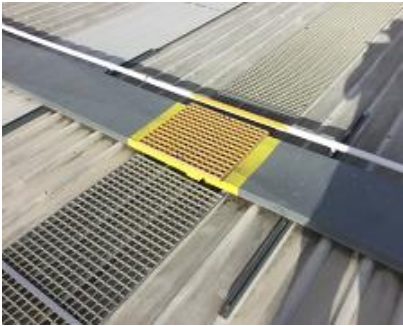
Cable tray installed over the walkway	Trips, Slips and Falls	Awareness induction	Med	Step bridge to be installed	Low	Client advised	Outstanding	OH&S REGULATIONS 3.7 AS/NZS 1657-2013 3.1.4
64	Building: General Stores Location Reference: L22 Task: Access to the roof

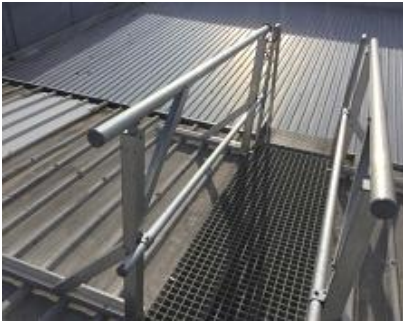
Sharp edges on handrails	Trips, Slips and Falls	Awareness induction	Med	Tek screws to be replaced with rivets	Low	Client advised	Outstanding	OH&S REGULATIONS 3.7 AS/NZS 1657-2013 5.6

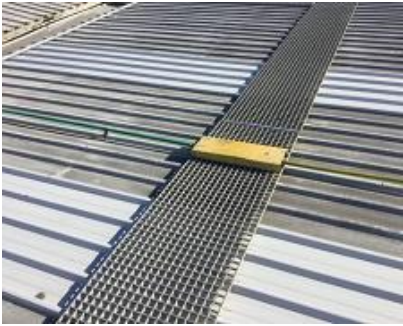
Pipes installed over the walkway path	Trips, Slips and Falls	Awareness induction	Med	Step over to be installed	Low	Client advised	Outstanding	OH&S REGULATIONS 3.7 AS/NZS 1657-2013 3.1.4
70	Building: General Stores Location Reference: L23 Task: Access to the roof

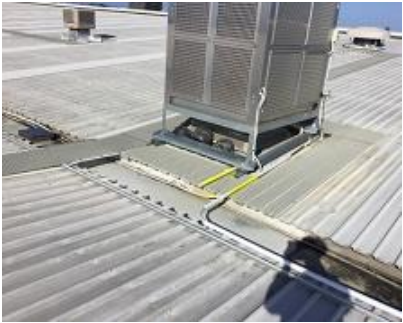
Pipes installed over the walkway path	Trips, Slips and Falls	Awareness induction	Med	Step over to be installed	Low	Client advised	Outstanding	OH&S REGULATIONS 3.7 AS/NZS 1657-2013 3.1.4

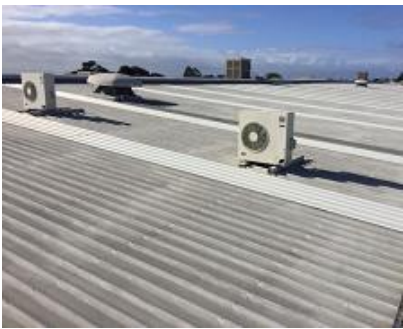
No safe access to the A/c units	Trips, Slips and Falls	N/A	Low	Supply walkway to the A/c units	Low	Client advised	Outstanding	-
72	Building: General Stores Location Reference: L24 Task: Access to the roof

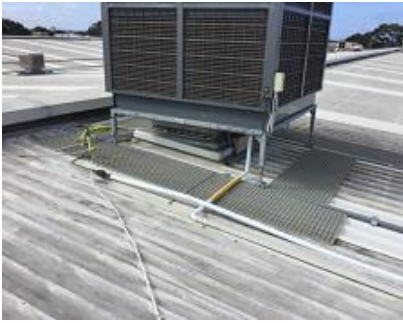
Pipes installed over the walkway path	Trips, Slips and Falls	Awareness induction	Med	Additional walkway sections and step over to be installed	Low	Client advised	Outstanding	OH&S REGULATIONS 3.7 AS/NZS 1657-2013 3.1.4

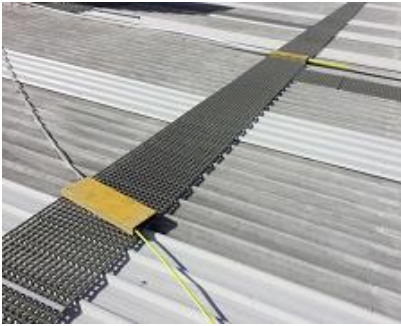
Pipes installed over the walkway path	Trips, Slips and Falls	Awareness induction	Med	Step over to be installed	Low	Client advised	Outstanding	OH&S REGULATIONS 3.7 AS/NZS 1657-2013 3.1.4
74	Building: General Stores Location Reference: L24 Task: Access to the roof

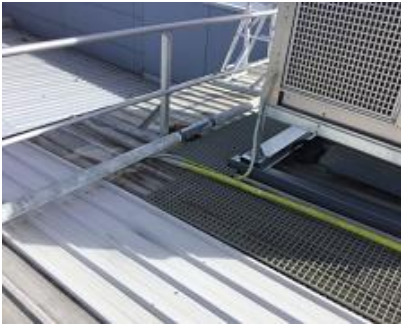
Pipes installed over the walkway path	Trips, Slips and Falls	Awareness induction	Med	Additional walkway sections and step over to be installed	Low	Client advised	Outstanding	OH&S REGULATIONS 3.7 AS/NZS 1657-2013 3.1.4
76	Building: General Stores Location Reference: L24 Task: Access to the roof

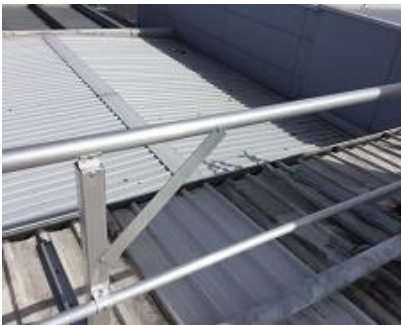
Sharp edges on handrails	Trips, Slips and Falls	Awareness induction	Med	Tek screws to be replaced with rivets	Low	Client advised	Outstanding	OH&S REGULATIONS 3.7 AS/NZS 1657-2013 5.6

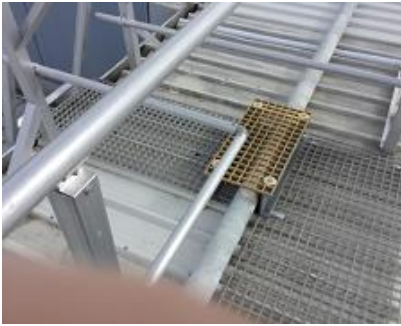
Non-complaint step is present	Trips, Slips and Falls	Awareness induction	Med	Existing step to be removed and new step to be installed	Low	Client advised	Outsta nding	OH&S REGULATIONS 3.7 AS/NZS 1657- 2013 3.1.4
78	Building: General Stores Location Reference: L24 Task: Access to the roof

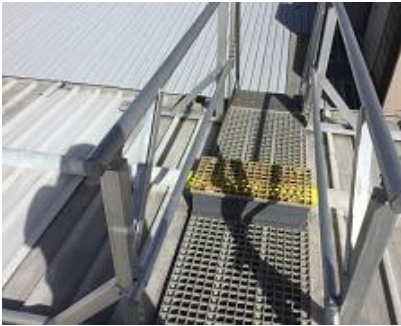
Non-complaint step is present	Trips, Slips and Falls	Awareness induction	Med	Existing step to be removed and new step to be installed	Low	Client advised	Outstanding	OH&S REGULATIONS 3.7 AS/NZS 1657-2013 3.1.4
82	Building: General Stores Location Reference: L25 Task: Access to the roof

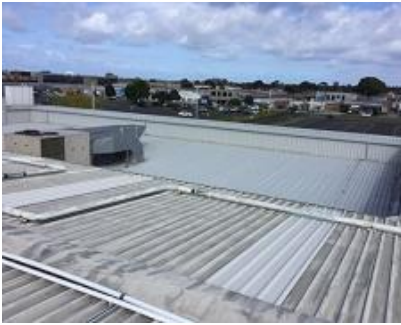
No height safety system installed	Trips, Slips and Falls	Awareness induction	High	Fall arrest anchors to be installed	Low	Client advised	Outstanding	OH&S REGULATIONS 3.55
86	Building: General Stores Location Reference: L25 Task: Access to the roof

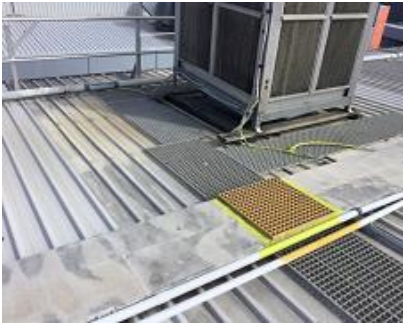
Cable tray installed over the walkway	Trips, Slips and Falls	Awareness induction	Med	Step bridge to be installed	Low	Client advised	Outstanding	OH&S REGULATIONS 3.7 AS/NZS 1657-2013 3.1.4
88	Building: General Stores Location Reference: L26 Task: Access to the roof

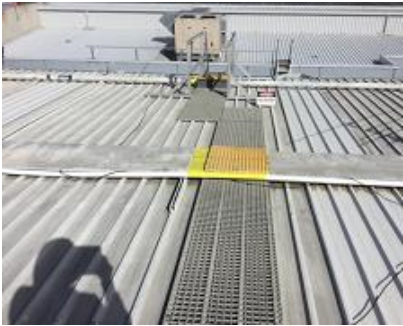
Cable tray installed over the walkway	Trips, Slips and Falls	Awareness induction	Med	Step bridge to be installed	Low	Client advised	Outstanding	OH&S REGULATIONS 3.7 AS/NZS 1657-2013 3.1.4
92	Building: General Stores Location Reference: L27 Task: Access to the roof

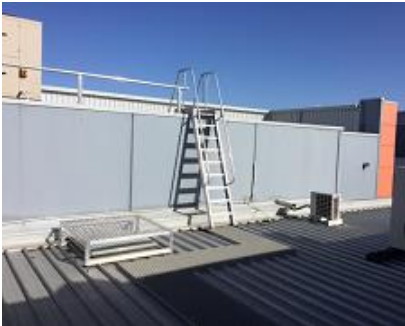
Gap between ladder and permanent structure is less than required minimum	Trips, Slips and Falls	Awareness induction	Med	Existing ladder to be re-installed with landing platforms and brackets	Low	Client advised	Outstanding	OH&S REGULATIONS 3.7 AS/NZS 1657-2013 7.4.5
98	Building: General Stores Location Reference: L28 Task: Restrict access to the roof

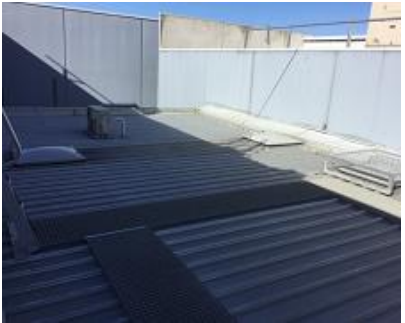
Brittle roof (Non-trafficable roof)	Trips, Slips and Falls	Restrict Access	High	"Warning-Keep Off-Brittle and Fragile Roof" signs to be installed	Low	Client advised	Outstanding	OH&S REGULATIONS 3.57

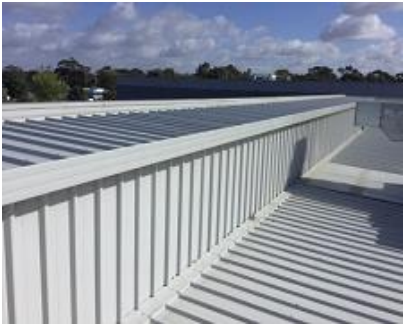
No height safety system installed	Trips, Slips and Falls	Awareness induction	High	Fall arrest anchors to be installed	Low	Client advised	Outstanding	OH&S REGULATIONS 3.55
102	Building: General Stores Location Reference: L29 Task: Access to the roof

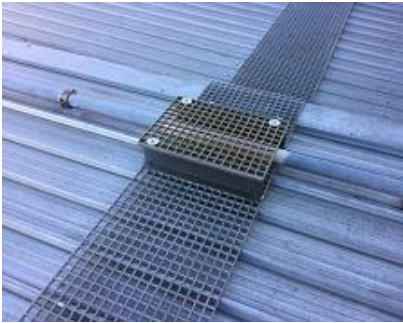
Non-complaint step is present	Trips, Slips and Falls	Awareness induction	Med	Existing step to be removed and new step to be installed	Low	Client advised	Outstanding	OH&S REGULATIONS 3.7 AS/NZS 1657-2013 3.1.4

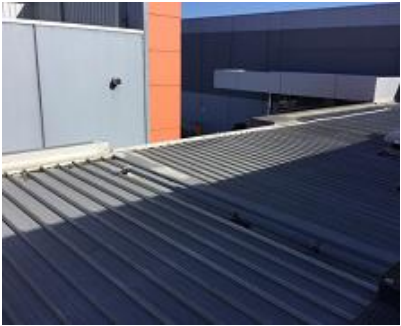
No height safety system installed	Trips, Slips and Falls	Awareness induction	High	Fall arrest anchors to be installed	Low	Client advised	Outstanding	OH&S REGULATIONS 3.55
104	Building: General Stores Location Reference: L29 Task: Access to the roof
