Roof Safety Report

DFO South Wharf, VIC 3006

Prepared By: Safemaster Safety Products
Date: 16 May 2018

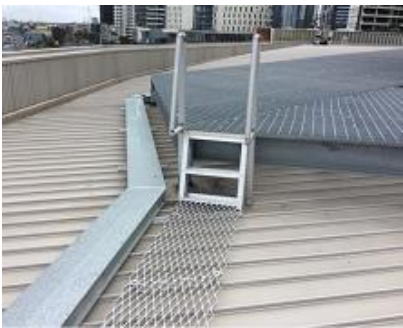
Bottom tread height is less than required minimum	Trips, Slips and Falls	Awareness induction	Med	Existing ladder to be removed and new ladder to be installed	Low	Client advised	Outstanding	OH&S REGULATIONS 3.7 AS/NZS 1657-2013 7.4.3.4
02	Building: General Stores Location Reference: L01 Task: Access to the roof

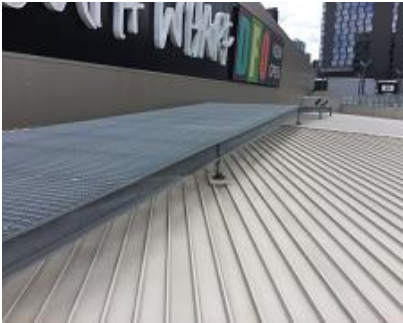
Variation in height between plant deck and roof is greater than required maximum	Trips, Slips and Falls	Awareness induction	Med	Handrail to be installed	Low	Client advised	Outstanding	OH&S REGULATIONS 3.7 AS/NZS 1657-2013 4.4

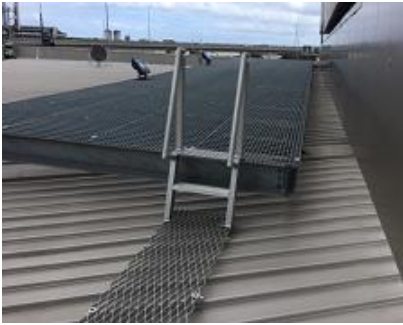
Bottom tread height is less than required minimum	Trips, Slips and Falls	Awareness induction	Med	Existing ladder to be removed and new ladder to be installed	Low	Client advised	Outstanding	OH&S REGULATIONS 3.7 AS/NZS 1657-2013 7.4.3.4
04	Building: General Stores Location Reference: L02 Task: Access to the A/c units

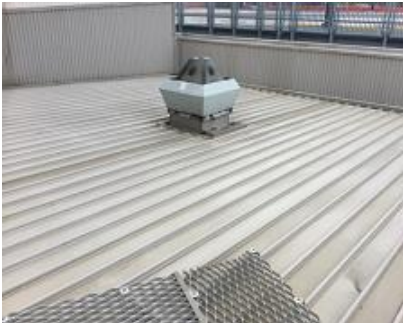
No safe access to the A/c units	Trips, Slips and Falls	N/A	Low	Supply walkway to the A/c units	Low	Client advised	Outstanding	-

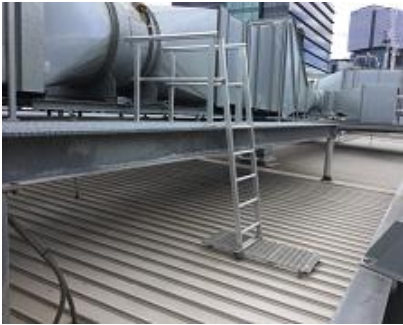
Bottom rung height is less than required minimum and landing is less than required minimum	Trips, Slips and Falls	Awareness induction	Med	Existing ladder to be re-installed with landing platform and brackets	Low	Client advised	Outstanding	OH&S REGULATIONS 3.7 AS/NZS 1657-2013 7.4.3.4 & 7.3.6
06	Building: General Stores Location Reference: L03 Task: Access to the ladder

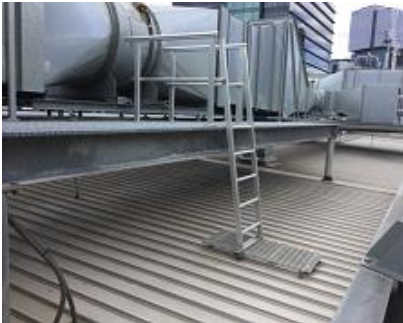
No safe access to the ladder	Trips, Slips and Falls	N/A	Low	Supply walkway to the ladder	Low	Client advised	Outstanding	-

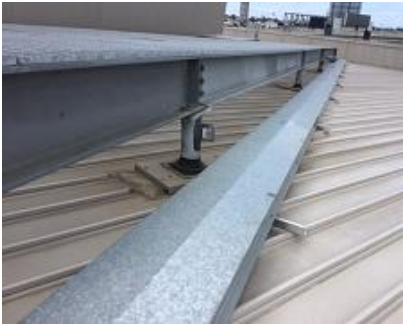
Non-complaint anchor is present	Trips, Slips and Falls	Awareness induction	Med	Existing anchor to removed and new anchor to be installed	Low	Client advised	Outstanding	OH&S REGULATIONS 3.55
08	Building: General Stores Location Reference: L05 Task: Access to the roof

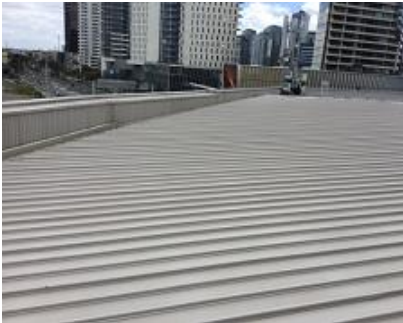
No height safety system installed	Trips, Slips and Falls	Awareness induction	High	Fall arrest anchors to be installed	Low	Client advised	Outstanding	OH&S REGULATIONS 3.55

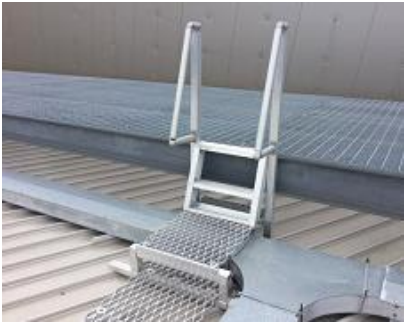
Bottom tread height is less than required minimum	Trips, Slips and Falls	Awareness induction	Med	Existing ladder to be removed and new ladder to be installed	Low	Client advised	Outstanding	OH&S REGULATIONS 3.7 AS/NZS 1657-2013 7.4.3.4
10	Building: General Stores Location Reference: L08 Task: Access to the roof

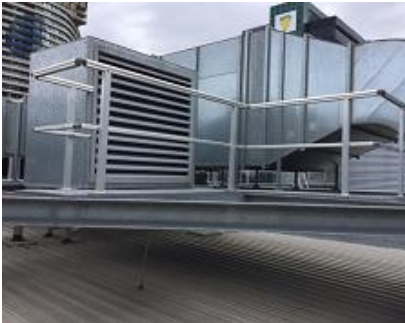
Sharp edges on handrails	Trips, Slips and Falls	Awareness induction	Med	Tek screws to be replaced with rivets	Low	Client advised	Outstanding	OH&S REGULATIONS 3.7 AS/NZS 1657-2013 5.6

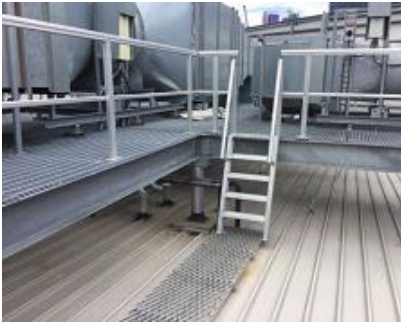
Landing width is less than required minimum	Trips, Slips and Falls	Awareness induction	Med	Additional walkway sections to be installed	Low	Client advised	Outstanding	OH&S REGULATIONS 3.7 AS/NZS 1657-2013 7.3.6
12	Building: General Stores Location Reference: L09 Task: Access to the roof

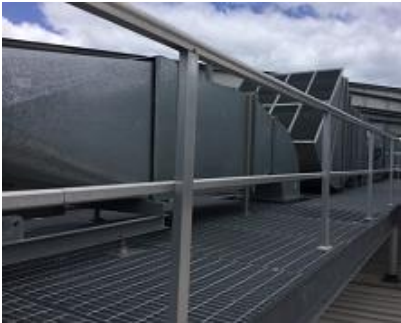
Sharp edges on handrails	Trips, Slips and Falls	Awareness induction	Med	Tek screws to be replaced with rivets	Low	Client advised	Outstanding	OH&S REGULATIONS 3.7 AS/NZS 1657-2013 5.6

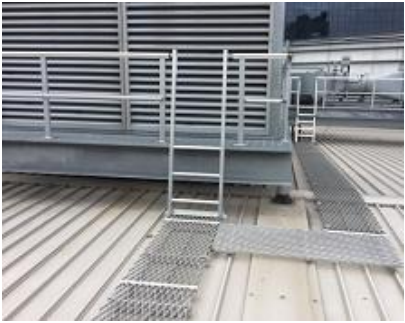
Bottom rung height is less than required minimum	Trips, Slips and Falls	Awareness induction	Med	Landing platform to be installed	Low	Client advised	Outstanding	OH&S REGULATIONS 3.7 AS/NZS 1657-2013 7.4.3.4
14	Building: General Stores Location Reference: L09 Task: Access to the roof

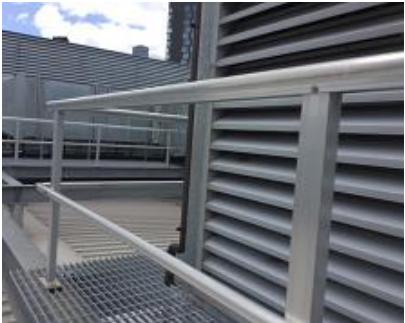
Sharp edges on handrails	Trips, Slips and Falls	Awareness induction	Med	Tek screws to be replaced with rivets	Low	Client advised	Outstanding	OH&S REGULATIONS 3.7 AS/NZS 1657-2013 5.6

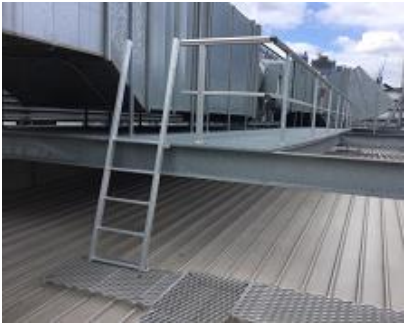
Bottom rung height is less than required minimum	Trips, Slips and Falls	Awareness induction	Med	Landing platform to be installed	Low	Client advised	Outstanding	OH&S REGULATIONS 3.7 AS/NZS 1657-2013 7.4.3.4
16	Building: General Stores Location Reference: L10 Task: Access to the roof

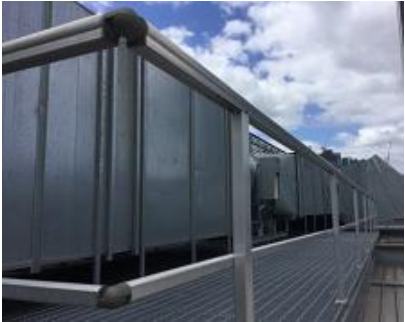
Sharp edges on handrails	Trips, Slips and Falls	Awareness induction	Med	Tek screws to be replaced with rivets	Low	Client advised	Outstanding	OH&S REGULATIONS 3.7 AS/NZS 1657-2013 5.6

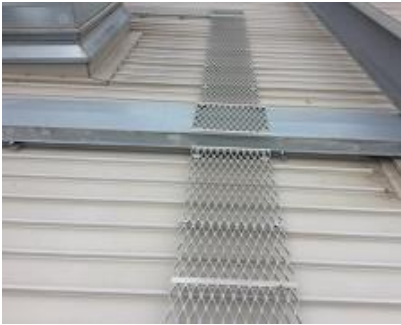
Variation in height between walkway panels are greater than required maximum	Trips, Slips and Falls	Awareness induction	Med	High visibility safety yellow nosing's to be installed	Low	Client advised	Outstanding	OH&S REGULATIONS 3.7 AS/NZS 1657-2013 3.3.4
18	Building: General Stores Location Reference: L1 Task: Access to the roof

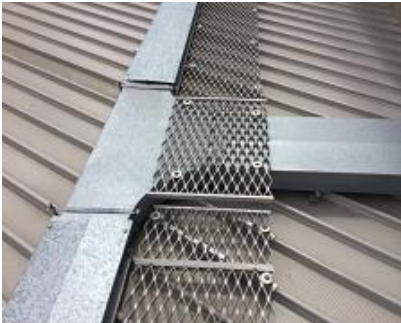
Variation in height between walkway panels are greater than required maximum	Trips, Slips and Falls	Awareness induction	Med	High visibility safety yellow nosing's to be installed	Low	Client advised	Outstanding	OH&S REGULATIONS 3.7 AS/NZS 1657-2013 3.3.4

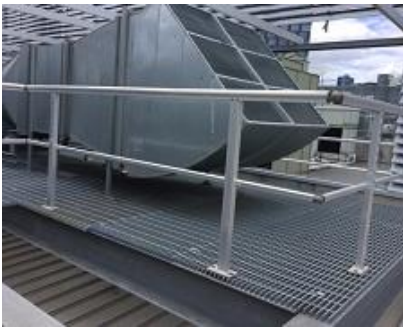
Sharp edges on handrails	Trips, Slips and Falls	Awareness induction	Med	Tek screws to be replaced with rivets	Low	Client advised	Outstanding	OH&S REGULATIONS 3.7 AS/NZS 1657-2013 5.6
20	Building: General Stores Location Reference: L12 Task: Access to the roof

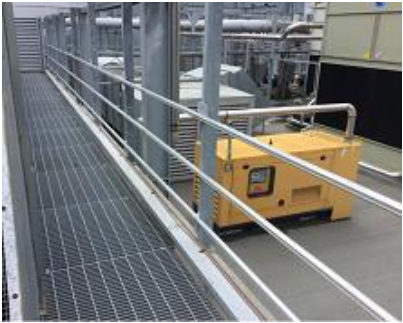
Handrail height is greater than required maximum	Trips, Slips and Falls	Awareness induction	Med	Handrail to be modified and re-installed	Low	Client advised	Outstanding	OH&S REGULATIONS 3.7 AS/NZS 1657-2013 4.4

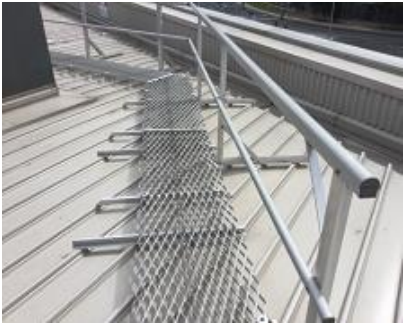
Sharp edges on handrails	Trips, Slips and Falls	Awareness induction	Med	Tek screws to be replaced with rivets	Low	Client advised	Outstanding	OH&S REGULATIONS 3.7 AS/NZS 1657-2013 5.6
22	Building: General Stores Location Reference: L13 Task: Access to the roof

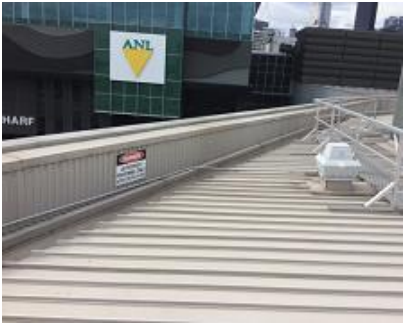
No height safety system installed	Trips, Slips and Falls	Awareness induction	High	Fall arrest anchors to be installed	Low	Client advised	Outstanding	OH&S REGULATIONS 3.55

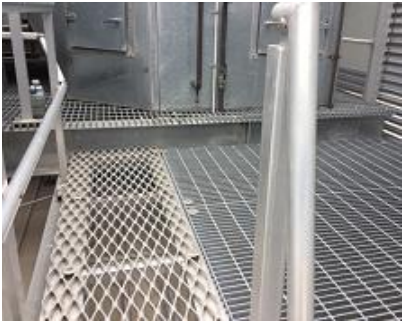
Sharp edges on handrails	Trips, Slips and Falls	Awareness induction	Med	Tek screws to be replaced with rivets	Low	Client advised	Outstanding	OH&S REGULATIONS 3.7 AS/NZS 1657-2013 5.6
24	Building: General Stores Location Reference: L14 Task: Access to the roof

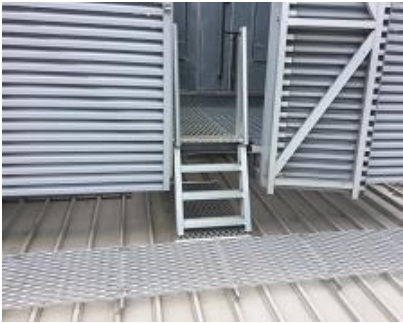
Bottom tread height is less than required minimum and landing is less than required minimum	Trips, Slips and Falls	Awareness induction	Med	Landing platform to be installed	Low	Client advised	Outstanding	OH&S REGULATIONS 3.7 AS/NZS 1657-2013 7.4.3.4 & 7.3.6

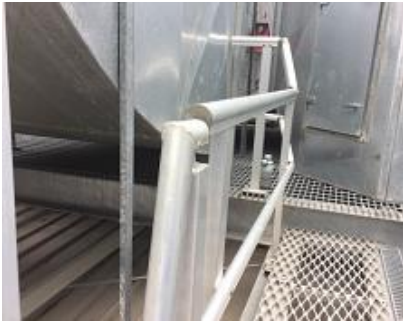
Variation in height between walkway panels are greater than required maximum	Trips, Slips and Falls	Awareness induction	Med	High visibility safety yellow nosing's to be installed	Low	Client advised	Outstanding	OH&S REGULATIONS 3.7 AS/NZS 1657-2013 3.3.4
26	Building: General Stores Location Reference: L16 Task: Access to the roof

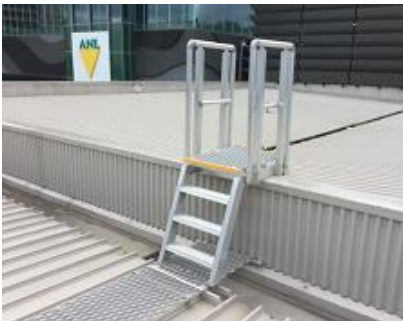
Bottom tread height is less than required minimum, handrail projecting towards the user and gap between ladder and permanent structure is less than required minimum	Trips, Slips and Falls	Awareness induction	Med	Existing ladder to be removed and new ladder to be installed	Low	Client advised	Outstanding	OH&S REGULATIONS 3.7 AS/NZS 1657-2013 7.4.3.4, 7.4.8.5 & 7.4.5

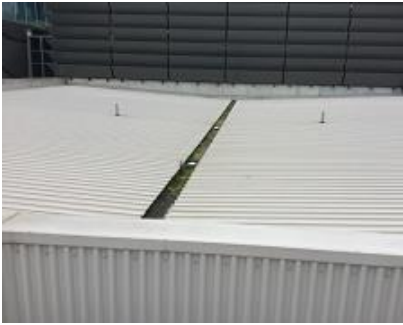
Non-complaint anchors are present	Trips, Slips and Falls	Awareness induction	Med	Existing anchors to be removed	Low	Client advised	Outstanding	OH&S REGULATIONS 3.55
28	Building: General Stores Location Reference: L17 Task: Access to the roof

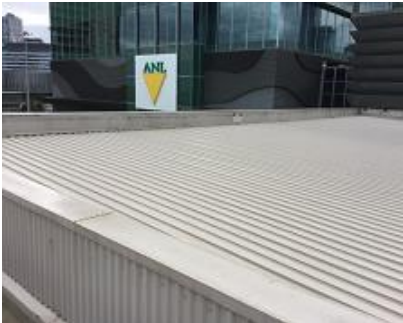
Not enough anchors are installed	Trips, Slips and Falls	Awareness induction	High	Fall arrest anchors to be installed	Low	Client advised	Outstanding	OH&S REGULATIONS 3.55

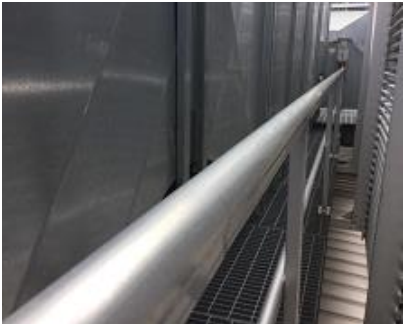
Sharp edges on handrails	Trips, Slips and Falls	Awareness induction	Med	Tek screws to be replaced with rivets	Low	Client advised	Outstanding	OH&S REGULATIONS 3.7 AS/NZS 1657-2013 5.6

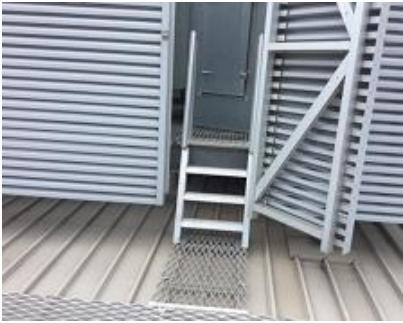
Bottom tread height is less than required minimum	Trips, Slips and Falls	Awareness induction	Med	Landing platform to be installed	Low	Client advised	Outstanding	OH&S REGULATIONS 3.7 AS/NZS 1657-2013 7.4.3.4
32	Building: General Stores Location Reference: L21 Task: Access to the roof

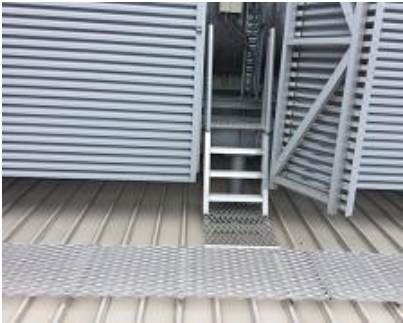
Bottom tread height is less than required minimum	Trips, Slips and Falls	Awareness induction	Med	Landing platform to be installed	Low	Client advised	Outstanding	OH&S REGULATIONS 3.7 AS/NZS 1657-2013 7.4.3.4

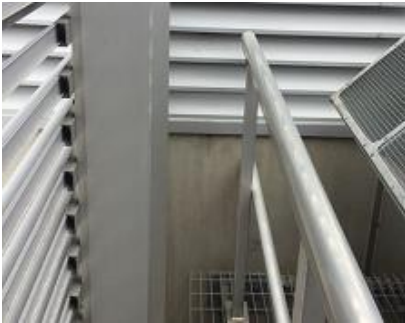
Sharp edges on handrails	Trips, Slips and Falls	Awareness induction	Med	Tek screws to be replaced with rivets	Low	Client advised	Outsta nding	OH&S REGULATIONS 3.7 AS/NZS 1657- 2013 5.6
34	Building: General Stores Location Reference: L21 Task: Access to the A/c units

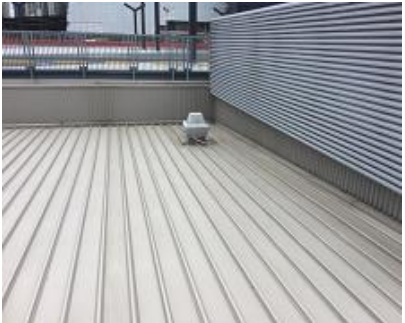
No safe access to the A/c units	Trips, Slips and Falls	N/A	Low	Supply walkway to the A/c units	Low	Client advised	Outsta nding	-

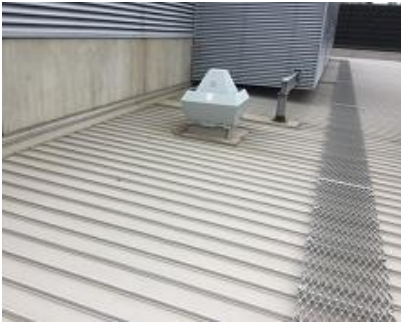
No safe access to the A/c units	Trips, Slips and Falls	N/A	Low	Supply walkway to the A/c units	Low	Client advised	Outstanding	-
36	Building: General Stores Location Reference: L22 Task: Access to the roof

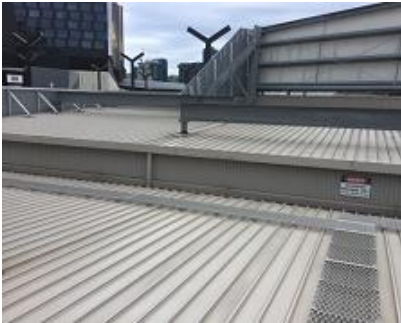
Variation in height between roofs are greater than required maximum	Trips, Slips and Falls	Awareness induction	Med	Access ladder to be installed	Low	Client advised	Outstanding	OH&S REGULATIONS 3.7 AS/NZS 1657-2013 3.1.4

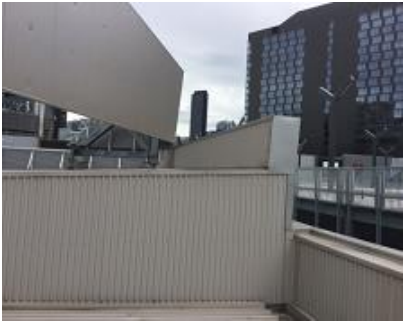
No height safety system installed	Trips, Slips and Falls	Awareness induction	High	Fall arrest anchors to be installed	Low	Client advised	Outstanding	OH&S REGULATIONS 3.55
38	Building: General Stores Location Reference: L23 Task: Access to the roof

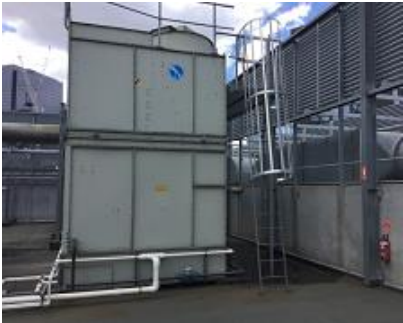
No slip resistance on ladder rungs	Trips, Slips and Falls	Awareness induction	Med	Existing ladder to be removed and new ladder to be installed	Low	Client advised	Outstanding	OH&S REGULATIONS 3.7 AS/NZS 1657-2013 7.4.3.1

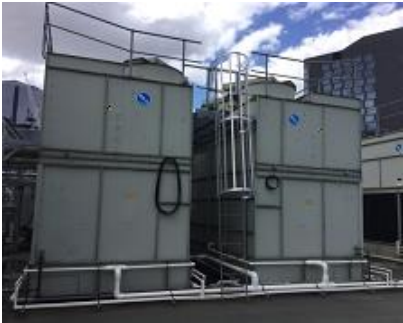
No slip resistance on ladder rungs	Trips, Slips and Falls	Awareness induction	Med	Existing ladder to be removed and new ladder to be installed	Low	Client advised	Outstanding	OH&S REGULATIONS 3.7 AS/NZS 1657-2013 7.4.3.1
40	Building: General Stores Location Reference: L24 Task: Access to the roof

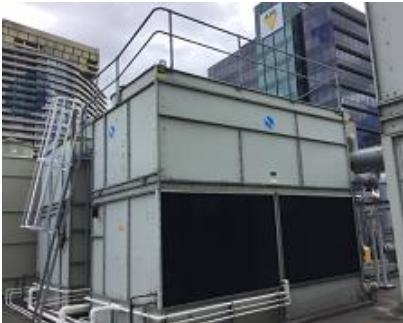
Gap between midrail and handrail is greater than required maximum	Trips, Slips and Falls	Awareness induction	Med	Existing midrail to be adjusted	Low	Client advised	Outstanding	OH&S REGULATIONS 3.7 AS/NZS 1657-2013 4.4
