# Roof Safety Report

**Milton Village Shopping  
Centre, QLD 4064**

Prepared By: Safemaster Safety Products  
Date: 23-11-2019

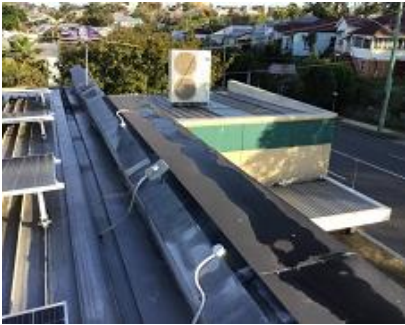
Variation in height between roofs are greater than required maximum	Trips, Slips and Falls	Awareness induction	Med	Access ladder to be installed	Low	Client advised	Outstanding	OH&S REGULATIONS 3.7  AS/NZS 1657-2013 3.1.4
06	Building: General Stores Location Reference: <a href="#">L04</a> Task: Access to the roof

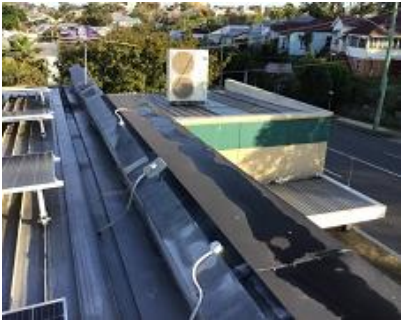
No height safety system installed	Trips, Slips and Falls	Awareness induction	High	Anchors to be installed	Low	Client advised	Outstanding	OH&S REGULATIONS 3.55

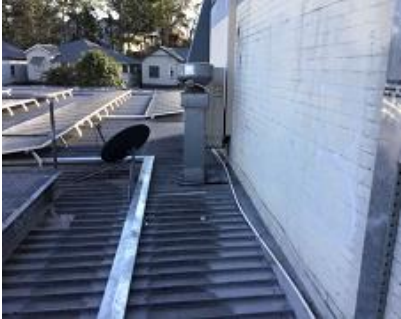
Supply walkway to the A/c units	Trips, Slips and Falls	N/A	Low	Supply walkway and step bridge to the A/c units	Low	Client advised	Outstanding	-
10	Building: General Stores Location Reference: <a href="#">L06</a> Task: Access to the roof

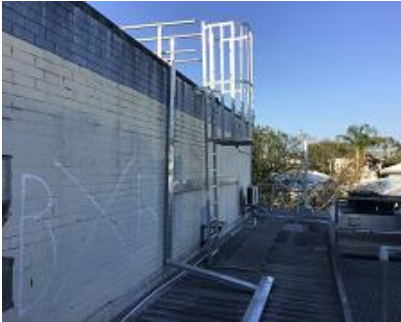
Non-complaint ladder is present	Trips, Slips and Falls	Awareness induction	Med	Existing ladder to be replaced	Low	Client advised	Outstanding	OH&S REGULATIONS 3.7  AS/NZS 1657-2013 7.4

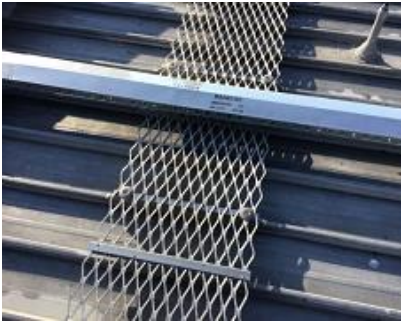
Cable tray installed over the walkway path	Trips, Slips and Falls	Awareness induction	Med	Step bridge to be installed	Low	Client advised	Outstanding	OH&S REGULATIONS 3.7  AS/NZS 1657-2013 3.1.4
18	Building: General Stores Location Reference: <a href="#">L08</a> Task: Access to the roof

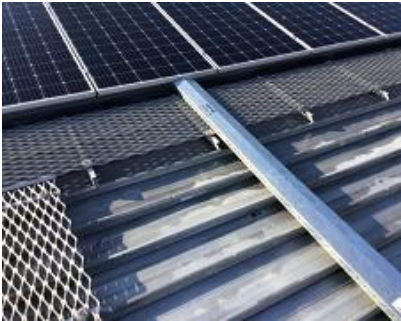
Cable tray installed over the walkway path	Trips, Slips and Falls	Awareness induction	Med	Step bridge to be installed	Low	Client advised	Outstanding	OH&S REGULATIONS 3.7  AS/NZS 1657-2013 3.1.4

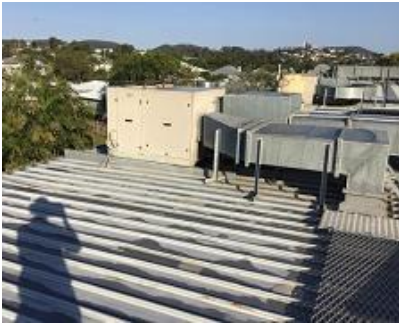
No safe access to the A/c units	Trips, Slips and Falls	N/A	Low	Supply walkway and handrail to the A/c units	Low	Client advised	Outstanding	-
20	Building: General Stores Location Reference: <a href="#">L09</a> Task: Access to the A/c unit

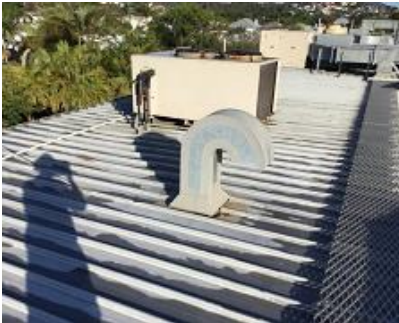
No safe access to the A/c units	Trips, Slips and Falls	N/A	Low	Supply walkway and handrail to the A/c units	Low	Client advised	Outstanding	-

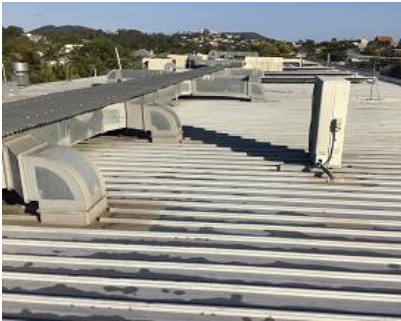
No safe access to the A/c units	Trips, Slips and Falls	N/A	Low	Supply walkway and Step bridge over the duct to the A/c units	Low	Client advised	Outstanding	-
24	Building: General Stores Location Reference: <a href="#">L11</a> Task: Access to the roof

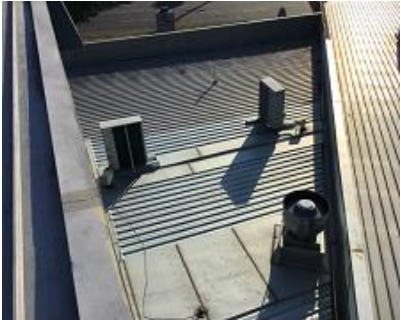
No height safety system installed	Trips, Slips and Falls	Awareness induction	High	Ladder access bracket, sign, strop, return ladder and anchors to be installed	Low	Client advised	Outstanding	OH&S REGULATIONS 3.55

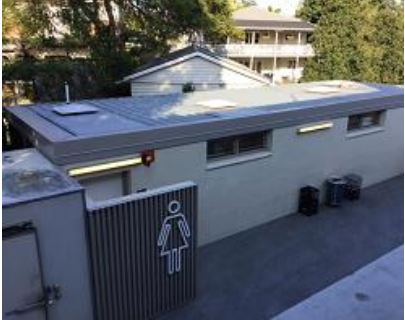
No height safety system installed	Trips, Slips and Falls	Awareness induction	High	Ladder bracket, sign, fragile roof sign, strop and anchors to be installed	Low	Client advised	Outstanding	OH&S REGULATIONS 3.55 & 3.57
