Roof Safety Report

**Milton Village Shopping Centre,
QLD 4064**

Prepared By: Safemaster Safety Products
Date: 20-10-2020

Roof Safety Report for
Milton Village Shopping Centre, QLD 4064

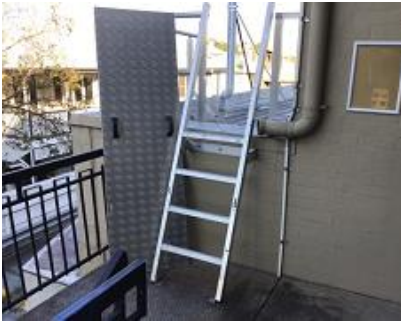
No	Photo of Hazard	Details of Hazard	Details of Risk	Existing/ Immediate Control Measure	Curre nt Risk Level	Proposed Permanent Solution	Resid ual Risk Asse sme nt	Details of Action Taken	Status	Reference
01	Building: General Stores Location Reference: L01 Task: Access to the roof

Non-complaint aluminium ladder is present	Trips, Slips and Falls	Awareness induction	Med	Existing ladder to be replaced with parapet ladder	Low	Client advised	Outstanding	OH&S REGULATIONS 3.7 AS/NZS 1657-2013 7.4
02	Building: General Stores Location Reference: L01 Task: Access to the roof

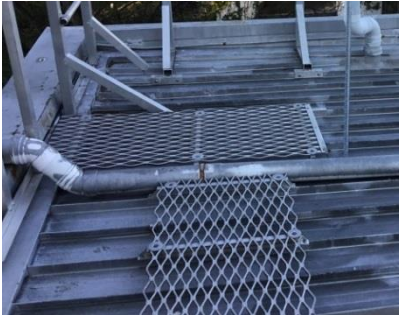
Pipe installed over the walkway path	Trips, Slips and Falls	Awareness induction	Med	High visibility safety yellow tape to be installed	Low	Client advised	Outstanding	OH&S REGULATIONS 3.7

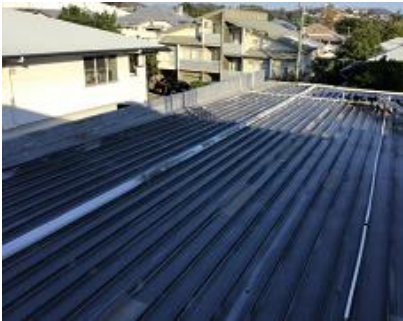
No	Photo of Hazard	Details of Hazard	Details of Risk	Existing/ Immediate Control Measure	Curre nt Risk Level	Proposed Permanent Solution	Resid ual Risk Asse sme nt	Details of Action Taken	Status	Reference
03	Building: General Stores Location Reference: L02 Task: Access to the roof

No height safety system installed	Trips, Slips and Falls	Awareness induction	High	Anchors to be installed	Low	Client advised	Outstanding	OH&S REGULATIONS 3.55
04	Building: General Stores Location Reference: L03 Task: Restrict access to the roof

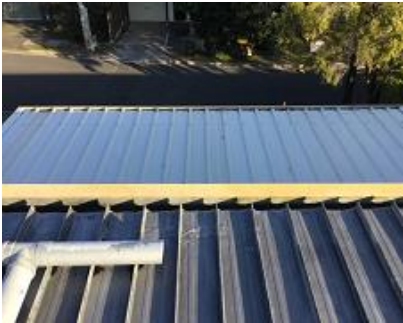
No height safety system installed (No serviceable items)	Trips, Slips and Falls	Restrict Access	High	"EWP Access Only" sign to be installed	Low	Client advised	Outstanding	OH&S REGULATIONS 3.55 & 3.11

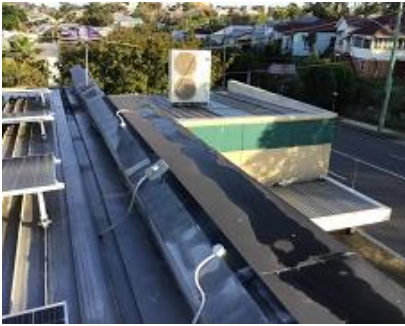
No	Photo of Hazard	Details of Hazard	Details of Risk	Existing/ Immediate Control Measure	Curre nt Risk Level	Proposed Permanent Solution	Resid ual Risk Asse sme nt	Details of Action Taken	Status	Reference
05	Building: General Stores Location Reference: L04 Task: Access to the roof

Variation in height between roofs are greater than required maximum	Trips, Slips and Falls	Awareness induction	Med	Access ladder to be installed	Low	Client advised	Outstanding	OH&S REGULATIONS 3.7 AS/NZS 1657-2013 3.1.4
06	Building: General Stores Location Reference: L04 Task: Access to the roof

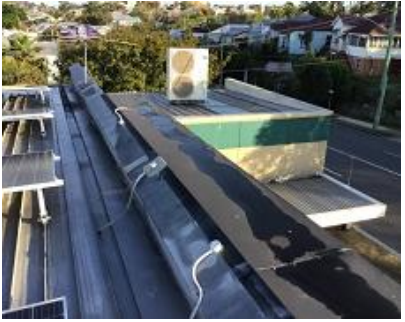
No height safety system installed	Trips, Slips and Falls	Awareness induction	High	Anchors to be installed	Low	Client advised	Outstanding	OH&S REGULATIONS 3.55

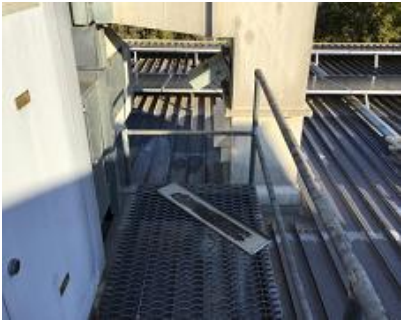
No	Photo of Hazard	Details of Hazard	Details of Risk	Existing/ Immediate Control Measure	Curre nt Risk Level	Proposed Permanent Solution	Resid ual Risk Asse sme nt	Details of Action Taken	Status	Reference
07	Building: General Stores Location Reference: L05 Task: Access to the roof

Handrail section is damaged	Trips, Slips and Falls	Awareness induction	Med	Damaged handrail section to be removed and new handrail section to be installed	Low	Client advised	Outsta nding	OH&S REGULATIONS 3.7 AS/NZS 1657- 2013 4.4
08	Building: General Stores Location Reference: L05 Task: Access to the roof

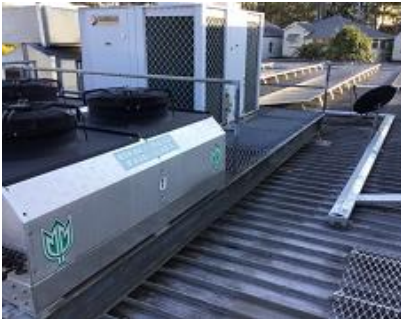
Variation in height between plant deck and roof is greater than required maximum	Trips, Slips and Falls	Awareness induction	Med	Single step and handrail to be installed	Low	Client advised	Outsta nding	OH&S REGULATIONS 3.7 AS/NZS 1657- 2013 3.1.4 & 4.4

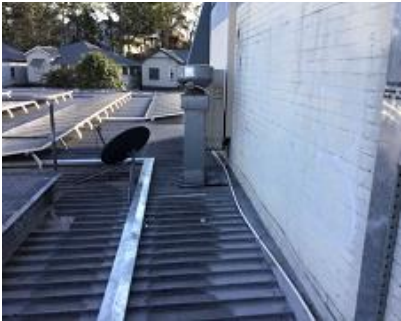
No	Photo of Hazard	Details of Hazard	Details of Risk	Existing/ Immediate Control Measure	Curre nt Risk Level	Proposed Permanent Solution	Resid ual Risk Asse ssme nt	Details of Action Taken	Status	Reference
09	Building: General Stores Location Reference: L05 Task: Access to the A/c units

Supply walkway to the A/c units	Trips, Slips and Falls	N/A	Low	Supply walkway and step bridge to the A/c units	Low	Client advised	Outstanding	-
10	Building: General Stores Location Reference: L06 Task: Access to the roof

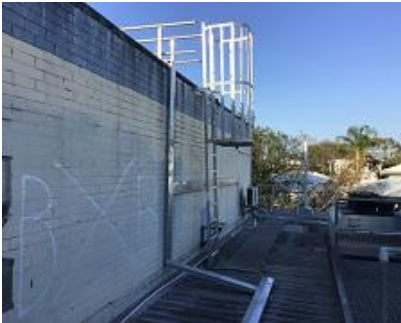
Non-complaint ladder is present	Trips, Slips and Falls	Awareness induction	Med	Existing ladder to be replaced	Low	Client advised	Outstanding	OH&S REGULATIONS 3.7 AS/NZS 1657-2013 7.4

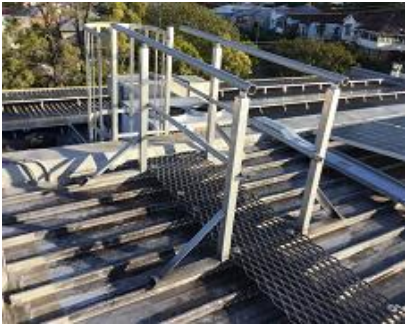
No	Photo of Hazard	Details of Hazard	Details of Risk	Existing/ Immediate Control Measure	Curre nt Risk Level	Proposed Permanent Solution	Resid ual Risk Asse sme nt	Details of Action Taken	Status	Reference
11	Building: General Stores Location Reference: L06 Task: Access to the roof

Handrail is not fully secured	Trips, Slips and Falls	Awareness induction	Med	Additional handrail posts to be installed	Low	Client advised	Outsta nding	OH&S REGULATIONS 3.7 AS/NZS 1657- 2013 4.4
12	Building: General Stores Location Reference: L07 Task: Access to the roof

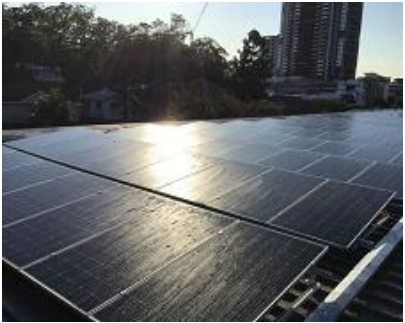
No height safety system installed	Trips, Slips and Falls	Awareness induction	High	Anchors to be installed	Low	Client advised	Outsta nding	OH&S REGULATIONS 3.55

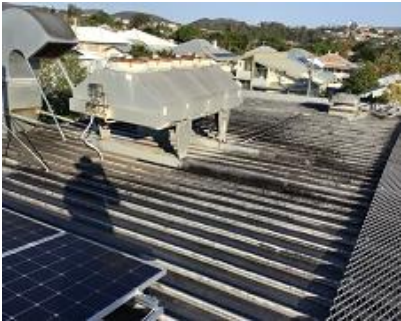
No	Photo of Hazard	Details of Hazard	Details of Risk	Existing/ Immediate Control Measure	Curre nt Risk Level	Proposed Permanent Solution	Resid ual Risk Asse sme nt	Details of Action Taken	Status	Reference
13	Building: General Stores Location Reference: L07 Task: Access to the A/c units

No safe access to the A/c units	Trips, Slips and Falls	N/A	Low	Supply walkway to the A/c units	Low	Client advised	Outstanding	-
14	Building: General Stores Location Reference: L08 Task: Access to the roof

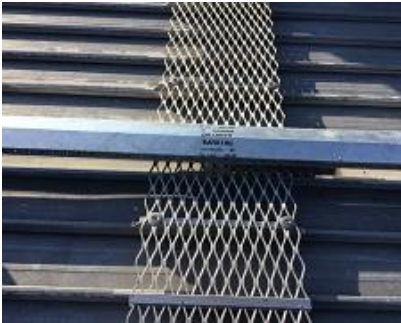
Cable tray installed over the walkway path	Trips, Slips and Falls	Awareness induction	Med	Step bridge to be installed	Low	Client advised	Outstanding	OH&S REGULATIONS 3.7 AS/NZS 1657-2013 3.1.4

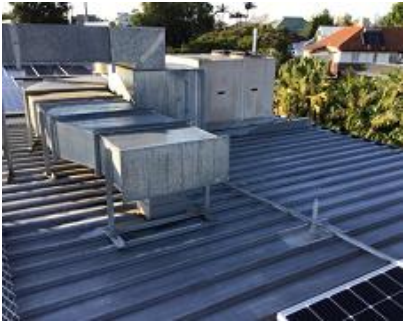
No	Photo of Hazard	Details of Hazard	Details of Risk	Existing/ Immediate Control Measure	Curre nt Risk Level	Proposed Permanent Solution	Resid ual Risk Asse sme nt	Details of Action Taken	Status	Reference
15	Building: General Stores Location Reference: L08 Task: Access to the A/c units

No safe access to the A/c units	Trips, Slips and Falls	N/A	Low	Supply walkway and handrail to the A/c units	Low	Client advised	Outstanding	-
16	Building: General Stores Location Reference: L08 Task: Access to the A/c units

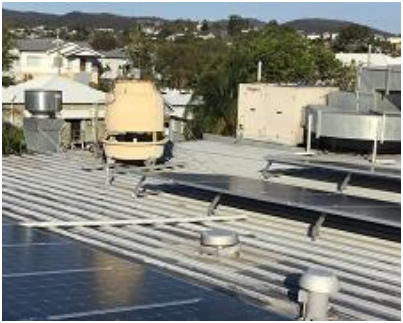
No safe access to the A/c units	Trips, Slips and Falls	N/A	Low	Supply walkway and handrail to the A/c units	Low	Client advised	Outstanding	-

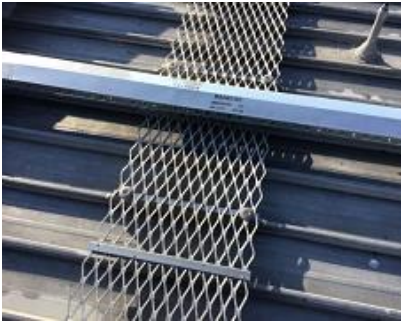
No	Photo of Hazard	Details of Hazard	Details of Risk	Existing/ Immediate Control Measure	Curre nt Risk Level	Proposed Permanent Solution	Resid ual Risk Asse sme nt	Details of Action Taken	Status	Reference
17	Building: General Stores Location Reference: L08 Task: Access to the roof

Cable tray installed over the walkway path	Trips, Slips and Falls	Awareness induction	Med	Step bridge to be installed	Low	Client advised	Outstanding	OH&S REGULATIONS 3.7 AS/NZS 1657-2013 3.1.4
18	Building: General Stores Location Reference: L08 Task: Access to the roof

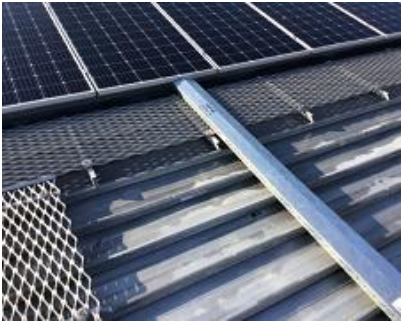
Cable tray installed over the walkway path	Trips, Slips and Falls	Awareness induction	Med	Step bridge to be installed	Low	Client advised	Outstanding	OH&S REGULATIONS 3.7 AS/NZS 1657-2013 3.1.4

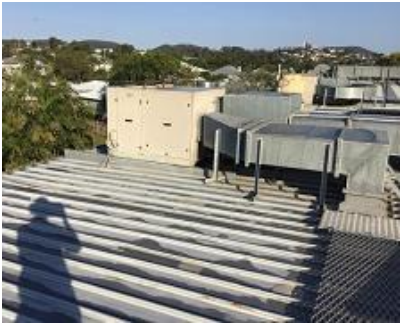
No	Photo of Hazard	Details of Hazard	Details of Risk	Existing/ Immediate Control Measure	Curre nt Risk Level	Proposed Permanent Solution	Resid ual Risk Asse sme nt	Details of Action Taken	Status	Reference
19	Building: General Stores Location Reference: L09 Task: Access to the A/c unit

No safe access to the A/c units	Trips, Slips and Falls	N/A	Low	Supply walkway and handrail to the A/c units	Low	Client advised	Outstanding	-
20	Building: General Stores Location Reference: L09 Task: Access to the A/c unit

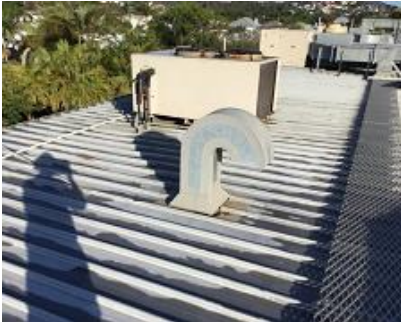
No safe access to the A/c units	Trips, Slips and Falls	N/A	Low	Supply walkway and handrail to the A/c units	Low	Client advised	Outstanding	-

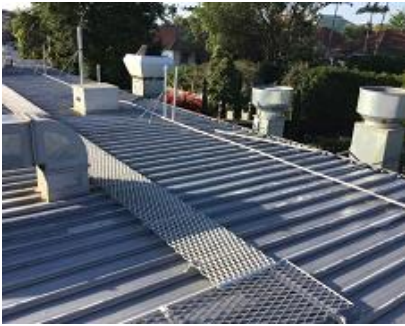
No	Photo of Hazard	Details of Hazard	Details of Risk	Existing/ Immediate Control Measure	Curre nt Risk Level	Proposed Permanent Solution	Resid ual Risk Asse sme nt	Details of Action Taken	Status	Reference
21	Building: General Stores Location Reference: L10 Task: Access to the A/c units

No safe access to the A/c units	Trips, Slips and Falls	N/A	Low	Supply walkway and handrail to the A/c units	Low	Client advised	Outstanding	-
22	Building: General Stores Location Reference: L10 Task: Access to the A/c units

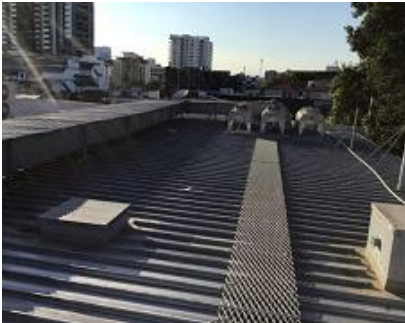
No safe access to the A/c units	Trips, Slips and Falls	N/A	Low	Supply walkway and handrail to the A/c units	Low	Client advised	Outstanding	-

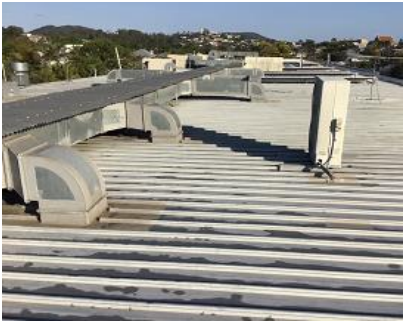
No	Photo of Hazard	Details of Hazard	Details of Risk	Existing/ Immediate Control Measure	Curre nt Risk Level	Proposed Permanent Solution	Resid ual Risk Asse sme nt	Details of Action Taken	Status	Reference
23	Building: General Stores Location Reference: L10 Task: Access to the A/c units

No safe access to the A/c units	Trips, Slips and Falls	N/A	Low	Supply walkway and Step bridge over the duct to the A/c units	Low	Client advised	Outstanding	-
24	Building: General Stores Location Reference: L11 Task: Access to the roof

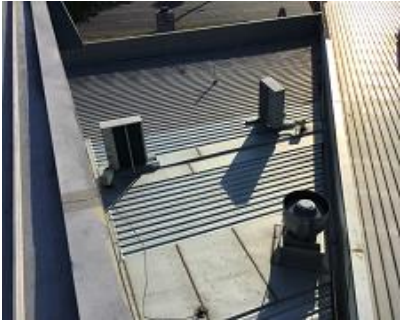
No height safety system installed	Trips, Slips and Falls	Awareness induction	High	Ladder access bracket, sign, strop, return ladder and anchors to be installed	Low	Client advised	Outstanding	OH&S REGULATIONS 3.55

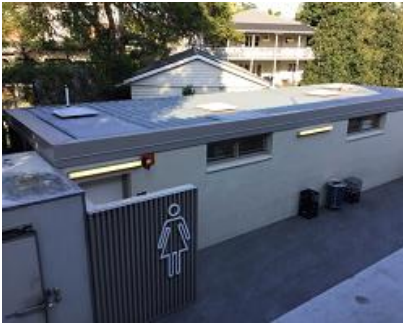
No	Photo of Hazard	Details of Hazard	Details of Risk	Existing/ Immediate Control Measure	Curre nt Risk Level	Proposed Permanent Solution	Resid ual Risk Asse sme nt	Details of Action Taken	Status	Reference
25	Building: General Stores Location Reference: L12 Task: Access to the roof

No height safety system installed	Trips, Slips and Falls	Awareness induction	High	Ladder bracket, sign, fragile roof sign, strop and anchors to be installed	Low	Client advised	Outstanding	OH&S REGULATIONS 3.55 & 3.57
