Roof Safety Report

Mount Pleasant Centre,

Prepared By: Safemaster Safety Products
Date: 25-08-2020

Roof Safety Report for
Mount Pleasant Centre, QLD 4740

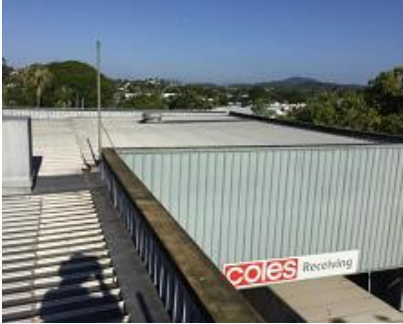
No	Photo of Hazard	Details of Hazard	Details of Risk	Existing/ Immediate Control Measure	Curre nt Risk Level	Proposed Permanent Solution	Resid ual Risk Asse sme nt	Details of Action Taken	Status	Reference
01	Building: General Stores Location Reference: L01 Task: Access to the roof

No height safety system installed	Trips, Slips and Falls	Awareness induction	High	Fall arrest anchors to be installed	Low	Client advised	Outstanding	OH&S REGULATIONS 3.55
02	Building: General Stores Location Reference: L01 Task: Access to the A/c units

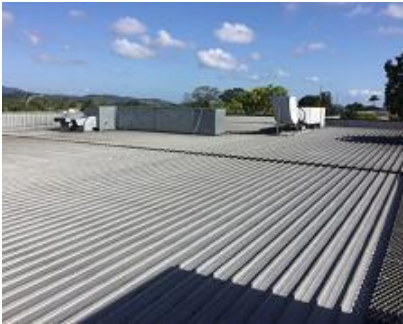
No safe access to the A/c units	Trips, Slips and Falls	N/A	Low	Supply Walkway and handrail to the A/c units	Low	Client advised	Outstanding	-

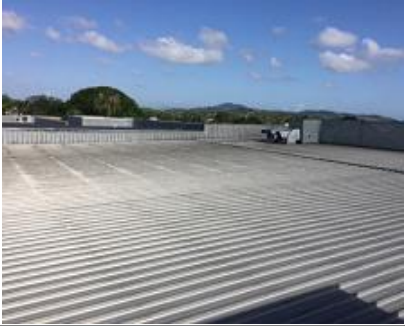
No	Photo of Hazard	Details of Hazard	Details of Risk	Existing/ Immediate Control Measure	Curren t Risk Level	Proposed Permanent Solution	Residu al Risk Assess ment	Details of Action Taken	Status	Reference
03	Building: General Stores Location Reference: L02 Task: Access to the roof

No height safety system installed	Trips, Slips and Falls	Awareness induction	High	Fall arrest anchors to be installed	Low	Client advised	Outsta nding	OH&S REGULATIONS 3.55
04	Building: General Stores Location Reference: L02 Task: Access to the roof

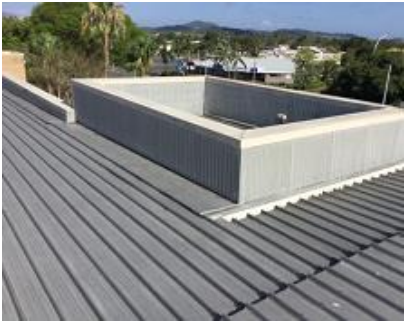
Variation in height between roofs are greater than required maximum	Trips, Slips and Falls	Awareness induction	Med	Access ladder to be installed	Low	Client advised	Outsta nding	OH&S REGULATIONS 3.7 AS/NZS 1657-2013 3.1.4

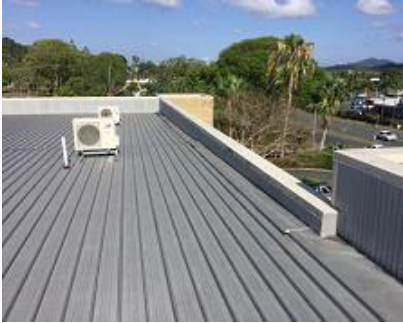
No	Photo of Hazard	Details of Hazard	Details of Risk	Existing/ Immediate Control Measure	Curre nt Risk Level	Proposed Permanent Solution	Resid ual Risk Asse sme nt	Details of Action Taken	Status	Reference
05	Building: General Stores Location Reference: L03 Task: Access to the roof

No height safety system installed	Trips, Slips and Falls	Awareness induction	High	Fall arrest anchors to be installed	Low	Client advised	Outstanding	OH&S REGULATIONS 3.55
06	Building: General Stores Location Reference: L03 Task: Access to the A/c units

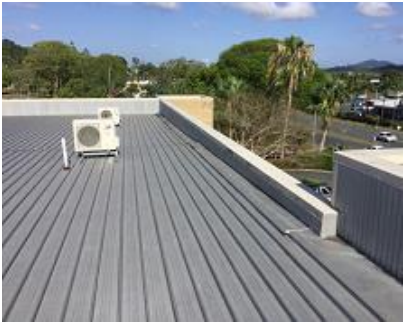
No safe access to the A/c units	Trips, Slips and Falls	N/A	Low	Supply Walkway to the A/c units	Low	Client advised	Outstanding	-

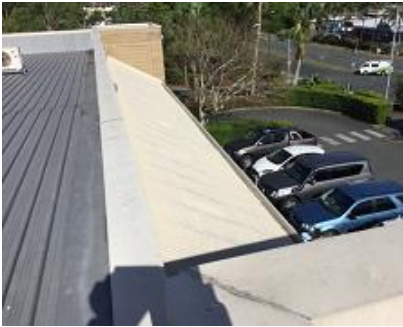
No	Photo of Hazard	Details of Hazard	Details of Risk	Existing/ Immediate Control Measure	Curren t Risk Level	Proposed Permanent Solution	Residu al Risk Assess ment	Details of Action Taken	Status	Reference
07	Building: General Stores Location Reference: L03 Task: Restrict access to the roof

No height safety system installed (No serviceable items on roof)	Trips, Slips and Falls	Restrict Access	High	"EWP Access Only" signs to be installed	Low	Client advised	Outstanding	OH&S REGULATIONS 3.55 & 3.11
08	Building: General Stores Location Reference: L04 Task: Restrict access to the roof

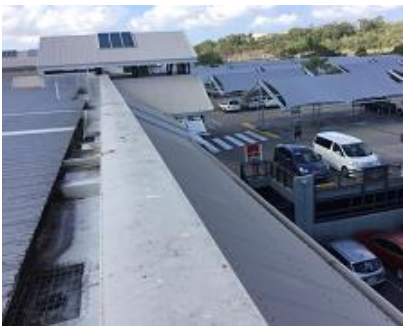
No height safety system installed (No serviceable items on roof)	Trips, Slips and Falls	Restrict Access	High	"EWP Access Only" signs to be installed	Low	Client advised	Outstanding	OH&S REGULATIONS 3.55 & 3.11

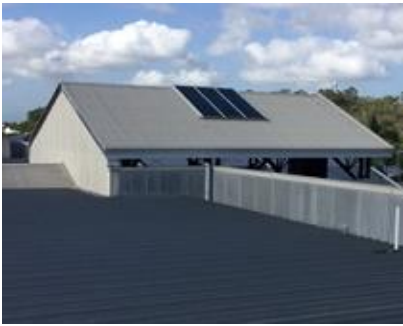
No	Photo of Hazard	Details of Hazard	Details of Risk	Existing/ Immediate Control Measure	Curre nt Risk Level	Proposed Permanent Solution	Resid ual Risk Asse sme nt	Details of Action Taken	Status	Reference
09	Building: General Stores Location Reference: L04 Task: Restrict access to the roof

Brittle roof (Non-trafficable roof)	Trips, Slips and Falls	Restrict Access	High	"Warning-Keep Off-Brittle and Fragile Roof" signs to be installed	Low	Client advised	Outstanding	OH&S REGULATIONS 3.57
10	Building: General Stores Location Reference: L05 Task: Access to the plant deck

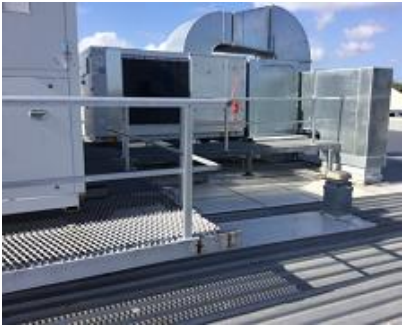
Sharp edges on handrails	Trips, Slips and Falls	Awareness induction	Med	Tek screws to be replaced with rivets	Low	Client advised	Outstanding	OH&S REGULATIONS 3.7 AS/NZS 1657-2013 5.6

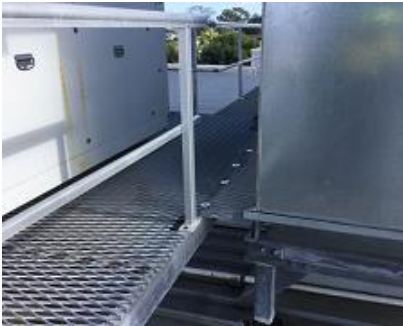
No	Photo of Hazard	Details of Hazard	Details of Risk	Existing/ Immediate Control Measure	Curre nt Risk Level	Proposed Permanent Solution	Resid ual Risk Asse sme nt	Details of Action Taken	Status	Reference
11	Building: General Stores Location Reference: L05 Task: Access to the plant deck

Gap between handrails and unit is greater than required maximum	Trips, Slips and Falls	Awareness induction	Med	Handrail to be installed	Low	Client advised	Outstanding	OH&S REGULATIONS 3.7 AS/NZS 1657-2013 4.4
12	Building: General Stores Location Reference: L05 Task: Access to the plant deck

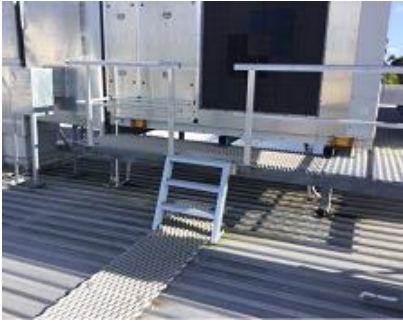
Non-complaint ladder is present	Trips, Slips and Falls	Awareness induction	Med	Existing ladder to be removed and new ladder to be installed	Low	Client advised	Outstanding	OH&S REGULATIONS 3.7 AS/NZS 1657-2013 7.3

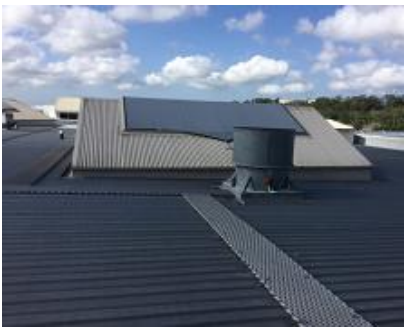
No	Photo of Hazard	Details of Hazard	Details of Risk	Existing/ Immediate Control Measure	Current Risk Level	Proposed Permanent Solution	Residual Risk Assessment	Details of Action Taken	Status	Reference
13	Building: General Stores Location Reference: L06 Task: Restrict access to the roof

Brittle roof (Non-trafficable roof)	Trips, Slips and Falls	Restrict Access	High	"Warning-Keep Off-Brittle and Fragile Roof" signs to be installed	Low	Client advised	Outstanding	OH&S REGULATIONS 3.57
14	Building: General Stores Location Reference: L07 Task: Access to the roof

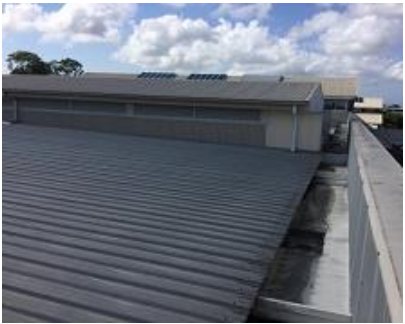
No height safety system installed	Trips, Slips and Falls	Awareness induction	High	Fall arrest anchors, anchor stop and ladder access bracket to be installed	Low	Client advised	Outstanding	OH&S REGULATIONS 3.55

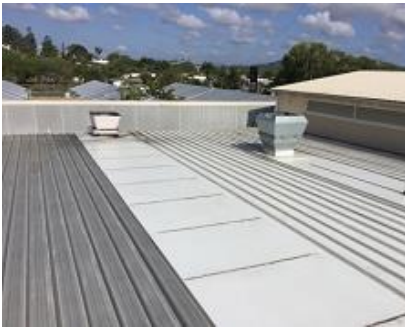
No	Photo of Hazard	Details of Hazard	Details of Risk	Existing/ Immediate Control Measure	Curre nt Risk Level	Proposed Permanent Solution	Resid ual Risk Asse sme nt	Details of Action Taken	Status	Reference
15	Building: General Stores Location Reference: L07 Task: Access to the A/c units

No safe access to the A/c units	Trips, Slips and Falls	N/A	Low	Supply Walkway and step bridge to the A/c units	Low	Client advised	Outstanding	-
16	Building: General Stores Location Reference: L08 Task: Access to the A/c units

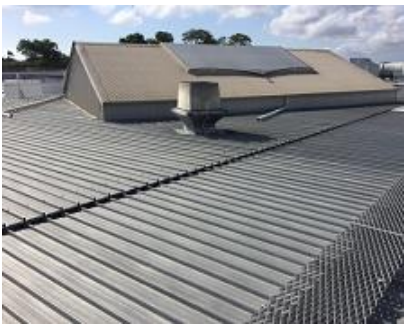
No safe access to the A/c units	Trips, Slips and Falls	N/A	Low	Supply Walkway to the A/c units	Low	Client advised	Outstanding	-

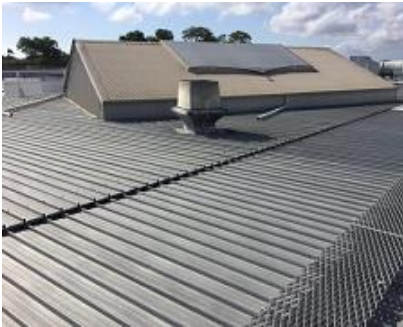
No	Photo of Hazard	Details of Hazard	Details of Risk	Existing/ Immediate Control Measure	Curre nt Risk Level	Proposed Permanent Solution	Resid ual Risk Asse sme nt	Details of Action Taken	Status	Reference
17	Building: General Stores Location Reference: L08 Task: Restrict access to the roof

Brittle roof (Non-trafficable roof)	Trips, Slips and Falls	Restrict Access	High	"Warning-Keep Off-Brittle and Fragile Roof" signs to be installed	Low	Client advised	Outstanding	OH&S REGULATIONS 3.57
18	Building: General Stores Location Reference: L08 Task: Access to the roof

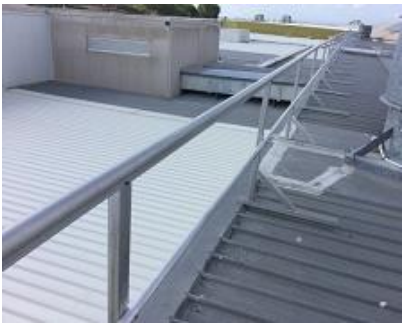
Sharp edges on handrails	Trips, Slips and Falls	Awareness induction	Med	Tek screws to be replaced with rivets	Low	Client advised	Outstanding	OH&S REGULATIONS 3.7 AS/NZS 1657-2013 5.6

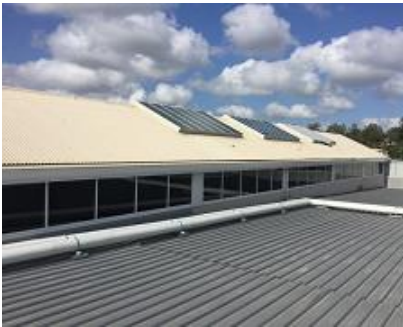
No	Photo of Hazard	Details of Hazard	Details of Risk	Existing/ Immediate Control Measure	Curre nt Risk Level	Proposed Permanent Solution	Resid ual Risk Asse sme nt	Details of Action Taken	Status	Reference
19	Building: General Stores Location Reference: L09 Task: Restrict access to the roof

Brittle roof (Non-trafficable roof)	Trips, Slips and Falls	Restrict Access	High	"Warning-Keep Off-Brittle and Fragile Roof" signs to be installed	Low	Client advised	Outstanding	OH&S REGULATIONS 3.57
20	Building: General Stores Location Reference: L09 Task: Access to the roof

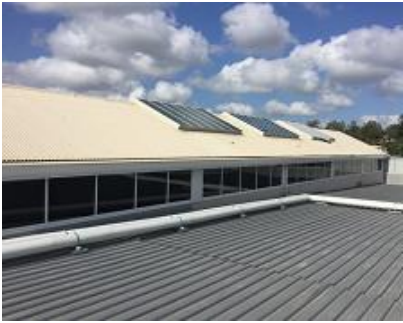
No height safety system installed	Trips, Slips and Falls	Awareness induction	High	Fall arrest anchors, anchor strop and ladder access bracket to be installed	Low	Client advised	Outstanding	OH&S REGULATIONS 3.55

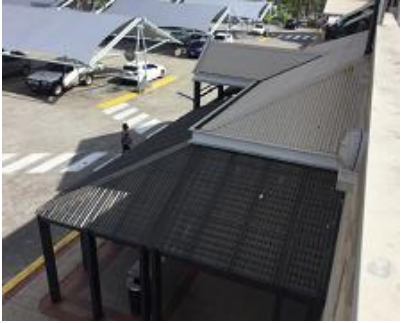
No	Photo of Hazard	Details of Hazard	Details of Risk	Existing/ Immediate Control Measure	Curre nt Risk Level	Proposed Permanent Solution	Resid ual Risk Asse sme nt	Details of Action Taken	Status	Reference
21	Building: General Stores Location Reference: L10 Task: Restrict access to the roof

No height safety system installed (No serviceable items on roof)	Trips, Slips and Falls	Restrict Access	High	"EWP Access Only" signs to be installed	Low	Client advised	Outstanding	OH&S REGULATIONS 3.55 & 3.11
22	Building: General Stores Location Reference: L11 Task: Access to the roof

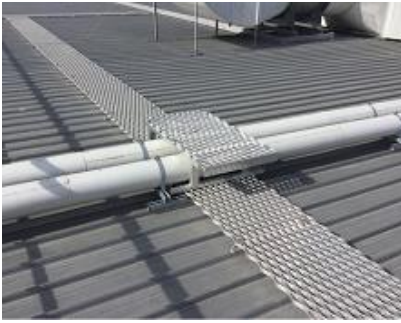
Step height is greater than required maximum	Trips, Slips and Falls	Awareness induction	Med	Handrail including additional steps to be installed	Low	Client advised	Outstanding	OH&S REGULATIONS 3.7 AS/NZS 1657-2013 7.2

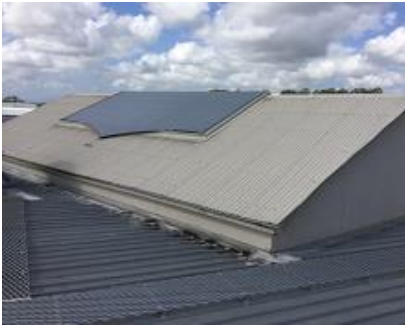
No	Photo of Hazard	Details of Hazard	Details of Risk	Existing/ Immediate Control Measure	Curre nt Risk Level	Proposed Permanent Solution	Resid ual Risk Asse sme nt	Details of Action Taken	Status	Reference
23	Building: General Stores Location Reference: L12 Task: Restrict access to the roof

Brittle roof (Non-trafficable roof)	Trips, Slips and Falls	Restrict Access	High	"Warning-Keep Off-Brittle and Fragile Roof" signs to be installed	Low	Client advised	Outstanding	OH&S REGULATIONS 3.57
24	Building: General Stores Location Reference: L13 Task: Access to the roof

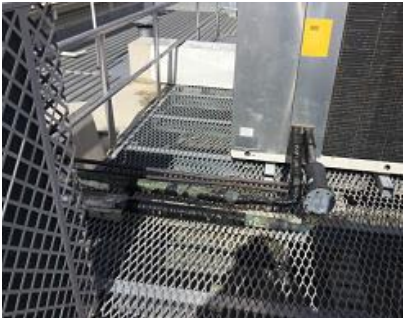
Pipes in the way to access a/c units	Trips, Slips and Falls	Awareness induction	Med	Step bridge to be installed	Low	Client advised	Outstanding	OH&S REGULATIONS 3.7 AS/NZS 1657-2013 3.1.4

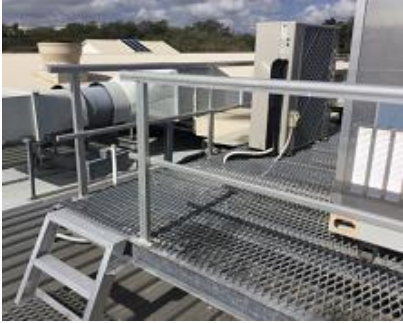
No	Photo of Hazard	Details of Hazard	Details of Risk	Existing/ Immediate Control Measure	Curre nt Risk Level	Proposed Permanent Solution	Resid ual Risk Asse sme nt	Details of Action Taken	Status	Reference
25	Building: General Stores Location Reference: L13 Task: Access to the roof

Non-complaint ladder is present	Trips, Slips and Falls	Awareness induction	Med	Existing ladder to be removed and new ladder to be installed	Low	Client advised	Outstanding	OH&S REGULATIONS 3.7 AS/NZS 1657-2013 7.3
26	Building: General Stores Location Reference: L13 Task: Access to the roof

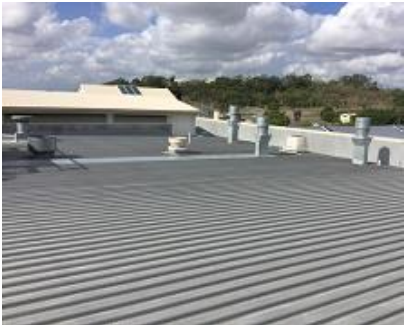
No	Photo of Hazard	Details of Hazard	Details of Risk	Existing/ Immediate Control Measure	Curre nt Risk Level	Proposed Permanent Solution	Resid ual Risk Asse sme nt	Details of Action Taken	Status	Reference
27	Building: General Stores Location Reference: L13 Task: Access to the A/c units

No safe access to the A/c units	Trips, Slips and Falls	N/A	Low	Supply Walkway to the A/c units	Low	Client advised	Outstanding	-
28	Building: General Stores Location Reference: L14 Task: Restrict access to the roof

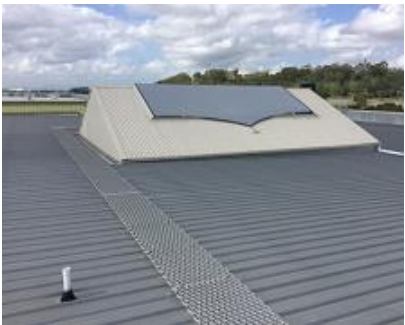
Brittle roof (Non-trafficable roof)	Trips, Slips and Falls	Restrict Access	High	"Warning-Keep Off-Brittle and Fragile Roof" signs to be installed	Low	Client advised	Outstanding	OH&S REGULATIONS 3.57

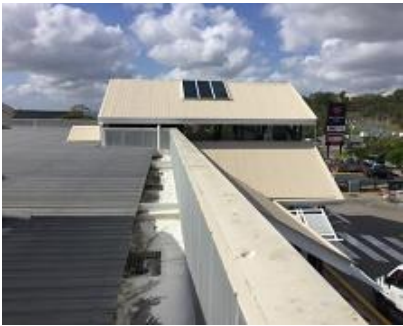
No	Photo of Hazard	Details of Hazard	Details of Risk	Existing/ Immediate Control Measure	Curre nt Risk Level	Proposed Permanent Solution	Resid ual Risk Asse sme nt	Details of Action Taken	Status	Reference
29	Building: General Stores Location Reference: L15 Task: Restrict access to the roof

Brittle roof (Non-trafficable roof)	Trips, Slips and Falls	Restrict Access	High	"Warning-Keep Off-Brittle and Fragile Roof" signs to be installed	Low	Client advised	Outstanding	OH&S REGULATIONS 3.57
30	Building: General Stores Location Reference: L15 Task: Restrict access to the roof

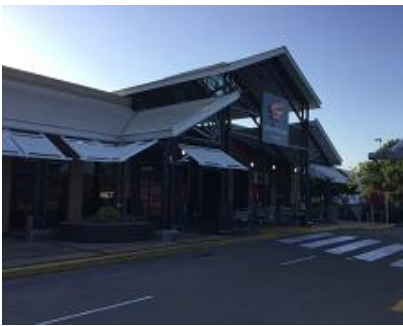
No height safety system installed (No serviceable items on roof)	Trips, Slips and Falls	Restrict Access	High	"EWP Access Only" signs to be installed	Low	Client advised	Outstanding	OH&S REGULATIONS 3.55 & 3.11

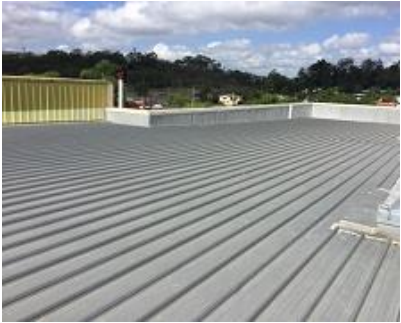
No	Photo of Hazard	Details of Hazard	Details of Risk	Existing/ Immediate Control Measure	Curre nt Risk Level	Proposed Permanent Solution	Resid ual Risk Asse sme nt	Details of Action Taken	Status	Reference
31	Building: General Stores Location Reference: L15 Task: Access to the roof

No height safety system installed	Trips, Slips and Falls	Awareness induction	High	Fall arrest anchors to be installed	Low	Client advised	Outstanding	OH&S REGULATIONS 3.55
32	Building: General Stores Location Reference: L15 Task: Access to the roof

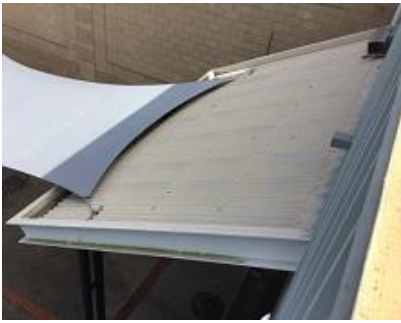
No height safety system installed (No serviceable items on roof)	Trips, Slips and Falls	Restrict Access	High	"EWP Access Only" signs to be installed	Low	Client advised	Outstanding	OH&S REGULATIONS 3.55 & 3.11

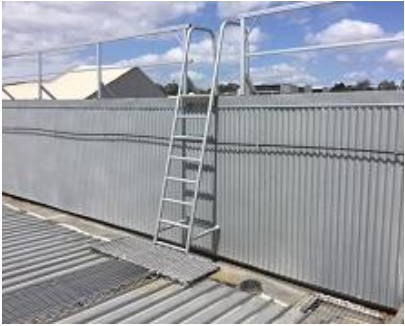
No	Photo of Hazard	Details of Hazard	Details of Risk	Existing/ Immediate Control Measure	Curre nt Risk Level	Proposed Permanent Solution	Resid ual Risk Asse sme nt	Details of Action Taken	Status	Reference
33	Building: General Stores Location Reference: L16 Task: Access to the roof

Bottom rung height is less than required minimum and gap between ladder and permanent structure is less than required minimum	Trips, Slips and Falls	Awareness induction	Med	Existing ladder to be removed and new ladder to be installed	Low	Client advised	Outstanding	OH&S REGULATIONS 3.7 AS/NZS 1657-2013 7.4.3.4 & 7.4.5
34	Building: General Stores Location Reference: L16 Task: Access to the roof

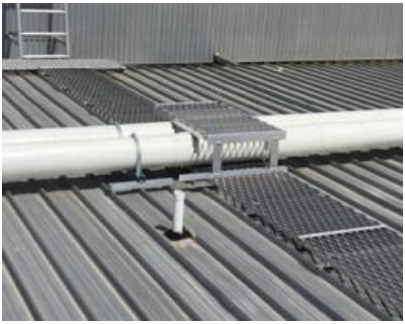
Step height is greater than required maximum	Trips, Slips and Falls	Awareness induction	Med	Handrail including additional steps to be installed	Low	Client advised	Outstanding	OH&S REGULATIONS 3.7 AS/NZS 1657-2013 7.2

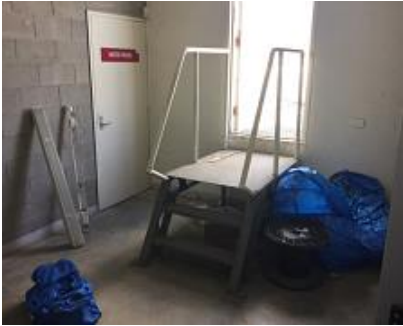
No	Photo of Hazard	Details of Hazard	Details of Risk	Existing/ Immediate Control Measure	Curre nt Risk Level	Proposed Permanent Solution	Resid ual Risk Asse sme nt	Details of Action Taken	Status	Reference
35	Building: General Stores Location Reference: L17 Task: Access to the roof

Mid rail is missing for landing	Trips, Slips and Falls	Awareness induction	Med	Mid rail to be installed	Low	Client advised	Outstanding	OH&S REGULATIONS 3.7 AS/NZS 1657-2013 6.2.1.2
36	Building: General Stores Location Reference: L17 Task: Access to the A/c units

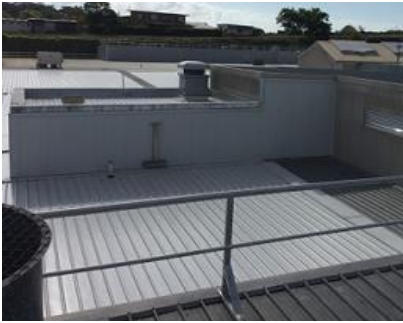
Variation in height between roofs are greater than required maximum	Trips, Slips and Falls	Awareness induction	Med	Access ladder including walkway to be installed	Low	Client advised	Outstanding	OH&S REGULATIONS 3.7 AS/NZS 1657-2013 3.1.4

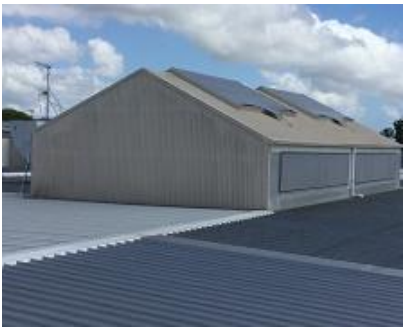
No	Photo of Hazard	Details of Hazard	Details of Risk	Existing/ Immediate Control Measure	Curre nt Risk Level	Proposed Permanent Solution	Resid ual Risk Asse sme nt	Details of Action Taken	Status	Reference
37	Building: General Stores Location Reference: L19 Task: Restrict access to the roof

Brittle roof (Non-trafficable roof)	Trips, Slips and Falls	Restrict Access	High	"Warning-Keep Off-Brittle and Fragile Roof" signs to be installed	Low	Client advised	Outstanding	OH&S REGULATIONS 3.57
38	Building: General Stores Location Reference: L20 Task: Access to the A/c units

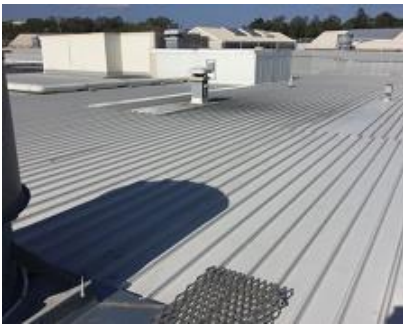
No safe access to the A/c units	Trips, Slips and Falls	N/A	Low	Supply Walkway to the A/c units	Low	Client advised	Outstanding	-

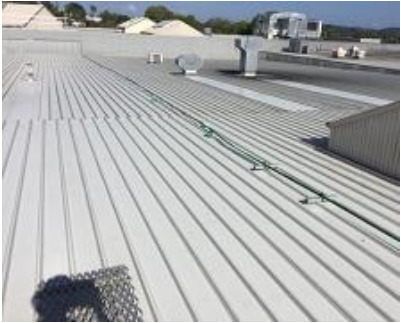
No	Photo of Hazard	Details of Hazard	Details of Risk	Existing/ Immediate Control Measure	Curre nt Risk Level	Proposed Permanent Solution	Resid ual Risk Asse sme nt	Details of Action Taken	Status	Reference
39	Building: General Stores Location Reference: L20 Task: Access to the A/c units

No safe access to the A/c units	Trips, Slips and Falls	N/A	Low	Supply Walkway to the A/c units	Low	Client advised	Outstanding	-
40	Building: General Stores Location Reference: L20 Task: Restrict access to the roof

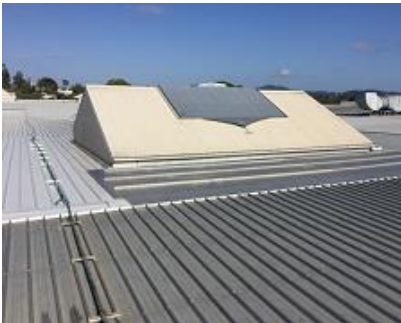
Brittle roof (Non-trafficable roof)	Trips, Slips and Falls	Restrict Access	High	"Warning-Keep Off-Brittle and Fragile Roof" signs to be installed	Low	Client advised	Outstanding	OH&S REGULATIONS 3.57

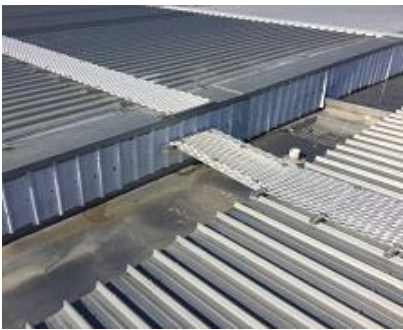
No	Photo of Hazard	Details of Hazard	Details of Risk	Existing/ Immediate Control Measure	Curre nt Risk Level	Proposed Permanent Solution	Resid ual Risk Asse sme nt	Details of Action Taken	Status	Reference
41	Building: General Stores Location Reference: L21 Task: Access to the roof

Variation in height between walkway and adjacent surface is greater than required maximum	Trips, Slips and Falls	Awareness induction	Med	Handrail to be installed	Low	Client advised	Outstanding	OH&S REGULATIONS 3.7 AS/NZS 1657-2013 4.4
42	Building: General Stores Location Reference: L22 Task: Access to the A/c units

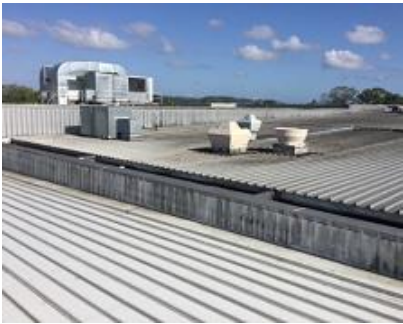
No safe access to the A/c units	Trips, Slips and Falls	N/A	Low	Supply Walkway to the A/c units	Low	Client advised	Outstanding	-

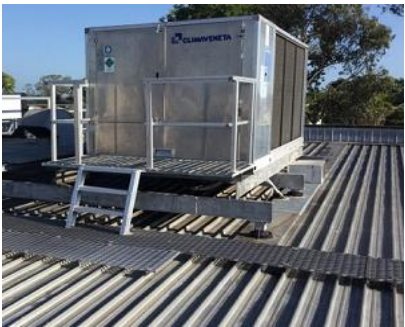
No	Photo of Hazard	Details of Hazard	Details of Risk	Existing/ Immediate Control Measure	Curre nt Risk Level	Proposed Permanent Solution	Resid ual Risk Asse ssme nt	Details of Action Taken	Status	Reference
43	Building: General Stores Location Reference: L23 Task: Access to the roof

Sharp edges on handrails	Trips, Slips and Falls	Awareness induction	Med	Tek screws to be replaced with rivets	Low	Client advised	Outsta nding	OH&S REGULATIONS 3.7 AS/NZS 1657- 2013 5.6
44	Building: General Stores Location Reference: L23 Task: Access to the roof

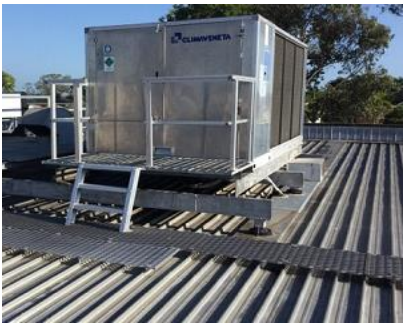
Non-complaint ladder is present	Trips, Slips and Falls	Awareness induction	Med	Existing ladder to be removed and new ladder to be installed	Low	Client advised	Outsta nding	OH&S REGULATIONS 3.7 AS/NZS 1657- 2013 7.3

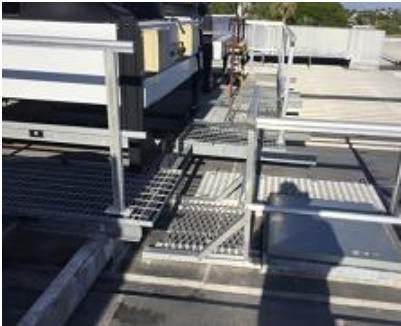
No	Photo of Hazard	Details of Hazard	Details of Risk	Existing/ Immediate Control Measure	Current Risk Level	Proposed Permanent Solution	Residual Risk Assessment	Details of Action Taken	Status	Reference
45	Building: General Stores Location Reference: L23 Task: Access to the roof

Variation in height between plant deck and roof is greater than required maximum	Trips, Slips and Falls	Awareness induction	Med	Steps and additional handrail sections to be installed	Low	Client advised	Outstanding	OH&S REGULATIONS 3.7 AS/NZS 1657-2013 3.1.4 & 4.4
46	Building: General Stores Location Reference: L24 Task: Access to the roof

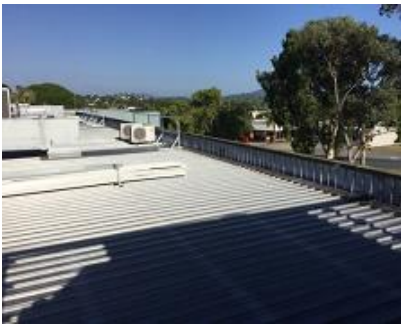
No height safety system installed	Trips, Slips and Falls	Awareness induction	High	Fall arrest anchors to be installed	Low	Client advised	Outstanding	OH&S REGULATIONS 3.55

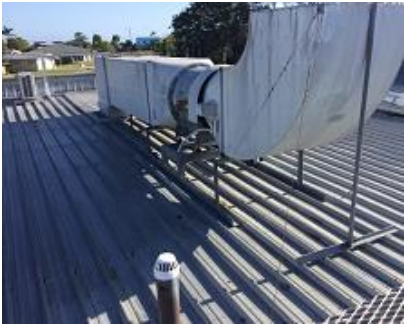
No	Photo of Hazard	Details of Hazard	Details of Risk	Existing/ Immediate Control Measure	Curre nt Risk Level	Proposed Permanent Solution	Resid ual Risk Asse sme nt	Details of Action Taken	Status	Reference
47	Building: General Stores Location Reference: L24 Task: Access to the A/c units

No safe access to the A/c units	Trips, Slips and Falls	N/A	Low	Supply Walkway to the A/c units	Low	Client advised	Outstanding	-
48	Building: General Stores Location Reference: L25 Task: Access to the roof

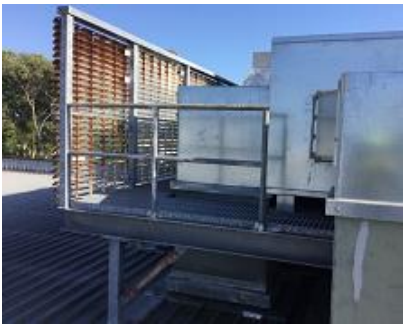
Non-complaint handrail is present	Trips, Slips and Falls	Awareness induction	Med	Existing handrail to be removed and new handrail to be installed	Low	Client advised	Outstanding	OH&S REGULATIONS 3.7 AS/NZS 1657-2013 4.4

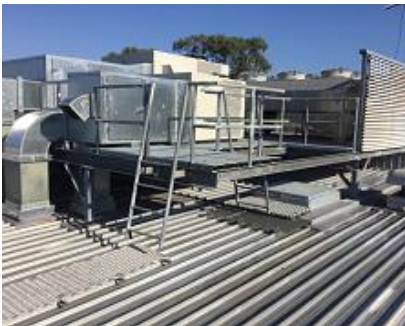
Non-complaint handrail is present	Trips, Slips and Falls	Awareness induction	Med	Existing handrail to be removed and new handrail to be installed	Low	Client advised	Outstanding	OH&S REGULATIONS 3.7 AS/NZS 1657-2013 4.4
50	Building: General Stores Location Reference: L25 Task: Access to the roof

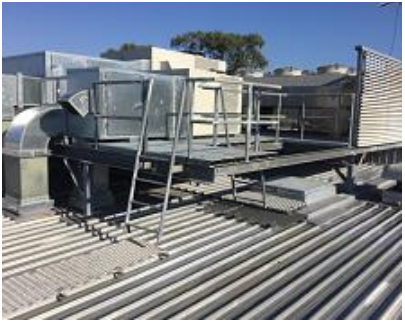
Non-complaint ladder is present	Trips, Slips and Falls	Awareness induction	Med	Existing ladder to be removed and new ladder to be installed	Low	Client advised	Outstanding	OH&S REGULATIONS 3.7 AS/NZS 1657-2013 7.4

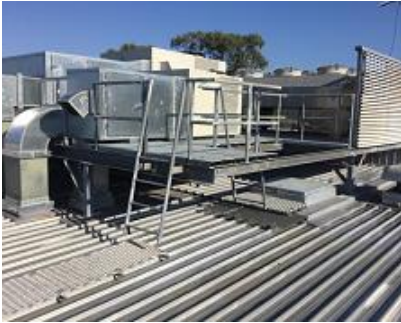
Non-complaint ladder is present	Trips, Slips and Falls	Awareness induction	Med	Existing ladder to be removed and new ladder to be installed	Low	Client advised	Outstanding	OH&S REGULATIONS 3.7 AS/NZS 1657-2013 7.4
52	Building: General Stores Location Reference: L25 Task: Access to the roof

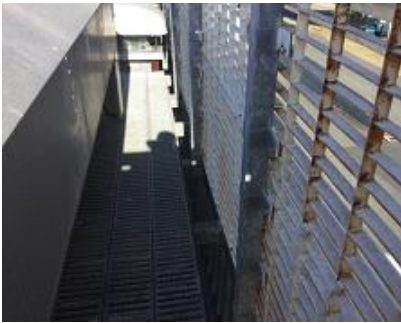
Gap between plant deck and permanent structure is greater than required maximum	Trips, Slips and Falls	Awareness induction	Med	Gap to be closed	Low	Client advised	Outstanding	OH&S REGULATIONS 3.7 AS/NZS 1657-2013 4.4

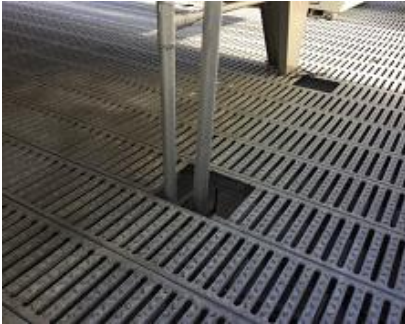
Un-protected cut outs are present	Trips, Slips and Falls	Awareness induction	Med	Cut outs to be closed	Low	Client advised	Outstanding	OH&S REGULATIONS 3.7
54	Building: General Stores Location Reference: L26 Task: Access to the A/c units

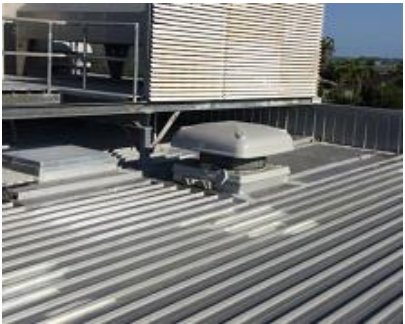
No safe access to the A/c units	Trips, Slips and Falls	N/A	Low	Supply Walkway to the A/c units	Low	Client advised	Outstanding	-

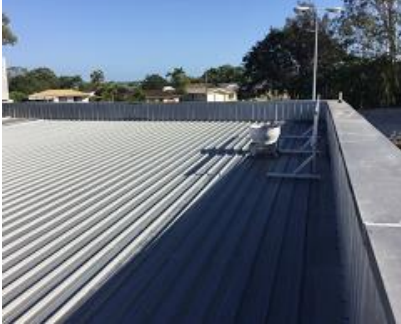
No safe access to the A/c units	Trips, Slips and Falls	N/A	Low	Supply Walkway to the A/c units	Low	Client advised	Outstanding	-
56	Building: General Stores Location Reference: L26 Task: Access to the roof

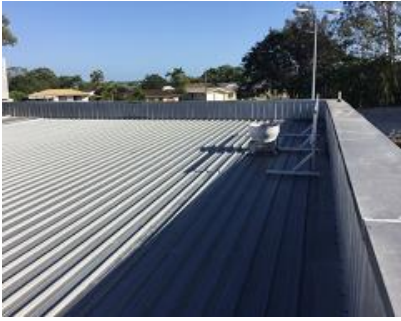
No height safety system installed	Trips, Slips and Falls	Awareness induction	High	Fall arrest anchors to be installed	Low	Client advised	Outstanding	OH&S REGULATIONS 3.55

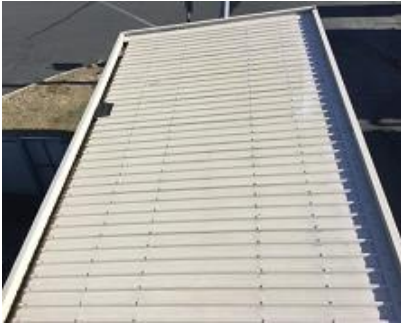
No height safety system installed (No serviceable items on roof)	Trips, Slips and Falls	Restrict Access	High	"EWP Access Only" signs to be installed	Low	Client advised	Outstanding	OH&S REGULATIONS 3.55 & 3.11
58	Building: General Stores Location Reference: L28 Task: Restrict access to the roof

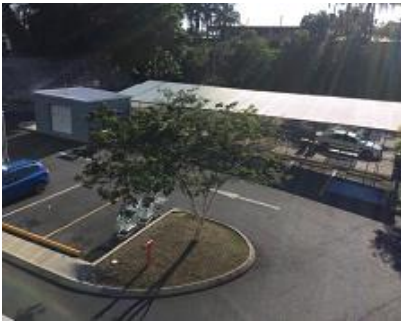
No height safety system installed (No serviceable items on roof)	Trips, Slips and Falls	Restrict Access	High	"EWP Access Only" signs to be installed	Low	Client advised	Outstanding	OH&S REGULATIONS 3.55 & 3.11

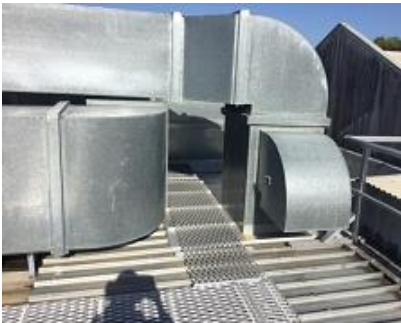
No height safety system installed (No serviceable items on roof)	Trips, Slips and Falls	Restrict Access	High	"EWP Access Only" signs to be installed	Low	Client advised	Outstanding	OH&S REGULATIONS 3.55 & 3.11
60	Building: General Stores Location Reference: L29 Task: Access to the roof

Headroom is less than required minimum	Trips, Slips and Falls	Awareness induction	Med	"Caution-Low Headroom" signs to be installed	Low	Client advised	Outstanding	OH&S REGULATIONS 3.7 AS/NZS 1657-2013 3.1.5

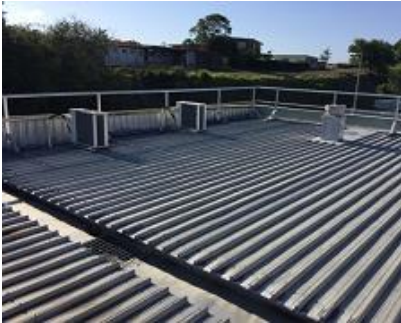
No safe access to the A/c units	Trips, Slips and Falls	N/A	Low	Supply Walkway to the A/c units	Low	Client advised	Outstanding	-
62	Building: General Stores Location Reference: L29 Task: Access to the roof

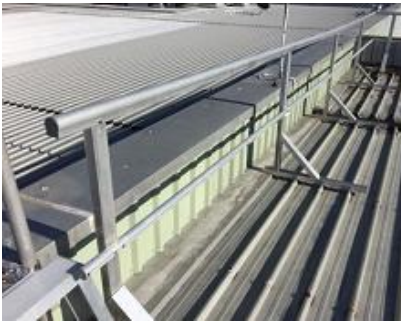
Sharp edges on handrails	Trips, Slips and Falls	Awareness induction	Med	Tek screws to be replaced with rivets	Low	Client advised	Outstanding	OH&S REGULATIONS 3.7 AS/NZS 1657-2013 5.6

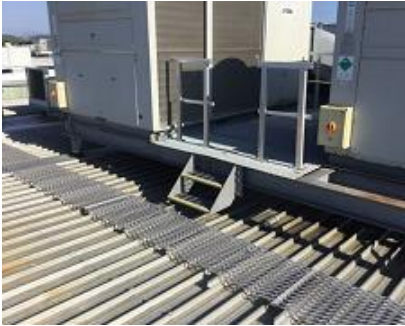
Sharp edges on handrails	Trips, Slips and Falls	Awareness induction	Med	Tek screws to be replaced with rivets	Low	Client advised	Outstanding	OH&S REGULATIONS 3.7 AS/NZS 1657-2013 5.6
64	Building: General Stores Location Reference: L29 Task: Access to the roof

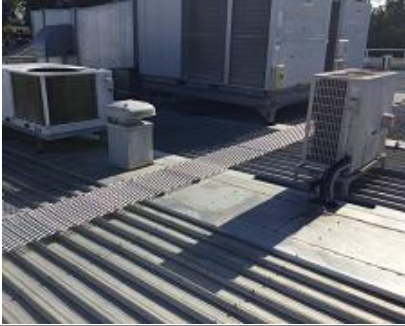
No safe access to the A/c units	Trips, Slips and Falls	N/A	Low	Supply Walkway to the A/c units	Low	Client advised	Outstanding	-
66	Building: General Stores Location Reference: L29 Task: Access to the roof

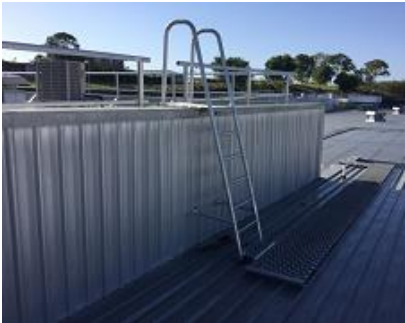
Landing is less than required minimum	Trips, Slips and Falls	Awareness induction	Med	Landing platform to be installed	Low	Client advised	Outstanding	OH&S REGULATIONS 3.7 AS/NZS 1657-2013 7.3.6

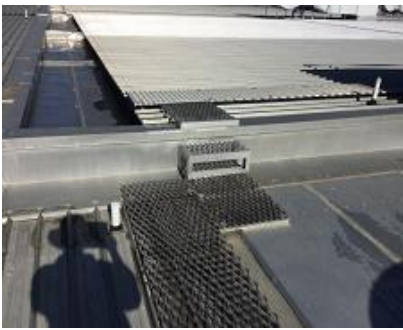
Variation in height between walkway and adjacent surface is greater than required maximum	Trips, Slips and Falls	Awareness induction	Med	Handrail to be installed	Low	Client advised	Outstanding	OH&S REGULATIONS 3.7 AS/NZS 1657-2013 4.4
68	Building: General Stores Location Reference: L30 Task: Restrict access to the roof

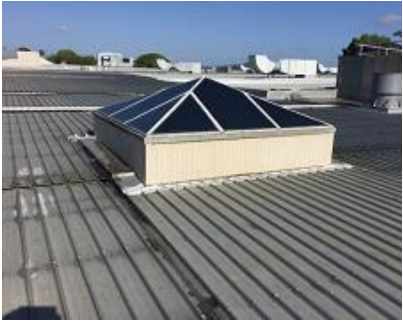
Brittle roof (Non-trafficable roof)	Trips, Slips and Falls	Restrict Access	High	"Warning-Keep Off-Brittle and Fragile Roof" signs to be installed	Low	Client advised	Outstanding	OH&S REGULATIONS 3.57

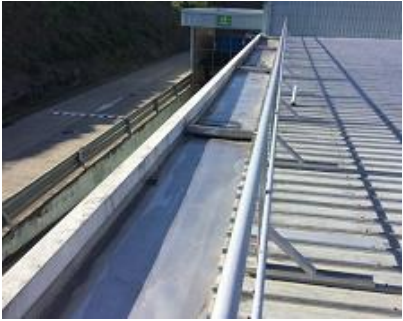
No height safety system installed	Trips, Slips and Falls	Awareness induction	High	Fall arrest anchors to be installed	Low	Client advised	Outstanding	OH&S REGULATIONS 3.55

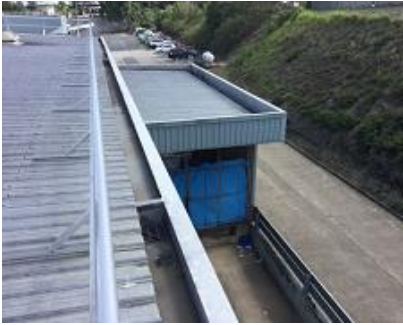
No height safety system installed (No serviceable items on roof)	Trips, Slips and Falls	Restrict Access	High	"EWP Access Only" signs to be installed	Low	Client advised	Outstanding	OH&S REGULATIONS 3.55 & 3.11
72	Building: General Stores Location Reference: L33 Task: Access to the roof

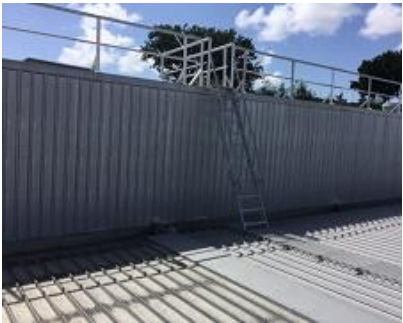
Bottom tread height is less than required minimum	Trips, Slips and Falls	Awareness induction	Med	Landing platform to be installed	Low	Client advised	Outstanding	OH&S REGULATIONS 3.7 AS/NZS 1657-2013 7.4.3.4

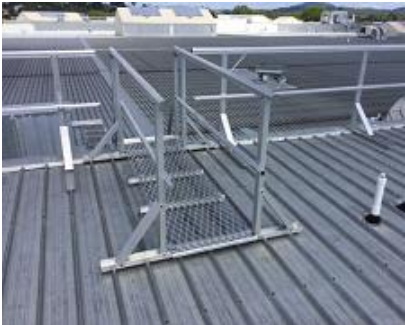
Sharp edges on handrails	Trips, Slips and Falls	Awareness induction	Med	Tek screws to be replaced with rivets	Low	Client advised	Outsta nding	OH&S REGULATIONS 3.7 AS/NZS 1657- 2013 5.6
74	Building: General Stores Location Reference: L33 Task: Access to the A/c units

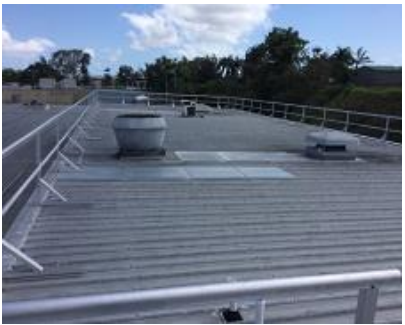
No safe access to the A/c units	Trips, Slips and Falls	N/A	Low	Supply Walkway to the A/c units	Low	Client advised	Outsta nding	-

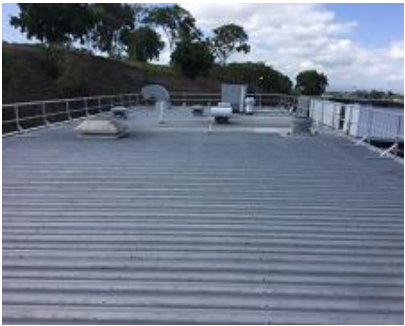
No safe access to the A/c units	Trips, Slips and Falls	N/A	Low	Supply Walkway to the A/c units	Low	Client advised	Outstanding	-
76	Building: General Stores Location Reference: L34 Task: Access to the roof

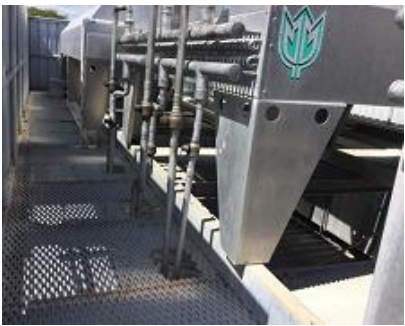
Gap between plant deck and unit is greater than required maximum	Trips, Slips and Falls	Awareness induction	Med	Mid rail to be installed	Low	Client advised	Outstanding	OH&S REGULATIONS 3.7 AS/NZS 1657-2013 6.2.1.2

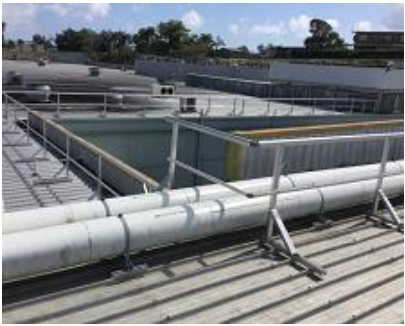
Sharp edges on handrails	Trips, Slips and Falls	Awareness induction	Med	Tek screws to be replaced with rivets	Low	Client advised	Outstanding	OH&S REGULATIONS 3.7 AS/NZS 1657-2013 5.6
80	Building: General Stores Location Reference: L37 Task: Access to the A/c units

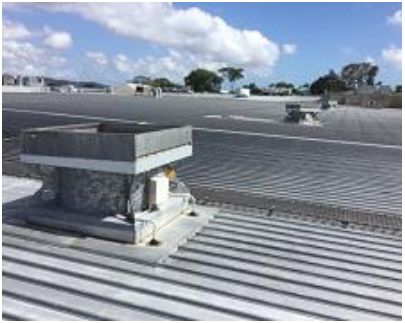
No safe access to the A/c units	Trips, Slips and Falls	N/A	Low	Supply Walkway to the A/c units	Low	Client advised	Outstanding	-

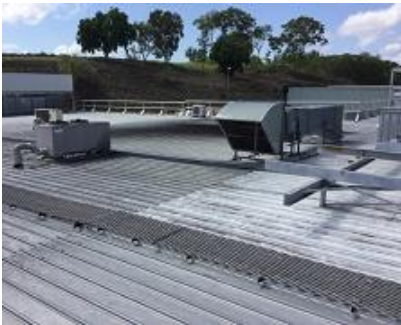
No safe access to the A/c units	Trips, Slips and Falls	N/A	Low	Supply Walkway to the A/c units	Low	Client advised	Outstanding	-
82	Building: General Stores Location Reference: L37 Task: Access to the A/c units

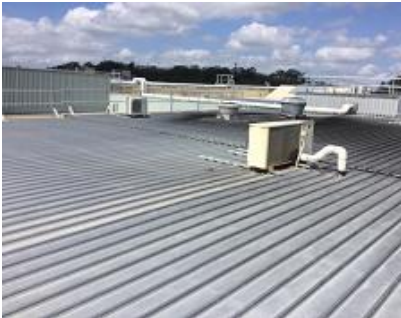
No safe access to the A/c units	Trips, Slips and Falls	N/A	Low	Supply Walkway to the A/c units	Low	Client advised	Outstanding	-

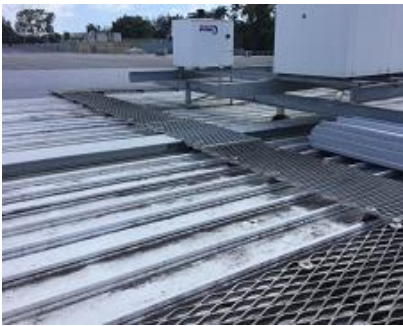
Variation in height between walkway panels are greater than required maximum	Trips, Slips and Falls	Awareness induction	Med	High visibility safety yellow nosing's to be installed	Low	Client advised	Outstanding	OH&S REGULATIONS 3.7 AS/NZS 1657-2013 3.3.4
84	Building: General Stores Location Reference: L38 Task: Access to the roof

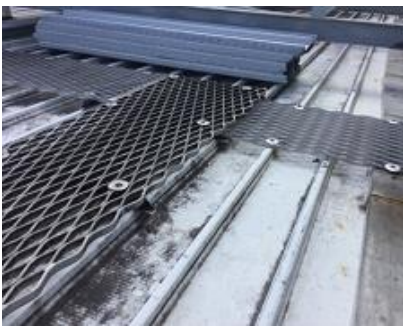
Variation in height between walkway panels are greater than required maximum	Trips, Slips and Falls	Awareness induction	Med	High visibility safety yellow nosing's to be installed	Low	Client advised	Outstanding	OH&S REGULATIONS 3.7 AS/NZS 1657-2013 3.3.4

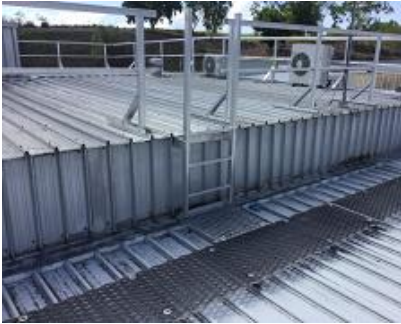
Top rung not levelled with landing and bottom rung height is less than required minimum	Trips, Slips and Falls	Awareness induction	Med	Existing ladder to be re-installed with landing platforms, brackets and handrails	Low	Client advised	Outstanding	OH&S REGULATIONS 3.7 AS/NZS 1657-2013 7.4.3.3 & 7.4.3.4
86	Building: General Stores Location Reference: L38 Task: Access to the roof

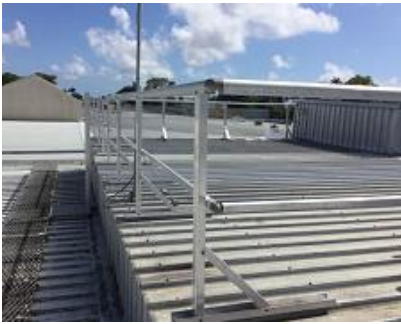
Sharp edges on handrails	Trips, Slips and Falls	Awareness induction	Med	Tek screws to be replaced with rivets	Low	Client advised	Outstanding	OH&S REGULATIONS 3.7 AS/NZS 1657-2013 5.6

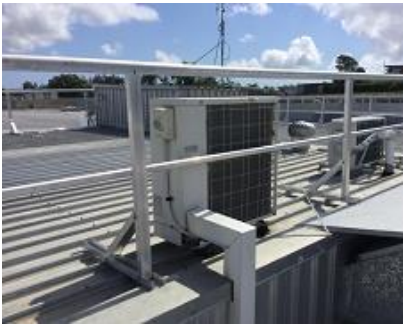
No safe access to the A/c units	Trips, Slips and Falls	N/A	Low	Supply Walkway to the A/c units	Low	Client advised	Outstanding	-
88	Building: General Stores Location Reference: L39 Task: Restrict access to the roof

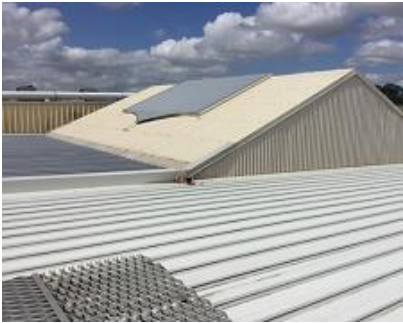
Brittle roof (Non-trafficable roof)	Trips, Slips and Falls	Restrict Access	High	"Warning-Keep Off-Brittle and Fragile Roof" signs to be installed	Low	Client advised	Outstanding	OH&S REGULATIONS 3.57

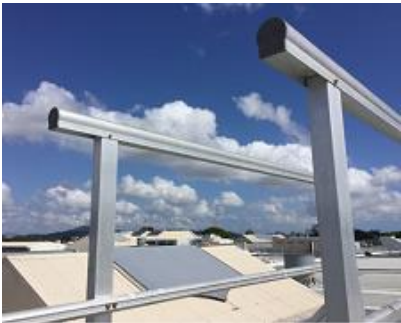
Sharp edges on handrails	Trips, Slips and Falls	Awareness induction	Med	Tek screws to be replaced with rivets	Low	Client advised	Outsta nding	OH&S REGULATIONS 3.7 AS/NZS 1657- 2013 5.6
90	Building: General Stores Location Reference: L40 Task: Access to the roof

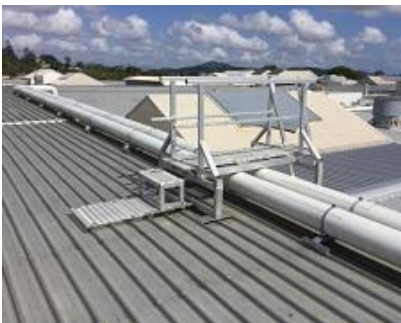
Non-complaint step is present	Trips, Slips and Falls	Awareness induction	Med	Existing step to be removed and new step to be installed	Low	Client advised	Outsta nding	OH&S REGULATIONS 3.7 AS/NZS 1657- 2013 7.2

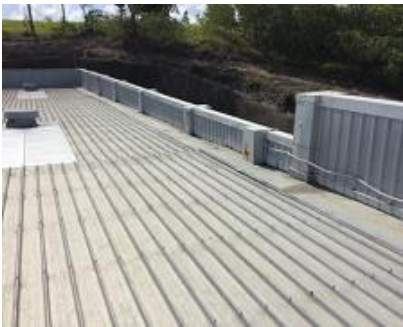
No height safety system installed	Trips, Slips and Falls	Awareness induction	High	Fall arrest anchors to be installed	Low	Client advised	Outstanding	OH&S REGULATIONS 3.55
92	Building: General Stores Location Reference: L41 Task: Access to the A/c units

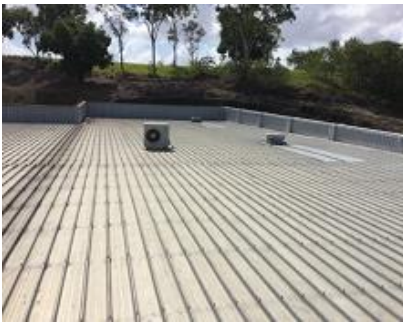
No safe access to the A/c units	Trips, Slips and Falls	N/A	Low	Supply Walkway to the A/c units	Low	Client advised	Outstanding	-

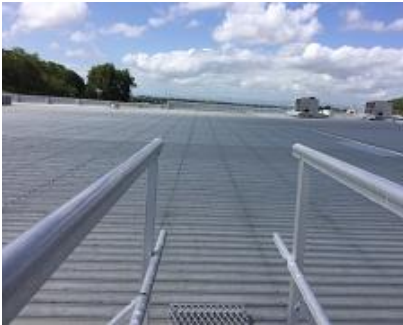
No safe access to the A/c units	Trips, Slips and Falls	N/A	Low	Supply Walkway to the A/c units	Low	Client advised	Outstanding	-
94	Building: General Stores Location Reference: L42 Task: Access to the roof

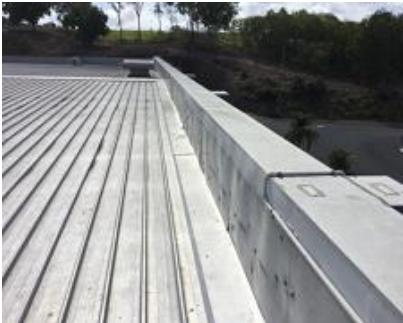
No height safety system installed	Trips, Slips and Falls	Awareness induction	High	Fall arrest anchors to be installed	Low	Client advised	Outstanding	OH&S REGULATIONS 3.55

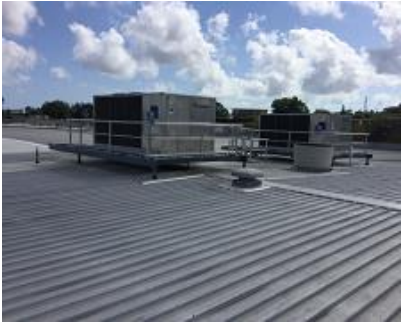
No safe access to the A/c units	Trips, Slips and Falls	N/A	Low	Supply Walkway to the A/c units	Low	Client advised	Outstanding	-
96	Building: General Stores Location Reference: L43 Task: Access to the roof

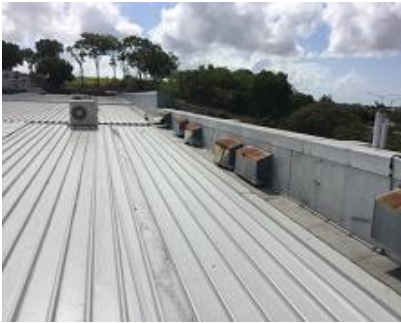
No height safety system installed	Trips, Slips and Falls	Awareness induction	High	Fall arrest anchors to be installed	Low	Client advised	Outstanding	OH&S REGULATIONS 3.55

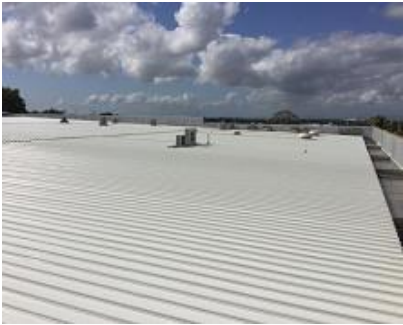
No safe access to the A/c units	Trips, Slips and Falls	N/A	Low	Supply Walkway to the A/c units	Low	Client advised	Outstanding	-
98	Building: General Stores Location Reference: L44 Task: Access to the roof

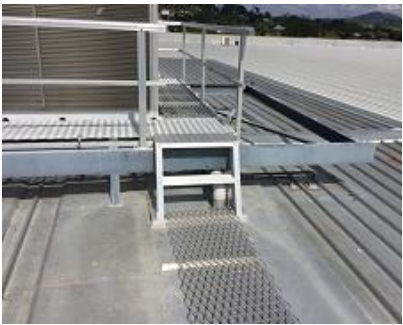
Non-compliant ladder is present	Trips, Slips and Falls	Awareness induction	Med	Existing ladder to be removed and new ladder to be installed	Low	Client advised	Outstanding	OH&S REGULATIONS 3.7 AS/NZS 1657-2013 7.3

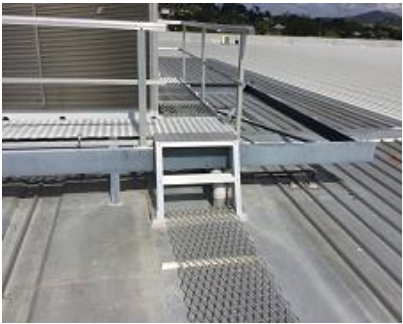
Sharp edges on handrails	Trips, Slips and Falls	Awareness induction	Med	Tek screws to be replaced with rivets	Low	Client advised	Outstanding	OH&S REGULATIONS 3.7 AS/NZS 1657-2013 5.6
100	Building: General Stores Location Reference: L44 Task: Access to the roof

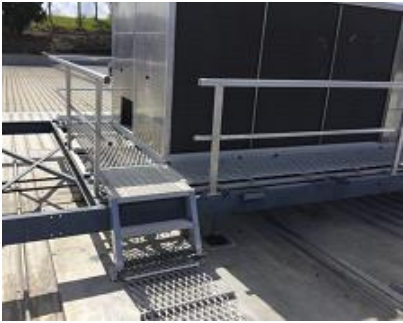
Non-complaint ladder is present	Trips, Slips and Falls	Awareness induction	Med	Existing ladder to be removed and new ladder to be installed	Low	Client advised	Outstanding	OH&S REGULATIONS 3.7 AS/NZS 1657-2013 7.3

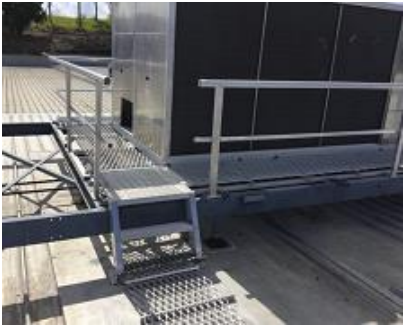
Sharp edges on handrails	Trips, Slips and Falls	Awareness induction	Med	Tek screws to be replaced with rivets	Low	Client advised	Outstanding	OH&S REGULATIONS 3.7 AS/NZS 1657-2013 5.6
102	Building: General Stores Location Reference: L44 Task: Access to the roof

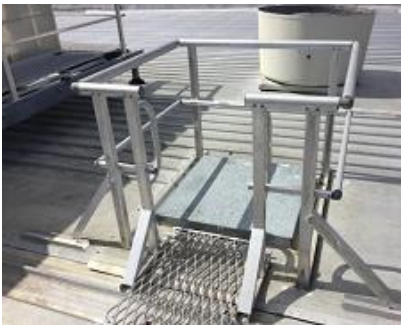
Sharp edges on handrails	Trips, Slips and Falls	Awareness induction	Med	Tek screws to be replaced with rivets	Low	Client advised	Outstanding	OH&S REGULATIONS 3.7 AS/NZS 1657-2013 5.6

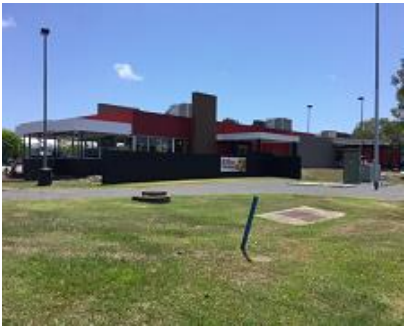
No height safety system installed	Trips, Slips and Falls	Awareness induction	High	Fall arrest anchors, anchor strops, ladder access brackets and signs to be installed	Low	Client advised	Outstanding	OH&S REGULATIONS 3.55
104	Building: General Stores Location Reference: L46 Task: Restrict access to the roof

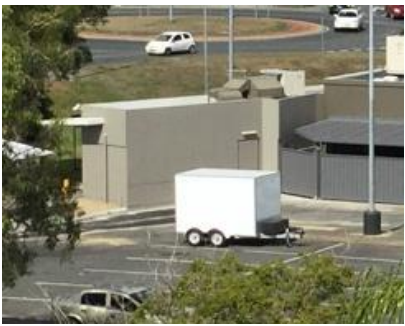
No height safety system installed (No serviceable items on roof)	Trips, Slips and Falls	Restrict Access	High	"EWP Access Only" signs to be installed	Low	Client advised	Outstanding	OH&S REGULATIONS 3.55 & 3.11

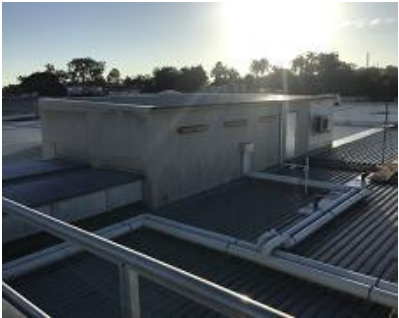
No height safety system installed	Trips, Slips and Falls	Awareness induction	High	Access ladder, anchor strop and anchors to be installed	Low	Client advised	Outstanding	OH&S REGULATIONS 3.7 & 3.55 AS/NZS 1657-2018 3.1.4
106	Building: General Stores Location Reference: L19 Task: Access to the A/c units

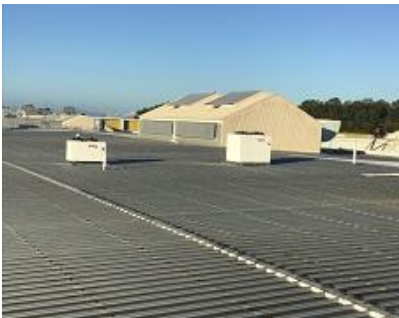
No safe access to the A/c units	Trips, Slips and Falls	Awareness induction	Low	Supply walkway to the A/c units	Low	Client advised	Outstanding	-

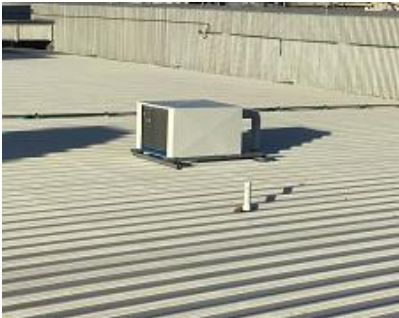
No safe access to the A/c units	Trips, Slips and Falls	Awareness induction	Low	Supply walkway to the A/c units	Low	Client advised	Outstanding	-
