Roof Safety Report

**Taigum Square,
QLD 4018**

Prepared By: Safemaster Safety Products
Date: 08 Aug 2017

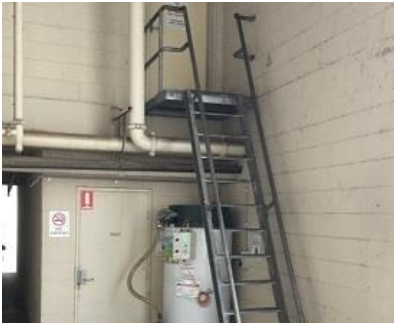
No	Photo of Hazard	Details of Hazard	Details of Risk	Existing/ Immediate Control Measure	Current Risk Level	Proposed Permanent Solution	Residual Risk Assessment	Details of Action Taken	Status	Reference
01	Building: General Stores Location Reference: L01 Task: Access to the roof

Toe board is missing at landing	Head Injury	Awareness induction	Med	Toe board to be installed	Low	Client advised	Outstanding	OH&S REGULATIONS 3.7 AS/NZS 1657-2013 4.6
02	Building: General Stores Location Reference: L02 Task: Access to the tower

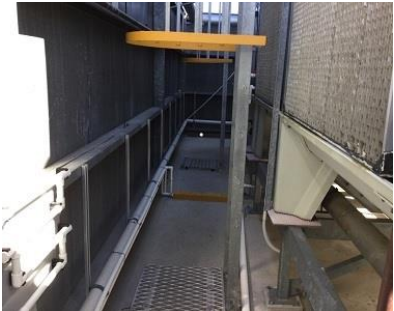
Headroom is less than required minimum	Head Injury	Awareness induction	Med	"Warning-Low headroom" signs to be installed	Low	Client advised	Outstanding	OH&S REGULATIONS 3.7 AS/NZS 1657-2013 3.1.5

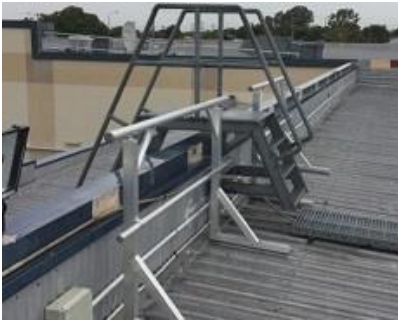
No	Photo of Hazard	Details of Hazard	Details of Risk	Existing/ Immediate Control Measure	Current Risk Level	Proposed Permanent Solution	Residual Risk Assessment	Details of Action Taken	Status	Reference
03	Building: General Stores Location Reference: L03 Task: Access to the roof

Bottom tread height is less than required minimum	Trips, Slips and Falls	Awareness induction	Med	Landing platform to level with the bottom tread to be installed	Low	Client advised	Outstanding	OH&S REGULATIONS 3.7 AS/NZS 1657-2013 7.4.3.4
04	Building: General Stores Location Reference: L03 Task: Access to the roof

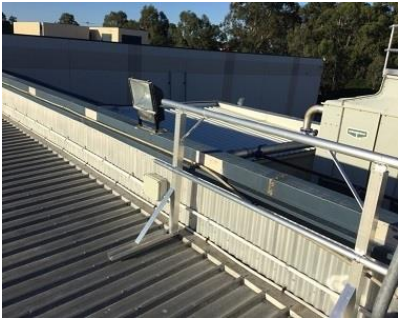
No height safety system installed (Parapet wall height is less than required minimum)	Trips, Slips and Falls	Awareness induction	High	Additional handrail section to be installed	Low	Client advised	Outstanding	OH&S REGULATIONS 3.55

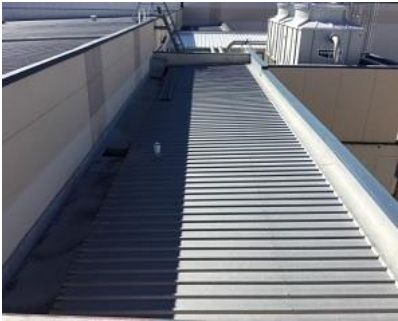
No	Photo of Hazard	Details of Hazard	Details of Risk	Existing/ Immediate Control Measure	Curre nt Risk Level	Proposed Permanent Solution	Resid ual Risk Asse ssme nt	Details of Action Taken	Status	Reference
05	Building: General Stores Location Reference: L04 Task: Access to the roof

No height safety system installed	Trips, Slips and Falls	Awareness induction	High	Fall arrest anchors and Access ladder including handrails to be installed	Low	Client advised	Outstanding	OH&S REGULATIONS 3.55 & 3.7 AS/NZS 1657-2013 3.1.4
06	Building: General Stores Location Reference: L05 Task: Access to the roof

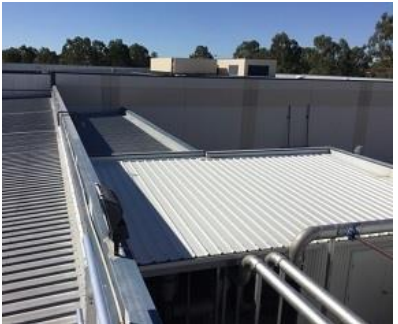
No height safety system installed	Trips, Slips and Falls	Awareness induction	High	Fall arrest anchors and Access ladder including handrails to be installed	Low	Client advised	Outstanding	OH&S REGULATIONS 3.55 & 3.7 AS/NZS 1657-2013 3.1.4

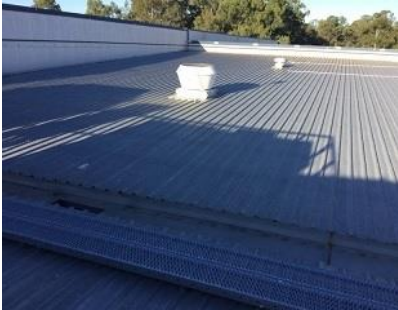
No safe access to the A/c units	Trips, Slips and Falls	N/A	Low	Supply walkway to the A/c units	Low	Client advised	Outstanding	-
08	Building: BIG W Location Reference: L07 Task: Access to the A/c units

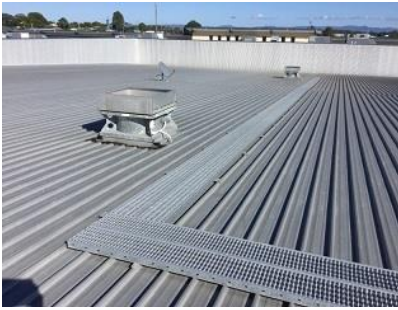
No safe access to the A/c units	Trips, Slips and Falls	N/A	Low	Supply walkway to the A/c units	Low	Client advised	Outstanding	-

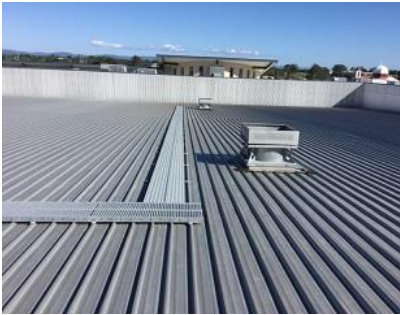
No	Photo of Hazard	Details of Hazard	Details of Risk	Existing/ Immediate Control Measure	Current Risk Level	Proposed Permanent Solution	Residual Risk Assessment	Details of Action Taken	Status	Reference
09	Building: BIG W Location Reference: L08 Task: Access to the roof

No safe access to the A/c units	Trips, Slips and Falls	N/A	Low	Supply walkway to the A/c units	Low	Client advised	Outstanding	-
10	Building: BIG W Location Reference: L09 Task: Access to the roof

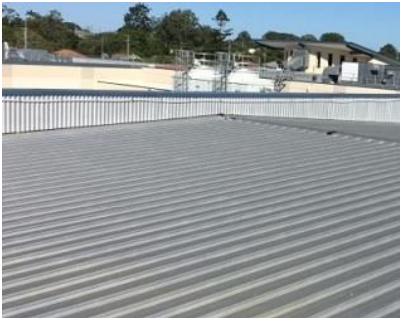
No height safety system installed	Trips, Slips and Falls	Awareness induction	High	Fall arrest anchors to be installed	Low	Client advised	Outstanding	OH&S REGULATIONS 3.55

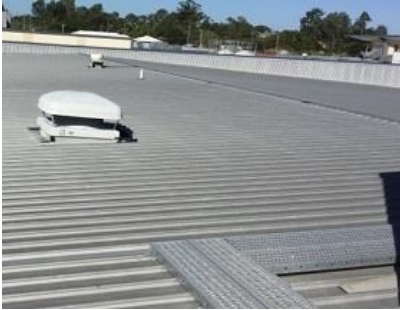
No safe access to the A/c units	Trips, Slips and Falls	N/A	Low	Supply walkway to the A/c units	Low	Client advised	Outstanding	-
12	Building: BIG W Location Reference: L11 Task: Restrict access to the roof

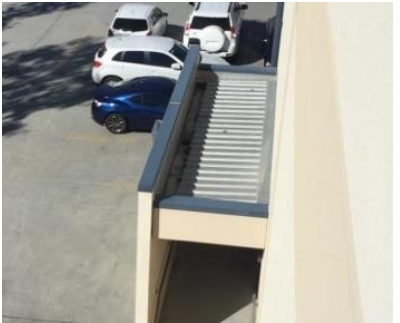
No height safety system installed (No serviceable items)	Trips, Slips and Falls	Awareness induction	High	"EWP Access Only" sign to be installed	Low	Client advised	Outstanding	OH&S REGULATIONS 3.55 & 3.11

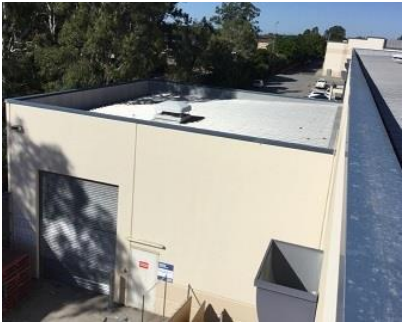
No	Photo of Hazard	Details of Hazard	Details of Risk	Existing/ Immediate Control Measure	Current Risk Level	Proposed Permanent Solution	Residual Risk Assessment	Details of Action Taken	Status	Reference
13	Building: BIG W Location Reference: L12 Task: Access to the roof

No height safety system installed	Trips, Slips and Falls	Awareness induction	High	Fall arrest anchors and Access ladder including handrails to be installed	Low	Client advised	Outstanding	OH&S REGULATIONS 3.55 AS/NZS 1657-2013 3.1.4
14	Building: BIG W Location Reference: L13 Task: Access to the roof

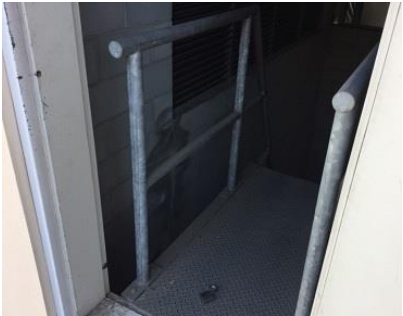
Toe board is missing at landing	Trips, Slips and Falls	Awareness induction	Med	Toe board to be installed	Low	Client advised	Outstanding	OH&S REGULATIONS 3.7 AS/NZS 1657-2013 4.6

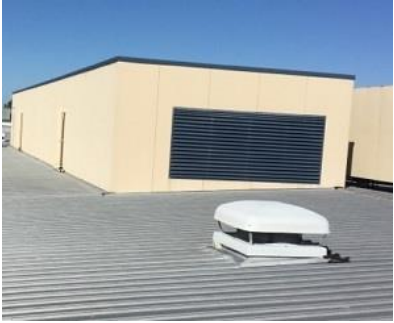
No	Photo of Hazard	Details of Hazard	Details of Risk	Existing/ Immediate Control Measure	Curre nt Risk Level	Proposed Permanent Solution	Resid ual Risk Asse ssme nt	Details of Action Taken	Status	Reference
15	Building: BIG W Location Reference: L13 Task: Access to the roof

No height safety system installed	Trips, Slips and Falls	Awareness induction	High	Ladder access bracket, Anchor strop and Fall arrest anchors to be installed	Low	Client advised	Outstanding	OH&S REGULATIONS 3.55
16	Building: BIG W Location Reference: L14 Task: Access to the A/c units

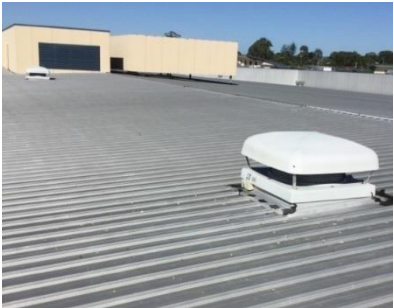
No safe access to the A/c units	Trips, Slips and Falls	N/A	Low	Supply walkway to the A/c units	Low	Client advised	Outstanding	-

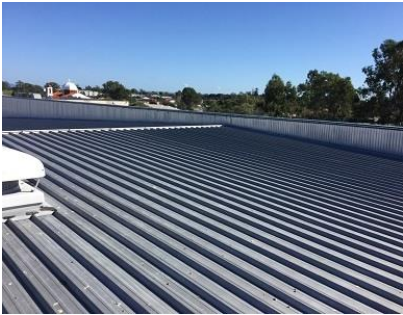
No	Photo of Hazard	Details of Hazard	Details of Risk	Existing/ Immediate Control Measure	Current Risk Level	Proposed Permanent Solution	Residual Risk Assessment	Details of Action Taken	Status	Reference
17	Building: BIG W Location Reference: L15 Task: Access to the roof

No height safety system installed (Parapet wall is less than required minimum)	Trips, Slips and Falls	Awareness induction	High	Fall arrest anchors to be installed	Low	Client advised	Outstanding	OH&S REGULATIONS 3.55
18	Building: BIG W Location Reference: L16 Task: Access to the plant deck

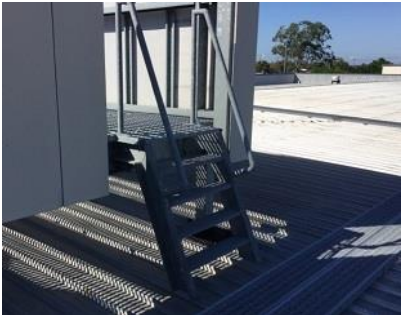
Landing is less than required minimum	Trips, Slips and Falls	Awareness induction	Med	Landing platform to be installed	Low	Client advised	Outstanding	OH&S REGULATIONS 3.7 AS/NZS 1657-2013 7.3.6

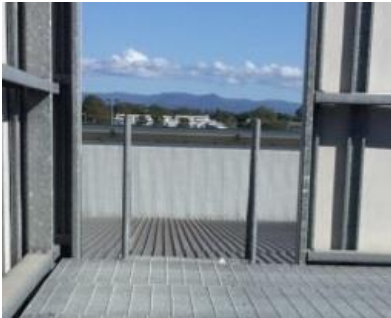
Gap between handrail and permanent structure is greater than required maximum	Trips, Slips and Falls	Awareness induction	Med	Gap to be closed	Low	Client advised	Outstanding	OH&S REGULATIONS 3.7 AS/NZS 1657-2013 4.4
20	Building: BIG W Location Reference: L17 Task: Access to the plant deck

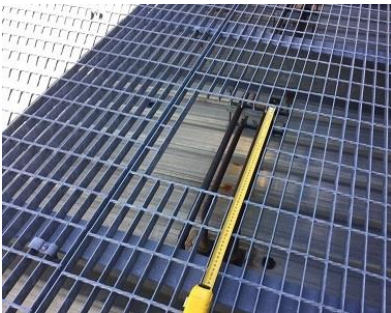
Gap between grating panels are greater than required maximum	Trips, Slips and Falls	Awareness induction	Med	Gap to be closed	Low	Client advised	Outstanding	OH&S REGULATIONS 3.6 AS/NZS 1657-2013 3.2.3.4

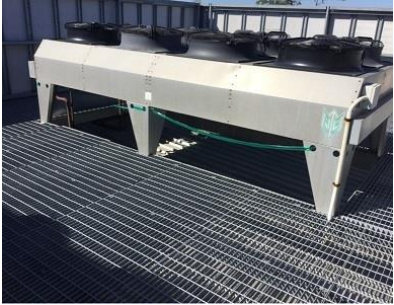
Gap between plant deck and unit is greater than required maximum	Trips, Slips and Falls	Awareness induction	Med	Mid rail to be installed	Low	Client advised	Outstanding	OH&S REGULATIONS 3.6 AS/NZS 1657-2013 4.4
22	Building: BIG W Location Reference: L17 Task: Access to the plant deck

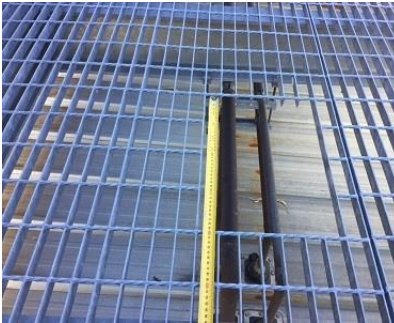
Gap between grating panels are greater than required maximum	Trips, Slips and Falls	Awareness induction	Med	Gap to be closed	Low	Client advised	Outstanding	OH&S REGULATIONS 3.6 AS/NZS 1657-2013 3.2.3.4

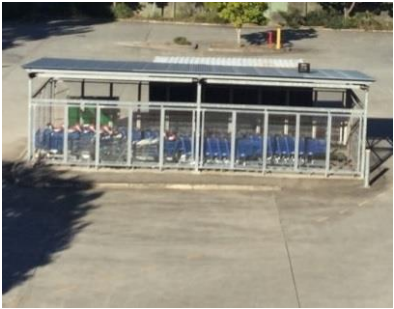
No height safety system installed	Trips, Slips and Falls	Restrict Access	High	"EWP Access Only" sign to be installed	Low	Client advised	Outstanding	OH&S REGULATIONS 3.55 & 3.11
24	Building: BIG W Location Reference: L19 Task: Restrict access to the roof

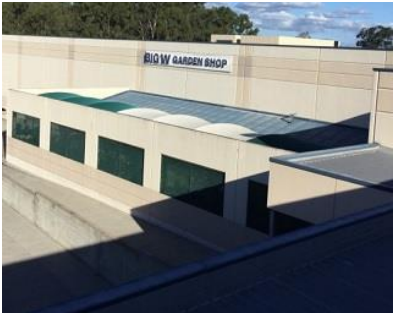
No height safety system installed	Trips, Slips and Falls	Restrict Access	High	"EWP Access Only" signs to be installed	Low	Client advised	Outstanding	OH&S REGULATIONS 3.55 & 3.11

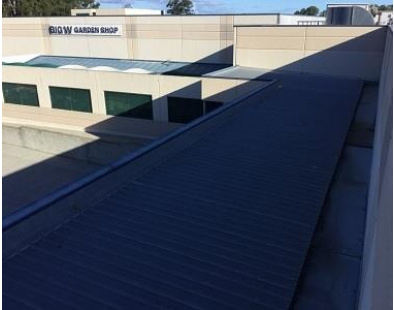
No height safety system installed	Trips, Slips and Falls	Restrict Access	High	"EWP Access Only" sign to be installed	Low	Client advised	Outstanding	OH&S REGULATIONS 3.55 & 3.11
26	Building: Best & Less Location Reference: L21 Task: Access to the roof

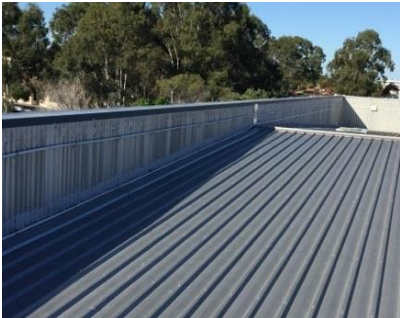
No height safety system installed (Parapet wall height is less than required minimum)	Trips, Slips and Falls	Awareness induction	High	Fall arrest anchors to be installed	Low	Client advised	Outstanding	OH&S REGULATIONS 3.55

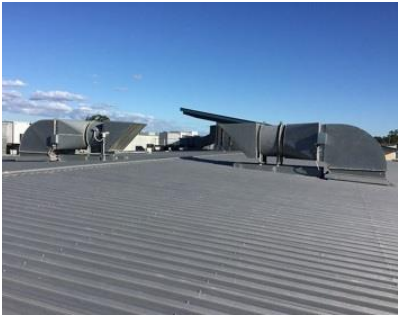
No	Photo of Hazard	Details of Hazard	Details of Risk	Existing/ Immediate Control Measure	Curre nt Risk Level	Proposed Permanent Solution	Resid ual Risk Asse ssme nt	Details of Action Taken	Status	Reference
27	Building: Best & Less Location Reference: L22 Task: Access to the A/c units

No safe access to the A/c units	Trips, Slips and Falls	N/A	Low	Supply walkway to the A/c units	Low	Client advised	Outstanding	-
28	Building: Best & Less Location Reference: L23 Task: Access to the A/c unit

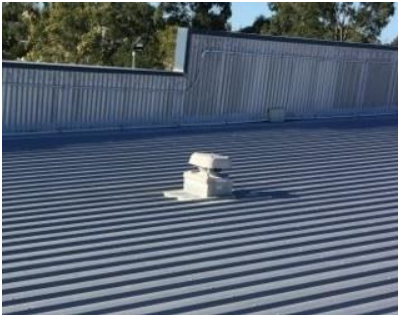
No safe access to the A/c unit	Trips, Slips and Falls	N/A	Low	Supply walkway to the A/c units	Low	Client advised	Outstanding	-

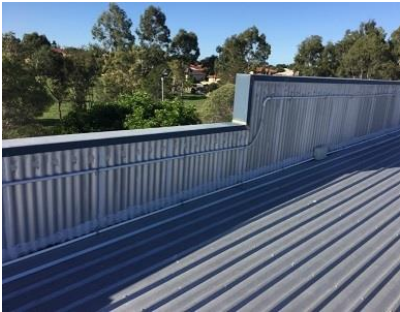
No	Photo of Hazard	Details of Hazard	Details of Risk	Existing/ Immediate Control Measure	Current Risk Level	Proposed Permanent Solution	Residual Risk Assessment	Details of Action Taken	Status	Reference
29	Building: Best & Less Location Reference: L24 Task: Access to the roof

No height safety system installed	Trips, Slips and Falls	Awareness induction	High	Fall arrest anchor to be installed	Low	Client advised	Outstanding	OH&S REGULATIONS 3.55
30	Building: General Stores Location Reference: L25 Task: Access to the roof

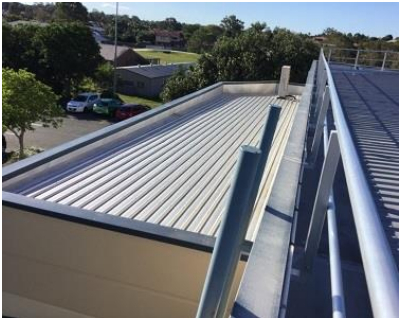
No height safety system installed	Trips, Slips and Falls	Awareness induction	High	Fall arrest anchors, Access ladder including handrails to be installed	Low	Client advised	Outstanding	OH&S REGULATIONS 3.55 & 3.7 AS/NZS 1657-2013 3.1.4

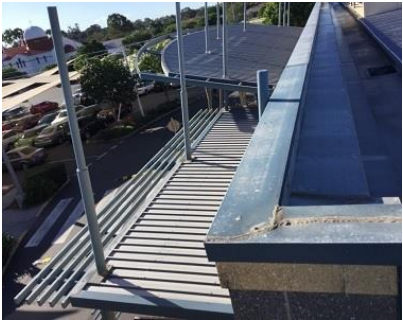
No	Photo of Hazard	Details of Hazard	Details of Risk	Existing/ Immediate Control Measure	Current Risk Level	Proposed Permanent Solution	Residual Risk Assessment	Details of Action Taken	Status	Reference
31	Building: General Stores Location Reference: L26 Task: Restrict access to the roof

No height safety system installed	Trips, Slips and Falls	Awareness induction	High	"EWP Access Only" signs to be installed	Low	Client advised	Outstanding	OH&S REGULATIONS 3.7 AS/NZS 1657-2013 7.3.3.1
32	Building: General Stores Location Reference: L27 Task: Access to the plant deck

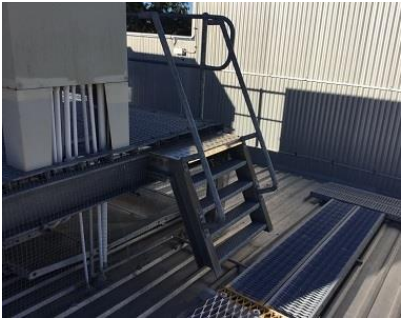
Landing at base is less than required minimum and Top tread not levelled with landing. Non-complaint ladder	Trips, Slips and Falls	Awareness induction	Med	Existing non-complaint ladder to be removed and access ladder including handrails to be installed	Low	Client advised	Outstanding	OH&S REGULATIONS 3.7 AS/NZS 1657-2013 7.4.3.3 & 7.3.6

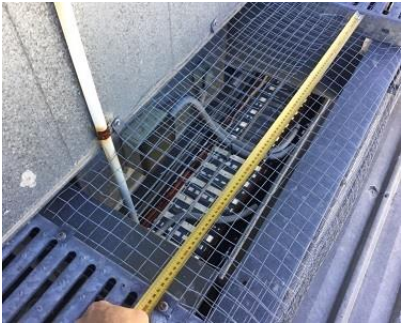
No	Photo of Hazard	Details of Hazard	Details of Risk	Existing/ Immediate Control Measure	Current Risk Level	Proposed Permanent Solution	Residual Risk Assessment	Details of Action Taken	Status	Reference
33	Building: General Stores Location Reference: L28 Task: Access to the plant deck

Walkway panel is missing	Trips, Slips and Falls	Awareness induction	Med	Walkway panel to be installed	Low	Client advised	Outstanding	OH&S REGULATIONS 3.6 AS/NZS 1657-2013 3.2.3.4
34	Building: General Stores Location Reference: L28 Task: Access to the plant deck

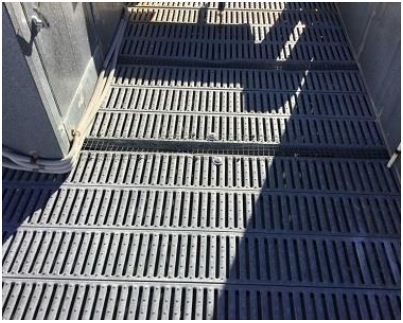
Gap between panels are greater than required maximum	Trips, Slips and Falls	Awareness induction	Med	Gap to be closed	Low	Client advised	Outstanding	OH&S REGULATIONS 3.6 AS/NZS 1657-2013 3.2.3.4

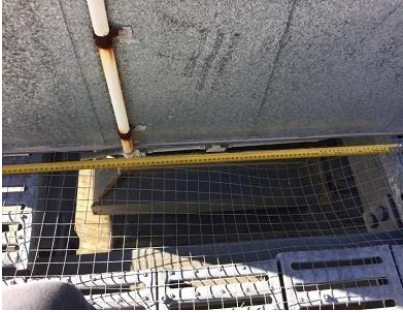
No	Photo of Hazard	Details of Hazard	Details of Risk	Existing/ Immediate Control Measure	Current Risk Level	Proposed Permanent Solution	Residual Risk Assessment	Details of Action Taken	Status	Reference
35	Building: General Stores Location Reference: L28 Task: Access to the plant deck

Walkway panel is missing	Trips, Slips and Falls	Awareness induction	Med	Walkway panel to be installed	Low	Client advised	Outstanding	OH&S REGULATIONS 3.6 AS/NZS 1657-2013 3.2.3.4
36	Building: General Stores Location Reference: L28 Task: Access to the plant deck

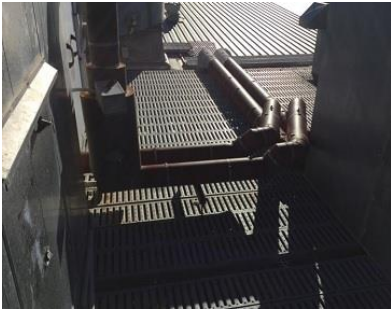
Pipes installed over the walkway path	Trips, Slips and Falls	Awareness induction	Med	Step over to be installed	Low	Client advised	Outstanding	OH&S REGULATIONS 3.6 AS/NZS 1657-2013 3.1.4

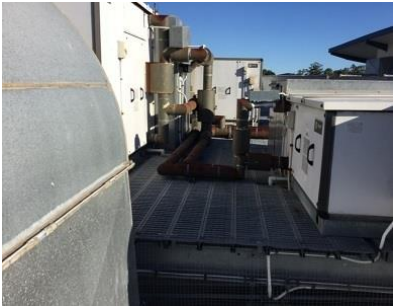
Pipes installed over the walkway path	Trips, Slips and Falls	Awareness induction	Med	Step over to be installed	Low	Client advised	Outstanding	OH&S REGULATIONS 3.6 AS/NZS 1657-2013 3.1.4
38	Building: General Stores Location Reference: L28 Task: Access to the plant deck

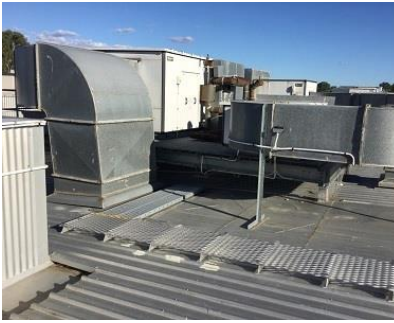
Variation in height between plant deck and roof is greater than required maximum	Trips, Slips and Falls	Awareness induction	Med	Access ladder including handrails to be installed	Low	Client advised	Outstanding	OH&S REGULATIONS 3.7 AS/NZS 1657-2013 3.1.4

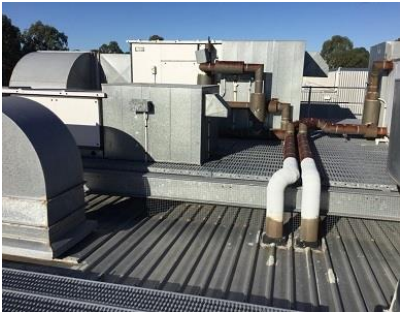
No	Photo of Hazard	Details of Hazard	Details of Risk	Existing/ Immediate Control Measure	Current Risk Level	Proposed Permanent Solution	Residual Risk Assessment	Details of Action Taken	Status	Reference
39	Building: General Stores Location Reference: L28 Task: Access to the plant deck

Variation in height between plant deck and roof is greater than required maximum	Trips, Slips and Falls	Awareness induction	Med	Handrails to be installed	Low	Client advised	Outstanding	OH&S REGULATIONS 3.6 AS/NZS 1657-2013 4.4
40	Building: General Stores Location Reference: L28 Task: Access to the plant deck

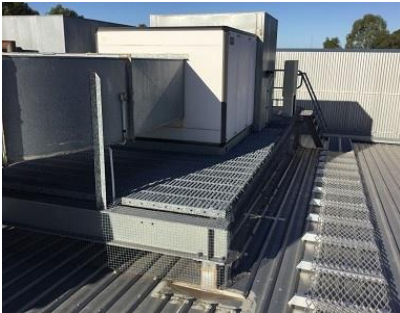
Variation in height between plant deck and roof is greater than required maximum	Trips, Slips and Falls	Awareness induction	Med	Handrails to be installed	Low	Client advised	Outstanding	OH&S REGULATIONS 3.6 AS/NZS 1657-2013 4.4

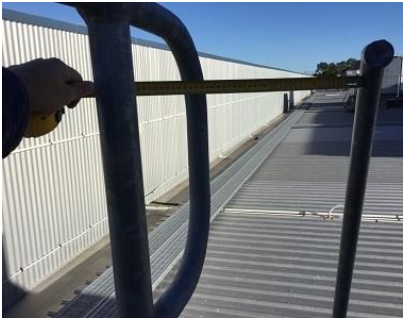
No	Photo of Hazard	Details of Hazard	Details of Risk	Existing/ Immediate Control Measure	Current Risk Level	Proposed Permanent Solution	Residual Risk Assessment	Details of Action Taken	Status	Reference
41	Building: General Stores Location Reference: L28 Task: Access to the plant deck

Gap between handrails is greater than required maximum	Trips, Slips and Falls	Awareness induction	Med	Gap to be closed	Low	Client advised	Outstanding	OH&S REGULATIONS 3.6 AS/NZS 1657-2013 4.4
42	Building: General Stores Location Reference: L29 Task: Access to the plant deck

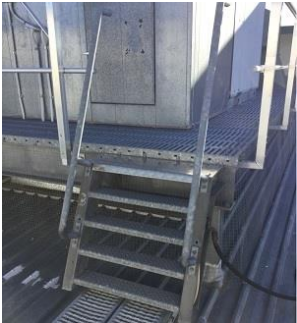
Bottom tread height is less than required minimum and top tread not levelled with landing	Trips, Slips and Falls	Awareness induction	Med	Existing ladder to be removed and Access ladder including handrails to be installed	Low	Client advised	Outstanding	OH&S REGULATIONS 3.7 AS/NZS 1657-2013 7.4.3.3 & 7.4.3.4

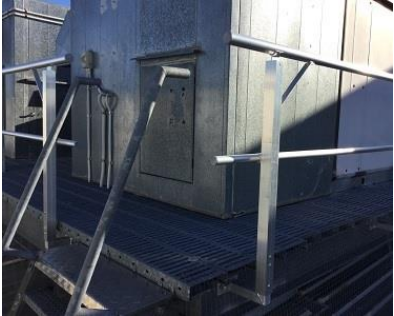
No	Photo of Hazard	Details of Hazard	Details of Risk	Existing/ Immediate Control Measure	Current Risk Level	Proposed Permanent Solution	Residual Risk Assessment	Details of Action Taken	Status	Reference
43	Building: General Stores Location Reference: L29 Task: Access to the plant deck

Gap between handrails is greater than required maximum	Trips, Slips and Falls	Awareness induction	Med	Gap to be closed	Low	Client advised	Outstanding	OH&S REGULATIONS 3.6 AS/NZS 1657-2013 4.4
44	Building: General Stores Location Reference: L29 Task: Access to the plant deck

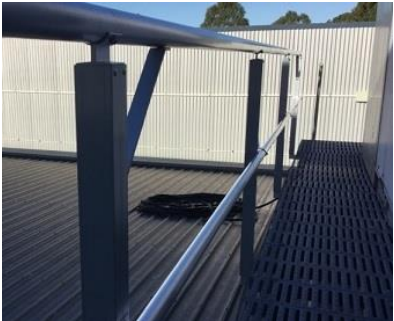
Sharp edges on handrails	Hand Injury	Awareness induction	Med	Tek screws to be replaced with rivets	Low	Client advised	Outstanding	OH&S REGULATIONS 3.6 AS/NZS 1657-2013 5.6

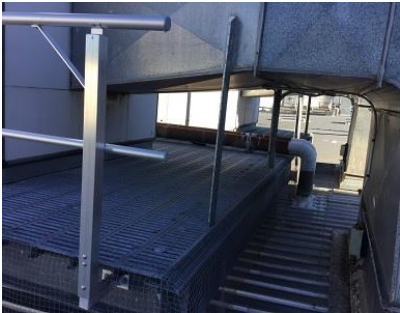
No	Photo of Hazard	Details of Hazard	Details of Risk	Existing/ Immediate Control Measure	Current Risk Level	Proposed Permanent Solution	Residual Risk Assessment	Details of Action Taken	Status	Reference
45	Building: General Stores Location Reference: L29 Task: Access to the plant deck

Variation in height between plant deck and roof is greater than required maximum	Trips, Slips and Falls	Awareness induction	Med	Handrails to be installed	Low	Client advised	Outstanding	OH&S REGULATIONS 3.6 AS/NZS 1657-2013 4.4
46	Building: General Stores Location Reference: L29 Task: Access to the plant deck

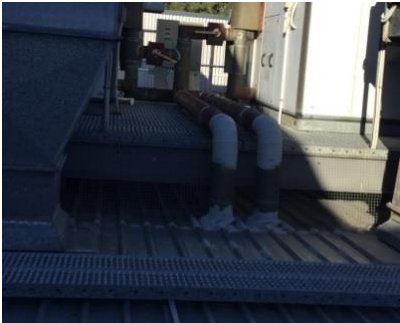
Variation in height between plant deck and roof is greater than required maximum	Trips, Slips and Falls	Awareness induction	Med	Access ladder including handrails to be installed	Low	Client advised	Outstanding	OH&S REGULATIONS 3.7 AS/NZS 1657-2013 3.1.4

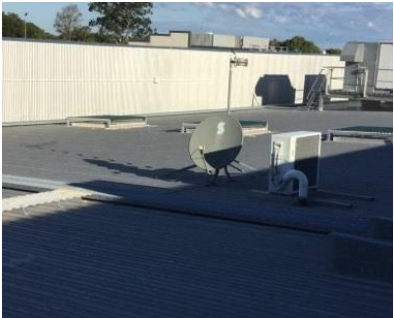
No safe access to the A/c unit	Trips, Slips and Falls	N/A	Low	Supply walkway to the A/c unit	Low	Client advised	Outstanding	-
48	Building: General Stores Location Reference: L31 Task: Restrict access to the roof

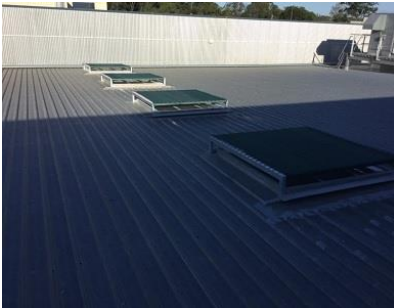
Brittle and fragile roof (Non-trafficable roof)	Trips, Slips and Falls	Restrict Access	High	"Warning - Brittle and Fragile Roof" signs to be installed	Low	Client advised	Outstanding	OH&S REGULATIONS 3.57

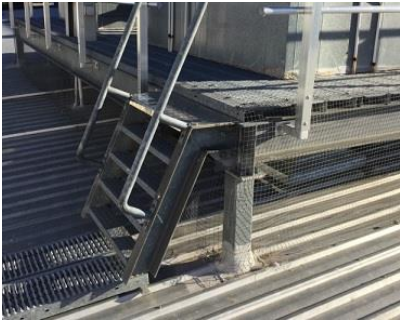
Bottom tread height is less than required minimum and top tread not levelled with landing	Trips, Slips and Falls	Awareness induction	Med	Existing ladder to be removed and Access ladder including handrails to be installed	Low	Client advised	Outstanding	OH&S REGULATIONS 3.7 AS/NZS 1657-2013 7.4.3.3 & 7.4.3.4
50	Building: General Stores Location Reference: L32 Task: Access to the plant deck

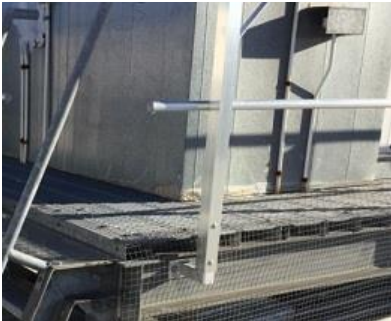
Gap between handrails is greater than required maximum	Trips, Slips and Falls	Awareness induction	Med	Gap to be closed	Low	Client advised	Outstanding	OH&S REGULATIONS 3.6 AS/NZS 1657-2013 4.4

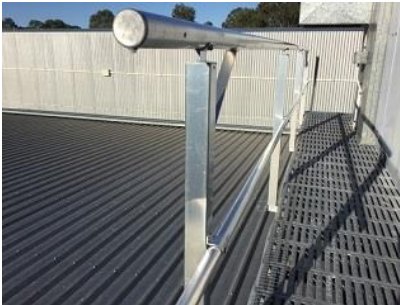
Sharp edges on handrails	Hand Injury	Awareness induction	Med	Tek screws to be replaced with rivets	Low	Client advised	Outstanding	OH&S REGULATIONS 3.6 AS/NZS 1657-2013 5.6
52	Building: General Stores Location Reference: L32 Task: Access to the plant deck

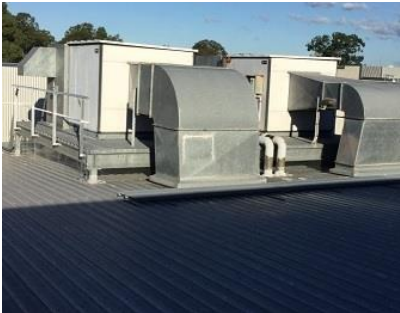
Variation in height between plant deck and roof is greater than required maximum	Trips, Slips and Falls	Awareness induction	Med	Handrails to be installed	Low	Client advised	Outstanding	OH&S REGULATIONS 3.6 AS/NZS 1657-2013 4.4

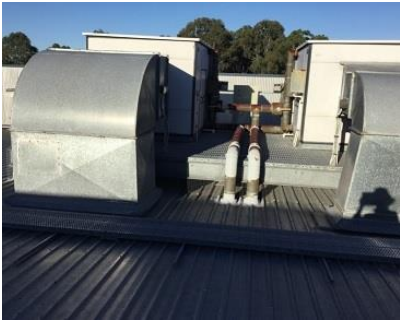
Variation in height between plant deck and roof is greater than required maximum	Trips, Slips and Falls	Awareness induction	Med	Access ladder including handrails and step over to be installed	Low	Client advised	Outstanding	OH&S REGULATIONS 3.7 AS/NZS 1657-2013 3.1.4
54	Building: General Stores Location Reference: L33 Task: Access to the A/c units

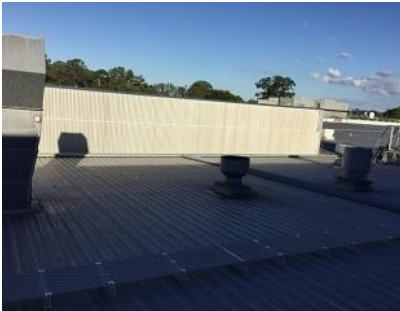
No safe access to the A/c units	Trips, Slips and Falls	N/A	Low	Supply walkway to the A/c units	Low	Client advised	Outstanding	-

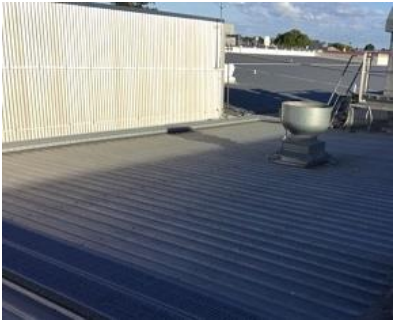
No safe access to the A/c units	Trips, Slips and Falls	N/A	Low	Supply walkway to the A/c units	Low	Client advised	Outstanding	-
56	Building: General Stores Location Reference: L35 Task: Access to the roof

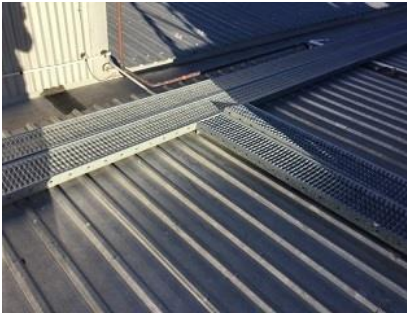
Roof walkway not secured to roof	Trips, Slips and Falls	Awareness induction	Med	Roof walkway to be re-installed	Low	Client advised	Outstanding	OH&S REGULATIONS 3.6

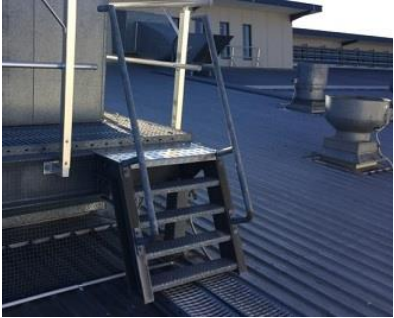
Bottom tread height is less than required minimum and top tread not levelled with landing	Trips, Slips and Falls	Awareness induction	Med	Existing ladder to be removed and Access ladder including handrails to be installed	Low	Client advised	Outstanding	OH&S REGULATIONS 3.7 AS/NZS 1657-2013 7.4.3.3 & 7.4.3.4
58	Building: General Stores Location Reference: L36 Task: Access to the plant deck

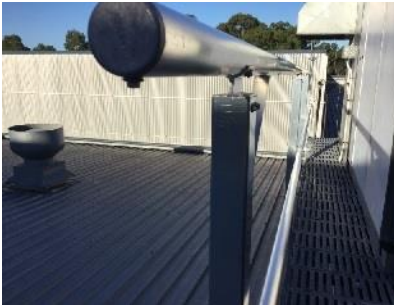
Sharp edges on handrails	Hand Injury	Awareness induction	Med	Tek screws to be replaced with rivets	Low	Client advised	Outstanding	OH&S REGULATIONS 3.6 AS/NZS 1657-2013 5.6

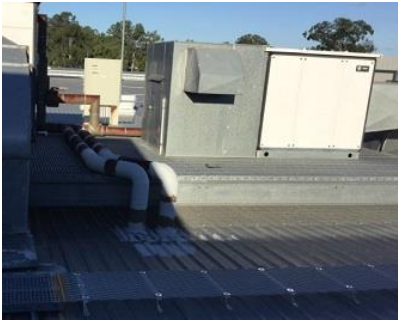
Pipe installed over the walkway path	Trips, Slips and Falls	Awareness induction	Med	Step over to be installed	Low	Client advised	Outstanding	OH&S REGULATIONS 3.6 AS/NZS 1657-2013 3.1.4
60	Building: General Stores Location Reference: L36 Task: Access to the plant deck

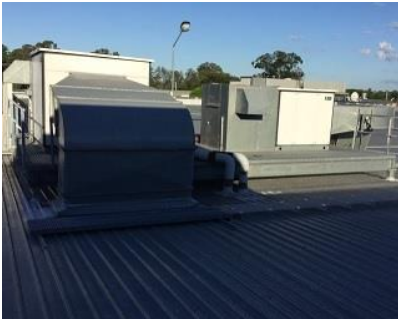
Variation in height between plant deck and roof is greater than required maximum	Trips, Slips and Falls	Awareness induction	Med	Handrail to be installed	Low	Client advised	Outstanding	OH&S REGULATIONS 3.6 AS/NZS 1657-2013 4.4

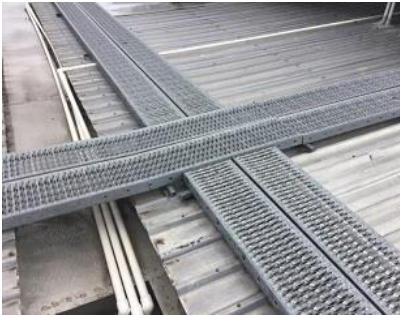
Roof walkway not secured to roof	Trips, Slips and Falls	Awareness induction	Med	Roof walkway to be re-installed	Low	Client advised	Outstanding	OH&S REGULATIONS 3.6
62	Building: General Stores Location Reference: L38 Task: Access to the plant deck

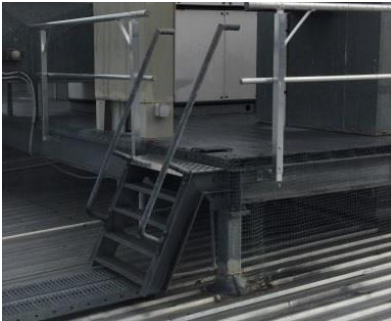
Bottom tread height is less than required minimum and top tread not levelled with landing	Trips, Slips and Falls	Awareness induction	Med	Existing ladder to be removed and Access ladder including handrails to be installed	Low	Client advised	Outstanding	OH&S REGULATIONS 3.7 AS/NZS 1657-2013 7.4.3.3 & 7.4.3.4

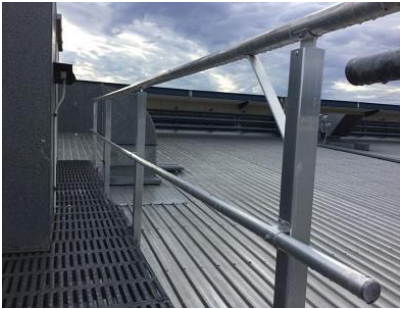
Sharp edges on handrails	Hand Injury	Awareness induction	Med	Tek screws to be replaced with rivets	Low	Client advised	Outstanding	OH&S REGULATIONS 3.6 AS/NZS 1657-2013 5.6
64	Building: General Stores Location Reference: L38 Task: Access to the plant deck

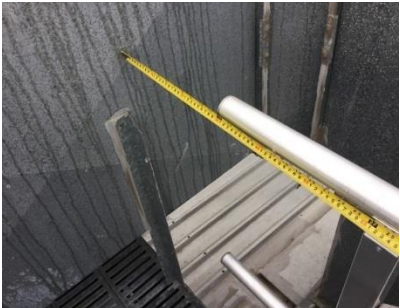
Gap between handrail and permanent structure is greater than required maximum	Trips, Slips and Falls	Awareness induction	Med	Handrail to be extended	Low	Client advised	Outstanding	OH&S REGULATIONS 3.6 AS/NZS 1657-2013 4.4

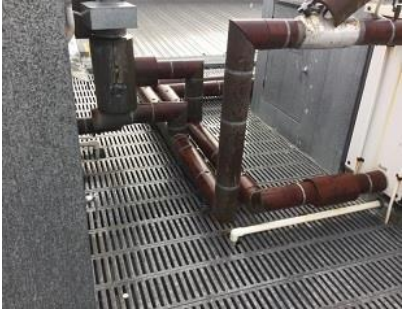
Pipes installed over the walkway path	Trips, Slips and Falls	Awareness induction	Med	Step overs to be installed	Low	Client advised	Outstanding	OH&S REGULATIONS 3.6 AS/NZS 1657-2013 3.1.4
66	Building: General Stores Location Reference: L38 Task: Access to the plant deck

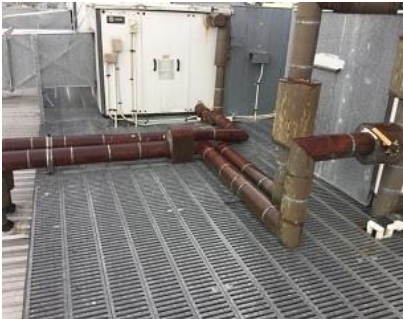
Pipes installed over the walkway path	Trips, Slips and Falls	Awareness induction	Med	Step overs to be installed	Low	Client advised	Outstanding	OH&S REGULATIONS 3.6 AS/NZS 1657-2013 3.1.4

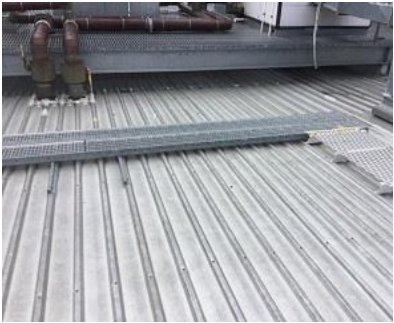
Roof walkway not secured to roof	Trips, Slips and Falls	Awareness induction	Med	Roof walkway to be re-installed	Low	Client advised	Outstanding	OH&S REGULATIONS 3.6
68	Building: General Stores Location Reference: L38 Task: Access to the plant deck

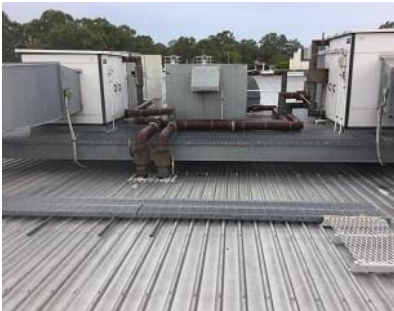
Variation in height between plant deck and roof is greater than required maximum	Trips, Slips and Falls	Awareness induction	Med	Handrail to be installed	Low	Client advised	Outstanding	OH&S REGULATIONS 3.6 AS/NZS 1657-2013 4.4

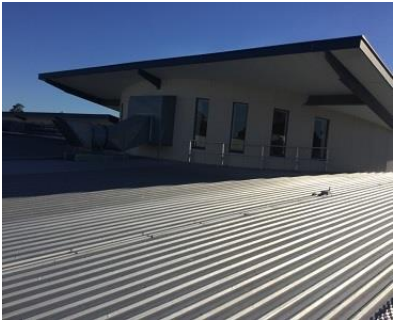
No height safety system installed	Trips, Slips and Falls	Awareness induction	High	Fall arrest anchors to be installed	Low	Client advised	Outstanding	OH&S REGULATIONS 3.55
70	Building: General Stores Location Reference: L41 Task: Access to the roof

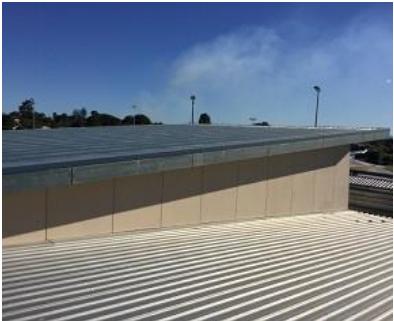
No height safety system installed	Trips, Slips and Falls	Awareness induction	High	Fall arrest anchors to be installed	Low	Client advised	Outstanding	OH&S REGULATIONS 3.55

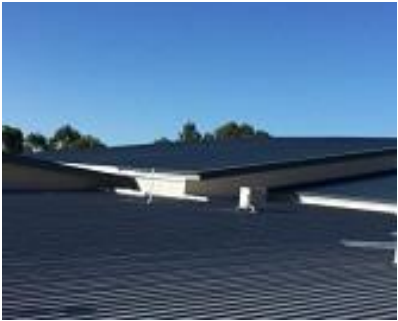
Variation in height between roof is greater than required maximum	Trips, Slips and Falls	Awareness induction	Med	Access ladder including handrails to be installed	Low	Client advised	Outstanding	OH&S REGULATIONS 3.7 AS/NZS 1657-2013 3.1.4
72	Building: General Stores Location Reference: L43 Task: Access to the roof

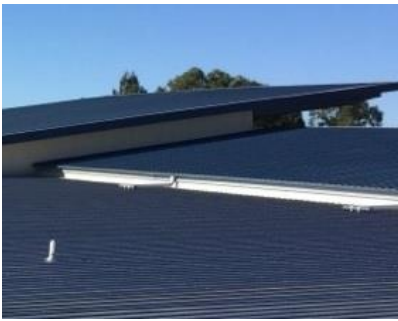
Variation in height between roof is greater than required maximum	Trips, Slips and Falls	Awareness induction	Med	Single step to be installed	Low	Client advised	Outstanding	OH&S REGULATIONS 3.7 AS/NZS 1657-2013 3.1.4

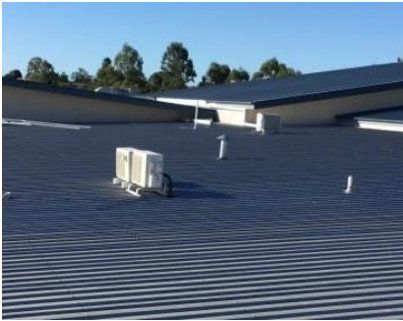
No safe access to the A/c units	Trips, Slips and Falls	N/A	Low	Supply walkway to the A/c units	Low	Client advised	Outstanding	-
74	Building: General Stores Location Reference: L45 Task: Restrict access to the roof

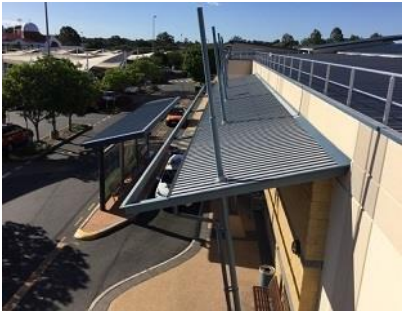
No height safety system installed	Trips, Slips and Falls	Restrict Access	High	"EWP Access Only" signs to be installed	Low	Client advised	Outstanding	OH&S REGULATIONS 3.55 & 3.11

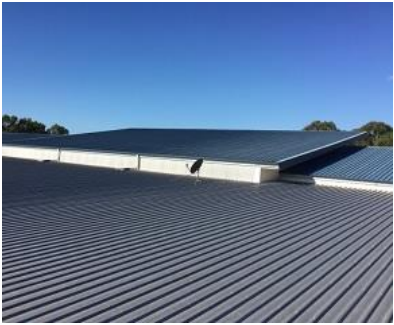
No height safety system installed	Trips, Slips and Falls	Awareness induction	High	Fall arrest anchors and Access ladder including handrails to be installed	Low	Client advised	Outstanding	OH&S REGULATIONS 3.55 & 3.7 AS/NZS 1657-2013 3.1.4
76	Building: General Stores Location Reference: L48 Task: Access to the A/c units

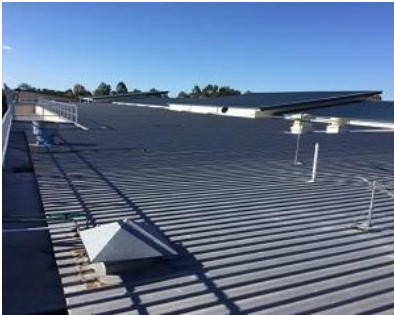
No safe access to the A/c units	Trips, Slips and Falls	N/A	Low	Supply walkway to the A/c units	Low	Client advised	Outstanding	-

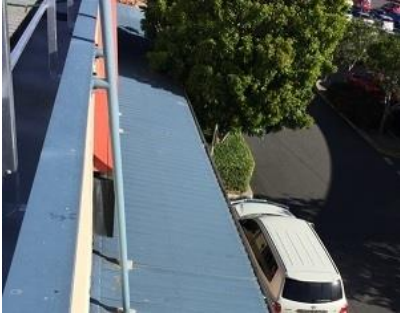
No height safety system installed	Trips, Slips and Falls	Restrict Access	High	"EWP Access Only" signs to be installed	Low	Client advised	Outstanding	OH&S REGULATIONS 3.55 & 3.11
78	Building: General Stores Location Reference: L50 Task: Restrict access to the roof

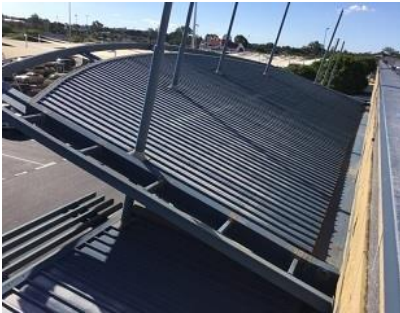
No height safety system installed	Trips, Slips and Falls	Restrict Access	High	"EWP Access Only" signs to be installed	Low	Client advised	Outstanding	OH&S REGULATIONS 3.55 & 3.11

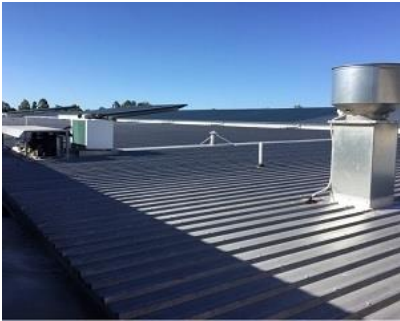
No safe access to the A/c units	Trips, Slips and Falls	N/A	Low	Supply walkway to the A/c units	Low	Client advised	Outstanding	-
80	Building: General Stores Location Reference: L52 Task: Access to the roof

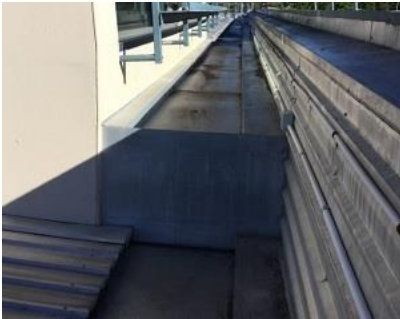
Variation in height between roofs is greater than required maximum	Trips, Slips and Falls	Awareness induction	Med	Access ladder including handrails to be installed	Low	Client advised	Outstanding	OH&S REGULATIONS 3.7 AS/NZS 1657-2013 3.1.4

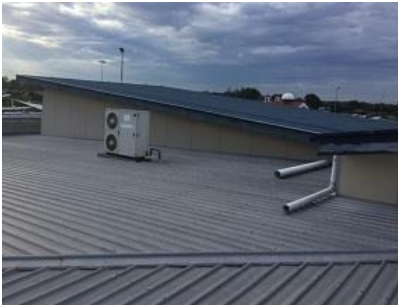
No height safety system installed	Trips, Slips and Falls	Awareness induction	High	Fall arrest anchor to be installed	Low	Client advised	Outstanding	OH&S REGULATIONS 3.55
82	Building: General Stores Location Reference: L54 Task: Access to the A/c units

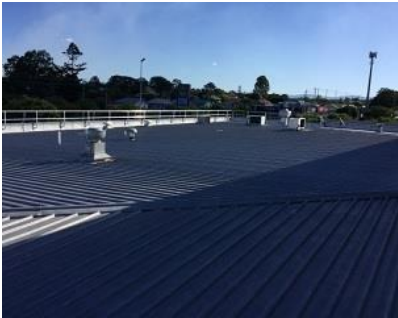
No safe access to the A/c units	Trips, Slips and Falls	N/A	Low	Supply walkway to the A/c units	Low	Client advised	Outstanding	-

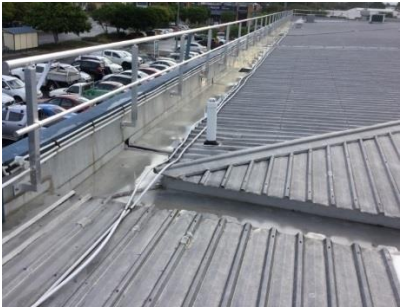
Sharp edges on handrails	Hand Injury	Awareness induction	Med	Tek screws to be replaced with rivets	Low	Client advised	Outstanding	OH&S REGULATIONS 3.6 AS/NZS 1657-2013 5.6
84	Building: General Stores Location Reference: L56 & L57 Task: Restrict access to the roof

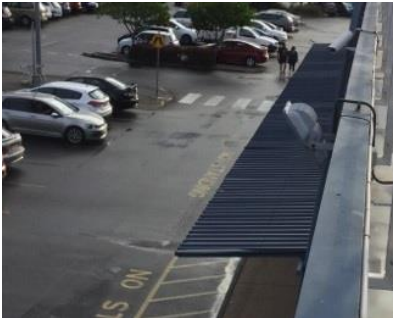
No height safety system installed	Trips, Slips and Falls	Restrict Access	High	"EWP Access Only" signs to be installed	Low	Client advised	Outstanding	OH&S REGULATIONS 3.55 & 3.11

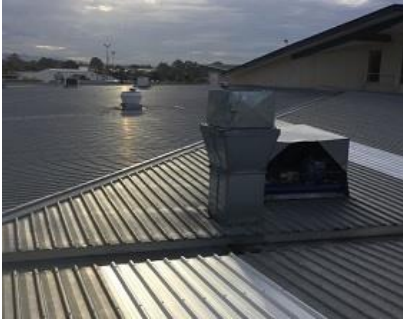
No safe access to the A/c units	Trips, Slips and Falls	N/A	Low	Supply walkway to the A/c units	Low	Client advised	Outstanding	-
86	Building: General Stores Location Reference: L59 Task: Access to the roof

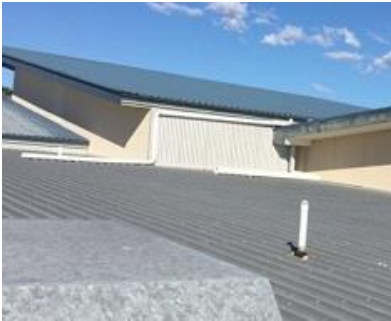
Variation in height between roofs are greater than required maximum	Trips, Slips and Falls	Awareness induction	Med	Access ladder including handrails to be installed	Low	Client advised	Outstanding	OH&S REGULATIONS 3.7 AS/NZS 1657-2013 3.1.4

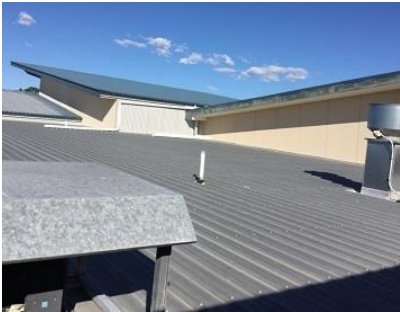
No height safety system installed	Trips, Slips and Falls	Awareness induction	High	Access step over and Fall arrest anchors to be installed	Low	Client advised	Outstanding	OH&S REGULATIONS 3.55 & 3.7 AS/NZS 1657-2013 3.1.4
88	Building: General Stores Location Reference: L61 Task: Access to the roof

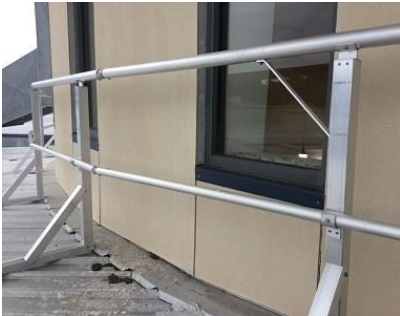
Sharp edges on handrails	Hand Injury	Awareness induction	Med	Tek screws to be replaced rivets	Low	Client advised	Outstanding	OH&S REGULATIONS 3.6 AS/NZS 1657-2013 5.6

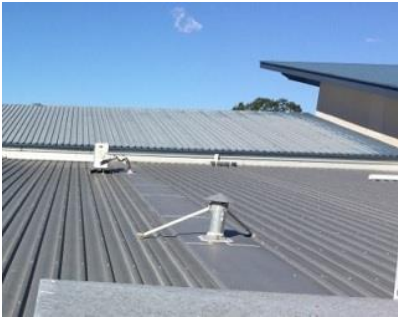
No safe access to the roof	Trips, Slips and Falls	Awareness induction	Med	Access step to be installed	Low	Client advised	Outstanding	OH&S REGULATIONS 3.7 AS/NZS 1657-2013 3.1.4
90	Building: General Stores Location Reference: L63 Task: Access to the A/c unit

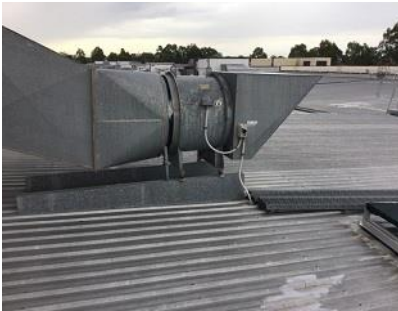
No safe access to the A/c unit	Trips, Slips and Falls	N/A	Low	Supply walkway to the A/c unit	Low	Client advised	Outstanding	-

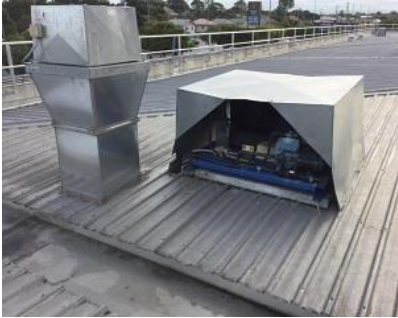
No safe access to the A/c unit	Trips, Slips and Falls	N/A	Low	Supply walkway to the A/c unit	Low	Client advised	Outstanding	-
92	Building: General Stores Location Reference: L65 Task: Access to the roof

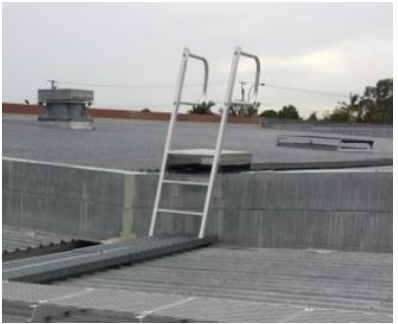
Bottom rung height is less than required minimum	Trips, Slips and Falls	Awareness induction	Med	Aluminium ladder support platforms to be installed	Low	Client advised	Outstanding	OH&S REGULATIONS 3.7 AS/NZS 1657-2013 7.4.3.4

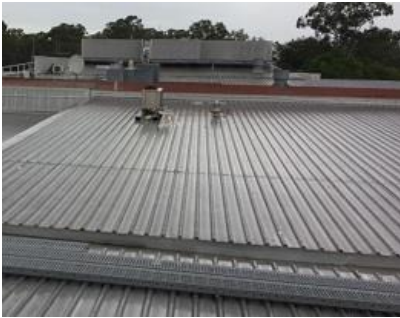
No safe access to the A/c units	Trips, Slips and Falls	N/A	Low	Supply walkway to the A/c units	Low	Client advised	Outstanding	-
94	Building: General Stores Location Reference: L67 Task: Access to the roof

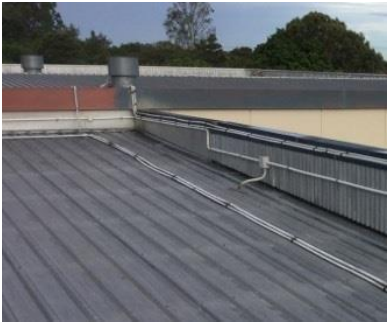
No height safety system installed	Trips, Slips and Falls	Awareness induction	High	Handrails to be installed	Low	Client advised	Outstanding	OH&S REGULATIONS 3.55

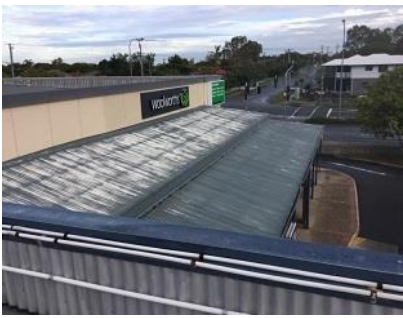
No height safety system installed (No serviceable items on roof)	Trips, Slips and Falls	Restrict access	High	"EWP Access Only" signs to be installed	Low	Client advised	Outstanding	OH&S REGULATIONS 3.55 & 3.11
96	Building: Woolworths Location Reference: L69 Task: Restrict access to the roof

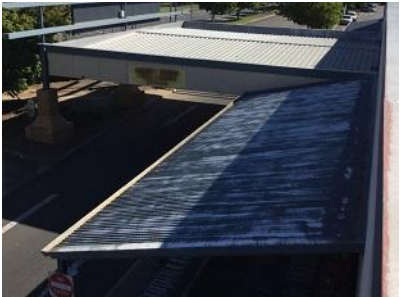
No height safety system installed (No serviceable items on roof)	Trips, Slips and Falls	Restrict access	High	"EWP Access Only" signs to be installed	Low	Client advised	Outstanding	OH&S REGULATIONS 3.55 & 3.11

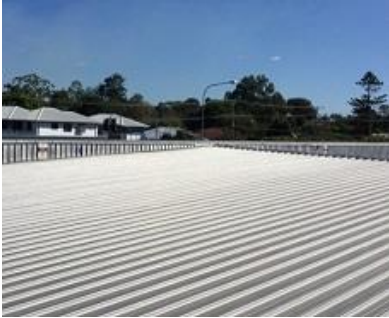
No height safety system installed	Trips, Slips and Falls	Awareness induction	High	Fall arrest anchors to be installed	Low	Client advised	Outstanding	OH&S REGULATIONS 3.55
98	Building: Woolworths Location Reference: L71 Task: Access to the A/c units

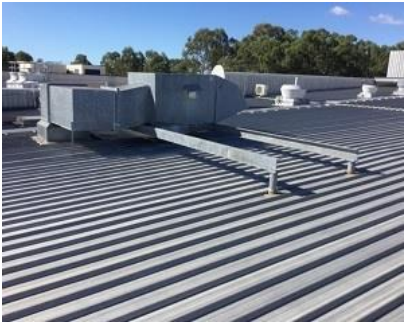
No safe access to the A/c units	Trips, Slips and Falls	N/A	Low	Supply walkway to the A/c units	Low	Client advised	Outstanding	-

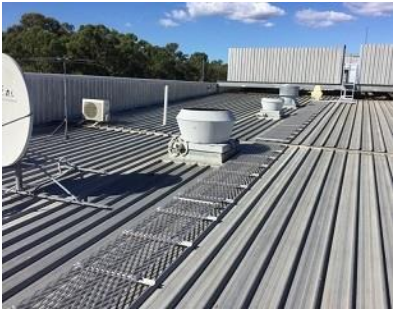
No safe access to the A/c units	Trips, Slips and Falls	N/A	Low	Supply walkway to the A/c units	Low	Client advised	Outstanding	-
100	Building: Woolworths Location Reference: L74 Task: Access to the roof

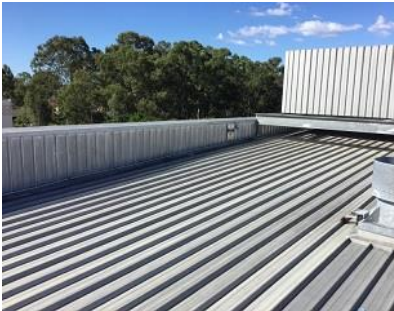
No height safety system installed	Trips, Slips and Falls	Awareness induction	High	Fall arrest anchor to be installed	Low	Client advised	Outstanding	OH&S REGULATIONS 3.55

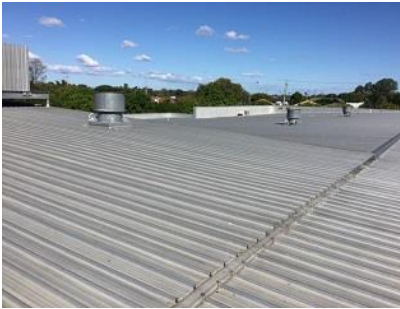
No safe access to the A/c units	Trips, Slips and Falls	N/A	Low	Supply walkway to the A/c units	Low	Client advised	Outstanding	-
102	Building: Woolworths Location Reference: L76 Task: Access to the roof

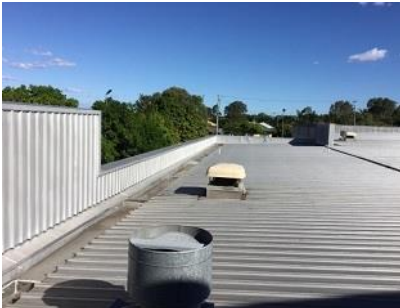
No height safety system installed	Trips, Slips and Falls	Awareness induction	High	Fall arrest anchors to be installed	Low	Client advised	Outstanding	OH&S REGULATIONS 3.55

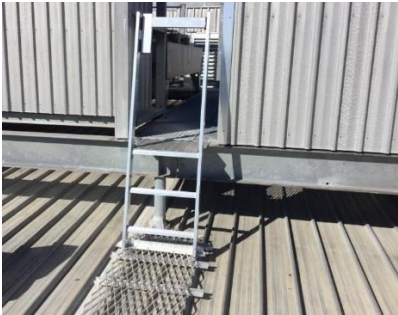
Bottom rung height is less than required minimum	Trips, Slips and Falls	Awareness induction	Med	Ladder support platform to be installed	Low	Client advised	Outstanding	OH&S REGULATIONS 3.7 AS/NZS 1657-2013 7.4.3.4
104	Building: Woolworths Location Reference: L78 Task: Access to the plant deck

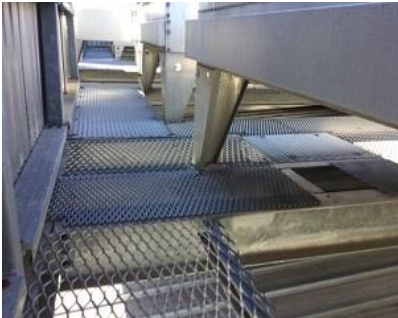
Variation in height between plant deck and unit is greater than required maximum	Trips, Slips and Falls	Awareness induction	Med	Midrail to be installed	Low	Client advised	Outstanding	OH&S REGULATIONS 3.6 AS/NZS 1657-2013 4.4

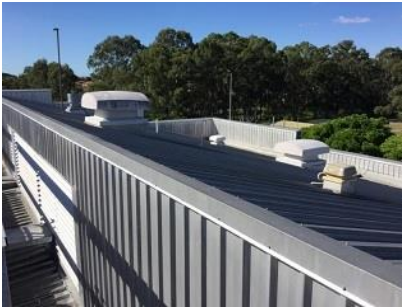
No height safety system installed	Trips, Slips and Falls	Awareness induction	High	Fall arrest anchors and Access ladder including handrails to be installed	Low	Client advised	Outstanding	OH&S REGULATIONS 3.55 & 3.7 AS/NZS 1657-2013 3.1.4
106	Building: Woolworths Location Reference: L80 Task: Access to the roof

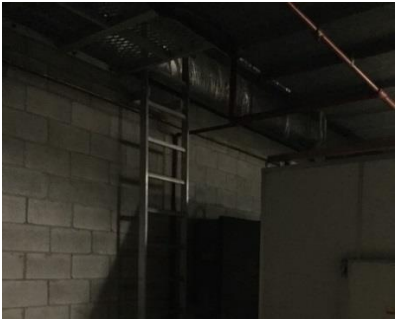
Fall arrest static line is missing	Trips, Slips and Falls	Awareness induction	Med	Fall arrest static line to be installed	Low	Client advised	Outstanding	OH&S REGULATIONS 3.7 AS/NZS 1657-2013 APPENDIX H

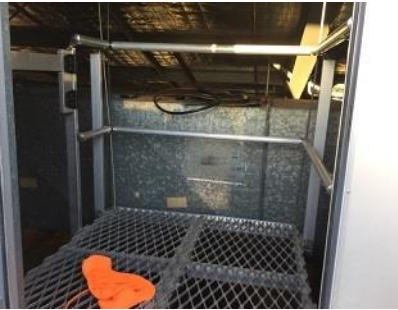
No	Photo of Hazard	Details of Hazard	Details of Risk	Existing/ Immediate Control Measure	Curre nt Risk Level	Proposed Permanent Solution	Resid ual Risk Asse ssme nt	Details of Action Taken	Status	Reference
107	Building: Woolworths Location Reference: L80 Task: Access to the roof

Headroom is less than required minimum and Toe board is missing at landing	Trips, Slips and Falls	Awareness induction	Med	"Low Headroom" sign and Toe board to be installed	Low	Client advised	Outstanding	OH&S REGULATIONS 3.7 AS/NZS 1657-2013 3.1.5 & 4.6
108	Building: General Stores Location Reference: L81 Task: Restrict access to the roof

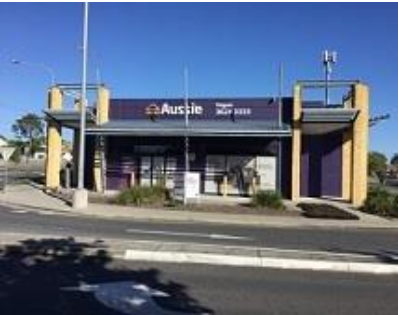
No height safety system installed	Trips, Slips and Falls	Restrict Access	High	"EWP Access Only" signs to be installed	Low	Client advised	Outstanding	OH&S REGULATIONS 3.55 & 3.11

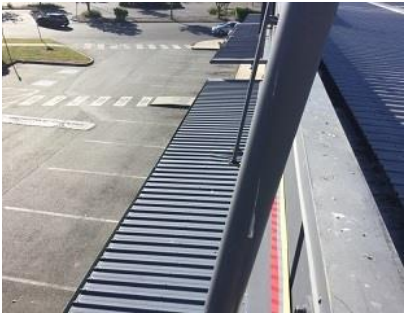
No	Photo of Hazard	Details of Hazard	Details of Risk	Existing/ Immediate Control Measure	Current Risk Level	Proposed Permanent Solution	Residual Risk Assessment	Details of Action Taken	Status	Reference
109	Building: General Stores Location Reference: L82 Task: Restrict access to the roof

No height safety system installed	Trips, Slips and Falls	Restrict Access	High	"EWP Access Only" signs to be installed	Low	Client advised	Outstanding	OH&S REGULATIONS 3.55 & 3.11
110	Building: General Stores Location Reference: L83 Task: Restrict access to the roof

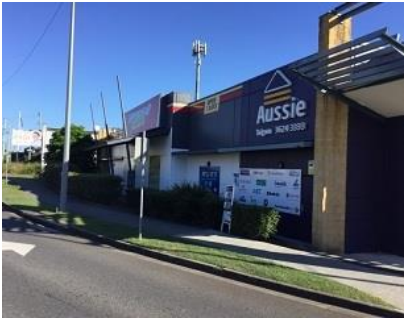
No height safety system installed	Trips, Slips and Falls	Restrict Access	High	"EWP Access Only" signs to be installed	Low	Client advised	Outstanding	OH&S REGULATIONS 3.55 & 3.11
