Roof Safety Report

**Taigum Square,
QLD 4018**

Prepared By: Safemaster Safety Products
Date: 08 Aug 2017

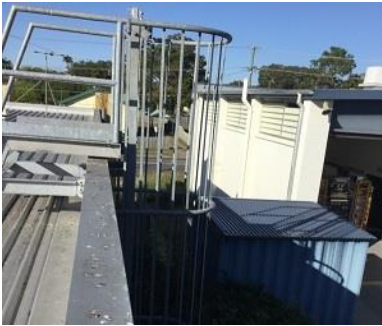
No	Photo of Hazard	Details of Hazard	Details of Risk	Existing/ Immediate Control Measure	Current Risk Level	Proposed Permanent Solution	Residual Risk Assessment	Details of Action Taken	Status	Reference
111	Building: General Stores Location Reference: L84 Task: Access to the roof

No slip resistance on rung caps, Mid rest platform is missing and bottom rung height is less than required minimum	Trips, Slips and Falls	Awareness induction	Med	Existing ladder to be removed and New ladder to be installed	Low	Client advised	Outstanding	OH&S REGULATIONS 3.7 AS/NZS 1657-2013 3.1.4
112	Building: General Stores Location Reference: L84 Task: Access to the A/c unit

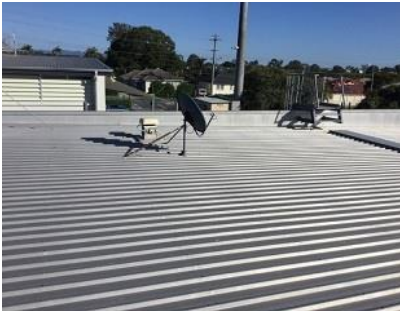
No safe access to the A/c unit	Trips, Slips and Falls	N/A	Low	Supply walkway to the A/c unit	Low	Client advised	Outstanding	-

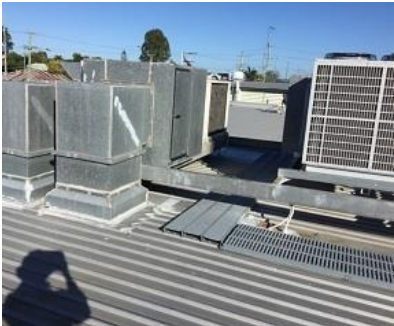
No	Photo of Hazard	Details of Hazard	Details of Risk	Existing/ Immediate Control Measure	Current Risk Level	Proposed Permanent Solution	Residual Risk Assessment	Details of Action Taken	Status	Reference
113	Building: General Stores Location Reference: L85 Task: Access to the A/c unit

Steel beam installed over the walkway path and no safe access to the A/c unit	Trips, Slips and Falls	Awareness induction	Med	Step over and walkway to be installed	Low	Client advised	Outstanding	OH&S REGULATIONS 3.7 AS/NZS 1657-2013 3.1.4
114	Building: General Stores Location Reference: L86 Task: Access to the A/c unit

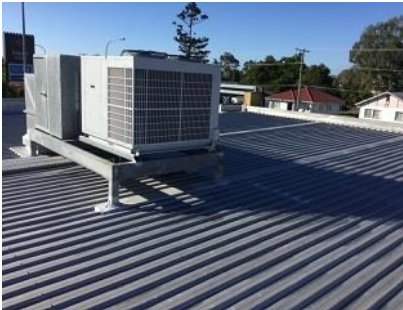
No safe access to the A/c unit	Trips, Slips and Falls	N/A	Low	Supply walkway to the A/c unit	Low	Client advised	Outstanding	-

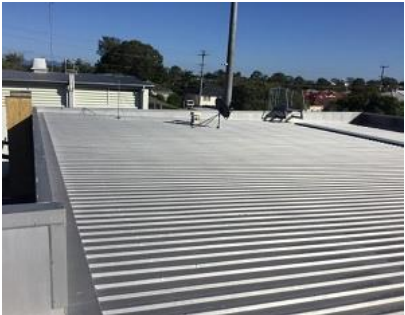
No	Photo of Hazard	Details of Hazard	Details of Risk	Existing/ Immediate Control Measure	Current Risk Level	Proposed Permanent Solution	Residual Risk Assessment	Details of Action Taken	Status	Reference
115	Building: General Stores Location Reference: L87 Task: Access to the roof

No height safety system installed	Trips, Slips and Falls	Awareness induction	High	Fall arrest anchors to be installed	Low	Client advised	Outstanding	OH&S REGULATIONS 3.55
116	Building: General Stores Location Reference: L88 Task: Access to the roof

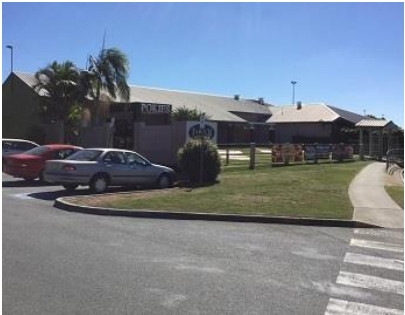
No height safety system installed	Trips, Slips and Falls	Awareness induction	High	Fall arrest anchors, Ladder access bracket, Anchor strop and Signage to be installed	Low	Client advised	Outstanding	OH&S REGULATIONS 3.55

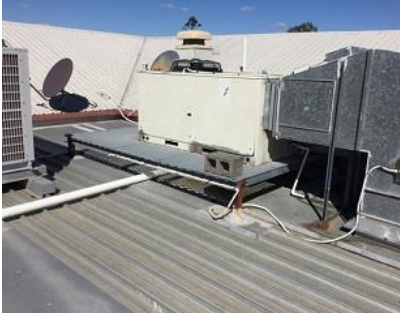
No	Photo of Hazard	Details of Hazard	Details of Risk	Existing/ Immediate Control Measure	Current Risk Level	Proposed Permanent Solution	Residual Risk Assessment	Details of Action Taken	Status	Reference
117	Building: General Stores Location Reference: L89 Task: Access to the plant deck

Variation in height between roof and plant deck is greater than required maximum	Trips, Slips and Falls	Awareness induction	Med	Guardrail around plant deck and Access step to be installed	Low	Client advised	Outstanding	OH&S REGULATIONS 3.6 AS/NZS 1657-2013 4.4
118	Building: General Stores Location Reference: L90 Task: Access to the roof

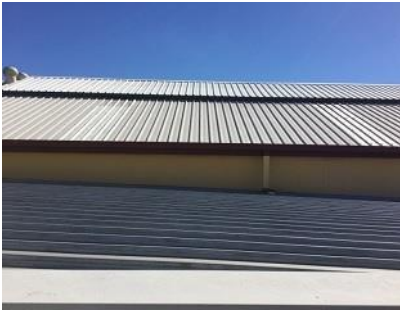
Variation in height between roofs are greater than required maximum	Trips, Slips and Falls	Awareness induction	Med	Access ladder including handrails to be installed	Low	Client advised	Outstanding	OH&S REGULATIONS 3.7 AS/NZS 1657-2013 3.1.4

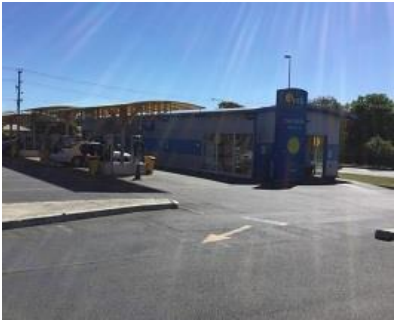
No	Photo of Hazard	Details of Hazard	Details of Risk	Existing/ Immediate Control Measure	Current Risk Level	Proposed Permanent Solution	Residual Risk Assessment	Details of Action Taken	Status	Reference
119	Building: General Stores Location Reference: L91 & 92 Task: Restrict access to the roof

No height safety system installed (No serviceable items)	Trips, Slips and Falls	Awareness induction	High	"EWP Access only" signs to be installed	Low	Client advised	Outstanding	OH&S REGULATIONS 3.55 & 3.11
120	Building: General Stores Location Reference: L93 Task: Access to the roof

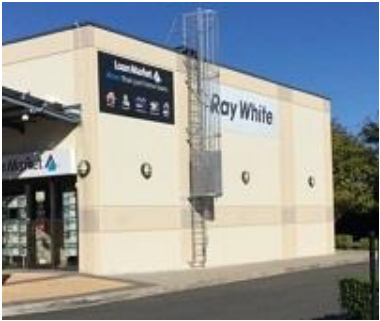
Non-complaint ladder	Trips, Slips and Falls	Awareness induction	High	Existing ladder to be removed and New ladder including handrails to be installed	Low	Client advised	Outstanding	OH&S REGULATIONS 3.7 AS/NZS 1657-2013 3.1.3 & 7.3.6

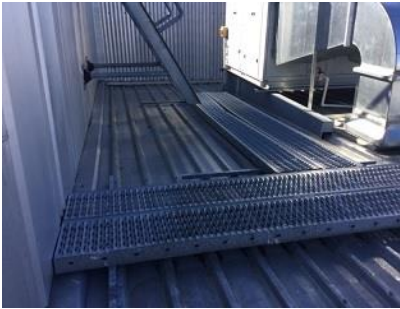
No	Photo of Hazard	Details of Hazard	Details of Risk	Existing/ Immediate Control Measure	Current Risk Level	Proposed Permanent Solution	Residual Risk Assessment	Details of Action Taken	Status	Reference
121	Building: General Stores Location Reference: L93 Task: Access to the A/c units

Roof walkway not secured to roof	Trips, Slips and Falls	Awareness induction	Med	Roof walkway to be secured to roof	Low	Client advised	Outstanding	OH&S REGULATIONS 3.6
122	Building: General Stores Location Reference: L94 Task: Access to the A/c units

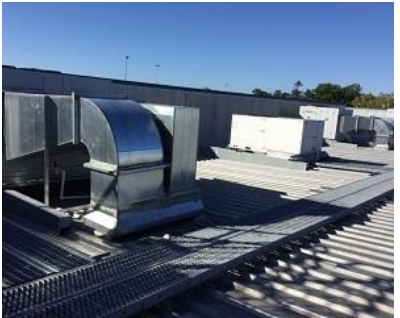
No safe access to the A/c units	Trips, Slips and Falls	N/A	Low	Supply walkway to the A/c units	Low	Client advised	Outstanding	-

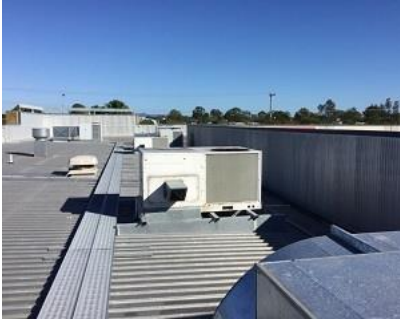
No	Photo of Hazard	Details of Hazard	Details of Risk	Existing/ Immediate Control Measure	Current Risk Level	Proposed Permanent Solution	Residual Risk Assessment	Details of Action Taken	Status	Reference
123	Building: General Stores Location Reference: L95 Task: Access to the A/c units

No safe access to the A/c units	Trips, Slips and Falls	N/A	Low	Supply walkway to the A/c units	Low	Client advised	Outstanding	-
124	Building: General Stores Location Reference: L95 Task: Access to the A/c units

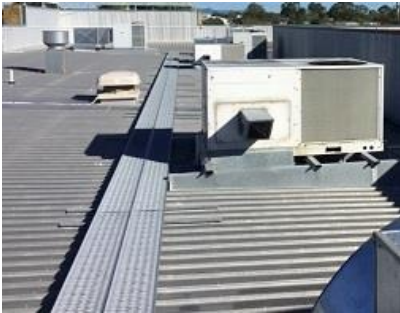
Roof walkway not secured to roof	Trips, Slips and Falls	Awareness induction	Med	Roof walkway to be secured to roof	Low	Client advised	Outstanding	OH&S REGULATIONS 3.6

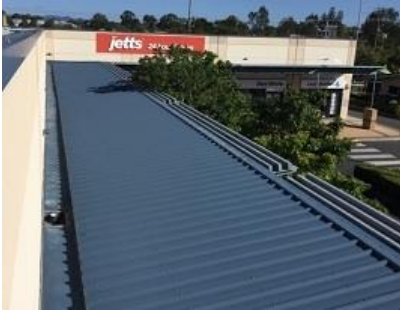
No	Photo of Hazard	Details of Hazard	Details of Risk	Existing/ Immediate Control Measure	Current Risk Level	Proposed Permanent Solution	Residual Risk Assessment	Details of Action Taken	Status	Reference
125	Building: General Stores Location Reference: L96 Task: Restrict access to the roof

No height safety system installed	Trips, Slips and Falls	Restrict Access	High	"EWP Access Only" signs to be installed	Low	Client advised	Outstanding	OH&S REGULATIONS 3.55 & 3.11
126	Building: General Stores Location Reference: L97 Task: Restrict access to the roof

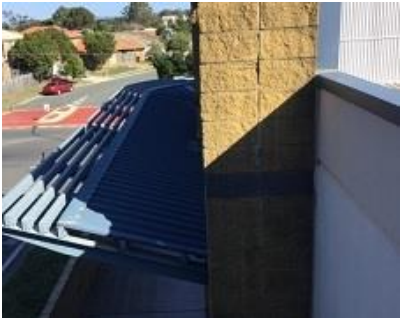
No height safety system installed	Trips, Slips and Falls	Restrict Access	High	"EWP Access Only" signs to be installed	Low	Client advised	Outstanding	OH&S REGULATIONS 3.55 & 3.11

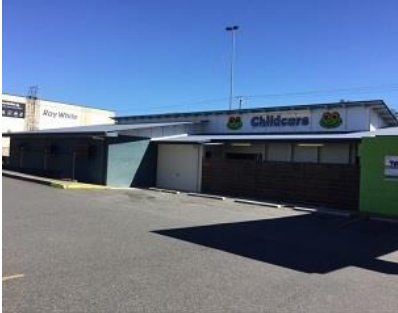
No	Photo of Hazard	Details of Hazard	Details of Risk	Existing/ Immediate Control Measure	Curre nt Risk Level	Proposed Permanent Solution	Resid ual Risk Asse ssme nt	Details of Action Taken	Status	Reference
127	Building: General Stores Location Reference: L98 Task: Access to the roof

No height safety system installed	Trips, Slips and Falls	Awareness induction	High	Fall arrest anchors, Anchor strops, Ladder access brackets and Signs to be installed	Low	Client advised	Outstanding	OH&S REGULATIONS 3.55

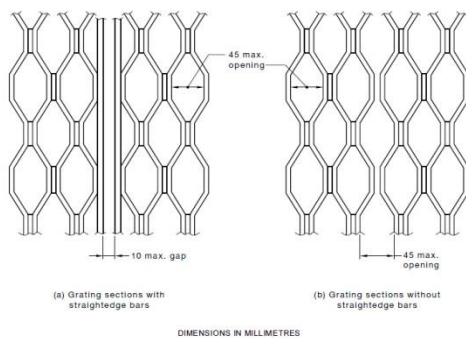
Where straightedge bars are not fitted, the size of any opening at the joint between adjacent panels shall not exceed the requirements for openings in the grating, as given in Figure 3.1.

FIGURE 3.1 CLEARANCES BETWEEN ADJOINING PANELS OF GRATING

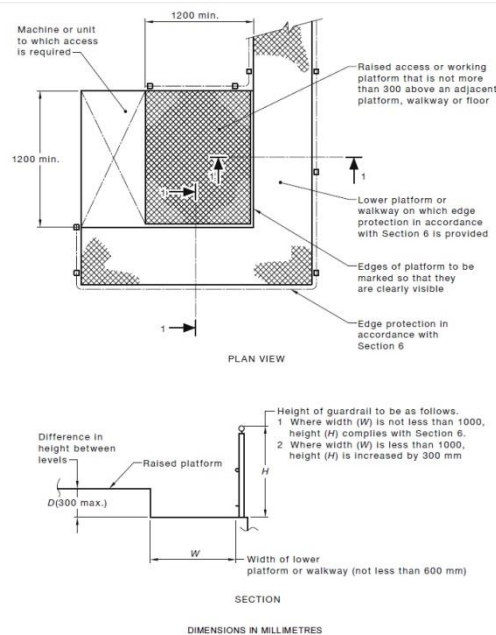
NOTE: Figure 4.1 illustrates guardrail details in relation to platform configurations

FIGURE 4.1 GUARDRAILS ON PLATFORMS

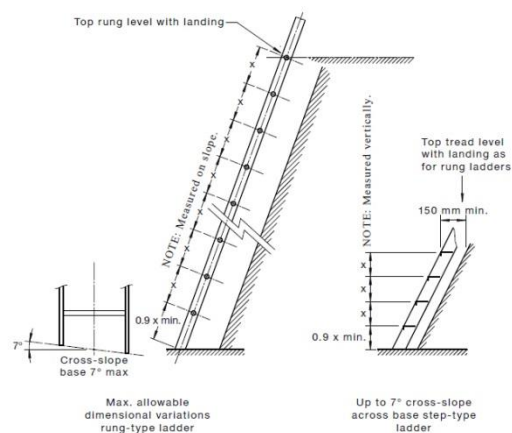
The distance between the bottom rung/tread and the bottom landing shall be not less than 90% and not greater than 100% of the rung/tread spacing (see Figure 7.5).

- 1 This distance should be measured at the ladder centre-line where the landing has a cross-slope (see Figure 7.5).
- 2 Where possible, the distance between the landing and the first rung/tread should be equal to the rung/tread spacing.

FIGURE 7.5 VARIATION OF RUNG/TREAD SPACING
