Roof Safety Report

Altona Gate, VIC 3025

Prepared By: Safemaster Safety Products
Date: 27-10-2019

Roof Safety Report for
Altona Gate Shopping Centre, VIC 3025

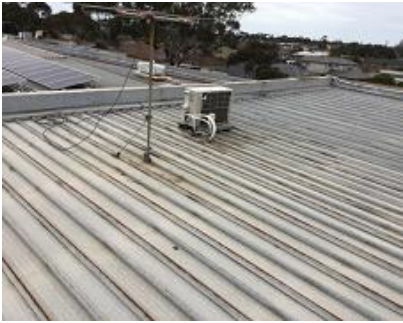
No safe access to the A/c units	Trips, Slips and Falls	N/A	Low	Supply walkway to the A/c units	Low	Client advised	Outstanding	-

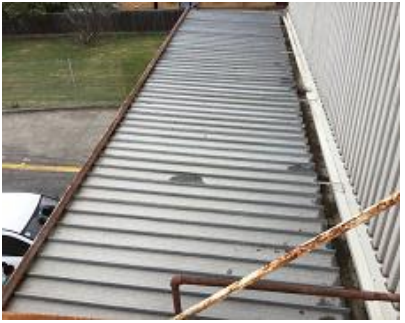
No height safety system installed	Trips, Slips and Falls	Awareness induction	High	"EWP Access Only" sign to be installed	Low	Client advised	Outstanding	OH&S REGULATIONS 3.55 & 3.11

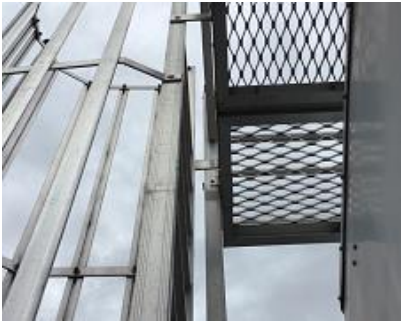
Gap between top rung and landing is greater than required maximum	Trips, Slips and Falls	Awareness induction	Med	Gap to be filled	Low	Client advised	Outstanding	OH&S REGULATIONS 3.7 AS 1657-2018 7.4.3.3

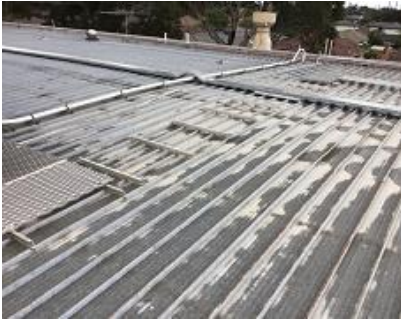
Walkway sections been removed during solar panel installation and cable tray in the way	Trips, Slips and Falls	Awareness induction	Med	Walkway and Step bridges to be installed	Low	Client advised	Outstanding	OH&S REGULATIONS 3.7 AS 1657-2018 3.1.4

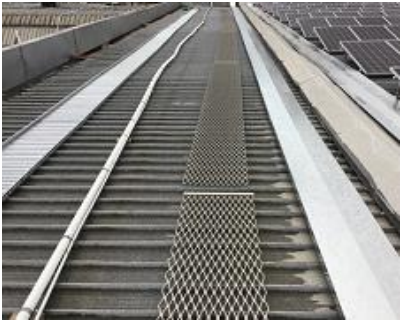
Walkway not secured to roof	Trips, Slips and Falls	Awareness induction	Med	Walkway to be secured	Low	Client advised	Outstanding	OH&S REGULATIONS 3.7

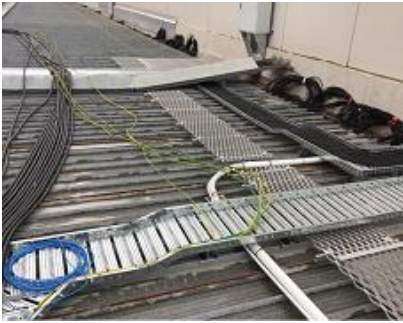
Cable trays installed over the walkway path	Trips, Slips and Falls	Awareness induction	Med	Step bridges to be installed	Low	Client advised	Outstanding	OH&S REGULATIONS 3.7 AS 1657-2018 3.1.4

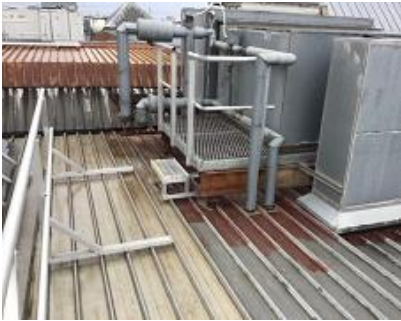
No safe access to the A/c units	Trips, Slips and Falls	N/A	Low	Supply walkway to the A/c units	Low	Client advised	Outstanding	-

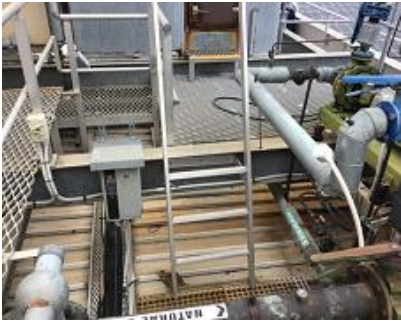
Gap between top rung and landing is greater than required maximum	Trips, Slips and Falls	Awareness induction	Med	Gap to be filled	Low	Client advised	Outstanding	OH&S REGULATIONS 3.7 AS 1657-2018 7.4.8.4

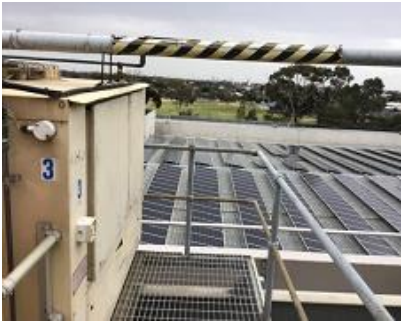
Headroom is less than required minimum	Trips, Slips and Falls	Awareness induction	Med	"Caution-Low headroom" signs to be installed	Low	Client advised	Outstanding	OH&S REGULATIONS 3.7 AS 1657-2018 3.1.5

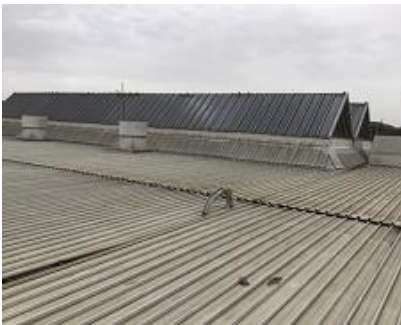
Brittle roof section is present	Trips, Slips and Falls	Restrict Access	High	"Warning-Brittle and Fragile Roof" signs to be installed	Low	Client advised	Outstanding	OH&S REGULATIONS 3.57

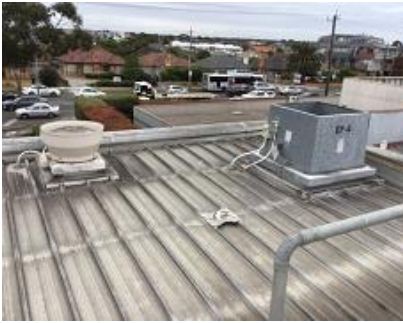
A/c units are too close to the fall edge	Trips, Slips and Falls	Awareness induction	Med	Handrail to be installed	Low	Client advised	Outstanding	OH&S REGULATIONS 3.7 & 3.55

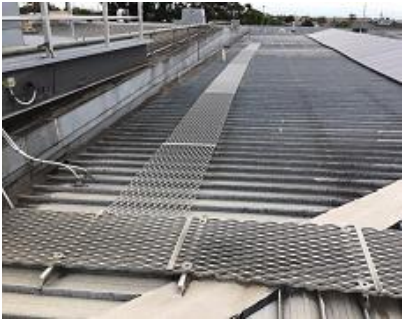
Walkway not secured to roof	Trips, Slips and Falls	Awareness induction	Med	Existing walkway to be fully secured to roof	Low	Client advised	Outstanding	OH&S REGULATIONS 3.7

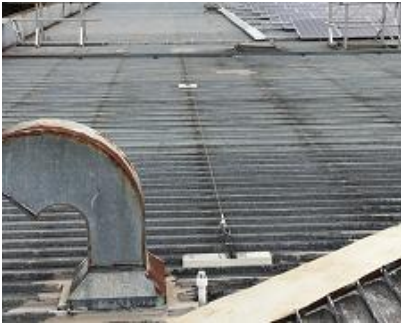
Static line over 10 years old	Trips, Slips and Falls	Awareness induction	High	Existing static line to be replaced	Low	Client advised	Outsta nding	OH&S REGULATIONS 3.55 AS/NZS 1891.4:2009 6.3
66	Building: General Stores Location Reference: L40 Task: Access to the roof

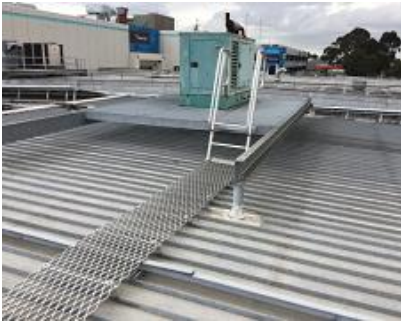
Non-complaint ladder is present	Trips, Slips and Falls	Awareness induction	Med	Existing ladder to be replaced	Low	Client advised	Outsta nding	OH&S REGULATIONS 3.7 AS 1657-2018 7.4

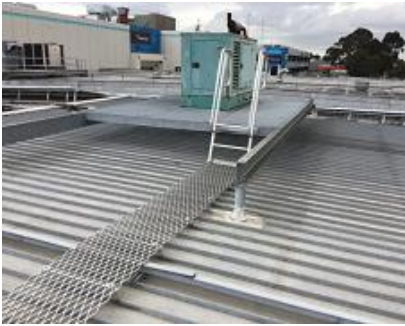
Variation in height between plant deck and roof is greater than required maximum	Trips, Slips and Falls	Awareness induction	Med	Handrail to be installed	Low	Client advised	Outstanding	OH&S REGULATIONS 3.7 AS 1657-2018 4.4
68	Building: General Stores Location Reference: L41 Task: Access to the roof

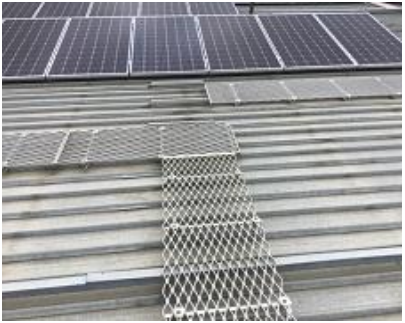
Gap between walkway panels are greater than required maximum	Trips, Slips and Falls	Awareness induction	Med	Additional walkway sections to be installed	Low	Client advised	Outstanding	OH&S REGULATIONS 3.7

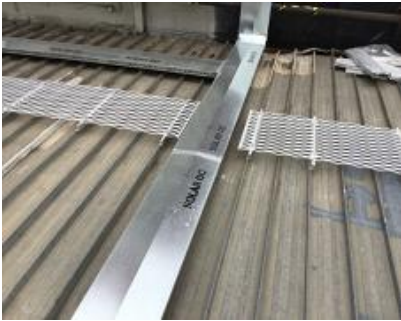
Cable tray installed over the walkway path	Trips, Slips and Falls	Awareness induction	Med	Step bridge to be installed	Low	Client advised	Outstanding	OH&S REGULATIONS 3.7 AS 1657-2018 3.2.3.4
70	Building: General Stores Location Reference: L42 Task: Access to the roof

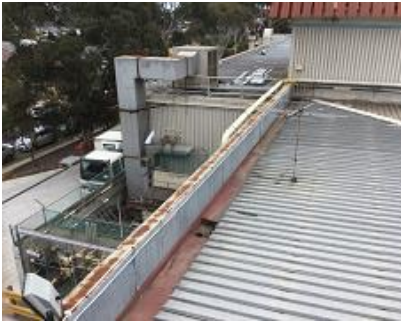
No height safety system installed	Trips, Slips and Falls	Awareness induction	High	Anchors to be installed	Low	Client advised	Outstanding	OH&S REGULATIONS 3.55

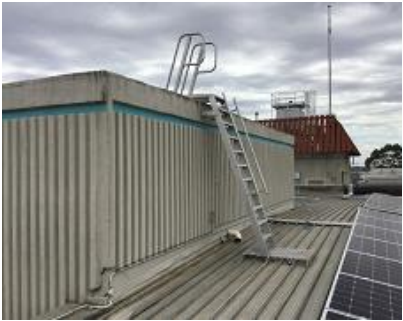
Handrail projecting towards the user, landing is less than required minimum & ladder location is in-correct	Trips, Slips and Falls	Awareness induction	Med	Existing ladder to be re-installed with new landing platforms, preformed handrails and brackets at new location	Low	Client advised	Outstanding	OH&S REGULATIONS 3.7 AS 1657-2018 7.4.8.5 & 7.3.6
72	Building: General Stores Location Reference: L43 Task: Access to the roof

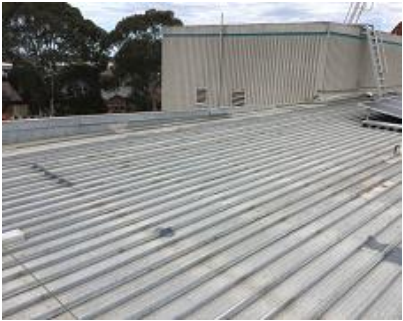
No height safety system installed	Trips, Slips and Falls	Awareness induction	High	Anchors to be installed	Low	Client advised	Outstanding	OH&S REGULATIONS 3.55

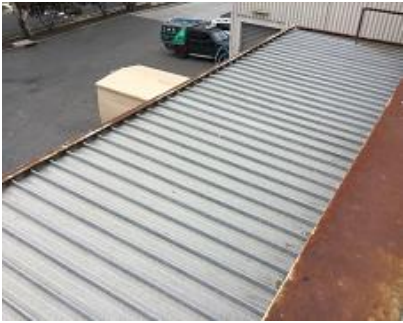
No height safety system installed (no serviceable items on roof)	Trips, Slips and Falls	Restrict access	High	"EWP Access Only" sign to be installed	Low	Client advised	Outstanding	OH&S REGULATIONS 3.55 & 3.11
74	Building: General Stores Location Reference: L44 Task: Access to the roof

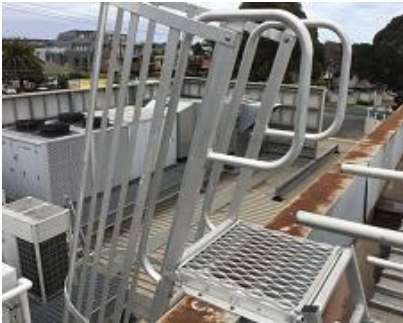
Handrail projecting towards the user and landing platforms not installed	Trips, Slips and Falls	Awareness induction	Med	Handrails to be replaced and landing platforms to be installed	Low	Client advised	Outstanding	OH&S REGULATIONS 3.7 AS 1657-2018 7.4.8.5 & 7.3.6

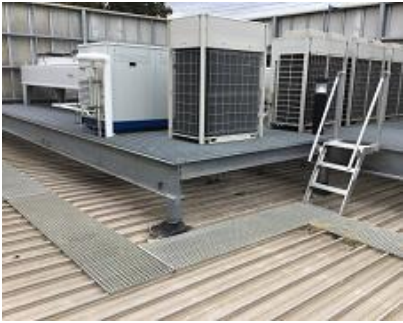
Variation in height between plant deck and roof is greater than required maximum	Trips, Slips and Falls	Awareness induction	Med	Handrails to be installed	Low	Client advised	Outstanding	OH&S REGULATIONS 3.7 AS 1657-2018 4.4
76	Building: General Stores Location Reference: L45 Task: Access to the roof

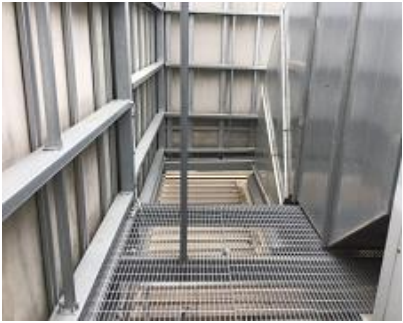
Variation in height between plant deck and roof is greater than required maximum	Trips, Slips and Falls	Awareness induction	Med	Handrails to be installed	Low	Client advised	Outstanding	OH&S REGULATIONS 3.7 AS 1657-2018 4.4

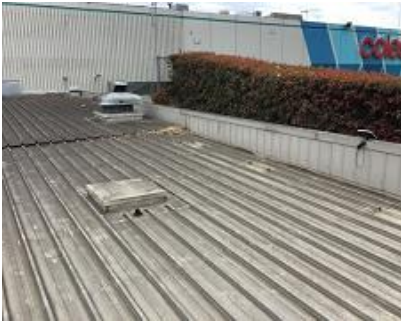
No height safety system installed	Trips, Slips and Falls	Awareness induction	High	Anchors to be installed	Low	Client advised	Outstanding	OH&S REGULATIONS 3.55
78	Building: General Stores Location Reference: L47 Task: Access to the roof

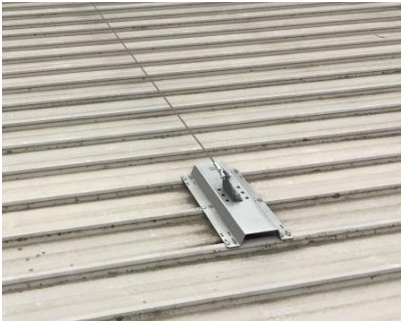
Static line over 10 years old	Trips, Slips and Falls	Awareness induction	High	Existing static line to be replaced	Low	Client advised	Outstanding	OH&S REGULATIONS 3.55 AS/NZS 1891.4:2009 6.3
