# Roof Safety Report

**Armidale Central,  
NSW 2350**

Prepared By: Safemaster Safety Products  
Date: 09 Aug 2017

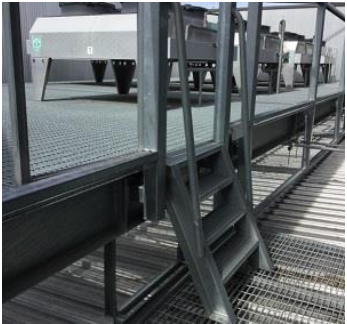
No safe access to the A/c units	Trips, Slips and Falls	N/A	Low	Levelled roof walkway including handrails to be installed	Low	Client advised	Outstanding	-
02	Building: Woolworths Location Reference: <a href="#">L02</a> Task: Access to the plant deck

Handrails projecting towards the user	Trips, Slips and Falls	Awareness induction	Med	Existing handrails to be removed and New handrails to be installed	Low	Client advised	Outstanding	OH&S REGULATIONS 3.7 AS/NZS 1657-2013 7.4.8.5

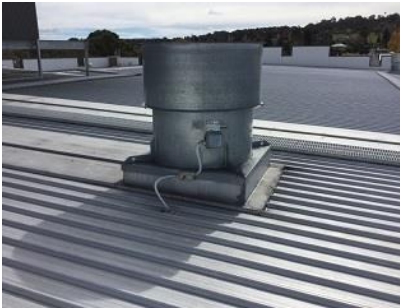
Handrails projecting towards the user and Landing at base is less than required minimum	Trips, Slips and Falls	Awareness induction	Med	Existing handrails to be removed and New aluminium handrails and landing platform to be installed	Low	Client advised	Outstanding	OH&S REGULATIONS 3.7  AS/NZS 1657-2013 7.4.8.5 & 7.3.6
04	Building: Woolworths Location Reference: <a href="#">L04</a> Task: Access to the A/c unit

No safe access to the A/c unit	Trips, Slips and Falls	N/A	Low	Supply walkway to the A/c unit	Low	Client advised	Outstanding	-

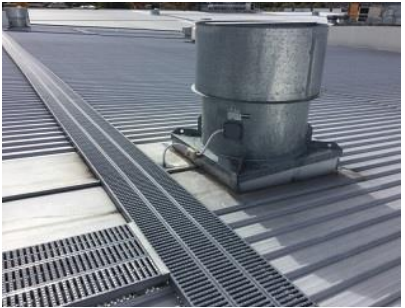
Variation in height between roof walkway panels are greater than required maximum	Trips, Slips and Falls	Awareness induction	Med	High visibility safety yellow nosing to be installed	Low	Client advised	Outstanding	OH&S REGULATIONS 3.7  AS/NZS 1657-2013 3.3.4
06	Building: Woolworths Location Reference: <a href="#">L05</a> Task: Access to the A/c unit

No safe access to the A/c unit	Trips, Slips and Falls	N/A	Low	Supply walkway to the A/c units	Low	Client advised	Outstanding	-

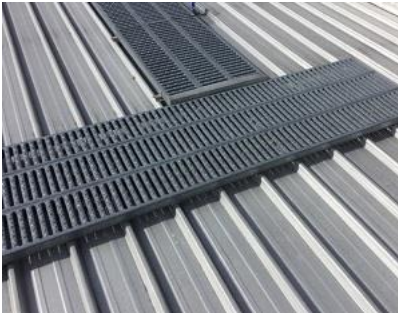
Variation in height between roof walkway panels are greater than required maximum	Trips, Slips and Falls	Awareness induction	Med	High visibility safety yellow nosing to be installed	Low	Client advised	Outstanding	OH&S REGULATIONS 3.7  AS/NZS 1657-2013 3.3.4
08	Building: Woolworths Location Reference: <a href="#">L07</a> Task: Access to the A/c unit

Variation in height between roof walkway panels are greater than required maximum	Trips, Slips and Falls	Awareness induction	Med	High visibility safety yellow nosing to be installed	Low	Client advised	Outstanding	OH&S REGULATIONS 3.7  AS/NZS 1657-2013 3.3.4

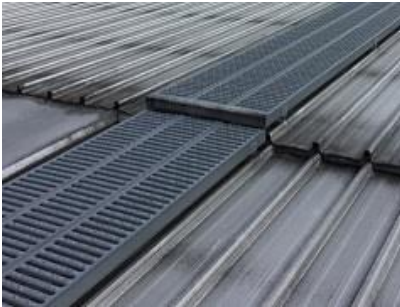
No safe access to the A/c units	Trips, Slips and Falls	N/A	Low	Supply walkway to the A/c units	Low	Client advised	Outstanding	-
14	Building: Woolworths Location Reference: <a href="#">L12</a> Task: Access to the roof

Variation in height between roof walkway panels are greater than required maximum	Trips, Slips and Falls	Awareness induction	Med	High visibility safety yellow nosing to be installed	Low	Client advised	Outstanding	OH&S REGULATIONS 3.7  AS/NZS 1657-2013 3.3.4

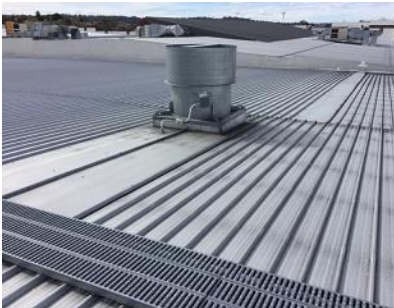
Variation in height between roof walkway panels are greater than required maximum	Trips, Slips and Falls	Awareness induction	Med	High visibility safety yellow nosing to be installed	Low	Client advised	Outstanding	OH&S REGULATIONS 3.7  AS/NZS 1657-2013 3.3.4
16	Building: Woolworths Location Reference: <a href="#">L14</a> Task: Access to the A/c unit

No safe access to the A/c unit	Trips, Slips and Falls	N/A	Low	Supply walkway to the A/c unit	Low	Client advised	Outstanding	-

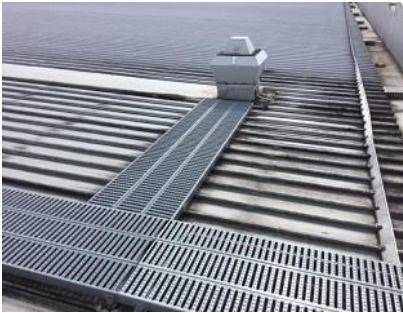
Stair width is less than required minimum	Trips, Slips and Falls	Awareness induction	Med	Existing stair to be removed and New access ladder including handrails to be installed	Low	Client advised	Outstanding	OH&S REGULATIONS 3.7  AS/NZS 1657-2013 7.2.1
18	Building: Woolworths Location Reference: <a href="#">L15</a> Task: Access to the Switch

No safe access to the switch	Trips, Slips and Falls	N/A	Low	Supply walkway to the switch	Low	Client advised	Outstanding	-

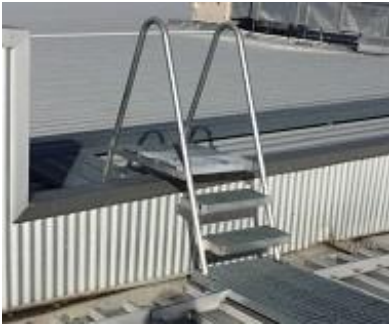
No safe access to the A/c units	Trips, Slips and Falls	N/A	Low	Supply walkway to the A/c units	Low	Client advised	Outstanding	-
26	Building: General Stores Location Reference: <a href="#">L20</a> Task: Access to the roof

Stair width is less than required minimum	Trips, Slips and Falls	Awareness induction	Med	Existing stair to be removed and New access ladder including handrails to be installed	Low	Client advised	Outstanding	OH&S REGULATIONS 3.7  AS/NZS 1657-2013 7.2.1

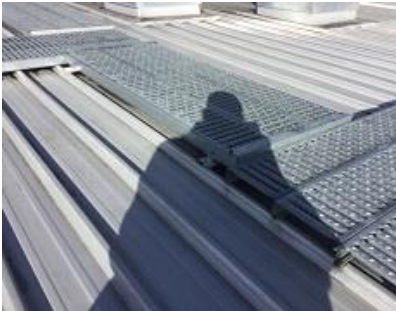
Ladder slope is less than required minimum	Trips, Slips and Falls	Awareness induction	Med	Existing ladder to be removed and New ladder to be installed	Low	Client advised	Outstanding	OH&S REGULATIONS 3.7  AS/NZS 1657-2013 7.4.1
28	Building: General Stores Location Reference: <a href="#">L22</a> Task: Access to the A/c unit

Variation in height between walkway panels are greater than required maximum	Trips, Slips and Falls	Awareness induction	Med	High visibility safety yellow nosing's to be installed	Low	Client advised	Outstanding	OH&S REGULATIONS 3.6  AS/NZS 1657-2013 3.3.4

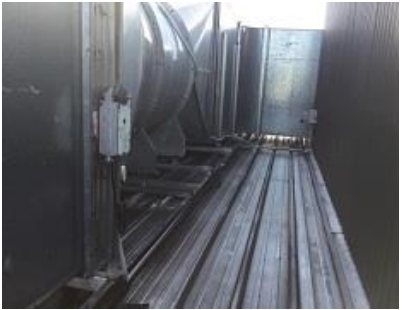
No safe access to the A/c unit	Trips, Slips and Falls	N/A	Low	Supply walkway to the A/c unit	Low	Client advised	Outstanding	-
32	Building: General Stores Location Reference: <a href="#">L24</a> Task: Access to the switch's

No safe access to the switch's	Trips, Slips and Falls	N/A	Low	Supply walkway to the switch's	Low	Client advised	Outstanding	-

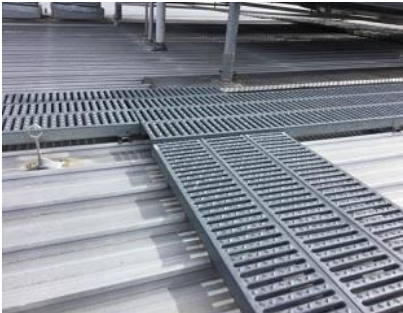
No safe access to the switch's	Trips, Slips and Falls	N/A	Low	Supply walkway to the switch's	Low	Client advised	Outstanding	-
36	Building: General Stores Location Reference: <a href="#">L26</a> Task: Access to the A/c unit

Variation in height between walkway panels are greater than required maximum	Trips, Slips and Falls	Awareness induction	Med	High visibility safety yellow nosing's to be installed	Low	Client advised	Outstanding	OH&S REGULATIONS 3.6  AS/NZS 1657-2013 3.3.4

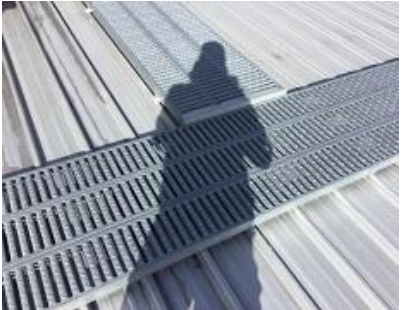
Variation in height between walkway panels are greater than required maximum	Trips, Slips and Falls	Awareness induction	Med	High visibility safety yellow nosing's to be installed	Low	Client advised	Outstanding	OH&S REGULATIONS 3.6  AS/NZS 1657-2013 3.3.4
38	Building: General Stores Location Reference: <a href="#">L27</a> Task: Access to the A/c unit

Variation in height between walkway panels are greater than required maximum	Trips, Slips and Falls	Awareness induction	Med	High visibility safety yellow nosing's to be installed	Low	Client advised	Outstanding	OH&S REGULATIONS 3.6  AS/NZS 1657-2013 3.3.4

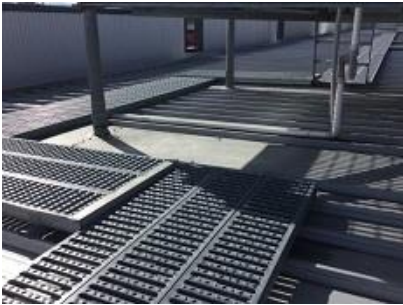
No safe access to the switch's	Trips, Slips and Falls	N/A	Low	Supply walkway to the switch's	Low	Client advised	Outstanding	-
42	Building: General Stores Location Reference: <a href="#">L28</a> Task: Access to the A/c units

Variation in height between walkway panels are greater than required maximum	Trips, Slips and Falls	Awareness induction	Med	High visibility safety yellow nosing's to be installed	Low	Client advised	Outstanding	OH&S REGULATIONS 3.6  AS/NZS 1657-2013 3.3.4

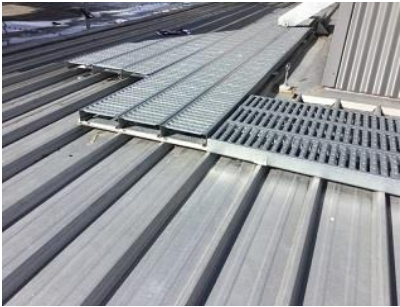
Variation in height between walkway panels are greater than required maximum	Trips, Slips and Falls	Awareness induction	Med	High visibility safety yellow nosing's to be installed	Low	Client advised	Outstanding	OH&S REGULATIONS 3.6  AS/NZS 1657-2013 3.3.4
46	Building: General Stores Location Reference: <a href="#">L30</a> Task: Access to the A/c unit

Variation in height between walkway panels are greater than required maximum	Trips, Slips and Falls	Awareness induction	Med	High visibility safety yellow nosing's to be installed	Low	Client advised	Outstanding	OH&S REGULATIONS 3.6  AS/NZS 1657-2013 3.3.4

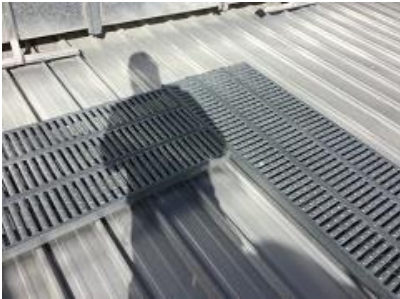
Variation in height between walkway panels are greater than required maximum	Trips, Slips and Falls	Awareness induction	Med	High visibility safety yellow nosing's to be installed	Low	Client advised	Outstanding	OH&S REGULATIONS 3.6  AS/NZS 1657-2013 3.3.4
50	Building: General Stores Location Reference: <a href="#">L34</a> Task: Access to the roof

Variation in height between walkway panels are greater than required maximum	Trips, Slips and Falls	Awareness induction	Med	High visibility safety yellow nosing's to be installed	Low	Client advised	Outstanding	OH&S REGULATIONS 3.6  AS/NZS 1657-2013 3.3.4

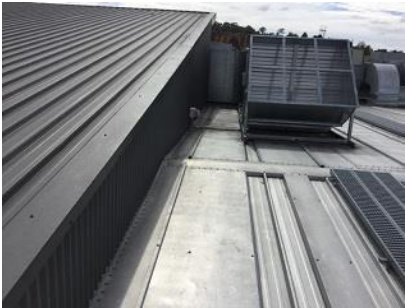
Variation in height between walkway panels are greater than required maximum	Trips, Slips and Falls	Awareness induction	Med	High visibility safety yellow nosing's to be installed	Low	Client advised	Outstanding	OH&S REGULATIONS 3.6  AS/NZS 1657-2013 3.3.4
54	Building: General Stores Location Reference: <a href="#">L36</a> Task: Access to the switch's

No safe access to the switch's	Trips, Slips and Falls	N/A	Low	Supply walkway to the switch's	Low	Client advised	Outstanding	-

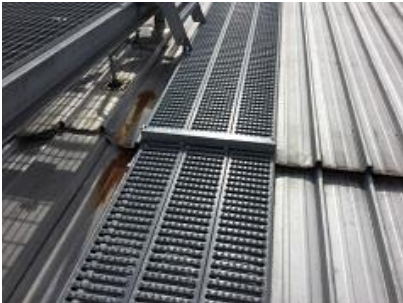
Variation in height between walkway panels are greater than required maximum	Trips, Slips and Falls	Awareness induction	Med	High visibility safety yellow nosing's to be installed	Low	Client advised	Outstanding	OH&S REGULATIONS 3.6  AS/NZS 1657-2013 3.3.4
60	Building: General Stores Location Reference: <a href="#">L41</a> Task: Access to the A/c units

Variation in height between walkway panels are greater than required maximum	Trips, Slips and Falls	Awareness induction	Med	High visibility safety yellow nosing's to be installed	Low	Client advised	Outstanding	OH&S REGULATIONS 3.6  AS/NZS 1657-2013 3.3.4

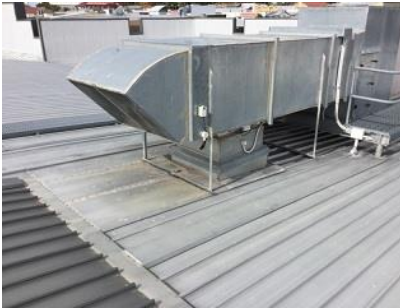
Landing is less than required minimum and slope of ladder is greater than required maximum	Trips, Slips and Falls	Awareness induction	Med	Existing ladder to be removed and New ladder to be installed	Low	Client advised	Outstanding	OH&S REGULATIONS 3.7  AS/NZS 1657-2013 7.3.6 & 7.2.1
62	Building: General Stores Location Reference: <a href="#">L41</a> Task: Access to the switch's

No safe access to the switch's	Trips, Slips and Falls	N/A	Low	Supply walkway to the switch's	Low	Client advised	Outstanding	-

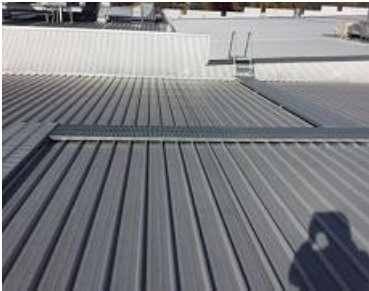
No height safety system installed (No serviceable items)	Trips, Slips and Falls	Awareness induction	High	"EWP Access Only" signs to be installed	Low	Client advised	Outstanding	OH&S REGULATIONS 3.55 & 3.11
66	Building: General Stores Location Reference: <a href="#">L46</a> Task: Access to the roof

Variation in height between walkway panels are greater than required maximum	Trips, Slips and Falls	Awareness induction	Med	High visibility safety yellow nosing's to be installed	Low	Client advised	Outstanding	OH&S REGULATIONS 3.6  AS/NZS 1657-2013 3.3.4

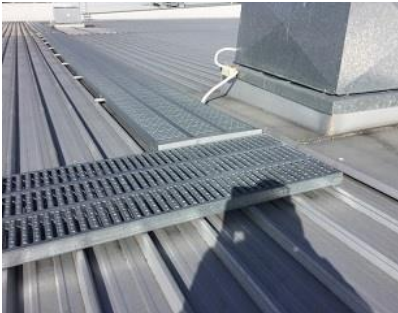
Variation in height between walkway panels are greater than required maximum	Trips, Slips and Falls	Awareness induction	Med	High visibility safety yellow nosing's to be installed	Low	Client advised	Outstanding	OH&S REGULATIONS 3.6  AS/NZS 1657-2013 3.3.4
68	Building: General Stores Location Reference: <a href="#">L48</a> Task: Access to the roof

Variation in height between walkway panels are greater than required maximum	Trips, Slips and Falls	Awareness induction	Med	High visibility safety yellow nosing's to be installed	Low	Client advised	Outstanding	OH&S REGULATIONS 3.6  AS/NZS 1657-2013 3.3.4

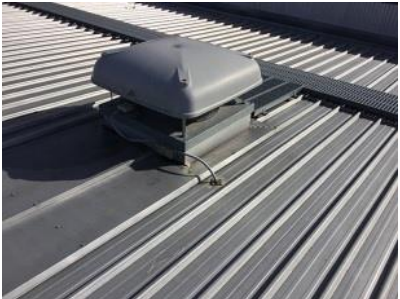
No safe access to the switch	Trips, Slips and Falls	N/A	Low	Supply walkway to the switch	Low	Client advised	Outstanding	-
70	Building: General Stores Location Reference: <a href="#">L50</a> Task: Access to the switch

No safe access to the switch	Trips, Slips and Falls	N/A	Low	Supply walkway to the switch	Low	Client advised	Outstanding	-

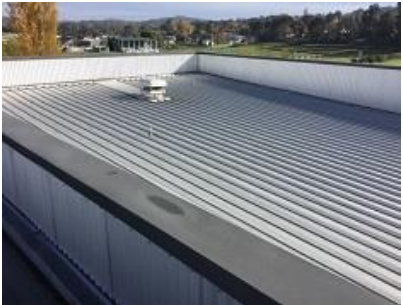
Variation in height between roofs are greater than required maximum	Trips, Slips and Falls	Awareness induction	Med	Access ladder including handrails to be installed	Low	Client advised	Outstanding	OH&S REGULATIONS 3.7  AS/NZS 1657-2013 3.1.4
72	Building: General Stores Location Reference: <a href="#">L52</a> Task: Access to the A/c unit

No safe access to the A/c unit	Trips, Slips and Falls	N/A	Low	Supply walkway to the A/c unit	Low	Client advised	Outstanding	-

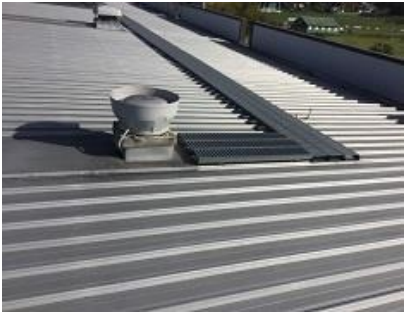
No	Photo of Hazard	Details of Hazard	Details of Risk	Existing/ Immediate Control Measure	Current Risk Level	Proposed Permanent Solution	Residual Risk Assessment	Details of Action Taken	Status	Reference
73	Building: General Stores Location Reference: <a href="#">L53</a> Task: Access to the A/c units

No safe access to the A/c units	Trips, Slips and Falls	N/A	Low	Supply walkway to the A/c unit	Low	Client advised	Outstanding	-
74	Building: General Stores Location Reference: <a href="#">L55</a> Task: Access to the plant deck

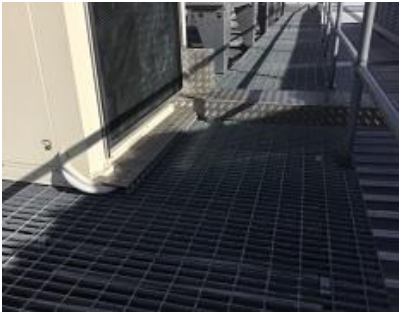
Cable tray installed over walkway path	Trips, Slips and Falls	Awareness induction	Med	High visibility safety yellow tape to be installed	Low	Client advised	Outstanding	OH&S REGULATIONS 3.6

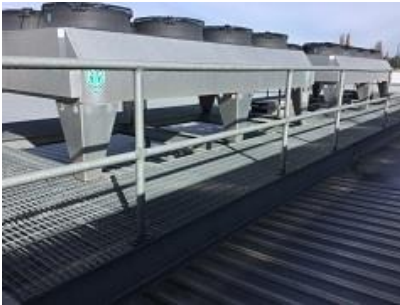
Variation in height between plant deck and unit is greater than required maximum	Trips, Slips and Falls	Awareness induction	Med	Mid rail to be installed	Low	Client advised	Outstanding	OH&S REGULATIONS 3.6  AS/NZS 1657-2013 4.4
76	Building: General Stores Location Reference: <a href="#">L56</a> Task: Access to the roof

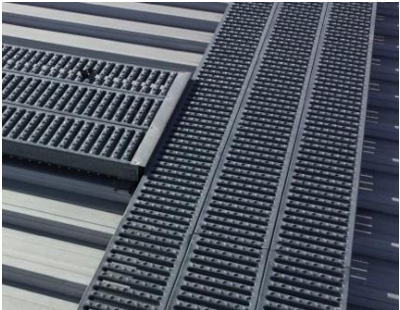
Variation in height between walkway panels are greater than required maximum	Trips, Slips and Falls	Awareness induction	Med	High visibility safety yellow nosing's to be installed	Low	Client advised	Outstanding	OH&S REGULATIONS 3.6  AS/NZS 1657-2013 3.3.4

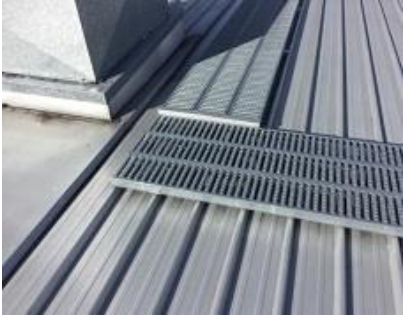
No	Photo of Hazard	Details of Hazard	Details of Risk	Existing/ Immediate Control Measure	Current Risk Level	Proposed Permanent Solution	Residual Risk Assessment	Details of Action Taken	Status	Reference
77	Building: General Stores Location Reference: <a href="#">L57</a> Task: Access to the A/c unit

Variation in height between walkway panels are greater than required maximum	Trips, Slips and Falls	Awareness induction	Med	High visibility safety yellow nosing's to be installed	Low	Client advised	Outstanding	OH&S REGULATIONS 3.6  AS/NZS 1657-2013 3.3.4
78	Building: General Stores Location Reference: <a href="#">L57</a> Task: Access to the A/c unit

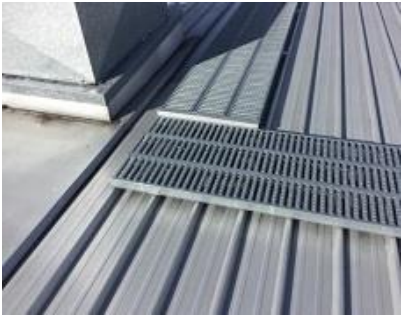
No safe access to the A/c unit	Trips, Slips and Falls	N/A	Low	Supply walkway to the A/c unit	Low	Client advised	Outstanding	-

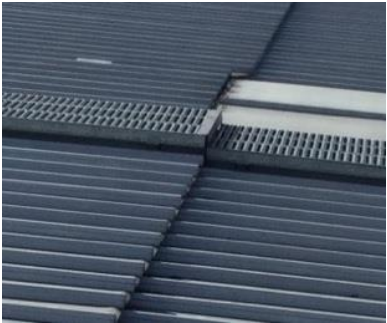
No	Photo of Hazard	Details of Hazard	Details of Risk	Existing/ Immediate Control Measure	Current Risk Level	Proposed Permanent Solution	Residual Risk Assessment	Details of Action Taken	Status	Reference
79	Building: General Stores Location Reference: <a href="#">L58</a> Task: Access to the roof

Variation in height between walkway panels are greater than required maximum	Trips, Slips and Falls	Awareness induction	Med	High visibility safety yellow nosing's to be installed	Low	Client advised	Outstanding	OH&S REGULATIONS 3.6  AS/NZS 1657-2013 3.3.4
80	Building: General Stores Location Reference: <a href="#">L59</a> Task: Access to the A/c unit

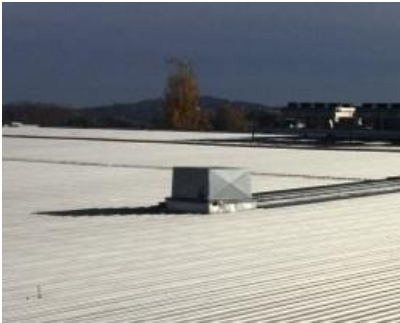
No safe access to the A/c unit	Trips, Slips and Falls	N/A	Low	Supply walkway to the A/c unit	Low	Client advised	Outstanding	-
