# Roof Safety Report

**Castle Plaza, SA 5039**

Prepared By: Safemaster Safety Products  
Date: 01 March 2018

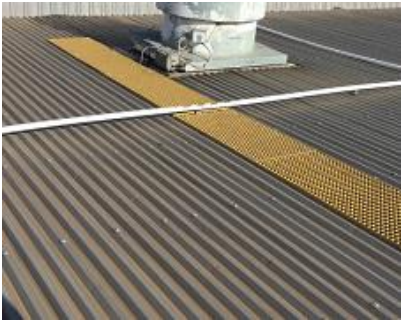
Pipe installed over the walkway path	Trips, Slips and Falls	Awareness induction	Med	Step bridge to be installed	Low	Client advised	Outstanding	OH&S REGULATIONS 3.7  AS/NZS 1657-2013 3.1.4

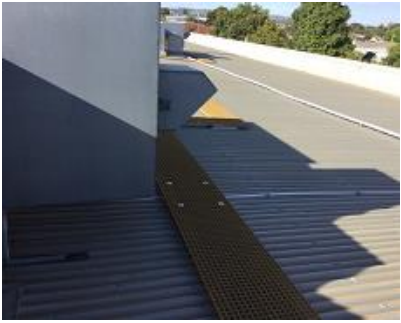
Duct protrudes over the walkway path	Trips, Slips and Falls	Awareness induction	Med	Additional walkway sections and high visibility safety yellow tape to be installed	Low	Client advised	Outstanding	OH&S REGULATIONS 3.7  AS/NZS 1657-2013 3.1.4

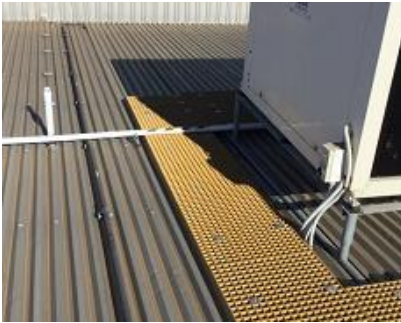
Pipe installed over the walkway path	Trips, Slips and Falls	Awareness induction	Med	Step bridge to be installed	Low	Client advised	Outstanding	OH&S REGULATIONS 3.7  AS/NZS 1657-2013 3.1.4

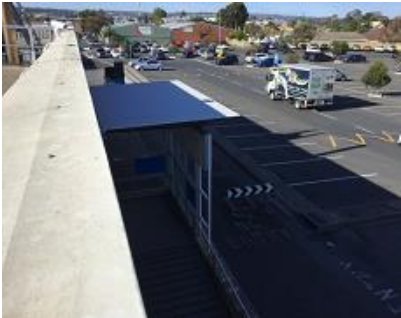
No height safety system installed (No serviceable items on roof)	Trips, Slips and Falls	Restrict Access	High	"EWP Access Only" sign to be installed	Low	Client advised	Outstanding	OH&S REGULATIONS 3.55 & 3.11

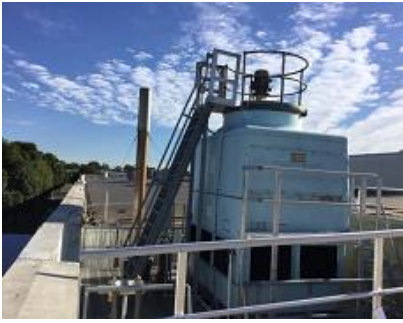
Self-closing gate at top landing and potential fall behind the ladder	Trips, Slips and Falls	Awareness induction	Med	Self-closing gate and Cage to be installed	Low	Client advised	Outsta nding	OH&S REGULATIONS 3.7  AS/NZS 1657- 2013 7.3

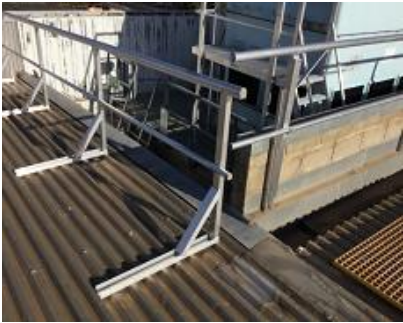
Handrail not fully secured	Trips, Slips and Falls	Awareness induction	Med	Additional handrail post to be installed	Low	Client advised	Outsta nding	OH&S REGULATIONS 3.7  AS/NZS 1657- 2013 4.4

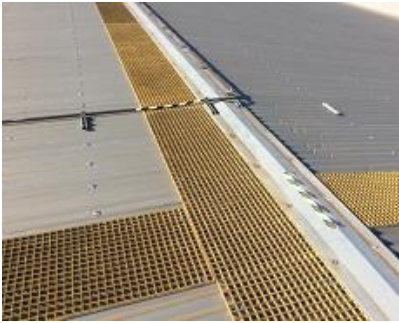
Pipe installed over the walkway path	Trips, Slips and Falls	Awareness induction	Med	Step bridge to be installed	Low	Client advised	Outstanding	OH&S REGULATIONS 3.7  AS/NZS 1657-2013 3.1.4
24	Building: General Stores Location Reference: <a href="#">L08</a> Task: Access to the roof

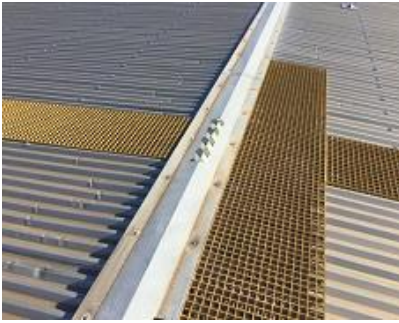
Gap between walkway panels are greater than required maximum	Trips, Slips and Falls	Awareness induction	Med	Additional walkway bridge to be installed	Low	Client advised	Outstanding	OH&S REGULATIONS 3.7  AS/NZS 1657-2013 3.2.3.4

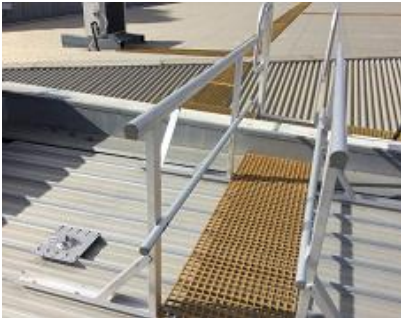
Sharp edges on handrails	Trips, Slips and Falls	Awareness induction	Med	Tek screws to be replaced with rivets	Low	Client advised	Outstanding	OH&S REGULATIONS 3.7  AS/NZS 1657-2013 5.6

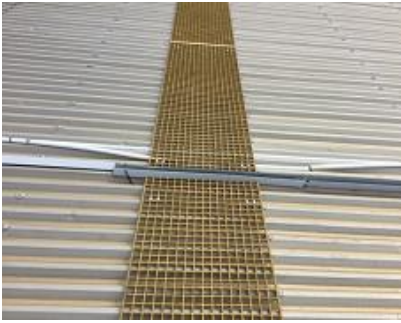
Pipe installed over the walkway path	Trips, Slips and Falls	Awareness induction	Med	Step bridge to be installed	Low	Client advised	Outstanding	OH&S REGULATIONS 3.7  AS/NZS 1657-2013 3.1.4

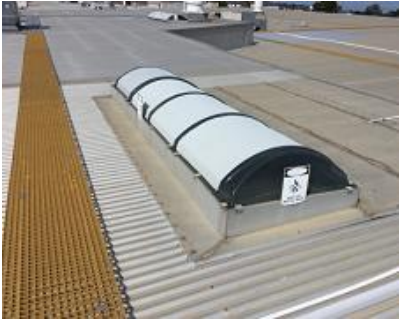
Existing signs are faded	Trips, Slips and Falls	Awareness induction	Med	Existing signs to be replaced with new signs	Low	Client advised	Outstanding	OH&S REGULATIONS 3.11

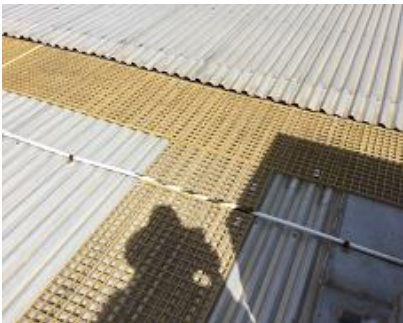
Pipe installed over the walkway path	Trips, Slips and Falls	Awareness induction	Med	Step bridge to be installed	Low	Client advised	Outstanding	OH&S REGULATIONS 3.7  AS/NZS 1657-2013 3.1.4

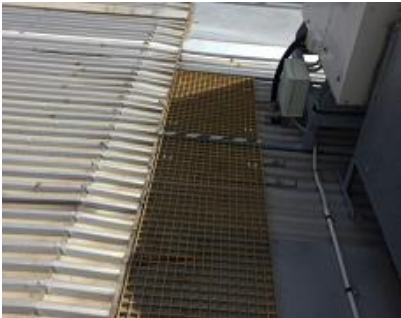
Pipe installed over the walkway path	Trips, Slips and Falls	Awareness induction	Med	Step bridge to be installed	Low	Client advised	Outstanding	OH&S REGULATIONS 3.7  AS/NZS 1657-2013 3.1.4
38	Building: General Stores Location Reference: <a href="#">L14</a> Task: Access to the roof

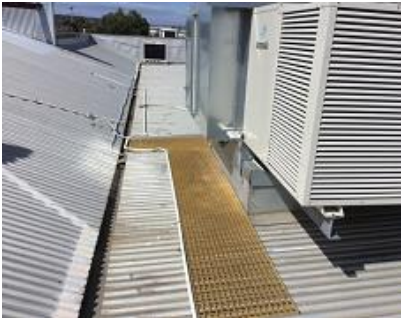
Duct protrudes over the walkway path	Trips, Slips and Falls	Awareness induction	Med	Additional walkway section to be installed	Low	Client advised	Outstanding	OH&S REGULATIONS 3.7  AS/NZS 1657-2013 3.1.4

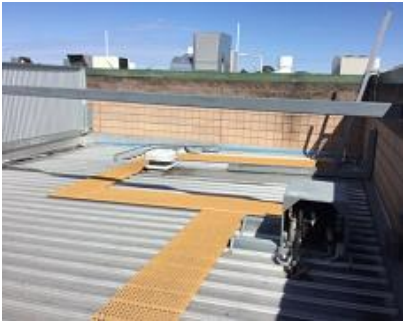
Head room is less than required minimum	Trips, Slips and Falls	Awareness induction	High	"Caution-Low Head Room" signs to be installed	Low	Client advised	Outstanding	OH&S REGULATIONS 3.7  AS/NZS 1657-2013 3.1.5
44	Building: General Stores Location Reference: <a href="#">L16</a> Task: Access to the roof

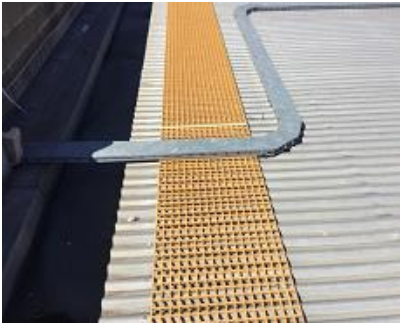
Pipe installed over the walkway path	Trips, Slips and Falls	Awareness induction	Med	Step bridge to be installed	Low	Client advised	Outstanding	OH&S REGULATIONS 3.7  AS/NZS 1657-2013 3.1.4
46	Building: General Stores Location Reference: <a href="#">L17</a> Task: Access to the roof

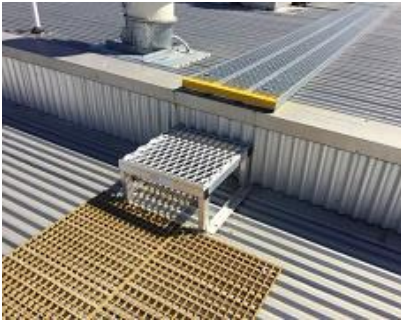
Non-complaint step is present	Trips, Slips and Falls	Awareness induction	Med	Existing step to be removed and new ladder to be installed	Low	Client advised	Outstanding	OH&S REGULATIONS 3.7  AS/NZS 1657-2013 7.2

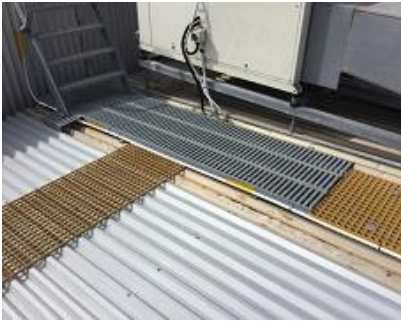
Variation in height between walkway panels are greater than required maximum	Trips, Slips and Falls	Awareness induction	Med	High visibility safety nosing to be installed	Low	Client advised	Outstanding	OH&S REGULATIONS 3.7  AS/NZS 1657-2013 3.3.4

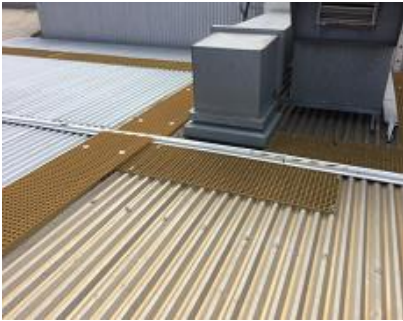
Pipe installed over the walkway path	Trips, Slips and Falls	Awareness induction	Med	Step bridge to be installed	Low	Client advised	Outstanding	OH&S REGULATIONS 3.7  AS/NZS 1657-2013 3.1.4
52	Building: General Stores Location Reference: <a href="#">L19</a> Task: Access to the roof

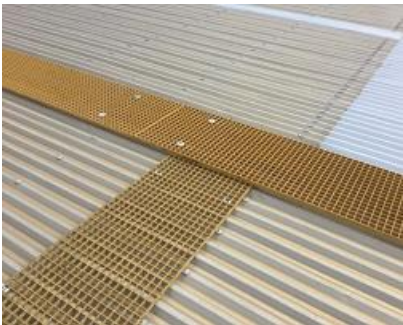
Variation in height between walkway panels are greater than required maximum	Trips, Slips and Falls	Awareness induction	Med	High visibility safety nosing to be installed	Low	Client advised	Outstanding	OH&S REGULATIONS 3.7  AS/NZS 1657-2013 3.3.4

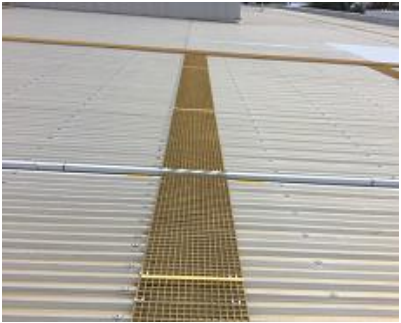
Pipe installed over the walkway path	Trips, Slips and Falls	Awareness induction	Med	Step bridge to be installed	Low	Client advised	Outstanding	OH&S REGULATIONS 3.7  AS/NZS 1657-2013 3.1.4

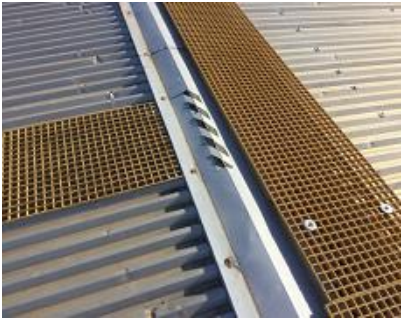
Gap between walkway panels are greater than required maximum	Trips, Slips and Falls	Awareness induction	Med	Additional walkway bridge to be installed	Low	Client advised	Outstanding	OH&S REGULATIONS 3.7  AS/NZS 1657-2013 3.2.3.4
56	Building: General Stores Location Reference: <a href="#">L20</a> Task: Access to the roof

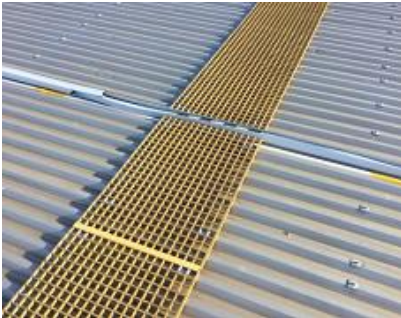
Pipe installed over the walkway path	Trips, Slips and Falls	Awareness induction	Med	Step bridge to be installed	Low	Client advised	Outstanding	OH&S REGULATIONS 3.7  AS/NZS 1657-2013 3.1.4

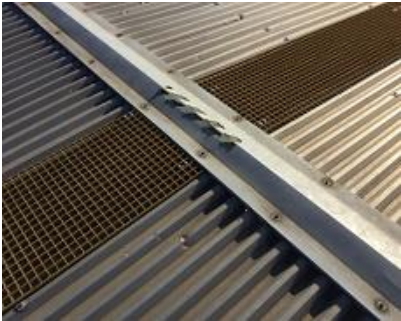
Gap between walkway panels are greater than required maximum	Trips, Slips and Falls	Awareness induction	Med	Additional walkway bridge to be installed	Low	Client advised	Outstanding	OH&S REGULATIONS 3.7  AS/NZS 1657-2013 3.2.3.4
58	Building: General Stores Location Reference: <a href="#">L21</a> Task: Access to the roof

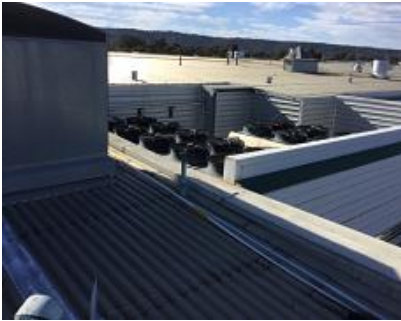
No height safety system installed	Trips, Slips and Falls	Awareness induction	High	Fall arrest anchors to be installed	Low	Client advised	Outstanding	OH&S REGULATIONS 3.55

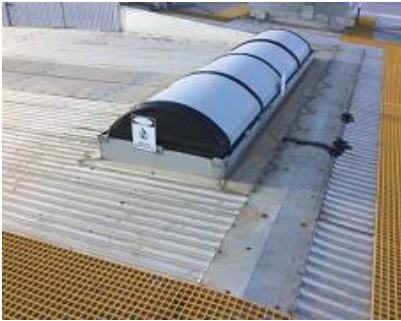
Existing signs are faded	Trips, Slips and Falls	Awareness induction	Med	Existing signs to be replaced with new signs	Low	Client advised	Outsta nding	OH&S REGULATIONS 3.11
66	Building: General Stores Location Reference: <a href="#">L25</a> Task: Restrict access to the roof

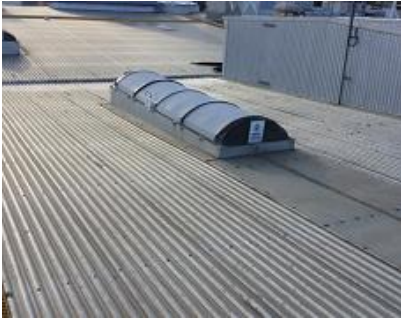
Existing signs are faded	Trips, Slips and Falls	Awareness induction	Med	Existing signs to be replaced with new signs	Low	Client advised	Outsta nding	OH&S REGULATIONS 3.11

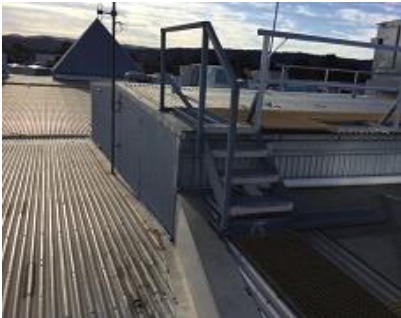
Non-complaint stair is present	Trips, Slips and Falls	Awareness induction	Med	Existing stair to be removed and new ladder to be installed	Low	Client advised	Outsta nding	OH&S REGULATIONS 3.7  AS/NZS 1657- 2013 7.2
68	Building: General Stores Location Reference: <a href="#">L26</a> Task: Access to the roof

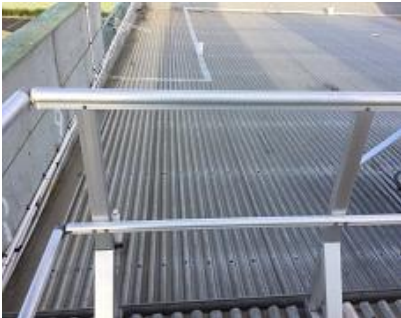
Sharp edges on handrails	Trips, Slips and Falls	Awareness induction	Med	Tek screws to be replaced with rivets	Low	Client advised	Outsta nding	OH&S REGULATIONS 3.7  AS/NZS 1657- 2013 5.6

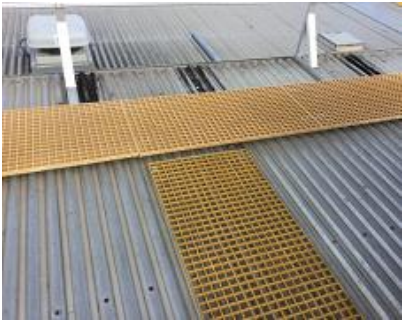
Variation in height between walkway panels are greater than required maximum	Trips, Slips and Falls	Awareness induction	Med	High visibility safety nosing to be installed	Low	Client advised	Outstanding	OH&S REGULATIONS 3.7  AS/NZS 1657-2013 3.3.4
70	Building: General Stores Location Reference: <a href="#">L26</a> Task: Restrict access to the roof

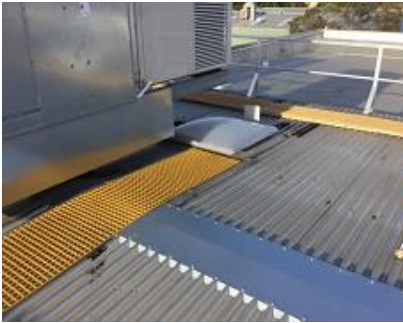
Brittle roof (Non-trafficable roof)	Trips, Slips and Falls	Restrict Access	High	"Warning-Keep Off-Brittle and Fragile Roof" sign to be installed	Low	Client advised	Outstanding	OH&S REGULATIONS 3.57

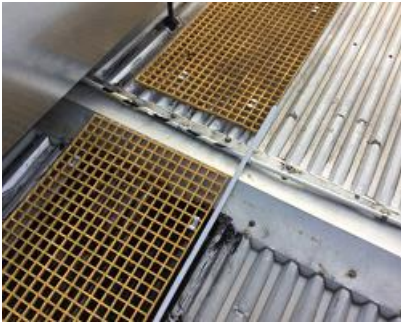
Gap between walkway panels are greater than required maximum	Trips, Slips and Falls	Awareness induction	Med	Additional walkway bridge to be installed	Low	Client advised	Outstanding	OH&S REGULATIONS 3.7  AS/NZS 1657-2013 3.2.3.4

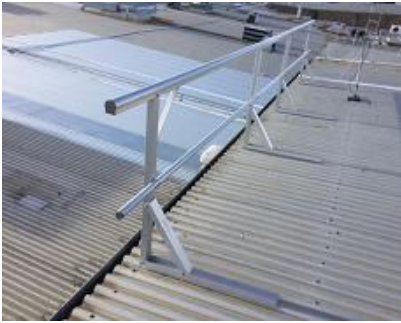
Sharp edges on handrails	Trips, Slips and Falls	Awareness induction	Med	Tek screws to be replaced with rivets	Low	Client advised	Outstanding	OH&S REGULATIONS 3.7  AS/NZS 1657-2013 5.6
74	Building: General Stores Location Reference: <a href="#">L26</a> Task: Access to the roof

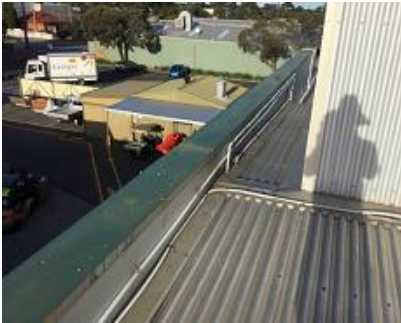
No height safety system installed	Trips, Slips and Falls	Awareness induction	High	Handrail to be installed	Low	Client advised	Outstanding	OH&S REGULATIONS 3.55

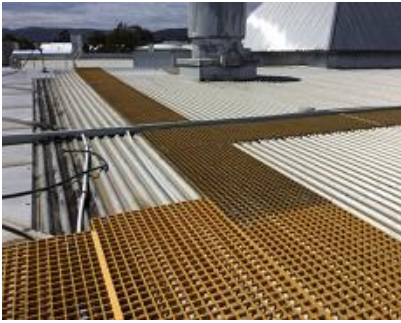
Pipe installed over the walkway path	Trips, Slips and Falls	Awareness induction	Med	Step bridge to be installed	Low	Client advised	Outstanding	OH&S REGULATIONS 3.7  AS/NZS 1657-2013 3.1.4

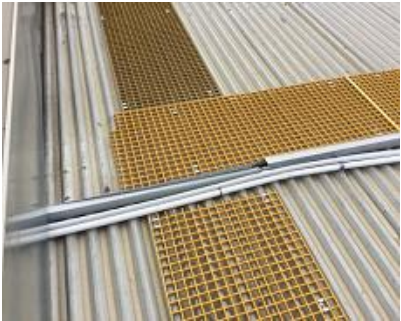
Pipe installed over the walkway path	Trips, Slips and Falls	Awareness induction	Med	Step bridge to be installed	Low	Client advised	Outstanding	OH&S REGULATIONS 3.7  AS/NZS 1657-2013 3.1.4
78	Building: General Stores Location Reference: <a href="#">L28</a> Task: Restrict access to the roof

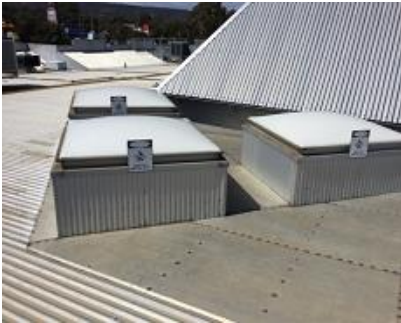
Existing signs are faded	Trips, Slips and Falls	Awareness induction	Med	Existing signs to be replaced with new signs	Low	Client advised	Outstanding	OH&S REGULATIONS 3.11

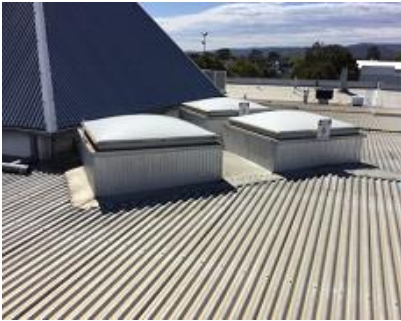
Existing signs are faded	Trips, Slips and Falls	Awareness induction	Med	Existing signs to be replaced with new signs	Low	Client advised	Outstanding	OH&S REGULATIONS 3.11
80	Building: General Stores Location Reference: <a href="#">L28</a> Task: Access to the roof

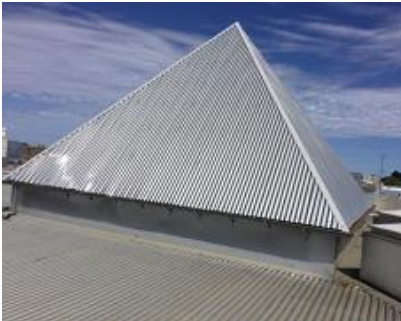
No height safety system installed	Trips, Slips and Falls	Awareness induction	High	"No Access" signs to be installed	Low	Client advised	Outstanding	OH&S REGULATIONS 3.55 & 3.11

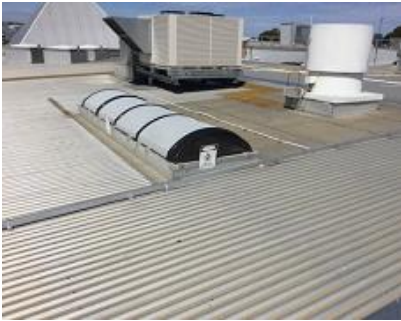
Existing signs are faded	Trips, Slips and Falls	Awareness induction	Med	Existing signs to be replaced with new signs	Low	Client advised	Outstanding	OH&S REGULATIONS 3.11
82	Building: General Stores Location Reference: <a href="#">L29</a> Task: Restrict access to the roof

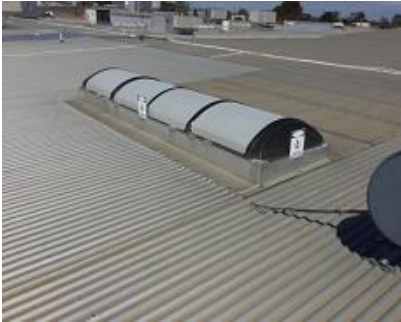
Existing signs are faded	Trips, Slips and Falls	Awareness induction	Med	Existing signs to be replaced with new signs	Low	Client advised	Outstanding	OH&S REGULATIONS 3.11

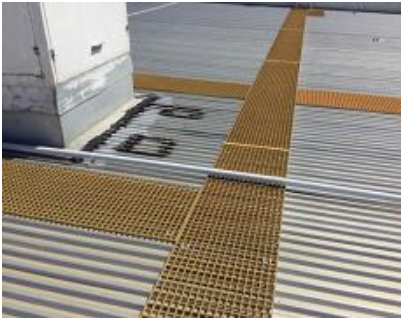
Pipe installed over the walkway path	Trips, Slips and Falls	Awareness induction	Med	Step bridge to be installed	Low	Client advised	Outstanding	OH&S REGULATIONS 3.7  AS/NZS 1657-2013 3.1.4

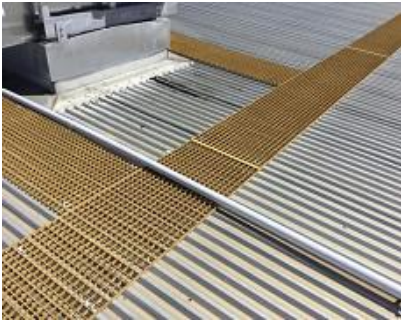
Pipe installed over the walkway path	Trips, Slips and Falls	Awareness induction	Med	Step bridge to be installed	Low	Client advised	Outstanding	OH&S REGULATIONS 3.7  AS/NZS 1657-2013 3.1.4
86	Building: General Stores Location Reference: <a href="#">L30</a> Task: Access to the roof

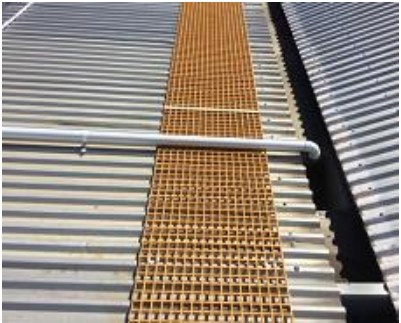
Pipe installed over the walkway path	Trips, Slips and Falls	Awareness induction	Med	Step bridge to be installed	Low	Client advised	Outstanding	OH&S REGULATIONS 3.7  AS/NZS 1657-2013 3.1.4

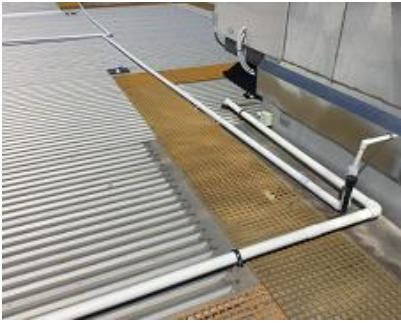
Pipe installed over the walkway path	Trips, Slips and Falls	Awareness induction	Med	Step bridges to be installed	Low	Client advised	Outstanding	OH&S REGULATIONS 3.7  AS/NZS 1657-2013 3.1.4

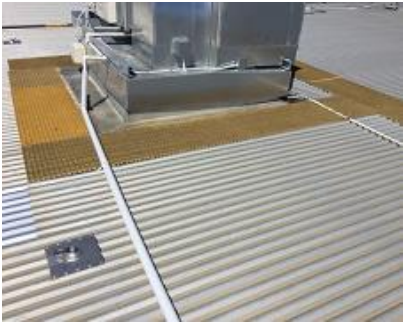
Pipe installed over the walkway path	Trips, Slips and Falls	Awareness induction	Med	Step bridges to be installed	Low	Client advised	Outstanding	OH&S REGULATIONS 3.7  AS/NZS 1657-2013 3.1.4

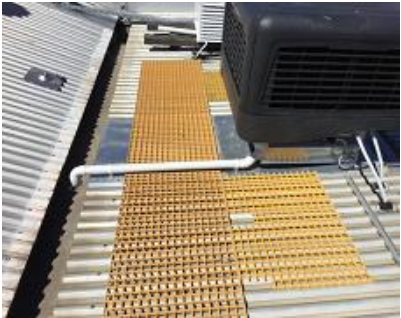
Pipe installed over the walkway path	Trips, Slips and Falls	Awareness induction	Med	Step bridge to be installed	Low	Client advised	Outstanding	OH&S REGULATIONS 3.7  AS/NZS 1657-2013 3.1.4
92	Building: General Stores Location Reference: <a href="#">L31</a> Task: Access to the roof

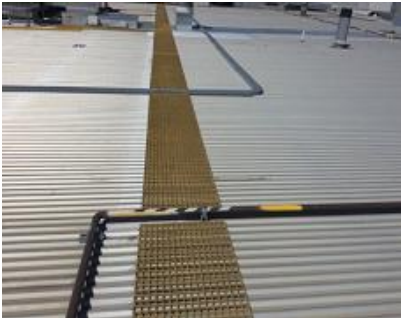
Pipe installed over the walkway path	Trips, Slips and Falls	Awareness induction	Med	Step bridges to be installed	Low	Client advised	Outstanding	OH&S REGULATIONS 3.7  AS/NZS 1657-2013 3.1.4

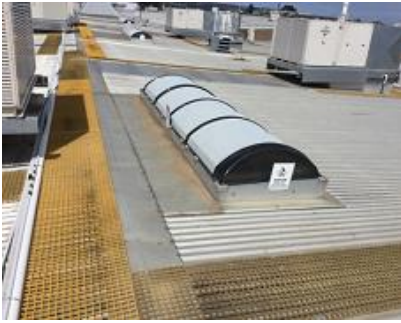
Existing signs are faded	Trips, Slips and Falls	Awareness induction	Med	Existing signs to be replaced with new signs	Low	Client advised	Outstanding	OH&S REGULATIONS 3.11

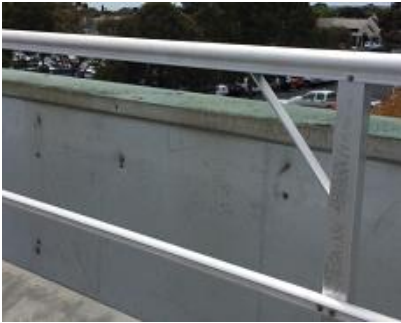
Sharp edges on handrails	Trips, Slips and Falls	Awareness induction	Med	Tek screws to be replaced with rivets	Low	Client advised	Outstanding	OH&S REGULATIONS 3.7  AS/NZS 1657-2013 5.6

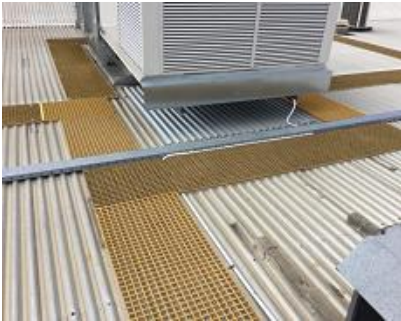
Pipe installed over the walkway path	Trips, Slips and Falls	Awareness induction	Med	Step bridges to be installed	Low	Client advised	Outstanding	OH&S REGULATIONS 3.7  AS/NZS 1657-2013 3.1.4
98	Building: General Stores Location Reference: <a href="#">L34</a> Task: Access to the roof

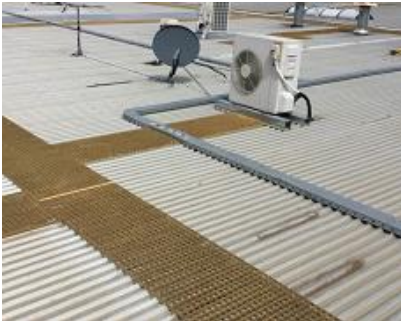
Pipe installed over the walkway path	Trips, Slips and Falls	Awareness induction	Med	Step bridge to be installed	Low	Client advised	Outstanding	OH&S REGULATIONS 3.7  AS/NZS 1657-2013 3.1.4

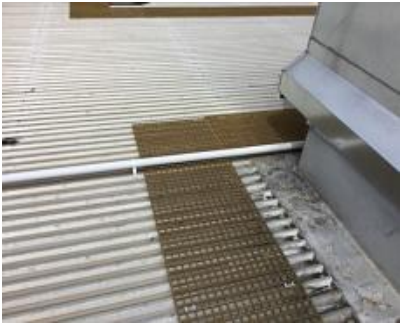
Pipe installed over the walkway path	Trips, Slips and Falls	Awareness induction	Med	Step bridge to be installed	Low	Client advised	Outstanding	OH&S REGULATIONS 3.7  AS/NZS 1657-2013 3.1.4
100	Building: General Stores Location Reference: <a href="#">L34</a> Task: Access to the roof

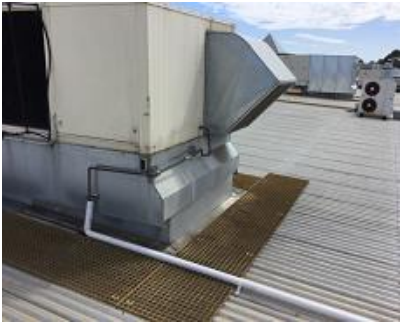
Pipe installed over the walkway path and duct protrudes over the walkway path	Trips, Slips and Falls	Awareness induction	Med	Step bridge and additional walkway section to be installed	Low	Client advised	Outstanding	OH&S REGULATIONS 3.7  AS/NZS 1657-2013 3.1.4

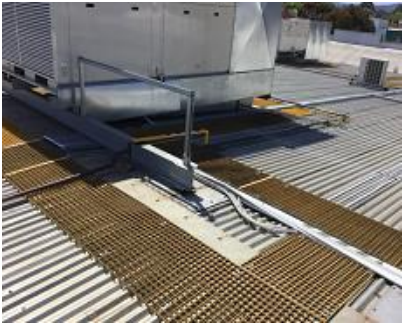
Pipe installed over the walkway path	Trips, Slips and Falls	Awareness induction	Med	Step bridge to be installed	Low	Client advised	Outstanding	OH&S REGULATIONS 3.7  AS/NZS 1657-2013 3.1.4

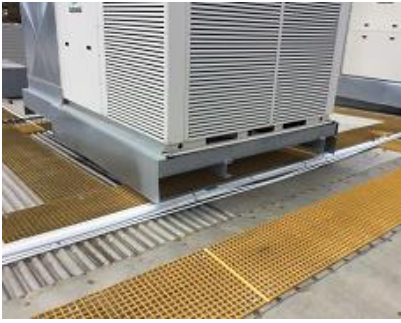
Pipe installed over the walkway path	Trips, Slips and Falls	Awareness induction	Med	Step bridge to be installed	Low	Client advised	Outstanding	OH&S REGULATIONS 3.7  AS/NZS 1657-2013 3.1.4

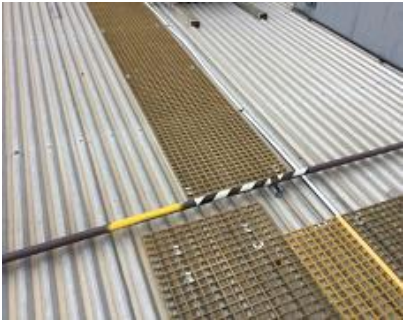
Pipe installed over the walkway path	Trips, Slips and Falls	Awareness induction	Med	Step bridge to be installed	Low	Client advised	Outstanding	OH&S REGULATIONS 3.7  AS/NZS 1657-2013 3.1.4
106	Building: General Stores Location Reference: <a href="#">L34</a> Task: Access to the roof

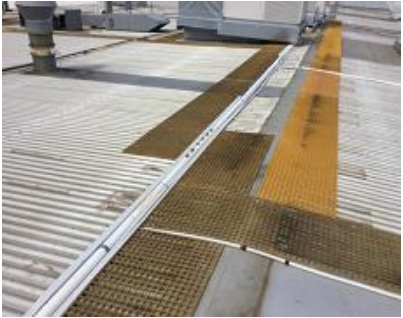
Pipe installed over the walkway path	Trips, Slips and Falls	Awareness induction	Med	Step bridge to be installed	Low	Client advised	Outstanding	OH&S REGULATIONS 3.7  AS/NZS 1657-2013 3.1.4

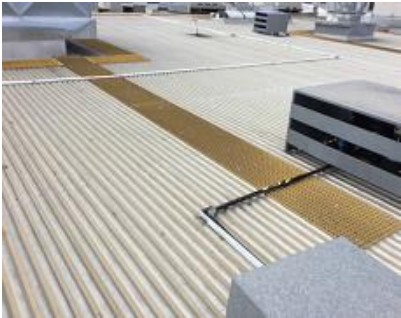
Pipe installed over the walkway path	Trips, Slips and Falls	Awareness induction	Med	Step bridges to be installed	Low	Client advised	Outstanding	OH&S REGULATIONS 3.7  AS/NZS 1657-2013 3.1.4
108	Building: General Stores Location Reference: <a href="#">L35</a> Task: Restrict access to the roof

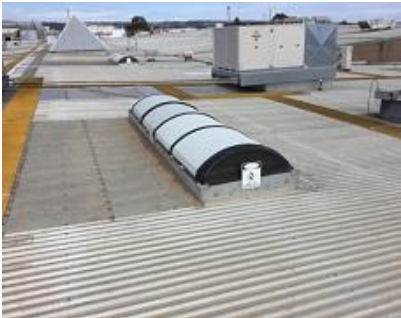
Existing signs are faded	Trips, Slips and Falls	Restrict Access	Med	Existing signs to be replaced with new signs	Low	Client advised	Outstanding	OH&S REGULATIONS 3.11

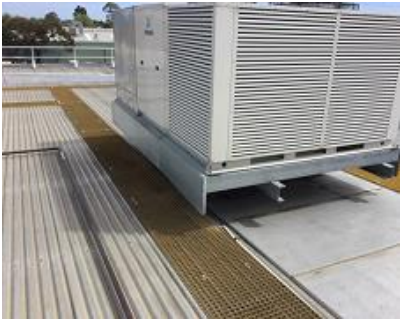
Unit protrudes over the walkway path	Trips, Slips and Falls	Awareness induction	Med	Additional walkway sections to be installed	Low	Client advised	Outstanding	OH&S REGULATIONS 3.7  AS/NZS 1657-2013 5.1.3
110	Building: General Stores Location Reference: <a href="#">L35</a> Task: Access to the roof

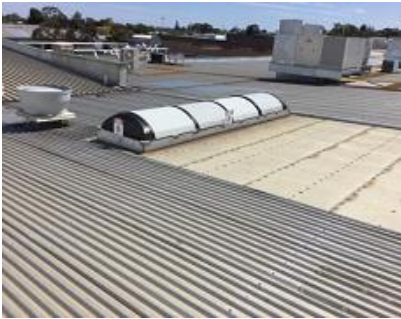
Existing signs are faded	Trips, Slips and Falls	Restrict Access	Med	Existing signs to be replaced with new signs	Low	Client advised	Outstanding	OH&S REGULATIONS 3.11

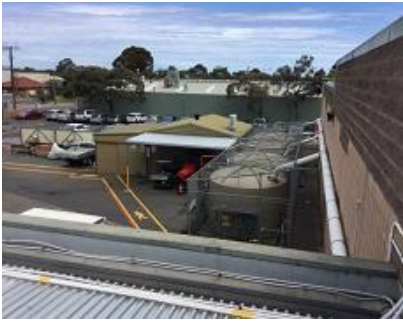
No height safety system installed	Trips, Slips and Falls	Restrict Access	High	"EWP Access Only" signs to be installed	Low	Client advised	Outstanding	OH&S REGULATIONS 3.55 & 3.11
112	Building: General Stores Location Reference: <a href="#">L37</a> Task: Restrict access to the roof

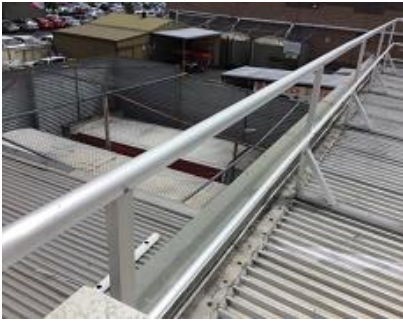
Sharp edges on handrails	Trips, Slips and Falls	Awareness induction	Med	Tek screws to be replaced with rivets	Low	Client advised	Outstanding	OH&S REGULATIONS 3.7  AS/NZS 1657-2013 5.6
114	Building: General Stores Location Reference: <a href="#">L37</a> Task: Access to the roof

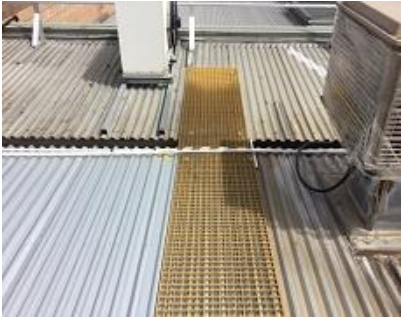
Pipe installed over the walkway path	Trips, Slips and Falls	Awareness induction	Med	Step bridge to be installed	Low	Client advised	Outstanding	OH&S REGULATIONS 3.7  AS/NZS 1657-2013 3.1.4

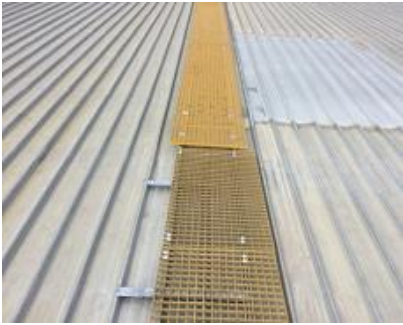
Variation in height between walkway panels are greater than required maximum	Trips, Slips and Falls	Awareness induction	Med	High visibility safety nosing to be installed	Low	Client advised	Outstanding	OH&S REGULATIONS 3.7  AS/NZS 1657-2013 3.3.4
116	Building: General Stores Location Reference: <a href="#">L38</a> Task: Restrict access to the roof

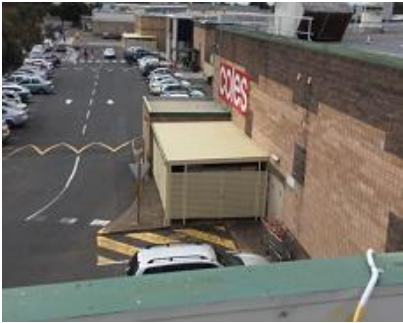
No height safety system installed	Trips, Slips and Falls	Restrict Access	High	"EWP Access Only" signs to be installed	Low	Client advised	Outstanding	OH&S REGULATIONS 3.55 & 3.11

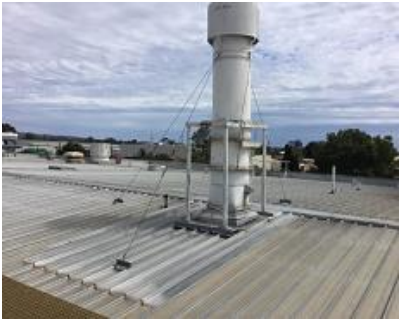
No safe access to the A/c units	Trips, Slips and Falls	N/A	Low	Supply walkway to the A/c units	Low	Client advised	Outstanding	-
118	Building: General Stores Location Reference: <a href="#">L38</a> Task: Access to the A/c units

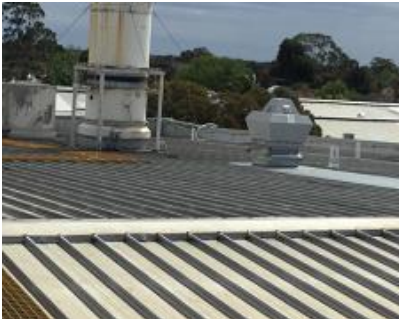
No safe access to the A/c units	Trips, Slips and Falls	N/A	Low	Supply walkway to the A/c units	Low	Client advised	Outstanding	-

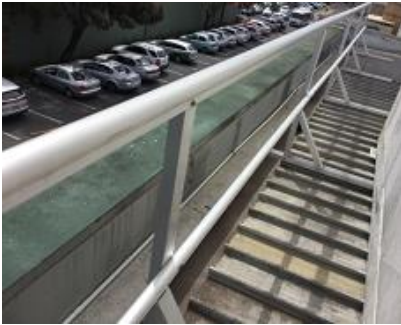
Sharp edges on handrails	Trips, Slips and Falls	Awareness induction	Med	Tek screws to be replaced with rivets	Low	Client advised	Outstanding	OH&S REGULATIONS 3.7  AS/NZS 1657-2013 5.6
120	Building: General Stores Location Reference: <a href="#">L38</a> Task: Access to the roof

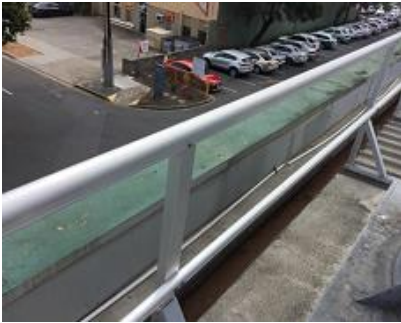
Sharp edges on handrails	Trips, Slips and Falls	Awareness induction	Med	Tek screws to be replaced with rivets	Low	Client advised	Outstanding	OH&S REGULATIONS 3.7  AS/NZS 1657-2013 5.6

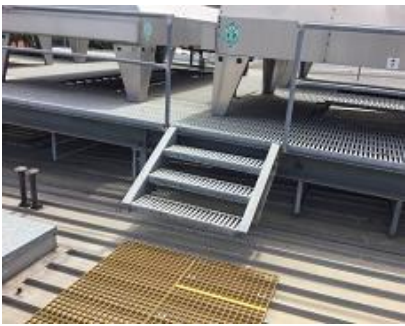
Non-complaint stair is present	Trips, Slips and Falls	Awareness induction	Med	Existing stair to be removed and new ladder to be installed	Low	Client advised	Outstanding	OH&S REGULATIONS 3.7  AS/NZS 1657-2013 7.2
122	Building: General Stores Location Reference: <a href="#">L40</a> Task: Access to the roof

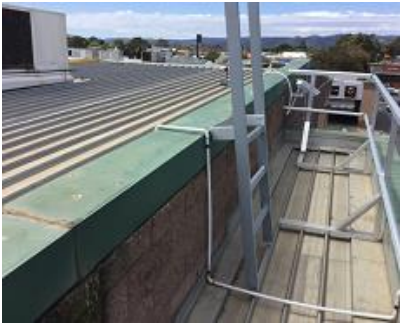
Top rung not levelled with landing and no landing at base	Trips, Slips and Falls	Awareness induction	Med	Existing ladder to be removed and new ladder to be installed	Low	Client advised	Outstanding	OH&S REGULATIONS 3.7  AS/NZS 1657-2013 7.4.3.3 & 7.3.6

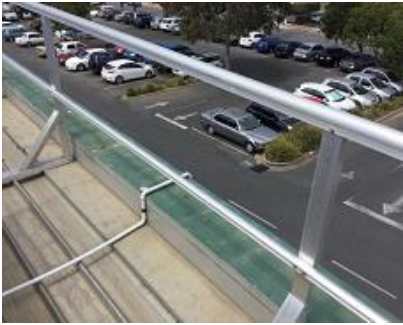
Sharp edges on handrails	Trips, Slips and Falls	Awareness induction	Med	Tek screws to be replaced with rivets	Low	Client advised	Outstanding	OH&S REGULATIONS 3.7  AS/NZS 1657-2013 5.6
124	Building: General Stores Location Reference: <a href="#">L40</a> Task: Access to the roof

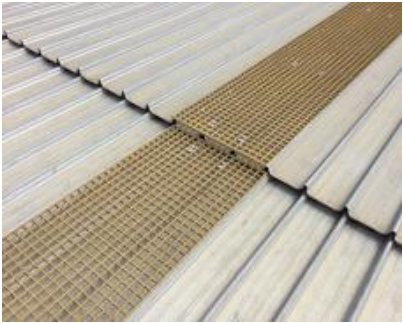
Variation in height between walkway panels are greater than required maximum	Trips, Slips and Falls	Awareness induction	Med	High visibility safety nosing to be installed	Low	Client advised	Outstanding	OH&S REGULATIONS 3.7  AS/NZS 1657-2013 3.3.4

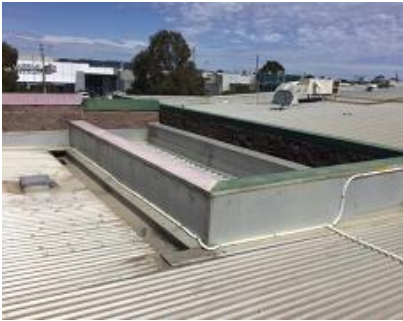
No height safety system installed	Trips, Slips and Falls	Awareness induction	High	Fall arrest anchor to be installed	Low	Client advised	Outstanding	OH&S REGULATIONS 3.55
126	Building: General Stores Location Reference: <a href="#">L41</a> Task: Access to the A/c units

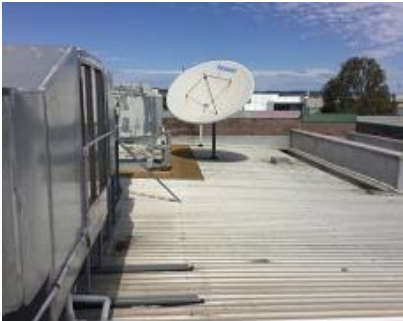
No safe access to the A/c units	Trips, Slips and Falls	N/A	Low	Supply walkway to the A/c units	Low	Client advised	Outstanding	-

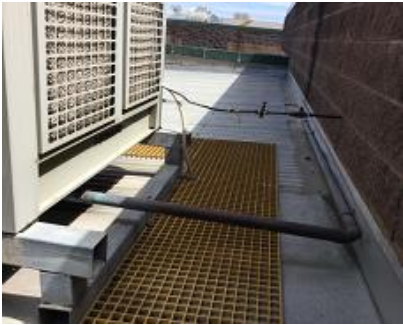
Pipe installed over the walkway path	Trips, Slips and Falls	Awareness induction	Med	Step bridge to be installed	Low	Client advised	Outstanding	OH&S REGULATIONS 3.7  AS/NZS 1657-2013 3.1.4
128	Building: General Stores Location Reference: <a href="#">L42</a> Task: Access to the roof

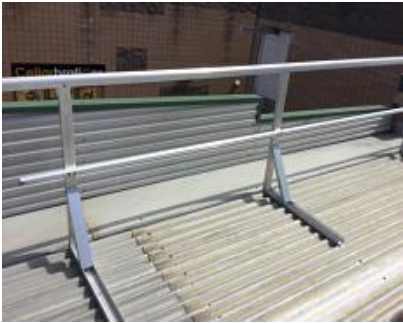
Sharp edges on handrails	Trips, Slips and Falls	Awareness induction	Med	Tek screws to be replaced with rivets	Low	Client advised	Outstanding	OH&S REGULATIONS 3.7  AS/NZS 1657-2013 5.6

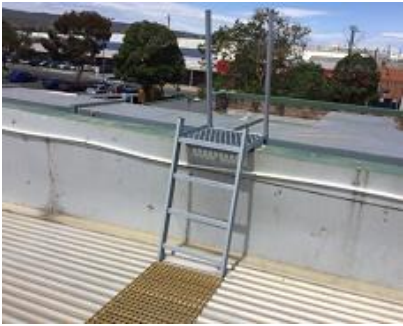
Top rung not levelled with landing and bottom rung height is less than required minimum and handrail is missing for landing	Trips, Slips and Falls	Awareness induction	Med	Existing ladder to be re-installed with landing platforms and handrails	Low	Client advised	Outstanding	OH&S REGULATIONS 3.7  AS/NZS 1657-2013 7.4.3.3, 7.4.3.4 & 4.4
130	Building: General Stores Location Reference: <a href="#">L43</a> Task: Access to the roof

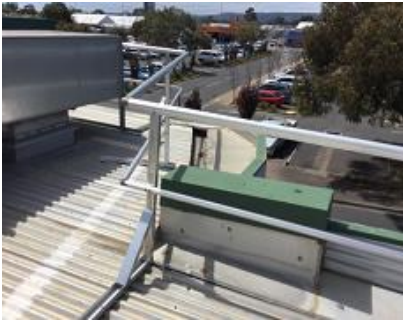
Sharp edges on handrails	Trips, Slips and Falls	Awareness induction	Med	Tek screws to be replaced with rivets	Low	Client advised	Outstanding	OH&S REGULATIONS 3.7  AS/NZS 1657-2013 5.6

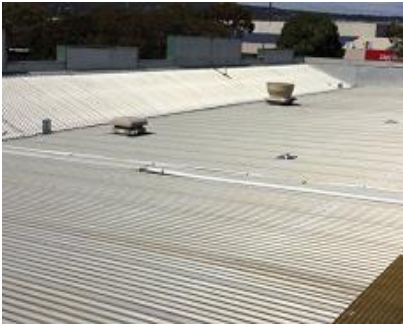
No safe access to the A/c units	Trips, Slips and Falls	N/A	Low	Supply walkway to the A/c units	Low	Client advised	Outstanding	-
132	Building: General Stores Location Reference: <a href="#">L44</a> Task: Access to the A/c units

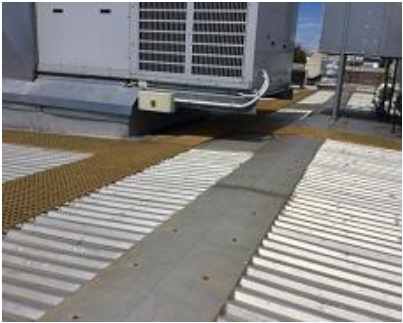
Unit protrudes over the walkway path	Trips, Slips and Falls	Awareness induction	Med	Additional walkway sections to be installed	Low	Client advised	Outstanding	OH&S REGULATIONS 3.7  AS/NZS 1657-2013 3.1.4

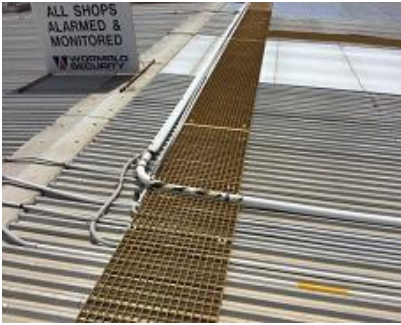
Pipe installed over the walkway path	Trips, Slips and Falls	Awareness induction	Med	Step bridge to be installed	Low	Client advised	Outstanding	OH&S REGULATIONS 3.7  AS/NZS 1657-2013 3.1.4
134	Building: General Stores Location Reference: <a href="#">L44</a> Task: Access to the A/c units

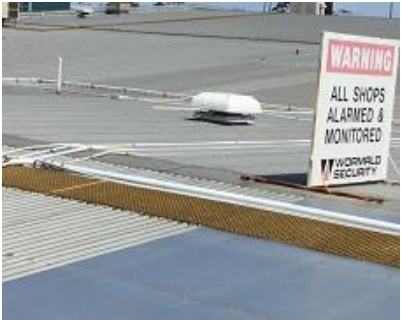
No safe access to the A/c units	Trips, Slips and Falls	N/A	Low	Supply walkway to the A/c units	Low	Client advised	Outstanding	-

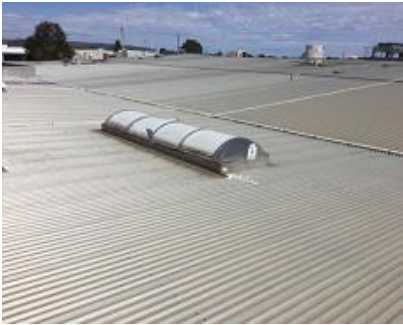
Existing signs are faded	Trips, Slips and Falls	Restrict Access	Med	Existing signs to be replaced with new signs	Low	Client advised	Outstanding	OH&S REGULATIONS 3.11
136	Building: General Stores Location Reference: <a href="#">L44</a> Task: Access to the A/c units

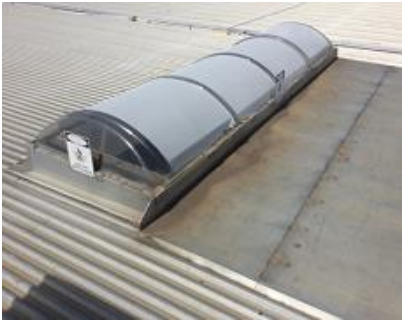
Existing signs are faded	Trips, Slips and Falls	Restrict Access	Med	Existing signs to be replaced with new signs	Low	Client advised	Outstanding	OH&S REGULATIONS 3.11

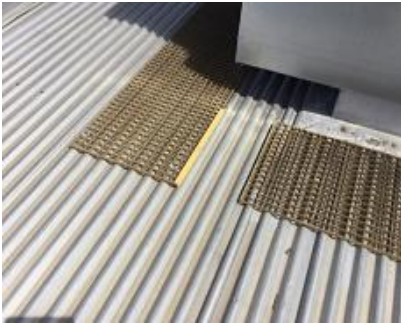
No safe access to the A/c units	Trips, Slips and Falls	N/A	Low	Supply walkway to the A/c units	Low	Client advised	Outstanding	-
140	Building: General Stores Location Reference: <a href="#">L45</a> Task: Access to the roof

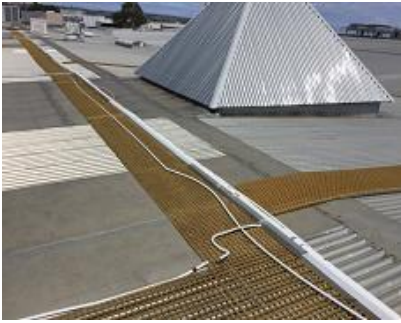
Pipe installed over the walkway path	Trips, Slips and Falls	Awareness induction	Med	Step bridge to be installed	Low	Client advised	Outstanding	OH&S REGULATIONS 3.7  AS/NZS 1657-2013 3.1.4

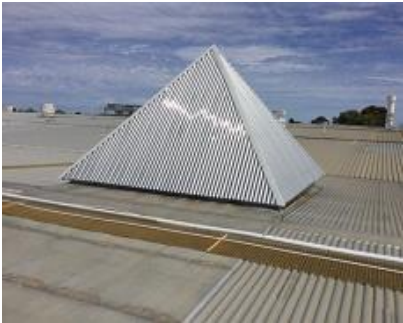
No height safety system installed	Trips, Slips and Falls	Restrict Access	High	"No Access to Roof" signs to be installed	Low	Client advised	Outstanding	OH&S REGULATIONS 3.11
