Roof Safety Report

**Chadstone Shopping Centre,
VIC 3148**

Prepared By: Safemaster Safety Products
Date: 20 April 2018

Roof Safety Report for
Chadstone Shopping Centre, VIC 3148

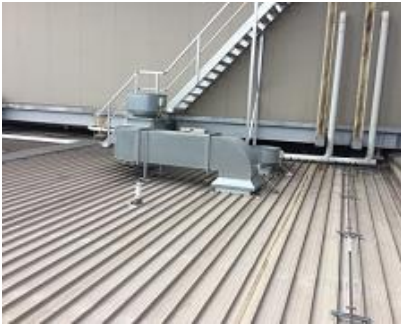
No safe access to the A/c units	Trips, Slips and Falls	N/A	Low	Supply walkway to the A/c units	Low	Client advised	Outstanding	-
02	Building: General Stores Location Reference: L01 Task: Access to the roof

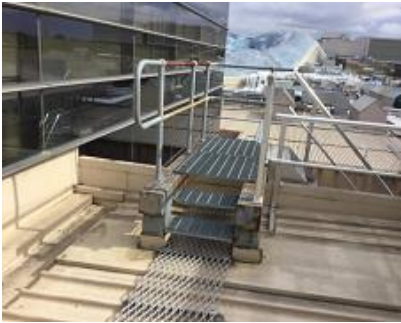
No height safety system installed	Trips, Slips and Falls	Awareness induction	High	Handrail to be installed	Low	Client advised	Outstanding	OH&S REGULATIONS 3.7 & 3.55

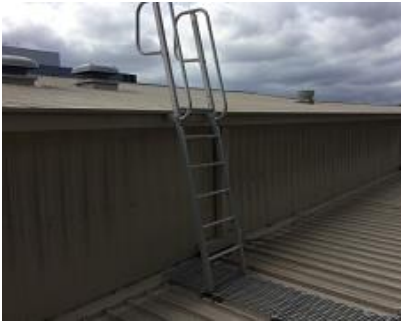
Top rung not levelled with landing and handrail projecting towards the user	Trips, Slips and Falls	Awareness induction	Med	Existing handrail to be removed. Existing ladder to be re-installed with landing platforms, handrails and brackets	Low	Client advised	Outstanding	OH&S REGULATIONS 3.7 AS/NZS 1657-2013 7.4.3.3 & 7.4.8.5
04	Building: General Stores Location Reference: L03 Task: Access to the A/c units

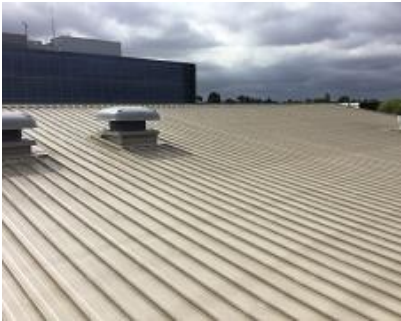
No safe access to the A/c units	Trips, Slips and Falls	N/A	Low	Supply walkway and handrails to the A/c units	Low	Client advised	Outstanding	-

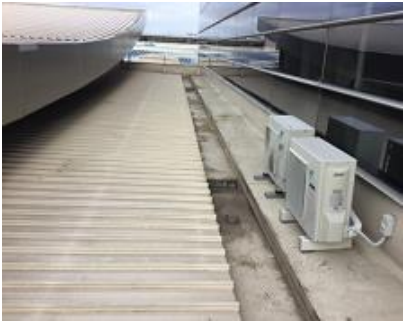
No safe access to the A/c units	Trips, Slips and Falls	N/A	Low	Supply walkway to the A/c units	Low	Client advised	Outstanding	-

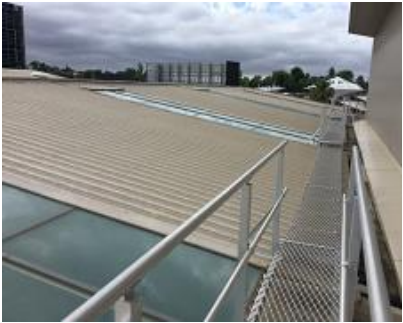
Brittle roof (Non-trafficable roof)	Trips, Slips and Falls	Restrict Access	High	"Warning - Keep Off - Brittle and Fragile Roof" signs to be installed	Low	Client advised	Outstanding	OH&S REGULATIONS 3.57

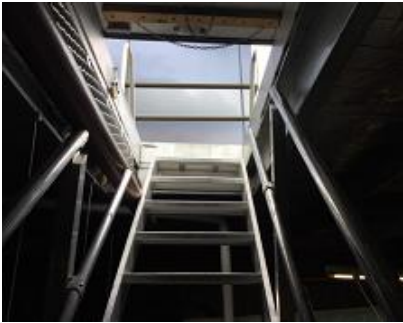
Non-complaint handrail is present	Trips, Slips and Falls	Awareness induction	Med	Existing hatch grabrail to be relocated and fixings to stair handrail to be installed to secure the connections	Low	Client advised	Outstanding	OH&S REGULATIONS 3.7 AS/NZS 1657-2013 4.4

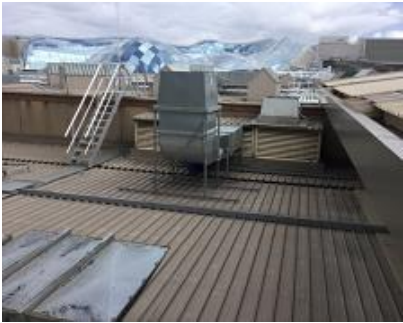
No safe access to the A/c units	Trips, Slips and Falls	N/A	Low	Supply walkway to the A/c units	Low	Client advised	Outstanding	-

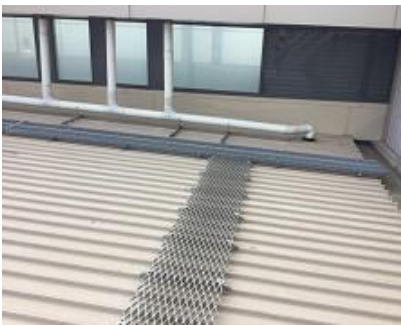
Variation in height between walkway panels are greater than required maximum	Trips, Slips and Falls	Awareness induction	Med	High visibility safety yellow nosing to be installed	Low	Client advised	Outstanding	OH&S REGULATIONS 3.7 AS/NZS 1657-2013 3.3.4
14	Building: General Stores Location Reference: L10 Task: Access to the roof

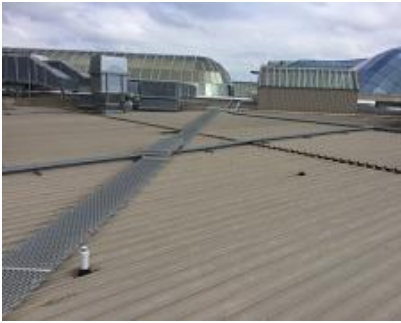
Variation in height between walkway panels are greater than required maximum	Trips, Slips and Falls	Awareness induction	Med	High visibility safety yellow nosing to be installed	Low	Client advised	Outstanding	OH&S REGULATIONS 3.7 AS/NZS 1657-2013 3.3.4

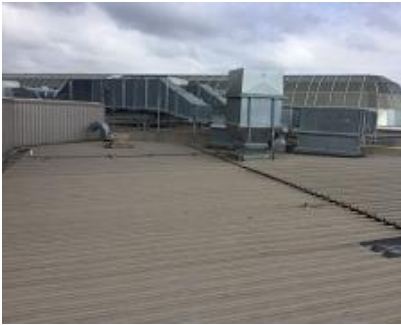
No safe access to the A/c units	Trips, Slips and Falls	N/A	Low	Supply walkway to the A/c units	Low	Client advised	Outstanding	-
16	Building: General Stores Location Reference: L11 Task: Restrict access to the roof

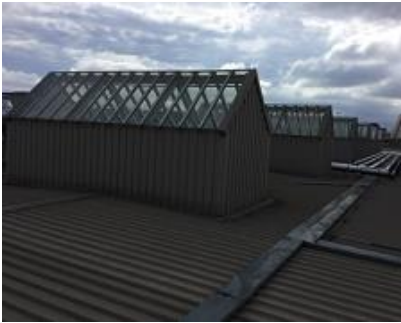
Brittle roof (Non-trafficable roof)	Trips, Slips and Falls	Restrict Access	High	"Warning – Keep Off – Brittle and Fragile Roof" signs to be installed	Low	Client advised	Outstanding	OH&S REGULATIONS 3.57

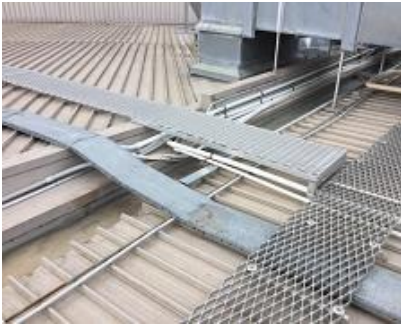
Variation in height between walkway and adjacent surface is greater than required maximum	Trips, Slips and Falls	Awareness induction	Med	Handrail to be installed	Low	Client advised	Outstanding	OH&S REGULATIONS 3.7 AS/NZS 1657-2013 4.4
18	Building: General Stores Location Reference: L12 Task: Access to the roof

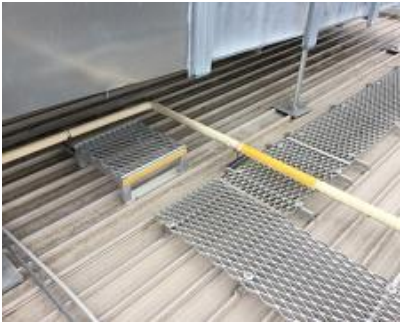
Pipe installed over the walkway path	Trips, Slips and Falls	Awareness induction	Med	Step over to be installed	Low	Client advised	Outstanding	OH&S REGULATIONS 3.7 AS/NZS 1657-2013 3.1.4

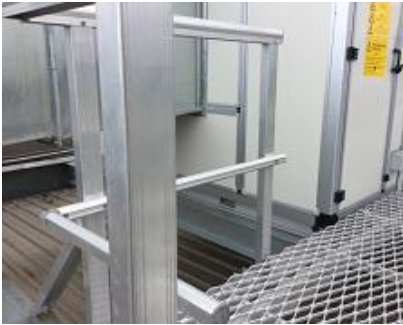
Handrail section is missing	Trips, Slips and Falls	Awareness induction	Med	Handrail to be installed	Low	Client advised	Outsta nding	OH&S REGULATIONS 3.7 AS/NZS 1657- 2013 4.4
20	Building: General Stores Location Reference: L13 Task: Access to the plant deck

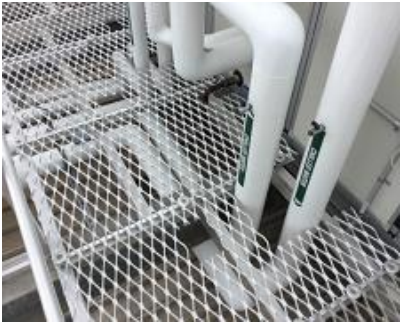
Gap between walkway and unit is greater than required maximum	Trips, Slips and Falls	Awareness induction	Med	Gap to be closed	Low	Client advised	Outsta nding	OH&S REGULATIONS 3.7 AS/NZS 1657- 2013 3.2.3.4

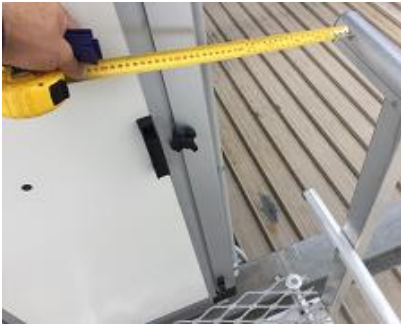
Handrail section is missing	Trips, Slips and Falls	Awareness induction	Med	Handrail to be installed	Low	Client advised	Outstanding	OH&S REGULATIONS 3.7 AS/NZS 1657-2013 4.4
22	Building: General Stores Location Reference: L13 Task: Access to the A/c units

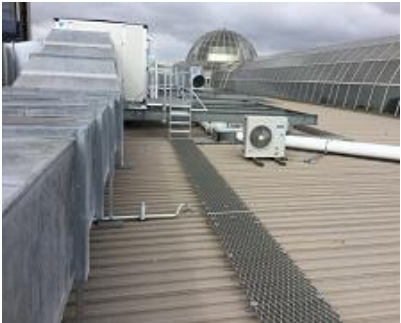
No safe access to the A/c units	Trips, Slips and Falls	N/A	Low	Supply walkway to the A/c units	Low	Client advised	Outstanding	-

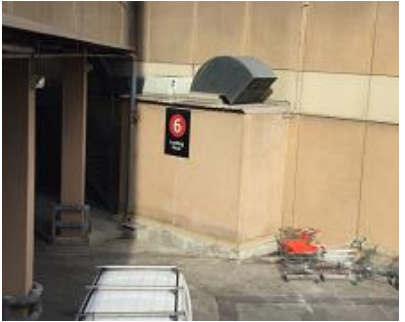
No height safety system installed	Trips, Slips and Falls	Restrict Access	High	"EWP Access to Roof" sign to be installed	Low	Client advised	Outstanding	OH&S REGULATIONS 3.55 & 3.11

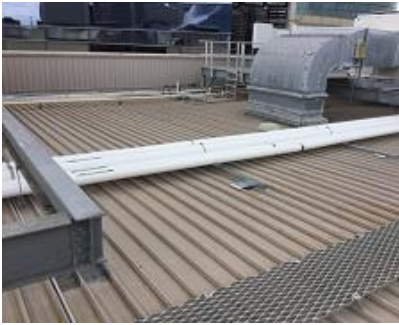
No safe access to the ladder	Trips, Slips and Falls	N/A	Low	Supply walkway and step bridge to the ladder	Low	Client advised	Outstanding	-
26	Building: General Stores Location Reference: L14 Task: Access to the plant deck

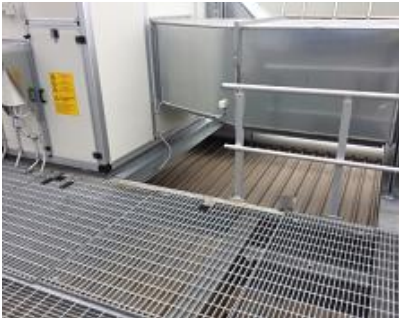
Handrail section is missing	Trips, Slips and Falls	Awareness induction	Med	Handrail to be installed	Low	Client advised	Outstanding	OH&S REGULATIONS 3.7 AS/NZS 1657-2013 4.4

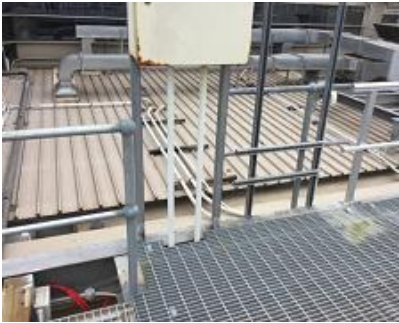
Handrail section is missing	Trips, Slips and Falls	Awareness induction	Med	Handrail to be installed	Low	Client advised	Outsta nding	OH&S REGULATIONS 3.7 AS/NZS 1657- 2013 4.4
28	Building: General Stores Location Reference: L14 Task: Access to the plant deck

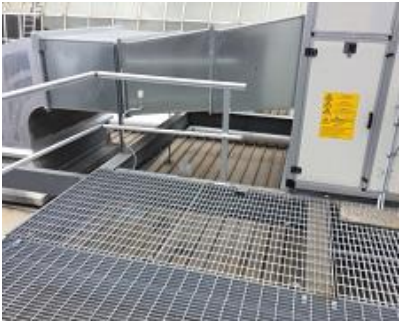
Handrail section is missing	Trips, Slips and Falls	Awareness induction	Med	Handrail to be installed	Low	Client advised	Outsta nding	OH&S REGULATIONS 3.7 AS/NZS 1657- 2013 4.4

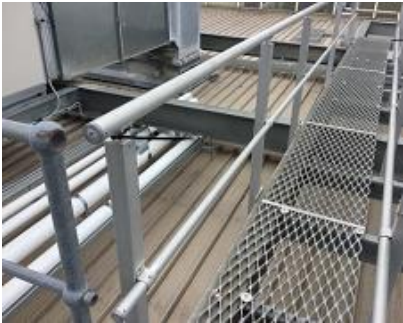
Sharp edges on handrails	Trips, Slips and Falls	Awareness induction	Med	Tek screws to be replaced with rivets	Low	Client advised	Outstanding	OH&S REGULATIONS 3.7 AS/NZS 1657-2013 5.6

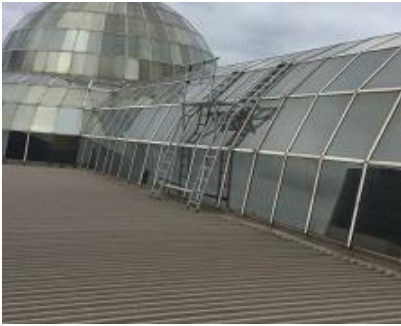
Non-complaint ladders are present	Trips, Slips and Falls	Awareness induction	Med	Further investigation required with Centre Management and Window cleaners to propose permanent solution	Low	Client advised	Outstanding	OH&S REGULATIONS 3.7 AS/NZS 1657-2013 3.1.4
32	Building: General Stores Location Reference: L17 Task: Access to the plant deck

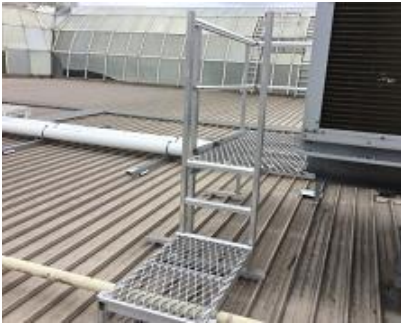
Handrail section is missing	Trips, Slips and Falls	Awareness induction	Med	Handrail to be installed	Low	Client advised	Outstanding	OH&S REGULATIONS 3.7 AS/NZS 1657-2013 4.4

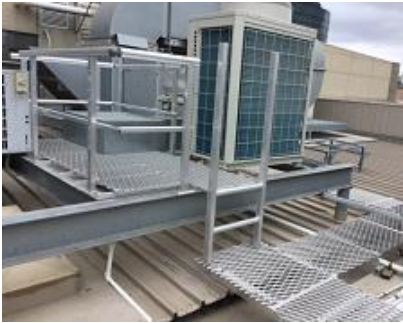
Handrail section is missing	Trips, Slips and Falls	Awareness induction	Med	Handrail to be installed	Low	Client advised	Outstanding	OH&S REGULATIONS 3.7 AS/NZS 1657-2013 4.4

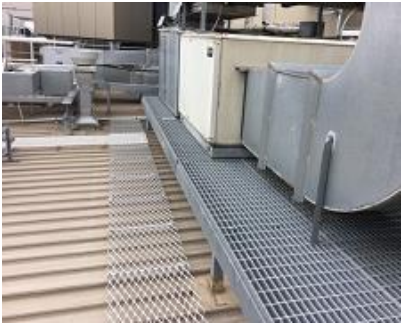
Variation in height between plant deck and roof is greater than required maximum	Trips, Slips and Falls	Awareness induction	Med	Handrails to be installed	Low	Client advised	Outstanding	OH&S REGULATIONS 3.7 AS/NZS 1657-2013 4.4
36	Building: General Stores Location Reference: L19 Task: Access to the roof

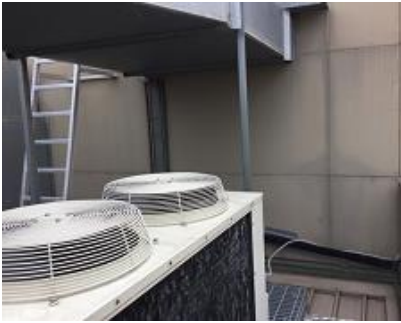
Headroom is less than required minimum	Trips, Slips and Falls	Awareness induction	Med	"Caution low head room" signs to be installed	Low	Client advised	Outstanding	OH&S REGULATIONS 3.7 AS/NZS 1657-2013 3.1.5

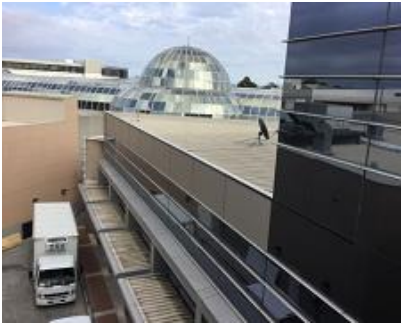
No height safety system installed	Trips, Slips and Falls	Awareness induction	High	Fall arrest anchors to be installed	Low	Client advised	Outstanding	OH&S REGULATIONS 3.55

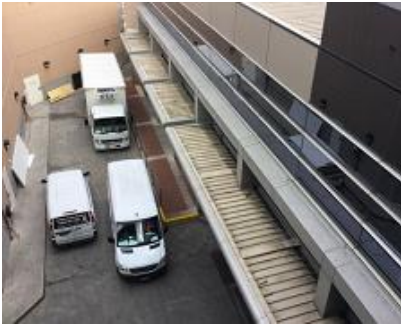
No height safety system installed	Trips, Slips and Falls	Restrict Access	High	"EWP Access to Roof" sign to be installed	Low	Client advised	Outstanding	OH&S REGULATIONS 3.55 & 3.11
40	Building: General Stores Location Reference: L21 Task: Access to the A/c units

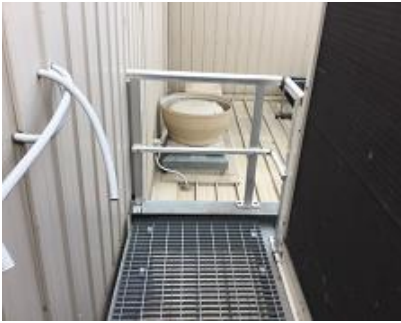
No safe access to the A/c unit	Trips, Slips and Falls	Awareness induction	Med	Existing handrail section to be removed and access ladder and walkway to be installed	Low	Client advised	Outstanding	OH&S REGULATIONS 3.7 AS/NZS 1657-2013 3.1.4

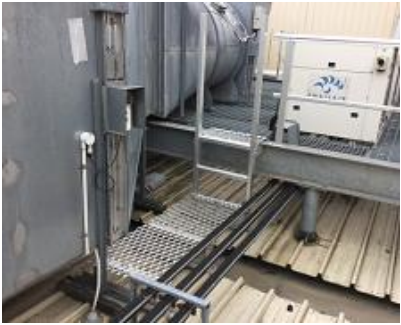
Handrail section is missing	Trips, Slips and Falls	Awareness induction	Med	Handrail to be installed	Low	Client advised	Outsta nding	OH&S REGULATIONS 3.7 AS/NZS 1657- 2013 4.4
42	Building: General Stores Location Reference: L21 Task: Access to the plant deck

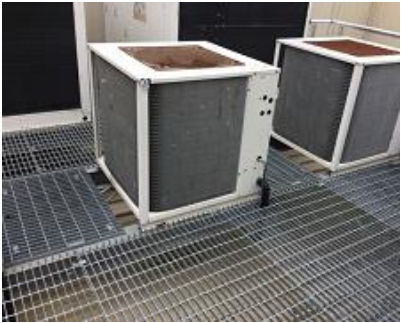
Gap between plant deck and unit is greater than required maximum	Trips, Slips and Falls	Awareness induction	Med	Gap to be closed	Low	Client advised	Outsta nding	OH&S REGULATIONS 3.7 AS/NZS 1657- 2013 4.4

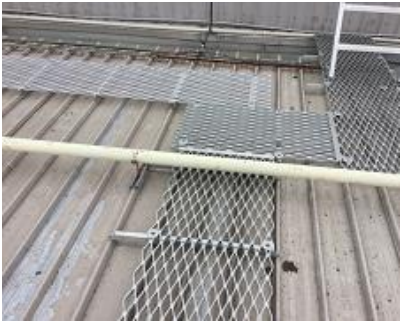
Pipe installed over the walkway path	Trips, Slips and Falls	Awareness induction	Med	Step over to be installed	Low	Client advised	Outsta nding	OH&S REGULATIONS 3.7 AS/NZS 1657- 2013 3.1.4

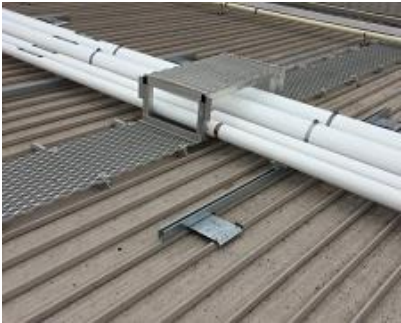
Variation in height between walkway and adjacent surface is greater than required maximum	Trips, Slips and Falls	Awareness induction	Med	Handrail to be installed	Low	Client advised	Outstanding	OH&S REGULATIONS 3.7 AS/NZS 1657-2013 4.4
46	Building: General Stores Location Reference: L23 Task: Access to the roof

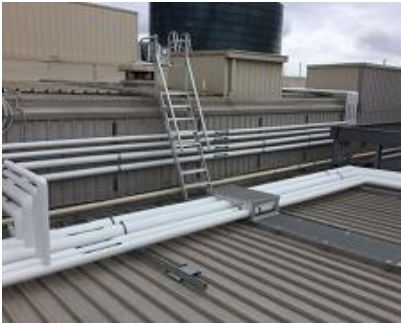
Handrail is projecting towards the user and landing is less than required minimum	Trips, Slips and Falls	Awareness induction	Med	Existing handrail to be removed. Existing ladder to be re-installed landing platforms, handrails and brackets	Low	Client advised	Outstanding	OH&S REGULATIONS 3.7 AS/NZS 1657-2013 7.4.8.5 & 7.3.6

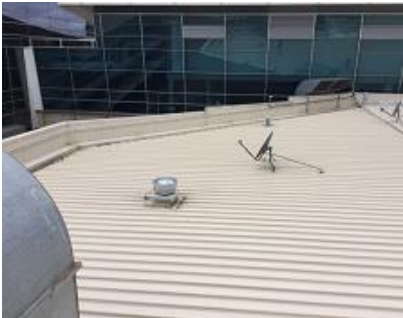
No height safety system installed	Trips, Slips and Falls	Awareness induction	High	Fall arrest anchors to be installed	Low	Client advised	Outstanding	OH&S REGULATIONS 3.55

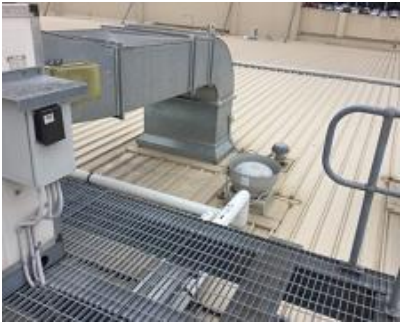
Variation in height between plant deck and roof is greater than required maximum	Trips, Slips and Falls	Awareness induction	Med	Handrail to be installed	Low	Client advised	Outstanding	OH&S REGULATIONS 3.7 AS/NZS 1657-2013 4.4

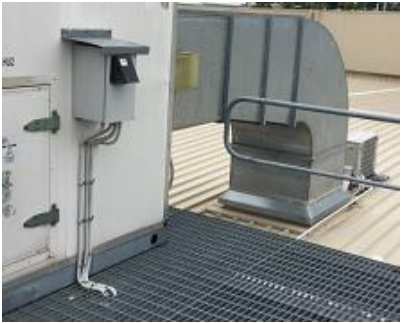
Variation in height between plant deck and roof is greater than required maximum	Trips, Slips and Falls	Awareness induction	Med	Handrail to be installed	Low	Client advised	Outstanding	OH&S REGULATIONS 3.7 AS/NZS 1657-2013 4.4
52	Building: General Stores Location Reference: L26 Task: Access to the plant deck

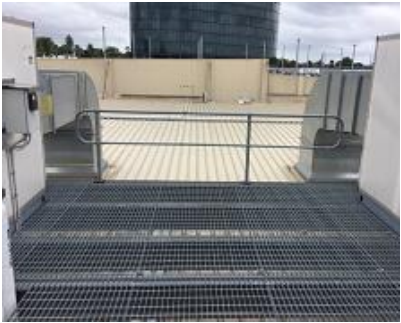
Variation in height between plant deck and roof is greater than required maximum	Trips, Slips and Falls	Awareness induction	Med	Handrail to be installed	Low	Client advised	Outstanding	OH&S REGULATIONS 3.7 AS/NZS 1657-2013 4.4

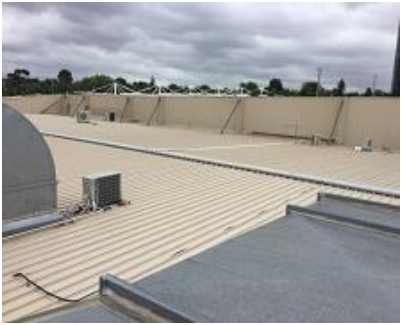
No safe access to the A/c units	Trips, Slips and Falls	N/A	Low	Supply walkway to the A/c units	Low	Client advised	Outstanding	-
54	Building: General Stores Location Reference: L27 Task: Restrict access to the roof

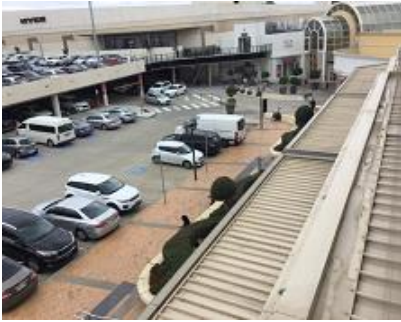
No height safety system installed	Trips, Slips and Falls	Restrict Access	High	"EWP Access to Roof" sign to be installed	Low	Client advised	Outstanding	OH&S REGULATIONS 3.55 & 3.11

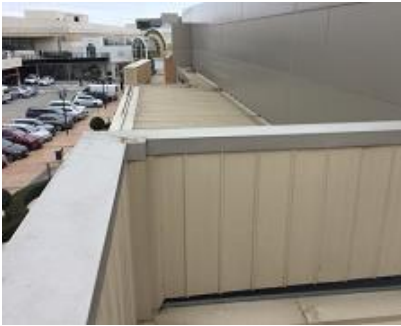
No height safety system installed	Trips, Slips and Falls	Awareness induction	High	Fall arrest anchors, Anchor strop, Ladder access bracket, access ladder and sign to be installed	Low	Client advised	Outstanding	OH&S REGULATIONS 3.55
56	Building: General Stores Location Reference: L28 Task: Access to the roof

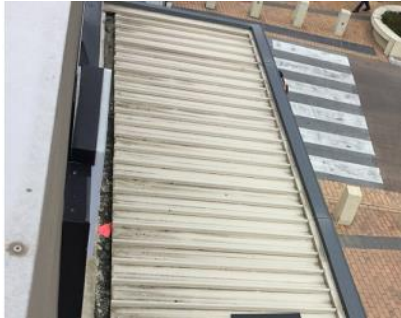
No height safety system installed	Trips, Slips and Falls	Awareness induction	High	Fall arrest anchors, Anchor strop, Ladder access bracket and sign to be installed	Low	Client advised	Outstanding	OH&S REGULATIONS 3.55

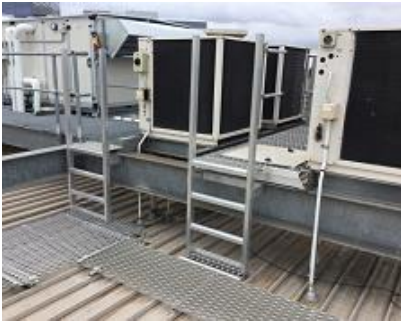
Landing is less than required minimum	Trips, Slips and Falls	Awareness induction	Med	Additional walkway section to be installed	Low	Client advised	Outstanding	OH&S REGULATIONS 3.7 AS/NZS 1657-2013 7.3.6

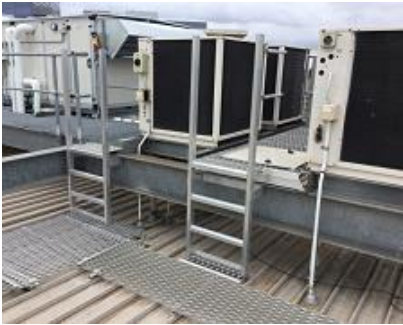
Variation in height between plant deck and roof is greater than required maximum	Trips, Slips and Falls	Awareness induction	Med	Handrail to be installed	Low	Client advised	Outstanding	OH&S REGULATIONS 3.7 AS/NZS 1657-2013 4.4
60	Building: General Stores Location Reference: L29 Task: Access to the plant deck

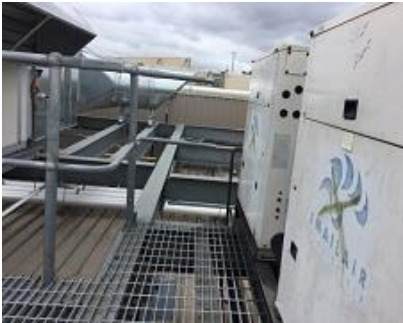
Variation in height between plant deck and roof is greater than required maximum	Trips, Slips and Falls	Awareness induction	Med	Handrail to be installed	Low	Client advised	Outstanding	OH&S REGULATIONS 3.7 AS/NZS 1657-2013 4.4

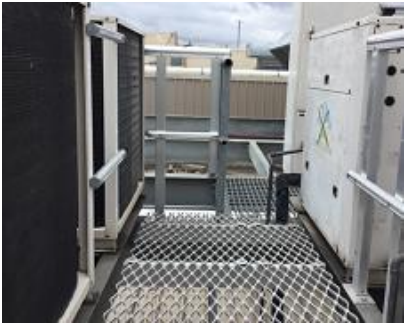
Variation in height between plant deck and roof is greater than required maximum	Trips, Slips and Falls	Awareness induction	Med	Handrail to be installed	Low	Client advised	Outstanding	OH&S REGULATIONS 3.7 AS/NZS 1657-2013 4.4
62	Building: General Stores Location Reference: L30 Task: Access to the roof

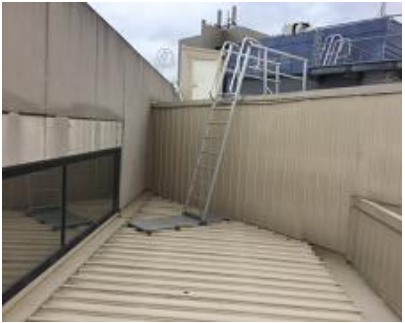
Bottom rung height is less than required minimum and gap between top rung and landing is greater than required maximum and handrail projecting towards the user	Trips, Slips and Falls	Awareness induction	Med	Existing handrail to be removed. Existing ladder to be re-installed with landing platforms, brackets and handrails	Low	Client advised	Outstanding	OH&S REGULATIONS 3.7 AS/NZS 1657-2013 7.4.3.4, 7.4.8.4 & 7.4.8.5

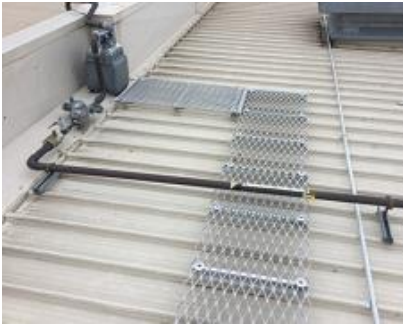
Pipe installed over the walkway path	Trips, Slips and Falls	Awareness induction	Med	Step bridge to be installed	Low	Client advised	Outstanding	OH&S REGULATIONS 3.7 AS/NZS 1657-2013 3.1.4
64	Building: General Stores Location Reference: L31 Task: Access to the A/c units

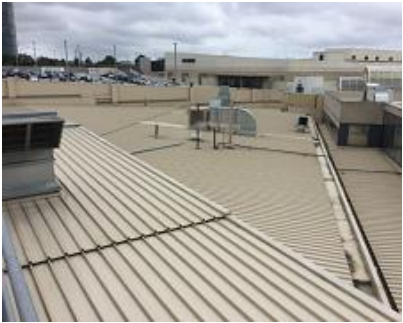
No safe access to the A/c units	Trips, Slips and Falls	N/A	Low	Supply walkway and step bridge to the A/c units	Low	Client advised	Outstanding	-

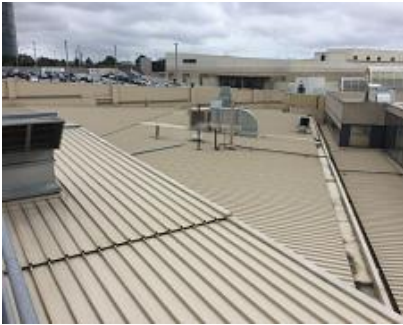
No height safety system installed	Trips, Slips and Falls	Awareness induction	High	Fall arrest anchors to be installed	Low	Client advised	Outstanding	OH&S REGULATIONS 3.55
66	Building: General Stores Location Reference: L31 Task: Access to the A/c units

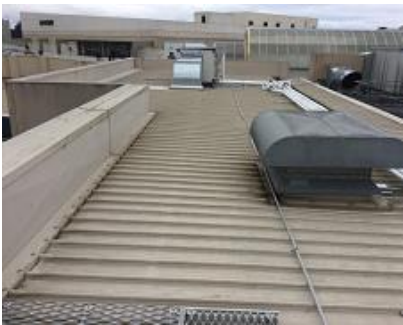
No safe access to the A/c units	Trips, Slips and Falls	N/A	Low	Supply walkway and step bridges to the A/c units	Low	Client advised	Outstanding	-

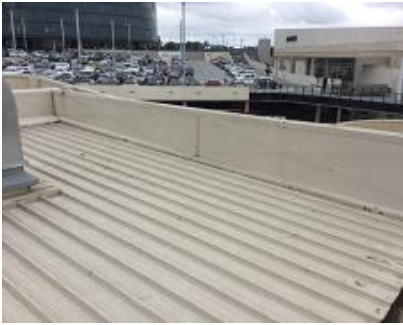
No height safety system installed	Trips, Slips and Falls	Awareness induction	High	Fall arrest anchors to be installed	Low	Client advised	Outstanding	OH&S REGULATIONS 3.55
68	Building: General Stores Location Reference: L32 Task: Access to the roof

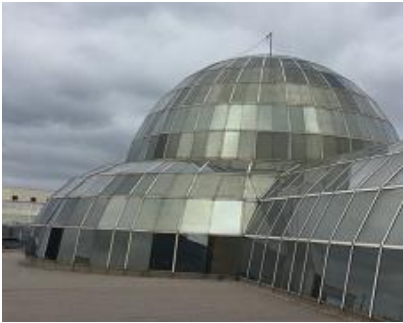
Non-certifiable anchor is present	Trips, Slips and Falls	Awareness induction	High	Further investigation required with Centre Management and Window cleaners to propose permanent solution	Low	Client advised	Outstanding	OH&S REGULATIONS 3.55

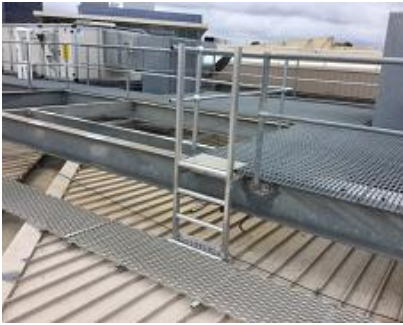
No	Photo of Hazard	Details of Hazard	Details of Risk	Existing/ Immediate Control Measure	Curre nt Risk Level	Proposed Permanent Solution	Resid ual Risk Asse sme nt	Details of Action Taken	Status	Reference
69	Building: General Stores Location Reference: L33 Task: Access to the plant deck

Landing is less than required minimum	Trips, Slips and Falls	Awareness induction	Med	Additional walkway section to be installed	Low	Client advised	Outstanding	OH&S REGULATIONS 3.7 AS/NZS 1657-2013 7.3.6
70	Building: General Stores Location Reference: L33 Task: Access to the plant deck

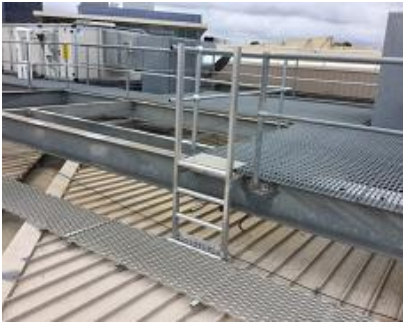
Variation in height between plant deck and roof is greater than required maximum	Trips, Slips and Falls	Awareness induction	Med	Handrail to be installed	Low	Client advised	Outstanding	OH&S REGULATIONS 3.7 AS/NZS 1657-2013 4.4

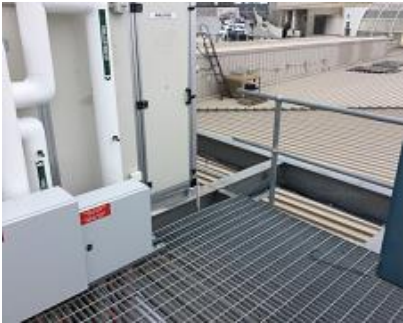
No	Photo of Hazard	Details of Hazard	Details of Risk	Existing/ Immediate Control Measure	Curre nt Risk Level	Proposed Permanent Solution	Resid ual Risk Asse sme nt	Details of Action Taken	Status	Reference
71	Building: General Stores Location Reference: L33 Task: Access to the plant deck

Variation in height between plant deck and roof is greater than required maximum	Trips, Slips and Falls	Awareness induction	Med	Gap to be filled and Handrail to be installed	Low	Client advised	Outstanding	OH&S REGULATIONS 3.7 AS/NZS 1657-2013 4.4
72	Building: General Stores Location Reference: L34 Task: Access to the roof

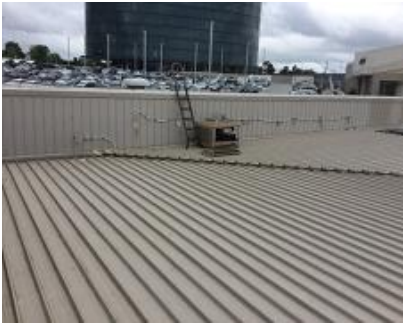
Non-complaint ladder is present	Trips, Slips and Falls	Awareness induction	Med	Existing ladder to be removed and new ladder to be installed	Low	Client advised	Outstanding	OH&S REGULATIONS 3.7 AS/NZS 1657-2013 7.4

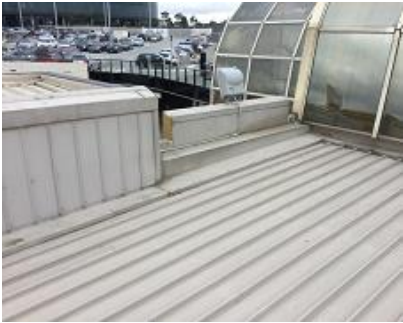
No height safety system installed	Trips, Slips and Falls	Awareness induction	High	Fall arrest anchors to be installed	Low	Client advised	Outstanding	OH&S REGULATIONS 3.55

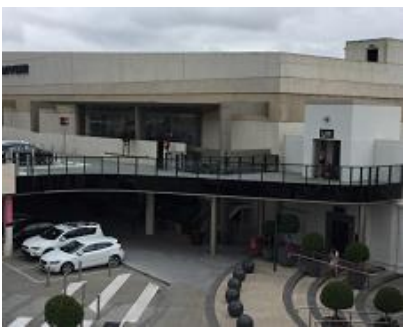
No height safety system installed	Trips, Slips and Falls	Awareness induction	High	Fall arrest anchors, Anchor strops, Ladder access brackets and signs to be installed	Low	Client advised	Outstanding	OH&S REGULATIONS 3.55

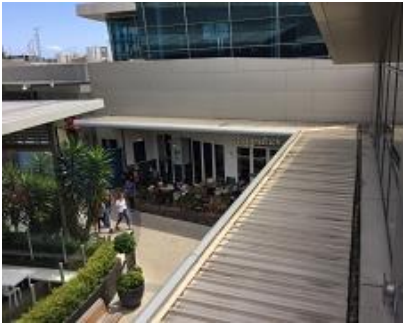
No	Photo of Hazard	Details of Hazard	Details of Risk	Existing/ Immediate Control Measure	Curre nt Risk Level	Proposed Permanent Solution	Resid ual Risk Asse sme nt	Details of Action Taken	Status	Reference
77	Building: General Stores Location Reference: L36 Task: Access to the roof

No height safety system installed	Trips, Slips and Falls	Awareness induction	High	Fall arrest anchors, Anchor stop, Ladder access bracket and sign to be installed	Low	Client advised	Outstanding	OH&S REGULATIONS 3.55
78	Building: General Stores Location Reference: L37 Task: Restrict access to the roof

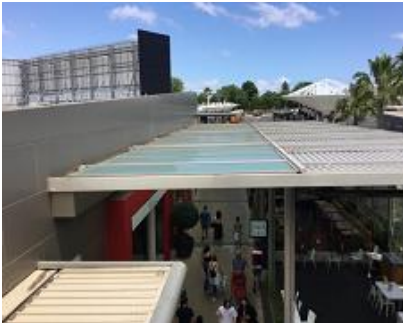
No height safety system installed and Brittle roof (Non-trafficable roof)	Trips, Slips and Falls	Restrict Access	High	"EWP Access to Roof" and "Warning-Keep Off-Brittle and Fragile Roof" signs to be installed	Low	Client advised	Outstanding	OH&S REGULATIONS 3.55, 3.57 & 3.11

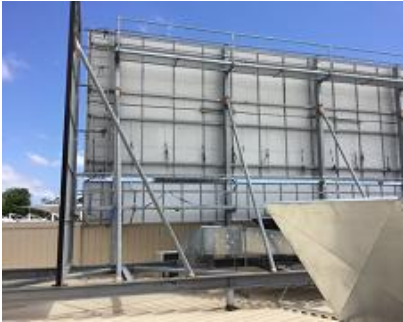
No slip resistance on rungs and fall arrest static line is missing and gap between ladder and landing is greater than required maximum	Trips, Slips and Falls	Awareness induction	Med	Existing ladder to be removed and new ladder including self-closing gate to be installed	Low	Client advised	Outstanding	OH&S REGULATIONS 3.7 AS/NZS 1657-2013 7.4.3.1 & 7.4.8.2

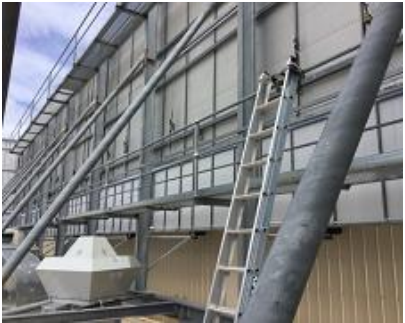
Gate is missing for safe access	Trips, Slips and Falls	Awareness induction	Med	Self-closing gate to be installed	Low	Client advised	Outstanding	OH&S REGULATIONS 3.7 AS/NZS 1657-2013 4.4

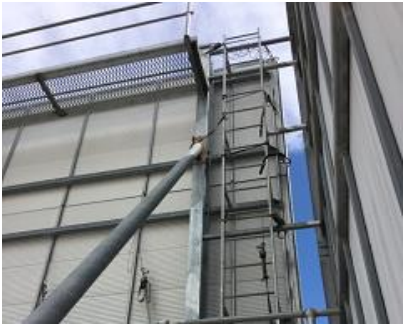
No	Photo of Hazard	Details of Hazard	Details of Risk	Existing/ Immediate Control Measure	Curre nt Risk Level	Proposed Permanent Solution	Resid ual Risk Asse sme nt	Details of Action Taken	Status	Reference
83	Building: General Stores Location Reference: L38 Task: Access to the roof

No slip resistance on rungs and fall arrest static line is missing and gap between ladder and landing is greater than required maximum	Trips, Slips and Falls	Awareness induction	Med	Existing ladder to be removed and new ladder including self-closing gate to be installed	Low	Client advised	Outstanding	OH&S REGULATIONS 3.7 AS/NZS 1657-2013 7.4.3.1 & 7.4.8.2
84	Building: General Stores Location Reference: L39 Task: Access to the roof

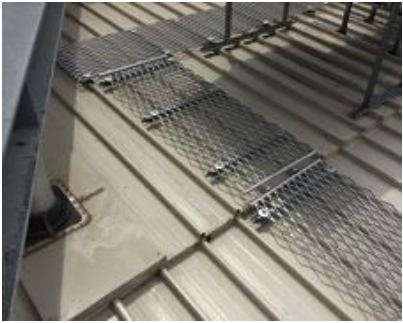
Variation in height between walkway panels are greater than required maximum	Trips, Slips and Falls	Awareness induction	Med	High visibility safety yellow nosing's to be installed	Low	Client advised	Outstanding	OH&S REGULATIONS 3.7 AS/NZS 1657-2013 3.3.4

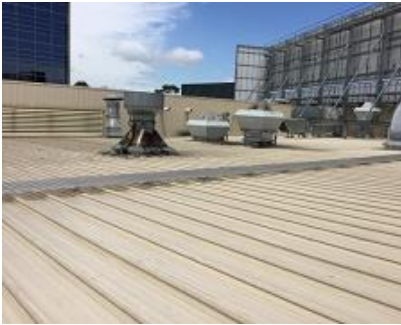
No	Photo of Hazard	Details of Hazard	Details of Risk	Existing/ Immediate Control Measure	Curre nt Risk Level	Proposed Permanent Solution	Resid ual Risk Asse sme nt	Details of Action Taken	Status	Reference
85	Building: General Stores Location Reference: L39 Task: Access to the A/c units

No safe access to the A/c units	Trips, Slips and Falls	N/A	Low	Supply walkway to the A/c units	Low	Client advised	Outstanding	-
86	Building: General Stores Location Reference: L39 Task: Access to the roof

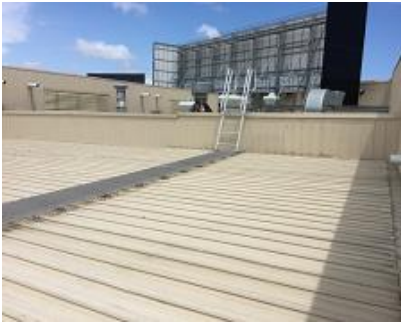
Bottom rung height is less than required minimum, gap between top rung and landing is greater than required maximum and handrail projecting towards the user	Trips, Slips and Falls	Awareness induction	Med	Existing handrail to be removed. Existing ladder to be re-installed with landing platforms, brackets and handrail	Low	Client advised	Outstanding	OH&S REGULATIONS 3.7 AS/NZS 1657-2013 7.4.3.4, 7.4.8.4 & 7.4.8.5

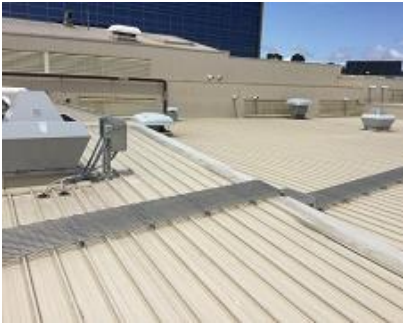
No	Photo of Hazard	Details of Hazard	Details of Risk	Existing/ Immediate Control Measure	Curre nt Risk Level	Proposed Permanent Solution	Resid ual Risk Asse sme nt	Details of Action Taken	Status	Reference
87	Building: General Stores Location Reference: L40 Task: Access to the roof

Variation in height between walkway and adjacent surface is greater than required maximum	Trips, Slips and Falls	Awareness induction	Med	Handrail to be installed	Low	Client advised	Outstanding	OH&S REGULATIONS 3.7 AS/NZS 1657-2013 4.4
88	Building: General Stores Location Reference: L40 Task: Access to the A/c units

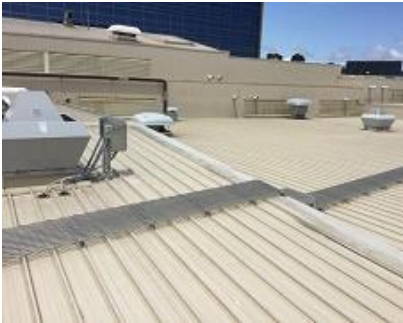
No safe access to the A/c units	Trips, Slips and Falls	N/A	Low	Supply walkway to the A/c units	Low	Client advised	Outstanding	-

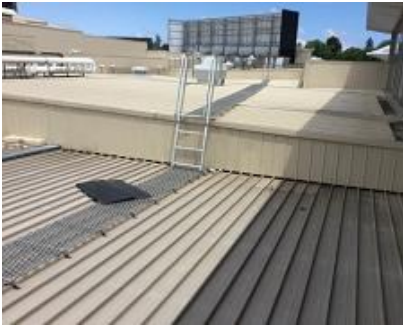
No	Photo of Hazard	Details of Hazard	Details of Risk	Existing/ Immediate Control Measure	Curre nt Risk Level	Proposed Permanent Solution	Resid ual Risk Asse sme nt	Details of Action Taken	Status	Reference
89	Building: General Stores Location Reference: L41 Task: Access to the roof

Bottom rung height is less than required minimum, gap between top rung and landing is greater than required maximum and handrail projecting towards the user	Trips, Slips and Falls	Awareness induction	Med	Existing handrail to be removed. Existing ladder to be re-installed with landing platforms, brackets and handrail	Low	Client advised	Outsta nding	OH&S REGULATIONS 3.7 AS/NZS 1657- 2013 7.4.3.4, 7.4.8.4 & 7.4.8.5
90	Building: General Stores Location Reference: L42 Task: Access to the ladder

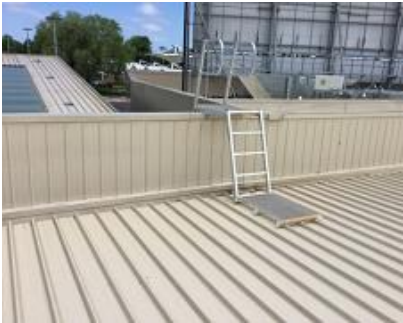
No safe access to the ladder	Trips, Slips and Falls	N/A	Low	Supply walkway to the ladder	Low	Client advised	Outsta nding	-

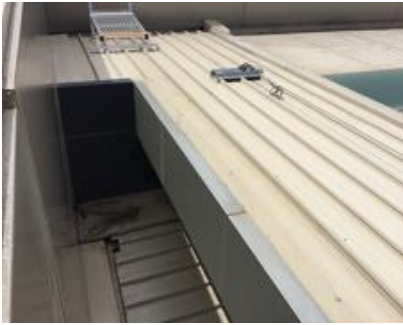
No	Photo of Hazard	Details of Hazard	Details of Risk	Existing/ Immediate Control Measure	Curre nt Risk Level	Proposed Permanent Solution	Resid ual Risk Asse sme nt	Details of Action Taken	Status	Reference
91	Building: General Stores Location Reference: L43 Task: Access to the roof

No height safety system installed	Trips, Slips and Falls	Awareness induction	High	Fall arrest static line, Anchor stop, Ladder access bracket and sign to be installed	Low	Client advised	Outstanding	OH&S REGULATIONS 3.55
92	Building: General Stores Location Reference: L44 Task: Access to the roof

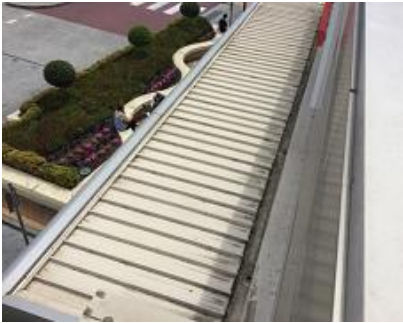
No height safety system installed	Trips, Slips and Falls	Awareness induction	High	Fall arrest static line, Anchor stop, Ladder access bracket and sign to be installed	Low	Client advised	Outstanding	OH&S REGULATIONS 3.55

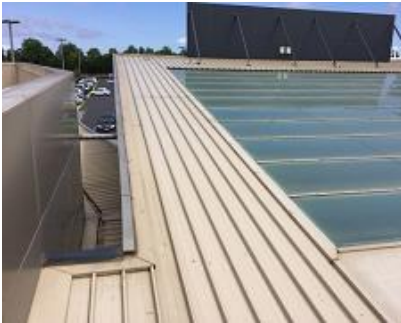
No	Photo of Hazard	Details of Hazard	Details of Risk	Existing/ Immediate Control Measure	Curre nt Risk Level	Proposed Permanent Solution	Resid ual Risk Asse sme nt	Details of Action Taken	Status	Reference
93	Building: General Stores Location Reference: L45 Task: Access to the roof

No height safety system installed	Trips, Slips and Falls	Awareness induction	High	Fall arrest static line to be installed	Low	Client advised	Outstanding	OH&S REGULATIONS 3.55
94	Building: General Stores Location Reference: L45 Task: Restrict access to the roof

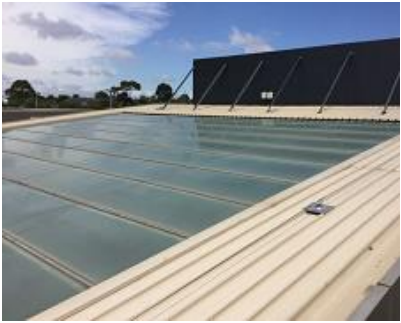
Brittle roof (Non-trafficable roof)	Trips, Slips and Falls	Restrict Access	High	"Caution-Keep Off-Brittle and Fragile Roof" signs to be installed	Low	Client advised	Outstanding	OH&S REGULATIONS 3.57

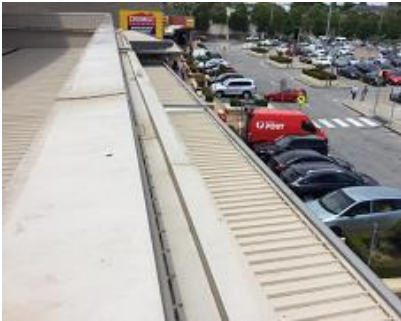
No	Photo of Hazard	Details of Hazard	Details of Risk	Existing/ Immediate Control Measure	Curre nt Risk Level	Proposed Permanent Solution	Resid ual Risk Asse sme nt	Details of Action Taken	Status	Reference
95	Building: General Stores Location Reference: L46 Task: Restrict access to the roof

No height safety system installed	Trips, Slips and Falls	Restrict Access	High	"EWP Access to Roof" signs to be installed	Low	Client advised	Outstanding	OH&S REGULATIONS 3.55 & 3.11
96	Building: General Stores Location Reference: L47 Task: Access to the A/c units

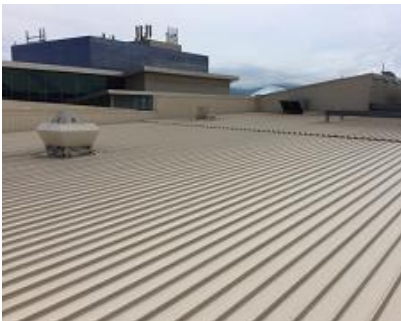
No safe access to the A/c units	Trips, Slips and Falls	N/A	Low	Supply walkway to the A/c units	Low	Client advised	Outstanding	-

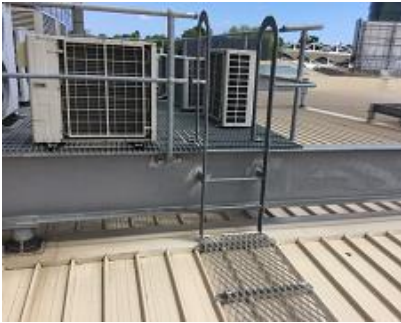
No	Photo of Hazard	Details of Hazard	Details of Risk	Existing/ Immediate Control Measure	Curre nt Risk Level	Proposed Permanent Solution	Resid ual Risk Asse sme nt	Details of Action Taken	Status	Reference
97	Building: General Stores Location Reference: L48 Task: Access to the plant deck

Gap between ladder and permanent structure is less than required minimum and no slip resistance on ladder rungs	Trips, Slips and Falls	Awareness induction	Med	Existing ladder to be removed and new ladder to be installed	Low	Client advised	Outstanding	OH&S REGULATIONS 3.7 AS/NZS 1657-2013 7.4.8.4 & 7.4.5
98	Building: General Stores Location Reference: L48 Task: Access to the A/c units

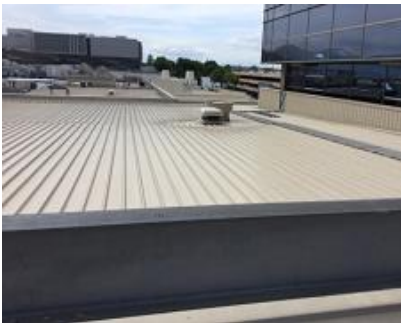
No safe access to the A/c units	Trips, Slips and Falls	N/A	Low	Supply walkway to the A/c units	Low	Client advised	Outstanding	-

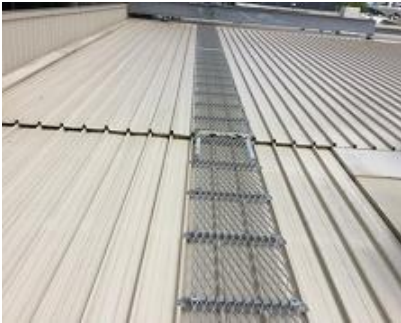
No	Photo of Hazard	Details of Hazard	Details of Risk	Existing/ Immediate Control Measure	Curre nt Risk Level	Proposed Permanent Solution	Resid ual Risk Asse sme nt	Details of Action Taken	Status	Reference
99	Building: General Stores Location Reference: L48 Task: Access to the roof

Variation in height between walkway panels is greater than required maximum	Trips, Slips and Falls	Awareness induction	Med	High visibility safety yellow nosing to be installed	Low	Client advised	Outstanding	OH&S REGULATIONS 3.7 AS/NZS 1657-2013 3.3.4
100	Building: General Stores Location Reference: L49 Task: Access to the plant deck

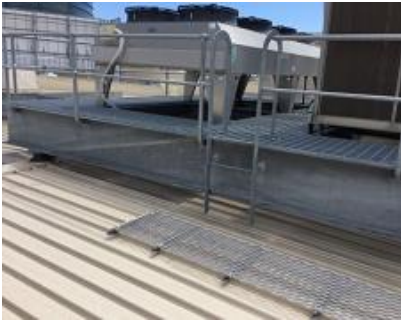
Gap between ladder and permanent structure is less than required minimum and no slip resistance on ladder rungs	Trips, Slips and Falls	Awareness induction	Med	Existing ladder to be removed and new ladder to be installed	Low	Client advised	Outstanding	OH&S REGULATIONS 3.7 AS/NZS 1657-2013 7.4.8.4 & 7.4.5

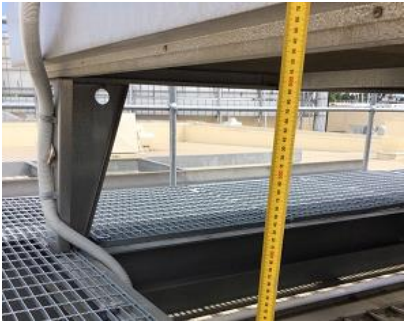
No	Photo of Hazard	Details of Hazard	Details of Risk	Existing/ Immediate Control Measure	Curre nt Risk Level	Proposed Permanent Solution	Resid ual Risk Asse sme nt	Details of Action Taken	Status	Reference
101	Building: General Stores Location Reference: L49 Task: Access to the plant deck

Variation in height between plant deck and unit is greater than required maximum	Trips, Slips and Falls	Awareness induction	Med	Mid rail to be installed	Low	Client advised	Outstanding	OH&S REGULATIONS 3.7 AS/NZS 1657-2013 4.4
102	Building: General Stores Location Reference: L49 Task: Access to the roof

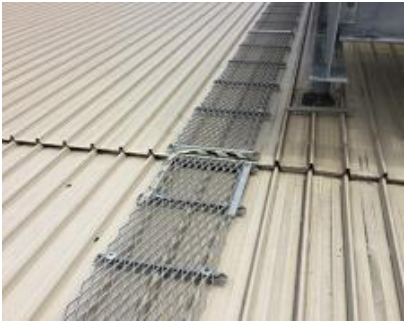
Variation in height between walkway panels is greater than required maximum	Trips, Slips and Falls	Awareness induction	Med	High visibility safety yellow nosing to be installed	Low	Client advised	Outstanding	OH&S REGULATIONS 3.7 AS/NZS 1657-2013 3.3.4

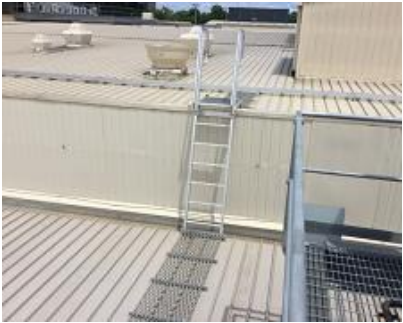
Bottom rung height is less than required minimum, gap between ladder and permanent structure is less than required minimum and handrail projecting towards the user	Trips, Slips and Falls	Awareness induction	Med	Existing handrail to be removed. Existing ladder to be re-installed with landing platforms, brackets and handrails	Low	Client advised	Outstanding	OH&S REGULATIONS 3.7 AS/NZS 1657-2013 7.4.3.4, 7.4.5 & 7.4.8.5

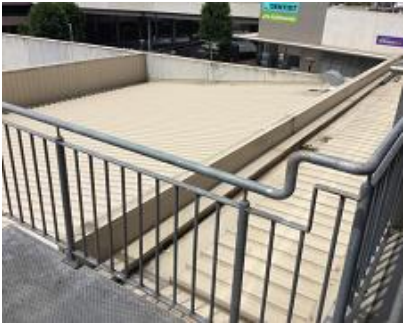
No	Photo of Hazard	Details of Hazard	Details of Risk	Existing/ Immediate Control Measure	Curre nt Risk Level	Proposed Permanent Solution	Resid ual Risk Asse sme nt	Details of Action Taken	Status	Reference
105	Building: General Stores Location Reference: L52 Task: Access to the roof

No height safety system installed	Trips, Slips and Falls	Awareness induction	High	Fall arrest anchors to be installed	Low	Client advised	Outstanding	OH&S REGULATIONS 3.55
106	Building: General Stores Location Reference: L53 Task: Access to the roof

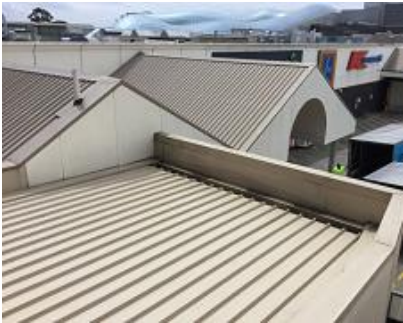
No height safety system installed	Trips, Slips and Falls	Awareness induction	High	Fall arrest anchors to be installed	Low	Client advised	Outstanding	OH&S REGULATIONS 3.55

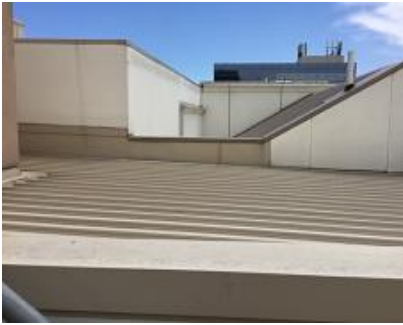
No	Photo of Hazard	Details of Hazard	Details of Risk	Existing/ Immediate Control Measure	Curre nt Risk Level	Proposed Permanent Solution	Resid ual Risk Asse sme nt	Details of Action Taken	Status	Reference
107	Building: General Stores Location Reference: L53 Task: Access to the roof

Variation in height between roofs are greater than required maximum	Trips, Slips and Falls	Awareness induction	Med	Access ladder to be installed	Low	Client advised	Outstanding	OH&S REGULATIONS 3.7 AS/NZS 1657-2013 3.1.4
108	Building: General Stores Location Reference: L53 Task: Access to the A/c units

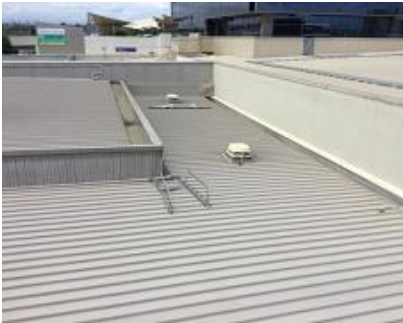
No safe access to the A/c units	Trips, Slips and Falls	N/A	Low	Supply walkway to the A/c units	Low	Client advised	Outstanding	-

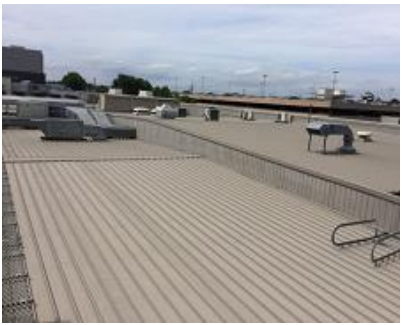
No safe access to the A/c units	Trips, Slips and Falls	N/A	Low	Supply walkway and handrail to the A/c units	Low	Client advised	Outstanding	-

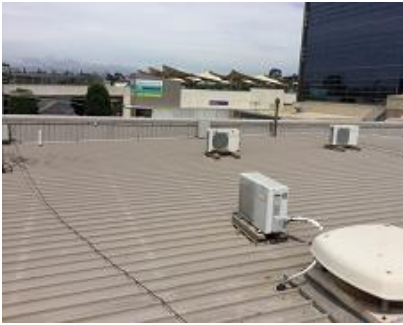
No	Photo of Hazard	Details of Hazard	Details of Risk	Existing/ Immediate Control Measure	Curre nt Risk Level	Proposed Permanent Solution	Resid ual Risk Asse sme nt	Details of Action Taken	Status	Reference
111	Building: General Stores Location Reference: L54 Task: Access to the roof

No height safety system installed	Trips, Slips and Falls	Awareness induction	High	Fall arrest anchors to be installed	Low	Client advised	Outstanding	OH&S REGULATIONS 3.55
112	Building: General Stores Location Reference: L54 Task: Access to the roof

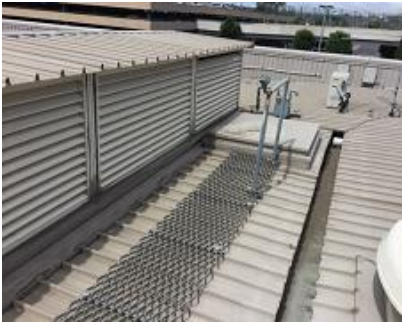
Non-complaint grabrail is present	Trips, Slips and Falls	Awareness induction	Med	Existing grabrail to be removed and new grabrail to be installed	Low	Client advised	Outstanding	OH&S REGULATIONS 3.7 AS/NZS 1657-2013 3.1.4

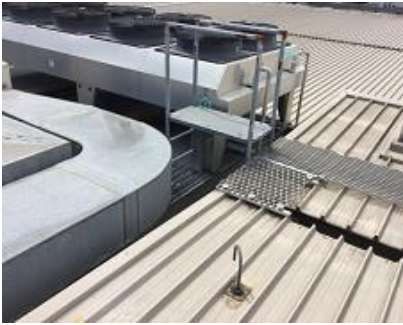
No	Photo of Hazard	Details of Hazard	Details of Risk	Existing/ Immediate Control Measure	Curre nt Risk Level	Proposed Permanent Solution	Resid ual Risk Asse sme nt	Details of Action Taken	Status	Reference
113	Building: General Stores Location Reference: L54 Task: Access to the roof

Non-complaint ladder is present	Trips, Slips and Falls	Awareness induction	Med	Existing ladder to be removed and new ladder to be installed	Low	Client advised	Outstanding	OH&S REGULATIONS 3.7 AS/NZS 1657-2013 7.4
114	Building: General Stores Location Reference: L55 Task: Access to the roof

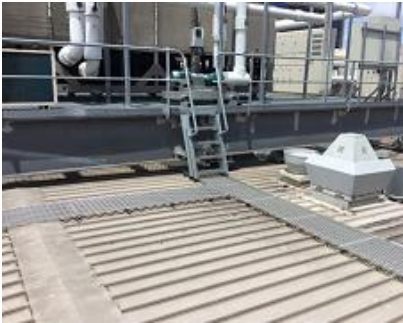
Bottom tread height is less than required minimum	Trips, Slips and Falls	Awareness induction	Med	Landing platform to be installed	Low	Client advised	Outstanding	OH&S REGULATIONS 3.7 AS/NZS 1657-2013 7.3.3

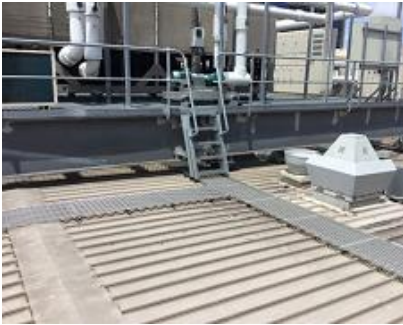
No	Photo of Hazard	Details of Hazard	Details of Risk	Existing/ Immediate Control Measure	Curre nt Risk Level	Proposed Permanent Solution	Resid ual Risk Asse sme nt	Details of Action Taken	Status	Reference
115	Building: General Stores Location Reference: L55 Task: Access to the A/c units

No safe access to the A/c units	Trips, Slips and Falls	N/A	Low	Supply walkway to the A/c units	Low	Client advised	Outstanding	-
116	Building: General Stores Location Reference: L55 Task: Access to the roof

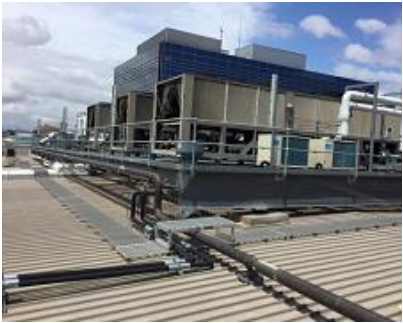
Variation in height between landing and adjacent surface is greater than required maximum	Trips, Slips and Falls	Awareness induction	Med	Handrail to be installed	Low	Client advised	Outstanding	OH&S REGULATIONS 3.7 AS/NZS 1657-2013 4.4

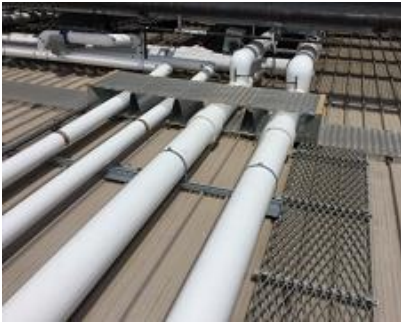
No	Photo of Hazard	Details of Hazard	Details of Risk	Existing/ Immediate Control Measure	Curre nt Risk Level	Proposed Permanent Solution	Resid ual Risk Asse sme nt	Details of Action Taken	Status	Reference
117	Building: General Stores Location Reference: L55 Task: Access to the roof

Variation in height between landing and adjacent surface is greater than required maximum	Trips, Slips and Falls	Awareness induction	Med	Handrail to be installed	Low	Client advised	Outstanding	OH&S REGULATIONS 3.7 AS/NZS 1657-2013 4.4
118	Building: General Stores Location Reference: L55 Task: Access to the roof

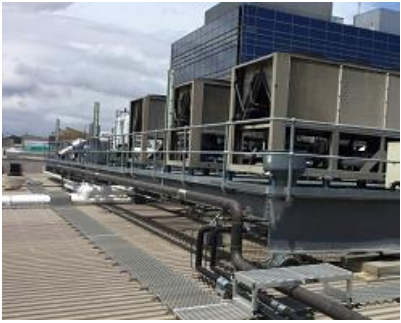
Variation in height between landing and adjacent surface is greater than required maximum	Trips, Slips and Falls	Awareness induction	Med	Handrail to be installed	Low	Client advised	Outstanding	OH&S REGULATIONS 3.7 AS/NZS 1657-2013 4.4

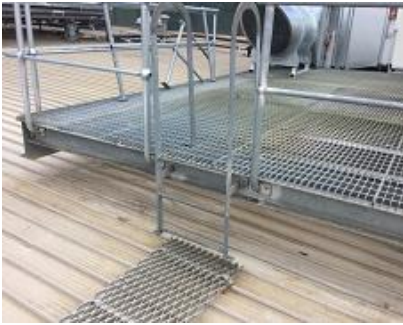
No	Photo of Hazard	Details of Hazard	Details of Risk	Existing/ Immediate Control Measure	Curre nt Risk Level	Proposed Permanent Solution	Resid ual Risk Asse sme nt	Details of Action Taken	Status	Reference
119	Building: General Stores Location Reference: L56 Task: Access to the plant deck

Non-complaint ladder is present	Trips, Slips and Falls	Awareness induction	Med	Existing ladder to be removed and new ladder to be installed	Low	Client advised	Outstanding	OH&S REGULATIONS 3.7 AS/NZS 1657-2013 7.4
120	Building: General Stores Location Reference: L56 Task: Access to the plant deck

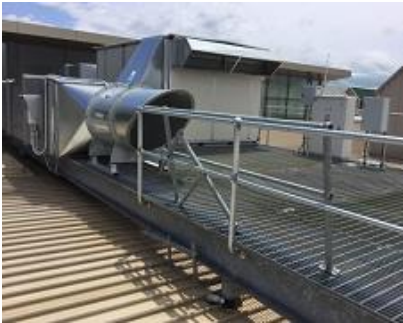
Un-secured handrail is present	Trips, Slips and Falls	Awareness induction	Med	Existing un-secured handrail to be removed	Low	Client advised	Outstanding	OH&S REGULATIONS 3.7 AS/NZS 1657-2013 3.1.4

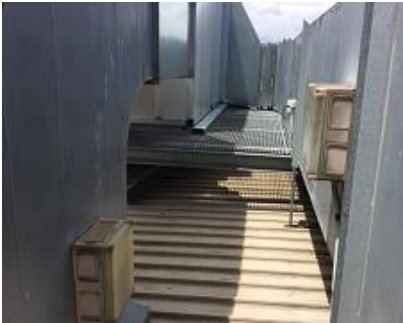
Variation in height between plant deck and roof is greater than required maximum	Trips, Slips and Falls	Awareness induction	Med	Access ladder and handrail to be installed	Low	Client advised	Outstanding	OH&S REGULATIONS 3.7 AS/NZS 1657-2013 3.1.4 & 4.4

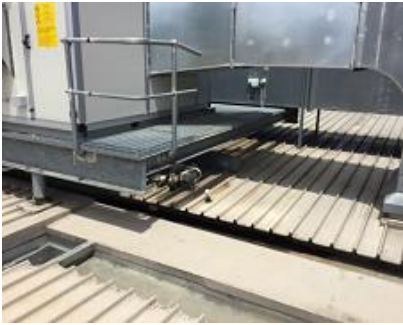
No	Photo of Hazard	Details of Hazard	Details of Risk	Existing/ Immediate Control Measure	Curre nt Risk Level	Proposed Permanent Solution	Resid ual Risk Asse sme nt	Details of Action Taken	Status	Reference
123	Building: General Stores Location Reference: L56 Task: Access to the plant deck

Variation in height between plant deck and roof is greater than required maximum	Trips, Slips and Falls	Awareness induction	Med	Access ladder and handrail to be installed	Low	Client advised	Outstanding	OH&S REGULATIONS 3.7 AS/NZS 1657-2013 3.1.4 & 4.4
124	Building: General Stores Location Reference: L56 Task: Access to the roof
