Roof Safety Report

**Chadstone Shopping Centre,
VIC 3148**

Prepared By: Safemaster Safety Products
Date: 20 April 2018

Roof Safety Report for
Chadstone Shopping Centre, VIC 3148

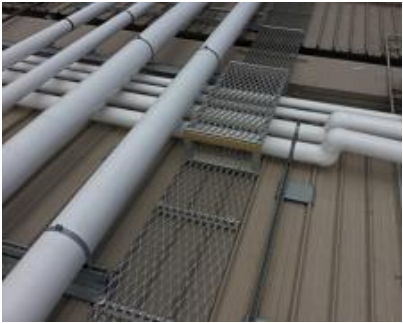
Variation in height between landing and adjacent surface is greater than required maximum	Trips, Slips and Falls	Awareness induction	Med	Handrail to be installed	Low	Client advised	Outstanding	OH&S REGULATIONS 3.7 AS/NZS 1657-2013 4.4

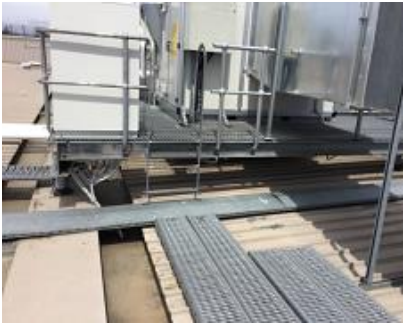
Non-complaint ladder is present	Trips, Slips and Falls	Awareness induction	Med	Existing ladder to be removed and new ladder to be installed	Low	Client advised	Outstanding	OH&S REGULATIONS 3.7 AS/NZS 1657-2013 7.4

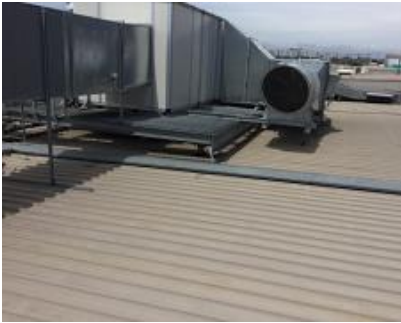
No	Photo of Hazard	Details of Hazard	Details of Risk	Existing/ Immediate Control Measure	Curre nt Risk Level	Proposed Permanent Solution	Resid ual Risk Asse sme nt	Details of Action Taken	Status	Reference
127	Building: General Stores Location Reference: L57 Task: Access to the plant deck

Variation in height between plant deck and roof is greater than required maximum	Trips, Slips and Falls	Awareness induction	Med	Access ladder, walkway and handrail to be installed	Low	Client advised	Outstanding	OH&S REGULATIONS 3.7 AS/NZS 1657-2013 3.1.4 & 4.4
128	Building: General Stores Location Reference: L58 Task: Access to the roof

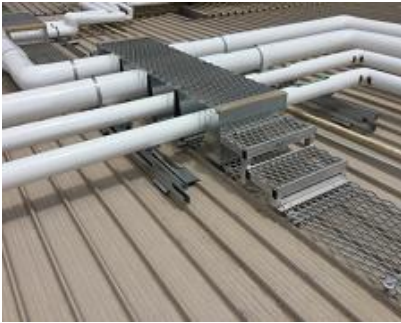
Variation in height between landing and adjacent surface is greater than required maximum	Trips, Slips and Falls	Awareness induction	Med	Handrail to be installed	Low	Client advised	Outstanding	OH&S REGULATIONS 3.7 AS/NZS 1657-2013 4.4

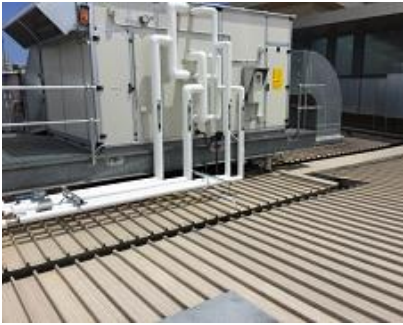
No	Photo of Hazard	Details of Hazard	Details of Risk	Existing/ Immediate Control Measure	Curre nt Risk Level	Proposed Permanent Solution	Resid ual Risk Asse sme nt	Details of Action Taken	Status	Reference
129	Building: General Stores Location Reference: L58 Task: Access to the A/c units

No safe access to the A/c units	Trips, Slips and Falls	N/A	Low	Supply walkway to the A/c units	Low	Client advised	Outstanding	-
130	Building: General Stores Location Reference: L58 Task: Access to the A/c units

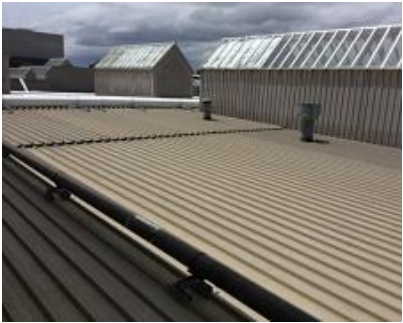
No safe access to the A/c units	Trips, Slips and Falls	N/A	Low	Supply walkway to the A/c units	Low	Client advised	Outstanding	-

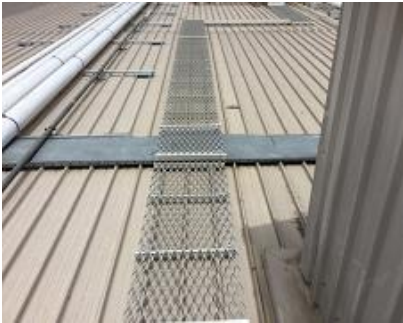
No	Photo of Hazard	Details of Hazard	Details of Risk	Existing/ Immediate Control Measure	Curre nt Risk Level	Proposed Permanent Solution	Resid ual Risk Asse sme nt	Details of Action Taken	Status	Reference
131	Building: General Stores Location Reference: L58 Task: Access to the roof

Variation in height between walkway panels is greater than required maximum	Trips, Slips and Falls	Awareness induction	Med	High visibility safety yellow nosing to be installed	Low	Client advised	Outstanding	OH&S REGULATIONS 3.7 AS/NZS 1657-2013 3.3.4
132	Building: General Stores Location Reference: L58 Task: Access to the A/c units

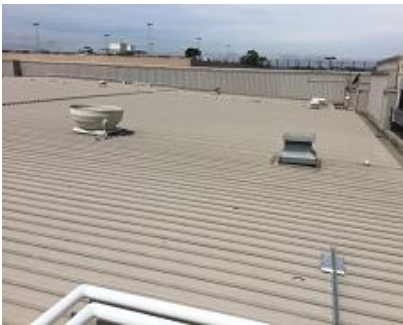
No safe access to the A/c units	Trips, Slips and Falls	N/A	Low	Supply walkway to the A/c units	Low	Client advised	Outstanding	-

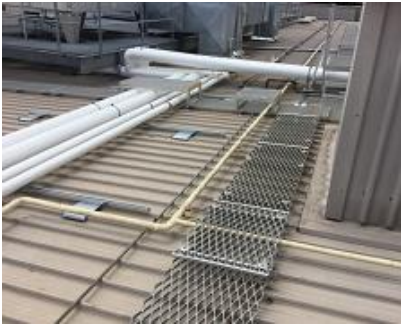
No	Photo of Hazard	Details of Hazard	Details of Risk	Existing/ Immediate Control Measure	Curre nt Risk Level	Proposed Permanent Solution	Resid ual Risk Asse sme nt	Details of Action Taken	Status	Reference
133	Building: General Stores Location Reference: L59 Task: Access to the roof

Variation in height between walkway panels is greater than required maximum	Trips, Slips and Falls	Awareness induction	Med	High visibility safety yellow nosing to be installed	Low	Client advised	Outstanding	OH&S REGULATIONS 3.7 AS/NZS 1657-2013 3.3.4
134	Building: General Stores Location Reference: L59 Task: Access to the roof

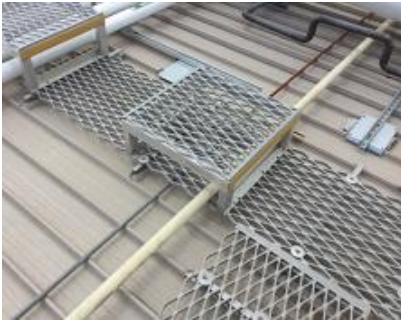
Variation in height between landing and adjacent surface is greater than required maximum	Trips, Slips and Falls	Awareness induction	Med	Handrail to be installed	Low	Client advised	Outstanding	OH&S REGULATIONS 3.7 AS/NZS 1657-2013 4.4

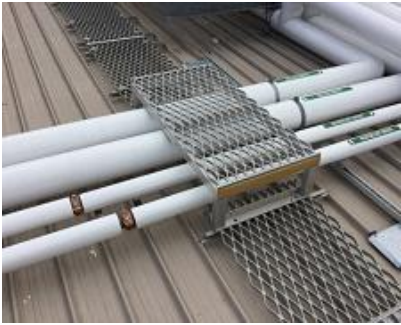
Variation in height between landing and adjacent surface is greater than required maximum	Trips, Slips and Falls	Awareness induction	Med	Handrail to be installed	Low	Client advised	Outstanding	OH&S REGULATIONS 3.7 AS/NZS 1657-2013 4.4
136	Building: General Stores Location Reference: L59 Task: Access to the roof

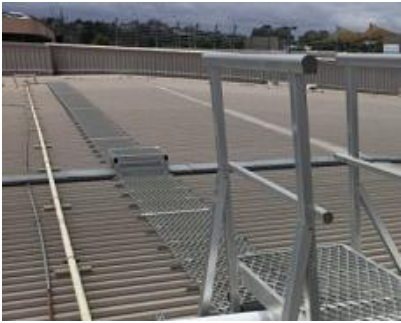
Variation in height between landing and adjacent surface is greater than required maximum	Trips, Slips and Falls	Awareness induction	Med	Handrail to be installed	Low	Client advised	Outstanding	OH&S REGULATIONS 3.7 AS/NZS 1657-2013 4.4

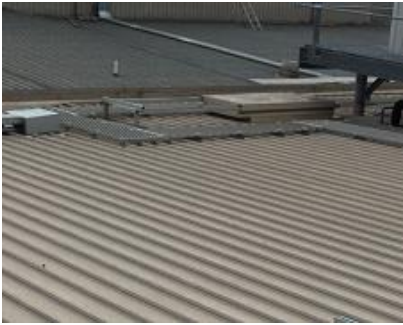
Non-accessible hatch is present	Trips, Slips and Falls	Awareness induction	Med	"No Access" sign to be installed	Low	Client advised	Outstanding	OH&S REGULATIONS 3.55 & 3.11
138	Building: General Stores Location Reference: L59 Task: Access to the plant deck

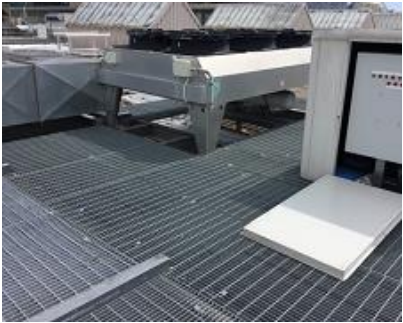
Variation in height between plant deck and unit is greater than required maximum	Trips, Slips and Falls	Awareness induction	Med	Mid rail to be installed	Low	Client advised	Outstanding	OH&S REGULATIONS 3.7 AS/NZS 1657-2013 4.4

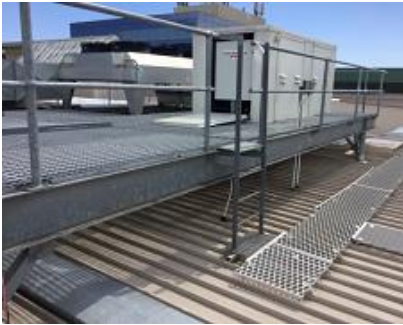
Non-complaint ladder is present	Trips, Slips and Falls	Awareness induction	Med	Existing ladder to be removed and new ladder to be installed	Low	Client advised	Outstanding	OH&S REGULATIONS 3.7 AS/NZS 1657-2013 7.4
140	Building: General Stores Location Reference: L59 Task: Access to the plant deck

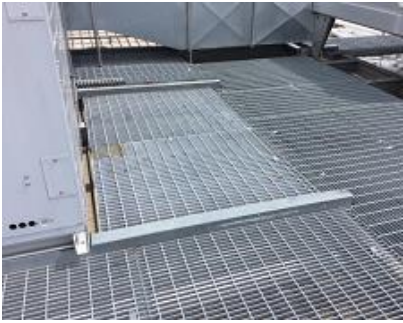
Bracings installed over the plant deck access area	Trips, Slips and Falls	Awareness induction	Med	High visibility safety yellow tape to be installed	Low	Client advised	Outstanding	OH&S REGULATIONS 3.7 AS/NZS 1657-2013 3.3.4

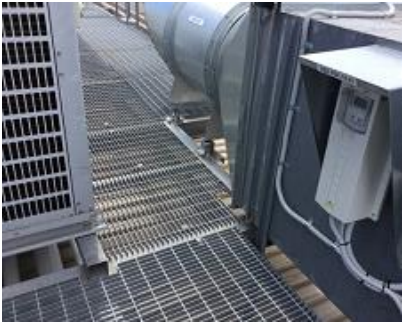
Gap between grating and unit is greater than required maximum	Trips, Slips and Falls	Awareness induction	Med	Gap to be filled	Low	Client advised	Outstanding	OH&S REGULATIONS 3.7 AS/NZS 1657-2013 4.4
142	Building: General Stores Location Reference: L59 Task: Access to the plant deck

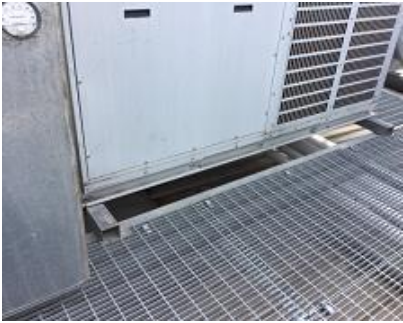
Gap between grating and unit is greater than required maximum	Trips, Slips and Falls	Awareness induction	Med	Gap to be filled	Low	Client advised	Outstanding	OH&S REGULATIONS 3.7 AS/NZS 1657-2013 4.4

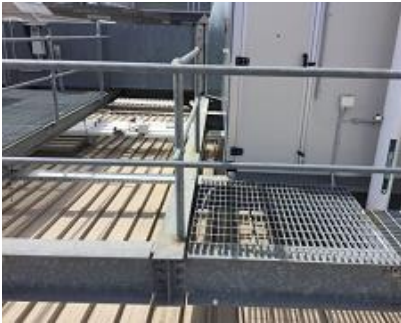
Handrail section is missing	Trips, Slips and Falls	Awareness induction	Med	Handrail to be installed	Low	Client advised	Outstanding	OH&S REGULATIONS 3.7 AS/NZS 1657-2013 4.4
144	Building: General Stores Location Reference: L59 Task: Access to the plant deck

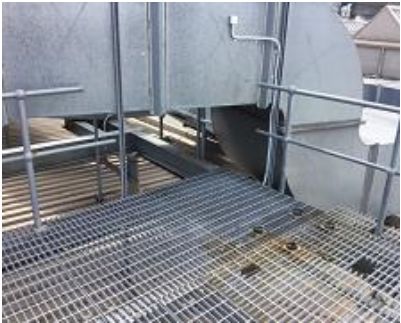
Variation in height between plant deck and unit is greater than required maximum	Trips, Slips and Falls	Awareness induction	Med	Handrail to be installed	Low	Client advised	Outstanding	OH&S REGULATIONS 3.7 AS/NZS 1657-2013 4.4

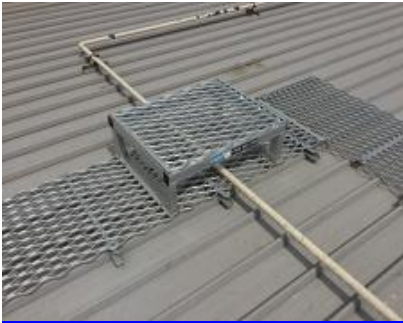
Variation in height between landing and adjacent surface is greater than required maximum	Trips, Slips and Falls	Awareness induction	Med	Handrail to be installed	Low	Client advised	Outstanding	OH&S REGULATIONS 3.7 AS/NZS 1657-2013 4.4

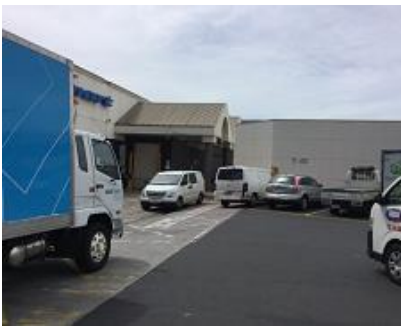
No height safety system installed	Trips, Slips and Falls	Awareness induction	High	Fall arrest anchors, Anchor stop and access ladder to be installed	Low	Client advised	Outstanding	OH&S REGULATIONS 3.7 & 3.55 AS/NZS 1657-2013 3.1.4
148	Building: General Stores Location Reference: L61 Task: Access to the A/c units

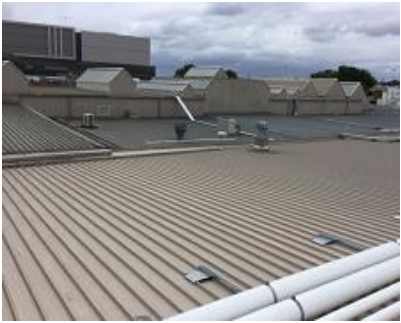
No safe access to the A/c units	Trips, Slips and Falls	N/A	Low	Supply walkway to the A/c units	Low	Client advised	Outstanding	-

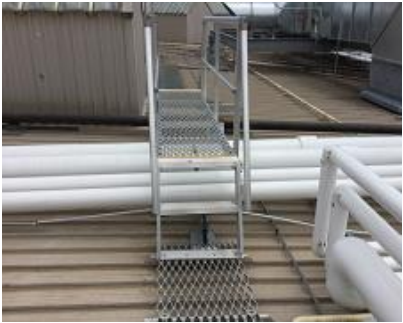
Bottom tread height is greater than required maximum	Trips, Slips and Falls	Awareness induction	Med	Existing ladder to be re-installed with landing platforms	Low	Client advised	Outstanding	OH&S REGULATIONS 3.7 AS/NZS 1657-2013 7.3.3

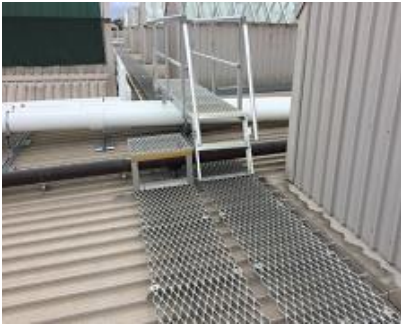
Non-complaint step is present	Trips, Slips and Falls	Awareness induction	Med	Additional steps and handrail to existing step to be installed	Low	Client advised	Outstanding	OH&S REGULATIONS 3.7 AS/NZS 1657-2013 3.1.4
152	Building: General Stores Location Reference: L62 Task: Access to the roof

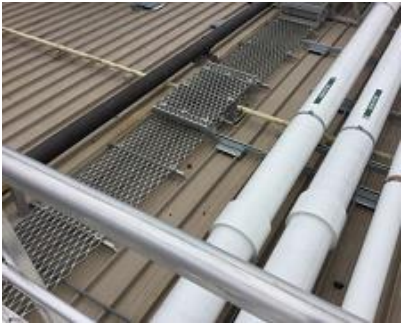
Variation in height between walkway panels is greater than required maximum	Trips, Slips and Falls	Awareness induction	Med	High visibility safety yellow nosing to be installed	Low	Client advised	Outstanding	OH&S REGULATIONS 3.7 AS/NZS 1657-2013 3.3.4

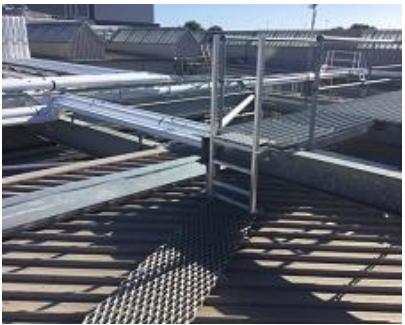
Bottom rung height is less than required minimum and landing is less than required minimum	Trips, Slips and Falls	Awareness induction	Med	Existing ladder to be re-installed with landing platform, brackets and handrail	Low	Client advised	Outstanding	OH&S REGULATIONS 3.7 AS/NZS 1657-2013 7.4.3.4 & 7.3.6

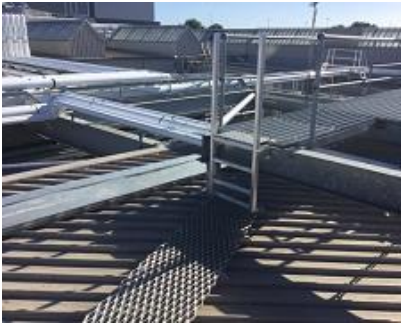
Handrail section is missing	Trips, Slips and Falls	Awareness induction	Med	Handrail to be installed	Low	Client advised	Outstanding	OH&S REGULATIONS 3.7 AS/NZS 1657-2013 4.4
156	Building: General Stores Location Reference: L63 Task: Access to the plant deck

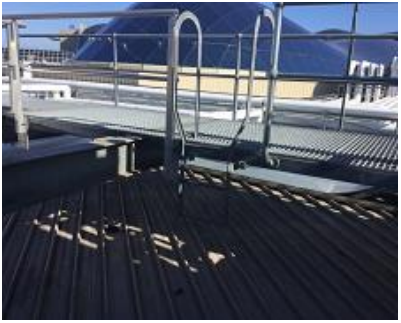
Non-complaint ladder is present	Trips, Slips and Falls	Awareness induction	Med	Existing ladder to be removed. New ladder including landing platforms and handrail	Low	Client advised	Outstanding	OH&S REGULATIONS 3.7 AS/NZS 1657-2013 7.4.3.4 & 7.4.3.1

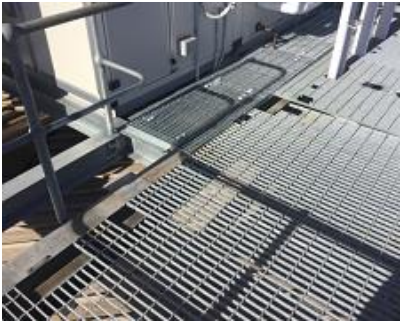
Un-protected Cut-outs in grating	Trips, Slips and Falls	Awareness induction	Med	Gap to be filled	Low	Client advised	Outsta nding	OH&S REGULATIONS 3.7 AS/NZS 1657- 2013 3.2.3.4
158	Building: General Stores Location Reference: L63 Task: Access to the roof

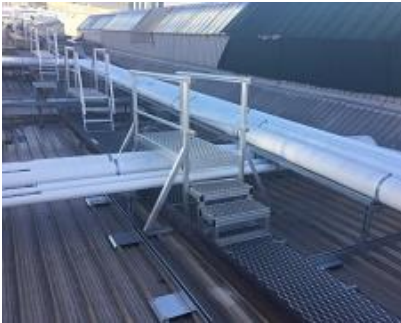
Tread heights are un-even	Trips, Slips and Falls	Awareness induction	Med	Existing steps to be removed and new steps to be installed	Low	Client advised	Outsta nding	OH&S REGULATIONS 3.7 AS/NZS 1657- 2013 7.2.3

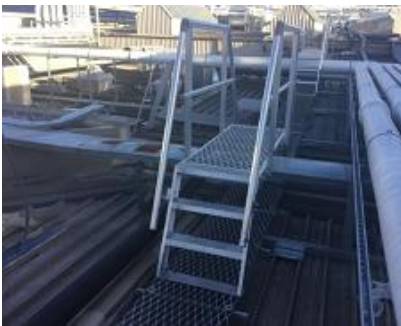
Bottom tread height is less than required minimum and Ladder not fully secured	Trips, Slips and Falls	Awareness induction	Med	Existing ladder to be fully secured including landing platform and brackets	Low	Client advised	Outstanding	OH&S REGULATIONS 3.7 AS/NZS 1657-2013 7.4.3.4
160	Building: General Stores Location Reference: L64 Task: Access to the roof

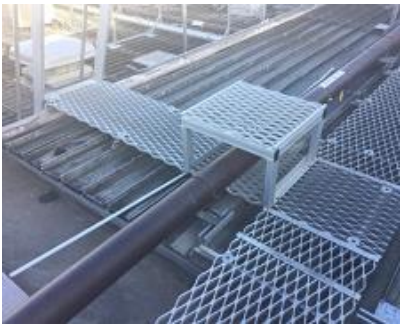
Variation in height between landing and adjacent surface is greater than required maximum	Trips, Slips and Falls	Awareness induction	Med	Handrail to be installed	Low	Client advised	Outstanding	OH&S REGULATIONS 3.7 AS/NZS 1657-2013 4.4

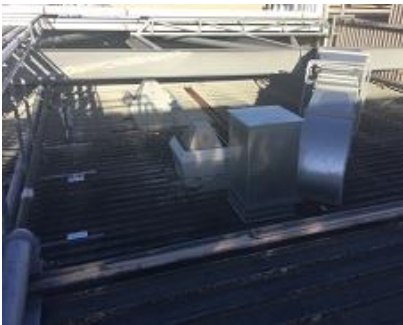
No safe access to the A/c units	Trips, Slips and Falls	N/A	Low	Supply walkway and "Caution-Low Headroom" signs to the A/c units	Low	Client advised	Outstanding	-

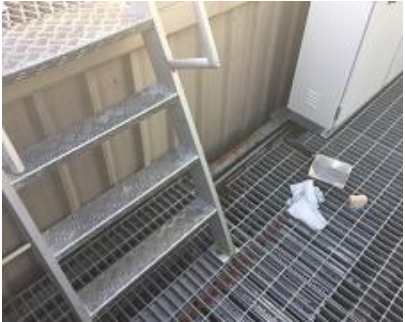
Un-protected cut puts on plant deck	Trips, Slips and Falls	Awareness induction	Med	Gaps to be filled	Low	Client advised	Outstanding	OH&S REGULATIONS 3.7 AS/NZS 1657-2013 3.2.3.4

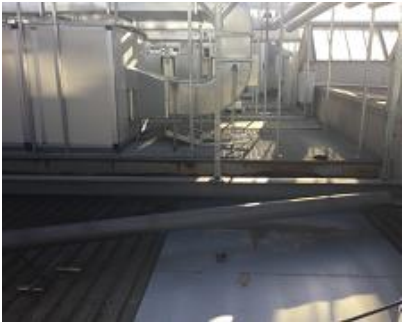
Variation in height between plant deck and roof is greater than required maximum	Trips, Slips and Falls	Awareness induction	Med	Handrails to be installed	Low	Client advised	Outstanding	OH&S REGULATIONS 3.7 AS/NZS 1657-2013 4.4

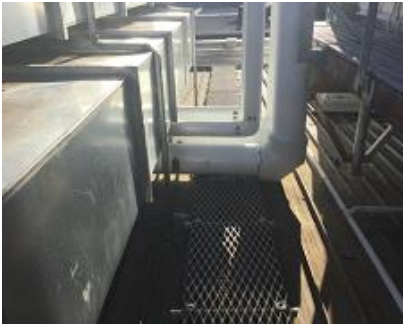
Pipe installed over the walkway path	Trips, Slips and Falls	Awareness induction	Med	Step bridge including ladders to be installed	Low	Client advised	Outstanding	OH&S REGULATIONS 3.7 AS/NZS 1657-2013 3.1.4
168	Building: General Stores Location Reference: L67 Task: Access to the roof

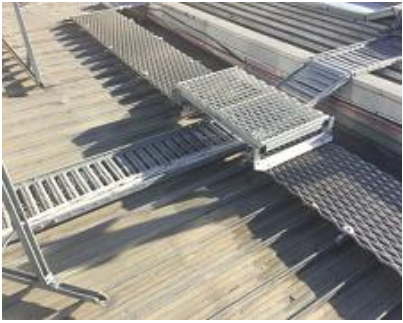
Variation in height between walkway panels are greater than required maximum	Trips, Slips and Falls	Awareness induction	Med	High visibility safety yellow nosing's to be installed	Low	Client advised	Outstanding	OH&S REGULATIONS 3.7 AS/NZS 1657-2013 3.3.4

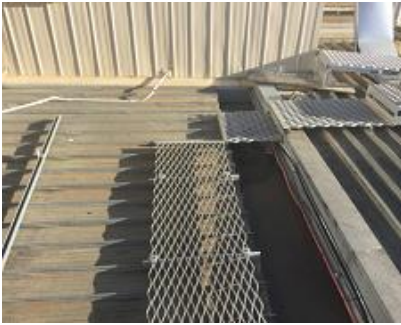
Gap between walkway panels are greater than required maximum	Trips, Slips and Falls	Awareness induction	Med	Additional walkway sections to be installed	Low	Client advised	Outstanding	OH&S REGULATIONS 3.7 AS/NZS 1657-2013 3.2.3.4
170	Building: General Stores Location Reference: L67 Task: Access to the roof

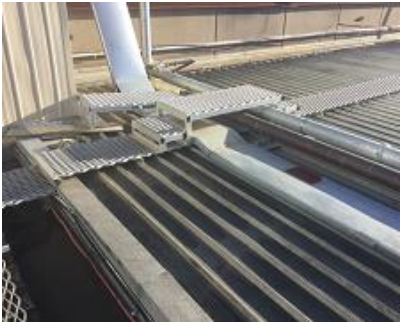
Variation in height between landing and adjacent surface is greater than required maximum	Trips, Slips and Falls	Awareness induction	Med	Handrail to be installed	Low	Client advised	Outstanding	OH&S REGULATIONS 3.7 AS/NZS 1657-2013 4.4

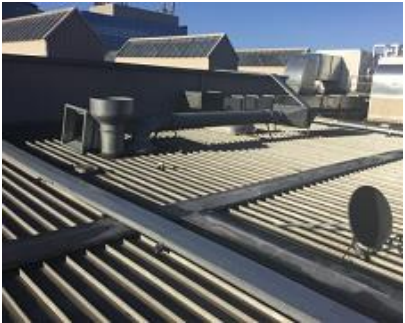
No safe access to the A/c units	Trips, Slips and Falls	N/A	Low	Supply walkway and step over to the A/c units	Low	Client advised	Outstanding	-

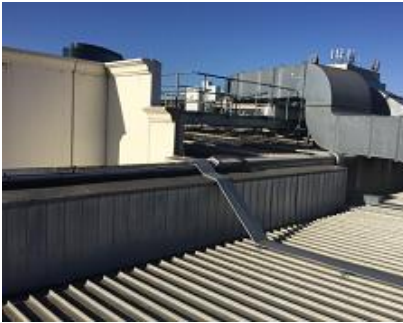
No height safety system installed	Trips, Slips and Falls	Awareness induction	High	Fall arrest anchor to be installed	Low	Client advised	Outstanding	OH&S REGULATIONS 3.55

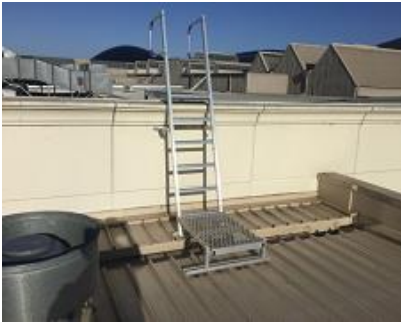
Variation in height between landing and roof is greater than required maximum	Trips, Slips and Falls	Awareness induction	Med	Handrail to be installed	Low	Client advised	Outstanding	OH&S REGULATIONS 3.7 AS/NZS 1657-2013 4.4
176	Building: General Stores Location Reference: L70 Task: Access to the roof

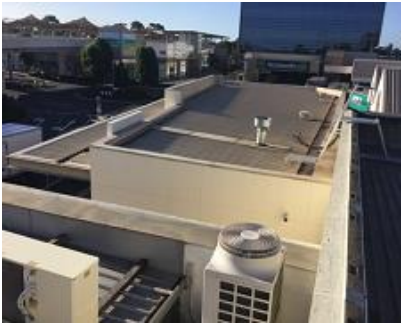
No height safety system installed	Trips, Slips and Falls	Awareness induction	High	Fall arrest anchors, Anchor stop and access ladder to be installed	Low	Client advised	Outstanding	OH&S REGULATIONS 3.7 & 3.55 AS/NZS 1657-2013 3.1.4

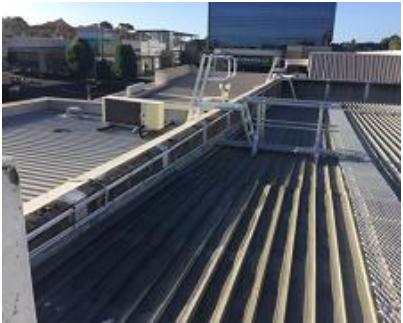
Bottom rung height is greater than required maximum and variation in height between landing and roof is greater than required maximum	Trips, Slips and Falls	Awareness induction	Med	Existing ladder to be re-installed with landing platforms, brackets and handrail	Low	Client advised	Outstanding	OH&S REGULATIONS 3.7 AS/NZS 1657-2013 7.4.3.4 & 4.4

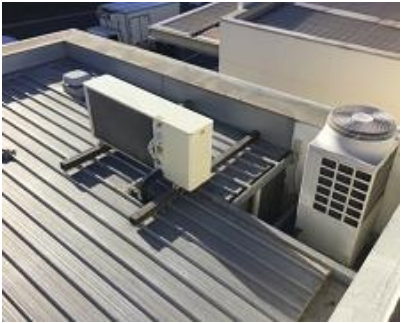
No safe access to the A/c units	Trips, Slips and Falls	N/A	Low	Supply walkway and handrail to the A/c units	Low	Client advised	Outstanding	-

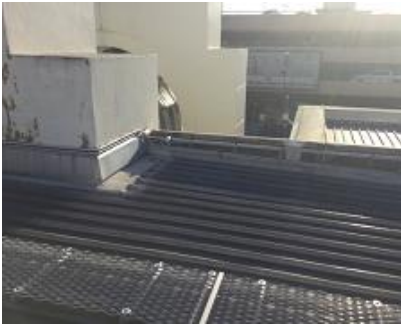
No height safety system installed	Trips, Slips and Falls	Awareness induction	High	Fall arrest anchors to be installed	Low	Client advised	Outstanding	OH&S REGULATIONS 3.55
182	Building: General Stores Location Reference: L72 Task: Restrict access to the roof

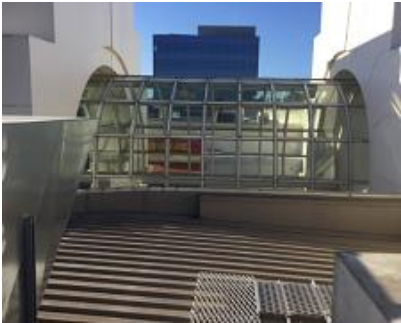
No height safety system installed	Trips, Slips and Falls	Restrict Access	High	"EWP Access to Roof" signs to be installed	Low	Client advised	Outstanding	OH&S REGULATIONS 3.55 & 3.11

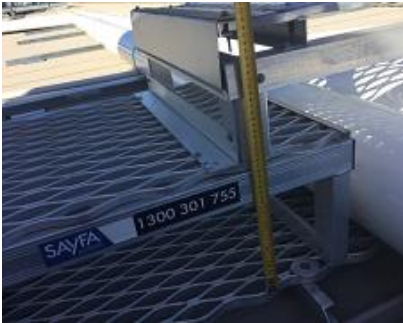
Un-even tread heights and handrail is missing	Trips, Slips and Falls	Awareness induction	Med	Existing stair to be modified and re-installed with steps and handrails	Low	Client advised	Outstanding	OH&S REGULATIONS 3.7 AS/NZS 1657-2013 7.2.3

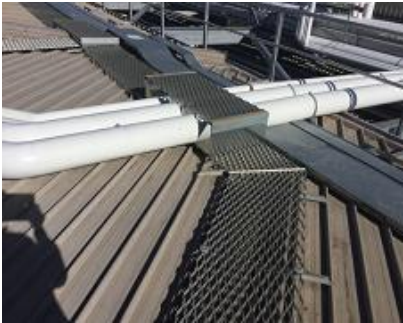
Variation in height between landing and roof is greater than required maximum	Trips, Slips and Falls	Awareness induction	Med	Handrail to be installed	Low	Client advised	Outstanding	OH&S REGULATIONS 3.7 AS/NZS 1657-2013 4.4
186	Building: General Stores Location Reference: L74 Task: Access to the roof

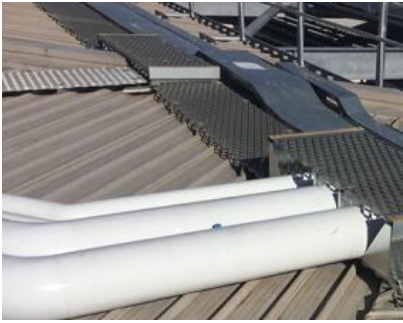
Variation in height between walkway panels are greater than required maximum	Trips, Slips and Falls	Awareness induction	Med	High visibility safety yellow nosing's to be installed	Low	Client advised	Outstanding	OH&S REGULATIONS 3.7 AS/NZS 1657-2013 3.3.4

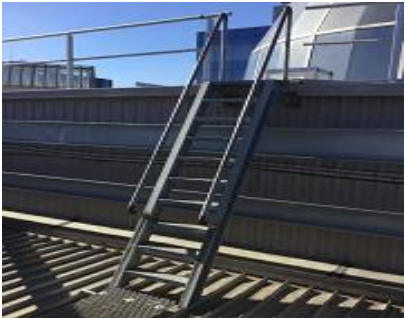
Non-complaint handrail is present	Trips, Slips and Falls	Awareness induction	Med	Existing handrail to be removed and new handrail to be installed	Low	Client advised	Outstanding	OH&S REGULATIONS 3.7 AS/NZS 1657-2013 7.3.4

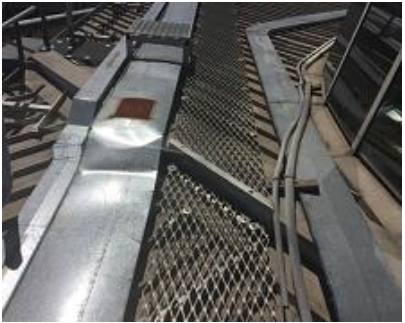
Bracings installed over the walkway path	Trips, Slips and Falls	Awareness induction	Med	High visibility safety yellow tape to be installed	Low	Client advised	Outstanding	OH&S REGULATIONS 3.7 AS/NZS 1657-2013 3.1.4

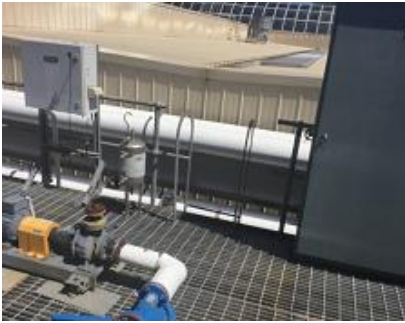
Non-complaint ladder is present	Trips, Slips and Falls	Awareness induction	Med	Existing ladder to be removed. New step bridge including additional walkway to be installed	Low	Client advised	Outstanding	OH&S REGULATIONS 3.7 AS/NZS 1657-2013 7.4

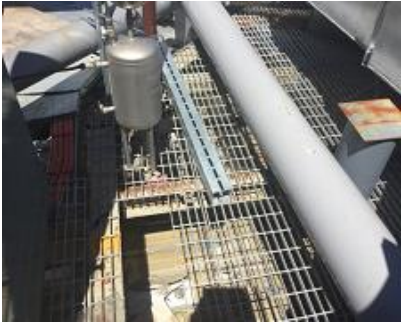
Variation in height between plant deck and roof is greater than required maximum	Trips, Slips and Falls	Awareness induction	Med	Handrail to be installed or gap to be closed	Low	Client advised	Outstanding	OH&S REGULATIONS 3.7 AS/NZS 1657-2013 4.4

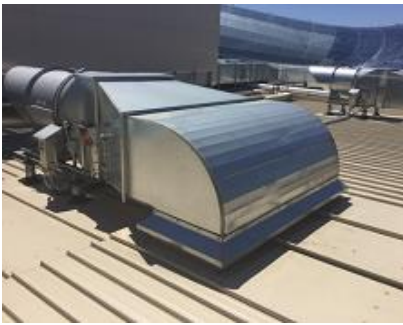
No safe access to the A/c units	Trips, Slips and Falls	N/A	Low	Supply walkway and handrail to the A/c units	Low	Client advised	Outstanding	-

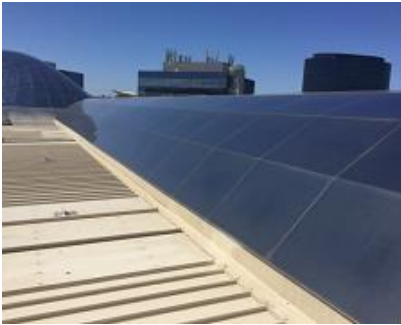
Brittle roof (Non-trafficable roof)	Trips, Slips and Falls	Restrict Access	High	"Warning-Keep Off-Brittle and Fragile Roof" signs to be installed	Low	Client advised	Outstanding	OH&S REGULATIONS 3.57
198	Building: General Stores Location Reference: L78 Task: Access to the roof

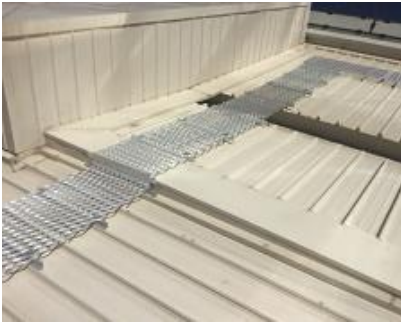
Variation in height between walkway panels are greater than required maximum	Trips, Slips and Falls	Awareness induction	Med	High visibility safety yellow nosing to be installed	Low	Client advised	Outstanding	OH&S REGULATIONS 3.7 AS/NZS 1657-2013 3.3.4

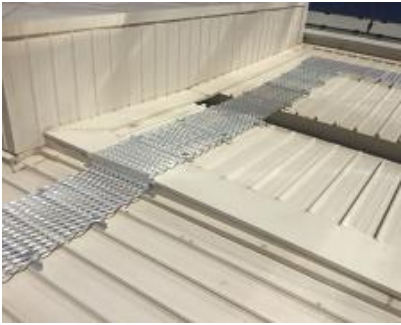
Variation in height between walkway and adjacent surface is greater than required maximum	Trips, Slips and Falls	Awareness induction	Med	Handrail to be installed	Low	Client advised	Outstanding	OH&S REGULATIONS 3.7 AS/NZS 1657-2013 4.4
200	Building: General Stores Location Reference: L79 Task: Access to the A/c units

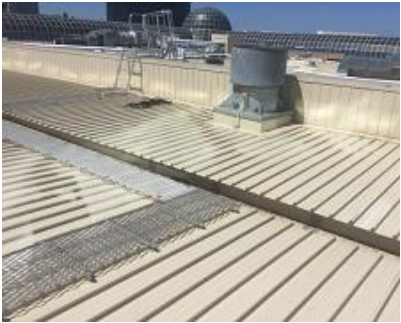
No safe access to the A/c units	Trips, Slips and Falls	N/A	Low	Supply walkway and high visibility safety yellow nosing to the A/c units	Low	Client advised	Outstanding	-

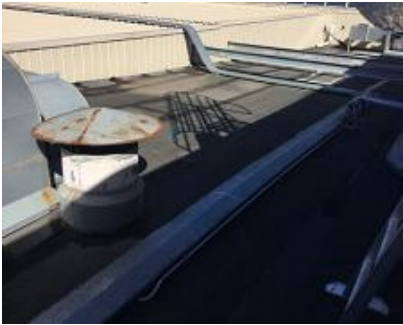
No safe access to the A/c units	Trips, Slips and Falls	N/A	Low	Supply walkway, step bridge, step over and handrail to the A/c units	Low	Client advised	Outstanding	-
202	Building: General Stores Location Reference: L79 Task: Access to the roof

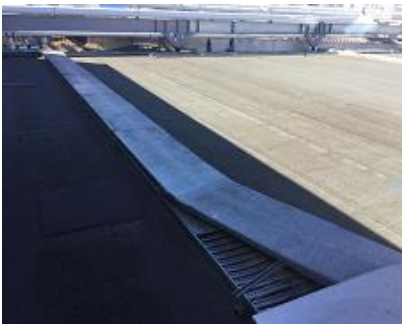
Cable tray installed on the way to the access A/c units	Trips, Slips and Falls	N/A	Low	Supply walkway and step bridge to the A/c units	Low	Client advised	Outstanding	-

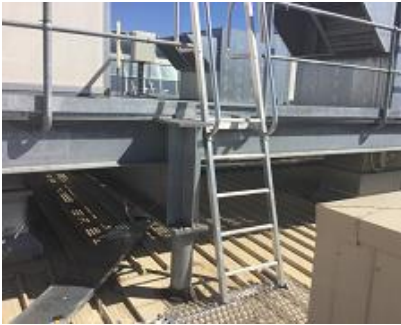
Bottom rung height is less than required minimum, gap between top rung and landing is greater than required maximum and handrail projecting towards the user	Trips, Slips and Falls	Awareness induction	Med	Existing handrail to be removed. Existing ladder to be re-installed with landing platforms, brackets and handrails	Low	Client advised	Outstanding	OH&S REGULATIONS 3.7 AS/NZS 1657-2013 7.4.3.4, 7.4.8.4 & 7.4.8.5
204	Building: General Stores Location Reference: L81 Task: Access to the plant deck

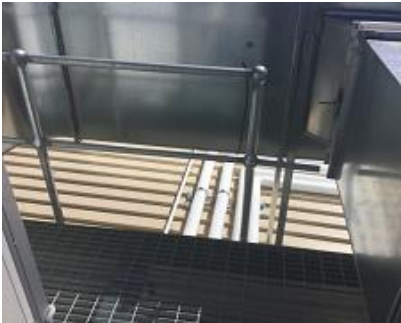
Variation in height between plant deck and roof is greater than required maximum	Trips, Slips and Falls	Awareness induction	Med	Handrail to be installed	Low	Client advised	Outstanding	OH&S REGULATIONS 3.7 AS/NZS 1657-2013 4.4

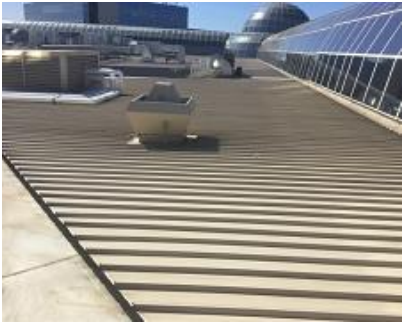
No safe access to the A/c units	Trips, Slips and Falls	N/A	Low	Supply walkway and handrail to the A/c units	Low	Client advised	Outstanding	-

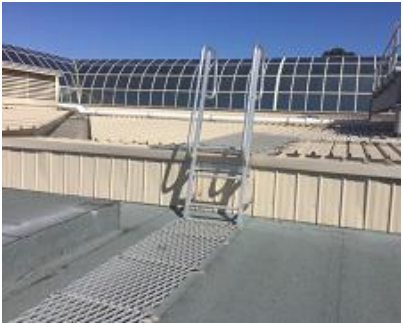
Top rung not levelled with landing, bottom rung height is less than required minimum and handrail projecting towards the user	Trips, Slips and Falls	Awareness induction	Med	Existing handrail to be removed. Existing ladder to be re- installed with landing platforms, brackets and handrails	Low	Client advised	Outsta nding	OH&S REGULATIONS 3.7 AS/NZS 1657- 2013 7.4.3.3, 7.4.3.4 & 7.4.8.5

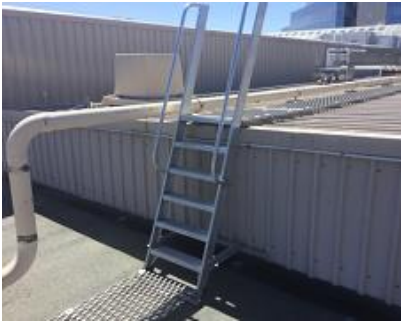
Bottom tread height is less than required minimum and gap behind the ladder is less than required minimum	Trips, Slips and Falls	Awareness induction	Med	Existing ladder to be re-installed with landing platforms and brackets	Low	Client advised	Outstanding	OH&S REGULATIONS 3.7 AS/NZS 1657-2013 7.3.3 & 7.3.5
210	Building: General Stores Location Reference: L86 Task: Access to roof

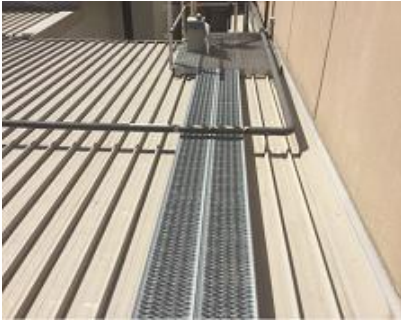
Pipe installed over the walkway path	Trips, Slips and Falls	Awareness induction	Med	Step bridge to be installed	Low	Client advised	Outstanding	OH&S REGULATIONS 3.7 AS/NZS 1657-2013 3.1.4

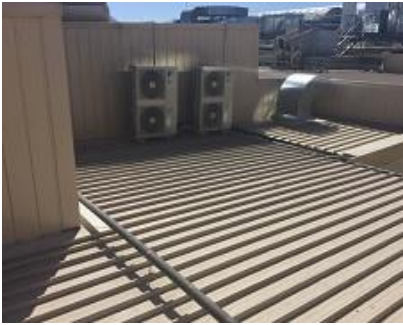
No safe access to the A/c units	Trips, Slips and Falls	N/A	Low	Supply walkway to the A/c units	Low	Client advised	Outstanding	-
212	Building: General Stores Location Reference: L86 Task: Access to the A/c units

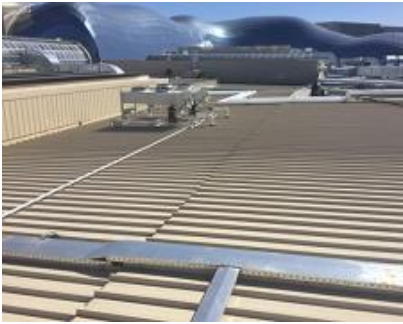
No safe access to the A/c units	Trips, Slips and Falls	N/A	Low	Supply walkway, step bridge and handrail to the A/c units	Low	Client advised	Outstanding	-

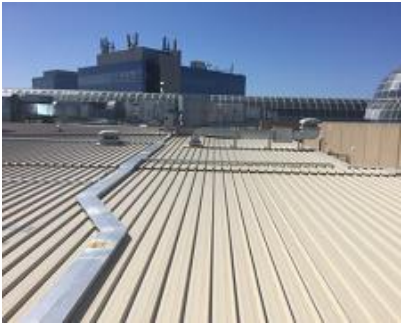
No safe access to the A/c units	Trips, Slips and Falls	N/A	Low	Supply walkway, step bridge and handrail to the A/c units	Low	Client advised	Outstanding	-
214	Building: General Stores Location Reference: L87 Task: Access to the roof

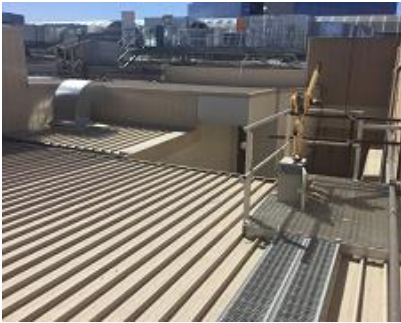
No height safety system installed	Trips, Slips and Falls	Awareness induction	High	Fall arrest anchors to be installed	Low	Client advised	Outstanding	OH&S REGULATIONS 3.55

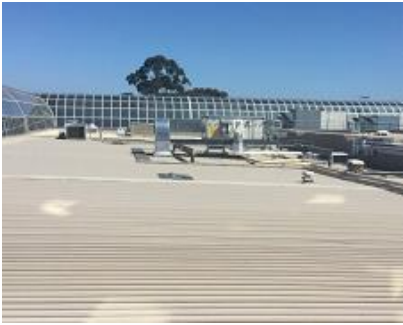
No safe access to the A/c units	Trips, Slips and Falls	N/A	Low	Supply walkway and step bridge to the A/c units	Low	Client advised	Outstanding	-
216	Building: General Stores Location Reference: L87 Task: Access to the A/c units

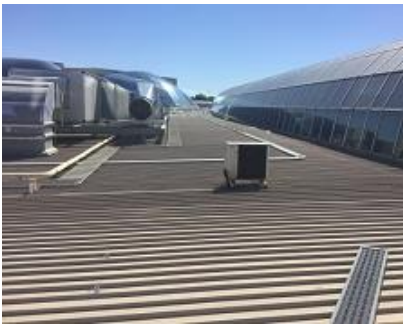
No safe access to the A/c units	Trips, Slips and Falls	N/A	Low	Supply walkway to the A/c units	Low	Client advised	Outstanding	-

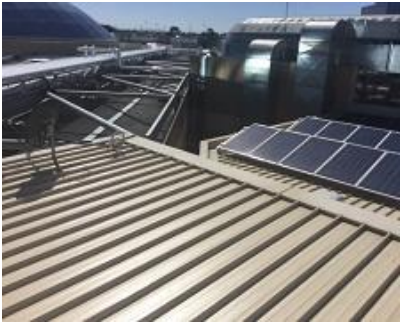
No height safety system installed	Trips, Slips and Falls	Awareness induction	High	Fall arrest anchors to be installed	Low	Client advised	Outstanding	OH&S REGULATIONS 3.55
218	Building: General Stores Location Reference: L88 Task: Access to the plant deck

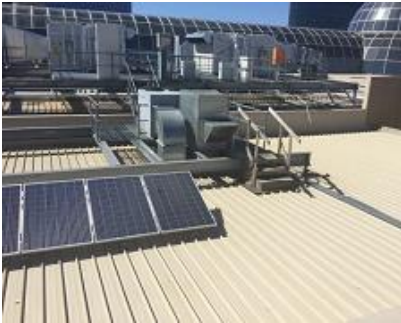
Non-complaint stair is present	Trips, Slips and Falls	Awareness induction	Med	Existing stair to be removed and new ladder to be installed	Low	Client advised	Outstanding	OH&S REGULATIONS 3.7 AS/NZS 1657-2013 7.2

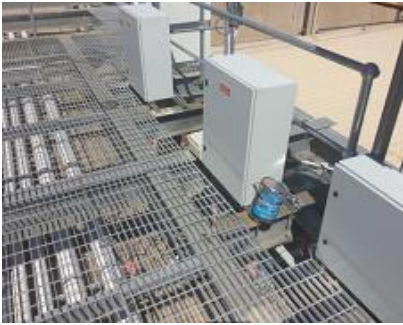
Un-protected cut outs are present	Trips, Slips and Falls	Awareness induction	Med	Gaps to be closed	Low	Client advised	Outstanding	OH&S REGULATIONS 3.7 AS/NZS 1657-2013 3.2.3.4
220	Building: General Stores Location Reference: L88 Task: Access to the plant deck

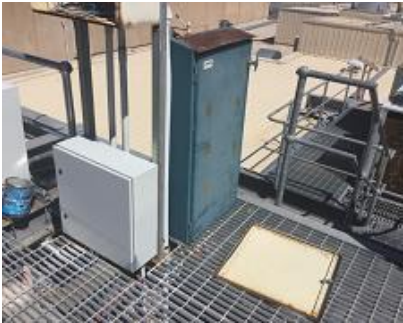
Handrail section is missing	Trips, Slips and Falls	Awareness induction	Med	Handrail to be installed	Low	Client advised	Outstanding	OH&S REGULATIONS 3.7 AS/NZS 1657-2013 4.4

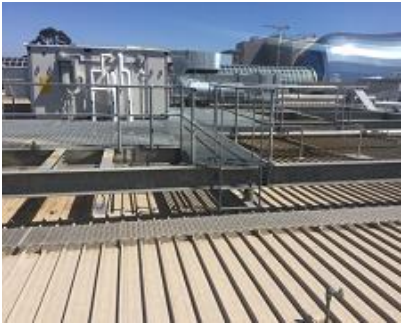
No slip resistance on rungs and landing is less than required minimum	Trips, Slips and Falls	Awareness induction	Med	Existing ladder to be removed and new ladder to be installed	Low	Client advised	Outstanding	OH&S REGULATIONS 3.7 AS/NZS 1657-2013 7.4.3.1 & 7.3.6

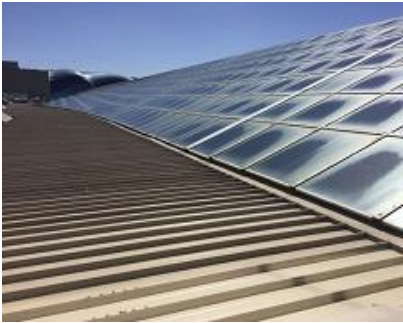
Glass roof is present	Trips, Slips and Falls	Restrict Access	High	Centre management to confirm the glass roof is trafficable or not to install signs	Low	Client advised	Outstanding	OH&S REGULATIONS 3.55 & 3.57

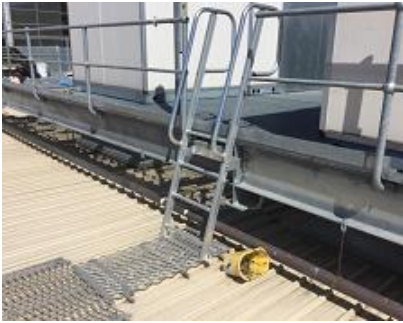
Top rung not levelled with landing, bottom rung height is less than required minimum, clearance behind the ladder is less than required minimum and handrail projecting towards the user	Trips, Slips and Falls	Awareness induction	Med	Existing ladder to be removed and new ladder to be installed	Low	Client advised	Outstanding	OH&S REGULATIONS 3.7 AS/NZS 1657-2013 7.4.3.3, 7.4.3.4, 7.4.5 & 7.4.8.5

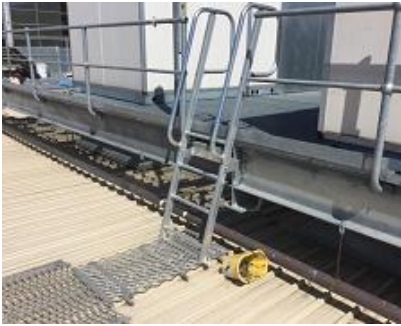
Toe board installed at access point	Trips, Slips and Falls	Awareness induction	Med	Toe board to be removed at access point	Low	Client advised	Outstanding	OH&S REGULATIONS 3.7 AS/NZS 1657-2013 3.1.4
22 8	Building: General Stores Location Reference: L92 Task: Access to the plant deck

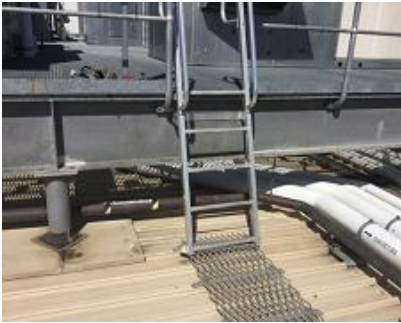
Top rung not levelled with landing, bottom rung height is less than required minimum, clearance behind the ladder is less than required minimum and handrail projecting towards the user	Trips, Slips and Falls	Awareness induction	Med	Existing ladder to be removed and new ladder to be installed	Low	Client advised	Outstanding	OH&S REGULATIONS 3.7 AS/NZS 1657-2013 7.4.3.3, 7.4.3.4, 7.4.5 & 7.4.8.5

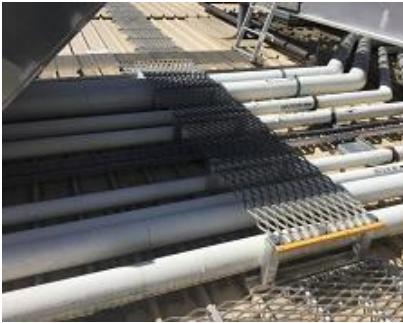
Variation in height between landing and roof is greater than required maximum	Trips, Slips and Falls	Awareness induction	Med	Handrail to be installed	Low	Client advised	Outstanding	OH&S REGULATIONS 3.7 AS/NZS 1657-2013 4.4

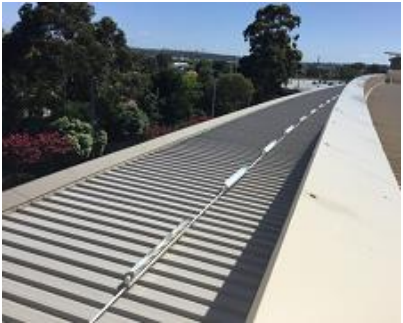
No height safety system installed	Trips, Slips and Falls	Awareness induction	High	Fall arrest anchors and access ladder to be installed	Low	Client advised	Outstanding	OH&S REGULATIONS 3.55 & 3.7 AS/NZS 1657-2013 3.1.4

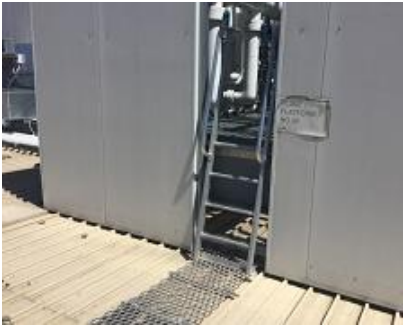
Top rung not levelled with landing, bottom rung height is less than required minimum and handrail projecting towards the user	Trips, Slips and Falls	Awareness induction	Med	Existing ladder to be removed and new ladder to be installed	Low	Client advised	Outstanding	OH&S REGULATIONS 3.7 AS/NZS 1657-2013 7.4.3.3, 7.4.3.4 & 7.4.8.5
23 4	Building: General Stores Location Reference: L94 Task: Access to the plant deck

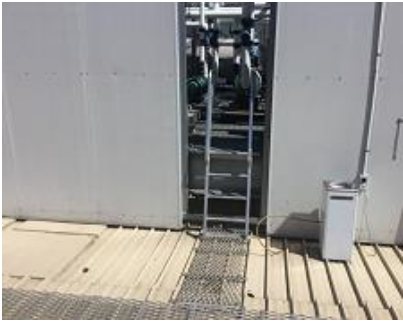
Top rung not levelled with landing, bottom rung height is less than required minimum and handrail projecting towards the user	Trips, Slips and Falls	Awareness induction	Med	Existing ladder to be removed and new ladder to be installed	Low	Client advised	Outstanding	OH&S REGULATIONS 3.7 AS/NZS 1657-2013 7.4.3.3, 7.4.3.4 & 7.4.8.5

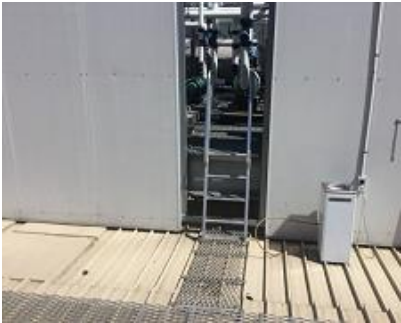
Gap between ladder and structure is greater than required maximum	Trips, Slips and Falls	Awareness induction	Med	Handrail to be installed	Low	Client advised	Outstanding	OH&S REGULATIONS 3.7 AS/NZS 1657-2013 4.4
236	Building: General Stores Location Reference: L94 Task: Access to the A/c units

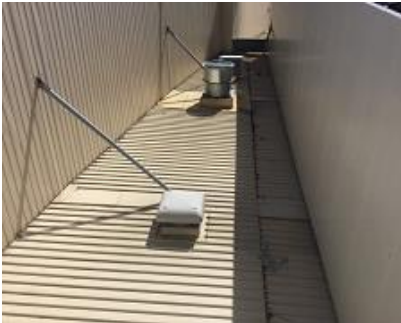
No safe access to the A/c units	Trips, Slips and Falls	N/A	Low	Supply walkway, Access ladder, step bridge and handrail to the A/c units	Low	Client advised	Outstanding	-

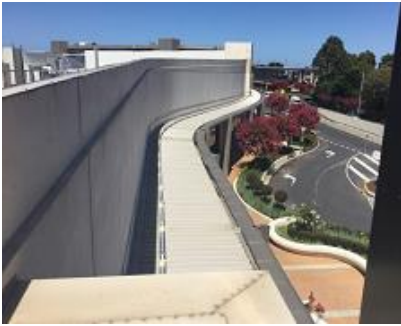
No height safety system installed	Trips, Slips and Falls	Awareness induction	High	Fall arrest static line, fall arrest anchor, anchor stop, ladder access bracket and sign to be installed	Low	Client advised	Outstanding	OH&S REGULATIONS 3.55
23 8	Building: General Stores Location Reference: L96 Task: Access to the roof

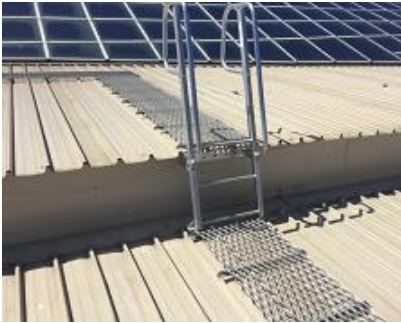
Top rung not levelled with landing, bottom rung height is less than required minimum and handrail projecting towards the user	Trips, Slips and Falls	Awareness induction	Med	Existing ladder to be removed and new ladder to be installed	Low	Client advised	Outstanding	OH&S REGULATIONS 3.7 AS/NZS 1657-2013 7.4.3.3, 7.4.3.4 & 7.4.8.5

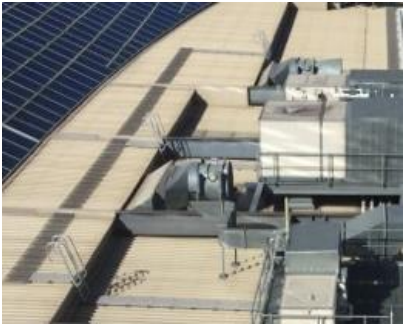
No safe access to the A/c units	Trips, Slips and Falls	N/A	Low	Supply walkway to the A/c units	Low	Client advised	Outstanding	-
240	Building: General Stores Location Reference: L96 Task: Access to the roof

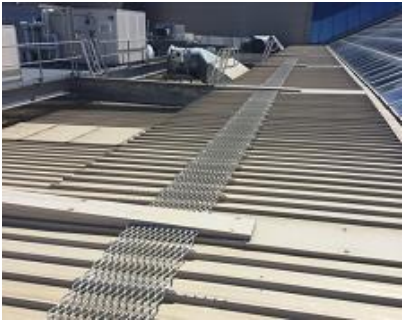
Gap between walkway panels are greater than required maximum	Trips, Slips and Falls	Awareness induction	Med	Step bridges to be installed	Low	Client advised	Outstanding	OH&S REGULATIONS 3.7 AS/NZS 1657-2013 3.2.3.4

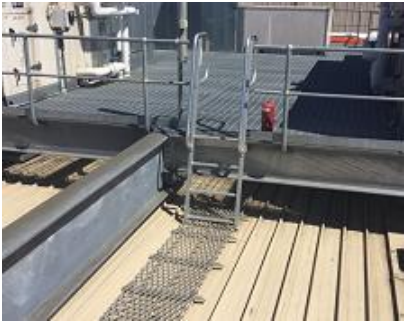
Top rung not levelled with landing, bottom rung height is less than required minimum and handrail projecting towards the user	Trips, Slips and Falls	Awareness induction	Med	Existing ladder to be removed and new ladder to be installed	Low	Client advised	Outstanding	OH&S REGULATIONS 3.7 AS/NZS 1657-2013 7.4.3.3, 7.4.3.4 & 7.4.8.5

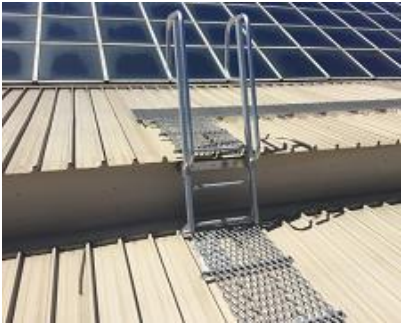
Top rung not levelled with landing, bottom rung height is less than required minimum and handrail projecting towards the user	Trips, Slips and Falls	Awareness induction	Med	Existing ladder to be removed and new ladder to be installed	Low	Client advised	Outstanding	OH&S REGULATIONS 3.7 AS/NZS 1657-2013 7.4.3.3, 7.4.3.4 & 7.4.8.5
24 4	Building: General Stores Location Reference: L98 Task: Access to the roof

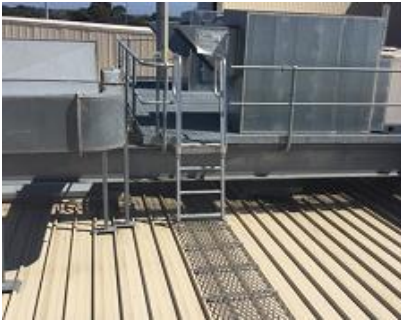
Top rung not levelled with landing, bottom rung height is less than required minimum and handrail projecting towards the user	Trips, Slips and Falls	Awareness induction	Med	Existing ladder to be removed and new ladder to be installed	Low	Client advised	Outstanding	OH&S REGULATIONS 3.7 AS/NZS 1657-2013 7.4.3.3, 7.4.3.4 & 7.4.8.5

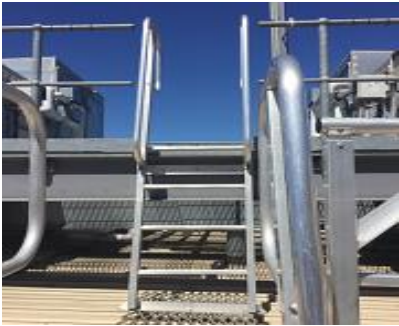
Top rung not levelled with landing, bottom rung height is less than required minimum and handrail projecting towards the user	Trips, Slips and Falls	Awareness induction	Med	Existing ladder to be removed and new ladder to be installed	Low	Client advised	Outstanding	OH&S REGULATIONS 3.7 AS/NZS 1657-2013 7.4.3.3, 7.4.3.4 & 7.4.8.5
24 6	Building: General Stores Location Reference: L99 Task: Access to the roof

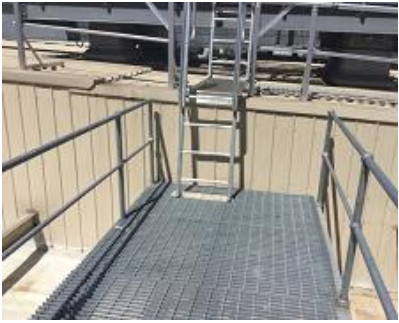
Top rung not levelled with landing, bottom rung height is less than required minimum and handrail projecting towards the user	Trips, Slips and Falls	Awareness induction	Med	Existing ladder to be removed and new ladder to be installed	Low	Client advised	Outstanding	OH&S REGULATIONS 3.7 AS/NZS 1657-2013 7.4.3.3, 7.4.3.4 & 7.4.8.5

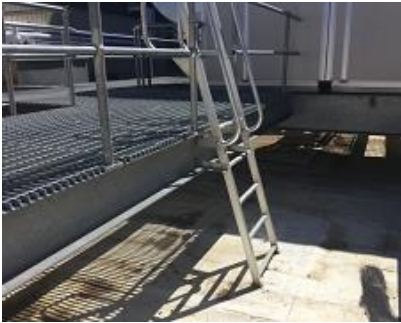
Top rung not levelled with landing, bottom rung height is less than required minimum and handrail projecting towards the user	Trips, Slips and Falls	Awareness induction	Med	Existing ladder to be removed and new ladder to be installed	Low	Client advised	Outstanding	OH&S REGULATIONS 3.7 AS/NZS 1657-2013 7.4.3.3, 7.4.3.4 & 7.4.8.5
248	Building: General Stores Location Reference: L99 Task: Access to the roof

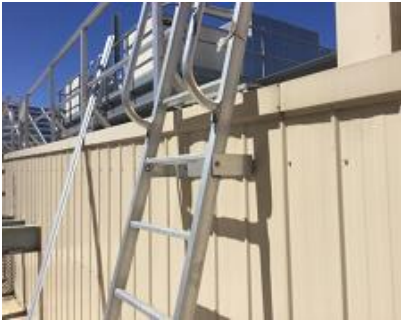
Top rung not levelled with landing, bottom rung height is less than required minimum and handrail projecting towards the user	Trips, Slips and Falls	Awareness induction	Med	Existing ladder to be removed and new ladder to be installed	Low	Client advised	Outstanding	OH&S REGULATIONS 3.7 AS/NZS 1657-2013 7.4.3.3, 7.4.3.4 & 7.4.8.5

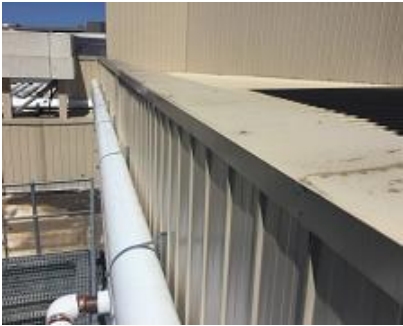
No height safety system installed	Trips, Slips and Falls	Awareness induction	High	Fall arrest anchors, anchor strop and access ladder to be installed	Low	Client advised	Outstanding	OH&S REGULATIONS 3.55 AS/NZS 1657-2013 3.1.4
25 0	Building: General Stores Location Reference: L100 Task: Access to the roof

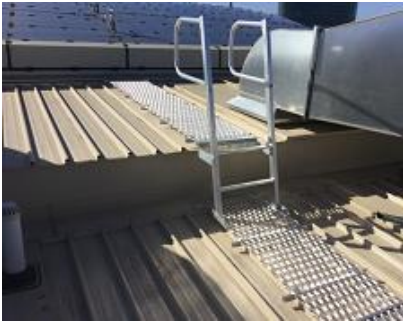
Gap between top rung and landing is greater than required maximum	Trips, Slips and Falls	Awareness induction	Med	Existing ladder to be re-installed with landing platforms and brackets	Low	Client advised	Outstanding	OH&S REGULATIONS 3.7 AS/NZS 1657-2013 7.3.6

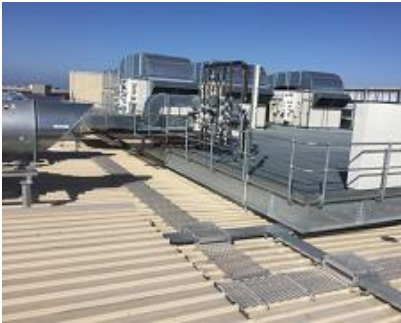
Variation in height between walkway panels are greater than required maximum	Trips, Slips and Falls	Awareness induction	Med	High visibility safety yellow nosing's to be installed	Low	Client advised	Outstanding	OH&S REGULATIONS 3.7 AS/NZS 1657-2013 3.3.4
252	Building: General Stores Location Reference: L100 Task: Access to the plant deck

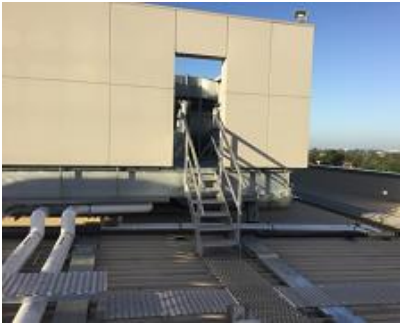
Gap between stair and permanent structure is greater than required maximum	Trips, Slips and Falls	Awareness induction	Med	Handrail to be installed	Low	Client advised	Outstanding	OH&S REGULATIONS 3.7 AS/NZS 1657-2013 4.4

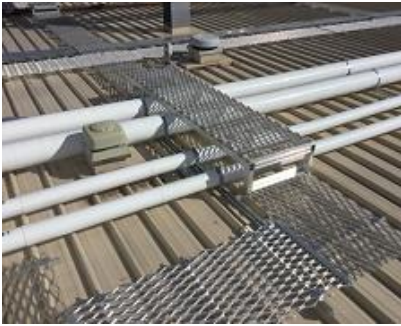
Variation in height between landing and roof is greater than required maximum	Trips, Slips and Falls	Awareness induction	Med	Handrail to be installed	Low	Client advised	Outstanding	OH&S REGULATIONS 3.7 AS/NZS 1657-2013 4.4
25 4	Building: General Stores Location Reference: L100 Task: Access to the roof

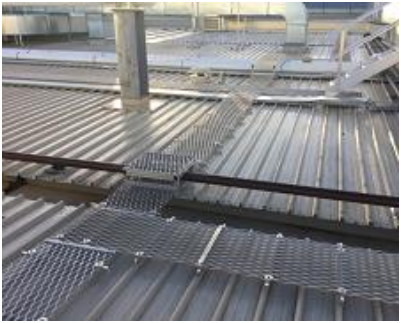
Variation in height between walkway panels are greater than required maximum and Variation in height between walkway and adjacent surface is greater than required maximum	Trips, Slips and Falls	Awareness induction	Med	High visibility safety yellow nosing's including handrail to be installed	Low	Client advised	Outstanding	OH&S REGULATIONS 3.7 AS/NZS 1657-2013 3.3.4 & 4.4

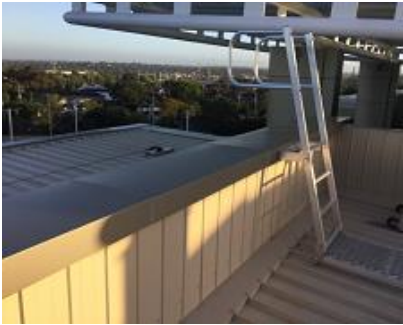
Non-complaint ladder is present	Trips, Slips and Falls	Awareness induction	Med	Existing ladder to be removed and new ladder to be installed	Low	Client advised	Outstanding	OH&S REGULATIONS 3.7 AS/NZS 1657-2013 7.4
25 6	Building: General Stores Location Reference: L101 Task: Access to the roof

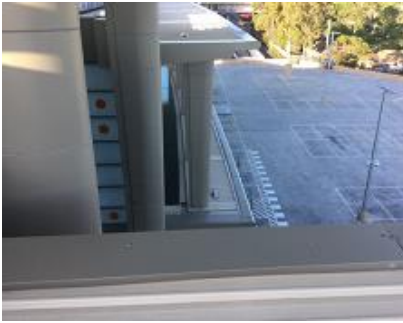
No safe access to lower awning roof	Trips, Slips and Falls	Awareness induction	High	"EWP Access to Roof" sign on lower awning roof to be installed	Low	Client advised	Outstanding	OH&S REGULATIONS 3.55 & 3.11
