Roof Safety Report

**Chadstone Shopping Centre,
VIC 3148**

Prepared By: Safemaster Safety Products
Date: 20 April 2018

Roof Safety Report for
Chadstone Shopping Centre, VIC 3148

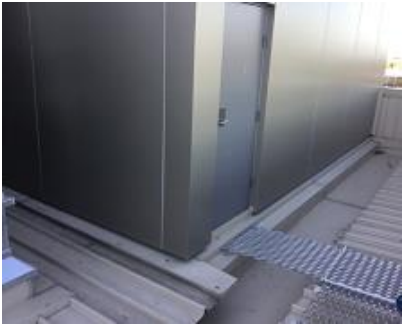
Variation in height between walkway and adjacent surface is greater than required maximum	Trips, Slips and Falls	Awareness induction	Med	Handrail to be installed	Low	Client advised	Outstanding	OH&S REGULATIONS 3.7 AS/NZS 1657-2013 4.4
25 8	Building: General Stores Location Reference: L102 Task: Restrict access to the roof

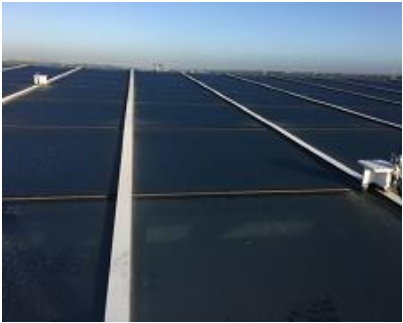
Glass roof is present	Trips, Slips and Falls	Restrict Access	High	Centre management to confirm the glass roof is trafficable or not to install signs	Low	Client advised	Outstanding	OH&S REGULATIONS 3.55 & 3.57

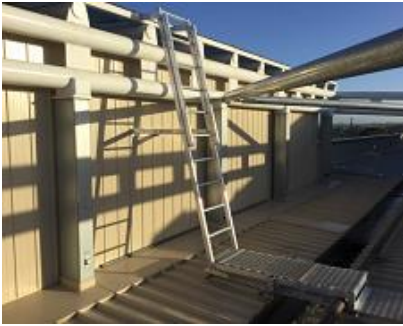
Gap between top rung and landing is greater than required maximum, clearance front of ladder is less than required minimum and handrail is missing for landing	Trips, Slips and Falls	Awareness induction	Med	Existing ladder to be re-located with new brackets, landing platforms, anchor stop and handrails	Low	Client advised	Outstanding	OH&S REGULATIONS 3.7 AS/NZS 1657-2013 7.4.8.4, 7.4.5 & 4.4
260	Building: General Stores Location Reference: L102 Task: Access to the roof

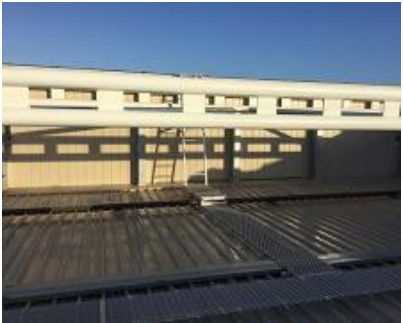
Headroom is less than required minimum	Trips, Slips and Falls	Awareness induction	High	"Caution-Low Headroom" signs to be installed	Low	Client advised	Outstanding	OH&S REGULATIONS 3.7 AS/NZS 1657-2013 3.1.5

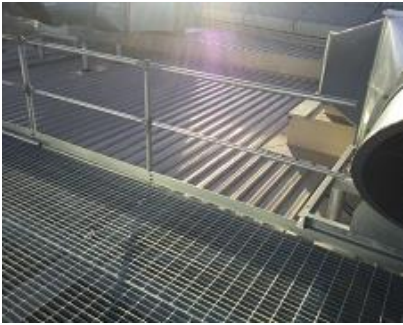
Handrail not fully secured	Trips, Slips and Falls	Awareness induction	Med	Handrail post to be installed	Low	Client advised	Outstanding	OH&S REGULATIONS 3.7 AS/NZS 1657-2013 4.4
262	Building: General Stores Location Reference: L103 Task: Access to the plant deck

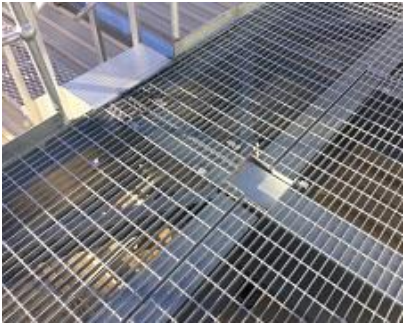
Un-protected cut outs are present	Trips, Slips and Falls	Awareness induction	Med	Gap to be closed	Low	Client advised	Outstanding	OH&S REGULATIONS 3.7 AS/NZS 1657-2013 3.2.3.4

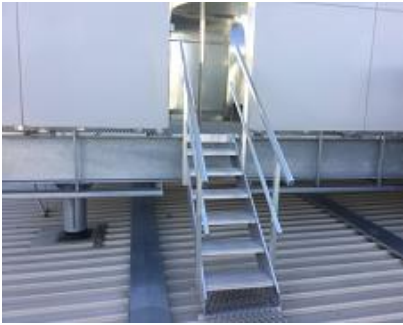
Gap between handrail and permanent structure is greater than required maximum	Trips, Slips and Falls	Awareness induction	Med	Handrail posts to be installed or Gap to be closed	Low	Client advised	Outstanding	OH&S REGULATIONS 3.7 AS/NZS 1657-2013 4.4
26 4	Building: General Stores Location Reference: L103 Task: Access to the plant deck

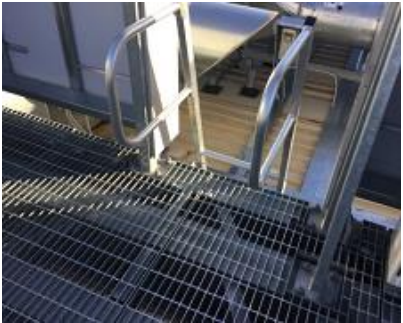
Gap between top rung and landing is greater than required maximum and landing is less than required minimum	Trips, Slips and Falls	Awareness induction	Med	Landing platforms to be installed	Low	Client advised	Outstanding	OH&S REGULATIONS 3.7 AS/NZS 1657-2013 7.3.6

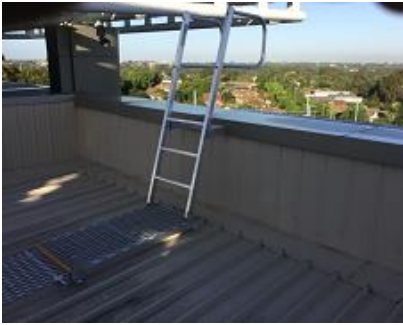
Non-complaint ladder is present	Trips, Slips and Falls	Awareness induction	Med	Existing ladder to be removed and new ladder to be installed	Low	Client advised	Outstanding	OH&S REGULATIONS 3.7 AS/NZS 1657-2013 7.4
26 6	Building: General Stores Location Reference: L105 Task: Access to the roof

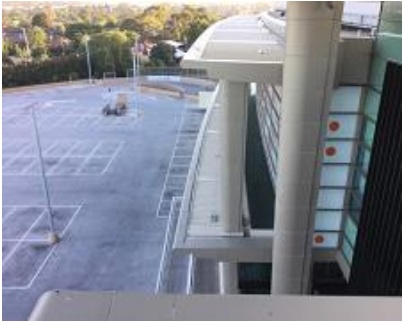
No safe access to lower awning roof	Trips, Slips and Falls	Awareness induction	High	"EWP Access to Roof" sign on lower awning roof to be installed	Low	Client advised	Outstanding	OH&S REGULATIONS 3.55 & 3.11

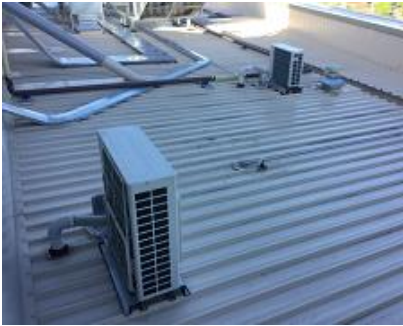
No safe access to the A/c units	Trips, Slips and Falls	N/A	Low	Supply walkway to the A/c units	Low	Client advised	Outstanding	-
26 8	Building: General Stores Location Reference: L106 Task: Access to the roof

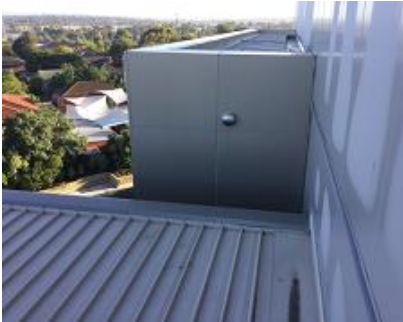
No height safety and safe access system installed	Trips, Slips and Falls	Awareness induction	High	Fall arrest static line, anchor strop and access ladder to be installed	Low	Client advised	Outstanding	OH&S REGULATIONS 3.7 & 3.55 AS/NZS 1657-2013 3.1.4

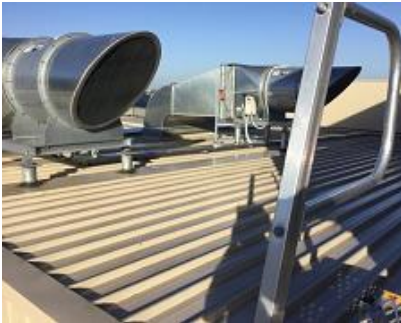
No safe access to the A/c units	Trips, Slips and Falls	N/A	Low	Supply walkway, step overs and handrail to the A/c units	Low	Client advised	Outstanding	-
27 0	Building: General Stores Location Reference: L107 Task: Access to the roof

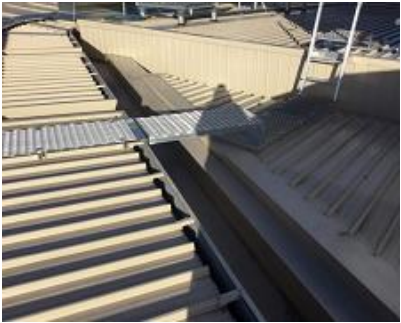
Variation in height between landing and adjacent surface is greater than required maximum	Trips, Slips and Falls	Awareness induction	Med	Handrails to be installed	Low	Client advised	Outstanding	OH&S REGULATIONS 3.7 AS/NZS 1657-2013 4.4

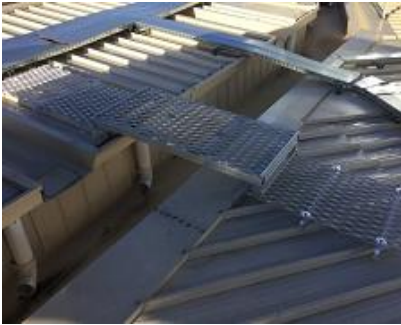
Variation in height between landing and adjacent surface is greater than required maximum	Trips, Slips and Falls	Awareness induction	Med	Handrails to be installed	Low	Client advised	Outstanding	OH&S REGULATIONS 3.7 AS/NZS 1657-2013 4.4
272	Building: General Stores Location Reference: L108 Task: Access to the roof

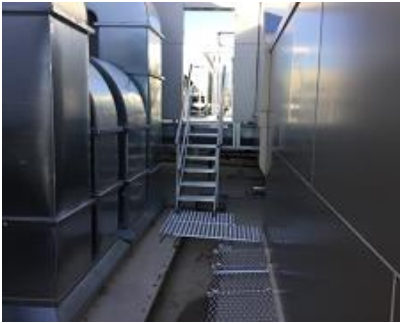
Gap between handrail and permanent structure is greater than required maximum	Trips, Slips and Falls	Awareness induction	Med	Handrail posts to be installed or Gap to be closed	Low	Client advised	Outstanding	OH&S REGULATIONS 3.7 AS/NZS 1657-2013 4.4

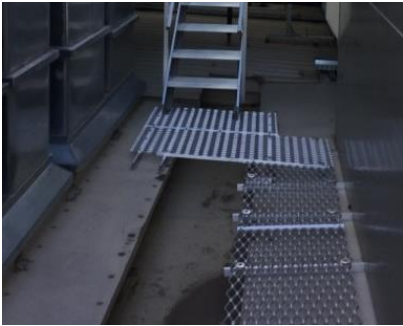
Variation in height between walkway and adjacent surface is greater than required maximum	Trips, Slips and Falls	Awareness induction	Med	Handrails or additional walkway to be installed	Low	Client advised	Outstanding	OH&S REGULATIONS 3.7 AS/NZS 1657-2013 4.4
27 4	Building: General Stores Location Reference: L109 Task: Access to the roof

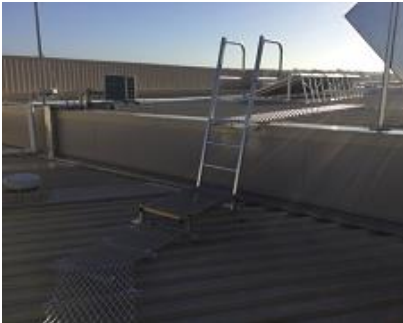
Gap between top rung and landing is greater than required maximum	Trips, Slips and Falls	Awareness induction	Med	Gap to be closed	Low	Client advised	Outstanding	OH&S REGULATIONS 3.7 AS/NZS 1657-2013 7.4.8.4

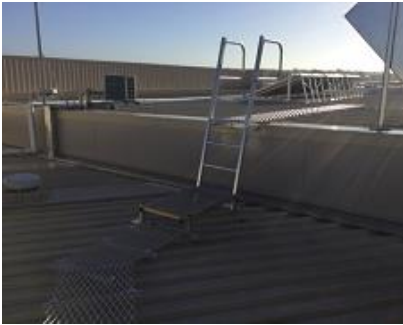
No safe access to the A/c units	Trips, Slips and Falls	N/A	Low	Supply walkway, step overs and handrail to the A/c units	Low	Client advised	Outstanding	-
27 6	Building: General Stores Location Reference: L109 Task: Access to the roof

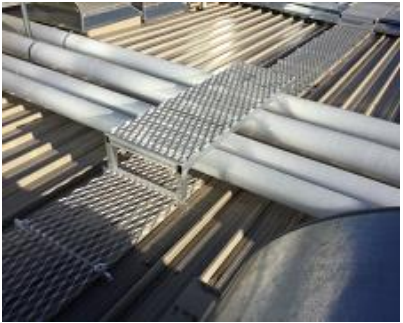
Variation in height between landing and adjacent surface is greater than required maximum	Trips, Slips and Falls	Awareness induction	Med	Handrails to be installed	Low	Client advised	Outstanding	OH&S REGULATIONS 3.7 AS/NZS 1657-2013 4.4

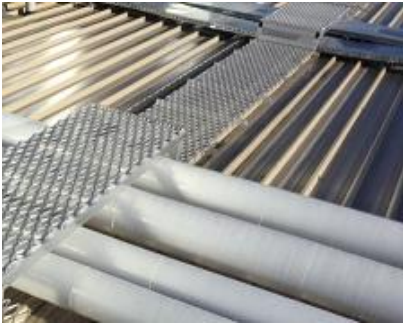
Variation in height between walkway panels are greater than required maximum	Trips, Slips and Falls	Awareness induction	Med	High visibility safety yellow nosing's to be installed	Low	Client advised	Outstanding	OH&S REGULATIONS 3.7 AS/NZS 1657-2013 3.3.4
27 8	Building: General Stores Location Reference: L110 Task: Access to the roof

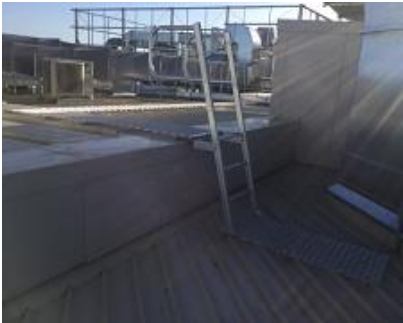
Gap between top rung and landing is greater than required maximum	Trips, Slips and Falls	Awareness induction	Med	Gap to be closed	Low	Client advised	Outstanding	OH&S REGULATIONS 3.7 AS/NZS 1657-2013 7.4.8.4

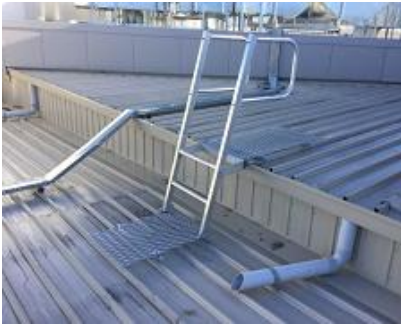
Gap between top rung and landing is greater than required maximum	Trips, Slips and Falls	Awareness induction	Med	Gap to be closed	Low	Client advised	Outstanding	OH&S REGULATIONS 3.7 AS/NZS 1657-2013 7.4.8.4
28 0	Building: General Stores Location Reference: L110 Task: Access to the roof

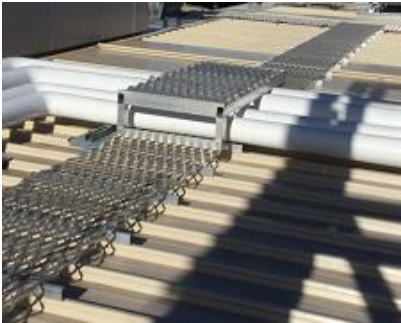
Variation in height between landing and adjacent surface is greater than required maximum	Trips, Slips and Falls	Awareness induction	Med	Handrails to be installed	Low	Client advised	Outstanding	OH&S REGULATIONS 3.7 AS/NZS 1657-2013 4.4

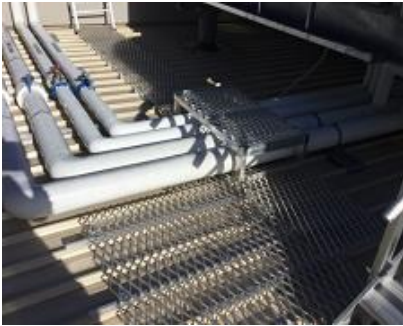
Variation in height between landing and adjacent surface is greater than required maximum	Trips, Slips and Falls	Awareness induction	Med	Handrails to be installed	Low	Client advised	Outstanding	OH&S REGULATIONS 3.7 AS/NZS 1657-2013 4.4
282	Building: General Stores Location Reference: L111 Task: Access to the plant deck

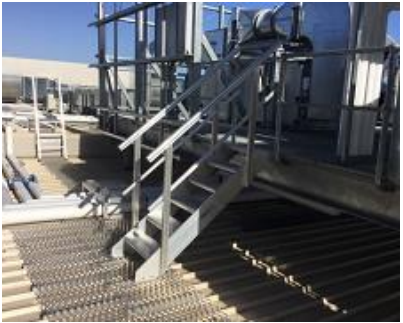
Variation in height between plant deck and roof is greater than required maximum	Trips, Slips and Falls	Awareness induction	Med	Handrail to be installed	Low	Client advised	Outstanding	OH&S REGULATIONS 3.7 AS/NZS 1657-2013 4.4

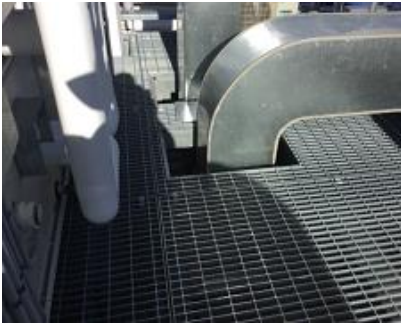
Un-protected cut outs are present	Trips, Slips and Falls	Awareness induction	Med	Gap to be closed	Low	Client advised	Outstanding	OH&S REGULATIONS 3.7 AS/NZS 1657-2013 3.2.3.4
28 4	Building: General Stores Location Reference: L112 Task: Access to the roof

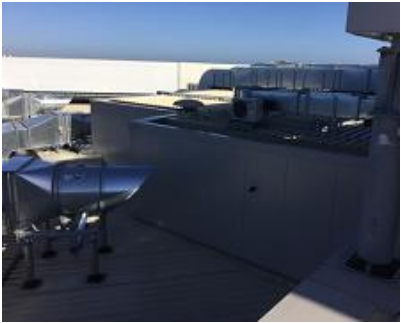
No safe access and height safety system installed	Trips, Slips and Falls	Awareness induction	Med	Fall arrest anchors, anchor strop and access ladder to be installed	Low	Client advised	Outstanding	OH&S REGULATIONS 3.7 & 3.55 AS/NZS 1657-2013 3.1.4

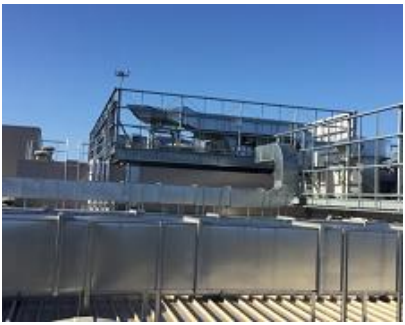
Variation in height between plant deck and roof is greater than required maximum	Trips, Slips and Falls	Awareness induction	Med	Handrail to be installed	Low	Client advised	Outstanding	OH&S REGULATIONS 3.7 AS/NZS 1657-2013 4.4

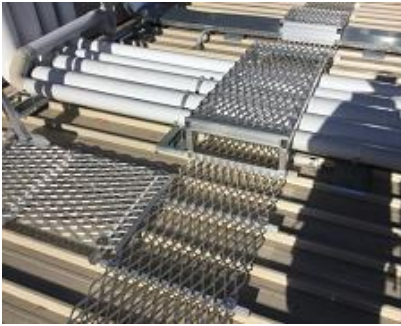
Variation in height between landing and adjacent surface is greater than required maximum	Trips, Slips and Falls	Awareness induction	Med	Handrails to be installed	Low	Client advised	Outstanding	OH&S REGULATIONS 3.7 AS/NZS 1657-2013 4.4
28 8	Building: General Stores Location Reference: L112 Task: Access to the roof

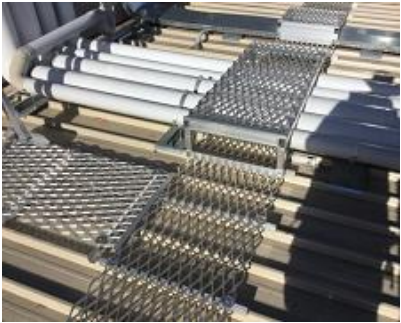
Variation in height between walkway panels are greater than required maximum	Trips, Slips and Falls	Awareness induction	Med	High visibility safety yellow nosing's to be installed	Low	Client advised	Outstanding	OH&S REGULATIONS 3.7 AS/NZS 1657-2013 3.3.4

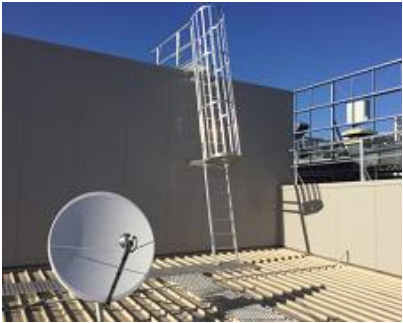
Landing is less than required minimum	Trips, Slips and Falls	Awareness induction	Med	Additional walkway sections to be installed	Low	Client advised	Outstanding	OH&S REGULATIONS 3.7 AS/NZS 1657-2013 7.3.6
29 0	Building: General Stores Location Reference: L113 Task: Access to the roof

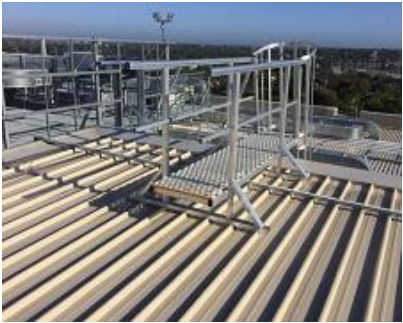
Variation in height between landing and roof is greater than required maximum	Trips, Slips and Falls	Awareness induction	Med	Step to be installed	Low	Client advised	Outstanding	OH&S REGULATIONS 3.7 AS/NZS 1657-2013 3.1.4

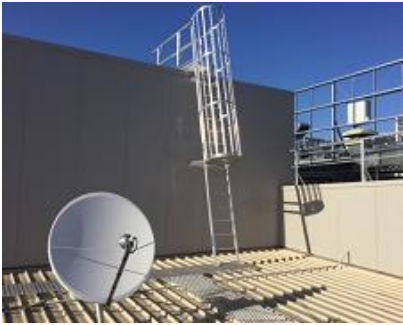
No safe access to the A/c units	Trips, Slips and Falls	N/A	Low	Supply walkway to the A/c units	Low	Client advised	Outstanding	-
292	Building: General Stores Location Reference: L114 Task: Access to the A/c units

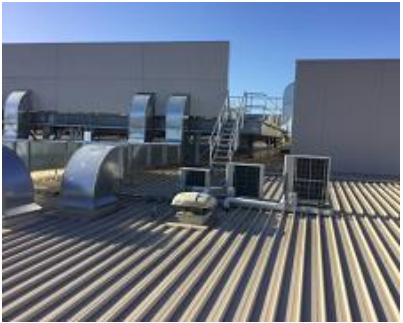
No safe access to the A/c units	Trips, Slips and Falls	N/A	Low	Supply walkway to the A/c units	Low	Client advised	Outstanding	-

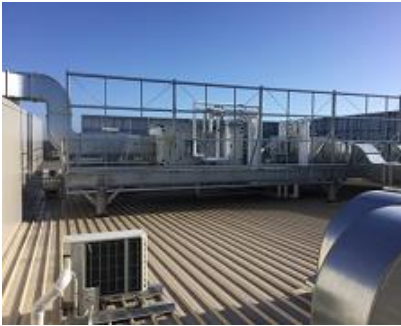
Variation in height between plant deck and roof is greater than required maximum	Trips, Slips and Falls	Awareness induction	Med	Handrail to be installed	Low	Client advised	Outstanding	OH&S REGULATIONS 3.7 AS/NZS 1657-2013 4.4
29 4	Building: General Stores Location Reference: L114 Task: Access to the A/c units

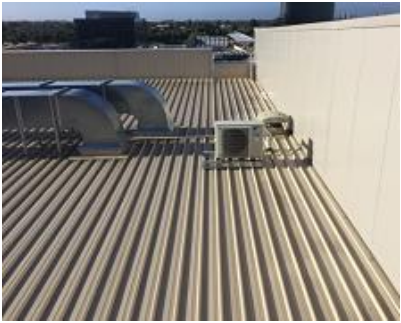
No safe access to the A/c units	Trips, Slips and Falls	N/A	Low	Supply walkway, Step over and handrail to the A/c units	Low	Client advised	Outstanding	-

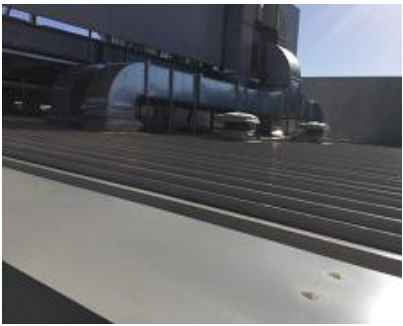
No safe access to the A/c units	Trips, Slips and Falls	N/A	Low	Supply walkway to the A/c units	Low	Client advised	Outstanding	-

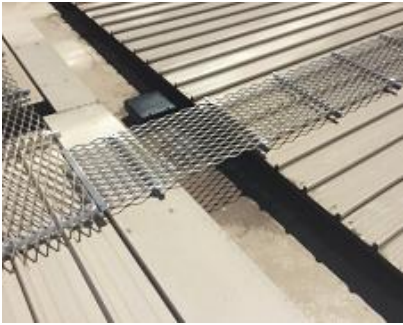
Variation in height between walkway and adjacent surface is greater than required maximum	Trips, Slips and Falls	Awareness induction	Med	Handrail to be installed	Low	Client advised	Outstanding	OH&S REGULATIONS 3.7 AS/NZS 1657-2013 4.4
29 8	Building: General Stores Location Reference: L117 Task: Access to the plant deck

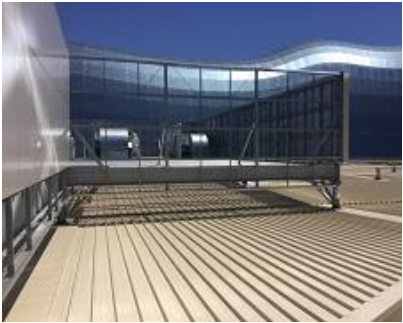
Variation in height between plant deck and roof is greater than required maximum	Trips, Slips and Falls	Awareness induction	Med	Handrail to be installed	Low	Client advised	Outstanding	OH&S REGULATIONS 3.7 AS/NZS 1657-2013 4.4

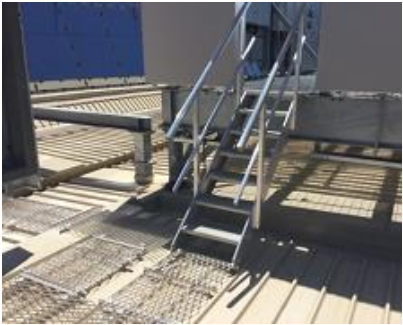
Gap between handrail and permanent structure is greater than required maximum	Trips, Slips and Falls	Awareness induction	Med	Handrail post to be installed or gap to be closed	Low	Client advised	Outstanding	OH&S REGULATIONS 3.7 AS/NZS 1657-2013 4.4
30 0	Building: General Stores Location Reference: L117 Task: Access to the roof

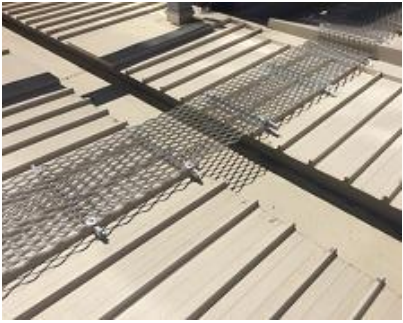
Variation in height between walkway and adjacent surface is greater than required maximum	Trips, Slips and Falls	Awareness induction	Med	Handrail to be installed	Low	Client advised	Outstanding	OH&S REGULATIONS 3.7 AS/NZS 1657-2013 4.4

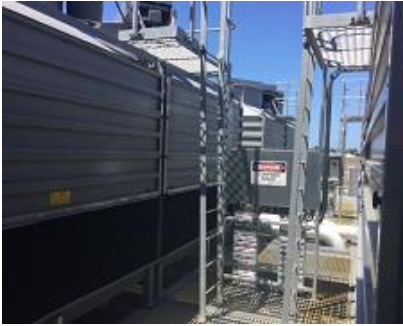
No slip resistance on ladder rungs	Trips, Slips and Falls	Awareness induction	Med	Non-slip high visibility safety yellow nosing caps to be installed	Low	Client advised	Outstanding	OH&S REGULATIONS 3.7 AS/NZS 1657-2013 7.4.3.1
302	Building: General Stores Location Reference: L118 Task: Access to the plant deck

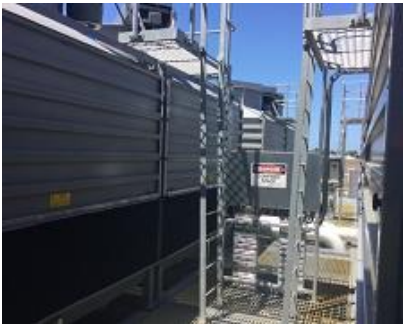
No slip resistance on ladder rungs	Trips, Slips and Falls	Awareness induction	Med	Non-slip high visibility safety yellow nosing caps to be installed	Low	Client advised	Outstanding	OH&S REGULATIONS 3.7 AS/NZS 1657-2013 7.4.3.1

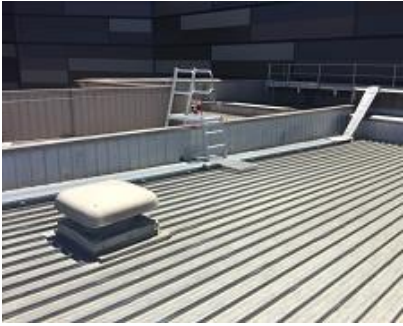
No safe access to the ladder	Trips, Slips and Falls	N/A	Low	Supply walkway to the ladder	Low	Client advised	Outstanding	-
306	Building: General Stores Location Reference: L119 Task: Access to the A/c units

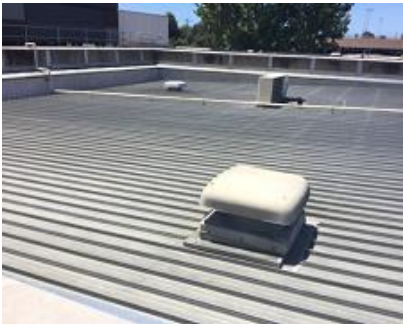
No safe access to the A/c units	Trips, Slips and Falls	N/A	Low	Supply walkway, step over and handrail to the A/c units	Low	Client advised	Outstanding	-

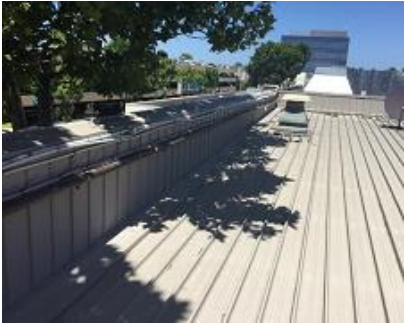
No height safety system installed	Trips, Slips and Falls	Awareness induction	High	Fall arrest anchors to be installed	Low	Client advised	Outstanding	OH&S REGULATIONS 3.55
30 8	Building: General Stores Location Reference: L120 Task: Access to the roof

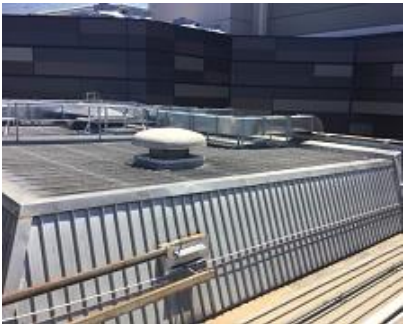
No height safety system installed	Trips, Slips and Falls	Awareness induction	High	Fall arrest anchors to be installed	Low	Client advised	Outstanding	OH&S REGULATIONS 3.55

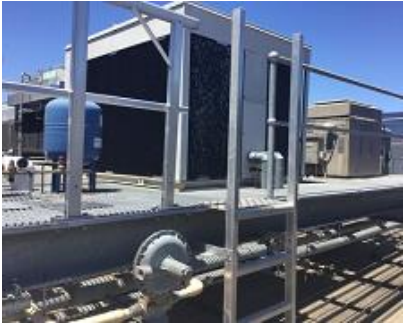
Gap between handrail and ladder is greater than required maximum	Trips, Slips and Falls	Awareness induction	Med	Handrail posts to be installed	Low	Client advised	Outstanding	OH&S REGULATIONS 3.7 AS/NZS 1657-2013 4.4
310	Building: General Stores Location Reference: L122 Task: Access to the roof

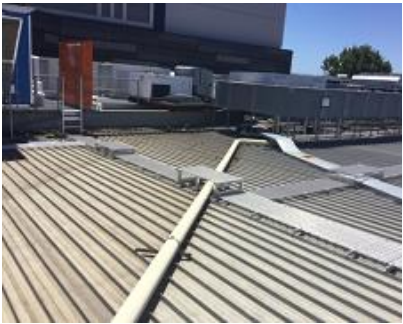
Variation in height between walkway panels are greater than required maximum	Trips, Slips and Falls	Awareness induction	Med	High visibility safety yellow nosing's to be installed	Low	Client advised	Outstanding	OH&S REGULATIONS 3.7 AS/NZS 1657-2013 3.3.4

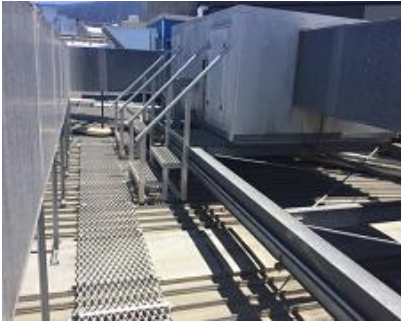
Handrail height is less than required minimum	Trips, Slips and Falls	Awareness induction	Med	Existing handrail to be removed and new handrail to be installed	Low	Client advised	Outstanding	OH&S REGULATIONS 3.7 AS/NZS 1657-2013 7.2.6
312	Building: General Stores Location Reference: L123 Task: Access to the roof

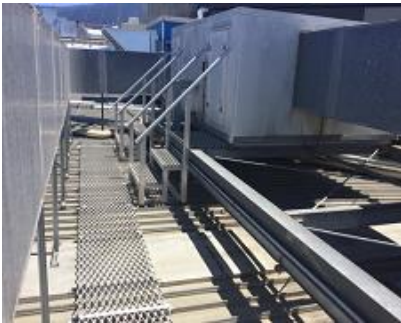
Handrail height is less than required minimum	Trips, Slips and Falls	Awareness induction	Med	Existing handrail to be removed and new handrail to be installed	Low	Client advised	Outstanding	OH&S REGULATIONS 3.7 AS/NZS 1657-2013 7.2.6

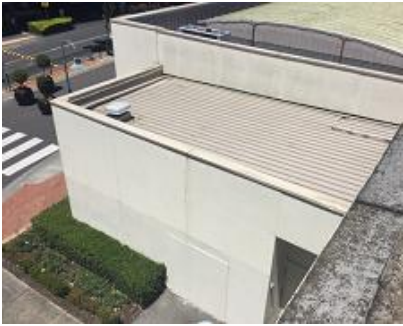
No height safety system installed	Trips, Slips and Falls	Awareness induction	High	Fall arrest anchors and access ladder to be installed	Low	Client advised	Outstanding	OH&S REGULATIONS 3.55 & 3.7 AS/NZS 1657-2013 3.1.4
314	Building: General Stores Location Reference: L124 Task: Access to the A/c units

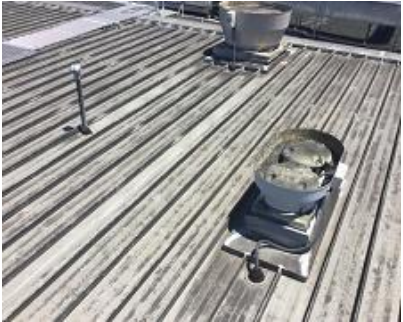
No safe access to the A/c units	Trips, Slips and Falls	N/A	Low	Supply walkway and handrail to the A/c units	Low	Client advised	Outstanding	-

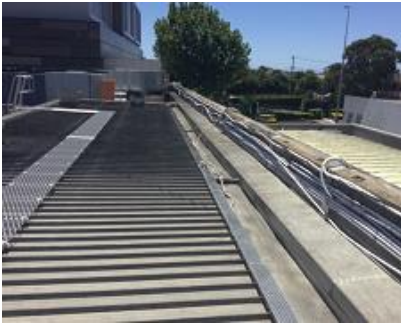
No height safety system installed	Trips, Slips and Falls	Awareness induction	High	Fall arrest anchors to be installed	Low	Client advised	Outstanding	OH&S REGULATIONS 3.55
316	Building: General Stores Location Reference: L124 Task: Access to the roof

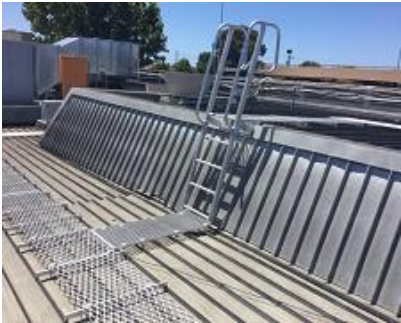
Top rung not levelled with landing, bottom rung height is less than required minimum, clearance behind the ladder is less than required minimum and handrail projecting towards the user	Trips, Slips and Falls	Awareness induction	Med	Existing ladder to be removed and new ladder to be installed	Low	Client advised	Outstanding	OH&S REGULATIONS 3.7 AS/NZS 1657-2013 7.4.3.3, 7.4.3.4, 7.4.5 & 7.4.8.5

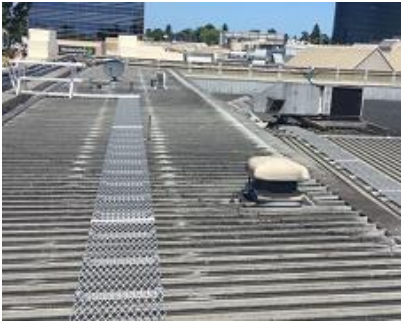
No safe access to the A/c units	Trips, Slips and Falls	N/A	Low	Supply walkway and handrail to the A/c units	Low	Client advised	Outstanding	-
318	Building: General Stores Location Reference: L124 Task: Access to the A/c units

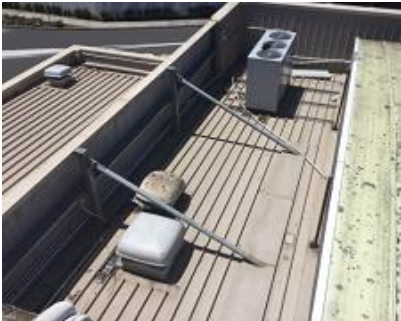
No safe access to the A/c units	Trips, Slips and Falls	N/A	Low	Supply walkway to the A/c units	Low	Client advised	Outstanding	-

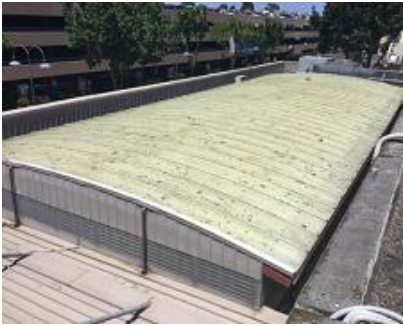
Brittle roof (Non-trafficable roof)	Trips, Slips and Falls	Restrict Access	High	"Warning-Keep Off-Brittle and Fragile Roof" signs to be installed	Low	Client advised	Outstanding	OH&S REGULATIONS 3.57
320	Building: General Stores Location Reference: L124 Task: Access to the roof

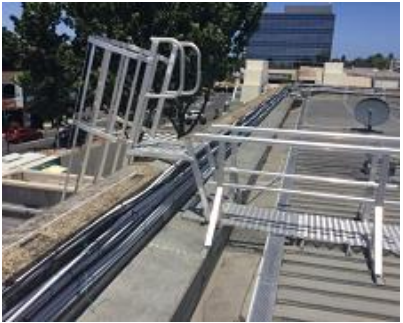
Bottom rung heights are less than required minimum	Trips, Slips and Falls	Awareness induction	Med	Landing platforms to be installed	Low	Client advised	Outstanding	OH&S REGULATIONS 3.7 AS/NZS 1657-2013 7.3.6

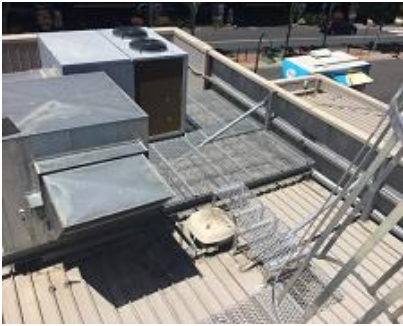
Variation in height between landing and roof is greater than required maximum	Trips, Slips and Falls	Awareness induction	Med	Handrails to be installed	Low	Client advised	Outstanding	OH&S REGULATIONS 3.7 AS/NZS 1657-2013 4.4
322	Building: General Stores Location Reference: L124 Task: Access to the roof

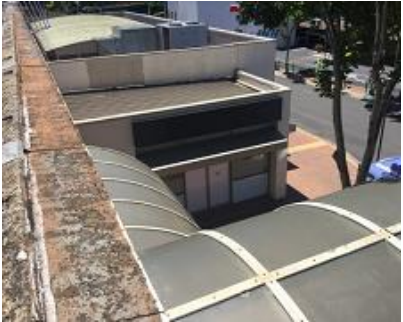
No height safety system installed	Trips, Slips and Falls	Awareness induction	High	Fall arrest anchors and access ladder to be installed	Low	Client advised	Outstanding	OH&S REGULATIONS 3.55 & 3.7 AS/NZS 1657-2013 3.1.4

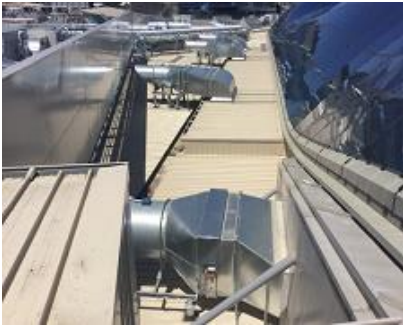
No safe access to the A/c units	Trips, Slips and Falls	N/A	Low	Supply walkway, access ladder and handrail to the A/c units	Low	Client advised	Outstanding	-
32 4	Building: General Stores Location Reference: L125 Task: Access to the roof

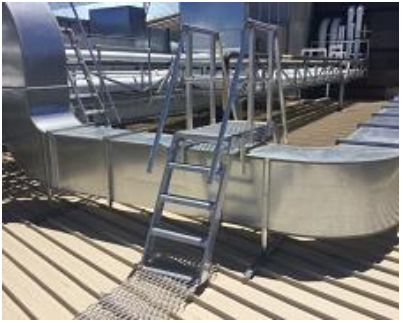
Bottom tread heights are greater than required maximum	Trips, Slips and Falls	Awareness induction	Med	Landing platforms to be installed	Low	Client advised	Outstanding	OH&S REGULATIONS 3.7 AS/NZS 1657-2013 7.3.3

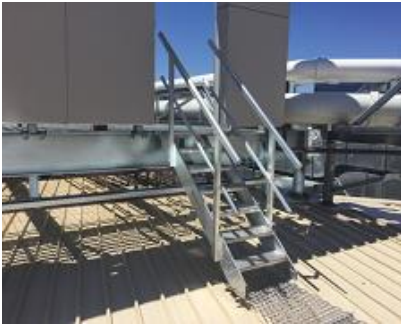
Gap between stair and permanent structure is greater than required maximum	Trips, Slips and Falls	Awareness induction	Med	Handrail to be installed or gap to be closed	Low	Client advised	Outstanding	OH&S REGULATIONS 3.7 AS/NZS 1657-2013 4.4
32 6	Building: General Stores Location Reference: L126 Task: Access to the roof

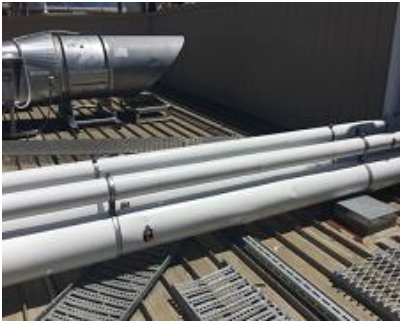
Pipe installed on the way to access to the A/c units	Trips, Slips and Falls	Awareness induction	Med	Access ladder to be installed	Low	Client advised	Outstanding	OH&S REGULATIONS 3.7 AS/NZS 1657-2013 3.1.4

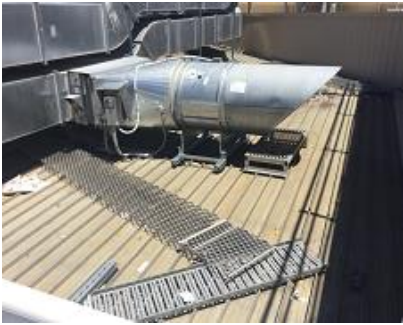
No safe access to the A/c units	Trips, Slips and Falls	N/A	Low	Supply walkway to the A/c units	Low	Client advised	Outstanding	-
32 8	Building: General Stores Location Reference: L127 Task: Access to the roof

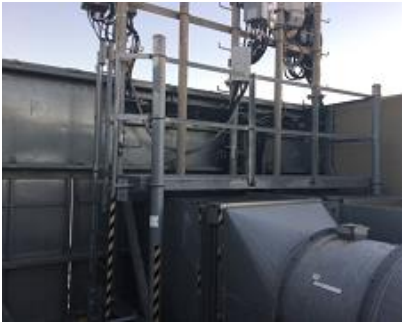
No slip resistance on ladder rungs and static line out of date	Trips, Slips and Falls	Awareness induction	Med	Existing ladder to be removed and new ladder to be installed	Low	Client advised	Outstanding	OH&S REGULATIONS 3.7 AS/NZS 1657-2013 7.4.3.1

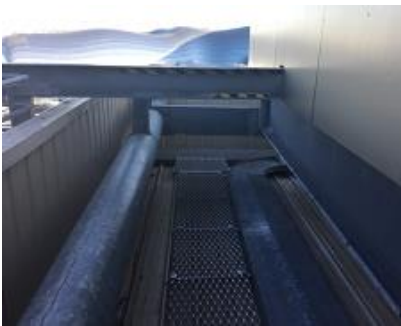
Head room is less than required minimum	Trips, Slips and Falls	Awareness induction	Med	"Caution-Low Headroom" signs to be installed	Low	Client advised	Outstanding	OH&S REGULATIONS 3.7 AS/NZS 1657-2013 3.1.5
330	Building: General Stores Location Reference: L127 Task: Access to the roof

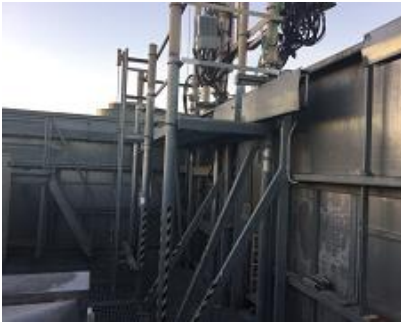
No slip resistance on ladder rungs and static line out of date	Trips, Slips and Falls	Awareness induction	Med	Existing ladder to be removed and new ladder to be installed	Low	Client advised	Outstanding	OH&S REGULATIONS 3.7 AS/NZS 1657-2013 7.4.3.1

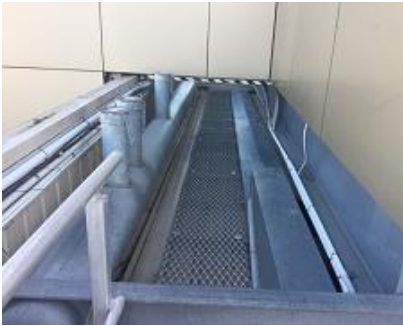
Head room is less than required minimum	Trips, Slips and Falls	Awareness induction	Med	"Caution-Low Headroom" signs to be installed	Low	Client advised	Outstanding	OH&S REGULATIONS 3.7 AS/NZS 1657-2013 3.1.5
332	Building: General Stores Location Reference: L127 Task: Access to the roof

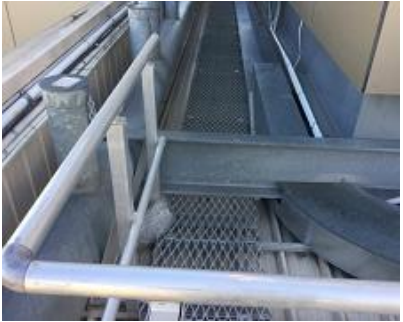
Bracings installed over the walkway path	Trips, Slips and Falls	Awareness induction	Med	Access ladder to be installed	Low	Client advised	Outstanding	OH&S REGULATIONS 3.7 AS/NZS 1657-2013 3.1.4

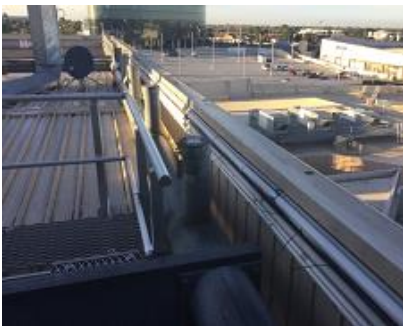
No height safety system installed	Trips, Slips and Falls	Awareness induction	High	Fall arrest anchors to be installed	Low	Client advised	Outstanding	OH&S REGULATIONS 3.55
33 4	Building: General Stores Location Reference: L128 Task: Access to the roof

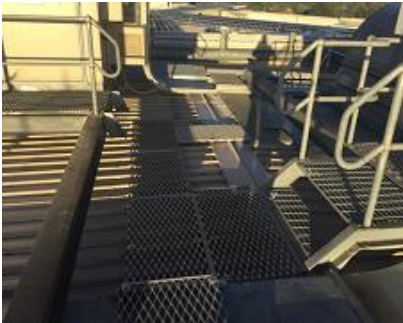
Variation in height between walkway panels are greater than required maximum	Trips, Slips and Falls	Awareness induction	Med	High visibility safety yellow nosing's to be installed	Low	Client advised	Outstanding	OH&S REGULATIONS 3.7 AS/NZS 1657-2013 3.3.4

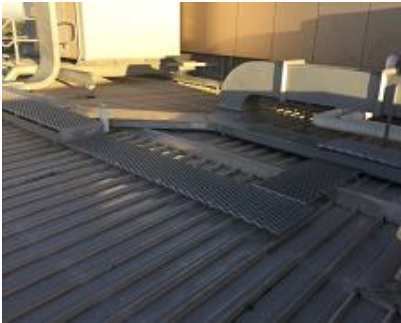
Variation in height between walkway panels are greater than required maximum	Trips, Slips and Falls	Awareness induction	Med	High visibility safety yellow nosing's to be installed	Low	Client advised	Outstanding	OH&S REGULATIONS 3.7 AS/NZS 1657-2013 3.3.4
33 6	Building: General Stores Location Reference: L129 Task: Access to the roof

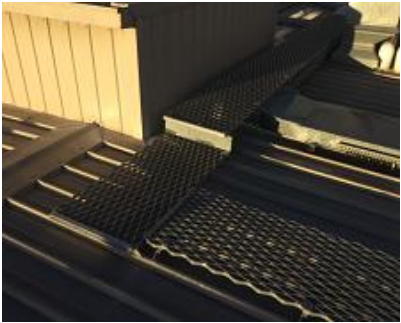
Variation in height between walkway panels are greater than required maximum	Trips, Slips and Falls	Awareness induction	Med	High visibility safety yellow nosing's to be installed	Low	Client advised	Outstanding	OH&S REGULATIONS 3.7 AS/NZS 1657-2013 3.3.4

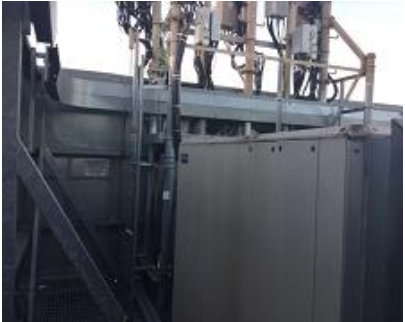
Top rung not levelled with landing, no slip resistance on ladder rungs and static line out of date	Trips, Slips and Falls	Awareness induction	Med	Existing ladder to be removed and new ladder to be installed	Low	Client advised	Outstanding	OH&S REGULATIONS 3.7 AS/NZS 1657-2013 7.4.3.3 & 7.4.3.1

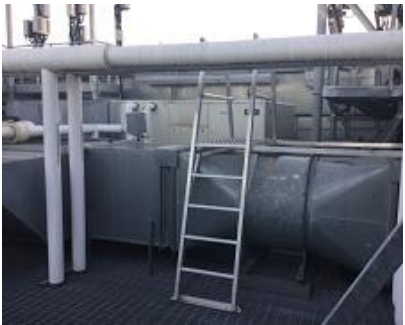
Headroom is less than required minimum	Trips, Slips and Falls	Awareness induction	Med	"Caution-Low Headroom" signs to be installed	Low	Client advised	Outstanding	OH&S REGULATIONS 3.7 AS/NZS 1657-2013 3.1.5

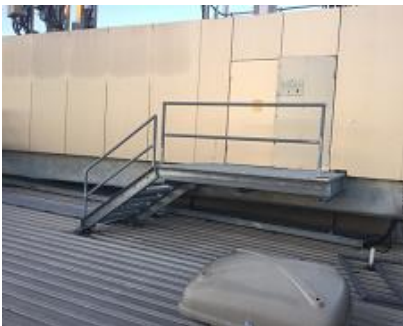
Handrail is missing for landing	Trips, Slips and Falls	Awareness induction	Med	Handrail to be installed	Low	Client advised	Outstanding	OH&S REGULATIONS 3.7 AS/NZS 1657-2013 7.2.6 & 4.4
342	Building: General Stores Location Reference: L129 Task: Access to the plant deck

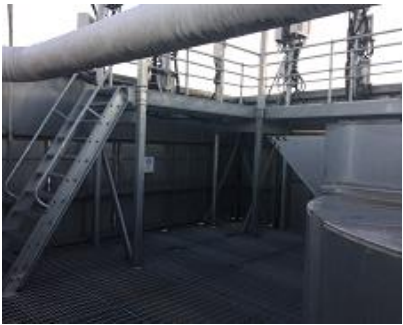
Slope of ladder is less than required minimum	Trips, Slips and Falls	Awareness induction	Med	Existing ladder to be removed and new ladder to be installed	Low	Client advised	Outstanding	OH&S REGULATIONS 3.7 AS/NZS 1657-2013 7.3.1

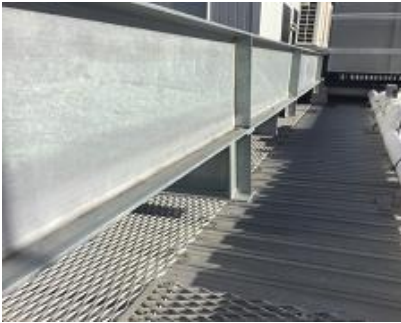
No safe access to the A/c units	Trips, Slips and Falls	N/A	Low	Re-locate the existing walkway	Low	Client advised	Outstanding	-
34 4	Building: General Stores Location Reference: L131 Task: Access to the A/c units

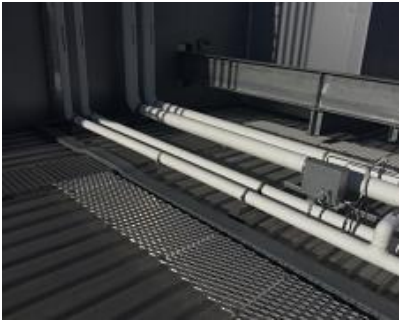
Pipes installed on the way to access A/c units	Trips, Slips and Falls	Awareness induction	Med	Step bridge to be installed	Low	Client advised	Outstanding	OH&S REGULATIONS 3.7 AS/NZS 1657-2013 3.1.4

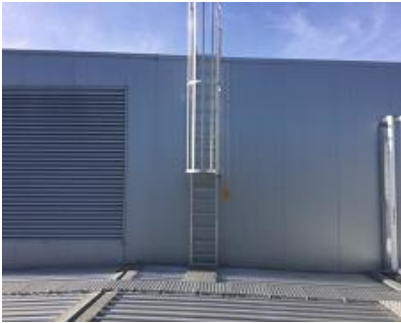
Top rung not levelled with landing, bottom rung height is less than required minimum and landing is less than required minimum	Trips, Slips and Falls	Awareness induction	Med	Existing ladder to be re-installed with landing platforms, ladder section, brackets and handrails	Low	Client advised	Outstanding	OH&S REGULATIONS 3.7 AS/NZS 1657-2013 7.4.3.3, 7.4.3.4 & 7.3.6
34 6	Building: General Stores Location Reference: L132 Task: Access to the roof

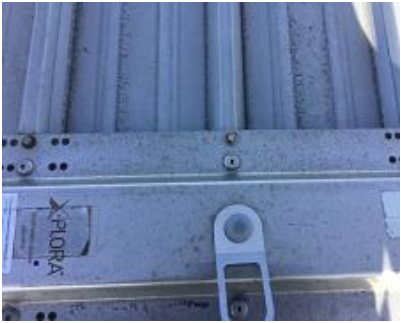
Non-certifiable anchor is present (Rusted)	Trips, Slips and Falls	Awareness induction	High	Existing anchor to be removed and new anchor to be installed	Low	Client advised	Outstanding	OH&S REGULATIONS 3.55

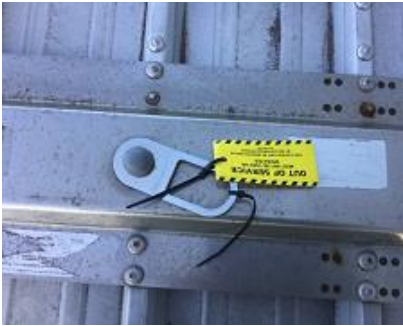
Non-certifiable anchor is present (Rusted)	Trips, Slips and Falls	Awareness induction	High	Existing anchor to be removed and new anchor to be installed	Low	Client advised	Outstanding	OH&S REGULATIONS 3.55
34 8	Building: General Stores Location Reference: L133 Task: Access to the roof

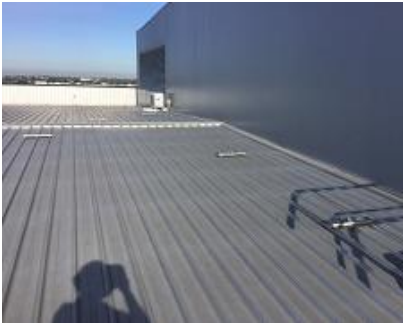
No safe access to the A/c units	Trips, Slips and Falls	N/A	Low	Supply walkway to the A/c units	Low	Client advised	Outstanding	-

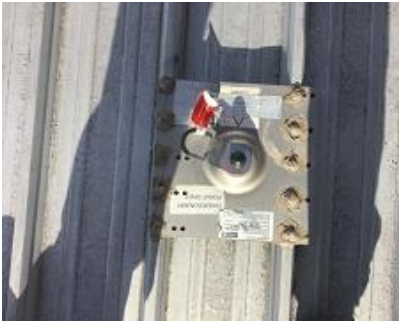
Anchor tagged as out of service. This anchor not required	Trips, Slips and Falls	Awareness induction	High	Existing anchor to be removed	Low	Client advised	Outstanding	OH&S REGULATIONS 3.55
35 0	Building: General Stores Location Reference: L133 Task: Access to the roof

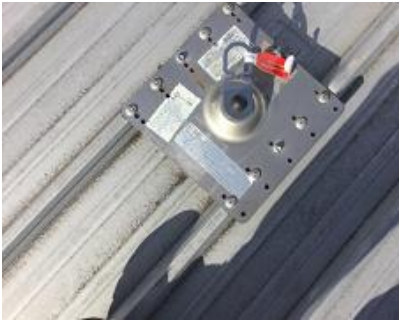
Anchor tagged as out of service. This anchor not required	Trips, Slips and Falls	Awareness induction	High	Existing anchor to be removed	Low	Client advised	Outstanding	OH&S REGULATIONS 3.55

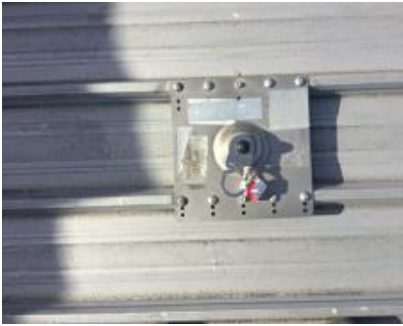
Anchor tagged as out of service. This anchor not required	Trips, Slips and Falls	Awareness induction	High	Existing anchor to be removed	Low	Client advised	Outstanding	OH&S REGULATIONS 3.55
352	Building: General Stores Location Reference: L133 Task: Access to the roof

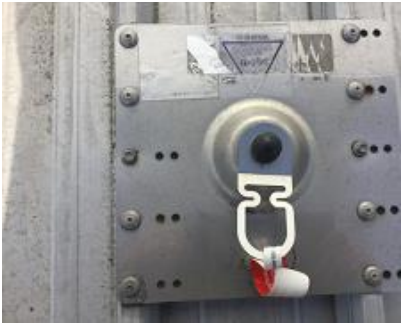
Anchor tagged as out of service. This anchor not required	Trips, Slips and Falls	Awareness induction	High	Existing anchor to be removed	Low	Client advised	Outstanding	OH&S REGULATIONS 3.55

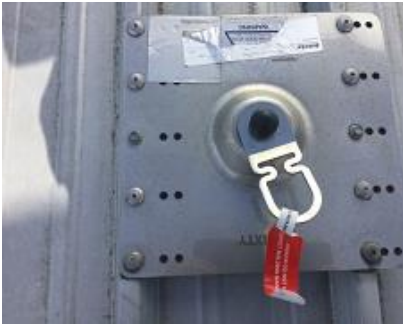
Anchor tagged as out of service. This anchor not required	Trips, Slips and Falls	Awareness induction	High	Existing anchor to be removed	Low	Client advised	Outstanding	OH&S REGULATIONS 3.55
35 4	Building: General Stores Location Reference: L134 Task: Access to the roof

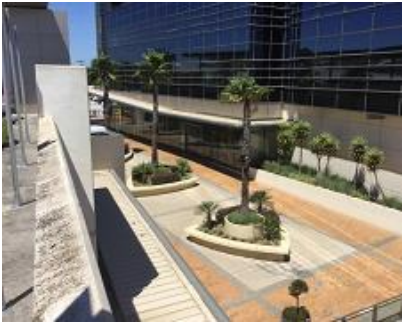
No height safety system installed	Trips, Slips and Falls	Awareness induction	High	Fall arrest anchors, anchor strop, ladder access bracket and sign to be installed	Low	Client advised	Outstanding	OH&S REGULATIONS 3.55

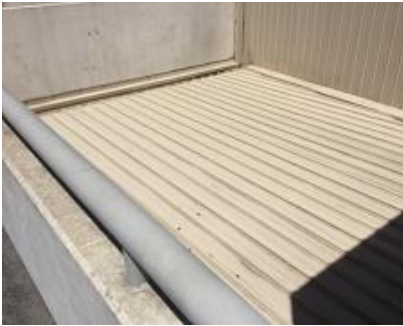
No safe access to the roof	Trips, Slips and Falls	Awareness induction	Med	Access ladder and ladder access bracket to be installed	Low	Client advised	Outstanding	OH&S REGULATIONS 3.7 AS/NZS 1657-2013 3.1.4
35 6	Building: General Stores Location Reference: L136 Task: Access to the roof

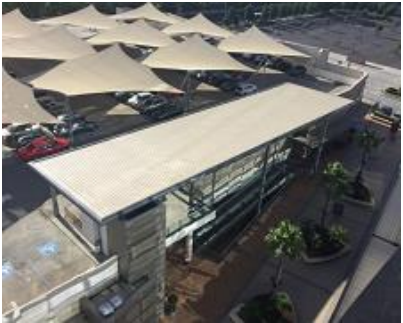
No height safety system installed	Trips, Slips and Falls	Awareness induction	High	Fall arrest anchors, anchor strop, ladder access bracket and sign to be installed	Low	Client advised	Outstanding	OH&S REGULATIONS 3.55

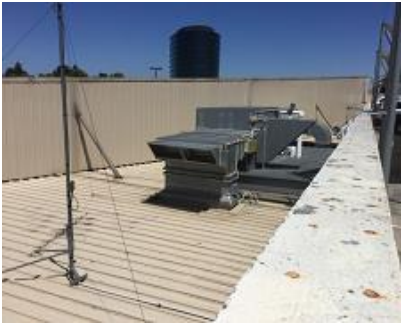
Variation in height between plant deck and roof is greater than required maximum	Trips, Slips and Falls	Awareness induction	Med	Handrail and access ladder to be installed	Low	Client advised	Outstanding	OH&S REGULATIONS 3.7 AS/NZS 1657-2013 3.1.4 & 4.4

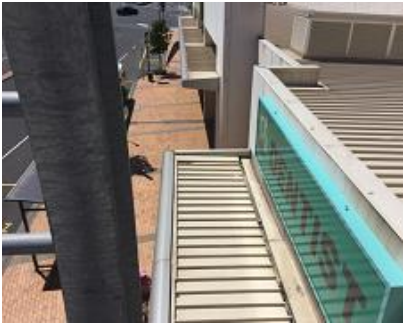
No height safety system installed	Trips, Slips and Falls	Restrict Access	High	"EWP Access to Roof" signs to be installed	Low	Client advised	Outstanding	OH&S REGULATIONS 3.55 & 3.11
360	Building: General Stores Location Reference: L139 Task: Access to the roof

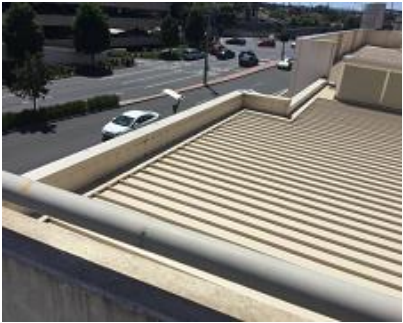
No height safety system installed	Trips, Slips and Falls	Awareness induction	High	Fall arrest anchors to be installed	Low	Client advised	Outstanding	OH&S REGULATIONS 3.55

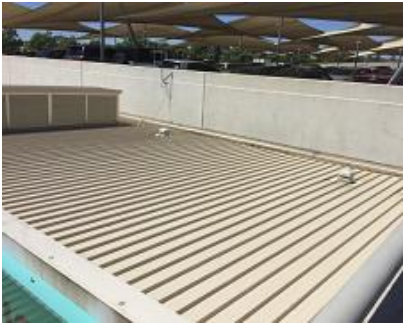
No safe access to the roof	Trips, Slips and Falls	Awareness induction	Med	Access ladder and ladder access bracket to be installed	Low	Client advised	Outstanding	OH&S REGULATIONS 3.7 AS/NZS 1657-2013 3.1.4
362	Building: General Stores Location Reference: L140 Task: Access to the roof

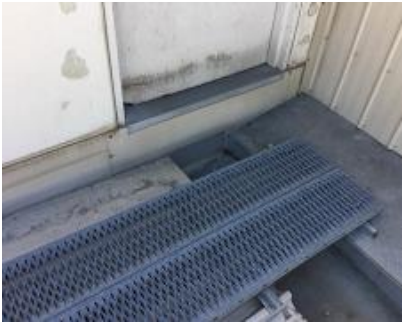
No landing at access point	Trips, Slips and Falls	Awareness induction	Med	Landing platform including handrail to be installed	Low	Client advised	Outstanding	OH&S REGULATIONS 3.7 AS/NZS 1657-2013 3.1.4

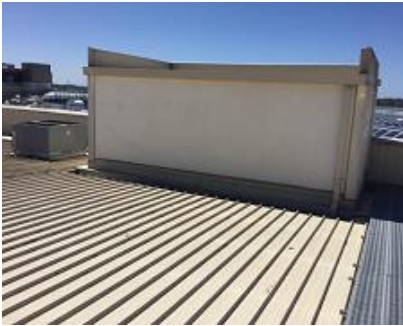
No	Photo of Hazard	Details of Hazard	Details of Risk	Existing/ Immediate Control Measure	Curre nt Risk Level	Proposed Permanent Solution	Resid ual Risk Asse sme nt	Details of Action Taken	Status	Reference
36 3	Building: General Stores Location Reference: L140 Task: Access to the roof

No height safety and safe access system installed	Trips, Slips and Falls	Awareness induction	High	Fall arrest anchors, anchor strop and access ladder to be installed	Low	Client advised	Outstanding	OH&S REGULATIONS 3.55 AS/NZS 1657-2013 3.1.4
36 4	Building: General Stores Location Reference: L140 Task: Access to the A/c units

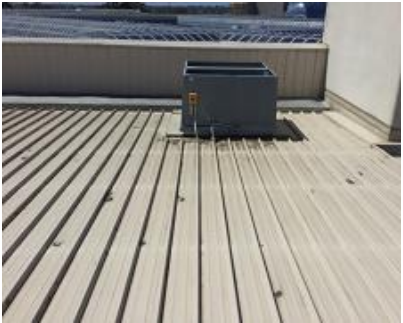
No safe access to the A/c units	Trips, Slips and Falls	N/A	Low	Supply walkway to the A/c units	Low	Client advised	Outstanding	-

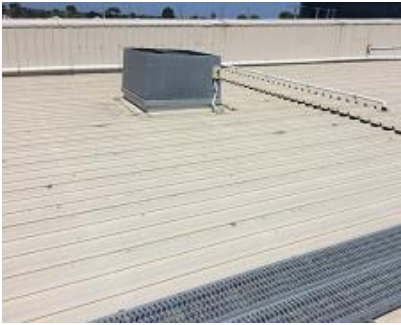
No	Photo of Hazard	Details of Hazard	Details of Risk	Existing/ Immediate Control Measure	Curre nt Risk Level	Proposed Permanent Solution	Resid ual Risk Asse sme nt	Details of Action Taken	Status	Reference
36 5	Building: General Stores Location Reference: L140 Task: Access to the A/c units

No safe access to the A/c units	Trips, Slips and Falls	N/A	Low	Supply walkway to the A/c units	Low	Client advised	Outstanding	-
36 6	Building: General Stores Location Reference: L140 Task: Access to the roof

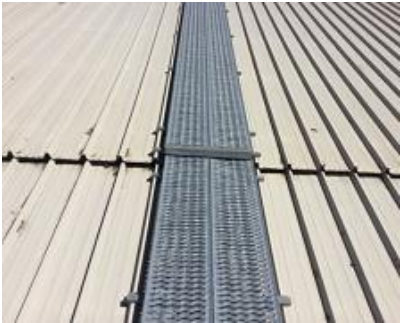
Variation in height between walkway panels are greater than required maximum	Trips, Slips and Falls	Awareness induction	Med	High visibility safety yellow nosing to be installed	Low	Client advised	Outstanding	OH&S REGULATIONS 3.7 AS/NZS 1657-2013 3.3.4

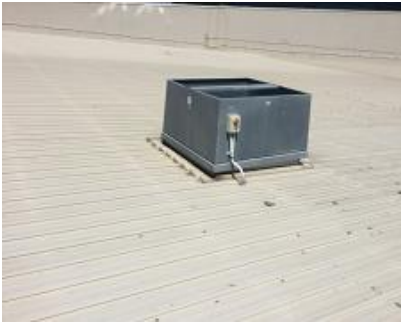
No	Photo of Hazard	Details of Hazard	Details of Risk	Existing/ Immediate Control Measure	Curre nt Risk Level	Proposed Permanent Solution	Resid ual Risk Asse sme nt	Details of Action Taken	Status	Reference
36 7	Building: General Stores Location Reference: L140 Task: Access to the A/c units

No safe access to the A/c units	Trips, Slips and Falls	N/A	Low	Supply walkway to the A/c units	Low	Client advised	Outstanding	-
36 8	Building: General Stores Location Reference: L141 Task: Restrict access to the roof

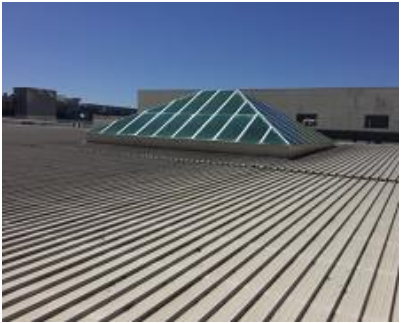
Brittle roof (Non-trafficable roof)	Trips, Slips and Falls	Restrict Access	High	"Warning-Keep Off-Brittle and Fragile Roof" signs to be installed	Low	Client advised	Outstanding	OH&S REGULATIONS 3.57

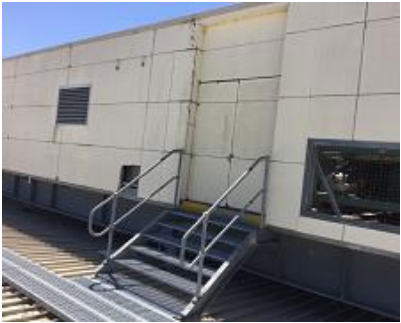
No	Photo of Hazard	Details of Hazard	Details of Risk	Existing/ Immediate Control Measure	Curre nt Risk Level	Proposed Permanent Solution	Resid ual Risk Asse sme nt	Details of Action Taken	Status	Reference
36 9	Building: General Stores Location Reference: L142 Task: Access to the roof

No landing installed at access point	Trips, Slips and Falls	Awareness induction	Med	Existing stair to be removed and new ladder to be installed	Low	Client advised	Outstanding	OH&S REGULATIONS 3.7 AS/NZS 1657-2013 7.2.4
37 0	Building: General Stores Location Reference: L142 Task: Access to the roof

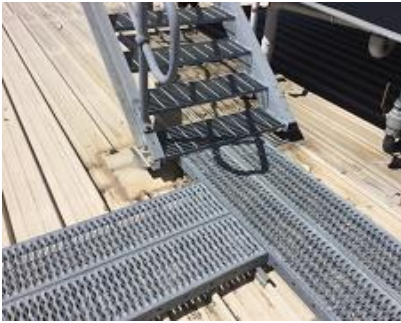
Bottom tread height is less than required minimum	Trips, Slips and Falls	Awareness induction	Med	Landing platform to be installed	Low	Client advised	Outstanding	OH&S REGULATIONS 3.7 AS/NZS 1657-2013 7.2.3

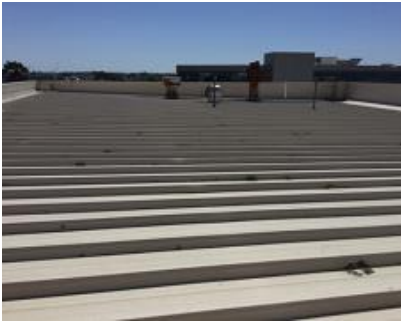
No	Photo of Hazard	Details of Hazard	Details of Risk	Existing/ Immediate Control Measure	Curre nt Risk Level	Proposed Permanent Solution	Resid ual Risk Asse sme nt	Details of Action Taken	Status	Reference
371	Building: General Stores Location Reference: L142 Task: Access to the roof

No height safety and safe access system installed	Trips, Slips and Falls	Awareness induction	High	Fall arrest anchors, anchor stop and access ladder to be installed	Low	Client advised	Outstanding	OH&S REGULATIONS 3.7 & 3.55 AS/NZS 1657-2013 3.1.4
372	Building: General Stores Location Reference: L143 Task: Access to the A/c units

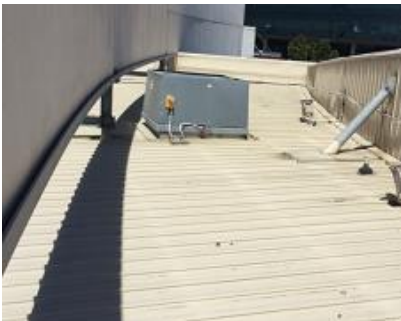
No safe access to the A/c units	Trips, Slips and Falls	N/A	Low	Supply walkway to the A/c units	Low	Client advised	Outstanding	-

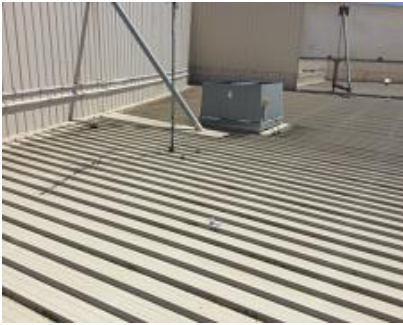
No	Photo of Hazard	Details of Hazard	Details of Risk	Existing/ Immediate Control Measure	Curre nt Risk Level	Proposed Permanent Solution	Resid ual Risk Asse sme nt	Details of Action Taken	Status	Reference
37 3	Building: General Stores Location Reference: L143 Task: Access to the A/c units

No safe access to the A/c units	Trips, Slips and Falls	N/A	Low	Supply walkway to the A/c units	Low	Client advised	Outstanding	-
37 4	Building: General Stores Location Reference: L143 Task: Access to the roof
