Roof Safety Report

**Chadstone Shopping Centre,
VIC 3148**

Prepared By: Safemaster Safety Products
Date: 20 April 2018

Roof Safety Report for
Chadstone Shopping Centre, VIC 3148

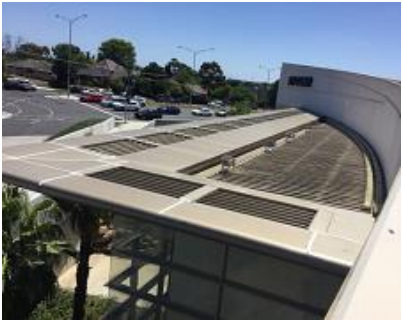
No height safety and safe access system installed	Trips, Slips and Falls	Awareness induction	High	Fall arrest anchors and access ladder to be installed	Low	Client advised	Outstanding	OH&S REGULATIONS 3.7 & 3.55 AS/NZS 1657-2013 3.1.4

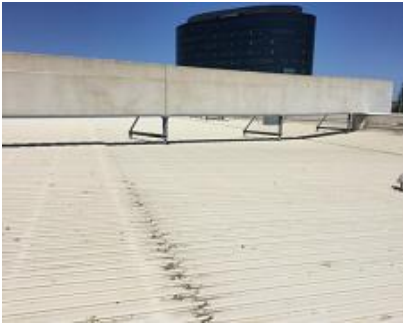
No	Photo of Hazard	Details of Hazard	Details of Risk	Existing/ Immediate Control Measure	Curre nt Risk Level	Proposed Permanent Solution	Resid ual Risk Asse sme nt	Details of Action Taken	Status	Reference
37 5	Building: General Stores Location Reference: L144 Task: Access to the roof

Headroom is less than required minimum	Trips, Slips and Falls	Awareness induction	Med	"Caution-Low Headroom" signs to be installed	Low	Client advised	Outstanding	OH&S REGULATIONS 3.7 AS/NZS 1657-2013 3.1.5
37 6	Building: General Stores Location Reference: L144 Task: Access to the roof

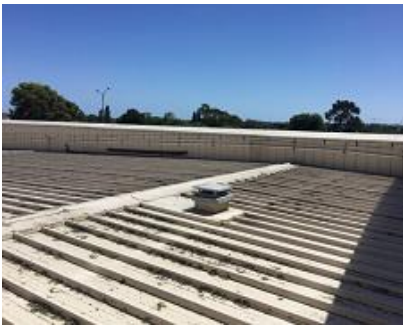
No height safety system installed	Trips, Slips and Falls	Awareness induction	High	Fall arrest anchors to be installed	Low	Client advised	Outstanding	OH&S REGULATIONS 3.55

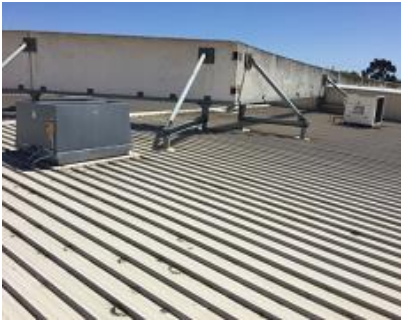
No	Photo of Hazard	Details of Hazard	Details of Risk	Existing/ Immediate Control Measure	Curre nt Risk Level	Proposed Permanent Solution	Resid ual Risk Asse sme nt	Details of Action Taken	Status	Reference
37 7	Building: General Stores Location Reference: L145 Task: Access to the A/c units

No safe access to the A/c units	Trips, Slips and Falls	N/A	Low	Supply walkway to the A/c units	Low	Client advised	Outstanding	-
37 8	Building: General Stores Location Reference: L145 Task: Access to the roof

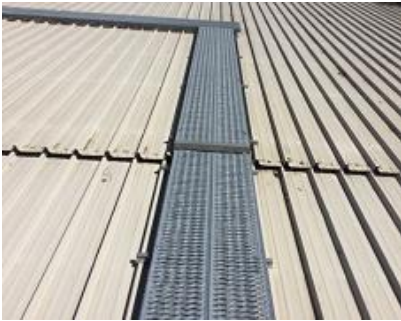
Variation in height between walkway panels are greater than required maximum	Trips, Slips and Falls	Awareness induction	Med	High visibility safety yellow nosing to be installed	Low	Client advised	Outstanding	OH&S REGULATIONS 3.7 AS/NZS 1657-2013 3.3.4

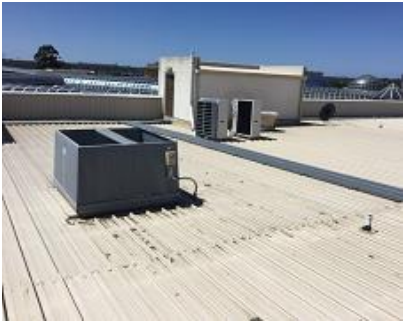
No	Photo of Hazard	Details of Hazard	Details of Risk	Existing/ Immediate Control Measure	Curre nt Risk Level	Proposed Permanent Solution	Resid ual Risk Asse sme nt	Details of Action Taken	Status	Reference
37 9	Building: General Stores Location Reference: L145 Task: Access to the A/c units

No safe access to the A/c units	Trips, Slips and Falls	N/A	Low	Supply walkway to the A/c units	Low	Client advised	Outstanding	-
38 0	Building: General Stores Location Reference: L145 Task: Access to the roof

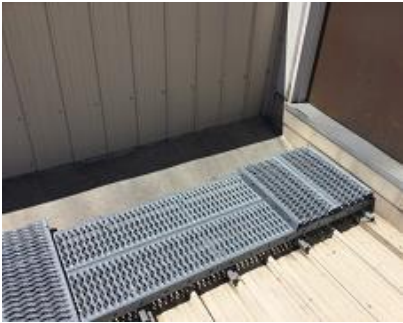
No landing at access point	Trips, Slips and Falls	Awareness induction	Med	Landing platform including handrail to be installed	Low	Client advised	Outstanding	OH&S REGULATIONS 3.7 AS/NZS 1657-2013 3.1.4

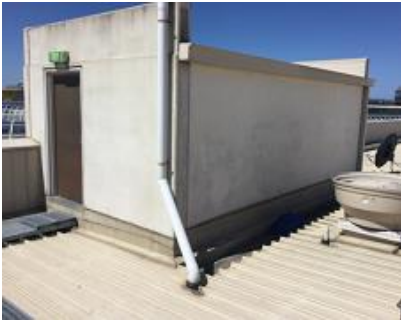
No	Photo of Hazard	Details of Hazard	Details of Risk	Existing/ Immediate Control Measure	Curre nt Risk Level	Proposed Permanent Solution	Resid ual Risk Asse sme nt	Details of Action Taken	Status	Reference
381	Building: General Stores Location Reference: L145 Task: Access to the roof

No height safety and safe access system installed	Trips, Slips and Falls	Awareness induction	High	Fall arrest anchors, anchor stop and access ladder to be installed	Low	Client advised	Outstanding	OH&S REGULATIONS 3.7 & 3.55 AS/NZS 1657-2013 3.1.4
382	Building: General Stores Location Reference: L146 Task: Access to the A/c units

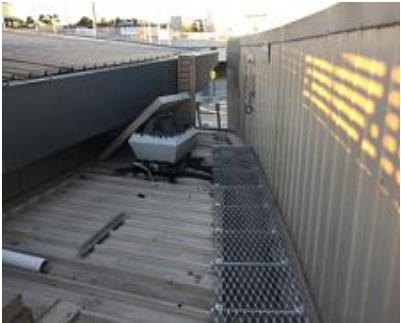
No safe access to the A/c units	Trips, Slips and Falls	N/A	Low	Supply walkway to the A/c units	Low	Client advised	Outstanding	-

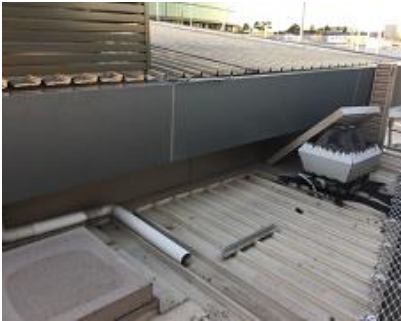
No	Photo of Hazard	Details of Hazard	Details of Risk	Existing/ Immediate Control Measure	Curre nt Risk Level	Proposed Permanent Solution	Resid ual Risk Asse sme nt	Details of Action Taken	Status	Reference
38 3	Building: General Stores Location Reference: L146 Task: Access to the roof

Variation in height between roofs are greater than required maximum	Trips, Slips and Falls	Awareness induction	Med	Access ladder, anchor and anchor strop to be installed	Low	Client advised	Outstanding	OH&S REGULATIONS 3.7 AS/NZS 1657-2013 3.1.4
38 4	Building: General Stores Location Reference: L146 Task: Access to the roof

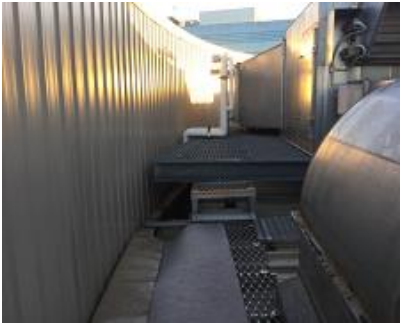
Variation in height between plant deck and roof is greater than required maximum	Trips, Slips and Falls	Awareness induction	Med	Handrail to be installed	Low	Client advised	Outstanding	OH&S REGULATIONS 3.7 AS/NZS 1657-2013 4.4

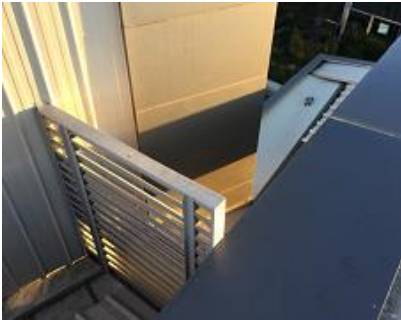
No	Photo of Hazard	Details of Hazard	Details of Risk	Existing/ Immediate Control Measure	Curre nt Risk Level	Proposed Permanent Solution	Resid ual Risk Asse sme nt	Details of Action Taken	Status	Reference
38 5	Building: General Stores Location Reference: L146 Task: Access to the roof

No height safety and safe access system installed	Trips, Slips and Falls	Awareness induction	High	Fall arrest anchors, anchor stop, ladder access bracket and sign to be installed	Low	Client advised	Outstanding	OH&S REGULATIONS 3.7 & 3.55 AS/NZS 1657-2013 3.1.4
38 6	Building: General Stores Location Reference: L147 Task: Access to the roof

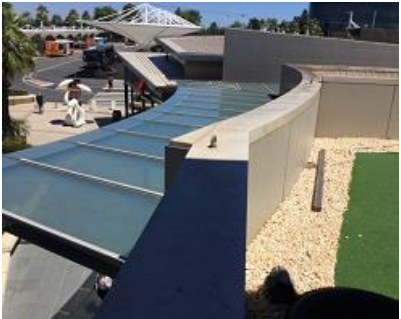
Non-complaint anchors are present	Trips, Slips and Falls	Awareness induction	High	Existing anchors to be removed	Low	Client advised	Outstanding	OH&S REGULATIONS 3.55

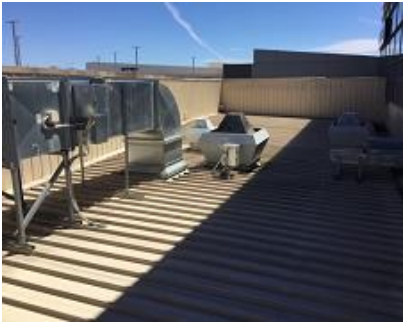
No	Photo of Hazard	Details of Hazard	Details of Risk	Existing/ Immediate Control Measure	Curre nt Risk Level	Proposed Permanent Solution	Resid ual Risk Asse sme nt	Details of Action Taken	Status	Reference
38 7	Building: General Stores Location Reference: L147 Task: Access to the A/c units

No safe access to the A/c units	Trips, Slips and Falls	N/A	Low	Supply walkway to the A/c units	Low	Client advised	Outstanding	-
38 8	Building: General Stores Location Reference: L148 Task: Access to the roof

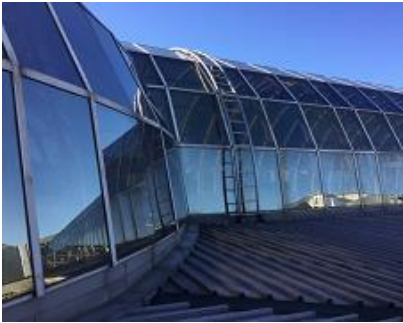
No slip resistance on ladder rungs	Trips, Slips and Falls	Awareness induction	Med	Non-slip high visibility safety yellow rung caps to be installed	Low	Client advised	Outstanding	OH&S REGULATIONS 3.7 AS/NZS 1657-2013 7.4.3.1

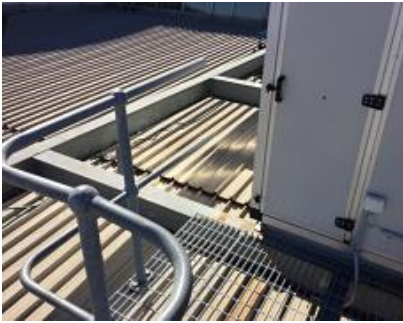
No	Photo of Hazard	Details of Hazard	Details of Risk	Existing/ Immediate Control Measure	Curre nt Risk Level	Proposed Permanent Solution	Resid ual Risk Asse sme nt	Details of Action Taken	Status	Reference
38 9	Building: General Stores Location Reference: L149 Task: Access to the plant deck

Handrail section is missing	Trips, Slips and Falls	Awareness induction	Med	Handrail to be installed	Low	Client advised	Outstanding	OH&S REGULATIONS 3.7 AS/NZS 1657-2013 4.4
39 0	Building: General Stores Location Reference: L149 Task: Access to the plant deck

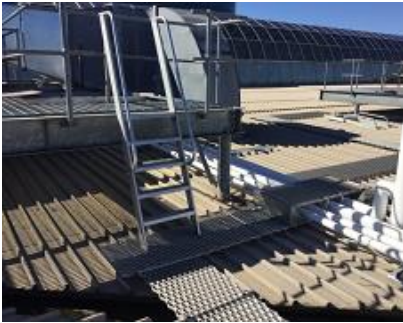
Top tread not levelled with landing and landing is less than required minimum	Trips, Slips and Falls	Awareness induction	Med	Existing ladder to be removed and new ladder to be installed	Low	Client advised	Outstanding	OH&S REGULATIONS 3.7 AS/NZS 1657-2013 7.4.3.3 & 7.3.6

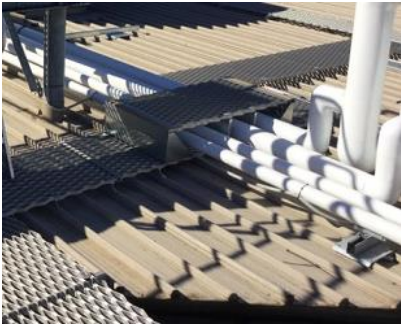
No	Photo of Hazard	Details of Hazard	Details of Risk	Existing/ Immediate Control Measure	Curre nt Risk Level	Proposed Permanent Solution	Resid ual Risk Asse sme nt	Details of Action Taken	Status	Reference
391	Building: General Stores Location Reference: L149 Task: Access to the plant deck

Variation in height between landing and roof is greater than required maximum	Trips, Slips and Falls	Awareness induction	Med	Handrail to be installed	Low	Client advised	Outstanding	OH&S REGULATIONS 3.7 AS/NZS 1657-2013 4.4
392	Building: General Stores Location Reference: L149 Task: Access to the roof

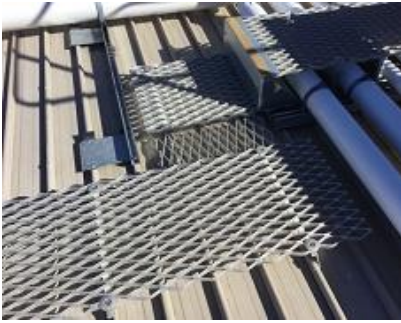
Gap between the walkway panels are greater than required maximum	Trips, Slips and Falls	Awareness induction	Med	Additional walkway section to be installed	Low	Client advised	Outstanding	OH&S REGULATIONS 3.7 AS/NZS 1657-2013 3.2.3.4

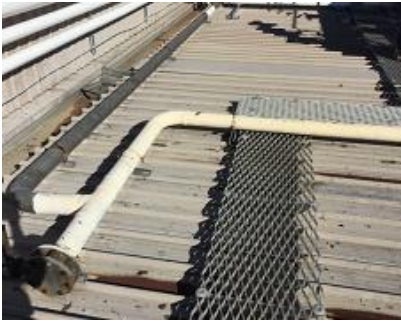
Pipe installed over the walkway path	Trips, Slips and Falls	Awareness induction	Med	Step over to be installed	Low	Client advised	Outstanding	OH&S REGULATIONS 3.7 AS/NZS 1657-2013 3.1.4
39 4	Building: General Stores Location Reference: L149 Task: Access to the A/c units

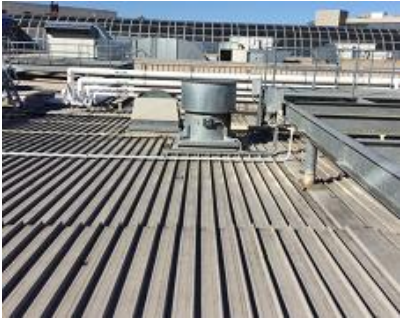
No safe access to the A/c units	Trips, Slips and Falls	N/A	Low	Supply walkway to the A/c units	Low	Client advised	Outstanding	-

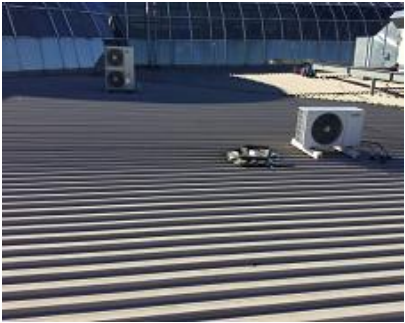
No safe access to the A/c units	Trips, Slips and Falls	N/A	Low	Supply walkway to the A/c units	Low	Client advised	Outstanding	-
39 6	Building: General Stores Location Reference: L150 Task: Access to the roof

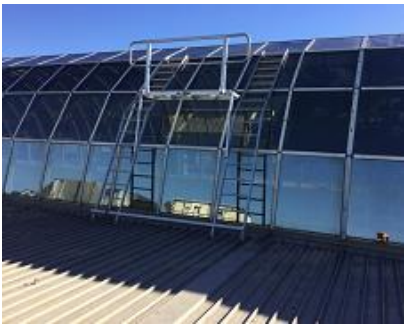
Non-complaint ladders are present	Trips, Slips and Falls	Awareness induction	Med	Further investigation required with Centre Management and Window cleaners to propose permanent solution	Low	Client advised	Outstanding	OH&S REGULATIONS 3.7 AS/NZS 1657-2013 3.1.4

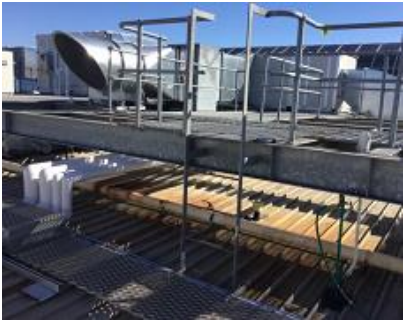
No slip resistance on ladder rungs and landing is less than required minimum	Trips, Slips and Falls	Awareness induction	Med	Existing ladder to be removed and new ladder to be installed	Low	Client advised	Outstanding	OH&S REGULATIONS 3.7 AS/NZS 1657-2013 7.4.3.1 & 7.3.6
39 8	Building: General Stores Location Reference: L151 Task: Access to the roof

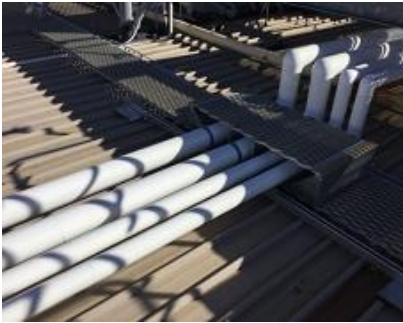
Variation in height between landing and roof is greater than required maximum	Trips, Slips and Falls	Awareness induction	Med	Handrail to be installed	Low	Client advised	Outstanding	OH&S REGULATIONS 3.7 AS/NZS 1657-2013 4.4

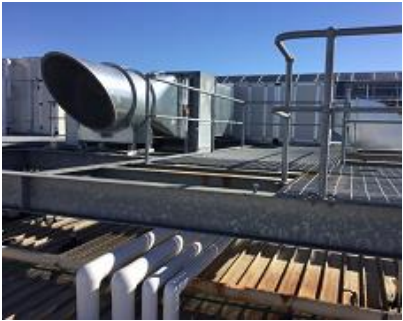
Variation in height between plant deck and roof is greater than required maximum	Trips, Slips and Falls	Awareness induction	Med	Handrail to be installed	Low	Client advised	Outstanding	OH&S REGULATIONS 3.7 AS/NZS 1657-2013 4.4
40 0	Building: General Stores Location Reference: L151 Task: Access to the plant deck

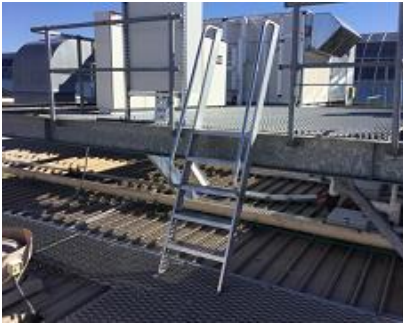
Top rung not levelled with landing	Trips, Slips and Falls	Awareness induction	Med	Existing ladder to be removed and new ladder to be installed	Low	Client advised	Outstanding	OH&S REGULATIONS 3.7 AS/NZS 1657-2013 7.4.3.3

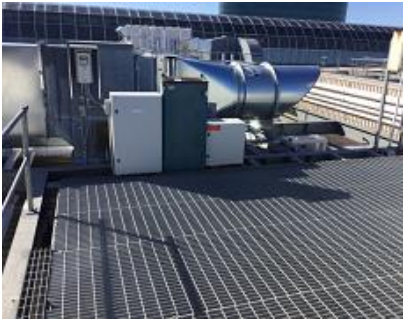
Variation in height between plant deck and roof is greater than required maximum	Trips, Slips and Falls	Awareness induction	Med	Handrail to be installed	Low	Client advised	Outstanding	OH&S REGULATIONS 3.7 AS/NZS 1657-2013 4.4
40 2	Building: General Stores Location Reference: L151 Task: Access to the A/c units

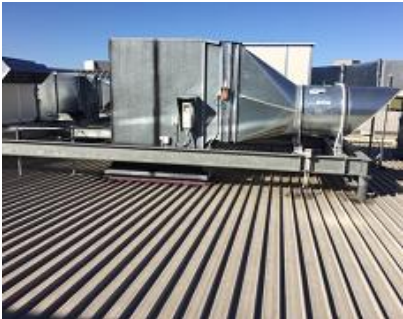
No safe access to the A/c units	Trips, Slips and Falls	N/A	Low	Supply walkway and step over to the A/c units	Low	Client advised	Outstanding	-

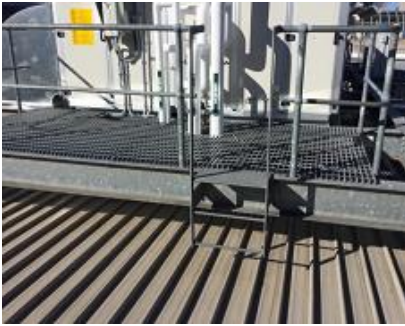
No slip resistance on ladder rungs and no landing platform installed	Trips, Slips and Falls	Awareness induction	Med	Existing ladder to be removed and new ladder to be installed	Low	Client advised	Outstanding	OH&S REGULATIONS 3.7 AS/NZS 1657-2013 7.4.3.1 & 7.3.6
40 4	Building: General Stores Location Reference: L151 Task: Access to the plant deck

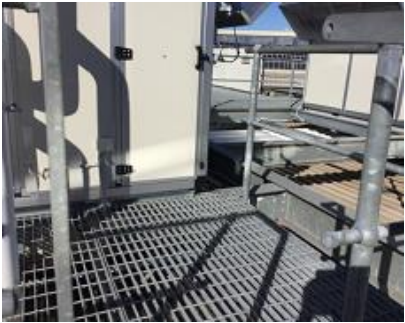
Handrail section is missing	Trips, Slips and Falls	Awareness induction	Med	Handrail to be installed	Low	Client advised	Outstanding	OH&S REGULATIONS 3.7 AS/NZS 1657-2013 4.4

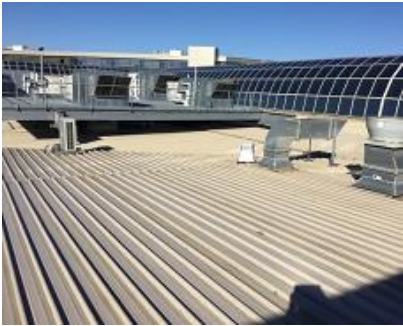
No safe access to the A/c units	Trips, Slips and Falls	N/A	Low	Supply walkway and handrail to the A/c units	Low	Client advised	Outstanding	-
40 6	Building: General Stores Location Reference: L153 Task: Access to the plant deck

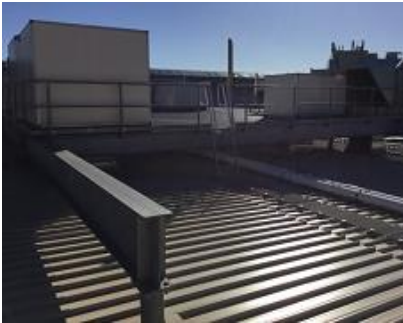
Handrail projecting towards the user	Trips, Slips and Falls	Awareness induction	Med	Existing handrail to be removed and new handrail to be installed	Low	Client advised	Outstanding	OH&S REGULATIONS 3.7 AS/NZS 1657-2013 7.4.8.5

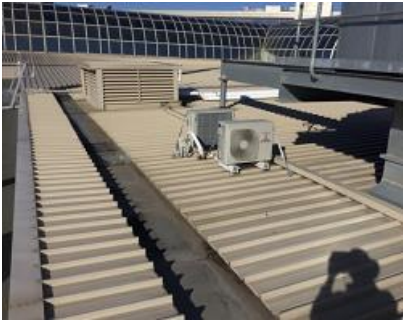
No safe access to the A/c units	Trips, Slips and Falls	N/A	Low	Supply walkway and step over to the A/c units	Low	Client advised	Outstanding	-
40 8	Building: General Stores Location Reference: L154 Task: Access to the roof

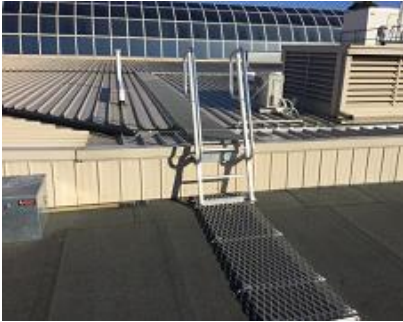
Top rung not levelled with landing, handrail projecting towards the user and ladder not fully secured	Trips, Slips and Falls	Awareness induction	Med	Existing ladder to be removed and new ladder to be installed	Low	Client advised	Outstanding	OH&S REGULATIONS 3.7 AS/NZS 1657-2013 7.4.3.3 & 7.4.8.5

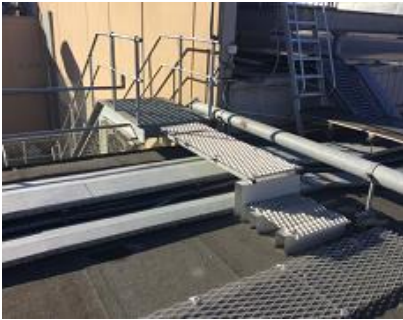
Variation in height between landing and roof is greater than required maximum	Trips, Slips and Falls	Awareness induction	Med	Handrail to be installed	Low	Client advised	Outstanding	OH&S REGULATIONS 3.7 AS/NZS 1657-2013 4.4
41 0	Building: General Stores Location Reference: L155 Task: Access to the roof

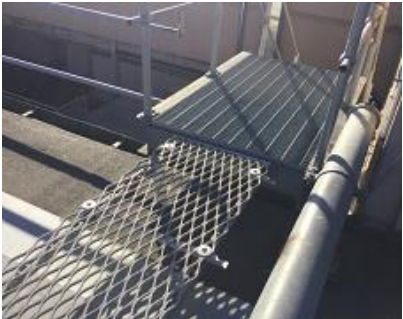
Variation in height between panels are greater than required maximum	Trips, Slips and Falls	Awareness induction	Med	High visibility safety yellow nosing to be installed	Low	Client advised	Outstanding	OH&S REGULATIONS 3.7 AS/NZS 1657-2013 3.3.4

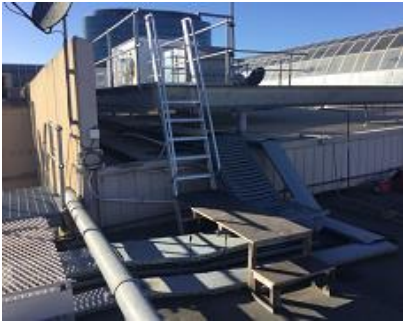
Variation in height between landing and roof is greater than required maximum	Trips, Slips and Falls	Awareness induction	Med	Existing step and landing to be removed. New landing including step and handrail to be installed	Low	Client advised	Outstanding	OH&S REGULATIONS 3.7 AS/NZS 1657-2013 4.4
412	Building: General Stores Location Reference: L155 Task: Access to the plant deck

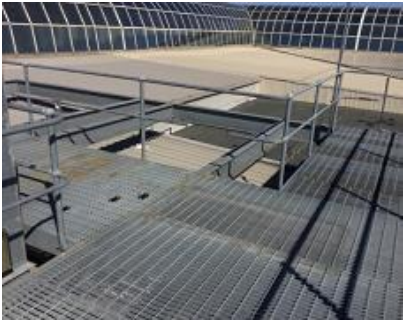
Mid rail is missing	Trips, Slips and Falls	Awareness induction	Med	Mid rail to be installed	Low	Client advised	Outstanding	OH&S REGULATIONS 3.7 AS/NZS 1657-2013 6.2.1

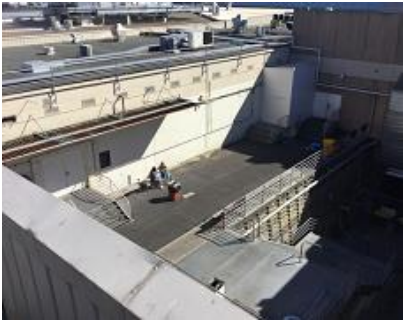
No height safety system installed	Trips, Slips and Falls	Awareness induction	High	Fall arrest anchors, anchor strop, ladder access bracket and sign to be installed	Low	Client advised	Outstanding	OH&S REGULATIONS 3.55
414	Building: General Stores Location Reference: L157 Task: Access to the plant deck

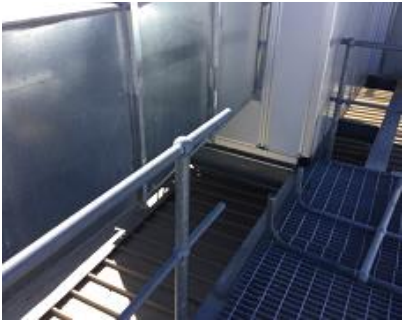
Handrail section is missing	Trips, Slips and Falls	Awareness induction	Med	Handrail to be installed	Low	Client advised	Outstanding	OH&S REGULATIONS 3.7 AS/NZS 1657-2013 4.4

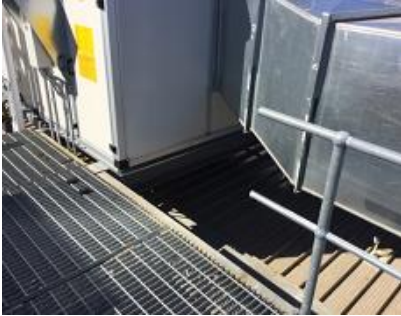
Handrail section is missing	Trips, Slips and Falls	Awareness induction	Med	Handrail to be installed	Low	Client advised	Outstanding	OH&S REGULATIONS 3.7 AS/NZS 1657-2013 4.4
416	Building: General Stores Location Reference: L157 Task: Access to the plant deck

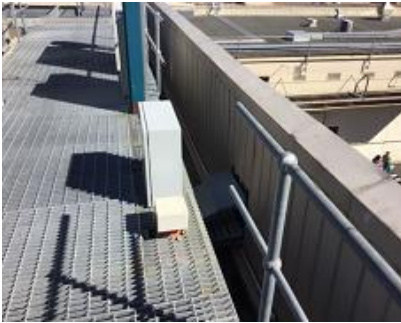
Handrail section is missing	Trips, Slips and Falls	Awareness induction	Med	Handrail to be installed	Low	Client advised	Outstanding	OH&S REGULATIONS 3.7 AS/NZS 1657-2013 4.4

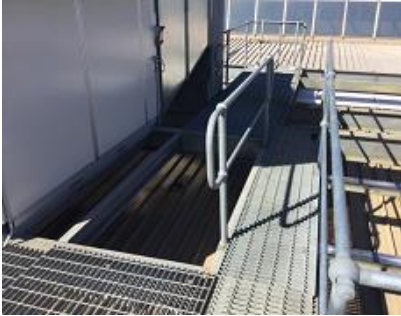
Handrail section is missing	Trips, Slips and Falls	Awareness induction	Med	Handrail to be installed	Low	Client advised	Outstanding	OH&S REGULATIONS 3.7 AS/NZS 1657-2013 4.4
418	Building: General Stores Location Reference: L158 Task: Access to the plant deck

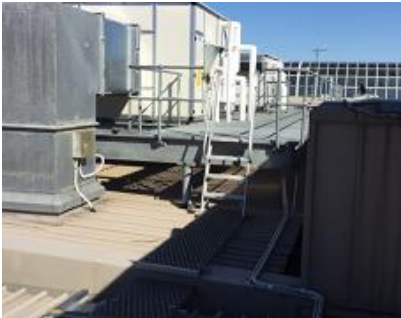
Ladder not fully secured	Trips, Slips and Falls	Awareness induction	Med	Existing ladder to be fully secured	Low	Client advised	Outstanding	OH&S REGULATIONS 3.7 AS/NZS 1657-2013 3.1.4

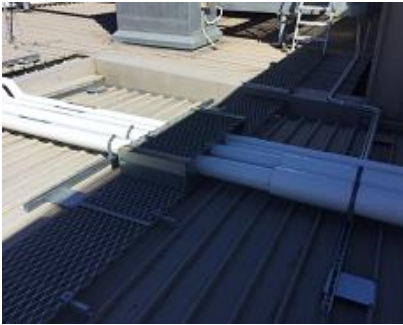
Variation in height between walkway panels are greater than required maximum	Trips, Slips and Falls	Awareness induction	Med	High visibility safety yellow nosing to be installed	Low	Client advised	Outstanding	OH&S REGULATIONS 3.7 AS/NZS 1657-2013 3.3.4
420	Building: General Stores Location Reference: L158 Task: Access to the roof

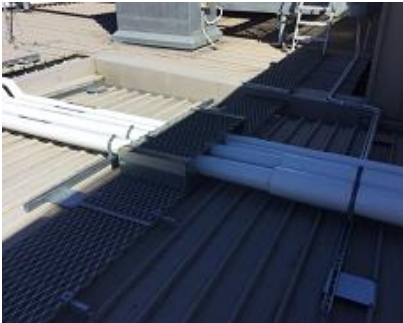
Variation in height between landing and roof is greater than required maximum	Trips, Slips and Falls	Awareness induction	Med	Handrail to be installed	Low	Client advised	Outstanding	OH&S REGULATIONS 3.7 AS/NZS 1657-2013 4.4

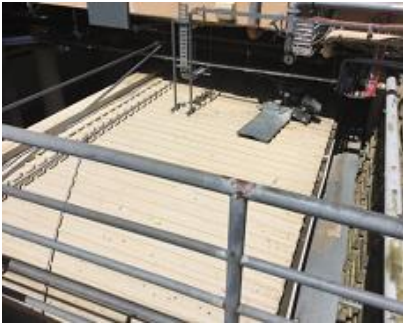
No height safety system installed	Trips, Slips and Falls	Restrict Access	High	"EWP Access to Roof" sign to be installed	Low	Client advised	Outstanding	OH&S REGULATIONS 3.55 & 3.11
422	Building: General Stores Location Reference: L160 Task: Access to the plant deck

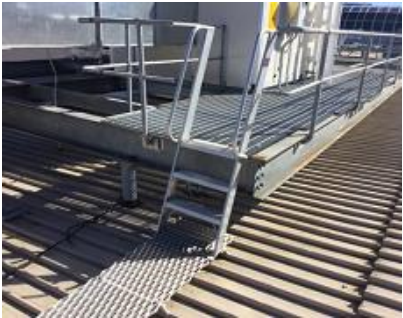
Ladder not fully secured	Trips, Slips and Falls	Awareness induction	Med	Existing ladder to be fully secured	Low	Client advised	Outstanding	OH&S REGULATIONS 3.7 AS/NZS 1657-2013 3.1.4

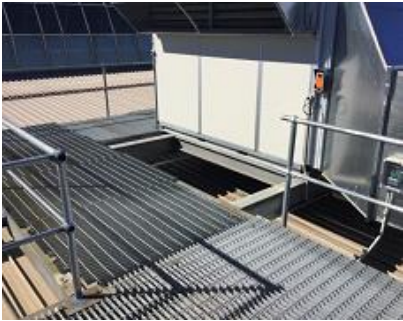
Variation in height between plant deck and roof is greater than required maximum	Trips, Slips and Falls	Awareness induction	Med	Handrail to be installed	Low	Client advised	Outstanding	OH&S REGULATIONS 3.7 AS/NZS 1657-2013 4.4
42 4	Building: General Stores Location Reference: L160 Task: Access to the plant deck

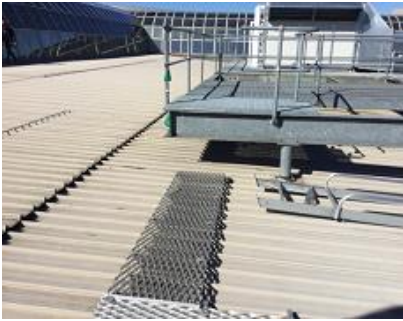
Non-complaint ladder is present	Trips, Slips and Falls	Awareness induction	Med	Existing ladder to be removed and new ladder to be installed	Low	Client advised	Outstanding	OH&S REGULATIONS 3.7 AS/NZS 1657-2013 7.4

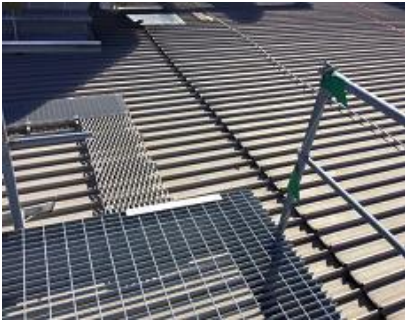
No	Photo of Hazard	Details of Hazard	Details of Risk	Existing/ Immediate Control Measure	Curre nt Risk Level	Proposed Permanent Solution	Resid ual Risk Asse sme nt	Details of Action Taken	Status	Reference
42 5	Building: General Stores Location Reference: L160 Task: Access to the plant deck

Handrail section is missing	Trips, Slips and Falls	Awareness induction	Med	Handrail to be installed	Low	Client advised	Outsta nding	OH&S REGULATIONS 3.7 AS/NZS 1657- 2013 4.4
42 6	Building: General Stores Location Reference: L160 Task: Access to the A/c units

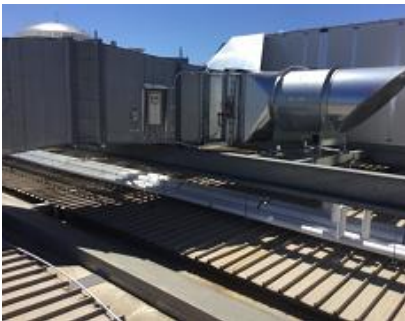
No safe access to the A/c units	Trips, Slips and Falls	N/A	Low	Supply walkway, step overs and handrail to the A/c units	Low	Client advised	Outsta nding	-

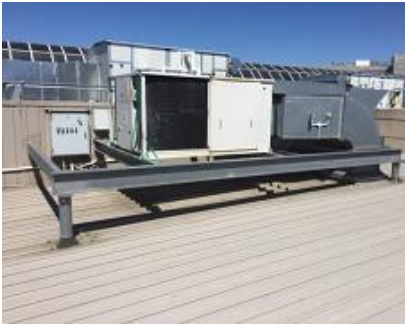
No	Photo of Hazard	Details of Hazard	Details of Risk	Existing/ Immediate Control Measure	Curre nt Risk Level	Proposed Permanent Solution	Resid ual Risk Asse sme nt	Details of Action Taken	Status	Reference
42 7	Building: General Stores Location Reference: L160 Task: Access to the A/c units

No safe access to the A/c units	Trips, Slips and Falls	N/A	Low	Supply walkway, Access ladder and handrail to the A/c units	Low	Client advised	Outstanding	-
42 8	Building: General Stores Location Reference: L161 Task: Access to the roof

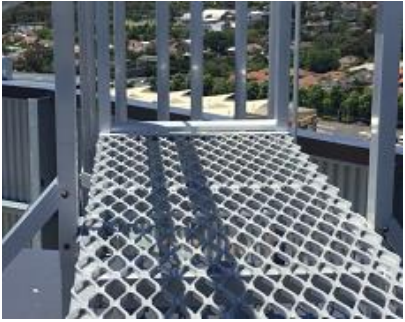
Top rung not levelled with landing	Trips, Slips and Falls	Awareness induction	Med	Existing landing platform to be re-installed	Low	Client advised	Outstanding	OH&S REGULATIONS 3.7 AS/NZS 1657-2013 7.4.3.3

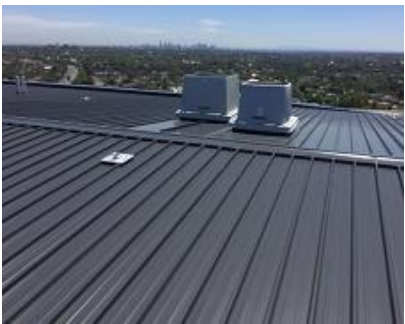
No	Photo of Hazard	Details of Hazard	Details of Risk	Existing/ Immediate Control Measure	Curre nt Risk Level	Proposed Permanent Solution	Resid ual Risk Asse sme nt	Details of Action Taken	Status	Reference
42 9	Building: General Stores Location Reference: L161 Task: Access to the A/c units

No safe access to the A/c units	Trips, Slips and Falls	N/A	Low	Supply walkway to the A/c units	Low	Client advised	Outstanding	-
43 0	Building: General Stores Location Reference: L161 Task: Access to the A/c units

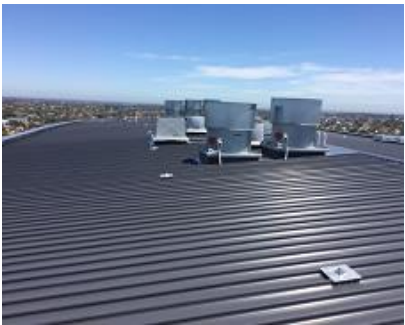
No safe access to the A/c units	Trips, Slips and Falls	N/A	Low	Supply walkway to the A/c units	Low	Client advised	Outstanding	-

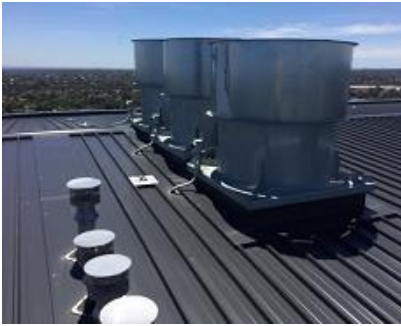
No	Photo of Hazard	Details of Hazard	Details of Risk	Existing/ Immediate Control Measure	Curre nt Risk Level	Proposed Permanent Solution	Resid ual Risk Asse sme nt	Details of Action Taken	Status	Reference
431	Building: General Stores Location Reference: L161 Task: Access to the A/c units

No safe access to the A/c units	Trips, Slips and Falls	N/A	Low	Supply walkway to the A/c units	Low	Client advised	Outstanding	-
432	Building: General Stores Location Reference: L162 Task: Access to the A/c units

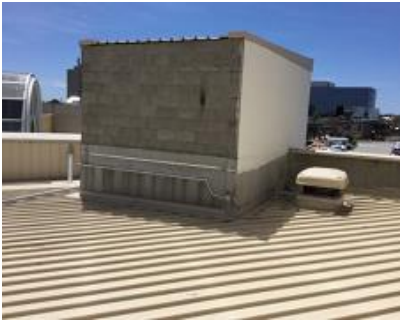
No safe access to the A/c units	Trips, Slips and Falls	N/A	Low	Supply walkway to the A/c units	Low	Client advised	Outstanding	-

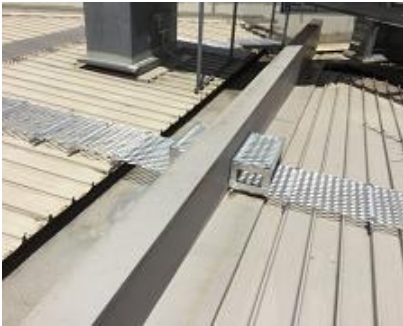
No	Photo of Hazard	Details of Hazard	Details of Risk	Existing/ Immediate Control Measure	Curre nt Risk Level	Proposed Permanent Solution	Resid ual Risk Asse sme nt	Details of Action Taken	Status	Reference
43 3	Building: General Stores Location Reference: L162 Task: Access to the roof

Non-complaint step access is present	Trips, Slips and Falls	Awareness induction	Med	Existing steps to be removed and new ladder to be installed	Low	Client advised	Outstanding	OH&S REGULATIONS 3.7 AS/NZS 1657-2013 3.1.4
43 4	Building: General Stores Location Reference: L162 Task: Access to the plant deck

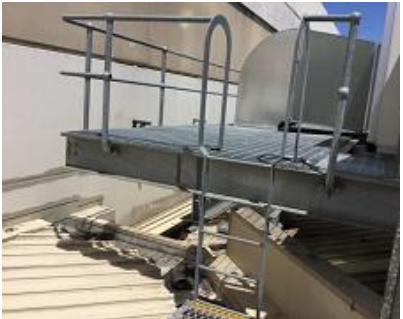
No slip resistance on ladder rungs and gap between top rung and landing is greater than required maximum	Trips, Slips and Falls	Awareness induction	Med	Existing ladder to be removed and new ladder to be installed	Low	Client advised	Outstanding	OH&S REGULATIONS 3.7 AS/NZS 1657-2013 7.4.3.1 & 7.4.8.4

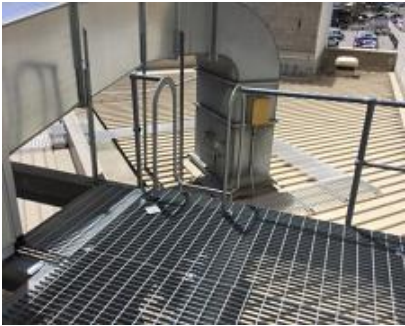
No	Photo of Hazard	Details of Hazard	Details of Risk	Existing/ Immediate Control Measure	Curre nt Risk Level	Proposed Permanent Solution	Resid ual Risk Asse sme nt	Details of Action Taken	Status	Reference
43 5	Building: General Stores Location Reference: L162 Task: Access to the plant deck

Mid rail is missing for handrail	Trips, Slips and Falls	Awareness induction	Med	Mid rail to be installed	Low	Client advised	Outstanding	OH&S REGULATIONS 3.7 AS/NZS 1657-2013 6.2.1
43 6	Building: General Stores Location Reference: L162 Task: Access to the plant deck

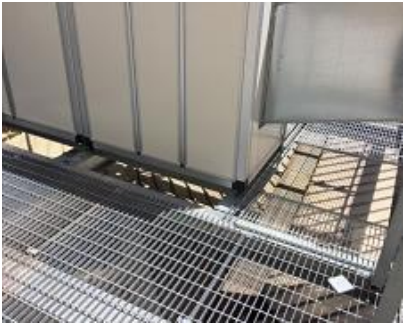
Gap between plant deck and unit is greater than required maximum	Trips, Slips and Falls	Awareness induction	Med	Gap to be closed	Low	Client advised	Outstanding	OH&S REGULATIONS 3.7 AS/NZS 1657-2013 4.4

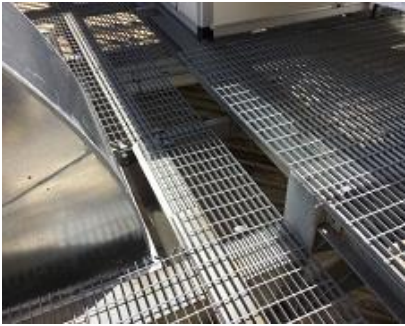
No	Photo of Hazard	Details of Hazard	Details of Risk	Existing/ Immediate Control Measure	Curre nt Risk Level	Proposed Permanent Solution	Resid ual Risk Asse sme nt	Details of Action Taken	Status	Reference
43 7	Building: General Stores Location Reference: L162 Task: Access to the plant deck

Gap between plant deck and unit is greater than required maximum	Trips, Slips and Falls	Awareness induction	Med	Gap to be closed	Low	Client advised	Outstanding	OH&S REGULATIONS 3.7 AS/NZS 1657-2013 4.4
43 8	Building: General Stores Location Reference: L162 Task: Access to the plant deck

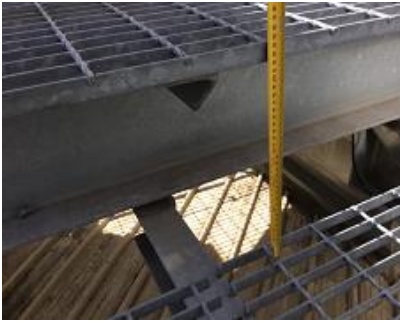
Variation in height between plant deck levels are greater than required maximum	Trips, Slips and Falls	Awareness induction	Med	Step to be installed	Low	Client advised	Outstanding	OH&S REGULATIONS 3.7 AS/NZS 1657-2013 3.1.4

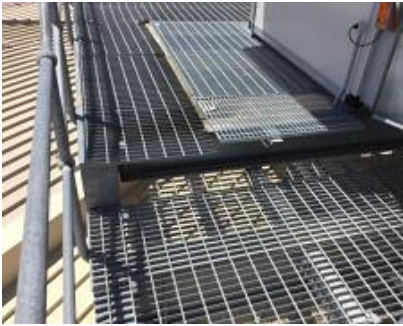
No	Photo of Hazard	Details of Hazard	Details of Risk	Existing/ Immediate Control Measure	Current Risk Level	Proposed Permanent Solution	Residual Risk Assessment	Details of Action Taken	Status	Reference
439	Building: General Stores Location Reference: L162 Task: Access to the plant deck

Variation in height between plant deck levels are greater than required maximum	Trips, Slips and Falls	Awareness induction	Med	Step to be installed	Low	Client advised	Outstanding	OH&S REGULATIONS 3.7 AS/NZS 1657-2013 3.1.4
440	Building: General Stores Location Reference: L162 Task: Access to the plant deck

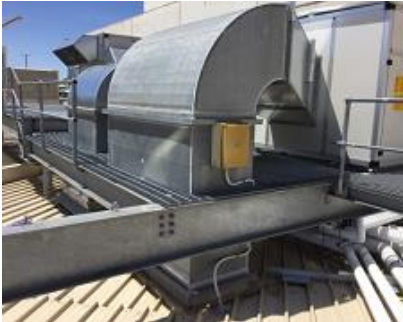
Handrail section is missing	Trips, Slips and Falls	Awareness induction	Med	Handrail to be installed	Low	Client advised	Outstanding	OH&S REGULATIONS 3.7 AS/NZS 1657-2013 4.4

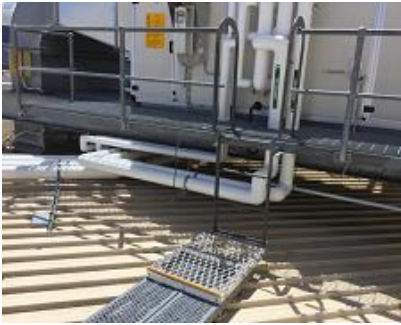
No	Photo of Hazard	Details of Hazard	Details of Risk	Existing/ Immediate Control Measure	Current Risk Level	Proposed Permanent Solution	Residual Risk Assessment	Details of Action Taken	Status	Reference
441	Building: General Stores Location Reference: L162 Task: Access to the plant deck

No slip resistance on ladder rungs and gap between top rung and landing is greater than required maximum	Trips, Slips and Falls	Awareness induction	Med	Existing ladder to be removed and new ladder to be installed	Low	Client advised	Outstanding	OH&S REGULATIONS 3.7 AS/NZS 1657-2013 7.4.3.1 & 7.4.8.4
442	Building: General Stores Location Reference: L162 Task: Access to the roof

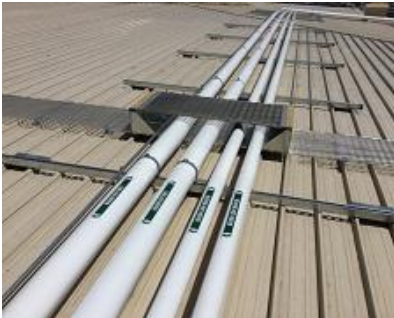
Variation in height between landing and roof is greater than required maximum	Trips, Slips and Falls	Awareness induction	Med	Handrail to be installed	Low	Client advised	Outstanding	OH&S REGULATIONS 3.7 AS/NZS 1657-2013 4.4

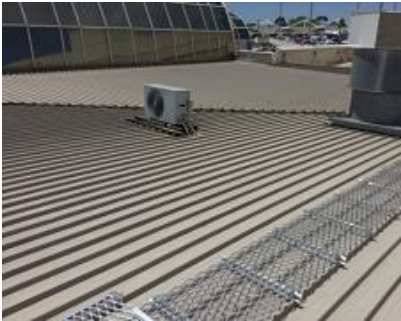
No	Photo of Hazard	Details of Hazard	Details of Risk	Existing/ Immediate Control Measure	Curre nt Risk Level	Proposed Permanent Solution	Resid ual Risk Asse sme nt	Details of Action Taken	Status	Reference
44 3	Building: General Stores Location Reference: L162 Task: Access to the A/c units

No safe access to the A/c units	Trips, Slips and Falls	N/A	Low	Supply walkway to the A/c units	Low	Client advised	Outstanding	-
44 4	Building: General Stores Location Reference: L163 Task: Access to the A/c units

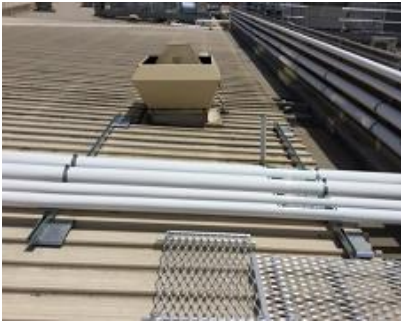
No safe access to the A/c units	Trips, Slips and Falls	N/A	Low	Supply walkway, step over and handrail to the A/c units	Low	Client advised	Outstanding	-

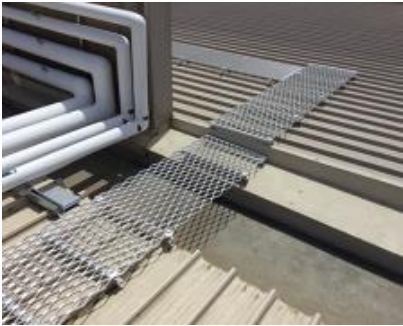
No	Photo of Hazard	Details of Hazard	Details of Risk	Existing/ Immediate Control Measure	Curre nt Risk Level	Proposed Permanent Solution	Resid ual Risk Asse sme nt	Details of Action Taken	Status	Reference
44 5	Building: General Stores Location Reference: L163 Task: Access to the roof

Variation in height between walkway panels are greater than required maximum	Trips, Slips and Falls	Awareness induction	Med	High visibility safety yellow nosing to be installed	Low	Client advised	Outstanding	OH&S REGULATIONS 3.7 AS/NZS 1657-2013 3.3.4
44 6	Building: General Stores Location Reference: L163 Task: Access to the A/c units

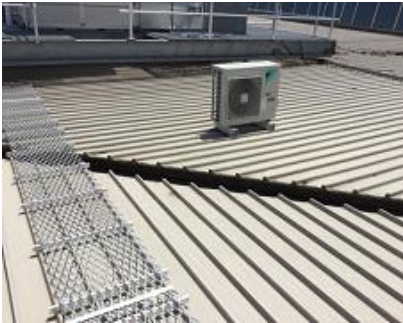
No safe access to the A/c units	Trips, Slips and Falls	N/A	Low	Supply walkway to the A/c units	Low	Client advised	Outstanding	-

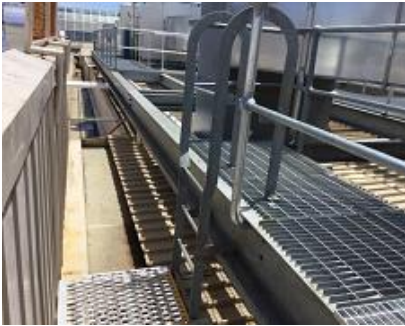
No	Photo of Hazard	Details of Hazard	Details of Risk	Existing/ Immediate Control Measure	Curre nt Risk Level	Proposed Permanent Solution	Resid ual Risk Asse sme nt	Details of Action Taken	Status	Reference
44 7	Building: General Stores Location Reference: L164 Task: Access to the plant deck

No slip resistance on ladder rungs and gap between top rung and landing is greater than required maximum	Trips, Slips and Falls	Awareness induction	Med	Existing ladder to be removed and new ladder to be installed	Low	Client advised	Outstanding	OH&S REGULATIONS 3.7 AS/NZS 1657-2013 7.4.3.1 & 7.4.8.4
44 8	Building: General Stores Location Reference: L164 Task: Access to the plant deck

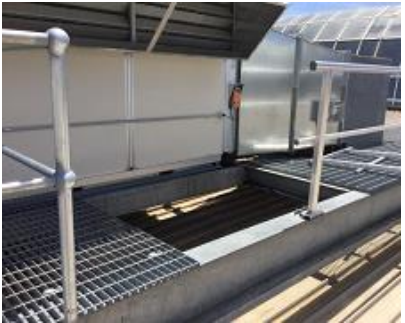
Un-protected cut out is present	Trips, Slips and Falls	Awareness induction	Med	Mesh and handrail to be installed	Low	Client advised	Outstanding	OH&S REGULATIONS 3.7 AS/NZS 1657-2013 4.4

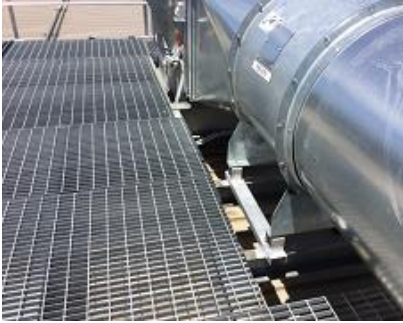
No	Photo of Hazard	Details of Hazard	Details of Risk	Existing/ Immediate Control Measure	Curre nt Risk Level	Proposed Permanent Solution	Resid ual Risk Asse sme nt	Details of Action Taken	Status	Reference
44 9	Building: General Stores Location Reference: L164 Task: Access to the plant deck

Gap between plant deck and unit is greater than required maximum	Trips, Slips and Falls	Awareness induction	Med	Gap to be closed	Low	Client advised	Outstanding	OH&S REGULATIONS 3.7 AS/NZS 1657-2013 4.4
45 0	Building: General Stores Location Reference: L164 Task: Access to the plant deck

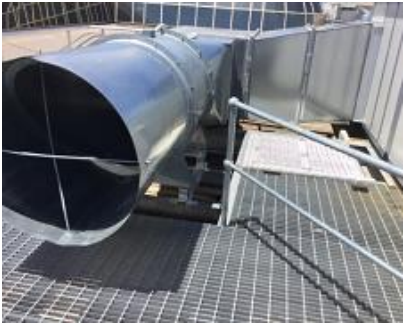
Gap between handrail and unit is greater than required maximum	Trips, Slips and Falls	Awareness induction	Med	Handrail to be installed	Low	Client advised	Outstanding	OH&S REGULATIONS 3.7 AS/NZS 1657-2013 4.4

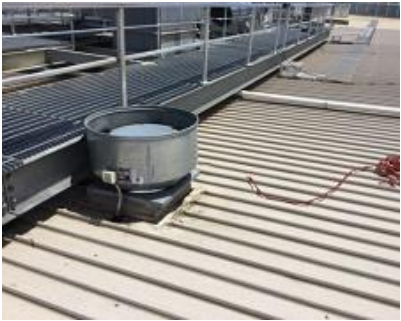
No	Photo of Hazard	Details of Hazard	Details of Risk	Existing/ Immediate Control Measure	Curre nt Risk Level	Proposed Permanent Solution	Resid ual Risk Asse sme nt	Details of Action Taken	Status	Reference
451	Building: General Stores Location Reference: L164 Task: Access to the A/c unit

No safe access to the A/c units	Trips, Slips and Falls	N/A	Low	Supply walkway and step over to the A/c units	Low	Client advised	Outstanding	-
452	Building: General Stores Location Reference: L164 Task: Access to the plant deck

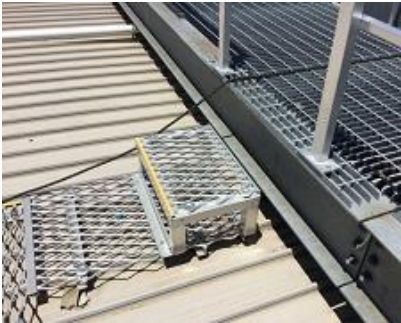
Gap between step and plant deck is greater than required maximum	Trips, Slips and Falls	Awareness induction	Med	Existing step to be re-located	Low	Client advised	Outstanding	OH&S REGULATIONS 3.7 AS/NZS 1657-2013 7.2

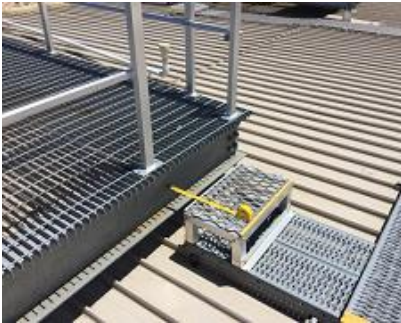
No	Photo of Hazard	Details of Hazard	Details of Risk	Existing/ Immediate Control Measure	Curre nt Risk Level	Proposed Permanent Solution	Resid ual Risk Asse sme nt	Details of Action Taken	Status	Reference
45 3	Building: General Stores Location Reference: L164 Task: Access to the plant deck

Gap between step and plant deck is greater than required maximum	Trips, Slips and Falls	Awareness induction	Med	Existing step to be re-located	Low	Client advised	Outstanding	OH&S REGULATIONS 3.7 AS/NZS 1657-2013 7.2
45 4	Building: General Stores Location Reference: L164 Task: Access to the plant deck

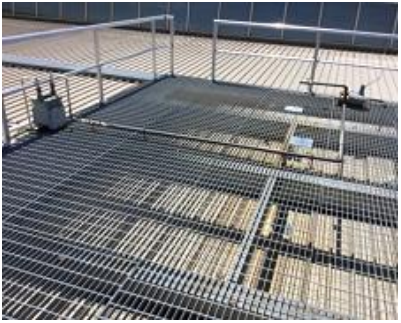
Pipe installed over the plant deck	Trips, Slips and Falls	Awareness induction	Med	High visibility safety yellow tape to be installed	Low	Client advised	Outstanding	OH&S REGULATIONS 3.7 AS/NZS 1657-2013 3.1.4

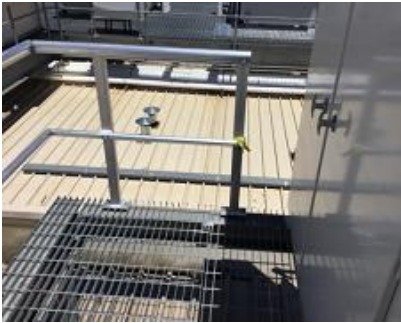
No	Photo of Hazard	Details of Hazard	Details of Risk	Existing/ Immediate Control Measure	Curre nt Risk Level	Proposed Permanent Solution	Resid ual Risk Asse sme nt	Details of Action Taken	Status	Reference
45 5	Building: General Stores Location Reference: L165 Task: Access to the plant deck

Handrail section is missing	Trips, Slips and Falls	Awareness induction	Med	Handrail to be installed	Low	Client advised	Outsta nding	OH&S REGULATIONS 3.7 AS/NZS 1657- 2013 4.4
45 6	Building: General Stores Location Reference: L165 Task: Access to the plant deck

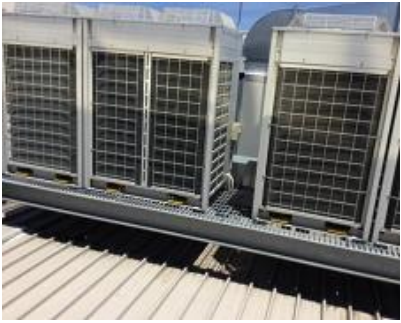
Handrail section is missing	Trips, Slips and Falls	Awareness induction	Med	Handrail to be installed	Low	Client advised	Outsta nding	OH&S REGULATIONS 3.7 AS/NZS 1657- 2013 4.4

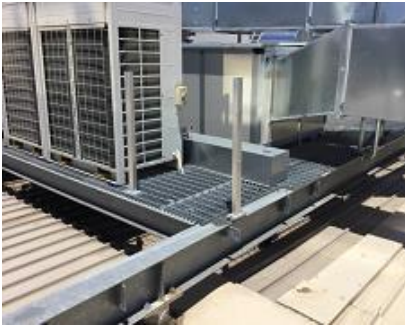
No	Photo of Hazard	Details of Hazard	Details of Risk	Existing/ Immediate Control Measure	Curre nt Risk Level	Proposed Permanent Solution	Resid ual Risk Asse sme nt	Details of Action Taken	Status	Reference
45 7	Building: General Stores Location Reference: L165 Task: Access to the plant deck

Handrail section is missing	Trips, Slips and Falls	Awareness induction	Med	Handrail to be installed	Low	Client advised	Outsta nding	OH&S REGULATIONS 3.7 AS/NZS 1657- 2013 4.4
45 8	Building: General Stores Location Reference: L166 Task: Access to the plant deck

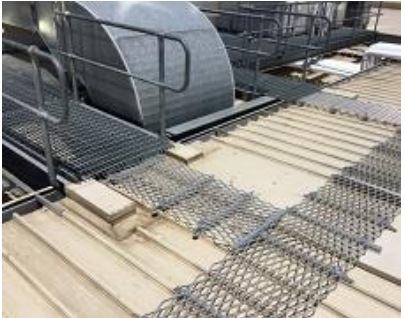
Variation in height between walkway panels are greater than required maximum	Trips, Slips and Falls	Awareness induction	Med	High visibility safety yellow nosing's to be installed	Low	Client advised	Outsta nding	OH&S REGULATIONS 3.7 AS/NZS 1657- 2013 3.3.4

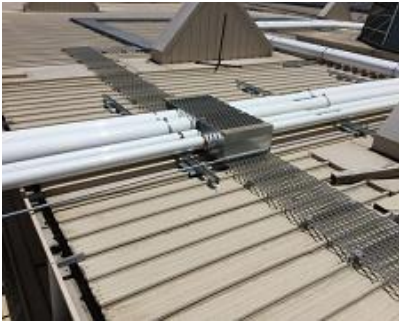
No	Photo of Hazard	Details of Hazard	Details of Risk	Existing/ Immediate Control Measure	Curre nt Risk Level	Proposed Permanent Solution	Resid ual Risk Asse sme nt	Details of Action Taken	Status	Reference
45 9	Building: General Stores Location Reference: L166 Task: Access to the roof

Variation in height between landing and roof is greater than required maximum	Trips, Slips and Falls	Awareness induction	Med	Handrail to be installed	Low	Client advised	Outstanding	OH&S REGULATIONS 3.7 AS/NZS 1657-2013 4.4
46 0	Building: General Stores Location Reference: L166 Task: Access to the roof

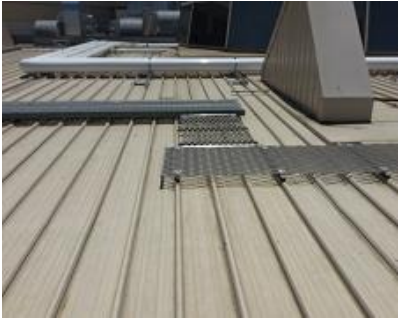
Variation in height between walkway panels are greater than required maximum	Trips, Slips and Falls	Awareness induction	Med	High visibility safety yellow nosing's to be installed	Low	Client advised	Outstanding	OH&S REGULATIONS 3.7 AS/NZS 1657-2013 3.3.4

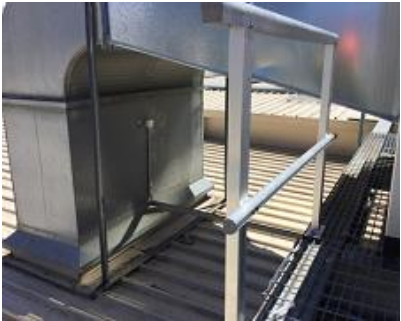
No	Photo of Hazard	Details of Hazard	Details of Risk	Existing/ Immediate Control Measure	Curre nt Risk Level	Proposed Permanent Solution	Resid ual Risk Asse sme nt	Details of Action Taken	Status	Reference
461	Building: General Stores Location Reference: L166 Task: Access to the plant deck

Handrail section is missing	Trips, Slips and Falls	Awareness induction	Med	Handrail to be installed	Low	Client advised	Outstanding	OH&S REGULATIONS 3.7 AS/NZS 1657-2013 4.4
462	Building: General Stores Location Reference: L166 Task: Access to the plant deck

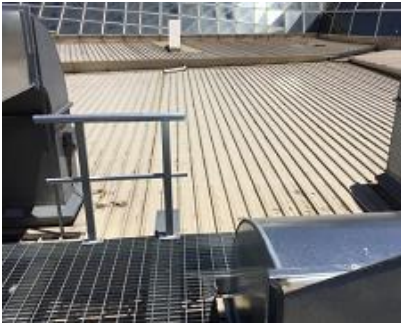
Handrail section is missing	Trips, Slips and Falls	Awareness induction	Med	Handrail to be installed	Low	Client advised	Outstanding	OH&S REGULATIONS 3.7 AS/NZS 1657-2013 4.4

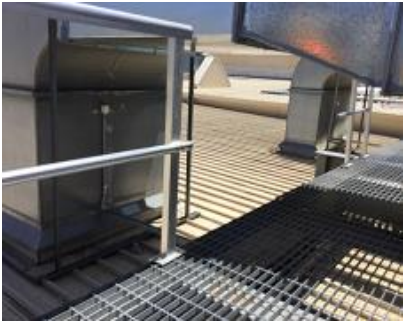
No	Photo of Hazard	Details of Hazard	Details of Risk	Existing/ Immediate Control Measure	Curre nt Risk Level	Proposed Permanent Solution	Resid ual Risk Asse sme nt	Details of Action Taken	Status	Reference
46 3	Building: General Stores Location Reference: L166 Task: Access to the roof

Handrail section is missing	Trips, Slips and Falls	Awareness induction	Med	Handrail to be installed	Low	Client advised	Outsta nding	OH&S REGULATIONS 3.7 AS/NZS 1657- 2013 4.4
46 4	Building: General Stores Location Reference: L166 Task: Access to the roof

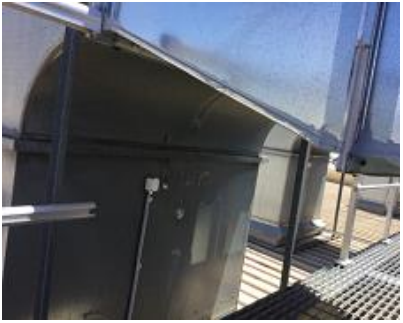
Handrail section is missing	Trips, Slips and Falls	Awareness induction	Med	Handrail to be installed	Low	Client advised	Outsta nding	OH&S REGULATIONS 3.7 AS/NZS 1657- 2013 4.4

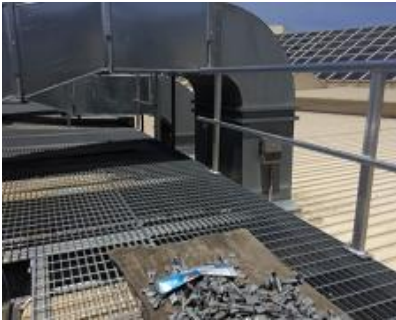
No	Photo of Hazard	Details of Hazard	Details of Risk	Existing/ Immediate Control Measure	Curre nt Risk Level	Proposed Permanent Solution	Resid ual Risk Asse sme nt	Details of Action Taken	Status	Reference
46 5	Building: General Stores Location Reference: L166 Task: Access to the roof

Handrail section is missing	Trips, Slips and Falls	Awareness induction	Med	Handrail to be installed	Low	Client advised	Outsta nding	OH&S REGULATIONS 3.7 AS/NZS 1657- 2013 4.4
46 6	Building: General Stores Location Reference: L166 Task: Access to the roof

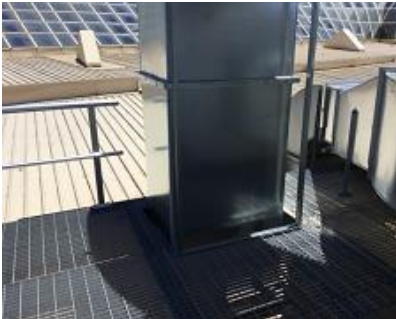
Handrail section is missing	Trips, Slips and Falls	Awareness induction	Med	Handrail to be installed	Low	Client advised	Outsta nding	OH&S REGULATIONS 3.7 AS/NZS 1657- 2013 4.4

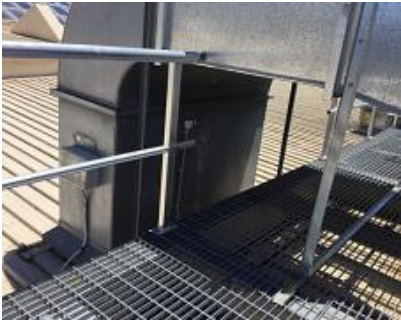
No	Photo of Hazard	Details of Hazard	Details of Risk	Existing/ Immediate Control Measure	Curre nt Risk Level	Proposed Permanent Solution	Resid ual Risk Asse sme nt	Details of Action Taken	Status	Reference
46 7	Building: General Stores Location Reference: L166 Task: Access to the roof

Handrail section is missing	Trips, Slips and Falls	Awareness induction	Med	Handrail to be installed	Low	Client advised	Outsta nding	OH&S REGULATIONS 3.7 AS/NZS 1657- 2013 4.4
46 8	Building: General Stores Location Reference: L166 Task: Access to the plant deck

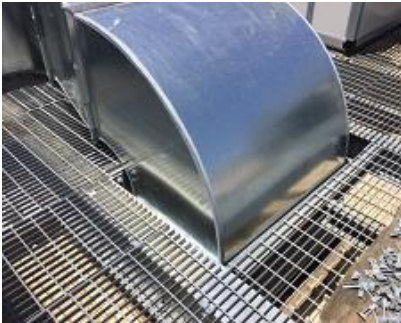
Gap between plant deck and unit is greater than required maximum	Trips, Slips and Falls	Awareness induction	Med	Gap to be closed	Low	Client advised	Outsta nding	OH&S REGULATIONS 3.7 AS/NZS 1657- 2013 4.4

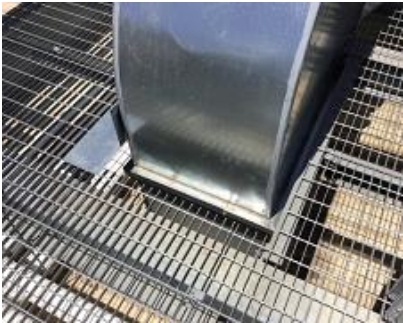
No	Photo of Hazard	Details of Hazard	Details of Risk	Existing/ Immediate Control Measure	Curre nt Risk Level	Proposed Permanent Solution	Resid ual Risk Asse sme nt	Details of Action Taken	Status	Reference
46 9	Building: General Stores Location Reference: L166 Task: Access to the plant deck

Gap between plant deck and unit is greater than required maximum	Trips, Slips and Falls	Awareness induction	Med	Gap to be closed	Low	Client advised	Outstanding	OH&S REGULATIONS 3.7 AS/NZS 1657-2013 4.4
47 0	Building: General Stores Location Reference: L166 Task: Access to the A/c units

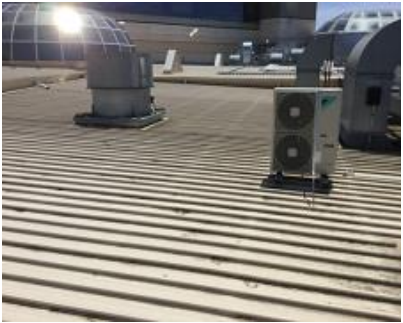
No safe access to the A/c units	Trips, Slips and Falls	N/A	Low	Supply walkway and access ladder to the A/c units	Low	Client advised	Outstanding	-

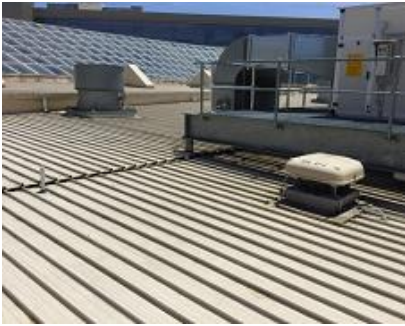
No	Photo of Hazard	Details of Hazard	Details of Risk	Existing/ Immediate Control Measure	Curre nt Risk Level	Proposed Permanent Solution	Resid ual Risk Asse sme nt	Details of Action Taken	Status	Reference
471	Building: General Stores Location Reference: L166 Task: Access to the A/c units

No safe access to the A/c units	Trips, Slips and Falls	N/A	Low	Supply walkway to the A/c units	Low	Client advised	Outstanding	-
472	Building: General Stores Location Reference: L166 Task: Access to the A/c units

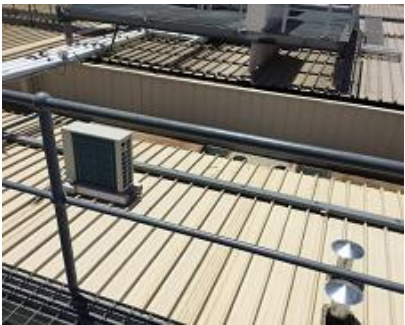
No safe access to the A/c units	Trips, Slips and Falls	N/A	Low	Supply walkway and access ladder to the A/c units	Low	Client advised	Outstanding	-
