Roof Safety Report

**Chadstone Shopping Centre,
VIC 3148**

Prepared By: Safemaster Safety Products
Date: 20 April 2018

Roof Safety Report for
Chadstone Shopping Centre, VIC 3148

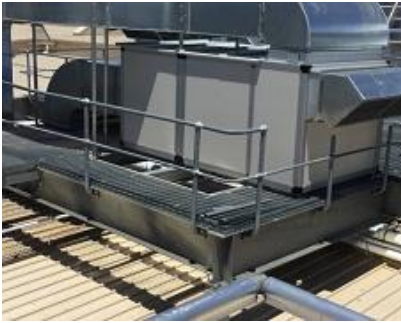
No	Photo of Hazard	Details of Hazard	Details of Risk	Existing/ Immediate Control Measure	Curre nt Risk Level	Proposed Permanent Solution	Resid ual Risk Asse sme nt	Details of Action Taken	Status	Reference
47 3	Building: General Stores Location Reference: L166 Task: Access to the plant deck

Variation in height between plant deck and roof is greater than required maximum	Trips, Slips and Falls	Awareness induction	Med	Handrail/mesh to be installed	Low	Client advised	Outstanding	OH&S REGULATIONS 3.7 AS/NZS 1657-2013 4.4
47 4	Building: General Stores Location Reference: L166 Task: Access to the plant deck

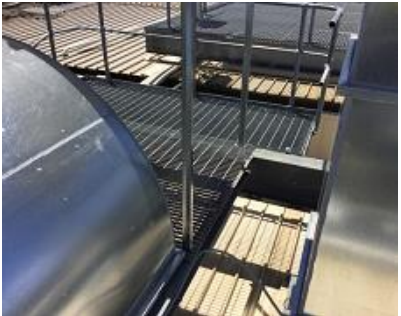
Variation in height between plant deck and roof is greater than required maximum	Trips, Slips and Falls	Awareness induction	Med	Handrail/mesh to be installed	Low	Client advised	Outstanding	OH&S REGULATIONS 3.7 AS/NZS 1657-2013 4.4

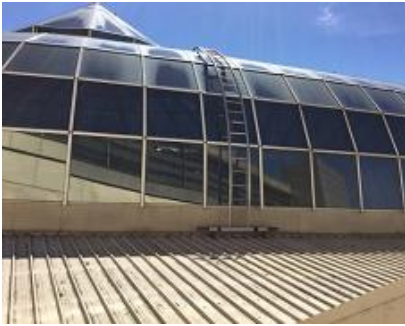
No	Photo of Hazard	Details of Hazard	Details of Risk	Existing/ Immediate Control Measure	Curre nt Risk Level	Proposed Permanent Solution	Resid ual Risk Asse sme nt	Details of Action Taken	Status	Reference
47 5	Building: General Stores Location Reference: L167 Task: Access to the roof

Non-compliance ladder is present and no slip resistance on ladder rungs	Trips, Slips and Falls	Awareness induction	Med	Further investigation required with Centre Management and Window cleaners to propose permanent solution. Non-slip high visibility safety yellow rung caps to be installed	Low	Client advised	Outstanding	OH&S REGULATIONS 3.7 AS/NZS 1657-2013 3.1.4 & 7.4.3.1
47 6	Building: General Stores Location Reference: L168 Task: Access to the roof

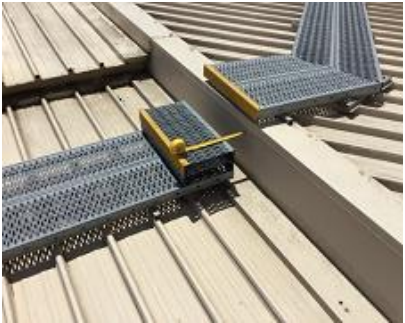
Non-complaint step is present and handrail is missing	Trips, Slips and Falls	Awareness induction	Med	Existing step to be re-located and handrail to be installed	Low	Client advised	Outstanding	OH&S REGULATIONS 3.7 AS/NZS 1657-2013 7.2 & 4.4

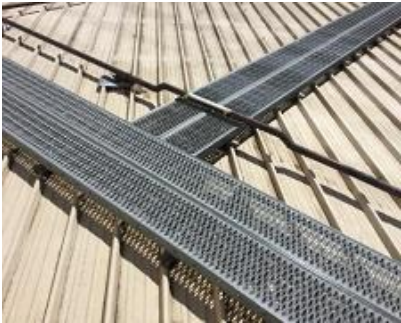
No	Photo of Hazard	Details of Hazard	Details of Risk	Existing/ Immediate Control Measure	Curre nt Risk Level	Proposed Permanent Solution	Resid ual Risk Asse sme nt	Details of Action Taken	Status	Reference
47 7	Building: General Stores Location Reference: L169 Task: Access to the roof

Pipe installed over the walkway path	Trips, Slips and Falls	Awareness induction	Med	Step over to be installed	Low	Client advised	Outstanding	OH&S REGULATIONS 3.7 AS/NZS 1657-2013 3.1.4
47 8	Building: General Stores Location Reference: L169 Task: Access to the roof

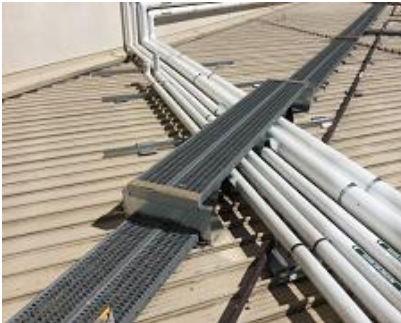
Variation in height between landing and roof is greater than required maximum	Trips, Slips and Falls	Awareness induction	Med	Handrail to be installed	Low	Client advised	Outstanding	OH&S REGULATIONS 3.7 AS/NZS 1657-2013 4.4

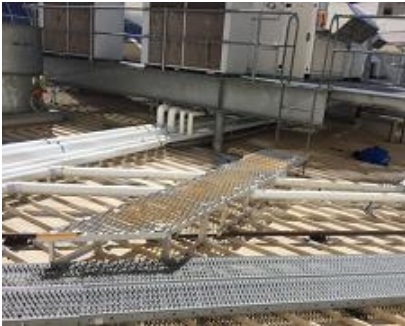
No	Photo of Hazard	Details of Hazard	Details of Risk	Existing/ Immediate Control Measure	Curre nt Risk Level	Proposed Permanent Solution	Resid ual Risk Asse sme nt	Details of Action Taken	Status	Reference
47 9	Building: General Stores Location Reference: L170 Task: Access to the roof

Variation in height between landing and roof is greater than required maximum	Trips, Slips and Falls	Awareness induction	Med	Handrail to be installed	Low	Client advised	Outstanding	OH&S REGULATIONS 3.7 AS/NZS 1657-2013 4.4
48 0	Building: General Stores Location Reference: L170 Task: Access to the plant deck

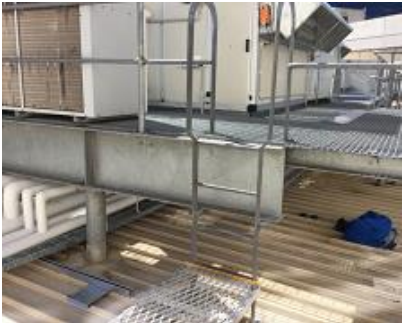
Gap between top rung and landing is greater than required maximum and no slip resistance on ladder rungs	Trips, Slips and Falls	Awareness induction	Med	Existing ladder to be removed and new ladder to be installed	Low	Client advised	Outstanding	OH&S REGULATIONS 3.7 AS/NZS 1657-2013 7.4.8.4 & 7.4.3.1

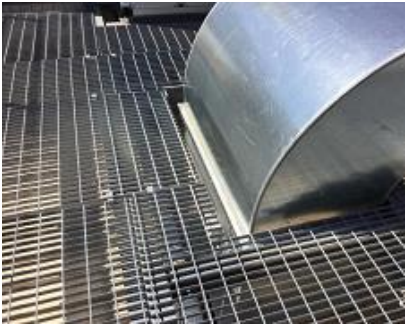
No	Photo of Hazard	Details of Hazard	Details of Risk	Existing/ Immediate Control Measure	Curre nt Risk Level	Proposed Permanent Solution	Resid ual Risk Asse sme nt	Details of Action Taken	Status	Reference
481	Building: General Stores Location Reference: L170 Task: Access to the plant deck

Gap between plant deck and unit is greater than required maximum	Trips, Slips and Falls	Awareness induction	Med	Gap to be closed	Low	Client advised	Outstanding	OH&S REGULATIONS 3.7 AS/NZS 1657-2013 4.4
482	Building: General Stores Location Reference: L170 Task: Access to the plant deck

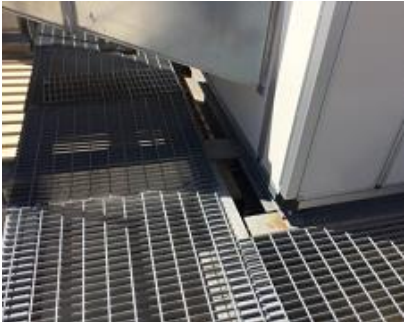
Gap between plant deck and unit is greater than required maximum	Trips, Slips and Falls	Awareness induction	Med	Gap to be closed	Low	Client advised	Outstanding	OH&S REGULATIONS 3.7 AS/NZS 1657-2013 4.4

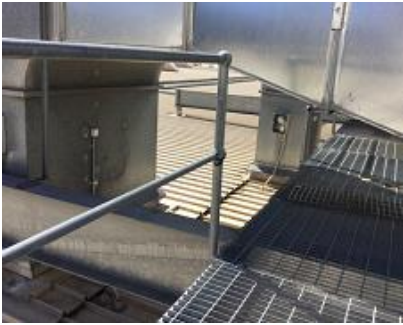
No	Photo of Hazard	Details of Hazard	Details of Risk	Existing/ Immediate Control Measure	Curre nt Risk Level	Proposed Permanent Solution	Resid ual Risk Asse sme nt	Details of Action Taken	Status	Reference
48 3	Building: General Stores Location Reference: L170 Task: Access to the plant deck

Handrail section is missing	Trips, Slips and Falls	Awareness induction	Med	Handrail to be installed	Low	Client advised	Outsta nding	OH&S REGULATIONS 3.7 AS/NZS 1657- 2013 4.4
48 4	Building: General Stores Location Reference: L170 Task: Access to the plant deck

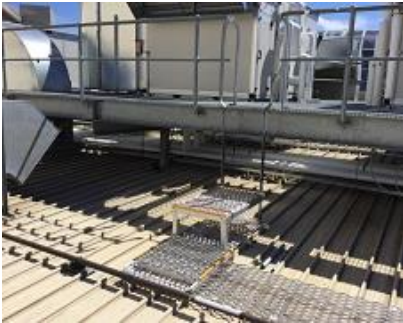
Gap between top rung and landing is greater than required maximum and no slip resistance on ladder rungs	Trips, Slips and Falls	Awareness induction	Med	Existing ladder to be removed and new ladder to be installed	Low	Client advised	Outsta nding	OH&S REGULATIONS 3.7 AS/NZS 1657- 2013 7.4.8.4 & 7.4.3.1

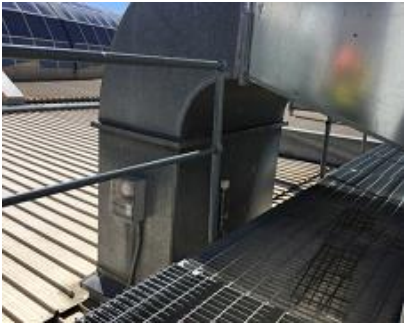
No	Photo of Hazard	Details of Hazard	Details of Risk	Existing/ Immediate Control Measure	Curre nt Risk Level	Proposed Permanent Solution	Resid ual Risk Asse sme nt	Details of Action Taken	Status	Reference
48 5	Building: General Stores Location Reference: L170 Task: Access to the plant deck

Handrail section is missing	Trips, Slips and Falls	Awareness induction	Med	Handrail to be installed	Low	Client advised	Outsta nding	OH&S REGULATIONS 3.7 AS/NZS 1657- 2013 4.4
48 6	Building: General Stores Location Reference: L170 Task: Access to the plant deck

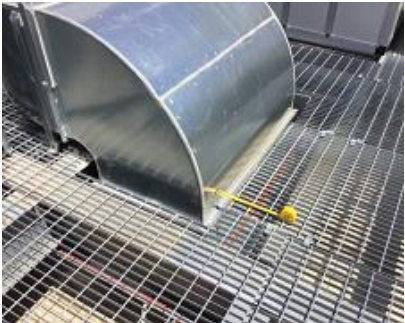
Gap between plant deck and unit is greater than required maximum	Trips, Slips and Falls	Awareness induction	Med	Gap to be closed	Low	Client advised	Outsta nding	OH&S REGULATIONS 3.7 AS/NZS 1657- 2013 4.4

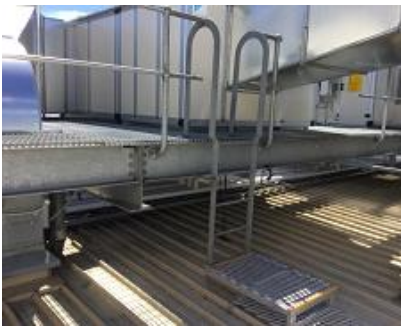
Gap between top rung and landing is greater than required maximum and no slip resistance on ladder rungs	Trips, Slips and Falls	Awareness induction	Med	Existing ladder to be removed and new ladder to be installed	Low	Client advised	Outstanding	OH&S REGULATIONS 3.7 AS/NZS 1657-2013 7.4.8.4 & 7.4.3.1
488	Building: General Stores Location Reference: L170 Task: Access to the plant deck

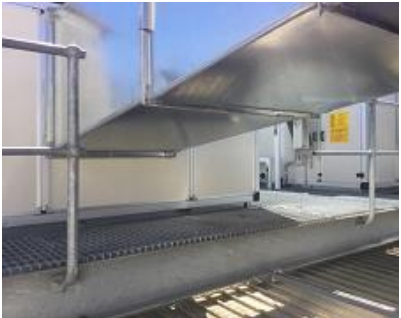
Handrail section is missing	Trips, Slips and Falls	Awareness induction	Med	Handrail to be installed	Low	Client advised	Outstanding	OH&S REGULATIONS 3.7 AS/NZS 1657-2013 4.4

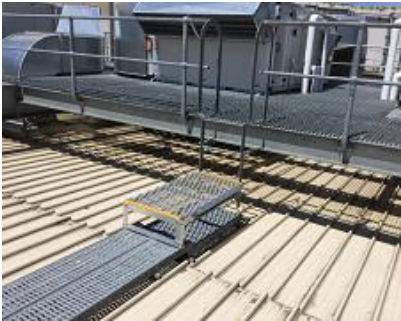
Gap between top rung and landing is greater than required maximum and no slip resistance on ladder rungs	Trips, Slips and Falls	Awareness induction	Med	Existing ladder to be removed and new ladder to be installed	Low	Client advised	Outstanding	OH&S REGULATIONS 3.7 AS/NZS 1657-2013 7.4.8.4 & 7.4.3.1
49 0	Building: General Stores Location Reference: L170 Task: Access to the plant deck

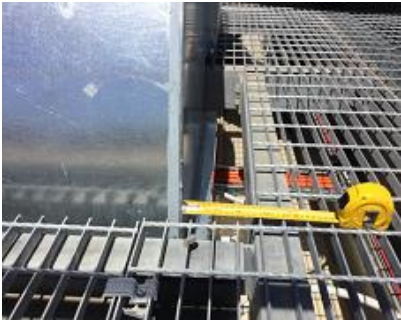
Gap between plant deck and unit is greater than required maximum	Trips, Slips and Falls	Awareness induction	Med	Gap to be closed	Low	Client advised	Outstanding	OH&S REGULATIONS 3.7 AS/NZS 1657-2013 4.4

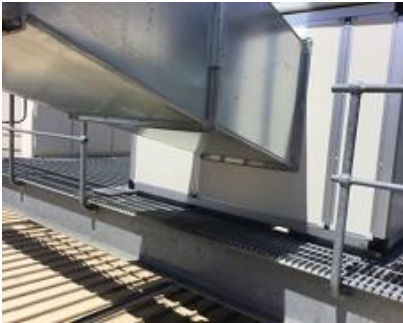
Handrail section is missing	Trips, Slips and Falls	Awareness induction	Med	Handrail to be installed	Low	Client advised	Outstanding	OH&S REGULATIONS 3.7 AS/NZS 1657-2013 4.4
492	Building: General Stores Location Reference: L170 Task: Access to the A/c units

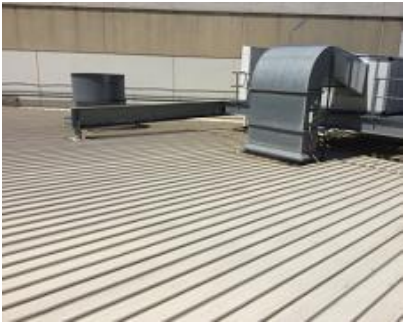
No safe access to the A/c units	Trips, Slips and Falls	N/A	Low	Supply walkway to the A/c units	Low	Client advised	Outstanding	-

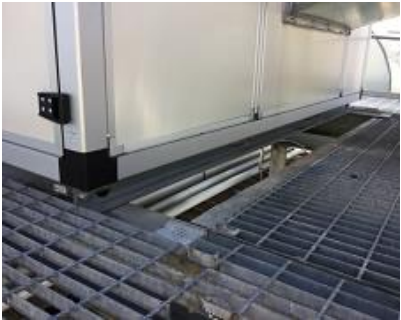
Gap between plant deck and unit is greater than required maximum	Trips, Slips and Falls	Awareness induction	Med	Gap to be closed	Low	Client advised	Outstanding	OH&S REGULATIONS 3.7 AS/NZS 1657-2013 4.4
49 4	Building: General Stores Location Reference: L170 Task: Access to the plant deck

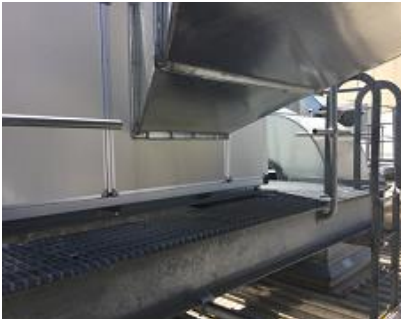
Handrail section is missing	Trips, Slips and Falls	Awareness induction	Med	Handrail to be installed	Low	Client advised	Outstanding	OH&S REGULATIONS 3.7 AS/NZS 1657-2013 4.4

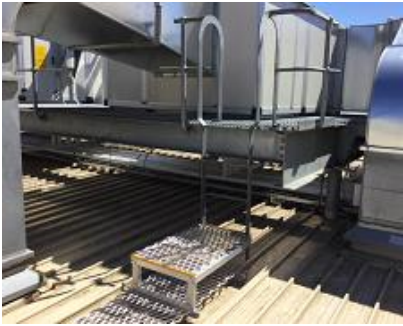
Gap between top rung and landing is greater than required maximum and no slip resistance on ladder rungs	Trips, Slips and Falls	Awareness induction	Med	Existing ladder to be removed and new ladder to be installed	Low	Client advised	Outstanding	OH&S REGULATIONS 3.7 AS/NZS 1657-2013 7.4.8.4 & 7.4.3.1
49 6	Building: General Stores Location Reference: L170 Task: Access to the plant deck

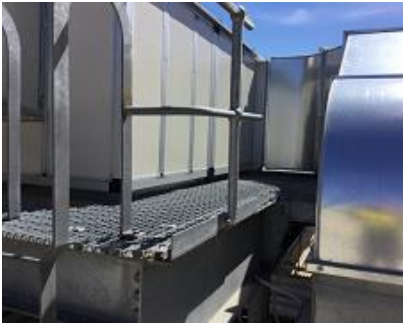
Handrail section is missing	Trips, Slips and Falls	Awareness induction	Med	Handrail to be installed	Low	Client advised	Outstanding	OH&S REGULATIONS 3.7 AS/NZS 1657-2013 4.4

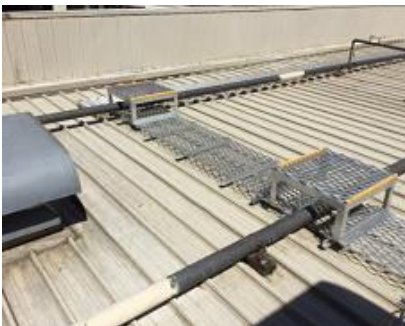
Variation in height between landing and roof is greater than required maximum	Trips, Slips and Falls	Awareness induction	Med	Existing step to be modified and re-installed	Low	Client advised	Outstanding	OH&S REGULATIONS 3.7 AS/NZS 1657-2013 4.4
49 8	Building: General Stores Location Reference: L170 Task: Access to the roof

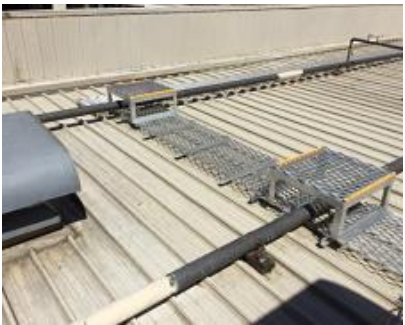
Variation in height between landing and roof is greater than required maximum	Trips, Slips and Falls	Awareness induction	Med	Existing step to be modified and re-installed	Low	Client advised	Outstanding	OH&S REGULATIONS 3.7 AS/NZS 1657-2013 4.4

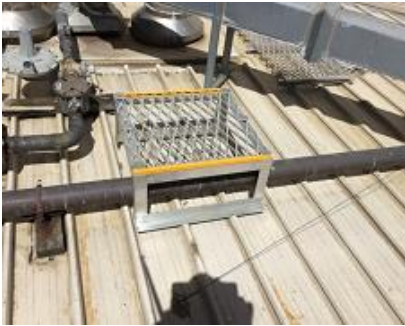
Variation in height between landing and roof is greater than required maximum	Trips, Slips and Falls	Awareness induction	Med	Existing step to be modified and re-installed	Low	Client advised	Outstanding	OH&S REGULATIONS 3.7 AS/NZS 1657-2013 4.4
50	Building: General Stores Location Reference: L171 Task: Access to the roof									
0

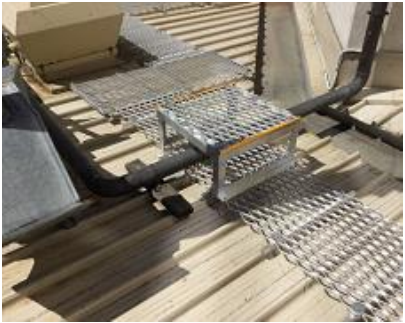
Variation in height between landing and roof is greater than required maximum	Trips, Slips and Falls	Awareness induction	Med	Existing step to be modified and re-installed	Low	Client advised	Outstanding	OH&S REGULATIONS 3.7 AS/NZS 1657-2013 4.4

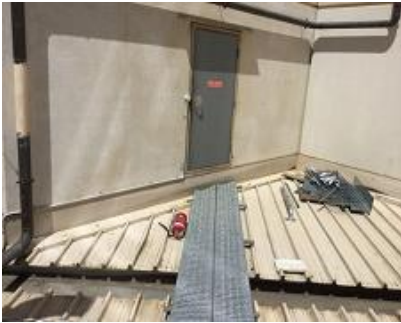
No landing platform at door access point	Trips, Slips and Falls	Awareness induction	Med	Landing platform including handrail to be installed	Low	Client advised	Outstanding	OH&S REGULATIONS 3.7 AS/NZS 1657-2013 4.4
502	Building: General Stores Location Reference: L172 Task: Access to the A/c units

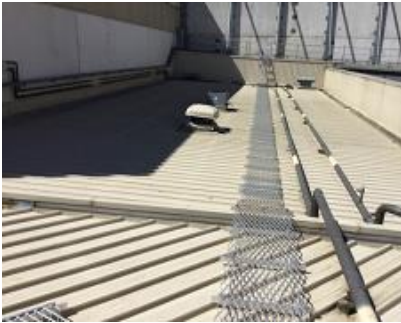
No safe access to the A/c units	Trips, Slips and Falls	N/A	Low	Supply walkway to the A/c units	Low	Client advised	Outstanding	-

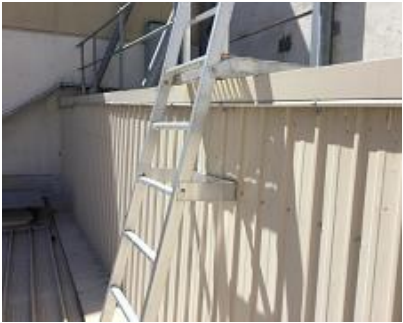
Clearance behind the ladder is less than required minimum	Trips, Slips and Falls	Awareness induction	Med	Existing ladder to be re-installed with landing platforms, brackets and handrails	Low	Client advised	Outstanding	OH&S REGULATIONS 3.7 AS/NZS 1657-2013 7.4.5
50 4	Building: General Stores Location Reference: L173 Task: Access to the roof

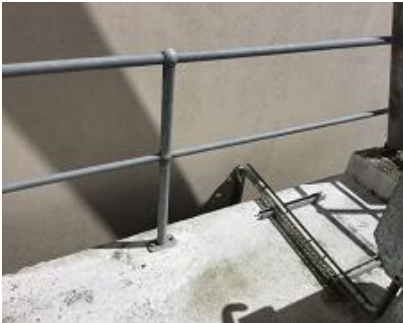
Toe board is missing for handrails	Trips, Slips and Falls	Awareness induction	Med	Toe board to be installed	Low	Client advised	Outstanding	OH&S REGULATIONS 3.7 AS/NZS 1657-2013 4.6

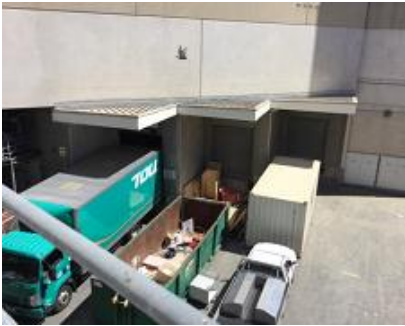
No height safety system installed	Trips, Slips and Falls	Restrict Access	High	"EWP Access to Roof" sign to be installed	Low	Client advised	Outstanding	OH&S REGULATIONS 3.55 & 3.11
50 6	Building: General Stores Location Reference: L171 Task: Access to the roof

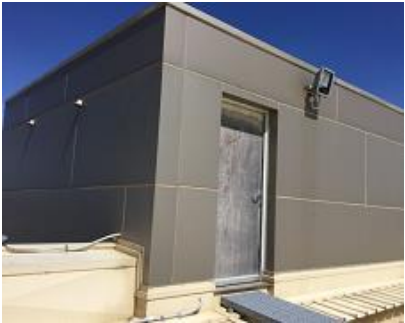
No height safety system installed	Trips, Slips and Falls	Awareness induction	High	Fall arrest anchors, anchor strop, walkway and access ladder to be installed	Low	Client advised	Outstanding	OH&S REGULATIONS 3.7 & 3.55 AS/NZS 1657-2013 3.1.4

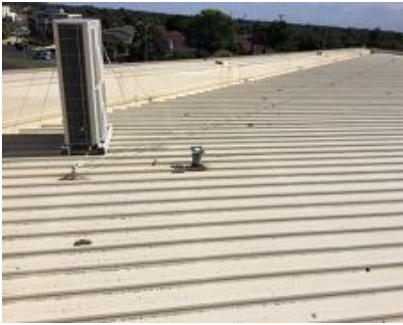
Non-complaint static line is present	Trips, Slips and Falls	Awareness induction	High	Existing static line to be removed and new static line to be installed	Low	Client advised	Outstanding	OH&S REGULATIONS 3.55 AS1891.4:2009
50 8	Building: General Stores Location Reference: L175 Task: Access to the A/c units

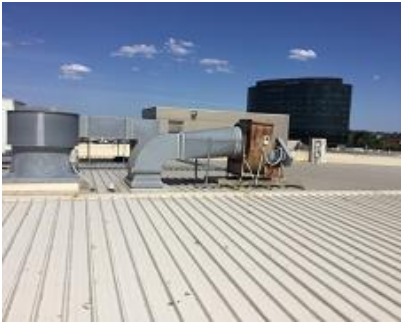
No safe access to the A/c units	Trips, Slips and Falls	N/A	Low	Supply walkway to the A/c units	Low	Client advised	Outstanding	-

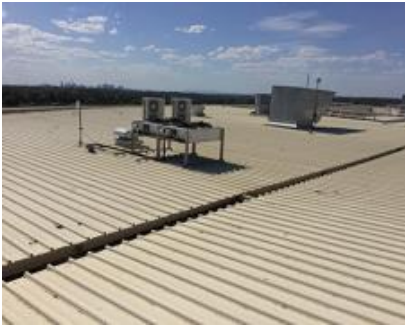
No safe access to the A/c units	Trips, Slips and Falls	N/A	Low	Supply walkway to the A/c units	Low	Client advised	Outstanding	-
510	Building: General Stores Location Reference: L175 Task: Access to the roof

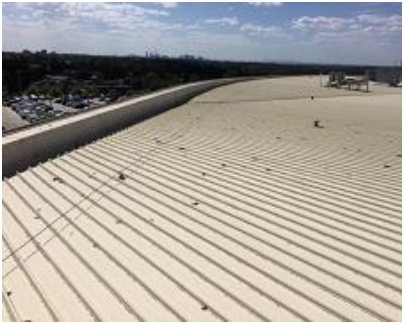
Non-complaint static line is present	Trips, Slips and Falls	Awareness induction	High	Existing static line to be removed and new static line to be installed	Low	Client advised	Outstanding	OH&S REGULATIONS 3.55 AS1891.4:2009

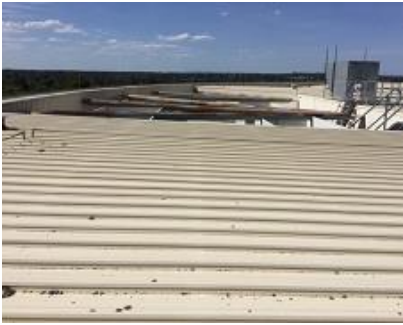
Non-complaint static line is present	Trips, Slips and Falls	Awareness induction	High	Existing static line to be removed and new static line to be installed	Low	Client advised	Outstanding	OH&S REGULATIONS 3.55 AS1891.4:2009
512	Building: General Stores Location Reference: L175 Task: Access to the roof

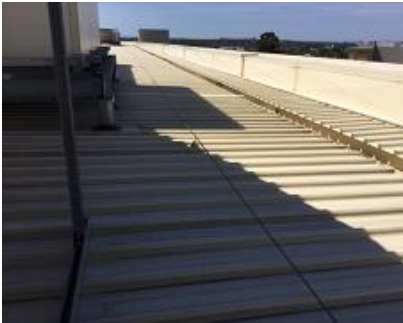
Non-complaint static line is present	Trips, Slips and Falls	Awareness induction	High	Existing static line to be removed and new static line to be installed	Low	Client advised	Outstanding	OH&S REGULATIONS 3.55 AS1891.4:2009

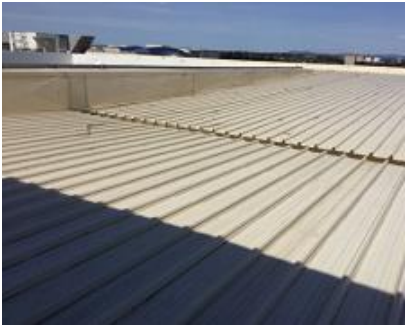
Non-complaint static line is present	Trips, Slips and Falls	Awareness induction	High	Existing static line to be removed and new static line to be installed	Low	Client advised	Outstanding	OH&S REGULATIONS 3.55 AS1891.4:2009
514	Building: General Stores Location Reference: L176 Task: Access to the roof

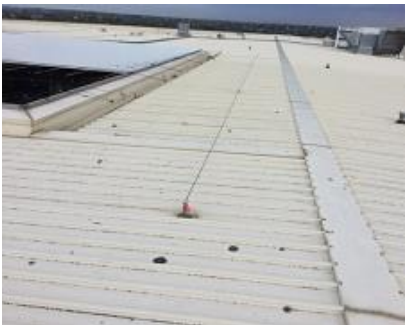
Non-complaint static line is present	Trips, Slips and Falls	Awareness induction	High	Existing static line to be removed and new static line to be installed	Low	Client advised	Outstanding	OH&S REGULATIONS 3.55 AS1891.4:2009

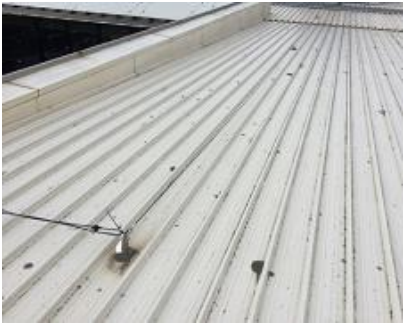
Non-complaint static line is present	Trips, Slips and Falls	Awareness induction	High	Existing static line to be removed and new static line to be installed	Low	Client advised	Outstanding	OH&S REGULATIONS 3.55 AS1891.4:2009
516	Building: General Stores Location Reference: L177 Task: Access to the roof

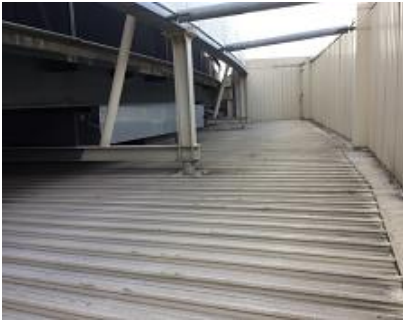
Headroom is less than required minimum	Trips, Slips and Falls	Awareness induction	Med	"Caution-Low Headroom" signs to be installed	Low	Client advised	Outstanding	OH&S REGULATIONS 3.7 AS/NZS 1657-2013 3.1.5

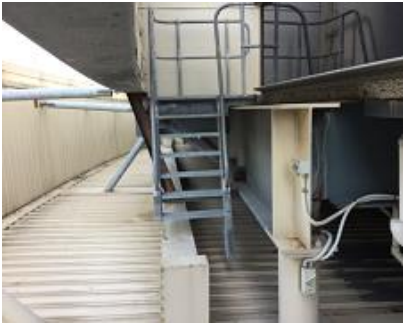
No	Photo of Hazard	Details of Hazard	Details of Risk	Existing/ Immediate Control Measure	Curre nt Risk Level	Proposed Permanent Solution	Resid ual Risk Asse sme nt	Details of Action Taken	Status	Reference
517	Building: General Stores Location Reference: L178 Task: Access to the roof

Bottom tread height is less than required minimum, Landing platform is missing, and Headroom is less than required minimum	Trips, Slips and Falls	Awareness induction	Med	Landing platform including "Caution-Low Headroom" signs to be installed	Low	Client advised	Outstanding	OH&S REGULATIONS 3.7 AS/NZS 1657-2013 7.3.3 & 7.3.6
518	Building: General Stores Location Reference: L179 Task: Access to the roof

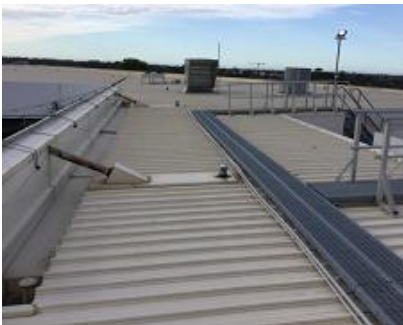
No height safety system installed	Trips, Slips and Falls	Awareness induction	High	Fall arrest anchors to be installed	Low	Client advised	Outstanding	OH&S REGULATIONS 3.55

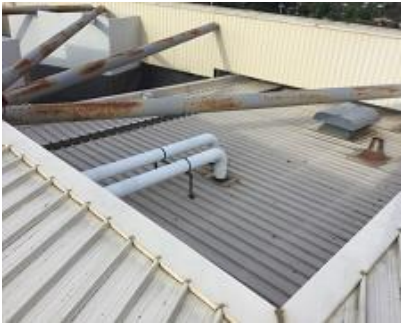
No	Photo of Hazard	Details of Hazard	Details of Risk	Existing/ Immediate Control Measure	Curre nt Risk Level	Proposed Permanent Solution	Resid ual Risk Asse sme nt	Details of Action Taken	Status	Reference
519	Building: General Stores Location Reference: L181 Task: Access to the roof

No height safety and access system installed	Trips, Slips and Falls	Awareness induction	High	Fall arrest anchors, anchor stop and access ladder to be installed	Low	Client advised	Outstanding	OH&S REGULATIONS 3.7 & 3.55 AS/NZS 1657-2013 3.1.4
520	Building: General Stores Location Reference: L181 Task: Access to the roof

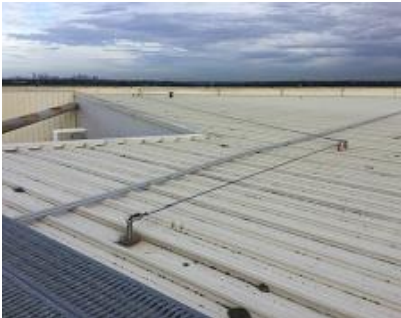
Non-complaint static line is present	Trips, Slips and Falls	Awareness induction	High	Existing static line to be removed and new static line to be installed	Low	Client advised	Outstanding	OH&S REGULATIONS 3.55 AS1891.4:2009

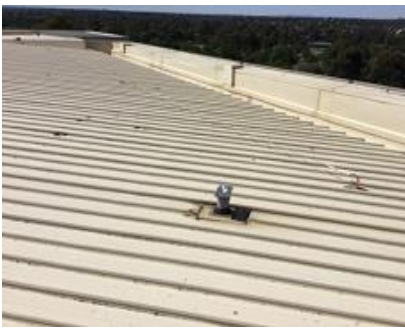
No	Photo of Hazard	Details of Hazard	Details of Risk	Existing/ Immediate Control Measure	Curre nt Risk Level	Proposed Permanent Solution	Resid ual Risk Asse sme nt	Details of Action Taken	Status	Reference
521	Building: General Stores Location Reference: L181 Task: Access to the roof

Non-complaint static line is present	Trips, Slips and Falls	Awareness induction	High	Existing static line to be removed and new static line to be installed	Low	Client advised	Outstanding	OH&S REGULATIONS 3.55 AS1891.4:2009
522	Building: General Stores Location Reference: L181 Task: Access to the A/c units

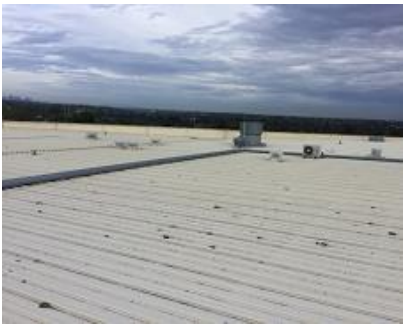
No safe access to the A/c units	Trips, Slips and Falls	N/A	Low	Supply walkway to the A/c units	Low	Client advised	Outstanding	-

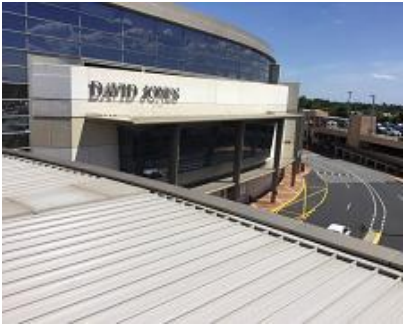
No	Photo of Hazard	Details of Hazard	Details of Risk	Existing/ Immediate Control Measure	Curre nt Risk Level	Proposed Permanent Solution	Resid ual Risk Asse sme nt	Details of Action Taken	Status	Reference
52 3	Building: General Stores Location Reference: L182 Task: Restrict access to the roof

No height safety system installed	Trips, Slips and Falls	Restrict Access	High	"EWP Access to Roof" sign to be installed	Low	Client advised	Outstanding	OH&S REGULATIONS 3.55 & 3.11
52 4	Building: General Stores Location Reference: L183 Task: Access to the roof

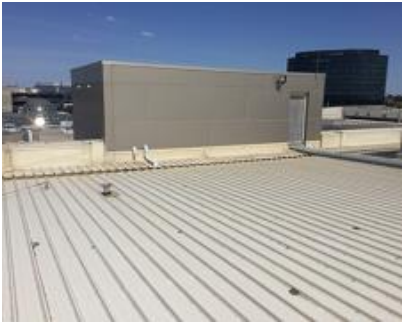
No height safety and access system installed	Trips, Slips and Falls	Awareness induction	High	Fall arrest anchors, anchor strop, walkway and access ladder to be installed	Low	Client advised	Outstanding	OH&S REGULATIONS 3.7 & 3.55 AS/NZS 1657-2013 3.1.4

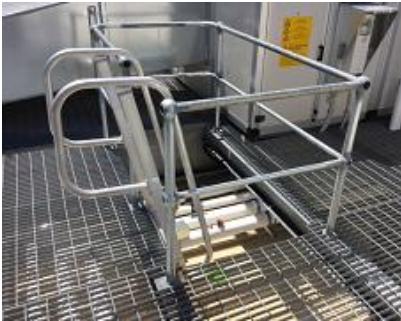
No	Photo of Hazard	Details of Hazard	Details of Risk	Existing/ Immediate Control Measure	Curre nt Risk Level	Proposed Permanent Solution	Resid ual Risk Asse sme nt	Details of Action Taken	Status	Reference
52 5	Building: General Stores Location Reference: L184 Task: Access to the plant deck

Bottom rung height is less than required minimum and handrail projecting towards the user	Trips, Slips and Falls	Awareness induction	Med	Existing ladder to be re-installed with landing platform, brackets and handrail	Low	Client advised	Outstanding	OH&S REGULATIONS 3.7 AS/NZS 1657-2013 7.4.3.4 & 7.4.8.5
52 6	Building: General Stores Location Reference: L184 Task: Access to the plant deck

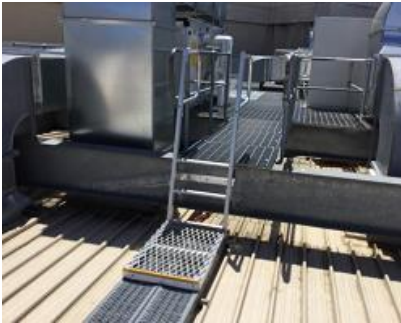
Gap between ladder and handrail is greater than required maximum	Trips, Slips and Falls	Awareness induction	Med	Handrail to be installed	Low	Client advised	Outstanding	OH&S REGULATIONS 3.7 AS/NZS 1657-2013 4.4

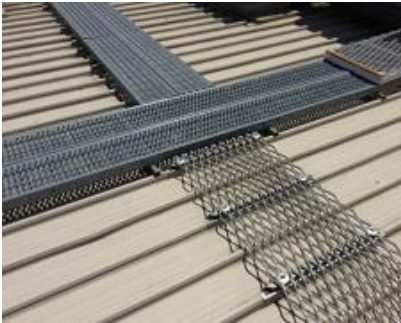
No	Photo of Hazard	Details of Hazard	Details of Risk	Existing/ Immediate Control Measure	Curre nt Risk Level	Proposed Permanent Solution	Resid ual Risk Asse sme nt	Details of Action Taken	Status	Reference
52 7	Building: General Stores Location Reference: L184 Task: Access to the roof

Variation in height between walkway panels are greater than required maximum	Trips, Slips and Falls	Awareness induction	Med	High visibility safety yellow nosing's to be installed	Low	Client advised	Outstanding	OH&S REGULATIONS 3.7 AS/NZS 1657-2013 3.3.4
52 8	Building: General Stores Location Reference: L184 Task: Access to the roof

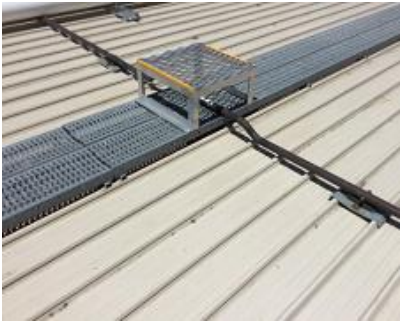
Step height is greater than required maximum	Trips, Slips and Falls	Awareness induction	Med	Existing step to be modified and re-installed	Low	Client advised	Outstanding	OH&S REGULATIONS 3.7 AS/NZS 1657-2013 3.1.4

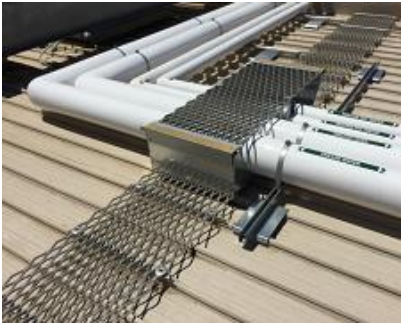
No	Photo of Hazard	Details of Hazard	Details of Risk	Existing/ Immediate Control Measure	Curre nt Risk Level	Proposed Permanent Solution	Resid ual Risk Asse sme nt	Details of Action Taken	Status	Reference
52 9	Building: General Stores Location Reference: L184 Task: Access to the roof

Variation in height between landing and roof is greater than required maximum	Trips, Slips and Falls	Awareness induction	Med	Handrail to be installed	Low	Client advised	Outstanding	OH&S REGULATIONS 3.7 AS/NZS 1657-2013 4.4
53 0	Building: General Stores Location Reference: L184 Task: Access to the roof

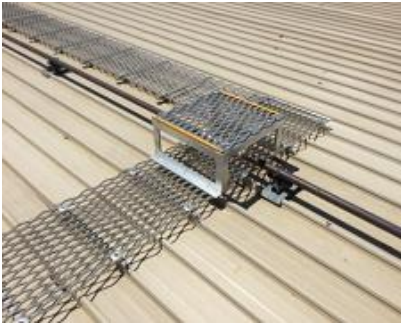
Step height is greater than required maximum	Trips, Slips and Falls	Awareness induction	Med	Existing step to be modified and re-installed	Low	Client advised	Outstanding	OH&S REGULATIONS 3.7 AS/NZS 1657-2013 3.1.4

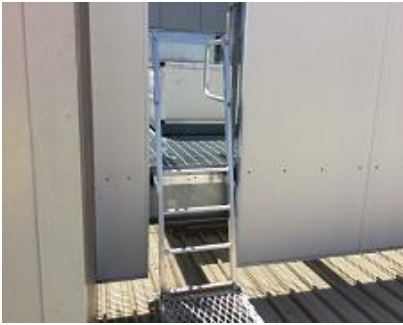
No	Photo of Hazard	Details of Hazard	Details of Risk	Existing/ Immediate Control Measure	Curre nt Risk Level	Proposed Permanent Solution	Resid ual Risk Asse sme nt	Details of Action Taken	Status	Reference
531	Building: General Stores Location Reference: L185 Task: Access to the plant deck

Gap between top rung and landing is greater than required maximum	Trips, Slips and Falls	Awareness induction	Med	Existing ladder to be re-installed with brackets	Low	Client advised	Outstanding	OH&S REGULATIONS 3.7 AS/NZS 1657-2013 7.4.8.4
532	Building: General Stores Location Reference: L185 Task: Access to the roof

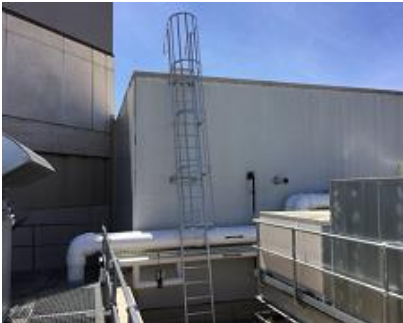
Clearance behind the ladder is less than required minimum	Trips, Slips and Falls	Awareness induction	Med	Existing ladder to be re-installed with new brackets and landing platforms	Low	Client advised	Outstanding	OH&S REGULATIONS 3.7 AS/NZS 1657-2013 7.4.5

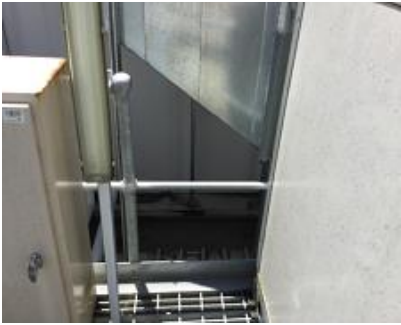
No	Photo of Hazard	Details of Hazard	Details of Risk	Existing/ Immediate Control Measure	Curre nt Risk Level	Proposed Permanent Solution	Resid ual Risk Asse sme nt	Details of Action Taken	Status	Reference
53 3	Building: General Stores Location Reference: L185 Task: Access to the plant deck

Handrail section is missing	Trips, Slips and Falls	Awareness induction	Med	Handrail to be installed	Low	Client advised	Outsta nding	OH&S REGULATIONS 3.7 AS/NZS 1657- 2013 4.4
53 4	Building: General Stores Location Reference: L185 Task: Access to the A/c units

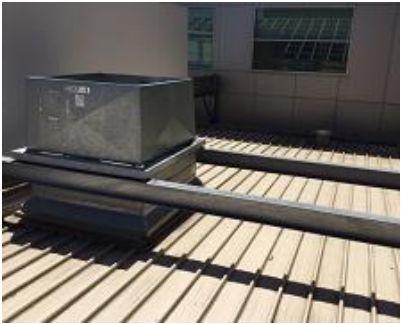
No safe access to the A/c units	Trips, Slips and Falls	N/A	Low	Supply walkway and Step bridge to the A/c units	Low	Client advised	Outsta nding	-

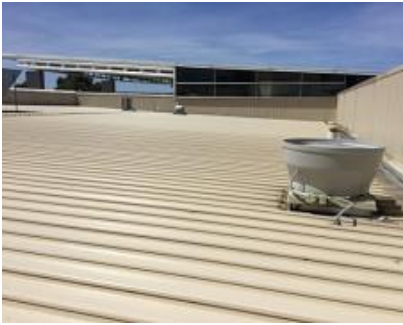
No	Photo of Hazard	Details of Hazard	Details of Risk	Existing/ Immediate Control Measure	Curre nt Risk Level	Proposed Permanent Solution	Resid ual Risk Asse sme nt	Details of Action Taken	Status	Reference
53 5	Building: General Stores Location Reference: L186 Task: Access to the A/c units

No safe access to the A/c units	Trips, Slips and Falls	N/A	Low	Supply walkway to the A/c units	Low	Client advised	Outstanding	-
53 6	Building: General Stores Location Reference: L186 Task: Access to the A/c units

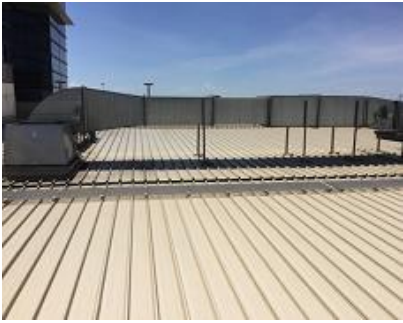
No safe access to the A/c units	Trips, Slips and Falls	N/A	Low	Supply walkway to the A/c units	Low	Client advised	Outstanding	-

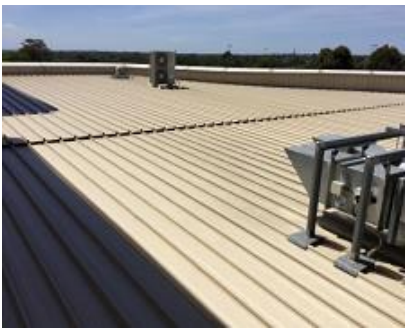
No	Photo of Hazard	Details of Hazard	Details of Risk	Existing/ Immediate Control Measure	Curre nt Risk Level	Proposed Permanent Solution	Resid ual Risk Asse sme nt	Details of Action Taken	Status	Reference
53 7	Building: General Stores Location Reference: L186 Task: Access to the A/c units

No safe access to the A/c units	Trips, Slips and Falls	N/A	Low	Supply walkway to the A/c units	Low	Client advised	Outstanding	-
53 8	Building: General Stores Location Reference: L187 Task: Access to the roof

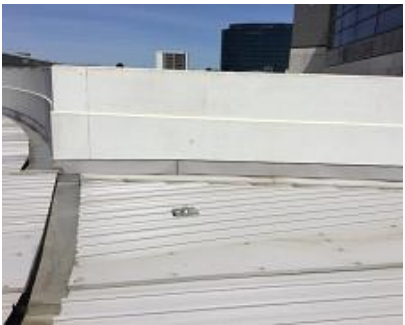
No safe access to the roof	Trips, Slips and Falls	Awareness induction	Med	Access ladder, access anchor and anchor strop to be installed	Low	Client advised	Outstanding	OH&S REGULATIONS 3.7 AS/NZS 1657-2013 3.1.4

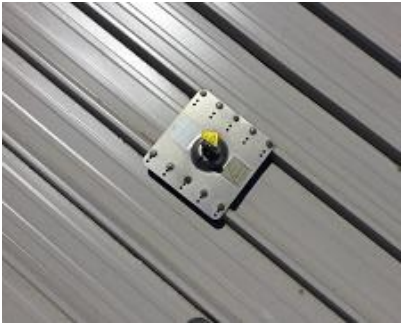
No	Photo of Hazard	Details of Hazard	Details of Risk	Existing/ Immediate Control Measure	Curre nt Risk Level	Proposed Permanent Solution	Resid ual Risk Asse sme nt	Details of Action Taken	Status	Reference
53 9	Building: General Stores Location Reference: L187 Task: Access to the roof

Rusted screws on anchor is present	Trips, Slips and Falls	Awareness induction	Med	Existing screws to be replaced	Low	Client advised	Outstanding	OH&S REGULATIONS 3.55
54 0	Building: General Stores Location Reference: L187 Task: Access to the roof

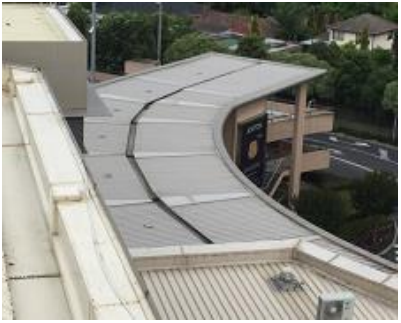
Not enough anchors installed to cover the fall edge	Trips, Slips and Falls	Awareness induction	High	Fall arrest anchors to be installed	Low	Client advised	Outstanding	OH&S REGULATIONS 3.55

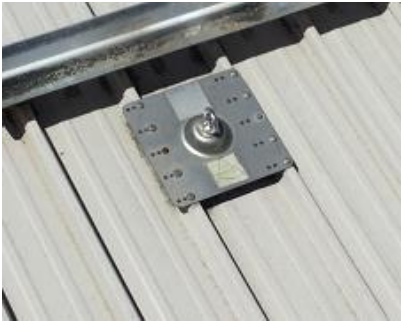
No	Photo of Hazard	Details of Hazard	Details of Risk	Existing/ Immediate Control Measure	Curre nt Risk Level	Proposed Permanent Solution	Resid ual Risk Asse sme nt	Details of Action Taken	Status	Reference
541	Building: General Stores Location Reference: L187 Task: Access to the roof

Rusted screws on anchor is present	Trips, Slips and Falls	Awareness induction	Med	Existing screws to be replaced	Low	Client advised	Outstanding	OH&S REGULATIONS 3.55
542	Building: General Stores Location Reference: L187 Task: Access to the roof

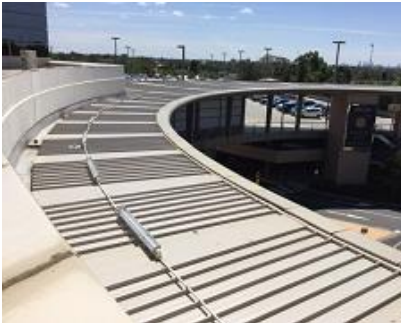
Not enough anchors installed to cover the fall edge	Trips, Slips and Falls	Awareness induction	High	Fall arrest anchors to be installed	Low	Client advised	Outstanding	OH&S REGULATIONS 3.55

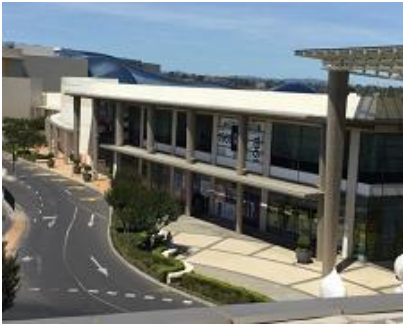
No	Photo of Hazard	Details of Hazard	Details of Risk	Existing/ Immediate Control Measure	Curre nt Risk Level	Proposed Permanent Solution	Resid ual Risk Asse sme nt	Details of Action Taken	Status	Reference
54 3	Building: General Stores Location Reference: L93 Task: Restrict access to the roof

No height safety system installed on lower awning roof	Trips, Slips and Falls	Restrict Access	High	"EWP Access to Roof" sign to be installed	Low	Client advised	Outstanding	OH&S REGULATIONS 3.55 & 3.11
