Roof Safety Report

**Colonnades Shopping Centre,
SA 5168**

Prepared By: Safemaster Safety Products
Date: 02 October 2018

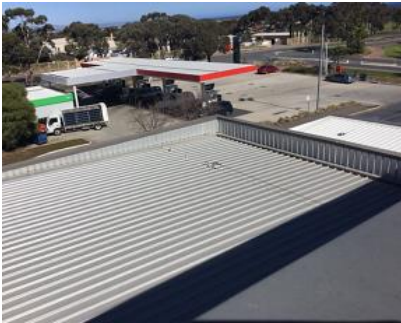
Incorrect installation of static line is present. Ladder bracket is too high to use a portable ladder	Trips, Slips and Falls	Awareness induction	High	Anchors and Access ladder from lower roof to be installed	Low	Client advised	Outstanding	OH&S REGULATIONS 3.7 & 3.55 AS/NZS 1657-2013 3.1.4
02	Building: General Stores Location Reference: L03 Task: Access to the roof

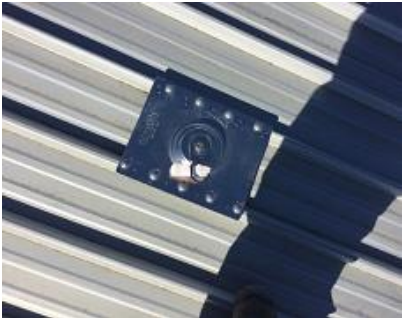
In-correct installation of anchor points	Trips, Slips and Falls	Awareness induction	High	Existing anchor points to be replaced	Low	Client advised	Outstanding	OH&S REGULATIONS 3.55

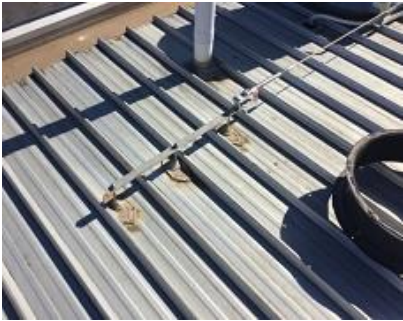
Incorrect installation of static line is present	Trips, Slips and Falls	Awareness induction	High	Existing static line to be replaced	Low	Client advised	Outstanding	OH&S REGULATIONS 3.55
06	Building: General Stores Location Reference: L10 Task: Access to the roof

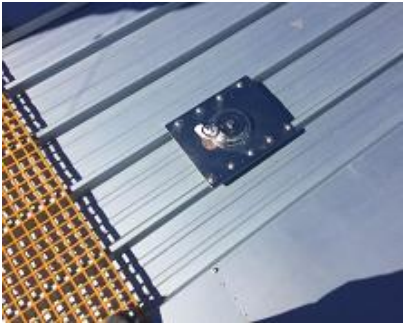
In-correct installation of anchor points	Trips, Slips and Falls	Awareness induction	High	Existing anchor points to be replaced	Low	Client advised	Outstanding	OH&S REGULATIONS 3.55

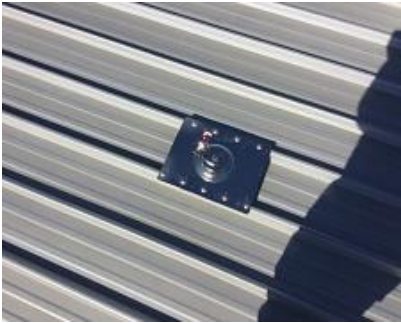
In-correct installation of anchor points	Trips, Slips and Falls	Awareness induction	High	Existing anchor points to be replaced	Low	Client advised	Outstanding	OH&S REGULATIONS 3.55
08	Building: General Stores Location Reference: L13 Task: Access to the roof

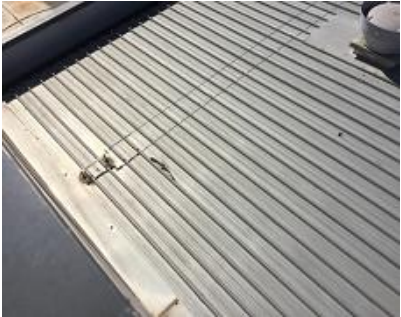
Incorrect installation of static line is present	Trips, Slips and Falls	Awareness induction	High	Existing static line to be removed and new anchors and strop to be installed	Low	Client advised	Outstanding	OH&S REGULATIONS 3.55

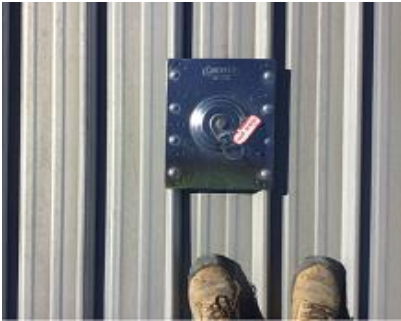
In-correct installation of anchor points	Trips, Slips and Falls	Awareness induction	High	Existing anchor points to be replaced	Low	Client advised	Outstanding	OH&S REGULATIONS 3.55
10	Building: General Stores Location Reference: L15 Task: Access to the roof

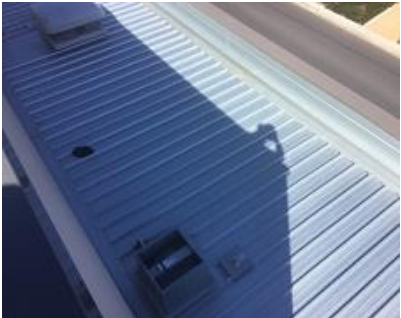
No safe access to roof	Trips, Slips and Falls	Restrict Access	High	EWP Access to Roof sign to be installed	Low	Client advised	Outstanding	OH&S REGULATIONS 3.55 & 3.11

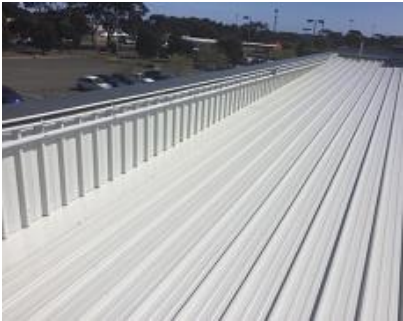
No height safety system installed	Trips, Slips and Falls	Awareness induction	High	Anchors to be installed	Low	Client advised	Outstanding	OH&S REGULATIONS 3.55
12	Building: General Stores Location Reference: L16 Task: Access to the roof

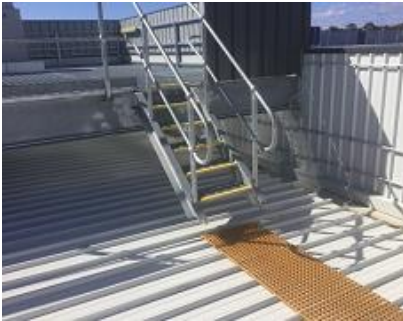
Last step height is greater than required maximum	Trips, Slips and Falls	Awareness induction	Med	Step to be installed at base	Low	Client advised	Outstanding	OH&S REGULATIONS 3.7 AS/NZS 1657-2013 7.2.3.2

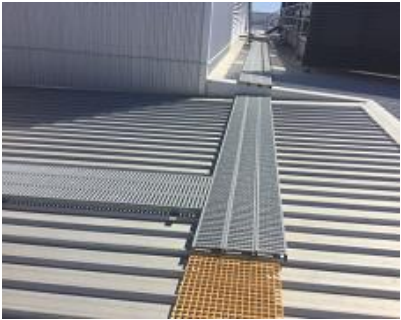
Variation in height between walkway panels are greater than required maximum	Trips, Slips and Falls	Awareness induction	Med	High visibility safety yellow nosing's to be installed	Low	Client advised	Outstanding	OH&S REGULATIONS 3.7 AS/NZS 1657-2013 3.3.4
14	Building: General Stores Location Reference: L03 Task: Access to the roof

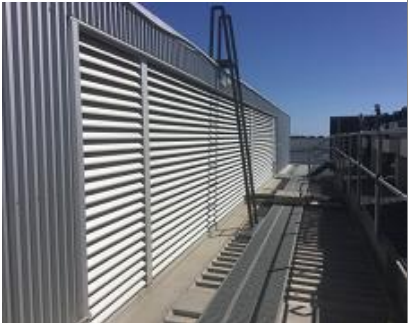
Non-complaint ladder is present	Trips, Slips and Falls	Awareness induction	Med	Existing ladder to be removed and new ladder to be installed	Low	Client advised	Outstanding	OH&S REGULATIONS 3.7 AS/NZS 1657-2013 7.4

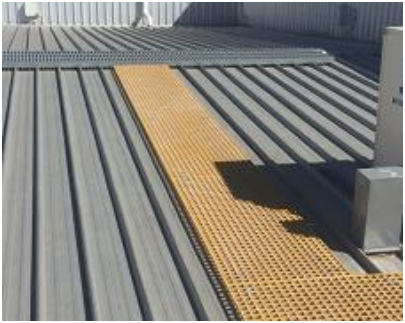
Variation in height between walkway panels are greater than required maximum	Trips, Slips and Falls	Awareness induction	Med	High visibility safety yellow nosing's to be installed	Low	Client advised	Outstanding	OH&S REGULATIONS 3.7 AS/NZS 1657-2013 3.3.4

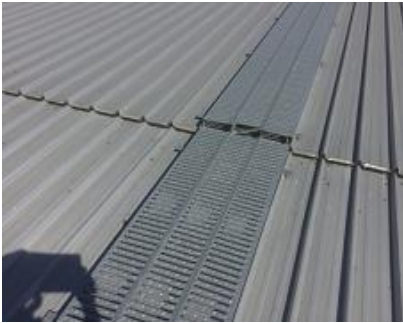
Variation in height between walkway panels are greater than required maximum	Trips, Slips and Falls	Awareness induction	Med	High visibility safety yellow nosing's to be installed	Low	Client advised	Outstanding	OH&S REGULATIONS 3.7 AS/NZS 1657-2013 3.3.4
18	Building: General Stores Location Reference: L17 Task: Access to the A/c units

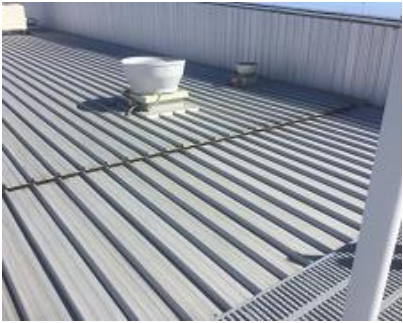
No safe access to the A/c units	Trips, Slips and Falls	N/A	Low	Supply Walkway to the A/c units	Low	Client advised	Outstanding	-

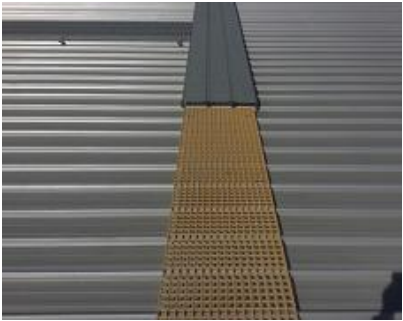
Variation in height between walkway panels are greater than required maximum	Trips, Slips and Falls	Awareness induction	Med	High visibility safety yellow nosing's to be installed	Low	Client advised	Outstanding	OH&S REGULATIONS 3.7 AS/NZS 1657-2013 3.3.4
20	Building: General Stores Location Reference: L18 Task: Access to the roof

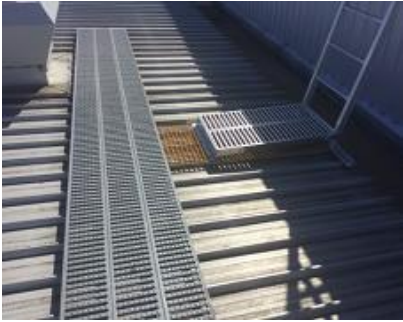
Variation in height between walkway panels are greater than required maximum	Trips, Slips and Falls	Awareness induction	Med	Existing walkway to be extended	Low	Client advised	Outstanding	OH&S REGULATIONS 3.7 AS/NZS 1657-2013 3.3.4

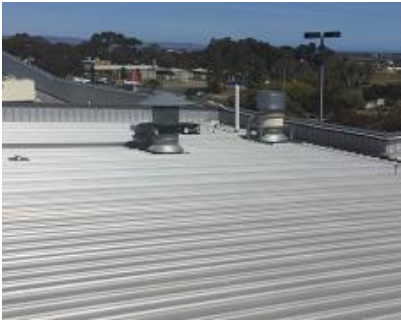
No safe access to the A/c units	Trips, Slips and Falls	N/A	Low	Supply Walkway to the A/c units	Low	Client advised	Outstanding	-
22	Building: General Stores Location Reference: L18 Task: Access to the roof

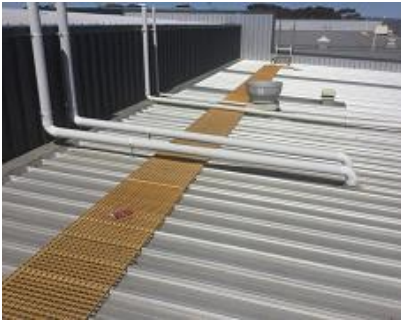
Pipe installed over the walkway path	Trips, Slips and Falls	Awareness induction	Med	Step bridges including handrails to be installed	Low	Client advised	Outstanding	OH&S REGULATIONS 3.7 AS/NZS 1657-2013 3.1.4

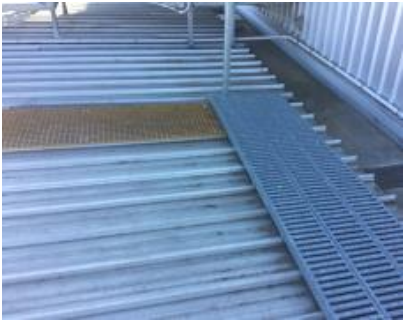
Variation in height between walkway panels are greater than required maximum	Trips, Slips and Falls	Awareness induction	Med	High visibility safety yellow nosing's to be installed	Low	Client advised	Outstanding	OH&S REGULATIONS 3.7 AS/NZS 1657-2013 3.3.4
24	Building: General Stores Location Reference: L20 Task: Access to the roof

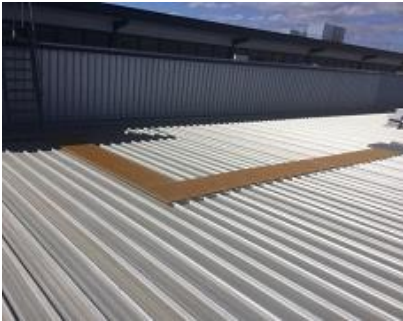
Variation in height between walkway panels are greater than required maximum	Trips, Slips and Falls	Awareness induction	Med	High visibility safety yellow nosing's to be installed	Low	Client advised	Outstanding	OH&S REGULATIONS 3.7 AS/NZS 1657-2013 3.3.4

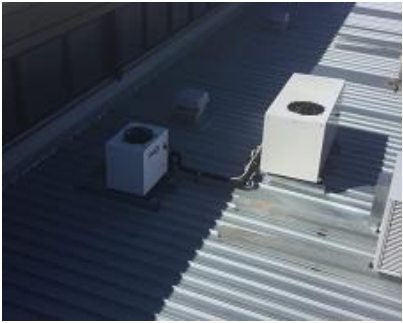
No safe access to the A/c units	Trips, Slips and Falls	N/A	Low	Supply Walkway to the A/c units	Low	Client advised	Outstanding	-

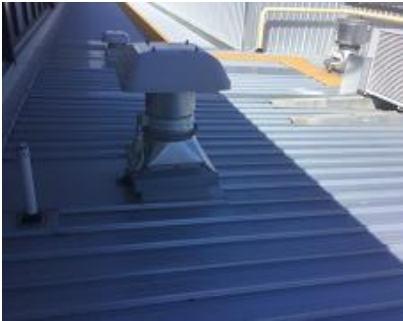
No safe access to the A/c units	Trips, Slips and Falls	N/A	Low	Supply Walkway to the A/c units	Low	Client advised	Outstanding	-
28	Building: General Stores Location Reference: L04 Task: Access to the A/c units

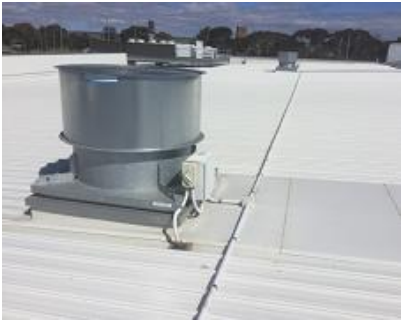
No safe access to the A/c units	Trips, Slips and Falls	N/A	Low	Supply Walkway to the A/c units	Low	Client advised	Outstanding	-

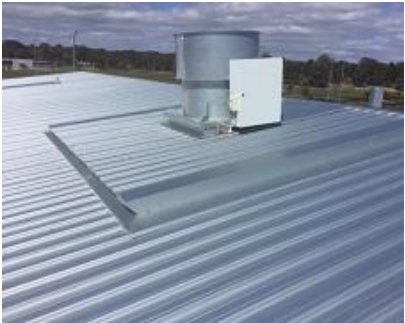
No safe access to the A/c units	Trips, Slips and Falls	N/A	Low	Supply Walkway and handrail to the A/c units	Low	Client advised	Outstanding	-

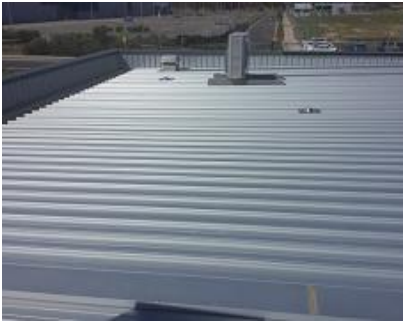
No safe access to the A/c units	Trips, Slips and Falls	N/A	Low	Supply Walkway to the A/c units	Low	Client advised	Outstanding	-

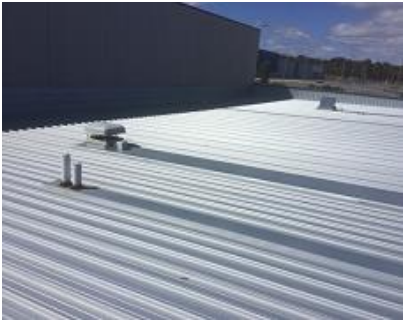
No safe access to the A/c units	Trips, Slips and Falls	N/A	Low	Supply Walkway to the A/c units	Low	Client advised	Outstanding	-
34	Building: General Stores Location Reference: L12 Task: Access to the roof

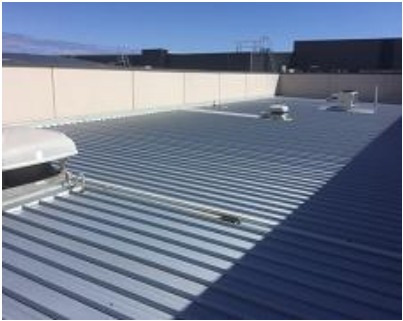
No safe access to the A/c units	Trips, Slips and Falls	N/A	Low	Supply Walkway to the A/c units	Low	Client advised	Outstanding	-

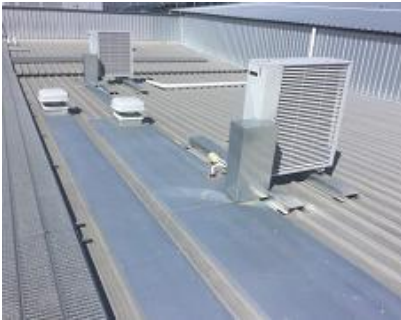
No safe access to the A/c units	Trips, Slips and Falls	N/A	Low	Supply Walkway to the A/c units	Low	Client advised	Outstanding	-
36	Building: General Stores Location Reference: L23 Task: Access to the A/c units

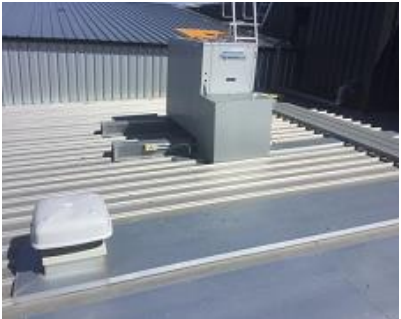
No safe access to the A/c units	Trips, Slips and Falls	N/A	Low	Supply Walkway to the A/c units	Low	Client advised	Outstanding	-

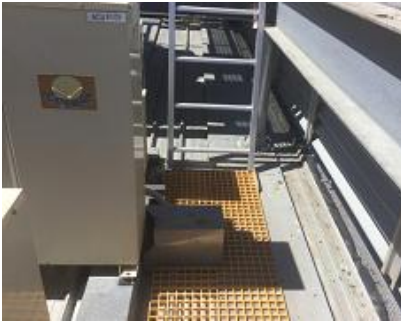
Bottom rung height is less than required minimum	Trips, Slips and Falls	Awareness induction	Med	Landing platform to be installed	Low	Client advised	Outstanding	OH&S REGULATIONS 3.7 AS/NZS 1657-2013 7.4.3.4

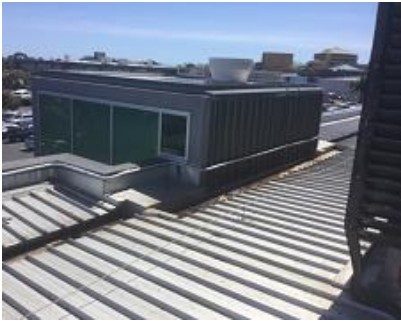
No height safety system installed	Trips, Slips and Falls	Awareness induction	High	Anchor point, Strop and Access ladder to be installed	Low	Client advised	Outstanding	OH&S REGULATIONS 3.7 & 3.55 AS/NZS 1657-2013 3.1.4
40	Building: General Stores Location Reference: L25 Task: Access to the roof

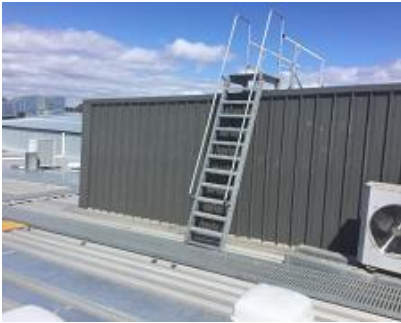
Landing at base is less than required minimum	Trips, Slips and Falls	Awareness induction	Med	Additional walkway section to be installed	Low	Client advised	Outstanding	OH&S REGULATIONS 3.7 AS/NZS 1657-2013 7.3.6

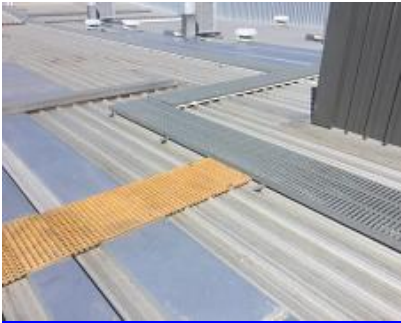
Variation in height between walkway panels are greater than required maximum	Trips, Slips and Falls	Awareness induction	Med	High visibility safety yellow nosing's to be installed	Low	Client advised	Outstanding	OH&S REGULATIONS 3.7 AS/NZS 1657-2013 3.3.4
42	Building: General Stores Location Reference: L26 Task: Access to the roof

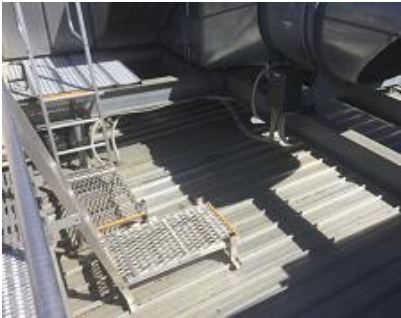
Variation in height between plant deck and roof is greater than required maximum	Trips, Slips and Falls	Awareness induction	Med	Handrail to be installed	Low	Client advised	Outstanding	OH&S REGULATIONS 3.7 AS/NZS 1657-2013 4.4

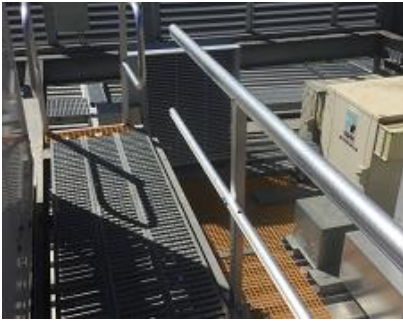
Handrail ends not fully secured	Trips, Slips and Falls	Awareness induction	Med	Additional post to be installed	Low	Client advised	Outstanding	OH&S REGULATIONS 3.7 AS/NZS 1657-2013 4.4

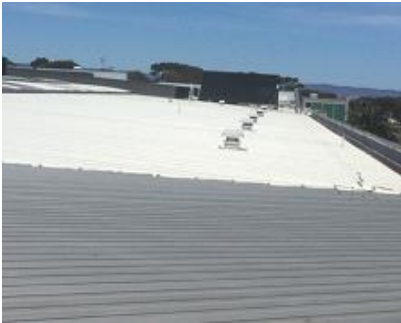
No safe access to the A/c units	Trips, Slips and Falls	N/A	Low	Supply Walkway to the A/c units	Low	Client advised	Outstanding	-

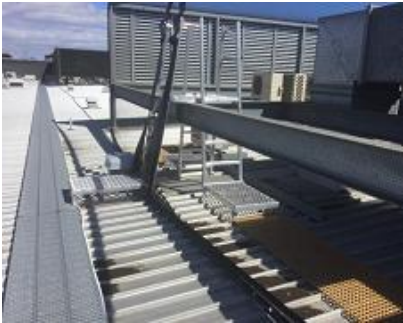
Variation in height between walkway panels are greater than required maximum	Trips, Slips and Falls	Awareness induction	Med	High visibility safety yellow nosing's to be installed	Low	Client advised	Outstanding	OH&S REGULATIONS 3.7 AS/NZS 1657-2013 3.3.4

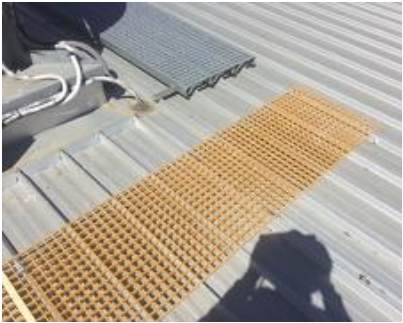
Gap between walkway panels are greater than required maximum	Trips, Slips and Falls	Awareness induction	Med	Additional walkway section to be installed	Low	Client advised	Outstanding	OH&S REGULATIONS 3.7 AS/NZS 1657-2013 3.2.3.4

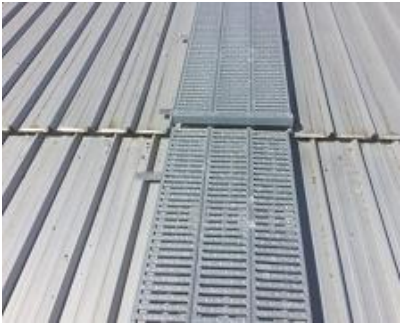
Variation in height between walkway panels are greater than required maximum	Trips, Slips and Falls	Awareness induction	Med	High visibility safety yellow nosing's to be installed	Low	Client advised	Outstanding	OH&S REGULATIONS 3.7 AS/NZS 1657-2013 3.3.4
52	Building: General Stores Location Reference: L30 Task: Access to the roof

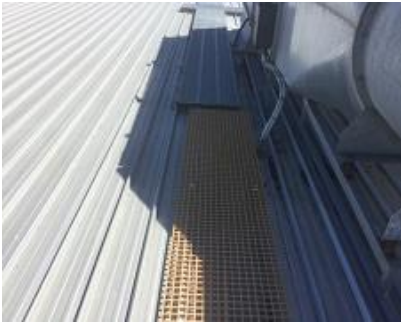
Variation in height between walkway panels are greater than required maximum	Trips, Slips and Falls	Awareness induction	Med	High visibility safety yellow nosing's to be installed	Low	Client advised	Outstanding	OH&S REGULATIONS 3.7 AS/NZS 1657-2013 3.3.4

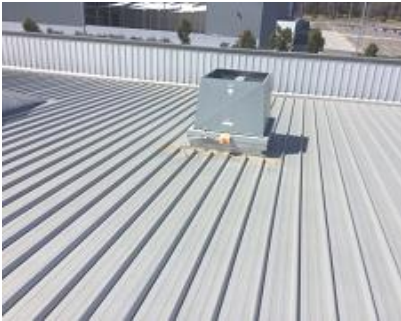
No safe access to the A/c units	Trips, Slips and Falls	N/A	Low	Supply Walkway to the A/c units	Low	Client advised	Outstanding	-
54	Building: General Stores Location Reference: L30 Task: Access to the roof

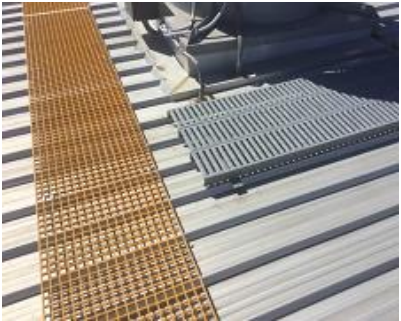
Gap between walkway panels are greater than required maximum	Trips, Slips and Falls	Awareness induction	Med	Additional walkway section to be installed	Low	Client advised	Outstanding	OH&S REGULATIONS 3.7 AS/NZS 1657-2013 3.2.3.4

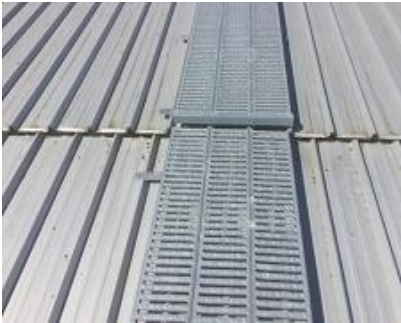
Variation in height between walkway panels are greater than required maximum	Trips, Slips and Falls	Awareness induction	Med	High visibility safety yellow nosing's to be installed	Low	Client advised	Outstanding	OH&S REGULATIONS 3.7 AS/NZS 1657-2013 3.3.4
56	Building: General Stores Location Reference: L30 Task: Access to the roof

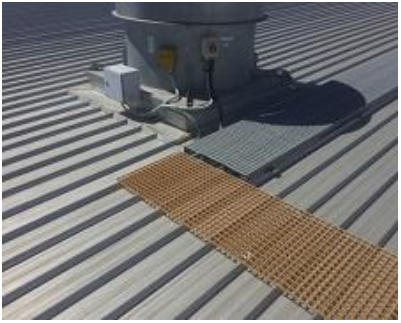
Variation in height between walkway panels are greater than required maximum	Trips, Slips and Falls	Awareness induction	Med	High visibility safety yellow nosing's to be installed	Low	Client advised	Outstanding	OH&S REGULATIONS 3.7 AS/NZS 1657-2013 3.3.4

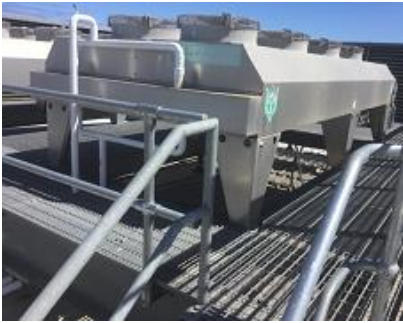
Variation in height between plant deck and unit is greater than required maximum	Trips, Slips and Falls	Awareness induction	Med	Mid rail to be installed	Low	Client advised	Outstanding	OH&S REGULATIONS 3.7 AS/NZS 1657-2013 6.1

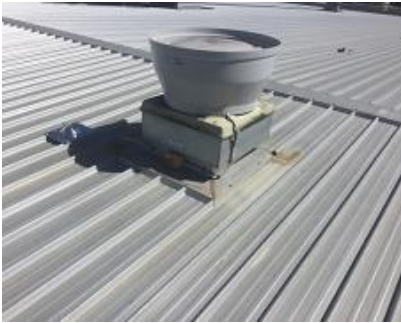
No safe access to the A/c units	Trips, Slips and Falls	N/A	Low	Supply Walkway to the A/c units	Low	Client advised	Outstanding	-

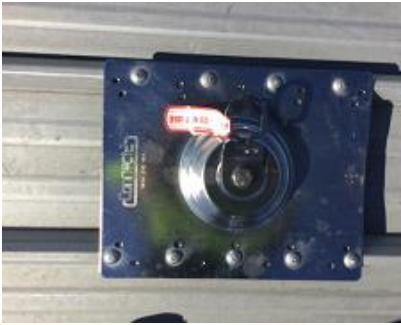
Non-complaint anchor points are present	Trips, Slips and Falls	Restrict Access	High	Existing anchors to be replaced	Low	Client advised	Outstanding	OH&S REGULATIONS 3.55
62	Building: General Stores Location Reference: L31 Task: Access to the A/c units

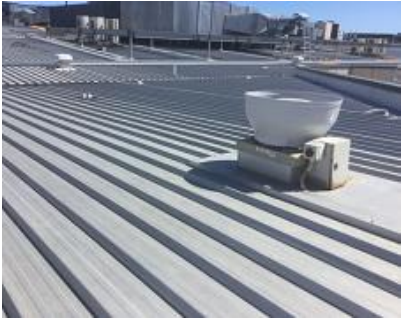
No safe access to the A/c units	Trips, Slips and Falls	N/A	Low	Supply Walkway to the A/c units	Low	Client advised	Outstanding	-

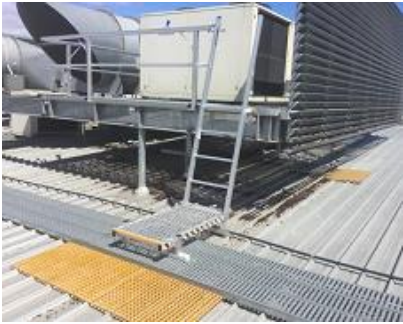
Variation in height between walkway panels are greater than required maximum	Trips, Slips and Falls	Awareness induction	Med	High visibility safety yellow nosing's to be installed	Low	Client advised	Outstanding	OH&S REGULATIONS 3.7 AS/NZS 1657-2013 3.3.4

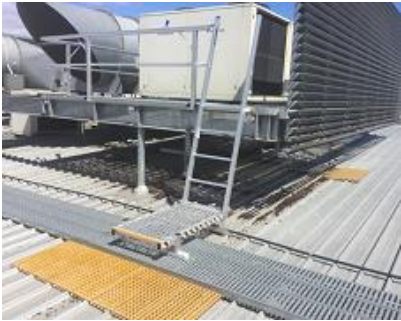
Gap between ladder and permanent structure is greater than required maximum	Trips, Slips and Falls	Awareness induction	Med	Handrail to be installed	Low	Client advised	Outstanding	OH&S REGULATIONS 3.7 AS/NZS 1657-2013 4.4
66	Building: General Stores Location Reference: L33 Task: Access to the roof

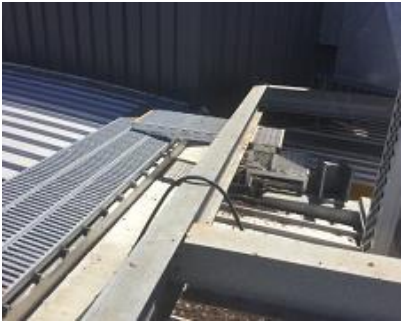
Non-complaint stair access is present	Trips, Slips and Falls	Awareness induction	Med	Existing stair to be replaced with ladder	Low	Client advised	Outstanding	OH&S REGULATIONS 3.7 AS/NZS 1657-2013 7.2

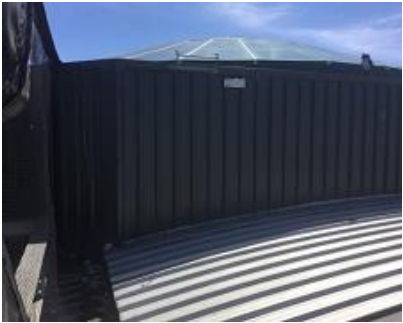
Non-complaint ladder access bracket	Trips, Slips and Falls	Awareness induction	Med	Ladder access bracket to be replaced with ladder	Low	Client advised	Outstanding	OH&S REGULATIONS 3.7 AS/NZS 1657-2013 3.1.4

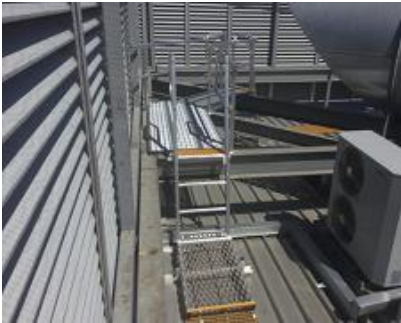
Gap between ladder and permanent structure is greater than required maximum	Trips, Slips and Falls	Awareness induction	Med	Handrail to be installed	Low	Client advised	Outstanding	OH&S REGULATIONS 3.7 AS/NZS 1657-2013 4.4
72	Building: General Stores Location Reference: L35 Task: Access to the roof

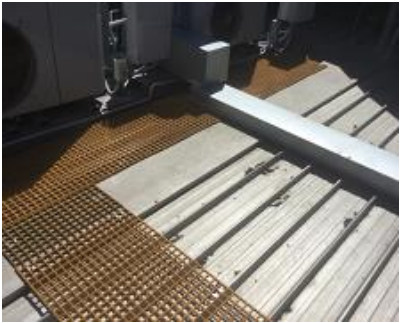
Cable tray installed over the walkway path	Trips, Slips and Falls	Awareness induction	Med	Step bridge including handrail to be installed	Low	Client advised	Outstanding	OH&S REGULATIONS 3.7 AS/NZS 1657-2013 3.1.4

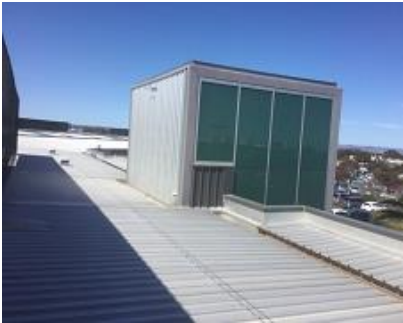
No safe access to roof	Trips, Slips and Falls	Awareness induction	High	Anchors, strop and access ladder to be installed	Low	Client advised	Outstanding	OH&S REGULATIONS 3.55

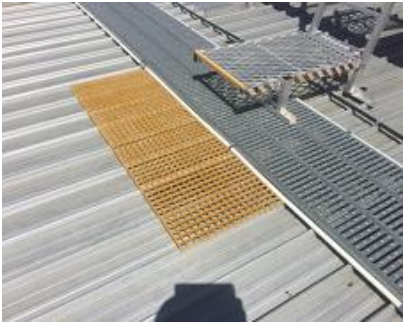
Variation in height between walkway panels are greater than required maximum	Trips, Slips and Falls	Awareness induction	Med	High visibility safety yellow nosing's to be installed	Low	Client advised	Outstanding	OH&S REGULATIONS 3.7 AS/NZS 1657-2013 3.3.4

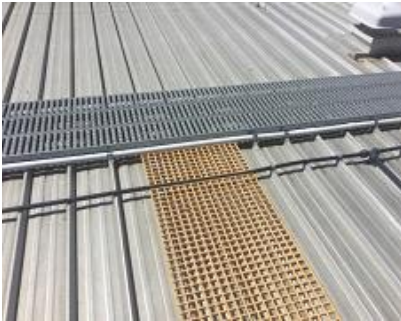
Pipes installed over the walkway path	Trips, Slips and Falls	Awareness induction	Med	Step bridge to be installed	Low	Client advised	Outstanding	OH&S REGULATIONS 3.7 AS/NZS 1657-2013 3.1.4
78	Building: General Stores Location Reference: L37 Task: Access to the roof

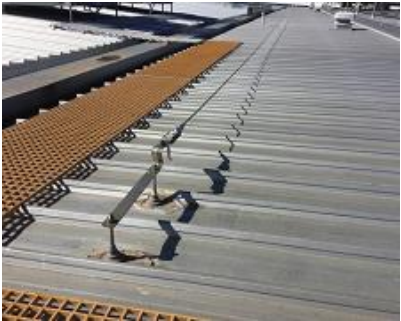
Non-complaint static line is present	Trips, Slips and Falls	Awareness induction	High	Existing static line to be removed	Low	Client advised	Outstanding	OH&S REGULATIONS 3.55

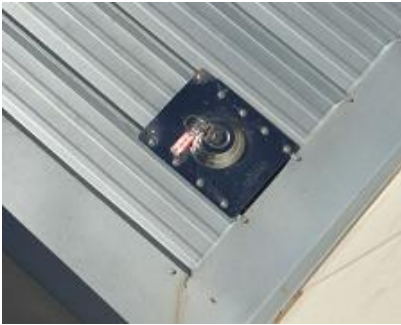
Non-complaint anchor points are present	Trips, Slips and Falls	Restrict Access	High	Existing anchors to be replaced	Low	Client advised	Outstanding	OH&S REGULATIONS 3.55
80	Building: General Stores Location Reference: L38 Task: Access to the ladder

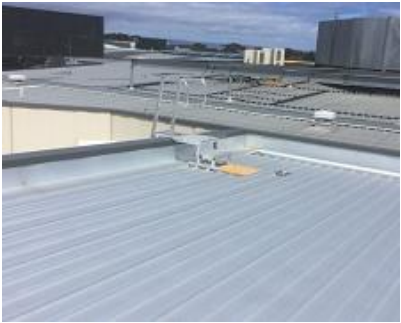
No safe access to the ladder	Trips, Slips and Falls	N/A	Low	Supply Walkway to the ladder	Low	Client advised	Outstanding	-

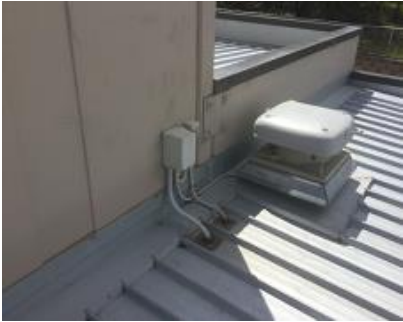
No safe access to the A/c units	Trips, Slips and Falls	N/A	Low	Supply Walkway to the A/c units	Low	Client advised	Outstanding	-

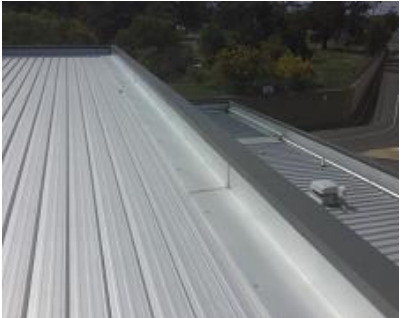
No height safety system installed	Trips, Slips and Falls	Awareness induction	High	Anchor points to be installed	Low	Client advised	Outstanding	OH&S REGULATIONS 3.55

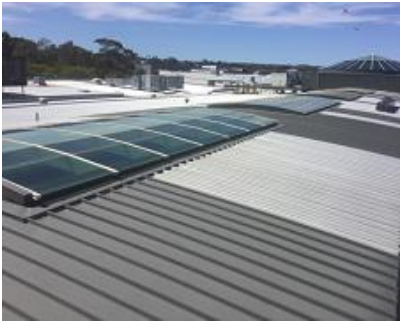
Brittle and Fragile roof sections are present	Trips, Slips and Falls	Restrict Access	High	"Brittle and Fragile Roof" signs to be installed	Low	Client advised	Outstanding	OH&S REGULATIONS 3.57

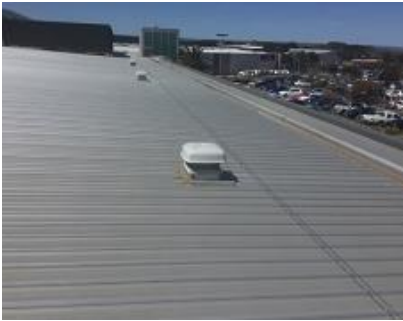
No safe access to the A/c units	Trips, Slips and Falls	N/A	Low	Supply Walkway to the A/c units	Low	Client advised	Outstanding	-
88	Building: General Stores Location Reference: L41 Task: Access to the roof

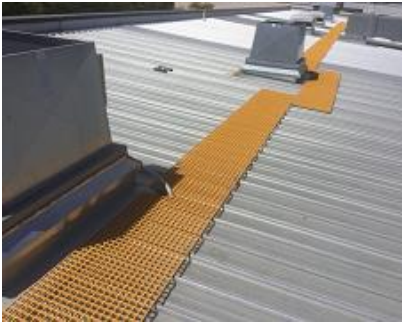
Walkway width is less than required minimum	Trips, Slips and Falls	Awareness induction	Med	Additional walkway section to be installed	Low	Client advised	Outstanding	OH&S REGULATIONS 3.7 AS/NZS 1657-2013 5.1.3

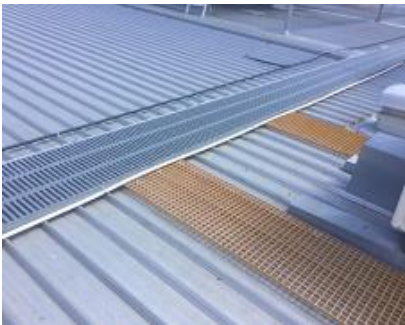
Variation in height between walkway panels are greater than required maximum	Trips, Slips and Falls	Awareness induction	Med	High visibility safety yellow nosing's to be installed	Low	Client advised	Outstanding	OH&S REGULATIONS 3.7 AS/NZS 1657-2013 3.3.4

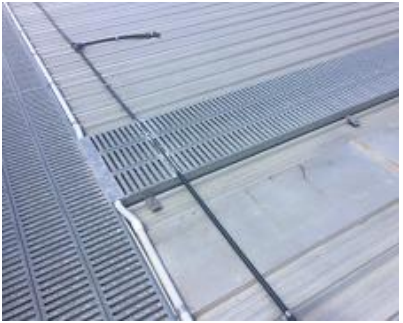
Pipe installed over the walkway path	Trips, Slips and Falls	Awareness induction	Med	Step bridge to be installed	Low	Client advised	Outstanding	OH&S REGULATIONS 3.7 AS/NZS 1657-2013 3.1.4

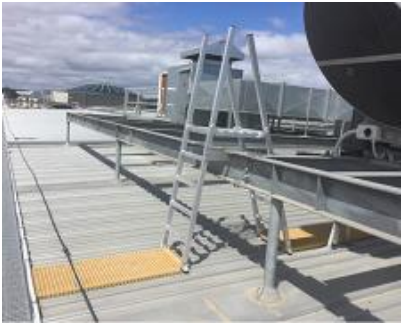
Handrail is missing for ladder/landing	Trips, Slips and Falls	Awareness induction	Med	Handrail to be installed	Low	Client advised	Outstanding	OH&S REGULATIONS 3.7 AS/NZS 1657-2013 4.4
94	Building: General Stores Location Reference: L42 Task: Access to the roof

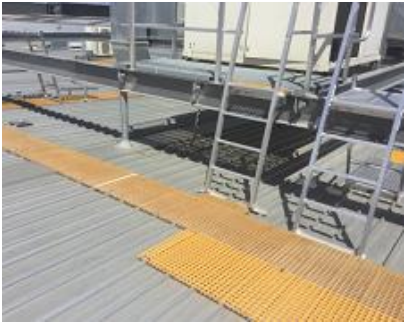
Landing is less than required minimum	Trips, Slips and Falls	Awareness induction	Med	Additional walkway section to be installed	Low	Client advised	Outstanding	OH&S REGULATIONS 3.7 AS/NZS 1657-2013 7.3.6

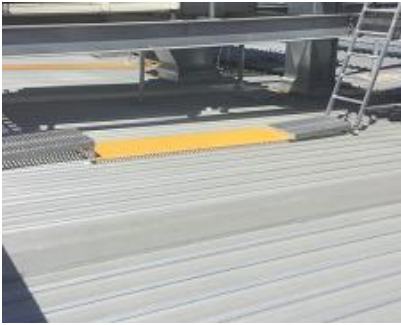
Variation in height between walkway panels are greater than required maximum	Trips, Slips and Falls	Awareness induction	Med	High visibility safety yellow nosing's to be installed	Low	Client advised	Outstanding	OH&S REGULATIONS 3.7 AS/NZS 1657-2013 3.3.4
98	Building: General Stores Location Reference: L43 Task: Access to the roof

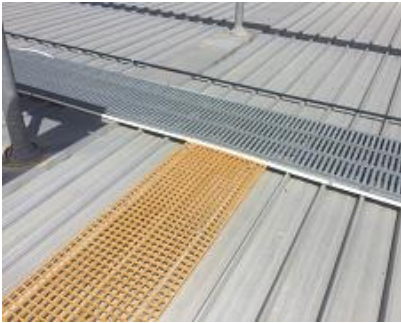
Variation in height between walkway panels are greater than required maximum	Trips, Slips and Falls	Awareness induction	Med	High visibility safety yellow nosing's to be installed	Low	Client advised	Outstanding	OH&S REGULATIONS 3.7 AS/NZS 1657-2013 3.3.4

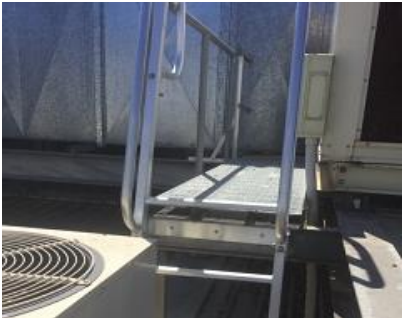
A/c unit in the way to access the ladder and mid rail is missing for landing	Trips, Slips and Falls	Awareness induction	Med	Existing ladder to be re-located and mid rail to be installed	Low	Client advised	Outstanding	OH&S REGULATIONS 3.7 AS/NZS 1657-2013 3.1.4

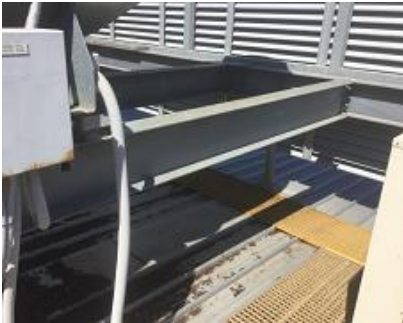
No safe access provided	Trips, Slips and Falls	Awareness induction	Med	Access ladders, landing platform and handrails to be installed	Low	Client advised	Outstanding	OH&S REGULATIONS 3.7 AS/NZS 1657-2013 3.1.4

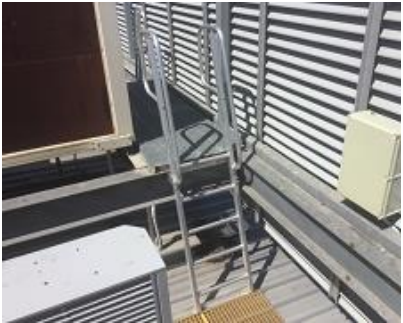
Bottom rung height is less than required minimum, handrail projecting towards the user and gap between ladder and permanent structure is greater than required maximum	Trips, Slips and Falls	Awareness induction	Med	Existing handrail to be removed. Landing platform, handrail to ladder and gap between ladder and structure to be filled	Low	Client advised	Outstanding	OH&S REGULATIONS 3.7 AS/NZS 1657-2013 7.4.3.4 & 7.4.8.5

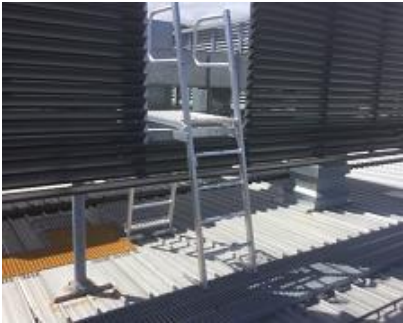
Landing is less than required minimum and variation in height between walkway panels are greater than required maximum	Trips, Slips and Falls	Awareness induction	Med	Additional walkway section and high visibility safety yellow nosing's to be installed	Low	Client advised	Outstanding	OH&S REGULATIONS 3.7 AS/NZS 1657-2013 7.3.6 & 3.3.4

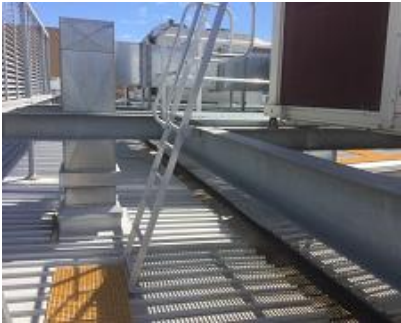
Landing is less than required minimum and handrail projecting towards the user	Trips, Slips and Falls	Awareness induction	Med	Existing handrails for ladder to be replaced and additional walkway section at base to be installed	Low	Client advised	Outstanding	OH&S REGULATIONS 3.7 AS/NZS 1657-2013 7.3.6 & 7.4.8.5
108	Building: General Stores Location Reference: L46 Task: Access to the roof

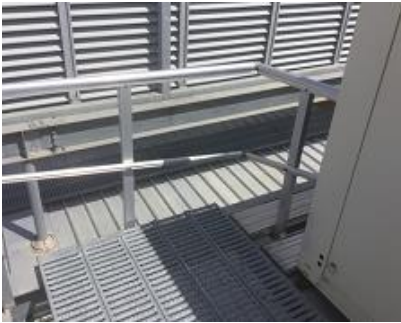
Existing handrail not fully secured	Trips, Slips and Falls	Awareness induction	Med	Existing handrail to be secured with additional posts	Low	Client advised	Outstanding	OH&S REGULATIONS 3.7 AS/NZS 1657-2013 4.4

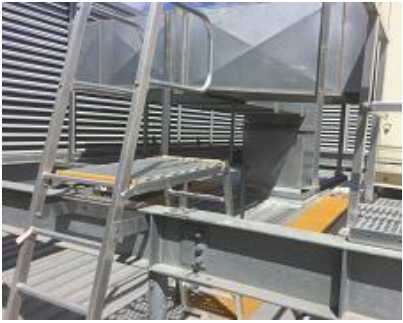
Headroom is less than required minimum	Trips, Slips and Falls	Awareness induction	Med	"Caution-Low Headroom" signs to be installed	Low	Client advised	Outstanding	OH&S REGULATIONS 3.7 AS/NZS 1657-2013 3.1.5

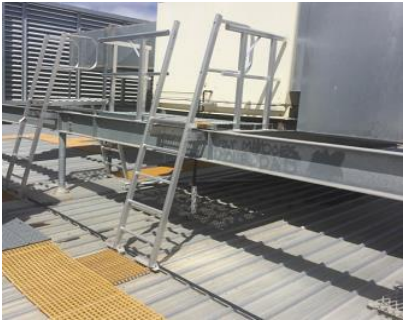
Bottom rung height is less than required	Trips, Slips and Falls	Awareness induction	Med	Landing platform at base to be installed	Low	Client advised	Outstanding	OH&S REGULATIONS 3.7 AS/NZS 1657-2013 7.4.3.4

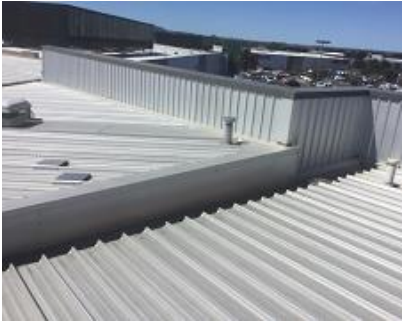
No height safety system installed	Trips, Slips and Falls	Awareness induction	High	Anchor point to be installed	Low	Client advised	Outstanding	OH&S REGULATIONS 3.55

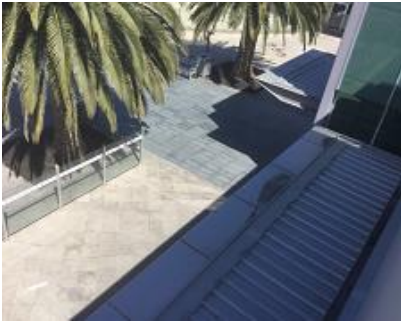
No	Photo of Hazard	Details of Hazard	Details of Risk	Existing/ Immediate Control Measure	Curre nt Risk Level	Proposed Permanent Solution	Resid ual Risk Asse sme nt	Details of Action Taken	Status	Reference
117	Building: General Stores Location Reference: L49 Task: Access to the roof

No height safety system installed	Trips, Slips and Falls	Awareness induction	High	Anchor points, strop, ladder access bracket and sign to be installed	Low	Client advised	Outstanding	OH&S REGULATIONS 3.55
118	Building: General Stores Location Reference: L49 Task: Access to the roof

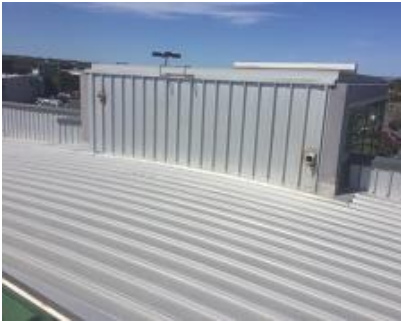
No height safety system installed	Trips, Slips and Falls	Awareness induction	High	Anchor points, strops, ladder access bracket, access ladder and sign to be installed	Low	Client advised	Outstanding	OH&S REGULATIONS 3.55

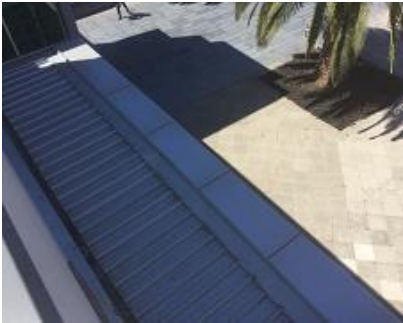
No	Photo of Hazard	Details of Hazard	Details of Risk	Existing/ Immediate Control Measure	Curre nt Risk Level	Proposed Permanent Solution	Resid ual Risk Asse sme nt	Details of Action Taken	Status	Reference
119	Building: General Stores Location Reference: L49 Task: Access to the roof

No height safety system installed	Trips, Slips and Falls	Awareness induction	High	Anchor points, strop, ladder access bracket and sign to be installed	Low	Client advised	Outstanding	OH&S REGULATIONS 3.55
120	Building: General Stores Location Reference: L49 Task: Access to the roof

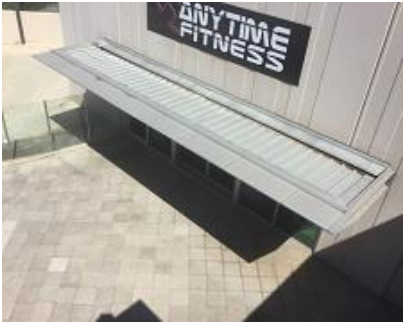
No height safety system installed	Trips, Slips and Falls	Awareness induction	High	Anchor points, strop, ladder access bracket and sign to be installed	Low	Client advised	Outstanding	OH&S REGULATIONS 3.55

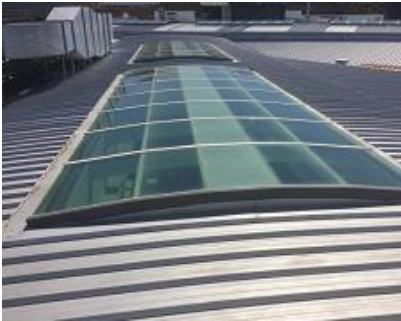
No	Photo of Hazard	Details of Hazard	Details of Risk	Existing/ Immediate Control Measure	Curre nt Risk Level	Proposed Permanent Solution	Resid ual Risk Asse sme nt	Details of Action Taken	Status	Reference
121	Building: General Stores Location Reference: L49 Task: Restrict access to the roof

Brittle and Fragile roof sections are present	Trips, Slips and Falls	Restrict Access	High	"Brittle and Fragile Roof" signs to be installed	Low	Client advised	Outstanding	OH&S REGULATIONS 3.57
122	Building: General Stores Location Reference: L49 Task: Access to the A/c units

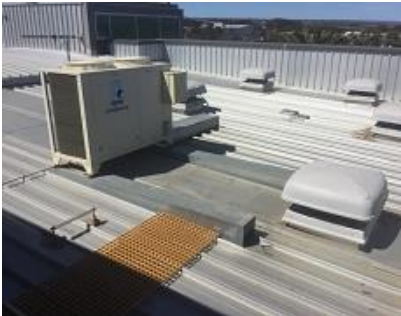
No safe access to the A/c units	Trips, Slips and Falls	N/A	Low	Supply Walkway to the A/c units	Low	Client advised	Outstanding	-

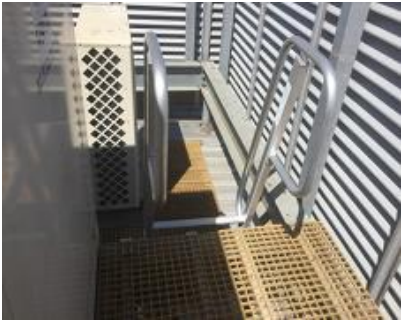
No	Photo of Hazard	Details of Hazard	Details of Risk	Existing/ Immediate Control Measure	Curre nt Risk Level	Proposed Permanent Solution	Resid ual Risk Asse sme nt	Details of Action Taken	Status	Reference
123	Building: General Stores Location Reference: L49 Task: Access to the roof

Handrail projecting towards the user and gap between structure and ladder is greater than required maximum	Trips, Slips and Falls	Awareness induction	Med	Existing handrail to be replaced and gap to be filled	Low	Client advised	Outstanding	OH&S REGULATIONS 3.7 AS/NZS 1657-2013 7.4.8.5 & 4.4
124	Building: General Stores Location Reference: L49 Task: Access to the roof

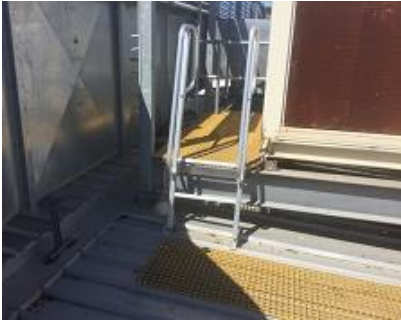
Handrail projecting towards the user and landing is less than required minimum	Trips, Slips and Falls	Awareness induction	Med	Existing handrail to be replaced and landing platform to be installed	Low	Client advised	Outstanding	OH&S REGULATIONS 3.7 AS/NZS 1657-2013 7.4.8.5 & 7.3.6

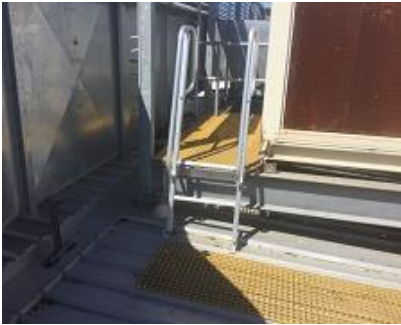
No	Photo of Hazard	Details of Hazard	Details of Risk	Existing/ Immediate Control Measure	Curre nt Risk Level	Proposed Permanent Solution	Resid ual Risk Asse sme nt	Details of Action Taken	Status	Reference
125	Building: General Stores Location Reference: L49 Task: Access to the roof

Gap between plant deck and structure is greater than required maximum	Trips, Slips and Falls	Awareness induction	Med	Handrail to be installed	Low	Client advised	Outstanding	OH&S REGULATIONS 3.7 AS/NZS 1657-2013 4.4
126	Building: General Stores Location Reference: L49 Task: Access to the roof

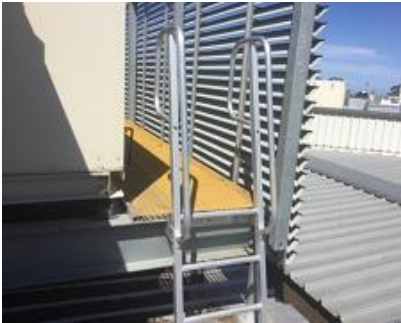
Handrail projecting towards the user and gap between structure and ladder is greater than required maximum	Trips, Slips and Falls	Awareness induction	Med	Existing handrail to be replaced and gap to be filled	Low	Client advised	Outstanding	OH&S REGULATIONS 3.7 AS/NZS 1657-2013 7.4.8.5 & 4.4

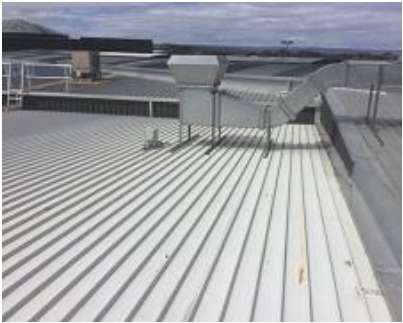
No safe access to the A/c units	Trips, Slips and Falls	N/A	Low	Supply Walkway to the A/c units	Low	Client advised	Outsta nding	-

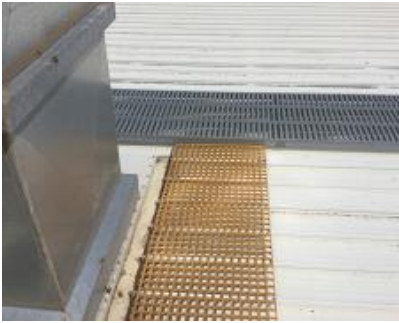
Variation in height between walkway panels are greater than required maximum	Trips, Slips and Falls	Awareness induction	Med	High visibility safety yellow nosing's to be installed	Low	Client advised	Outstanding	OH&S REGULATIONS 3.7 AS/NZS 1657-2013 3.3.4

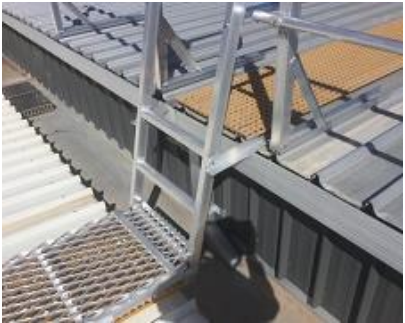
Gap between top rung and landing is greater than required maximum	Trips, Slips and Falls	Awareness induction	Med	Walkway to be extended to close the gap	Low	Client advised	Outstanding	OH&S REGULATIONS 3.7 AS/NZS 1657-2013 7.4.8.4

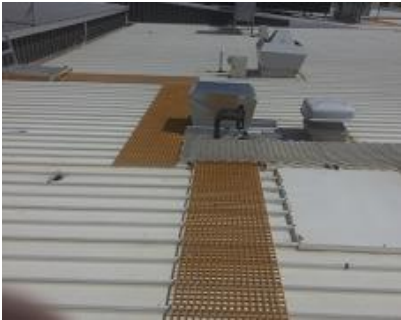
No	Photo of Hazard	Details of Hazard	Details of Risk	Existing/ Immediate Control Measure	Curre nt Risk Level	Proposed Permanent Solution	Resid ual Risk Asse sme nt	Details of Action Taken	Status	Reference
133	Building: General Stores Location Reference: L51 Task: Access to the roof

Variation in height between walkway panels are greater than required maximum	Trips, Slips and Falls	Awareness induction	Med	High visibility safety yellow nosing's to be installed	Low	Client advised	Outstanding	OH&S REGULATIONS 3.7 AS/NZS 1657-2013 3.3.4
134	Building: General Stores Location Reference: L51 Task: Access to the A/c units

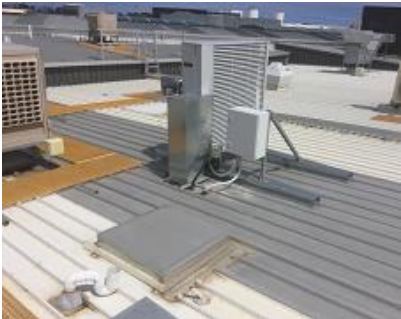
No safe access to the A/c units	Trips, Slips and Falls	N/A	Low	Supply Walkway to the A/c units	Low	Client advised	Outstanding	-

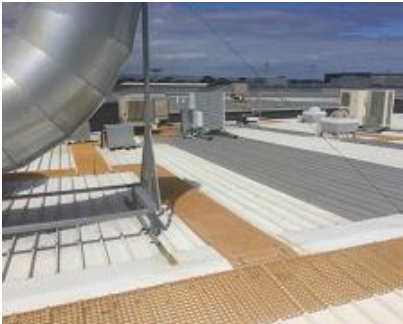
Cable in the way to access units	Trips, Slips and Falls	Awareness induction	Med	Additional walkway sections to be installed	Low	Client advised	Outstanding	OH&S REGULATIONS 3.7 AS/NZS 1657-2013 3.1.5

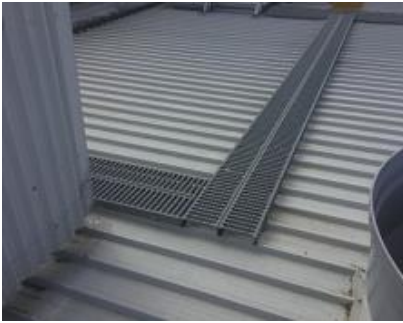
Walkway width is less than required minimum	Trips, Slips and Falls	Awareness induction	Med	Existing walkway to be replaced	Low	Client advised	Outstanding	OH&S REGULATIONS 3.7 AS/NZS 1657-2013 5.1.3

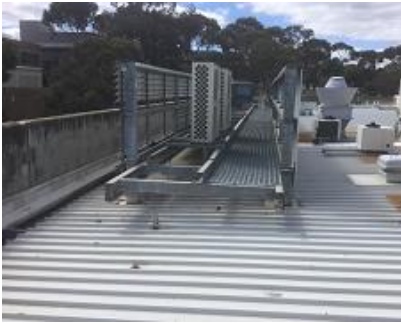
Plant deck not in use and no safe access provided	Trips, Slips and Falls	Awareness induction	Med	"No access" signs to be installed	Low	Client advised	Outstanding	OH&S REGULATIONS 3.7 & 3.11

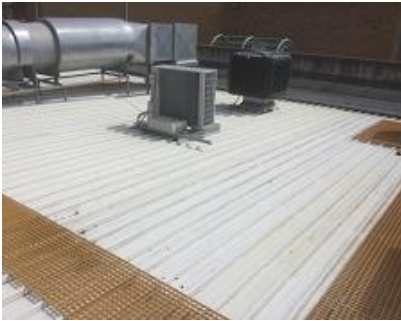
No safe access to the A/c units	Trips, Slips and Falls	N/A	Low	Supply Walkway to the A/c units	Low	Client advised	Outstanding	-

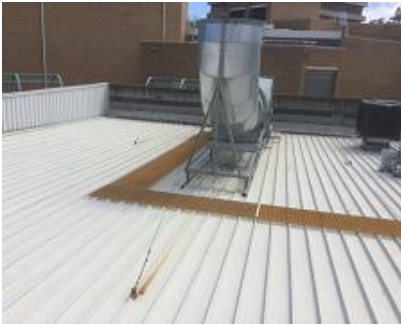
No	Photo of Hazard	Details of Hazard	Details of Risk	Existing/ Immediate Control Measure	Curre nt Risk Level	Proposed Permanent Solution	Resid ual Risk Asse ssme nt	Details of Action Taken	Status	Reference
143	Building: General Stores Location Reference: L54 Task: Access to the roof

Cable in the way to access units	Trips, Slips and Falls	Awareness induction	Med	Additional walkway sections to be installed	Low	Client advised	Outstanding	OH&S REGULATIONS 3.7 AS/NZS 1657-2013 3.1.5
144	Building: General Stores Location Reference: L55 Task: Access to the roof

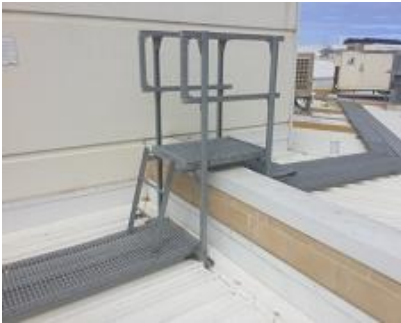
Non-complaint ladder is present	Trips, Slips and Falls	Awareness induction	Med	Existing ladder to be replaced	Low	Client advised	Outstanding	OH&S REGULATIONS 3.7 AS/NZS 1657-2013 7.4

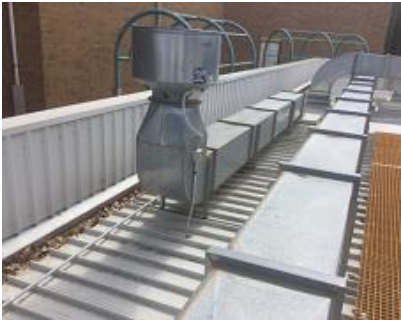
No	Photo of Hazard	Details of Hazard	Details of Risk	Existing/ Immediate Control Measure	Curre nt Risk Level	Proposed Permanent Solution	Resid ual Risk Asse sme nt	Details of Action Taken	Status	Reference
145	Building: General Stores Location Reference: L55 Task: Access to the A/c units

No safe access to the A/c units	Trips, Slips and Falls	N/A	Low	Supply Walkway and access ladder to the A/c units	Low	Client advised	Outstanding	-
146	Building: General Stores Location Reference: L55 Task: Access to the roof

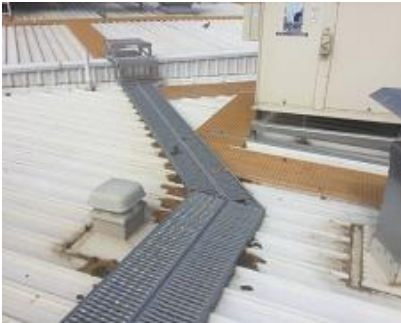
Walkway width is less than required minimum	Trips, Slips and Falls	Awareness induction	Med	Existing walkway to be replaced	Low	Client advised	Outstanding	OH&S REGULATIONS 3.7 AS/NZS 1657-2013 5.1.3

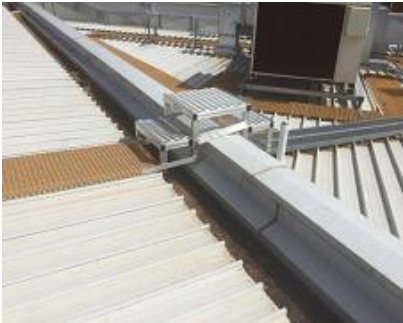
No	Photo of Hazard	Details of Hazard	Details of Risk	Existing/ Immediate Control Measure	Curre nt Risk Level	Proposed Permanent Solution	Resid ual Risk Asse sme nt	Details of Action Taken	Status	Reference
147	Building: General Stores Location Reference: L55 Task: Access to the roof

Non-complaint stair is present	Trips, Slips and Falls	Awareness induction	Med	Existing stair to be replaced with ladder	Low	Client advised	Outsta nding	OH&S REGULATIONS 3.7 AS/NZS 1657- 2013 7.2
148	Building: General Stores Location Reference: L56 Task: Access to the roof

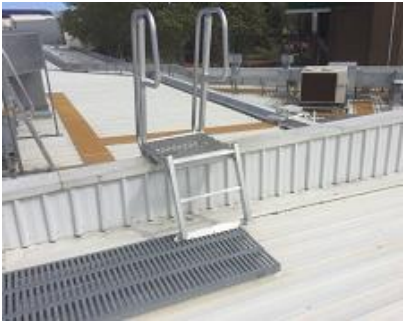
Landing is less than required minimum and handrail projecting towards the user	Trips, Slips and Falls	Awareness induction	Med	Existing handrail to be replaced and landing platforms to be installed	Low	Client advised	Outsta nding	OH&S REGULATIONS 3.7 AS/NZS 1657- 2013 7.3.6 & 7.4.8.5

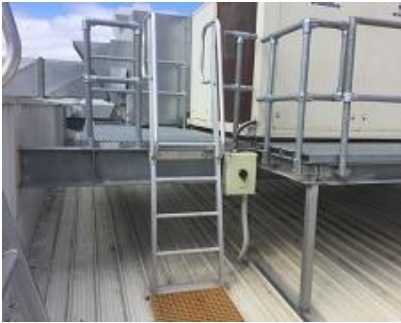
No	Photo of Hazard	Details of Hazard	Details of Risk	Existing/ Immediate Control Measure	Curre nt Risk Level	Proposed Permanent Solution	Resid ual Risk Asse sme nt	Details of Action Taken	Status	Reference
149	Building: General Stores Location Reference: L56 Task: Access to the roof

Handrail projecting towards the user and gap between top rung and plant deck is greater than required maximum	Trips, Slips and Falls	Awareness induction	Med	Existing handrail to be replaced and gap to filled	Low	Client advised	Outstanding	OH&S REGULATIONS 3.7 AS/NZS 1657-2013 7.4.8.5 & 7.4.8.4
150	Building: General Stores Location Reference: L56 Task: Access to the roof

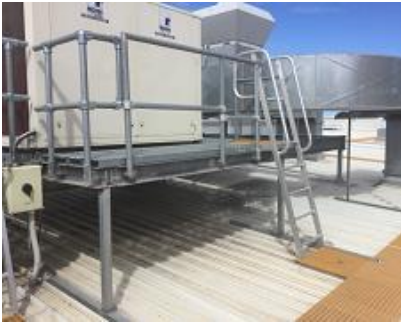
Handrail projecting towards the user and bottom rung height is less than required minimum	Trips, Slips and Falls	Awareness induction	Med	Existing handrail to be replaced and landing platform to be installed	Low	Client advised	Outstanding	OH&S REGULATIONS 3.7 AS/NZS 1657-2013 7.4.8.5 & 7.4.3.4

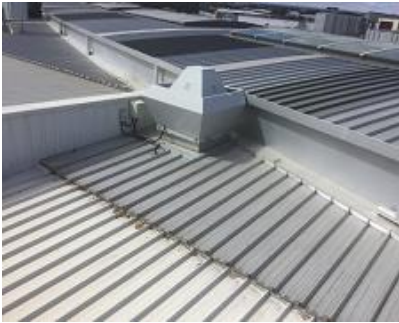
No safe access to the A/c units	Trips, Slips and Falls	N/A	Low	Supply walkway to the A/c units	Low	Client advised	Outstanding	-

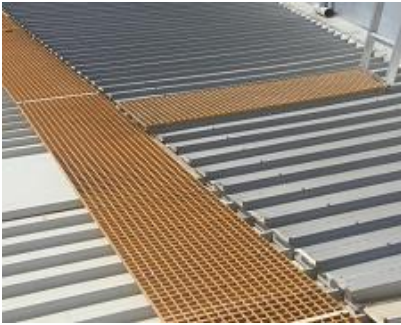
No	Photo of Hazard	Details of Hazard	Details of Risk	Existing/ Immediate Control Measure	Curre nt Risk Level	Proposed Permanent Solution	Resid ual Risk Asse sme nt	Details of Action Taken	Status	Reference
153	Building: General Stores Location Reference: L57 Task: Access to the roof

Variation in height between walkway panels are greater than required maximum	Trips, Slips and Falls	Awareness induction	Med	High visibility safety yellow nosing's to be installed	Low	Client advised	Outstanding	OH&S REGULATIONS 3.7 AS/NZS 1657-2013 3.3.4
154	Building: General Stores Location Reference: L58 Task: Restrict access to the roof

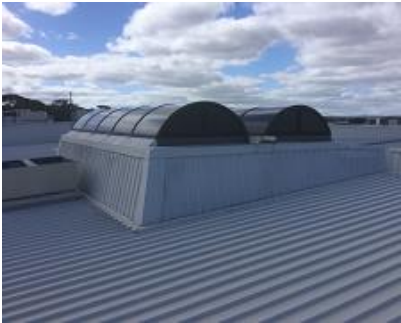
Brittle and Fragile roof sections are present	Trips, Slips and Falls	Restrict Access	High	"Brittle and Fragile Roof" signs to be installed	Low	Client advised	Outstanding	OH&S REGULATIONS 3.57
