Roof Safety Report

**Colonnades Shopping Centre,
SA 5168**

Prepared By: Safemaster Safety Products
Date: 02 October 2018

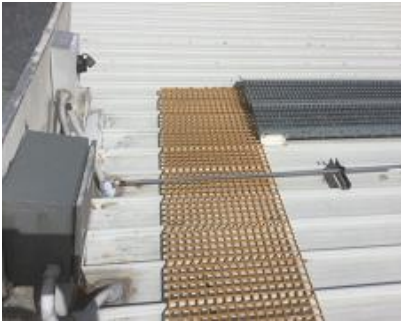
No	Photo of Hazard	Details of Hazard	Details of Risk	Existing/ Immediate Control Measure	Curre nt Risk Level	Proposed Permanent Solution	Resid ual Risk Asse sme nt	Details of Action Taken	Status	Reference
155	Building: General Stores Location Reference: L58 Task: Access to the roof

Variation in height between walkway panels are greater than required maximum	Trips, Slips and Falls	Awareness induction	Med	High visibility safety yellow nosing's to be installed	Low	Client advised	Outstanding	OH&S REGULATIONS 3.7 AS/NZS 1657-2013 3.3.4
156	Building: General Stores Location Reference: L58 Task: Access to the roof

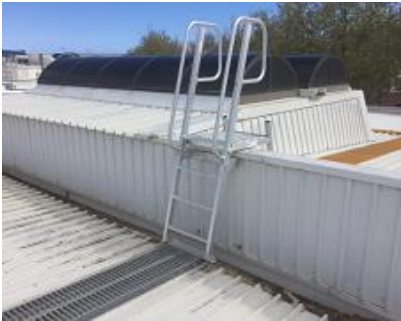
Handrail projecting towards the user and bottom rung height is less than required minimum	Trips, Slips and Falls	Awareness induction	Med	Existing handrail to be replaced and landing platform to be installed	Low	Client advised	Outstanding	OH&S REGULATIONS 3.7 AS/NZS 1657-2013 7.4.8.5 & 7.4.3.4

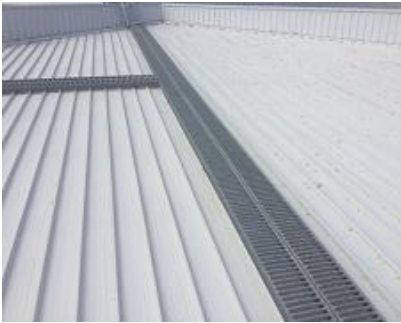
No	Photo of Hazard	Details of Hazard	Details of Risk	Existing/ Immediate Control Measure	Curre nt Risk Level	Proposed Permanent Solution	Resid ual Risk Asse sme nt	Details of Action Taken	Status	Reference
157	Building: General Stores Location Reference: L58 Task: Access to the roof

Walkway width is less than required minimum	Trips, Slips and Falls	Awareness induction	Med	Existing walkway to be replaced	Low	Client advised	Outstanding	OH&S REGULATIONS 3.7 AS/NZS 1657-2013 5.1.3
158	Building: General Stores Location Reference: L59 Task: Access to the roof

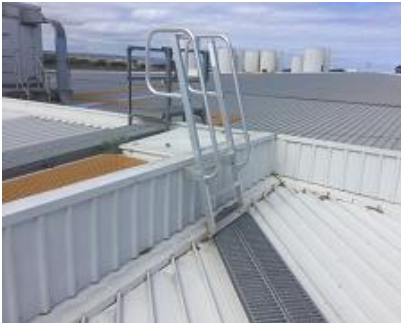
Non-complaint ladder is present	Trips, Slips and Falls	Awareness induction	Med	Existing ladder to be replaced	Low	Client advised	Outstanding	OH&S REGULATIONS 3.7 AS/NZS 1657-2013 7.4

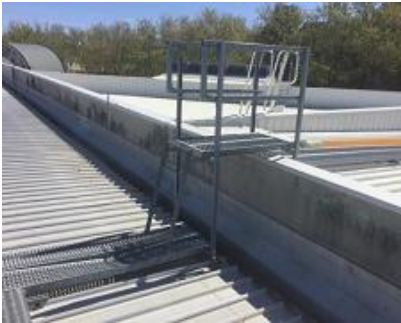
No	Photo of Hazard	Details of Hazard	Details of Risk	Existing/ Immediate Control Measure	Curre nt Risk Level	Proposed Permanent Solution	Resid ual Risk Asse sme nt	Details of Action Taken	Status	Reference
159	Building: General Stores Location Reference: L59 Task: Access to the roof

Non-complaint ladder is present	Trips, Slips and Falls	Awareness induction	Med	Existing ladder to be replaced	Low	Client advised	Outstanding	OH&S REGULATIONS 3.7 AS/NZS 1657-2013 7.4
160	Building: General Stores Location Reference: L59 Task: Access to the roof

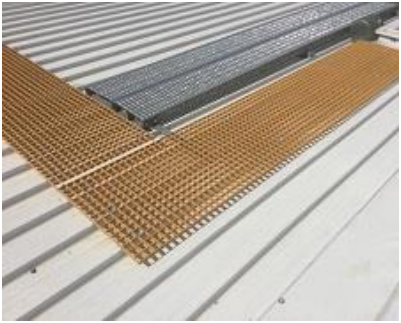
Variation in height between walkway panels are greater than required maximum	Trips, Slips and Falls	Awareness induction	Med	High visibility safety yellow nosing's to be installed	Low	Client advised	Outstanding	OH&S REGULATIONS 3.7 AS/NZS 1657-2013 3.3.4

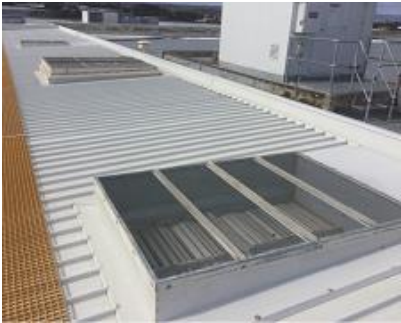
No	Photo of Hazard	Details of Hazard	Details of Risk	Existing/ Immediate Control Measure	Curre nt Risk Level	Proposed Permanent Solution	Resid ual Risk Asse sme nt	Details of Action Taken	Status	Reference
161	Building: General Stores Location Reference: L59 Task: Restrict access to the roof

Brittle and Fragile roof sections are present	Trips, Slips and Falls	Restrict Access	High	"Brittle and Fragile Roof" signs to be installed	Low	Client advised	Outstanding	OH&S REGULATIONS 3.57
162	Building: General Stores Location Reference: L60 Task: Access to the roof

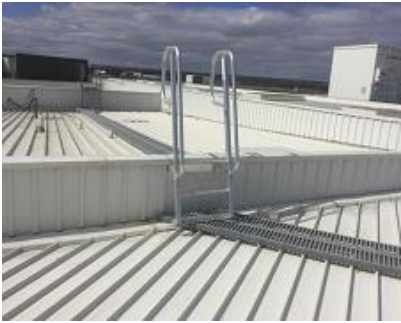
Non-complaint ladder is present	Trips, Slips and Falls	Awareness induction	Med	Existing ladder to be replaced	Low	Client advised	Outstanding	OH&S REGULATIONS 3.7 AS/NZS 1657-2013 7.4

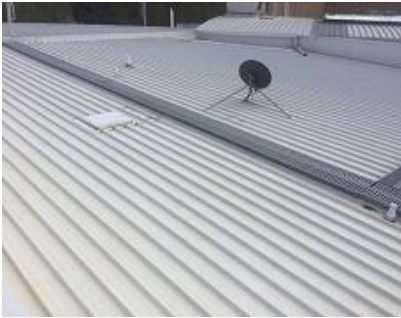
No	Photo of Hazard	Details of Hazard	Details of Risk	Existing/ Immediate Control Measure	Curre nt Risk Level	Proposed Permanent Solution	Resid ual Risk Asse sme nt	Details of Action Taken	Status	Reference
163	Building: General Stores Location Reference: L60 Task: Access to the roof

Walkway width is less than required minimum	Trips, Slips and Falls	Awareness induction	Med	Existing walkway to be replaced	Low	Client advised	Outstanding	OH&S REGULATIONS 3.7 AS/NZS 1657-2013 5.1.3
164	Building: General Stores Location Reference: L60 Task: Access to the roof

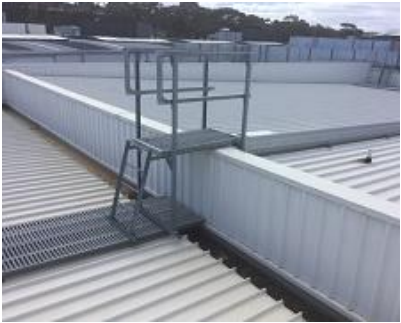
Non-complaint ladder is present	Trips, Slips and Falls	Awareness induction	Med	Existing ladder to be replaced	Low	Client advised	Outstanding	OH&S REGULATIONS 3.7 AS/NZS 1657-2013 7.4

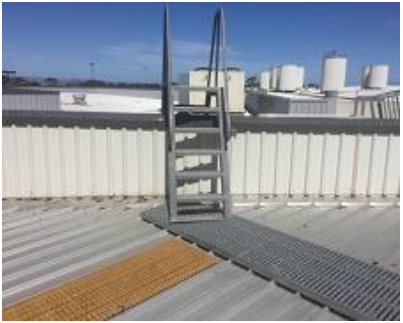
Landing is less than required minimum	Trips, Slips and Falls	Awareness induction	Med	Landing platforms to be installed	Low	Client advised	Outstanding	OH&S REGULATIONS 3.7 AS/NZS 1657-2013 7.3.6

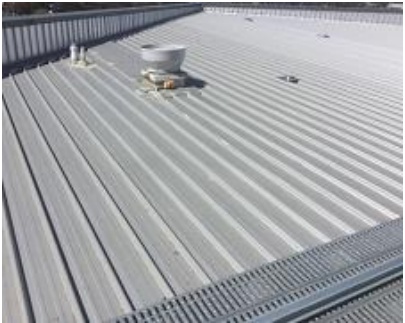
No safe access to the A/c units	Trips, Slips and Falls	N/A	Low	Supply walkway to the A/c units	Low	Client advised	Outstanding	-

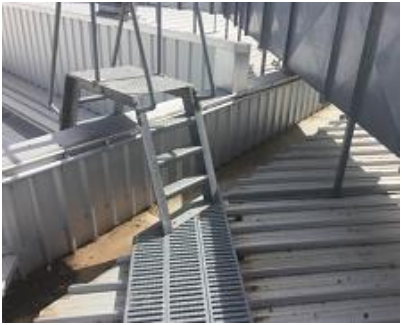
No	Photo of Hazard	Details of Hazard	Details of Risk	Existing/ Immediate Control Measure	Curre nt Risk Level	Proposed Permanent Solution	Resid ual Risk Asse sme nt	Details of Action Taken	Status	Reference
169	Building: General Stores Location Reference: L62 Task: Access to the roof

Ladder not fully secured and landing is less than required minimum	Trips, Slips and Falls	Awareness induction	Med	Existing ladder to be fully secured with new landing platforms	Low	Client advised	Outstanding	OH&S REGULATIONS 3.7 AS/NZS 1657-2013 7.3.6
170	Building: General Stores Location Reference: L62 Task: Access to the A/c units

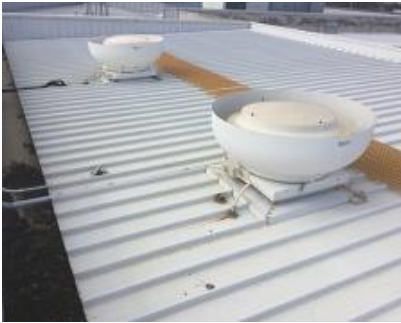
No safe access to the A/c units	Trips, Slips and Falls	N/A	Low	Supply walkway to the A/c units	Low	Client advised	Outstanding	-

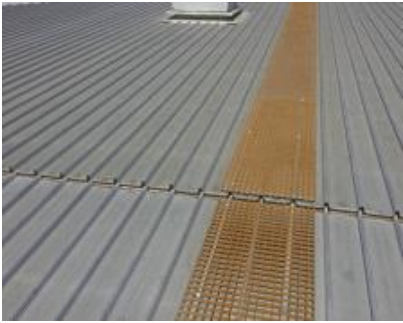
Variation in height between walkway panels are greater than required maximum	Trips, Slips and Falls	Awareness induction	Med	High visibility safety yellow nosing's to be installed	Low	Client advised	Outstanding	OH&S REGULATIONS 3.7 AS/NZS 1657-2013 3.3.4

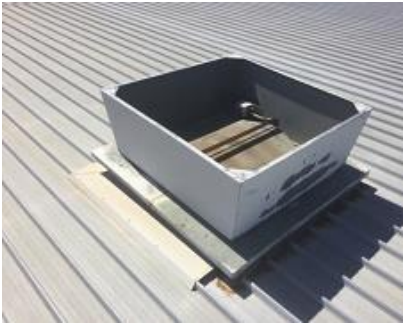
No safe access to the A/c units	Trips, Slips and Falls	N/A	Low	Supply walkway to the A/c units	Low	Client advised	Outstanding	-

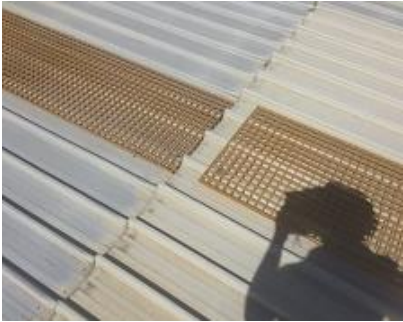
Gap between walkway panels are greater than required maximum	Trips, Slips and Falls	Awareness induction	Med	Additional walkway sections to be installed	Low	Client advised	Outstanding	OH&S REGULATIONS 3.7 AS/NZS 1657-2013 3.2.3.4

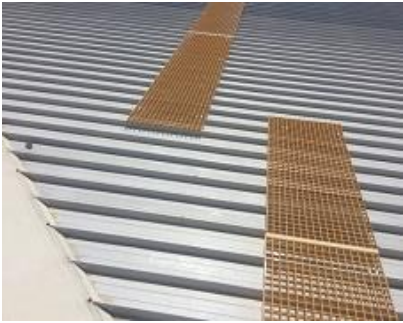
No	Photo of Hazard	Details of Hazard	Details of Risk	Existing/ Immediate Control Measure	Curre nt Risk Level	Proposed Permanent Solution	Resid ual Risk Asse sme nt	Details of Action Taken	Status	Reference
177	Building: General Stores Location Reference: L64 Task: Access to the roof

Gap between walkway panels are greater than required maximum	Trips, Slips and Falls	Awareness induction	Med	Additional walkway sections to be installed	Low	Client advised	Outstanding	OH&S REGULATIONS 3.7 AS/NZS 1657-2013 3.2.3.4
178	Building: General Stores Location Reference: L65 Task: Restrict access to the roof

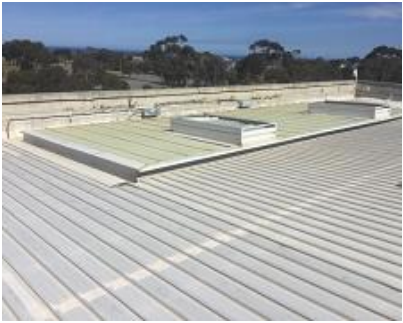
Brittle and Fragile roof sections are present	Trips, Slips and Falls	Restrict Access	High	"Brittle and Fragile Roof" signs to be installed	Low	Client advised	Outstanding	OH&S REGULATIONS 3.57

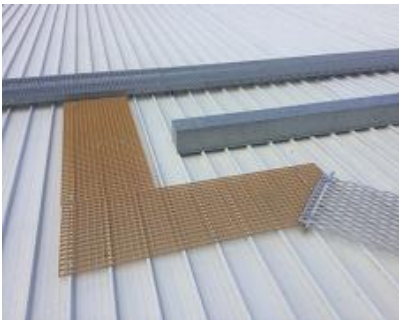
Variation in height between walkway panels are greater than required maximum	Trips, Slips and Falls	Awareness induction	Med	High visibility safety yellow nosing's to be installed	Low	Client advised	Outstanding	OH&S REGULATIONS 3.7 AS/NZS 1657-2013 3.3.4

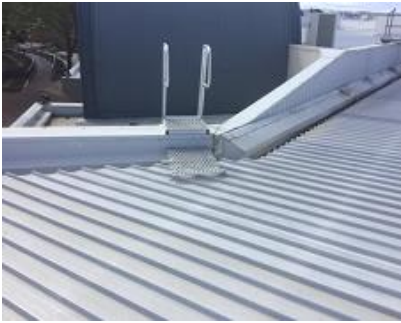
No	Photo of Hazard	Details of Hazard	Details of Risk	Existing/ Immediate Control Measure	Curre nt Risk Level	Proposed Permanent Solution	Resid ual Risk Asse sme nt	Details of Action Taken	Status	Reference
183	Building: General Stores Location Reference: L66 Task: Access to the ladder

No safe access to the ladder	Trips, Slips and Falls	N/A	Low	Supply walkway to the ladder	Low	Client advised	Outstanding	-
184	Building: General Stores Location Reference: L66 Task: Access to the roof

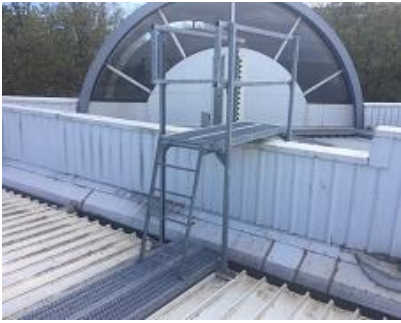
Non-complaint ladder is present	Trips, Slips and Falls	Awareness induction	Med	Existing ladder to be replaced	Low	Client advised	Outstanding	OH&S REGULATIONS 3.7 AS/NZS 1657-2013 7.4

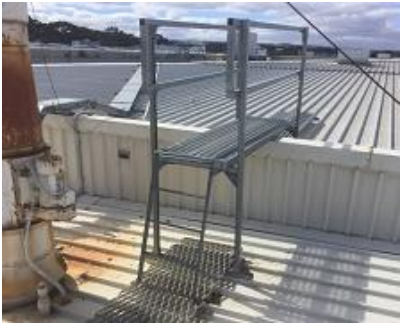
No	Photo of Hazard	Details of Hazard	Details of Risk	Existing/ Immediate Control Measure	Curre nt Risk Level	Proposed Permanent Solution	Resid ual Risk Asse sme nt	Details of Action Taken	Status	Reference
185	Building: General Stores Location Reference: L67 Task: Access to the roof

Non-complaint ladder is present	Trips, Slips and Falls	Awareness induction	Med	Existing ladder to be replaced	Low	Client advised	Outstanding	OH&S REGULATIONS 3.7 AS/NZS 1657-2013 7.4
186	Building: General Stores Location Reference: L67 Task: Access to the roof

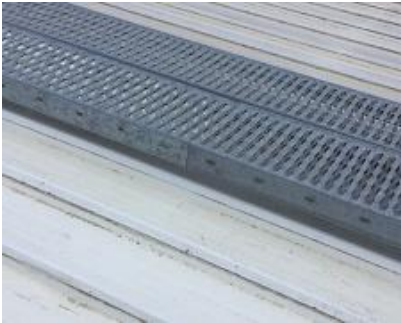
Walkway ends not fully secured	Trips, Slips and Falls	Awareness induction	Med	Additional channels to be installed	Low	Client advised	Outstanding	OH&S REGULATIONS 3.7

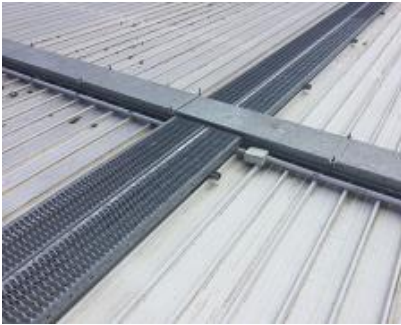
No	Photo of Hazard	Details of Hazard	Details of Risk	Existing/ Immediate Control Measure	Curre nt Risk Level	Proposed Permanent Solution	Resid ual Risk Asse sme nt	Details of Action Taken	Status	Reference
187	Building: General Stores Location Reference: L67 Task: Access to the roof

Cable tray installed over the walkway path	Trips, Slips and Falls	Awareness induction	Med	Step bridge including handrails to be installed	Low	Client advised	Outstanding	OH&S REGULATIONS 3.7
188	Building: General Stores Location Reference: L68 Task: Restrict access to the roof

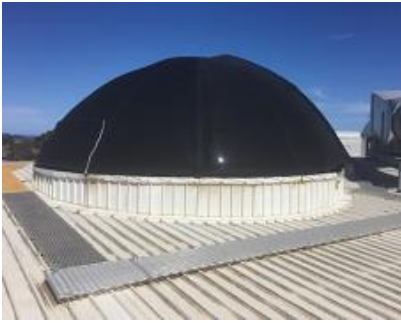
Brittle and Fragile roof and non-complaint ladder is present	Trips, Slips and Falls	Restrict Access	High	"Brittle and Fragile Roof" and "No Access" signs to be installed	Low	Client advised	Outstanding	OH&S REGULATIONS 3.57 & 3.11

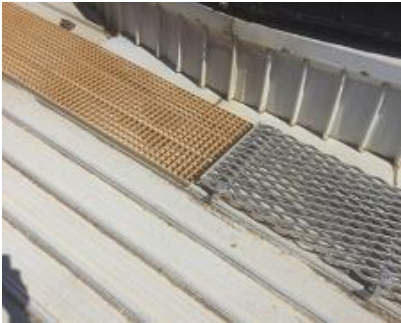
No	Photo of Hazard	Details of Hazard	Details of Risk	Existing/ Immediate Control Measure	Curre nt Risk Level	Proposed Permanent Solution	Resid ual Risk Asse sme nt	Details of Action Taken	Status	Reference
189	Building: General Stores Location Reference: L68 Task: Access to the roof

Variation in height between walkway panels are greater than required maximum	Trips, Slips and Falls	Awareness induction	Med	High visibility safety yellow nosing's to be installed	Low	Client advised	Outstanding	OH&S REGULATIONS 3.7 AS/NZS 1657-2013 3.3.4
190	Building: General Stores Location Reference: L68 Task: Access to the roof

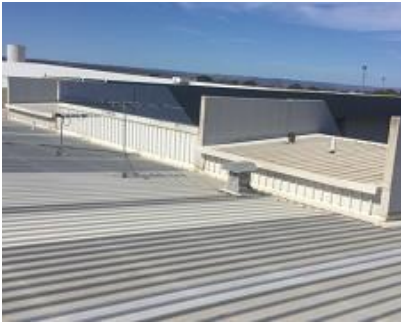
No height safety system installed	Trips, Slips and Falls	Awareness induction	High	Anchor points to be installed	Low	Client advised	Outstanding	OH&S REGULATIONS 3.55

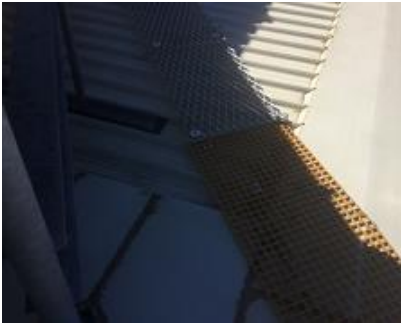
Variation in height between walkway panels are greater than required maximum	Trips, Slips and Falls	Awareness induction	Med	High visibility safety yellow nosing's to be installed	Low	Client advised	Outstanding	OH&S REGULATIONS 3.7 AS/NZS 1657-2013 3.3.4
192	Building: General Stores Location Reference: L69 Task: Restrict access to the roof

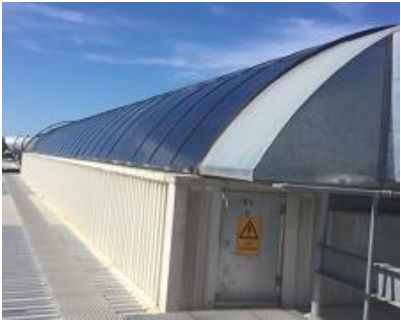
Brittle and Fragile roof and non-complaint ladder is present	Trips, Slips and Falls	Restrict Access	High	"Brittle and Fragile Roof" and "No Access" signs to be installed	Low	Client advised	Outstanding	OH&S REGULATIONS 3.57 & 3.11

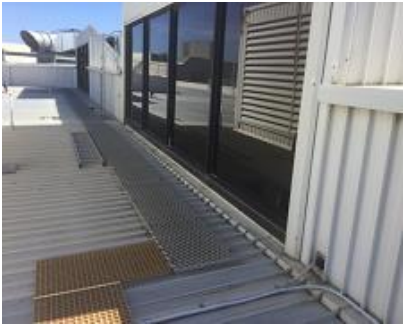
Variation in height between walkway panels are greater than required maximum	Trips, Slips and Falls	Awareness induction	Med	High visibility safety yellow nosing's to be installed	Low	Client advised	Outstanding	OH&S REGULATIONS 3.7 AS/NZS 1657-2013 3.3.4
194	Building: General Stores Location Reference: L69 Task: Access to the A/c units

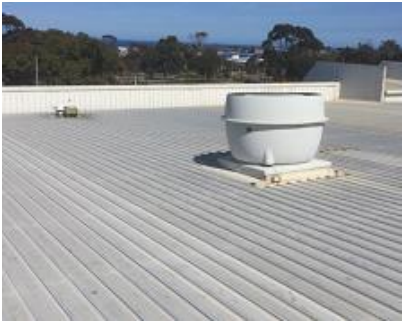
No safe access to the A/c units	Trips, Slips and Falls	N/A	Low	Supply walkway to the A/c units	Low	Client advised	Outstanding	-

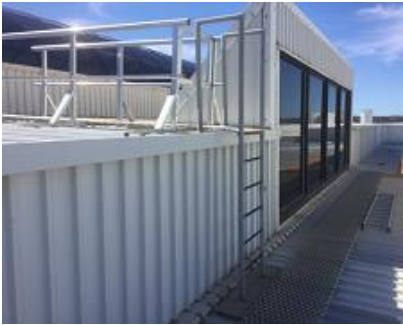
Non-complaint ladder is present	Trips, Slips and Falls	Awareness induction	Med	Existing ladder to be replaced	Low	Client advised	Outstanding	OH&S REGULATIONS 3.7 AS/NZS 1657-2013 7.4
196	Building: General Stores Location Reference: L70 Task: Access to the roof

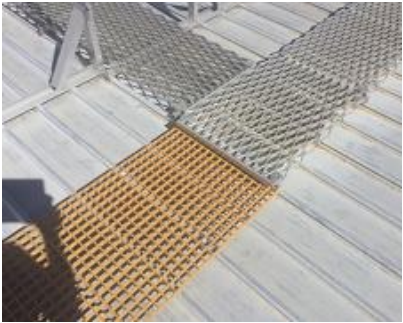
Variation in height between walkway panels are greater than required maximum	Trips, Slips and Falls	Awareness induction	Med	High visibility safety yellow nosing's to be installed	Low	Client advised	Outstanding	OH&S REGULATIONS 3.7 AS/NZS 1657-2013 3.3.4

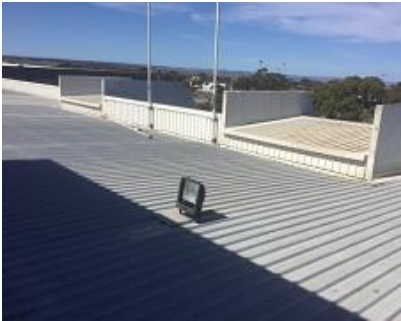
No height safety system installed	Trips, Slips and Falls	Awareness induction	High	Anchor points to be installed	Low	Client advised	Outstanding	OH&S REGULATIONS 3.55
198	Building: General Stores Location Reference: L71 Task: Access to the roof

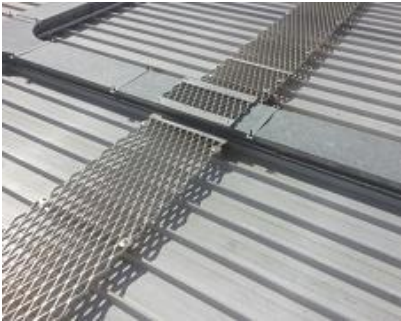
Cable tray installed over the walkway path	Trips, Slips and Falls	Awareness induction	Med	Step bridge including handrails to be installed	Low	Client advised	Outstanding	OH&S REGULATIONS 3.7

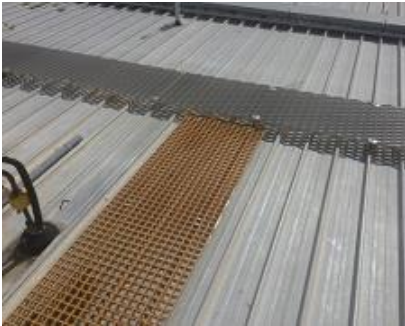
Variation in height between walkway panels are greater than required maximum	Trips, Slips and Falls	Awareness induction	Med	High visibility safety yellow nosing's to be installed	Low	Client advised	Outstanding	OH&S REGULATIONS 3.7 AS/NZS 1657-2013 3.3.4
200	Building: General Stores Location Reference: L71 Task: Access to the roof

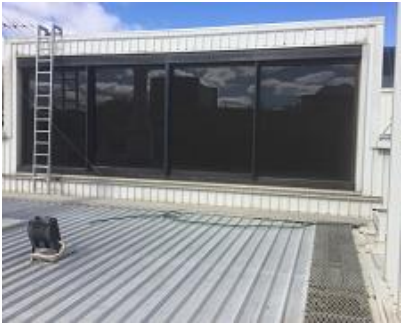
Non-complaint ladder is present	Trips, Slips and Falls	Awareness induction	Med	Existing ladder to be removed or "No access" sign to be installed	Low	Client advised	Outstanding	OH&S REGULATIONS 3.7 & 3.11

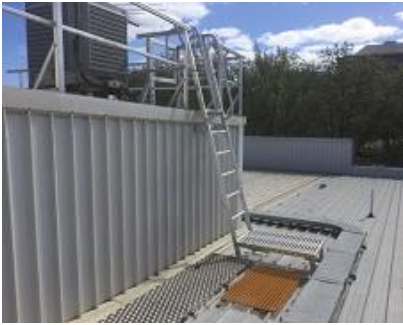
Gap between ladder and structure is less than required minimum and handrail projecting towards the user	Trips, Slips and Falls	Awareness induction	Med	Existing ladder to be re-installed with new handrails and high visibility safety yellow nosing's	Low	Client advised	Outstanding	OH&S REGULATIONS 3.7 AS/NZS 1657-2013 7.4.5 & 7.4.8.5
202	Building: General Stores Location Reference: L71 Task: Access to the roof

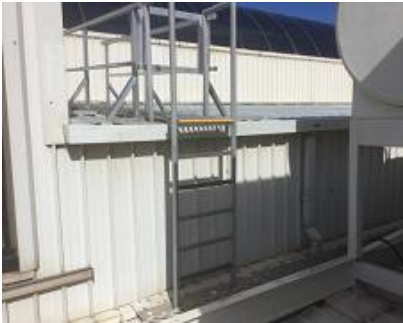
Non-complaint ladder is present	Trips, Slips and Falls	Awareness induction	Med	Existing ladder to be replaced	Low	Client advised	Outstanding	OH&S REGULATIONS 3.7 AS/NZS 1657-2013 7.4

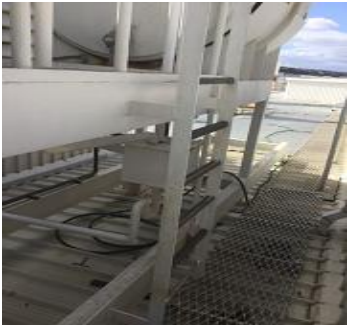
Non-complaint ladder is present	Trips, Slips and Falls	Awareness induction	Med	Existing ladder to be replaced	Low	Client advised	Outstanding	OH&S REGULATIONS 3.7 AS/NZS 1657-2013 7.4
20 4	Building: General Stores Location Reference: L71 Task: Access to the roof

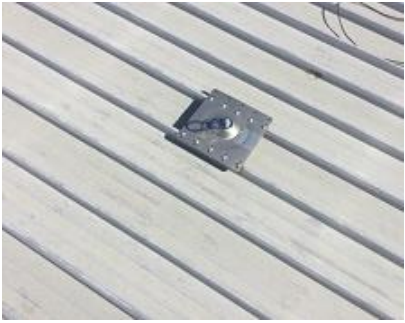
Non-complaint anchors are present	Trips, Slips and Falls	Awareness induction	High	Anchor points to be installed	Low	Client advised	Outstanding	OH&S REGULATIONS 3.55

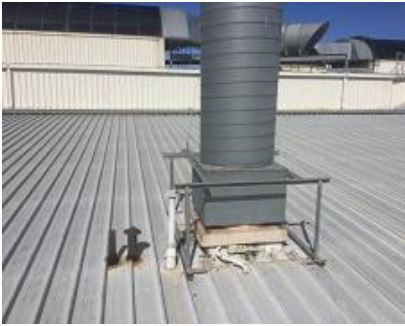
No safe access to the A/c units	Trips, Slips and Falls	N/A	Low	Supply walkway to the A/c units	Low	Client advised	Outstanding	-
20 6	Building: General Stores Location Reference: L72 Task: Access to the roof

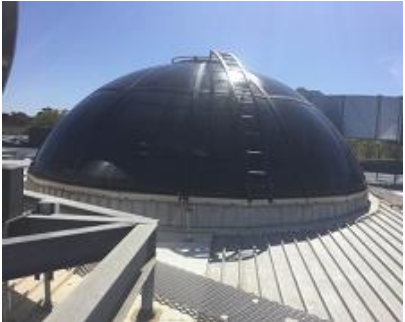
Brittle and Fragile roof and non-complaint ladder is present	Trips, Slips and Falls	Restrict Access	High	"Brittle and Fragile Roof" and "No Access" signs to be installed	Low	Client advised	Outstanding	OH&S REGULATIONS 3.57 & 3.11

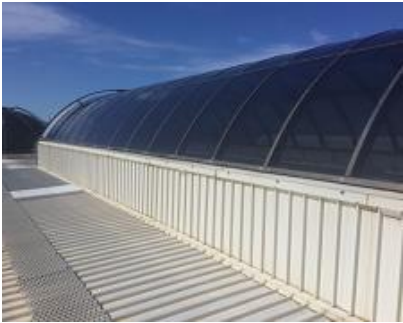
Brittle and Fragile roof and non-complaint ladder is present	Trips, Slips and Falls	Restrict Access	High	"Brittle and Fragile Roof" and "No Access" signs to be installed	Low	Client advised	Outstanding	OH&S REGULATIONS 3.57 & 3.11
20 8	Building: General Stores Location Reference: L73 Task: Access to the roof

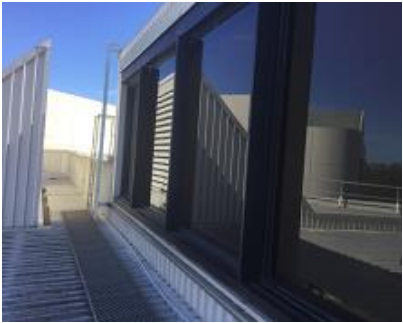
Non-complaint ladder is present	Trips, Slips and Falls	Awareness induction	Med	Existing ladder to be removed or "No access" sign to be installed	Low	Client advised	Outstanding	OH&S REGULATIONS 3.7 & 3.11

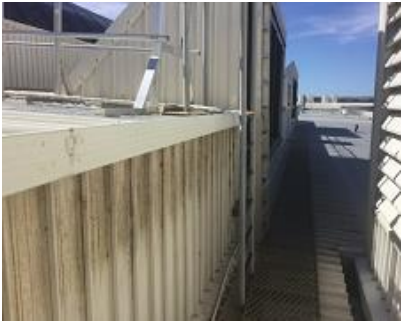
Non-complaint ladder is present	Trips, Slips and Falls	Awareness induction	Med	Existing ladder to be replaced	Low	Client advised	Outstanding	OH&S REGULATIONS 3.7 AS/NZS 1657-2013 7.4
210	Building: General Stores Location Reference: L73 Task: Access to the roof

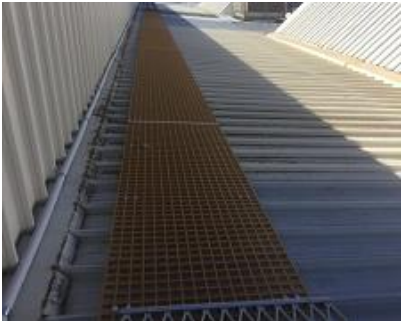
Variation in height between walkway panels are greater than required maximum	Trips, Slips and Falls	Awareness induction	Med	High visibility safety yellow nosing's to be installed	Low	Client advised	Outstanding	OH&S REGULATIONS 3.7 AS/NZS 1657-2013 3.3.4

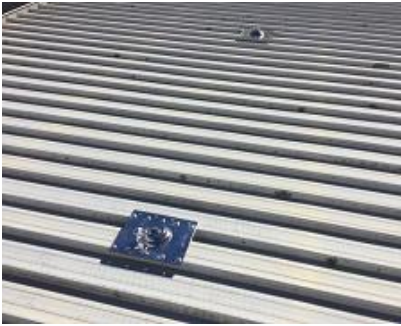
Non-complaint anchors are present	Trips, Slips and Falls	Awareness induction	High	Existing anchors to be replaced	Low	Client advised	Outstanding	OH&S REGULATIONS 3.55
212	Building: General Stores Location Reference: L74 Task: Access to the roof

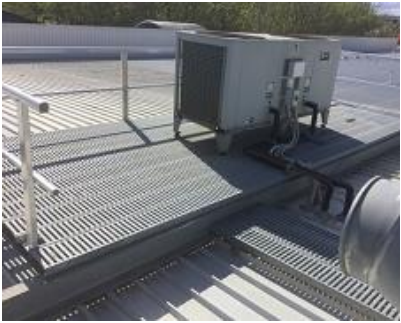
Variation in height between plant deck and roof is greater than required maximum	Trips, Slips and Falls	Awareness induction	Med	Handrail to be installed	Low	Client advised	Outstanding	OH&S REGULATIONS 3.7 AS/NZS 1657-2013 4.4

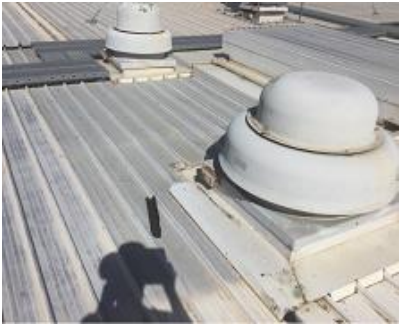
No safe access to the A/c units	Trips, Slips and Falls	N/A	Low	Supply walkway to the A/c units	Low	Client advised	Outstanding	-
214	Building: General Stores Location Reference: L75 Task: Access to the roof

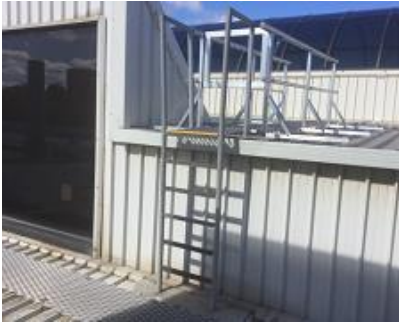
Non-complaint ladder is present	Trips, Slips and Falls	Awareness induction	Med	Existing ladder to be replaced	Low	Client advised	Outstanding	OH&S REGULATIONS 3.7 AS/NZS 1657-2013 7.4

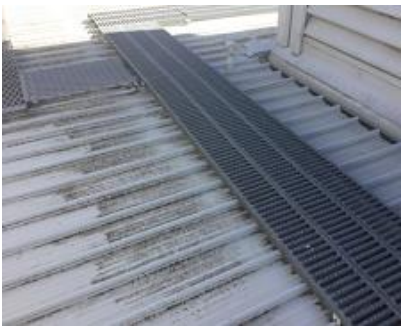
Walkway not fully secured	Trips, Slips and Falls	Awareness induction	Med	Walkway to be secured	Low	Client advised	Outsta nding	OH&S REGULATIONS 3.7
216	Building: General Stores Location Reference: L75 Task: Access to the roof

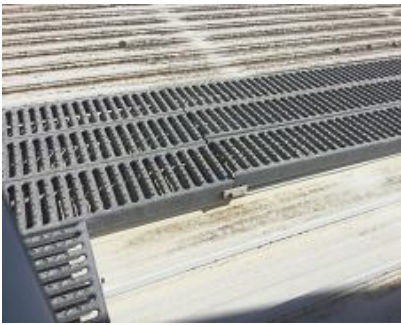
Walkway not fully secured	Trips, Slips and Falls	Awareness induction	Med	Walkway to be secured	Low	Client advised	Outsta nding	OH&S REGULATIONS 3.7

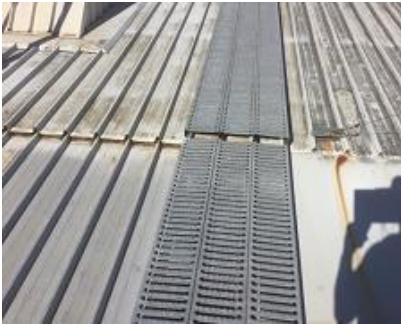
Variation in height between walkway panels are greater than required maximum	Trips, Slips and Falls	Awareness induction	Med	High visibility safety yellow nosing's to be installed	Low	Client advised	Outstanding	OH&S REGULATIONS 3.7 AS/NZS 1657-2013 3.3.4
218	Building: General Stores Location Reference: L75 Task: Access to the roof

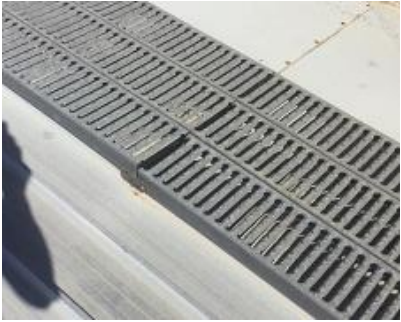
Walkway not fully secured	Trips, Slips and Falls	Awareness induction	Med	Walkway to be secured	Low	Client advised	Outstanding	OH&S REGULATIONS 3.7

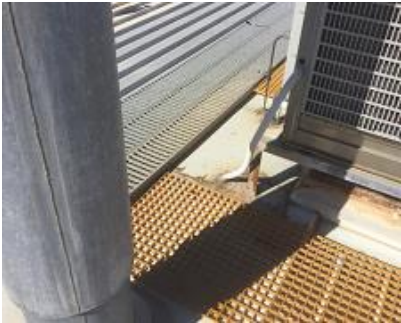
Variation in height between walkway panels are greater than required maximum	Trips, Slips and Falls	Awareness induction	Med	High visibility safety yellow nosing's to be installed	Low	Client advised	Outstanding	OH&S REGULATIONS 3.7 AS/NZS 1657-2013 3.3.4
220	Building: General Stores Location Reference: L75 Task: Access to the roof

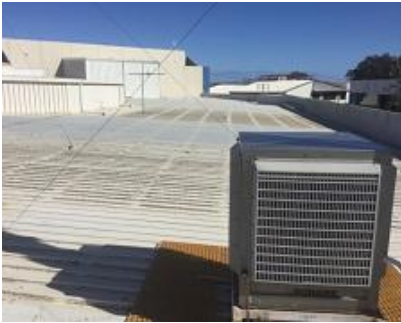
Headroom is less than required minimum	Trips, Slips and Falls	Awareness induction	Med	"Caution-Low headroom" signs to be installed	Low	Client advised	Outstanding	OH&S REGULATIONS 3.7 AS/NZS 1657-2013 3.1.5

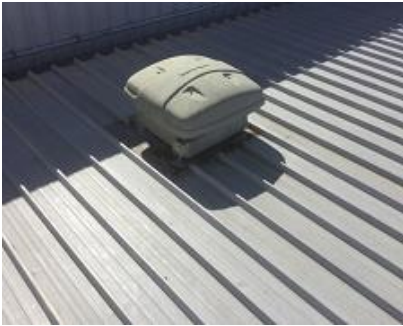
No safe access to the A/c units	Trips, Slips and Falls	N/A	Low	Supply walkway to the A/c units	Low	Client advised	Outstanding	-
222	Building: General Stores Location Reference: L76 Task: Access to the roof

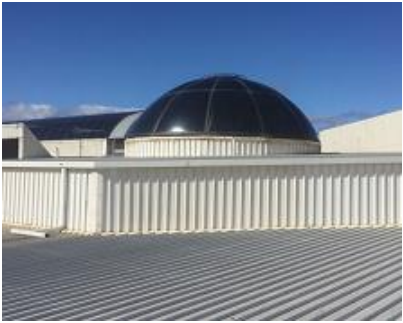
Brittle and Fragile roof and non-complaint ladder is present	Trips, Slips and Falls	Restrict Access	High	"Brittle and Fragile Roof" and "No Access" signs to be installed	Low	Client advised	Outstanding	OH&S REGULATIONS 3.57 & 3.11

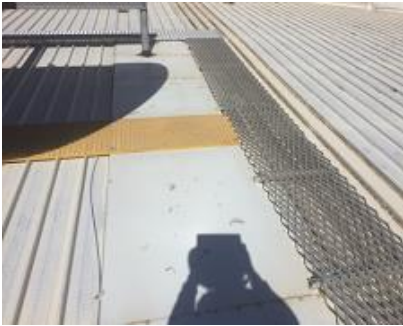
Variation in height between walkway panels are greater than required maximum	Trips, Slips and Falls	Awareness induction	Med	High visibility safety yellow nosing's to be installed	Low	Client advised	Outstanding	OH&S REGULATIONS 3.7 AS/NZS 1657-2013 3.3.4
22 4	Building: General Stores Location Reference: L77 Task: Access to the roof

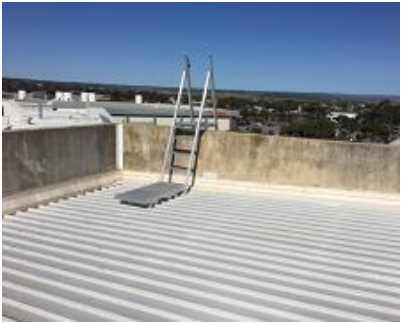
No safe access to the ladder	Trips, Slips and Falls	Awareness induction	Med	Anchor and stop to be installed	Low	Client advised	Outstanding	OH&S REGULATIONS 3.7 & 3.55

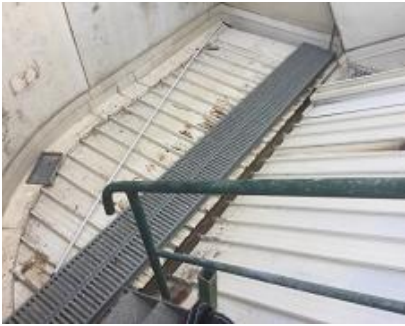
Walkway width is less than required minimum	Trips, Slips and Falls	Awareness induction	Med	Existing walkway to be replaced	Low	Client advised	Outstanding	OH&S REGULATIONS 3.7 AS/NZS 1657-2013 5.1.3
22 6	Building: General Stores Location Reference: L78 Task: Access to the roof

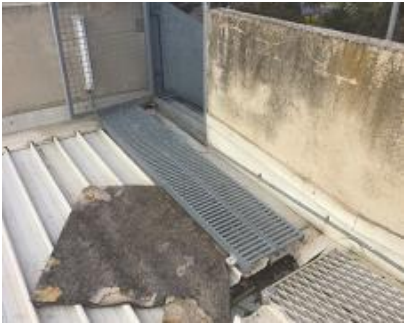
Walkway width is less than required minimum	Trips, Slips and Falls	Awareness induction	Med	Existing walkway to be replaced and Landing at access point to be installed	Low	Client advised	Outstanding	OH&S REGULATIONS 3.7 AS/NZS 1657-2013 5.1.3 & 7.3.6

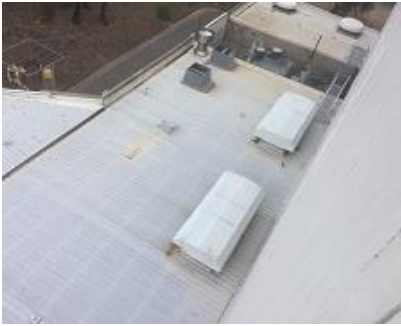
No safe access to the A/c units	Trips, Slips and Falls	N/A	Low	Supply walkway to the A/c units	Low	Client advised	Outstanding	-
22 8	Building: General Stores Location Reference: L80 Task: Access to the roof

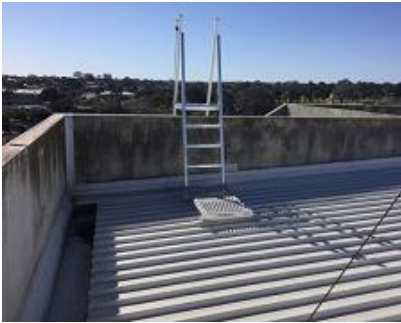
No safe access to the ladder	Trips, Slips and Falls	Awareness induction	Med	Anchor and stop to be installed	Low	Client advised	Outstanding	OH&S REGULATIONS 3.7 & 3.55

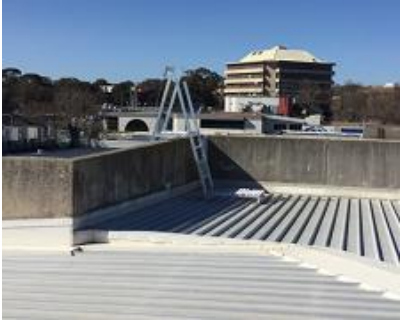
No safe access to the ladder	Trips, Slips and Falls	Awareness induction	Med	Anchor and strop to be installed	Low	Client advised	Outstanding	OH&S REGULATIONS 3.7 & 3.55
230	Building: General Stores Location Reference: L82 Task: Access to the roof

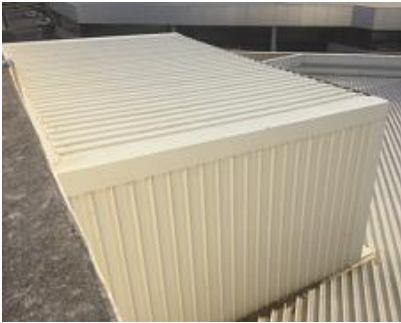
No safe access to roof	Trips, Slips and Falls	Awareness induction	High	Anchors, strop and access ladder to be installed	Low	Client advised	Outstanding	OH&S REGULATIONS 3.7 & 3.55 AS/NZS 1657-2013 3.1.4

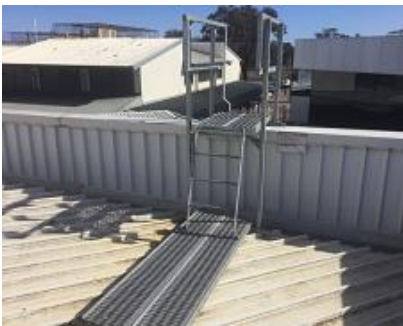
Non-complaint ladder is present	Trips, Slips and Falls	Awareness induction	Med	Existing ladder to be replaced	Low	Client advised	Outstanding	OH&S REGULATIONS 3.7 AS/NZS 1657-2013 7.4
232	Building: General Stores Location Reference: L83 Task: Access to the roof

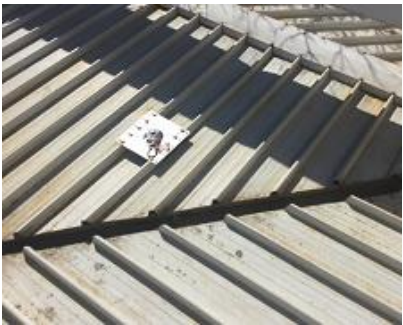
Non-complaint anchors are present	Trips, Slips and Falls	Awareness induction	High	Existing anchors to be replaced	Low	Client advised	Outstanding	OH&S REGULATIONS 3.55

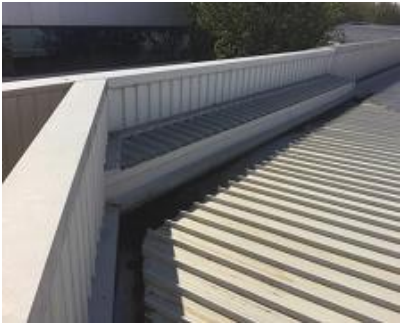
No height safety system installed	Trips, Slips and Falls	Awareness induction	High	Anchor points to be installed	Low	Client advised	Outstanding	OH&S REGULATIONS 3.55
23 4	Building: General Stores Location Reference: L83 Task: Access to the roof

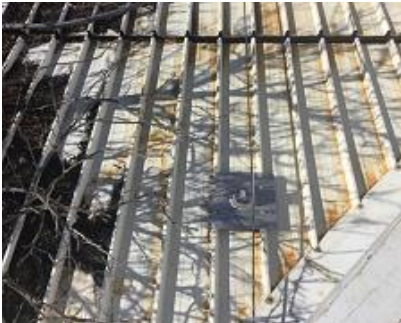
Non-complaint intermediate anchor point	Trips, Slips and Falls	Awareness induction	High	Intermediate anchor point to be replaced	Low	Client advised	Outstanding	OH&S REGULATIONS 3.55

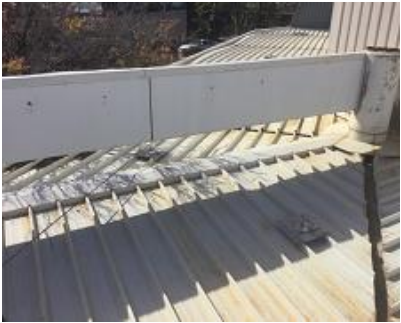
Variation in height between roofs are greater than required maximum	Trips, Slips and Falls	Awareness induction	Med	Access ladder to be installed	Low	Client advised	Outstanding	OH&S REGULATIONS 3.7 AS/NZS 1657-2013 3.1.4
23 6	Building: General Stores Location Reference: L83 Task: Access to the roof

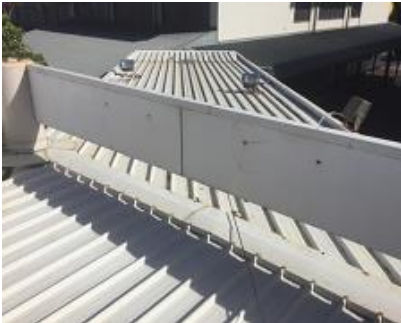
Variation in height between roofs are greater than required maximum	Trips, Slips and Falls	Awareness induction	Med	Access ladder to be installed	Low	Client advised	Outstanding	OH&S REGULATIONS 3.7 AS/NZS 1657-2013 3.1.4

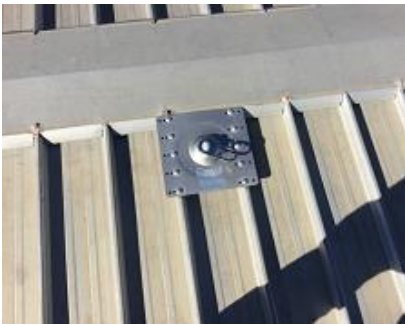
Non-complaint anchors are present	Trips, Slips and Falls	Awareness induction	High	Existing anchors to be replaced	Low	Client advised	Outstanding	OH&S REGULATIONS 3.55
23 8	Building: General Stores Location Reference: L84 Task: Access to the roof

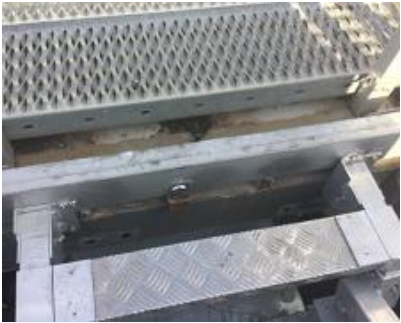
Gap between hatch and walkway panel is greater than required maximum	Trips, Slips and Falls	Awareness induction	Med	Gap to be filled	Low	Client advised	Outstanding	OH&S REGULATIONS 3.7 AS/NZS 1657-2013 3.2.3.4

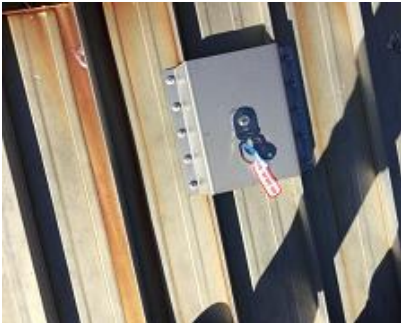
Non-complaint anchors are present	Trips, Slips and Falls	Awareness induction	High	Existing anchors to be replaced	Low	Client advised	Outstanding	OH&S REGULATIONS 3.55
24 0	Building: General Stores Location Reference: L85 Task: Access to the roof

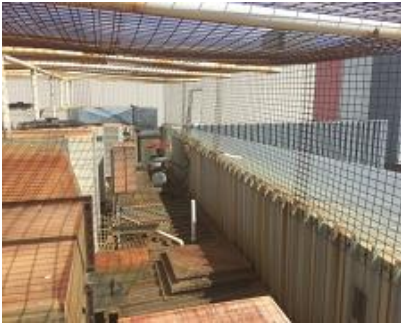
Variation in height between plant deck and roof is greater than required maximum	Trips, Slips and Falls	Awareness induction	Med	Access ladder, handrail and low head room sign to be installed	Low	Client advised	Outstanding	OH&S REGULATIONS 3.7 AS/NZS 1657-2013 3.1.4 & 4.4

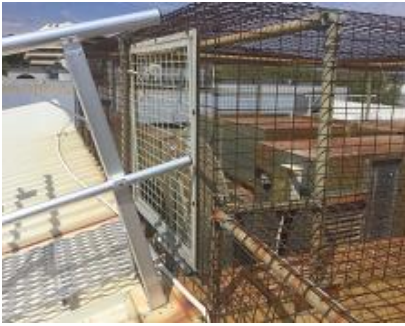
Head room is less than required minimum	Trips, Slips and Falls	Awareness induction	Med	"Caution-Low headroom" signs to be installed	Low	Client advised	Outstanding	OH&S REGULATIONS 3.7 AS/NZS 1657-2013 3.1.5
242	Building: General Stores Location Reference: L85 Task: Access to the roof

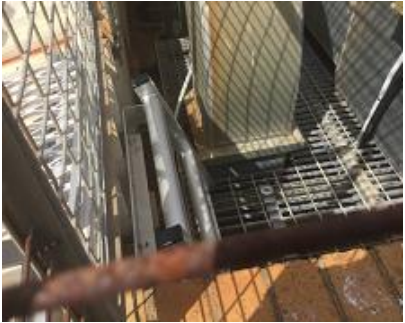
Non-complaint ladder is present	Trips, Slips and Falls	Awareness induction	Med	Existing ladder to be replaced with step ladder including "Watch Your Step" signs to be installed	Low	Client advised	Outstanding	OH&S REGULATIONS 3.7 & 3.11 AS/NZS 1657-2013 7.4

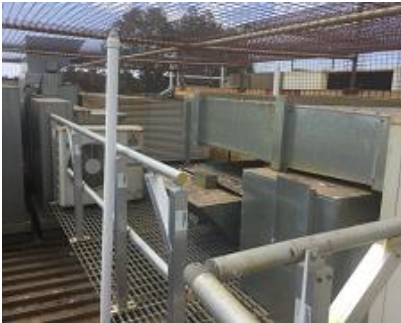
No safe access to the A/c units	Trips, Slips and Falls	N/A	Low	Supply walkway to the A/c units	Low	Client advised	Outstanding	-
24 4	Building: General Stores Location Reference: L85 Task: Access to the roof

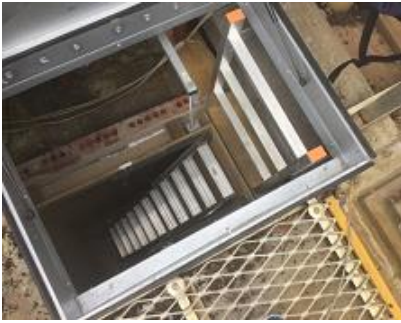
Un-even rungs are present for ceiling ladder	Trips, Slips and Falls	Awareness induction	Med	Existing ceiling ladder to be replaced	Low	Client advised	Outstanding	OH&S REGULATIONS 3.7 AS/NZS 1657-2013 7.4

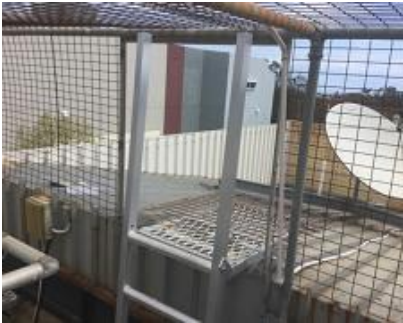
Headroom is less than required minimum	Trips, Slips and Falls	Awareness induction	Med	"Caution-Low headroom" signs to hatch, ladder and plant deck to be installed	Low	Client advised	Outstanding	OH&S REGULATIONS 3.7 AS/NZS 1657-2013 3.1.5
24 6	Building: General Stores Location Reference: L85 Task: Access to the roof

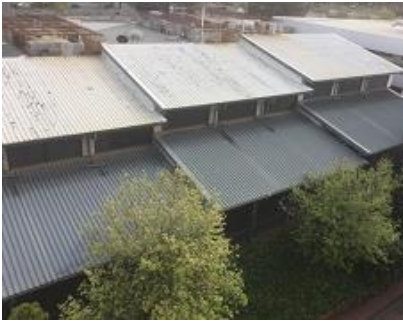
No height safety system installed	Trips, Slips and Falls	Awareness induction	High	Anchor points, strop, ladder access bracket and sign to be installed	Low	Client advised	Outstanding	OH&S REGULATIONS 3.55
