Roof Safety Report

**Corio Central Shopping Centre,
VIC 3214**

Prepared By: Safemaster Safety Products
Date: 23 April 2018

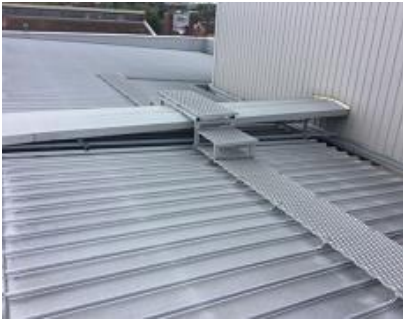
Variation in height between landing and roof is greater than required maximum	Trips, Slips and Falls	Awareness induction	Med	Handrail to be installed	Low	Client advised	Outstanding	OH&S REGULATIONS 3.7 AS/NZS 1657-2013 4.4

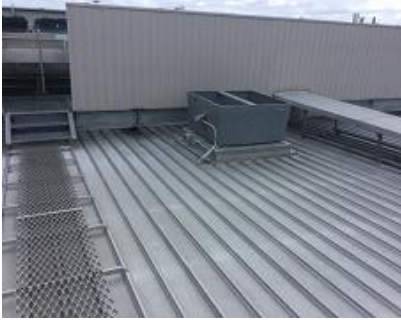
No safe access to the A/c units	Trips, Slips and Falls	N/A	Low	Supply walkway to the A/c units	Low	Client advised	Outstanding	-

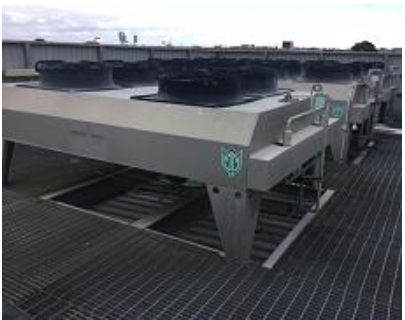
Variation in height between plant deck and unit is greater than required maximum	Trips, Slips and Falls	Awareness induction	Med	Mid rail to be installed	Low	Client advised	Outstanding	OH&S REGULATIONS 3.7 AS/NZS 1657-2013 6.2.1.2

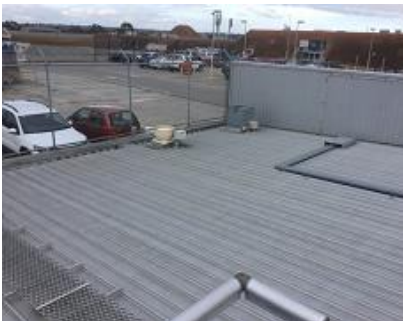
No safe access to the A/c units	Trips, Slips and Falls	N/A	Low	Supply walkway to the A/c units	Low	Client advised	Outstanding	-

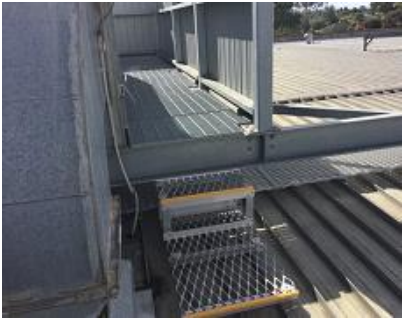
Variation in height between plant deck and roof is greater than required maximum	Trips, Slips and Falls	Awareness induction	Med	Handrail posts to be installed	Low	Client advised	Outstanding	OH&S REGULATIONS 3.7 AS/NZS 1657-2013 4.4

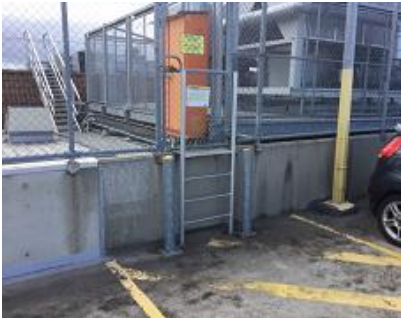
No slip resistance on ladder rungs	Trips, Slips and Falls	Awareness induction	Med	Existing ladder to be removed and new ladder to be installed	Low	Client advised	Outstanding	OH&S REGULATIONS 3.7 AS/NZS 1657-2013 7.4.3.1

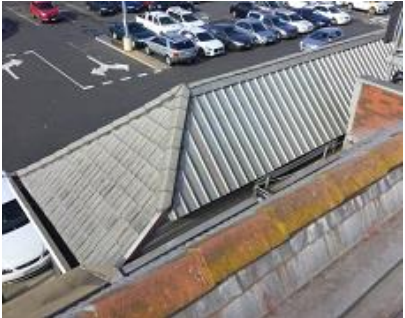
No height safety system installed	Trips, Slips and Falls	Restrict Access	High	"EWP Access Only" signs to be installed	Low	Client advised	Outstanding	OH&S REGULATIONS 3.55 & 3.11

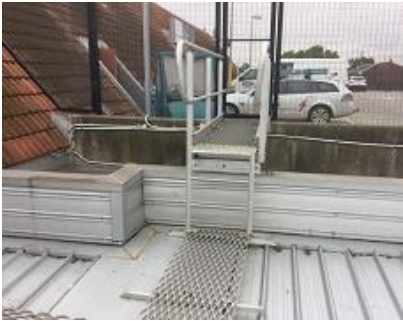
No slip resistance on ladder rungs	Trips, Slips and Falls	Awareness induction	Med	Existing ladder to be removed and new ladder to be installed	Low	Client advised	Outstanding	OH&S REGULATIONS 3.7 AS/NZS 1657-2013 7.4.3.1

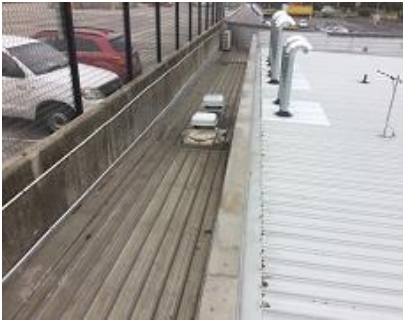
No safe access to the A/c units	Trips, Slips and Falls	N/A	Low	Supply walkway and access ladder to the A/c units	Low	Client advised	Outstanding	-

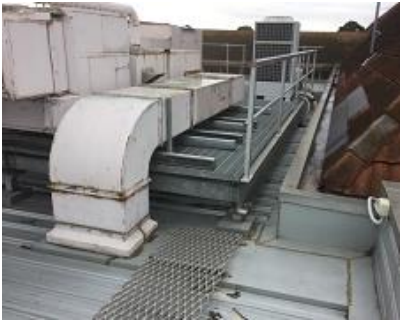
Bracings protruding over the walkway path on plant deck	Trips, Slips and Falls	Awareness induction	Med	High visibility safety yellow tape to be installed	Low	Client advised	Outstanding	OH&S REGULATIONS 3.7 AS/NZS 1657-2013 3.1.4

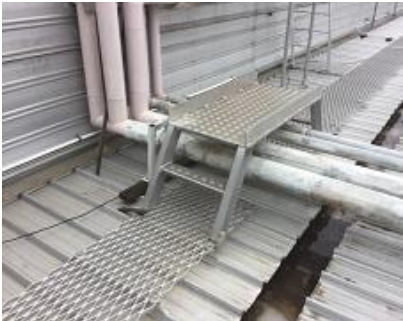
Variation in height between landing and roof is greater than required maximum	Trips, Slips and Falls	Awareness induction	Med	Handrail to be installed	Low	Client advised	Outstanding	OH&S REGULATIONS 3.7 AS/NZS 1657-2013 4.4

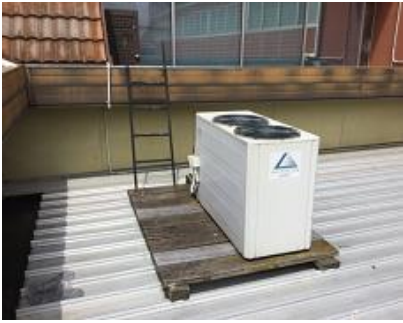
Non-complaint ladder is present	Trips, Slips and Falls	Awareness induction	Med	Existing ladder to be removed and new ladder to be installed	Low	Client advised	Outstanding	OH&S REGULATIONS 3.7 AS/NZS 1657-2013 7.4

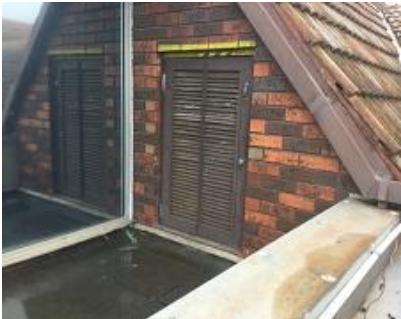
Headroom is less than required minimum	Trips, Slips and Falls	Awareness induction	Med	"Caution - Low Headroom" signs to be installed	Low	Client advised	Outstanding	OH&S REGULATIONS 3.7 AS/NZS 1657-2013 3.1.5

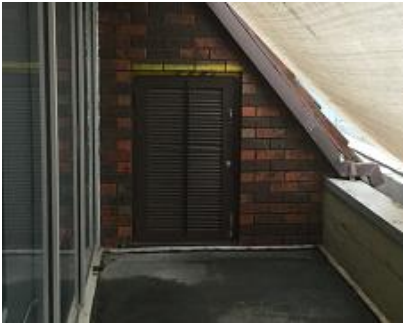
Headroom is less than required minimum	Trips, Slips and Falls	Awareness induction	Med	"Caution - Low Headroom" signs to be installed	Low	Client advised	Outstanding	OH&S REGULATIONS 3.7 AS/NZS 1657-2013 3.1.5

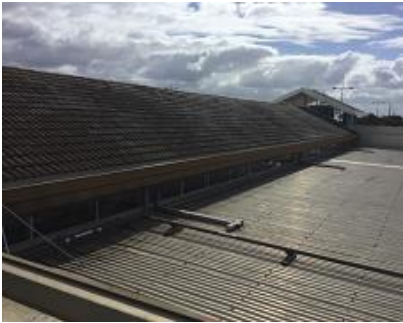
No height safety system installed (No serviceable items on roof)	Trips, Slips and Falls	Restrict Access	High	"No Access to Roof" signs to be installed	Low	Client advised	Outstanding	OH&S REGULATIONS 3.55 & 3.11

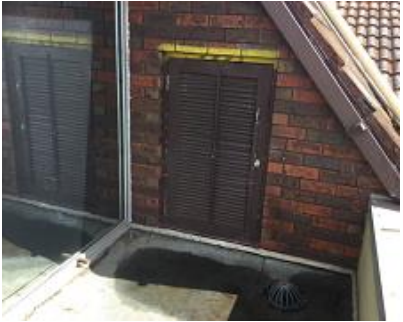
Headroom is less than required minimum	Trips, Slips and Falls	Awareness induction	Med	"Caution - Low Headroom" signs to be installed	Low	Client advised	Outstanding	OH&S REGULATIONS 3.7 AS/NZS 1657-2013 3.1.5

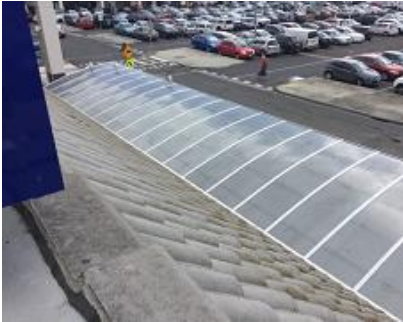
No height safety system installed	Trips, Slips and Falls	Restrict Access	High	"EWP Access to Roof" Signs to be installed	Low	Client advised	Outstanding	OH&S REGULATIONS 3.55 & 3.11

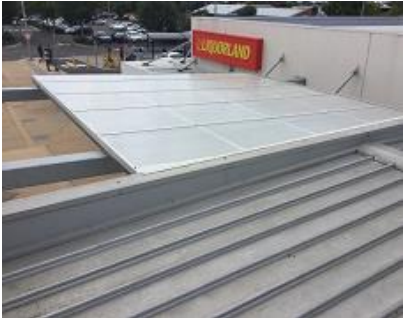
Brittle roof (non-trafficable roof)	Trips, Slips and Falls	Restrict Access	High	"Warning-Keep Off-Brittle and Fragile Roof" signs to be installed	Low	Client advised	Outstanding	OH&S REGULATIONS 3.57

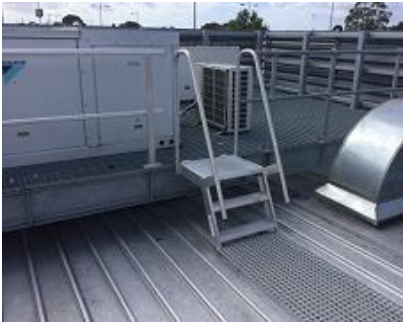
Bottom tread height is less than required minimum	Trips, Slips and Falls	Awareness induction	Med	Landing platform to be installed	Low	Client advised	Outstanding	OH&S REGULATIONS 3.7 AS/NZS 1657-2013 7.4.3.4

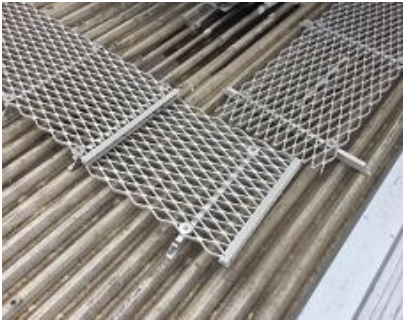
Walkway section not fully secured to roof	Trips, Slips and Falls	Awareness induction	Med	Additional walkway channels to be installed	Low	Client advised	Outstanding	OH&S REGULATIONS 3.7

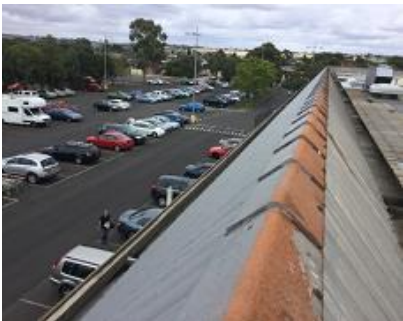
No height safety system installed	Trips, Slips and Falls	Restrict Access	High	"EWP Access to Roof" Signs to be installed	Low	Client advised	Outstanding	OH&S REGULATIONS 3.55 & 3.11

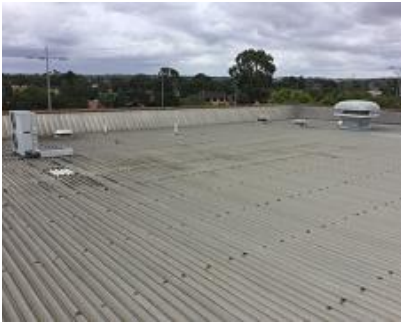
No safe access to the A/c units	Trips, Slips and Falls	N/A	Low	Supply walkway to the A/c units	Low	Client advised	Outstanding	-

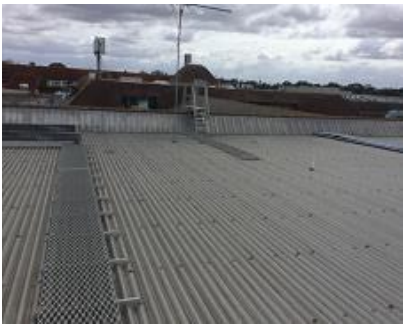
No safe access to the ladder	Trips, Slips and Falls	N/A	Low	Supply walkway to the ladder	Low	Client advised	Outstanding	-

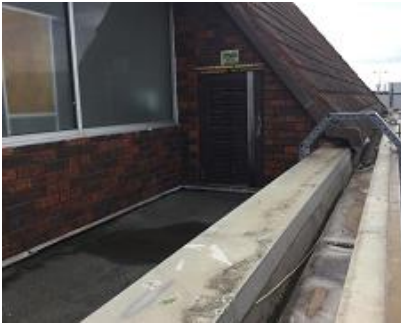
Headroom is less than required minimum	Trips, Slips and Falls	Awareness induction	Med	"Caution - Low Headroom" signs to be installed	Low	Client advised	Outstanding	OH&S REGULATIONS 3.7 AS/NZS 1657-2013 3.1.5

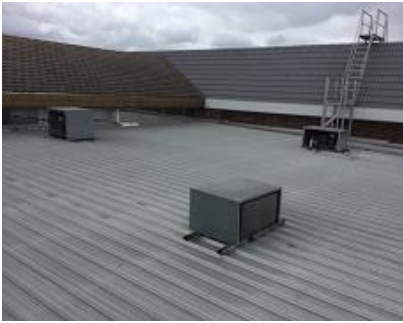
No safe access to the A/c units	Trips, Slips and Falls	N/A	Low	Supply walkway to the A/c units	Low	Client advised	Outstanding	-

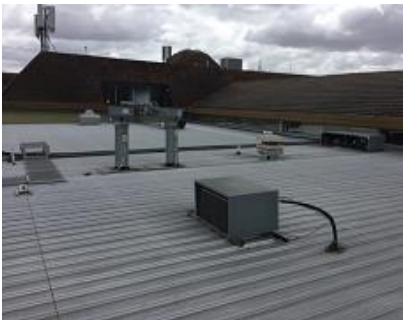
No safe access to the A/c units	Trips, Slips and Falls	N/A	Low	Supply walkway to the A/c units	Low	Client advised	Outstanding	-

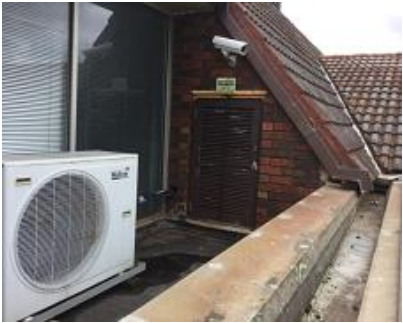
Headroom is less than required minimum	Trips, Slips and Falls	Awareness induction	Med	"Caution - Low Headroom" signs to be installed	Low	Client advised	Outstanding	OH&S REGULATIONS 3.7 AS/NZS 1657-2013 3.1.5

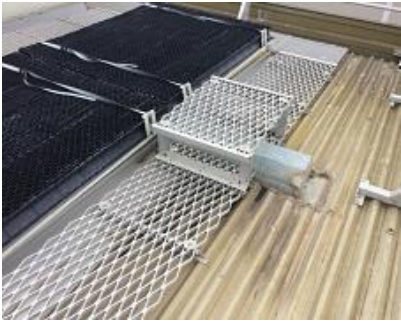
Variation in height between landing and roof is greater than required maximum	Trips, Slips and Falls	Awareness induction	Med	Step to be modified and re-installed or handrail to be installed	Low	Client advised	Outstanding	OH&S REGULATIONS 3.7 AS/NZS 1657-2013 4.4

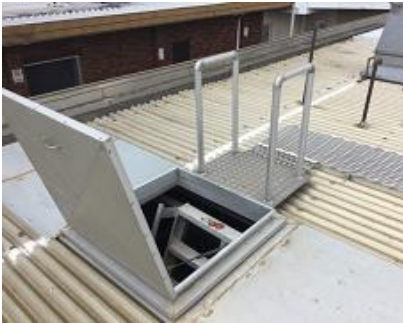
Handrail projecting towards the user	Trips, Slips and Falls	Awareness induction	Med	Existing handrail to be removed and new handrail to be installed	Low	Client advised	Outstanding	OH&S REGULATIONS 3.7 AS/NZS 1657-2013 7.4.8.5

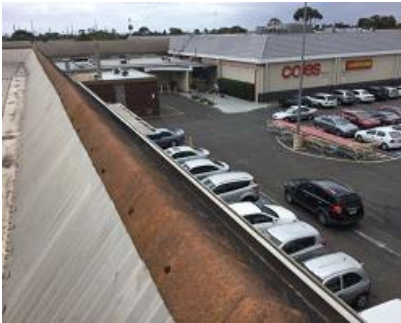
No height safety system installed	Trips, Slips and Falls	Restrict Access	High	"EWP Access Only" signs to be installed	Low	Client advised	Outstanding	OH&S REGULATIONS 3.55 & 3.11

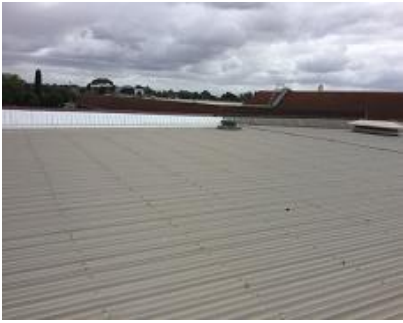
No height safety system installed	Trips, Slips and Falls	Awareness induction	High	Fall arrest anchors to be installed	Low	Client advised	Outstanding	OH&S REGULATIONS 3.55

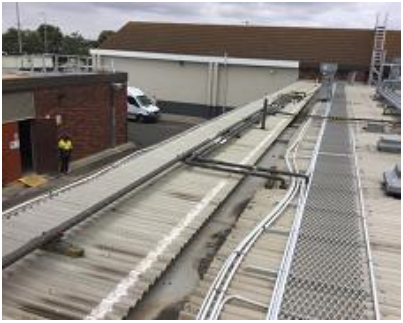
No height safety system installed	Trips, Slips and Falls	Awareness induction	High	Fall arrest anchors to be installed	Low	Client advised	Outstanding	OH&S REGULATIONS 3.55

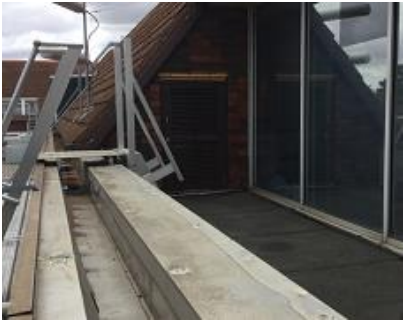
Headroom is less than required minimum	Trips, Slips and Falls	Awareness induction	Med	"Caution - Low Headroom" signs to be installed	Low	Client advised	Outstanding	OH&S REGULATIONS 3.7 AS/NZS 1657-2013 3.1.5

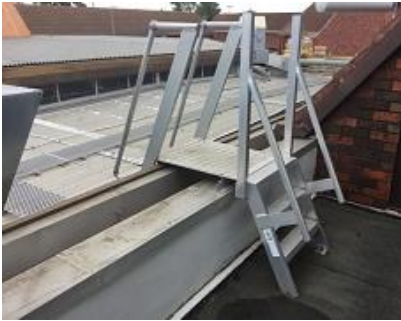
Gap between ladders and permanent structure is less than required minimum and handrail projecting towards the user	Trips, Slips and Falls	Awareness induction	Med	Existing handrails to be removed. Existing ladders to be re-installed with landing platforms, extended parapet platforms and handrails	Low	Client advised	Outstanding	OH&S REGULATIONS 3.7 AS/NZS 1657-2013 7.4.5 & 7.4.8.5

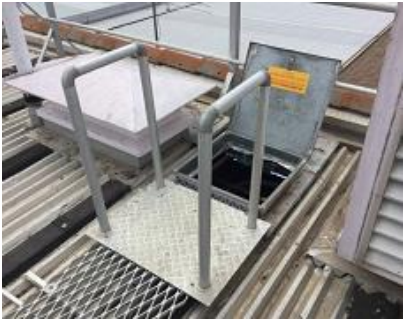
Clearance behind the ladder is less than required minimum and non-complaint handrail is present	Trips, Slips and Falls	Awareness induction	Med	Existing hatch and handrail to be removed. New hatch including hatch grabrails and access anchor to be installed	Low	Client advised	Outstanding	OH&S REGULATIONS 3.7 AS/NZS 1657-2013 7.4.5 & 7.4.8.5

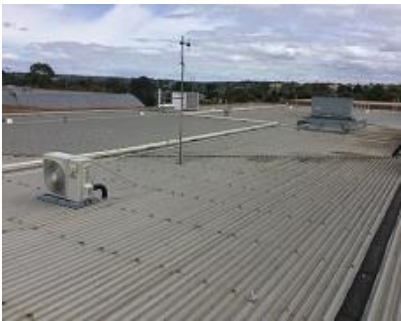
No safe access to the A/c units	Trips, Slips and Falls	N/A	Low	Supply walkway to the A/c units	Low	Client advised	Outstanding	-

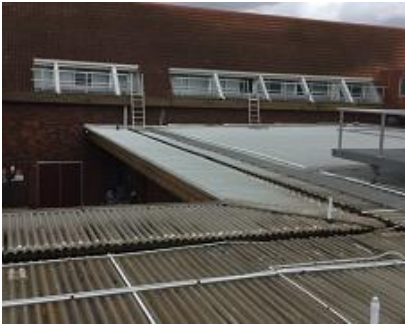
No height safety system installed	Trips, Slips and Falls	Awareness induction	High	Fall arrest anchors to be installed	Low	Client advised	Outstanding	OH&S REGULATIONS 3.55
88	Building: General Stores Location Reference: L46 Task: Restrict access to the roof

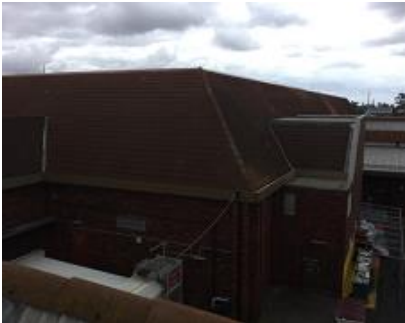
No height safety system installed	Trips, Slips and Falls	Restrict Access	High	"EWP Access Only" signs to be installed	Low	Client advised	Outstanding	OH&S REGULATIONS 3.55 & 3.11

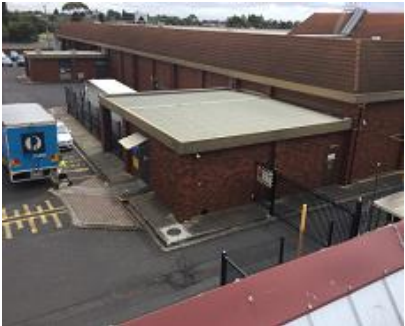
No height safety system installed	Trips, Slips and Falls	Awareness induction	High	Fall arrest anchors, anchor strop, ladder access bracket and sign to be installed	Low	Client advised	Outstanding	OH&S REGULATIONS 3.55
90	Building: General Stores Location Reference: L48 Task: Access to the roof

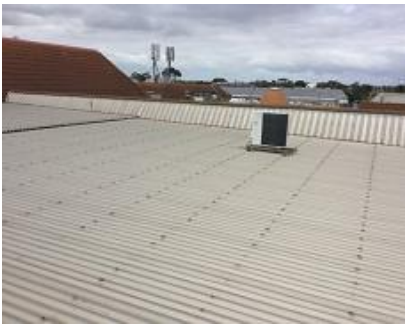
No height safety system installed	Trips, Slips and Falls	Awareness induction	High	Fall arrest anchors to be installed	Low	Client advised	Outstanding	OH&S REGULATIONS 3.55

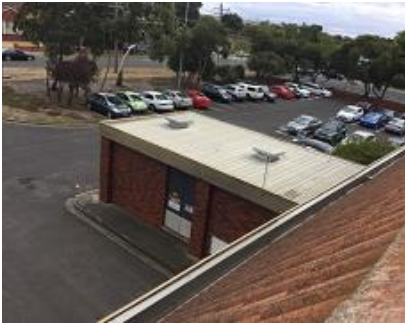
No height safety system installed	Trips, Slips and Falls	Awareness induction	High	Fall arrest anchors, anchor strop, ladder access bracket and sign to be installed	Low	Client advised	Outstanding	OH&S REGULATIONS 3.55
92	Building: General Stores Location Reference: L50 Task: Access to the A/c units

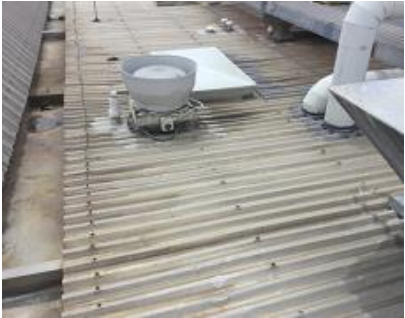
No safe access to the A/c units	Trips, Slips and Falls	N/A	Low	Supply walkway to the A/c units	Low	Client advised	Outstanding	-

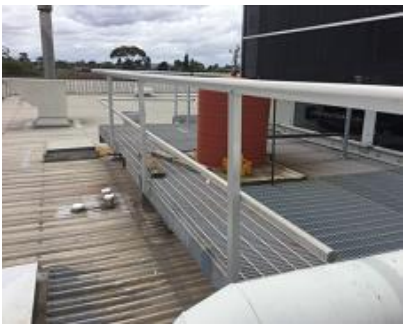
Sharp edges on handrails	Trips, Slips and Falls	Awareness induction	Med	Tek screws to be replaced with rivets	Low	Client advised	Outstanding	OH&S REGULATIONS 3.7 AS/NZS 1657-2013 5.6
94	Building: General Stores Location Reference: L50 Task: Access to the plant deck

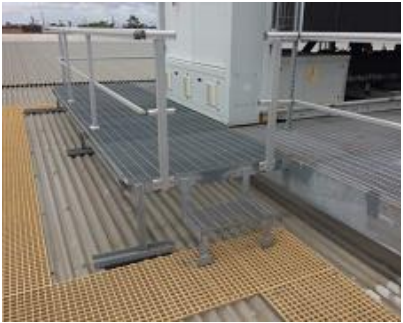
Non-complaint step is present	Trips, Slips and Falls	Awareness induction	Med	Existing step to be removed and new ladder to be installed	Low	Client advised	Outstanding	OH&S REGULATIONS 3.7 AS/NZS 1657-2013 3.1.4

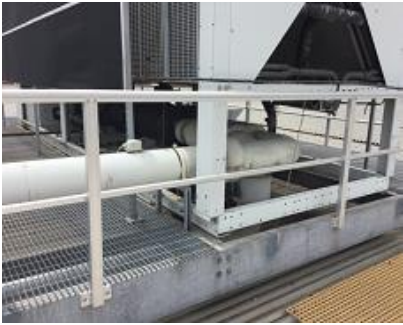
Variation in height between plant deck and unit is greater than required maximum	Trips, Slips and Falls	Awareness induction	Med	Mid rail to be installed	Low	Client advised	Outstanding	OH&S REGULATIONS 3.7 AS/NZS 1657-2013 4.4
96	Building: General Stores Location Reference: L51 Task: Access to the A/c units

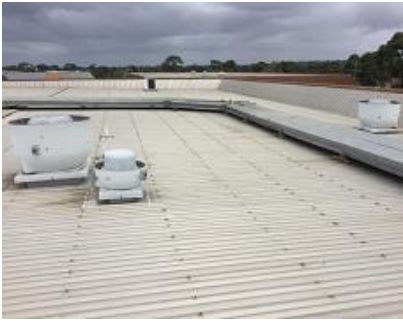
No safe access to the A/c units	Trips, Slips and Falls	N/A	Low	Supply walkway and step bridge to the A/c units	Low	Client advised	Outstanding	-

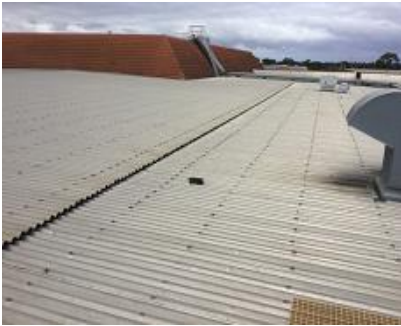
No safe access to the ladder	Trips, Slips and Falls	N/A	Low	Supply walkway to the ladder	Low	Client advised	Outstanding	-
98	Building: General Stores Location Reference: L52 Task: Access to the A/c units

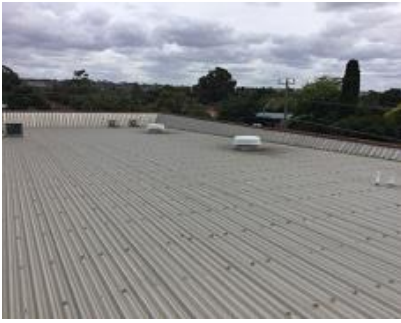
No safe access to the A/c units	Trips, Slips and Falls	N/A	Low	Supply walkway to the A/c units	Low	Client advised	Outstanding	-

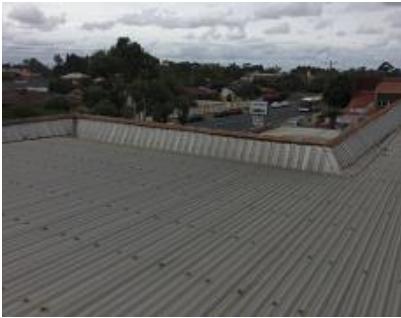
No height safety system installed	Trips, Slips and Falls	Awareness induction	High	Fall arrest anchors to be installed	Low	Client advised	Outstanding	OH&S REGULATIONS 3.55
100	Building: General Stores Location Reference: L52 Task: Access to the roof

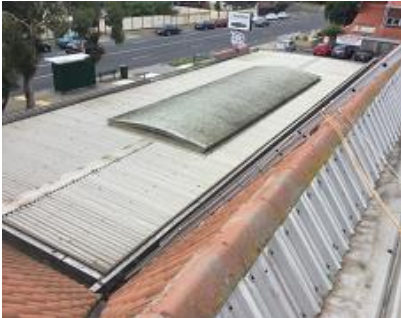
Non-complaint aluminium ladder is present	Trips, Slips and Falls	Awareness induction	Med	Existing ladder to be removed	Low	Client advised	Outstanding	OH&S REGULATIONS 3.7 AS/NZS 1657-2013 7.4

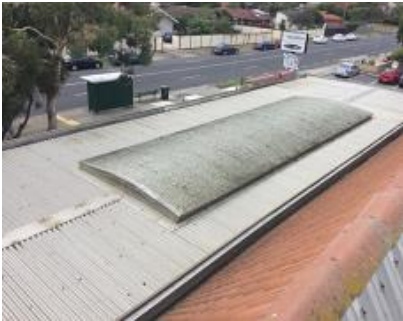
No	Photo of Hazard	Details of Hazard	Details of Risk	Existing/ Immediate Control Measure	Curre nt Risk Level	Proposed Permanent Solution	Resid ual Risk Asse sme nt	Details of Action Taken	Status	Reference
101	Building: General Stores Location Reference: L53 Task: Access to the roof

No height safety system installed, and brittle roof section is present	Trips, Slips and Falls	Awareness induction	High	Fall arrest anchors, anchor strop, ladder access bracket, brittle roof signs and access control sign to be installed	Low	Client advised	Outstanding	OH&S REGULATIONS 3.55 & 3.57
102	Building: General Stores Location Reference: L54 Task: Access to the roof

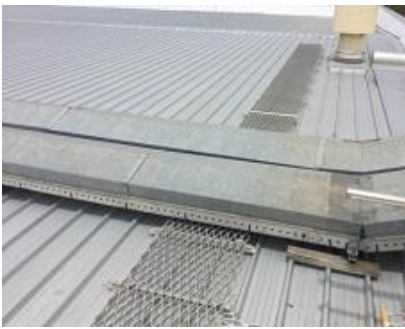
No	Photo of Hazard	Details of Hazard	Details of Risk	Existing/ Immediate Control Measure	Curre nt Risk Level	Proposed Permanent Solution	Resid ual Risk Asse sme nt	Details of Action Taken	Status	Reference
103	Building: General Stores Location Reference: L54 Task: Access to the roof

Cable tray installed over the walkway path	Trips, Slips and Falls	Awareness induction	Med	Step bridge to be installed	Low	Client advised	Outstanding	OH&S REGULATIONS 3.7 AS/NZS 1657-2013 3.1.4
104	Building: General Stores Location Reference: L54 Task: Access to the roof

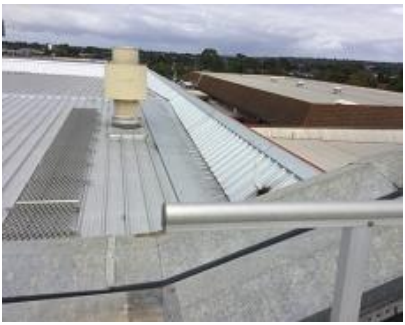
No height safety system installed	Trips, Slips and Falls	Awareness induction	High	Fall arrest anchors to be installed	Low	Client advised	Outstanding	OH&S REGULATIONS 3.55

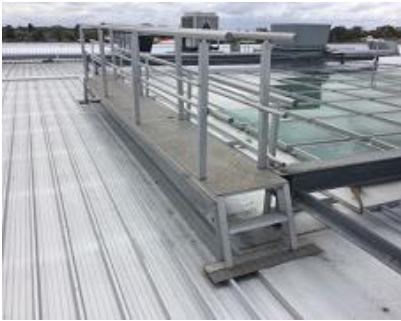
No	Photo of Hazard	Details of Hazard	Details of Risk	Existing/ Immediate Control Measure	Curre nt Risk Level	Proposed Permanent Solution	Resid ual Risk Asse sme nt	Details of Action Taken	Status	Reference
105	Building: General Stores Location Reference: L55 Task: Access to the roof

Non-complaint ladder is present	Trips, Slips and Falls	Awareness induction	Med	Existing ladder to be removed	Low	Client advised	Outstanding	OH&S REGULATIONS 3.7 AS/NZS 1657-2013 7.4
106	Building: General Stores Location Reference: L55 Task: Access to the roof

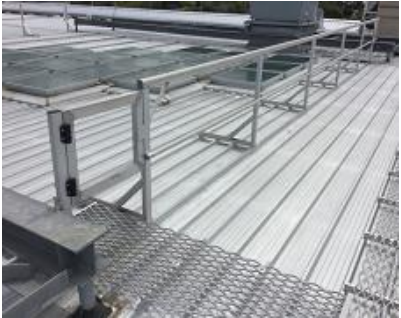
Sharp edges on handrails	Trips, Slips and Falls	Awareness induction	Med	Tek screws to be replaced with rivets	Low	Client advised	Outstanding	OH&S REGULATIONS 3.7 AS/NZS 1657-2013 5.6

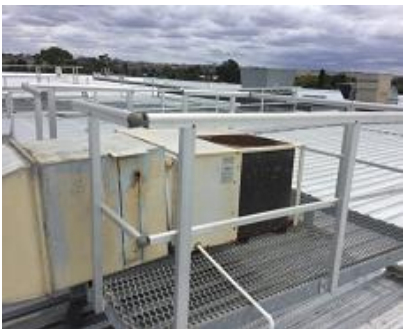
No	Photo of Hazard	Details of Hazard	Details of Risk	Existing/ Immediate Control Measure	Curre nt Risk Level	Proposed Permanent Solution	Resid ual Risk Asse sme nt	Details of Action Taken	Status	Reference
107	Building: General Stores Location Reference: L56 Task: Access to the plant deck

Sharp edges on handrails	Trips, Slips and Falls	Awareness induction	Med	Tek screws to be replaced with rivets	Low	Client advised	Outstanding	OH&S REGULATIONS 3.7 AS/NZS 1657-2013 5.6
108	Building: General Stores Location Reference: L57 Task: Access to the roof

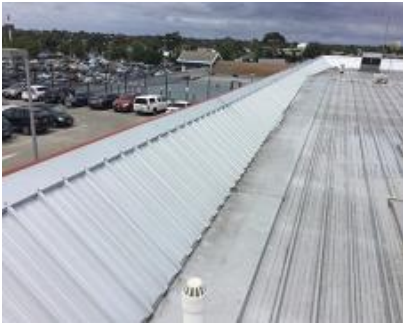
No height safety system installed	Trips, Slips and Falls	Awareness induction	High	Fall arrest anchors to be installed	Low	Client advised	Outstanding	OH&S REGULATIONS 3.55

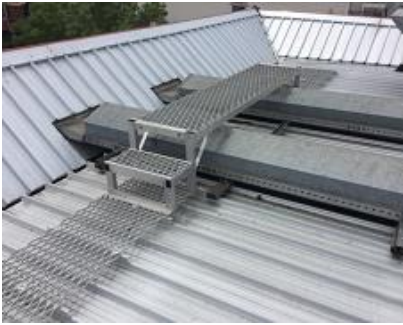
No	Photo of Hazard	Details of Hazard	Details of Risk	Existing/ Immediate Control Measure	Curre nt Risk Level	Proposed Permanent Solution	Resid ual Risk Asse sme nt	Details of Action Taken	Status	Reference
109	Building: General Stores Location Reference: L58 Task: Access to the roof

Variation in height between landing and roof is greater than required maximum	Trips, Slips and Falls	Awareness induction	Med	Handrail to be installed	Low	Client advised	Outstanding	OH&S REGULATIONS 3.7 AS/NZS 1657-2013 4.4
110	Building: General Stores Location Reference: L58 Task: Access to the roof

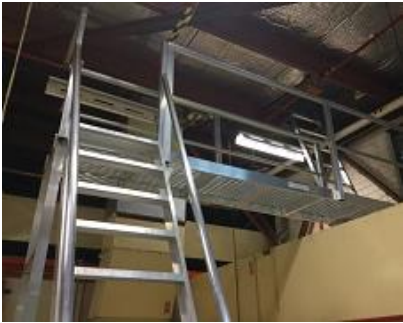
Top rung not levelled with landing, bottom rung height is less than required minimum and headroom is less than required minimum	Trips, Slips and Falls	Awareness induction	Med	Top section ladder to be removed and new ladder including landing platform to lower ladder and Caution low headroom signs to be installed	Low	Client advised	Outstanding	OH&S REGULATIONS 3.7 AS/NZS 1657-2013 7.4.3, 7.4.3.4 & 7.3.6

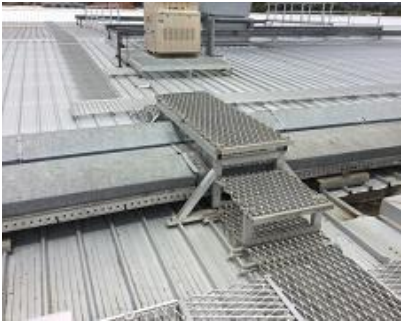
No	Photo of Hazard	Details of Hazard	Details of Risk	Existing/ Immediate Control Measure	Curre nt Risk Level	Proposed Permanent Solution	Resid ual Risk Asse sme nt	Details of Action Taken	Status	Reference
111	Building: General Stores Location Reference: L58 Task: Access to the roof

Variation in height between landing and roof is greater than required maximum	Trips, Slips and Falls	Awareness induction	Med	Handrail to be installed	Low	Client advised	Outstanding	OH&S REGULATIONS 3.7 AS/NZS 1657-2013 4.4
112	Building: General Stores Location Reference: L58 Task: Access to the roof

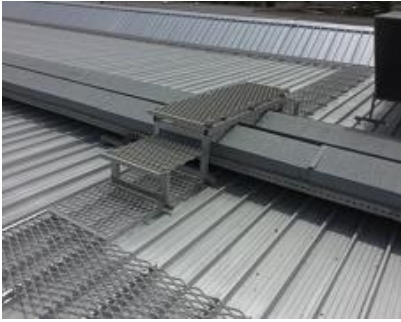
Variation in height between landing and roof is greater than required maximum	Trips, Slips and Falls	Awareness induction	Med	Handrail to be installed	Low	Client advised	Outstanding	OH&S REGULATIONS 3.7 AS/NZS 1657-2013 4.4

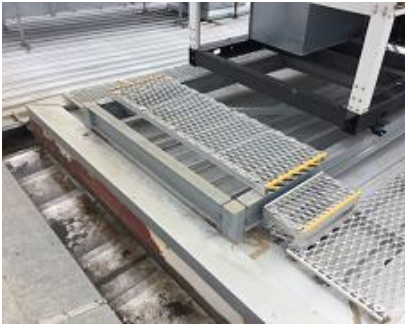
No	Photo of Hazard	Details of Hazard	Details of Risk	Existing/ Immediate Control Measure	Curre nt Risk Level	Proposed Permanent Solution	Resid ual Risk Asse sme nt	Details of Action Taken	Status	Reference
113	Building: General Stores Location Reference: L58 Task: Access to the roof

Variation in height between landing and roof is greater than required maximum	Trips, Slips and Falls	Awareness induction	Med	Handrail to be installed	Low	Client advised	Outstanding	OH&S REGULATIONS 3.7 AS/NZS 1657-2013 4.4
114	Building: General Stores Location Reference: L58 Task: Access to the roof

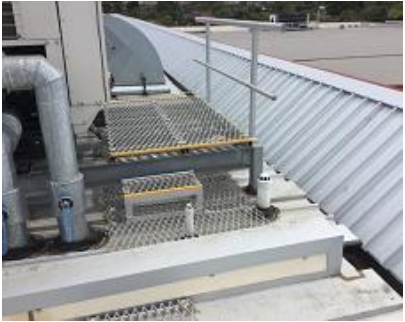
Non-complaint step is present and variation in height between landing and roof is greater than required maximum	Trips, Slips and Falls	Awareness induction	Med	Existing step to be removed and new step bridge and handrail to be installed	Low	Client advised	Outstanding	OH&S REGULATIONS 3.7 AS/NZS 1657-2013 3.1.4 & 4.4
