# Roof Safety Report

**DFO Homebush, NSW 2140**

Prepared By: Safemaster Safety Products  
Date: 24 May 2018

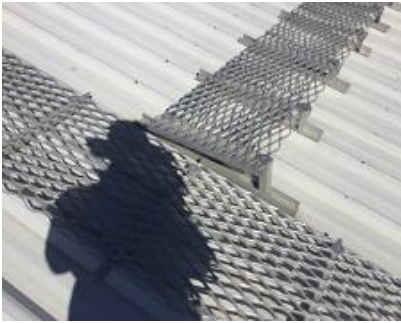
Variation in height between walkway panels are greater than required maximum	Trips, Slips and Falls	Awareness induction	Med	High visibility safety yellow nosing to be installed	Low	Client advised	Outstanding	OH&S REGULATIONS 3.7  AS/NZS 1657-2013 3.3.4

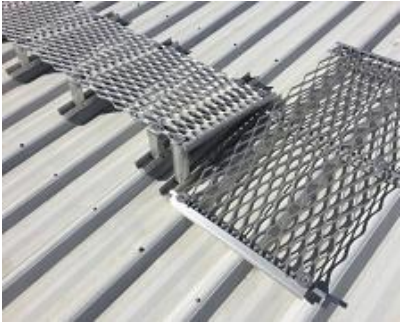
Variation in height between walkway panels are greater than required maximum	Trips, Slips and Falls	Awareness induction	Med	High visibility safety yellow nosing to be installed	Low	Client advised	Outstanding	OH&S REGULATIONS 3.7  AS/NZS 1657-2013 3.3.4

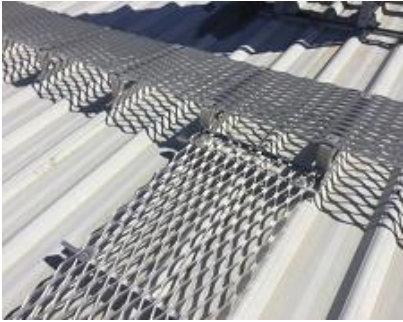
Variation in height between walkway panels are greater than required maximum	Trips, Slips and Falls	Awareness induction	Med	High visibility safety yellow nosing to be installed	Low	Client advised	Outstanding	OH&S REGULATIONS 3.7  AS/NZS 1657-2013 3.3.4

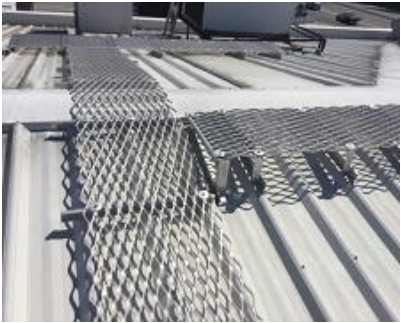
Variation in height between walkway panels are greater than required maximum	Trips, Slips and Falls	Awareness induction	Med	High visibility safety yellow nosing to be installed	Low	Client advised	Outstanding	OH&S REGULATIONS 3.7  AS/NZS 1657-2013 3.3.4

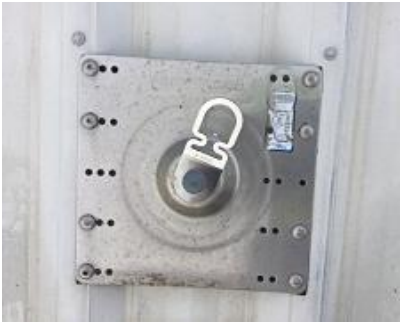
Not enough fixings installed (Anchors no longer required in this area)	Trips, Slips and Falls	Awareness induction	High	Existing anchors to be removed	Low	Client advised	Outstanding	OH&S REGULATIONS 3.55

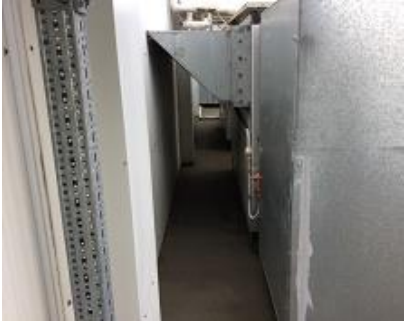
Headroom is less than required minimum	Trips, Slips and Falls	Awareness induction	Med	"Caution-Low Headroom" signs to be installed	Low	Client advised	Outstanding	OH&S REGULATIONS 3.7  AS/NZS 1657-2013 3.1.5
34	Building: General Stores Location Reference: <a href="#">L17</a> Task: Access to the roof

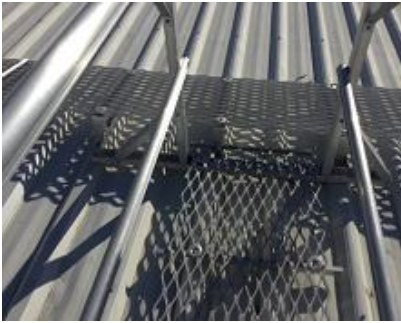
Variation in height between walkway panels are greater than required maximum	Trips, Slips and Falls	Awareness induction	Med	High visibility safety yellow nosing to be installed	Low	Client advised	Outstanding	OH&S REGULATIONS 3.7  AS/NZS 1657-2013 3.3.4

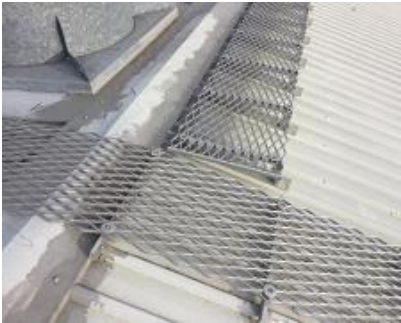
Variation in height between walkway panels are greater than required maximum	Trips, Slips and Falls	Awareness induction	Med	High visibility safety yellow nosing to be installed	Low	Client advised	Outstanding	OH&S REGULATIONS 3.7  AS/NZS 1657-2013 3.3.4

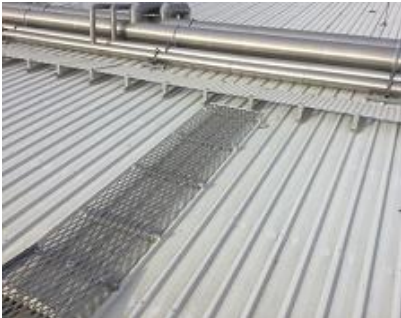
Variation in height between walkway panels are greater than required maximum	Trips, Slips and Falls	Awareness induction	Med	High visibility safety yellow nosing to be installed	Low	Client advised	Outstanding	OH&S REGULATIONS 3.7  AS/NZS 1657-2013 3.3.4

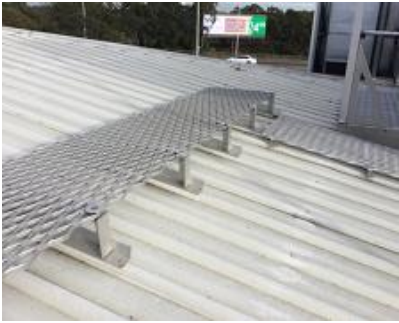
Variation in height between walkway panels are greater than required maximum	Trips, Slips and Falls	Awareness induction	Med	High visibility safety yellow nosing to be installed	Low	Client advised	Outstanding	OH&S REGULATIONS 3.7  AS/NZS 1657-2013 3.3.4

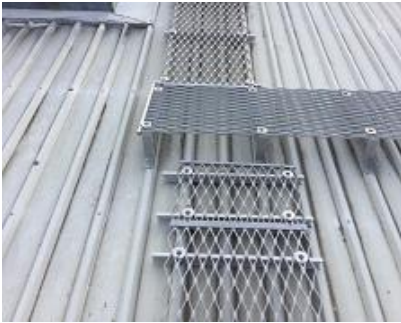
Variation in height between walkway panels are greater than required maximum	Trips, Slips and Falls	Awareness induction	Med	High visibility safety yellow nosing to be installed	Low	Client advised	Outstanding	OH&S REGULATIONS 3.7  AS/NZS 1657-2013 3.3.4

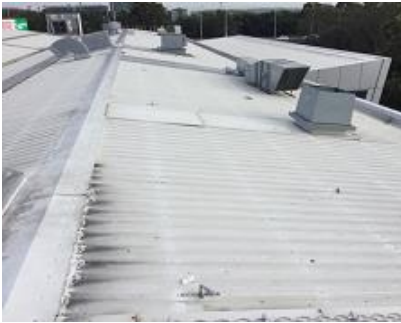
No safe access to the A/c units	Trips, Slips and Falls	N/A	Low	Supply Walkway to the A/c units	Low	Client advised	Outstanding	-

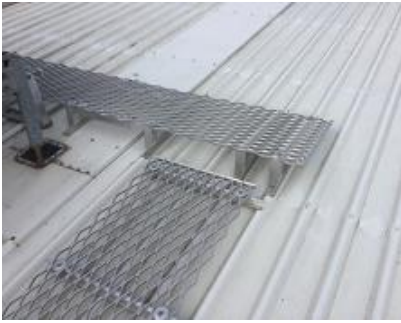
Variation in height between walkway panels are greater than required maximum	Trips, Slips and Falls	Awareness induction	Med	High visibility safety yellow nosing to be installed	Low	Client advised	Outstanding	OH&S REGULATIONS 3.7  AS/NZS 1657-2013 3.3.4

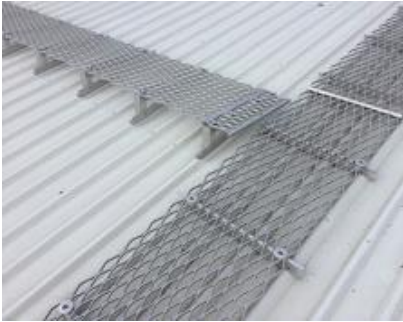
Variation in height between walkway panels are greater than required maximum	Trips, Slips and Falls	Awareness induction	Med	High visibility safety yellow nosing to be installed	Low	Client advised	Outstanding	OH&S REGULATIONS 3.7  AS/NZS 1657-2013 3.3.4

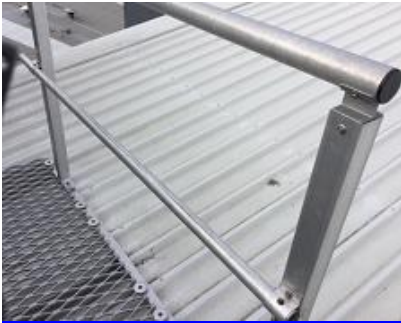
Sharp edges on handrails	Trips, Slips and Falls	Awareness induction	Med	Tek screws to be replaced with rivets	Low	Client advised	Outstanding	OH&S REGULATIONS 3.7  AS/NZS 1657-2013 5.6
64	Building: General Stores Location Reference: <a href="#">L29</a> Task: Access to the roof

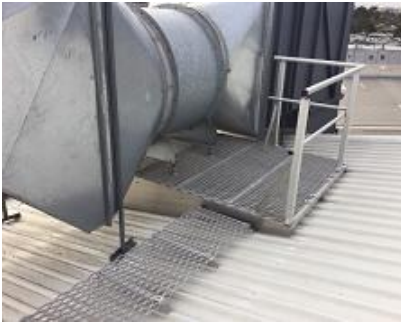
Variation in height between walkway panels are greater than required maximum	Trips, Slips and Falls	Awareness induction	Med	High visibility safety yellow nosing to be installed	Low	Client advised	Outstanding	OH&S REGULATIONS 3.7  AS/NZS 1657-2013 3.3.4

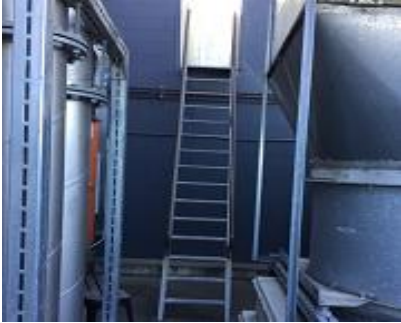
Gap between handrail and ladder is greater than required maximum	Trips, Slips and Falls	Awareness induction	Med	Existing handrail to be removed and new handrail to be installed	Low	Client advised	Outstanding	OH&S REGULATIONS 3.7  AS/NZS 1657-2013 7.3.5
66	Building: General Stores Location Reference: <a href="#">L30</a> Task: Access to the roof

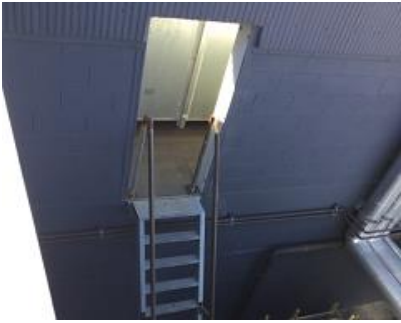
Head room is less than required minimum	Trips, Slips and Falls	Awareness induction	Med	"Caution-Low Head Room" signs to be installed	Low	Client advised	Outstanding	OH&S REGULATIONS 3.7  AS/NZS 1657-2013 3.1.5

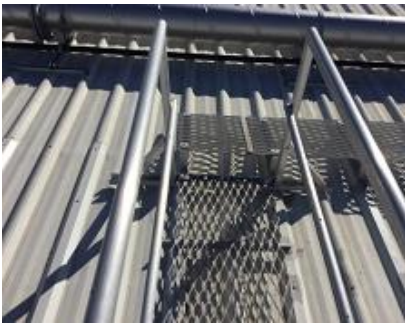
Variation in height between walkway panels are greater than required maximum	Trips, Slips and Falls	Awareness induction	Med	High visibility safety yellow nosing to be installed	Low	Client advised	Outstanding	OH&S REGULATIONS 3.7  AS/NZS 1657-2013 3.3.4

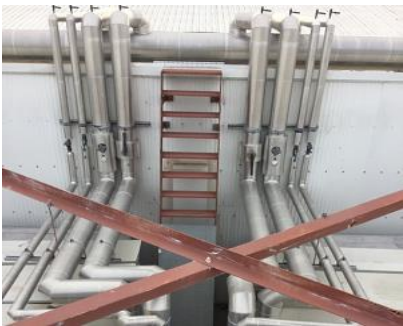
Non-complaint ladder is present (Not in use)	Trips, Slips and Falls	Awareness induction	Med	Existing ladder to be removed or "Not in Service" sign to be installed	Low	Client advised	Outstanding	OH&S REGULATIONS 3.7  AS/NZS 1657-2013 7.3
70	Building: General Stores Location Reference: <a href="#">L32</a> Task: Access to the roof

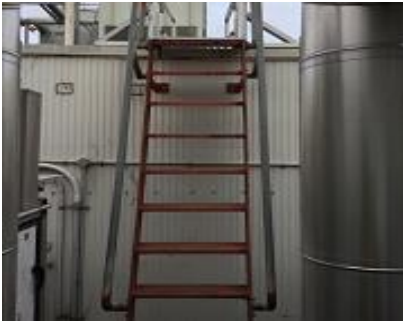
Gap between handrail and ladder is greater than required maximum and walkway installed over the top tread	Trips, Slips and Falls	Awareness induction	Med	Existing handrail to be removed and new handrail to be installed. Walkway to be re-located.	Low	Client advised	Outstanding	OH&S REGULATIONS 3.7  AS/NZS 1657-2013 7.4.3.3 & 7.3.5

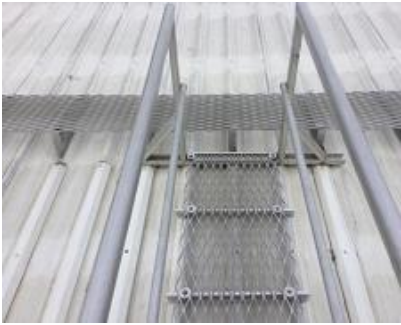
Variation in height between walkway panels are greater than required maximum	Trips, Slips and Falls	Awareness induction	Med	High visibility safety yellow nosing to be installed	Low	Client advised	Outstanding	OH&S REGULATIONS 3.7  AS/NZS 1657-2013 3.3.4
72	Building: General Stores Location Reference: <a href="#">L33</a> Task: Access to the roof

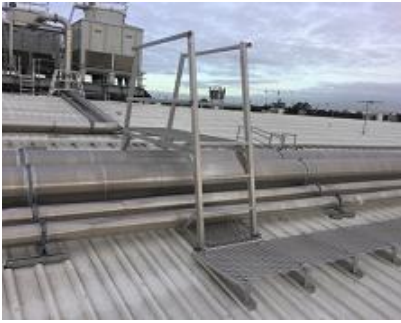
Landing is less than required minimum, sharp edges on handrail and not enough bracings	Trips, Slips and Falls	Awareness induction	Med	Landing platforms and bracings to be installed. Existing handrail to be removed and new handrail to be installed	Low	Client advised	Outstanding	OH&S REGULATIONS 3.7  AS/NZS 1657-2013 7.3.6 & 5.6

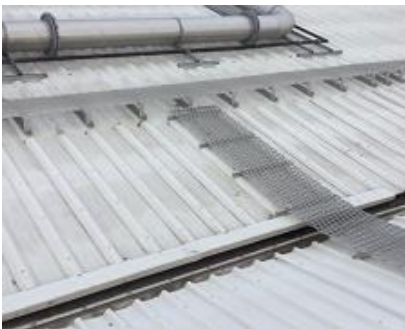
Variation in height between walkway panels are greater than required maximum	Trips, Slips and Falls	Awareness induction	Med	High visibility safety yellow nosing to be installed	Low	Client advised	Outstanding	OH&S REGULATIONS 3.7  AS/NZS 1657-2013 3.3.4
74	Building: General Stores Location Reference: <a href="#">L33</a> Task: Access to the roof

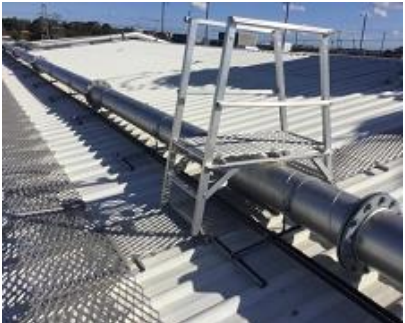
Landing is less than required minimum, sharp edges on handrail and not enough bracings	Trips, Slips and Falls	Awareness induction	Med	Landing platforms and bracings to be installed. Existing handrail to be removed and new handrail to be installed	Low	Client advised	Outstanding	OH&S REGULATIONS 3.7  AS/NZS 1657-2013 7.3.6 & 5.6

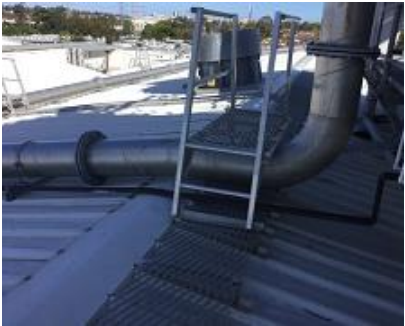
Bottom rung heights are less than required minimum and sharp edges on handrail	Trips, Slips and Falls	Awareness induction	Med	Existing handrail to be removed. New handrails including landing platforms to be installed	Low	Client advised	Outstanding	OH&S REGULATIONS 3.7  AS/NZS 1657-2013 7.4.3.4 & 5.6
76	Building: General Stores Location Reference: <a href="#">L34</a> Task: Access to the roof

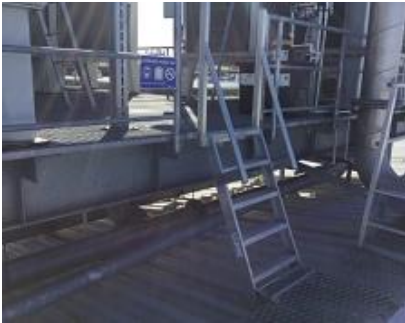
Bottom tread height is less than required minimum and handrail projecting towards the user	Trips, Slips and Falls	Awareness induction	Med	Existing ladder to be removed and new ladder to be installed	Low	Client advised	Outstanding	OH&S REGULATIONS 3.7  AS/NZS 1657-2013 7.3

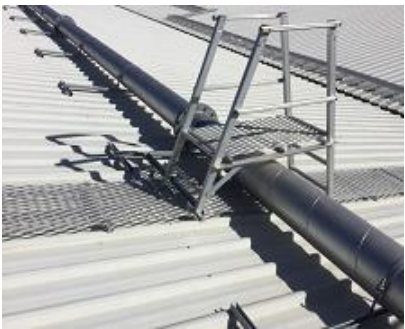
Bottom rung height is less than required minimum and sharp edges on handrails	Trips, Slips and Falls	Awareness induction	Med	Existing handrails to be removed. Landing platforms including handrails to be installed	Low	Client advised	Outstanding	OH&S REGULATIONS 3.7  AS/NZS 1657-2013 7.4.3.4 & 5.6
78	Building: General Stores Location Reference: <a href="#">L34</a> Task: Access to the roof

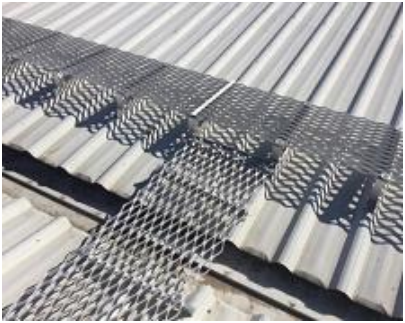
Variation in height between walkway panels are greater than required maximum	Trips, Slips and Falls	Awareness induction	Med	High visibility safety yellow nosing to be installed	Low	Client advised	Outstanding	OH&S REGULATIONS 3.7  AS/NZS 1657-2013 3.3.4

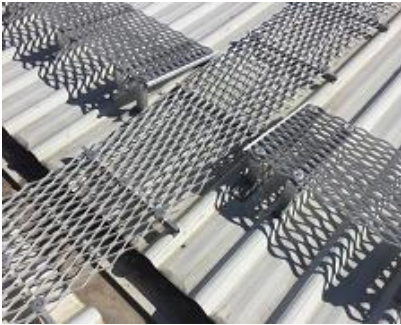
Variation in height between walkway panels are greater than required maximum	Trips, Slips and Falls	Awareness induction	Med	High visibility safety yellow nosing to be installed	Low	Client advised	Outstanding	OH&S REGULATIONS 3.7  AS/NZS 1657-2013 3.3.4
80	Building: General Stores Location Reference: <a href="#">L34</a> Task: Access to the roof

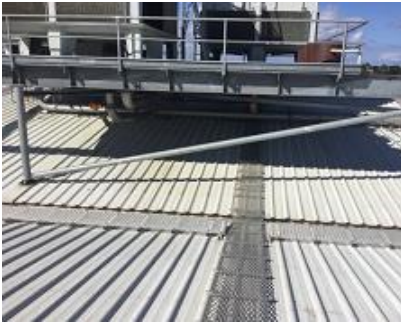
Headroom is less than required minimum	Trips, Slips and Falls	Awareness induction	Med	"Caution-Low Headroom" signs to be installed	Low	Client advised	Outstanding	OH&S REGULATIONS 3.7  AS/NZS 1657-2013 3.1.5

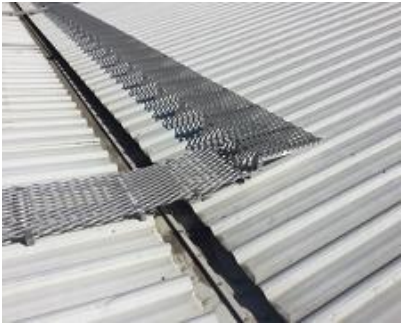
Variation in height between walkway panels are greater than required maximum	Trips, Slips and Falls	Awareness induction	Med	High visibility safety yellow nosing to be installed	Low	Client advised	Outstanding	OH&S REGULATIONS 3.7  AS/NZS 1657-2013 3.3.4
82	Building: General Stores Location Reference: <a href="#">L34</a> Task: Access to the roof

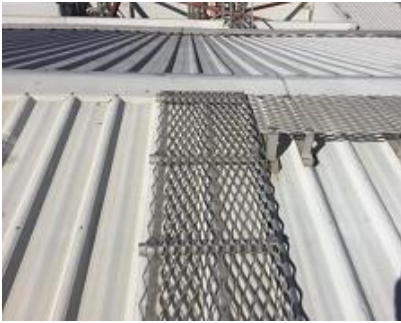
Variation in height between walkway panels are greater than required maximum	Trips, Slips and Falls	Awareness induction	Med	High visibility safety yellow nosing to be installed	Low	Client advised	Outstanding	OH&S REGULATIONS 3.7  AS/NZS 1657-2013 3.3.4

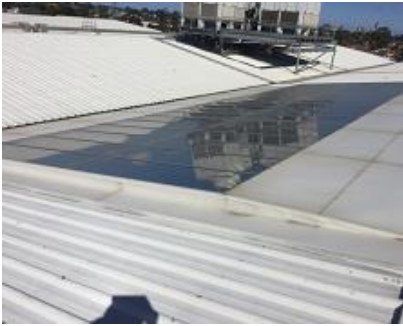
Brittle Roof (Non-trafficable roof)	Trips, Slips and Falls	Restrict Access	High	"Warning-Keep Off-Brittle and Fragile Roof" signs to be installed	Low	Client advised	Outstanding	OH&S REGULATIONS 3.57
84	Building: General Stores Location Reference: <a href="#">L36</a> Task: Access to the roof

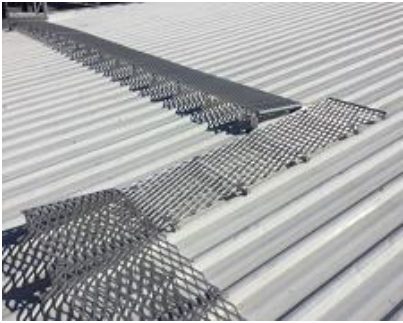
Variation in height between walkway panels are greater than required maximum	Trips, Slips and Falls	Awareness induction	Med	High visibility safety yellow nosing to be installed	Low	Client advised	Outstanding	OH&S REGULATIONS 3.7  AS/NZS 1657-2013 3.3.4

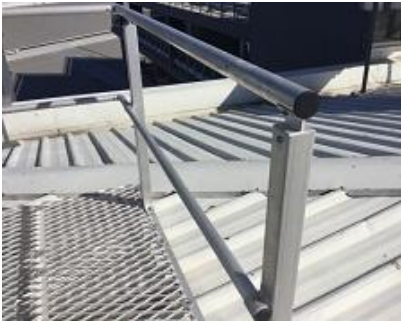
Sharp edges on handrails	Trips, Slips and Falls	Awareness induction	Med	Tek screws to be replaced with rivets	Low	Client advised	Outstanding	OH&S REGULATIONS 3.7  AS/NZS 1657-2013 5.6

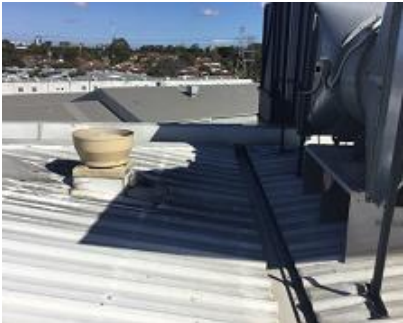
No safe access to the A/c units	Trips, Slips and Falls	N/A	Low	Supply Walkway to the A/c units	Low	Client advised	Outstanding	-
