# Roof Safety Report

**Eastlands, TAS 7018**

Prepared By: Safemaster Safety Products  
Date: 31-08-2020

CLIENT	BUILDINGS INSPECTED	SYSTEMS INSPECTED
Eastlands Shopping Centre	26 Bligh Street, Rosny Park TAS 7018	Anchor Points Signage Handrail Ladder Stair Mechanical Platform Roof Walkway

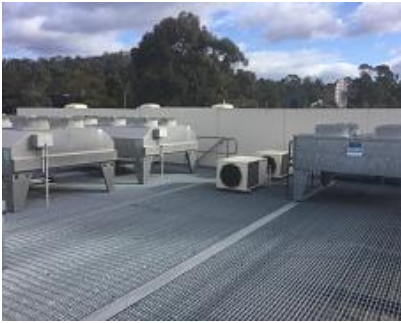
Variation in height between roofs are greater than required maximum	Trips, Slips and Falls	Awareness induction	Med	Access ladder to be installed	Low	Client advised	Outstanding	OH&S REGULATIONS 3.7  AS/NZS 1657-2013 3.1.4

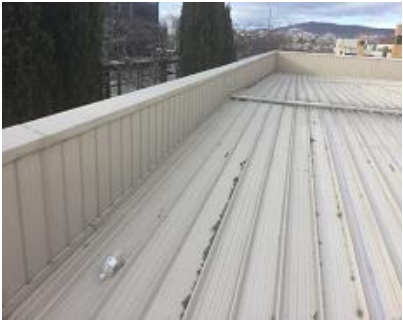
No height safety system installed	Trips, Slips and Falls	Awareness induction	High	Fall arrest anchors to be installed	Low	Client advised	Outstanding	OH&S REGULATIONS 3.55

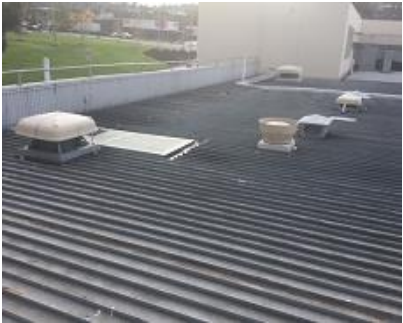
No safe access to the A/c units	Trips, Slips and Falls	N/A	Low	Supply walkway and step over to the A/c units	Low	Client advised	Outstanding	-

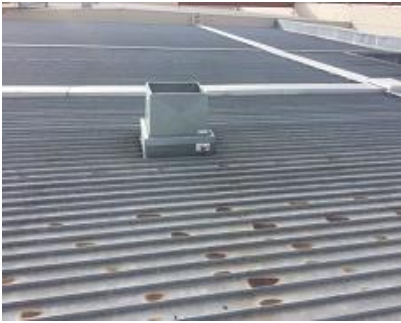
No safe access to the A/c units	Trips, Slips and Falls	N/A	Low	Supply walkway to the A/c units	Low	Client advised	Outstanding	-

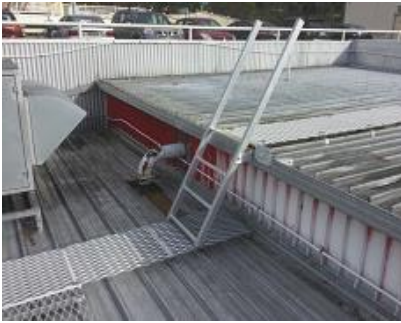
Non-complaint ladder is present	Trips, Slips and Falls	Awareness induction	Med	Existing ladder to be removed and new ladder to be installed	Low	Client advised	Outstanding	OH&S REGULATIONS 3.7  AS/NZS 1657-2013 7.3

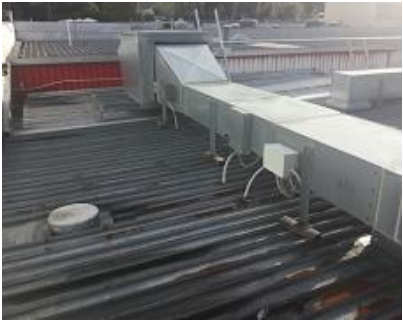
No safe access to the A/c units	Trips, Slips and Falls	N/A	Low	Supply walkway to the A/c units	Low	Client advised	Outstanding	-

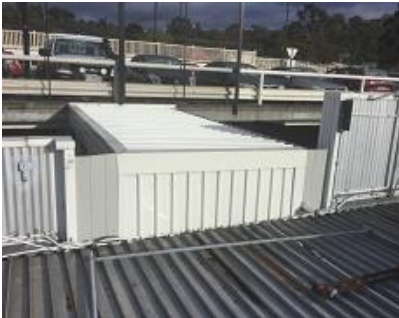
No height safety system installed	Trips, Slips and Falls	Awareness induction	High	Fall arrest anchors, anchor strop and access ladder to be installed	Low	Client advised	Outstanding	OH&S REGULATIONS 3.7 & 3.55  AS/NZS 1657-2013 3.1.4

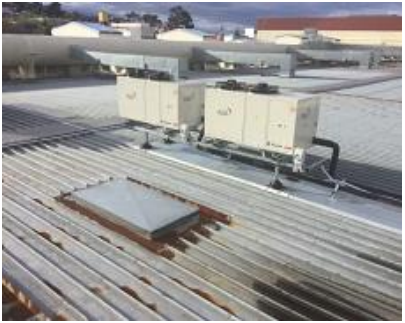
No safe access to the A/c units	Trips, Slips and Falls	N/A	Low	Supply walkway to the A/c units	Low	Client advised	Outsta nding	-

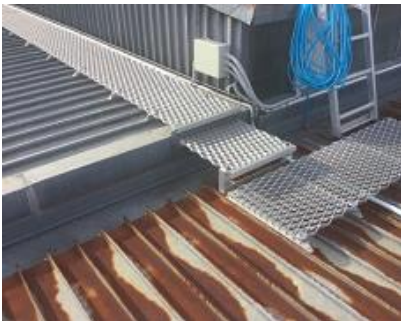
Non-complaint step is present	Trips, Slips and Falls	Awareness induction	Med	Existing step to be removed and new ladder to be installed	Low	Client advised	Outstanding	OH&S REGULATIONS 3.7  AS/NZS 1657-2013 3.1.4

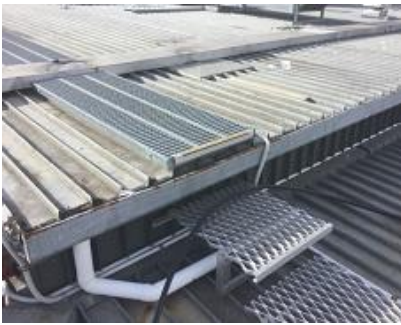
Non-complaint step is present	Trips, Slips and Falls	Awareness induction	Med	Existing step to be removed and new ladder to be installed	Low	Client advised	Outsta nding	OH&S REGULATIONS 3.7  AS/NZS 1657- 2013 3.1.4

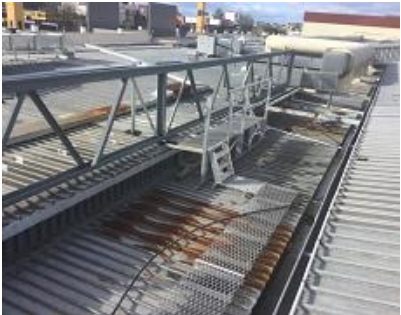
Non-complaint ladder is present	Trips, Slips and Falls	Awareness induction	Med	"Out of Service" tag to be installed	Low	Client advised	Outstanding	OH&S REGULATIONS 3.7  AS/NZS 1657-2013 7.3

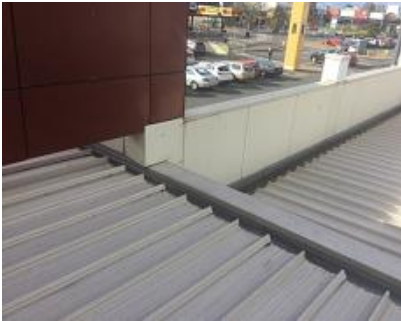
No height safety system installed	Trips, Slips and Falls	Awareness induction	High	Fall arrest anchor to be installed	Low	Client advised	Outstanding	OH&S REGULATIONS 3.55
28	Building: General Stores Location Reference: <a href="#">L15</a> Task: Restrict access to the roof

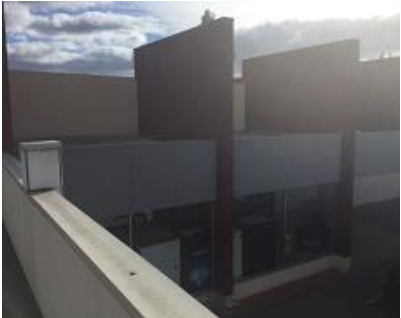
No height safety system installed	Trips, Slips and Falls	Restrict Access	High	"EWP Access Only" sign to be installed	Low	Client advised	Outstanding	OH&S REGULATIONS 3.55 & 3.11

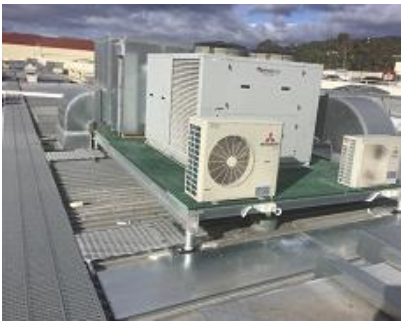
Variation in height between plant deck and roof is greater than required maximum	Trips, Slips and Falls	Awareness induction	Med	Step to be installed	Low	Client advised	Outstanding	OH&S REGULATIONS 3.7  AS/NZS 1657-2013 3.1.4

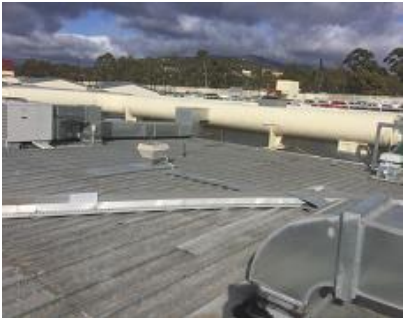
No safe access to the A/c units	Trips, Slips and Falls	N/A	Low	Supply walkway to the A/c units	Low	Client advised	Outstanding	-

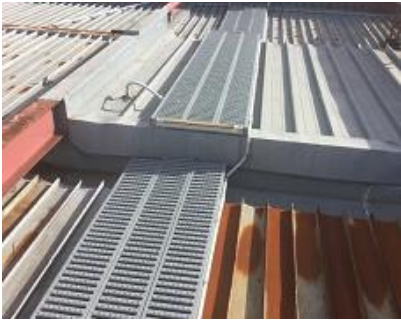
Variation in height between roofs are greater than required maximum	Trips, Slips and Falls	Awareness induction	Med	Step to be installed	Low	Client advised	Outstanding	OH&S REGULATIONS 3.7  AS/NZS 1657-2013 3.1.4
36	Building: General Stores Location Reference: <a href="#">L18</a> Task: Access to the roof

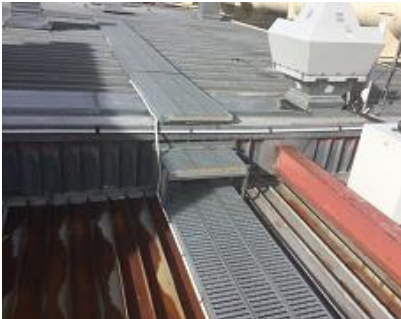
Non-complaint step is present	Trips, Slips and Falls	Awareness induction	Med	Existing step to be removed and new ladder to be installed	Low	Client advised	Outstanding	OH&S REGULATIONS 3.7  AS/NZS 1657-2013 3.1.4

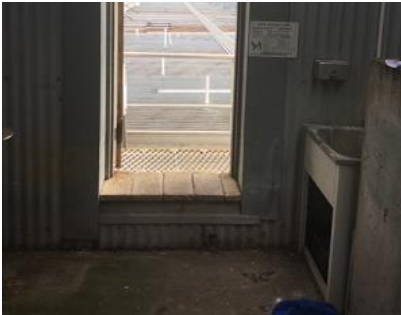
Variation in height between landing and plant deck is greater than required maximum	Trips, Slips and Falls	Awareness induction	Med	Step to be installed	Low	Client advised	Outstanding	OH&S REGULATIONS 3.7  AS/NZS 1657-2013 3.1.4

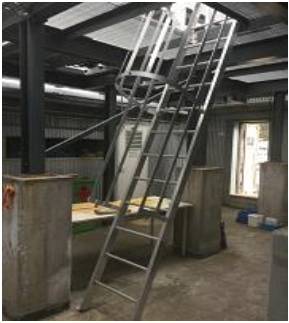
Top rung not levelled with landing and bottom rung height is greater than required maximum	Trips, Slips and Falls	Awareness induction	Med	Existing ladder to be re-installed with landing platform and brackets	Low	Client advised	Outstanding	OH&S REGULATIONS 3.7  AS/NZS 1657-2013 7.4.3.3 & 7.4.3.4

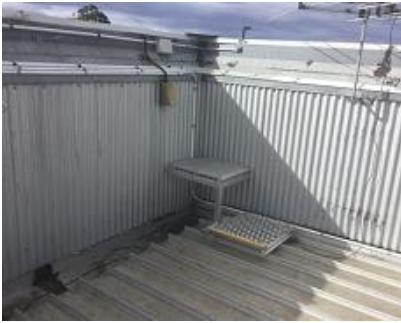
Non-complaint step is present	Trips, Slips and Falls	Awareness induction	Med	Existing step to be removed and new ladder to be installed	Low	Client advised	Outstanding	OH&S REGULATIONS 3.7  AS/NZS 1657-2013 3.1.4

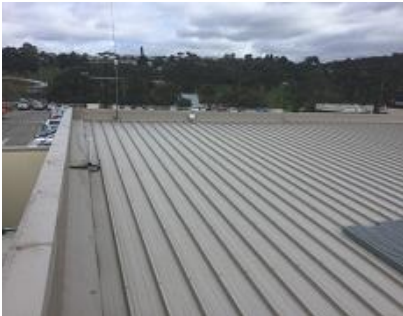
No height safety system installed	Trips, Slips and Falls	Awareness induction	High	Fall arrest anchors to be installed	Low	Client advised	Outsta nding	OH&S REGULATIONS 3.55

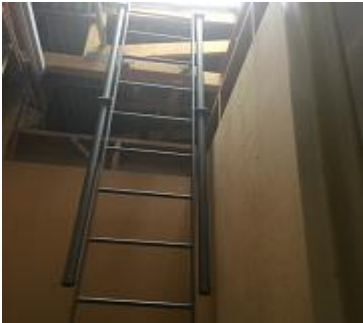
No slip resistance on ladder rungs and top rung not levelled with landing	Trips, Slips and Falls	Awareness induction	Med	Existing ladder to be removed and new ladder to be installed	Low	Client advised	Outstanding	OH&S REGULATIONS 3.7  AS/NZS 1657-2013 7.4.3.1 & 7.4.3.3

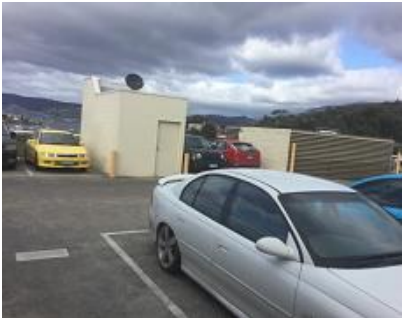
No height safety system installed	Trips, Slips and Falls	Restrict Access	High	"EWP Access Only" signs to be installed	Low	Client advised	Outstanding	OH&S REGULATIONS 3.55 & 3.11

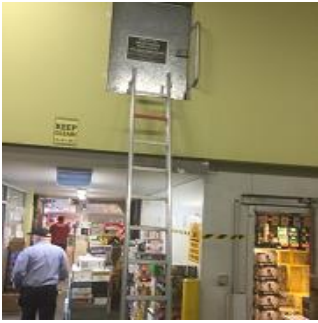
Non-complaint ladder is present and landing is missing at door step	Trips, Slips and Falls	Awareness induction	Med	Existing ladder to be removed and new ladder to be installed	Low	Client advised	Outstanding	OH&S REGULATIONS 3.7  AS/NZS 1657-2013 7.3

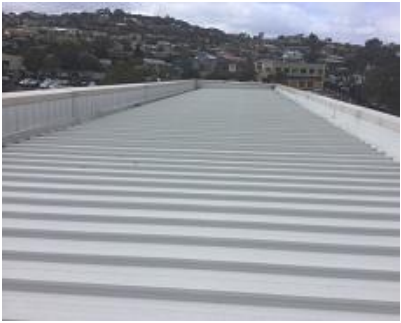
No height safety system installed	Trips, Slips and Falls	Awareness induction	High	Fall arrest anchors to be installed	Low	Client advised	Outstanding	OH&S REGULATIONS 3.55

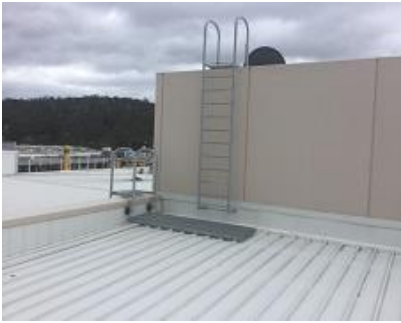
Rung spacings are less than required minimum and no slip resistance on ladder rungs	Trips, Slips and Falls	Awareness induction	Med	Existing ladder to be removed and new ladder to be installed	Low	Client advised	Outstanding	OH&S REGULATIONS 3.7  AS/NZS 1657-2013 7.4.3.2 & 7.4.3.1
78	Building: General Stores Location Reference: <a href="#">L35</a> Task: Access to the roof

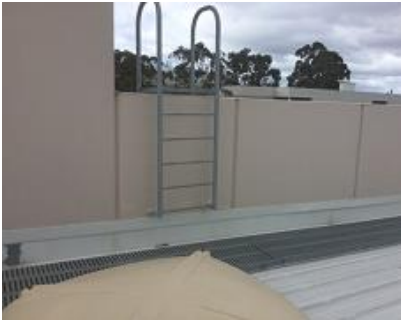
Rung spacings are less than required minimum and no slip resistance on ladder rungs	Trips, Slips and Falls	Awareness induction	Med	Existing ladder to be removed and new ladder to be installed	Low	Client advised	Outstanding	OH&S REGULATIONS 3.7  AS/NZS 1657-2013 7.4.3.2 & 7.4.3.1

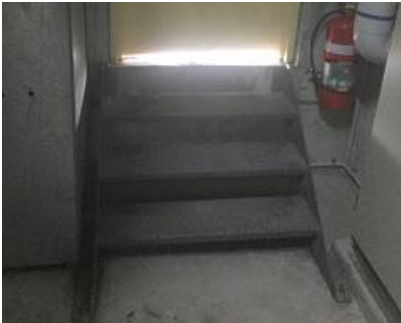
Handrails is missing for stair	Trips, Slips and Falls	Awareness induction	Med	Handrails to be installed	Low	Client advised	Outsta nding	OH&S REGULATIONS 3.7  AS/NZS 1657- 2013 7.2.6
80	Building: General Stores Location Reference: <a href="#">L35</a> Task: Access to the roof

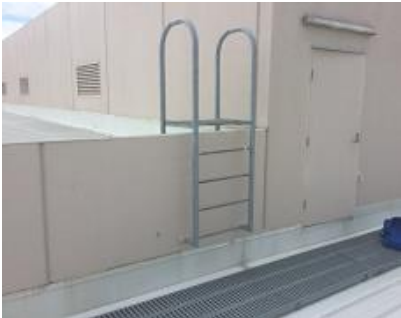
Rung spacings are less than required minimum and no slip resistance on ladder rungs	Trips, Slips and Falls	Awareness induction	Med	Existing ladder to be removed and new ladder to be installed	Low	Client advised	Outsta nding	OH&S REGULATIONS 3.7  AS/NZS 1657- 2013 7.4.3.2 & 7.4.3.1

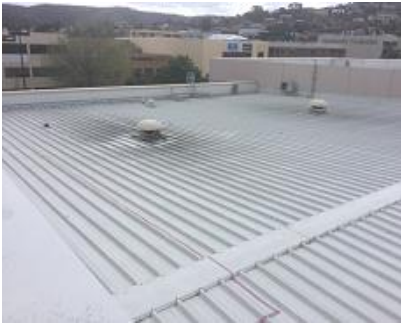
No safe access to the A/c units	Trips, Slips and Falls	N/A	Low	Supply walkway to the A/c units	Low	Client advised	Outstanding	-
82	Building: General Stores Location Reference: <a href="#">L37</a> Task: Access to the roof

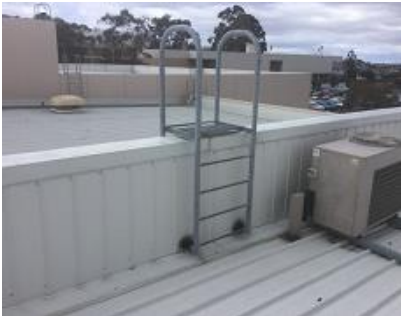
Rung spacings are less than required minimum and no slip resistance on ladder rungs and clearance behind the ladder is less than required minimum	Trips, Slips and Falls	Awareness induction	Med	Existing ladder to be removed and new ladder to be installed	Low	Client advised	Outstanding	OH&S REGULATIONS 3.7  AS/NZS 1657-2013 7.4.3.2 & 7.4.3.1 & 7.4.5

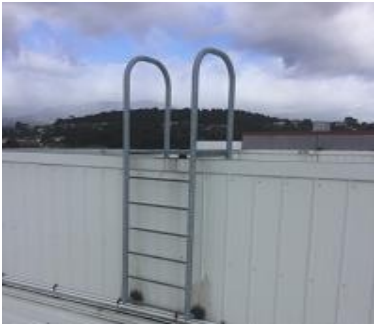
No safe access to the ladder	Trips, Slips and Falls	N/A	Low	Supply walkway to the ladder	Low	Client advised	Outsta nding	-
84	Building: General Stores Location Reference: <a href="#">L38</a> Task: Access to the roof

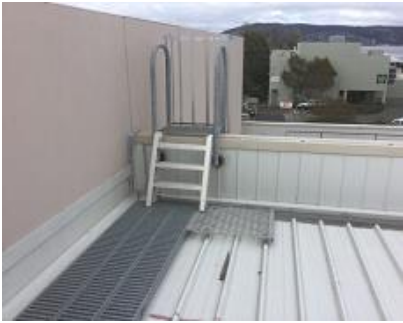
Rung spacings are less than required minimum and no slip resistance on ladder rungs and clearance behind the ladder is less than required minimum	Trips, Slips and Falls	Awareness induction	Med	Existing ladder to be removed and new ladder to be installed	Low	Client advised	Outsta nding	OH&S REGULATIONS 3.7  AS/NZS 1657- 2013 7.4.3.2 & 7.4.3.1 & 7.4.5

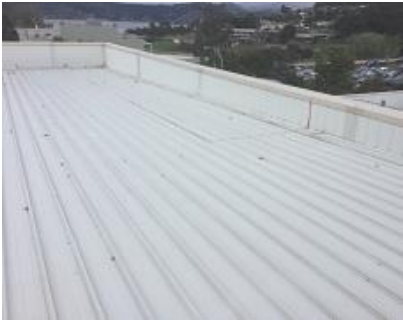
No height safety system installed	Trips, Slips and Falls	Awareness induction	High	Fall arrest anchor to be installed	Low	Client advised	Outstanding	OH&S REGULATIONS 3.55
86	Building: General Stores Location Reference: <a href="#">L39</a> Task: Access to the plant deck

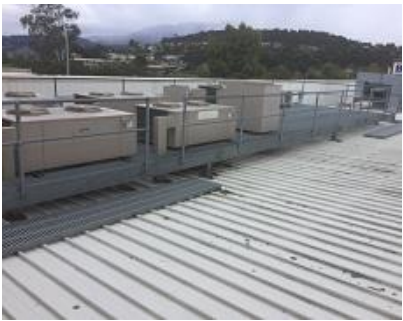
Variation in height between plant deck and roof is greater than required maximum	Trips, Slips and Falls	Awareness induction	Med	Step to be installed	Low	Client advised	Outstanding	OH&S REGULATIONS 3.7  AS/NZS 1657-2013 3.1.4

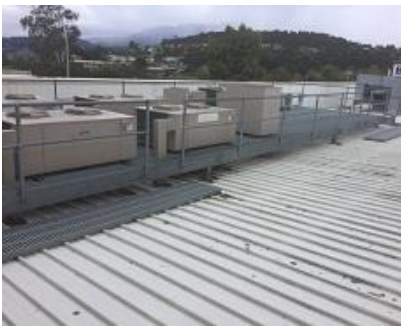
No safe access to the plant deck	Trips, Slips and Falls	N/A	Low	Supply walkway to the plant deck	Low	Client advised	Outstanding	-
88	Building: General Stores Location Reference: <a href="#">L39</a> Task: Access to the plant deck

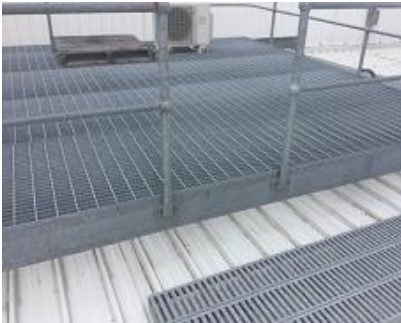
Variation in height between plant deck and roof is greater than required maximum	Trips, Slips and Falls	Awareness induction	Med	Step to be installed	Low	Client advised	Outstanding	OH&S REGULATIONS 3.7  AS/NZS 1657-2013 3.1.4

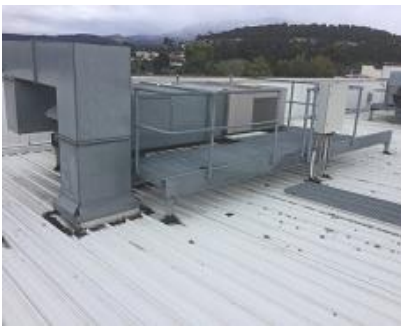
Variation in height between plant deck and roof is greater than required maximum	Trips, Slips and Falls	Awareness induction	Med	Step to be installed	Low	Client advised	Outstanding	OH&S REGULATIONS 3.7  AS/NZS 1657-2013 3.1.4
90	Building: General Stores Location Reference: <a href="#">L40</a> Task: Access to the plant deck

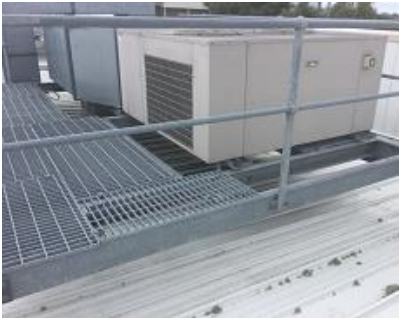
Grating panel is missing to access unit	Trips, Slips and Falls	Awareness induction	Med	Gap to be filled	Low	Client advised	Outstanding	OH&S REGULATIONS 3.7  AS/NZS 1657-2013 4.4

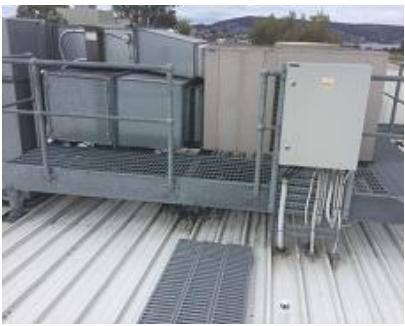
Variation in height between plant deck and roof is greater than required maximum	Trips, Slips and Falls	Awareness induction	Med	Step to be installed	Low	Client advised	Outstanding	OH&S REGULATIONS 3.7  AS/NZS 1657-2013 3.1.4
92	Building: General Stores Location Reference: <a href="#">L41</a> Task: Access to the A/c units

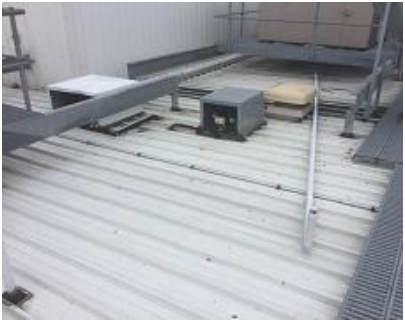
No safe access to the A/c units	Trips, Slips and Falls	N/A	Low	Supply walkway to the A/c units	Low	Client advised	Outstanding	-

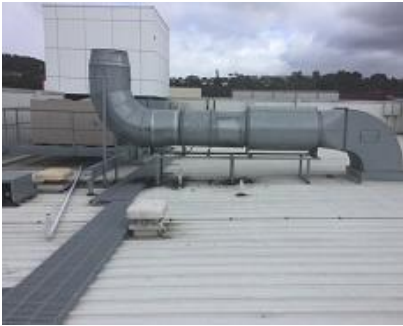
No safe access to the A/c units	Trips, Slips and Falls	N/A	Low	Supply walkway to the A/c units	Low	Client advised	Outstanding	-
94	Building: General Stores Location Reference: <a href="#">L42</a> Task: Access to the A/c units

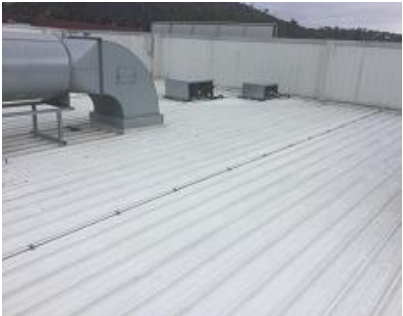
No safe access to the A/c units	Trips, Slips and Falls	N/A	Low	Supply walkway to the A/c units	Low	Client advised	Outstanding	-

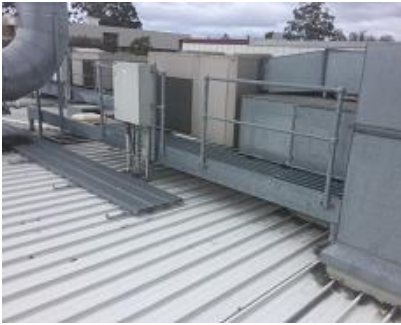
Variation in height between plant deck and roof is greater than required maximum	Trips, Slips and Falls	Awareness induction	Med	Step to be installed	Low	Client advised	Outstanding	OH&S REGULATIONS 3.7  AS/NZS 1657-2013 3.1.4
96	Building: General Stores Location Reference: <a href="#">L42</a> Task: Access to the plant deck

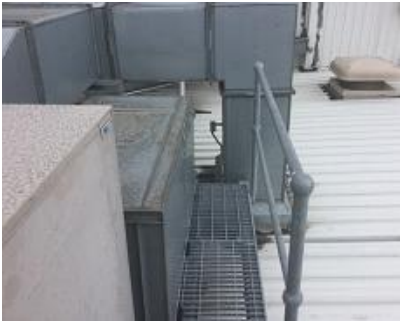
Handrail section is missing	Trips, Slips and Falls	Awareness induction	Med	Handrail to be installed	Low	Client advised	Outstanding	OH&S REGULATIONS 3.7  AS/NZS 1657-2013 4.4

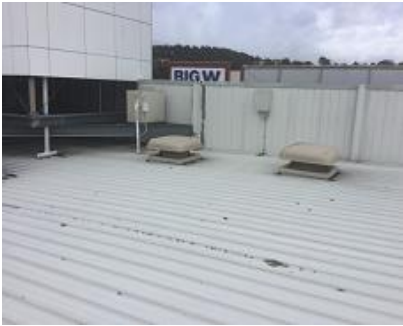
No safe access to the A/c units	Trips, Slips and Falls	N/A	Low	Supply walkway to the A/c units	Low	Client advised	Outstanding	-
98	Building: General Stores Location Reference: <a href="#">L43</a> Task: Restrict access to the roof

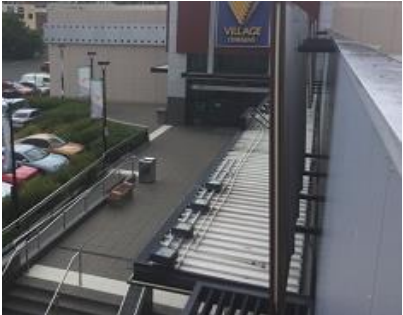
No height safety system installed	Trips, Slips and Falls	Restrict Access	High	"EWP Access Only" signs to be installed	Low	Client advised	Outstanding	OH&S REGULATIONS 3.55 & 3.11

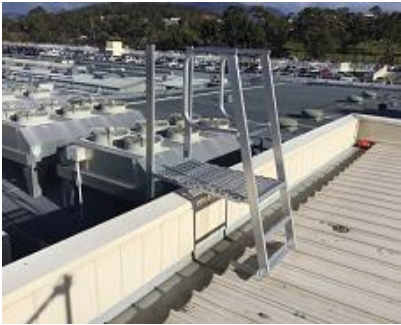
Level landing is missing for ladder	Trips, Slips and Falls	Awareness induction	Med	Landing platform to be installed	Low	Client advised	Outstanding	OH&S REGULATIONS 3.7  AS/NZS 1657-2018 7.3.6
100	Building: General Stores Location Reference: <a href="#">L33</a> Task: Access to the roof

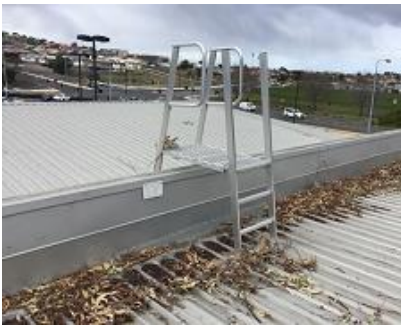
Level landing is missing for ladder	Trips, Slips and Falls	Awareness induction	Med	Landing platforms to be installed	Low	Client advised	Outstanding	OH&S REGULATIONS 3.7  AS/NZS 1657-2018 7.3.6

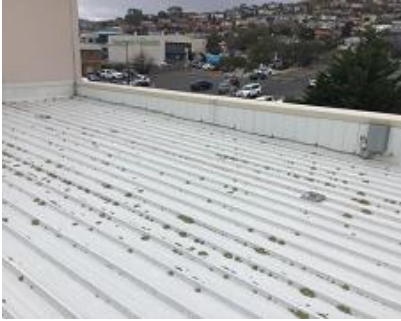
Not enough anchors installed to cover the fall edge	Trips, Slips and Falls	Awareness induction	High	Fall arrest anchors to be installed	Low	Client advised	Outstanding	OH&S REGULATIONS 3.55
