Roof Safety Report

Galleria, WA 6062

Prepared By: Safemaster Safety Products
Date: 08-09-2020

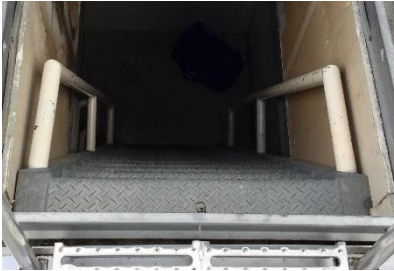
Clearance between handrail surface and permanent structure is less than required minimum	Trips, Slips and Falls	Awareness induction	Med	Existing ladder to be removed and new ladder to be installed	Low	Client advised	Outstanding	OH&S REGULATIONS 3.7 AS/NZS 1657-2013 7.3.4
02	Building: General Stores Location Reference: L1 Task: Access to the roof

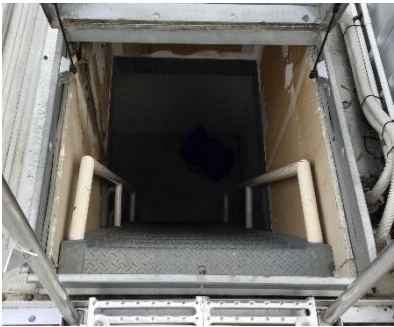
Headroom and clearance in front of the ladder is less than required minimum	Trips, Slips and Falls	Awareness induction	Med	Existing 900x900mm hatch to be removed and new 1200x800mm hatch to be installed	Low	Client advised	Outstanding	OH&S REGULATIONS 3.7 AS/NZS 1657-2013 7.3.5

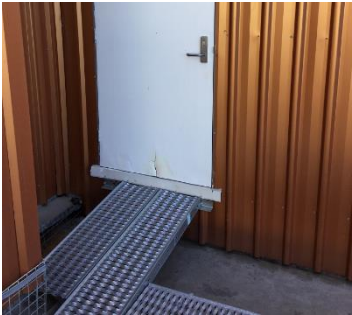
Walkway height is greater than required maximum from the adjacent area	Trips, Slips and Falls	Awareness induction	Med	Handrail and Larger platform to be installed	Low	Client advised	Outstanding	AS/NZS 1657-2013 5.4.1

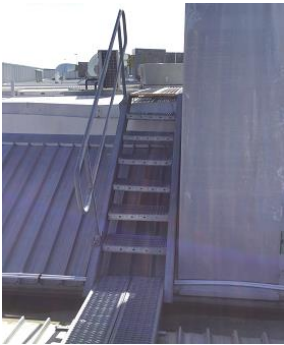
Walkway Bridge height is greater than required maximum from adjacent areas, Stair risers varies & not within tolerance, Handrails not extended at top landing and Walkway stops 100mm short to the stair treads at top	Trips, Slips and Falls	Awareness induction	Med	Handrail to be installed at both side of walkway at base, Existing stair to be removed and new stair to be installed including top landing platform and handrails	Low	Client advised	Outstanding	OH&S REGULATIONS 3.7 AS/NZS 1657-2013 3.2.3.2 & 5.4.1 & 7.2.3

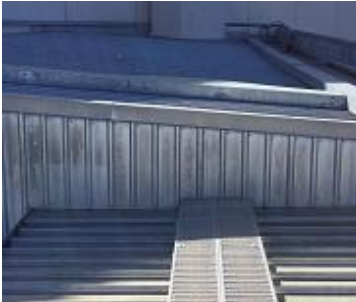
Variation in height between two roof levels are greater than required maximum	Trips, Slips and Falls	Awareness induction	Med	new mini access ladder to be installed with handrail	Low	Client advised	Outstanding	OH&S REGULATIONS 3.7 AS/NZS 1657-2013 3.1.4

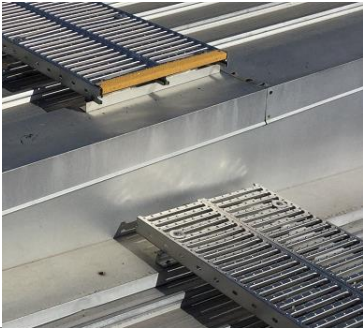
Variation in height between two roof levels are greater than required maximum	Trips, Slips and Falls	Awareness induction	Med	Step to be installed and walkway to be extended at top level	Low	Client advised	Outstanding	OH&S REGULATIONS 3.7 AS/NZS 1657-2013 3.1.4

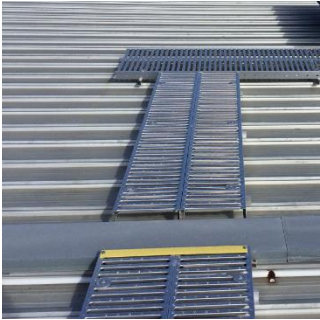
Gap between the walkway panels are greater than required maximum	Trips, Slips and Falls	Awareness induction	Med	Bridging platform to be installed between two walkway sections including high visibility safety yellow nosing's	Low	Client advised	Outstanding	OH&S REGULATIONS 3.7 AS/NZS 1657-2013 3.2.3.4

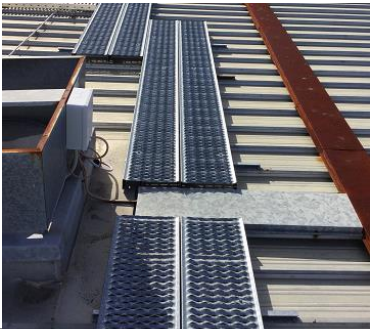
Gap between the walkway panels are greater than required maximum	Trips, Slips and Falls	Awareness induction	Med	Bridging platform to be installed between two walkway sections including high visibility safety yellow nosing's	Low	Client advised	Outstanding	OH&S REGULATIONS 3.6 AS/NZS 1657-2013 3.2.3.4
18	Building: General Stores Location Reference: L15 Task: Access to the A/c unit

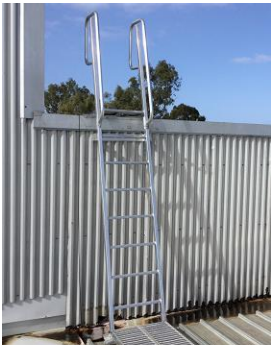
Top rung not levelled with landing and Clearance between the back edge of rung nosing and permanent structure is less than required minimum and gap between landing and top rung is greater than required maximum	Trips, Slips and Falls	Awareness induction	Med	Existing ladder to be removed and new ladder to be installed	Low	Client advised	Outstanding	OH&S REGULATIONS 3.7 AS/NZS 1657-2013 7.4.3.3 & 7.4.5 & 7.4.8.4

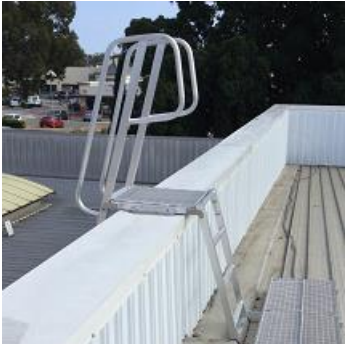
Bottom rung height is less than required minimum and landing is less than required minimum	Trips, Slips and Falls	Awareness induction	Med	Existing ladder to be removed and New parapet ladder including landing platforms to be installed	Low	Client advised	Outstanding	OH&S REGULATIONS 3.7 AS/NZS 1657-2013 7.4.3.4 & 7.3.6

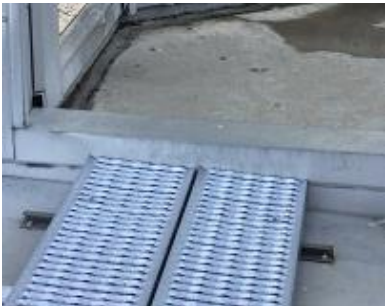
Variation in height between two levels are greater than required maximum	Trips, Slips and Falls	Awareness induction	Med	High visibility safety yellow tape to be installed	Low	Client advised	Outstanding	OH&S REGULATIONS 3.6 AS/NZS 1657-2013 3.3.4
22	Building: General Stores Location Reference: L19 Task: Access to the A/c unit

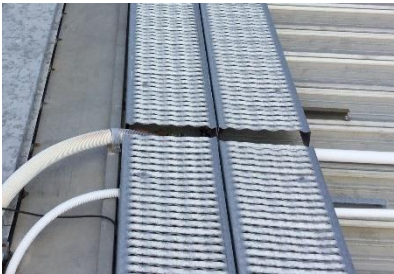
Gap between the walkway panels are greater than required maximum	Trips, Slips and Falls	Awareness induction	Med	Bridging platform to be installed between two walkway sections including high visibility safety yellow nosing's	Low	Client advised	Outstanding	OH&S REGULATIONS 3.6 AS/NZS 1657-2013 3.2.3.4

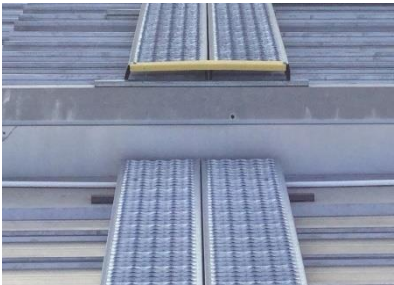
Variation in height between two level are greater than required maximum	Trips, Slips and Falls	Awareness induction	Med	Single step to be Installed	Low	Client advised	Outstanding	OH&S REGULATIONS 3.7 AS/NZS 1657-2013 3.1.4
24	Building: General Stores Location Reference: L22 & L23 Task: Access to the A/c unit

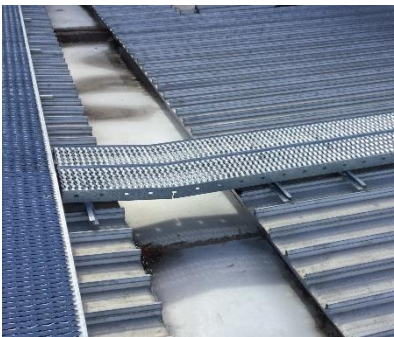
In-correct installation roof walkway and walkway height is greater than required maximum from adjacent area	Trips, Slips and Falls	Awareness induction	Med	Existing walkway to be removed and New walkway bridge including handrail to be installed	Low	Client advised	Outstanding	AS/NZS 1657-2013 5.4.1

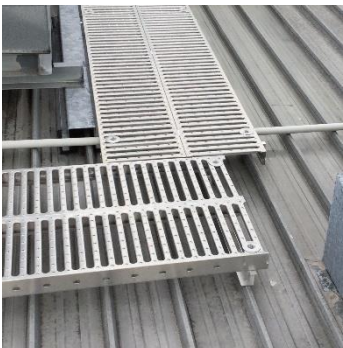
Walkway width is less than required minimum	Trips, Slips and Falls	Awareness induction	Med	Walkway to be extended	Low	Client advised	Outstanding	OH&S REGULATIONS 3.6 AS/NZS 1657-2013 5.1.3

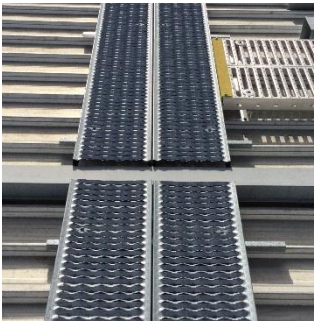
Gap between two walkway panels are greater than required maximum	Trips, Slips and Falls	Awareness induction	Med	Bridging platform to be installed between two walkway sections including high visibility safety yellow nosing's	Low	Client advised	Outstanding	OH&S REGULATIONS 3.6 AS/NZS 1657-2013 3.2.3.4
32	Building: General Stores Location Reference: L29 Task: Access to the A/c unit

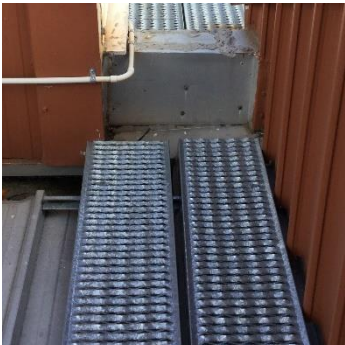
In-Correct installation of walkway	Trips, Slips and Falls	Awareness induction	Med	Walkway to be re-installed with new channels and fixings, High visibility safety yellow nosings to be installed at change in	Low	Client advised	Outstanding	OH&S REGULATIONS 3.6 AS/NZS 1657-2013 3.2.3.4

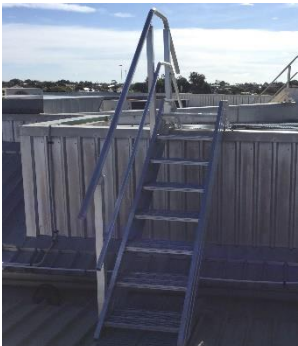
Bottom tread height is less than required minimum and Handrail is missing on one side	Trips, Slips and Falls	Awareness induction	Med	New landing platform to level with the bottom tread including high visibility safety yellow nosings to be installed and walkway to be re-routed with additional sections	Low	Client advised	Outstanding	OH&S REGULATIONS 3.7 AS/NZS 1657-2013 7.2.3.2

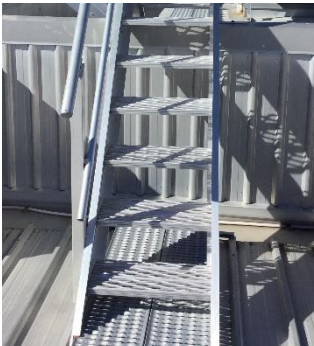
Bottom tread not uniformly spaced as remaining treads	Trips, Slips and Falls	Awareness induction	Med	New landing platform to level with the bottom tread including high visibility safety yellow nosings to be installed and walkway to be re-routed with additional sections if required	Low	Client advised	Outstanding	OH&S REGULATIONS 3.7 AS/NZS 1657-2013 7.2.3.2

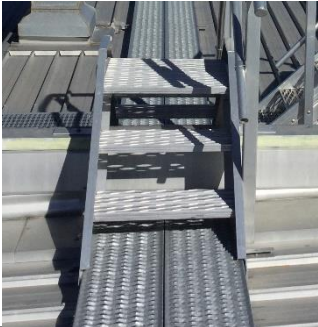
Bottom tread not uniformly spaced as remaining treads	Trips, Slips and Falls	Awareness induction	Med	New landing platform to level with the bottom tread including high visibility safety yellow nosings to be installed and walkway to be re-routed with additional sections if required	Low	Client advised	Outstanding	OH&S REGULATIONS 3.6 AS/NZS 1657-2013 7.2.3.2

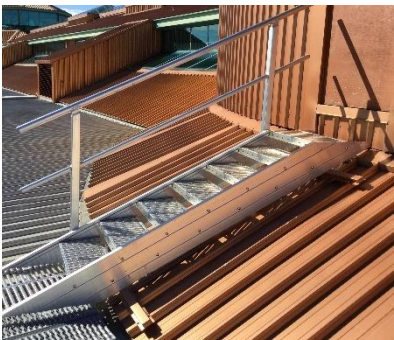
Stair landing length is less than required minimum and risers not uniformly spaced and gap between the walkway panels at base is greater than required maximum	Trips, Slips and Falls	Awareness induction	Med	Existing stair to be removed and new stair to be installed with landing platforms and walkway to be extended to close the gap	Low	Client advised	Outstanding	OH&S REGULATIONS 3.7 AS/NZS 1657-2013 3.2.3.4 & 7.2.4 & 7.2.3.2

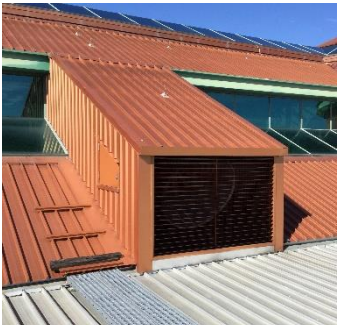
Roof pitch higher than the required minimum for a work area	Trips, Slips and Falls	Awareness induction	Med	Access platform and steps with handrail one side to be installed	Low	Client advised	Outstanding	OH&S REGULATIONS 3.7 AS/NZS 1657-2013 2.2
42	Building: General Stores Location Reference: L38 Task: Access to the A/c unit

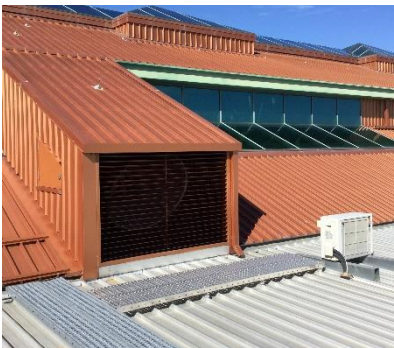
Roof pitch higher than the required minimum for a work area	Trips, Slips and Falls	Awareness induction	Med	Access platform and steps with handrail one side to be installed	Low	Client advised	Outstanding	OH&S REGULATIONS 3.7 AS/NZS 1657-2013 2.2

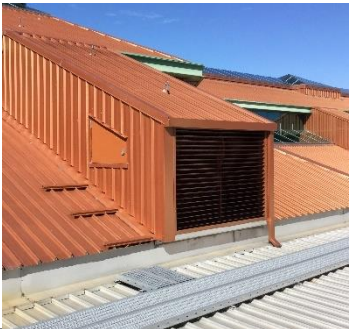
Roof pitch higher than the required minimum for a work area	Trips, Slips and Falls	Awareness induction	Med	Access platform and steps with handrail one side to be installed	Low	Client advised	Outstanding	OH&S REGULATIONS 3.7 AS/NZS 1657-2013 2.2
44	Building: General Stores Location Reference: L40 Task: Access to the A/c unit

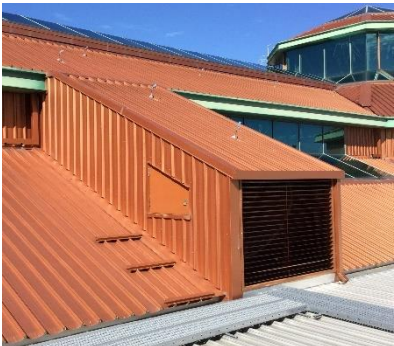
Roof pitch higher than the required minimum for a work area	Trips, Slips and Falls	Awareness induction	Med	Access platform and steps with handrail one side to be installed	Low	Client advised	Outstanding	OH&S REGULATIONS 3.7 AS/NZS 1657-2013 2.2

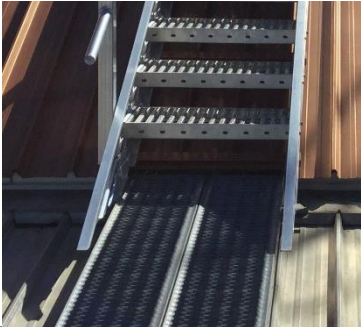
Bottom tread not uniformly spaced as remaining treads	Trips, Slips and Falls	Awareness induction	Med	New landing platform to level with the bottom tread including high visibility safety yellow nosings to be installed and walkway to be re-routed with additional sections if required	Low	Client advised	Outstanding	OH&S REGULATIONS 3.6 AS/NZS 1657-2013 7.2.3.2

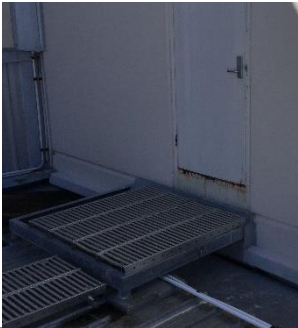
Landing platform height from adjacent area is greater than required maximum	Trips, Slips and Falls	Awareness induction	Med	Handrails to be installed and Hi-Vis tape on the step edge	Low	Client advised	Outstanding	OH&S REGULATIONS 3.7 AS/NZS 1657-2013 5.4.1
48	Building: General Stores Location Reference: L44 Task: Access to the A/c unit

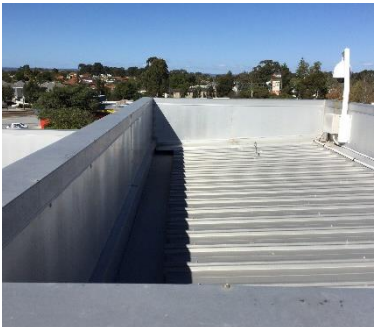
Variation in height between roof levels are greater than required maximum	Trips, Slips and Falls	Awareness induction	Med	New mini access ladder and additional anchor to be installed for safe access	Low	Client advised	Outstanding	OH&S REGULATIONS 3.7 AS/NZS 1657-2013 5.1.1 & 5.4.1
50	Building: General Stores Location Reference: L46 Task: Access to the A/c unit

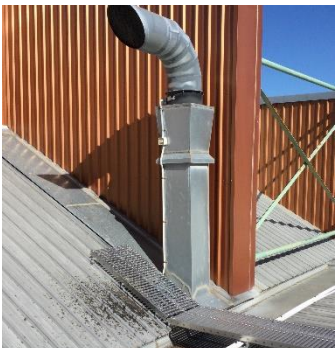
Walkway bridge height from adjacent area is greater than required maximum and Landing platform not levelled	Trips, Slips and Falls	Awareness induction	Med	Existing landing to be removed and New levelled landing platform including handrails to be installed	Low	Client advised	Outstanding	OH&S REGULATIONS 3.7 AS/NZS 1657-2013 5.1.1 & 5.4.1

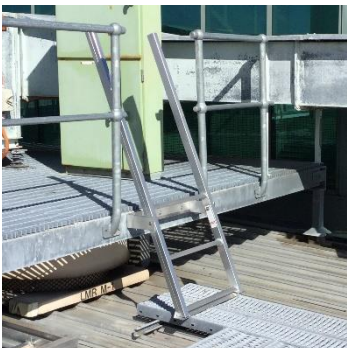
Top rung not levelled with landing, bottom rung height is less than required minimum and gap between top rung and landing is greater than required maximum	Trips, Slips and Falls	Awareness induction	Med	Existing ladder to be removed and New ladder to be installed	Low	Client advised	Outstanding	OH&S REGULATIONS 3.7 AS/NZS 1657-2013 7.4.3.3 & 7.4.3.4 & 7.4.8.4

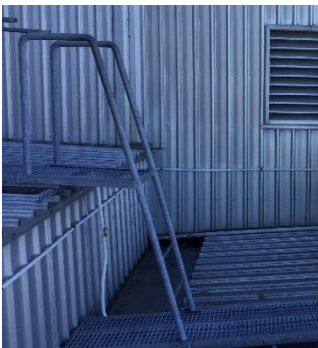
No slip resistance on ladder rungs	Trips, Slips and Falls	Awareness induction	Med	Non slip high visibility safety yellow rung caps to be installed	Low	Client advised	Outstanding	OH&S REGULATIONS 3.6 AS/NZS 1657-2013 3.1.3

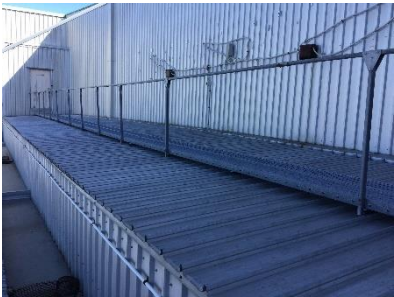
Midrail not installed and sharp edges on handrails	Trips, Slips and Falls	Awareness induction	Med	Existing handrail to be removed and New aluminium handrail to be installed	Low	Client advised	Outstanding	OH&S REGULATIONS 3.6 AS/NZS 16572013 5.6 & 6.2.1.2
58	Building: General Stores Location Reference: L53 Task: Access to the A/c unit

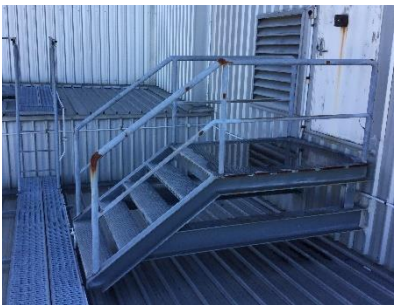
Bottom tread not uniformly spaced as remaining treads and landing at base is less than required minimum	Trips, Slips and Falls	Awareness induction	Med	New landing platform to level with the bottom tread including high visibility safety yellow nosings to be installed and walkway to be re-routed with additional sections if required	Low	Client advised	Outstanding	OH&S REGULATIONS 3.7 AS/NZS 16572013 7.2.3.2 & 7.2.4

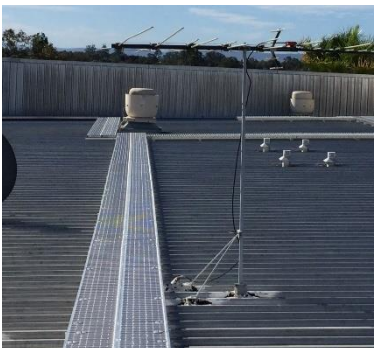
Antenna installed over the walkway path	Trips, Slips and Falls	Awareness induction	Med	Walkway to be re-routed with additional sections or Re-locate antenna	Low	Client advised	Outstanding	OH&S REGULATIONS 3.6

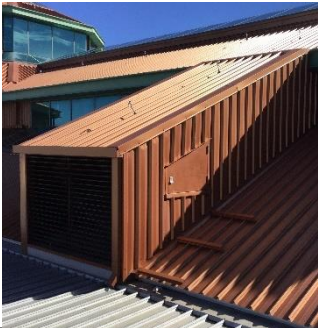
Roof pitch higher than the required minimum for a work area	Trips, Slips and Falls	Awareness induction	Med	Access platform and steps with handrail one side to be installed	Low	Client advised	Outstanding	OH&S REGULATIONS 3.7 AS/NZS 16572013 2.2
62	Building: General Stores Location Reference: L57 Task: Access to the A/c unit

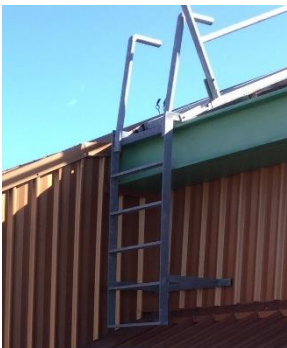
Extension of stiles above landing is less than required minimum and clearance between back edge of rung and permanent structure is less than required minimum and no landing at ladder base	Trips, Slips and Falls	Awareness induction	Med	Existing ladder to be removed and New ladder including landing platforms to be installed	Low	Client advised	Outstanding	OH&S REGULATIONS 3.7 AS/NZS 16572013 7.3.6 & 7.4.5 & 7.4.8

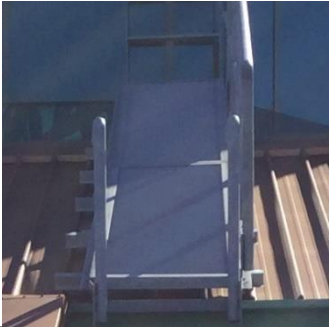
Walkway slope is greater than required maximum	Trips, Slips and Falls	Awareness induction	Med	Existing walkway to be removed and New stair to be installed including handrails	Low	Client advised	Outstanding	OH&S REGULATIONS 3.7 AS/NZS 16572013 5.1.1

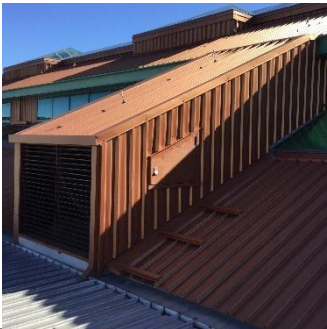
Roof pitch higher than the required minimum for a work area	Trips, Slips and Falls	Awareness induction	Med	Access platform and steps with handrail one side to be installed	Low	Client advised	Outstanding	OH&S REGULATIONS 3.7 AS/NZS 16572013 2.2
66	Building: General Stores Location Reference: L59 Task: Access to the A/c unit

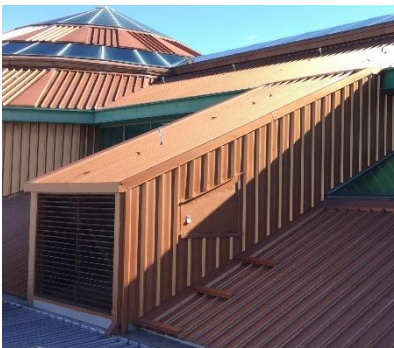
Roof pitch higher than the required minimum for a work area	Trips, Slips and Falls	Awareness induction	Med	Access platform and steps with handrail one side to be installed	Low	Client advised	Outstanding	OH&S REGULATIONS 3.7 AS/NZS 16572013 2.2

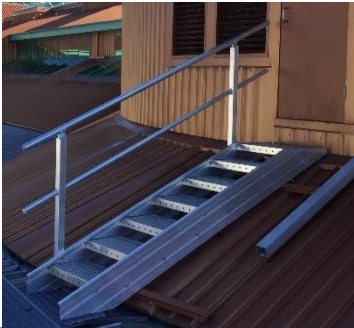
Landing is less than required minimum and bottom tread not uniformly spaced as remaining treads	Trips, Slips and Falls	Awareness induction	Med	Existing stair to be removed and New stair to be installed including landings	Low	Client advised	Outstanding	OH&S REGULATIONS 3.7 AS/NZS 16572013 7.2.3.2 & 7.2.4
68	Building: General Stores Location Reference: L61 Task: Access to the A/c unit

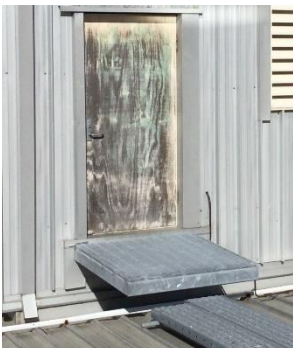
Platform height from adjacent area is greater than required maximum	Trips, Slips and Falls	Awareness induction	Med	Handrail and High visibility safety yellow noising to step to be installed	Low	Client advised	Outstanding	OH&S REGULATIONS 3.7 AS/NZS 16572013 5.4.1

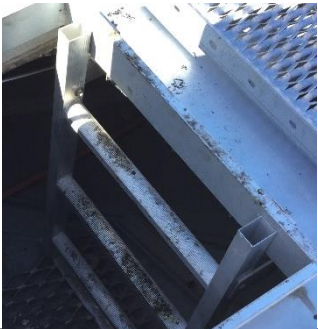
Top rung not levelled with landing, No extension stiles and clearance between the back edge of rung and the permanent structure is less required minimum	Trips, Slips and Falls	Awareness induction	Med	Existing ladder to be removed and New ladder to be installed	Low	Client advised	Outstanding	OH&S REGULATIONS 3.7 AS/NZS 16572013 7.4.3.3 & 7.4.5 & 7.4.8
70	Building: General Stores Location Reference: L62 Task: Access to the A/c unit

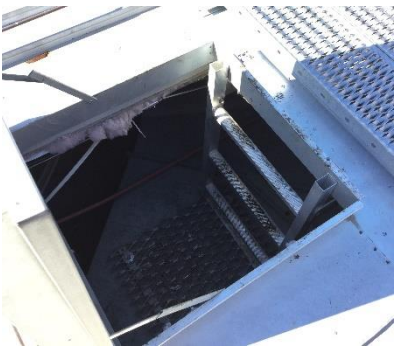
Clearance between the front edge of rung and hatch is less than required minimum (Hatch size is too small)	Trips, Slips and Falls	Awareness induction	Med	Existing hatch to be removed and New 1200x800mm hatch to be installed with access anchor	Low	Client advised	Outstanding	OH&S REGULATIONS 3.7 AS/NZS 16572013 7.4.5

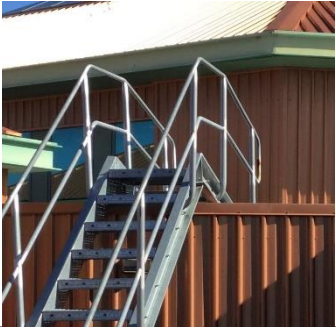
Handrail height at landing is less than required minimum and risers is less than required minimum	Trips, Slips and Falls	Awareness induction	Med	Exiting handrail and stair to be removed & New stair and handrail to be installed	Low	Client advised	Outstanding	OH&S REGULATIONS 3.7 AS/NZS 16572013 7.2.3.2 & 7.2.6

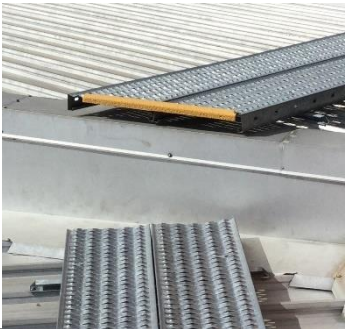
Variation in height between two levels are greater than required maximum	Trips, Slips and Falls	Awareness induction	Med	Step to be installed	Low	Client advised	Outstanding	OH&S REGULATIONS 3.7 AS/NZS 16572013 3.1.4
74	Building: General Stores Location Reference: L66 Task: Access to the A/c unit

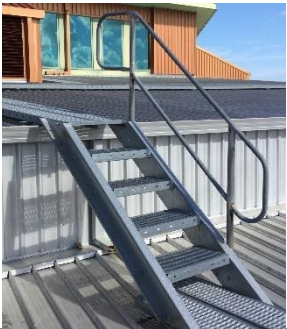
Bottom tread height is greater than required maximum and Handrail is missing on one side	Trips, Slips and Falls	Awareness induction	Med	New landing platform at base or walkway to rise to achieve uniform riser at bottom tread and Handrail to be installed	Low	Client advised	Outstanding	OH&S REGULATIONS 3.7 AS/NZS 16572013 7.2.3.2 & 7.2.5
77	Building: General Stores Location Reference: L68 Task: Access to the A/c unit

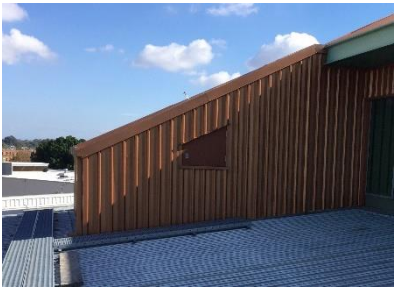
No	Photo of Hazard	Details of Hazard	Details of Risk	Existing/ Immediate Control Measure	Curre nt Risk Level	Proposed Permanent Solution	Resid ual Risk Asse ssme nt	Details of Action Taken	Status	Reference
79	Building: General Stores Location Reference: L71 Task: Access to the A/c unit

Roof pitch higher than the required minimum for a work area	Trips, Slips and Falls	Awareness induction	Med	Access platform and steps with handrail one side to be installed	Low	Client advised	Outstanding	OH&S REGULATIONS 3.7 AS/NZS 16572013 2.2
80	Building: General Stores Location Reference: L72 Task: Access to the A/c unit

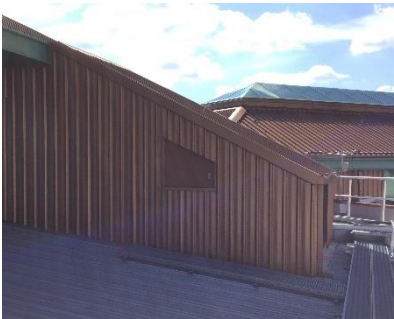
Roof pitch higher than the required minimum for a work area	Trips, Slips and Falls	Awareness induction	Med	Access platform and steps with handrail one side to be installed	Low	Client advised	Outstanding	OH&S REGULATIONS 3.7 AS/NZS 16572013 2.2

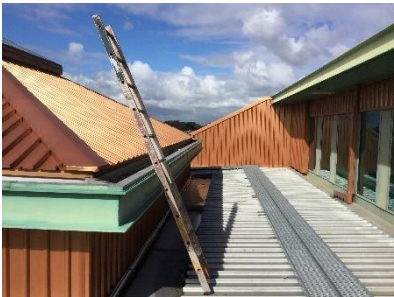
No	Photo of Hazard	Details of Hazard	Details of Risk	Existing/ Immediate Control Measure	Curre nt Risk Level	Proposed Permanent Solution	Resid ual Risk Asse sme nt	Details of Action Taken	Status	Reference
81	Building: General Stores Location Reference: L73 Task: Access to the A/c unit

Variation in height between roof levels are greater than required maximum	Trips, Slips and Falls	Awareness induction	Med	New mini access ladder and Walkway to be extended	Low	Client advised	Outstanding	OH&S REGULATIONS 3.7 AS/NZS 16572013 3.1.4
82	Building: General Stores Location Reference: L74 Task: Access to the A/c unit

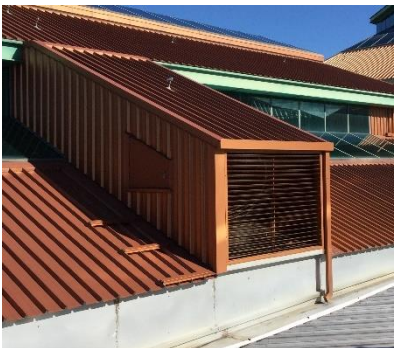
Roof pitch higher than the required minimum for a work area	Trips, Slips and Falls	Awareness induction	Med	Access platform and steps with handrail one side to be installed	Low	Client advised	Outstanding	OH&S REGULATIONS 3.7 AS/NZS 16572013 2.2

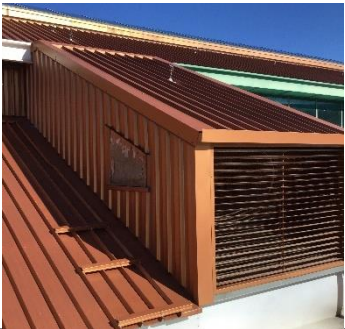
No	Photo of Hazard	Details of Hazard	Details of Risk	Existing/ Immediate Control Measure	Curre nt Risk Level	Proposed Permanent Solution	Resid ual Risk Asse ssme nt	Details of Action Taken	Status	Reference
83	Building: General Stores Location Reference: L75 Task: Access to the A/c unit

Roof pitch higher than the required minimum for a work area	Trips, Slips and Falls	Awareness induction	Med	Access platform and steps with handrail one side to be installed	Low	Client advised	Outstanding	OH&S REGULATIONS 3.7 AS/NZS 16572013 2.2
86	Building: General Stores Location Reference: L77 Task: Access to the A/c unit

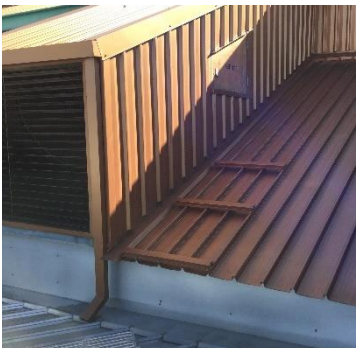
Roof pitch higher than the required minimum for a work area	Trips, Slips and Falls	Awareness induction	Med	Access platform and steps with handrail one side to be installed	Low	Client advised	Outstanding	OH&S REGULATIONS 3.7 AS/NZS 16572013 2.2

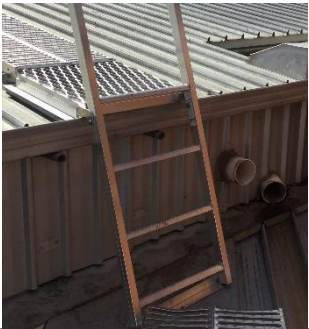
No	Photo of Hazard	Details of Hazard	Details of Risk	Existing/ Immediate Control Measure	Curre nt Risk Level	Proposed Permanent Solution	Resid ual Risk Asse sme nt	Details of Action Taken	Status	Reference
89	Building: General Stores Location Reference: L81 Task: Access to the A/c unit

Top rung not levelled with landing, bottom rung height is less than required minimum and insufficient landing at base	Trips, Slips and Falls	Awareness induction	Med	Existing ladder to be modified & re-installed or New ladder to be installed with landing platforms and fixings brackets	Low	Client advised	Outstanding	OH&S REGULATIONS 3.7 AS/NZS 16572013 7.4.3.3 & 7.4.3.4 & 7.3.6
90	Building: General Stores Location Reference: L82 Task: Access to the A/c unit

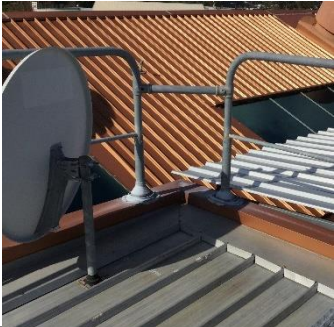
No	Photo of Hazard	Details of Hazard	Details of Risk	Existing/ Immediate Control Measure	Curre nt Risk Level	Proposed Permanent Solution	Resid ual Risk Asse ssme nt	Details of Action Taken	Status	Reference
92	Building: General Stores Location Reference: L84 Task: Access to the A/c unit

Midrail is missing and handrail not permitting unrestricted movement of the user's hand	Trips, Slips and Falls	Awareness induction	Med	Existing corner joint to be removed and New handrail section to be installed	Low	Client advised	Outstanding	AS/NZS 16572013 5.4.1 & 5.6.3

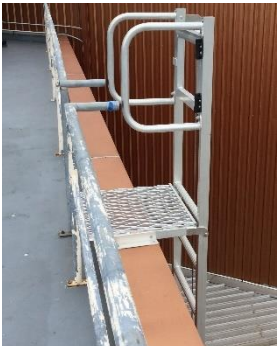
Top rung not levelled with landing and self closing gate installed in incorrect location and bottom rung height is less than required minimum	Trips, Slips and Falls	Awareness induction	Med	Existing ladder to be removed and new ladder to be installed and self closing gate to be re-located	Low	Client advised	Outstanding	OH&S REGULATIONS 3.7 AS/NZS 16572013 7.4.3.3 & 7.4.3.4 & APPENDIX J

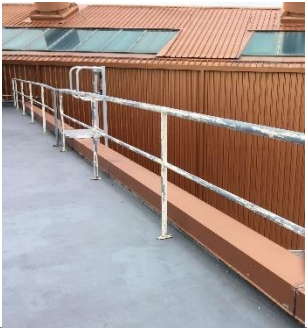
No	Photo of Hazard	Details of Hazard	Details of Risk	Existing/ Immediate Control Measure	Curre nt Risk Level	Proposed Permanent Solution	Resid ual Risk Asse sme nt	Details of Action Taken	Status	Reference
95	Building: General Stores Location Reference: L87 Task: Access to the A/c unit

Gap between midrail and floor is greater than required maximum	Trips, Slips and Falls	Awareness induction	Med	New midrail to be installed on existing handrail posts	Low	Client advised	Outstanding	AS/NZS 16572013 6.2.1.2
96	Building: General Stores Location Reference: L88 Task: Access to the A/c unit

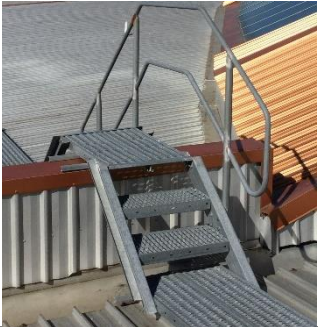
No	Photo of Hazard	Details of Hazard	Details of Risk	Existing/ Immediate Control Measure	Curre nt Risk Level	Proposed Permanent Solution	Resid ual Risk Asse ssme nt	Details of Action Taken	Status	Reference
97	Building: General Stores Location Reference: L89 Task: Access to the A/c unit

Risers and Goings varies greater than acceptable tolerance	Trips, Slips and Falls	Awareness induction	Med	Existing stair to be removed and New stair to be installed	Low	Client advised	Outstanding	OH&S REGULATIONS 3.7 AS/NZS 16572013 7.2.3.2

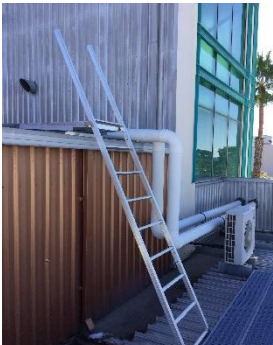
Top rung not levelled with landing and ladder slope is less than required minimum	Trips, Slips and Falls	Awareness induction	Med	Existing ladder to be removed and new ladder to be installed	Low	Client advised	Outstanding	OH&S REGULATIONS 3.7 AS/NZS 16572013 7.4.3.3 & 2.2(e)

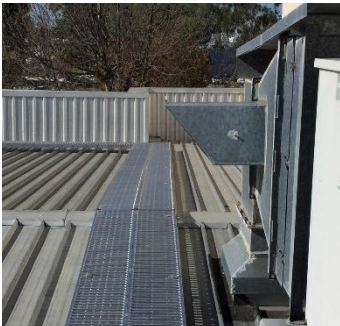
No	Photo of Hazard	Details of Hazard	Details of Risk	Existing/ Immediate Control Measure	Curre nt Risk Level	Proposed Permanent Solution	Resid ual Risk Asse ssme nt	Details of Action Taken	Status	Reference
102	Building: General Stores Location Reference: L96 Task: Access to the A/c unit

Duct over the walkway path	Trips, Slips and Falls	Awareness induction	Med	Walkway to be re- routed	Low	Client advised	Outsta nding	OH&S REGULATIONS 3.6 AS/NZS 16572013 4.1.3
104	Building: General Stores Location Reference: L98 Task: Access to the A/c unit

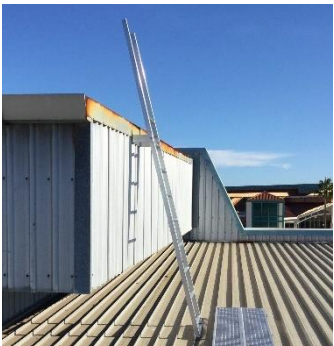
Top rung not levelled with landing/roof and bottom rung height is less than required minimum	Trips, Slips and Falls	Awareness induction	Med	Existing ladder to be removed and New ladder including ladder support platforms to be installed	Low	Client advised	Outsta nding	OH&S REGULATIONS 3.7 AS/NZS 16572013 7.4.3.3 & 7.4.3.4

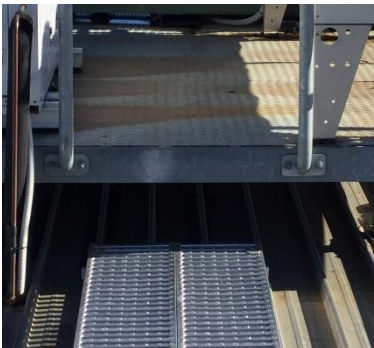
Variation in height between the plant deck and walkway is greater than required maximum	Trips, Slips and Falls	Awareness induction	Med	Single step to be installed	Low	Client advised	Outstanding	OH&S REGULATIONS 3.7 AS/NZS 16572013 3.1.4

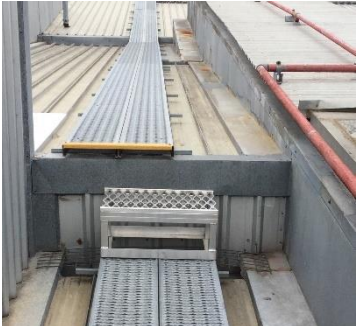
No	Photo of Hazard	Details of Hazard	Details of Risk	Existing/ Immediate Control Measure	Curre nt Risk Level	Proposed Permanent Solution	Resid ual Risk Asse sme nt	Details of Action Taken	Status	Reference
108	Building: General Stores Location Reference: L102 Task: Access to the A/c unit

Variation in height between landings is greater than required maximum and existing step not compliant	Trips, Slips and Falls	Awareness induction	Med	Existing step to be removed and New mini stair to be installed	Low	Client advised	Outstanding	OH&S REGULATIONS 3.7 AS/NZS 16572013 3.1.4
109	Building: General Stores Location Reference: L103 Task: Access to the A/c unit

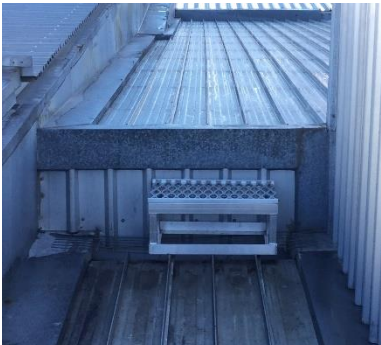
Variation in height between landings is greater than required maximum and existing step not compliant	Trips, Slips and Falls	Awareness induction	Med	Existing step to be removed and New mini stair to be installed	Low	Client advised	Outstanding	OH&S REGULATIONS 3.7 AS/NZS 16572013 3.1.4

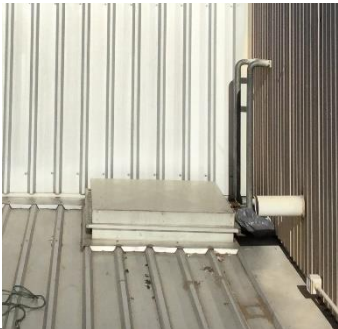
No	Photo of Hazard	Details of Hazard	Details of Risk	Existing/ Immediate Control Measure	Curre nt Risk Level	Proposed Permanent Solution	Resid ual Risk Asse ssme nt	Details of Action Taken	Status	Reference
111	Building: General Stores Location Reference: L105 Task: Access to the A/c unit

Hatch not in service	Trips, Slips and Falls	Awareness induction	Med	"OUT OF SERVICE" sign to be installed	Low	Client advised	Outstanding	OH&S REGULATIONS 3.11
112	Building: General Stores Location Reference: L105 Task: Access to the A/c unit

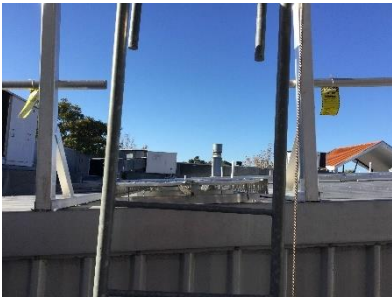
No slip resistance on ladder rungs and top rung not levelled with landing and in-correct installation of handrails	Trips, Slips and Falls	Awareness induction	Med	Existing ladder and handrail to be removed and new ladder including landing platforms and handrails to be installed	Low	Client advised	Outstanding	OH&S REGULATIONS 3.7 AS/NZS 16572013 3.1.3 & 5.6.1 & 7.4.3.3

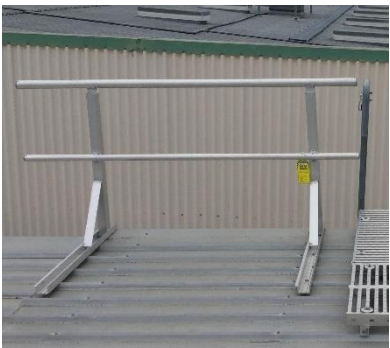
In-correct installation of handrail and it requires more supports/bracings	Trips, Slips and Falls	Awareness induction	Med	Existing handrail to be re-installed with additional bracings and fittings	Low	Client advised	Outstanding	OH&S REGULATIONS 3.6 AS/NZS 16572013 5.6.1

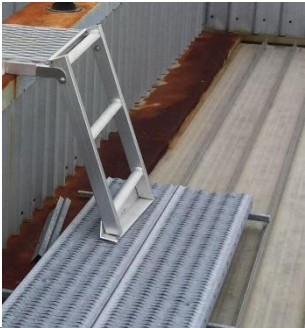
No	Photo of Hazard	Details of Hazard	Details of Risk	Existing/ Immediate Control Measure	Curre nt Risk Level	Proposed Permanent Solution	Resid ual Risk Asse ssme nt	Details of Action Taken	Status	Reference
118	Building: General Stores Location Reference: L110 Task: Access to the A/c unit

Landing is less than required minimum	Trips, Slips and Falls	Awareness induction	Med	New landing platform to be installed	Low	Client advised	Outstanding	OH&S REGULATIONS 3.7 AS/NZS 16572013 7.3.6
119	Building: General Stores Location Reference: L110 Task: Access to the A/c unit

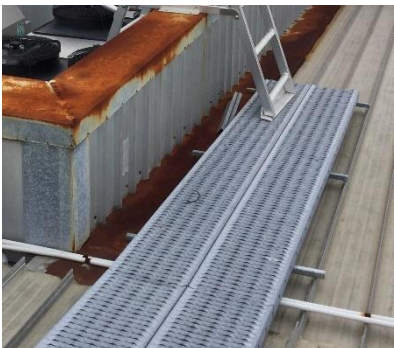
Walkway leads to a fall edge (No height safety system installed)	Trips, Slips and Falls	Awareness induction	Med	Walkway to be rerouted with additional sections and handrails to be installed at access point	Low	Client advised	Outstanding	OH&S REGULATIONS 3.55 AS/NZS 16572013 5.4.1

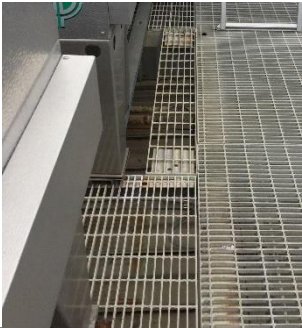
No	Photo of Hazard	Details of Hazard	Details of Risk	Existing/ Immediate Control Measure	Curre nt Risk Level	Proposed Permanent Solution	Resid ual Risk Asse ssme nt	Details of Action Taken	Status	Reference
121	Building: General Stores Location Reference: L110 Task: Access to the A/c unit

Gap between the platform grating and the structure is greater than required maximum	Trips, Slips and Falls	Awareness induction	Med	Additional grating to be installed to close the gap	Low	Client advised	Outstanding	OH&S REGULATIONS 3.6 AS/NZS 16572013 4.4
122	Building: General Stores Location Reference: L110 Task: Access to the A/c unit

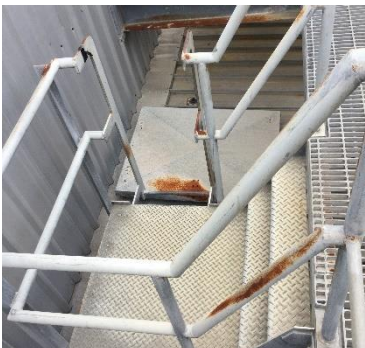
Hatch and Step ladder not in service	Trips, Slips and Falls	Awareness induction	Med	Chain/bracket to be installed between the handrail posts and "OUT OF SERVICE" signs to be installed on hatch and ladder	Low	Client advised	Outstanding	OH&S REGULATIONS 3.11

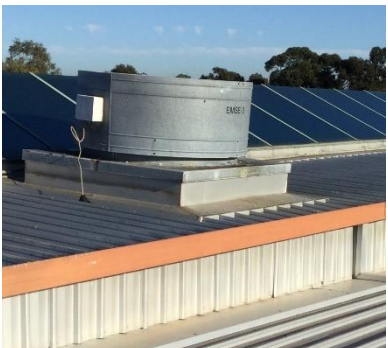
Variation in height between two levels are greater than required maximum	Trips, Slips and Falls	Awareness induction	Med	Step to be installed	Low	Client advised	Outstanding	OH&S REGULATIONS 3.7 AS/NZS 16572013 3.1.4

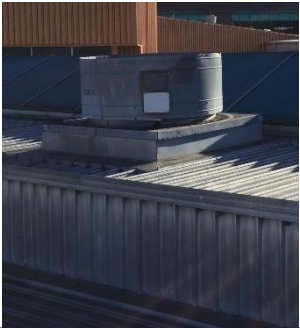
No	Photo of Hazard	Details of Hazard	Details of Risk	Existing/ Immediate Control Measure	Curre nt Risk Level	Proposed Permanent Solution	Resid ual Risk Asse ssme nt	Details of Action Taken	Status	Reference
125	Building: General Stores Location Reference: L113 Task: Access to the A/c unit

Variation in height between two levels are greater than required maximum	Trips, Slips and Falls	Awareness induction	Med	Ladder to be installed	Low	Client advised	Outstanding	OH&S REGULATIONS 3.7 AS/NZS 16572013 3.1.4
126	Building: General Stores Location Reference: L115 Task: Access to the A/c unit

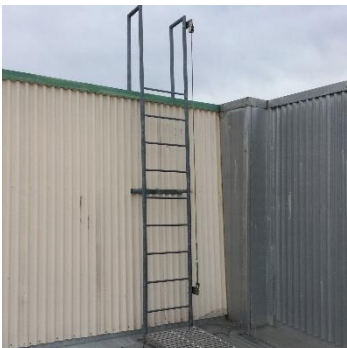
No slip resistance on ladder rungs and no handrails on top landing	Trips, Slips and Falls	Awareness induction	Med	Non-Slip high visibility safety yellow rung caps to be installed on existing ladders and handrail to be installed at access point	Low	Client advised	Outstanding	OH&S REGULATIONS 3.7 AS/NZS 16572013 3.1.3 & 5.4.1

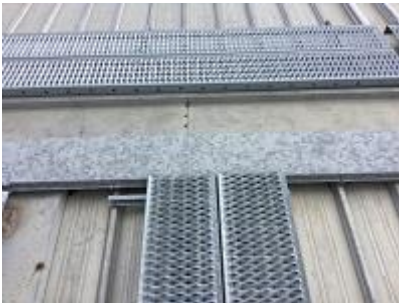
No	Photo of Hazard	Details of Hazard	Details of Risk	Existing/ Immediate Control Measure	Curre nt Risk Level	Proposed Permanent Solution	Resid ual Risk Asse ssme nt	Details of Action Taken	Status	Reference
137	Building: General Stores Location Reference: L16 Task: Access to the A/c unit

Gap between the walkway panels are greater than required maximum	Trips, Slips and Falls	Awareness induction	Med	Bridging platform to be installed between two walkway sections including high visibility safety yellow nosing's	Low	Client advised	Outstanding	OH&S REGULATIONS 3.7 AS/NZS 1657-2013 3.2.3.4

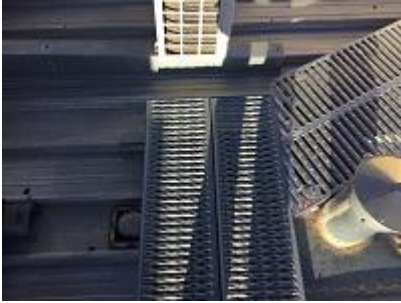
No safe access to the A/c unit	Trips, Slips and Falls	Awareness induction	Med	Additional walkway sections including high visibility safety yellow nosing to be installed	Low	Client advised	Outsta nding	OH&S REGULATIONS 3.7

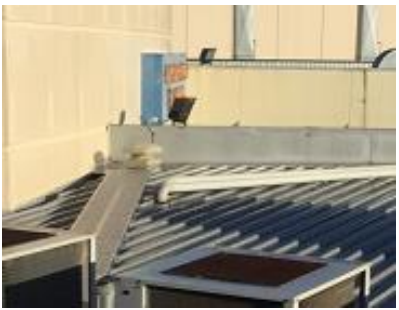
Walkway within 2m of fall edge	Trips, Slips and Falls	Awareness induction	Med	Handrails to be installed	Low	Client advised	Outstanding	OH&S REGULATIONS 3.7 AS/NZS 1657-2013 5.4.1

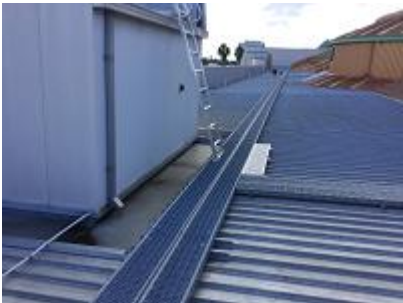
No	Photo of Hazard	Details of Hazard	Details of Risk	Existing/ Immediate Control Measure	Curre nt Risk Level	Proposed Permanent Solution	Resid ual Risk Asse sme nt	Details of Action Taken	Status	Reference
147	Building: General Stores Location Reference: L34 Task: Access to the roof

Landing is less than required minimum	Trips, Slips and Falls	Awareness induction	Med	Landing platform to be installed	Low	Client advised	Outstanding	OH&S REGULATIONS 3.7 AS/NZS 1657-2013 7.3.6

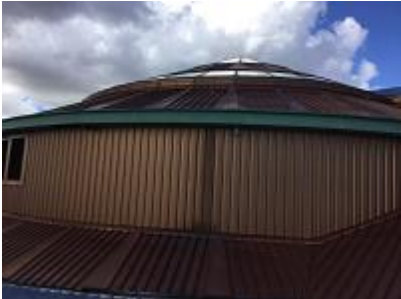
No	Photo of Hazard	Details of Hazard	Details of Risk	Existing/ Immediate Control Measure	Curre nt Risk Level	Proposed Permanent Solution	Resid ual Risk Asse sme nt	Details of Action Taken	Status	Reference
150	Building: General Stores Location Reference: L36 Task: Access to the roof

No height safety system installed	Trips, Slips and Falls	Awareness induction	High	Fall arrest anchors to be installed	Low	Client advised	Outstanding	OH&S REGULATIONS 3.55

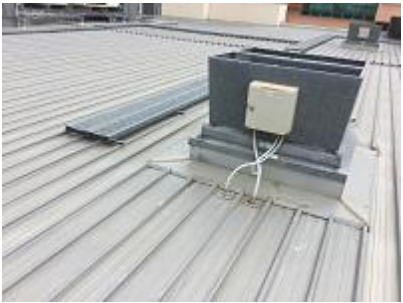
No safe access to the A/c unit	Trips, Slips and Falls	N/A	Low	Supply walkway to the A/c unit	Low	Client advised	Outstanding	-

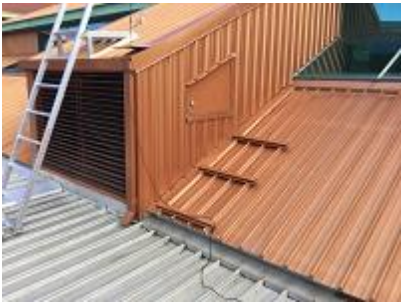
No	Photo of Hazard	Details of Hazard	Details of Risk	Existing/ Immediate Control Measure	Curre nt Risk Level	Proposed Permanent Solution	Resid ual Risk Asse ssme nt	Details of Action Taken	Status	Reference
164	Building: General Stores Location Reference: L63 Task: Access to the roof

No safe access to the door	Trips, Slips and Falls	Awareness induction	Med	Access platform and steps with handrail one side to be installed	Low	Client advised	Outstanding	OH&S REGULATIONS 3.7 AS/NZS 1657- 2013 3.1.4

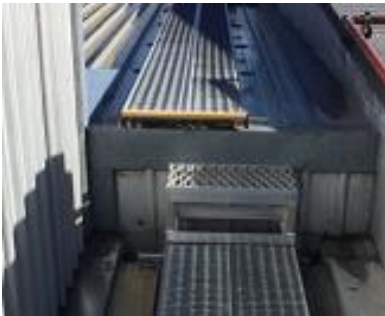
No	Photo of Hazard	Details of Hazard	Details of Risk	Existing/ Immediate Control Measure	Curre nt Risk Level	Proposed Permanent Solution	Resid ual Risk Asse sme nt	Details of Action Taken	Status	Reference
175	Building: General Stores Location Reference: L102 Task: Access to the roof

Walkway width at access point is less than required minimum	Trips, Slips and Falls	Awareness induction	Med	Additional walkway section to be installed	Low	Client advised	Outstanding	OH&S REGULATIONS 3.7 AS/NZS 1657-2013 5.1.3
176	Building: General Stores Location Reference: L99 Task: Access to the A/c units

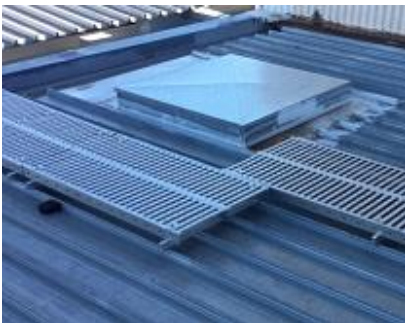
Walkway width is less than required minimum	Trips, Slips and Falls	Awareness induction	Med	Additional walkway section to be installed	Low	Client advised	Outstanding	OH&S REGULATIONS 3.7 AS/NZS 1657-2013 5.1.3

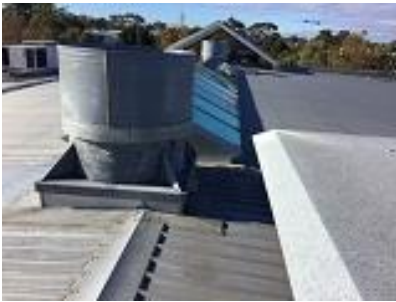
No	Photo of Hazard	Details of Hazard	Details of Risk	Existing/ Immediate Control Measure	Curre nt Risk Level	Proposed Permanent Solution	Resid ual Risk Asse ssme nt	Details of Action Taken	Status	Reference
179	Building: General Stores Location Reference: L106 Task: Access to the A/c units

No safe access to the A/c units	Trips, Slips and Falls	N/A	Low	Supply walkway to the A/c units	Low	Client advised	Outstanding	-
180	Building: General Stores Location Reference: L109 Task: Access to the A/c unit

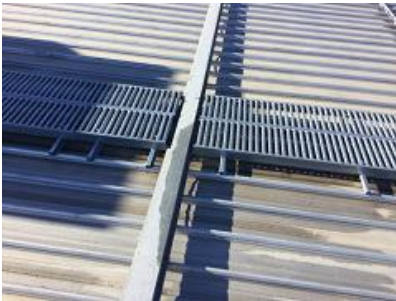
Gap between the walkway panels are greater than required maximum	Trips, Slips and Falls	Awareness induction	Med	Walkway bridge including high visibility safety yellow nosing's to be installed	Low	Client advised	Outstanding	OH&S REGULATIONS 3.7 AS/NZS 1657-2013 3.2.3.4

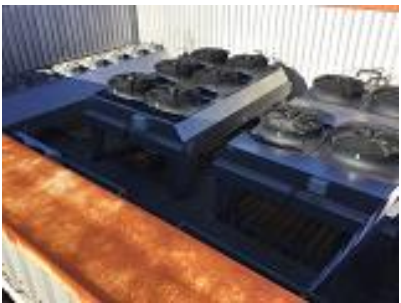
Variation in height between plant deck and unit is greater than required maximum	Trips, Slips and Falls	Awareness induction	Med	Midrails to units to be installed	Low	Client advised	Outstanding	OH&S REGULATIONS 3.7 AS/NZS 1657-2013 4.4

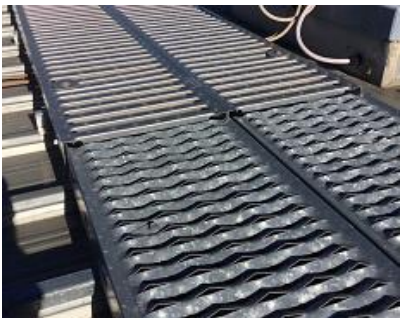
Variation in height between walkway panels are greater than required maximum	Trips, Slips and Falls	Awareness induction	Med	High visibility safety yellow nosing's to be installed	Low	Client advised	Outstanding	OH&S REGULATIONS 3.7 AS/NZS 1657-2018 3.3.4

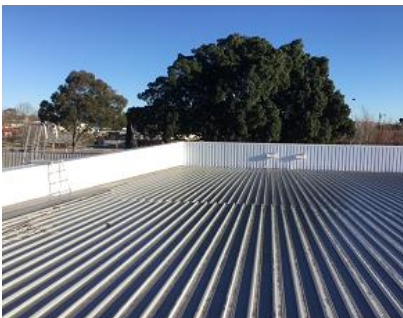
No safe access to the A/c units	Trips, Slips and Falls	N/A	Low	Supply walkway to the A/c units	Low	Client advised	Outstanding	-

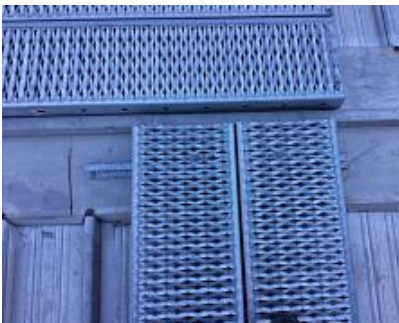
Gap between walkway panels are greater than required maximum	Trips, Slips and Falls	Awareness induction	Med	Walkway bridge and high visibility safety yellow nosing's to be installed	Low	Client advised	Outstanding	OH&S REGULATIONS 3.7 AS/NZS 1657-2018 3.2.3.4

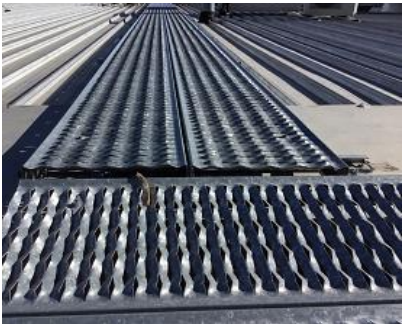
Variation in height between walkway panels are greater than required maximum	Trips, Slips and Falls	Awareness induction	Med	High visibility safety yellow nosing's to be installed	Low	Client advised	Outstanding	OH&S REGULATIONS 3.7 AS/NZS 1657-2018 3.3.4

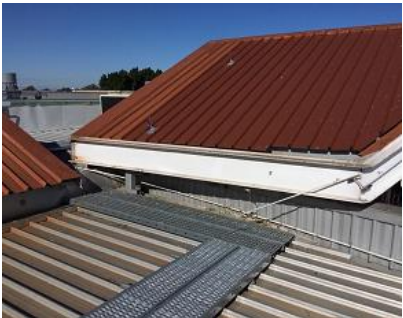
Variation in height between roofs are greater than required maximum	Trips, Slips and Falls	Awareness induction	Med	Access ladder to be installed	Low	Client advised	Outstanding	OH&S REGULATIONS 3.7 AS/NZS 1657-2018 3.1.4

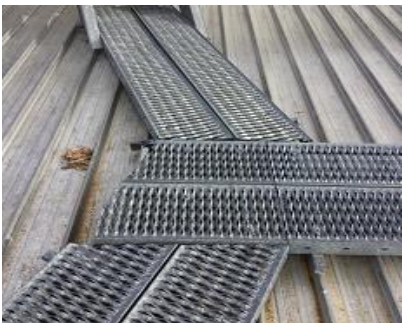
Variation in height between walkway panels are greater than required maximum	Trips, Slips and Falls	Awareness induction	Med	High visibility safety yellow nosing's to be installed	Low	Client advised	Outstanding	OH&S REGULATIONS 3.7 AS/NZS 1657-2018 3.3.4

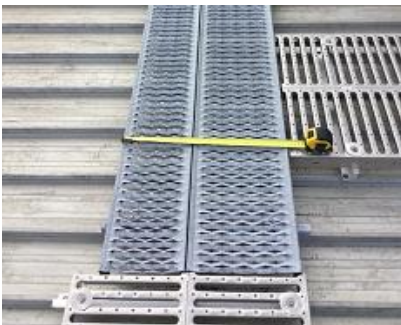
Walkway width is less than required minimum	Trips, Slips and Falls	Awareness induction	Med	Existing walkway to be removed and new walkway to be installed	Low	Client advised	Outstanding	OH&S REGULATIONS 3.7 AS/NZS 1657-2018 5.1.3

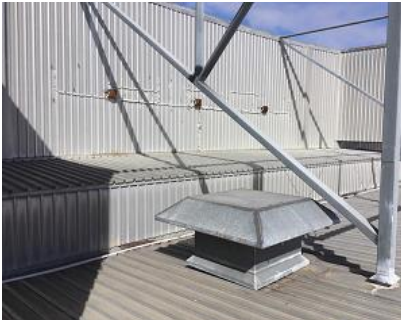
No safe access to the A/c units	Trips, Slips and Falls	N/A	Low	Supply walkway to the A/c units	Low	Client advised	Outstanding	-

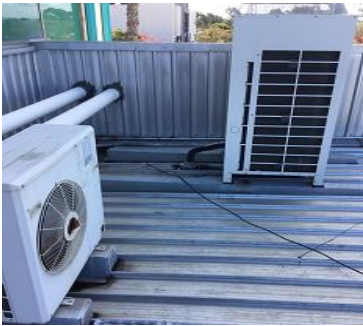
No	Photo of Hazard	Details of Hazard	Details of Risk	Existing/ Immediate Control Measure	Curre nt Risk Level	Proposed Permanent Solution	Resid ual Risk Asse sme nt	Details of Action Taken	Status	Reference
214	Building: General Stores Location Reference: L93 Task: Access to the A/c unit

No safe access to the A/c units	Trips, Slips and Falls	N/A	Low	Supply walkway to the A/c units	Low	Client advised	Outstanding	-
215	Building: General Stores Location Reference: L92 Task: Access to the roof

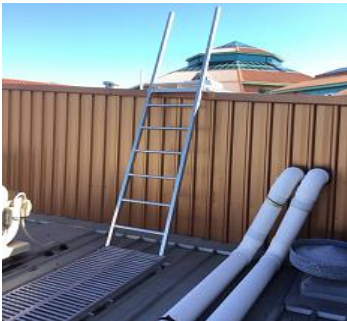
Bottom rung height is less than required minimum and top rung not levelled with landing	Trips, Slips and Falls	Awareness induction	Med	Existing ladder to be re-installed with landing platforms and brackets	Low	Client advised	Outstanding	OH&S REGULATIONS 3.7 AS/NZS 1657-2018 7.4.3.4 & 7.4.3.3

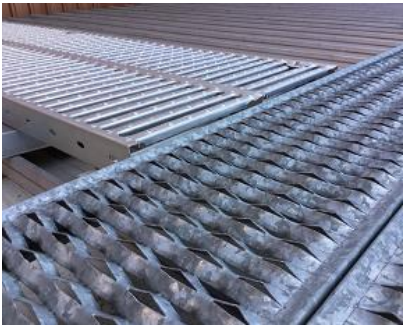
No	Photo of Hazard	Details of Hazard	Details of Risk	Existing/ Immediate Control Measure	Curre nt Risk Level	Proposed Permanent Solution	Resid ual Risk Asse ssme nt	Details of Action Taken	Status	Reference
216	Building: General Stores Location Reference: L92 Task: Access to the roof

Variation in height between walkway panels are greater than required maximum	Trips, Slips and Falls	Awareness induction	Med	High visibility safety yellow nosing's to be installed	Low	Client advised	Outstanding	OH&S REGULATIONS 3.7 AS/NZS 1657-2018 3.3.4
217	Building: General Stores Location Reference: L92 Task: Access to the roof

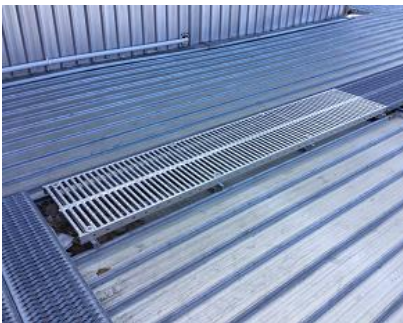
Gap between walkway panels are greater than required maximum	Trips, Slips and Falls	Awareness induction	Med	Checker plate to be installed	Low	Client advised	Outstanding	OH&S REGULATIONS 3.7 AS/NZS 1657-2018 3.2.3.4

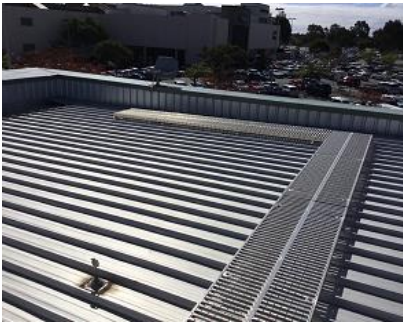
Gap between walkway and fall edge is less than required minimum	Trips, Slips and Falls	Awareness induction	Med	"Safety Harness to be attached to anchor point" sign to be installed	Low	Client advised	Outstanding	OH&S REGULATIONS 3.7 AS/NZS 1657-2018 5.4.1
219	Building: General Stores Location Reference: L94 Task: Access to the roof

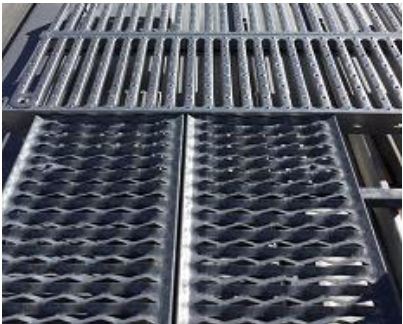
Variation in height between walkway panels are greater than required maximum	Trips, Slips and Falls	Awareness induction	Med	High visibility safety yellow nosing's to be installed	Low	Client advised	Outstanding	OH&S REGULATIONS 3.7 AS/NZS 1657-2018 3.3.4

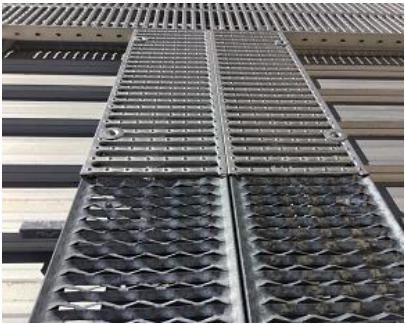
Variation in height between walkway panels are greater than required maximum	Trips, Slips and Falls	Awareness induction	Med	High visibility safety yellow nosing's to be installed	Low	Client advised	Outstanding	OH&S REGULATIONS 3.7 AS/NZS 1657-2018 3.3.4
221	Building: General Stores Location Reference: L96 Task: Access to the roof

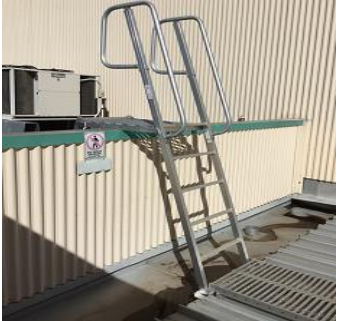
Bottom rung heights are less than required minimum, landing is less than required minimum and handrail projecting towards the user	Trips, Slips and Falls	Awareness induction	Med	Existing ladder to be removed and new ladder to be installed	Low	Client advised	Outstanding	OH&S REGULATIONS 3.7 AS/NZS 1657-2018 7.4.3.4, 7.3.6 & 7.4.8.5

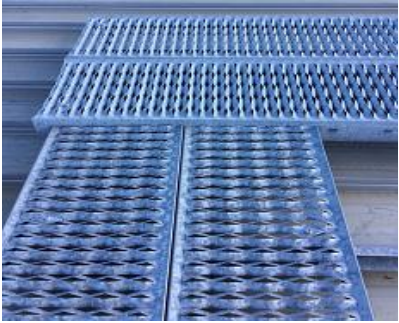
Variation in height between walkway panels are greater than required maximum	Trips, Slips and Falls	Awareness induction	Med	High visibility safety yellow nosing's to be installed	Low	Client advised	Outstanding	OH&S REGULATIONS 3.7 AS/NZS 1657-2018 3.3.4
22 3	Building: General Stores Location Reference: L98 Task: Access to the roof
