Roof Safety Report

Galleria, WA 6062

Prepared By: Safemaster Safety Products
Date: 08-09-2020

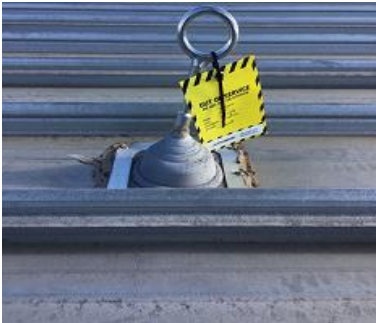
Damaged anchor points(x2) are present	Trips, Slips and Falls	Awareness induction	High	New anchor points to be installed	Low	Client advised	Outstanding	OH&S REGULATIONS 3.55

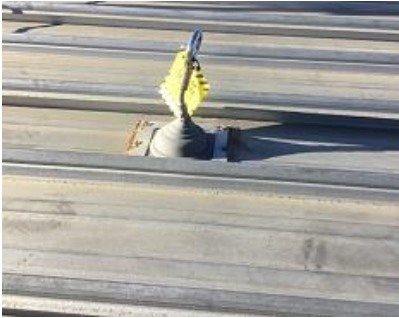
Damaged anchor points(x2) are present	Trips, Slips and Falls	Awareness induction	High	New anchor points to be installed	Low	Client advised	Outsta nding	OH&S REGULATIONS 3.55
22 5	Building: General Stores Location Reference: L100 Task: Access to the roof

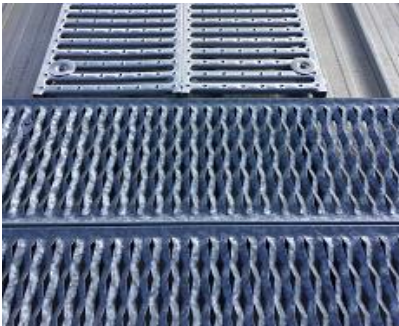
Variation in height between walkway panels are greater than required maximum	Trips, Slips and Falls	Awareness induction	Med	High visibility safety yellow nosing's to be installed	Low	Client advised	Outsta nding	OH&S REGULATIONS 3.7 AS/NZS 1657- 2018 3.3.4

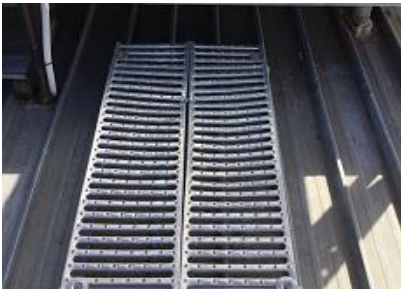
Damaged walkway is present	Trips, Slips and Falls	Awareness induction	Med	Damaged walkway section to be replaced	Low	Client advised	Outstanding	OH&S REGULATIONS 3.7

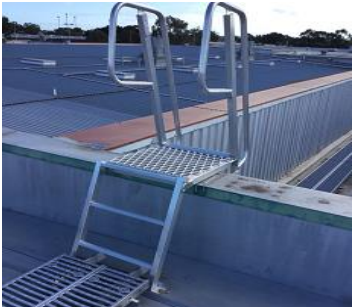
Bottom rung heights are less than required minimum, landing is less than required minimum and handrail projecting towards the user	Trips, Slips and Falls	Awareness induction	Med	Existing ladder to be removed and new ladder to be installed	Low	Client advised	Outstanding	OH&S REGULATIONS 3.7 AS/NZS 1657-2018 7.4.3.4, 7.3.6 & 7.4.8.5

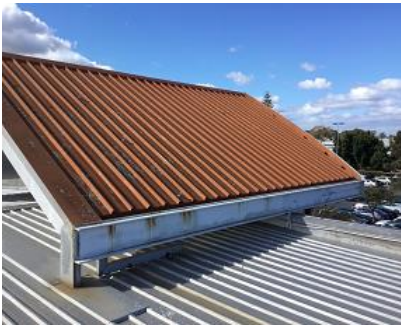
No safe access to the anchors	Trips, Slips and Falls	Awareness induction	Med	Access ladder to be installed	Low	Client advised	Outstanding	OH&S REGULATIONS 3.7 AS/NZS 1657-2018 3.1.4
231	Building: General Stores Location Reference: L109 Task: Access to the roof

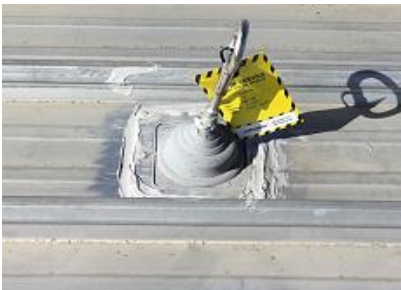
Damaged anchor point (x1) is present	Trips, Slips and Falls	Awareness induction	High	New anchor point to be installed	Low	Client advised	Outstanding	OH&S REGULATIONS 3.55

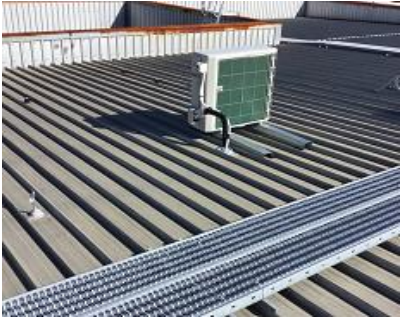
No safe access to the A/c units	Trips, Slips and Falls	N/A	Low	Supply walkway to the A/c units	Low	Client advised	Outstanding	-
23 3	Building: General Stores Location Reference: L110 Task: Access to the roof

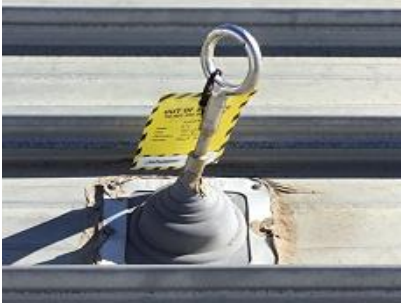
Damaged anchor point (x1) is present	Trips, Slips and Falls	Awareness induction	High	New anchor point to be installed	Low	Client advised	Outstanding	OH&S REGULATIONS 3.55

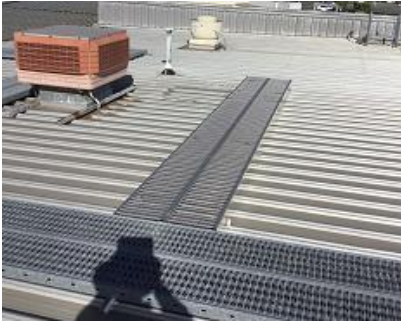
No safe access to the A/c units	Trips, Slips and Falls	N/A	Low	Supply walkway to the A/c units	Low	Client advised	Outstanding	-
23 5	Building: General Stores Location Reference: L114 Task: Access to the roof

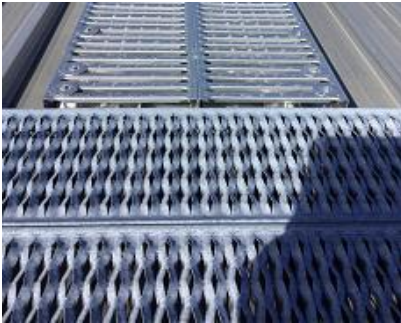
Variation in height between walkway panels are greater than required maximum	Trips, Slips and Falls	Awareness induction	Med	High visibility safety yellow nosing's to be installed	Low	Client advised	Outstanding	OH&S REGULATIONS 3.7 AS/NZS 1657-2018 3.3.4

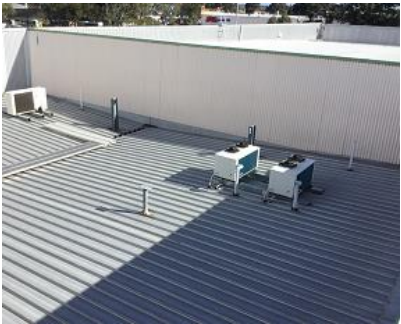
No safe access to the A/c units	Trips, Slips and Falls	N/A	Low	Supply walkway to the A/c units	Low	Client advised	Outstanding	-
23 7	Building: General Stores Location Reference: L118 Task: Access to the roof

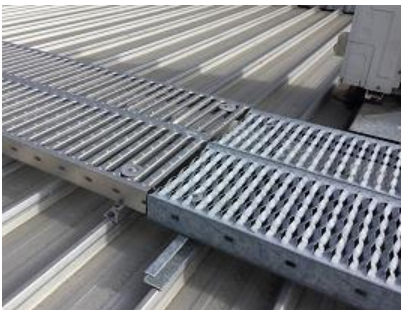
Variation in height between walkway panels are greater than required maximum	Trips, Slips and Falls	Awareness induction	Med	High visibility safety yellow nosing's to be installed	Low	Client advised	Outstanding	OH&S REGULATIONS 3.7 AS/NZS 1657-2018 3.3.4

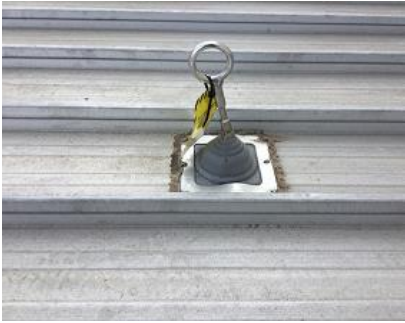
Damaged anchor point (x1) is present	Trips, Slips and Falls	Awareness induction	High	New anchor point to be installed	Low	Client advised	Outstanding	OH&S REGULATIONS 3.55
23 9	Building: General Stores Location Reference: L88 Task: Access to the roof

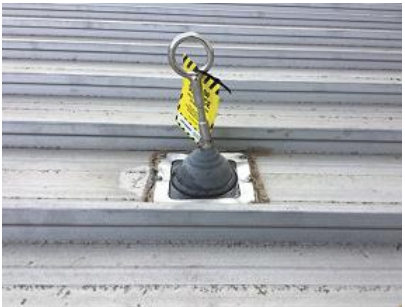
Damaged anchor point (x1) is present	Trips, Slips and Falls	Awareness induction	High	New anchor point to be installed	Low	Client advised	Outstanding	OH&S REGULATIONS 3.55

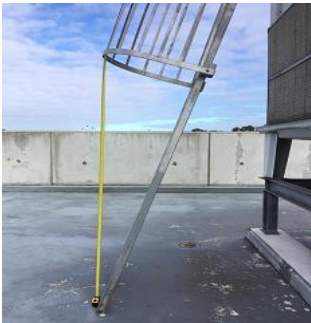
Ladder cage height is greater than required maximum and bottom rung height is greater than required maximum	Trips, Slips and Falls	Awareness induction	Med	Cage and landing at base including handrail to be installed	Low	Client advised	Outstanding	OH&S REGULATIONS 3.7 AS/NZS 1657-2018 7.4.7 & 7.4.3.4
241	Building: General Stores Location Reference: L81 Task: Access to the roof

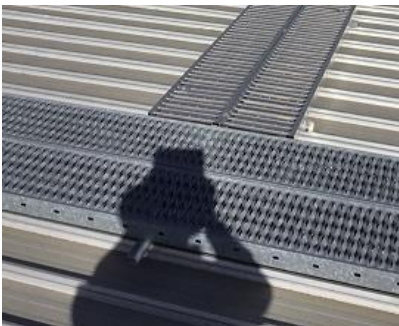
Variation in height between walkway panels are greater than required maximum	Trips, Slips and Falls	Awareness induction	Med	High visibility safety yellow nosing's to be installed	Low	Client advised	Outstanding	OH&S REGULATIONS 3.7 AS/NZS 1657-2018 3.3.4

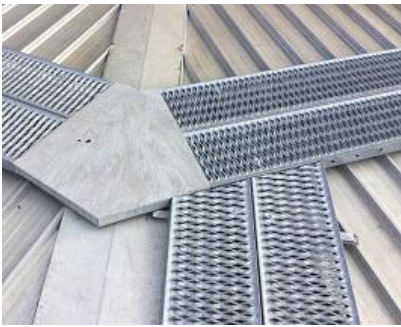
Variation in height between walkway panels are greater than required maximum	Trips, Slips and Falls	Awareness induction	Med	Checker plate for junction and High visibility safety yellow nosing's to be installed	Low	Client advised	Outstanding	OH&S REGULATIONS 3.7 AS/NZS 1657-2018 3.3.4
24 3	Building: General Stores Location Reference: L82 Task: Access to the roof

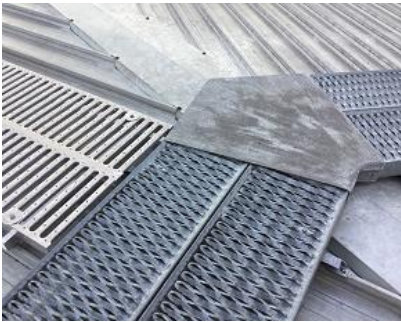
Variation in height between walkway panels are greater than required maximum	Trips, Slips and Falls	Awareness induction	Med	Checker plate for junction and High visibility safety yellow nosing's to be installed	Low	Client advised	Outstanding	OH&S REGULATIONS 3.7 AS/NZS 1657-2018 3.3.4

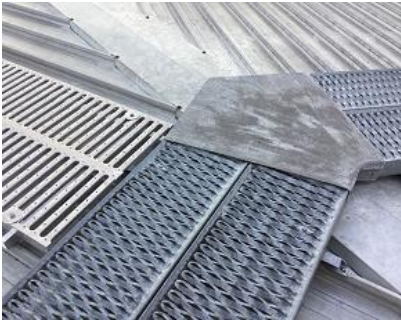
Variation in height between walkway panels are greater than required maximum	Trips, Slips and Falls	Awareness induction	Med	Checker plate for junction and High visibility safety yellow nosing's to be installed	Low	Client advised	Outsta nding	OH&S REGULATIONS 3.7 AS/NZS 1657- 2018 3.3.4
24 5	Building: General Stores Location Reference: L68 Task: Access to the roof

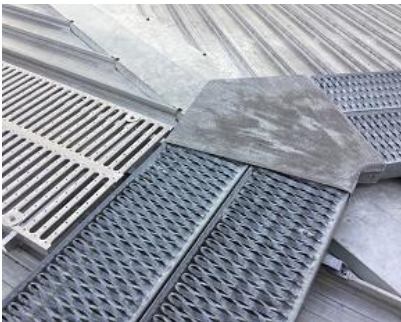
Variation in height between walkway panels are greater than required maximum	Trips, Slips and Falls	Awareness induction	Med	Checker plate for junction and High visibility safety yellow nosing's to be installed	Low	Client advised	Outsta nding	OH&S REGULATIONS 3.7 AS/NZS 1657- 2018 3.3.4

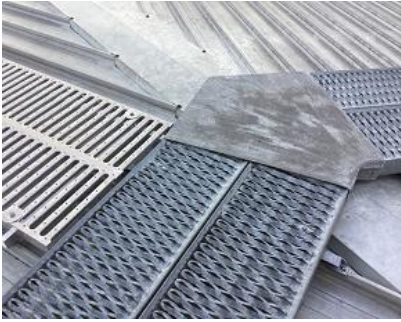
Variation in height between walkway panels are greater than required maximum	Trips, Slips and Falls	Awareness induction	Med	Checker plate for junction and High visibility safety yellow nosing's to be installed	Low	Client advised	Outstanding	OH&S REGULATIONS 3.7 AS/NZS 1657-2018 3.3.4
24 7	Building: General Stores Location Reference: L79 Task: Access to the roof

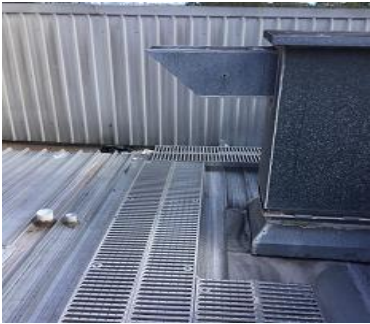
Duct protruding over the walkway path	Trips, Slips and Falls	Awareness induction	Med	Additional walkway section to be installed	Low	Client advised	Outstanding	OH&S REGULATIONS 3.7 AS/NZS 1657-2018 3.1.5

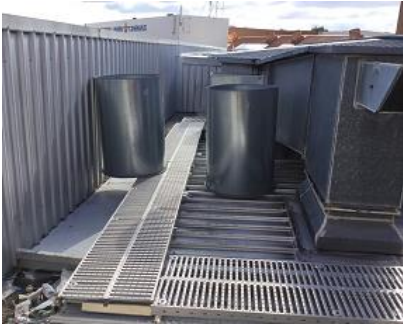
Variation in height between walkway and adjacent surface is greater than required maximum	Trips, Slips and Falls	Awareness induction	Med	Walkway to be re-installed with handrail and additional walkway sections	Low	Client advised	Outstanding	OH&S REGULATIONS 3.7 AS/NZS 1657-2018 5.4.1
24 9	Building: General Stores Location Reference: L122 Task: Access to the roof

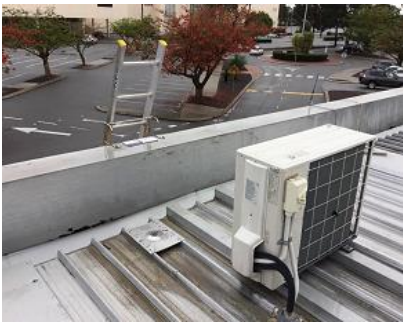
No safe access to the roof	Trips, Slips and Falls	Awareness induction	Med	Ladder dock and mini ladder including landing platforms and handrail to be installed	Low	Client advised	Outstanding	OH&S REGULATIONS 3.7 AS/NZS 1657-2018 3.1.4

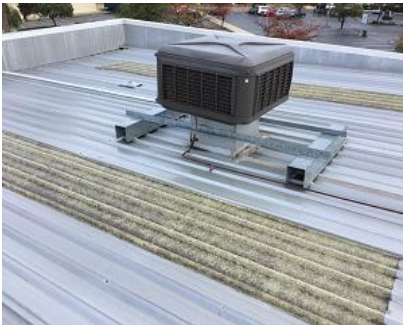
Brittle roof sections are present and no safe access around A/c units	Trips, Slips and Falls	Awareness induction	High	Brittle and Fragile roof signs including handrail around A/c units to be installed	Low	Client advised	Outstanding	OH&S REGULATIONS 3.57 & 3.7

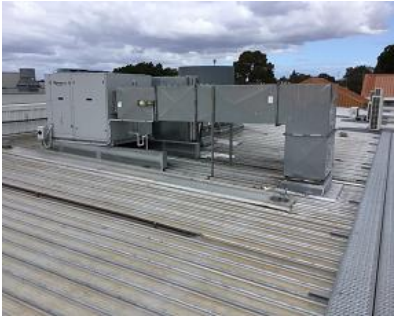
No safe access to the A/c units	Trips, Slips and Falls	N/A	Low	Supply walkway to the A/c units	Low	Client advised	Outstanding	-
252	Building: General Stores Location Reference: L62 Task: Access to the roof

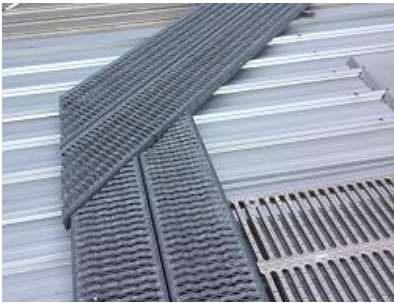
Walkway damaged	Trips, Slips and Falls	Awareness induction	Med	Walkway to be replaced and high vis nosing's to be installed	Low	Client advised	Outstanding	OH&S REGULATIONS 3.7 AS/NZS 1657-2018 3.3.4

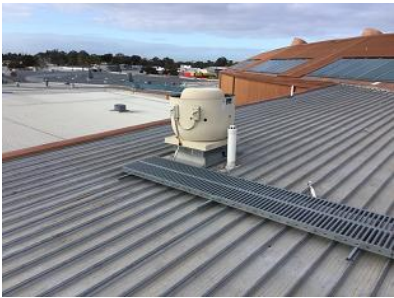
Walkway too close to the fall edge	Trips, Slips and Falls	Awareness induction	Med	Handrail to be installed	Low	Client advised	Outstanding	OH&S REGULATIONS 3.7 AS/NZS 1657-2018 5.4.1
25 4	Building: General Stores Location Reference: L12 Task: Access to the roof

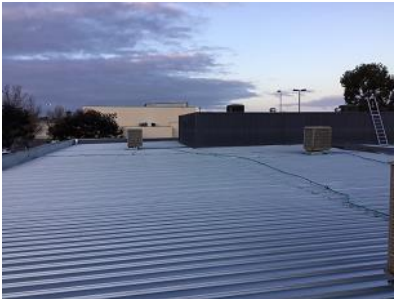
Anchors not re-installed since re-roofed	Trips, Slips and Falls	Awareness induction	High	7x Anchors to be installed	Low	Client advised	Outstanding	OH&S REGULATIONS 3.55
