Roof Safety Report

Galleria, WA 6062

Prepared By: Safemaster Safety Products
Date: 20-August-2018

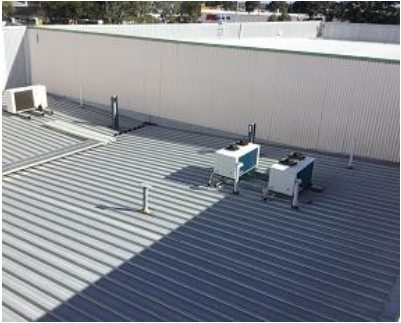
No	Photo of Hazard	Details of Hazard	Details of Risk	Existing/ Immediate Control Measure	Curren t Risk Level	Proposed Permanent Solution	Residu al Risk Assess ment	Details of Action Taken	Status	Reference
23 6	Building: General Stores Location Reference: L115 Task: Access to the A/c units

No safe access to the A/c units	Trips, Slips and Falls	N/A	Low	Supply walkway to the A/c units	Low	Client advised	Outstanding	-
23 7	Building: General Stores Location Reference: L118 Task: Access to the roof

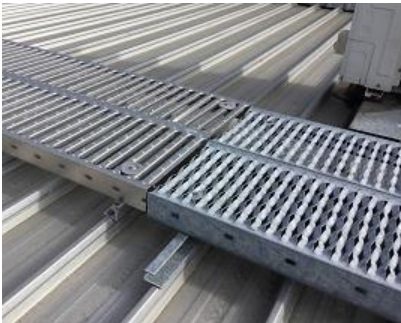
Variation in height between walkway panels are greater than required maximum	Trips, Slips and Falls	Awareness induction	Med	High visibility safety yellow nosing's to be installed	Low	Client advised	Outstanding	OH&S REGULATIONS 3.7 AS/NZS 1657-2018 3.3.4

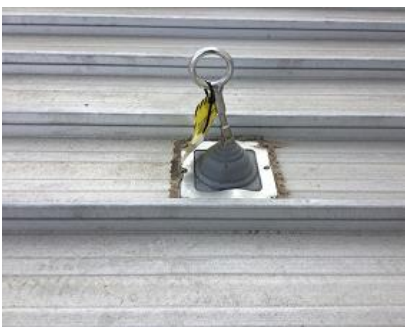
No	Photo of Hazard	Details of Hazard	Details of Risk	Existing/ Immediate Control Measure	Curren t Risk Level	Proposed Permanent Solution	Residu al Risk Assess ment	Details of Action Taken	Status	Reference
23 8	Building: General Stores Location Reference: L88 Task: Access to the roof

260	Anchor Point-Purlin Fix-21kN	Safemaster	L88	1/04/2014	20/07/2018	20/07/2019	AS1891.4:2009	Fail	Anchor is bent
261	Anchor Point-Surface Mount-15kN	Safemaster	L88	1/02/2018	20/07/2018	20/07/2019	AS1891.4:2009	Pass	
262	Anchor Point-Purlin Fix-21kN	Safemaster	L88	1/04/2014	20/07/2018	20/07/2019	AS1891.4:2009	Fail	Anchor is bent
263	Anchor Point-Surface Mount-15kN	Safemaster	L88	1/02/2018	20/07/2018	20/07/2019	AS1891.4:2009	Pass	
264	Anchor Point-Purlin Fix-21kN	Safemaster	L88	1/04/2014	20/07/2018	20/07/2019	AS1891.4:2009	Pass

Damaged anchor point (x1) is present	Trips, Slips and Falls	Awareness induction	High	New anchor point to be installed	Low	Client advised	Outstanding	OH&S REGULATIONS 3.55
23 9	Building: General Stores Location Reference: L88 Task: Access to the roof

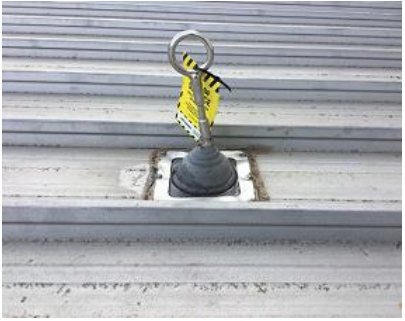
Damaged anchor point (x1) is present	Trips, Slips and Falls	Awareness induction	High	New anchor point to be installed	Low	Client advised	Outstanding	OH&S REGULATIONS 3.55

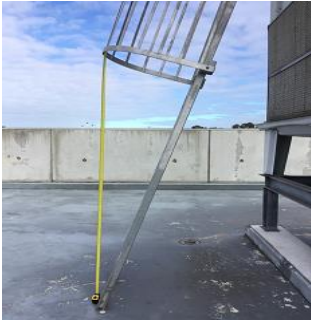
No	Photo of Hazard	Details of Hazard	Details of Risk	Existing/ Immediate Control Measure	Curren t Risk Level	Proposed Permanent Solution	Residu al Risk Assess ment	Details of Action Taken	Status	Reference
240	Building: General Stores Location Reference: L86 Task: Access to the roof

Ladder cage height is greater than required maximum and bottom rung height is greater than required maximum	Trips, Slips and Falls	Awareness induction	Med	Cage and landing at base including handrail to be installed	Low	Client advised	Outstanding	OH&S REGULATIONS 3.7 AS/NZS 1657-2018 7.4.7 & 7.4.3.4
241	Building: General Stores Location Reference: L81 Task: Access to the roof

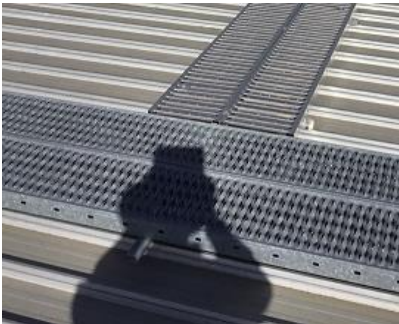
Variation in height between walkway panels are greater than required maximum	Trips, Slips and Falls	Awareness induction	Med	High visibility safety yellow nosing's to be installed	Low	Client advised	Outstanding	OH&S REGULATIONS 3.7 AS/NZS 1657-2018 3.3.4

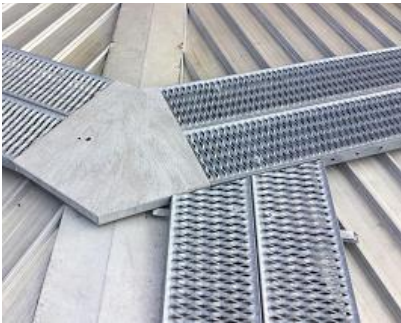
No	Photo of Hazard	Details of Hazard	Details of Risk	Existing/ Immediate Control Measure	Curren t Risk Level	Proposed Permanent Solution	Residu al Risk Assess ment	Details of Action Taken	Status	Reference
24 2	Building: General Stores Location Reference: L.64 Task: Access to the roof

Variation in height between walkway panels are greater than required maximum	Trips, Slips and Falls	Awareness induction	Med	Checker plate for junction and High visibility safety yellow nosing's to be installed	Low	Client advised	Outstanding	OH&S REGULATIONS 3.7 AS/NZS 1657-2018 3.3.4
24 3	Building: General Stores Location Reference: L.82 Task: Access to the roof

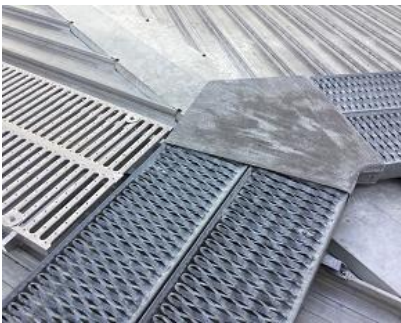
Variation in height between walkway panels are greater than required maximum	Trips, Slips and Falls	Awareness induction	Med	Checker plate for junction and High visibility safety yellow nosing's to be installed	Low	Client advised	Outstanding	OH&S REGULATIONS 3.7 AS/NZS 1657-2018 3.3.4

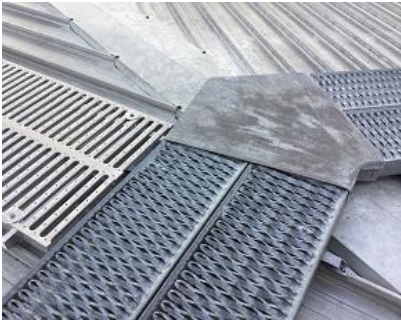
No	Photo of Hazard	Details of Hazard	Details of Risk	Existing/ Immediate Control Measure	Curren t Risk Level	Proposed Permanent Solution	Residu al Risk Assess ment	Details of Action Taken	Status	Reference
24 4	Building: General Stores Location Reference: L71 Task: Access to the roof

Variation in height between walkway panels are greater than required maximum	Trips, Slips and Falls	Awareness induction	Med	Checker plate for junction and High visibility safety yellow nosing's to be installed	Low	Client advised	Outsta nding	OH&S REGULATIONS 3.7 AS/NZS 1657- 2018 3.3.4
24 5	Building: General Stores Location Reference: L68 Task: Access to the roof

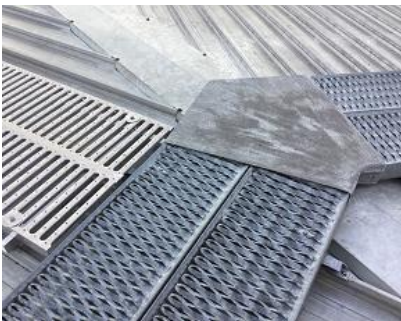
Variation in height between walkway panels are greater than required maximum	Trips, Slips and Falls	Awareness induction	Med	Checker plate for junction and High visibility safety yellow nosing's to be installed	Low	Client advised	Outsta nding	OH&S REGULATIONS 3.7 AS/NZS 1657- 2018 3.3.4

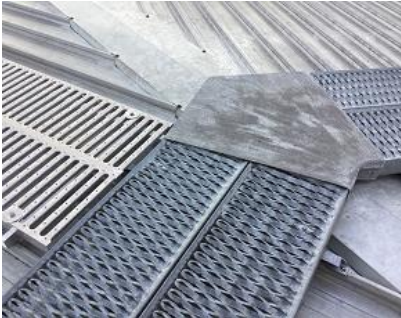
No	Photo of Hazard	Details of Hazard	Details of Risk	Existing/ Immediate Control Measure	Curren t Risk Level	Proposed Permanent Solution	Residu al Risk Assess ment	Details of Action Taken	Status	Reference
24 6	Building: General Stores Location Reference: L68 Task: Access to the roof

Variation in height between walkway panels are greater than required maximum	Trips, Slips and Falls	Awareness induction	Med	Checker plate for junction and High visibility safety yellow nosing's to be installed	Low	Client advised	Outsta nding	OH&S REGULATIONS 3.7 AS/NZS 1657- 2018 3.3.4
24 7	Building: General Stores Location Reference: L79 Task: Access to the roof

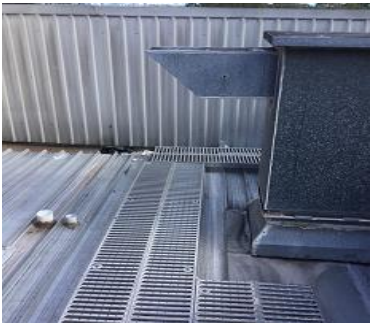
Duct protruding over the walkway path	Trips, Slips and Falls	Awareness induction	Med	Additional walkway section to be installed	Low	Client advised	Outsta nding	OH&S REGULATIONS 3.7 AS/NZS 1657- 2018 3.1.5

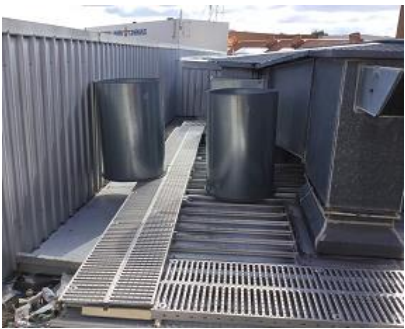
No	Photo of Hazard	Details of Hazard	Details of Risk	Existing/ Immediate Control Measure	Curren t Risk Level	Proposed Permanent Solution	Residu al Risk Assess ment	Details of Action Taken	Status	Reference
24 8	Building: General Stores Location Reference: L79 Task: Access to the roof

Variation in height between walkway and adjacent surface is greater than required maximum	Trips, Slips and Falls	Awareness induction	Med	Walkway to be re-installed with handrail and additional walkway sections	Low	Client advised	Outstanding	OH&S REGULATIONS 3.7 AS/NZS 1657-2018 5.4.1
24 9	Building: General Stores Location Reference: L122 Task: Access to the roof

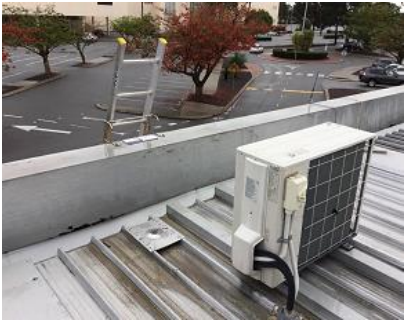
No safe access to the roof	Trips, Slips and Falls	Awareness induction	Med	Ladder dock and mini ladder including landing platforms and handrail to be installed	Low	Client advised	Outstanding	OH&S REGULATIONS 3.7 AS/NZS 1657-2018 3.1.4

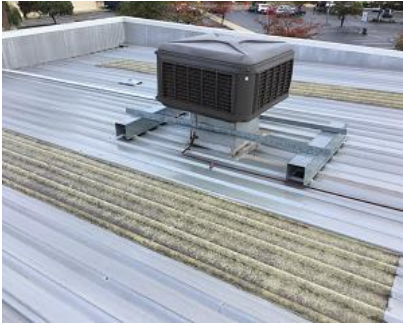
No	Photo of Hazard	Details of Hazard	Details of Risk	Existing/ Immediate Control Measure	Curren t Risk Level	Proposed Permanent Solution	Residu al Risk Assess ment	Details of Action Taken	Status	Reference
25 0	Building: General Stores Location Reference: L122 Task: Access to the roof

Brittle roof sections are present and no safe access around A/c units	Trips, Slips and Falls	Awareness induction	High	Brittle and Fragile roof signs including handrail around A/c units to be installed	Low	Client advised	Outstanding	OH&S REGULATIONS 3.57 & 3.7
