Roof Safety Report

**Gateway Plaza Leopold,
VIC 3224**

Prepared By: Safemaster Safety Products
Date: 26 February 2018

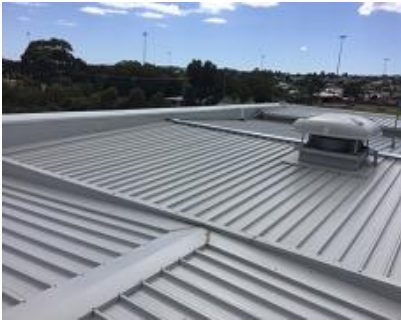
No height safety system installed	Trips, Slips and Falls	Awareness induction	High	Fall arrest anchors to be installed	Low	Client advised	Outstanding	OH&S REGULATIONS 3.55

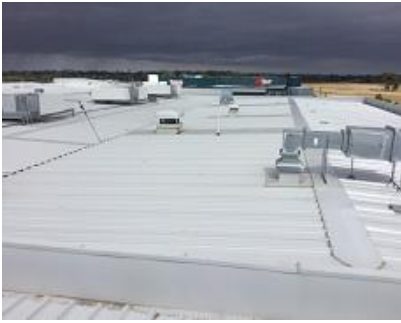
No safe access to the A/c units	Trips, Slips and Falls	N/A	Low	Supply walkway and handrail to the A/c units	Low	Client advised	Outstanding	-

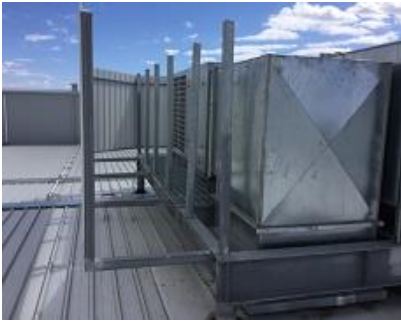
Variation in height between plant deck and roof is greater than required maximum	Trips, Slips and Falls	Awareness induction	Med	Handrails to be installed	Low	Client advised	Outstanding	OH&S REGULATIONS 3.7 AS/NZS 1657-2013 4.4

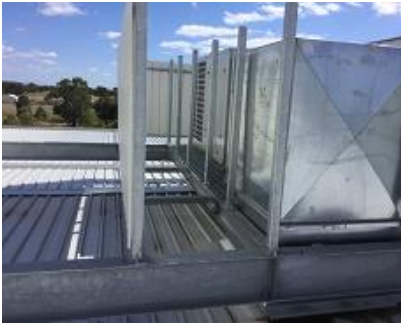
Variation in height between plant deck and roof is greater than required maximum	Trips, Slips and Falls	Awareness induction	Med	Handrails to be installed	Low	Client advised	Outstanding	OH&S REGULATIONS 3.7 AS/NZS 1657-2013 4.4

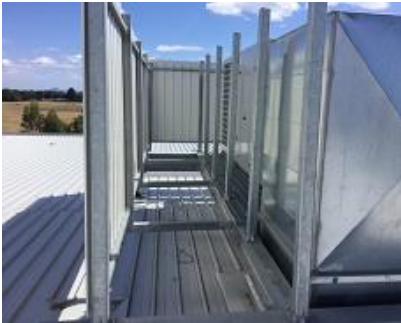
Variation in height between plant deck and roof is greater than required maximum	Trips, Slips and Falls	Awareness induction	Med	Handrails to be installed	Low	Client advised	Outstanding	OH&S REGULATIONS 3.7 AS/NZS 1657-2013 4.4

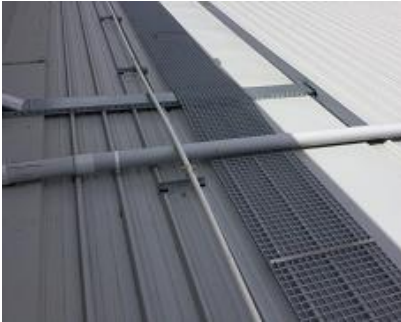
Pipe installed over the walkway path	Trips, Slips and Falls	Awareness induction	Med	Step bridge to be installed	Low	Client advised	Outstanding	OH&S REGULATIONS 3.7 AS/NZS 1657-2013 3.1.4

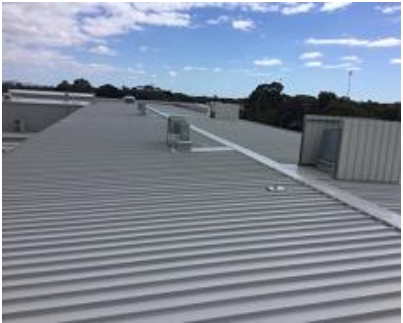
No safe access to the A/c units	Trips, Slips and Falls	N/A	Low	Supply walkway to the A/c units	Low	Client advised	Outstanding	-

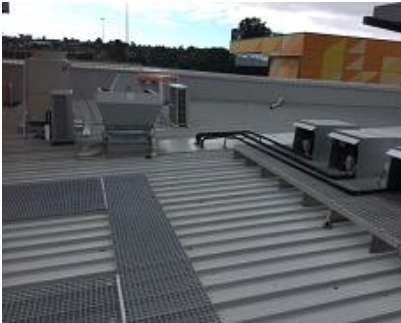
No safe access to the A/c units	Trips, Slips and Falls	N/A	Low	Supply walkway to the A/c units	Low	Client advised	Outstanding	-

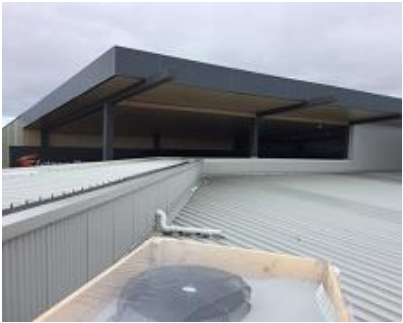
No height safety system installed	Trips, Slips and Falls	Awareness induction	High	Fall arrest anchors to be installed	Low	Client advised	Outstanding	OH&S REGULATIONS 3.55

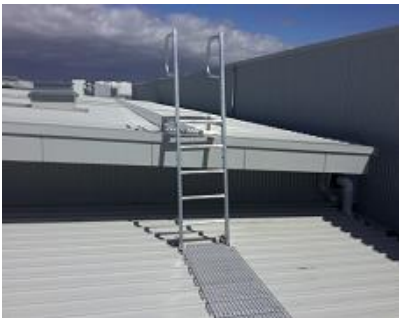
Top rung not levelled with landing	Trips, Slips and Falls	Awareness induction	Med	Existing ladder to be re-installed with new brackets and landing platform	Low	Client advised	Outstanding	OH&S REGULATIONS 3.7 AS/NZS 1657-2013 7.4.3.3

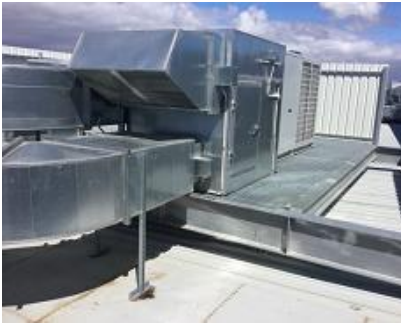
Variation in height between plant deck and roof is greater than required maximum	Trips, Slips and Falls	Awareness induction	Med	Handrails to be installed	Low	Client advised	Outstanding	OH&S REGULATIONS 3.7 AS/NZS 1657-2013 4.4

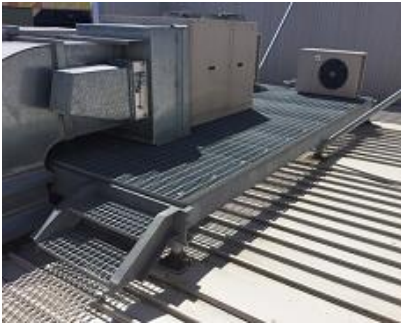
Non-complaint stair is present	Trips, Slips and Falls	Awareness induction	Med	Existing stair to be removed and new ladder to be installed	Low	Client advised	Outstanding	OH&S REGULATIONS 3.7 AS/NZS 1657-2013 7.2

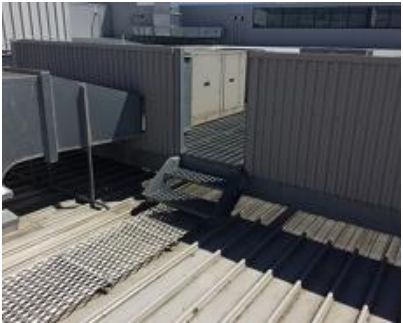
Non-complaint stair is present	Trips, Slips and Falls	Awareness induction	Med	Existing stair to be removed and new ladder to be installed	Low	Client advised	Outstanding	OH&S REGULATIONS 3.7 AS/NZS 1657-2013 7.2

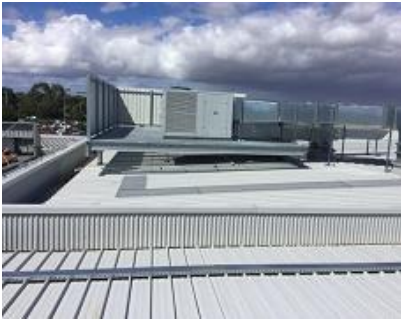
Variation in height between plant deck and roof is greater than required maximum	Trips, Slips and Falls	Awareness induction	Med	Access ladder and guardrails to be installed	Low	Client advised	Outstanding	OH&S REGULATIONS 3.7 AS/NZS 1657-2013 3.1.4 & 4.4

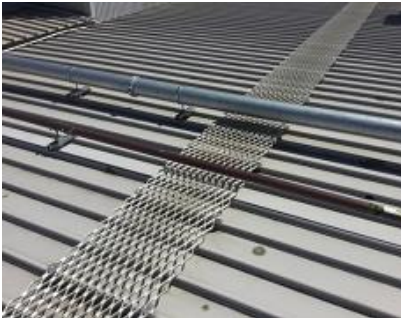
Pipes installed over the walkway path	Trips, Slips and Falls	Awareness induction	Med	Step bridge including handrail to be installed	Low	Client advised	Outstanding	OH&S REGULATIONS 3.7 AS/NZS 1657-2013 3.1.4

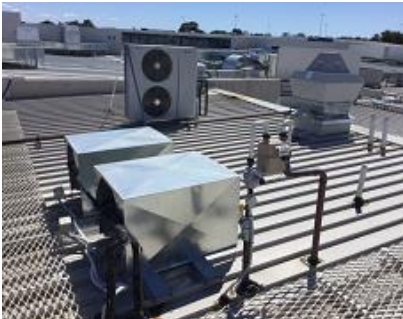
No safe access to the A/c units	Trips, Slips and Falls	N/A	Low	Supply walkway and handrail to the A/c units	Low	Client advised	Outstanding	-

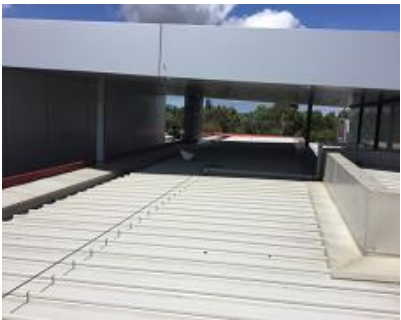
Static line is out of date and head room is less than required minimum	Trips, Slips and Falls	Awareness induction	Med	Existing static line to be removed and new static line including "Low-Headroom" signs to be installed	Low	Client advised	Outstanding	OH&S REGULATIONS 3.7 & 3.55 AS/NZS 1657-2013 3.1.5

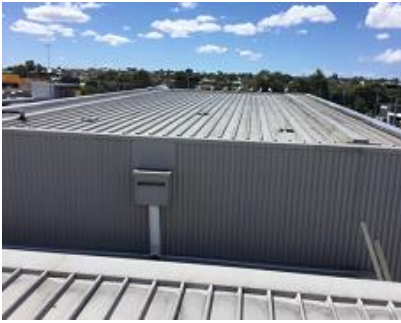
No height safety system installed	Trips, Slips and Falls	Awareness induction	High	Fall arrest anchors to be installed	Low	Client advised	Outstanding	OH&S REGULATIONS 3.55

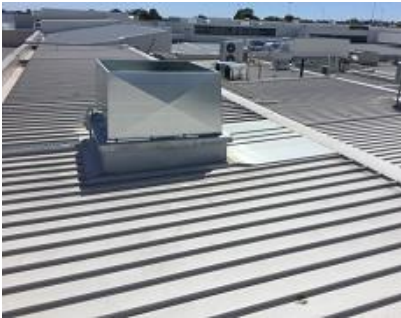
Variation in height between roofs are greater than required maximum	Trips, Slips and Falls	Awareness induction	Med	Access ladder to be installed	Low	Client advised	Outstanding	OH&S REGULATIONS 3.7 AS/NZS 1657-2013 3.1.4

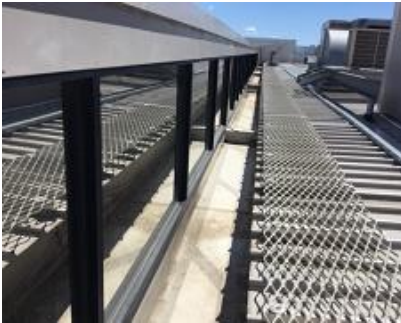
Variation in height between walkway and adjacent area is greater than required maximum	Trips, Slips and Falls	Awareness induction	Med	Existing walkway to be re-installed with handrails	Low	Client advised	Outstanding	OH&S REGULATIONS 3.7 AS/NZS 1657-2013 4.4

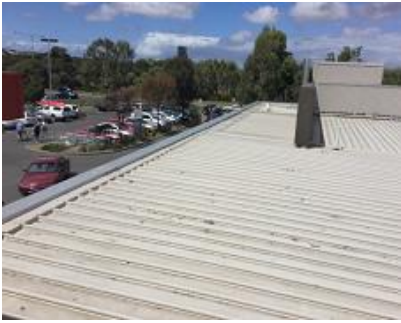
No height safety system installed	Trips, Slips and Falls	Awareness induction	High	Fall arrest anchors to be installed	Low	Client advised	Outstanding	OH&S REGULATIONS 3.55

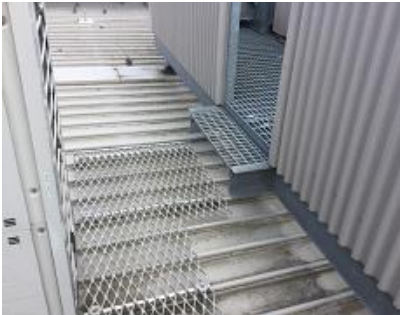
Non-complaint step is present	Trips, Slips and Falls	Awareness induction	Med	Existing step to be removed and new step to be installed	Low	Client advised	Outstanding	OH&S REGULATIONS 3.7 AS/NZS 1657-2013 3.1.4

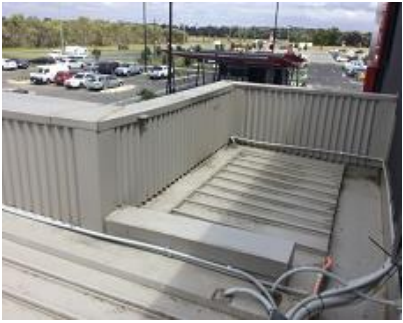
No height safety system installed	Trips, Slips and Falls	Awareness induction	High	Fall arrest anchor to be installed	Low	Client advised	Outstanding	OH&S REGULATIONS 3.55

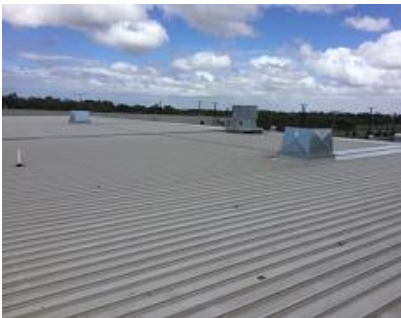
No safe access to the A/c units	Trips, Slips and Falls	N/A	Low	Supply walkway to the A/c units	Low	Client advised	Outstanding	-

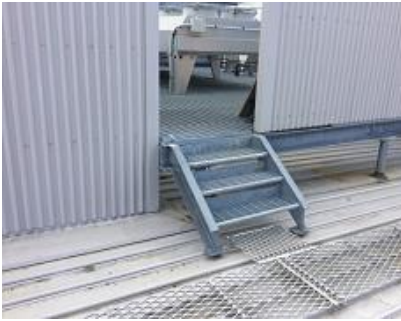
Non-complaint stair is present	Trips, Slips and Falls	Awareness induction	Med	Existing stair to be removed and new ladder to be installed	Low	Client advised	Outstanding	OH&S REGULATIONS 3.7 AS/NZS 1657-2013 7.2

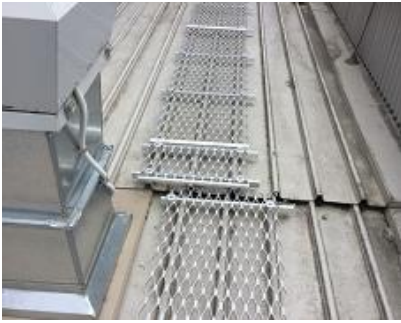
Variation in height between walkway panels are greater than required maximum and panels are not lined up for safe access	Trips, Slips and Falls	Awareness induction	Med	High visibility safety yellow nosing including additional walkway section to be installed	Low	Client advised	Outstanding	OH&S REGULATIONS 3.7 AS/NZS 1657-2013 3.3.4

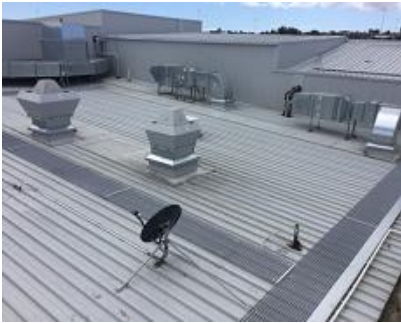
No safe access to the A/c units	Trips, Slips and Falls	N/A	Low	Supply walkway to the A/c units	Low	Client advised	Outstanding	-

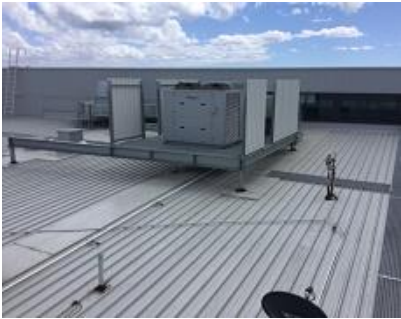
Variation in height between plant deck and roof is greater than required maximum	Trips, Slips and Falls	Awareness induction	Med	Access ladder to be installed	Low	Client advised	Outstanding	OH&S REGULATIONS 3.7 AS/NZS 1657-2013 3.1.4

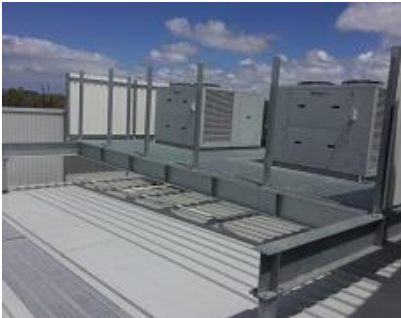
Variation in height between plant deck and roof is greater than required maximum	Trips, Slips and Falls	Awareness induction	Med	Access ladder and handrails to be installed	Low	Client advised	Outstanding	OH&S REGULATIONS 3.7 AS/NZS 1657-2013 3.1.4 & 4.4

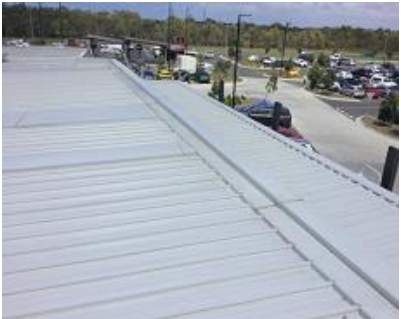
No height safety system installed	Trips, Slips and Falls	Awareness induction	High	Fall arrest anchors and anchor strop to be installed	Low	Client advised	Outstanding	OH&S REGULATIONS 3.55

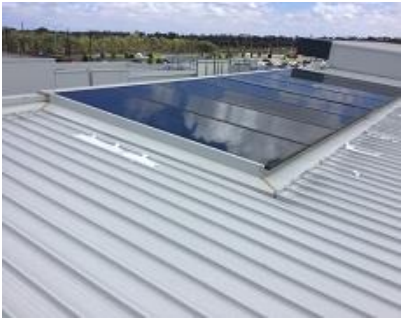
Brittle roof (Non-trafficable roof)	Trips, Slips and Falls	Restrict Access	High	"Warning-Keep Off-Brittle and Fragile Roof" signs to be installed	Low	Client advised	Outstanding	OH&S REGULATIONS 3.57

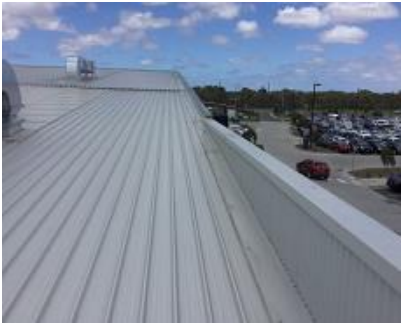
No height safety system installed	Trips, Slips and Falls	Awareness induction	High	Fall arrest anchors to be installed	Low	Client advised	Outstanding	OH&S REGULATIONS 3.55

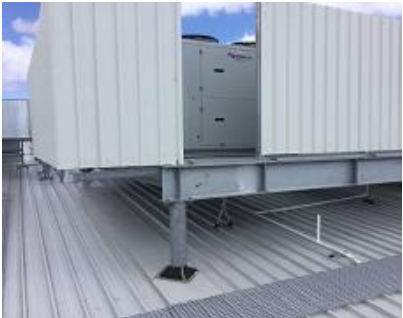
Variation in height between plant deck and roof is greater than required maximum	Trips, Slips and Falls	Awareness induction	Med	Access ladder to be installed	Low	Client advised	Outstanding	OH&S REGULATIONS 3.7 AS/NZS 1657-2013 3.1.4

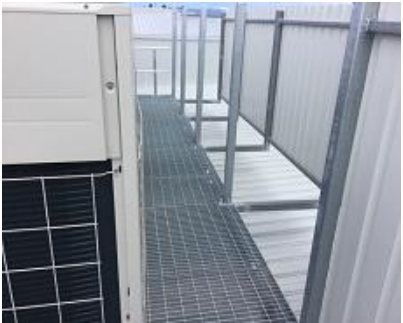
Variation in height between plant deck and roof is greater than required maximum	Trips, Slips and Falls	Awareness induction	Med	Handrails to be installed	Low	Client advised	Outstanding	OH&S REGULATIONS 3.7 AS/NZS 1657-2013 4.4

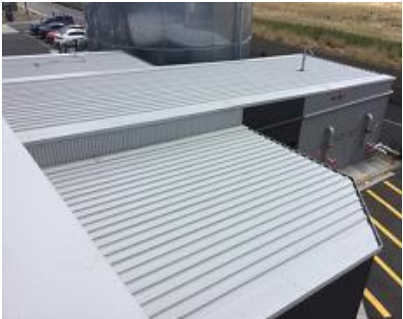
No height safety system installed	Trips, Slips and Falls	Awareness induction	High	Fall arrest anchors, Anchor strops, Ladder access brackets and signs to be installed	Low	Client advised	Outstanding	OH&S REGULATIONS 3.55

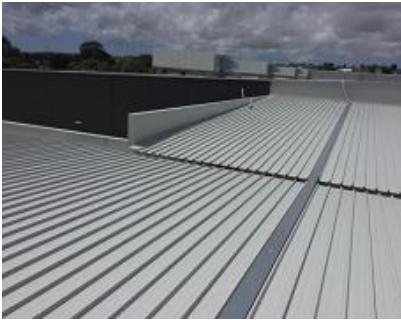
No height safety system installed	Trips, Slips and Falls	Awareness induction	High	Fall arrest anchors to be installed	Low	Client advised	Outstanding	OH&S REGULATIONS 3.55
86	Building: General Stores Location Reference: L49 Task: Access to the plant deck

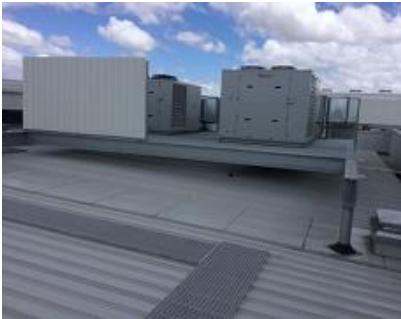
Variation in height between plant deck and roof is greater than required maximum	Trips, Slips and Falls	Awareness induction	Med	Access ladder, handrails and walkway to be installed	Low	Client advised	Outstanding	OH&S REGULATIONS 3.7 AS/NZS 1657-2013 3.1.4 & 4.4

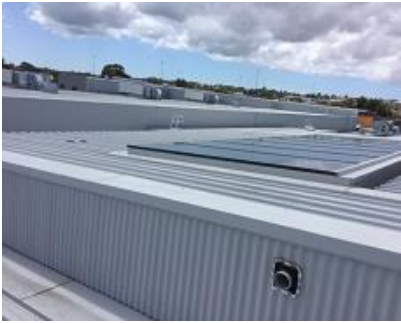
Brittle roof (Non-trafficable roof)	Trips, Slips and Falls	Restrict Access	High	"Warning-Keep Off-Brittle and Fragile Roof" signs to be installed	Low	Client advised	Outstanding	OH&S REGULATIONS 3.57
88	Building: General Stores Location Reference: L51 Task: Access to the roof

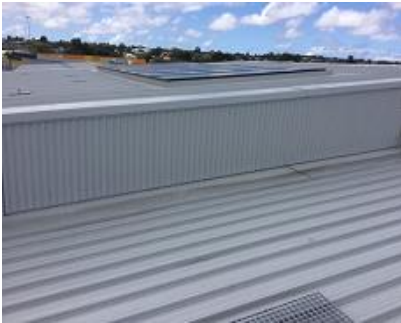
Variation in height between roofs are greater than required maximum	Trips, Slips and Falls	Awareness induction	Med	Access ladder, Anchor strop and walkway to be installed	Low	Client advised	Outstanding	OH&S REGULATIONS 3.7 AS/NZS 1657-2013 3.1.4

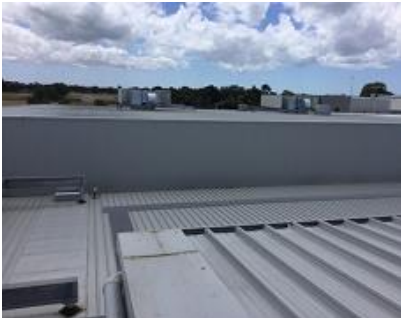
No height safety system installed	Trips, Slips and Falls	Awareness induction	High	Fall arrest anchors to be installed	Low	Client advised	Outstanding	OH&S REGULATIONS 3.55
90	Building: General Stores Location Reference: L54 Task: Access to the A/c units

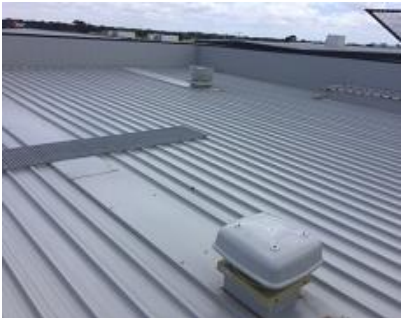
No safe access to the A/c units	Trips, Slips and Falls	N/A	Low	Supply walkway to the A/c units	Low	Client advised	Outstanding	-

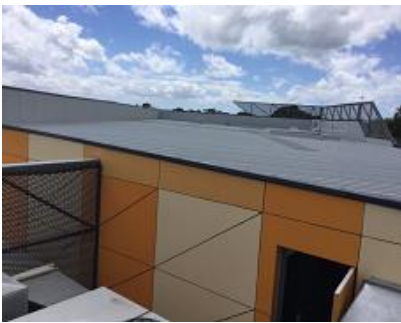
No height safety system installed	Trips, Slips and Falls	Awareness induction	High	Fall arrest anchors to be installed	Low	Client advised	Outstanding	OH&S REGULATIONS 3.55
92	Building: General Stores Location Reference: L55 Task: Access to the roof

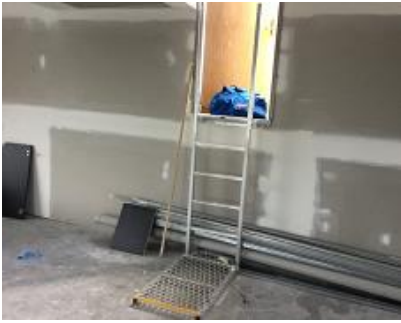
Gap between top rung and landing is greater than required maximum	Trips, Slips and Falls	Awareness induction	Med	Existing ladder to be re-installed with new brackets and landing platform	Low	Client advised	Outstanding	OH&S REGULATIONS 3.7 AS/NZS 1657-2013 7.4.8.4

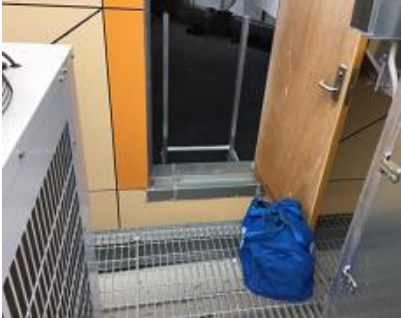
Gap between plant deck and door is greater than required maximum and no landing at door step	Trips, Slips and Falls	Awareness induction	Med	Landing platform to be installed	Low	Client advised	Outstanding	OH&S REGULATIONS 3.7 AS/NZS 1657-2013 3.1.4 & 4.4
94	Building: General Stores Location Reference: L55 Task: Access to the plant deck

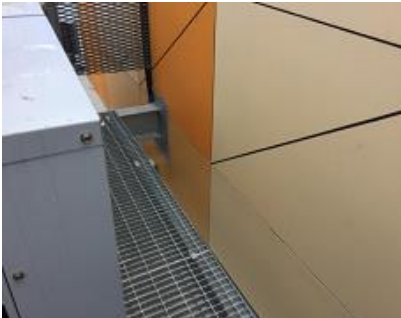
Variation in height between plant deck and roof is greater than required maximum	Trips, Slips and Falls	Awareness induction	Med	Handrails to be installed	Low	Client advised	Outstanding	OH&S REGULATIONS 3.7 AS/NZS 1657-2013 4.4

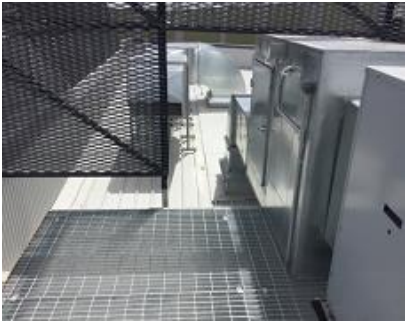
Variation in height between plant deck and roof is greater than required maximum	Trips, Slips and Falls	Awareness induction	Med	Access ladder to be installed	Low	Client advised	Outstanding	OH&S REGULATIONS 3.7 AS/NZS 1657-2013 3.1.4
96	Building: General Stores Location Reference: L55 Task: Access to the A/c units

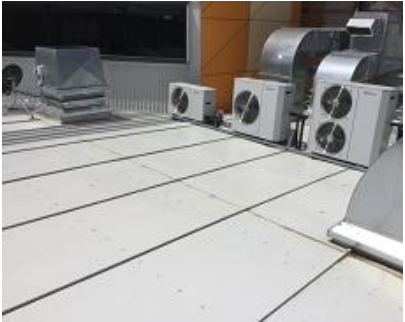
No safe access to the A/c units	Trips, Slips and Falls	N/A	Low	Supply walkway to the A/c units	Low	Client advised	Outstanding	-

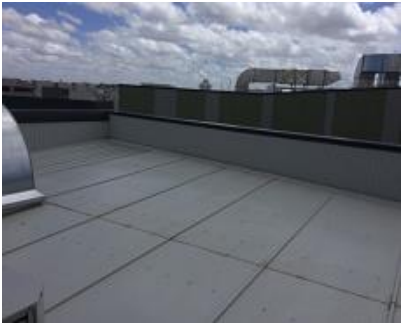
No height safety system installed	Trips, Slips and Falls	Awareness induction	High	Fall arrest anchors to be installed	Low	Client advised	Outstanding	OH&S REGULATIONS 3.55
