Roof Safety Report

Halls Head Central, WA 6210

Prepared By: Safemaster Safety Products
Date: 09-09-2020

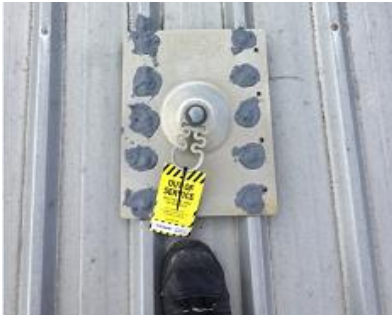
Unknown anchor is present	Trips, Slips and Falls	Awareness induction	High	Anchor to be replaced	Low	Client advised	Outstanding	OH&S REGULATIONS 3.55

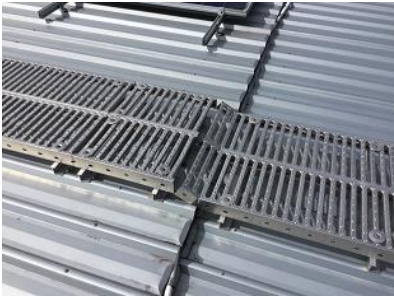
No	Photo of Hazard	Details of Hazard	Details of Risk	Existing/ Immediate Control Measure	Curren t Risk Level	Proposed Permanent Solution	Residu al Risk Assess ment	Details of Action Taken	Status	Reference
111	Building: General Stores Location Reference: L58 Task: Access to the roof

Damaged walkway section is present	Trips, Slips and Falls	Awareness induction	Med	Damaged walkway to be replaced	Low	Client advised	Outstanding	OH&S REGULATIONS 3.7 AS1657-2018 5.1
112	Building: General Stores Location Reference: L47 Task: Access to the roof

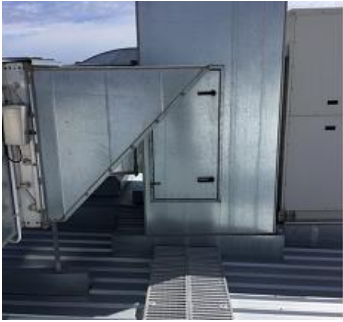
Duct protruding over the walkway	Trips, Slips and Falls	Awareness induction	Med	Additional walkway sections to be installed	Low	Client advised	Outstanding	OH&S REGULATIONS 3.7 AS1657-2018 5.1

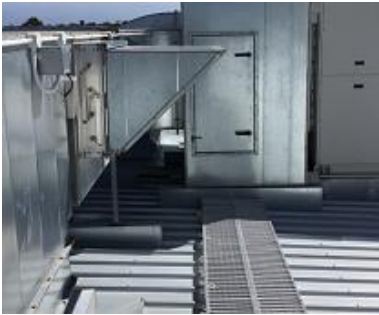
No	Photo of Hazard	Details of Hazard	Details of Risk	Existing/ Immediate Control Measure	Curren t Risk Level	Proposed Permanent Solution	Residu al Risk Assess ment	Details of Action Taken	Status	Reference
113	Building: General Stores Location Reference: L48 Task: Access to the roof

Duct protruding over the walkway	Trips, Slips and Falls	Awareness induction	Med	Additional walkway sections to be installed	Low	Client advised	Outstanding	OH&S REGULATIONS 3.7 AS1657-2018 5.1
114	Building: General Stores Location Reference: L49 Task: Access to the roof

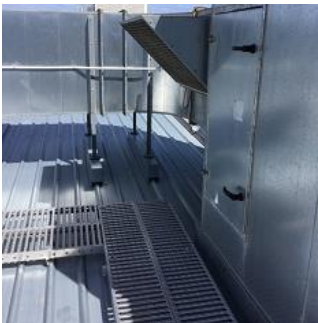
Duct protruding over the walkway	Trips, Slips and Falls	Awareness induction	Med	Additional walkway sections to be installed	Low	Client advised	Outstanding	OH&S REGULATIONS 3.7 AS1657-2018 5.1

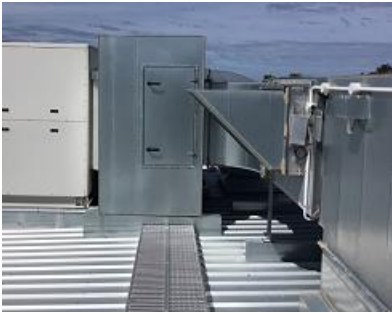
No	Photo of Hazard	Details of Hazard	Details of Risk	Existing/ Immediate Control Measure	Curren t Risk Level	Proposed Permanent Solution	Residu al Risk Assess ment	Details of Action Taken	Status	Reference
115	Building: General Stores Location Reference: L52 Task: Access to the roof

Duct protruding over the walkway	Trips, Slips and Falls	Awareness induction	Med	Additional walkway sections to be installed	Low	Client advised	Outstanding	OH&S REGULATIONS 3.7 AS1657-2018 5.1
116	Building: General Stores Location Reference: L58 Task: Access to the roof

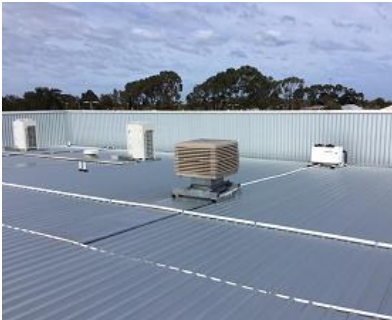
No safe access to the A/c units	Trips, Slips and Falls	Awareness induction	Low	Supply walkway to the A/c units	Low	Client advised	Outstanding	-

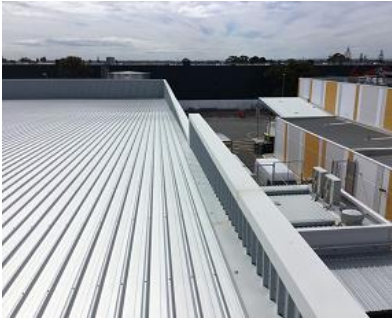
No	Photo of Hazard	Details of Hazard	Details of Risk	Existing/ Immediate Control Measure	Curren t Risk Level	Proposed Permanent Solution	Residu al Risk Assess ment	Details of Action Taken	Status	Reference
117	Building: General Stores Location Reference: L52 Task: Access to the roof

No height safety system installed	Trips, Slips and Falls	Awareness induction	High	Anchors to be installed	Low	Client advised	Outstanding	OH&S REGULATIONS 3.55
118	Building: General Stores Location Reference: L56 Task: Access to the roof

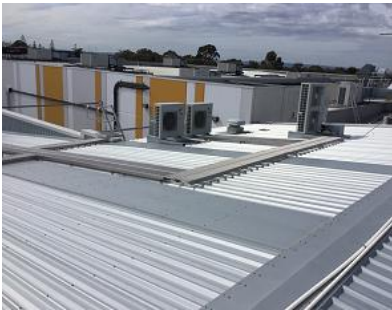
2x Anchors is missing	Trips, Slips and Falls	Awareness induction	High	Anchors to be installed	Low	Client advised	Outstanding	OH&S REGULATIONS 3.55
