Roof Safety Report

Mandurah Forum, WA 6210

Prepared By: Safemaster Safety Products
Date: 28 May 2018

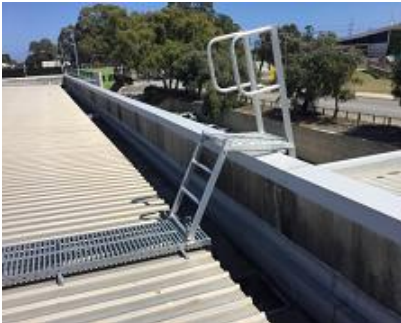
Top rung not levelled with landing, bottom rung heights are less than required minimum and handrails projecting towards the user	Trips, Slips and Falls	Awareness induction	Med	Existing ladder to be re-installed with landing platforms and handrails	Low	Client advised	Outstanding	OH&S REGULATIONS 3.7 AS/NZS 1657-2013 7.4.3.3 & 7.4.3.4 & 7.4.8.5

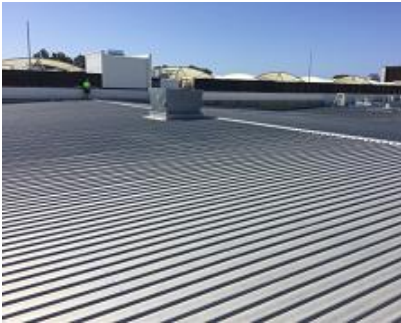
No safe access to the A/c units	Trips, Slips and Falls	N/A	Low	Supply walkway to the A/c units	Low	Client advised	Outstanding	-

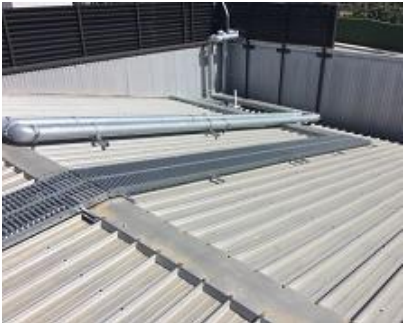
Walkway slope across the walking path is greater than required maximum and pipes in the way	Trips, Slips and Falls	Awareness induction	Med	Levelled walkway including step bridge to be installed	Low	Client advised	Outstanding	OH&S REGULATIONS 3.7 AS/NZS 1657-2013 5.1.1

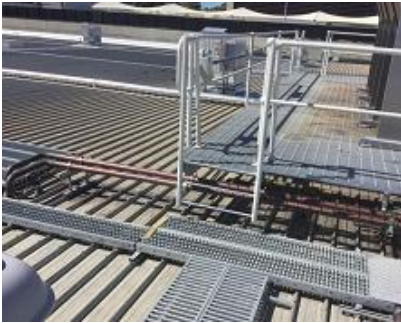
Bottom rung height is less than required minimum and no slip resistance on ladder rungs	Trips, Slips and Falls	Awareness induction	Med	Existing ladder to be removed and new ladder to be installed	Low	Client advised	Outstanding	OH&S REGULATIONS 3.7 AS/NZS 1657-2013 7.4.3.4 & 7.4.3.1

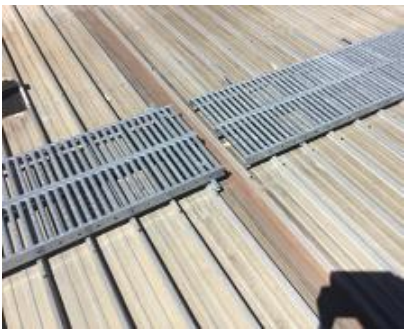
No	Photo of Hazard	Details of Hazard	Details of Risk	Existing/ Immediate Control Measure	Curre nt Risk Level	Proposed Permanent Solution	Resid ual Risk Asse sme nt	Details of Action Taken	Status	Reference
57	Building: General Stores Location Reference: L34 Task: Access to the roof

Gap between walkway panels are greater than required maximum	Trips, Slips and Falls	Awareness induction	Med	Step bridge to be installed	Low	Client advised	Outstanding	OH&S REGULATIONS 3.7 AS/NZS 1657-2013 3.2.3.4
58	Building: General Stores Location Reference: L34 Task: Access to the roof

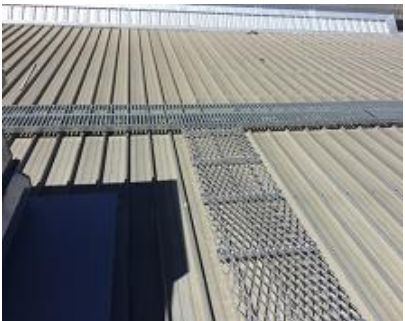
Variation in height between walkway panels are greater than required maximum	Trips, Slips and Falls	Awareness induction	Med	High visibility safety yellow nosing to be installed	Low	Client advised	Outstanding	OH&S REGULATIONS 3.7 AS/NZS 1657-2013 3.3.4

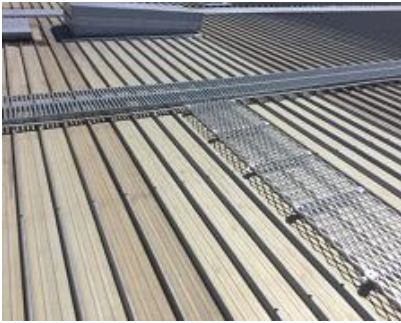
Variation in height between walkway panels are greater than required maximum	Trips, Slips and Falls	Awareness induction	Med	High visibility safety yellow nosing to be installed	Low	Client advised	Outstanding	OH&S REGULATIONS 3.7 AS/NZS 1657-2013 3.3.4

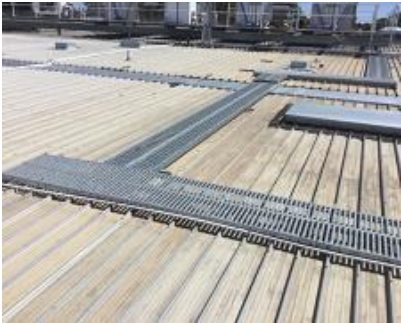
No	Photo of Hazard	Details of Hazard	Details of Risk	Existing/ Immediate Control Measure	Curre nt Risk Level	Proposed Permanent Solution	Resid ual Risk Asse sme nt	Details of Action Taken	Status	Reference
61	Building: General Stores Location Reference: L36 Task: Access to the roof

Existing walkway not fully secured	Trips, Slips and Falls	Awareness induction	Med	Existing walkway to be re-installed with additional channels	Low	Client advised	Outstanding	OH&S REGULATIONS 3.7
62	Building: General Stores Location Reference: L36 Task: Access to the roof

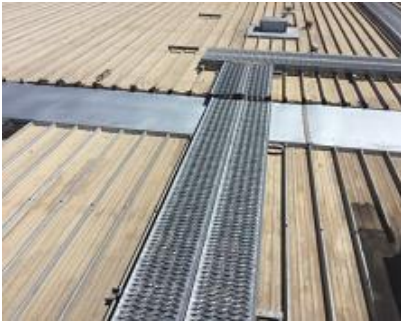
Variation in height between walkway panels are greater than required maximum	Trips, Slips and Falls	Awareness induction	Med	High visibility safety yellow nosing to be installed	Low	Client advised	Outstanding	OH&S REGULATIONS 3.7 AS/NZS 1657-2013 3.3.4

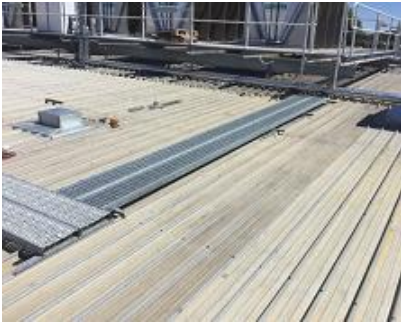
No	Photo of Hazard	Details of Hazard	Details of Risk	Existing/ Immediate Control Measure	Curre nt Risk Level	Proposed Permanent Solution	Resid ual Risk Asse sme nt	Details of Action Taken	Status	Reference
63	Building: General Stores Location Reference: L36 Task: Access to the roof

Existing walkway not fully secured	Trips, Slips and Falls	Awareness induction	Med	Existing walkway to be re-installed with additional channels	Low	Client advised	Outstanding	OH&S REGULATIONS 3.7
