# Roof Safety Report

**Northgate, TAS 7010**

Prepared By: Safemaster Safety Products  
Date: 14 March 2018

CLIENT	BUILDINGS INSPECTED	SYSTEMS INSPECTED
Northgate Shopping Centre	387-393 Main Road, Glenorchy TAS 7010	Anchor Points Signage Handrail Ladder Stair Mechanical Platform Roof Walkway

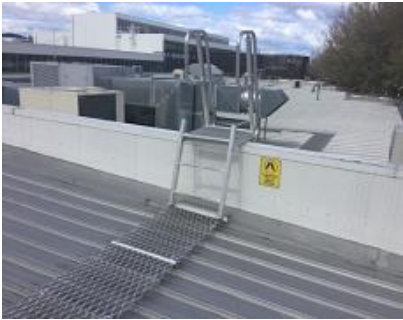
Bottom rung height is less than required minimum and handrails projecting towards the user	Trips, Slips and Falls	Awareness induction	Med	Existing handrails to be removed. Landing platforms and handrails to be installed	Low	Client advised	Outstanding	OH&S REGULATIONS 3.7  AS/NZS 1657-2013 7.4.3.4 & 7.4.8.5
22	Building: General Stores Location Reference: <a href="#">L16</a> Task: Access to the A/c units

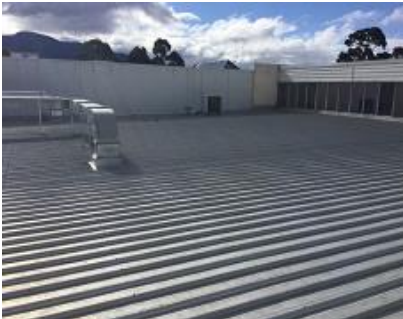
No safe access to the A/c units	Trips, Slips and Falls	N/A	Low	Supply walkway to the A/c units	Low	Client advised	Outstanding	-

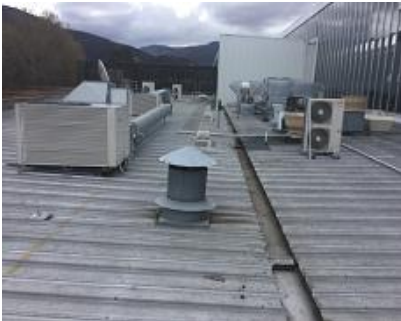
No safe access to the A/c units	Trips, Slips and Falls	N/A	Low	Supply walkway to the A/c units	Low	Client advised	Outstanding	-

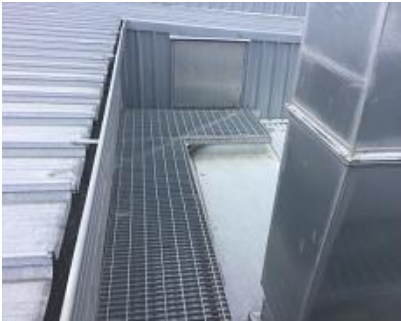
Headroom is less than required minimum	Trips, Slips and Falls	Awareness induction	Med	"Caution-Low Headroom" signs to be installed	Low	Client advised	Outstanding	OH&S REGULATIONS 3.7  AS/NZS 1657-2013 3.1.5
44	Building: General Stores Location Reference: <a href="#">L28</a> Task: Access to the A/c units

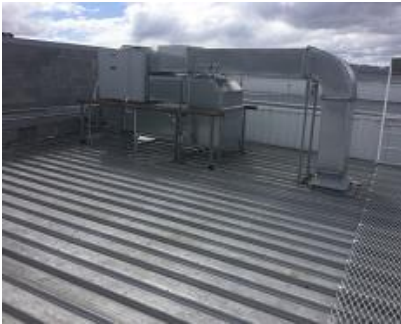
No safe access to the A/c units	Trips, Slips and Falls	N/A	Low	Supply walkway to the A/c units	Low	Client advised	Outstanding	-

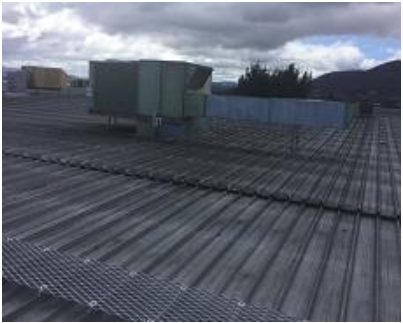
No safe access to the A/c units	Trips, Slips and Falls	N/A	Low	Supply walkway to the A/c units	Low	Client advised	Outstanding	-

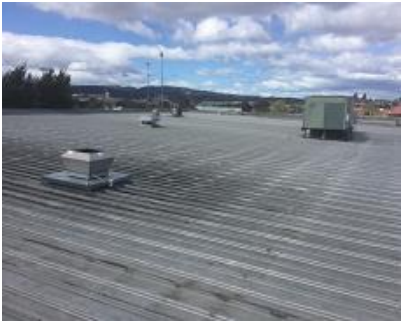
No safe access to the A/c units	Trips, Slips and Falls	N/A	Low	Supply walkway to the A/c units	Low	Client advised	Outstanding	-
54	Building: General Stores Location Reference: <a href="#">L32</a> Task: Access to the roof

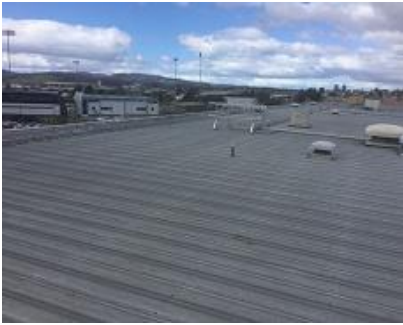
No height safety system installed	Trips, Slips and Falls	Awareness induction	High	Fall arrest anchors to be installed	Low	Client advised	Outstanding	OH&S REGULATIONS 3.55
58	Building: General Stores Location Reference: <a href="#">L34</a> Task: Access to the A/c units

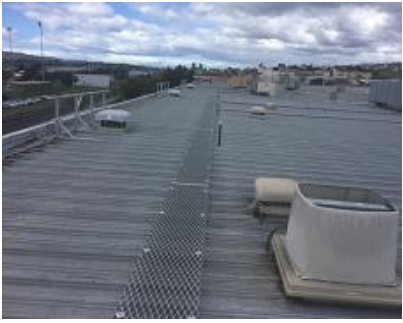
No safe access to the A/c units	Trips, Slips and Falls	N/A	Low	Supply walkway to the A/c units	Low	Client advised	Outstanding	-

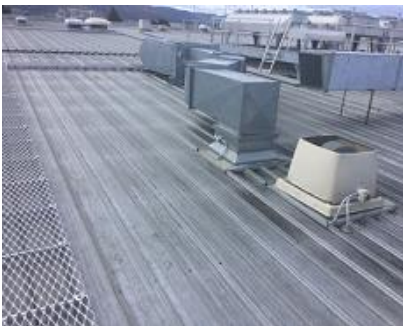
No safe access to the A/c units	Trips, Slips and Falls	N/A	Low	Supply walkway to the A/c units	Low	Client advised	Outstanding	-
66	Building: General Stores Location Reference: <a href="#">L39</a> Task: Access to the roof

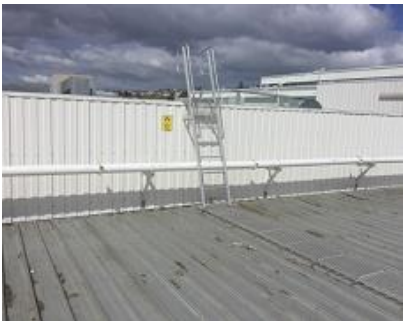
Bottom rung heights are less than required minimum and handrails protruding towards the user	Trips, Slips and Falls	Awareness induction	Med	Existing ladder to be re-installed with landing platforms, brackets and handrails	Low	Client advised	Outstanding	OH&S REGULATIONS 3.7  AS/NZS 1657-2013 7.4.3.4 & 7.4.8.5

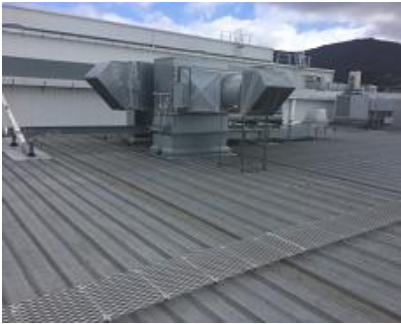
No safe access to the A/c units	Trips, Slips and Falls	N/A	Low	Supply walkway to the A/c units	Low	Client advised	Outstanding	-

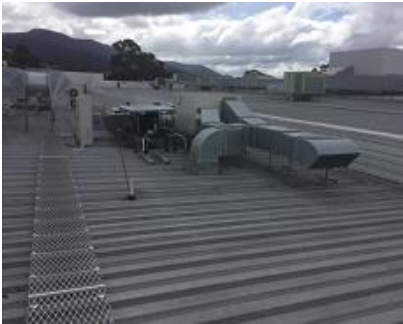
No safe access to the A/c units	Trips, Slips and Falls	N/A	Low	Supply walkway to the A/c units	Low	Client advised	Outstanding	-

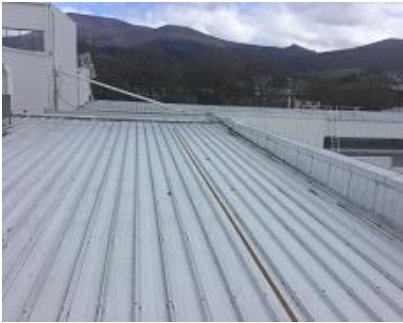
No height safety system installed	Trips, Slips and Falls	Awareness induction	High	Fall arrest anchors to be installed	Low	Client advised	Outstanding	OH&S REGULATIONS 3.55

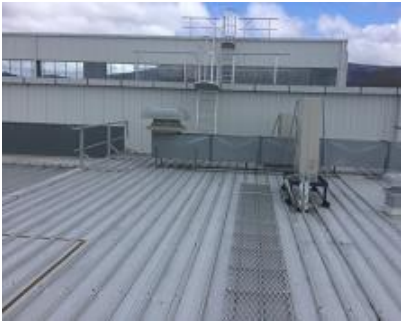
No	Photo of Hazard	Details of Hazard	Details of Risk	Existing/ Immediate Control Measure	Curre nt Risk Level	Proposed Permanent Solution	Resid ual Risk Asse sme nt	Details of Action Taken	Status	Reference
75	Building: General Stores Location Reference: <a href="#">L44</a> Task: Access to the ladder

No safe access to the ladder	Trips, Slips and Falls	N/A	Low	Supply walkway to the ladder	Low	Client advised	Outstanding	-
76	Building: General Stores Location Reference: <a href="#">L44</a> Task: Access to the roof

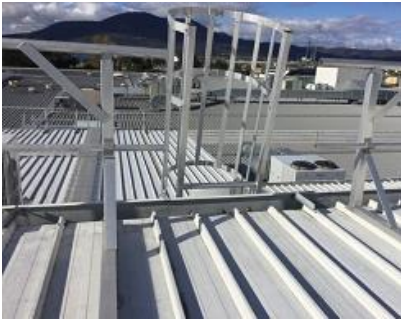
Landing is less than required minimum and required more supports for ladder	Trips, Slips and Falls	Awareness induction	Med	Landing platforms and brackets to be installed	Low	Client advised	Outstanding	OH&S REGULATIONS 3.7  AS/NZS 1657-2013 7.3.6

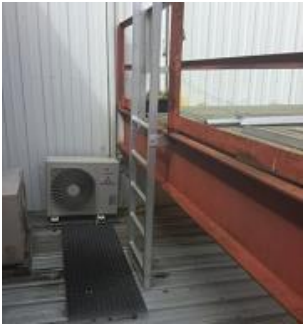
Bottom rung height is less than required minimum and landing is less than required minimum	Trips, Slips and Falls	Awareness induction	Med	Existing ladder to be re-installed with landing platforms and brackets	Low	Client advised	Outstanding	OH&S REGULATIONS 3.7  AS/NZS 1657-2013 7.4.3.4 & 7.3.6
78	Building: General Stores Location Reference: <a href="#">L45</a> Task: Access to the A/c units

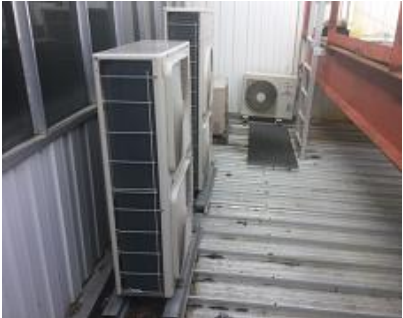
No safe access to the A/c units	Trips, Slips and Falls	N/A	Low	Supply walkway to the A/c units	Low	Client advised	Outstanding	-

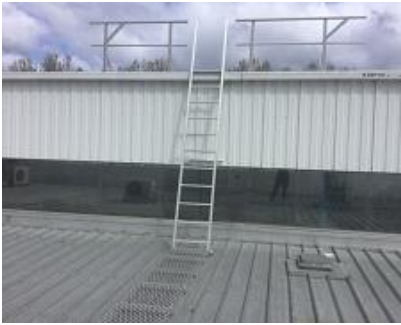
No	Photo of Hazard	Details of Hazard	Details of Risk	Existing/ Immediate Control Measure	Curre nt Risk Level	Proposed Permanent Solution	Resid ual Risk Asse sme nt	Details of Action Taken	Status	Reference
85	Building: General Stores Location Reference: <a href="#">L49</a> Task: Access to the roof

Bottom rung height is less than required minimum, gap between ladder and permanent structure is less than required minimum and landing is less than required minimum	Trips, Slips and Falls	Awareness induction	Med	Existing ladder to be re-installed with landing platforms, brackets and handrails	Low	Client advised	Outstanding	OH&S REGULATIONS 3.7  AS/NZS 1657-2013 7.4.3.4, 7.4.5 & 7.3.6
86	Building: General Stores Location Reference: <a href="#">L50</a> Task: Access to the A/c units

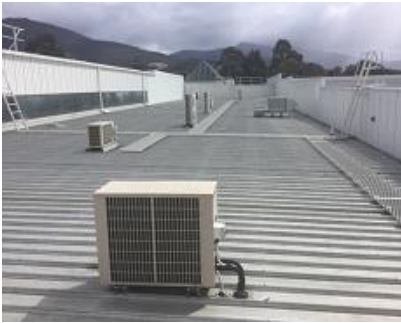
No safe access to the A/c units	Trips, Slips and Falls	N/A	Low	Supply walkway to the A/c units	Low	Client advised	Outstanding	-

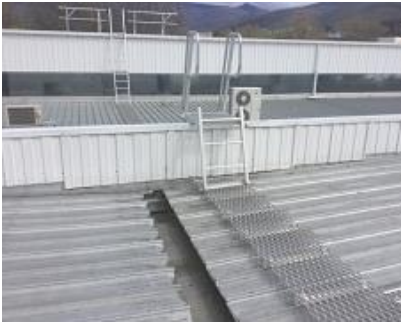
Bottom rung height is less than required minimum and handrails projecting towards the user	Trips, Slips and Falls	Awareness induction	Med	Existing handrails to be removed. Existing ladder to be re-installed with landing platforms, brackets and handrails	Low	Client advised	Outstanding	OH&S REGULATIONS 3.7  AS/NZS 1657-2013 7.4.3.4 & 7.4.8.5

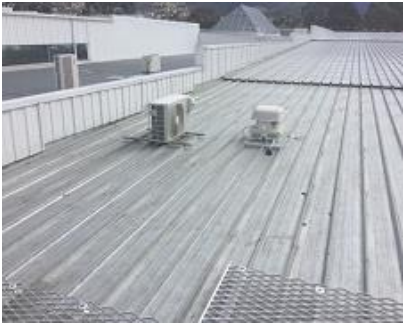
No safe access to the A/c units	Trips, Slips and Falls	N/A	Low	Supply walkway to the A/c units	Low	Client advised	Outstanding	-
90	Building: General Stores Location Reference: <a href="#">L52</a> Task: Access to the roof

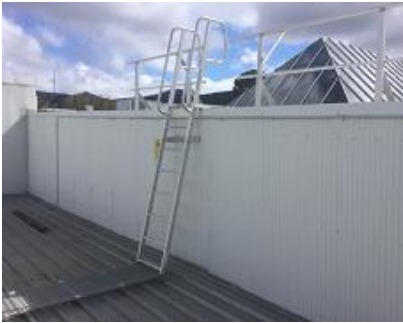
Bottom rung height is less than required minimum and handrails projecting towards the user	Trips, Slips and Falls	Awareness induction	Med	Existing handrails to be removed. Existing ladder to be re-installed with landing platforms, brackets and handrails	Low	Client advised	Outstanding	OH&S REGULATIONS 3.7  AS/NZS 1657-2013 7.4.3.4 & 7.4.8.5
