# Roof Safety Report

**Northgate, TAS 7010**

Prepared By: Safemaster Safety Products  
Date: 31-08-2020

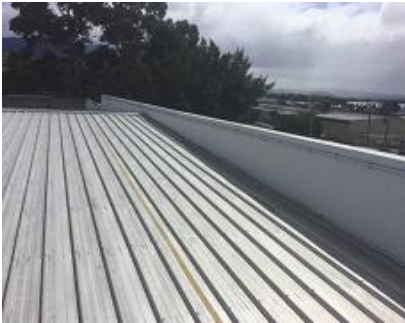
No height safety system installed	Trips, Slips and Falls	Awareness induction	High	Fall arrest anchors to be installed	Low	Client advised	Outstanding	OH&S REGULATIONS 3.55

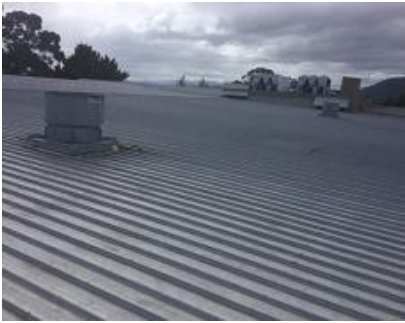
No safe access to the A/c units	Trips, Slips and Falls	N/A	Low	Supply walkway to the A/c units	Low	Client advised	Outstanding	-

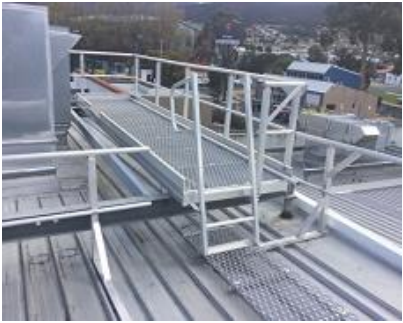
Variation in height between plant deck and roof is greater than required maximum	Trips, Slips and Falls	Awareness induction	Med	Handrail to be installed	Low	Client advised	Outstanding	OH&S REGULATIONS 3.7  AS/NZS 1657-2013 4.4

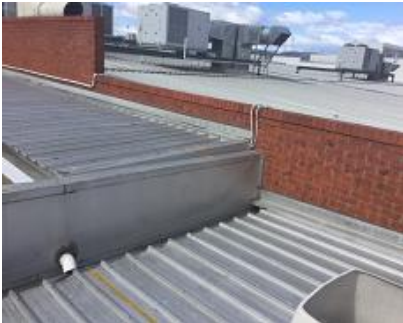
Variation in height between roofs are greater than required maximum	Trips, Slips and Falls	Awareness induction	Med	Access ladders to be installed	Low	Client advised	Outstanding	OH&S REGULATIONS 3.7  AS/NZS 1657-2013 3.1.4

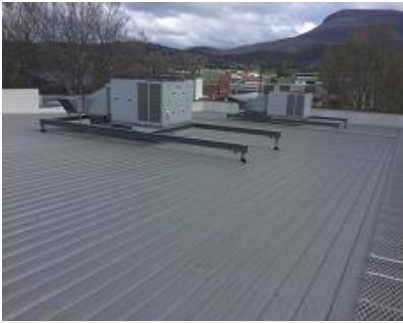
No safe access to the A/c units	Trips, Slips and Falls	Awareness induction	Med	Access ladders, Grating, Handrails and walkway to be installed	Low	Client advised	Outstanding	OH&S REGULATIONS 3.7  AS/NZS 1657-2013 3.1.4

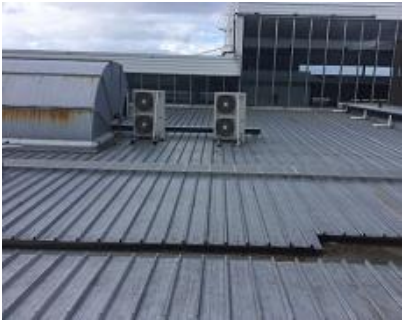
No safe access to the A/c units	Trips, Slips and Falls	N/A	Low	Supply walkway to the A/c units	Low	Client advised	Outstanding	-

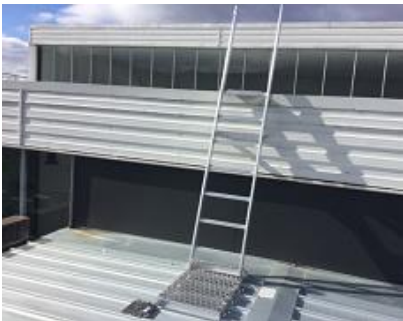
Landing is less than required minimum and gap between ladder and permanent structure is less than required minimum	Trips, Slips and Falls	Awareness induction	Med	Existing ladder to be re-installed with landing platforms, brackets and preformed handrails	Low	Client advised	Outstanding	OH&S REGULATIONS 3.7  AS/NZS 1657-2013 7.3.6 & 7.4.8.4

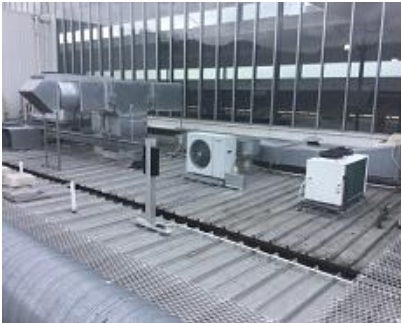
No safe access to the A/c units	Trips, Slips and Falls	N/A	Low	Supply walkway to the A/c units	Low	Client advised	Outstanding	-

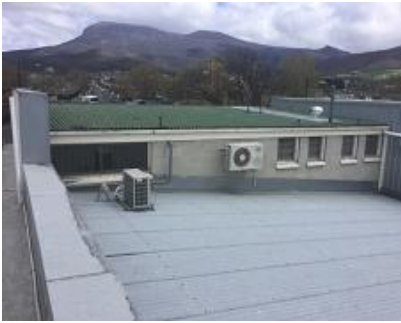
No height safety system installed	Trips, Slips and Falls	Awareness induction	High	Fall arrest anchors to be installed	Low	Client advised	Outstanding	OH&S REGULATIONS 3.55

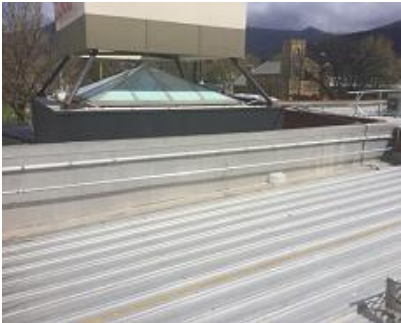
No height safety system installed	Trips, Slips and Falls	Awareness induction	High	Fall arrest anchors to be installed	Low	Client advised	Outstanding	OH&S REGULATIONS 3.55

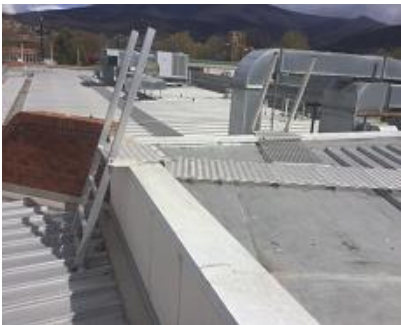
Landing is less than required minimum	Trips, Slips and Falls	Awareness induction	Med	Existing ladder to be re-installed with landing platforms, brackets and handrails	Low	Client advised	Outstanding	OH&S REGULATIONS 3.7  AS/NZS 1657-2013 7.3.6

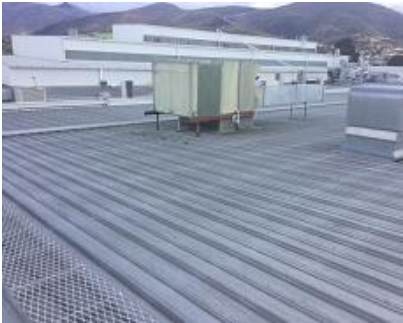
No safe access to the A/c units	Trips, Slips and Falls	N/A	Low	Supply walkway to the A/c units	Low	Client advised	Outstanding	-

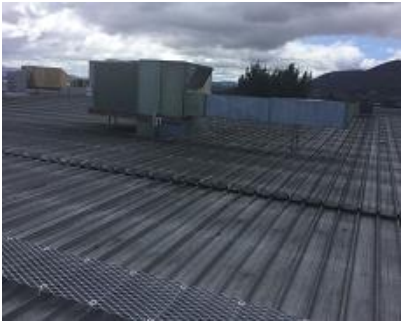
No safe access to the A/c units	Trips, Slips and Falls	N/A	Low	Supply walkway to the A/c units	Low	Client advised	Outstanding	-

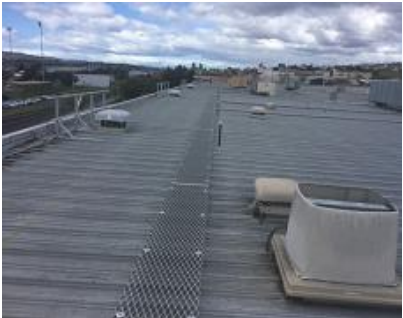
No safe access to the A/c units	Trips, Slips and Falls	N/A	Low	Supply walkway to the A/c units	Low	Client advised	Outstanding	-

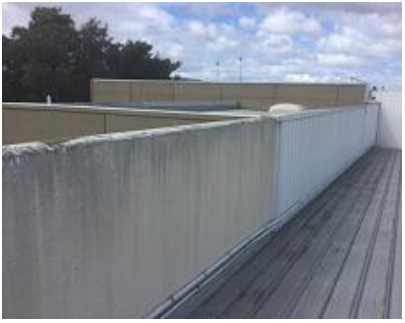
Variation in height between roofs are greater than required maximum	Trips, Slips and Falls	Awareness induction	Med	Access ladder to be installed	Low	Client advised	Outstanding	OH&S REGULATIONS 3.7  AS/NZS 1657-2013 3.1.4

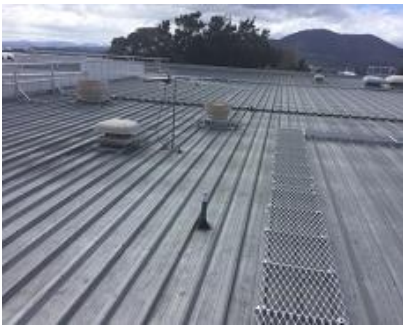
No safe access to the A/c units	Trips, Slips and Falls	N/A	Low	Supply walkway to the A/c units	Low	Client advised	Outstanding	-

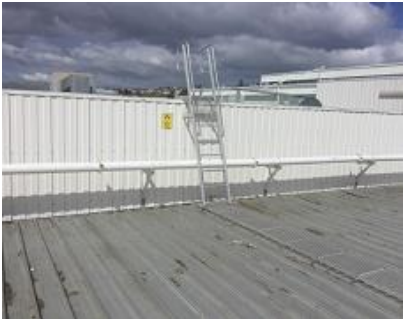
Bottom rung heights are less than required minimum and handrails protruding towards the user	Trips, Slips and Falls	Awareness induction	Med	Existing ladder to be re-installed with landing platforms, brackets and handrails	Low	Client advised	Outstanding	OH&S REGULATIONS 3.7  AS/NZS 1657-2013 7.4.3.4 & 7.4.8.5

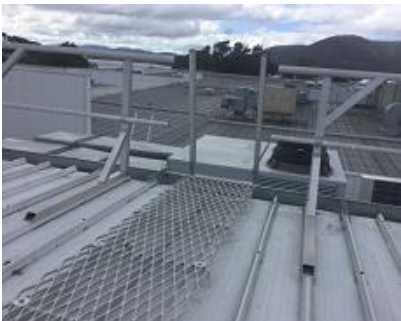
Bottom rung heights are less than required minimum, landing is less than required minimum and gap between ladder and permanent structure is less than required minimum	Trips, Slips and Falls	Awareness induction	Med	Existing ladder to be re-installed with landing platforms, brackets and handrails	Low	Client advised	Outstanding	OH&S REGULATIONS 3.7  AS/NZS 1657-2013 7.4.3.4, 7.3.6 & 7.4.8.4

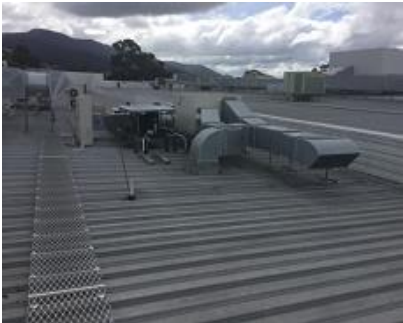
No safe access to the A/c units	Trips, Slips and Falls	N/A	Low	Supply walkway to the A/c units	Low	Client advised	Outstanding	-

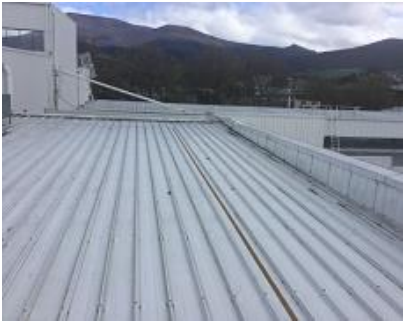
No height safety system installed	Trips, Slips and Falls	Awareness induction	High	Fall arrest anchors to be installed	Low	Client advised	Outstanding	OH&S REGULATIONS 3.55

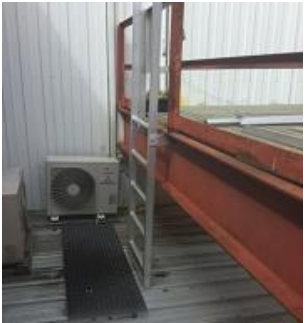
Bottom rung height is less than required minimum and landing is less than required minimum	Trips, Slips and Falls	Awareness induction	Med	Existing ladder to be re-installed with landing platforms and brackets	Low	Client advised	Outstanding	OH&S REGULATIONS 3.7  AS/NZS 1657-2013 7.4.3.4 & 7.3.6
78	Building: General Stores Location Reference: <a href="#">L45</a> Task: Access to the A/c units

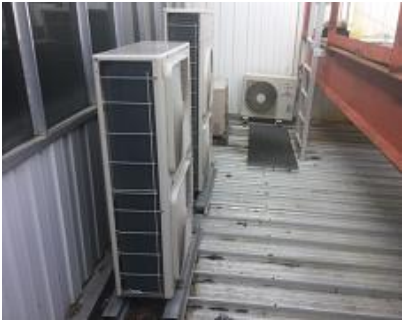
No safe access to the A/c units	Trips, Slips and Falls	N/A	Low	Supply walkway to the A/c units	Low	Client advised	Outstanding	-

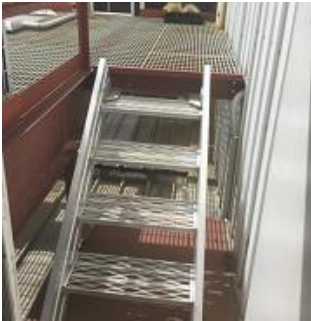
Non-complaint ladder is present	Trips, Slips and Falls	Awareness induction	Med	Existing ladder to be removed and new ladder to be installed	Low	Client advised	Outstanding	OH&S REGULATIONS 3.7  AS/NZS 1657-2013 7.3
80	Building: General Stores Location Reference: <a href="#">L46</a> Task: Access to the roof

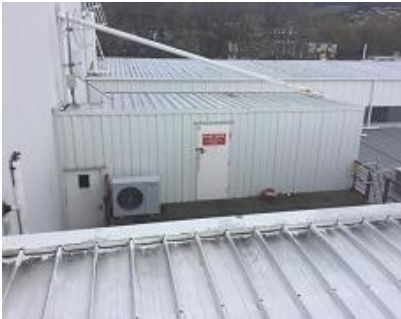
No height safety system installed	Trips, Slips and Falls	Awareness induction	High	Fall arrest anchors, anchor strop and ladder access bracket to be installed	Low	Client advised	Outstanding	OH&S REGULATIONS 3.55

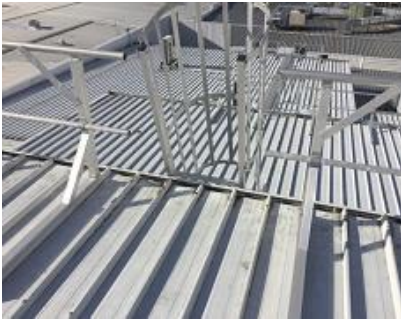
No	Photo of Hazard	Details of Hazard	Details of Risk	Existing/ Immediate Control Measure	Curre nt Risk Level	Proposed Permanent Solution	Resid ual Risk Asse sme nt	Details of Action Taken	Status	Reference
81	Building: General Stores Location Reference: <a href="#">L47</a> Task: Access to the ladder

No safe access to the ladder	Trips, Slips and Falls	N/A	Low	Supply walkway to the ladder	Low	Client advised	Outsta nding	-
82	Building: General Stores Location Reference: <a href="#">L47</a> Task: Access to the roof

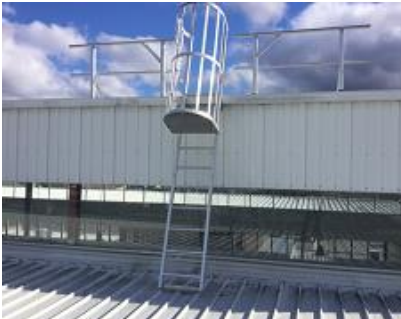
Bottom rung height is less than required minimum and gap between ladder and permanent structure is less than required minimum	Trips, Slips and Falls	Awareness induction	Med	Existing ladder to be re-installed with landing platforms, brackets and handrails	Low	Client advised	Outsta nding	OH&S REGULATIONS 3.7  AS/NZS 1657- 2013 7.4.3.4 & 7.4.5

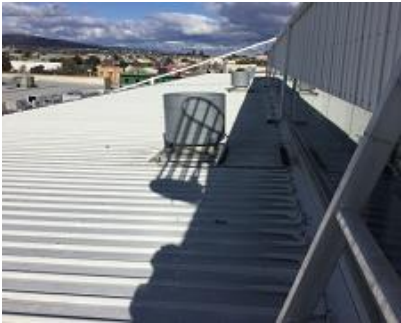
No safe access to the A/c units	Trips, Slips and Falls	N/A	Low	Supply walkway to the A/c units	Low	Client advised	Outstanding	-
84	Building: General Stores Location Reference: <a href="#">L48</a> Task: Access to the roof

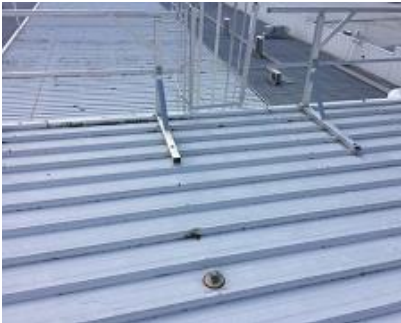
Bottom rung height is less than required minimum and gap between ladder and permanent structure is less than required minimum	Trips, Slips and Falls	Awareness induction	Med	Existing ladder to be re-installed with landing platforms, anchor strop, brackets and handrails	Low	Client advised	Outstanding	OH&S REGULATIONS 3.7  AS/NZS 1657-2013 7.4.3.4 & 7.4.5

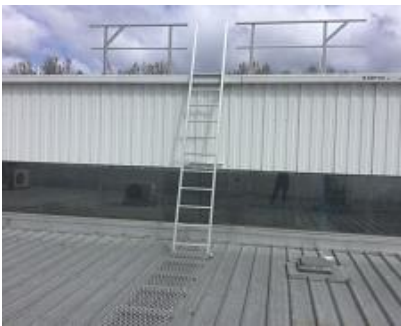
No	Photo of Hazard	Details of Hazard	Details of Risk	Existing/ Immediate Control Measure	Curre nt Risk Level	Proposed Permanent Solution	Resid ual Risk Asse sme nt	Details of Action Taken	Status	Reference
85	Building: General Stores Location Reference: <a href="#">L49</a> Task: Access to the roof

Bottom rung height is less than required minimum, gap between ladder and permanent structure is less than required minimum and landing is less than required minimum	Trips, Slips and Falls	Awareness induction	Med	Existing ladder to be re-installed with landing platforms, brackets and handrails	Low	Client advised	Outstanding	OH&S REGULATIONS 3.7  AS/NZS 1657-2013 7.4.3.4, 7.4.5 & 7.3.6
86	Building: General Stores Location Reference: <a href="#">L50</a> Task: Access to the A/c units

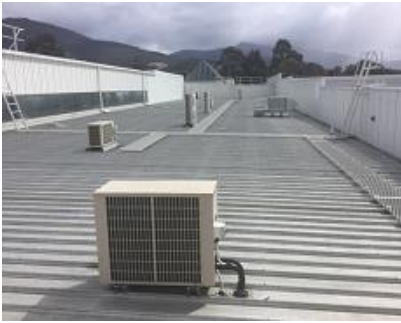
No safe access to the A/c units	Trips, Slips and Falls	N/A	Low	Supply walkway to the A/c units	Low	Client advised	Outstanding	-

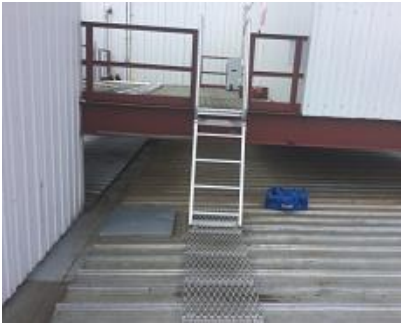
No	Photo of Hazard	Details of Hazard	Details of Risk	Existing/ Immediate Control Measure	Curre nt Risk Level	Proposed Permanent Solution	Resid ual Risk Asse sme nt	Details of Action Taken	Status	Reference
87	Building: General Stores Location Reference: <a href="#">L50</a> Task: Access to the roof

Bottom rung height is less than required minimum and handrails projecting towards the user	Trips, Slips and Falls	Awareness induction	Med	Existing handrails to be removed. Existing ladder to be re-installed with landing platforms, brackets and handrails	Low	Client advised	Outstanding	OH&S REGULATIONS 3.7  AS/NZS 1657-2013 7.4.3.4 & 7.4.8.5
88	Building: General Stores Location Reference: <a href="#">L51</a> Task: Access to the roof

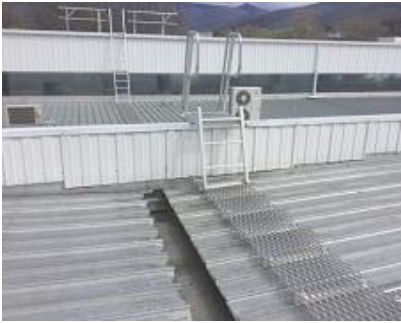
Bottom rung height is less than required minimum and handrails projecting towards the user	Trips, Slips and Falls	Awareness induction	Med	Existing handrails to be removed. Existing ladder to be re-installed with landing platforms, brackets and handrails	Low	Client advised	Outstanding	OH&S REGULATIONS 3.7  AS/NZS 1657-2013 7.4.3.4 & 7.4.8.5

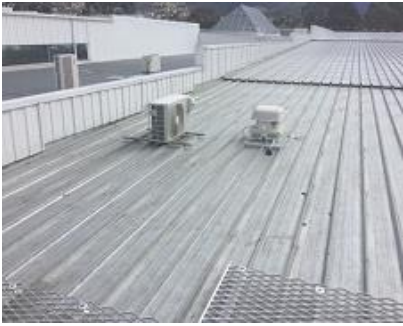
No safe access to the A/c units	Trips, Slips and Falls	N/A	Low	Supply walkway to the A/c units	Low	Client advised	Outstanding	-
90	Building: General Stores Location Reference: <a href="#">L52</a> Task: Access to the roof

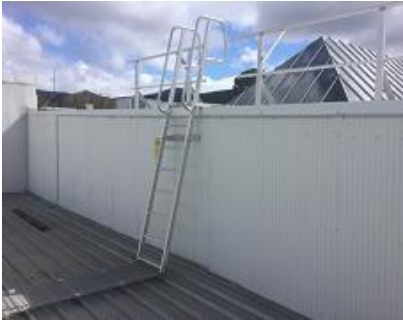
Bottom rung height is less than required minimum and handrails projecting towards the user	Trips, Slips and Falls	Awareness induction	Med	Existing handrails to be removed. Existing ladder to be re-installed with landing platforms, brackets and handrails	Low	Client advised	Outstanding	OH&S REGULATIONS 3.7  AS/NZS 1657-2013 7.4.3.4 & 7.4.8.5

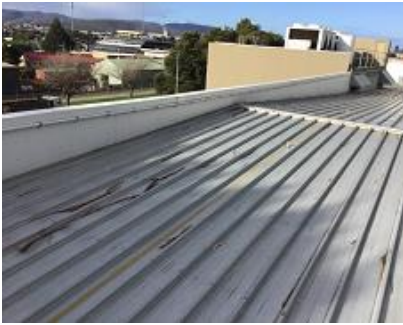
No	Photo of Hazard	Details of Hazard	Details of Risk	Existing/ Immediate Control Measure	Curre nt Risk Level	Proposed Permanent Solution	Resid ual Risk Asse sme nt	Details of Action Taken	Status	Reference
91	Building: General Stores Location Reference: <a href="#">L02</a> Task: Access to the roof

Not enough anchors installed to protect fall edge	Trips, Slips and Falls	Awareness induction	High	Fall arrest anchors to be installed	Low	Client advised	Outstanding	OH&S REGULATIONS 3.55
92	Building: General Stores Location Reference: <a href="#">L05</a> Task: Access to the roof

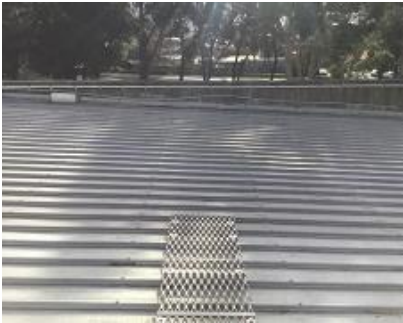
Not enough anchors installed to protect fall edge	Trips, Slips and Falls	Awareness induction	High	Fall arrest anchors to be installed	Low	Client advised	Outstanding	OH&S REGULATIONS 3.55

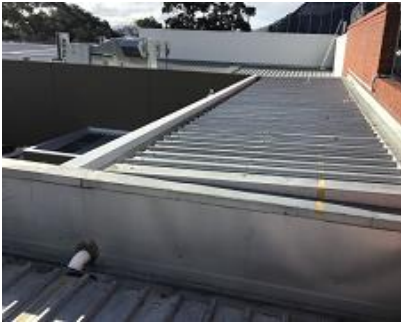
No	Photo of Hazard	Details of Hazard	Details of Risk	Existing/ Immediate Control Measure	Curre nt Risk Level	Proposed Permanent Solution	Resid ual Risk Asse sme nt	Details of Action Taken	Status	Reference
93	Building: General Stores Location Reference: <a href="#">L12</a> Task: Access to the roof

Not enough anchors installed to protect fall edge	Trips, Slips and Falls	Awareness induction	High	Fall arrest anchors to be installed	Low	Client advised	Outstanding	OH&S REGULATIONS 3.55
94	Building: General Stores Location Reference: <a href="#">L24</a> Task: Access to the roof

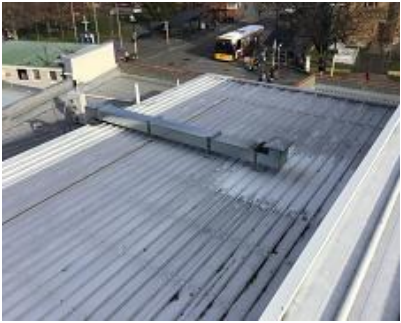
Not enough anchors installed to protect fall edge	Trips, Slips and Falls	Awareness induction	High	Fall arrest anchors to be installed	Low	Client advised	Outstanding	OH&S REGULATIONS 3.55

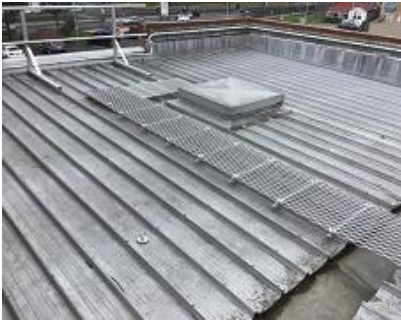
No	Photo of Hazard	Details of Hazard	Details of Risk	Existing/ Immediate Control Measure	Curre nt Risk Level	Proposed Permanent Solution	Resid ual Risk Asse sme nt	Details of Action Taken	Status	Reference
95	Building: General Stores Location Reference: <a href="#">L30</a> Task: Access to the roof

No safe access around hatch	Trips, Slips and Falls	Awareness induction	Med	Guardrail to be installed	Low	Client advised	Outstanding	OH&S REGULATIONS 3.7  AS/NZS 1657-2018 4.4
96	Building: General Stores Location Reference: <a href="#">L35</a> Task: Access to the roof

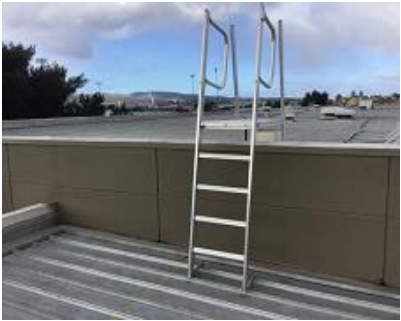
Ladder not fully secured, and landing platforms are missing	Trips, Slips and Falls	Awareness induction	Med	Ladder to be re-installed with landing platforms	Low	Client advised	Outstanding	OH&S REGULATIONS 3.7  AS/NZS 1657-2013 7.3.6

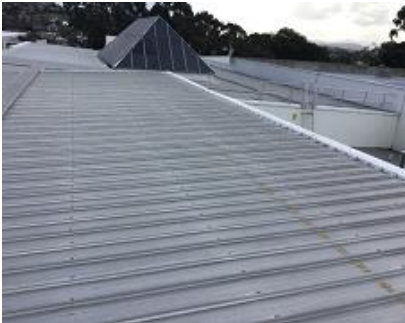
No	Photo of Hazard	Details of Hazard	Details of Risk	Existing/ Immediate Control Measure	Curre nt Risk Level	Proposed Permanent Solution	Resid ual Risk Asse sme nt	Details of Action Taken	Status	Reference
97	Building: General Stores Location Reference: <a href="#">L52</a> Task: Access to the roof

Not enough anchors installed to protect fall edge	Trips, Slips and Falls	Awareness induction	High	Fall arrest anchors to be installed	Low	Client advised	Outstanding	OH&S REGULATIONS 3.55
