# Roof Safety Report

Northland, VIC 3072

Prepared By: Safemaster Safety Products  
Date: 10-09-2020

10-09-2020

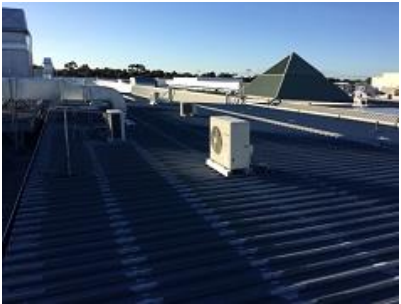
No safe access to the A/c units	Trips, Slips and Falls	N/A	Low	Supply walkway to the A/c units	Low	Client advised	Outsta nding	-

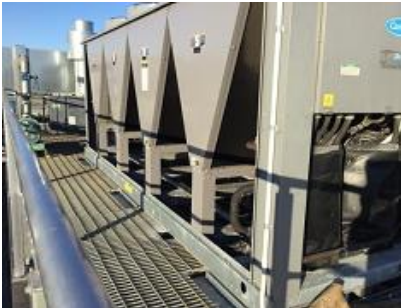
Variation in height between plant deck and roof is greater than required maximum	Trips, Slips and Falls	Awareness induction	Med	Handrails to be installed	Low	Client advised	Outstanding	OH&S REGULATIONS 3.7  AS/NZS 1657-2013 4.4
06	Building: General Stores Location Reference: <a href="#">L03</a> Task: Access to the A/c units

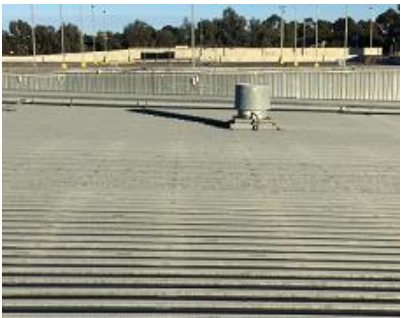
No safe access to the A/c units	Trips, Slips and Falls	N/A	Low	Supply walkway to the A/c units	Low	Client advised	Outstanding	-

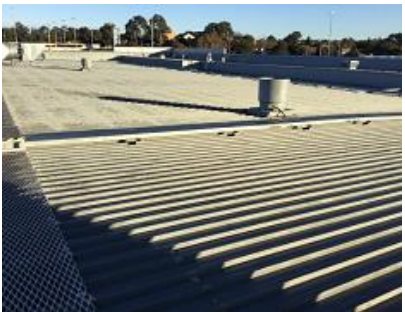
No safe access to the A/c units	Trips, Slips and Falls	N/A	Low	Supply walkway to the A/c units	Low	Client advised	Outstanding	-

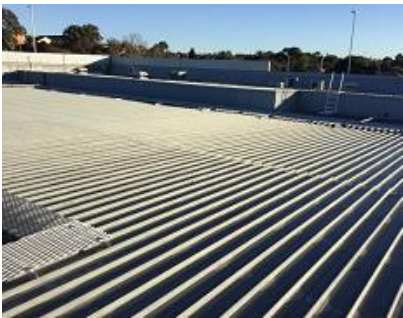
No safe access to the ladder	Trips, Slips and Falls	N/A	Low	Supply walkway and step over to the ladder	Low	Client advised	Outstanding	-

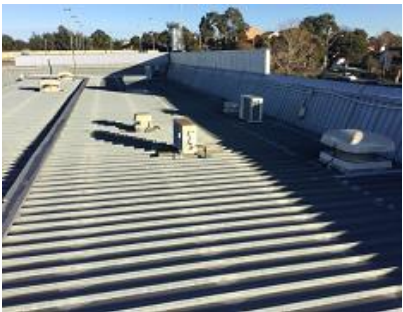
No safe access to the A/c units	Trips, Slips and Falls	N/A	Low	Supply walkway, Step overs and handrails to the A/c units	Low	Client advised	Outstanding	-

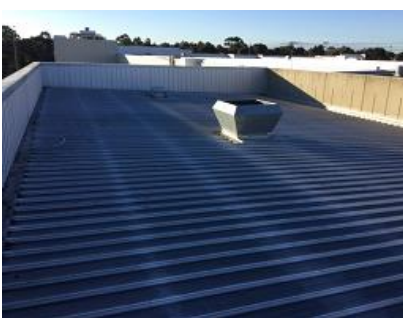
No safe access to the A/c units	Trips, Slips and Falls	N/A	Low	Supply walkway to the A/c units	Low	Client advised	Outstanding	-

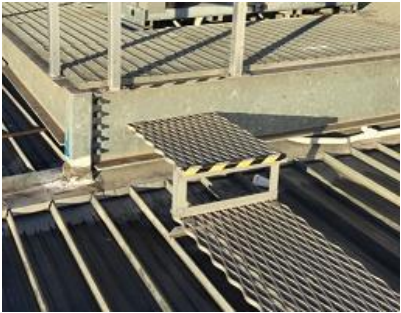
Non-complaint step is present	Trips, Slips and Falls	Awareness induction	Med	Existing step to be removed and new ladder to be installed	Low	Client advised	Outsta nding	OH&S REGULATIONS 3.7  AS/NZS 1657- 2013 3.1.4
22	Building: General Stores Location Reference: <a href="#">L09</a> Task: Access to the plant deck

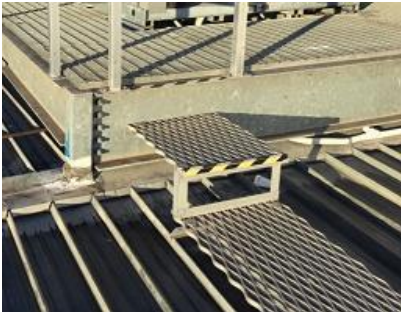
Non-complaint step is present	Trips, Slips and Falls	Awareness induction	Med	Existing step to be removed and new ladder to be installed	Low	Client advised	Outsta nding	OH&S REGULATIONS 3.7  AS/NZS 1657-2013 3.1.4

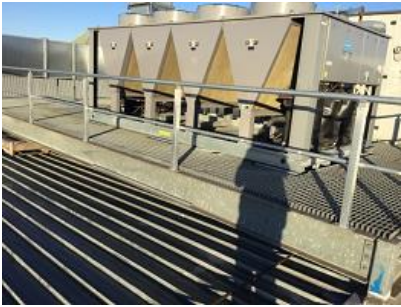
Variation in height between plant deck and roof is greater than required maximum	Trips, Slips and Falls	Awareness induction	Med	Handrails to be installed	Low	Client advised	Outstanding	OH&S REGULATIONS 3.7  AS/NZS 1657-2013 4.4
24	Building: General Stores Location Reference: <a href="#">L10</a> Task: Access to the A/c units

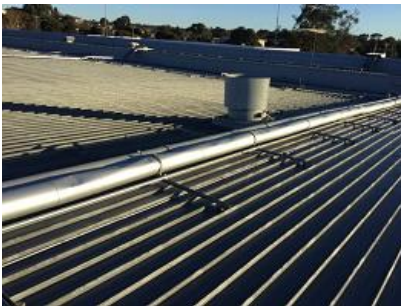
No safe access to the A/c units	Trips, Slips and Falls	N/A	Low	Supply walkway to the A/c units	Low	Client advised	Outstanding	-

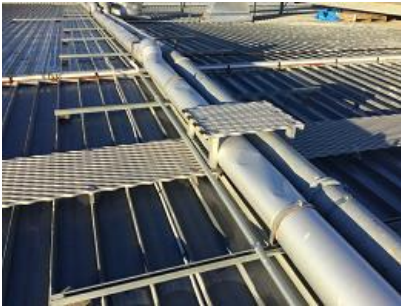
Variation in height between platform and roof is greater than required maximum	Trips, Slips and Falls	Awareness induction	Med	Handrails to be installed	Low	Client advised	Outstanding	OH&S REGULATIONS 3.7  AS/NZS 1657-2013 4.4
26	Building: General Stores Location Reference: <a href="#">L10</a> Task: Access to the roof

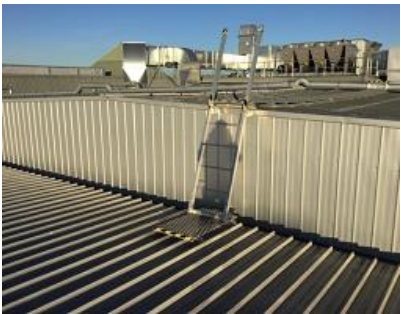
Top rung not levelled with landing, gap between top rung and landing is greater than required maximum and bottom rung height is greater than required maximum	Trips, Slips and Falls	Awareness induction	Med	Existing ladder to be re-installed with new landing platform, brackets and handrails	Low	Client advised	Outstanding	OH&S REGULATIONS 3.7  AS/NZS 1657-2013 3.1.4 & 4.4

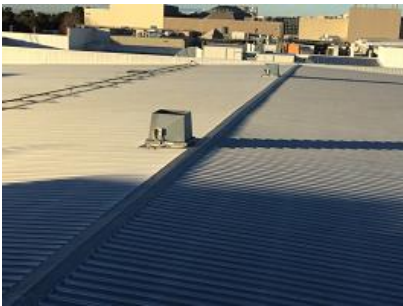
No safe access to the A/c units	Trips, Slips and Falls	N/A	Low	Supply walkway to the A/c units	Low	Client advised	Outstanding	-

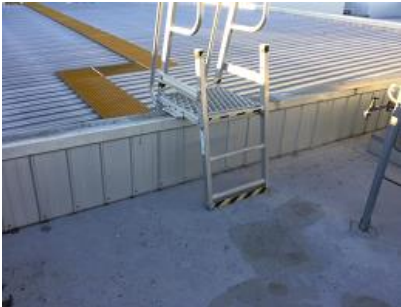
Bottom rung height is less than required minimum and handrails projecting towards the user	Trips, Slips and Falls	Awareness induction	Med	Existing handrails to be removed and new landing platforms and handrails to be installed	Low	Client advised	Outstanding	OH&S REGULATIONS 3.7  AS/NZS 1657-2013 7.4.3.4 & 7.4.8.5

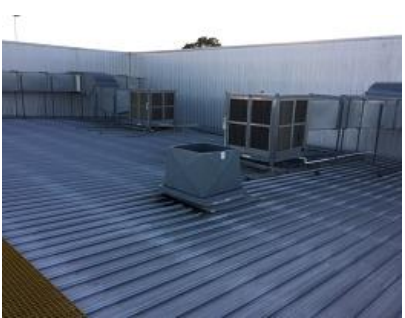
No safe access to the A/c units	Trips, Slips and Falls	N/A	Low	Supply walkway to the A/c units	Low	Client advised	Outstanding	-

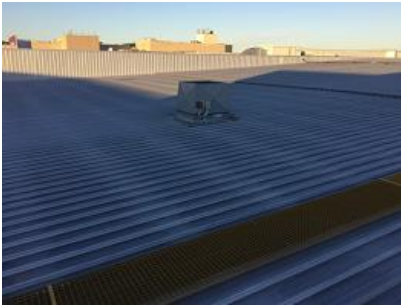
No safe access to the A/c units	Trips, Slips and Falls	N/A	Low	Supply walkway to the A/c units	Low	Client advised	Outsta nding	-
38	Building: General Stores Location Reference: <a href="#">L16</a> Task: Access to the A/c units

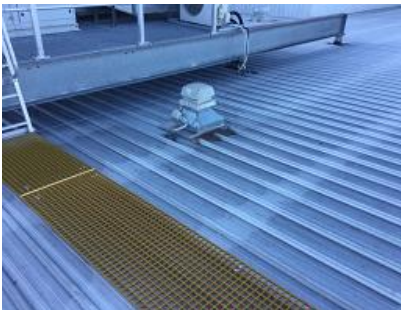
No safe access to the A/c units	Trips, Slips and Falls	N/A	Low	Supply walkway to the A/c units	Low	Client advised	Outsta nding	-

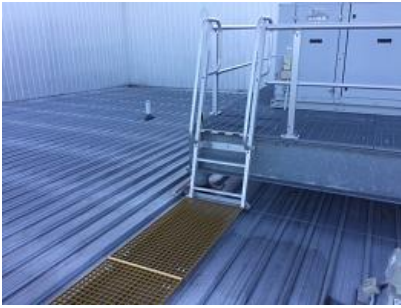
Bottom rung height is less than required minimum and handrail projecting towards the user	Trips, Slips and Falls	Awareness induction	Med	Existing handrail to be removed and new handrail and landing platform to be installed	Low	Client advised	Outstanding	OH&S REGULATIONS 3.7  AS/NZS 1657-2013 7.4.3.4 & 7.4.8.5
40	Building: General Stores Location Reference: <a href="#">L16</a> Task: Access to the plant deck

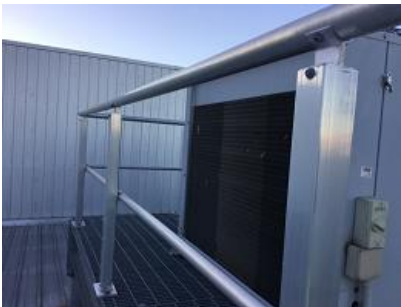
Sharp edges on handrails	Trips, Slips and Falls	Awareness induction	Med	Tek screws to be replaced with rivets	Low	Client advised	Outstanding	OH&S REGULATIONS 3.7  AS/NZS 1657-2013 7.3.3.1

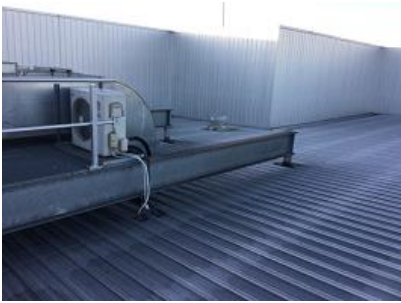
No safe access to the A/c unit	Trips, Slips and Falls	N/A	Low	Supply walkway to the A/c unit	Low	Client advised	Outsta nding	-

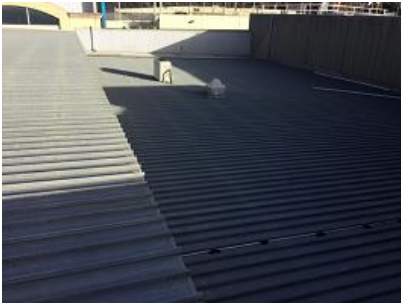
Variation in height between roofs are greater than required maximum	Trips, Slips and Falls	Awareness induction	Med	Access ladder to be installed	Low	Client advised	Outstanding	OH&S REGULATIONS 3.7  AS/NZS 1657-2013 3.1.4
46	Building: General Stores Location Reference: <a href="#">L18</a> Task: Access to the A/c units

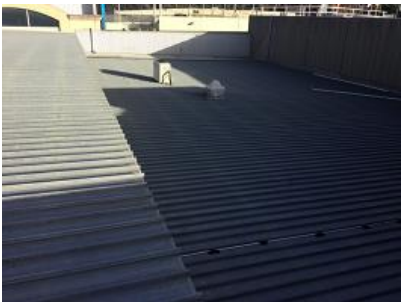
No safe access to the A/c units	Trips, Slips and Falls	N/A	Low	Supply walkway to the A/c units	Low	Client advised	Outstanding	-

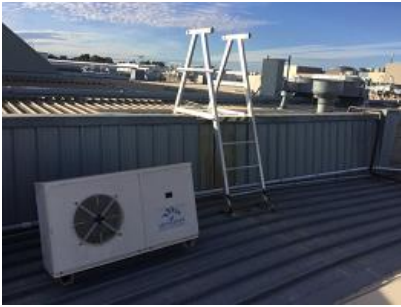
No landing platform at base and handrails projecting towards the user	Trips, Slips and Falls	Awareness induction	Med	Existing handrails to be removed and new landing platform and preformed handrails to be installed	Low	Client advised	Outstanding	OH&S REGULATIONS 3.7  AS/NZS 1657-2013 7.3.6 & 7.4.8.5
48	Building: General Stores Location Reference: <a href="#">L19</a> Task: Access to the roof

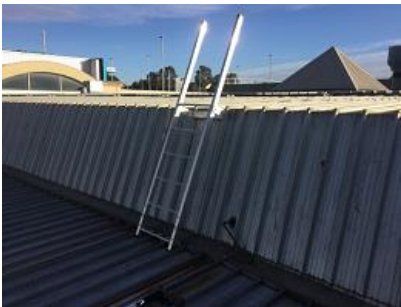
Bottom rung height is less than required minimum and gap between top rung and landing is greater than required maximum	Trips, Slips and Falls	Awareness induction	Med	Existing ladder to be re-installed with landing platforms and brackets	Low	Client advised	Outstanding	OH&S REGULATIONS 3.7  AS/NZS 1657-2013 7.4.3.4 & 7.4.8.4

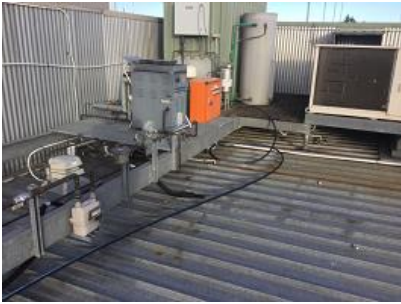
Variation in height between plant deck and roof is greater than required maximum	Trips, Slips and Falls	Awareness induction	Med	Access ladder and guardrails to be installed	Low	Client advised	Outstanding	OH&S REGULATIONS 3.7  AS/NZS 1657-2013 3.1.4 & 4.4
50	Building: General Stores Location Reference: <a href="#">L20</a> Task: Access to the A/c units

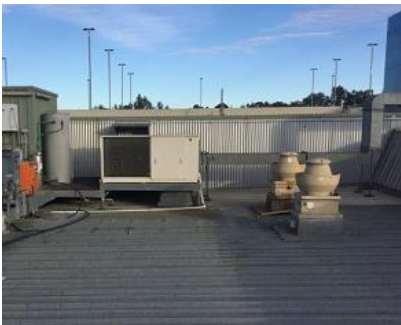
No safe access to the A/c units	Trips, Slips and Falls	N/A	Low	Supply walkway to the A/c units	Low	Client advised	Outstanding	-

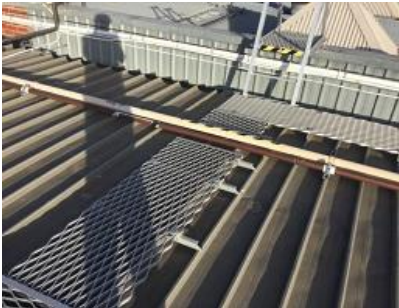
Pipes installed over the walkway path	Trips, Slips and Falls	Awareness induction	Med	Step over to be installed	Low	Client advised	Outstanding	OH&S REGULATIONS 3.7
52	Building: General Stores Location Reference: <a href="#">L21</a> Task: Access to the roof

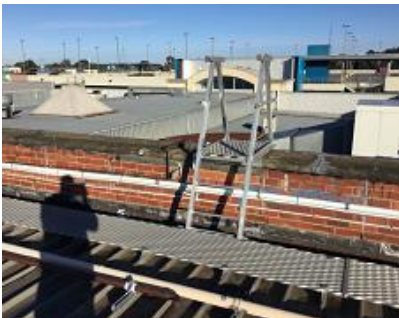
Bottom rung height is less than required minimum, landing is less than required minimum and handrails projecting towards the user.	Trips, Slips and Falls	Awareness induction	Med	Existing handrails to be removed and new handrails and landing platforms to be installed	Low	Client advised	Outstanding	OH&S REGULATIONS 3.7  AS/NZS 1657-2013 7.4.3.4, 7.3.6 & 7.4.8.5

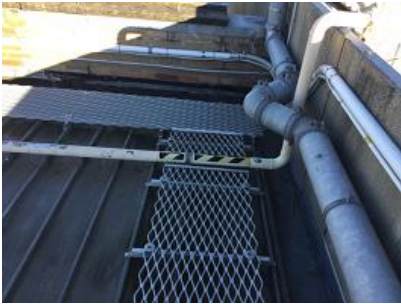
Pipe installed over the walkway path	Trips, Slips and Falls	Awareness induction	Med	Step over to be installed	Low	Client advised	Outsta nding	OH&S REGULATIONS 3.7
54	Building: General Stores Location Reference: <a href="#">L22</a> Task: Access to the roof

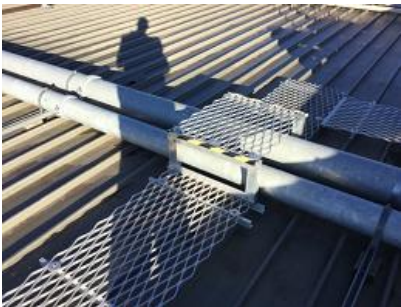
Variation in height between landing and roof is greater than required maximum	Trips, Slips and Falls	Awareness induction	Med	Handrail to be installed	Low	Client advised	Outsta nding	OH&S REGULATIONS 3.7  AS/NZS 1657-2013 4.4

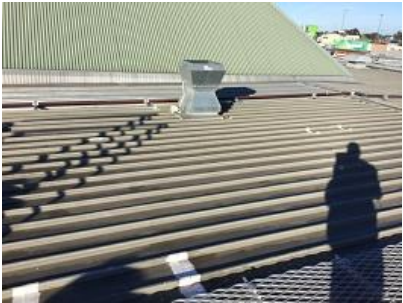
No safe access to the A/c units	Trips, Slips and Falls	N/A	Low	Supply walkway to the A/c units	Low	Client advised	Outsta nding	-

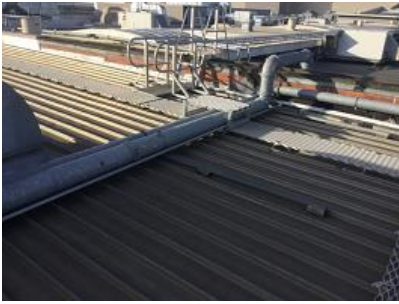
Variation in height between landing and roof is greater than required maximum	Trips, Slips and Falls	Awareness induction	Med	Handrail to be installed	Low	Client advised	Outstanding	OH&S REGULATIONS 3.7  AS/NZS 1657-2013 4.4
58	Building: General Stores Location Reference: <a href="#">L24</a> Task: Restrict access to the roof

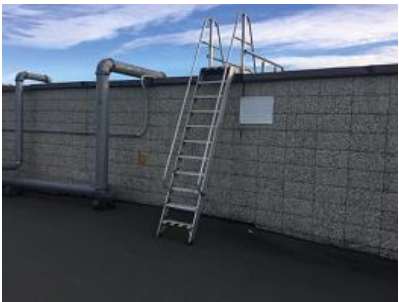
Gap between tread and structure is less than required minimum and Sharp edges on handrails and handrails not providing continuous hand hold	Trips, Slips and Falls	Awareness induction	Med	Existing ladder to be removed and new ladder to be installed. Tek screws to be replaced with rivets	Low	Client advised	Outstanding	OH&S REGULATIONS 3.7  AS/NZS 1657-2013 7.3.5, 5.6 & 7.3.4

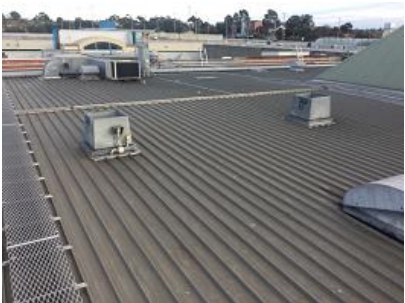
No safe access to the A/c units	Trips, Slips and Falls	N/A	Low	Supply walkway to the A/c units	Low	Client advised	Outstanding	-

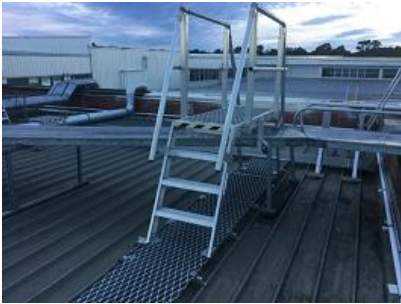
Sharp edges on handrails	Trips, Slips and Falls	Awareness induction	Med	Tek screws to be replaced with rivets	Low	Client advised	Outsta nding	OH&S REGULATIONS 3.7  AS/NZS 1657- 2013 5.6
62	Building: General Stores Location Reference: <a href="#">L25</a> Task: Access to the roof

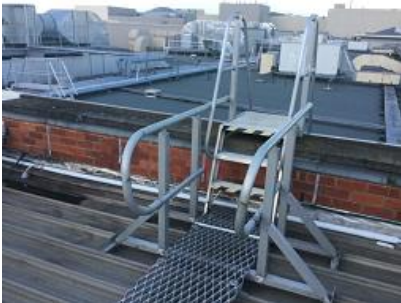
Handrails not providing continuous hand hold and sharp edges on handrails	Trips, Slips and Falls	Awareness induction	Med	Existing handrails to be removed and new handrails to be installed for existing ladder. Tek screws to be replaced with rivets	Low	Client advised	Outsta nding	OH&S REGULATIONS 3.7  AS/NZS 1657-2013 7.3.4 & 5.6

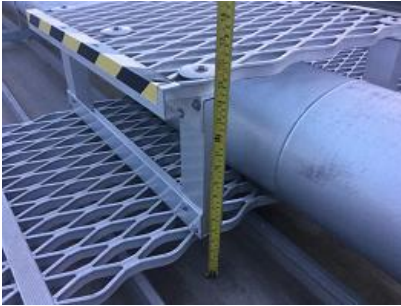
Variation in height between landing and roof is greater than required maximum	Trips, Slips and Falls	Awareness induction	Med	Handrail to be installed	Low	Client advised	Outstanding	OH&S REGULATIONS 3.7  AS/NZS 1657-2013 4.4

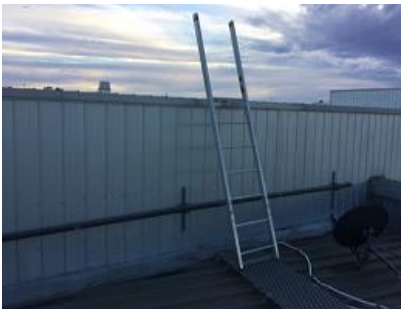
Bottom rung height is less than required minimum, top rung not levelled with landing, gap between top rung and landing is greater than required maximum and landing at top is less than required minimum	Trips, Slips and Falls	Awareness induction	Med	Existing ladder to be re-installed with landing platforms and brackets	Low	Client advised	Outstanding	OH&S REGULATIONS 3.7  AS/NZS 1657-2013 7.4.3.4, 7.4.3.3, 7.4.8.4 & 7.3.6

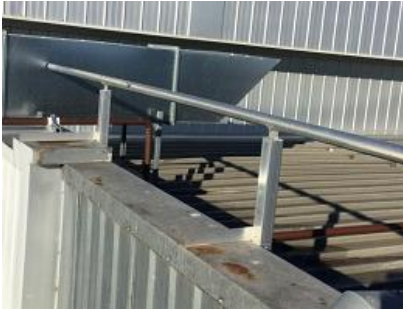
Sharp edges on handrails	Trips, Slips and Falls	Awareness induction	Med	Tek screws to be replaced with rivets	Low	Client advised	Outsta nding	OH&S REGULATIONS 3.7  AS/NZS 1657- 2013 5.6
70	Building: General Stores Location Reference: <a href="#">L27</a> Task: Access to the plant deck

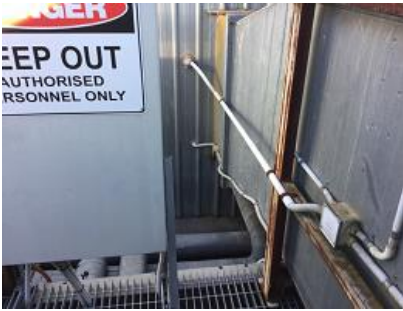
Variation in height between plant deck and roof is greater than required maximum	Trips, Slips and Falls	Awareness induction	Med	Handrail to be installed	Low	Client advised	Outsta nding	OH&S REGULATIONS 3.7  AS/NZS 1657-2013 4.4

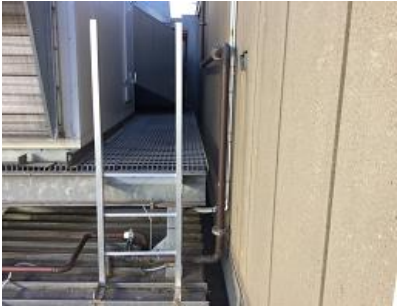
Gap between plant deck and structure is greater than required maximum	Trips, Slips and Falls	Awareness induction	Med	Gap to be closed or Handrail to be installed	Low	Client advised	Outstanding	OH&S REGULATIONS 3.7  AS/NZS 1657-2013 4.4

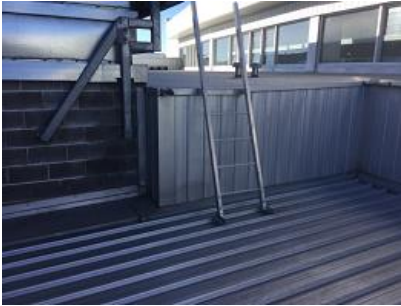
No landing platforms installed	Trips, Slips and Falls	Awareness induction	Med	Existing ladder to be re-installed with landing platforms and brackets	Low	Client advised	Outstanding	OH&S REGULATIONS 3.7  AS/NZS 1657-2013 7.3.6

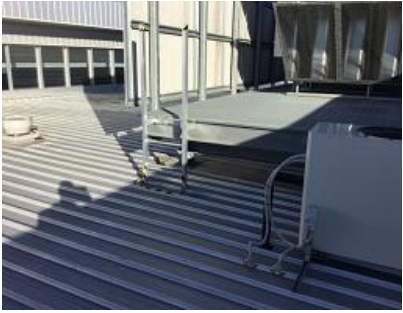
Gap between top rung and landing is greater than required maximum and no landing platform at base	Trips, Slips and Falls	Awareness induction	Med	Existing ladder to be removed and new ladder to be installed	Low	Client advised	Outstanding	OH&S REGULATIONS 3.7  AS/NZS 1657-2013 7.4.8.4 & 7.3.6

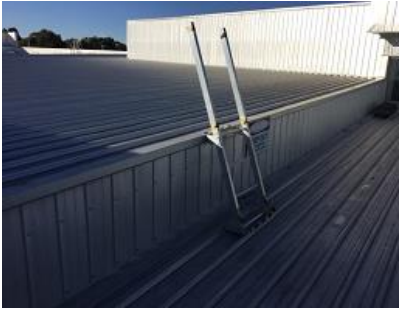
No landing platforms	Trips, Slips and Falls	Awareness induction	Med	Existing ladder to be re-installed with landing platforms and brackets	Low	Client advised	Outstanding	OH&S REGULATIONS 3.7  AS/NZS 1657-2013 7.3.6

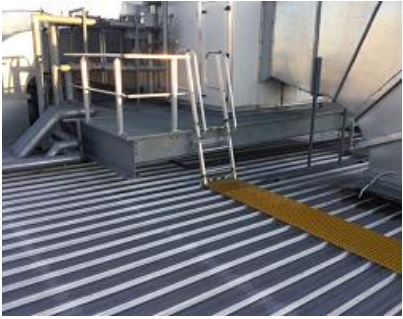
Bottom rung height is less than required minimum and handrail projecting towards the user	Trips, Slips and Falls	Awareness induction	Med	Existing handrail to be removed and new landing platform and handrails to be installed	Low	Client advised	Outstanding	OH&S REGULATIONS 3.7  AS/NZS 1657-2013 7.4.3.4 & 7.4.8.5

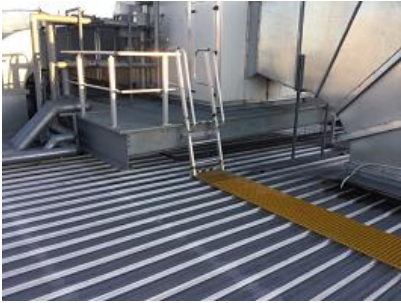
Variation in height between plant deck and roof is greater than required maximum	Trips, Slips and Falls	Awareness induction	Med	Handrail to be installed	Low	Client advised	Outstanding	OH&S REGULATIONS 3.7  AS/NZS 1657-2013 4.4
84	Building: General Stores Location Reference: <a href="#">L31</a> Task: Access to the plant deck

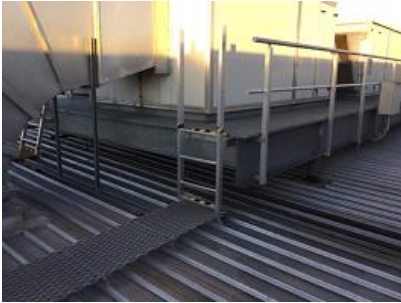
Bottom rung height is less than required minimum and gap between top rung and landing is greater than required maximum	Trips, Slips and Falls	Awareness induction	Med	Existing ladder to be re-installed with landing platform and brackets	Low	Client advised	Outstanding	OH&S REGULATIONS 3.7  AS/NZS 1657-2013 7.4.3.4 & 7.4.8.4

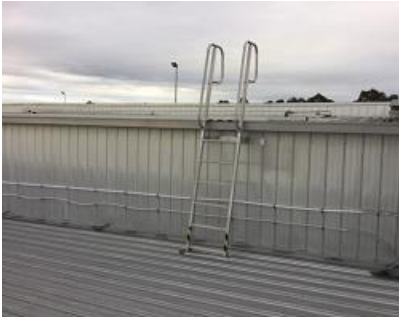
Bottom rung height is less than required minimum, Top rung not levelled with landing and handrail projecting towards the user	Trips, Slips and Falls	Awareness induction	Med	Existing handrails to be removed and existing ladder to be re-installed with landing platforms, handrails and brackets	Low	Client advised	Outstanding	OH&S REGULATIONS 3.7  AS/NZS 1657-2013 7.4.3.4, 7.4.3.3 & 7.4.8.5

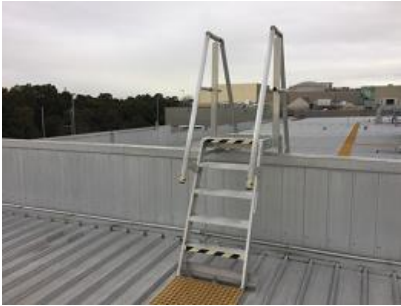
Sharp edges on handrails	Trips, Slips and Falls	Awareness induction	Med	Tek screws to be replaced with rivets	Low	Client advised	Outstanding	OH&S REGULATIONS 3.7  AS/NZS 1657-2013 5.6

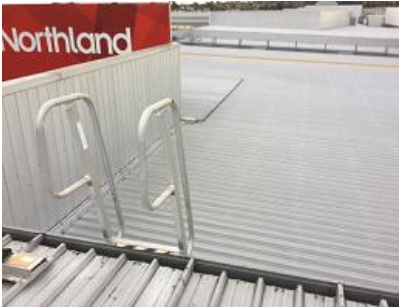
No safe access to the ladder	Trips, Slips and Falls	N/A	Low	Supply walkway to the ladder	Low	Client advised	Outstanding	-

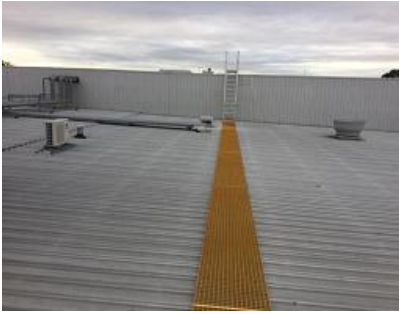
No safe access to the A/c units	Trips, Slips and Falls	N/A	Low	Supply walkway to the A/c units	Low	Client advised	Outstanding	-
92	Building: General Stores Location Reference: <a href="#">L34</a> Task: Access to the plant deck

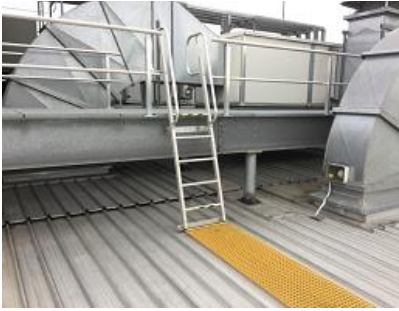
Bottom rung height is less than required minimum and handrails projecting towards the user	Trips, Slips and Falls	Awareness induction	Med	Existing handrails to be removed and new landing platform and handrails to be installed	Low	Client advised	Outstanding	OH&S REGULATIONS 3.7  AS/NZS 1657-2013 7.4.3.4 & 7.4.8.5

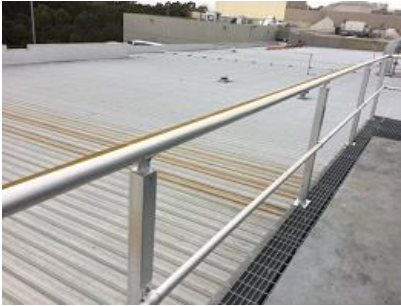
Sharp edges on handrails	Trips, Slips and Falls	Awareness induction	Med	Handrails to be installed	Low	Client advised	Outsta nding	OH&S REGULATIONS 3.7  AS/NZS 1657- 2013 5.6

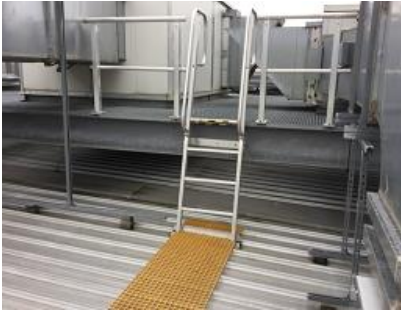
Bottom rung height is less than required minimum and handrails projecting towards the user	Trips, Slips and Falls	Awareness induction	Med	Existing handrails to be removed and new landing platform and handrails to be installed	Low	Client advised	Outstanding	OH&S REGULATIONS 3.7  AS/NZS 1657-2013 7.4.3.4 & 7.4.8.5

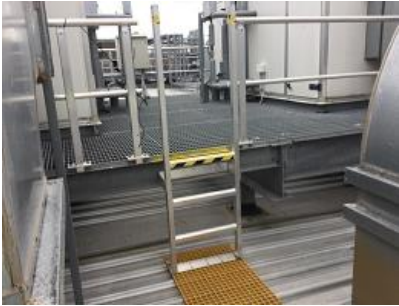
Gap between top rung and landing is greater than required maximum	Trips, Slips and Falls	Awareness induction	Med	Existing ladder to be re-installed	Low	Client advised	Outstanding	OH&S REGULATIONS 3.7  AS/NZS 1657-2013 7.4.8.4
98	Building: General Stores Location Reference: <a href="#">L35</a> Task: Access to the plant deck

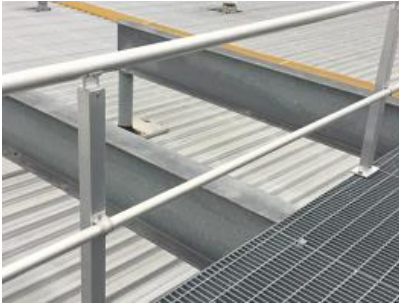
Sharp edges on handrails	Trips, Slips and Falls	Awareness induction	Med	Tek screws to be replaced with rivets	Low	Client advised	Outstanding	OH&S REGULATIONS 3.7  AS/NZS 1657-2013 5.6

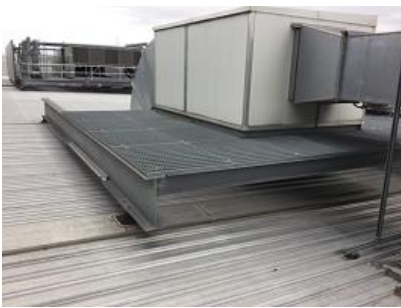
No safe access to the plant deck	Trips, Slips and Falls	Awareness induction	Med	Access ladder, handrails and walkway to be installed	Low	Client advised	Outstanding	OH&S REGULATIONS 3.7  AS/NZS 1657-2013 3.1.4
100	Building: General Stores Location Reference: <a href="#">L35</a> Task: Access to the plant deck

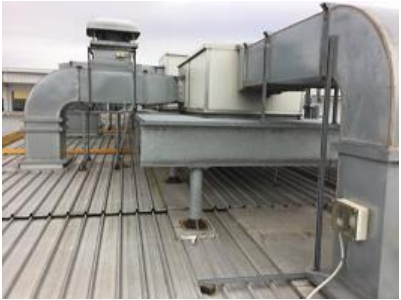
No safe access to the plant deck	Trips, Slips and Falls	Awareness induction	Med	Access ladder, handrails and walkway to be installed	Low	Client advised	Outstanding	OH&S REGULATIONS 3.7  AS/NZS 1657-2013 3.1.4

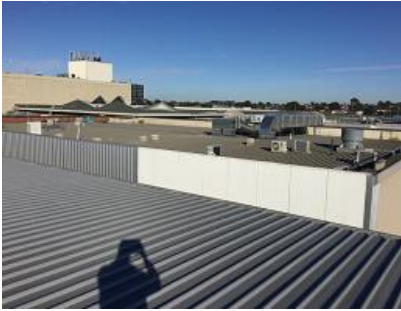
No safe access to the A/c units	Trips, Slips and Falls	N/A	Low	Supply walkway to the A/c units	Low	Client advised	Outstanding	-

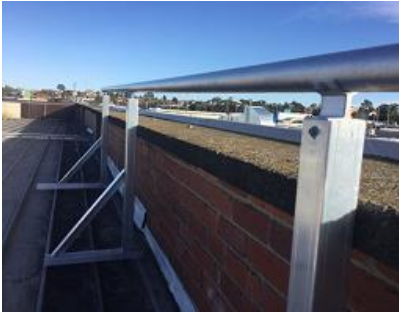
Sharp edges on handrails	Trips, Slips and Falls	Awareness induction	Med	Tek screws to be replaced with rivets	Low	Client advised	Outstanding	OH&S REGULATIONS 3.7  AS/NZS 1657-2013 5.6

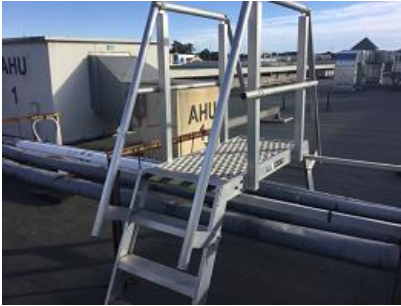
No	Photo of Hazard	Details of Hazard	Details of Risk	Existing/ Immediate Control Measure	Curren t Risk Level	Proposed Permanent Solution	Residu al Risk Assess ment	Details of Action Taken	Status	Reference
109	Building: General Stores Location Reference: <a href="#">L38</a> Task: Access to the roof

Sharp edges on handrails	Trips, Slips and Falls	Awareness induction	Med	Tek screws to be replaced with rivets	Low	Client advised	Outstanding	OH&S REGULATIONS 3.7  AS/NZS 1657-2013 5.6
110	Building: General Stores Location Reference: <a href="#">L39</a> Task: Access to the roof

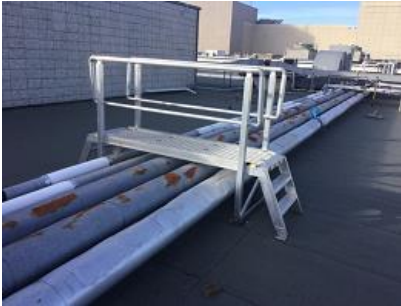
Ladder not fully secured to roof and sharp edges on handrails	Trips, Slips and Falls	Awareness induction	Med	Ladder to be fully secured and tek screws to be replaced with rivets	Low	Client advised	Outstanding	OH&S REGULATIONS 3.7  AS/NZS 1657-2013 5.6

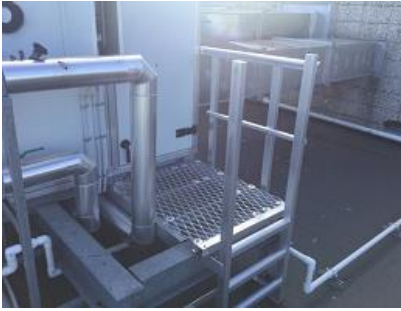
Variation in height between plant deck and roof is greater than required maximum	Trips, Slips and Falls	Awareness induction	Med	Handrails to be installed	Low	Client advised	Outstanding	OH&S REGULATIONS 3.7  AS/NZS 1657-2013 4.4
112	Building: General Stores Location Reference: <a href="#">L39</a> Task: Access to the plant deck

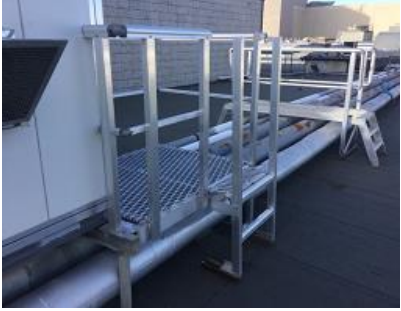
Bottom rung height is greater than required maximum	Trips, Slips and Falls	Awareness induction	Med	Landing platform to be installed	Low	Client advised	Outstanding	OH&S REGULATIONS 3.7  AS/NZS 1657-2013 7.4.3.4

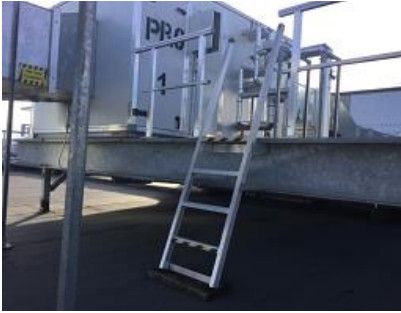
Bottom rung height is greater than required maximum	Trips, Slips and Falls	Awareness induction	Med	Landing platform to be installed	Low	Client advised	Outstanding	OH&S REGULATIONS 3.7  AS/NZS 1657-2013 7.4.3.4

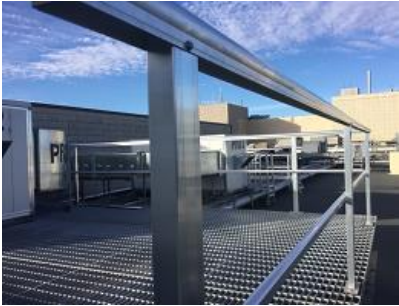
Sharp edges on handrails	Trips, Slips and Falls	Awareness induction	Med	Tek screws to be replaced with rivets	Low	Client advised	Outsta nding	OH&S REGULATIONS 3.7  AS/NZS 1657- 2013 5.6
116	Building: General Stores Location Reference: <a href="#">L40</a> Task: Access to the plant deck

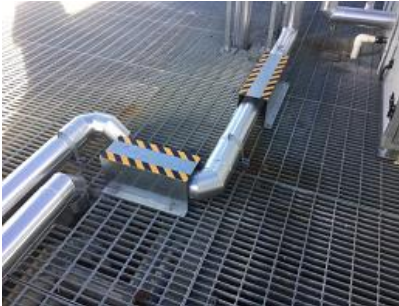
Non-complaint step overs	Trips, Slips and Falls	Awareness induction	Med	Complaint step over to be installed	Low	Client advised	Outsta nding	OH&S REGULATIONS 3.7

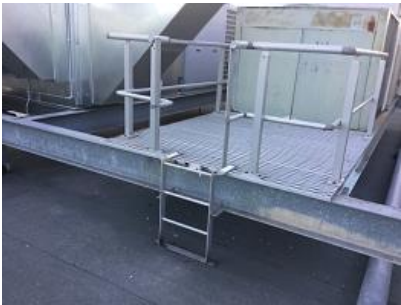
No slip resistance on ladder rungs	Trips, Slips and Falls	Awareness induction	Med	Existing ladder to be removed and new ladder to be installed	Low	Client advised	Outsta nding	OH&S REGULATIONS 3.7  AS/NZS 1657-2013 7.4.3.1

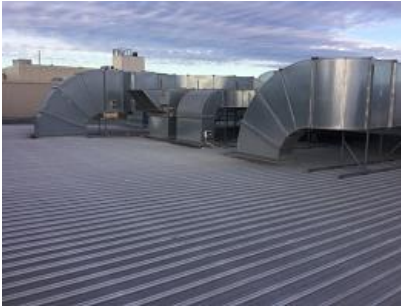
No safe access to the A/c units	Trips, Slips and Falls	N/A	Low	Supply walkway to the A/c units	Low	Client advised	Outstanding	-
124	Building: General Stores Location Reference: <a href="#">L43</a> Task: Access to the plant deck

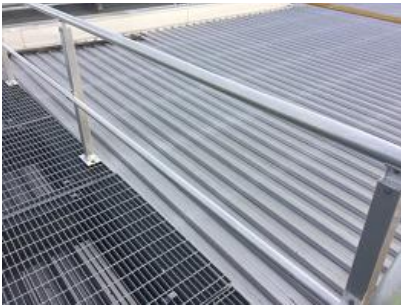
Sharp edges on handrails	Trips, Slips and Falls	Awareness induction	Med	Tek screws to be replaced with rivets	Low	Client advised	Outstanding	OH&S REGULATIONS 3.7  AS/NZS 1657-2013 5.6

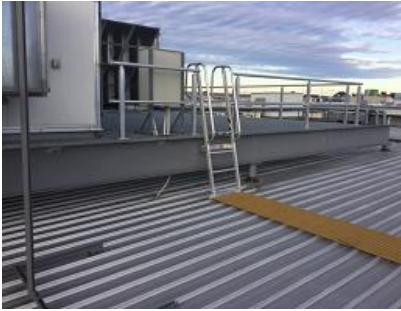
Bottom rung height is less than required minimum, top rung not levelled with landing and handrails projecting towards the user	Trips, Slips and Falls	Awareness induction	Med	Existing handrails to be removed. Existing ladder to be re-installed with landing platform, handrails and brackets	Low	Client advised	Outstanding	OH&S REGULATIONS 3.7  AS/NZS 1657-2013 7.4.3.4, 7.4.3.3 & 7.4.8.5
126	Building: General Stores Location Reference: <a href="#">L43</a> Task: Access to the A/c units

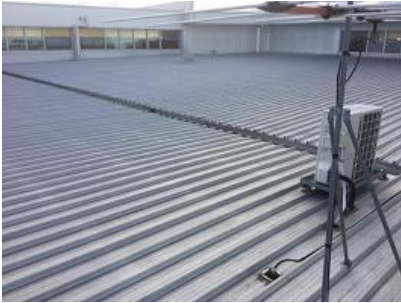
No safe access to the A/c units	Trips, Slips and Falls	N/A	Low	Supply walkway to the A/c units	Low	Client advised	Outstanding	-

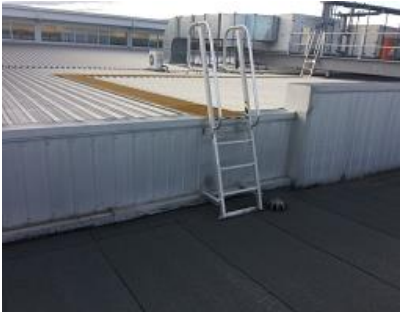
No	Photo of Hazard	Details of Hazard	Details of Risk	Existing/ Immediate Control Measure	Curren t Risk Level	Proposed Permanent Solution	Residu al Risk Assess ment	Details of Action Taken	Status	Reference
127	Building: General Stores Location Reference: <a href="#">L43</a> Task: Access to the roof

Handrails projecting towards the user	Trips, Slips and Falls	Awareness induction	Med	Existing handrails to be removed and new handrails to be installed	Low	Client advised	Outstanding	OH&S REGULATIONS 3.7  AS/NZS 1657-2013 7.4.8.5
128	Building: General Stores Location Reference: <a href="#">L44</a> Task: Access to the roof

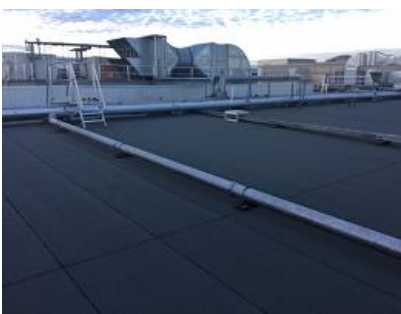
Pipe installed on the way to access A/c units	Trips, Slips and Falls	Awareness induction	Med	Step over to be installed	Low	Client advised	Outstanding	OH&S REGULATIONS 3.7

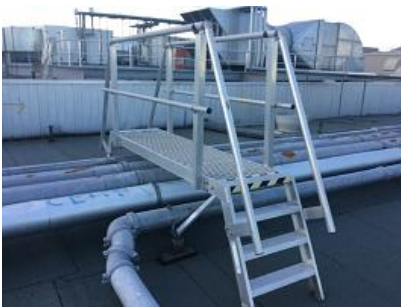
No	Photo of Hazard	Details of Hazard	Details of Risk	Existing/ Immediate Control Measure	Current Risk Level	Proposed Permanent Solution	Residual Risk Assessment	Details of Action Taken	Status	Reference
129	Building: General Stores Location Reference: <a href="#">L44</a> Task: Access to the roof

Sharp edges on handrails	Trips, Slips and Falls	Awareness induction	Med	Tek screws to be replaced with rivets	Low	Client advised	Outstanding	OH&S REGULATIONS 3.7  AS/NZS 1657-2013 5.6
130	Building: General Stores Location Reference: <a href="#">L44</a> Task: Access to the roof

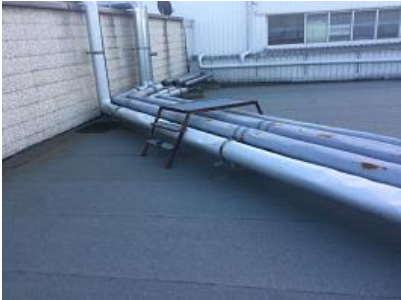
Non-compliant ladder and it is rusted	Trips, Slips and Falls	Awareness induction	Med	Existing ladder to be removed	Low	Client advised	Outstanding	OH&S REGULATIONS 3.7  AS/NZS 1657-2013 4.4

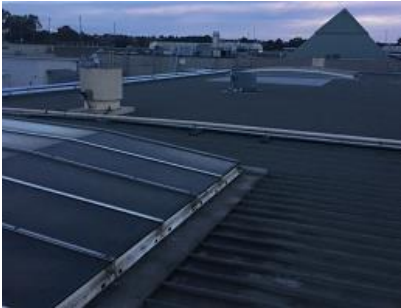
No safe access to the A/c units	Trips, Slips and Falls	N/A	Low	Supply walkway and step over to the A/c units	Low	Client advised	Outstanding	-

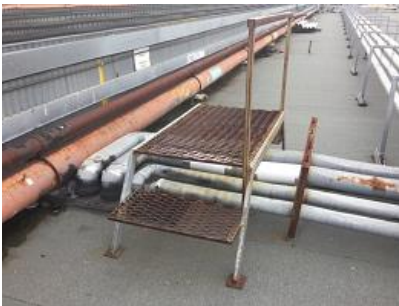
Non-compliant ladder is present and it is rusted	Trips, Slips and Falls	Awareness induction	Med	Existing ladder to be removed and new ladder to be installed	Low	Client advised	Outsta nding	OH&S REGULATIONS 3.7  AS/NZS 1657-2013 4.4 & 7.2.3.2

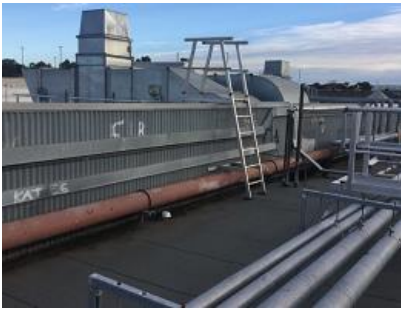
Bottom rung height is less than required minimum and handrails projecting towards the user	Trips, Slips and Falls	Awareness induction	Med	Existing handrails to be removed and new landing platform and handrails to be installed	Low	Client advised	Outsta nding	OH&S REGULATIONS 3.7  AS/NZS 1657-2013 7.4.3.4 & 7.4.8.5

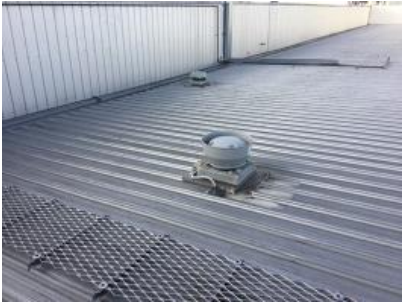
No safe access to the A/c units	Trips, Slips and Falls	N/A	Low	Supply walkway to the A/c units	Low	Client advised	Outstanding	-
138	Building: General Stores Location Reference: <a href="#">L47</a> Task: Access to the plant deck

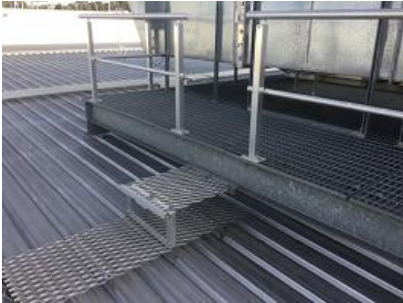
Step height is greater than required maximum	Trips, Slips and Falls	Awareness induction	Med	Existing step to be removed and new steps to be installed	Low	Client advised	Outstanding	OH&S REGULATIONS 3.7  AS/NZS 1657-2013 7.2.3.2

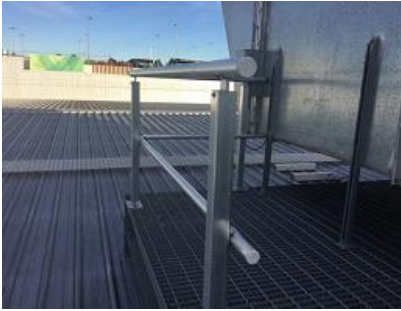
Sharp edges on handrails	Trips, Slips and Falls	Awareness induction	Med	Tek screws to be replaced with rivets	Low	Client advised	Outstanding	OH&S REGULATIONS 3.7  AS/NZS 1657-2013 5.6
140	Building: General Stores Location Reference: <a href="#">L47</a> Task: Access to the plant deck

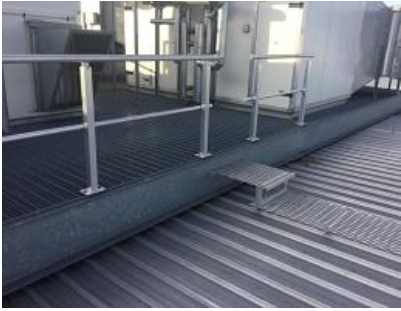
Step height is greater than required maximum	Trips, Slips and Falls	Awareness induction	Med	Existing step to be removed and new steps to be installed	Low	Client advised	Outstanding	OH&S REGULATIONS 3.7  AS/NZS 1657-2013 7.2.3.2

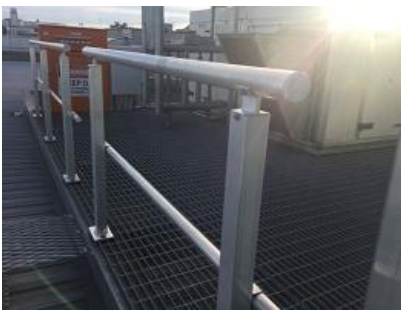
Sharp edges on handrails	Trips, Slips and Falls	Awareness induction	Med	Tek screws to be replaced with rivets	Low	Client advised	Outsta nding	OH&S REGULATIONS 3.7  AS/NZS 1657- 2013 5.6
142	Building: General Stores Location Reference: <a href="#">L47</a> Task: Access to the A/c units

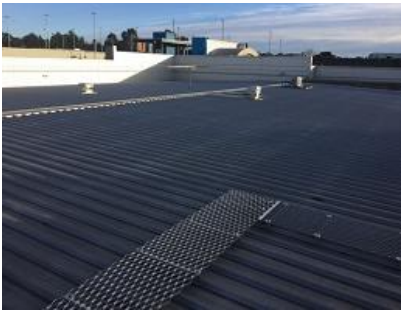
No safe access to the A/c units	Trips, Slips and Falls	N/A	Low	Supply walkway to the A/c units	Low	Client advised	Outsta nding	-

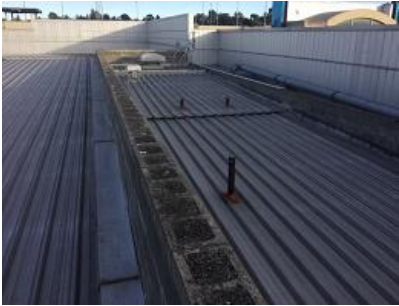
Variation in height between roofs are greater than required maximum	Trips, Slips and Falls	Awareness induction	Med	Access ladder including handrails to be installed	Low	Client advised	Outstanding	OH&S REGULATIONS 3.7  AS/NZS 1657-2013 3.1.4
144	Building: General Stores Location Reference: <a href="#">L47</a> Task: Access to the A/c units

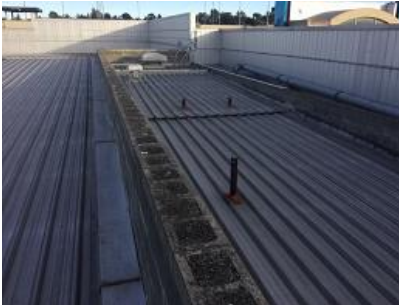
No safe access to the A/c units	Trips, Slips and Falls	N/A	Low	Supply walkway to the A/c units	Low	Client advised	Outstanding	-

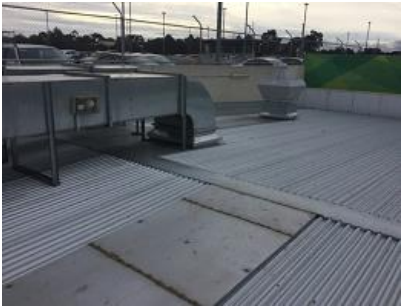
No safe access to the A/c units	Trips, Slips and Falls	N/A	Low	Supply walkway to the A/c units	Low	Client advised	Outstanding	-
148	Building: General Stores Location Reference: <a href="#">L49</a> Task: Access to the plant deck

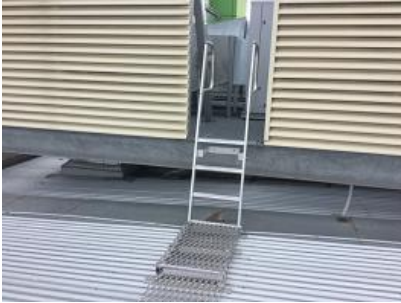
Gap between handrail and structure is greater than required maximum	Trips, Slips and Falls	Awareness induction	Med	Gap to be closed/Handrail post to be installed	Low	Client advised	Outstanding	OH&S REGULATIONS 3.7  AS/NZS 1657- 2013 4.4

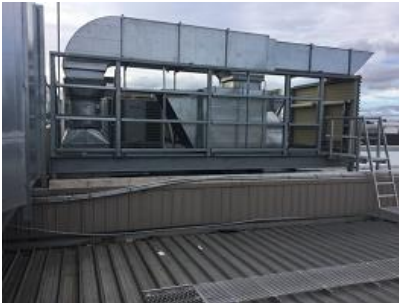
Variation in height between plant deck and roof is greater than required maximum	Trips, Slips and Falls	Awareness induction	Med	Handrails to be installed	Low	Client advised	Outstanding	OH&S REGULATIONS 3.7  AS/NZS 1657-2013 4.4

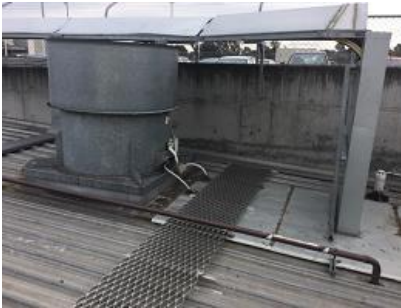
Pipe installed over the walkway path and Headroom is less than required minimum	Trips, Slips and Falls	Awareness induction	Med	Step over and "Low Headroom" sign to be installed	Low	Client advised	Outstanding	OH&S REGULATIONS 3.7  AS/NZS 1657-2013 3.1.5
152	Building: General Stores Location Reference: <a href="#">L50</a> Task: Access to the roof

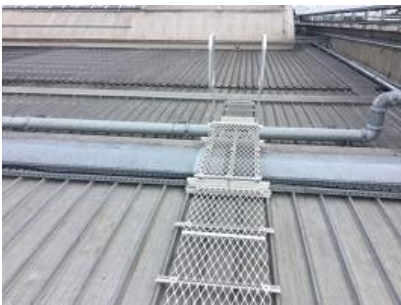
Variation in height between walkway panels are greater than required maximum	Trips, Slips and Falls	Awareness induction	Med	High visibility safety yellow nosing to be installed	Low	Client advised	Outstanding	OH&S REGULATIONS 3.7  AS/NZS 1657-2013 3.3.4

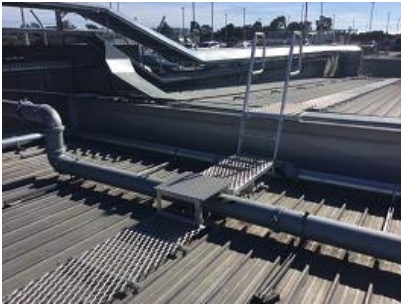
Variation in height between landing and roof is greater than required maximum	Trips, Slips and Falls	Awareness induction	Med	Handrails to be installed	Low	Client advised	Outstanding	OH&S REGULATIONS 3.7  AS/NZS 1657-2013 4.4
154	Building: General Stores Location Reference: <a href="#">L51</a> Task: Access to the plant deck

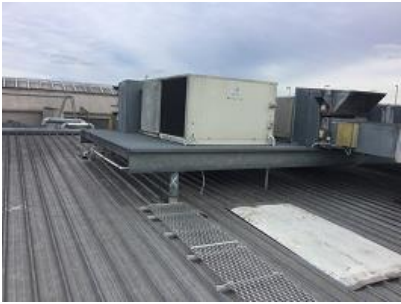
Variation in height between plant deck and roof is greater than required maximum	Trips, Slips and Falls	Awareness induction	Med	Access ladder, handrails and walkway to be installed	Low	Client advised	Outstanding	OH&S REGULATIONS 3.7  AS/NZS 1657-2013 3.1.4 & 4.4

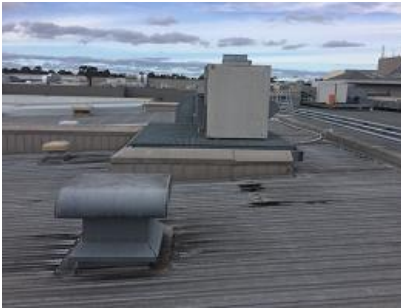
Variation in height between plant deck and roof is greater than required maximum	Trips, Slips and Falls	Awareness induction	Med	Access ladder, handrails and walkway to be installed	Low	Client advised	Outstanding	OH&S REGULATIONS 3.7  AS/NZS 1657-2013 3.1.4 & 4.4
156	Building: General Stores Location Reference: <a href="#">L52</a> Task: Access to the A/c units

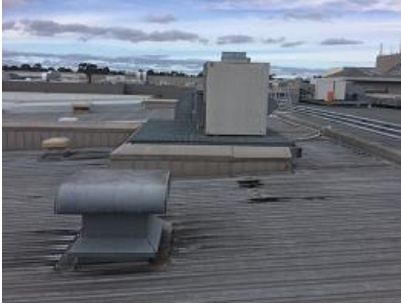
No safe access to the A/c units	Trips, Slips and Falls	N/A	Low	Supply walkway to the A/c units	Low	Client advised	Outstanding	-

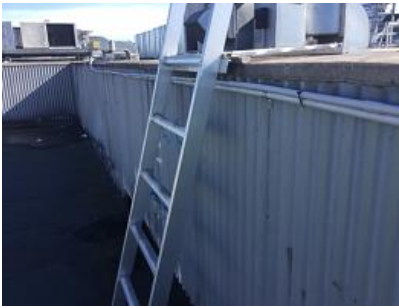
Gap between rung and permanent structure is less than required minimum	Trips, Slips and Falls	Awareness induction	Med	Existing ladder to be re-installed with new landing platform, handrails and brackets	Low	Client advised	Outstanding	OH&S REGULATIONS 3.7  AS/NZS 1657-2013 7.4.5
158	Building: General Stores Location Reference: <a href="#">L52</a> Task: Access to the roof

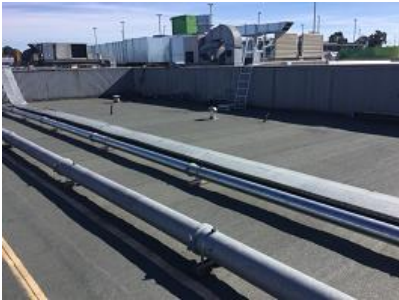
No safe access to the ladder (Pipes and cable tray in the way)	Trips, Slips and Falls	Awareness induction	Med	Step overs to be installed	Low	Client advised	Outstanding	OH&S REGULATIONS 3.7

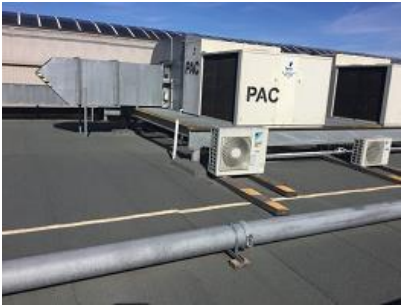
Variation in height between plant deck and roof is greater than required maximum	Trips, Slips and Falls	Awareness induction	Med	Access ladder and handrails to be installed	Low	Client advised	Outstanding	OH&S REGULATIONS 3.7  AS/NZS 1657-2013 3.1.4 & 4.4
160	Building: General Stores Location Reference: <a href="#">L53</a> Task: Access to the plant deck

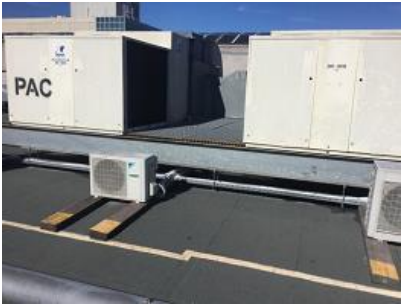
Variation in height between plant deck and roof is greater than required maximum	Trips, Slips and Falls	Awareness induction	Med	Access ladder and handrails to be installed	Low	Client advised	Outstanding	OH&S REGULATIONS 3.7  AS/NZS 1657-2013 3.1.4 & 4.4

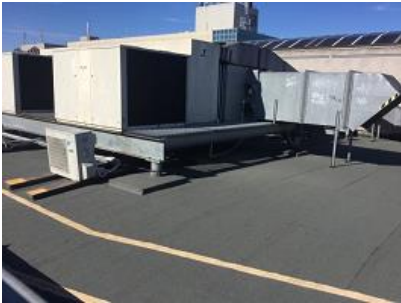
Variation in height between plant deck and roof is greater than required maximum	Trips, Slips and Falls	Awareness induction	Med	Access ladder and handrails to be installed	Low	Client advised	Outstanding	OH&S REGULATIONS 3.7  AS/NZS 1657-2013 3.1.4 & 4.4
162	Building: General Stores Location Reference: <a href="#">L54</a> Task: Access to the roof

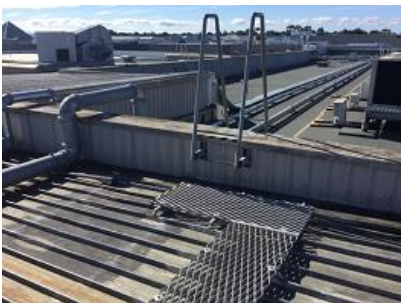
Non-complaint ladder is present	Trips, Slips and Falls	Awareness induction	Med	Existing ladder to be removed and new ladder to be installed	Low	Client advised	Outstanding	OH&S REGULATIONS 3.7  AS/NZS 1657-2013 7.3.6 & 7.4.3.1

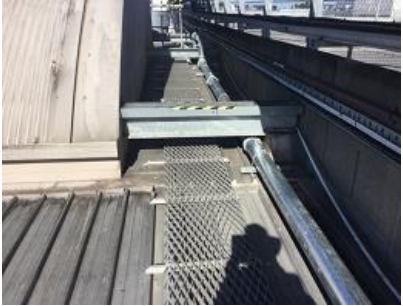
Duct installed over the walkway path	Trips, Slips and Falls	Awareness induction	Med	Access ladder and handrails to be installed	Low	Client advised	Outstanding	OH&S REGULATIONS 3.7  AS/NZS 1657- 2013 3.1.4

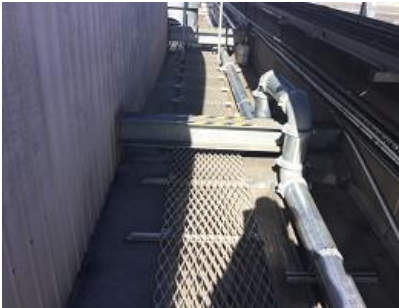
Duct installed over the walkway path	Trips, Slips and Falls	Awareness induction	Med	Access ladder and handrails to be installed	Low	Client advised	Outstanding	OH&S REGULATIONS 3.7  AS/NZS 1657-2013 3.1.4
166	Building: General Stores Location Reference: <a href="#">L55</a> Task: Access to the roof

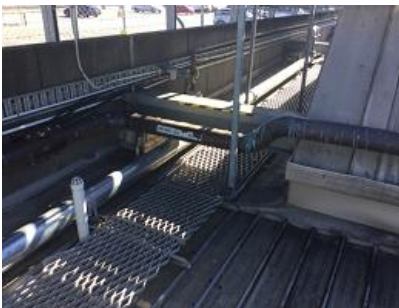
Duct installed over the walkway path and head room is less than required minimum	Trips, Slips and Falls	Awareness induction	Med	"Warning-Low Headroom" signs to be installed	Low	Client advised	Outstanding	OH&S REGULATIONS 3.7  AS/NZS 1657-2013 3.1.5

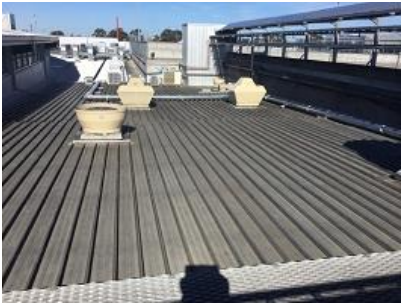
No safe access to the A/c units	Trips, Slips and Falls	N/A	Low	Supply walkway and step over to the A/c units	Low	Client advised	Outstanding	-

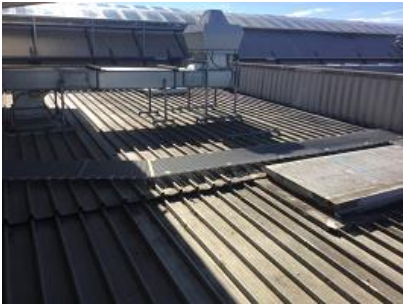
No safe access to the A/c units	Trips, Slips and Falls	N/A	Low	Supply walkway to the A/c unit	Low	Client advised	Outstanding	-

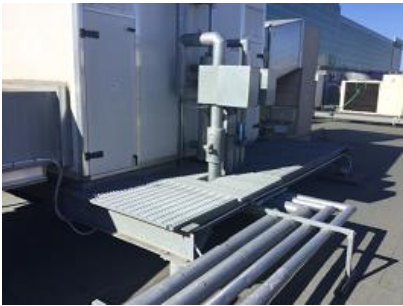
No	Photo of Hazard	Details of Hazard	Details of Risk	Existing/ Immediate Control Measure	Curre nt Risk Level	Proposed Permanent Solution	Resid ual Risk Asse ssme nt	Details of Action Taken	Status	Reference
173	Building: General Stores Location Reference: <a href="#">L58</a> Task: Access to the roof

Variation in height between plant deck and roof is greater than required maximum	Trips, Slips and Falls	Awareness induction	Med	Access ladder and handrails to be installed	Low	Client advised	Outstanding	OH&S REGULATIONS 3.7  AS/NZS 1657-2013 3.1.4 & 4.4
174	Building: General Stores Location Reference: <a href="#">L58</a> Task: Access to the A/c units

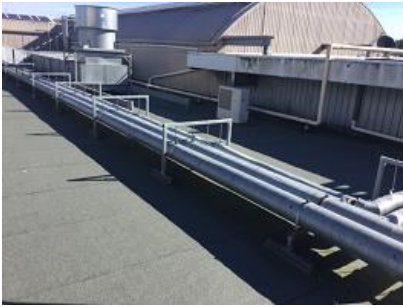
No safe access to the A/c units	Trips, Slips and Falls	Awareness induction	Med	Step bridge to be installed	Low	Client advised	Outstanding	OH&S REGULATIONS 3.7  AS/NZS 1657-2013 3.1.4

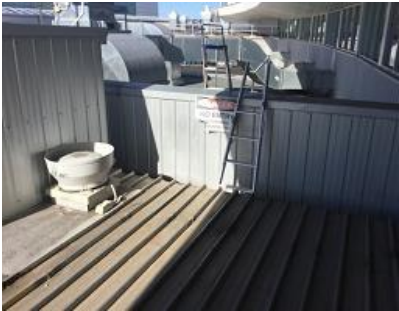
No	Photo of Hazard	Details of Hazard	Details of Risk	Existing/ Immediate Control Measure	Curre nt Risk Level	Proposed Permanent Solution	Resid ual Risk Asse sme nt	Details of Action Taken	Status	Reference
175	Building: General Stores Location Reference: <a href="#">L59</a> Task: Access to the roof

Non-complaint ladder is present	Trips, Slips and Falls	Awareness induction	Med	Existing ladder to be removed and new ladder to be installed	Low	Client advised	Outstanding	OH&S REGULATIONS 3.7  AS/NZS 1657-2013 3.1.4
176	Building: General Stores Location Reference: <a href="#">L59</a> Task: Access to the A/c unit

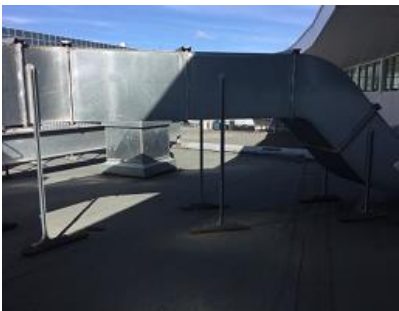
Headroom is less than required minimum	Trips, Slips and Falls	Awareness induction	Med	"Warning-Low Headroom" signs to be installed	Low	Client advised	Outstanding	OH&S REGULATIONS 3.7  AS/NZS 1657-2013 3.1.5

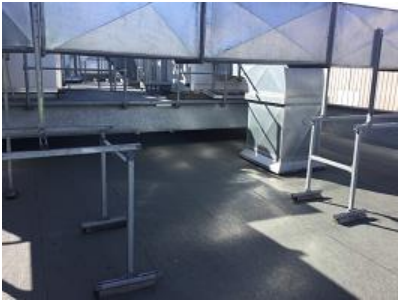
Headroom is less than required minimum	Trips, Slips and Falls	Awareness induction	Med	"Warning-Low Headroom" signs to be installed	Low	Client advised	Outstanding	OH&S REGULATIONS 3.7  AS/NZS 1657-2013 3.1.5
178	Building: General Stores Location Reference: <a href="#">L59</a> Task: Access to the plant deck

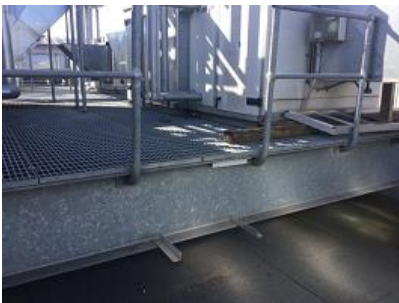
Variation in height between plant deck and roof is greater than required maximum	Trips, Slips and Falls	Awareness induction	Med	Access ladder and handrails to be installed	Low	Client advised	Outstanding	OH&S REGULATIONS 3.7  AS/NZS 1657-2013 3.1.4 & 4.4
