# Roof Safety Report

Northland, VIC 3072

Prepared By: Safemaster Safety Products  
Date: 10-09-2020

10-09-2020

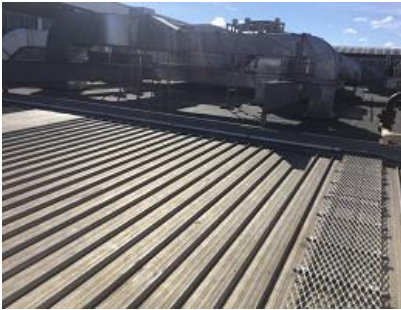
No	Photo of Hazard	Details of Hazard	Details of Risk	Existing/ Immediate Control Measure	Curre nt Risk Level	Proposed Permanent Solution	Resid ual Risk Asse ssme nt	Details of Action Taken	Status	Reference
179	Building: General Stores Location Reference: <a href="#">L59</a> Task: Access to the roof

Variation in height between roofs are greater than required maximum	Trips, Slips and Falls	Awareness induction	Med	Step bridge and walkway to be installed	Low	Client advised	Outstanding	OH&S REGULATIONS 3.7  AS/NZS 1657-2013 3.1.4

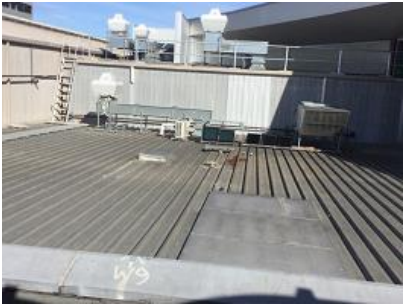
No	Photo of Hazard	Details of Hazard	Details of Risk	Existing/ Immediate Control Measure	Curre nt Risk Level	Proposed Permanent Solution	Resid ual Risk Asse ssme nt	Details of Action Taken	Status	Reference
181	Building: General Stores Location Reference: <a href="#">L61</a> Task: Access to the roof

No safe access to the A/c units	Trips, Slips and Falls	N/A	Low	Supply walkway to the A/c units	Low	Client advised	Outstanding	-
182	Building: General Stores Location Reference: <a href="#">L61</a> Task: Access to the roof

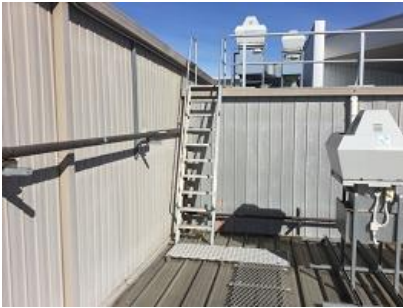
Clearance behind the ladder is less than required minimum and landing is less than required minimum	Trips, Slips and Falls	Awareness induction	Med	Existing ladder to be re-installed with new brackets and landing platform	Low	Client advised	Outstanding	OH&S REGULATIONS 3.7  AS/NZS 1657-2013 7.4.5 & 7.3.6

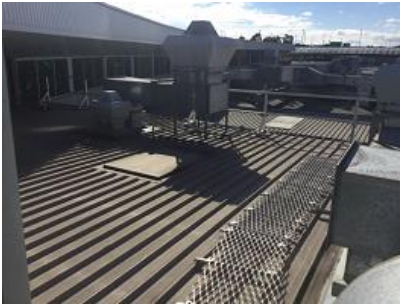
No safe access to the A/c units	Trips, Slips and Falls	N/A	Low	Supply walkway to the A/c units	Low	Client advised	Outstanding	-
184	Building: General Stores Location Reference: <a href="#">L62</a> Task: Access to the roof

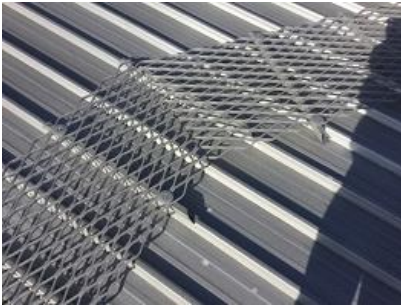
In-correct installation of walkway sections	Trips, Slips and Falls	Awareness induction	Med	Existing walkway to be re-installed with new channels and joining bars	Low	Client advised	Outstanding	OH&S REGULATIONS 3.7

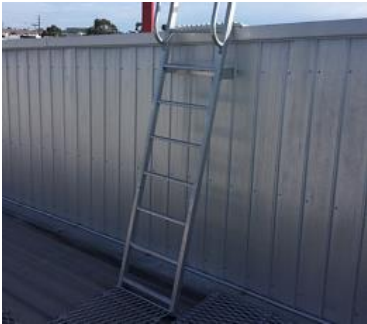
No	Photo of Hazard	Details of Hazard	Details of Risk	Existing/ Immediate Control Measure	Curre nt Risk Level	Proposed Permanent Solution	Resid ual Risk Asse ssme nt	Details of Action Taken	Status	Reference
185	Building: General Stores Location Reference: <a href="#">L62</a> Task: Access to the roof

Bottom rung height is less than required minimum, top rung not levelled with landing and handrails projecting towards the user	Trips, Slips and Falls	Awareness induction	Med	Existing ladder to be re-installed with new landing platforms, brackets and handrails	Low	Client advised	Outstanding	OH&S REGULATIONS 3.7  AS/NZS 1657-2013 7.4.3.4, 7.4.3.3 & 7.4.8.5

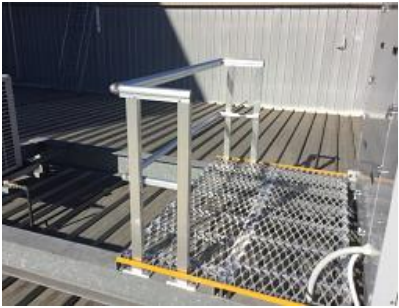
No	Photo of Hazard	Details of Hazard	Details of Risk	Existing/ Immediate Control Measure	Curre nt Risk Level	Proposed Permanent Solution	Resid ual Risk Asse sme nt	Details of Action Taken	Status	Reference
189	Building: General Stores Location Reference: <a href="#">L63</a> Task: Access to the roof

Sharp edges on handrails	Trips, Slips and Falls	Awareness induction	Med	Tek screws to be replaced with rivets	Low	Client advised	Outsta nding	OH&S REGULATIONS 3.7  AS/NZS 1657- 2013 5.6
190	Building: General Stores Location Reference: <a href="#">L63</a> Task: Access to the roof

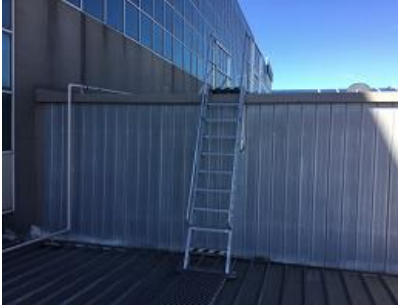
Clearance behind the ladder is less than required minimum	Trips, Slips and Falls	Awareness induction	Med	Existing ladder to be re-installed with landing platform and brackets	Low	Client advised	Outsta nding	OH&S REGULATIONS 3.7  AS/NZS 1657- 2013 7.4.5

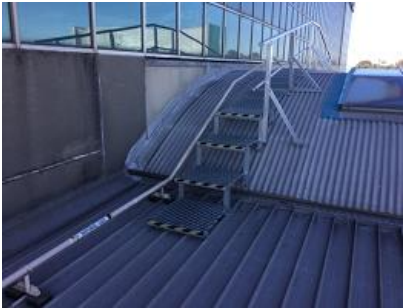
No	Photo of Hazard	Details of Hazard	Details of Risk	Existing/ Immediate Control Measure	Curre nt Risk Level	Proposed Permanent Solution	Resid ual Risk Asse ssme nt	Details of Action Taken	Status	Reference
191	Building: General Stores Location Reference: <a href="#">L64</a> Task: Access to the roof

Non-complaint steps is present	Trips, Slips and Falls	Awareness induction	Med	Existing steps to be removed and new steps to be installed	Low	Client advised	Outstanding	OH&S REGULATIONS 3.7  AS/NZS 1657-2013 5.1.1 & 5.4.2

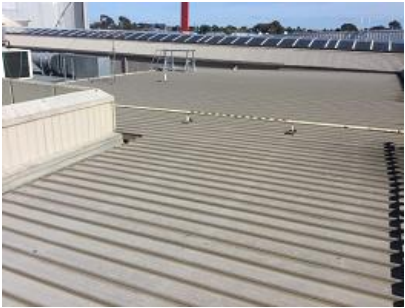
No safe access to the A/c units	Trips, Slips and Falls	N/A	Low	Supply walkway and step over to the A/c unit	Low	Client advised	Outstanding	-
194	Building: General Stores Location Reference: <a href="#">L64</a> Task: Access to the A/c units

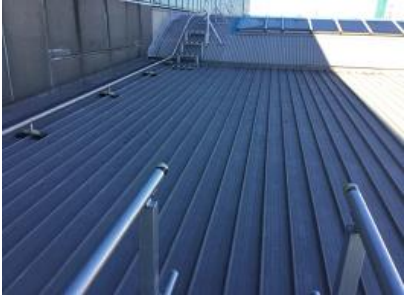
No safe access to the A/c units	Trips, Slips and Falls	N/A	Low	Supply walkway to the A/c unit	Low	Client advised	Outstanding	-

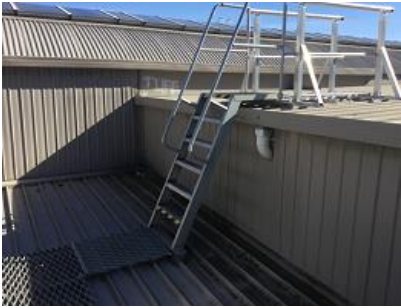
No	Photo of Hazard	Details of Hazard	Details of Risk	Existing/ Immediate Control Measure	Curre nt Risk Level	Proposed Permanent Solution	Resid ual Risk Asse ssme nt	Details of Action Taken	Status	Reference
196	Building: General Stores Location Reference: <a href="#">L65</a> Task: Access to the roof

Clearance behind the ladder is less than required minimum	Trips, Slips and Falls	Awareness induction	Med	Existing ladder to be re-installed with new brackets	Low	Client advised	Outstanding	OH&S REGULATIONS 3.7  AS/NZS 1657-2013 7.3.5

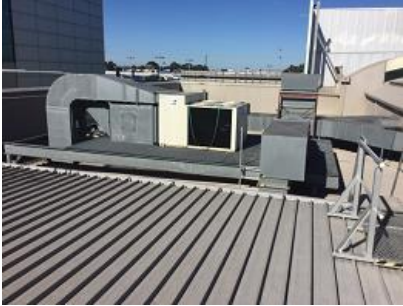
Variation in height between plant deck and roof is greater than required maximum	Trips, Slips and Falls	Awareness induction	Med	Handrails to be installed	Low	Client advised	Outstanding	OH&S REGULATIONS 3.7  AS/NZS 1657-2013 4.4

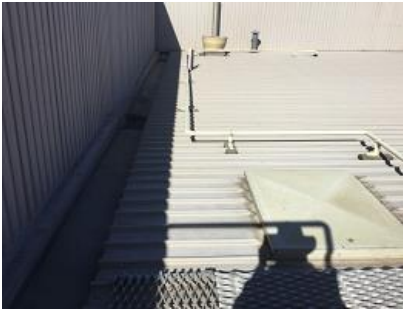
No safe access to the A/c unit	Trips, Slips and Falls	N/A	Low	Supply walkway and step over to the A/c unit	Low	Client advised	Outstanding	-

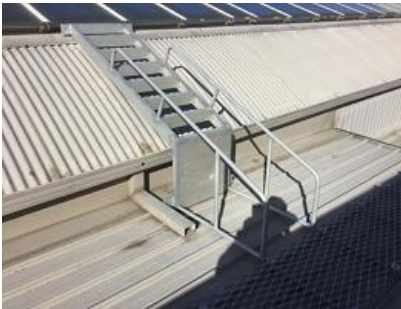
No	Photo of Hazard	Details of Hazard	Details of Risk	Existing/ Immediate Control Measure	Curre nt Risk Level	Proposed Permanent Solution	Resid ual Risk Asse ssme nt	Details of Action Taken	Status	Reference
201	Building: General Stores Location Reference: <a href="#">L67</a> Task: Access to the roof

Non-complaint ladder is present	Trips, Slips and Falls	Awareness induction	Med	Existing ladder to be removed	Low	Client advised	Outstanding	OH&S REGULATIONS 3.7  AS/NZS 1657-2013 7.3
202	Building: General Stores Location Reference: <a href="#">L67</a> Task: Access to the roof

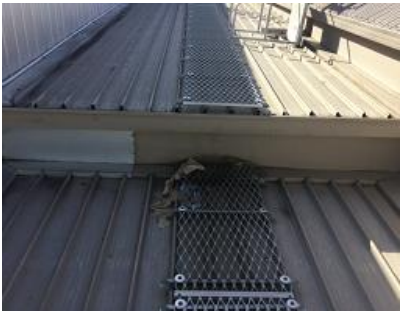
Variation in height between roofs are greater than required maximum	Trips, Slips and Falls	Awareness induction	Med	Access ladder to be installed	Low	Client advised	Outstanding	OH&S REGULATIONS 3.7  AS/NZS 1657-2013 3.1.4

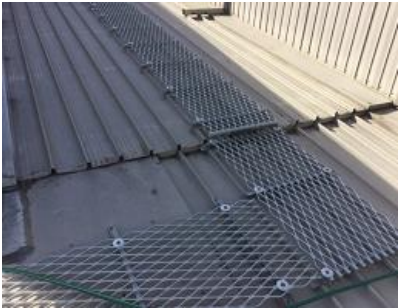
No	Photo of Hazard	Details of Hazard	Details of Risk	Existing/ Immediate Control Measure	Curre nt Risk Level	Proposed Permanent Solution	Resid ual Risk Asse ssme nt	Details of Action Taken	Status	Reference
203	Building: General Stores Location Reference: <a href="#">L67</a> Task: Access to the roof

Variation in height between walkway panels are greater than required maximum	Trips, Slips and Falls	Awareness induction	Med	High visibility safety yellow nosing to be installed	Low	Client advised	Outstanding	OH&S REGULATIONS 3.7  AS/NZS 1657-2013 3.3.4
204	Building: General Stores Location Reference: <a href="#">L68</a> Task: Access to the plant deck

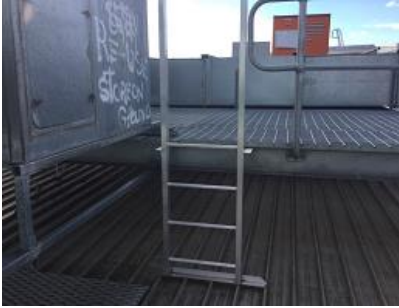
Bottom rung height is less than required minimum and gap between top rung and landing is greater than required maximum	Trips, Slips and Falls	Awareness induction	Med	Existing ladder to be re-installed with landing platform and brackets	Low	Client advised	Outstanding	OH&S REGULATIONS 3.7  AS/NZS 1657-2013 7.4.3.4 & 7.4.8.4

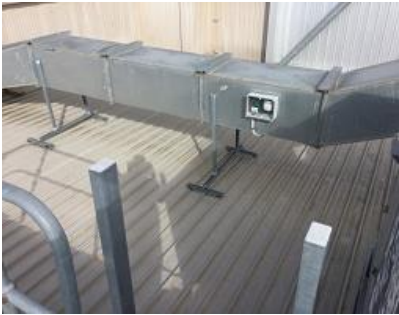
No	Photo of Hazard	Details of Hazard	Details of Risk	Existing/ Immediate Control Measure	Current Risk Level	Proposed Permanent Solution	Residual Risk Assessment	Details of Action Taken	Status	Reference
205	Building: General Stores Location Reference: <a href="#">L68</a> Task: Access to the switches

No safe access to the switches	Trips, Slips and Falls	N/A	Low	Supply walkway to the switches	Low	Client advised	Outstanding	-
206	Building: General Stores Location Reference: <a href="#">L68</a> Task: Access to the plant deck

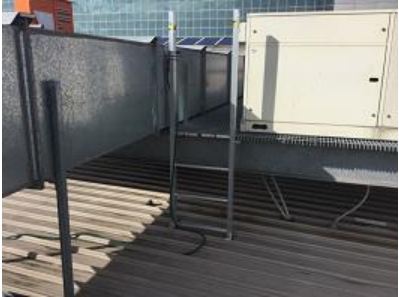
Bottom rung height is less than required minimum	Trips, Slips and Falls	Awareness induction	Med	Landing platform to be installed	Low	Client advised	Outstanding	OH&S REGULATIONS 3.7  AS/NZS 1657-2013 7.4.3.4

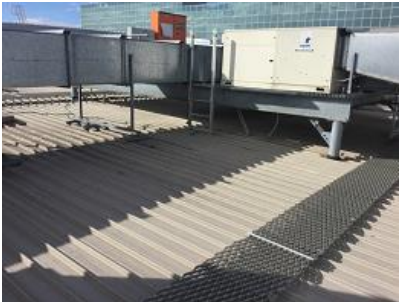
No safe access to the A/c units	Trips, Slips and Falls	N/A	Low	Supply walkway to the A/c units	Low	Client advised	Outstanding	-
20 8	Building: General Stores Location Reference: <a href="#">L68</a> Task: Access to the plant deck

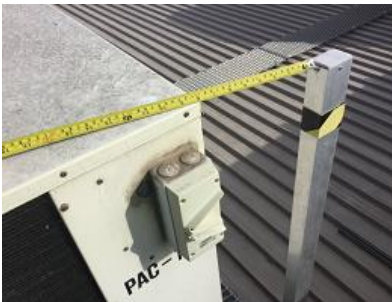
Gap between handrail and structure is greater than required maximum	Trips, Slips and Falls	Awareness induction	Med	Gap to be closed/ handrail post to be installed	Low	Client advised	Outstanding	OH&S REGULATIONS 3.7  AS/NZS 1657-2013 4.4

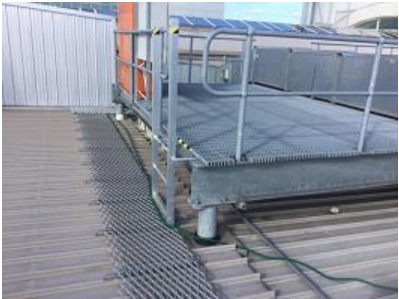
Bottom rung height is less than required minimum and gap between top rung and landing is greater than required maximum	Trips, Slips and Falls	Awareness induction	Med	Existing ladder to be re-installed with landing platform and brackets	Low	Client advised	Outstanding	OH&S REGULATIONS 3.7  AS/NZS 1657-2013 7.4.3.4 & 7.4.8.4
210	Building: General Stores Location Reference: <a href="#">L68</a> Task: Access to the A/c units

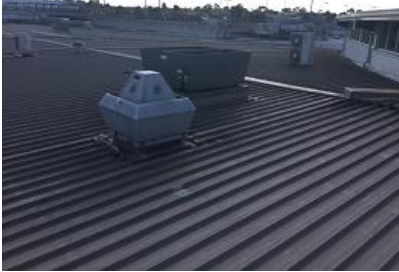
No safe access to the A/c units	Trips, Slips and Falls	N/A	Low	Supply walkway to the A/c units	Low	Client advised	Outstanding	-

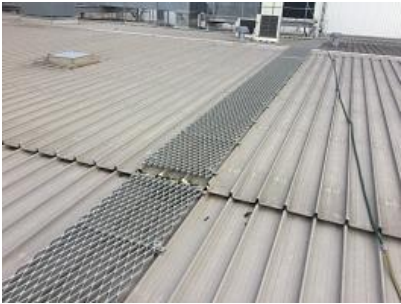
No	Photo of Hazard	Details of Hazard	Details of Risk	Existing/ Immediate Control Measure	Curren t Risk Level	Proposed Permanent Solution	Residu al Risk Assess ment	Details of Action Taken	Status	Reference
211	Building: General Stores Location Reference: <a href="#">L68</a> Task: Access to the roof

Gap between walkway panels are greater than required maximum	Trips, Slips and Falls	Awareness induction	Med	Additional walkway section to be installed	Low	Client advised	Outstanding	OH&S REGULATIONS 3.7  AS/NZS 1657-2013 3.2.3.4
212	Building: General Stores Location Reference: <a href="#">L69</a> Task: Access to the plant deck

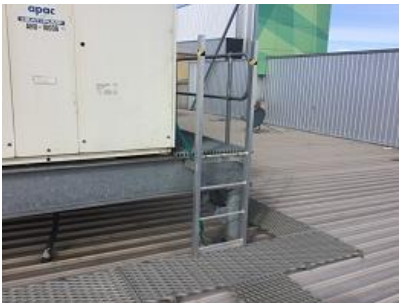
Bottom rung height is less than required minimum and gap between top rung and landing is greater than required maximum	Trips, Slips and Falls	Awareness induction	Med	Existing ladder to be re-installed with landing platform and brackets	Low	Client advised	Outstanding	OH&S REGULATIONS 3.7  AS/NZS 1657-2013 7.4.3.4 & 7.4.8.4

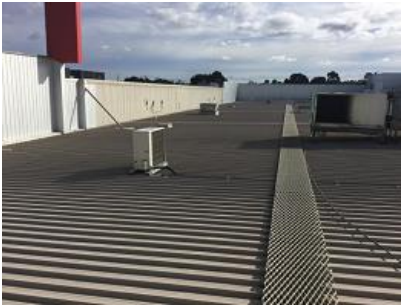
No safe access to the A/c units	Trips, Slips and Falls	N/A	Low	Supply walkway to the A/c units	Low	Client advised	Outstanding	-
216	Building: General Stores Location Reference: <a href="#">L70</a> Task: Access to the A/c units

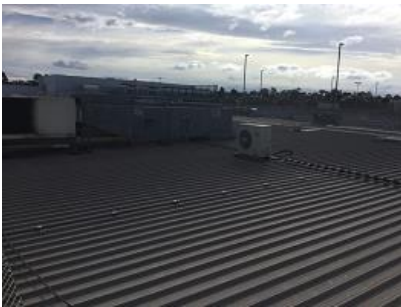
No safe access to the A/c units	Trips, Slips and Falls	N/A	Low	Supply walkway to the A/c units	Low	Client advised	Outstanding	-

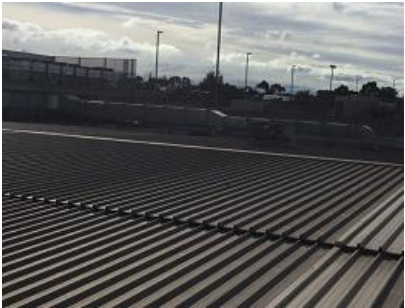
No safe access to the A/c units	Trips, Slips and Falls	N/A	Low	Supply walkway to the A/c units	Low	Client advised	Outstanding	-

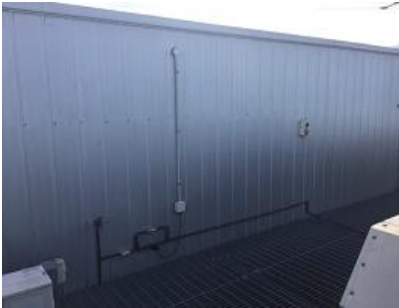
No	Photo of Hazard	Details of Hazard	Details of Risk	Existing/ Immediate Control Measure	Curren t Risk Level	Proposed Permanent Solution	Residu al Risk Assess ment	Details of Action Taken	Status	Reference
219	Building: General Stores Location Reference: <a href="#">L71</a> Task: Access to the roof

Variation in height between roof and plant deck is greater than required maximum	Trips, Slips and Falls	Awareness induction	Med	Access ladder to be installed	Low	Client advised	Outstanding	OH&S REGULATIONS 3.7  AS/NZS 1657-2013 3.1.4
220	Building: General Stores Location Reference: <a href="#">L71</a> Task: Access to the A/c units

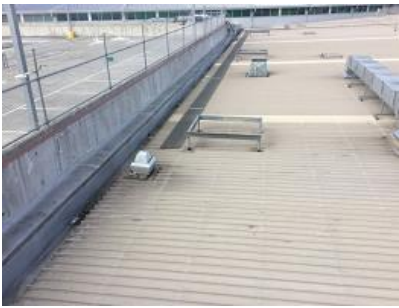
No safe access to the A/c units	Trips, Slips and Falls	N/A	Low	Supply walkway to the A/c units	Low	Client advised	Outstanding	-

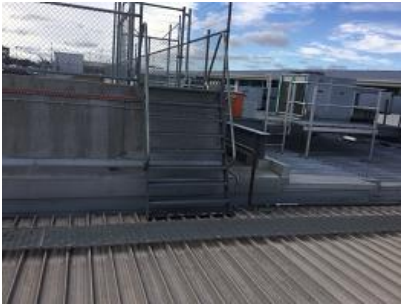
No	Photo of Hazard	Details of Hazard	Details of Risk	Existing/ Immediate Control Measure	Curren t Risk Level	Proposed Permanent Solution	Residu al Risk Assess ment	Details of Action Taken	Status	Reference
221	Building: General Stores Location Reference: <a href="#">L72</a> Task: Access to the roof

Ladder width is greater than required maximum	Trips, Slips and Falls	Awareness induction	Med	Existing ladder to be removed and new ladder to be installed	Low	Client advised	Outstanding	OH&S REGULATIONS 3.7  AS/NZS 1657-2013 7.3.1
222	Building: General Stores Location Reference: <a href="#">L72</a> Task: Access to the plant deck

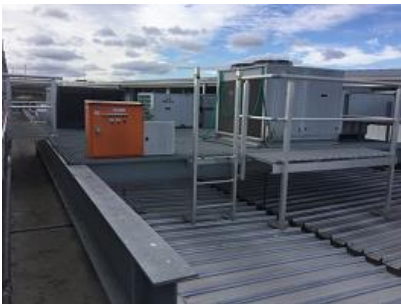
Bottom rung height is less than required minimum and gap between top rung and landing is greater than required maximum	Trips, Slips and Falls	Awareness induction	Med	Existing ladder to be re-installed with landing platform and brackets	Low	Client advised	Outstanding	OH&S REGULATIONS 3.7  AS/NZS 1657-2013 7.4.3.4 & 7.4.8.4

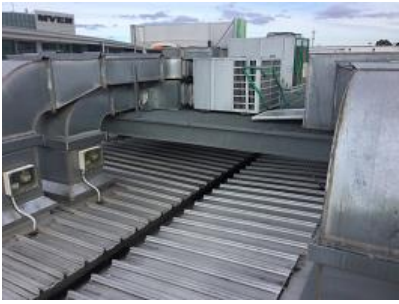
Variation in height between plant deck and roof is greater than required maximum	Trips, Slips and Falls	Awareness induction	Med	Handrails to be installed	Low	Client advised	Outstanding	OH&S REGULATIONS 3.7  AS/NZS 1657-2013 4.4
22 4	Building: General Stores Location Reference: <a href="#">L72</a> Task: Access to the A/c units

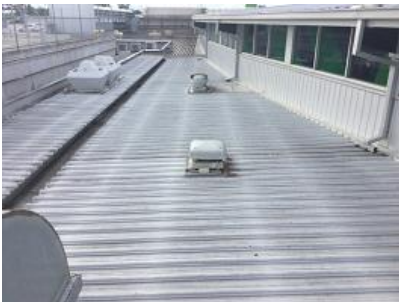
No safe access to the A/c units	Trips, Slips and Falls	N/A	Low	Supply walkway to the A/c units	Low	Client advised	Outstanding	-

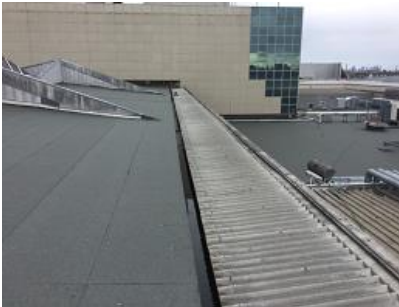
No	Photo of Hazard	Details of Hazard	Details of Risk	Existing/ Immediate Control Measure	Curren t Risk Level	Proposed Permanent Solution	Residu al Risk Assess ment	Details of Action Taken	Status	Reference
22 5	Building: General Stores Location Reference: <a href="#">L73</a> Task: Access to the roof

No height safety system installed	Trips, Slips and Falls	Awareness induction	High	Handrails to be installed	Low	Client advised	Outsta nding	OH&S REGULATIONS 3.55

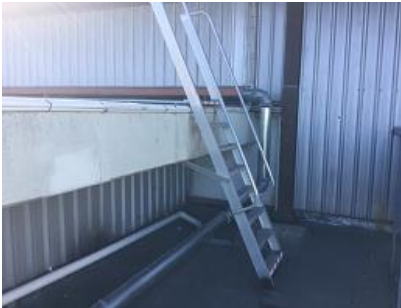
No	Photo of Hazard	Details of Hazard	Details of Risk	Existing/ Immediate Control Measure	Curren t Risk Level	Proposed Permanent Solution	Residu al Risk Assess ment	Details of Action Taken	Status	Reference
22 7	Building: General Stores Location Reference: <a href="#">L74</a> Task: Access to the roof

Bottom tread height is less than required minimum and clearance behind the ladder is less than required minimum	Trips, Slips and Falls	Awareness induction	Med	Existing ladder to be re-installed with landing platforms and brackets	Low	Client advised	Outstanding	OH&S REGULATIONS 3.7  AS/NZS 1657-2013 7.4.3.4 & 7.3.5
22 8	Building: General Stores Location Reference: <a href="#">L74</a> Task: Access to the roof

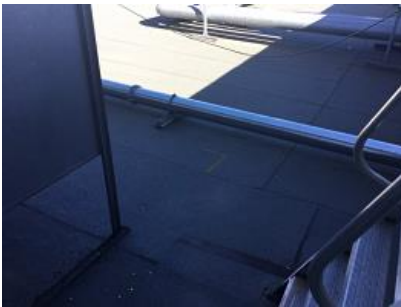
Pipes installed on the way to access the ladder	Trips, Slips and Falls	Awareness induction	Med	Step over to be installed	Low	Client advised	Outstanding	OH&S REGULATIONS 3.7  AS/NZS 1657-2013 3.1.4

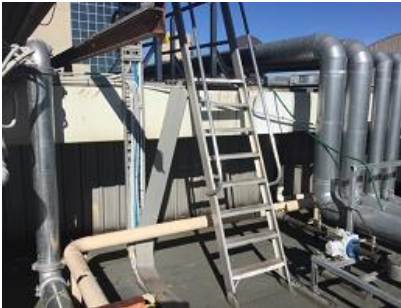
No	Photo of Hazard	Details of Hazard	Details of Risk	Existing/ Immediate Control Measure	Curren t Risk Level	Proposed Permanent Solution	Residu al Risk Assess ment	Details of Action Taken	Status	Reference
22 9	Building: General Stores Location Reference: <a href="#">L74</a> Task: Access to the roof

Clearance behind the ladder is less than required minimum and sharp edges on handrails	Trips, Slips and Falls	Awareness induction	Med	Existing ladder to be installed with new brackets and tek screws to be replaced with rivets	Low	Client advised	Outstanding	OH&S REGULATIONS 3.7  AS/NZS 1657-2013 7.3.5 & 5.6
23 0	Building: General Stores Location Reference: <a href="#">L75</a> Task: Access to the plant deck

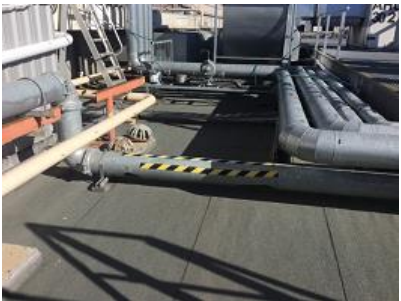
Pipes installed on the way to access the ladder	Trips, Slips and Falls	Awareness induction	Med	Step overs to be installed	Low	Client advised	Outstanding	OH&S REGULATIONS 3.7  AS/NZS 1657-2013 3.1.4

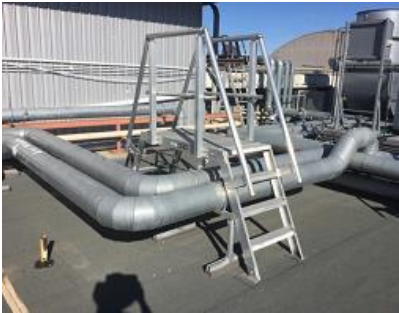
No	Photo of Hazard	Details of Hazard	Details of Risk	Existing/ Immediate Control Measure	Curren t Risk Level	Proposed Permanent Solution	Residu al Risk Assess ment	Details of Action Taken	Status	Reference
231	Building: General Stores Location Reference: <a href="#">L75</a> Task: Access to the roof

Sharp edges on handrails	Trips, Slips and Falls	Awareness induction	Med	Tek screws to be replaced with rivets	Low	Client advised	Outstanding	OH&S REGULATIONS 3.7  AS/NZS 1657-2013 5.6
232	Building: General Stores Location Reference: <a href="#">L75</a> Task: Access to the plant deck

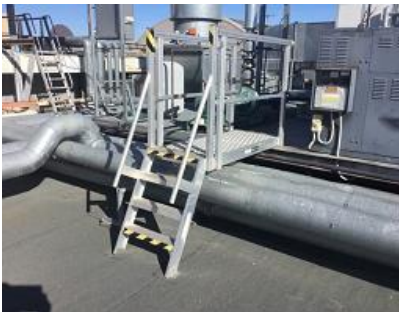
Handrails projecting towards the user and not providing continuous hand hold	Trips, Slips and Falls	Awareness induction	Med	Existing handrails to be removed and new handrails to be installed	Low	Client advised	Outstanding	OH&S REGULATIONS 3.7  AS/NZS 1657-2013 7.4.8.5 & 7.3.4

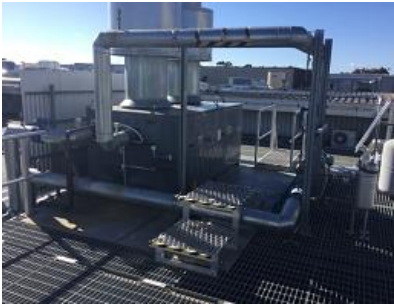
Step heights is greater than required maximum	Trips, Slips and Falls	Awareness induction	Med	Existing steps to be modified and re-installed with handrails and low headroom sign	Low	Client advised	Outstanding	OH&S REGULATIONS 3.7  AS/NZS 1657-2013 3.1.4
23 4	Building: General Stores Location Reference: <a href="#">L75</a> Task: Access to the plant deck

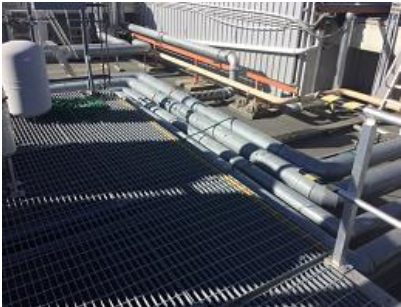
Variation in height between plant deck and roof is greater than required maximum	Trips, Slips and Falls	Awareness induction	Med	Handrails to be installed	Low	Client advised	Outstanding	OH&S REGULATIONS 3.7  AS/NZS 1657-2013 4.4

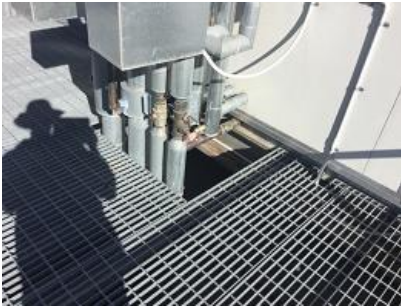
Gap between grating and unit is greater than required maximum	Trips, Slips and Falls	Awareness induction	Med	Gap to be filled	Low	Client advised	Outstanding	OH&S REGULATIONS 3.7  AS/NZS 1657-2013 3.2.3.4
23 6	Building: General Stores Location Reference: <a href="#">L75</a> Task: Access to the roof

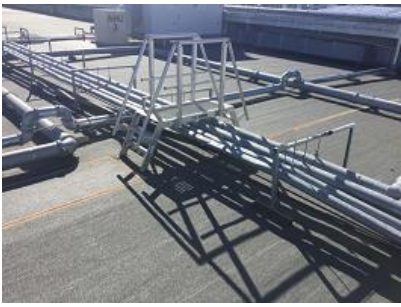
Sharp edges on handrails	Trips, Slips and Falls	Awareness induction	Med	Tek screws to be replaced with rivets	Low	Client advised	Outstanding	OH&S REGULATIONS 3.7  AS/NZS 1657-2013 5.6

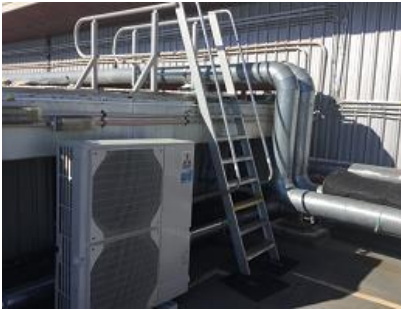
No	Photo of Hazard	Details of Hazard	Details of Risk	Existing/ Immediate Control Measure	Curren t Risk Level	Proposed Permanent Solution	Residu al Risk Assess ment	Details of Action Taken	Status	Reference
23 7	Building: General Stores Location Reference: <a href="#">L76</a> Task: Access to the roof

Clearance behind the ladder is less than required minimum and sharp edges on handrails	Trips, Slips and Falls	Awareness induction	Med	Existing ladder to be re-installed with new brackets and tek screws to be replaced with rivets	Low	Client advised	Outstanding	OH&S REGULATIONS 3.7  AS/NZS 1657-2013 7.3.5 & 5.6
23 8	Building: General Stores Location Reference: <a href="#">L76</a> Task: Access to the roof

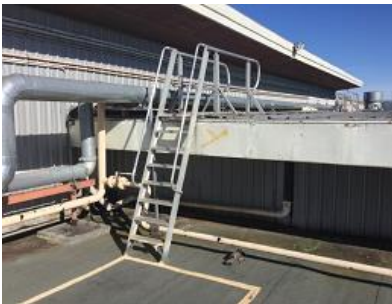
Clearance behind the ladder is less than required minimum and sharp edges on handrails	Trips, Slips and Falls	Awareness induction	Med	Existing ladder to be re-installed with new brackets and tek screws to be replaced with rivets	Low	Client advised	Outstanding	OH&S REGULATIONS 3.7  AS/NZS 1657-2013 7.3.5 & 5.6

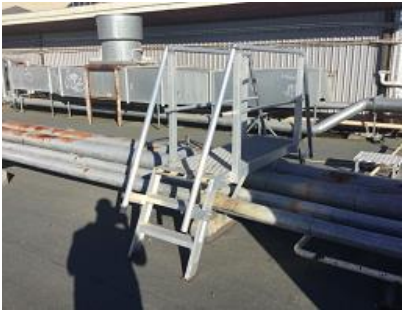
No	Photo of Hazard	Details of Hazard	Details of Risk	Existing/ Immediate Control Measure	Curren t Risk Level	Proposed Permanent Solution	Residu al Risk Assess ment	Details of Action Taken	Status	Reference
23 9	Building: General Stores Location Reference: <a href="#">L77</a> Task: Access to the roof

Sharp edges on handrails	Trips, Slips and Falls	Awareness induction	Med	Tek screws to be replaced with rivets	Low	Client advised	Outsta nding	OH&S REGULATIONS 3.7  AS/NZS 1657- 2013 5.6
24 0	Building: General Stores Location Reference: <a href="#">L78</a> Task: Access to the plant deck

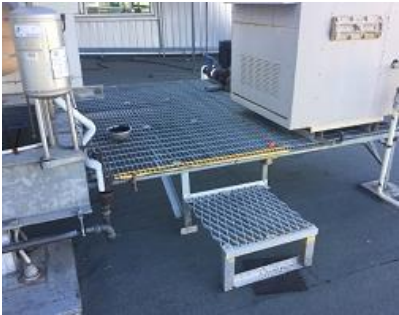
Variation in height between plant deck and roof is greater than required maximum	Trips, Slips and Falls	Awareness induction	Med	Handrails to be installed	Low	Client advised	Outstanding	OH&S REGULATIONS 3.7  AS/NZS 1657-2013 4.4
242	Building: General Stores Location Reference: <a href="#">L78</a> Task: Access to the plant deck

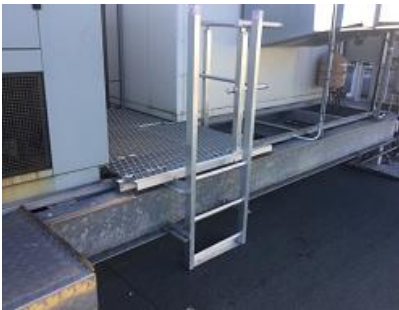
Bottom rung height is less than required minimum and gap between top rung and landing is greater than required maximum	Trips, Slips and Falls	Awareness induction	Med	Existing ladder to be re-installed with landing platform	Low	Client advised	Outstanding	OH&S REGULATIONS 3.7  AS/NZS 1657-2013 7.4.3.4 & 7.4.8.4

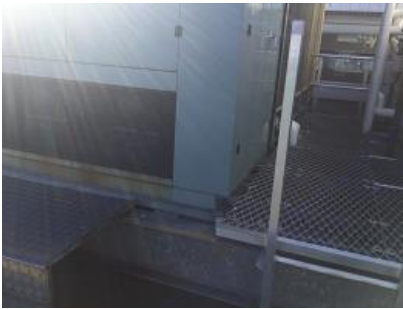
Gap between ladder and unit is greater than required maximum	Trips, Slips and Falls	Awareness induction	Med	Handrails to be installed	Low	Client advised	Outstanding	OH&S REGULATIONS 3.7  AS/NZS 1657-2013 4.4
24 4	Building: General Stores Location Reference: <a href="#">L78</a> Task: Access to the plant deck

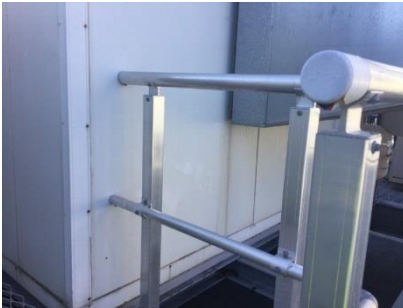
Sharp edges on handrails	Trips, Slips and Falls	Awareness induction	Med	Tek screws to be replaced with rivets	Low	Client advised	Outstanding	OH&S REGULATIONS 3.7  AS/NZS 1657-2013 5.6

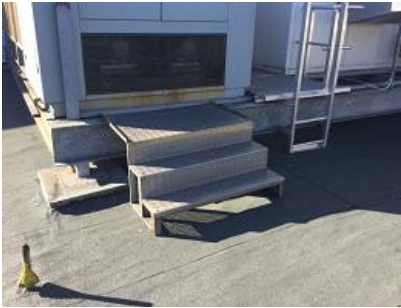
Handrails is missing for stair	Trips, Slips and Falls	Awareness induction	Med	Handrails to be installed	Low	Client advised	Outsta nding	OH&S REGULATIONS 3.7  AS/NZS 1657- 2013 7.2.6
24 6	Building: General Stores Location Reference: <a href="#">L78</a> Task: Access to the plant deck

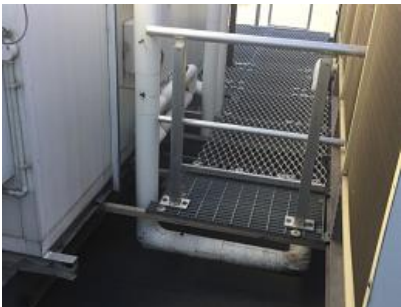
Gap between plant deck and unit is greater than required maximum	Trips, Slips and Falls	Awareness induction	Med	Gap to be closed/handrails to be installed	Low	Client advised	Outsta nding	OH&S REGULATIONS 3.7  AS/NZS 1657-2013 4.4

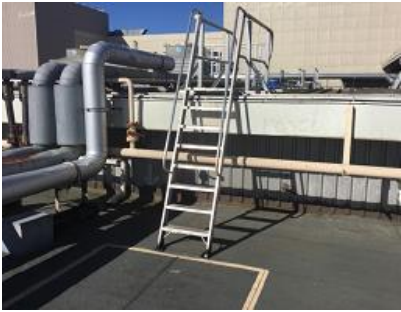
Clearance behind the ladder is less than required minimum	Trips, Slips and Falls	Awareness induction	Med	Existing ladder to be re-installed with new brackets	Low	Client advised	Outstanding	OH&S REGULATIONS 3.7  AS/NZS 1657-2013 7.3.5
24 8	Building: General Stores Location Reference: <a href="#">L79</a> Task: Access to the roof

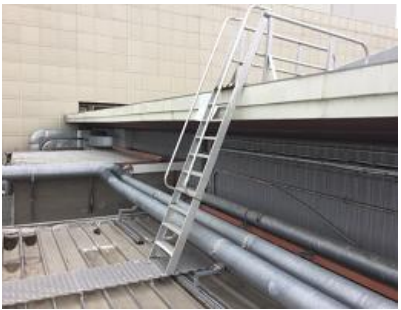
Clearance behind the ladder is less than required minimum	Trips, Slips and Falls	Awareness induction	Med	Existing ladder to be re-installed with new brackets and landing platform	Low	Client advised	Outstanding	OH&S REGULATIONS 3.7  AS/NZS 1657-2013 7.3.5

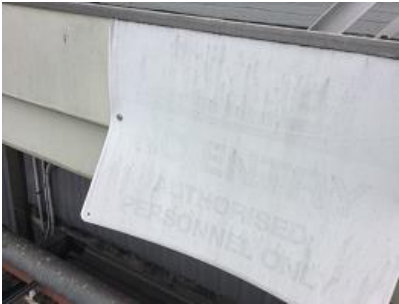
Non-complaint sign is present	Trips, Slips and Falls	Awareness induction	Med	Existing sign to be removed and new sign to be installed	Low	Client advised	Outsta nding	OH&S REGULATIONS 3.11
25 0	Building: General Stores Location Reference: <a href="#">L79</a> Task: Access to the roof

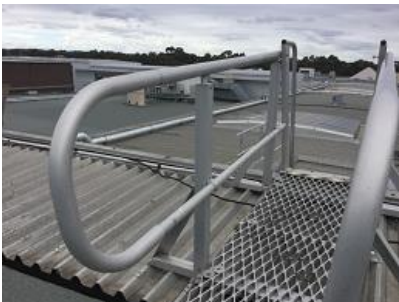
Sharp edges on handrails	Trips, Slips and Falls	Awareness induction	Med	Tek screws to be replaced with rivets	Low	Client advised	Outsta nding	OH&S REGULATIONS 3.7  AS/NZS 1657-2013 5.6

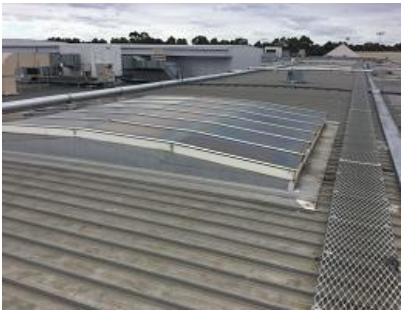
Gap between walkway and fall edge is less than required minimum	Trips, Slips and Falls	Awareness induction	Med	Handrails to be installed	Low	Client advised	Outsta nding	OH&S REGULATIONS 3.7  AS/NZS 1657-2013 5.4.1

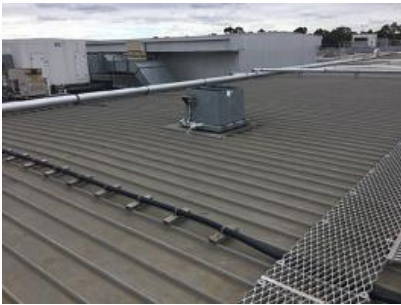
No safe access to the A/c units	Trips, Slips and Falls	N/A	Low	Supply walkway to the A/c units	Low	Client advised	Outsta nding	-
25 4	Building: General Stores Location Reference: <a href="#">L79</a> Task: Access to the roof

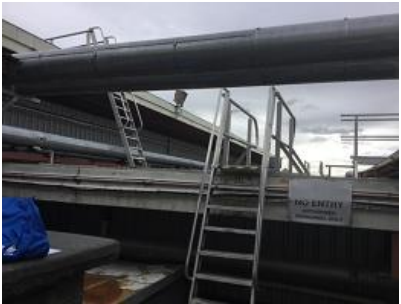
Clearance behind the ladder is less than required minimum and damaged treads are present	Trips, Slips and Falls	Awareness induction	Med	Existing ladder to be removed and new ladder including low head room sign to be installed	Low	Client advised	Outsta nding	OH&S REGULATIONS 3.7  AS/NZS 1657-2013 7.3.5

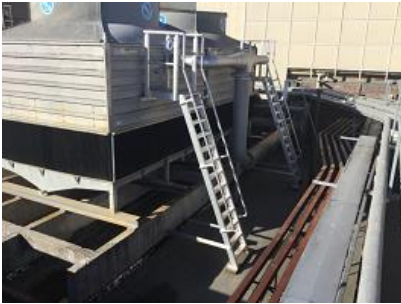
Clearance behind the ladder at base is less than required minimum, Handrail projecting towards the user and self-closing gate is missing at landing for safe access	Trips, Slips and Falls	Awareness induction	Med	Existing ladder to be removed and new ladder to be installed	Low	Client advised	Outstanding	OH&S REGULATIONS 3.7  AS/NZS 1657-2013 7.4.5 & 7.4.8.5
25 6	Building: General Stores Location Reference: <a href="#">L80</a> Task: Access to the A/c unit

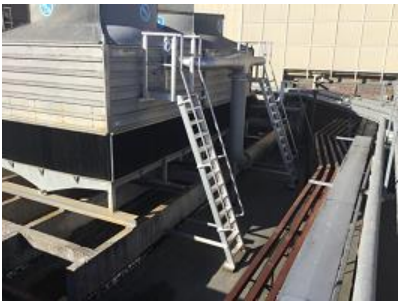
Clearance behind the ladder at base is less than required minimum, Handrail projecting towards the user and self-closing gate is missing at landing for safe access	Trips, Slips and Falls	Awareness induction	Med	Existing ladder to be removed and new ladder to be installed	Low	Client advised	Outstanding	OH&S REGULATIONS 3.7  AS/NZS 1657-2013 7.4.5 & 7.4.8.5

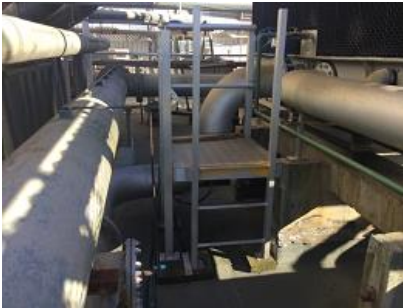
Bottom rung height is less than required minimum and clearance behind the ladder is less than required minimum	Trips, Slips and Falls	Awareness induction	Med	Existing ladder to be re-installed with landing platform and brackets	Low	Client advised	Outstanding	OH&S REGULATIONS 3.7  AS/NZS 1657-2013 7.4.3.4 & 7.4.5
25 8	Building: General Stores Location Reference: <a href="#">L80</a> Task: Access to the plant deck

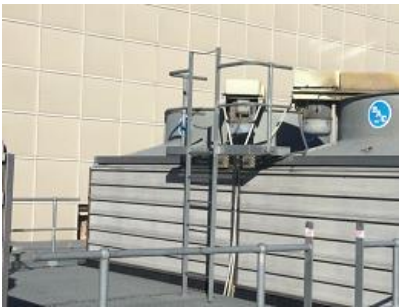
No slip resistance on ladder rungs	Trips, Slips and Falls	Awareness induction	Med	Non-slip rung caps to existing ladder to be installed	Low	Client advised	Outstanding	OH&S REGULATIONS 3.7  AS/NZS 1657-2013 7.4.3.1

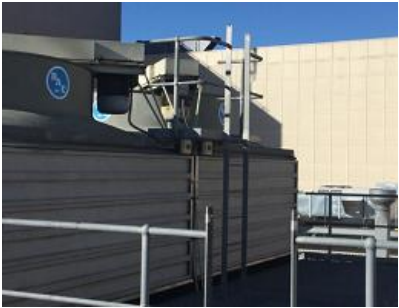
No slip resistance on ladder rungs	Trips, Slips and Falls	Awareness induction	Med	Non-slip rung caps to existing ladder to be installed	Low	Client advised	Outsta nding	OH&S REGULATIONS 3.7  AS/NZS 1657- 2013 7.4.3.1
26 0	Building: General Stores Location Reference: <a href="#">L80</a> Task: Access to the plant deck

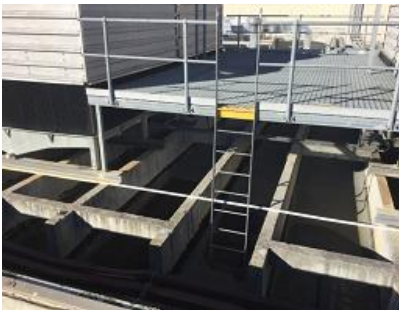
No slip resistance on ladder rungs and clearance behind the ladder is less than required minimum	Trips, Slips and Falls	Awareness induction	Med	Existing ladder to be removed and new ladder to be installed	Low	Client advised	Outsta nding	OH&S REGULATIONS 3.7  AS/NZS 1657-2013 7.4.3.1 & 7.4.5

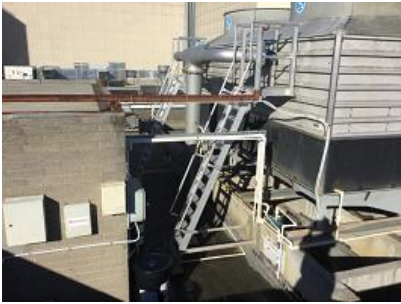
Clearance behind the ladder at base is less than required minimum, Handrail projecting towards the user and self-closing gate is missing at landing for safe access	Trips, Slips and Falls	Awareness induction	Med	Existing ladder to be removed and new ladder to be installed	Low	Client advised	Outstanding	OH&S REGULATIONS 3.7  AS/NZS 1657-2013 7.4.5 & 7.4.8.5
262	Building: General Stores Location Reference: <a href="#">L80</a> Task: Access to the A/c unit

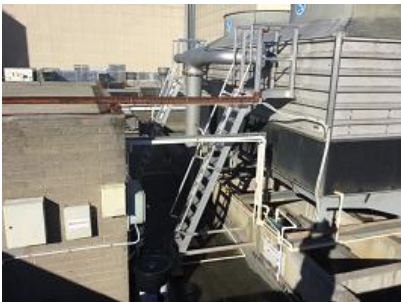
Clearance behind the ladder at base is less than required minimum, Handrail projecting towards the user and self-closing gate is missing at landing for safe access	Trips, Slips and Falls	Awareness induction	Med	Existing ladder to be removed and new ladder to be installed	Low	Client advised	Outstanding	OH&S REGULATIONS 3.7  AS/NZS 1657-2013 7.4.5 & 7.4.8.5

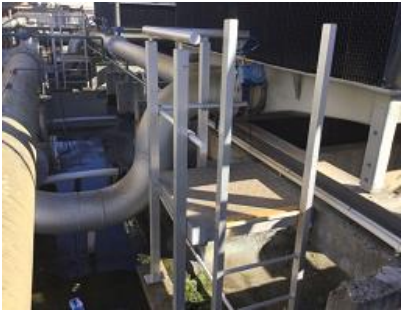
Bottom rung height is less than required minimum and clearance behind the ladder is less than required minimum	Trips, Slips and Falls	Awareness induction	Med	Existing ladder to be re-installed with landing platform and brackets	Low	Client advised	Outstanding	OH&S REGULATIONS 3.7  AS/NZS 1657-2013 7.4.3.4 & 7.4.5

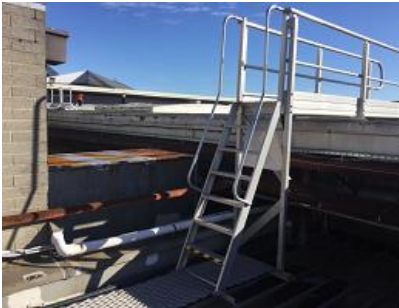
Clearance behind the ladder is less than required minimum and handrail projecting towards the user and sharp edges on handrails	Trips, Slips and Falls	Awareness induction	Med	Existing ladder to removed and new ladder to installed and tek screws to be replaced with rivets	Low	Client advised	Outstanding	OH&S REGULATIONS 3.7  AS/NZS 1657-2013 7.3.5, 7.4.8.5 & 5.6
26 6	Building: General Stores Location Reference: <a href="#">L81</a> Task: Access to the roof

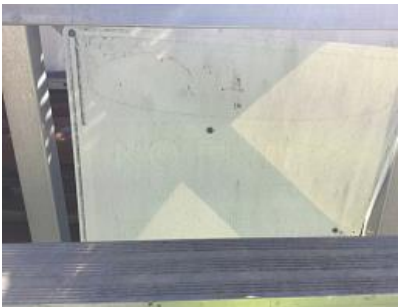
Non-complaint sign is present	Trips, Slips and Falls	Awareness induction	Med	Existing sign to be removed and new sign to be installed	Low	Client advised	Outstanding	OH&S REGULATIONS 3.11

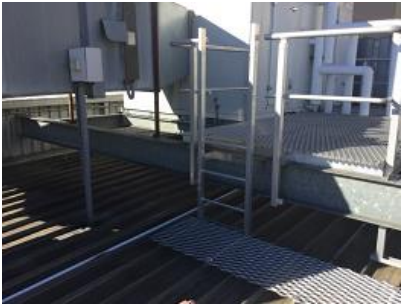
Bottom rung height is less than required minimum, Landing is less than required minimum and gap between top rung and landing is greater than required maximum	Trips, Slips and Falls	Awareness induction	Med	Existing ladder to be re-installed with landing platform and brackets	Low	Client advised	Outstanding	OH&S REGULATIONS 3.7  AS/NZS 1657-2013 7.4.3.4, 7.3.6 & 7.4.8.4
26 8	Building: General Stores Location Reference: <a href="#">L82</a> Task: Access to the plant deck

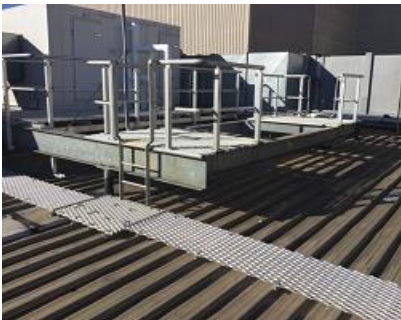
Landing is less than required minimum and Clearance behind the ladder is less than required minimum and no slip resistance on ladder rungs	Trips, Slips and Falls	Awareness induction	Med	Existing ladder to be removed and new ladder including landing platform to be installed	Low	Client advised	Outstanding	OH&S REGULATIONS 3.7  AS/NZS 1657-2013 7.3.6, 7.4.5 & 7.4.3.1

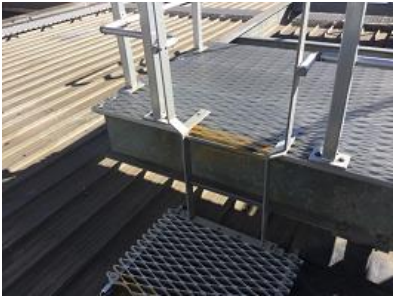
Landing is less than required minimum and Clearance behind the ladder is less than required minimum and no slip resistance on ladder rungs	Trips, Slips and Falls	Awareness induction	Med	Existing ladder to be removed and new ladder including landing platform to be installed	Low	Client advised	Outstanding	OH&S REGULATIONS 3.7  AS/NZS 1657-2013 7.3.6, 7.4.5 & 7.4.3.1
27 0	Building: General Stores Location Reference: <a href="#">L82</a> Task: Access to the plant deck

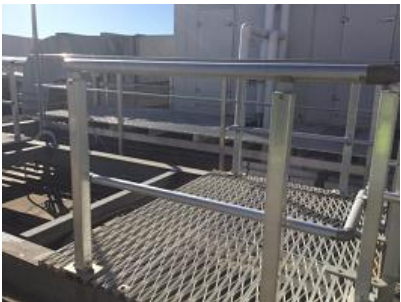
Sharp edges on handrails	Trips, Slips and Falls	Awareness induction	Med	Tek screws to be replaced with rivets	Low	Client advised	Outstanding	OH&S REGULATIONS 3.7  AS/NZS 1657-2013 5.6

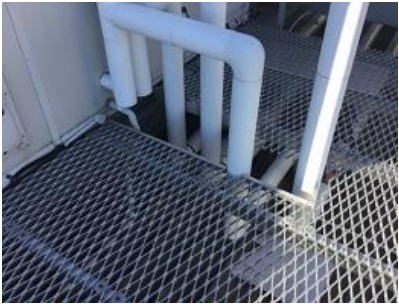
Gap between plant deck and pipes is greater than required maximum	Trips, Slips and Falls	Awareness induction	Med	Gap to be closed	Low	Client advised	Outstanding	OH&S REGULATIONS 3.7  AS/NZS 1657-2013 4.4
272	Building: General Stores Location Reference: <a href="#">L82</a> Task: Access to the roof

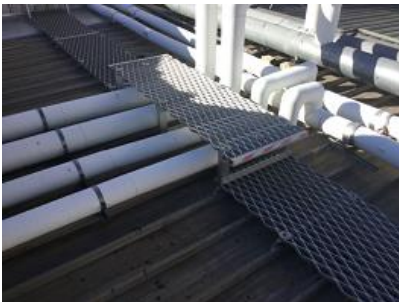
Variation in height between platform and roof is greater than required maximum	Trips, Slips and Falls	Awareness induction	Med	Handrails to be installed	Low	Client advised	Outstanding	OH&S REGULATIONS 3.7  AS/NZS 1657-2013 4.4

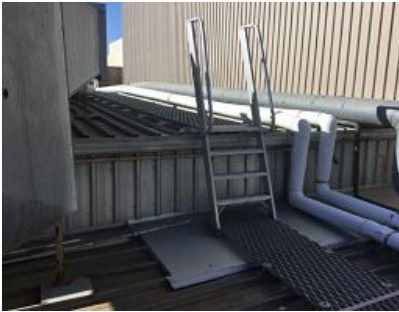
Gap behind the ladder is less than required minimum and top tread not levelled with landing	Trips, Slips and Falls	Awareness induction	Med	Existing ladder to be re-installed with landing platform and brackets	Low	Client advised	Outstanding	OH&S REGULATIONS 3.7  AS/NZS 1657-2013 7.3.5 & 7.4.3.3
27 4	Building: General Stores Location Reference: <a href="#">L83</a> Task: Access to the roof

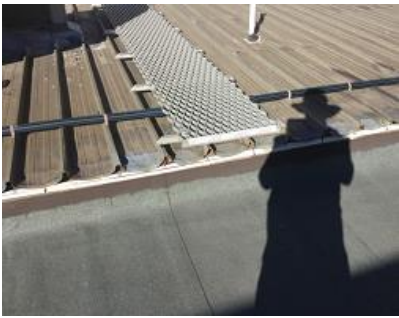
Variation in height between roofs are greater than required maximum	Trips, Slips and Falls	Awareness induction	Med	Single step to be installed	Low	Client advised	Outstanding	OH&S REGULATIONS 3.7  AS/NZS 1657-2013 3.1.4

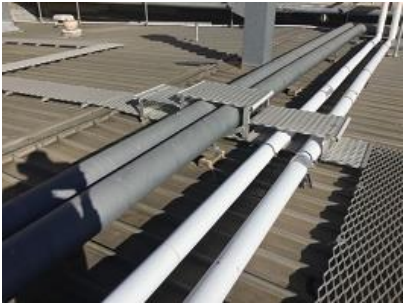
Un even step heights and handrails is missing	Trips, Slips and Falls	Awareness induction	Med	Existing steps to be modified and re-installed with handrails	Low	Client advised	Outstanding	OH&S REGULATIONS 3.7  AS/NZS 1657-2013 3.1.4
27 6	Building: General Stores Location Reference: <a href="#">L84</a> Task: Access to the A/c units

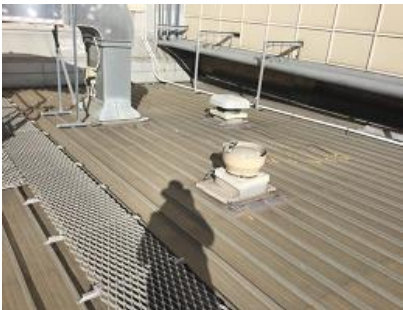
No safe access to the A/c units	Trips, Slips and Falls	N/A	Low	Supply walkway to the A/c units	Low	Client advised	Outstanding	-

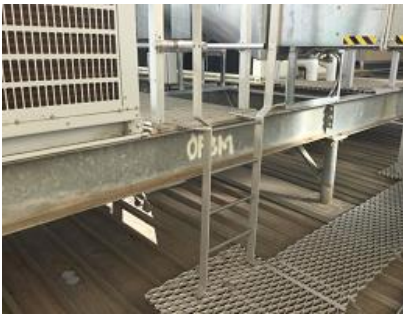
No slip resistance on ladder rungs and gap between top rung and landing is greater than required maximum	Trips, Slips and Falls	Awareness induction	Med	Existing ladder to be removed and new ladder to be installed	Low	Client advised	Outstanding	OH&S REGULATIONS 3.7  AS/NZS 1657-2013 7.4.3.1 & 7.4.8.4

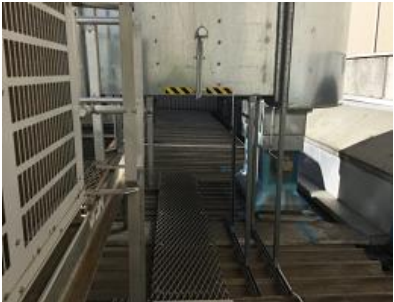
Headroom is less than required minimum	Trips, Slips and Falls	Awareness induction	Med	"Warning-Low head room" signs to be installed	Low	Client advised	Outsta nding	OH&S REGULATIONS 3.7  AS/NZS 1657-2013 3.1.5

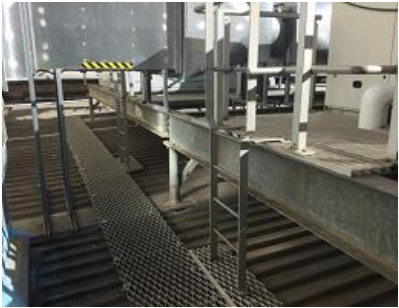
No slip resistance on ladder rungs and gap between top rung and landing is greater than required maximum	Trips, Slips and Falls	Awareness induction	Med	Existing ladder to be removed and new ladder to be installed	Low	Client advised	Outstanding	OH&S REGULATIONS 3.7  AS/NZS 1657-2013 7.4.3.1 & 7.4.8.4
282	Building: General Stores Location Reference: <a href="#">L84</a> Task: Access to the roof

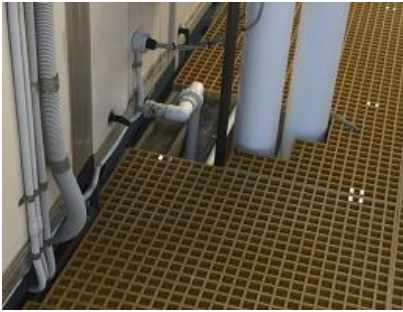
Gap between plant deck and pipes is greater than required maximum	Trips, Slips and Falls	Awareness induction	Med	Gap to be closed	Low	Client advised	Outstanding	OH&S REGULATIONS 3.7  AS/NZS 1657-2013 4.4
28 6	Building: General Stores Location Reference: <a href="#">L85</a> Task: Access to the roof

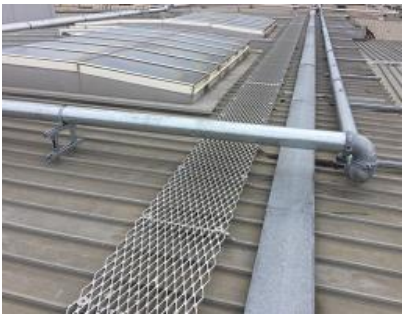
Pipe installed over the walkway path	Trips, Slips and Falls	Awareness induction	Med	Step overs including handrails to be installed	Low	Client advised	Outstanding	OH&S REGULATIONS 3.7  AS/NZS 1657-2013 3.1.4

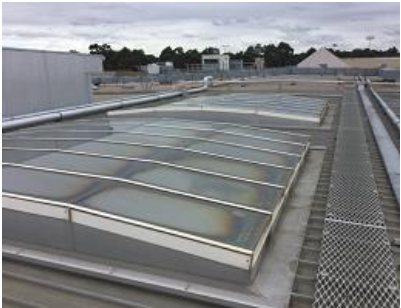
Gap between walkway and fall edge is less than required minimum	Trips, Slips and Falls	Awareness induction	Med	Handrails to be installed	Low	Client advised	Outstanding	OH&S REGULATIONS 3.7  AS/NZS 1657-2013 4.4
28 9	Building: General Stores Location Reference: <a href="#">L86</a> Task: Access to the roof

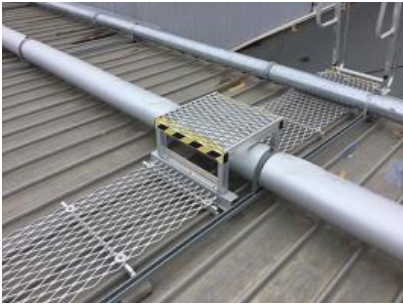
Step height is greater than required maximum and handrails is missing	Trips, Slips and Falls	Awareness induction	Med	Additional steps and handrails to be installed	Low	Client advised	Outstanding	OH&S REGULATIONS 3.7  AS/NZS 1657-2013 3.1.4
292	Building: General Stores Location Reference: <a href="#">L86</a> Task: Access to the roof

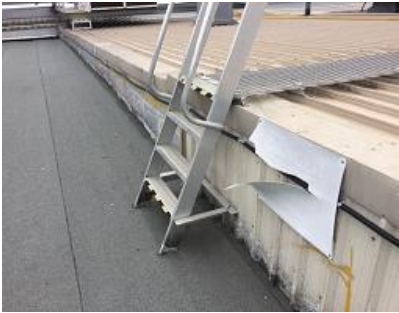
Clearance behind the ladder is less than required minimum and non-complaint signage is present	Trips, Slips and Falls	Awareness induction	Med	Existing ladder to be re-installed with brackets, landing platform and signage	Low	Client advised	Outstanding	OH&S REGULATIONS 3.7 & 3.11  AS/NZS 1657-2013 7.3.5
29 4	Building: General Stores Location Reference: <a href="#">L88</a> Task: Access to the plant deck

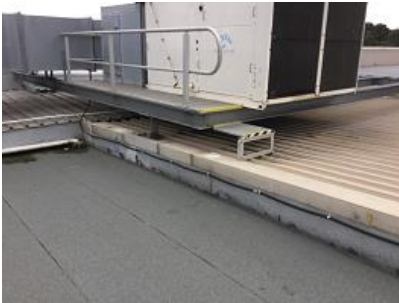
Step height is greater than required maximum and step width is less than required minimum	Trips, Slips and Falls	Awareness induction	Med	Existing step to be removed and new steps and handrails to be installed	Low	Client advised	Outstanding	OH&S REGULATIONS 3.7  AS/NZS 1657-2013 3.1.4

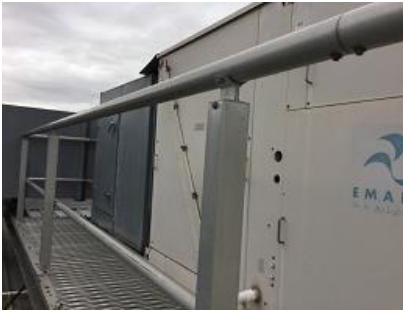
Sharp edges on handrails	Trips, Slips and Falls	Awareness induction	Med	Tek screws to be replaced with rivets	Low	Client advised	Outsta nding	OH&S REGULATIONS 3.7  AS/NZS 1657- 2013 5.6
29 6	Building: General Stores Location Reference: <a href="#">L88</a> Task: Access to the plant deck

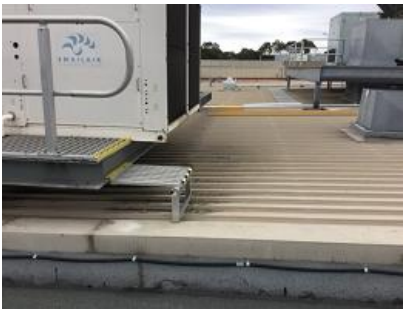
No safe access to the plant deck	Trips, Slips and Falls	N/A	Low	Supply walkway to the plant deck	Low	Client advised	Outsta nding	-

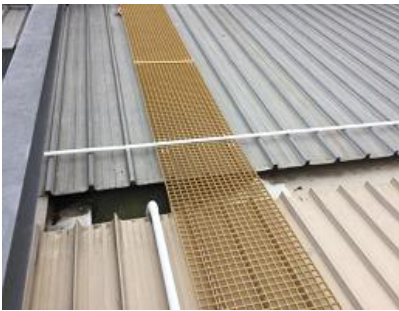
Variation in height between walkway surface and adjacent area is greater than required maximum and pipe installed over the walkway path	Trips, Slips and Falls	Awareness induction	Med	Handrails and step over to be installed	Low	Client advised	Outsta nding	OH&S REGULATIONS 3.7  AS/NZS 1657-2013 4.4

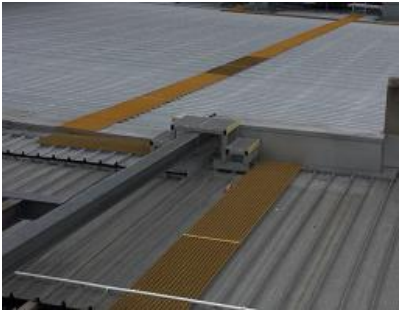
Handrails is missing for steps	Trips, Slips and Falls	Awareness induction	Med	Handrails to be installed	Low	Client advised	Outsta nding	OH&S REGULATIONS 3.7  AS/NZS 1657- 2013 4.4
30 0	Building: General Stores Location Reference: <a href="#">L88</a> Task: Access to the roof

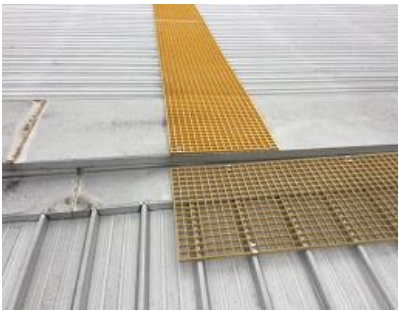
Variation in height between walkway panels are greater than required maximum	Trips, Slips and Falls	Awareness induction	Med	High visibility safety yellow nosing to be installed	Low	Client advised	Outsta nding	OH&S REGULATIONS 3.7  AS/NZS 1657-2013 3.3.4

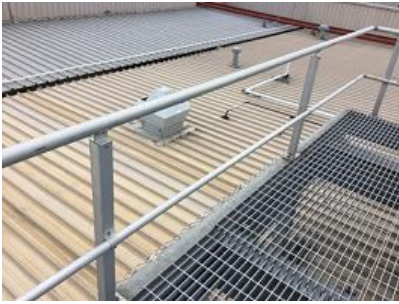
Sharp edges on handrails	Trips, Slips and Falls	Awareness induction	Med	Tek screws to be replaced with rivets	Low	Client advised	Outstanding	OH&S REGULATIONS 3.7  AS/NZS 1657-2013 5.6
302	Building: General Stores Location Reference: <a href="#">L89</a> Task: Access to the plant deck

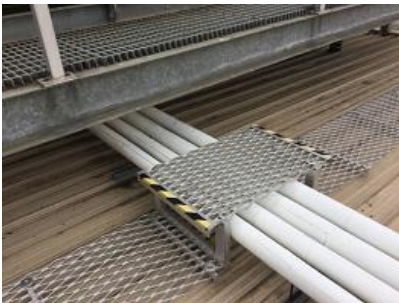
Step height is greater than required maximum and handrails is missing	Trips, Slips and Falls	Awareness induction	Med	Additional steps and handrails to be installed	Low	Client advised	Outstanding	OH&S REGULATIONS 3.7  AS/NZS 1657-2013 3.1.4

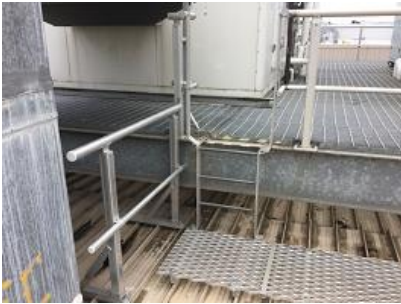
Gap between top rung and landing is greater than required maximum and no slip resistance on ladder rungs and landing at base is less than required minimum	Trips, Slips and Falls	Awareness induction	Med	Existing ladder to be removed and new ladder to be installed	Low	Client advised	Outstanding	OH&S REGULATIONS 3.7  AS/NZS 1657-2013 7.4.8.4, 7.4.3.1 & 7.3.6
304	Building: General Stores Location Reference: <a href="#">L89</a> Task: Access to the A/c units

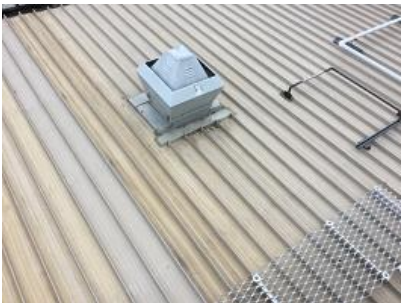
No safe access to the A/c units	Trips, Slips and Falls	N/A	Low	Supply walkway to the A/c units	Low	Client advised	Outstanding	-

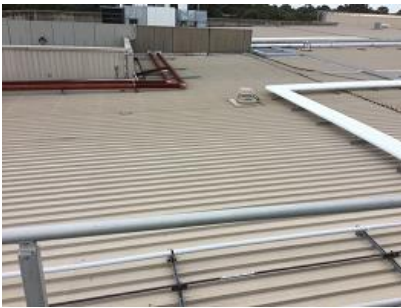
No safe access to the A/c units	Trips, Slips and Falls	N/A	Low	Supply walkway to the A/c units	Low	Client advised	Outstanding	-

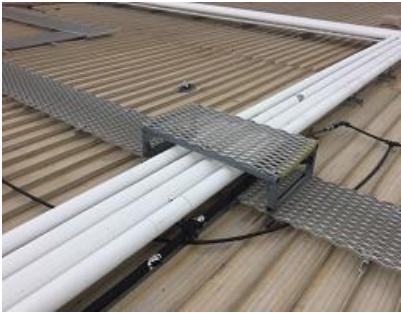
No	Photo of Hazard	Details of Hazard	Details of Risk	Existing/ Immediate Control Measure	Curren t Risk Level	Proposed Permanent Solution	Residu al Risk Assess ment	Details of Action Taken	Status	Reference
307	Building: General Stores Location Reference: <a href="#">L89</a> Task: Access to the roof

Variation in height between platform and roof is greater than required maximum	Trips, Slips and Falls	Awareness induction	Med	Handrails to be installed	Low	Client advised	Outstanding	OH&S REGULATIONS 3.7  AS/NZS 1657-2013 4.4
308	Building: General Stores Location Reference: <a href="#">L90</a> Task: Access to the plant deck
