# Roof Safety Report

Northland, VIC 3072

Prepared By: Safemaster Safety Products  
Date: 10-09-2020

10-09-2020

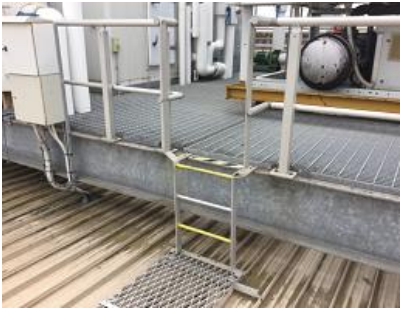
No slip resistance on ladder rungs and gap between top rung and landing is greater than required maximum	Trips, Slips and Falls	Awareness induction	Med	Existing ladder to be removed and new ladder to be installed	Low	Client advised	Outstanding	OH&S REGULATIONS 3.7  AS/NZS 1657-2013 7.4.3.1 & 7.4.8.4

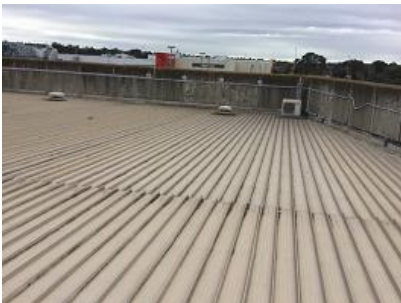
No safe access to the A/c units	Trips, Slips and Falls	N/A	Low	Supply walkway to the A/c units	Low	Client advised	Outstanding	-

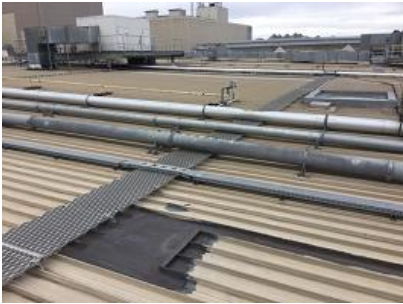
Pipes installed over the walkway path	Trips, Slips and Falls	Awareness induction	Med	Step bridge including handrails to be installed	Low	Client advised	Outstanding	OH&S REGULATIONS 3.7  AS/NZS 1657-2013 3.1.4
313	Building: General Stores Location Reference: <a href="#">L91</a> Task: Access to the roof

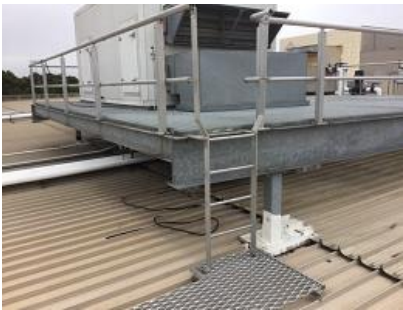
No slip resistance on ladder rungs and gap between top rung and landing is greater than required maximum	Trips, Slips and Falls	Awareness induction	Med	Existing ladder to be removed and new ladder to be installed	Low	Client advised	Outstanding	OH&S REGULATIONS 3.7  AS/NZS 1657-2013 7.4.3.1 & 7.4.8.4

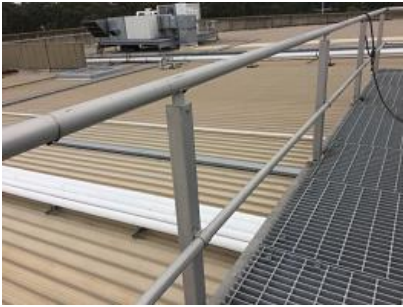
No	Photo of Hazard	Details of Hazard	Details of Risk	Existing/ Immediate Control Measure	Curren t Risk Level	Proposed Permanent Solution	Residu al Risk Assess ment	Details of Action Taken	Status	Reference
314	Building: General Stores Location Reference: <a href="#">L91</a> Task: Access to the roof

Sharp edges on handrails	Trips, Slips and Falls	Awareness induction	Med	Tek screws to be replaced with rivets	Low	Client advised	Outstanding	OH&S REGULATIONS 3.7  AS/NZS 1657-2013 5.6
315	Building: General Stores Location Reference: <a href="#">L91</a> Task: Access to the A/c units

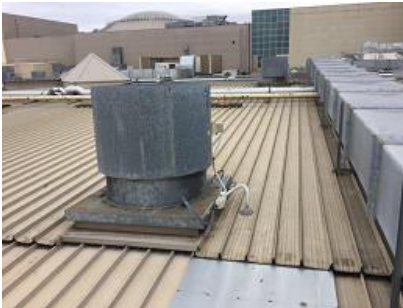
No safe access to the A/c units	Trips, Slips and Falls	N/A	Low	Supply walkway and step over to the A/c units	Low	Client advised	Outstanding	-

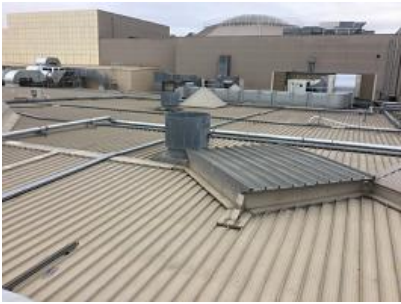
No safe access to the A/c units	Trips, Slips and Falls	N/A	Low	Supply walkway and step over and handrails to the A/c units	Low	Client advised	Outstanding	-
317	Building: General Stores Location Reference: <a href="#">L91</a> Task: Access to the A/c units

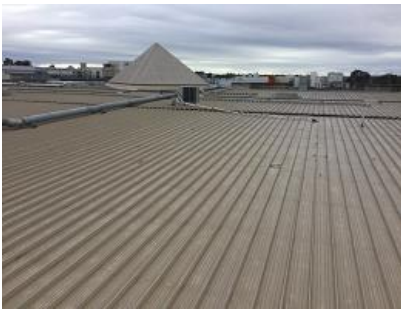
No safe access to the A/c units	Trips, Slips and Falls	N/A	Low	Supply walkway and step over and handrails to the A/c units	Low	Client advised	Outstanding	-

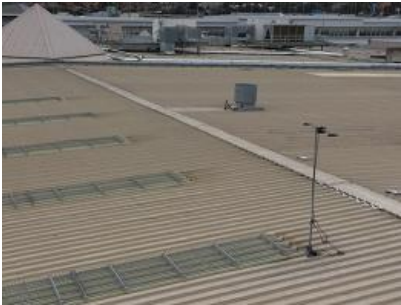
No safe access to the A/c units	Trips, Slips and Falls	N/A	Low	Supply walkway to the A/c units	Low	Client advised	Outstanding	-
321	Building: General Stores Location Reference: <a href="#">L92</a> Task: Access to the A/c units

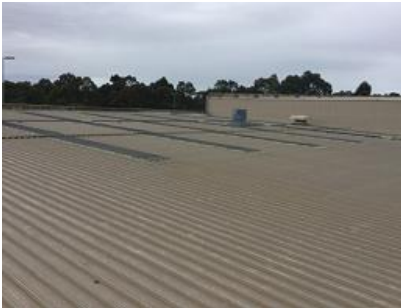
No safe access to the A/c units	Trips, Slips and Falls	N/A	Low	Supply walkway to the A/c units	Low	Client advised	Outstanding	-

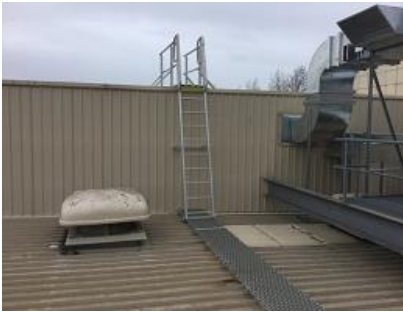
No	Photo of Hazard	Details of Hazard	Details of Risk	Existing/ Immediate Control Measure	Curren t Risk Level	Proposed Permanent Solution	Residu al Risk Assess ment	Details of Action Taken	Status	Reference
32 4	Building: General Stores Location Reference: <a href="#">L93</a> Task: Access to the roof

Bottom rung height is less than required minimum, handrails projecting towards the user, top rung not levelled with landing and sharp edges on handrails	Trips, Slips and Falls	Awareness induction	Med	Existing ladder to be re-installed with landing platform and handrails	Low	Client advised	Outstanding	OH&S REGULATIONS 3.7  AS/NZS 1657-2013 7.4.3.4, 7.4.8.5, 7.4.3.3 & 5.6
32 5	Building: General Stores Location Reference: <a href="#">L93</a> Task: Access to the roof

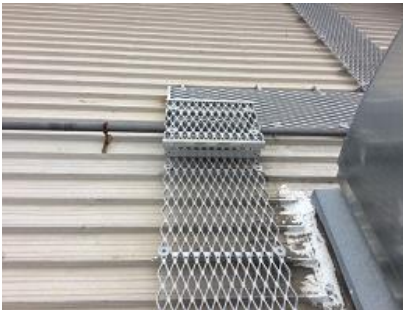
Variation in height between walkway panels are greater than required maximum	Trips, Slips and Falls	Awareness induction	Med	High visibility safety yellow nosing's to be installed	Low	Client advised	Outstanding	OH&S REGULATIONS 3.7  AS/NZS 1657-2013 3.3.4

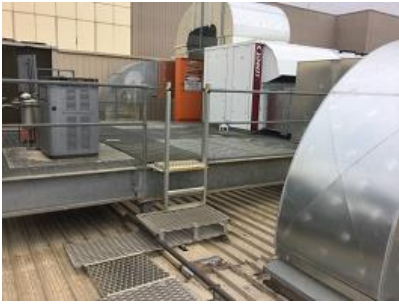
Un-even rung heights and landing is less than required minimum and handrails is missing	Trips, Slips and Falls	Awareness induction	Med	Existing ladder to be removed and new ladder including landing platform to be installed	Low	Client advised	Outstanding	OH&S REGULATIONS 3.7  AS/NZS 1657-2013 7.4.3.2, 7.3.6 & 4.4
32 7	Building: General Stores Location Reference: <a href="#">L93</a> Task: Access to the plant deck

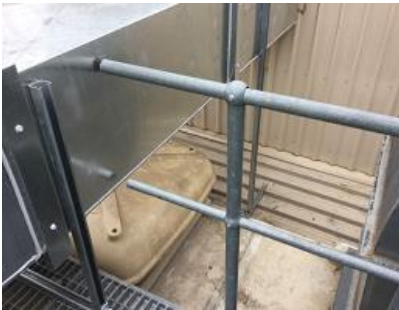
Sharp edges on handrails	Trips, Slips and Falls	Awareness induction	Med	Tek screws to be replaced with rivets	Low	Client advised	Outstanding	OH&S REGULATIONS 3.7  AS/NZS 1657-2013 5.6

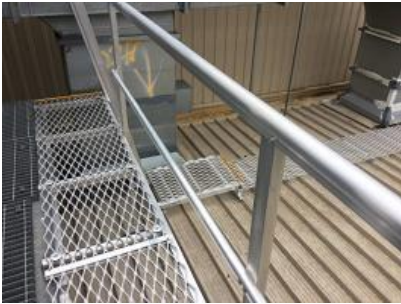
Sharp edges on handrails	Trips, Slips and Falls	Awareness induction	Med	Tek screws to be replaced with rivets	Low	Client advised	Outsta nding	OH&S REGULATIONS 3.7  AS/NZS 1657-2013 5.6
32 9	Building: General Stores Location Reference: <a href="#">L93</a> Task: Access to the plant deck

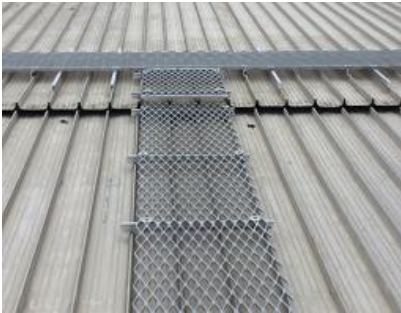
No	Photo of Hazard	Details of Hazard	Details of Risk	Existing/ Immediate Control Measure	Curren t Risk Level	Proposed Permanent Solution	Residu al Risk Assess ment	Details of Action Taken	Status	Reference
330	Building: General Stores Location Reference: <a href="#">L93</a> Task: Access to the roof

Variation in height between walkway panels are greater than required maximum	Trips, Slips and Falls	Awareness induction	Med	High visibility safety yellow nosing's to be installed	Low	Client advised	Outstanding	OH&S REGULATIONS 3.7  AS/NZS 1657-2013 3.3.4
331	Building: General Stores Location Reference: <a href="#">L93</a> Task: Access to the roof

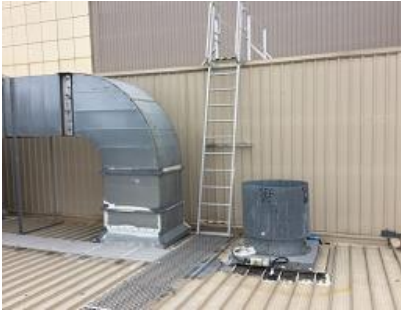
Bottom rung height is less than required minimum and handrails projecting towards the user	Trips, Slips and Falls	Awareness induction	Med	Existing handrails to be removed and new handrails and landing platform to be installed	Low	Client advised	Outstanding	OH&S REGULATIONS 3.7  AS/NZS 1657-2013 7.4.3.4 & 7.4.8.5

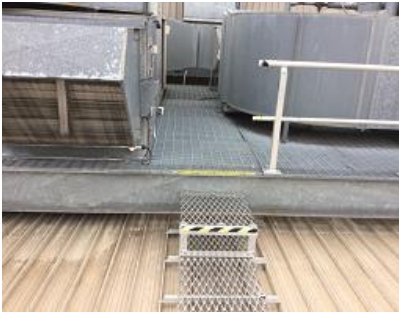
Step height is greater than required maximum	Trips, Slips and Falls	Awareness induction	Med	Existing step to be removed and new steps to be installed	Low	Client advised	Outstanding	OH&S REGULATIONS 3.7  AS/NZS 1657-2013 3.1.4
33 3	Building: General Stores Location Reference: <a href="#">L94</a> Task: Access to the plant deck

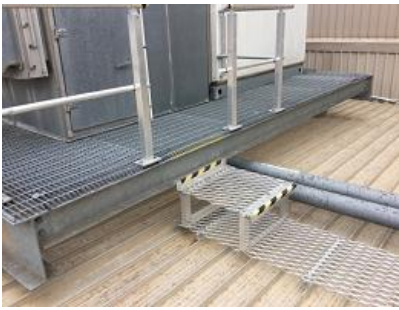
Step height is greater than required maximum	Trips, Slips and Falls	Awareness induction	Med	Existing step to be removed and new steps to be installed	Low	Client advised	Outstanding	OH&S REGULATIONS 3.7  AS/NZS 1657-2013 3.1.4

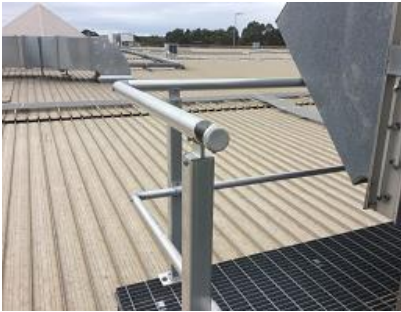
Sharp edges on handrails	Trips, Slips and Falls	Awareness induction	Med	Tek screws to be replaced with rivets	Low	Client advised	Outsta nding	OH&S REGULATIONS 3.7  AS/NZS 1657-2013 5.6
33 5	Building: General Stores Location Reference: <a href="#">L94</a> Task: Access to the plant deck

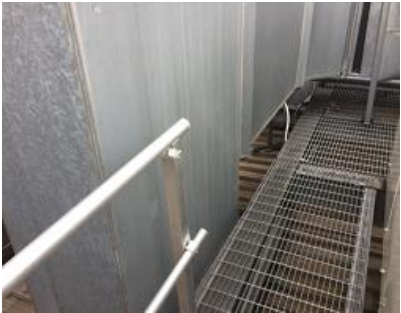
Handrails is missing	Trips, Slips and Falls	Awareness induction	Med	Handrails to be installed	Low	Client advised	Outsta nding	OH&S REGULATIONS 3.7  AS/NZS 1657- 2013 4.4

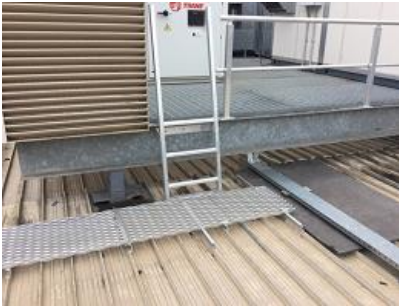
Bottom rung height is less than required minimum, top rung not levelled with landing and landing is less than required minimum	Trips, Slips and Falls	Awareness induction	Med	Landing platform to be installed and grating at top to be extended	Low	Client advised	Outstanding	OH&S REGULATIONS 3.7  AS/NZS 1657-2013 7.4.3.4, 7.4.3.3 & 7.3.6
33 7	Building: General Stores Location Reference: <a href="#">L95</a> Task: Access to the plant deck

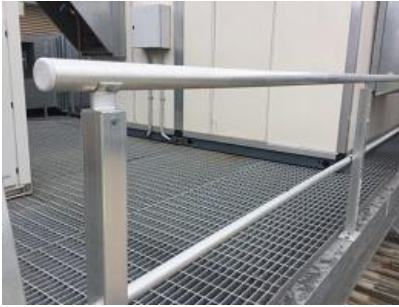
Sharp edges on handrails	Trips, Slips and Falls	Awareness induction	Med	Tek screws to be replaced with rivets	Low	Client advised	Outstanding	OH&S REGULATIONS 3.7  AS/NZS 1657-2013 5.6

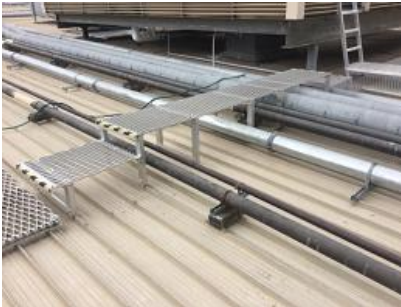
Handrails is missing for step bridge	Trips, Slips and Falls	Awareness induction	Med	Handrails to be installed	Low	Client advised	Outsta nding	OH&S REGULATIONS 3.7  AS/NZS 1657-2013 4.4

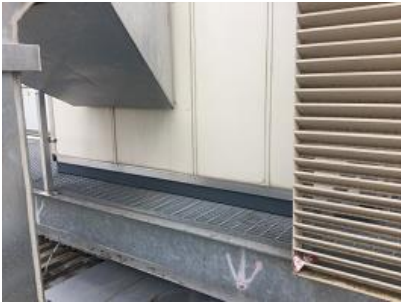
Variation in height between plant deck and roof is greater than required maximum	Trips, Slips and Falls	Awareness induction	Med	Handrails to be installed	Low	Client advised	Outstanding	OH&S REGULATIONS 3.7  AS/NZS 1657-2013 7.3.3.1
34 0	Building: General Stores Location Reference: <a href="#">L96</a> Task: Access to the plant deck

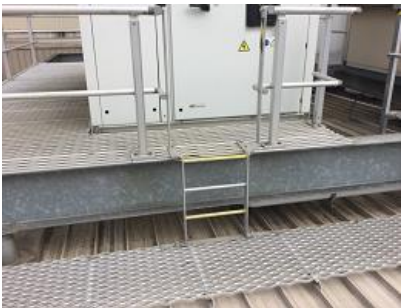
No slip resistance on ladder rungs and gap between top rung and landing is greater than required maximum and landing is less than required minimum	Trips, Slips and Falls	Awareness induction	Med	Existing ladder to be removed and new ladder to be installed	Low	Client advised	Outstanding	OH&S REGULATIONS 3.7  AS/NZS 1657-2013 7.4.3.1, 7.4.8.4 & 7.3.6

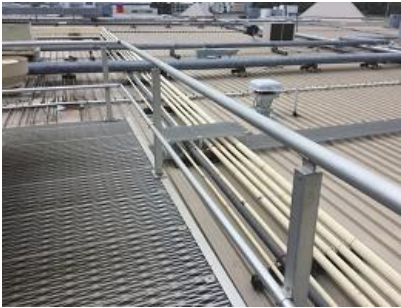
Sharp edges on handrails	Trips, Slips and Falls	Awareness induction	Med	Tek screws to be replaced with rivets	Low	Client advised	Outsta nding	OH&S REGULATIONS 3.7  AS/NZS 1657- 2013 5.6
34 2	Building: General Stores Location Reference: <a href="#">L96</a> Task: Access to the A/c units

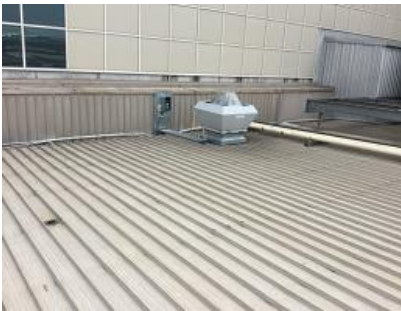
No safe access to the A/c units	Trips, Slips and Falls	N/A	Low	Supply walkway to the A/c units	Low	Client advised	Outsta nding	-

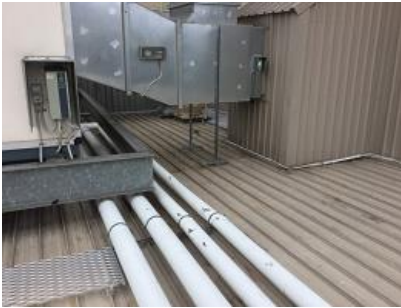
No safe access to the switches	Trips, Slips and Falls	Awareness induction	Med	Step bridge and walkway to be installed	Low	Client advised	Outsta nding	OH&S REGULATIONS 3.7  AS/NZS 1657-2013 3.1.4
34 6	Building: General Stores Location Reference: <a href="#">L96</a> Task: Access to the roof

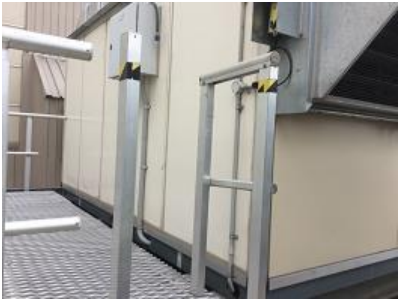
Sharp edges on handrails	Trips, Slips and Falls	Awareness induction	Med	Tek screws to be replaced with rivets	Low	Client advised	Outsta nding	OH&S REGULATIONS 3.7  AS/NZS 1657-2013 5.6

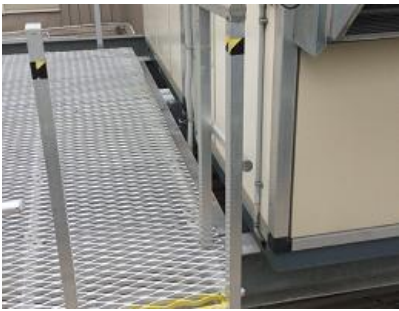
Gap between plant deck and unit is greater than required maximum	Trips, Slips and Falls	Awareness induction	Med	Gap to be filled	Low	Client advised	Outstanding	OH&S REGULATIONS 3.7  AS/NZS 1657-2013 4.4

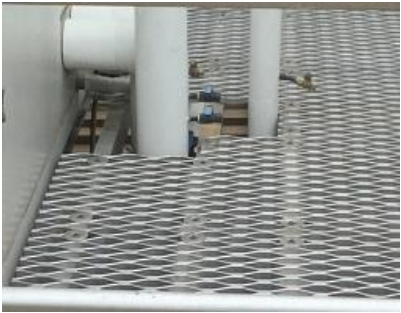
Gap between plant deck and unit is greater than required maximum	Trips, Slips and Falls	Awareness induction	Med	Gap to be filled	Low	Client advised	Outstanding	OH&S REGULATIONS 3.7  AS/NZS 1657-2013 4.4
35 0	Building: General Stores Location Reference: <a href="#">L97</a> Task: Access to the A/c units

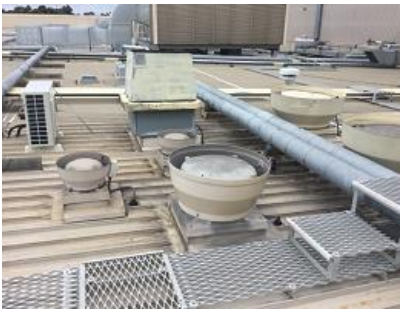
No safe access to the A/c units	Trips, Slips and Falls	N/A	Low	Supply walkway to the A/c units	Low	Client advised	Outstanding	-

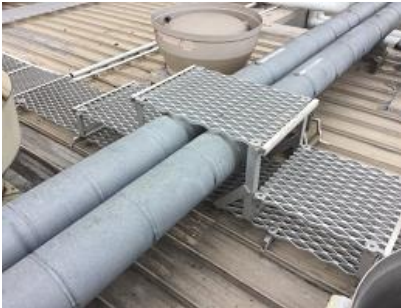
Handrails is missing for step bridge	Trips, Slips and Falls	Awareness induction	Med	Handrails to be installed	Low	Client advised	Outsta nding	OH&S REGULATIONS 3.7  AS/NZS 1657- 2013 4.4
35 2	Building: General Stores Location Reference: <a href="#">L97</a> Task: Access to the roof

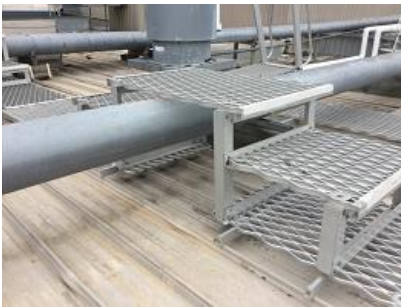
Handrails is missing for step bridge	Trips, Slips and Falls	Awareness induction	Med	Handrails to be installed	Low	Client advised	Outsta nding	OH&S REGULATIONS 3.7  AS/NZS 1657-2013 4.4

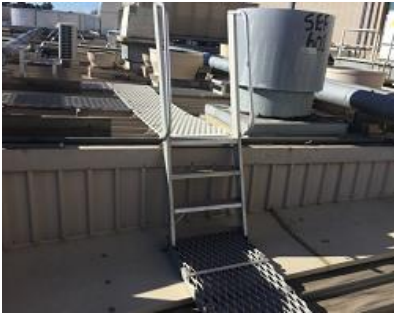
Clearance behind the ladder is less than required minimum	Trips, Slips and Falls	Awareness induction	Med	Existing ladder to be re-installed with new landing platform and brackets	Low	Client advised	Outstanding	OH&S REGULATIONS 3.7  AS/NZS 1657-2013 7.3.5
35 4	Building: General Stores Location Reference: <a href="#">L97</a> Task: Access to the roof

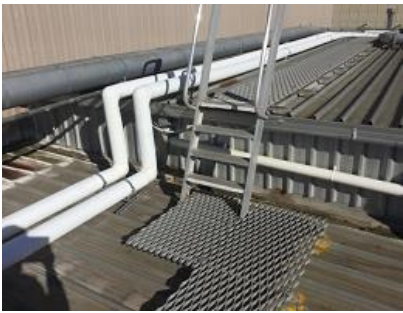
Clearance behind the ladder is less than required minimum	Trips, Slips and Falls	Awareness induction	Med	Existing ladder to be re-installed with new landing platform and brackets	Low	Client advised	Outstanding	OH&S REGULATIONS 3.7  AS/NZS 1657-2013 7.3.5

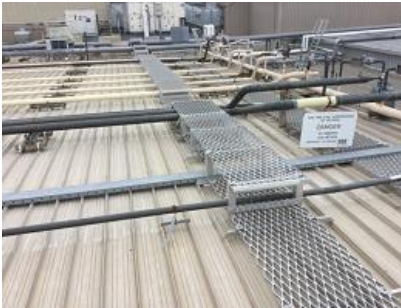
Handrails is missing for step bridge	Trips, Slips and Falls	Awareness induction	Med	Handrails to be installed	Low	Client advised	Outsta nding	OH&S REGULATIONS 3.7  AS/NZS 1657- 2013 4.4
35 6	Building: General Stores Location Reference: <a href="#">L97</a> Task: Access to the roof

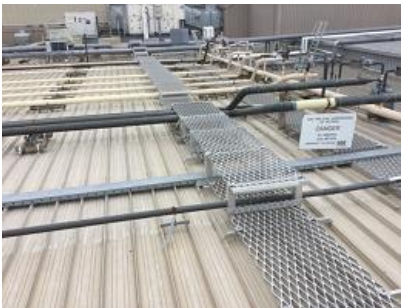
Handrails is missing for step bridge	Trips, Slips and Falls	Awareness induction	Med	Handrails to be installed	Low	Client advised	Outsta nding	OH&S REGULATIONS 3.7  AS/NZS 1657-2013 4.4

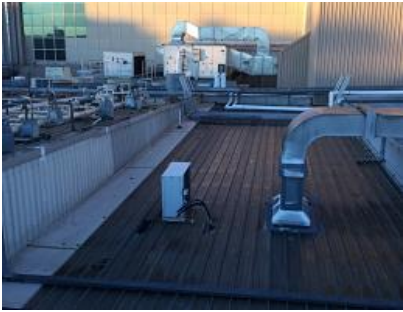
No safe access to the A/c unit	Trips, Slips and Falls	N/A	Low	Supply walkway and step overs to be installed	Low	Client advised	Outstanding	-
358	Building: General Stores Location Reference: <a href="#">L98</a> Task: Access to the roof

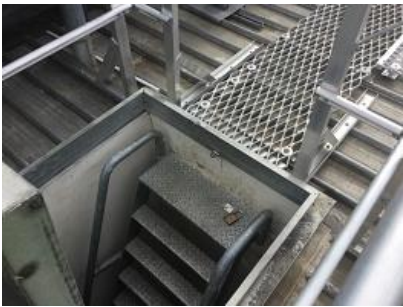
Top tread not levelled with landing	Trips, Slips and Falls	Awareness induction	Med	Existing ladder to be removed and new ladder to be installed	Low	Client advised	Outstanding	OH&S REGULATIONS 3.7  AS/NZS 1657-2013 7.4.3.3

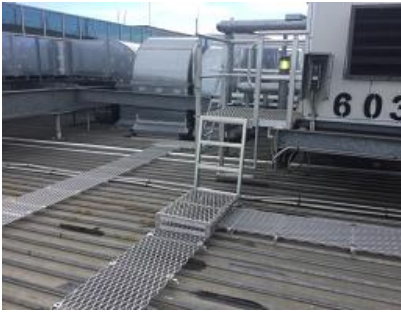
Non-compliant ladder is present	Trips, Slips and Falls	Awareness induction	Med	Existing ladder to be removed and new ladder to be installed	Low	Client advised	Outsta nding	OH&S REGULATIONS 3.7  AS/NZS 1657-2013 7.4
36 3	Building: General Stores Location Reference: <a href="#">L98</a> Task: Access to the plant deck

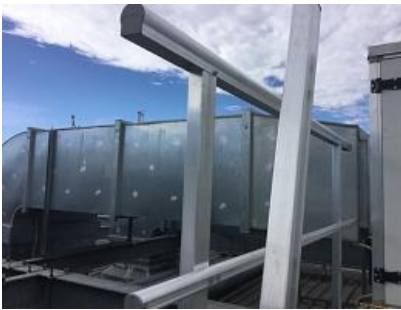
Sharp edges on handrails	Trips, Slips and Falls	Awareness induction	Med	Tek screws to be replaced with rivets	Low	Client advised	Outsta nding	OH&S REGULATIONS 3.7  AS/NZS 1657- 2013 5.6

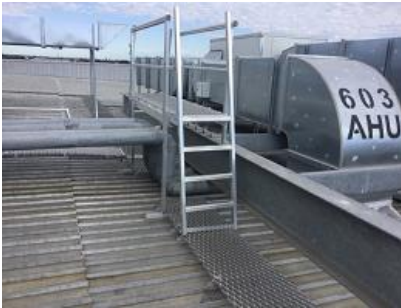
Bottom rung heights is less than required minimum	Trips, Slips and Falls	Awareness induction	Med	Landing platforms to be installed	Low	Client advised	Outstanding	OH&S REGULATIONS 3.7  AS/NZS 1657-2013 7.4.3.4
36 6	Building: General Stores Location Reference: <a href="#">L100</a> Task: Access to the plant deck

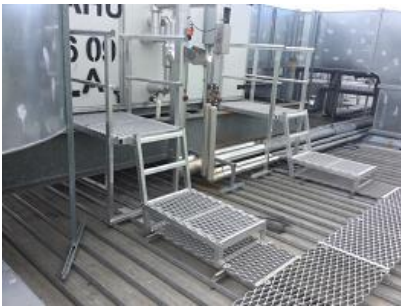
Non-complaint ladder is present	Trips, Slips and Falls	Awareness induction	Med	Existing ladder to be removed and new ladder to be installed	Low	Client advised	Outstanding	OH&S REGULATIONS 3.7  AS/NZS 1657-2013 7.4

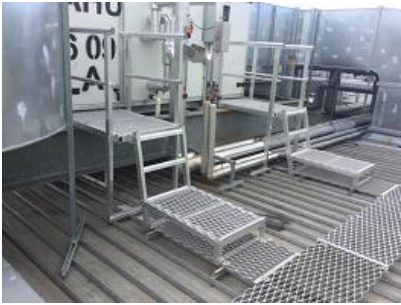
Non-compliant ladder is present	Trips, Slips and Falls	Awareness induction	Med	Existing ladder to be removed and new ladder to be installed	Low	Client advised	Outsta nding	OH&S REGULATIONS 3.7  AS/NZS 1657- 2013 7.4
36 8	Building: General Stores Location Reference: <a href="#">L100</a> Task: Access to the plant deck

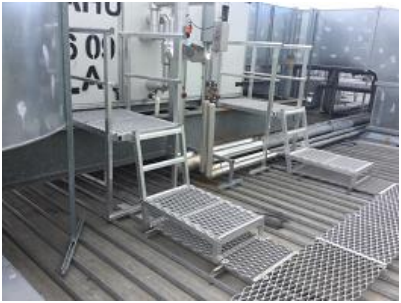
Sharp edges on handrails	Trips, Slips and Falls	Awareness induction	Med	Tek screws to be replaced with rivets	Low	Client advised	Outsta nding	OH&S REGULATIONS 3.7  AS/NZS 1657-2013 5.6

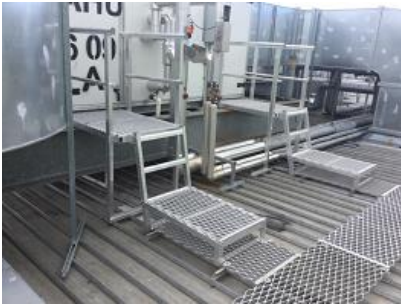
Sharp edges on handrails	Trips, Slips and Falls	Awareness induction	Med	Tek screws to be replaced with rivets	Low	Client advised	Outsta nding	OH&S REGULATIONS 3.7  AS/NZS 1657- 2013 5.6
37 0	Building: General Stores Location Reference: <a href="#">L101</a> Task: Access to the plant deck

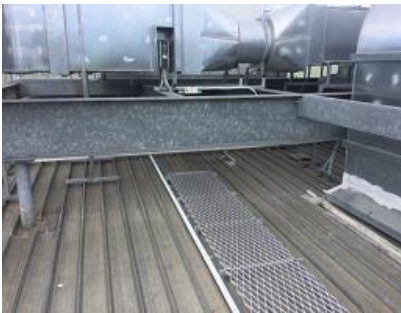
No safe access to the plant deck	Trips, Slips and Falls	Awareness induction	Med	Access ladder, grating and handrails to be installed	Low	Client advised	Outsta nding	OH&S REGULATIONS 3.7  AS/NZS 1657-2013 3.1.4

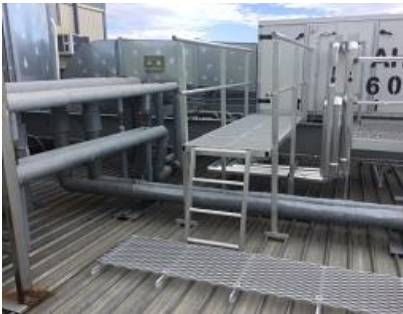
Non-compliant ladder is present	Trips, Slips and Falls	Awareness induction	Med	Existing ladder to be removed and new ladder to be installed	Low	Client advised	Outstanding	OH&S REGULATIONS 3.7  AS/NZS 1657-2013 7.4
372	Building: General Stores Location Reference: <a href="#">L101</a> Task: Access to the plant deck

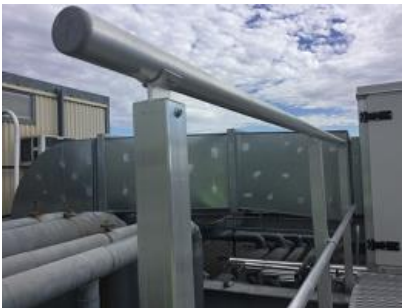
Sharp edges on handrails	Trips, Slips and Falls	Awareness induction	Med	Tek screws to be replaced with rivets	Low	Client advised	Outstanding	OH&S REGULATIONS 3.7  AS/NZS 1657-2013 5.6

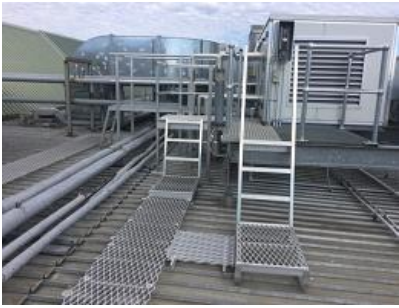
Non-compliant ladder is present	Trips, Slips and Falls	Awareness induction	Med	Existing ladder to be removed and new ladder to be installed	Low	Client advised	Outsta nding	OH&S REGULATIONS 3.7  AS/NZS 1657- 2013 7.4
37 4	Building: General Stores Location Reference: <a href="#">L101</a> Task: Access to the plant deck

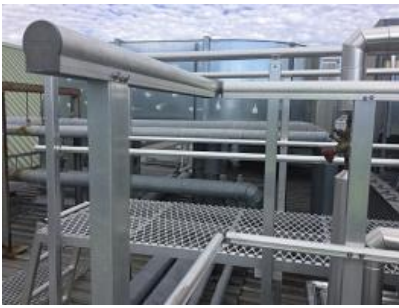
Sharp edges on handrails	Trips, Slips and Falls	Awareness induction	Med	Tek screws to be replaced with rivets	Low	Client advised	Outsta nding	OH&S REGULATIONS 3.7  AS/NZS 1657-2013 5.6

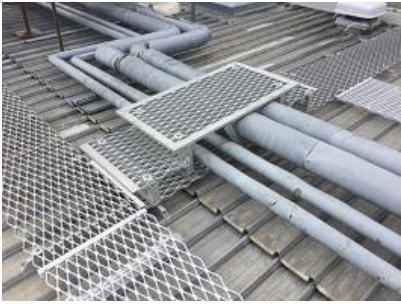
Variation in height between platform and roof is greater than required maximum	Trips, Slips and Falls	Awareness induction	Med	Handrails to be installed	Low	Client advised	Outstanding	OH&S REGULATIONS 3.7  AS/NZS 1657-2013 4.4
37 6	Building: General Stores Location Reference: <a href="#">L102</a> Task: Access to the plant deck

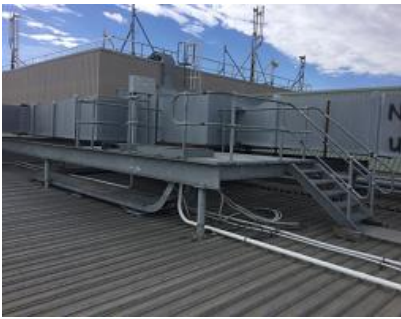
Variation in height between plant deck and roof is greater than required maximum	Trips, Slips and Falls	Awareness induction	Med	Handrails to be installed	Low	Client advised	Outstanding	OH&S REGULATIONS 3.7  AS/NZS 1657-2013 4.4

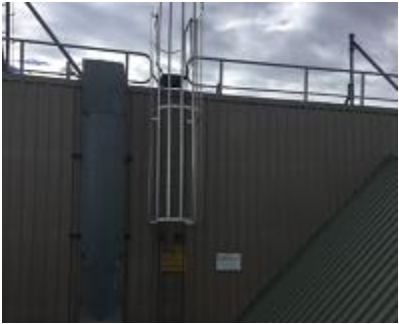
No slip resistance on ladder rungs	Trips, Slips and Falls	Awareness induction	Med	Non-slip rung caps to be installed	Low	Client advised	Outstanding	OH&S REGULATIONS 3.7  AS/NZS 1657-2013 7.4.3.1
37 9	Building: General Stores Location Reference: <a href="#">L103</a> Task: Access to the A/c unit

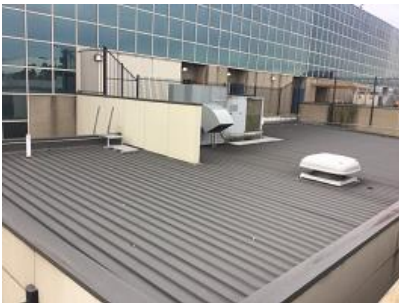
No safe access to the A/c unit	Trips, Slips and Falls	N/A	Low	Supply walkway to the A/c unit	Low	Client advised	Outstanding	-

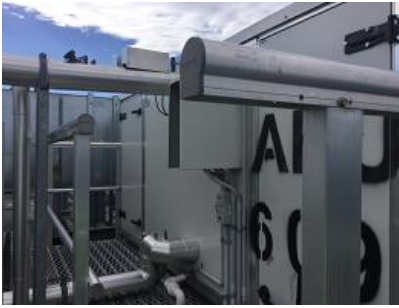
Sharp edges on handrails	Trips, Slips and Falls	Awareness induction	Med	Tek screws to be replaced with rivets	Low	Client advised	Outsta nding	OH&S REGULATIONS 3.7  AS/NZS 1657-2013 5.6
38 3	Building: General Stores Location Reference: <a href="#">L105</a> Task: Access to the roof

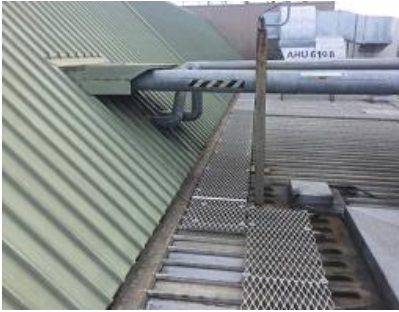
Headroom is less than required minimum	Trips, Slips and Falls	Awareness induction	Med	"Caution-Low Headroom" signs to be installed	Low	Client advised	Outsta nding	OH&S REGULATIONS 3.7 & 3.11  AS/NZS 1657- 2013 3.1.5

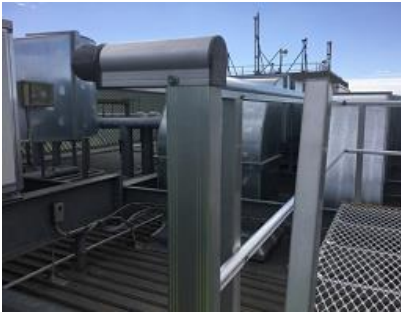
Sharp edges on handrails	Trips, Slips and Falls	Awareness induction	Med	Tek screws to be replaced with rivets	Low	Client advised	Outsta nding	OH&S REGULATIONS 3.7  AS/NZS 1657-2013 5.6
38 5	Building: General Stores Location Reference: <a href="#">L106</a> Task: Access to the plant deck

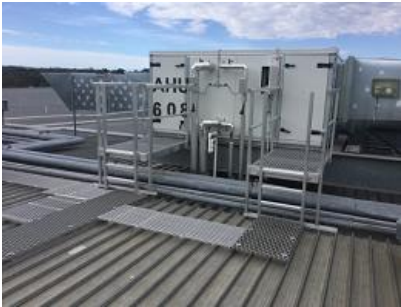
Clearance behind the ladder is less than required minimum	Trips, Slips and Falls	Awareness induction	Med	Existing ladder to be removed and new ladder to be installed	Low	Client advised	Outsta nding	OH&S REGULATIONS 3.7  AS/NZS 1657- 2013 7.4.5

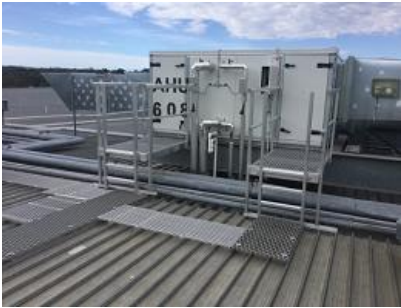
Clearance behind the ladder is less than required minimum	Trips, Slips and Falls	Awareness induction	Med	Existing ladder to be removed and new ladder to be installed	Low	Client advised	Outstanding	OH&S REGULATIONS 3.7  AS/NZS 1657-2013 7.4.5
38 7	Building: General Stores Location Reference: <a href="#">L106</a> Task: Access to the plant deck

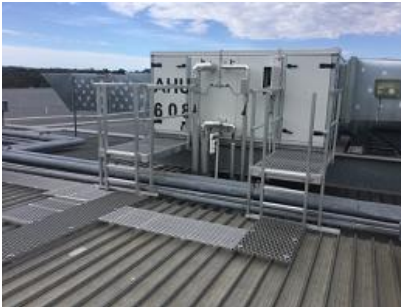
Sharp edges on handrails	Trips, Slips and Falls	Awareness induction	Med	Tek screws to be replaced with rivets	Low	Client advised	Outstanding	OH&S REGULATIONS 3.7  AS/NZS 1657-2013 5.6

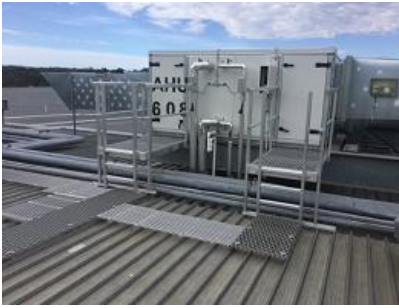
Sharp edges on handrails	Trips, Slips and Falls	Awareness induction	Med	Tek screws to be replaced with rivets	Low	Client advised	Outsta nding	OH&S REGULATIONS 3.7  AS/NZS 1657-2013 5.6
38 9	Building: General Stores Location Reference: <a href="#">L106</a> Task: Access to the plant deck

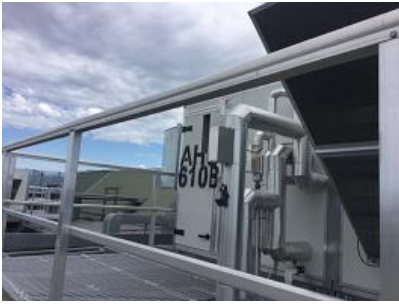
Sharp edges on handrails	Trips, Slips and Falls	Awareness induction	Med	Tek screws to be replaced with rivets	Low	Client advised	Outsta nding	OH&S REGULATIONS 3.7  AS/NZS 1657- 2013 5.6

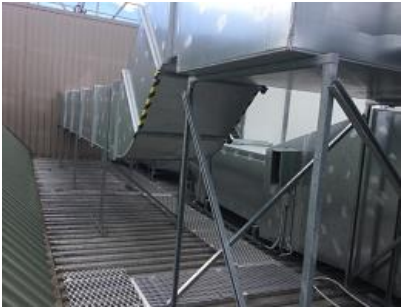
Headroom is less than required minimum	Trips, Slips and Falls	Awareness induction	Med	"Caution-Low Headroom" signs to be installed	Low	Client advised	Outstanding	OH&S REGULATIONS 3.7  AS/NZS 1657-2013 3.1.5
391	Building: General Stores Location Reference: <a href="#">L106</a> Task: Access to the roof

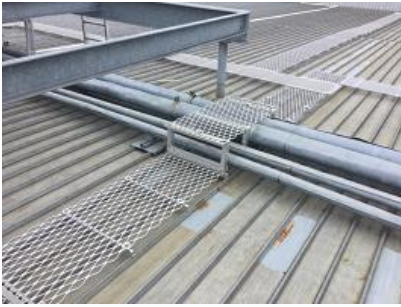
Variation in height between platform and roof is greater than required maximum	Trips, Slips and Falls	Awareness induction	Med	Handrails to be installed	Low	Client advised	Outstanding	OH&S REGULATIONS 3.7  AS/NZS 1657-2013 4.4

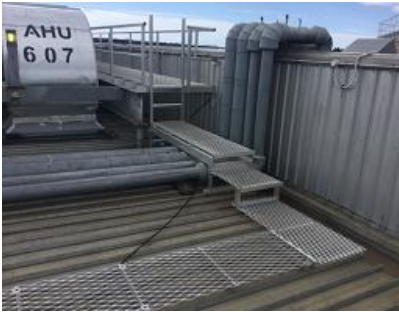
Variation in height between platform and roof is greater than required maximum	Trips, Slips and Falls	Awareness induction	Med	Handrails to be installed	Low	Client advised	Outstanding	OH&S REGULATIONS 3.7  AS/NZS 1657-2013 4.4
39 3	Building: General Stores Location Reference: <a href="#">L108</a> Task: Access to the roof

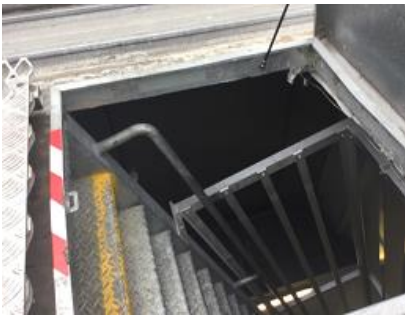
Top tread not levelled with landing, Step ladder slope is greater than required maximum and clearance behind the ladder is less than required minimum	Trips, Slips and Falls	Awareness induction	Med	Existing ladder and hatch to be removed and new ladder and hatch to be installed	Low	Client advised	Outstanding	OH&S REGULATIONS 3.7  AS/NZS 1657-2013 7.4.3.3 & 7.3.5

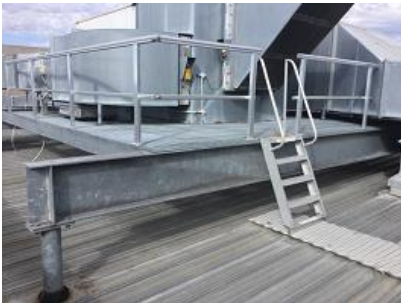
Bottom tread height is greater than required maximum	Trips, Slips and Falls	Awareness induction	Med	Landing platform to be installed	Low	Client advised	Outstanding	OH&S REGULATIONS 3.7  AS/NZS 1657-2013 7.3.3.2
39 5	Building: General Stores Location Reference: <a href="#">L108</a> Task: Access to the plant deck

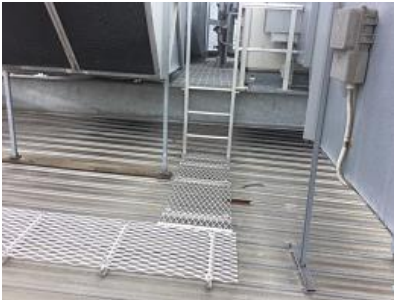
Bottom rung height is greater than required maximum	Trips, Slips and Falls	Awareness induction	Med	Landing platform to be installed	Low	Client advised	Outstanding	OH&S REGULATIONS 3.7  AS/NZS 1657-2013 7.4.3.4

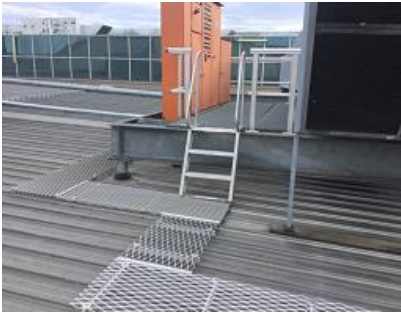
Bottom tread height is greater than required maximum	Trips, Slips and Falls	Awareness induction	Med	Landing platform to be installed	Low	Client advised	Outstanding	OH&S REGULATIONS 3.7  AS/NZS 1657-2013 7.3.3.2
39 7	Building: General Stores Location Reference: <a href="#">L108</a> Task: Access to the roof

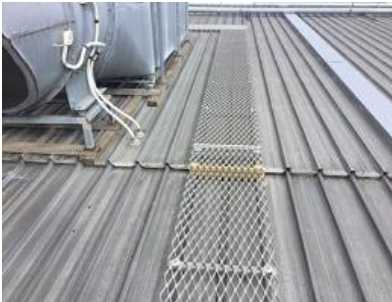
Variation in height between walkway panels are greater than required maximum	Trips, Slips and Falls	Awareness induction	Med	High visibility safety yellow nosing to be installed	Low	Client advised	Outstanding	OH&S REGULATIONS 3.7  AS/NZS 1657-2013 3.3.4

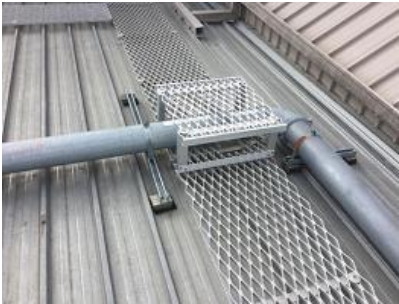
Variation in height between platform and roof is greater than required maximum	Trips, Slips and Falls	Awareness induction	Med	Handrails to be installed	Low	Client advised	Outstanding	OH&S REGULATIONS 3.7  AS/NZS 1657-2013 4.4
39 9	Building: General Stores Location Reference: <a href="#">L109</a> Task: Access to the roof

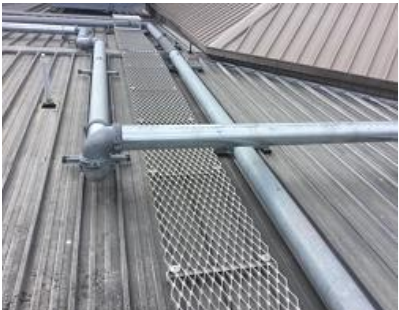
Pipe installed over the walkway path	Trips, Slips and Falls	Awareness induction	Med	Step bridge to be installed	Low	Client advised	Outstanding	OH&S REGULATIONS 3.7  AS/NZS 1657-2013 3.1.4

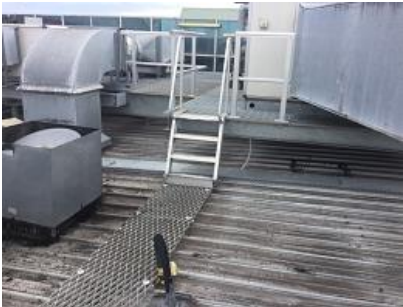
Bottom tread height is greater than required maximum	Trips, Slips and Falls	Awareness induction	Med	Landing platform to be installed	Low	Client advised	Outstanding	OH&S REGULATIONS 3.7  AS/NZS 1657-2013 7.3.3.2

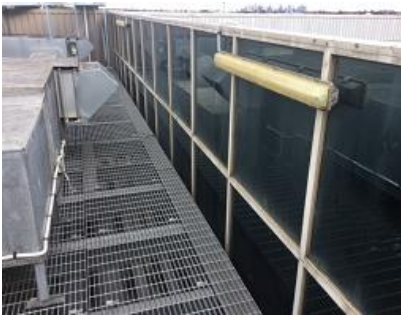
Gap between plant deck and structure is greater than required maximum	Trips, Slips and Falls	Awareness induction	Med	Handrails to be installed	Low	Client advised	Outstanding	OH&S REGULATIONS 3.7  AS/NZS 1657-2013 4.4
40 2	Building: General Stores Location Reference: <a href="#">L109</a> Task: Access to the plant deck

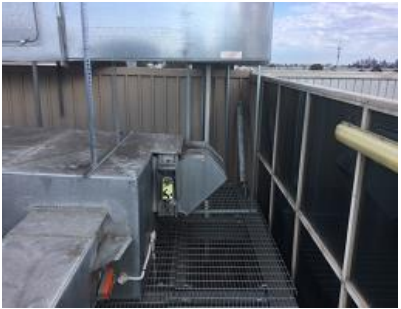
Headroom is less than required minimum	Trips, Slips and Falls	Awareness induction	Med	"Caution-Low Headroom" signs to be installed	Low	Client advised	Outstanding	OH&S REGULATIONS 3.7  AS/NZS 1657-2013 3.1.5

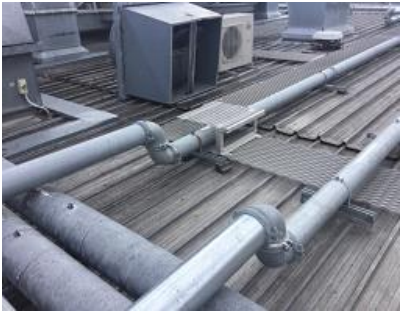
Step height is greater than required maximum	Trips, Slips and Falls	Awareness induction	Med	Existing step to be modified and re-installed	Low	Client advised	Outstanding	OH&S REGULATIONS 3.7  AS/NZS 1657-2013 3.1.4
404	Building: General Stores Location Reference: <a href="#">L109</a> Task: Access to the roof

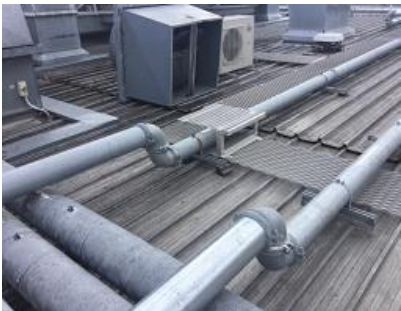
Pipe installed over the walkway path	Trips, Slips and Falls	Awareness induction	Med	Step over to be installed	Low	Client advised	Outstanding	OH&S REGULATIONS 3.7  AS/NZS 1657-2013 3.1.4

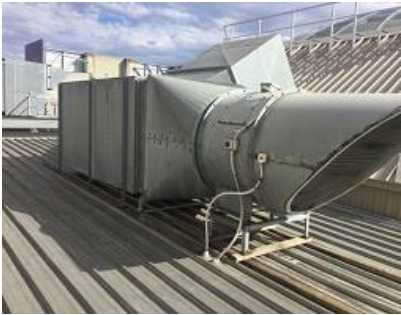
No safe access to the A/c unit	Trips, Slips and Falls	N/A	Low	Supply walkway to the A/c unit	Low	Client advised	Outsta nding	-

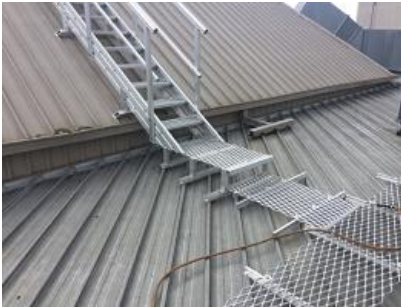
Variation in height between platform and roof is greater than required maximum	Trips, Slips and Falls	Awareness induction	Med	Handrails to be installed	Low	Client advised	Outstanding	OH&S REGULATIONS 3.7  AS/NZS 1657-2013 4.4
40 8	Building: General Stores Location Reference: <a href="#">L111</a> Task: Access to the roof

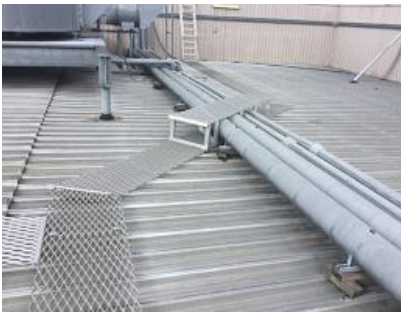
Step height is greater than required minimum and variation in height between platform and roof is greater than required maximum	Trips, Slips and Falls	Awareness induction	Med	Steps and handrails to be installed	Low	Client advised	Outstanding	OH&S REGULATIONS 3.7  AS/NZS 1657-2013 3.1.4 & 4.4

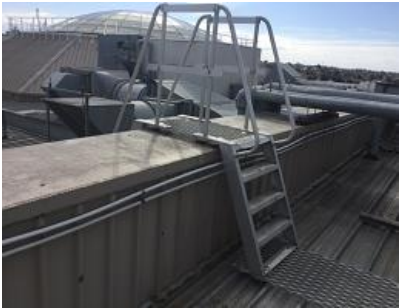
Bottom tread heights are greater than required maximum and sharp edges on handrails	Trips, Slips and Falls	Awareness induction	Med	Tek screws to be replaced with rivets and landing platforms to be installed	Low	Client advised	Outstanding	OH&S REGULATIONS 3.7  AS/NZS 1657-2013 7.3.3.2 & 5.6
41 0	Building: General Stores Location Reference: <a href="#">L112</a> Task: Access to the switches

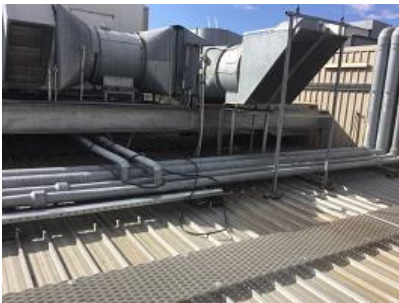
No safe access to the switches	Trips, Slips and Falls	Awareness induction	Med	Access ladder and landing platform to be installed	Low	Client advised	Outstanding	OH&S REGULATIONS 3.7  AS/NZS 1657-2013 3.1.4

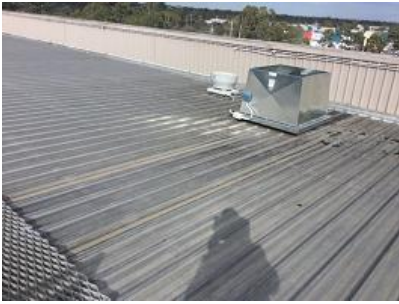
No safe access to the A/c units	Trips, Slips and Falls	N/A	Low	Supply walkway to the A/c units	Low	Client advised	Outstanding	-
412	Building: General Stores Location Reference: <a href="#">L113</a> Task: Access to the plant deck

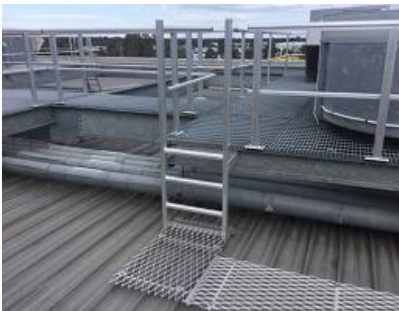
Gap between top rung and landing is greater than required maximum	Trips, Slips and Falls	Awareness induction	Med	Existing ladder to be re-installed with new brackets and landing platforms	Low	Client advised	Outstanding	OH&S REGULATIONS 3.7  AS/NZS 1657-2013 7.4.8.4

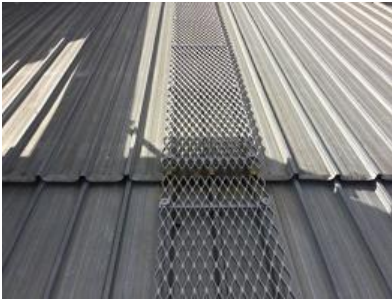
No	Photo of Hazard	Details of Hazard	Details of Risk	Existing/ Immediate Control Measure	Curren t Risk Level	Proposed Permanent Solution	Residu al Risk Assess ment	Details of Action Taken	Status	Reference
413	Building: General Stores Location Reference: <a href="#">L113</a> Task: Access to the roof

Variation in height between walkway panels are greater than required maximum	Trips, Slips and Falls	Awareness induction	Med	High visibility safety yellow nosing to be installed	Low	Client advised	Outstanding	OH&S REGULATIONS 3.7  AS/NZS 1657-2013 3.3.4
414	Building: General Stores Location Reference: <a href="#">L114</a> Task: Access to the plant deck

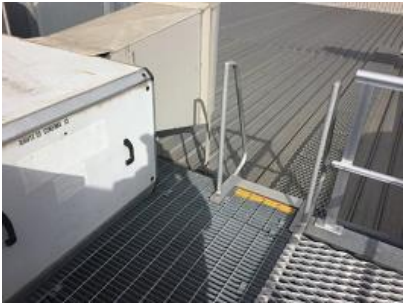
Handrail section is missing at access point	Trips, Slips and Falls	Awareness induction	Med	Handrails to be installed	Low	Client advised	Outstanding	OH&S REGULATIONS 3.7  AS/NZS 1657-2013 4.4

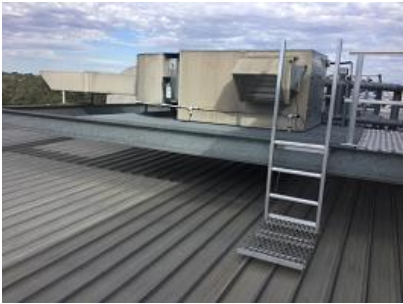
Variation in height between plant deck and roof is greater than required maximum	Trips, Slips and Falls	Awareness induction	Med	Handrails to be installed	Low	Client advised	Outstanding	OH&S REGULATIONS 3.7  AS/NZS 1657-2013 4.4

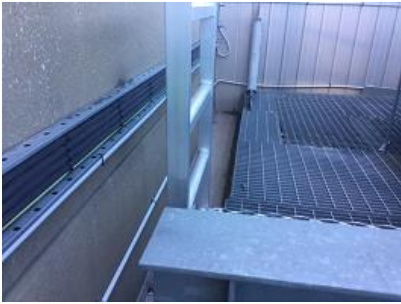
Gap between plant deck and structure is greater than required maximum	Trips, Slips and Falls	Awareness induction	Med	Handrails to be installed	Low	Client advised	Outstanding	OH&S REGULATIONS 3.7  AS/NZS 1657-2013 4.4

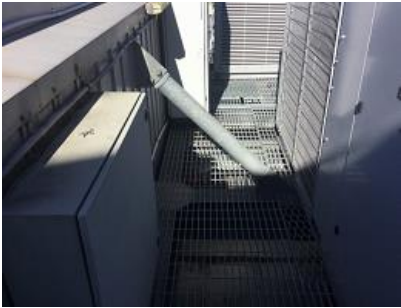
Bracings in the way	Trips, Slips and Falls	Awareness induction	Med	High visibility safety yellow tape to be installed	Low	Client advised	Outsta nding	OH&S REGULATIONS 3.7
422	Building: General Stores Location Reference: <a href="#">L118</a> Task: Access to the plant deck

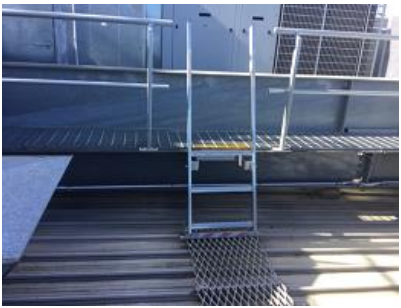
Bottom rung height is less than required minimum and gap between top rung and landing is greater than required maximum	Trips, Slips and Falls	Awareness induction	Med	Existing ladder to be re-installed with new brackets and landing platform	Low	Client advised	Outsta nding	OH&S REGULATIONS 3.7  AS/NZS 1657-2013 7.4.3.4 & 7.4.8.4

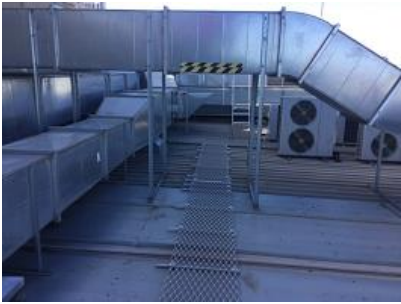
No	Photo of Hazard	Details of Hazard	Details of Risk	Existing/ Immediate Control Measure	Curren t Risk Level	Proposed Permanent Solution	Residu al Risk Assess ment	Details of Action Taken	Status	Reference
42 3	Building: General Stores Location Reference: <a href="#">L118</a> Task: Access to the roof

Headroom is less than required minimum	Trips, Slips and Falls	Awareness induction	Med	"Caution-Low Headroom" signs to be installed	Low	Client advised	Outstanding	OH&S REGULATIONS 3.7  AS/NZS 1657-2013 3.1.5
42 4	Building: General Stores Location Reference: <a href="#">L118</a> Task: Access to the plant deck

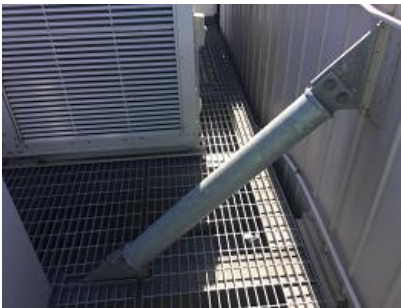
Bracings in the way	Trips, Slips and Falls	Awareness induction	Med	High visibility safety yellow tape to be installed	Low	Client advised	Outstanding	OH&S REGULATIONS 3.7

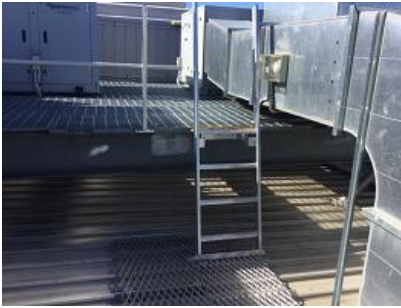
Bottom rung height is less than required minimum and gap between top rung and landing is greater than required maximum	Trips, Slips and Falls	Awareness induction	Med	Existing ladder to be re-installed with new brackets and landing platform	Low	Client advised	Outstanding	OH&S REGULATIONS 3.7  AS/NZS 1657-2013 7.4.3.4 & 7.4.8.4
42 6	Building: General Stores Location Reference: <a href="#">L118</a> Task: Access to the roof

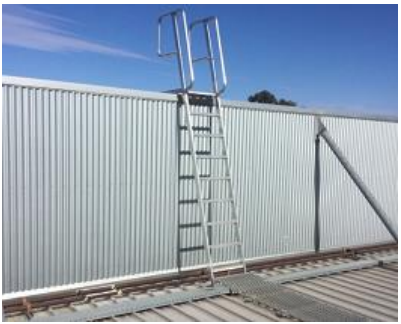
Bottom rung height is less than required minimum and handrails is projecting towards the user	Trips, Slips and Falls	Awareness induction	Med	Existing handrail to be removed and new handrails and landing platform to be installed	Low	Client advised	Outstanding	OH&S REGULATIONS 3.7  AS/NZS 1657-2013 7.4.3.4 & 7.4.8.5

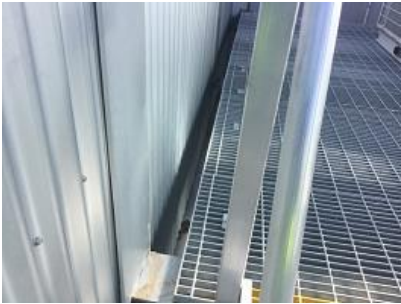
Gap between plant deck and structure is greater than required maximum	Trips, Slips and Falls	Awareness induction	Med	Gap to be closed/Handrail to be installed	Low	Client advised	Outstanding	OH&S REGULATIONS 3.7  AS/NZS 1657-2013 4.4
42 8	Building: General Stores Location Reference: <a href="#">L120</a> Task: Access to the A/c units

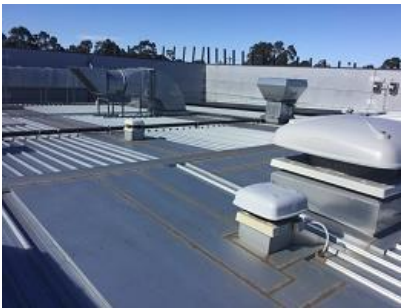
No safe access to the A/c units	Trips, Slips and Falls	N/A	Low	Supply walkway to the A/c units	Low	Client advised	Outstanding	-

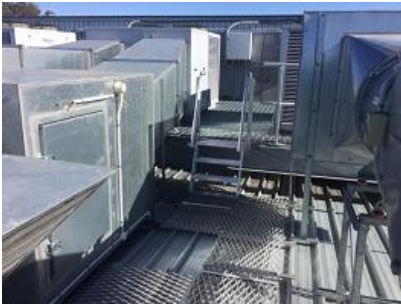
Gap between unit and ladder is greater than required maximum	Trips, Slips and Falls	Awareness induction	Med	Handrails to be installed	Low	Client advised	Outstanding	OH&S REGULATIONS 3.7  AS/NZS 1657-2013 4.4
43 0	Building: General Stores Location Reference: <a href="#">L120</a> Task: Access to the plant deck

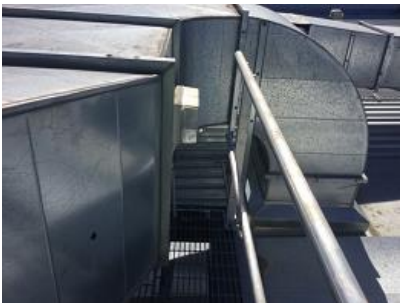
Gap between handrail post and structure is greater than required maximum	Trips, Slips and Falls	Awareness induction	Med	Handrail to be installed	Low	Client advised	Outstanding	OH&S REGULATIONS 3.7  AS/NZS 1657-2013 4.4

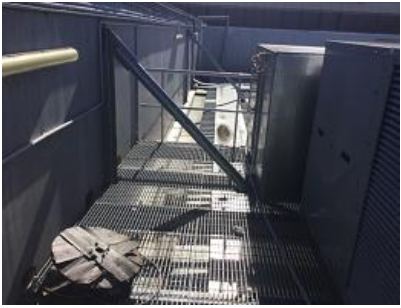
Bracings in the way	Trips, Slips and Falls	Awareness induction	Med	High visibility safety yellow tape to be installed	Low	Client advised	Outsta nding	OH&S REGULATIONS 3.7
43 2	Building: General Stores Location Reference: <a href="#">L12</a> Task: Access to the roof

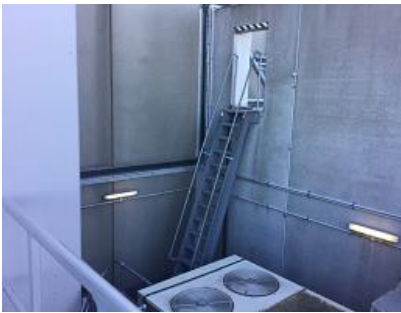
Landing is less than required minimum and headroom is less than required minimum	Trips, Slips and Falls	Awareness induction	Med	Existing ladder to be removed and new ladder including "Low Headroom" sign to be installed	Low	Client advised	Outsta nding	OH&S REGULATIONS 3.7  AS/NZS 1657-2013 7.3.6 & 3.1.5

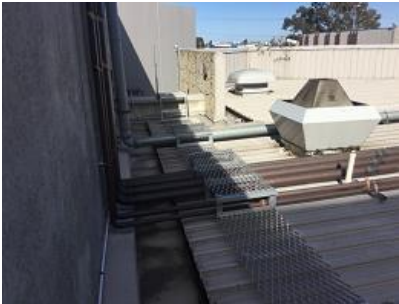
No	Photo of Hazard	Details of Hazard	Details of Risk	Existing/ Immediate Control Measure	Curren t Risk Level	Proposed Permanent Solution	Residu al Risk Assess ment	Details of Action Taken	Status	Reference
43 3	Building: General Stores Location Reference: <a href="#">L12</a> Task: Access to the roof

Variation in height between platform and roof is greater than required maximum	Trips, Slips and Falls	Awareness induction	Med	Handrail to be installed	Low	Client advised	Outstanding	OH&S REGULATIONS 3.7  AS/NZS 1657-2013 4.4
43 4	Building: General Stores Location Reference: <a href="#">L12</a> Task: Access to the roof

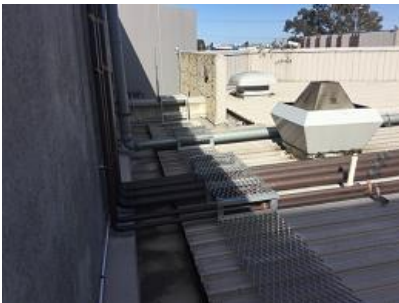
Variation in height between platform and roof is greater than required maximum	Trips, Slips and Falls	Awareness induction	Med	Handrail to be installed	Low	Client advised	Outstanding	OH&S REGULATIONS 3.7  AS/NZS 1657-2013 4.4

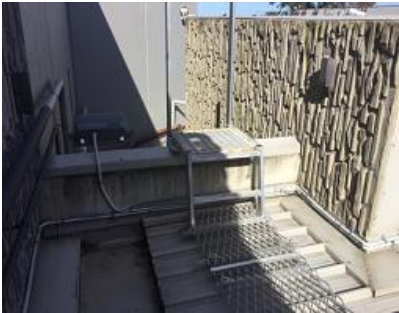
No	Photo of Hazard	Details of Hazard	Details of Risk	Existing/ Immediate Control Measure	Curren t Risk Level	Proposed Permanent Solution	Residu al Risk Assess ment	Details of Action Taken	Status	Reference
43 5	Building: General Stores Location Reference: <a href="#">L122</a> Task: Access to the roof

Bottom rung height is less than required minimum and handrail is missing at landing	Trips, Slips and Falls	Awareness induction	Med	Landing platform including handrails to be installed	Low	Client advised	Outstanding	OH&S REGULATIONS 3.7  AS/NZS 1657-2013 7.4.3.4 & 4.4
43 6	Building: General Stores Location Reference: <a href="#">L122</a> Task: Access to the roof

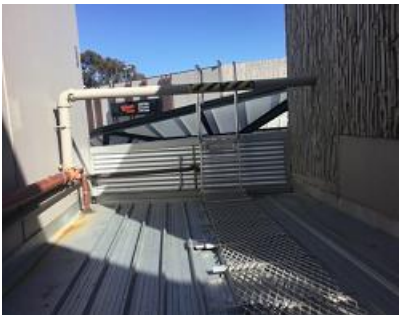
Non-complaint ladder is present and headroom is less than required minimum	Trips, Slips and Falls	Awareness induction	Med	Existing ladder to be removed and new ladder and "Caution-Low Headroom" sign to be installed	Low	Client advised	Outstanding	OH&S REGULATIONS 3.7  AS/NZS 1657-2013 3.1.4 & 3.1.5

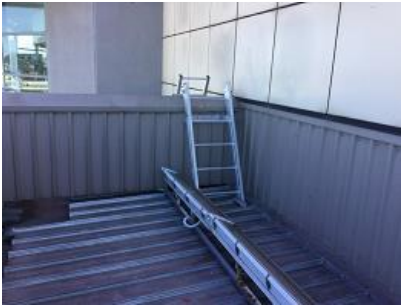
No	Photo of Hazard	Details of Hazard	Details of Risk	Existing/ Immediate Control Measure	Curren t Risk Level	Proposed Permanent Solution	Residu al Risk Assess ment	Details of Action Taken	Status	Reference
43 7	Building: General Stores Location Reference: <a href="#">L124</a> Task: Access to the roof

Non-compliant ladder is present	Trips, Slips and Falls	Awareness induction	Med	Existing ladder to be removed and new ladder to be installed	Low	Client advised	Outsta nding	OH&S REGULATIONS 3.7  AS/NZS 1657- 2013 7.4
43 8	Building: General Stores Location Reference: <a href="#">L124</a> Task: Access to the roof

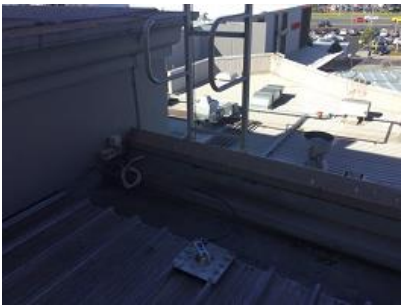
Landing is less than required minimum and handrails is missing at landing platform at base	Trips, Slips and Falls	Awareness induction	Med	Landing platforms, handrails and ladder section at roof side to be installed	Low	Client advised	Outsta nding	OH&S REGULATIONS 3.7  AS/NZS 1657-2013 7.3.6 & 3.1.4
