# Roof Safety Report

Northland, VIC 3072

Prepared By: Safemaster Safety Products  
Date: 10-09-2020

10-09-2020

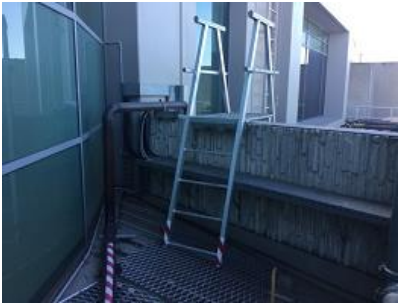
No	Photo of Hazard	Details of Hazard	Details of Risk	Existing/ Immediate Control Measure	Curren t Risk Level	Proposed Permanent Solution	Residu al Risk Assess ment	Details of Action Taken	Status	Reference
43 9	Building: General Stores Location Reference: <a href="#">L124</a> Task: Access to the roof

Bottom tread height is less than required minimum and handrails projecting towards the user	Trips, Slips and Falls	Awareness induction	Med	Existing handrails to be removed and new handrails including landing platforms to be installed	Low	Client advised	Outstanding	OH&S REGULATIONS 3.7  AS/NZS 1657-2013 7.4.3.4 & 7.4.8.5
44 0	Building: General Stores Location Reference: <a href="#">L124</a> Task: Access to the roof

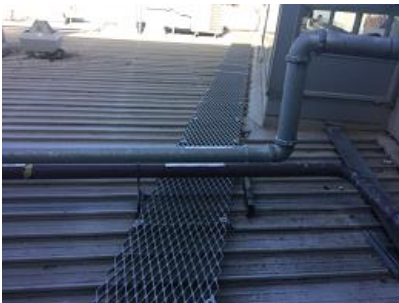
Pipes installed over the walkway path	Trips, Slips and Falls	Awareness induction	Med	Step overs to be installed	Low	Client advised	Outstanding	OH&S REGULATIONS 3.7  AS/NZS 1657-2013 3.1.4

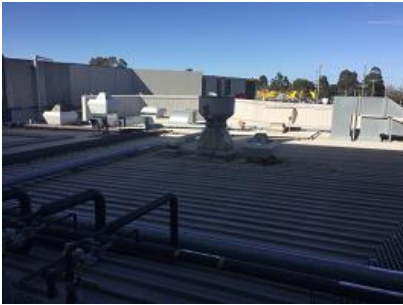
No safe access to the A/c units	Trips, Slips and Falls	N/A	Low	Supply walkway to the A/c units	Low	Client advised	Outstanding	-

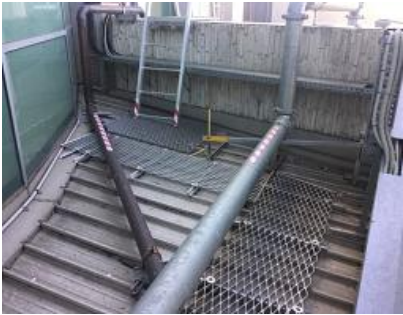
No	Photo of Hazard	Details of Hazard	Details of Risk	Existing/ Immediate Control Measure	Curren t Risk Level	Proposed Permanent Solution	Residu al Risk Assess ment	Details of Action Taken	Status	Reference
44 4	Building: General Stores Location Reference: <a href="#">L124</a> Task: Access to the roof

Pipes installed over the walkway path	Trips, Slips and Falls	Awareness induction	Med	Step overs to be installed	Low	Client advised	Outstanding	OH&S REGULATIONS 3.7  AS/NZS 1657-2013 3.1.4

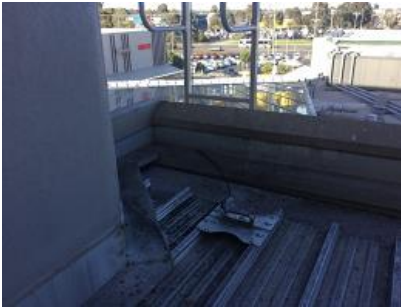
No	Photo of Hazard	Details of Hazard	Details of Risk	Existing/ Immediate Control Measure	Curren t Risk Level	Proposed Permanent Solution	Residu al Risk Assess ment	Details of Action Taken	Status	Reference
44 5	Building: General Stores Location Reference: <a href="#">L126</a> Task: Access to the roof

Gap between top rung and landing is greater than required maximum and landing is less than required minimum	Trips, Slips and Falls	Awareness induction	Med	Landing platform and return ladder to be installed	Low	Client advised	Outstanding	OH&S REGULATIONS 3.7  AS/NZS 1657-2013 7.4.8.4 & 7.3.6
44 6	Building: General Stores Location Reference: <a href="#">L126</a> Task: Access to the roof

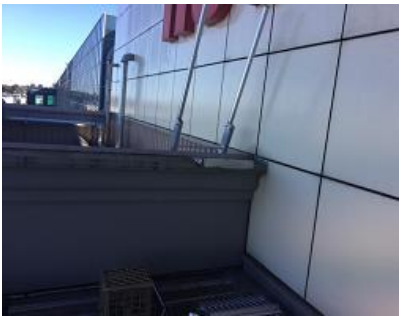
Non-complaint ladder is present	Trips, Slips and Falls	Awareness induction	Med	Existing ladder to be removed and new ladder to be installed	Low	Client advised	Outstanding	OH&S REGULATIONS 3.7  AS/NZS 1657-2013 7.4

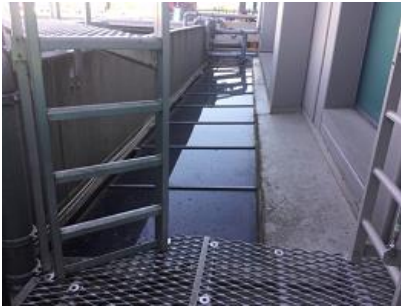
Bottom rung height is less than required minimum and handrails missing at landing platform	Trips, Slips and Falls	Awareness induction	Med	Landing platform and handrails to be installed	Low	Client advised	Outstanding	OH&S REGULATIONS 3.7  AS/NZS 1657-2013 7.4.3.4 & 4.4
44 8	Building: General Stores Location Reference: <a href="#">L126</a> Task: Access to the roof

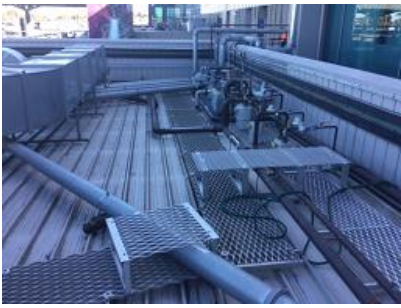
Variation in height between platform and roof is greater than required maximum	Trips, Slips and Falls	Awareness induction	Med	Handrails to be installed	Low	Client advised	Outstanding	OH&S REGULATIONS 3.7  AS/NZS 1657-2013 4.4

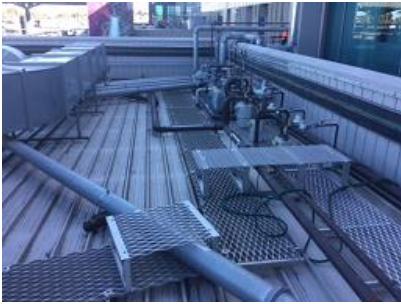
Variation in height between platform and roof is greater than required maximum	Trips, Slips and Falls	Awareness induction	Med	Handrails to be installed	Low	Client advised	Outstanding	OH&S REGULATIONS 3.7  AS/NZS 1657-2013 4.4
45 0	Building: General Stores Location Reference: <a href="#">L127</a> Task: Access to the A/c units

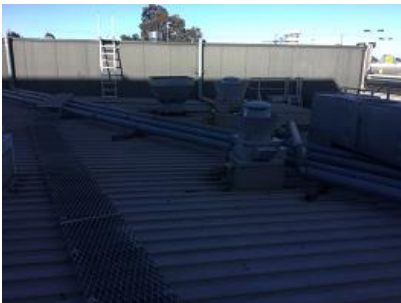
No safe access to the A/c units	Trips, Slips and Falls	N/A	Low	Supply walkway to the A/c units	Low	Client advised	Outstanding	-

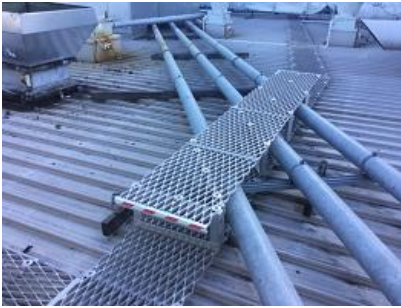
Variation in height between platform and roof is greater than required maximum	Trips, Slips and Falls	Awareness induction	Med	Handrails to be installed	Low	Client advised	Outstanding	OH&S REGULATIONS 3.7  AS/NZS 1657-2013 4.4
452	Building: General Stores Location Reference: <a href="#">L127</a> Task: Access to the roof

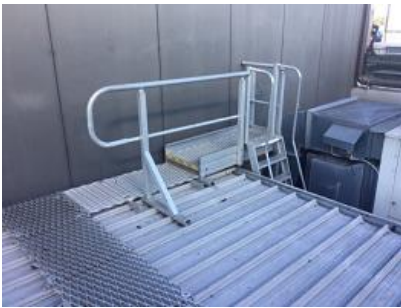
Top tread not levelled with landing and handrails projecting towards the user and clearance behind the ladder is less than required minimum	Trips, Slips and Falls	Awareness induction	Med	Existing ladder to be removed and new ladder to be installed	Low	Client advised	Outstanding	OH&S REGULATIONS 3.7  AS/NZS 1657-2013 7.4.3.3, 7.4.8.5 & 7.3.5

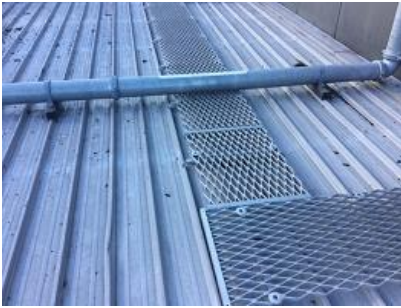
Pipe installed over the walkway path	Trips, Slips and Falls	Awareness induction	Med	Step over to be installed	Low	Client advised	Outsta nding	OH&S REGULATIONS 3.7
45 4	Building: General Stores Location Reference: <a href="#">L127</a> Task: Access to the roof

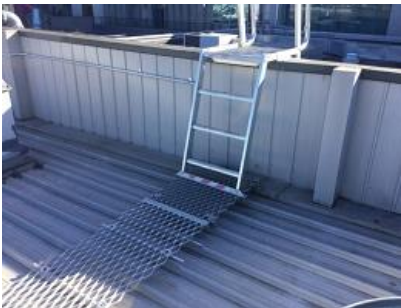
Bottom rung height is less than required minimum and handrails projecting towards the user	Trips, Slips and Falls	Awareness induction	Med	Existing handrails to be removed and new handrails and landing platforms to be installed	Low	Client advised	Outsta nding	OH&S REGULATIONS 3.7  AS/NZS 1657-2013 7.4.3.4 & 7.4.8.5

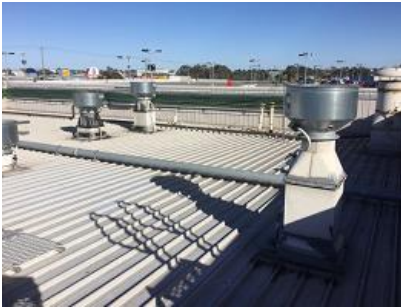
No safe access to the A/c units	Trips, Slips and Falls	N/A	Low	Supply walkway and step over to the A/c units	Low	Client advised	Outsta nding	-
45 6	Building: General Stores Location Reference: <a href="#">L127</a> Task: Access to the roof

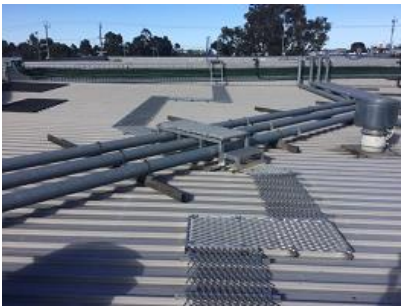
Variation in height between platform and roof is greater than required maximum	Trips, Slips and Falls	Awareness induction	Med	Handrails to be installed	Low	Client advised	Outsta nding	OH&S REGULATIONS 3.7  AS/NZS 1657-2013 4.4

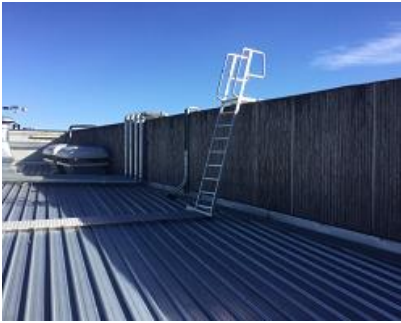
Bottom rung height is less than required minimum and handrails projecting towards the user	Trips, Slips and Falls	Awareness induction	Med	Existing handrails to be removed and new handrails and landing platforms to be installed	Low	Client advised	Outstanding	OH&S REGULATIONS 3.7  AS/NZS 1657-2013 7.4.3.4 & 7.4.8.5
45 8	Building: General Stores Location Reference: <a href="#">L128</a> Task: Access to the A/c units

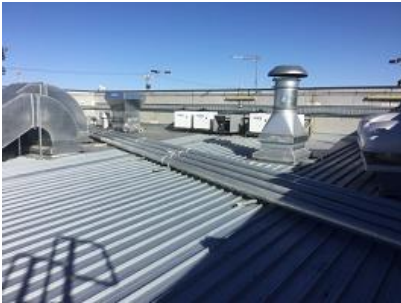
No safe access to the A/c units	Trips, Slips and Falls	N/A	Low	Supply walkway and step overs to be installed	Low	Client advised	Outstanding	-

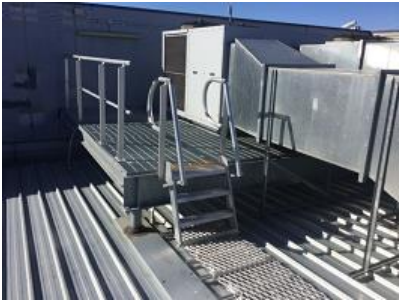
Handrails height is less than required minimum	Trips, Slips and Falls	Awareness induction	Med	Existing handrails to be removed and new handrails to be installed	Low	Client advised	Outstanding	OH&S REGULATIONS 3.7  AS/NZS 1657-2013 7.3.4
46 0	Building: General Stores Location Reference: <a href="#">L128</a> Task: Access to the plant deck

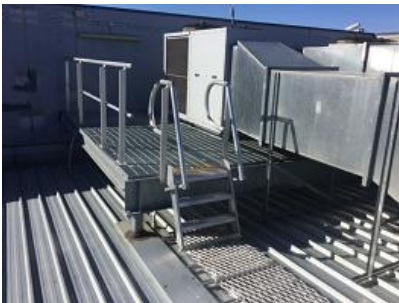
Handrails section is missing at access point	Trips, Slips and Falls	Awareness induction	Med	Handrails to be installed	Low	Client advised	Outstanding	OH&S REGULATIONS 3.7  AS/NZS 1657-2013 4.4

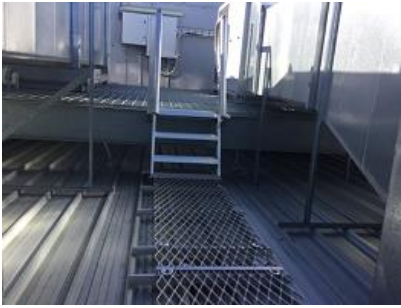
Bottom tread height is less than required minimum and handrail height is less than required minimum	Trips, Slips and Falls	Awareness induction	Med	Existing handrails to be removed and new handrails and landing platform to be installed	Low	Client advised	Outstanding	OH&S REGULATIONS 3.7  AS/NZS 1657-2013 7.3.3.2 & 7.3.4
462	Building: General Stores Location Reference: <a href="#">L128</a> Task: Access to the plant deck

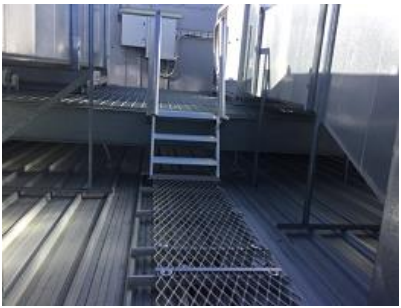
Handrails section is missing at access point	Trips, Slips and Falls	Awareness induction	Med	Handrails to be installed	Low	Client advised	Outstanding	OH&S REGULATIONS 3.7  AS/NZS 1657-2013 4.4

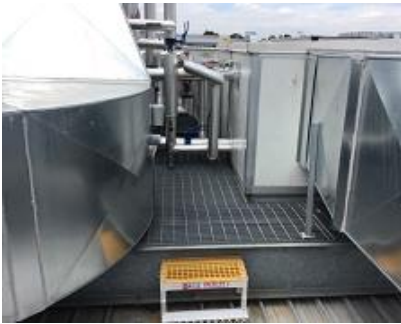
Step height is greater than required maximum and handrail is missing for platform entry point	Trips, Slips and Falls	Awareness induction	Med	Existing step to be removed and new step including handrail to be installed	Low	Client advised	Outstanding	OH&S REGULATIONS 3.7  AS/NZS 1657-2018 3.1.4 & 4.4
46 5	Building: General Stores Location Reference: <a href="#">L47</a> Task: Access to the roof

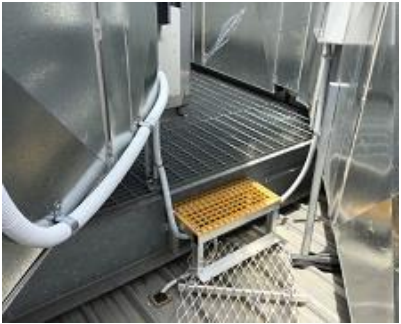
Step height is greater than required maximum and handrail is missing for platform entry point	Trips, Slips and Falls	Awareness induction	Med	Existing step to be removed and new step including handrail to be installed	Low	Client advised	Outstanding	OH&S REGULATIONS 3.7  AS/NZS 1657-2018 3.1.4 & 4.4

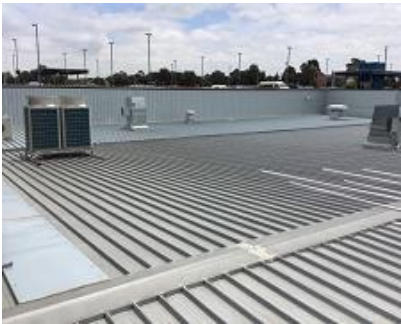
No safe access to the A/c units	Trips, Slips and Falls	N/A	Low	Supply walkway to the A/c units	Low	Client advised	Outstanding	-
46 7	Building: General Stores Location Reference: <a href="#">L18</a> Task: Access to the roof

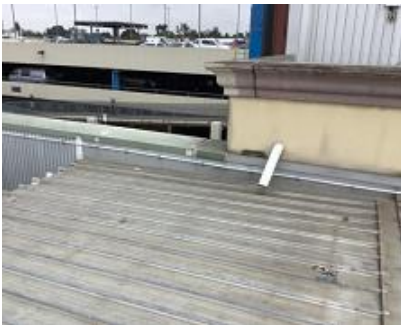
No height safety system installed to cover the fall edge	Trips, Slips and Falls	Awareness induction	High	Anchor point to be installed	Low	Client advised	Outstanding	OH&S REGULATIONS 3.55

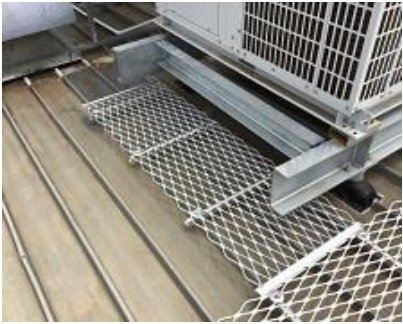
Walkway width is less than required minimum	Trips, Slips and Falls	Awareness induction	Med	Additional walkway section to be installed	Low	Client advised	Outstanding	OH&S REGULATIONS 3.7  AS/NZS 1657-2018 5.1.3
46 9	Building: General Stores Location Reference: <a href="#">L32</a> Task: Access to the roof

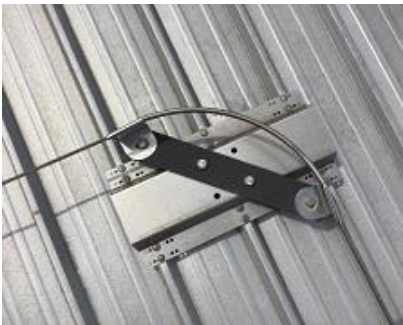
Static installed in-correctly	Trips, Slips and Falls	Awareness induction	High	Existing static line to be replaced	Low	Client advised	Outstanding	OH&S REGULATIONS 3.55

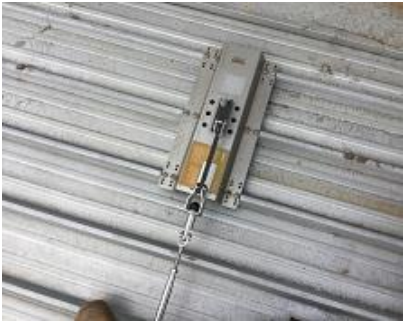
Static installed in-correctly	Trips, Slips and Falls	Awareness induction	High	Existing static line to be replaced	Low	Client advised	Outstanding	OH&S REGULATIONS 3.55
471	Building: General Stores Location Reference: <a href="#">L47</a> Task: Access to the roof

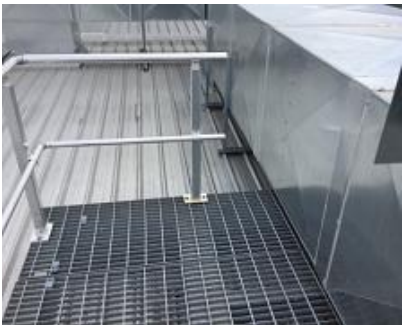
Gap between existing handrail and duct is greater than required maximum	Trips, Slips and Falls	Awareness induction	Med	Handrail to be extended	Low	Client advised	Outstanding	OH&S REGULATIONS 3.7 AS/NZS 1657-2013 4.4

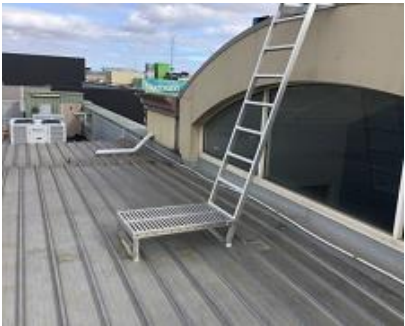
No safe access to the ladder	Trips, Slips and Falls	Awareness induction	Low	Supply walkway to the ladder	Low	Client advised	Outsta nding	-
47 3	Building: General Stores Location Reference: <a href="#">L19</a> Task: Access to the A/c units

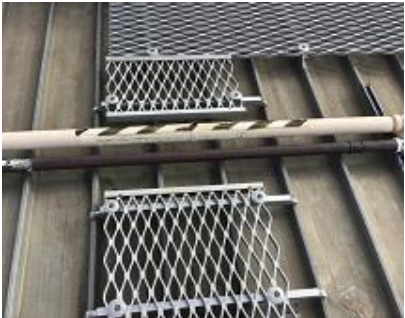
Pipe installed between walkway panel	Trips, Slips and Falls	Awareness induction	Med	Step over to be installed	Low	Client advised	Outsta nding	OH&S REGULATIONS 3.7  AS/NZS 1657- 2018 3.1.4

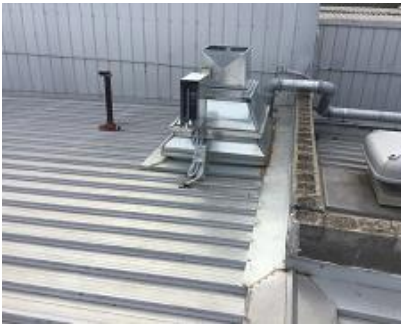
No safe access to the units	Trips, Slips and Falls	Awareness induction	Low	Supply walkway to the units	Low	Client advised	Outstanding	-
47 5	Building: General Stores Location Reference: <a href="#">L47</a> Task: Access to the A/c units

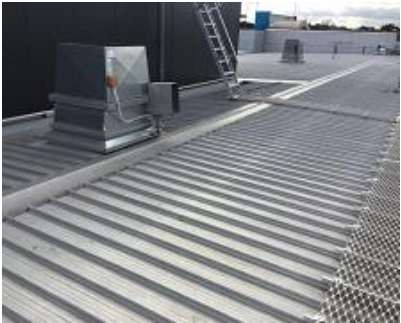
No safe access to the units	Trips, Slips and Falls	Awareness induction	Low	Supply walkway to the units	Low	Client advised	Outstanding	-

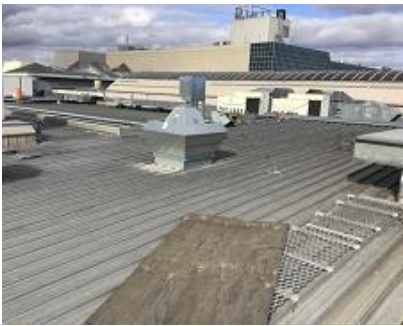
No safe access to the units	Trips, Slips and Falls	Awareness induction	Low	Supply walkway to the units	Low	Client advised	Outstanding	-
47 7	Building: General Stores Location Reference: <a href="#">L59</a> Task: Access to the A/c units

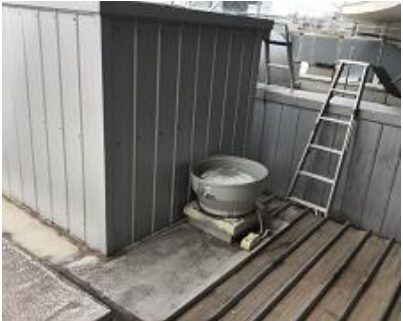
No safe access to the units	Trips, Slips and Falls	Awareness induction	Low	Supply walkway to the units	Low	Client advised	Outstanding	-

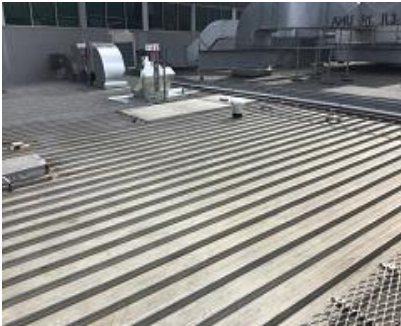
No	Photo of Hazard	Details of Hazard	Details of Risk	Existing/ Immediate Control Measure	Current Risk Level	Proposed Permanent Solution	Residual Risk Assessment	Details of Action Taken	Status	Reference
478	Building: General Stores Location Reference: <a href="#">L60</a> Task: Access to the A/c units

No safe access to the units	Trips, Slips and Falls	Awareness induction	Low	Supply walkway to the units	Low	Client advised	Outstanding	-
479	Building: General Stores Location Reference: <a href="#">L60</a> Task: Access to the roof

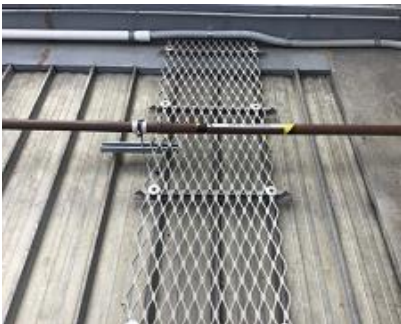
Pipe installed between walkway panel	Trips, Slips and Falls	Awareness induction	Med	Step over to be installed	Low	Client advised	Outstanding	OH&S REGULATIONS 3.7  AS/NZS 1657-2018 3.1.4

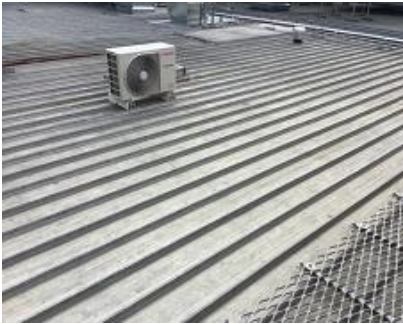
No	Photo of Hazard	Details of Hazard	Details of Risk	Existing/ Immediate Control Measure	Current Risk Level	Proposed Permanent Solution	Residual Risk Assessment	Details of Action Taken	Status	Reference
480	Building: General Stores Location Reference: <a href="#">L60</a> Task: Access to the A/c units

No safe access to the units	Trips, Slips and Falls	Awareness induction	Low	Supply walkway to the units	Low	Client advised	Outstanding	-
481	Building: General Stores Location Reference: <a href="#">L72</a> Task: Access to the roof

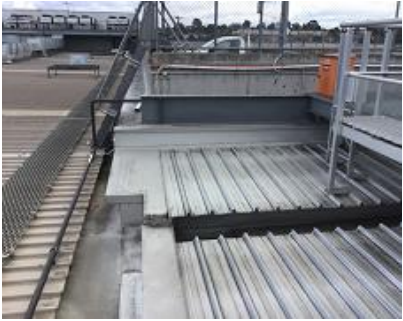
Variation in height between roofs are greater than required maximum	Trips, Slips and Falls	Awareness induction	Med	Access ladder and walkway to be installed	Low	Client advised	Outstanding	OH&S REGULATIONS 3.7  AS/NZS 1657-2018 3.1.4

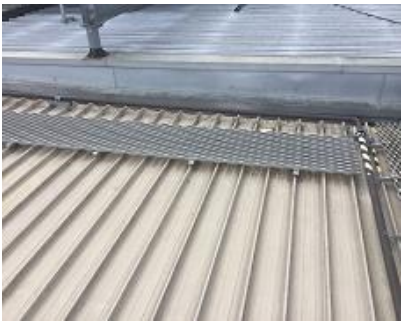
No	Photo of Hazard	Details of Hazard	Details of Risk	Existing/ Immediate Control Measure	Curren t Risk Level	Proposed Permanent Solution	Residu al Risk Assess ment	Details of Action Taken	Status	Reference
48 2	Building: General Stores Location Reference: <a href="#">L72</a> Task: Access to the roof

Pipe installed between walkway panel	Trips, Slips and Falls	Awareness induction	Med	Step over to be installed	Low	Client advised	Outstanding	OH&S REGULATIONS 3.7  AS/NZS 1657-2018 3.1.4
48 3	Building: General Stores Location Reference: <a href="#">L108</a> Task: Access to the roof

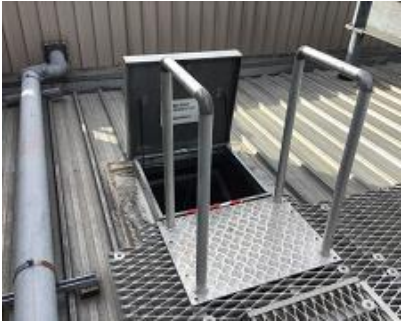
Non-complaint handrail is present	Trips, Slips and Falls	Awareness induction	Med	Existing handrail to be replaced	Low	Client advised	Outstanding	OH&S REGULATIONS 3.55  AS/NZS 1657-2018 4.4
