Roof Safety Report

**Queen Victoria Building,
NSW 2000**

Prepared By: Safemaster Safety Products
Date: 19 November 2018

Roof Safety Report for
Queen Victoria Building, NSW 2000

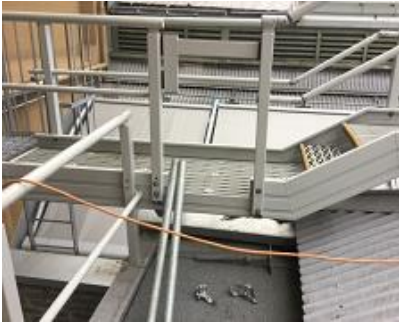
Variation in between roof and plant deck is greater than required maximum	Trips, Slips and Falls	Awareness induction	Med	Step to be installed	Low	Client advised	Outstanding	OH&S REGULATIONS 3.7 AS/NZS 1657-2013 3.1.4

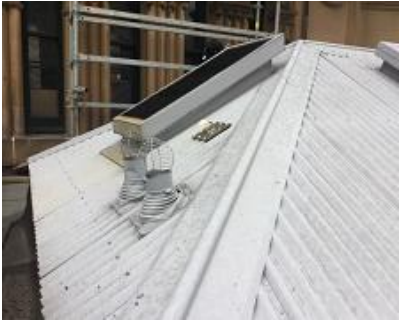
Non-complaint anchors are present as roof sheet is too small to support the anchors	Trips, Slips and Falls	Awareness induction	High	Existing anchors (x2) to be removed and an anchor to be installed	Low	Client advised	Outstanding	OH&S REGULATIONS 3.55

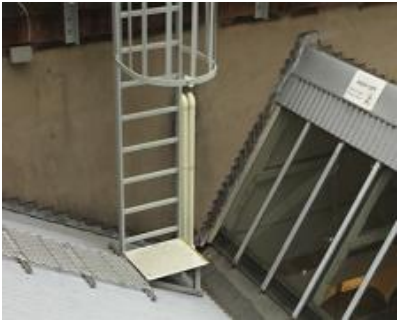
Bottom rung height is less than required minimum	Trips, Slips and Falls	Awareness induction	Med	Landing platform including handrail to be installed	Low	Client advised	Outstanding	OH&S REGULATIONS 3.7 AS/NZS 1657-2013 7.4.3.4

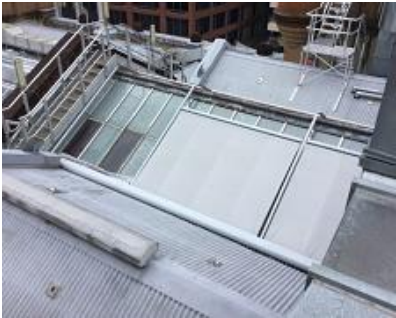
Brittle and Fragile roof section is present	Trips, Slips and Falls	Restrict Access	High	"Brittle and Fragile Roof" signs to be installed	Low	Client advised	Outstanding	OH&S REGULATIONS 3.57

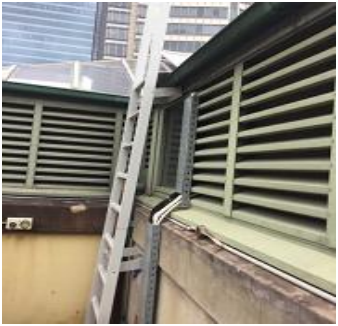
Non-complaint ladder is present	Trips, Slips and Falls	Awareness induction	Med	Existing ladder to be replaced	Low	Client advised	Outstanding	OH&S REGULATIONS 3.7 AS/NZS 1657-2013 7.4
58	Building: General Stores Location Reference: L36 Task: Restrict access to the roof

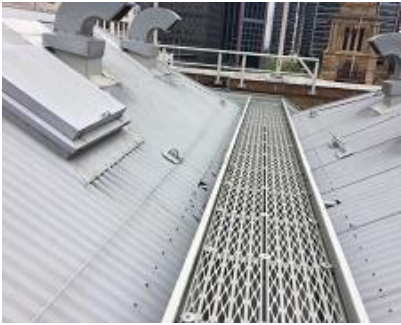
Static lines will be expired on May 2019	Trips, Slips and Falls	Awareness induction	High	Static lines to be replaced	Low	Client advised	Outstanding	OH&S REGULATIONS 3.55
60	Building: General Stores Location Reference: L39 Task: Access to the roof

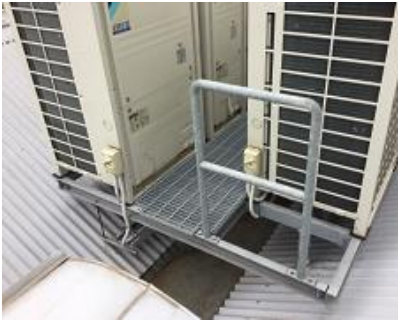
Non-complaint handrail section is present and cut out in plant deck not properly closed off and variation in height between plant deck and roof is greater than required maximum	Trips, Slips and Falls	Awareness induction	Med	Existing handrail to be replaced and additional mesh to be installed	Low	Client advised	Outstanding	OH&S REGULATIONS 3.7 AS/NZS 1657-2013 4.4

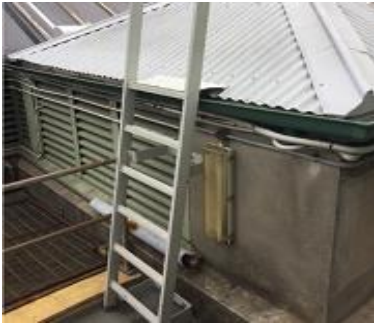
Non-complaint ladder is present	Trips, Slips and Falls	Awareness induction	Med	Existing ladder to be replaced	Low	Client advised	Outstanding	OH&S REGULATIONS 3.7 AS/NZS 1657-2013 7.4
