Roof Safety Report

Rockingham Centre, WA 6168

Prepared By: Safemaster Safety Products
Date: 10 Aug 2017

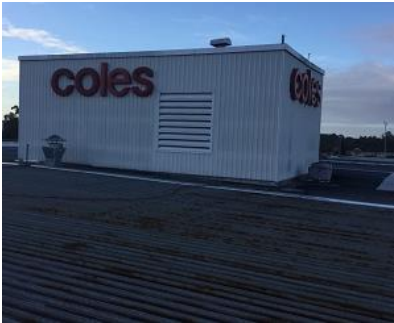
No height safety system installed	Trips, Slips and Falls	Awareness induction	High	Fall arrest anchors, anchor stop and access ladder to be installed	Low	Client advised	Outstanding	OH&S REGULATIONS 3.7 & 3.55 AS/NZS 1657-2013 3.1.4

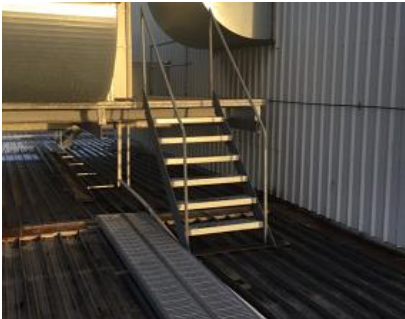
Non-compliant stair is present	Trips, Slips and Falls	Awareness induction	Med	Existing stair to be removed and new ladder including additional walkway section to be installed	Low	Client advised	Outstanding	OH&S REGULATIONS 3.7 AS/NZS 1657-2013 7.2

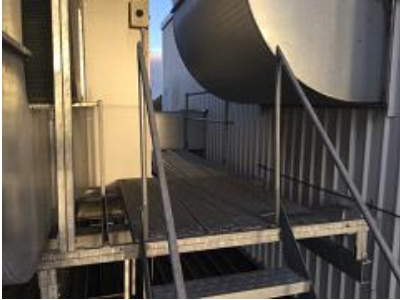
Missing mesh sections, gap between the mesh and structure is greater than required maximum and headroom is less than required minimum	Trips, Slips and Falls	Awareness induction	High	Walkway mesh to be installed to close the gap and "Low headroom" sign to be installed	Low	Client advised	Outstanding	OH&S REGULATIONS 3.7 AS/NZS 1657-2013 4.4 & 3.1.5
06	Building: General Stores Location Reference: L03 Task: Access to the roof

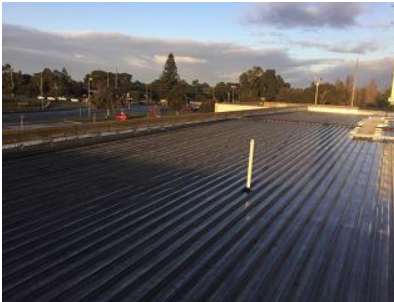
No height safety system installed	Trips, Slips and Falls	Awareness induction	High	Fall arrest anchors to be installed	Low	Client advised	Outstanding	OH&S REGULATIONS 3.55

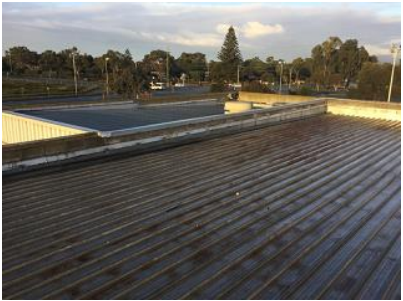
Variation in height between roofs are greater than required maximum	Trips, Slips and Falls	Awareness induction	Med	Access ladder to be installed	Low	Client advised	Outstanding	OH&S REGULATIONS 3.7 AS/NZS 1657-2013 3.1.4
10	Building: Coles Location Reference: L05 Task: Access to the A/c unit

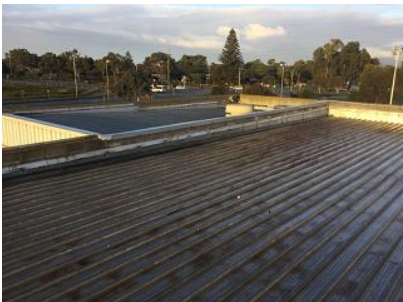
No safe access to the A/c unit	Trips, Slips and Falls	N/A	Low	Supply walkway to the A/c unit	Low	Client advised	Outstanding	-

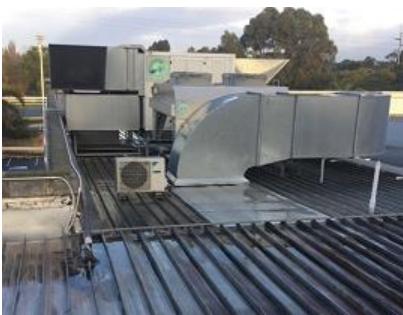
No safe access to the A/c unit	Trips, Slips and Falls	N/A	Low	Supply walkway to the A/c unit	Low	Client advised	Outstanding	-

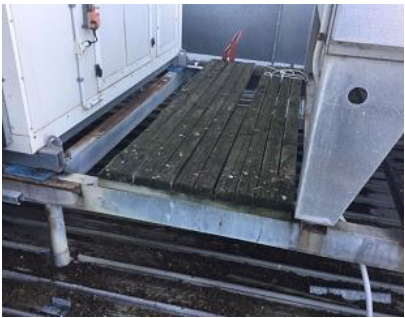
Variation in height between plant deck and roof is greater than required maximum and no safe access to switches	Trips, Slips and Falls	Awareness induction	Med	Access ladder, Walkway mesh and handrails to be installed	Low	Client advised	Outstanding	OH&S REGULATIONS 3.7 AS/NZS 1657-2013 3.1.4 & 4.4

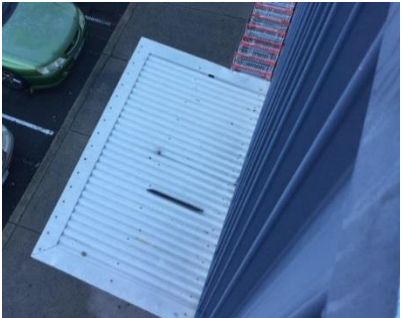
No height safety system installed (No serviceable items)	Trips, Slips and Falls	Restrict Access	High	"EWP Access Only" sign to be installed	Low	Client advised	Outstanding	OH&S REGULATIONS 3.55 & 3.11

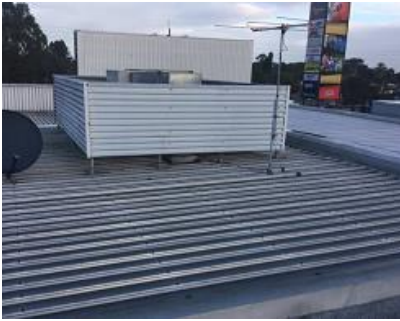
No safe access to the plant deck	Trips, Slips and Falls	Awareness induction	Med	Access ladder including handrails to be installed	Low	Client advised	Outstanding	OH&S REGULATIONS 3.7 AS/NZS 1657-2013 3.1.4

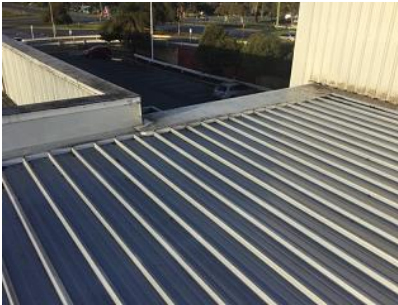
No height safety system installed	Trips, Slips and Falls	Awareness induction	High	Fall arrest anchor to be installed	Low	Client advised	Outstanding	OH&S REGULATIONS 3.55
20	Building: General Stores Location Reference: L12 Task: Restrict access to the roof

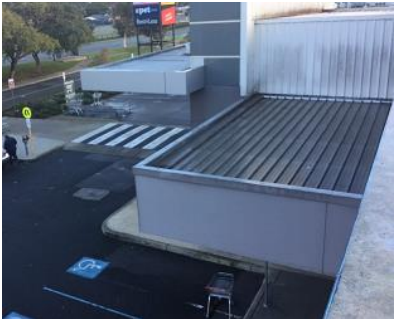
No height safety system installed (No serviceable items)	Trips, Slips and Falls	Restrict Access	High	"EWP Access Only" signs to be installed	Low	Client advised	Outstanding	OH&S REGULATIONS 3.55 & 3.11

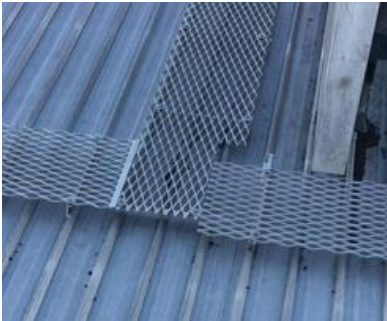
Roof walkway width is less than required minimum	Trips, Slips and Falls	Awareness induction	Med	Roof walkway section to be installed	Low	Client advised	Outstanding	OH&S REGULATIONS 3.7 AS/NZS 1657-2013 5.1.3

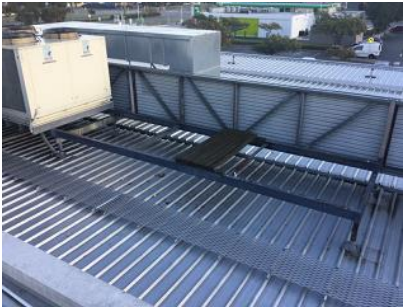
No safe access to the plant deck	Trips, Slips and Falls	Awareness induction	Med	Access ladder, Walkway mesh and handrails to be installed	Low	Client advised	Outstanding	OH&S REGULATIONS 3.7 AS/NZS 1657-2013 3.1.4 & 4.4

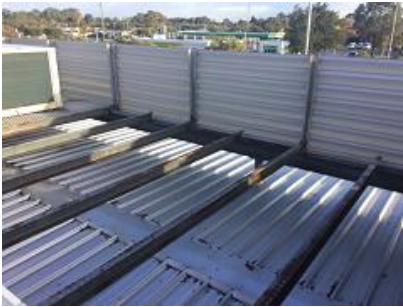
No safe access to the plant deck	Trips, Slips and Falls	Awareness induction	Med	Walkway mesh and handrails to be installed	Low	Client advised	Outstanding	OH&S REGULATIONS 3.7 AS/NZS 1657-2013 3.1.4 & 4.4

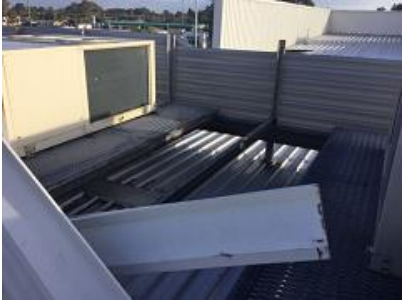
No safe access to the plant deck	Trips, Slips and Falls	Awareness induction	Med	Walkway mesh and handrails to be installed	Low	Client advised	Outstanding	OH&S REGULATIONS 3.7 AS/NZS 1657-2013 3.1.4 & 4.4
28	Building: General Stores Location Reference: L15 Task: Access to the plant deck

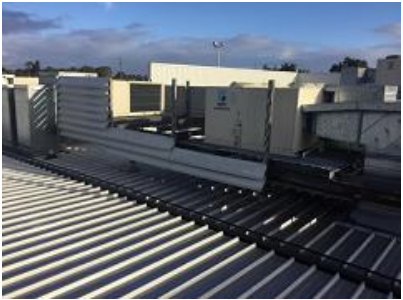
No safe access to the plant deck	Trips, Slips and Falls	Awareness induction	Med	Walkway mesh and handrails to be installed	Low	Client advised	Outstanding	OH&S REGULATIONS 3.7 AS/NZS 1657-2013 3.1.4 & 4.4

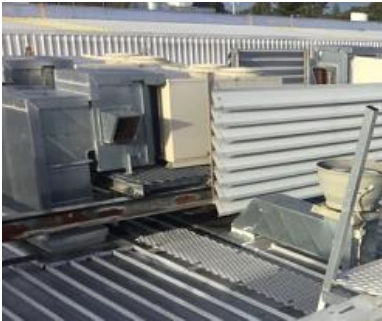
Variation in height between plant deck and roof is greater than required maximum	Trips, Slips and Falls	Awareness induction	Med	Access ladder including handrails to be installed	Low	Client advised	Outstanding	OH&S REGULATIONS 3.7 AS/NZS 1657-2013 3.1.4 & 4.4
30	Building: General Stores Location Reference: L17 Task: Access to the roof

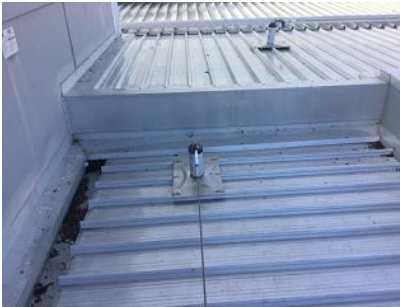
Variation in height between roofs are greater than required maximum	Trips, Slips and Falls	Awareness induction	Med	Single step to be installed	Low	Client advised	Outstanding	OH&S REGULATIONS 3.7 AS/NZS 1657-2013 3.1.4

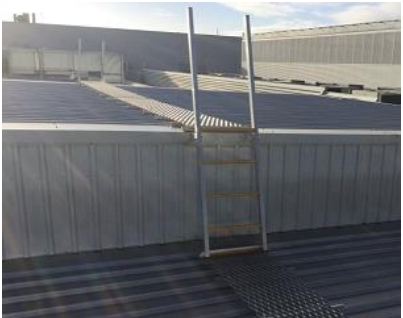
Bottom rung height is less than required minimum	Trips, Slips and Falls	Awareness induction	Med	Landing platform to be installed	Low	Client advised	Outstanding	OH&S REGULATIONS 3.7 AS/NZS 1657-2013 7.4.3.4

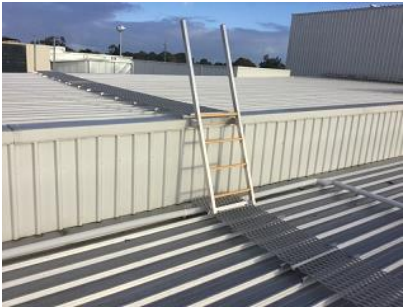
Gap between ladder and permanent structure is less than required minimum and Bottom rung height is less than required minimum	Trips, Slips and Falls	Awareness induction	Med	Existing ladder to be re-installed with landing platforms and brackets	Low	Client advised	Outstanding	OH&S REGULATIONS 3.7 AS/NZS 1657-2013 7.3.6 & 7.4.3.4

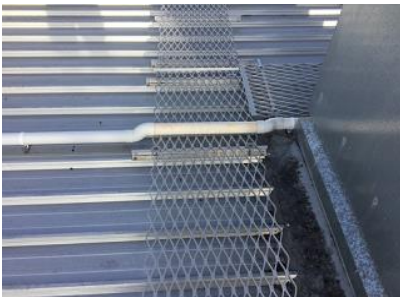
Pipe installed over the walkway path	Trips, Slips and Falls	Awareness induction	Med	Step over to be installed	Low	Client advised	Outstanding	OH&S REGULATIONS 3.7

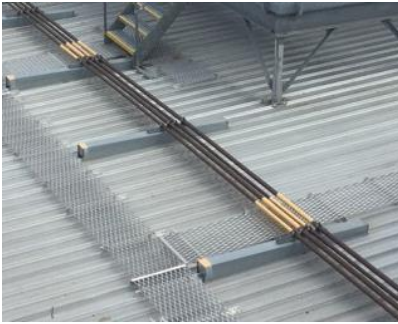
Pipes installed over the walkway path	Trips, Slips and Falls	Awareness induction	Med	Step overs to be installed	Low	Client advised	Outstanding	OH&S REGULATIONS 3.7

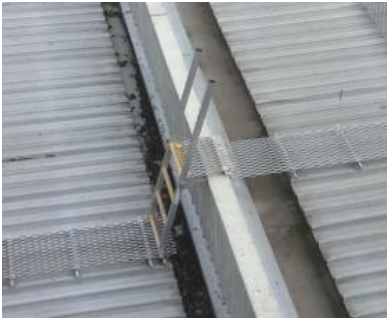
Landing is less than required minimum and bottom rung height is less than required minimum	Trips, Slips and Falls	Awareness induction	Med	Existing ladder to be re-installed with landing platforms	Low	Client advised	Outstanding	OH&S REGULATIONS 3.7 AS/NZS 1657-2013 7.3.6 & 7.4.3.4
40	Building: General Stores Location Reference: L26 Task: Access to the roof

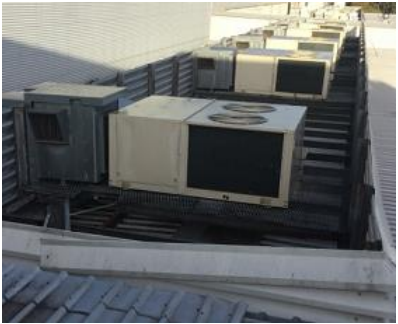
No safe access to the plant deck	Trips, Slips and Falls	Awareness induction	Med	Walkway mesh and handrails to be installed	Low	Client advised	Outstanding	OH&S REGULATIONS 3.7 AS/NZS 1657-2013 3.1.4 & 4.4

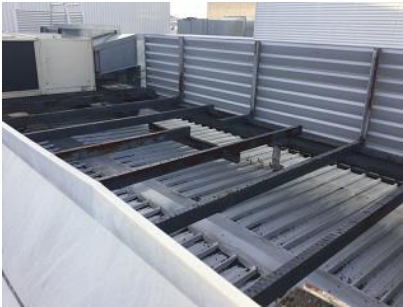
No	Photo of Hazard	Details of Hazard	Details of Risk	Existing/ Immediate Control Measure	Curre nt Risk Level	Proposed Permanent Solution	Resid ual Risk Asse ssme nt	Details of Action Taken	Status	Reference
43	Building: General Stores Location Reference: L28 Task: Access to the plant deck

No safe access to the plant deck	Trips, Slips and Falls	Awareness induction	Med	Walkway mesh and handrails to be installed	Low	Client advised	Outstanding	OH&S REGULATIONS 3.7 AS/NZS 1657-2013 3.1.4 & 4.4
44	Building: General Stores Location Reference: L28 Task: Access to the plant deck

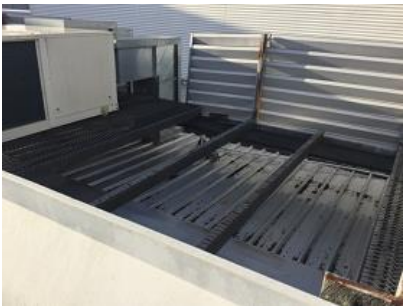
No safe access to the plant deck	Trips, Slips and Falls	Awareness induction	Med	Walkway mesh and handrails to be installed	Low	Client advised	Outstanding	OH&S REGULATIONS 3.7 AS/NZS 1657-2013 3.1.4 & 4.4

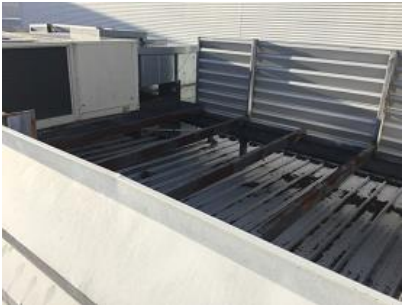
No	Photo of Hazard	Details of Hazard	Details of Risk	Existing/ Immediate Control Measure	Current Risk Level	Proposed Permanent Solution	Residual Risk Assessment	Details of Action Taken	Status	Reference
45	Building: General Stores Location Reference: L28 Task: Access to the plant deck

No safe access to the plant deck	Trips, Slips and Falls	Awareness induction	Med	Walkway mesh and handrails to be installed	Low	Client advised	Outstanding	OH&S REGULATIONS 3.7 AS/NZS 1657-2013 3.1.4 & 4.4
46	Building: General Stores Location Reference: L28 Task: Access to the plant deck

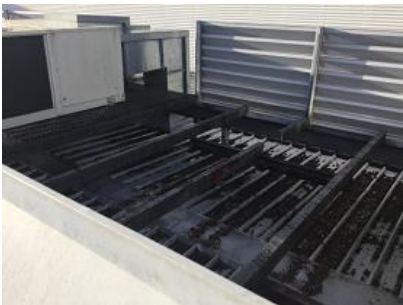
No safe access to the plant deck	Trips, Slips and Falls	Awareness induction	Med	Walkway mesh and handrails to be installed	Low	Client advised	Outstanding	OH&S REGULATIONS 3.7 AS/NZS 1657-2013 3.1.4 & 4.4

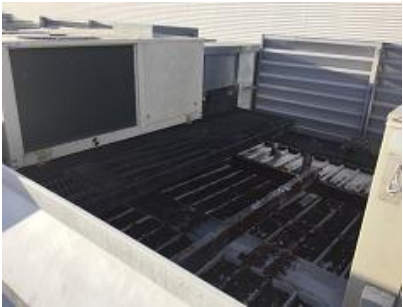
No	Photo of Hazard	Details of Hazard	Details of Risk	Existing/ Immediate Control Measure	Current Risk Level	Proposed Permanent Solution	Residual Risk Assessment	Details of Action Taken	Status	Reference
47	Building: General Stores Location Reference: L28 Task: Access to the plant deck

No safe access to the plant deck	Trips, Slips and Falls	Awareness induction	Med	Walkway mesh and handrails to be installed	Low	Client advised	Outstanding	OH&S REGULATIONS 3.7 AS/NZS 1657-2013 3.1.4 & 4.4
48	Building: General Stores Location Reference: L28 Task: Access to the plant deck

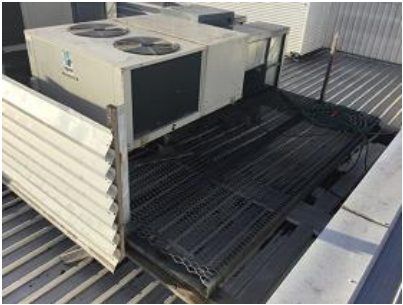
No safe access to the plant deck	Trips, Slips and Falls	Awareness induction	Med	Access ladder and handrails to be installed	Low	Client advised	Outstanding	OH&S REGULATIONS 3.7 AS/NZS 1657-2013 3.1.4 & 4.4

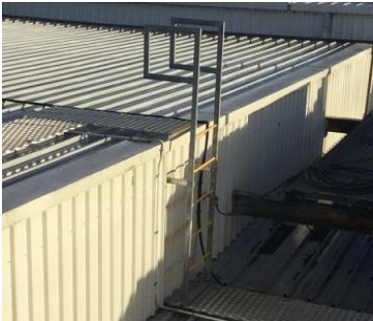
No	Photo of Hazard	Details of Hazard	Details of Risk	Existing/ Immediate Control Measure	Current Risk Level	Proposed Permanent Solution	Residual Risk Assessment	Details of Action Taken	Status	Reference
49	Building: General Stores Location Reference: L29 Task: Access to the roof

Non-complaint ladder is present	Trips, Slips and Falls	Awareness induction	Med	Existing ladder to be removed and new ladder including handrails to be installed	Low	Client advised	Outstanding	OH&S REGULATIONS 3.7 AS/NZS 1657-2013 3.1.4
50	Building: General Stores Location Reference: L30 Task: Access to the roof

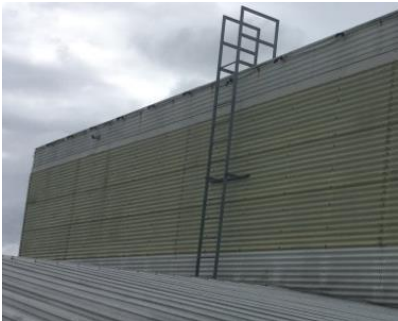
Non-complaint ladder is present	Trips, Slips and Falls	Awareness induction	Med	Existing ladder to be removed and new ladder including handrails to be installed	Low	Client advised	Outstanding	OH&S REGULATIONS 3.7 AS/NZS 1657-2013 3.1.4

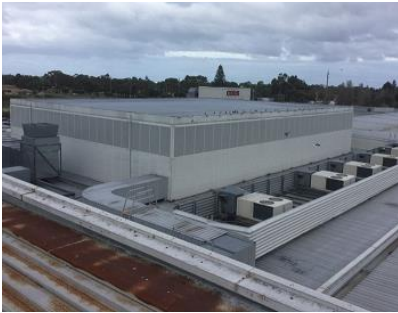
No height safety system installed	Trips, Slips and Falls	Awareness induction	High	Fall arrest anchors and anchor strop to be installed	Low	Client advised	Outstanding	OH&S REGULATIONS 3.55

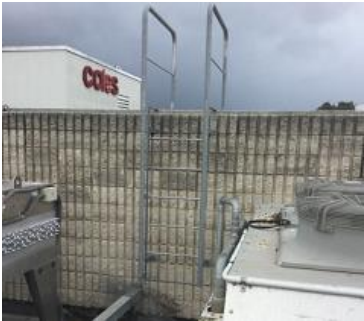
No	Photo of Hazard	Details of Hazard	Details of Risk	Existing/ Immediate Control Measure	Current Risk Level	Proposed Permanent Solution	Residual Risk Assessment	Details of Action Taken	Status	Reference
55	Building: General Stores Location Reference: L33 Task: Access to the roof

Non-compliant ladder is present	Trips, Slips and Falls	Awareness induction	Med	Existing ladder to be removed	Low	Client advised	Outstanding	OH&S REGULATIONS 3.7
56	Building: General Stores Location Reference: L33 Task: Access to the roof

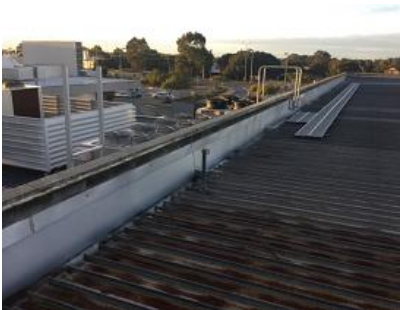
No safe access to the ladder	Trips, Slips and Falls	N/A	Low	Supply walkway to the ladder	Low	Client advised	Outstanding	-

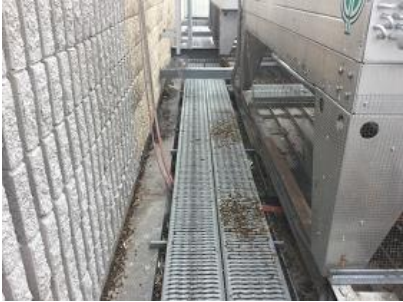
No	Photo of Hazard	Details of Hazard	Details of Risk	Existing/ Immediate Control Measure	Curre nt Risk Level	Proposed Permanent Solution	Resid ual Risk Asse ssme nt	Details of Action Taken	Status	Reference
57	Building: General Stores Location Reference: L33 Task: Access to the plant deck

Beams installed over the walkway path	Trips, Slips and Falls	Awareness induction	Med	Step bridges to be installed	Low	Client advised	Outstanding	OH&S REGULATIONS 3.7 AS/NZS 1657-2013 3.1.4
58	Building: General Stores Location Reference: L33 Task: Access to the plant deck

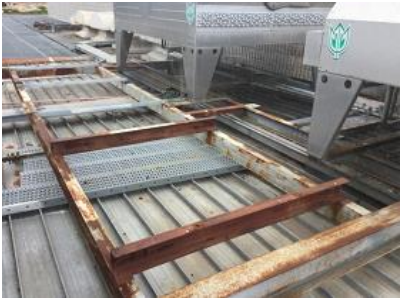
No safe access to the plant deck	Trips, Slips and Falls	Awareness induction	Med	Access steps, walkway mesh and handrails to be installed	Low	Client advised	Outstanding	OH&S REGULATIONS 3.7 AS/NZS 1657-2013 3.1.4

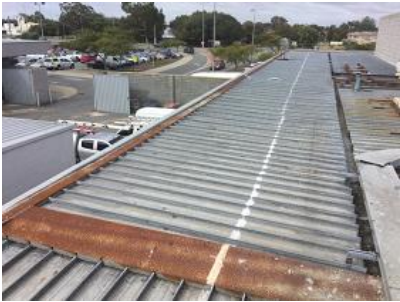
No	Photo of Hazard	Details of Hazard	Details of Risk	Existing/ Immediate Control Measure	Curre nt Risk Level	Proposed Permanent Solution	Resid ual Risk Asse ssme nt	Details of Action Taken	Status	Reference
59	Building: General Stores Location Reference: L34 Task: Access to the roof

No height safety system installed	Trips, Slips and Falls	Awareness induction	High	Fall arrest anchors to be installed	Low	Client advised	Outstanding	OH&S REGULATIONS 3.55
60	Building: General Stores Location Reference: L35 Task: Access to the roof

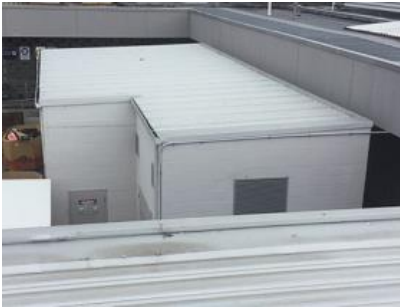
No height safety system installed	Trips, Slips and Falls	Awareness induction	High	Fall arrest anchors, anchor stop, ladder access bracket and signage to be installed	Low	Client advised	Outstanding	OH&S REGULATIONS 3.55

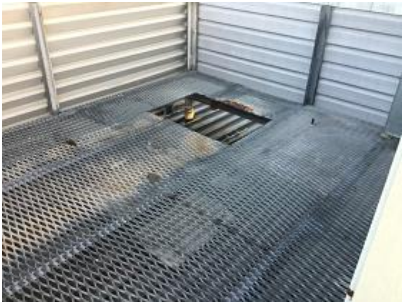
Hole in the plant deck mesh	Trips, Slips and Falls	Awareness induction	Med	Walkway mesh to be installed to cover the hole	Low	Client advised	Outstanding	OH&S REGULATIONS 3.7

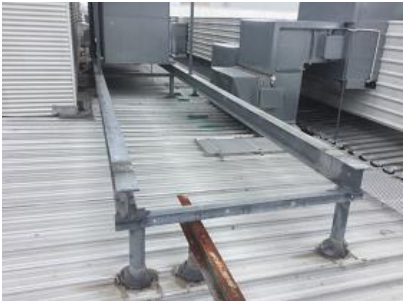
No	Photo of Hazard	Details of Hazard	Details of Risk	Existing/ Immediate Control Measure	Current Risk Level	Proposed Permanent Solution	Residual Risk Assessment	Details of Action Taken	Status	Reference
63	Building: General Stores Location Reference: L37 Task: Access to the plant deck

No safe access to plant deck	Trips, Slips and Falls	Awareness induction	Med	Access ladders, walkway mesh and handrails to be installed	Low	Client advised	Outstanding	OH&S REGULATIONS 3.7 AS/NZS 1657-2013 3.1.4
64	Building: General Stores Location Reference: L37 Task: Access to the plant deck

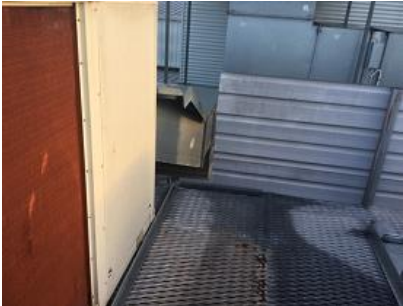
Handrails is missing to cover the fall edge	Trips, Slips and Falls	Awareness induction	Med	Handrails to be installed	Low	Client advised	Outstanding	OH&S REGULATIONS 3.7 AS/NZS 1657-2013 4.4

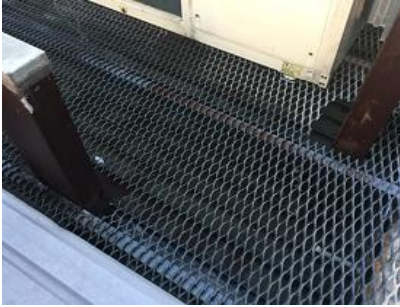
No	Photo of Hazard	Details of Hazard	Details of Risk	Existing/ Immediate Control Measure	Curre nt Risk Level	Proposed Permanent Solution	Resid ual Risk Asse ssme nt	Details of Action Taken	Status	Reference
67	Building: General Stores Location Reference: L37 Task: Access to the plant deck

Hole in the plant deck mesh	Trips, Slips and Falls	Awareness induction	Med	Walkway mesh to be installed to cover the holes	Low	Client advised	Outsta nding	OH&S REGULATIONS 3.7
68	Building: General Stores Location Reference: L37 Task: Access to the plant deck

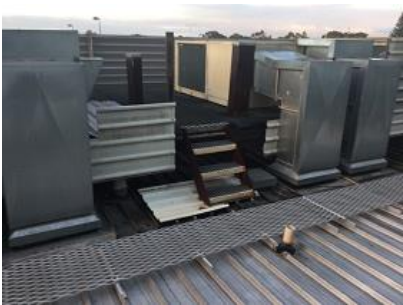
Non-complaint stair is present and handrail is missing	Trips, Slips and Falls	Awareness induction	Med	Existing stair to be removed and New ladder including handrails to be installed	Low	Client advised	Outstanding	OH&S REGULATIONS 3.7

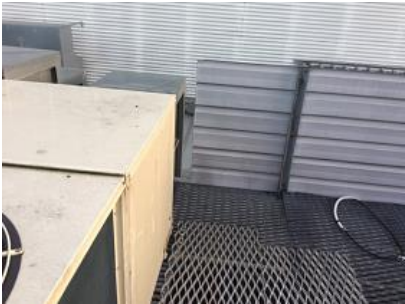
No	Photo of Hazard	Details of Hazard	Details of Risk	Existing/ Immediate Control Measure	Current Risk Level	Proposed Permanent Solution	Residual Risk Assessment	Details of Action Taken	Status	Reference
71	Building: General Stores Location Reference: L38 Task: Access to the plant deck

Gap between unit and structure is greater than required maximum	Trips, Slips and Falls	Awareness induction	Med	Handrail section to be installed	Low	Client advised	Outstanding	OH&S REGULATIONS 3.7 AS/NZS 1657-2013 4.4
72	Building: General Stores Location Reference: L38 Task: Access to the plant deck

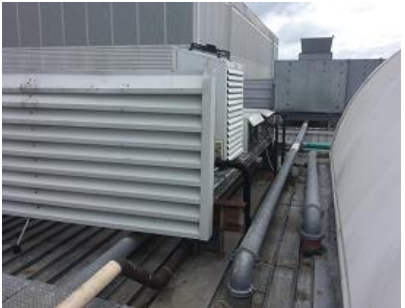
Variation in height between plant deck and roof is greater than required maximum	Trips, Slips and Falls	Awareness induction	Med	Handrail to be installed	Low	Client advised	Outstanding	OH&S REGULATIONS 3.7 AS/NZS 1657-2013 4.4

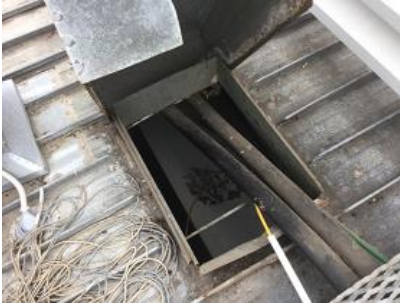
No	Photo of Hazard	Details of Hazard	Details of Risk	Existing/ Immediate Control Measure	Current Risk Level	Proposed Permanent Solution	Residual Risk Assessment	Details of Action Taken	Status	Reference
73	Building: General Stores Location Reference: L38 Task: Access to the roof

Existing hatch lid is weak and rusty	Trips, Slips and Falls	Awareness induction	Med	"Warning-Keep Off Brittle and Fragile lid" sign to be installed	Low	Client advised	Outstanding	OH&S REGULATIONS 3.57
74	Building: General Stores Location Reference: L38 Task: Access to the A/c units

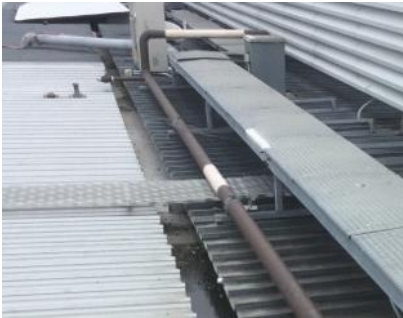
Variation in height between walkway panels are greater than required maximum and pipe installed over the walkway path	Trips, Slips and Falls	Awareness induction	Med	Step over to be installed	Low	Client advised	Outstanding	OH&S REGULATIONS 3.7 AS/NZS 1657-2013 3.3.4 & 3.1.4

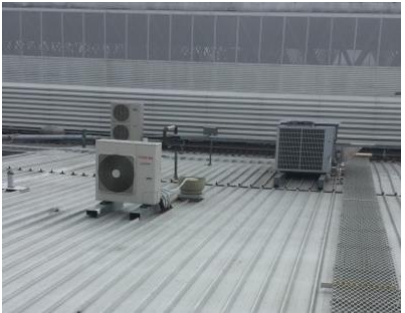
No safe access to the A/c units	Trips, Slips and Falls	N/A	Low	Supply walkway to the A/c units	Low	Client advised	Outstanding	-

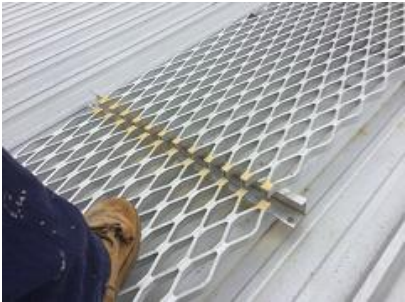
No	Photo of Hazard	Details of Hazard	Details of Risk	Existing/ Immediate Control Measure	Current Risk Level	Proposed Permanent Solution	Residual Risk Assessment	Details of Action Taken	Status	Reference
79	Building: General Stores Location Reference: L39 Task: Access to the A/c units

Roof walkway not fully secured to roof	Trips, Slips and Falls	Awareness induction	Med	Additional channels to be installed	Low	Client advised	Outstanding	OH&S REGULATIONS 3.7 AS/NZS 1657-2013 3.3.4
80	Building: General Stores Location Reference: L39 Task: Access to the A/c units

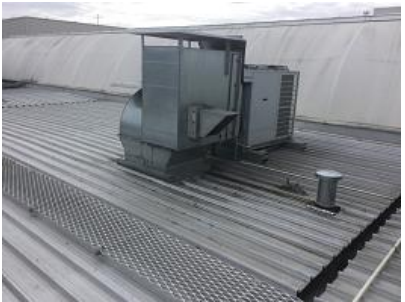
No safe access to the A/c units	Trips, Slips and Falls	N/A	Low	Supply walkway to the A/c units	Low	Client advised	Outstanding	-

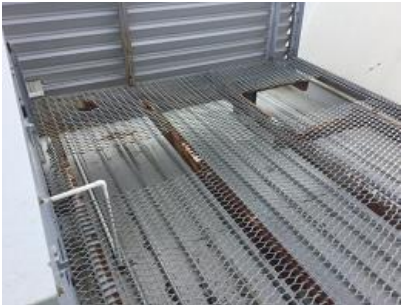
Holes in plant deck is present	Trips, Slips and Falls	Awareness induction	Med	Mesh/Checker plate to be installed to close the gap	Low	Client advised	Outstanding	OH&S REGULATIONS 3.7

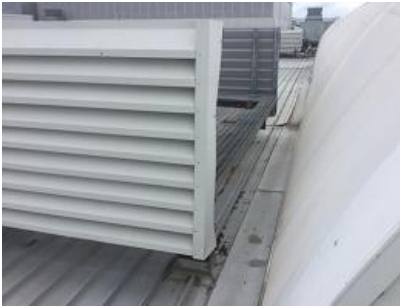
Variation in height between plant deck and roof is greater than required maximum	Trips, Slips and Falls	Awareness induction	Med	Handrails to be installed	Low	Client advised	Outstanding	OH&S REGULATIONS 3.7 AS/NZS 1657-2013 4.4
84	Building: General Stores Location Reference: L41 Task: Access to the roof

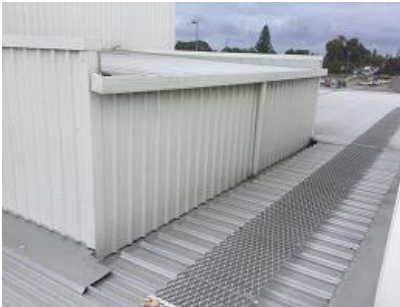
Variation in height between roofs are greater than required maximum	Trips, Slips and Falls	Awareness induction	Med	Access ladder including handrails to be installed	Low	Client advised	Outstanding	OH&S REGULATIONS 3.7 AS/NZS 1657-2013 3.1.4

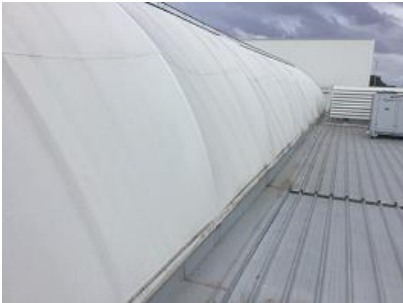
Brittle roof (Non-trafficable roof)	Trips, Slips and Falls	Restrict Access	High	"Warning-Keep Off-Brittle and Fragile Roof" signs to be installed	Low	Client advised	Outstanding	OH&S REGULATIONS 3.57

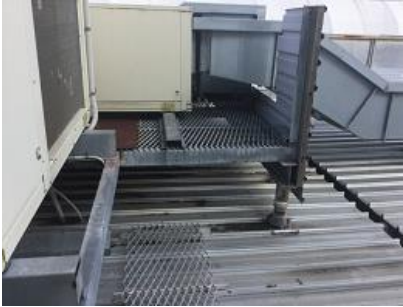
Variation in height between plant deck and roof is greater than required maximum	Trips, Slips and Falls	Awareness induction	Med	Access ladder including handrails to be installed	Low	Client advised	Outstanding	OH&S REGULATIONS 3.7 AS/NZS 1657-2013 3.1.4
88	Building: General Stores Location Reference: L45 Task: Access to the roof

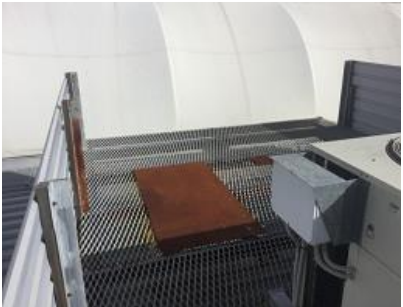
Variation in height between plant deck and roof is greater than required maximum	Trips, Slips and Falls	Awareness induction	Med	Handrails to be installed	Low	Client advised	Outstanding	OH&S REGULATIONS 3.7 AS/NZS 1657-2013 4.4

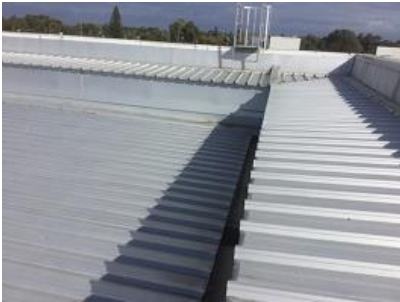
No height safety system installed	Trips, Slips and Falls	Awareness induction	High	Fall arrest anchors and anchor strop to be installed	Low	Client advised	Outstanding	OH&S REGULATIONS 3.55

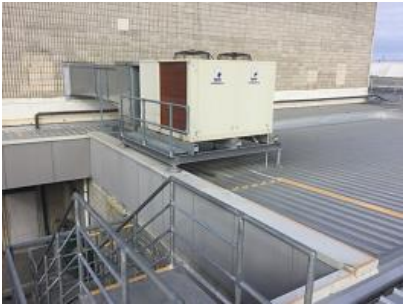
No safe access to the A/c unit	Trips, Slips and Falls	Awareness induction	Med	Walkway, step ups and handrails to be installed	Low	Client advised	Outstanding	OH&S REGULATIONS 3.7 AS/NZS 1657-2013 3.1.4

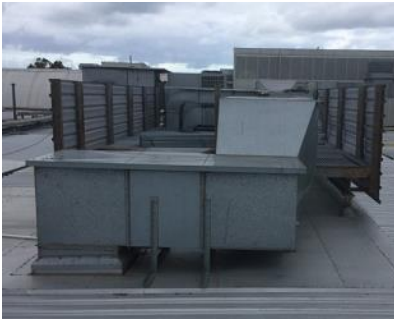
Variation in height between plant deck and roof is greater than required maximum	Trips, Slips and Falls	Awareness induction	Med	Handrails to be installed	Low	Client advised	Outstanding	OH&S REGULATIONS 3.7 AS/NZS 1657-2013 4.4

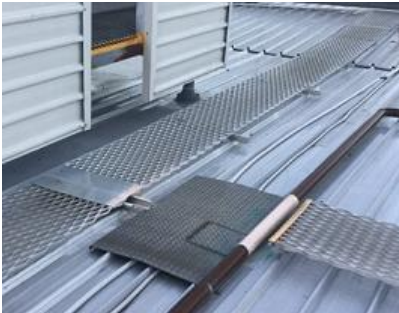
In-correct installation of roof walkway	Trips, Slips and Falls	Awareness induction	Med	Existing walkway to be re-installed with additional channels	Low	Client advised	Outstanding	OH&S REGULATIONS 3.7

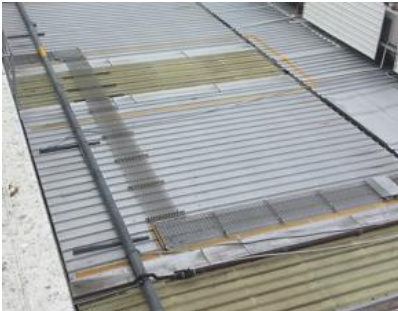
In-correct installation of roof walkway	Trips, Slips and Falls	Awareness induction	Med	Existing walkway to be re-installed with additional channels	Low	Client advised	Outstanding	OH&S REGULATIONS 3.7

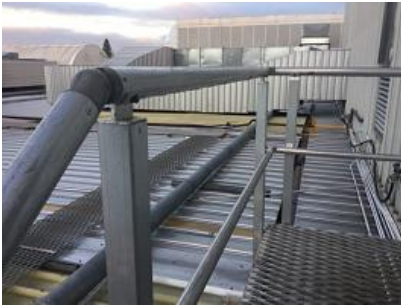
Sharp edges on handrails	Trips, Slips and Falls	Awareness induction	Med	Tek screws to be replaced with rivets	Low	Client advised	Outstanding	OH&S REGULATIONS 3.7 AS/NZS 1657-2013 5.6

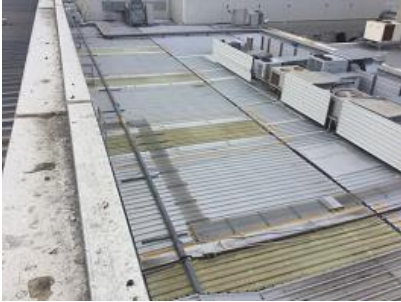
Brittle roof (Non-trafficable roof)	Trips, Slips and Falls	Restrict Access	High	"Warning-Keep Off-Brittle and Fragile Roof" signs to be installed	Low	Client advised	Outstanding	OH&S REGULATIONS 3.57
106	Building: General Stores Location Reference: L51 Task: Access to the roof

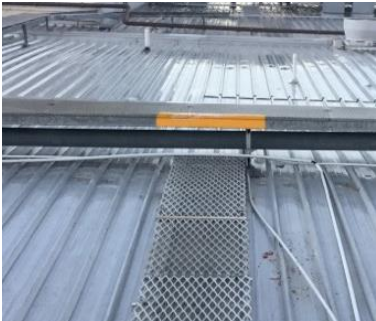
Variation in height between walkway panels are greater than required maximum	Trips, Slips and Falls	Awareness induction	Med	Single step to be installed	Low	Client advised	Outstanding	OH&S REGULATIONS 3.7 AS/NZS 1657-2013 3.1.4

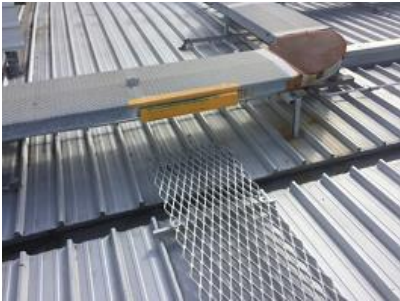
Variation in height between walkway panels are greater than required maximum	Trips, Slips and Falls	Awareness induction	Med	Single step to be installed	Low	Client advised	Outstanding	OH&S REGULATIONS 3.7 AS/NZS 1657-2013 3.1.4
108	Building: General Stores Location Reference: L52 Task: Access to the plant deck

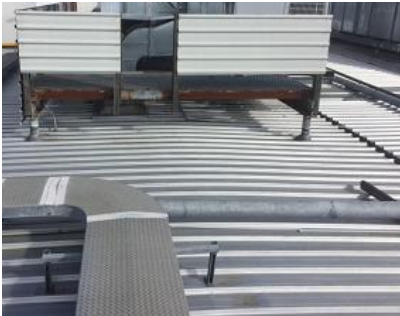
Variation in height between plant deck and roof is greater than required maximum	Trips, Slips and Falls	Awareness induction	Med	Access ladder including handrails, Walkway and step over to be installed	Low	Client advised	Outstanding	OH&S REGULATIONS 3.7 AS/NZS 1657-2013 3.1.4

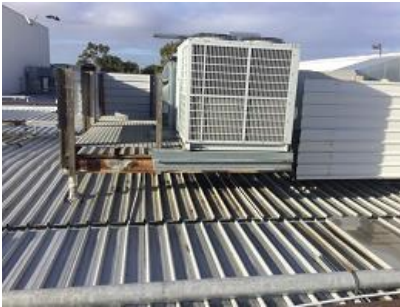
Variation in height between plant deck and roof is greater than required maximum	Trips, Slips and Falls	Awareness induction	Med	Handrails to be installed	Low	Client advised	Outstanding	OH&S REGULATIONS 3.7 AS/NZS 1657-2013 4.4
110	Building: General Stores Location Reference: L52 Task: Access to the plant deck

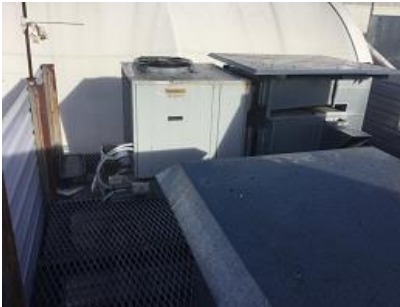
Variation in height between plant deck and roof is greater than required maximum	Trips, Slips and Falls	Awareness induction	Med	Handrails to be installed	Low	Client advised	Outstanding	OH&S REGULATIONS 3.7 AS/NZS 1657-2013 4.4

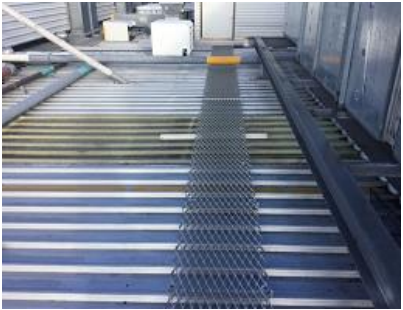
Pipe installed over the walkway path	Trips, Slips and Falls	Awareness induction	Med	Step over to be installed	Low	Client advised	Outstanding	OH&S REGULATIONS 3.7

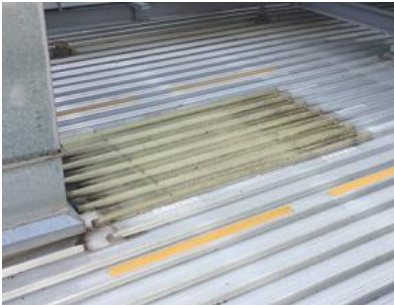
Brittle roof (Non-trafficable roof)	Trips, Slips and Falls	Restrict Access	High	"Warning-Keep Off-Brittle and Fragile roof" signs to be installed	Low	Client advised	Outstanding	OH&S REGULATIONS 3.57

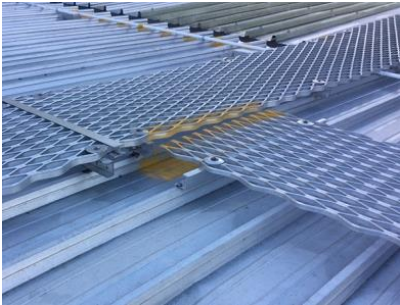
Variation in height between walkway panels are greater than required maximum and End channel not fully secured	Trips, Slips and Falls	Awareness induction	Med	End channel to be fully secured and high visibility safety yellow nosing to be installed	Low	Client advised	Outstanding	OH&S REGULATIONS 3.7 AS/NZS 1657-2013 3.3.4
116	Building: General Stores Location Reference: L55 Task: Access to the roof

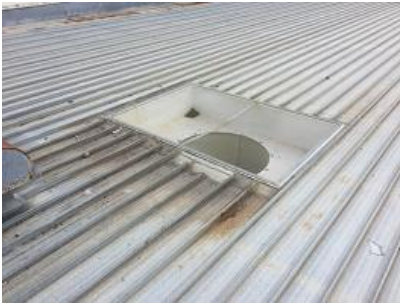
Un-Protected fall edge is present on roof	Trips, Slips and Falls	Awareness induction	High	Handrails to be installed	Low	Client advised	Outstanding	OH&S REGULATIONS 3.55 & 3.7

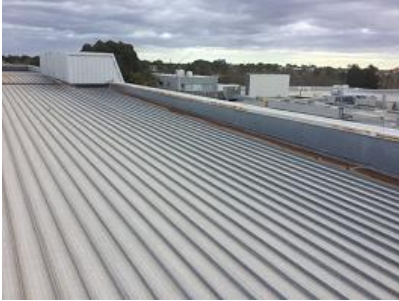
No height safety system installed	Trips, Slips and Falls	Awareness induction	High	Fall arrest anchors to be installed	Low	Client advised	Outstanding	OH&S REGULATIONS 3.55
118	Building: General Stores Location Reference: L55 Task: Access to the A/c units

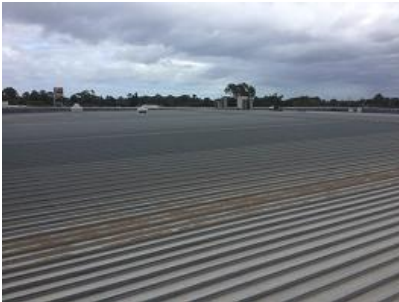
No safe access to the A/c units	Trips, Slips and Falls	N/A	Low	Supply walkway and handrail to the A/c units	Low	Client advised	Outstanding	-

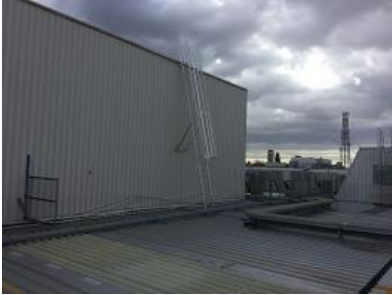
Landing platforms and return ladder is missing	Trips, Slips and Falls	Awareness induction	High	Landing platforms including handrails and return ladder to be installed	Low	Client advised	Outstanding	OH&S REGULATIONS 3.7 AS/NZS 1657-2013 7.3.6 & 3.1.4
120	Building: General Stores Location Reference: L56 Task: Access to the roof

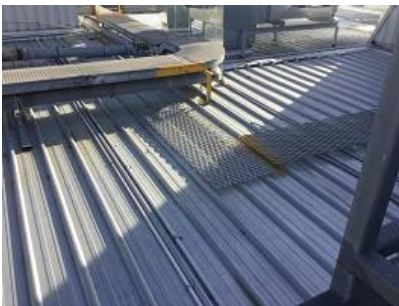
Variation in height between walkway panels are greater than required maximum	Trips, Slips and Falls	Awareness induction	Med	Single step to be installed	Low	Client advised	Outstanding	OH&S REGULATIONS 3.7 AS/NZS 1657-2013 3.1.4
122	Building: General Stores Location Reference: L56 Task: Access to the roof

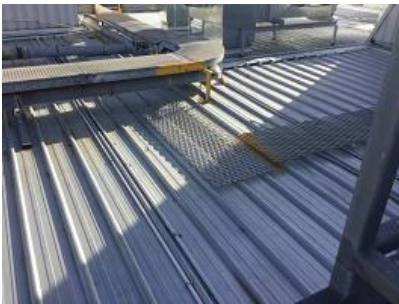
Roof walkway not secured to roof	Trips, Slips and Falls	Awareness induction	Med	Existing walkway fully secured to roof with new channels and fixings	Low	Client advised	Outstanding	OH&S REGULATIONS 3.7

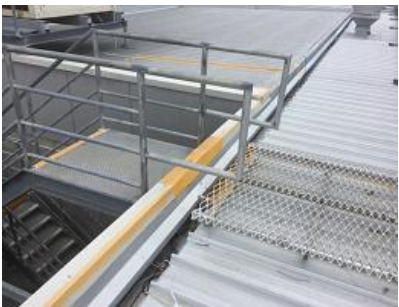
Variation in height between landing platform and roof is greater than required maximum	Trips, Slips and Falls	Awareness induction	Med	Access ladder including landing platforms, handrails and step to be installed	Low	Client advised	Outstanding	OH&S REGULATIONS 3.7 AS/NZS 1657-2013 3.1.4
124	Building: General Stores Location Reference: L57 Task: Access to the roof

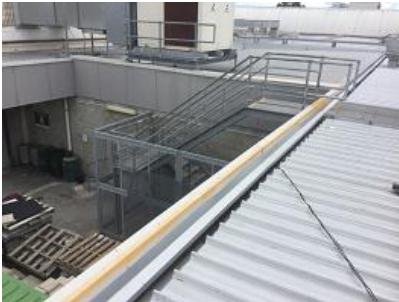
No height safety system installed	Trips, Slips and Falls	Awareness induction	High	Fall arrest anchors to be installed	Low	Client advised	Outstanding	OH&S REGULATIONS 3.55

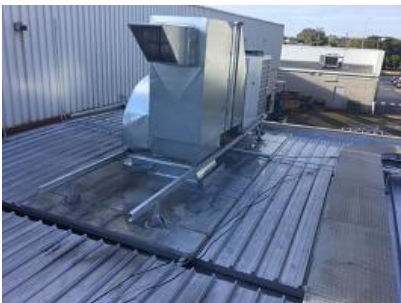
No safe access to the A/c unit	Trips, Slips and Falls	N/A	Low	Supply walkway, Single step and handrails to be installed	Low	Client advised	Outstanding	-
126	Building: General Stores Location Reference: L58 Task: Access to the roof

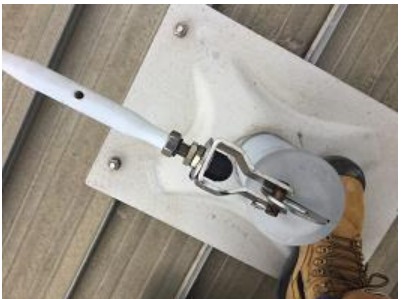
Static line components are rusty	Trips, Slips and Falls	Awareness induction	High	Existing static line to be removed and new static line to be installed	Low	Client advised	Outstanding	OH&S REGULATIONS 3.55

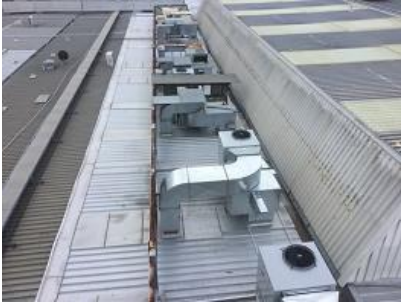
No safe access to the A/c units	Trips, Slips and Falls	N/A	Low	Supply walkway to the A/c units	Low	Client advised	Outstanding	-
128	Building: General Stores Location Reference: L60 Task: Access to the roof

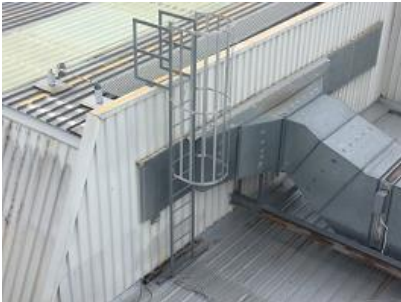
Clearance between ladder stiles and permanent structure is less than required minimum and Landing platforms are missing	Trips, Slips and Falls	Awareness induction	Med	Existing ladder to be removed and new ladder to be installed	Low	Client advised	Outstanding	OH&S REGULATIONS 3.7 AS/NZS 1657-2013 7.4.5 & 7.3.6

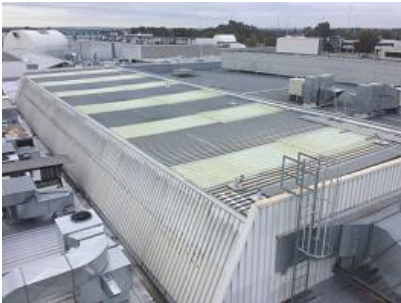
Brittle roof (Non-trafficable roof)	Trips, Slips and Falls	Restrict Access	High	"Warning-Keep off-Brittle and Fragile Roof" signs to be installed	Low	Client advised	Outstanding	OH&S REGULATIONS 3.57

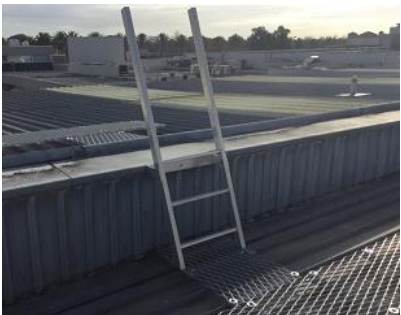
Bottom rung height is less than required minimum and landing is less than required minimum	Trips, Slips and Falls	Awareness induction	Med	Existing ladder to be re-installed with new landing platforms and brackets	Low	Client advised	Outstanding	OH&S REGULATIONS 3.7 AS/NZS 1657-2013 7.4.3.4 & 7.3.6

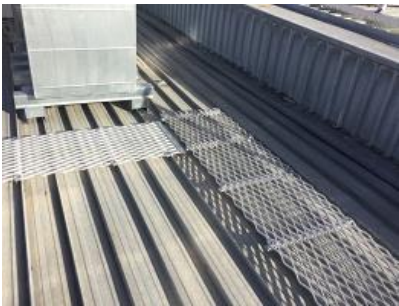
Variation in height between walkway panels are greater than required maximum	Trips, Slips and Falls	Awareness induction	Med	High visibility safety yellow nosing to be installed	Low	Client advised	Outstanding	OH&S REGULATIONS 3.7 AS/NZS 1657-2013 3.3.4
134	Building: General Stores Location Reference: L62 Task: Access to the A/c unit

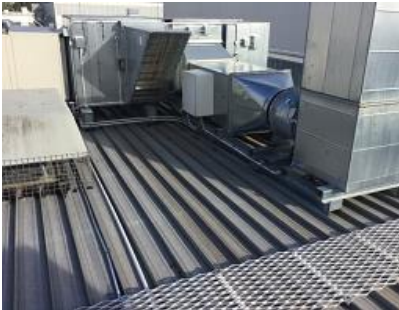
No safe access to the A/c unit	Trips, Slips and Falls	N/A	Low	Supply walkway to the A/c unit	Low	Client advised	Outstanding	-

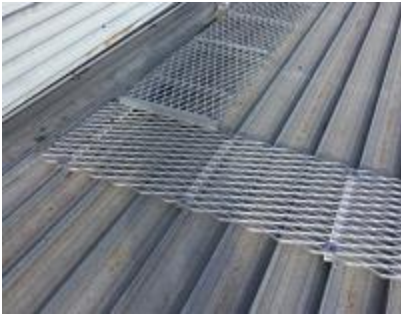
Variation in height between walkway panels are greater than required maximum	Trips, Slips and Falls	Awareness induction	Med	High visibility safety yellow nosing to be installed	Low	Client advised	Outstanding	OH&S REGULATIONS 3.7 AS/NZS 1657-2013 3.3.4

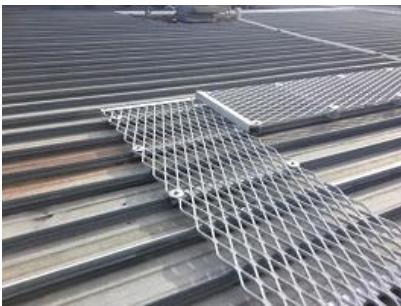
Variation in height between walkway panels are greater than required maximum	Trips, Slips and Falls	Awareness induction	Med	High visibility safety yellow nosing to be installed	Low	Client advised	Outstanding	OH&S REGULATIONS 3.7 AS/NZS 1657-2013 3.3.4
138	Building: General Stores Location Reference: L63 Task: Access to the roof

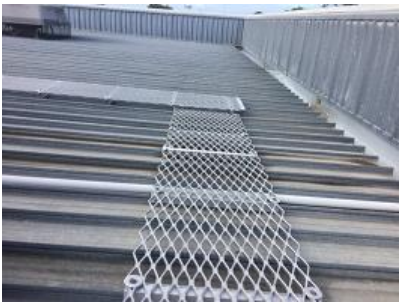
Variation in height between walkway panels are greater than required maximum	Trips, Slips and Falls	Awareness induction	Med	High visibility safety yellow nosing to be installed	Low	Client advised	Outstanding	OH&S REGULATIONS 3.7 AS/NZS 1657-2013 3.3.4

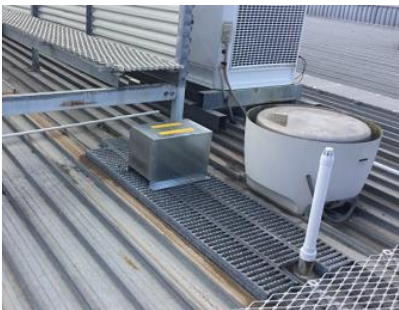
Variation in height between plant deck and roof is greater than required maximum	Trips, Slips and Falls	Awareness induction	Med	Access ladder including handrails to be installed	Low	Client advised	Outstanding	OH&S REGULATIONS 3.7 AS/NZS 1657-2013 3.1.4
140	Building: General Stores Location Reference: L63 Task: Access to the plant deck

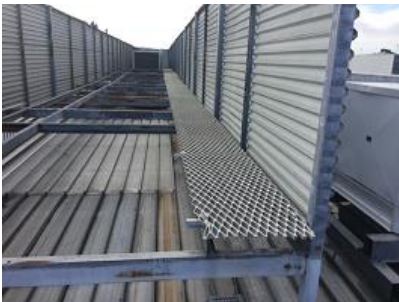
Variation in height between plant deck and roof is greater than required maximum	Trips, Slips and Falls	Awareness induction	Med	Handrails to be installed	Low	Client advised	Outstanding	OH&S REGULATIONS 3.7 AS/NZS 1657-2013 4.4

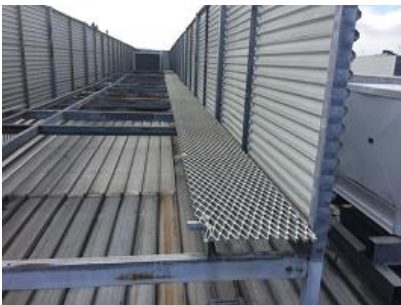
In-correct installation of walkway mesh	Trips, Slips and Falls	Awareness induction	Med	Additional channels to be installed for existing walkway	Low	Client advised	Outstanding	OH&S REGULATIONS 3.7
142	Building: General Stores Location Reference: L64 Task: Access to the plant deck

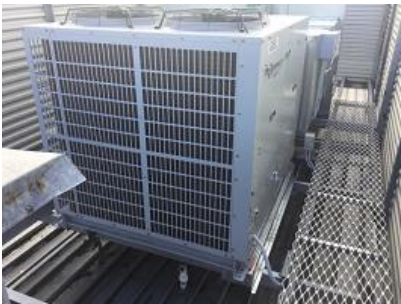
Variation in height between plant deck and roof is greater than required maximum	Trips, Slips and Falls	Awareness induction	Med	Additional walkway mesh and handrails to be installed	Low	Client advised	Outstanding	OH&S REGULATIONS 3.7 AS/NZS 1657-2013 4.4

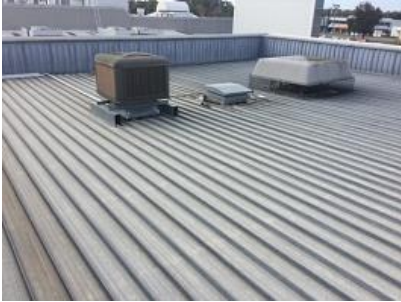
No safe access to the A/c units	Trips, Slips and Falls	N/A	Low	Supply walkway to the A/c units	Low	Client advised	Outstanding	-
144	Building: General Stores Location Reference: L65 Task: Access to the roof

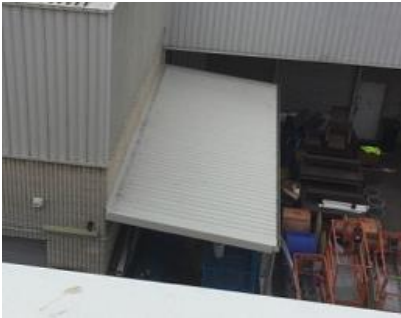
No height safety system installed	Trips, Slips and Falls	Awareness induction	High	Fall arrest anchors, anchor strop, ladder access bracket and signage to be installed	Low	Client advised	Outstanding	OH&S REGULATIONS 3.55

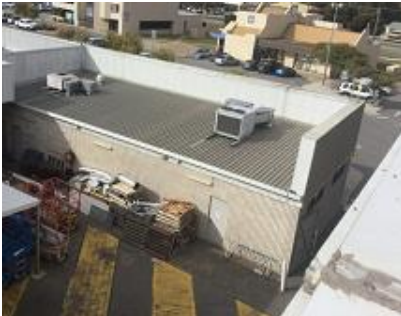
No safe access to the A/c units	Trips, Slips and Falls	N/A	Low	Supply walkway and handrails to the A/c units	Low	Client advised	Outstanding	-

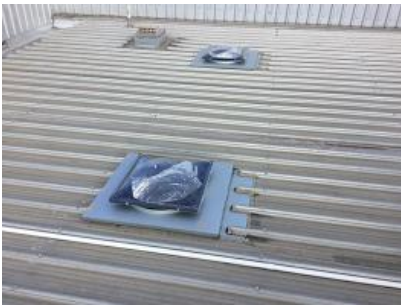
Brittle roof (Non-trafficable roof)	Trips, Slips and Falls	Restrict Access	High	"Warning-Keep Off-Brittle and Fragile Roof" signs to be installed	Low	Client advised	Outstanding	OH&S REGULATIONS 3.57
148	Building: General Stores Location Reference: L68 Task: Access to the roof

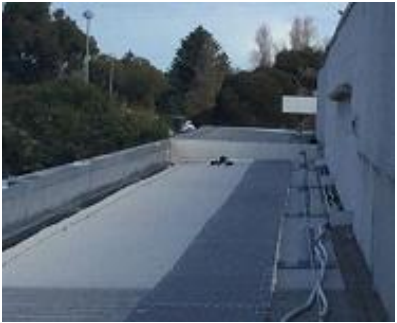
Variation in height between roofs are greater than required maximum	Trips, Slips and Falls	Awareness induction	Med	Single step to be installed	Low	Client advised	Outstanding	OH&S REGULATIONS 3.7 AS/NZS 1657-2013 3.1.4

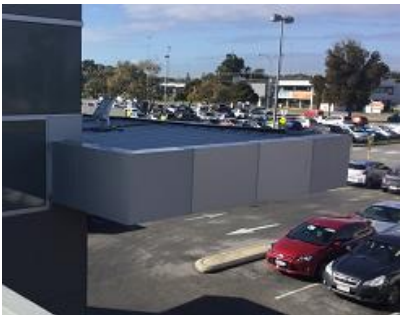
No height safety system installed	Trips, Slips and Falls	Restrict Access	High	"EWP Access Only" sign to be installed	Low	Client advised	Outstanding	OH&S REGULATIONS 3.55 & 3.11

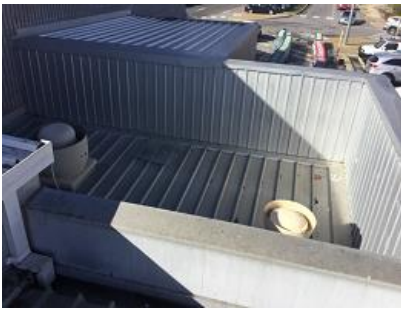
No height safety system installed	Trips, Slips and Falls	Awareness induction	High	Fall arrest anchors to be installed	Low	Client advised	Outstanding	OH&S REGULATIONS 3.55

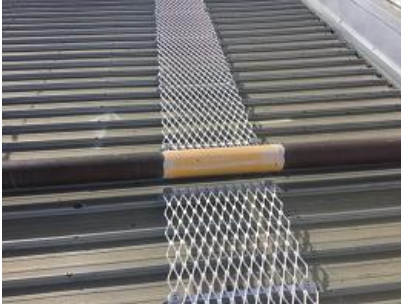
Pipe installed over the walkway path	Trips, Slips and Falls	Awareness induction	Med	Step over to be installed	Low	Client advised	Outstanding	OH&S REGULATIONS 3.7 AS/NZS 1657-2013 3.1.4
154	Building: General Stores Location Reference: L72 Task: Access to the roof

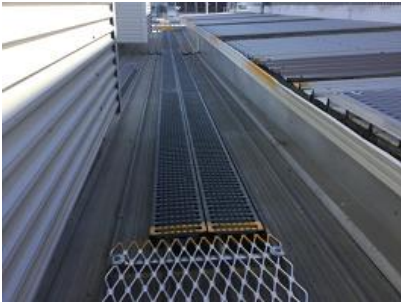
Roof walkway width is less than required minimum	Trips, Slips and Falls	Awareness induction	Med	Existing walkway to be removed and new walkway to be installed	Low	Client advised	Outstanding	OH&S REGULATIONS 3.7 AS/NZS 1657-2013 5.1.3

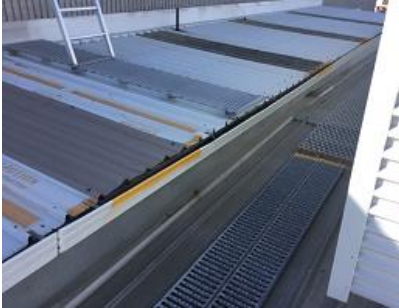
Variation in height between roofs are greater than required maximum	Trips, Slips and Falls	Awareness induction	Med	Single step to be installed	Low	Client advised	Outstanding	OH&S REGULATIONS 3.7 AS/NZS 1657-2013 3.1.4
156	Building: General Stores Location Reference: L72 Task: Restrict access to the roof

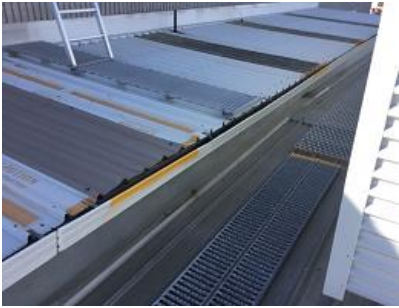
Brittle roof (Non-trafficable roof)	Trips, Slips and Falls	Restrict Access	High	"Warning-Keep Off-Brittle and fragile Roof" signs to be installed	Low	Client advised	Outstanding	OH&S REGULATIONS 3.57

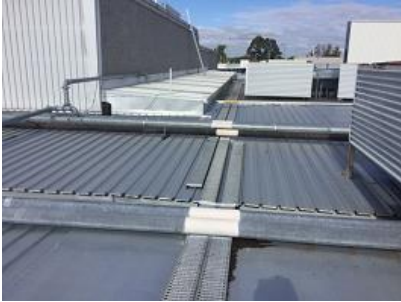
Pipes installed over the walkway path and variation in height between walkway panels are greater than required maximum	Trips, Slips and Falls	Awareness induction	Med	Step bridges and step to be installed	Low	Client advised	Outstanding	OH&S REGULATIONS 3.7 AS/NZS 1657-2013 3.1.4
158	Building: General Stores Location Reference: L73 Task: Access to the roof

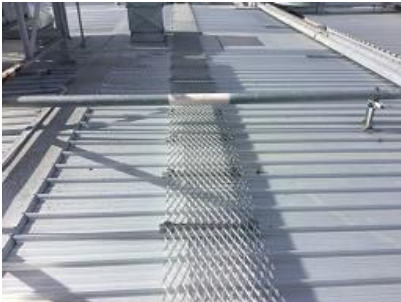
Pipe installed over the walkway path	Trips, Slips and Falls	Awareness induction	Med	Step bridge to be installed	Low	Client advised	Outstanding	OH&S REGULATIONS 3.7 AS/NZS 1657-2013 3.1.4

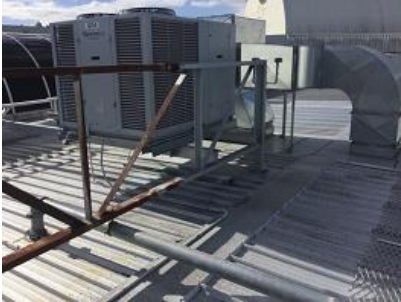
No safe access to the A/c units	Trips, Slips and Falls	Awareness induction	Med	Walkway, steps and handrails to be installed	Low	Client advised	Outstanding	OH&S REGULATIONS 3.7 AS/NZS 1657-2013 3.1.4
160	Building: General Stores Location Reference: L73 Task: Access to the A/c units

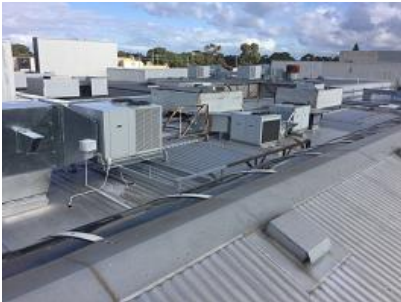
No safe access to the A/c units	Trips, Slips and Falls	Awareness induction	Low	Supply walkway to the A/c units	Low	Client advised	Outstanding	-

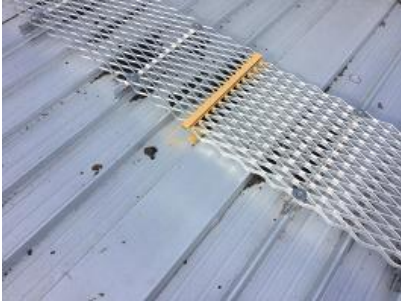
In-correct installation of walkway	Trips, Slips and Falls	Awareness induction	Med	Additional channels to be installed	Low	Client advised	Outstanding	OH&S REGULATIONS 3.7
162	Building: General Stores Location Reference: L73 Task: Access to the A/c unit

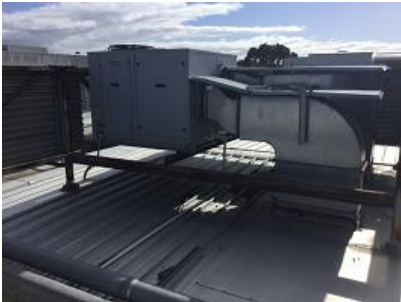
No safe access to the A/c unit	Trips, Slips and Falls	N/A	Low	Supply walkway to the A/c unit	Low	Client advised	Outstanding	-
