Roof Safety Report

Rockingham Centre, WA 6168

Prepared By: Safemaster Safety Products
Date: 10 Aug 2017

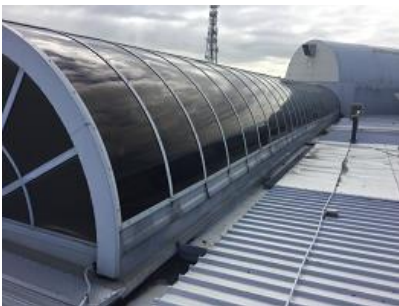
Brittle roof (Non-trafficable roof)	Trips, Slips and Falls	Restrict Access	High	"Warning-Keep off-Brittle and Fragile Roof" signs to be installed	Low	Client advised	Outstanding	OH&S REGULATIONS 3.57
164	Building: General Stores Location Reference: L74 Task: Access to the roof

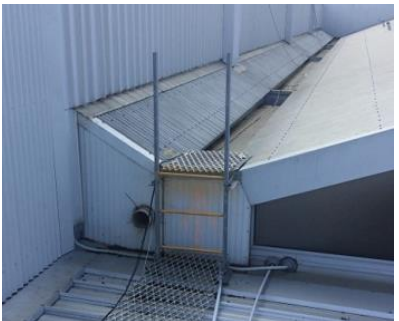
Bottom rung height is less than required minimum and clearance between ladder stiles and structure is less than required minimum	Trips, Slips and Falls	Awareness induction	Med	Existing ladder to be removed and new ladder to be installed	Low	Client advised	Outstanding	OH&S REGULATIONS 3.7 AS/NZS 1657-2013 7.4.3.4 & 7.4.5

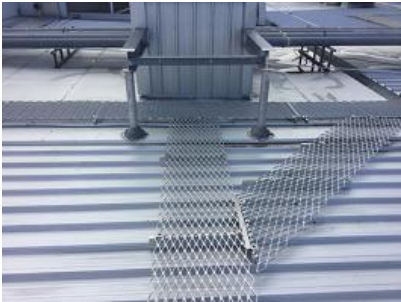
No safe access to the A/c unit	Trips, Slips and Falls	N/A	Low	Supply walkway to the A/c unit	Low	Client advised	Outstanding	-

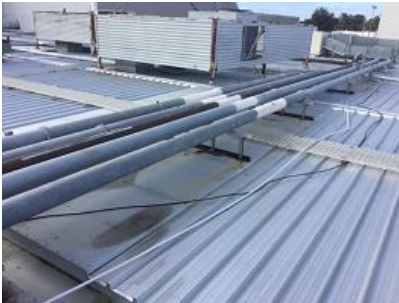
Pipes installed over the walkway path	Trips, Slips and Falls	Awareness induction	Med	Step Bridge to be installed	Low	Client advised	Outstanding	OH&S REGULATIONS 3.7 AS/NZS 1657-2013 3.1.4
168	Building: General Stores Location Reference: L75 Task: Access to the roof

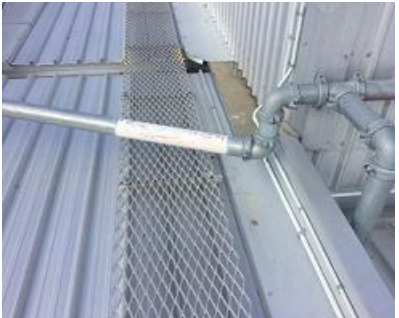
Pipe installed over the walkway path	Trips, Slips and Falls	Awareness induction	Med	Step over to be installed	Low	Client advised	Outstanding	OH&S REGULATIONS 3.7 AS/NZS 1657-2013 3.1.4

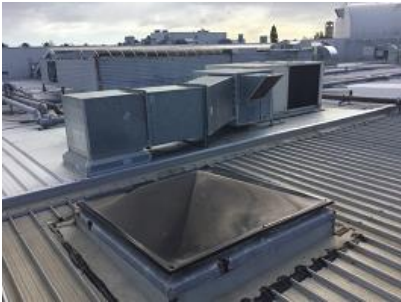
No safe access to the A/c unit	Trips, Slips and Falls	N/A	Low	Supply walkway to the A/c unit	Low	Client advised	Outstanding	-
170	Building: General Stores Location Reference: L75 Task: Access to the roof

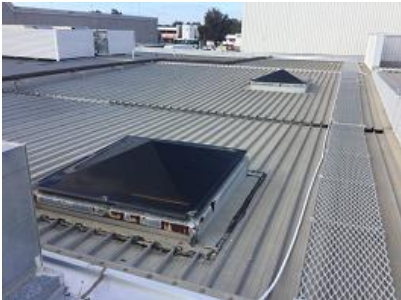
Gap between the walkway and fall edge is less than required minimum	Trips, Slips and Falls	Awareness induction	High	Handrails to be installed	Low	Client advised	Outstanding	OH&S REGULATIONS 3.7 AS/NZS 1657-2013 5.4.1

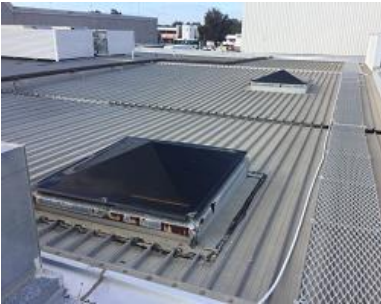
Brittle roof (Non-trafficable roof)	Trips, Slips and Falls	Restrict Access	High	"Warning-Keep Off-Brittle and Fragile Roof" signs to be installed	Low	Client advised	Outstanding	OH&S REGULATIONS 3.57
172	Building: General Stores Location Reference: L76 Task: Access to the roof

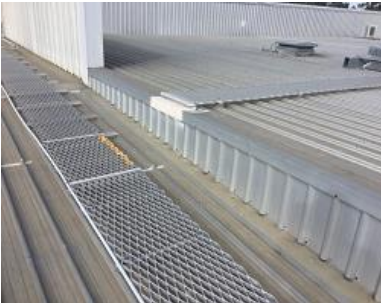
Variation in height between roofs are greater than required maximum	Trips, Slips and Falls	Awareness induction	Med	Single step including walkway section to be installed	Low	Client advised	Outstanding	OH&S REGULATIONS 3.7 AS/NZS 1657-2013 3.1.4

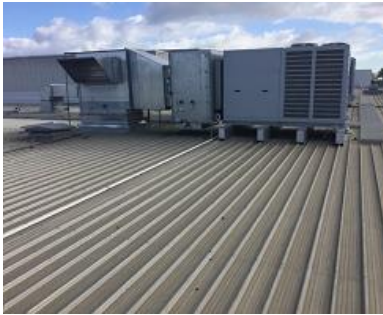
No safe access to the A/c unit	Trips, Slips and Falls	N/A	Low	Supply walkway to the A/c unit	Low	Client advised	Outstanding	-
174	Building: General Stores Location Reference: L76 Task: Access to the A/c unit

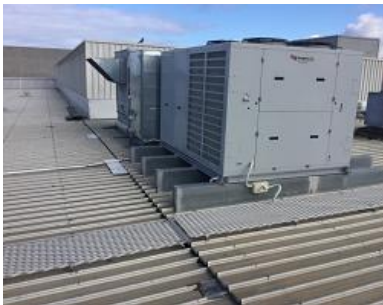
No safe access to the A/c unit	Trips, Slips and Falls	N/A	Low	Supply walkway to the A/c unit	Low	Client advised	Outstanding	-

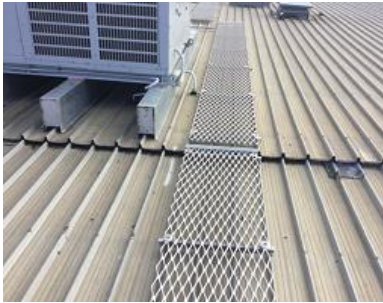
Variation in height between walkway panels are greater than required maximum	Trips, Slips and Falls	Awareness induction	Med	High visibility safety yellow nosing to be installed	Low	Client advised	Outstanding	OH&S REGULATIONS 3.7 AS/NZS 1657-2013 3.3.4
176	Building: General Stores Location Reference: L76 Task: Access to the roof

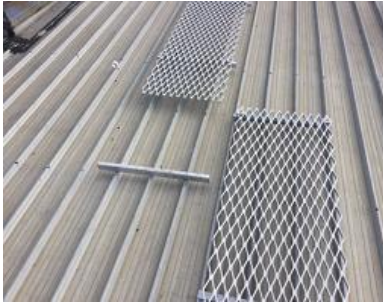
In-correct installation of walkway	Trips, Slips and Falls	Awareness induction	Med	Additional walkway section including channels to existing walkway to be installed	Low	Client advised	Outstanding	OH&S REGULATIONS 3.7

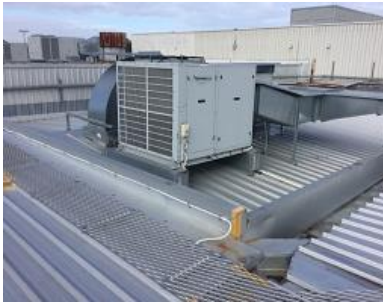
No safe access to the A/c unit	Trips, Slips and Falls	Awareness induction	Med	Walkway, steps and handrails to be installed	Low	Client advised	Outstanding	OH&S REGULATIONS 3.7 AS/NZS 1657-2013 3.1.4
178	Building: General Stores Location Reference: L77 Task: Access to the A/c units

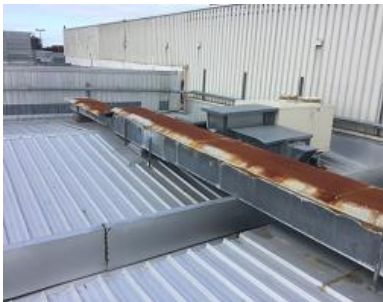
No safe access to the A/c unit	Trips, Slips and Falls	N/A	Low	Supply walkway to the A/c unit	Low	Client advised	Outstanding	-

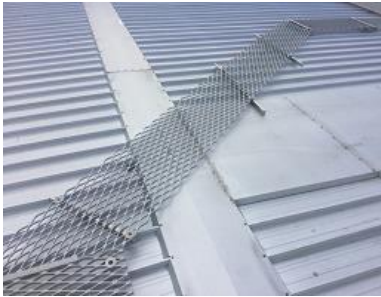
In-correct installation of walkway	Trips, Slips and Falls	Awareness induction	Med	Additional channels to be installed	Low	Client advised	Outstanding	OH&S REGULATIONS 3.7
180	Building: General Stores Location Reference: L78 Task: Access to the roof

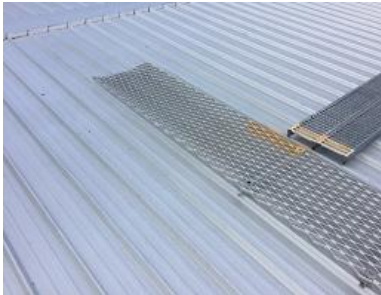
In-correct installation of walkway	Trips, Slips and Falls	Awareness induction	Med	Additional channels to be installed	Low	Client advised	Outstanding	OH&S REGULATIONS 3.7

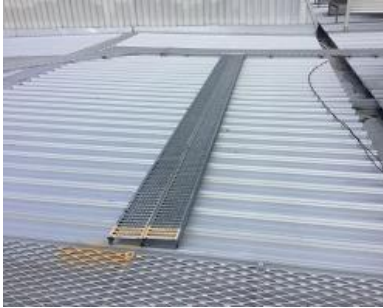
Walkway width is less than required minimum	Trips, Slips and Falls	Awareness induction	Med	Existing walkway to be removed and new walkway to be installed	Low	Client advised	Outstanding	OH&S REGULATIONS 3.7 AS/NZS 1657-2013 5.1.3
182	Building: General Stores Location Reference: L79 Task: Access to the roof

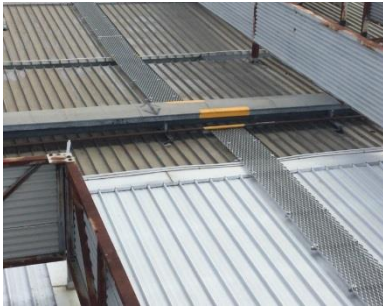
Variation in height between walkway panels are greater than required maximum	Trips, Slips and Falls	Awareness induction	Med	Steps to be installed	Low	Client advised	Outstanding	OH&S REGULATIONS 3.7 AS/NZS 1657-2013 3.1.4

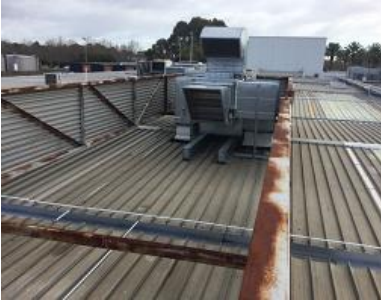
No safe access to the A/c unit	Trips, Slips and Falls	N/A	Low	Supply walkway to the A/c unit	Low	Client advised	Outstanding	-
184	Building: General Stores Location Reference: L79 Task: Access to the A/c unit

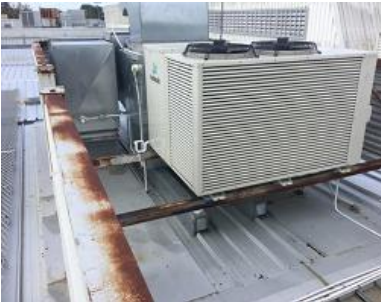
No safe access to the A/c unit	Trips, Slips and Falls	N/A	Low	Supply walkway to the A/c unit	Low	Client advised	Outstanding	-

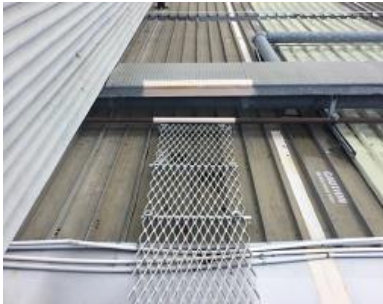
Variation in height between walkway panels are greater than required maximum	Trips, Slips and Falls	Awareness induction	Med	Steps to be installed	Low	Client advised	Outstanding	OH&S REGULATIONS 3.7 AS/NZS 1657-2013 3.1.4
186	Building: General Stores Location Reference: L79 Task: Access to the roof

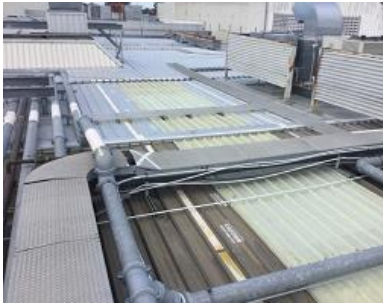
Walkway installed over the fragile roof	Trips, Slips and Falls	Awareness induction	Med	Handrails to be installed	Low	Client advised	Outstanding	OH&S REGULATIONS 3.7 AS/NZS 1657-2013 5.4.1

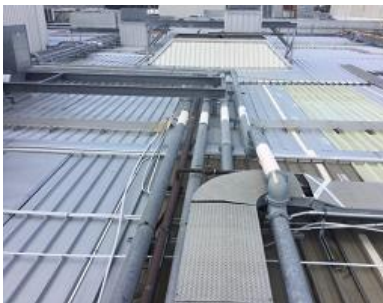
Pipes installed over the walkway path	Trips, Slips and Falls	Awareness induction	Med	Step bridge to be installed	Low	Client advised	Outstanding	OH&S REGULATIONS 3.7 AS/NZS 1657-2013 3.1.4
188	Building: General Stores Location Reference: L79 Task: Restrict access to the roof

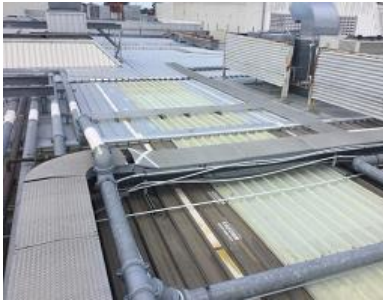
Brittle roof (Non-trafficable roof)	Trips, Slips and Falls	Restrict Access	High	"Warning-Keep Off-Brittle and fragile Roof" signs to be installed	Low	Client advised	Outstanding	OH&S REGULATIONS 3.57

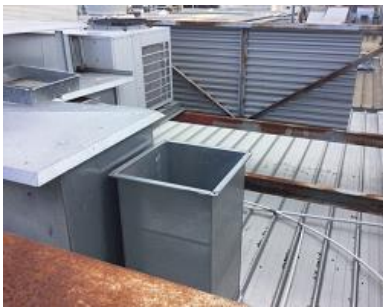
No	Photo of Hazard	Details of Hazard	Details of Risk	Existing/ Immediate Control Measure	Curre nt Risk Level	Proposed Permanent Solution	Resid ual Risk Asse ssme nt	Details of Action Taken	Status	Reference
189	Building: General Stores Location Reference: L80 Task: Access to the A/c unit

No safe access to the A/c unit	Trips, Slips and Falls	Awareness induction	Med	Walkway, Access ladder, walkway mesh and handrails to be installed	Low	Client advised	Outstanding	OH&S REGULATIONS 3.7 AS/NZS 1657-2013 3.1.4
190	Building: General Stores Location Reference: L81 Task: Access to the A/c unit

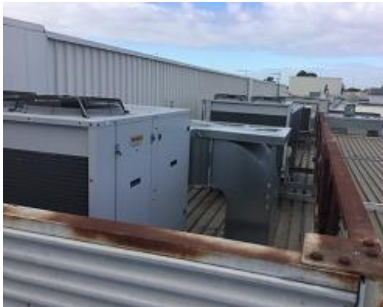
No safe access to the A/c unit	Trips, Slips and Falls	Awareness induction	Med	Walkway, Steps, walkway mesh, handrails and step bridge to be installed	Low	Client advised	Outstanding	OH&S REGULATIONS 3.7 AS/NZS 1657-2013 3.1.4

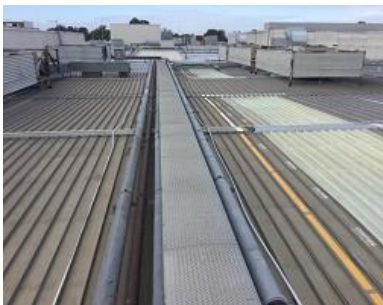
No	Photo of Hazard	Details of Hazard	Details of Risk	Existing/ Immediate Control Measure	Current Risk Level	Proposed Permanent Solution	Residual Risk Assessment	Details of Action Taken	Status	Reference
191	Building: General Stores Location Reference: L81 Task: Restrict access to the roof

Brittle roof (Non-trafficable roof)	Trips, Slips and Falls	Restrict Access	High	"Warning-Keep Off-Brittle and Fragile Roof" signs to be installed	Low	Client advised	Outstanding	OH&S REGULATIONS 3.57
192	Building: General Stores Location Reference: L82 Task: Access to the A/c units

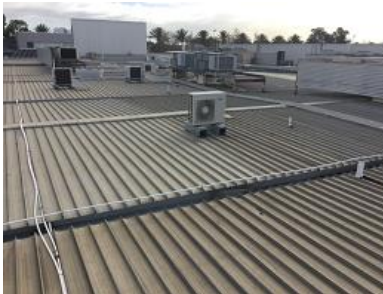
No safe access to the A/c units	Trips, Slips and Falls	N/A	Low	Supply walkway to the A/c units	Low	Client advised	Outstanding	-

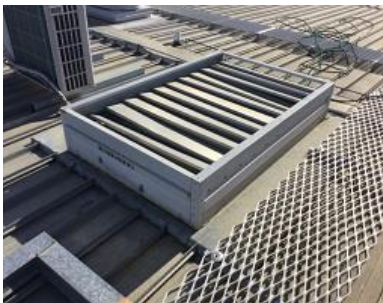
No	Photo of Hazard	Details of Hazard	Details of Risk	Existing/ Immediate Control Measure	Current Risk Level	Proposed Permanent Solution	Residual Risk Assessment	Details of Action Taken	Status	Reference
193	Building: General Stores Location Reference: L82 Task: Access to the roof

Gap between walkway and fragile roof is less than required minimum	Trips, Slips and Falls	Awareness induction	Med	Handrail to be installed	Low	Client advised	Outstanding	OH&S REGULATIONS 3.7 AS/NZS 1657-2013 5.4.1
194	Building: General Stores Location Reference: L82 Task: Restrict access to the roof

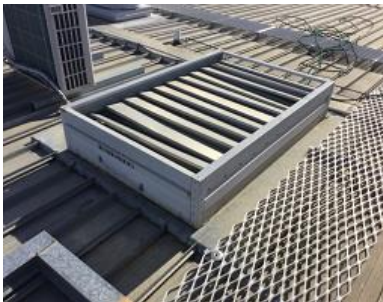
Brittle roof (Non-trafficable roof)	Trips, Slips and Falls	Restrict Access	High	"Warning-Keep Off-Brittle and Fragile Roof" sign to be installed	Low	Client advised	Outstanding	OH&S REGULATIONS 3.57

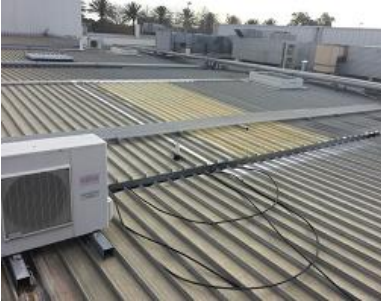
No	Photo of Hazard	Details of Hazard	Details of Risk	Existing/ Immediate Control Measure	Curre nt Risk Level	Proposed Permanent Solution	Resid ual Risk Asse ssme nt	Details of Action Taken	Status	Reference
195	Building: General Stores Location Reference: L83 Task: Restrict access to the roof

Brittle roof (Non-trafficable roof)	Trips, Slips and Falls	Restrict Access	High	"Warning-Keep Off-Brittle and Fragile Roof" sign to be installed	Low	Client advised	Outstanding	OH&S REGULATIONS 3.57
196	Building: General Stores Location Reference: L83 Task: Access to the roof

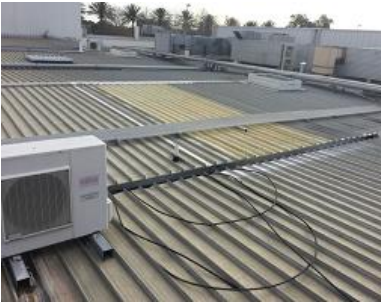
Walkway installed over the fragile roof	Trips, Slips and Falls	Awareness induction	High	Handrails to be installed	Low	Client advised	Outstanding	OH&S REGULATIONS 3.7 AS/NZS 1657-2013 5.4.1

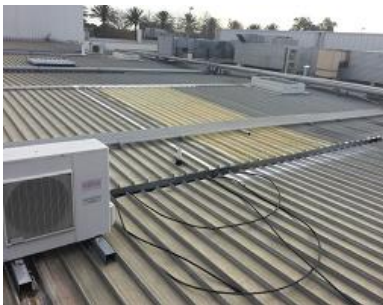
No	Photo of Hazard	Details of Hazard	Details of Risk	Existing/ Immediate Control Measure	Current Risk Level	Proposed Permanent Solution	Residual Risk Assessment	Details of Action Taken	Status	Reference
197	Building: General Stores Location Reference: L83 Task: Access to the roof

In-correct installation of walkway	Trips, Slips and Falls	Awareness induction	Med	Additional walkway channels to be installed	Low	Client advised	Outstanding	OH&S REGULATIONS 3.7
198	Building: General Stores Location Reference: L83 Task: Restrict access to the roof

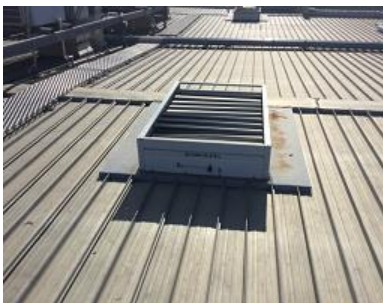
Brittle roof (Non-trafficable roof)	Trips, Slips and Falls	Restrict Access	High	"Warning-Keep Off-Brittle and Fragile Roof" sign to be installed	Low	Client advised	Outstanding	OH&S REGULATIONS 3.57

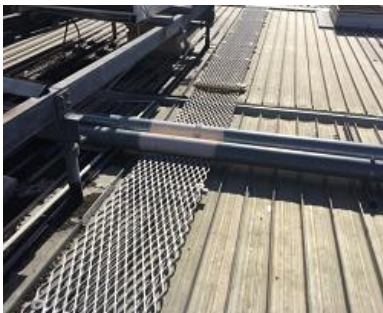
No	Photo of Hazard	Details of Hazard	Details of Risk	Existing/ Immediate Control Measure	Current Risk Level	Proposed Permanent Solution	Residual Risk Assessment	Details of Action Taken	Status	Reference
199	Building: General Stores Location Reference: L83 Task: Access to the roof

Pipes installed over the walkway path	Trips, Slips and Falls	Awareness induction	Med	Step over to be installed	Low	Client advised	Outstanding	OH&S REGULATIONS 3.7 AS/NZS 1657-2013 3.1.4
200	Building: General Stores Location Reference: L83 Task: Access to the roof

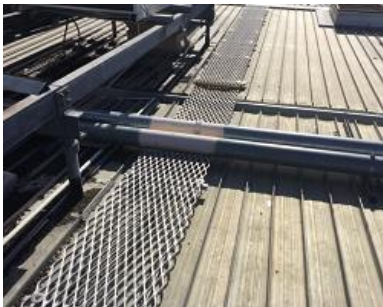
Variation in height between walkway panels are greater than required maximum	Trips, Slips and Falls	Awareness induction	Med	High visibility safety yellow nosing to be installed	Low	Client advised	Outstanding	OH&S REGULATIONS 3.7 AS/NZS 1657-2013 3.3.4

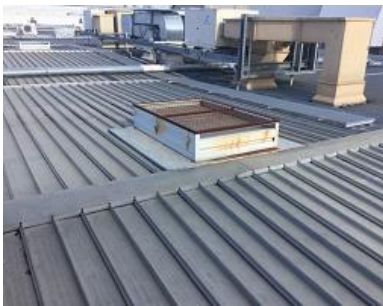
No	Photo of Hazard	Details of Hazard	Details of Risk	Existing/ Immediate Control Measure	Current Risk Level	Proposed Permanent Solution	Residual Risk Assessment	Details of Action Taken	Status	Reference
201	Building: General Stores Location Reference: L83 Task: Restrict access to the roof

Brittle roof (Non-trafficable roof)	Trips, Slips and Falls	Restrict Access	High	"Warning-Keep Off-Brittle and Fragile Roof" sign to be installed	Low	Client advised	Outstanding	OH&S REGULATIONS 3.57
202	Building: General Stores Location Reference: L84 Task: Restrict access to the roof

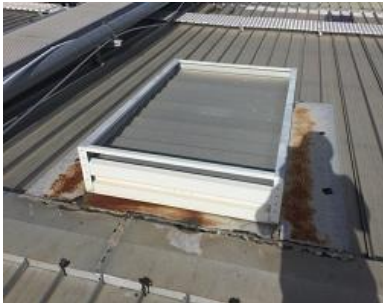
Brittle roof (Non-trafficable roof)	Trips, Slips and Falls	Restrict Access	High	"Warning-Keep Off-Brittle and Fragile Roof" sign to be installed	Low	Client advised	Outstanding	OH&S REGULATIONS 3.57

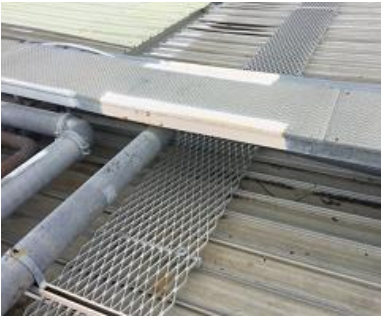
No	Photo of Hazard	Details of Hazard	Details of Risk	Existing/ Immediate Control Measure	Current Risk Level	Proposed Permanent Solution	Residual Risk Assessment	Details of Action Taken	Status	Reference
203	Building: General Stores Location Reference: L84 Task: Access to the roof

Variation in height between walkway panels are greater than required maximum	Trips, Slips and Falls	Awareness induction	Med	Steps to be installed	Low	Client advised	Outstanding	OH&S REGULATIONS 3.7 AS/NZS 1657-2013 3.3.4
204	Building: General Stores Location Reference: L84 Task: Access to the roof

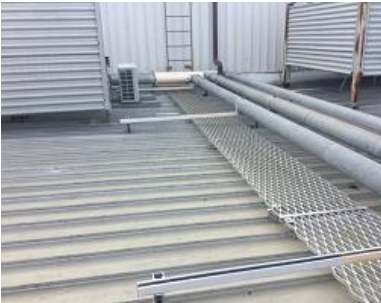
Bracings installed over the walkway path	Trips, Slips and Falls	Awareness induction	Med	Step over to be installed	Low	Client advised	Outstanding	OH&S REGULATIONS 3.7

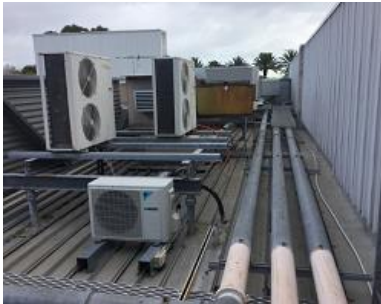
No	Photo of Hazard	Details of Hazard	Details of Risk	Existing/ Immediate Control Measure	Current Risk Level	Proposed Permanent Solution	Residual Risk Assessment	Details of Action Taken	Status	Reference
205	Building: General Stores Location Reference: L84 Task: Access to the A/c units

No safe access to the A/c units	Trips, Slips and Falls	Awareness induction	Med	Raised walkway, walkway mesh, ladder and handrails to be installed	Low	Client advised	Outstanding	OH&S REGULATIONS 3.7 AS/NZS 1657-2013 3.1.4
206	Building: General Stores Location Reference: L85 Task: Restrict access to the roof

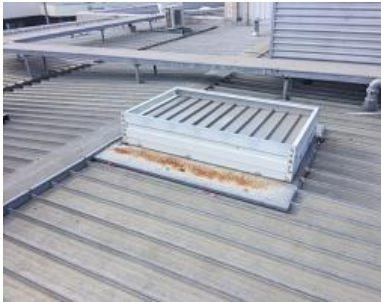
Brittle roof (Non-trafficable roof)	Trips, Slips and Falls	Restrict Access	High	"Warning-Keep Off-Brittle and Fragile Roof" sign to be installed	Low	Client advised	Outstanding	OH&S REGULATIONS 3.57

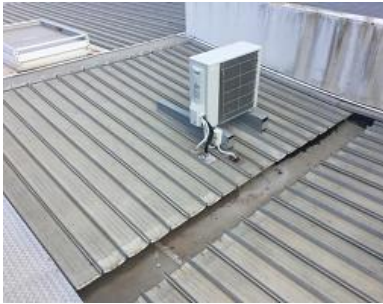
No	Photo of Hazard	Details of Hazard	Details of Risk	Existing/ Immediate Control Measure	Curre nt Risk Level	Proposed Permanent Solution	Resid ual Risk Asse ssme nt	Details of Action Taken	Status	Reference
207	Building: General Stores Location Reference: L85 Task: Access to the A/c unit

No safe access to the A/c unit	Trips, Slips and Falls	Awareness induction	Med	Walkway and step to be installed	Low	Client advised	Outsta nding	OH&S REGULATIONS 3.7 AS/NZS 1657- 2013 3.1.4
208	Building: General Stores Location Reference: L85 Task: Access to the roof

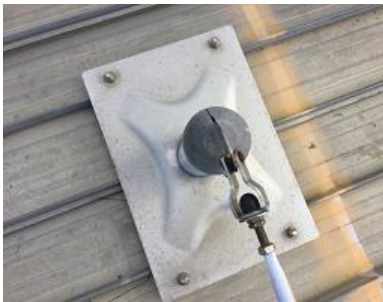
Non-complaint static line is present	Trips, Slips and Falls	Awareness induction	High	Existing static line to be removed and New static line to be installed	Low	Client advised	Outsta nding	OH&S REGULATIONS 3.55

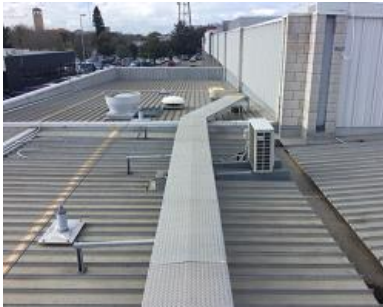
No	Photo of Hazard	Details of Hazard	Details of Risk	Existing/ Immediate Control Measure	Current Risk Level	Proposed Permanent Solution	Residual Risk Assessment	Details of Action Taken	Status	Reference
209	Building: General Stores Location Reference: L85 Task: Access to the A/c units

No safe access to the A/c units	Trips, Slips and Falls	Awareness induction	Med	Walkway and step to be installed	Low	Client advised	Outstanding	OH&S REGULATIONS 3.7 AS/NZS 1657-2013 3.1.4
210	Building: General Stores Location Reference: L86 Task: Restrict access to the roof

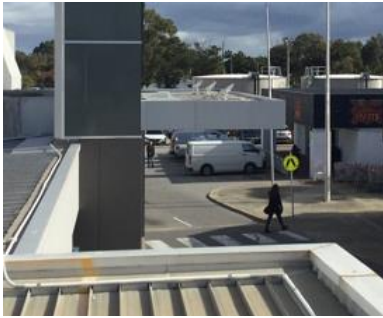
No height safety system installed	Trips, Slips and Falls	Restrict Access	High	"EWP Access Only" sign to be installed	Low	Client advised	Outstanding	OH&S REGULATIONS 3.55 & 3.11

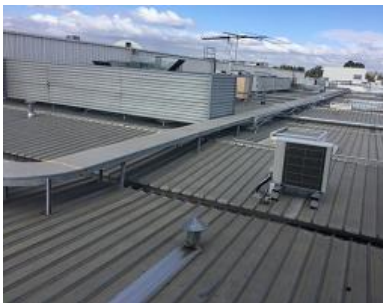
No	Photo of Hazard	Details of Hazard	Details of Risk	Existing/ Immediate Control Measure	Current Risk Level	Proposed Permanent Solution	Residual Risk Assessment	Details of Action Taken	Status	Reference
211	Building: General Stores Location Reference: L85 Task: Access to the roof

Variation in height between walkway and roof is greater than required maximum	Trips, Slips and Falls	Awareness induction	Med	Handrails to be installed	Low	Client advised	Outstanding	OH&S REGULATIONS 3.7 AS/NZS 1657-2013 4.4
212	Building: Kmart Location Reference: L87 Task: Access to the roof

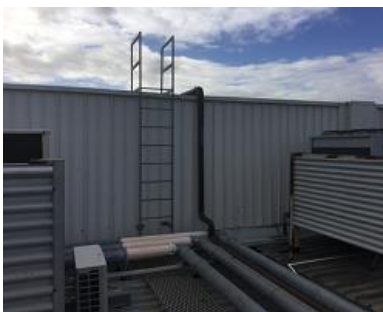
Non-complaint ladder is present	Trips, Slips and Falls	Awareness induction	Med	Existing ladder to be removed and New ladder to be installed	Low	Client advised	Outstanding	OH&S REGULATIONS 3.7 AS/NZS 1657-2013 7.4

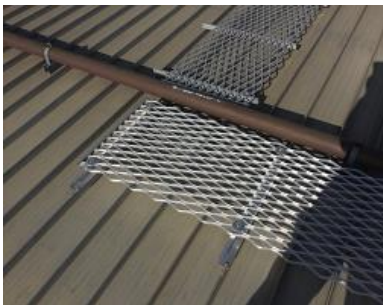
No	Photo of Hazard	Details of Hazard	Details of Risk	Existing/ Immediate Control Measure	Current Risk Level	Proposed Permanent Solution	Residual Risk Assessment	Details of Action Taken	Status	Reference
213	Building: Kmart Location Reference: L87 Task: Access to the roof

Pipes installed over the walkway path	Trips, Slips and Falls	Awareness induction	Med	Step over to be installed	Low	Client advised	Outstanding	OH&S REGULATIONS 3.7 AS/NZS 1657-2013 3.1.4
214	Building: Kmart Location Reference: L88 Task: Access to the roof

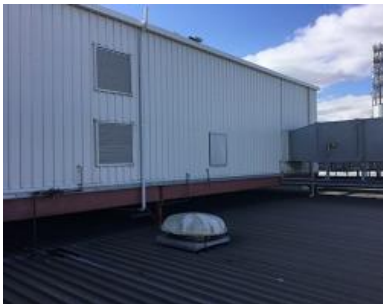
No safe access to the roof	Trips, Slips and Falls	Awareness induction	Med	Access ladder including handrails to be installed	Low	Client advised	Outstanding	OH&S REGULATIONS 3.7

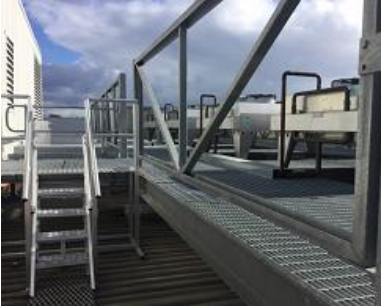
No	Photo of Hazard	Details of Hazard	Details of Risk	Existing/ Immediate Control Measure	Current Risk Level	Proposed Permanent Solution	Residual Risk Assessment	Details of Action Taken	Status	Reference
215	Building: Kmart Location Reference: L90 Task: Access to the plant deck

Variation in height between plant deck and roof is greater than required maximum	Trips, Slips and Falls	Awareness induction	Med	Handrails to be installed	Low	Client advised	Outstanding	OH&S REGULATIONS 3.7 AS/NZS 1657-2013 4.4
216	Building: Kmart Location Reference: L90 Task: Access to the plant deck

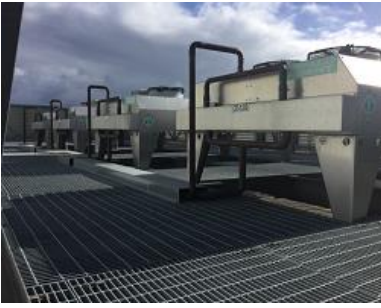
Variation in height between plant deck and unit is greater than required maximum	Trips, Slips and Falls	Awareness induction	Med	Midrails to be installed	Low	Client advised	Outstanding	OH&S REGULATIONS 3.7 AS/NZS 1657-2013 4.4

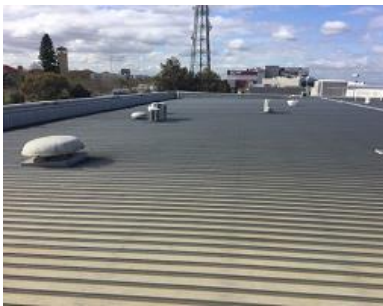
No	Photo of Hazard	Details of Hazard	Details of Risk	Existing/ Immediate Control Measure	Curre nt Risk Level	Proposed Permanent Solution	Resid ual Risk Asse ssme nt	Details of Action Taken	Status	Reference
217	Building: Kmart Location Reference: L91 Task: Access to the A/c units

No safe access to the A/c units	Trips, Slips and Falls	N/A	Low	Supply walkway to the A/c units	Low	Client advised	Outstanding	-
218	Building: Kmart Location Reference: L92 Task: Access to the roof

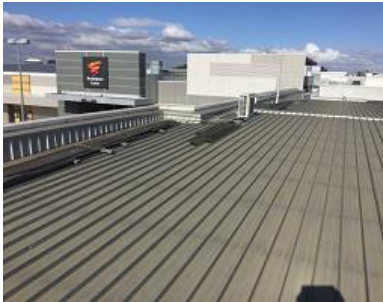
No height safety system installed	Trips, Slips and Falls	Awareness induction	High	Fall arrest anchors to be installed	Low	Client advised	Outstanding	OH&S REGULATIONS 3.55

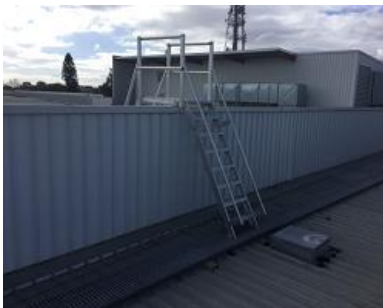
No	Photo of Hazard	Details of Hazard	Details of Risk	Existing/ Immediate Control Measure	Current Risk Level	Proposed Permanent Solution	Residual Risk Assessment	Details of Action Taken	Status	Reference
219	Building: Kmart Location Reference: L93 Task: Access to the roof

Non-compliant ladder is present	Trips, Slips and Falls	Awareness induction	Med	Existing ladder to be removed and new ladder to be installed	Low	Client advised	Outstanding	OH&S REGULATIONS 3.7 AS/NZS 1657-2013 7.3.6 & 7.3.3.2
220	Building: Kmart Location Reference: L93 Task: Access to the plant deck

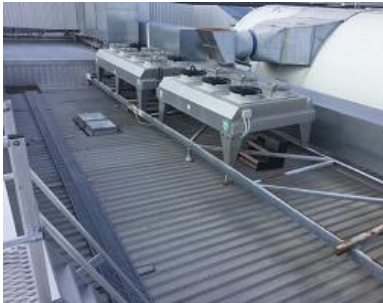
No safe access to the A/c units	Trips, Slips and Falls	Awareness induction	Med	Walkway, Walkway mesh, steps and handrails to be installed	Low	Client advised	Outstanding	OH&S REGULATIONS 3.7 AS/NZS 1657-2013 3.1.4

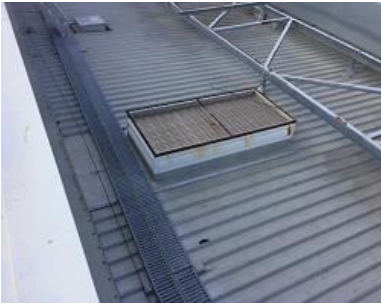
No	Photo of Hazard	Details of Hazard	Details of Risk	Existing/ Immediate Control Measure	Curre nt Risk Level	Proposed Permanent Solution	Resid ual Risk Asse ssme nt	Details of Action Taken	Status	Reference
221	Building: Kmart Location Reference: L93 Task: Restrict access to the roof

Brittle roof (Non-trafficable roof)	Trips, Slips and Falls	Restrict Access	High	"Warning-Keep Off-Brittle and Fragile Roof" sign to be installed	Low	Client advised	Outstanding	OH&S REGULATIONS 3.57
222	Building: Kmart Location Reference: L93 Task: Restrict access to the roof

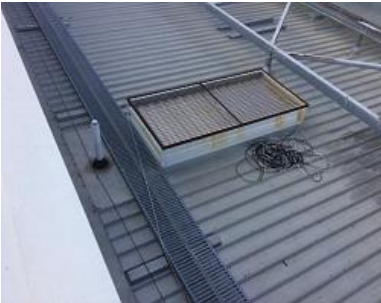
Brittle roof (Non-trafficable roof)	Trips, Slips and Falls	Restrict Access	High	"Warning-Keep Off-Brittle and Fragile Roof" sign to be installed	Low	Client advised	Outstanding	OH&S REGULATIONS 3.57

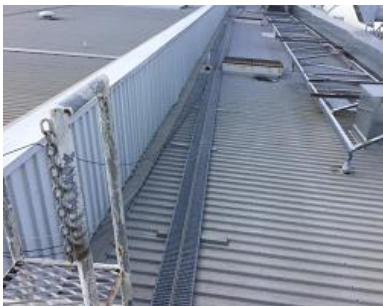
No	Photo of Hazard	Details of Hazard	Details of Risk	Existing/ Immediate Control Measure	Current Risk Level	Proposed Permanent Solution	Residual Risk Assessment	Details of Action Taken	Status	Reference
223	Building: Kmart Location Reference: L93 Task: Access to the roof

Walkway width is less than required minimum	Trips, Slips and Falls	Awareness induction	Med	Existing walkway to be removed and new walkway to be installed and handrails to be installed where brittle roof close to walkway	Low	Client advised	Outstanding	OH&S REGULATIONS 3.7 AS/NZS 1657-2013 5.1.3 & 5.4.1
224	Building: Kmart Location Reference: L94 Task: Access to the roof

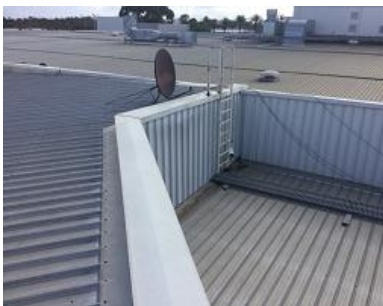
Non-complaint ladder is present	Trips, Slips and Falls	Awareness induction	Med	Existing ladder to be removed and New ladder to be installed	Low	Client advised	Outstanding	OH&S REGULATIONS 3.7 AS/NZS 1657-2013 7.4.3.4 & 7.3.6

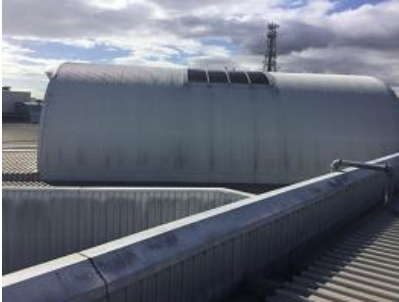
No	Photo of Hazard	Details of Hazard	Details of Risk	Existing/ Immediate Control Measure	Current Risk Level	Proposed Permanent Solution	Residual Risk Assessment	Details of Action Taken	Status	Reference
225	Building: Kmart Location Reference: L94 Task: Restrict access to the roof

No height safety system installed and Brittle roof is present	Trips, Slips and Falls	Restrict Access	High	"No Access" signs to be installed	Low	Client advised	Outstanding	OH&S REGULATIONS 3.55 & 3.11
226	Building: Kmart Location Reference: L95 Task: Access to the A/c units

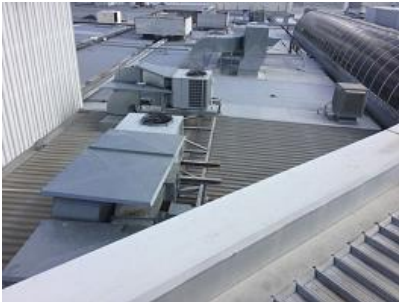
No safe access to the A/c units	Trips, Slips and Falls	N/A	Low	Supply walkway to the A/c units	Low	Client advised	Outstanding	-

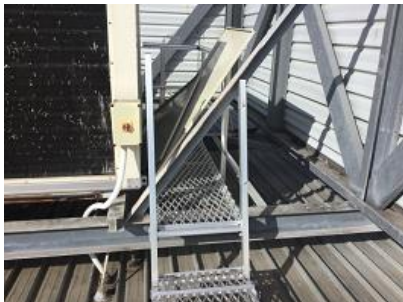
Bracings installed on walkway path and headroom is less than required minimum	Trips, Slips and Falls	Awareness induction	Med	"Trip Hazard" and "Warning-Low head room" signs to be installed including high visibility safety yellow tape	Low	Client advised	Outstanding	OH&S REGULATIONS 3.7 & 3.11 AS/NZS 1657-2013 3.1.5

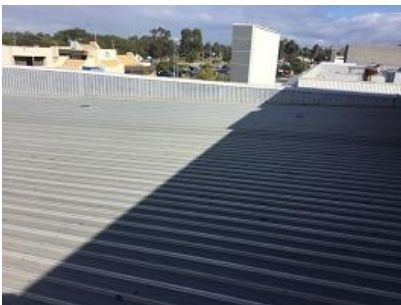
No	Photo of Hazard	Details of Hazard	Details of Risk	Existing/ Immediate Control Measure	Current Risk Level	Proposed Permanent Solution	Residual Risk Assessment	Details of Action Taken	Status	Reference
229	Building: Kmart Location Reference: L97 Task: Access to the roof

No height safety system installed	Trips, Slips and Falls	Awareness induction	High	Fall arrest anchor to be installed	Low	Client advised	Outstanding	OH&S REGULATIONS 3.55
230	Building: Kmart Location Reference: L97 Task: Access to the A/c units

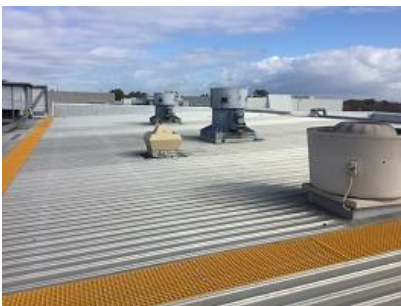
No safe access to the A/c units	Trips, Slips and Falls	N/A	Low	Supply walkway to the A/c units	Low	Client advised	Outstanding	-

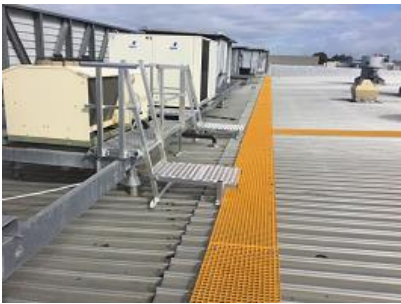
No	Photo of Hazard	Details of Hazard	Details of Risk	Existing/ Immediate Control Measure	Curre nt Risk Level	Proposed Permanent Solution	Resid ual Risk Asse ssme nt	Details of Action Taken	Status	Reference
231	Building: Kmart Location Reference: L98 Task: Access to the roof

Landing platform protrudes over the walkway path	Trips, Slips and Falls	Awareness induction	Med	Additional walkway section to be installed	Low	Client advised	Outstanding	OH&S REGULATIONS 3.7
232	Building: Kmart Location Reference: L98 Task: Access to the roof

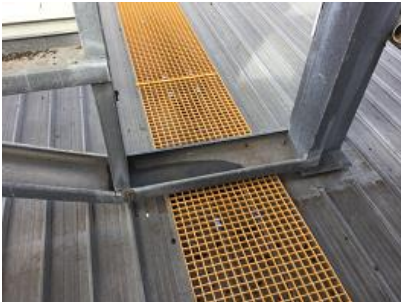
Bracings installed over the walkway path	Trips, Slips and Falls	Awareness induction	Med	Step over to be installed	Low	Client advised	Outstanding	OH&S REGULATIONS 3.7

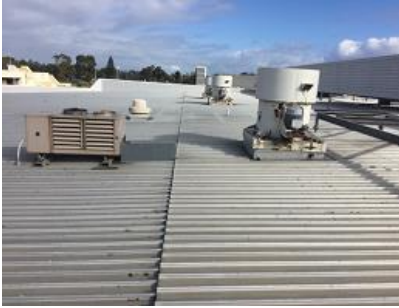
No	Photo of Hazard	Details of Hazard	Details of Risk	Existing/ Immediate Control Measure	Curre nt Risk Level	Proposed Permanent Solution	Resid ual Risk Asse ssme nt	Details of Action Taken	Status	Reference
233	Building: Woolworths Location Reference: L98 Task: Access to the A/c units

No safe access to the A/c units	Trips, Slips and Falls	N/A	Low	Supply walkway to the A/c units	Low	Client advised	Outstanding	-
234	Building: Woolworths Location Reference: L99 Task: Access to the A/c unit

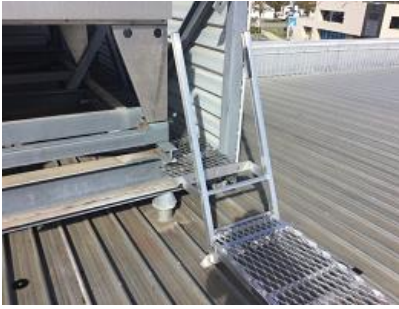
Gap between top rung and landing is greater than required maximum	Trips, Slips and Falls	Awareness induction	Med	Additional mesh to close the gap to be installed	Low	Client advised	Outstanding	OH&S REGULATIONS 3.7 AS/NZS 1657-2013 7.4.8.4

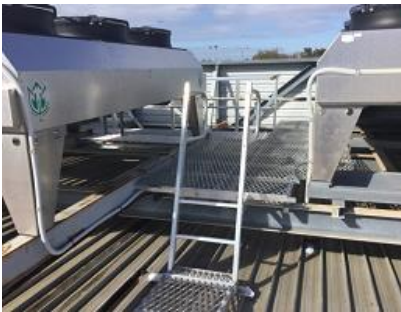
No	Photo of Hazard	Details of Hazard	Details of Risk	Existing/ Immediate Control Measure	Curre nt Risk Level	Proposed Permanent Solution	Resid ual Risk Asse ssme nt	Details of Action Taken	Status	Reference
235	Building: Woolworths Location Reference: L99 Task: Access to the A/c unit

Gap between top rung and landing is greater than required maximum	Trips, Slips and Falls	Awareness induction	Med	Additional mesh to close the gap to be installed	Low	Client advised	Outstanding	OH&S REGULATIONS 3.7 AS/NZS 1657-2013 7.4.8.4
236	Building: Woolworths Location Reference: L99 Task: Access to the A/c unit

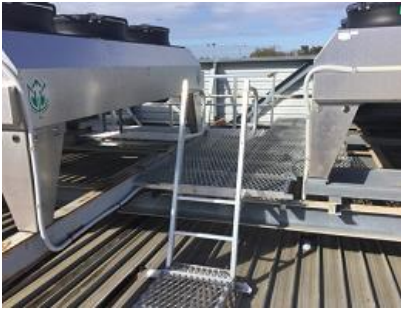
Variation in height between plant deck and roof is greater than required maximum	Trips, Slips and Falls	Awareness induction	Med	Handrails to be installed	Low	Client advised	Outstanding	OH&S REGULATIONS 3.7 AS/NZS 1657-2013 4.4

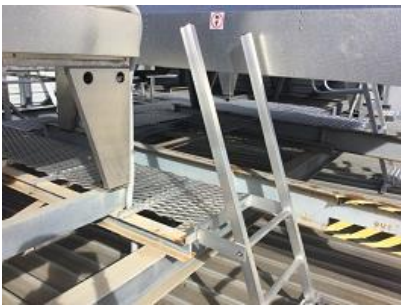
No	Photo of Hazard	Details of Hazard	Details of Risk	Existing/ Immediate Control Measure	Curre nt Risk Level	Proposed Permanent Solution	Resid ual Risk Asse ssme nt	Details of Action Taken	Status	Reference
237	Building: Woolworths Location Reference: L99 Task: Access to the A/c unit

Gap between top rung and landing is greater than required maximum	Trips, Slips and Falls	Awareness induction	Med	Additional mesh to close the gap to be installed	Low	Client advised	Outstanding	OH&S REGULATIONS 3.7 AS/NZS 1657-2013 7.4.8.4
238	Building: Woolworths Location Reference: L99 Task: Access to the A/c unit

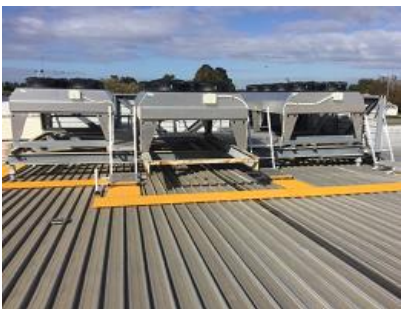
Variation in height between plant deck and roof is greater than required maximum	Trips, Slips and Falls	Awareness induction	Med	Handrails and Midrails to be installed	Low	Client advised	Outstanding	OH&S REGULATIONS 3.7 AS/NZS 1657-2013 4.4

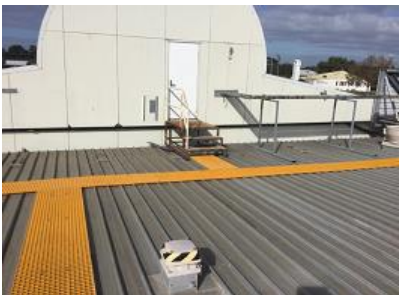
No	Photo of Hazard	Details of Hazard	Details of Risk	Existing/ Immediate Control Measure	Curre nt Risk Level	Proposed Permanent Solution	Resid ual Risk Asse ssme nt	Details of Action Taken	Status	Reference
239	Building: Woolworths Location Reference: L100 Task: Access to the roof

Non-compliant stair is present	Trips, Slips and Falls	Awareness induction	Med	Existing stair to be removed and new ladder to be installed	Low	Client advised	Outstanding	OH&S REGULATIONS 3.7 AS/NZS 1657-2013 7.2
240	Building: Woolworths Location Reference: L100 Task: Access to the roof

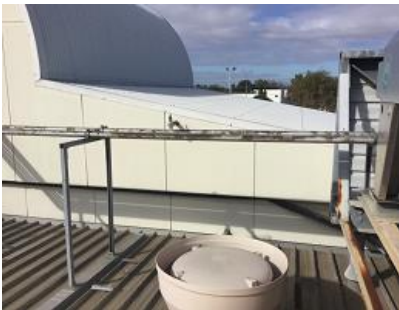
No height safety system installed	Trips, Slips and Falls	Awareness induction	High	Fall arrest anchor, anchor stop and Ladder access bracket to be installed	Low	Client advised	Outstanding	OH&S REGULATIONS 3.55

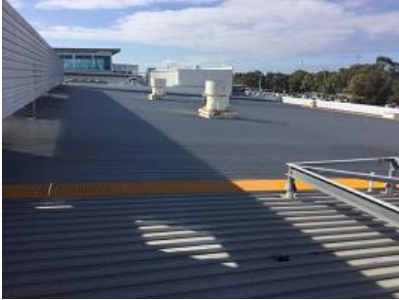
No	Photo of Hazard	Details of Hazard	Details of Risk	Existing/ Immediate Control Measure	Curre nt Risk Level	Proposed Permanent Solution	Resid ual Risk Asse ssme nt	Details of Action Taken	Status	Reference
241	Building: Woolworths Location Reference: L101 Task: Access to the A/c units

No safe access to the A/c units	Trips, Slips and Falls	N/A	Low	Supply walkway to the A/c units	Low	Client advised	Outstanding	-
242	Building: Woolworths Location Reference: L102 Task: Access to the A/c units

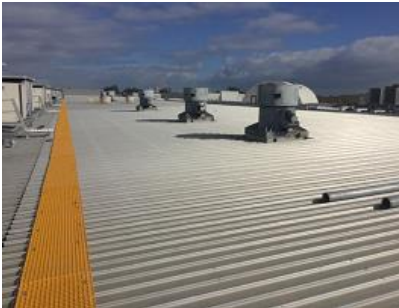
No safe access to the A/c units	Trips, Slips and Falls	N/A	Low	Supply walkway to the A/c units	Low	Client advised	Outstanding	-

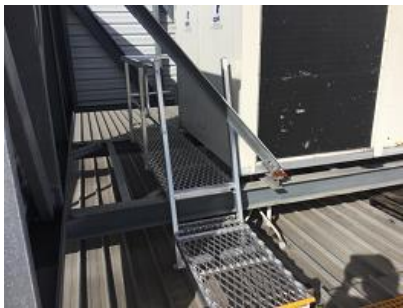
No	Photo of Hazard	Details of Hazard	Details of Risk	Existing/ Immediate Control Measure	Current Risk Level	Proposed Permanent Solution	Residual Risk Assessment	Details of Action Taken	Status	Reference
243	Building: Woolworths Location Reference: L103 Task: Access to the A/c unit

Bracings installed on walkway path and headroom is less than required minimum	Trips, Slips and Falls	Awareness induction	Med	"Trip Hazard" and "Warning-Low headroom" signs to be installed including high visibility safety yellow tape	Low	Client advised	Outstanding	OH&S REGULATIONS 3.7 & 3.11 AS/NZS 1657-2013 3.1.5
244	Building: Woolworths Location Reference: L103 Task: Access to the roof

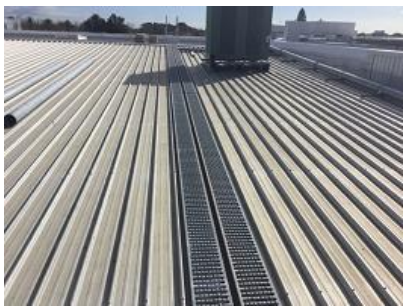
Walkway width is less than required minimum	Trips, Slips and Falls	Awareness induction	Med	Existing walkway to be removed and new walkway to be installed	Low	Client advised	Outstanding	OH&S REGULATIONS 3.7 AS/NZS 1657-2013 5.1.3

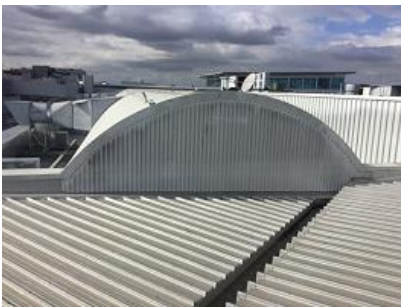
No	Photo of Hazard	Details of Hazard	Details of Risk	Existing/ Immediate Control Measure	Current Risk Level	Proposed Permanent Solution	Residual Risk Assessment	Details of Action Taken	Status	Reference
245	Building: Woolworths Location Reference: L106 Task: Access to the roof

Variation in height between roofs are greater than required maximum	Trips, Slips and Falls	Awareness induction	Med	Access ladder including handrails to be installed	Low	Client advised	Outstanding	OH&S REGULATIONS 3.7 AS/NZS 1657-2013 3.1.4
246	Building: Woolworths Location Reference: L106 Task: Restrict access to the roof

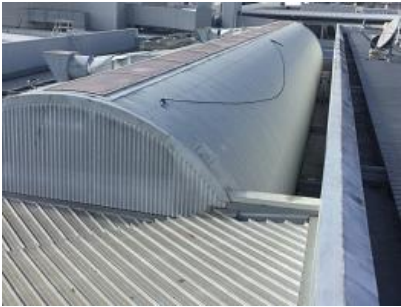
Brittle roof (Non-trafficable roof)	Trips, Slips and Falls	Restrict Access	High	"Warning-Keep Off-Brittle and Fragile Roof" signs to be installed	Low	Client advised	Outstanding	OH&S REGULATIONS 3.57

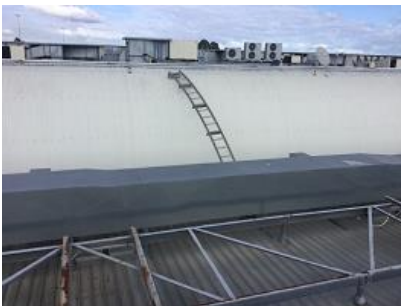
No	Photo of Hazard	Details of Hazard	Details of Risk	Existing/ Immediate Control Measure	Current Risk Level	Proposed Permanent Solution	Residual Risk Assessment	Details of Action Taken	Status	Reference
247	Building: Woolworths Location Reference: L106 Task: Access to the roof

Non-compliant ladder is present	Trips, Slips and Falls	Awareness induction	Med	Existing ladder to be removed	Low	Client advised	Outstanding	OH&S REGULATIONS 3.7 AS/NZS 1657-2013 7.4
248	Building: General Stores Location Reference: L107 Task: Restrict access to the roof

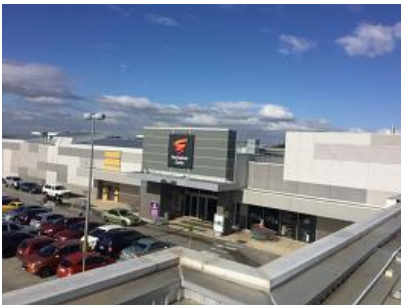
No height safety system installed	Trips, Slips and Falls	Restrict Access	High	"EWP Access Only" signs to be installed	Low	Client advised	Outstanding	OH&S REGULATIONS 3.55 & 3.11

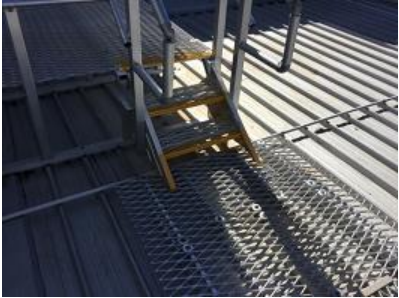
No	Photo of Hazard	Details of Hazard	Details of Risk	Existing/ Immediate Control Measure	Curre nt Risk Level	Proposed Permanent Solution	Resid ual Risk Asse ssme nt	Details of Action Taken	Status	Reference
249	Building: General Stores Location Reference: L108 Task: Access to the roof

Non-complaint stair is present	Trips, Slips and Falls	Awareness induction	Med	Existing stair to be removed and new ladder/stair to be installed	Low	Client advised	Outstanding	OH&S REGULATIONS 3.7 AS/NZS 1657-2013 7.2
250	Building: General Stores Location Reference: L108 Task: Access to the roof

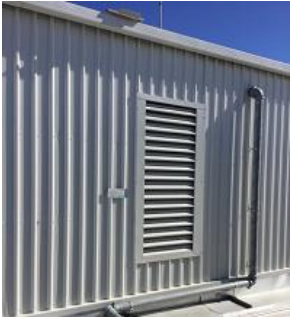
No safe access to the roof	Trips, Slips and Falls	Awareness induction	Med	Access ladder including handrails and anchor strop to be installed	Low	Client advised	Outstanding	OH&S REGULATIONS 3.55 & 3.7

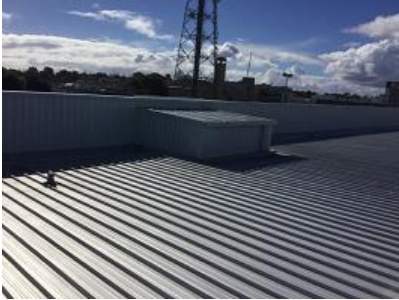
No	Photo of Hazard	Details of Hazard	Details of Risk	Existing/ Immediate Control Measure	Curre nt Risk Level	Proposed Permanent Solution	Resid ual Risk Asse ssme nt	Details of Action Taken	Status	Reference
251	Building: General Stores Location Reference: L109 Task: Access to the roof

No height safety system installed	Trips, Slips and Falls	Awareness induction	High	Fall arrest anchor to be installed	Low	Client advised	Outstanding	OH&S REGULATIONS 3.55
252	Building: General Stores Location Reference: L110 Task: Access to the A/c unit

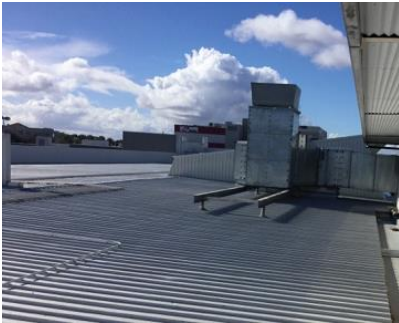
No safe access to the A/c unit	Trips, Slips and Falls	N/A	Low	Supply walkway to the A/c unit	Low	Client advised	Outstanding	-

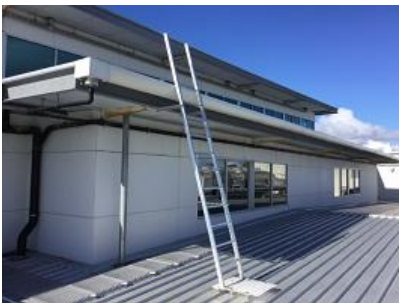
No	Photo of Hazard	Details of Hazard	Details of Risk	Existing/ Immediate Control Measure	Current Risk Level	Proposed Permanent Solution	Residual Risk Assessment	Details of Action Taken	Status	Reference
253	Building: General Stores Location Reference: L111 Task: Access to the roof

Gap between ladder and structure is less than required minimum and landing is less than required minimum	Trips, Slips and Falls	Awareness induction	Med	Existing ladder to be re-installed with new brackets, landing platforms, handrails and additional walkway sections	Low	Client advised	Outstanding	OH&S REGULATIONS 3.7 AS/NZS 1657-2013 7.4.5 & 7.3.6
254	Building: General Stores Location Reference: L111 Task: Access to the roof

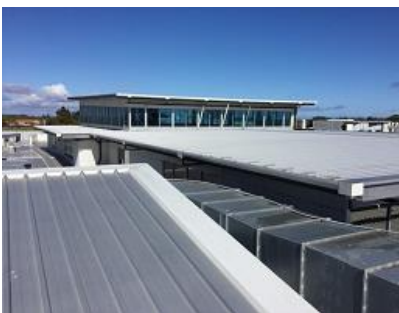
No height safety system installed	Trips, Slips and Falls	Awareness induction	High	Fall arrest anchors, anchor stop and access ladder to be installed	Low	Client advised	Outstanding	OH&S REGULATIONS 3.55 & 3.7 AS/NZS 1657-2013 3.1.4

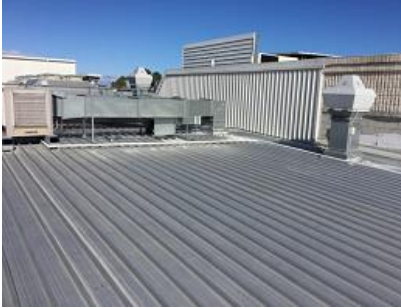
No	Photo of Hazard	Details of Hazard	Details of Risk	Existing/ Immediate Control Measure	Curre nt Risk Level	Proposed Permanent Solution	Resid ual Risk Asse ssme nt	Details of Action Taken	Status	Reference
255	Building: General Stores Location Reference: L112 Task: Access to the A/c units

No safe access to the A/c units	Trips, Slips and Falls	N/A	Low	Supply walkway to the A/c units	Low	Client advised	Outstanding	-
256	Building: General Stores Location Reference: L112 Task: Access to the plant deck

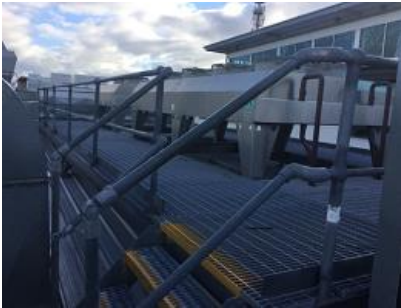
Variation in height between plant deck and unit is greater than required maximum	Trips, Slips and Falls	Awareness induction	Med	Midrails to be installed	Low	Client advised	Outstanding	OH&S REGULATIONS 3.7 AS/NZS 1657-2013 4.4

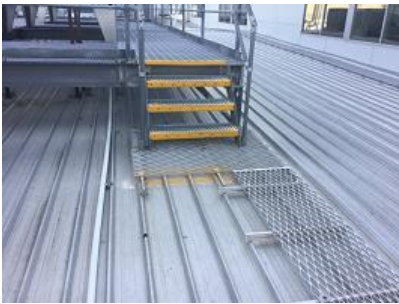
No	Photo of Hazard	Details of Hazard	Details of Risk	Existing/ Immediate Control Measure	Current Risk Level	Proposed Permanent Solution	Residual Risk Assessment	Details of Action Taken	Status	Reference
257	Building: General Stores Location Reference: L112 Task: Access to the plant deck

Non-complaint stair is present	Trips, Slips and Falls	Awareness induction	Med	Existing stair to be removed and new ladder to be installed	Low	Client advised	Outstanding	OH&S REGULATIONS 3.7 AS/NZS 1657-2013 7.2
258	Building: General Stores Location Reference: L112 Task: Access to the plant deck

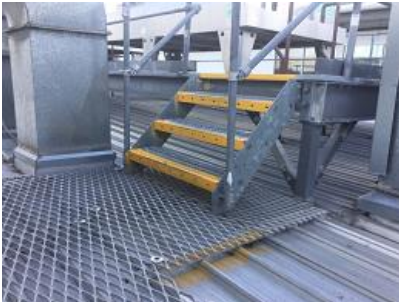
Non-complaint stair is present	Trips, Slips and Falls	Awareness induction	Med	Existing stair to be removed and new ladder to be installed	Low	Client advised	Outstanding	OH&S REGULATIONS 3.7 AS/NZS 1657-2013 7.2

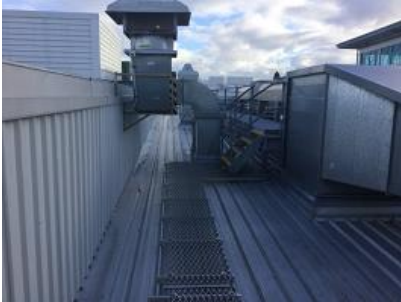
No	Photo of Hazard	Details of Hazard	Details of Risk	Existing/ Immediate Control Measure	Current Risk Level	Proposed Permanent Solution	Residual Risk Assessment	Details of Action Taken	Status	Reference
259	Building: General Stores Location Reference: L112 Task: Access to the plant deck

Headroom is less than required minimum	Head Injury	Awareness induction	High	"Warning-Low Headroom" signs to be installed	Low	Client advised	Outstanding	OH&S REGULATIONS 3.7 & 3.11 AS/NZS 1657-2013 3.1.5
260	Building: General Stores Location Reference: L112 Task: Access to the A/c unit

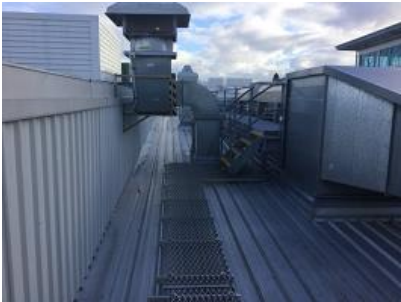
No safe access to the A/c unit	Trips, Slips and Falls	N/A	Low	Supply Walkway to the A/c unit	Low	Client advised	Outstanding	-

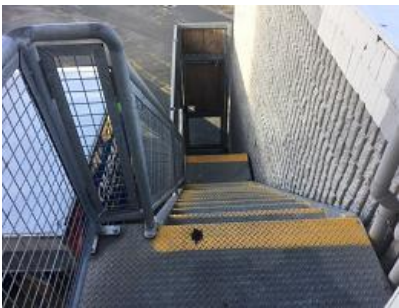
No	Photo of Hazard	Details of Hazard	Details of Risk	Existing/ Immediate Control Measure	Current Risk Level	Proposed Permanent Solution	Residual Risk Assessment	Details of Action Taken	Status	Reference
261	Building: General Stores Location Reference: L113 Task: Access to the roof

Toe board on landings is missing	Trips, Slips and Falls	Awareness induction	Med	Toe board for landing to be installed	Low	Client advised	Outstanding	OH&S REGULATIONS 3.7 AS/NZS 1657-2013 4.6
262	Building: General Stores Location Reference: L113 Task: Access to the roof

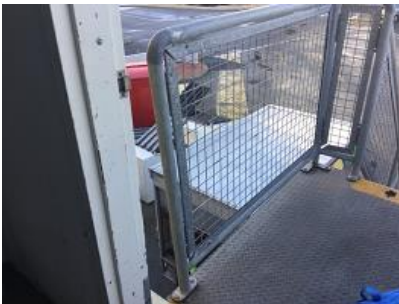
Gap between handrail post and structure is greater than required maximum	Trips, Slips and Falls	Awareness induction	High	Gap to filled with additional post/fabricated sheet	Low	Client advised	Outstanding	OH&S REGULATIONS 3.7 AS/NZS 1657-2013 4.4

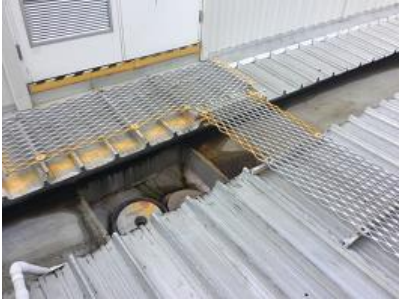
No	Photo of Hazard	Details of Hazard	Details of Risk	Existing/ Immediate Control Measure	Current Risk Level	Proposed Permanent Solution	Residual Risk Assessment	Details of Action Taken	Status	Reference
263	Building: General Stores Location Reference: L114 Task: Access to the roof

Variation in height between walkway and adjacent surface is greater than required maximum	Trips, Slips and Falls	Awareness induction	Med	Handrails to be installed	Low	Client advised	Outstanding	OH&S REGULATIONS 3.7 AS/NZS 1657-2013 5.4.1
264	Building: General Stores Location Reference: L114 Task: Access to the A/c units

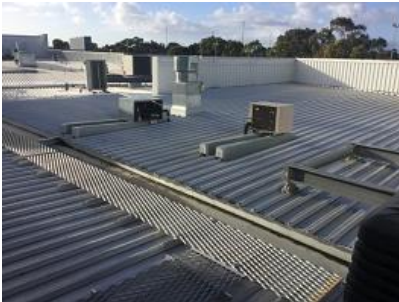
No safe access to the A/c units	Trips, Slips and Falls	N/A	Low	Supply walkway to the A/c units	Low	Client advised	Outstanding	-

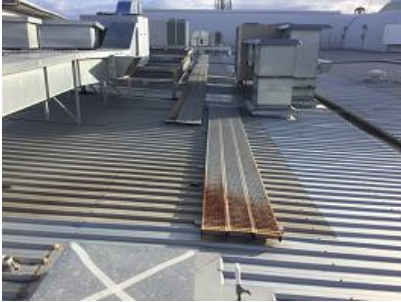
No	Photo of Hazard	Details of Hazard	Details of Risk	Existing/ Immediate Control Measure	Current Risk Level	Proposed Permanent Solution	Residual Risk Assessment	Details of Action Taken	Status	Reference
265	Building: General Stores Location Reference: L115 Task: Access to the A/c units

In-correct installation roof walkway	Trips, Slips and Falls	Awareness induction	Med	Existing walkway to be re-installed with new channels and fixings	Low	Client advised	Outstanding	OH&S REGULATIONS 3.7
266	Building: General Stores Location Reference: L115 Task: Access to the A/c units

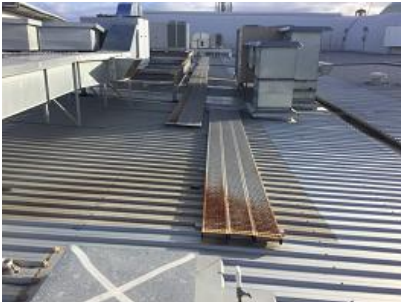
No safe access to the A/c units	Trips, Slips and Falls	N/A	Low	Supply walkway to the A/c units	Low	Client advised	Outstanding	-

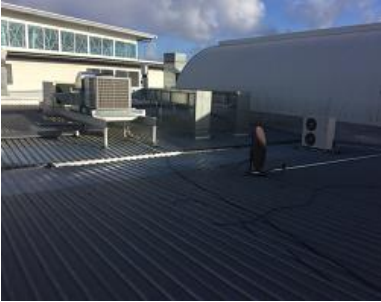
No	Photo of Hazard	Details of Hazard	Details of Risk	Existing/ Immediate Control Measure	Current Risk Level	Proposed Permanent Solution	Residual Risk Assessment	Details of Action Taken	Status	Reference
267	Building: General Stores Location Reference: L115 Task: Access to the A/c units

No safe access to the A/c units	Trips, Slips and Falls	N/A	Low	Supply walkway to the A/c units	Low	Client advised	Outstanding	-
268	Building: General Stores Location Reference: L115 Task: Access to the A/c units
