Roof Safety Report

Rockingham Centre, WA 6168

Prepared By: Safemaster Safety Products
Date: 10 Aug 2017

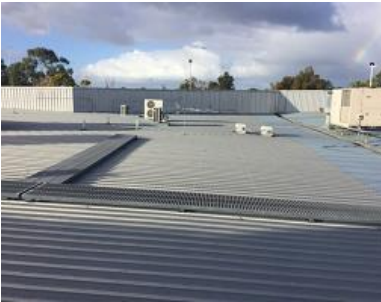
In-correct installation roof walkway	Trips, Slips and Falls	Awareness induction	Med	Existing walkway to be re-installed with additional channels and fixings	Low	Client advised	Outstanding	OH&S REGULATIONS 3.7

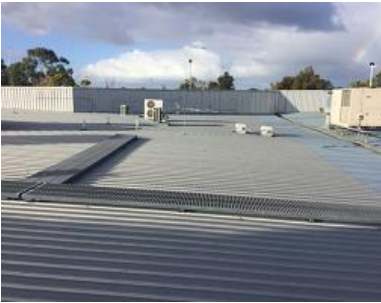
No	Photo of Hazard	Details of Hazard	Details of Risk	Existing/ Immediate Control Measure	Curre nt Risk Level	Proposed Permanent Solution	Resid ual Risk Asse ssme nt	Details of Action Taken	Status	Reference
269	Building: General Stores Location Reference: L115 Task: Access to the A/c units

No safe access to the A/c units	Trips, Slips and Falls	N/A	Low	Supply walkway to the A/c units	Low	Client advised	Outstanding	-
270	Building: General Stores Location Reference: L115 Task: Access to the A/c units

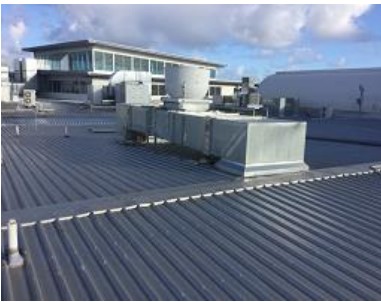
No safe access to the A/c units	Trips, Slips and Falls	N/A	Low	Supply walkway to the A/c units	Low	Client advised	Outstanding	-

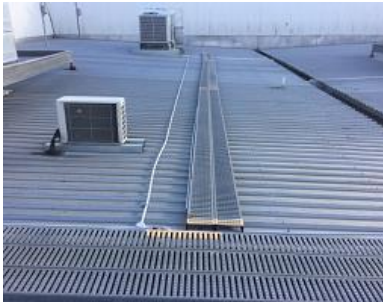
No	Photo of Hazard	Details of Hazard	Details of Risk	Existing/ Immediate Control Measure	Current Risk Level	Proposed Permanent Solution	Residual Risk Assessment	Details of Action Taken	Status	Reference
271	Building: General Stores Location Reference: L116 Task: Access to the A/c units

Walkway width is less than required minimum	Trips, Slips and Falls	Awareness induction	Med	Existing walkway to be removed and new walkway to be installed	Low	Client advised	Outstanding	OH&S REGULATIONS 3.7 AS/NZS 1657-2013 5.1.3
272	Building: General Stores Location Reference: L116 Task: Access to the A/c units

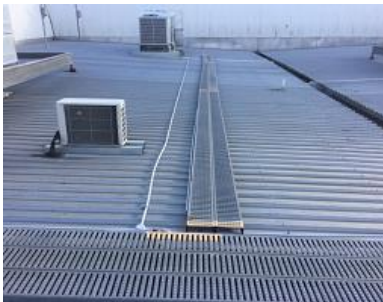
No safe access to the A/c units	Trips, Slips and Falls	N/A	Low	Supply walkway to the A/c units	Low	Client advised	Outstanding	-

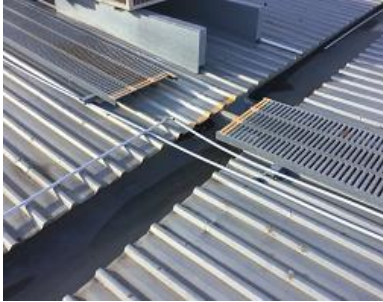
No	Photo of Hazard	Details of Hazard	Details of Risk	Existing/ Immediate Control Measure	Current Risk Level	Proposed Permanent Solution	Residual Risk Assessment	Details of Action Taken	Status	Reference
273	Building: General Stores Location Reference: L116 Task: Access to the A/c units

Gap between walkway panels are greater than required maximum	Trips, Slips and Falls	Awareness induction	Med	Walkway bridge to be installed	Low	Client advised	Outstanding	OH&S REGULATIONS 3.7 AS/NZS 1657-2013 3.2.3.4
274	Building: General Stores Location Reference: L116 Task: Access to the A/c units

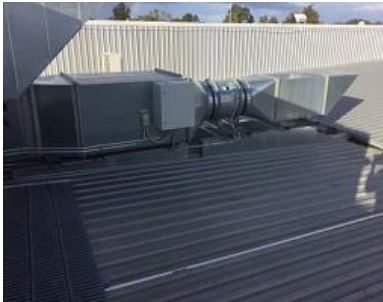
No safe access to the A/c units	Trips, Slips and Falls	N/A	Low	Supply walkway to the A/c units	Low	Client advised	Outstanding	-

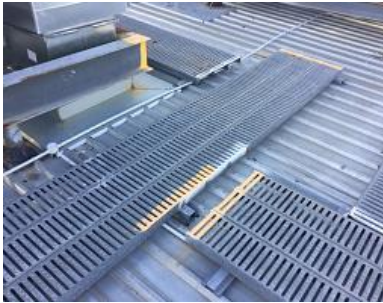
No	Photo of Hazard	Details of Hazard	Details of Risk	Existing/ Immediate Control Measure	Current Risk Level	Proposed Permanent Solution	Residual Risk Assessment	Details of Action Taken	Status	Reference
275	Building: General Stores Location Reference: L116 Task: Access to the A/c units

Gap between walkway panels are greater than required maximum	Trips, Slips and Falls	Awareness induction	Med	Additional walkway sections to be installed	Low	Client advised	Outstanding	OH&S REGULATIONS 3.7 AS/NZS 1657-2013 3.2.3.4
276	Building: General Stores Location Reference: L116 Task: Access to the A/c units

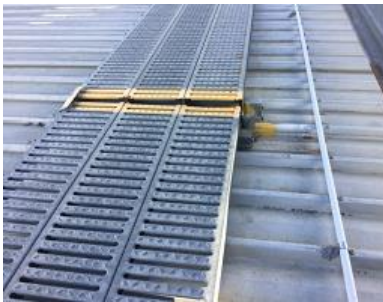
Walkway not fully secured	Trips, Slips and Falls	Awareness induction	Med	Walkway to be secured with additional fixings	Low	Client advised	Outstanding	OH&S REGULATIONS 3.7

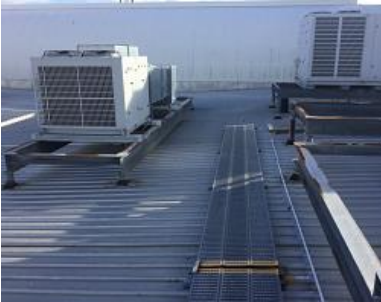
No	Photo of Hazard	Details of Hazard	Details of Risk	Existing/ Immediate Control Measure	Current Risk Level	Proposed Permanent Solution	Residual Risk Assessment	Details of Action Taken	Status	Reference
277	Building: General Stores Location Reference: L116 Task: Access to the A/c units

No safe access to the A/c units	Trips, Slips and Falls	N/A	Low	Supply walkway to the A/c units	Low	Client advised	Outstanding	-
278	Building: General Stores Location Reference: L116 Task: Access to the A/c units

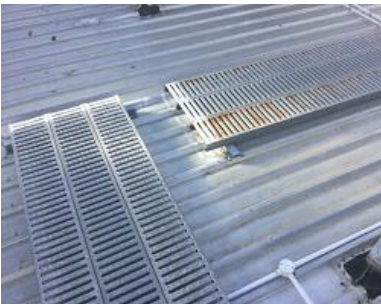
Gap between walkway panels are greater than required maximum	Trips, Slips and Falls	Awareness induction	Med	Additional walkway section to be installed	Low	Client advised	Outstanding	OH&S REGULATIONS 3.7 AS/NZS 1657-2013 3.2.3.4

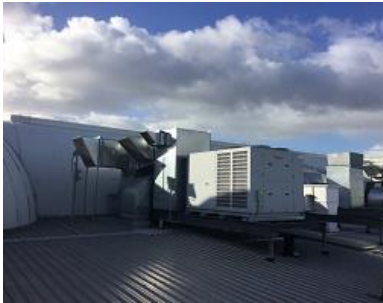
No	Photo of Hazard	Details of Hazard	Details of Risk	Existing/ Immediate Control Measure	Curre nt Risk Level	Proposed Permanent Solution	Resid ual Risk Asse ssme nt	Details of Action Taken	Status	Reference
279	Building: General Stores Location Reference: L116 Task: Access to the A/c units

No safe access to the A/c units	Trips, Slips and Falls	N/A	Low	Supply walkway to the A/c units	Low	Client advised	Outstanding	-
280	Building: General Stores Location Reference: L116 Task: Access to the A/c units

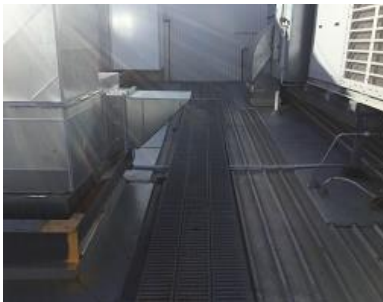
Duct protrudes over the walkway path	Trips, Slips and Falls	Awareness induction	Med	Additional walkway section to be installed	Low	Client advised	Outstanding	OH&S REGULATIONS 3.7

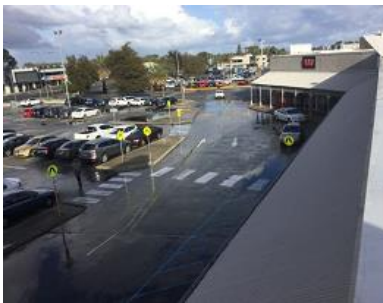
No	Photo of Hazard	Details of Hazard	Details of Risk	Existing/ Immediate Control Measure	Current Risk Level	Proposed Permanent Solution	Residual Risk Assessment	Details of Action Taken	Status	Reference
281	Building: General Stores Location Reference: L117 Task: Restrict access to the roof

No height safety system installed	Trips, Slips and Falls	Restrict Access	High	"EWP Access Only" signs to be installed	Low	Client advised	Outstanding	OH&S REGULATIONS 3.55 & 3.11
282	Building: General Stores Location Reference: L118 Task: Restrict access to the roof

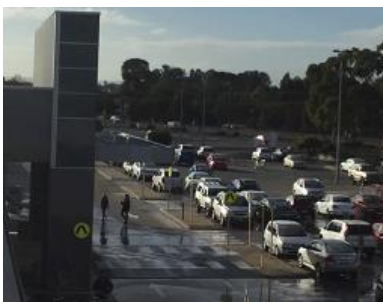
No height safety system installed	Trips, Slips and Falls	Restrict Access	High	"EWP Access Only" sign to be installed	Low	Client advised	Outstanding	OH&S REGULATIONS 3.55 & 3.11

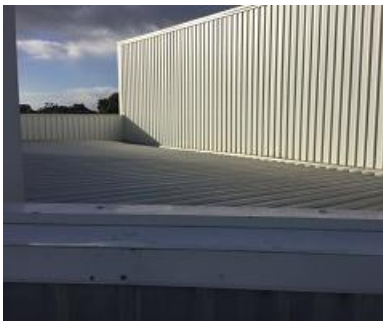
No	Photo of Hazard	Details of Hazard	Details of Risk	Existing/ Immediate Control Measure	Current Risk Level	Proposed Permanent Solution	Residual Risk Assessment	Details of Action Taken	Status	Reference
283	Building: General Stores Location Reference: L118 Task: Access to the roof

No height safety system installed and no safe access provided	Trips, Slips and Falls	Awareness induction	High	Fall arrest anchors, anchor stop and ladder to be installed	Low	Client advised	Outstanding	OH&S REGULATIONS 3.7 & 3.55 AS/NZS 1657-2013 3.1.4
284	Building: General Stores Location Reference: L119 Task: Restrict access to the roof

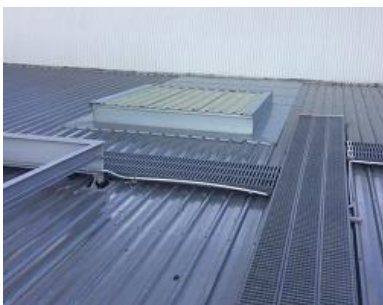
Brittle roof (Non-trafficable roof)	Trips, Slips and Falls	Restrict Access	High	"Warning-Keep Off-Brittle and Fragile Roof" sign to be installed	Low	Client advised	Outstanding	OH&S REGULATIONS 3.57

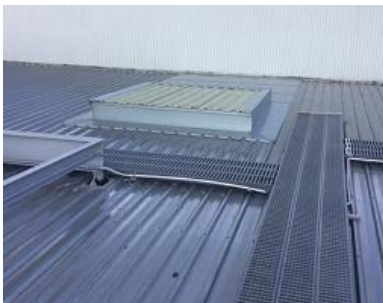
No	Photo of Hazard	Details of Hazard	Details of Risk	Existing/ Immediate Control Measure	Current Risk Level	Proposed Permanent Solution	Residual Risk Assessment	Details of Action Taken	Status	Reference
285	Building: General Stores Location Reference: L119 Task: Access to the roof

Gap between walkway and brittle roof is less than required minimum	Trips, Slips and Falls	Awareness induction	High	Handrail to be installed	Low	Client advised	Outstanding	OH&S REGULATIONS 3.7 AS/NZS 1657-2013 5.4.1
286	Building: General Stores Location Reference: L119 Task: Access to the A/c units

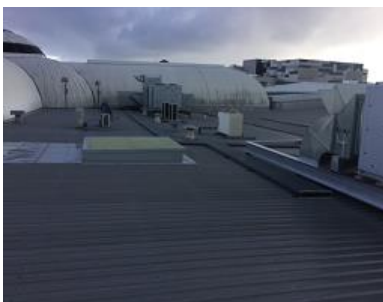
No safe access to the A/c units	Trips, Slips and Falls	N/A	Low	Supply walkway to the A/c units	Low	Client advised	Outstanding	-

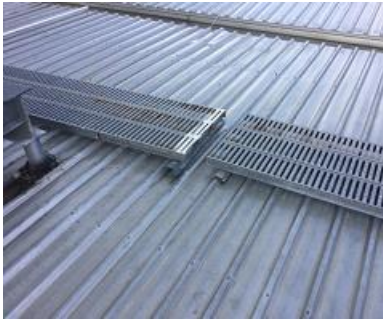
Gap between walkway panels are greater than required maximum	Trips, Slips and Falls	Awareness induction	Med	Additional walkway section to be installed	Low	Client advised	Outstanding	OH&S REGULATIONS 3.7
288	Building: General Stores Location Reference: L120 Task: Restrict access to the roof

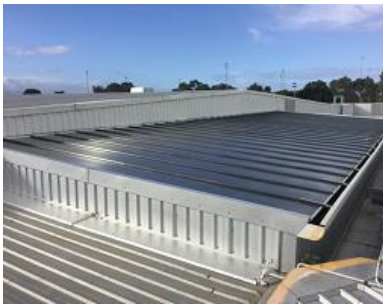
Brittle roof (Non-trafficable roof)	Trips, Slips and Falls	Restrict Access	High	"Warning-Keep Off-Brittle and Fragile Roof" signs to be installed	Low	Client advised	Outstanding	OH&S REGULATIONS 3.57

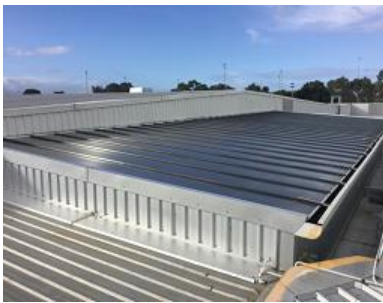
No height safety system installed	Trips, Slips and Falls	Awareness induction	High	Fall arrest anchors to be installed	Low	Client advised	Outstanding	OH&S REGULATIONS 3.55
290	Building: General Stores Location Reference: L121 Task: Access to the A/c unit

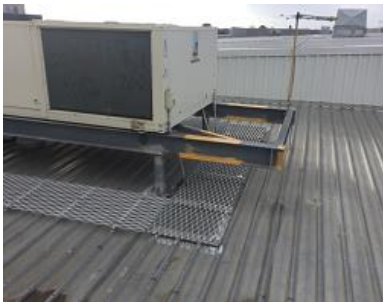
No safe access to the A/c unit and beam protrudes over the walkway path	Trips, Slips and Falls	Awareness induction	Med	Access ladder, Walkway mesh, handrails and additional walkway sections to be installed	Low	Client advised	Outstanding	OH&S REGULATIONS 3.7 AS/NZS 1657-2013 3.1.4

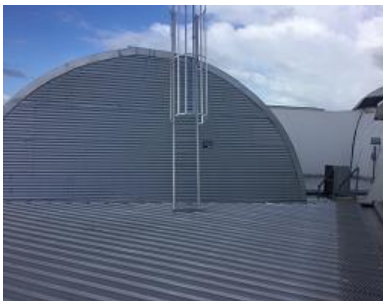
Un even rung heights, Gap between ladder and structure is less than required minimum and no levelled landing platform at top	Trips, Slips and Falls	Awareness induction	Med	Existing ladder to be removed and new ladder to be installed	Low	Client advised	Outstanding	OH&S REGULATIONS 3.7 AS/NZS 1657-2013 7.4.3.2 & 7.4.5 & 7.3.6
292	Building: General Stores Location Reference: L121 Task: Access to the roof

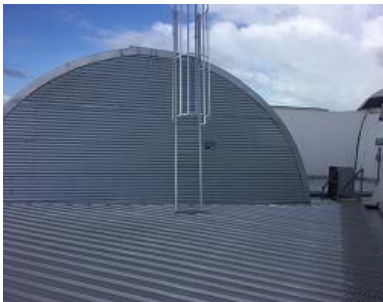
No safe access to the ladder	Trips, Slips and Falls	N/A	Low	Supply walkway to the ladder	Low	Client advised	Outstanding	-

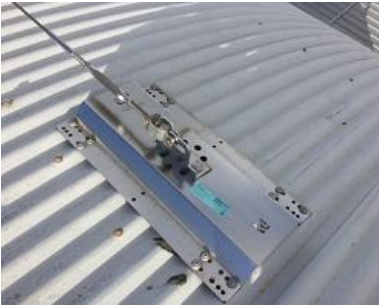
Screws missing for static line (Non-complaint)	Trips, Slips and Falls	Awareness induction	High	Existing static line to be removed and new static line to be installed	Low	Client advised	Outstanding	OH&S REGULATIONS 3.55
294	Building: General Stores Location Reference: L121 Task: Access to the roof

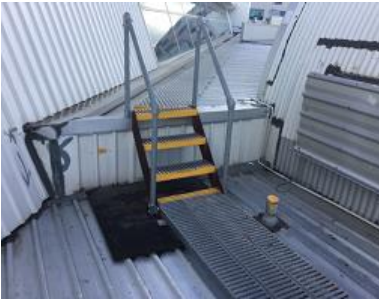
Non-complaint stair	Trips, Slips and Falls	Awareness induction	Med	Existing stair to be removed and New ladder including handrails to be installed	Low	Client advised	Outstanding	OH&S REGULATIONS 3.7 AS/NZS 1657-2013 7.2

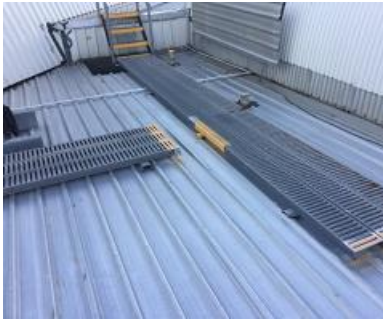
Gap between walkway panels are greater than required maximum	Trips, Slips and Falls	Awareness induction	Med	Additional walkway section to be installed	Low	Client advised	Outstanding	OH&S REGULATIONS 3.7 AS/NZS 1657-2013 3.2.3.4
296	Building: General Stores Location Reference: L121 Task: Access to the roof

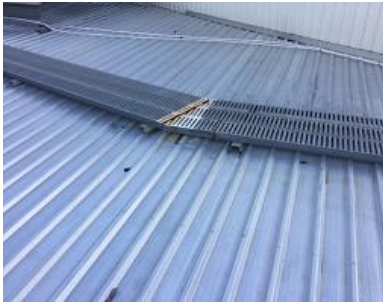
In-correct installation of walkway	Trips, Slips and Falls	Awareness induction	Med	Walkway to be fully secured with additional channels and fixings	Low	Client advised	Outstanding	OH&S REGULATIONS 3.7

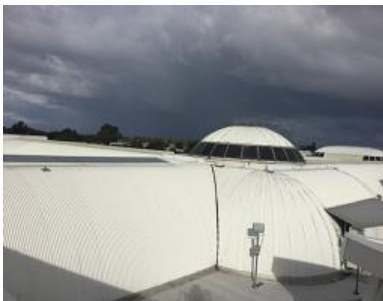
Brittle roof (Non-trafficable roof)	Trips, Slips and Falls	Restrict Access	High	"Warning-Keep Off-Brittle and Fragile Roof" signs to be installed	Low	Client advised	Outstanding	OH&S REGULATIONS 3.57
298	Building: General Stores Location Reference: L124 Task: Access to the roof

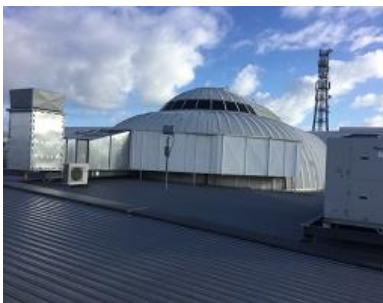
Not enough static line installed to cover the fall edge	Trips, Slips and Falls	Awareness induction	High	Static lines to be installed	Low	Client advised	Outstanding	OH&S REGULATIONS 3.55

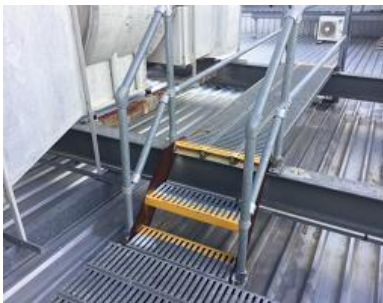
Un-even tread heights is present	Trips, Slips and Falls	Awareness induction	Med	Existing stairs to be removed and New ladders to be installed	Low	Client advised	Outstanding	OH&S REGULATIONS 3.7 AS/NZS 1657-2013 7.2
300	Building: General Stores Location Reference: L126 Task: Access to the A/c unit

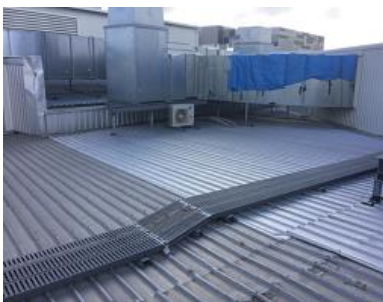
No safe access to the A/c unit	Trips, Slips and Falls	N/A	Low	Supply walkway to the A/c unit	Low	Client advised	Outstanding	-

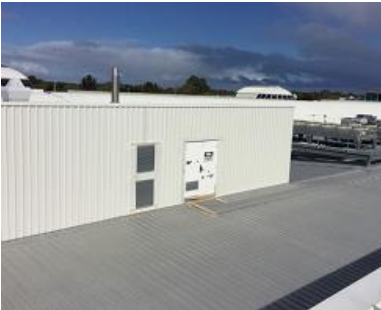
No safe access to the roof	Trips, Slips and Falls	Awareness induction	Med	Access ladder including handrails to be installed	Low	Client advised	Outsta nding	OH&S REGULATIONS 3.7 AS/NZS 1657- 2013 3.1.4
302	Building: General Stores Location Reference: L127 Task: Access to the A/c unit

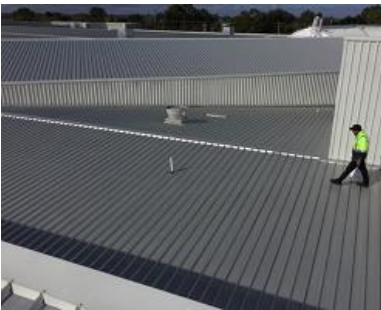
No safe access to the A/c unit	Trips, Slips and Falls	N/A	Low	Supply walkway to the A/c unit	Low	Client advised	Outsta nding	-

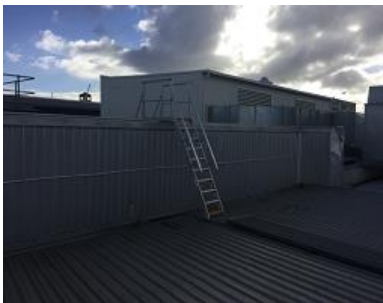
Landing is less than required minimum and handrail projecting towards the user	Trips, Slips and Falls	Awareness induction	Med	Existing handrails to be removed. New landing platforms and handrails to be installed	Low	Client advised	Outstanding	OH&S REGULATIONS 3.7 AS/NZS 1657-2013 7.3.6 & 7.4.8.5
304	Building: General Stores Location Reference: L129 Task: Access to the plant deck

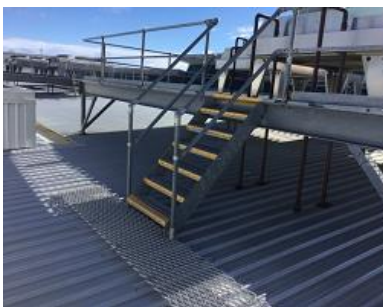
Un-even tread heights is present	Trips, Slips and Falls	Awareness induction	Med	Existing stair to be removed and new ladder including handrails to be installed	Low	Client advised	Outstanding	OH&S REGULATIONS 3.7 AS/NZS 1657-2013 7.2

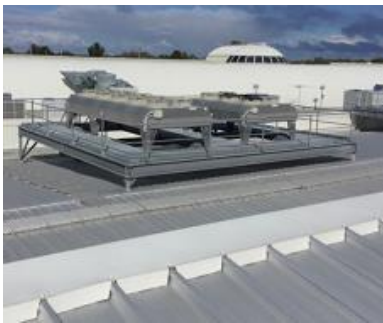
Variation in height between plant deck and unit is greater than required maximum	Trips, Slips and Falls	Awareness induction	Med	Midrail to be installed	Low	Client advised	Outstanding	OH&S REGULATIONS 3.7 AS/NZS 1657-2013 4.4
306	Building: General Stores Location Reference: L130 Task: Access to the plant deck

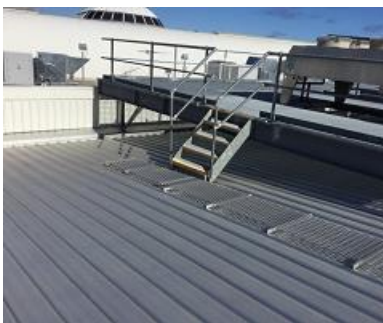
Un-even tread heights is present	Trips, Slips and Falls	Awareness induction	Med	Existing stair to be removed and new ladder including handrails to be installed	Low	Client advised	Outstanding	OH&S REGULATIONS 3.7 AS/NZS 1657-2013 7.2

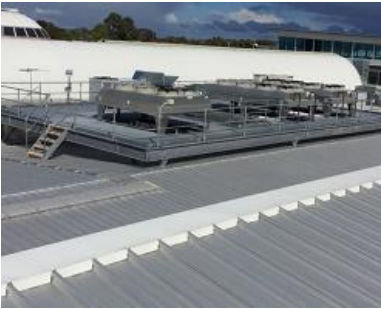
Variation in height between plant deck and unit is greater than required maximum	Trips, Slips and Falls	Awareness induction	Med	Midrail to be installed	Low	Client advised	Outstanding	OH&S REGULATIONS 3.7 AS/NZS 1657-2013 4.4
308	Building: General Stores Location Reference: L130 Task: Access to the A/c units

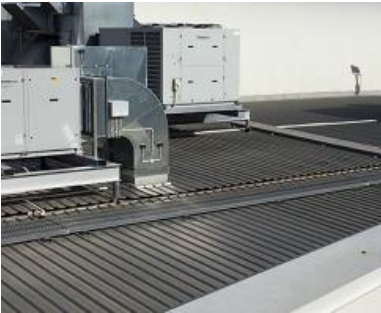
No safe access to the A/c units	Trips, Slips and Falls	N/A	Low	Supply walkway to the A/c units	Low	Client advised	Outstanding	-

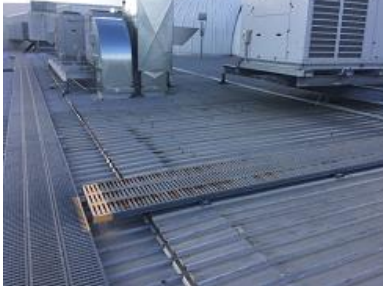
In-correct installation of walkway	Trips, Slips and Falls	Awareness induction	Med	Additional channels and fixings to be installed	Low	Client advised	Outstanding	OH&S REGULATIONS 3.7
310	Building: General Stores Location Reference: L130 Task: Access to the A/c units

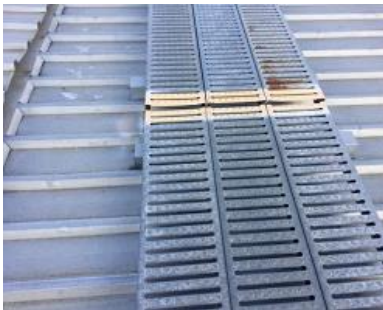
In-correct installation of walkway	Trips, Slips and Falls	Awareness induction	Med	Additional channels and fixings to be installed	Low	Client advised	Outstanding	OH&S REGULATIONS 3.7

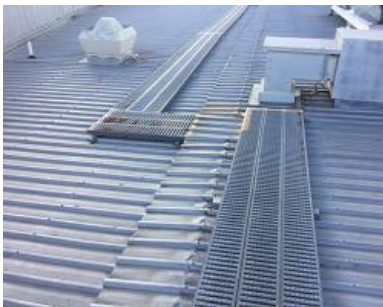
Gap between walkway panels are greater than required maximum	Trips, Slips and Falls	Awareness induction	Med	Additional walkway section to be installed	Low	Client advised	Outstanding	OH&S REGULATIONS 3.7 AS/NZS 1657-2013 3.2.3.4
312	Building: General Stores Location Reference: L130 Task: Access to the A/c units

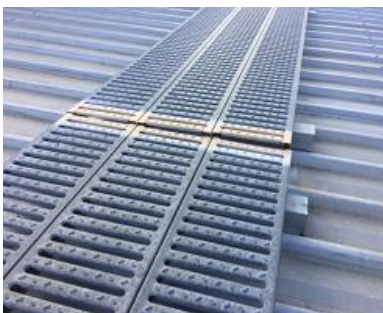
In-correct installation of walkway	Trips, Slips and Falls	Awareness induction	Med	Additional channels and fixings to be installed	Low	Client advised	Outstanding	OH&S REGULATIONS 3.7

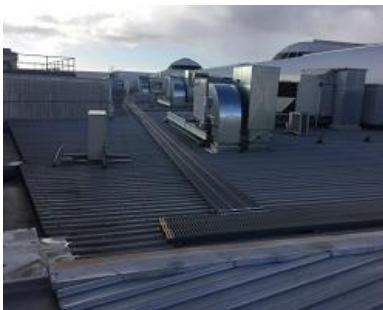
No safe access to the A/c units	Trips, Slips and Falls	N/A	Low	Supply walkway to the A/c units	Low	Client advised	Outstanding	-
314	Building: General Stores Location Reference: L131 Task: Access to the roof

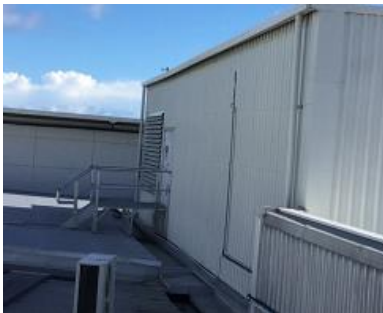
No safe access to the roof	Trips, Slips and Falls	Awareness induction	High	Access ladder including handrails to be installed	Low	Client advised	Outstanding	OH&S REGULATIONS 3.7 AS/NZS 1657-2013 3.1.4

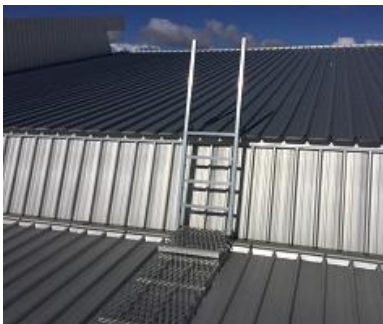
Landing platforms are missing and Gap between ladder and structure is less than required minimum	Trips, Slips and Falls	Awareness induction	Med	Existing ladder to be removed and new ladder including handrails to be installed	Low	Client advised	Outstanding	OH&S REGULATIONS 3.7 AS/NZS 1657-2013 7.3.6 & 7.4.5
316	Building: General Stores Location Reference: L133 Task: Access to the roof

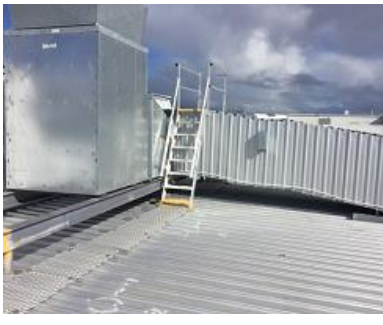
Bottom tread height is less than required minimum and handrails projecting towards the user	Trips, Slips and Falls	Awareness induction	Med	Existing handrails to be removed and new landing platforms and handrails to be installed	Low	Client advised	Outstanding	OH&S REGULATIONS 3.7 AS/NZS 1657-2013 7.3.3.2 & 7.3.4

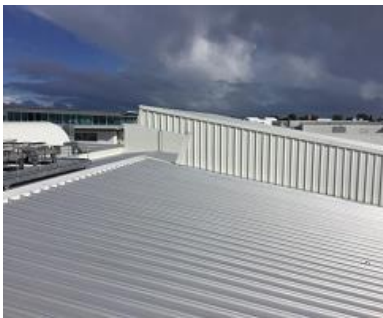
No height safety system installed	Trips, Slips and Falls	Awareness induction	High	Fall arrest anchors, anchor stop and Access ladder to be installed	Low	Client advised	Outstanding	OH&S REGULATIONS 3.7 AS/NZS 1657-2013 7.3.3.1
318	Building: General Stores Location Reference: L134 Task: Access to the roof

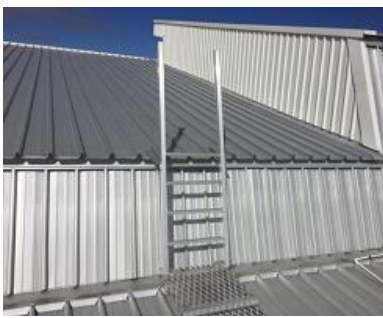
Landing platforms are missing and Gap between ladder and structure is less than required minimum	Trips, Slips and Falls	Awareness induction	Med	Existing ladder to be removed and new ladder including handrails to be installed	Low	Client advised	Outstanding	OH&S REGULATIONS 3.7 AS/NZS 1657-2013 7.3.6 & 7.4.5

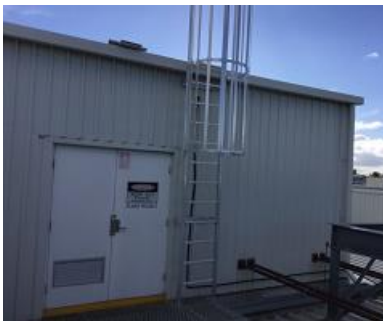
Gap between ladder and structure is less than required minimum and landing platform is missing at top	Trips, Slips and Falls	Awareness induction	Med	Existing ladder to be re-installed with new brackets, landing platforms and handrails. Existing ladder bracket to be removed.	Low	Client advised	Outstanding	OH&S REGULATIONS 3.7 AS/NZS 1657-2013 7.4.5 & 7.3.6
320	Building: General Stores Location Reference: L135 Task: Access to the A/c units

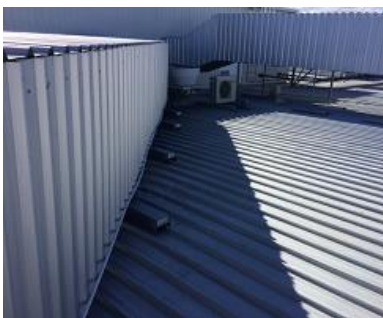
No safe access to the A/c units	Trips, Slips and Falls	N/A	Low	Supply walkway to the A/c units	Low	Client advised	Outstanding	-

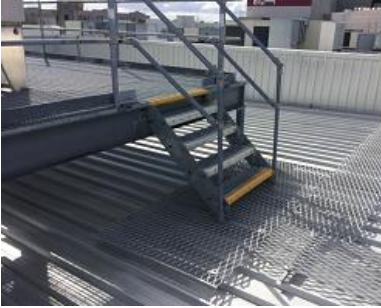
Un-even tread heights is present	Trips, Slips and Falls	Awareness induction	Med	Existing stair to be removed and new ladder including handrails to be installed	Low	Client advised	Outstanding	OH&S REGULATIONS 3.7 AS/NZS 1657-2013 7.2
322	Building: General Stores Location Reference: L136 Task: Access to the plant deck

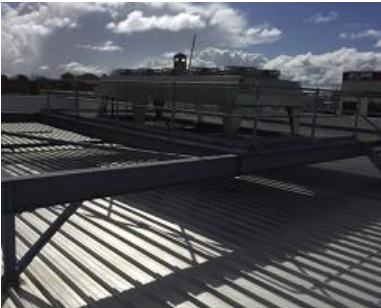
Variation in height between plant deck and unit is greater than required maximum	Trips, Slips and Falls	Awareness induction	Med	Midrail to be installed	Low	Client advised	Outstanding	OH&S REGULATIONS 3.7 AS/NZS 1657-2013 4.4

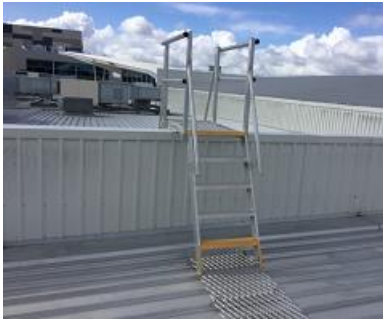
Bottom tread height is less than required minimum and handrails projecting towards the user	Trips, Slips and Falls	Awareness induction	Med	Existing handrails to be removed and New landing platforms and handrails to be installed	Low	Client advised	Outstanding	OH&S REGULATIONS 3.7 AS/NZS 1657-2013 7.3.3.2 & 7.4.8.5
324	Building: General Stores Location Reference: L137 Task: Access to the A/c unit

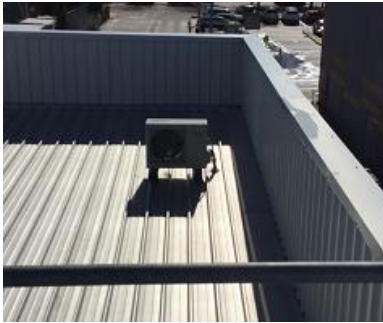
No safe access to the A/c unit	Trips, Slips and Falls	N/A	Low	Supply walkway to the A/c unit	Low	Client advised	Outstanding	-

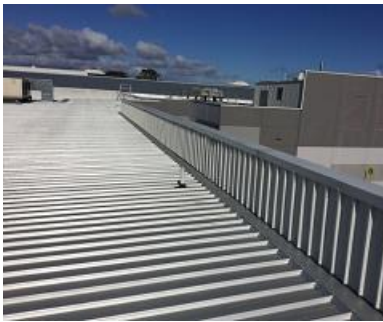
No height safety system installed	Trips, Slips and Falls	Awareness induction	High	Fall arrest anchors to be installed	Low	Client advised	Outstanding	OH&S REGULATIONS 3.55
326	Building: General Stores Location Reference: L139 Task: Access to the A/c unit

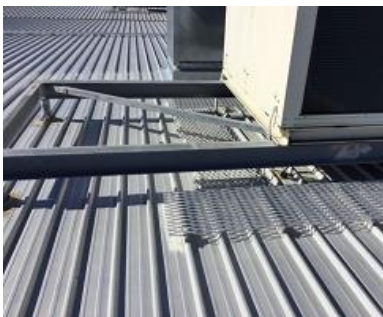
No safe access to the A/c unit	Trips, Slips and Falls	Awareness induction	Med	Steps, walkway mesh and handrails to be installed	Low	Client advised	Outstanding	OH&S REGULATIONS 3.7 AS/NZS 1657-2013 3.1.4

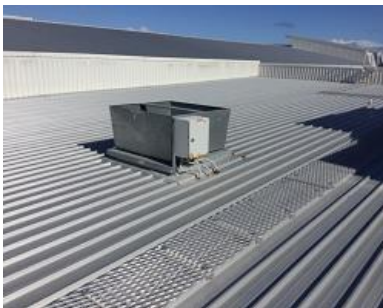
No safe access to the A/c unit	Trips, Slips and Falls	N/A	Low	Supply walkway to the A/c unit	Low	Client advised	Outstanding	-
328	Building: General Stores Location Reference: L140 Task: Access to the A/c unit

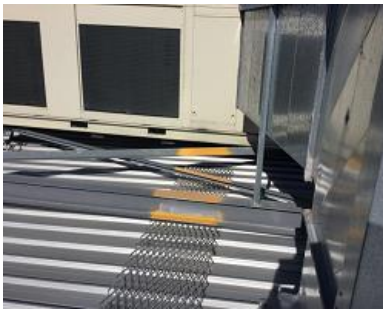
No safe access to the A/c unit	Trips, Slips and Falls	Awareness induction	Med	Steps, walkway mesh and handrails to be installed	Low	Client advised	Outstanding	OH&S REGULATIONS 3.7 AS/NZS 1657-2013 3.1.4

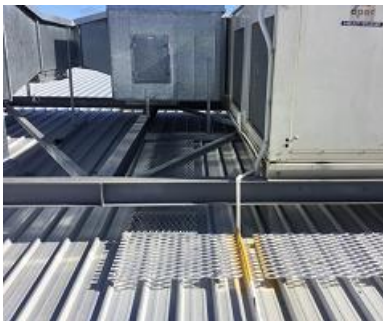
No safe access to the A/c unit	Trips, Slips and Falls	Awareness induction	Med	Steps, walkway mesh and handrails to be installed	Low	Client advised	Outstanding	OH&S REGULATIONS 3.7 AS/NZS 1657-2013 3.1.4
330	Building: General Stores Location Reference: L141 Task: Access to the A/c unit

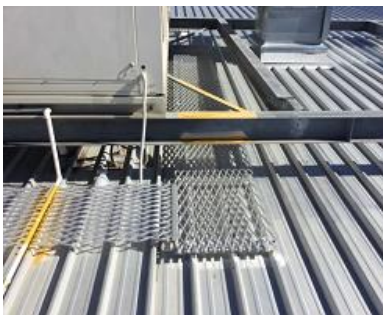
No safe access to the A/c unit	Trips, Slips and Falls	Awareness induction	Med	Steps, walkway mesh and handrails to be installed	Low	Client advised	Outstanding	OH&S REGULATIONS 3.7 AS/NZS 1657-2013 3.1.4

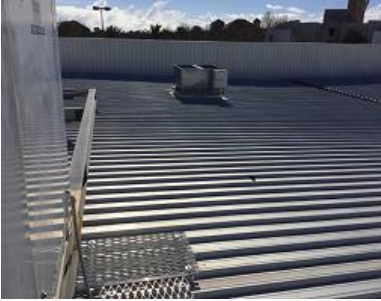
No safe access to the A/c unit	Trips, Slips and Falls	N/A	Low	Supply walkway to the A/c unit	Low	Client advised	Outstanding	-
332	Building: General Stores Location Reference: L142 Task: Access to the A/c unit

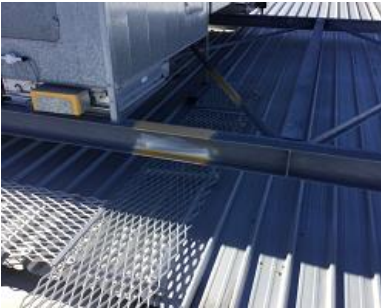
No safe access to the A/c unit	Trips, Slips and Falls	Awareness induction	Med	Steps, walkway mesh and handrails to be installed	Low	Client advised	Outstanding	OH&S REGULATIONS 3.7 AS/NZS 1657-2013 3.1.4

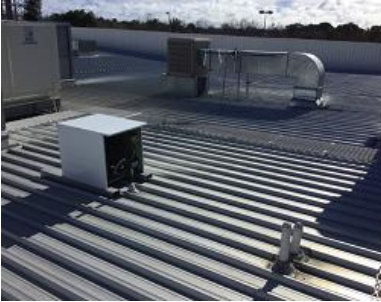
No safe access to the A/c unit	Trips, Slips and Falls	N/A	Low	Supply walkway to the A/c unit	Low	Client advised	Outstanding	-
334	Building: General Stores Location Reference: L142 Task: Access to the A/c unit

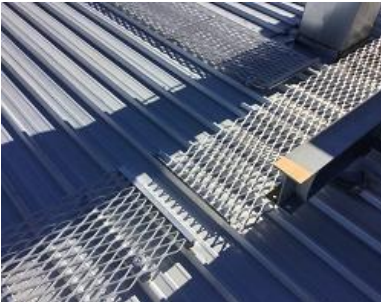
Gap between walkway panels are greater than required maximum	Trips, Slips and Falls	Awareness induction	Med	Additional walkway sections to be installed	Low	Client advised	Outstanding	OH&S REGULATIONS 3.7 AS/NZS 1657-2013 3.2.3.4

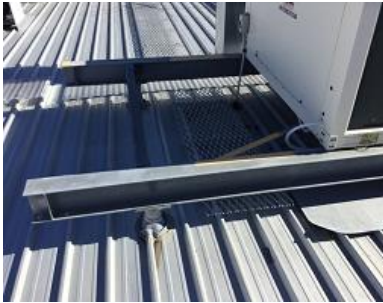
No safe access to the A/c unit	Trips, Slips and Falls	Awareness induction	Med	Steps, walkway mesh and handrails to be installed	Low	Client advised	Outstanding	OH&S REGULATIONS 3.7 AS/NZS 1657-2013 3.1.4
336	Building: General Stores Location Reference: L143 Task: Access to the A/c unit

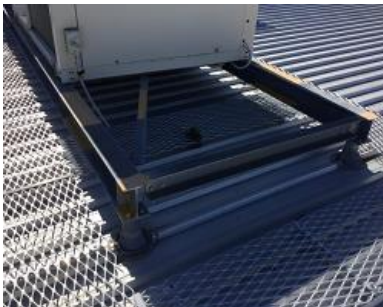
No safe access to the A/c unit	Trips, Slips and Falls	Awareness induction	Med	Steps, walkway mesh and handrails to be installed	Low	Client advised	Outstanding	OH&S REGULATIONS 3.7 AS/NZS 1657-2013 3.1.4

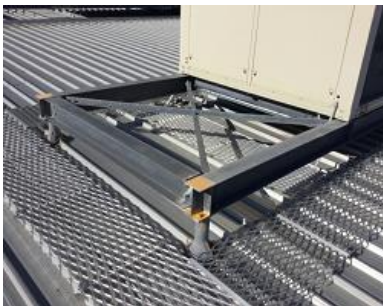
No safe access to the A/c unit	Trips, Slips and Falls	Awareness induction	Med	Steps, walkway mesh and handrails to be installed	Low	Client advised	Outstanding	OH&S REGULATIONS 3.7 AS/NZS 1657-2013 3.1.4
338	Building: General Stores Location Reference: L145 Task: Access to the A/c unit

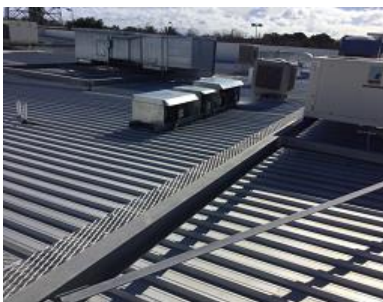
No safe access to the A/c unit	Trips, Slips and Falls	N/A	Low	Supply walkway to the A/c unit	Low	Client advised	Outstanding	-

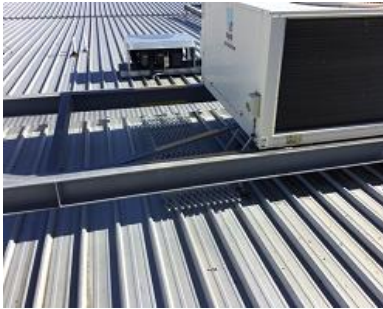
No safe access to the A/c unit	Trips, Slips and Falls	Awareness induction	Med	Steps, walkway mesh and handrails to be installed	Low	Client advised	Outstanding	OH&S REGULATIONS 3.7 AS/NZS 1657-2013 3.1.4
340	Building: General Stores Location Reference: L145 Task: Access to the A/c unit

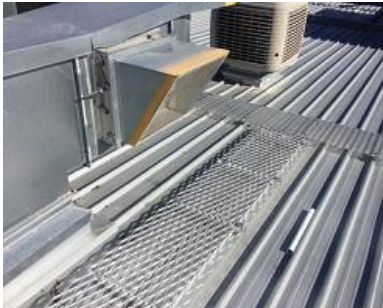
Duct protrudes over the walkway path	Trips, Slips and Falls	Awareness induction	Med	Additional walkway section to be installed	Low	Client advised	Outstanding	OH&S REGULATIONS 3.7

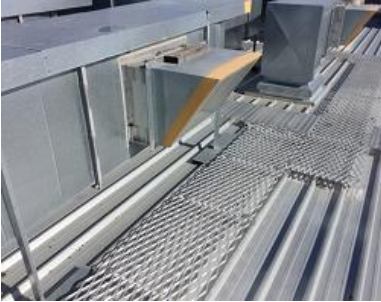
No safe access to the A/c unit	Trips, Slips and Falls	Awareness induction	Med	Additional walkway section to be installed	Low	Client advised	Outstanding	OH&S REGULATIONS 3.7
342	Building: General Stores Location Reference: L145 Task: Access to the A/c unit

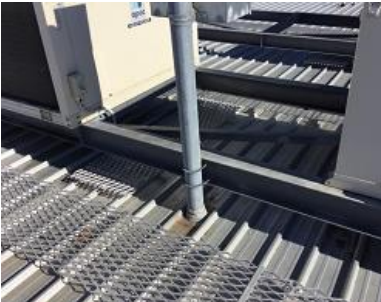
No safe access to the A/c unit	Trips, Slips and Falls	Awareness induction	Med	Steps, walkway mesh and handrails to be installed	Low	Client advised	Outstanding	OH&S REGULATIONS 3.7 AS/NZS 1657-2013 3.1.4

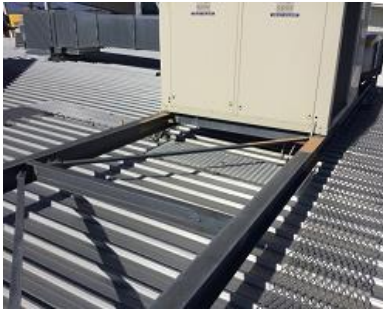
No safe access to the A/c unit	Trips, Slips and Falls	Awareness induction	Med	Steps, walkway mesh and handrails to be installed	Low	Client advised	Outstanding	OH&S REGULATIONS 3.7 AS/NZS 1657-2013 3.1.4
344	Building: General Stores Location Reference: L146 Task: Access to the roof

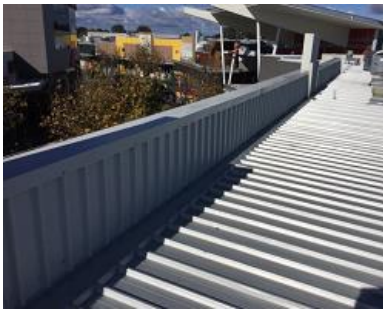
No height safety system installed	Trips, Slips and Falls	Awareness induction	High	Fall arrest anchors to be installed	Low	Client advised	Outstanding	OH&S REGULATIONS 3.55

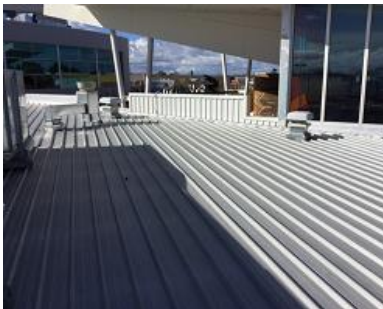
No safe access to the A/c units	Trips, Slips and Falls	N/A	Low	Supply walkway to the A/c units	Low	Client advised	Outstanding	-
346	Building: General Stores Location Reference: L147 Task: Access to the roof

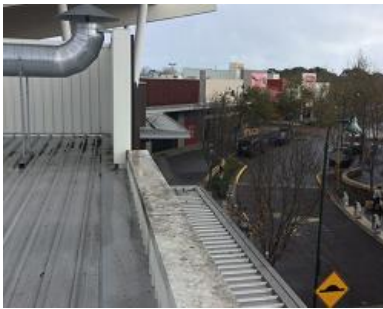
No height safety system installed	Trips, Slips and Falls	Awareness induction	High	Static line, anchor strop, ladder access bracket and signage to be installed	Low	Client advised	Outstanding	OH&S REGULATIONS 3.55

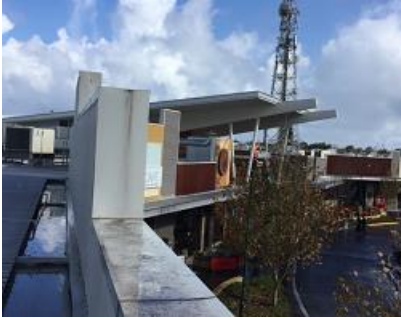
No height safety system installed	Trips, Slips and Falls	Awareness induction	High	Fall arrest anchors to be installed	Low	Client advised	Outstanding	OH&S REGULATIONS 3.55
348	Building: General Stores Location Reference: L149 Task: Access to the roof

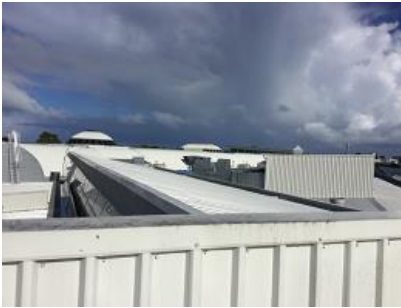
No height safety system installed and No safe access to the roof provided	Trips, Slips and Falls	Awareness induction	High	Fall arrest anchors and access ladder to be installed	Low	Client advised	Outstanding	OH&S REGULATIONS 3.7 & 3.55 AS/NZS 1657-2013 3.1.4

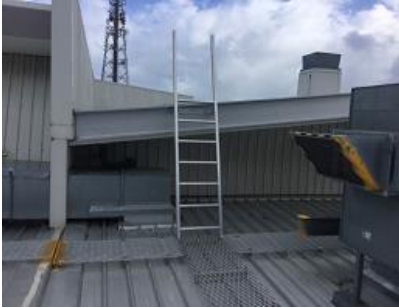
No	Photo of Hazard	Details of Hazard	Details of Risk	Existing/ Immediate Control Measure	Current Risk Level	Proposed Permanent Solution	Residual Risk Assessment	Details of Action Taken	Status	Reference
349	Building: General Stores Location Reference: L150 Task: Access to the roof

Bottom rung height is less than required minimum and top rung not levelled with landing	Trips, Slips and Falls	Awareness induction	Med	Existing ladder to be removed and new ladder including handrails to be installed	Low	Client advised	Outstanding	OH&S REGULATIONS 3.7 AS/NZS 1657-2013 7.4.3.4 & 7.4.3.3
350	Building: General Stores Location Reference: L150 Task: Access to the roof

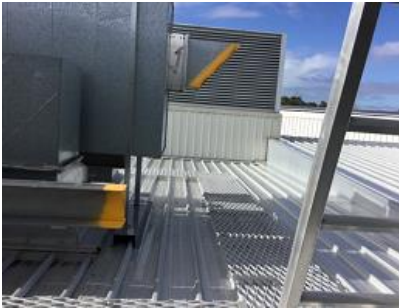
Duct protrudes over the walkway path	Trips, Slips and Falls	Awareness induction	Med	Additional walkway section to be installed	Low	Client advised	Outstanding	OH&S REGULATIONS 3.7

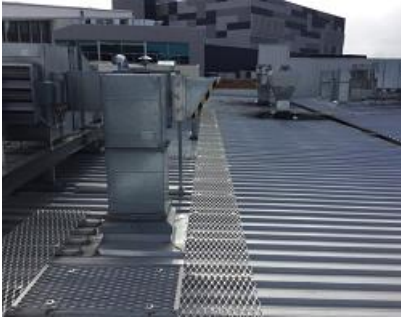
No	Photo of Hazard	Details of Hazard	Details of Risk	Existing/ Immediate Control Measure	Curre nt Risk Level	Proposed Permanent Solution	Resid ual Risk Asse ssme nt	Details of Action Taken	Status	Reference
351	Building: General Stores Location Reference: L150 Task: Access to the roof

Duct protrudes over the walkway path	Trips, Slips and Falls	Awareness induction	Med	Additional walkway section to be installed	Low	Client advised	Outstanding	OH&S REGULATIONS 3.7
352	Building: General Stores Location Reference: L150 Task: Access to the A/c units

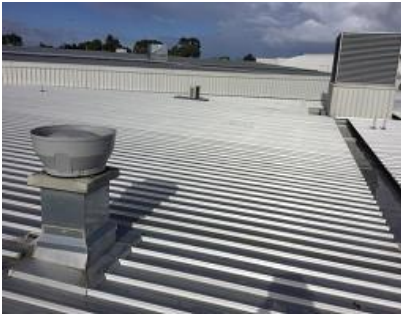
No safe access to the A/c units	Trips, Slips and Falls	N/A	Low	Supply walkway to the A/c units	Low	Client advised	Outstanding	-

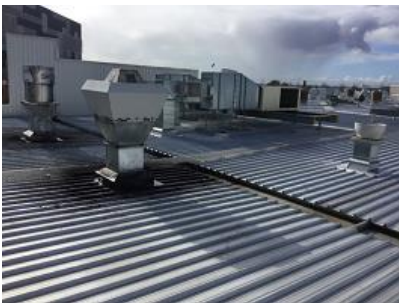
No	Photo of Hazard	Details of Hazard	Details of Risk	Existing/ Immediate Control Measure	Curre nt Risk Level	Proposed Permanent Solution	Resid ual Risk Asse ssme nt	Details of Action Taken	Status	Reference
353	Building: General Stores Location Reference: L150 Task: Access to the A/c units

No safe access to the A/c units	Trips, Slips and Falls	N/A	Low	Supply walkway to the A/c units	Low	Client advised	Outstanding	-
354	Building: General Stores Location Reference: L151 Task: Access to the roof

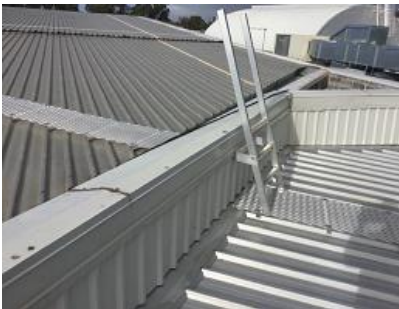
Landing is less than required minimum	Trips, Slips and Falls	Awareness induction	Med	Existing ladder to be removed and new ladder to be installed	Low	Client advised	Outstanding	OH&S REGULATIONS 3.7 AS/NZS 1657-2013 7.3.6

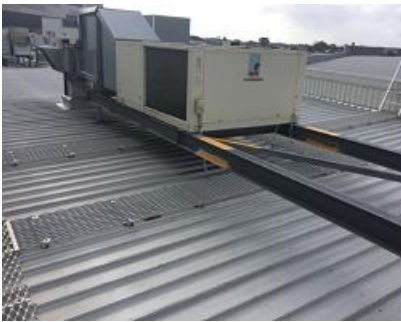
No	Photo of Hazard	Details of Hazard	Details of Risk	Existing/ Immediate Control Measure	Current Risk Level	Proposed Permanent Solution	Residual Risk Assessment	Details of Action Taken	Status	Reference
355	Building: General Stores Location Reference: L151 Task: Access to the plant deck

No safe access to the plant deck	Trips, Slips and Falls	Awareness induction	Med	Access ladders, walkway mesh and handrails to be installed	Low	Client advised	Outstanding	OH&S REGULATIONS 3.7 AS/NZS 1657-2013 3.1.4
356	Building: General Stores Location Reference: L152 Task: Access to the plant deck

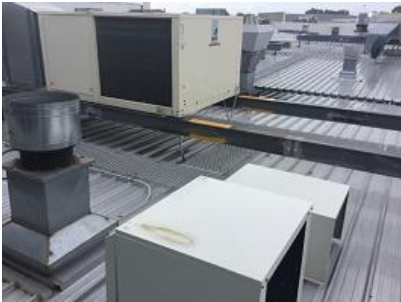
No safe access to the plant deck	Trips, Slips and Falls	Awareness induction	Med	Access ladders, walkway mesh and handrails to be installed	Low	Client advised	Outstanding	OH&S REGULATIONS 3.7 AS/NZS 1657-2013 3.1.4

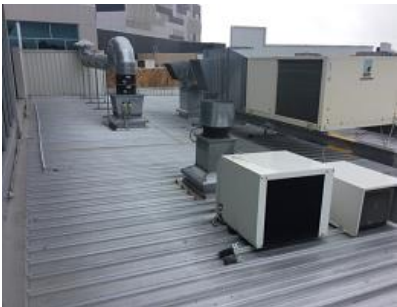
No	Photo of Hazard	Details of Hazard	Details of Risk	Existing/ Immediate Control Measure	Curre nt Risk Level	Proposed Permanent Solution	Resid ual Risk Asse ssme nt	Details of Action Taken	Status	Reference
357	Building: General Stores Location Reference: L152 Task: Access to the A/c units

No safe access to the A/c units	Trips, Slips and Falls	N/A	Low	Supply walkway to the A/c units	Low	Client advised	Outstanding	-
358	Building: General Stores Location Reference: L152 Task: Access to the roof

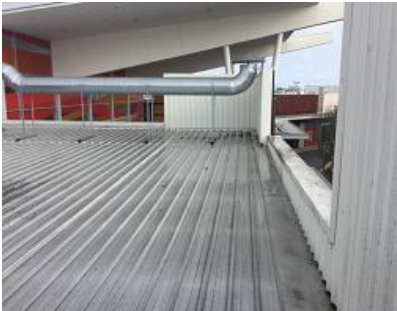
No height safety system installed	Trips, Slips and Falls	Awareness induction	High	Fall arrest anchors to be installed	Low	Client advised	Outstanding	OH&S REGULATIONS 3.55

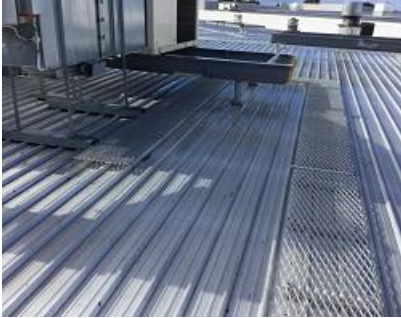
No	Photo of Hazard	Details of Hazard	Details of Risk	Existing/ Immediate Control Measure	Curre nt Risk Level	Proposed Permanent Solution	Resid ual Risk Asse ssme nt	Details of Action Taken	Status	Reference
359	Building: General Stores Location Reference: L153 Task: Access to the plant deck

No safe access to the plant deck	Trips, Slips and Falls	Awareness induction	Med	Access ladder, walkway mesh and handrails to be installed	Low	Client advised	Outstanding	OH&S REGULATIONS 3.7 AS/NZS 1657-2013 3.1.4
360	Building: General Stores Location Reference: L153 Task: Access to the plant deck

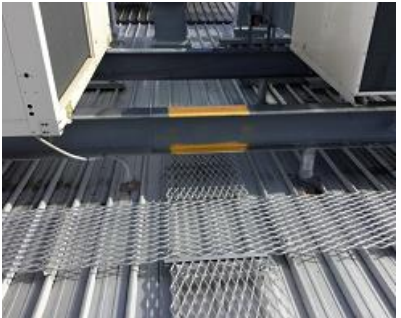
No safe access to the plant deck	Trips, Slips and Falls	Awareness induction	Med	Access ladder, walkway mesh and handrails to be installed	Low	Client advised	Outstanding	OH&S REGULATIONS 3.7 AS/NZS 1657-2013 3.1.4

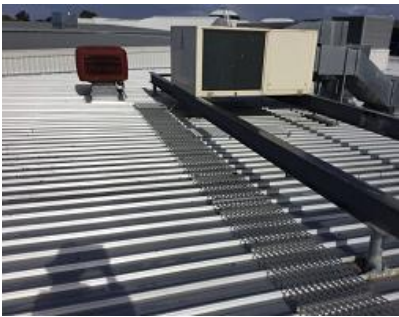
No	Photo of Hazard	Details of Hazard	Details of Risk	Existing/ Immediate Control Measure	Curre nt Risk Level	Proposed Permanent Solution	Resid ual Risk Asse ssme nt	Details of Action Taken	Status	Reference
361	Building: General Stores Location Reference: L154 Task: Access to the plant deck

No safe access to the plant deck	Trips, Slips and Falls	Awareness induction	Med	Access ladders, walkway mesh and handrails to be installed	Low	Client advised	Outstanding	OH&S REGULATIONS 3.7 AS/NZS 1657-2013 3.1.4
362	Building: General Stores Location Reference: L154 Task: Access to the A/c units

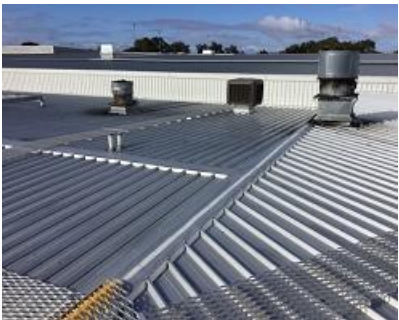
No safe access to the A/c units	Trips, Slips and Falls	N/A	Low	Supply walkway to the A/c units	Low	Client advised	Outstanding	-

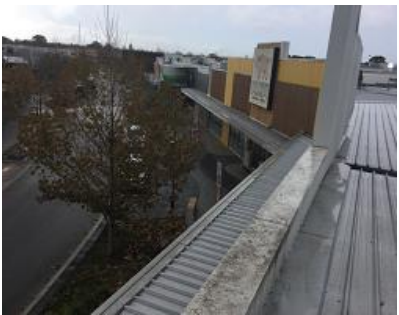
No	Photo of Hazard	Details of Hazard	Details of Risk	Existing/ Immediate Control Measure	Current Risk Level	Proposed Permanent Solution	Residual Risk Assessment	Details of Action Taken	Status	Reference
363	Building: General Stores Location Reference: L155 Task: Access to the roof

No height safety system installed	Trips, Slips and Falls	Awareness induction	High	Static lines, anchor strops, ladder brackets and signs to be installed	Low	Client advised	Outstanding	OH&S REGULATIONS 3.55
364	Building: General Stores Location Reference: L156 Task: Access to the A/c units

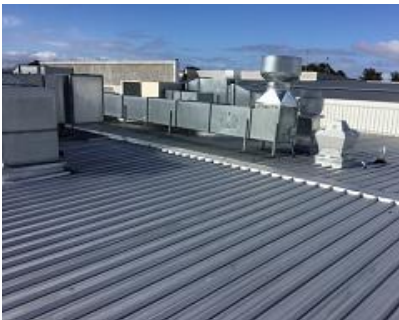
No safe access to the A/c units	Trips, Slips and Falls	N/A	Low	Supply walkway to the A/c units	Low	Client advised	Outstanding	-

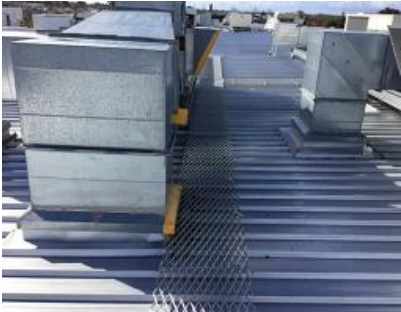
No	Photo of Hazard	Details of Hazard	Details of Risk	Existing/ Immediate Control Measure	Current Risk Level	Proposed Permanent Solution	Residual Risk Assessment	Details of Action Taken	Status	Reference
365	Building: General Stores Location Reference: L156 Task: Access to the A/c units

Duct protrudes over the walkway path	Trips, Slips and Falls	Awareness induction	Med	Additional walkway sections to be installed	Low	Client advised	Outstanding	OH&S REGULATIONS 3.7
366	Building: General Stores Location Reference: L156 Task: Access to the plant deck

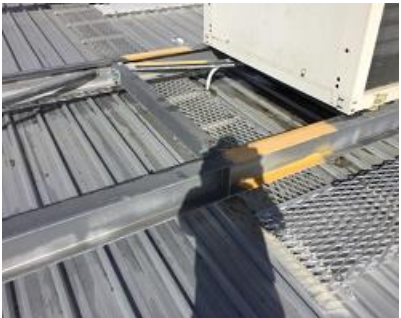
No safe access to the plant deck	Trips, Slips and Falls	Awareness induction	Med	Steps, walkway mesh and handrails to be installed	Low	Client advised	Outstanding	OH&S REGULATIONS 3.7 AS/NZS 1657-2013 3.1.4

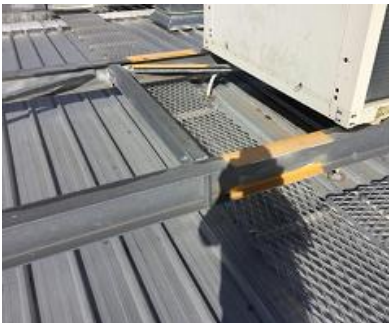
No	Photo of Hazard	Details of Hazard	Details of Risk	Existing/ Immediate Control Measure	Current Risk Level	Proposed Permanent Solution	Residual Risk Assessment	Details of Action Taken	Status	Reference
367	Building: General Stores Location Reference: L156 Task: Access to the plant deck

No safe access to the plant deck	Trips, Slips and Falls	Awareness induction	Med	Steps, walkway mesh and handrails to be installed	Low	Client advised	Outstanding	OH&S REGULATIONS 3.7 AS/NZS 1657-2013 3.1.4
368	Building: General Stores Location Reference: L156 Task: Access to the plant deck

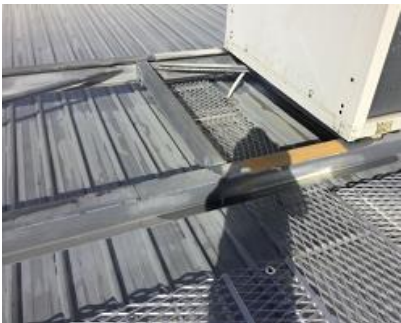
No safe access to the plant deck	Trips, Slips and Falls	Awareness induction	Med	Steps, walkway mesh and handrails to be installed	Low	Client advised	Outstanding	OH&S REGULATIONS 3.7 AS/NZS 1657-2013 3.1.4

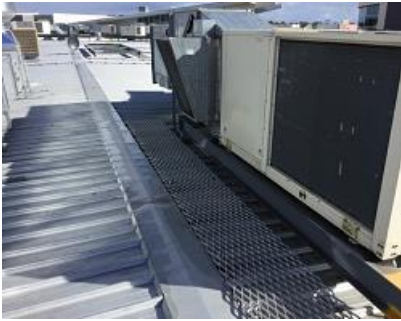
No	Photo of Hazard	Details of Hazard	Details of Risk	Existing/ Immediate Control Measure	Current Risk Level	Proposed Permanent Solution	Residual Risk Assessment	Details of Action Taken	Status	Reference
369	Building: General Stores Location Reference: L156 Task: Access to the A/c unit

Duct protrudes over the walkway path	Trips, Slips and Falls	Awareness induction	Med	Additional walkway section to be installed	Low	Client advised	Outstanding	OH&S REGULATIONS 3.7
370	Building: General Stores Location Reference: L156 Task: Access to the A/c unit

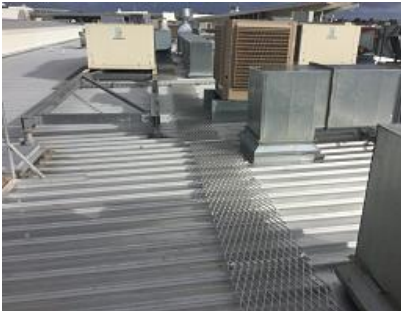
In-correct installation of walkway	Trips, Slips and Falls	Awareness induction	Med	Existing walkway to be re-installed	Low	Client advised	Outstanding	OH&S REGULATIONS 3.7 AS/NZS 1657-2013 5.1.3

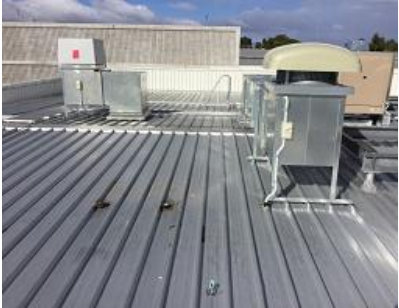
No	Photo of Hazard	Details of Hazard	Details of Risk	Existing/ Immediate Control Measure	Curre nt Risk Level	Proposed Permanent Solution	Resid ual Risk Asse ssme nt	Details of Action Taken	Status	Reference
371	Building: General Stores Location Reference: L156 Task: Access to the A/c units

No safe access to the A/c units	Trips, Slips and Falls	N/A	Low	Supply walkway to the A/c units	Low	Client advised	Outstanding	-
372	Building: General Stores Location Reference: L156 Task: Access to the roof

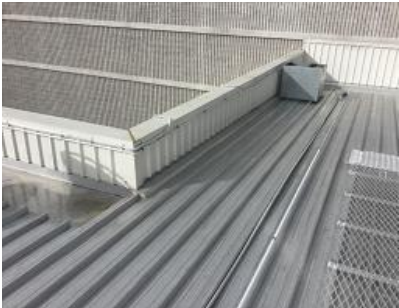
No height safety system installed	Trips, Slips and Falls	Awareness induction	High	Fall arrest anchor to be installed	Low	Client advised	Outstanding	OH&S REGULATIONS 3.55

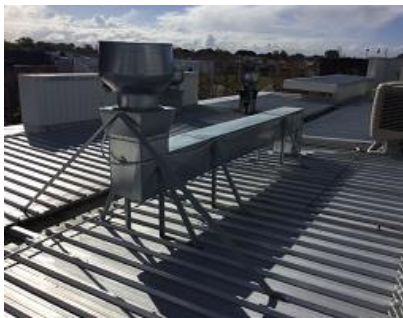
No	Photo of Hazard	Details of Hazard	Details of Risk	Existing/ Immediate Control Measure	Current Risk Level	Proposed Permanent Solution	Residual Risk Assessment	Details of Action Taken	Status	Reference
373	Building: General Stores Location Reference: L156 Task: Access to the A/c units

No safe access to the A/c units	Trips, Slips and Falls	N/A	Low	Supply walkway to the A/c units	Low	Client advised	Outstanding	-
374	Building: General Stores Location Reference: L157 Task: Access to the plant deck

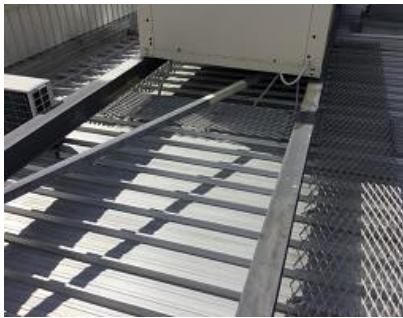
No safe access to the plant deck	Trips, Slips and Falls	Awareness induction	Med	Steps, walkway mesh and handrails to be installed	Low	Client advised	Outstanding	OH&S REGULATIONS 3.7 AS/NZS 1657-2013 3.1.4

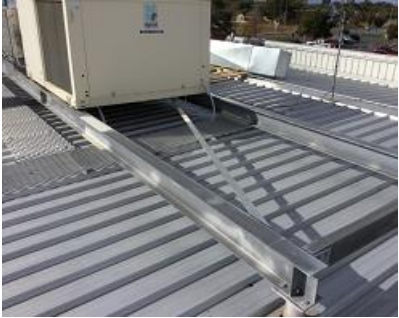
No	Photo of Hazard	Details of Hazard	Details of Risk	Existing/ Immediate Control Measure	Current Risk Level	Proposed Permanent Solution	Residual Risk Assessment	Details of Action Taken	Status	Reference
375	Building: General Stores Location Reference: L157 Task: Access to the plant deck

No safe access to the plant deck	Trips, Slips and Falls	Awareness induction	Med	Steps, walkway mesh and handrails to be installed	Low	Client advised	Outstanding	OH&S REGULATIONS 3.7 AS/NZS 1657-2013 3.1.4
376	Building: General Stores Location Reference: L158 Task: Access to the roof

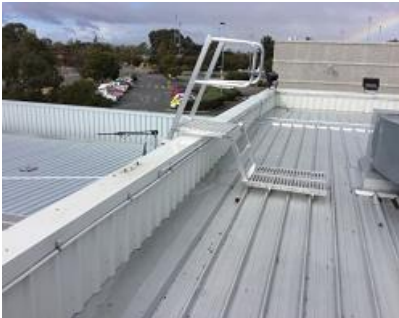
No safe access to the ladder	Trips, Slips and Falls	N/A	Low	Supply walkway to the ladder	Low	Client advised	Outstanding	-

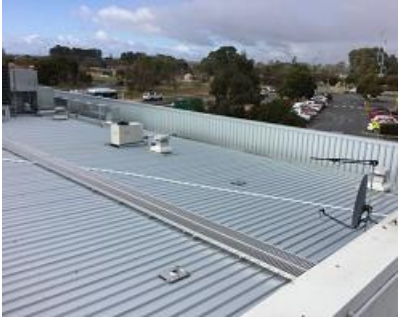
No	Photo of Hazard	Details of Hazard	Details of Risk	Existing/ Immediate Control Measure	Curre nt Risk Level	Proposed Permanent Solution	Resid ual Risk Asse ssme nt	Details of Action Taken	Status	Reference
377	Building: General Stores Location Reference: L158 Task: Access to the A/c units

No safe access to the A/c units	Trips, Slips and Falls	N/A	Low	Supply walkway to the A/c units	Low	Client advised	Outstanding	-
378	Building: General Stores Location Reference: L159 Task: Restrict access to the roof
