Roof Safety Report

Rockingham Centre, WA 6168

Prepared By: Safemaster Safety Products
Date: 10 Aug 2017

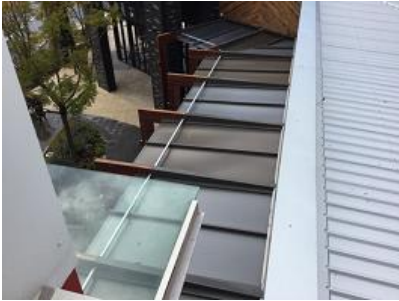
No safe access to the A/c units	Trips, Slips and Falls	N/A	Low	Supply walkway to the A/c units	Low	Client advised	Outstanding	-
378	Building: General Stores Location Reference: L159 Task: Restrict access to the roof

No height safety system installed (Non-trafficable roof)	Trips, Slips and Falls	Restrict Access	High	"No Access to Roof" sign to be installed	Low	Client advised	Outstanding	OH&S REGULATIONS 3.55 & 3.11

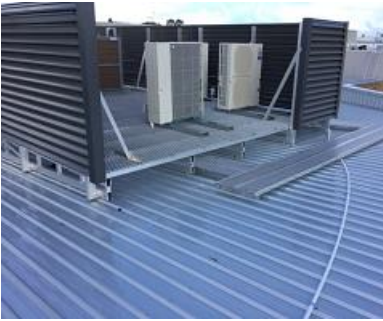
No	Photo of Hazard	Details of Hazard	Details of Risk	Existing/ Immediate Control Measure	Current Risk Level	Proposed Permanent Solution	Residual Risk Assessment	Details of Action Taken	Status	Reference
379	Building: General Stores Location Reference: L160 Task: Access to the plant deck

Variation in height between plant deck and roof is greater than required maximum	Trips, Slips and Falls	Awareness induction	Med	Handrails to be installed	Low	Client advised	Outstanding	OH&S REGULATIONS 3.7 AS/NZS 1657-2013 4.4
380	Building: General Stores Location Reference: L160 Task: Access to the A/c units

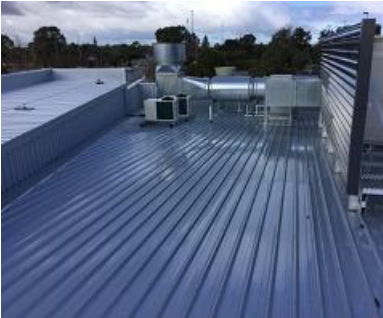
No safe access to the A/c units	Trips, Slips and Falls	N/A	Low	Supply walkway to the A/c units	Low	Client advised	Outstanding	-

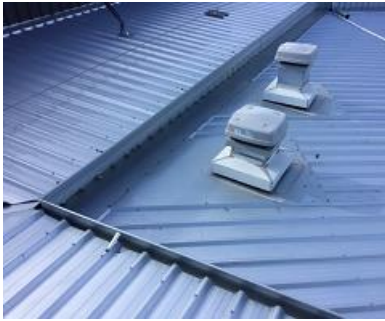
No safe access to the A/c units	Trips, Slips and Falls	N/A	Low	Supply walkway to the A/c units	Low	Client advised	Outstanding	-
382	Building: Target Location Reference: L161 Task: Restrict access to the roof

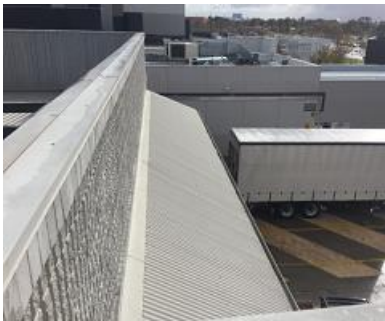
No height safety system installed (No serviceable items)	Trips, Slips and Falls	Restrict Access	High	"EWP Access Only" sign to be installed	Low	Client advised	Outstanding	OH&S REGULATIONS 3.55 & 3.11

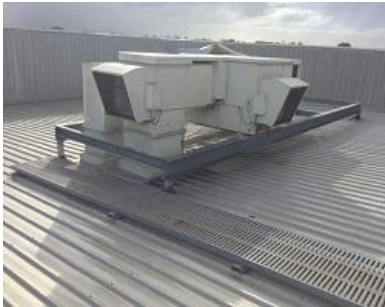
No safe access to the A/c units	Trips, Slips and Falls	N/A	Low	Supply walkway to the A/c units	Low	Client advised	Outstanding	-
384	Building: Target Location Reference: L162 Task: Access to the A/c units

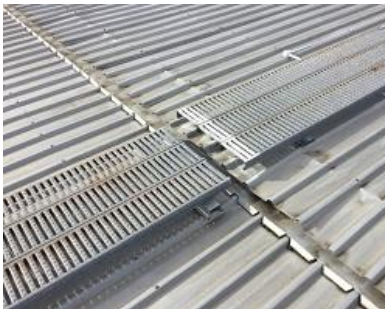
Gap between walkway panels are greater than required maximum	Trips, Slips and Falls	Awareness induction	Med	Additional walkway section to be installed	Low	Client advised	Outstanding	OH&S REGULATIONS 3.7 AS/NZS 1657-2013 3.2.3.4

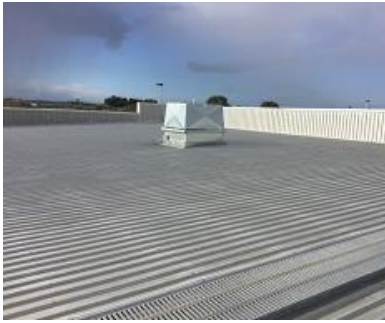
No safe access to the A/c units	Trips, Slips and Falls	N/A	Low	Supply walkway to the A/c units	Low	Client advised	Outstanding	-
386	Building: Target Location Reference: L163 Task: Access to the plant deck

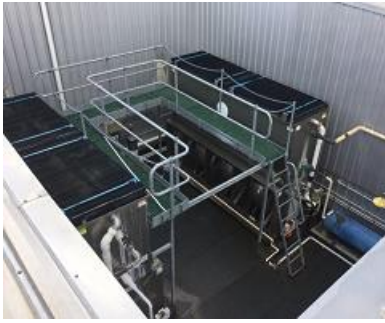
Non-complaint ladder is present	Trips, Slips and Falls	Awareness induction	Med	Existing ladder to be removed and new ladder to be installed	Low	Client advised	Outstanding	OH&S REGULATIONS 3.7 AS/NZS 1657-2013 7.4

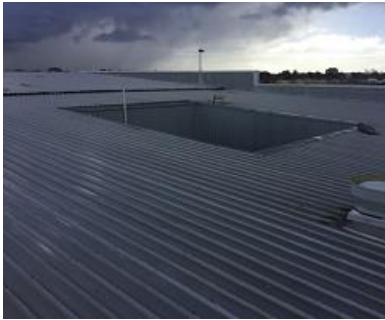
No height safety system installed	Trips, Slips and Falls	Awareness induction	High	Handrails to be installed	Low	Client advised	Outstanding	OH&S REGULATIONS 3.55
388	Building: Target Location Reference: L163 Task: Access to the roof

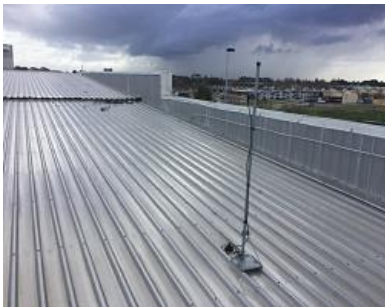
No height safety system installed	Trips, Slips and Falls	Awareness induction	High	Fall arrest anchors to be installed	Low	Client advised	Outstanding	OH&S REGULATIONS 3.55

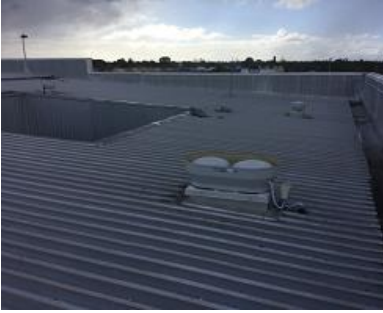
No safe access to the A/c units	Trips, Slips and Falls	N/A	Low	Supply walkway to the A/c units	Low	Client advised	Outstanding	-
390	Building: Target Location Reference: L163 Task: Access to the roof

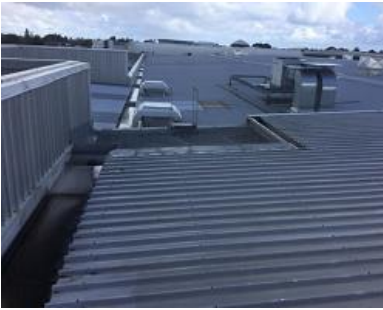
No height safety system installed	Trips, Slips and Falls	Awareness induction	High	Handrails to be installed	Low	Client advised	Outstanding	OH&S REGULATIONS 3.55

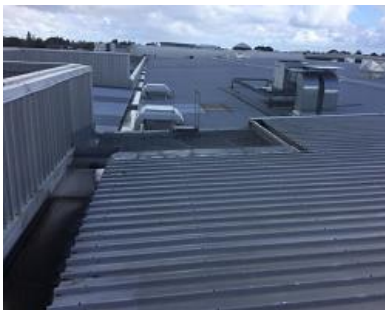
Variation in height between roofs are greater than required maximum	Trips, Slips and Falls	Awareness induction	Med	Access ladder including handrails to be installed	Low	Client advised	Outstanding	OH&S REGULATIONS 3.7 AS/NZS 1657-2013 3.1.4
392	Building: Target Location Reference: L164 Task: Access to the roof

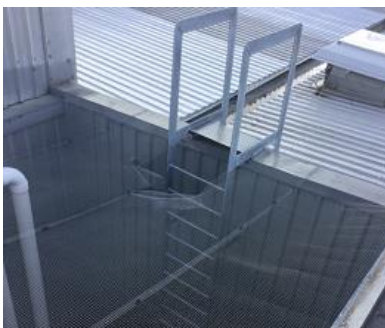
Non-complaint ladder is present	Trips, Slips and Falls	Awareness induction	Med	Existing ladder to be removed and new ladder to be installed	Low	Client advised	Outstanding	OH&S REGULATIONS 3.7 AS/NZS 1657-2013 7.4

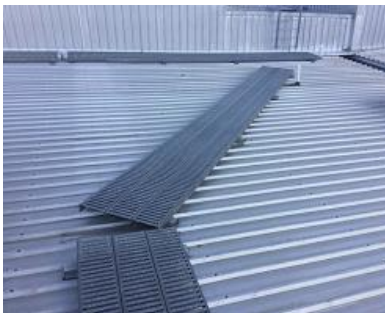
Gap between walkway panels are greater than required maximum	Trips, Slips and Falls	Awareness induction	Med	Existing walkway to be re-installed with additional channels and fixings	Low	Client advised	Outstanding	OH&S REGULATIONS 3.7 AS/NZS 1657-2013 3.2.3.4
394	Building: Target Location Reference: L165 Task: Access to the A/c units

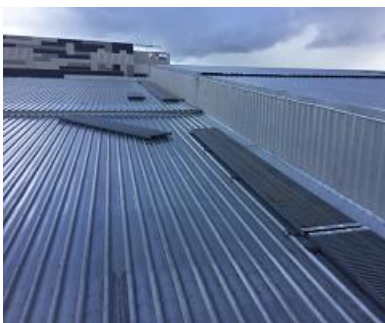
In-correct installation of walkway	Trips, Slips and Falls	Awareness induction	Med	Existing walkway to be fully secured to roof with new channels and fixings	Low	Client advised	Outstanding	OH&S REGULATIONS 3.7

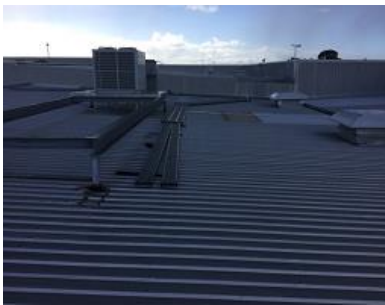
No safe access to the A/c unit	Trips, Slips and Falls	N/A	Low	Supply walkway to the A/c units	Low	Client advised	Outsta nding	-
396	Building: Target Location Reference: L166 Task: Access to the roof

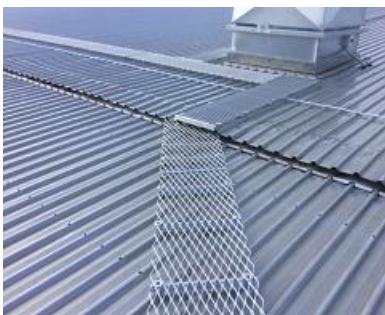
Variation in height between walkway panels are greater than required maximum	Trips, Slips and Falls	Awareness induction	Med	High visibility safety yellow nosing to be installed	Low	Client advised	Outsta nding	OH&S REGULATIONS 3.7

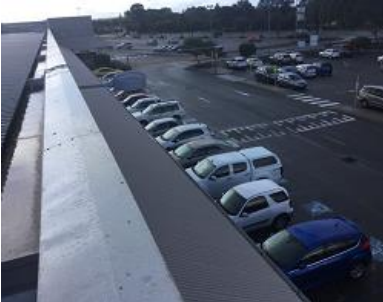
No height safety system installed	Trips, Slips and Falls	Restrict Access	High	"EWP Access Only" signs to be installed	Low	Client advised	Outstanding	OH&S REGULATIONS 3.55 & 3.11
398	Building: Target Location Reference: L168 Task: Access to the roof

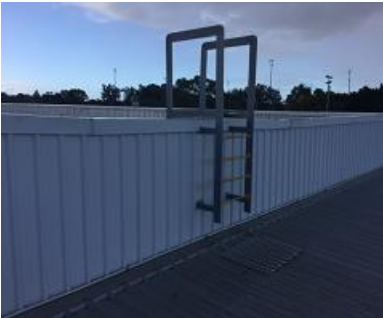
Non-complaint ladder is present	Trips, Slips and Falls	Awareness induction	Med	Existing ladder to be removed and new ladder to be installed	Low	Client advised	Outstanding	OH&S REGULATIONS 3.7 AS/NZS 1657-2013 7.4

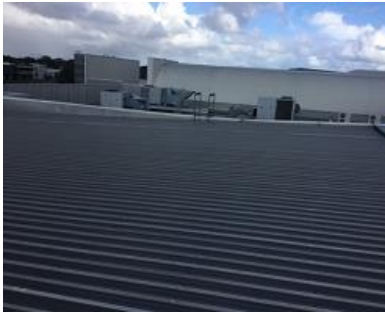
No safe access to the ladder	Trips, Slips and Falls	N/A	Low	Supply walkway to the ladder	Low	Client advised	Outstanding	-
400	Building: General Stores Location Reference: L169 Task: Restrict access to the roof

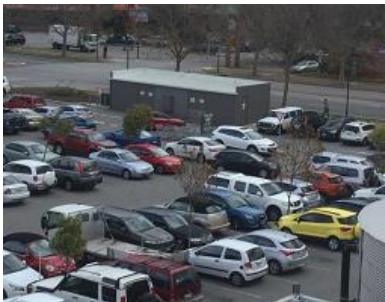
No height safety system installed	Trips, Slips and Falls	Restrict Access	High	"EWP Access Only" sign to be installed	Low	Client advised	Outstanding	OH&S REGULATIONS 3.55 & 3.11

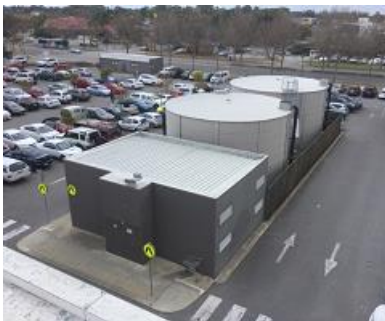
No height safety system installed	Trips, Slips and Falls	Restrict Access	High	"EWP Access Only" sign to be installed	Low	Client advised	Outstanding	OH&S REGULATIONS 3.55 & 3.11
402	Building: General Stores Location Reference: L171 Task: Access to the tank

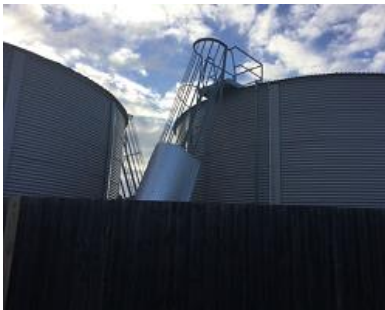
No slip resistance on ladder rungs	Trips, Slips and Falls	Awareness induction	Med	High visibility non-slip yellow rung caps to be installed	Low	Client advised	Outstanding	OH&S REGULATIONS 3.7 AS/NZS 1657-2013 7.4.3.1

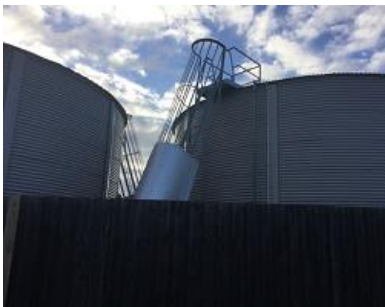
No slip resistance on ladder rungs	Trips, Slips and Falls	Awareness induction	Med	High visibility non-slip yellow rung caps to be installed	Low	Client advised	Outstanding	OH&S REGULATIONS 3.7 AS/NZS 1657-2013 7.4.3.1
404	Building: Rivers Store Location Reference: L173 Task: Access to the roof

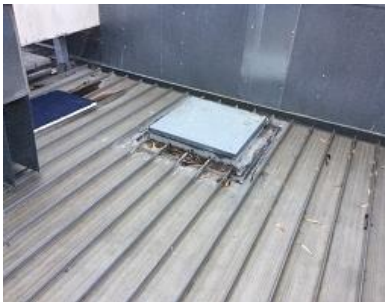
Hatch grabrails and access anchor is missing	Trips, Slips and Falls	Awareness induction	High	Hatch grabrails and access anchor to be installed	Low	Client advised	Outstanding	OH&S REGULATIONS 3.55

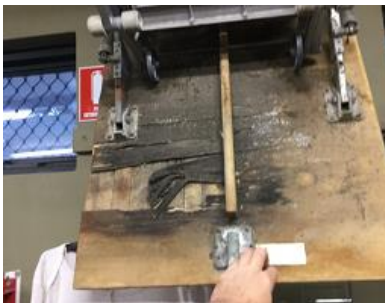
Fold down ladder damaged	Trips, Slips and Falls	Awareness induction	Med	Existing ladder to be removed and new ladder to be installed	Low	Client advised	Outstanding	OH&S REGULATIONS 3.7
406	Building: Rivers Store Location Reference: L173 Task: Access to the A/c units

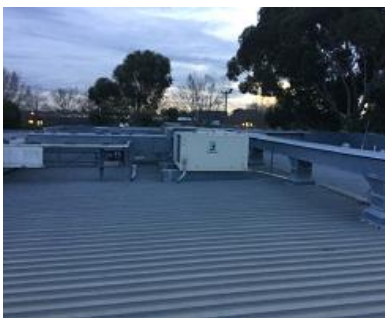
No safe access to the A/c units	Trips, Slips and Falls	N/A	Low	Supply walkway and step bridge to the A/c units	Low	Client advised	Outstanding	-

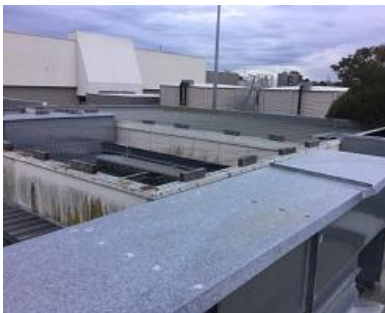
No height safety system installed and No safe access to roof provided	Trips, Slips and Falls	Awareness induction	High	Fall arrest anchors and access ladder to be installed	Low	Client advised	Outstanding	OH&S REGULATIONS 3.7 & 3.55 AS/NZS 1657-2013 3.1.4
408	Building: General Stores Location Reference: L174 Task: Access to the roof

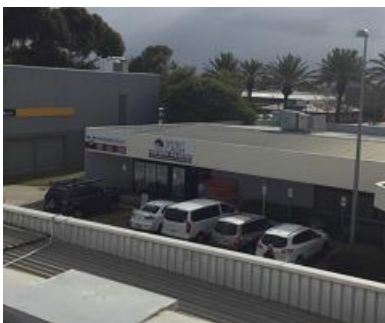
No height safety system installed	Trips, Slips and Falls	Awareness induction	High	Fall arrest anchors to be installed	Low	Client advised	Outstanding	OH&S REGULATIONS 3.55

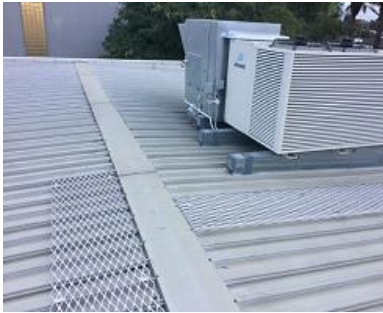
No safe access to the A/c units	Trips, Slips and Falls	N/A	Low	Supply walkway to the A/c units	Low	Client advised	Outstanding	-
410	Building: General Stores Location Reference: L174 Task: Access to the A/c units

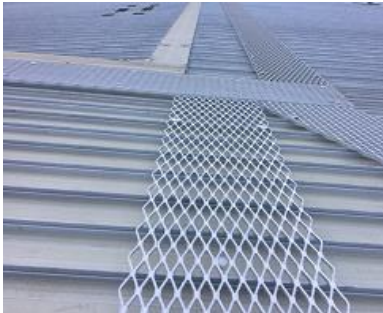
Variation in height between walkway panels are greater than required maximum	Trips, Slips and Falls	Awareness induction	Med	High visibility safety yellow nosing to be installed	Low	Client advised	Outstanding	OH&S REGULATIONS 3.7 AS/NZS 1657-2013 3.3.4

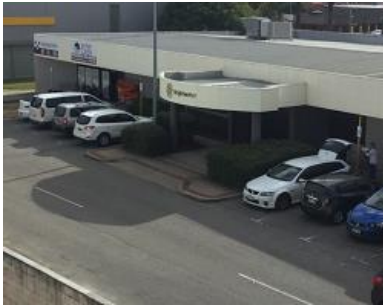
No height safety system installed and No safe access to roof provided	Trips, Slips and Falls	Awareness induction	High	Fall arrest anchors and access ladder to be installed	Low	Client advised	Outstanding	OH&S REGULATIONS 3.7 & 3.55 AS/NZS 1657-2013 3.1.4
412	Building: General Stores Location Reference: L175 Task: Access to the roof

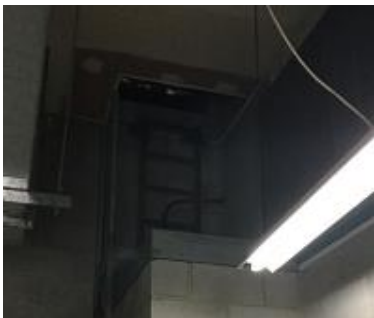
No	Photo of Hazard	Details of Hazard	Details of Risk	Existing/ Immediate Control Measure	Current Risk Level	Proposed Permanent Solution	Residual Risk Assessment	Details of Action Taken	Status	Reference
413	Building: General Stores Location Reference: L175 Task: Access to the roof

Non-compliant ladder is present	Trips, Slips and Falls	Awareness induction	Med	Existing ladder to be removed and new ladder to be installed	Low	Client advised	Outstanding	OH&S REGULATIONS 3.7 AS/NZS 1657-2013 7.4
414	Building: General Stores Location Reference: L175 Task: Access to the roof

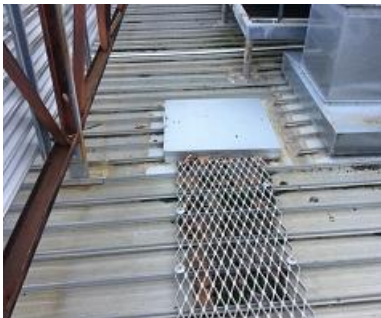
Clearance behind the ladder is less than required minimum	Trips, Slips and Falls	Awareness induction	High	Existing hatch to be removed and new hatch including grabrails to be installed	Low	Client advised	Outstanding	OH&S REGULATIONS 3.7 AS/NZS 1657-2013 7.4.5

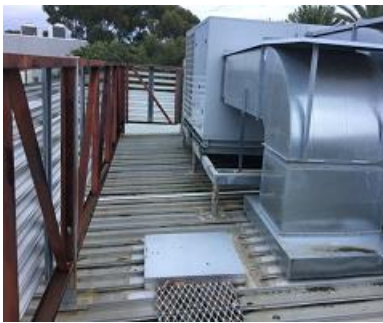
No	Photo of Hazard	Details of Hazard	Details of Risk	Existing/ Immediate Control Measure	Current Risk Level	Proposed Permanent Solution	Residual Risk Assessment	Details of Action Taken	Status	Reference
415	Building: General Stores Location Reference: L175 Task: Access to the A/c unit

No safe access to the A/c unit	Trips, Slips and Falls	N/A	Low	Supply walkway to the A/c unit	Low	Client advised	Outstanding	-
416	Building: General Stores Location Reference: L175 Task: Access to the A/c unit

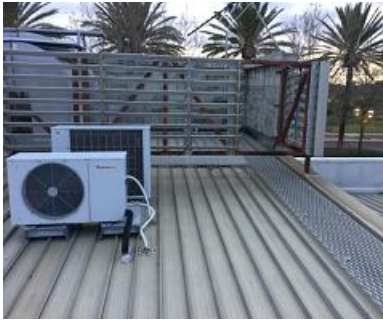
Headroom is less than required minimum and structure protrudes over the walkway path	Trips, Slips and Falls	Awareness induction	High	"Warning Low headroom" sign and high visibility safety yellow tape to be installed	Low	Client advised	Outstanding	OH&S REGULATIONS 3.7 AS/NZS 1657-2013 3.1.5

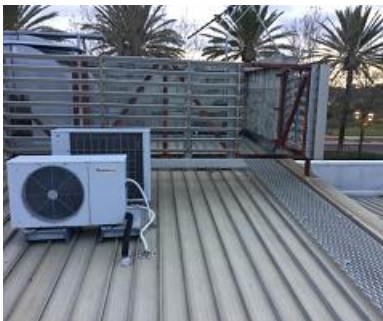
No	Photo of Hazard	Details of Hazard	Details of Risk	Existing/ Immediate Control Measure	Curre nt Risk Level	Proposed Permanent Solution	Resid ual Risk Asse ssme nt	Details of Action Taken	Status	Reference
417	Building: General Stores Location Reference: L175 Task: Access to the A/c units

No safe access to the A/c units	Trips, Slips and Falls	N/A	Low	Supply walkway to the A/c units	Low	Client advised	Outstanding	-
418	Building: General Stores Location Reference: L176 Task: Access to the A/c units

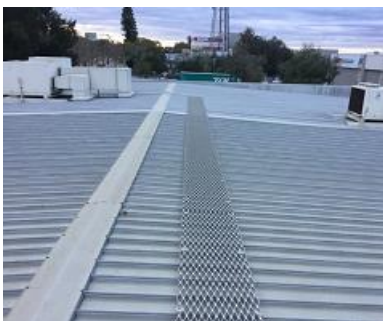
No safe access to the A/c units	Trips, Slips and Falls	N/A	Low	Supply walkway to the A/c units	Low	Client advised	Outstanding	-

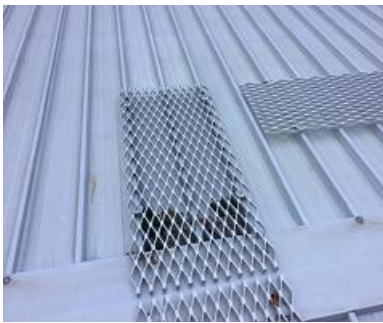
No	Photo of Hazard	Details of Hazard	Details of Risk	Existing/ Immediate Control Measure	Current Risk Level	Proposed Permanent Solution	Residual Risk Assessment	Details of Action Taken	Status	Reference
419	Building: General Stores Location Reference: L176 Task: Access to the roof

Gap between walkway panels are greater than required maximum	Trips, Slips and Falls	Awareness induction	Med	Additional walkway section to be installed	Low	Client advised	Outstanding	OH&S REGULATIONS 3.7 AS/NZS 1657-2013 3.2.3.4
420	Building: General Stores Location Reference: L176 Task: Access to the A/c units

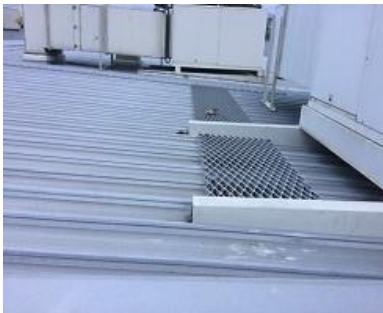
Bracings installed over the walkway path	Trips, Slips and Falls	Awareness induction	Med	High visibility safety yellow tape to be installed	Low	Client advised	Outstanding	OH&S REGULATIONS 3.7

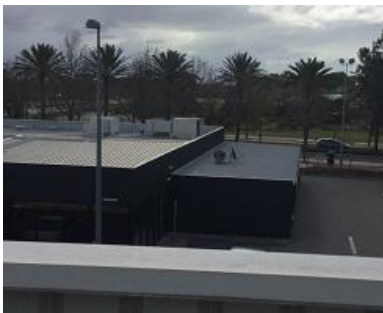
No	Photo of Hazard	Details of Hazard	Details of Risk	Existing/ Immediate Control Measure	Current Risk Level	Proposed Permanent Solution	Residual Risk Assessment	Details of Action Taken	Status	Reference
421	Building: General Stores Location Reference: L176 Task: Access to the roof

No height safety system installed and No safe access provided	Trips, Slips and Falls	Awareness induction	High	Fall arrest anchors and access ladder to be installed	Low	Client advised	Outstanding	OH&S REGULATIONS 3.55 & 3.7 AS/NZS 1657-2013 3.1.4
422	Building: General Stores Location Reference: L177 Task: Access to the roof

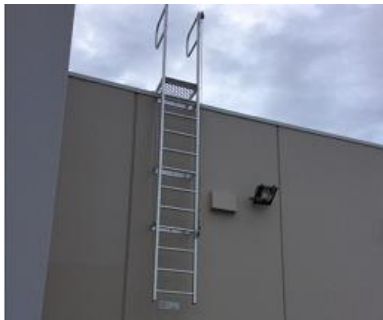
Bottom rung height is less than required minimum, top rung not levelled with landing and landing platforms is missing	Trips, Slips and Falls	Awareness induction	Med	Existing ladder to be re-installed with new Mid level landing platform, brackets and landing platform to be installed	Low	Client advised	Outstanding	OH&S REGULATIONS 3.7 AS/NZS 1657-2013 7.4.3.4 & 7.4.3.3 & 7.3.6

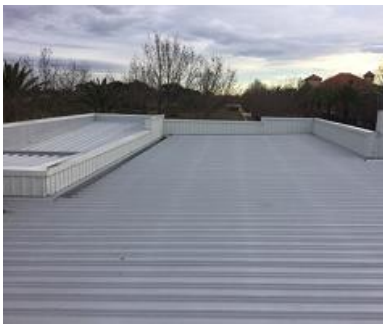
No	Photo of Hazard	Details of Hazard	Details of Risk	Existing/ Immediate Control Measure	Curre nt Risk Level	Proposed Permanent Solution	Resid ual Risk Asse ssme nt	Details of Action Taken	Status	Reference
423	Building: General Stores Location Reference: L177 Task: Access to the roof

No height safety system installed and No safe access provided	Trips, Slips and Falls	Awareness induction	High	Fall arrest anchors and access ladder to be installed	Low	Client advised	Outstanding	OH&S REGULATIONS 3.55 & 3.7 AS/NZS 1657-2013 3.1.4
424	Building: General Stores Location Reference: L177 Task: Access to the roof

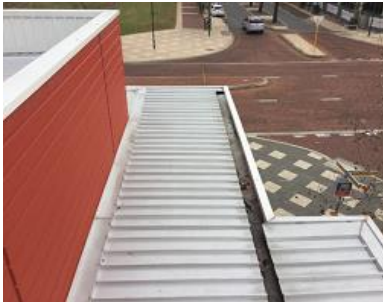
No height safety system installed	Trips, Slips and Falls	Awareness induction	High	Fall arrest anchors, anchor stop, ladder access bracket and signage to be installed	Low	Client advised	Outstanding	OH&S REGULATIONS 3.55

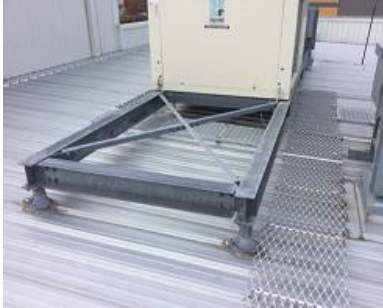
No	Photo of Hazard	Details of Hazard	Details of Risk	Existing/ Immediate Control Measure	Curre nt Risk Level	Proposed Permanent Solution	Resid ual Risk Asse ssme nt	Details of Action Taken	Status	Reference
425	Building: General Stores Location Reference: L177 Task: Access to the A/c unit

Walkway installed below plant deck	Trips, Slips and Falls	Awareness induction	Med	Additional walkway section to be installed	Low	Client advised	Outstanding	OH&S REGULATIONS 3.7
426	Building: General Stores Location Reference: L177 Task: Access to the A/c unit

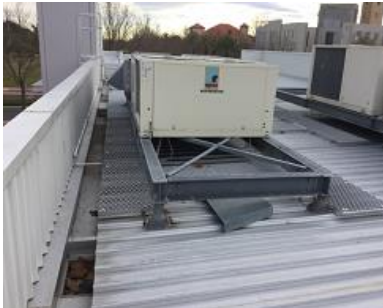
Walkway installed below plant deck	Trips, Slips and Falls	Awareness induction	Med	Additional walkway section to be installed	Low	Client advised	Outstanding	OH&S REGULATIONS 3.7

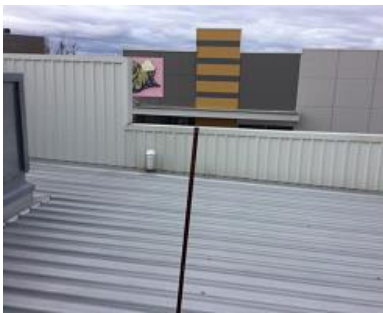
No	Photo of Hazard	Details of Hazard	Details of Risk	Existing/ Immediate Control Measure	Current Risk Level	Proposed Permanent Solution	Residual Risk Assessment	Details of Action Taken	Status	Reference
427	Building: General Stores Location Reference: L177 Task: Access to the roof

No height safety system installed	Trips, Slips and Falls	Awareness induction	High	Fall arrest anchors to be installed	Low	Client advised	Outstanding	OH&S REGULATIONS 3.55
428	Building: General Stores Location Reference: L179 Task: Access to the roof

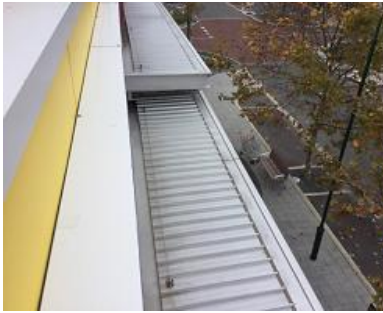
Variation in height between roofs are greater than required maximum	Trips, Slips and Falls	Awareness induction	Med	Access ladder including handrails to be installed	Low	Client advised	Outstanding	OH&S REGULATIONS 3.7 AS/NZS 1657-2013 3.1.4

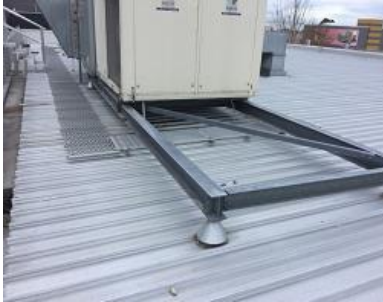
No	Photo of Hazard	Details of Hazard	Details of Risk	Existing/ Immediate Control Measure	Current Risk Level	Proposed Permanent Solution	Residual Risk Assessment	Details of Action Taken	Status	Reference
429	Building: General Stores Location Reference: L180 Task: Access to the A/c unit

Walkway installed below plant deck	Trips, Slips and Falls	Awareness induction	Med	Additional walkway section to be installed	Low	Client advised	Outstanding	OH&S REGULATIONS 3.7
430	Building: General Stores Location Reference: L181 Task: Access to the A/c unit

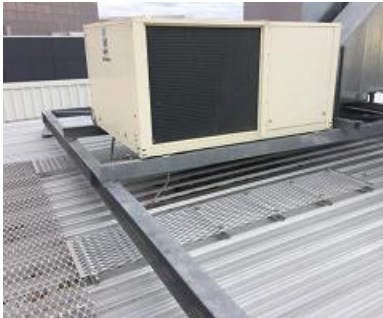
No safe access to the A/c unit	Trips, Slips and Falls	Awareness induction	Med	Access ladders, walkway mesh and handrails to be installed	Low	Client advised	Outstanding	OH&S REGULATIONS 3.7 AS/NZS 1657-2013 3.1.4

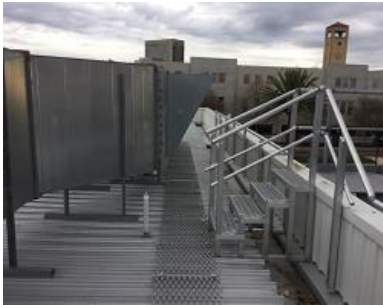
No	Photo of Hazard	Details of Hazard	Details of Risk	Existing/ Immediate Control Measure	Curre nt Risk Level	Proposed Permanent Solution	Resid ual Risk Asse ssme nt	Details of Action Taken	Status	Reference
431	Building: General Stores Location Reference: L180 Task: Access to the A/c unit

Duct protrudes over the walkway path	Trips, Slips and Falls	Awareness induction	Med	Additional walkway section to be installed	Low	Client advised	Outstanding	OH&S REGULATIONS 3.7 AS/NZS 1657-2013 5.1.3
432	Building: General Stores Location Reference: L184 Task: Access to the roof

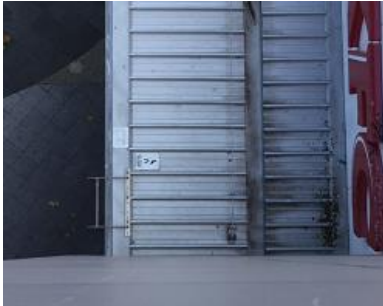
Access anchor is missing	Trips, Slips and Falls	Awareness induction	High	Anchor strop to be installed	Low	Client advised	Outstanding	OH&S REGULATIONS 3.55

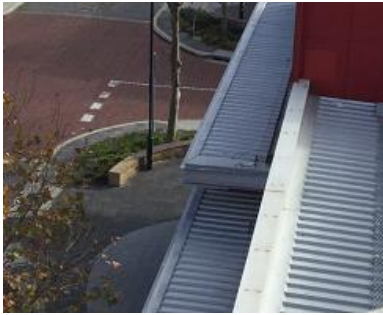
No	Photo of Hazard	Details of Hazard	Details of Risk	Existing/ Immediate Control Measure	Current Risk Level	Proposed Permanent Solution	Residual Risk Assessment	Details of Action Taken	Status	Reference
433	Building: General Stores Location Reference: L184 Task: Access to the roof

Variation in height between roofs are greater than required maximum	Trips, Slips and Falls	Awareness induction	Med	Access ladder including handrails to be installed	Low	Client advised	Outstanding	OH&S REGULATIONS 3.7 AS/NZS 1657-2013 3.1.4
434	Building: General Stores Location Reference: L184 Task: Access to the roof

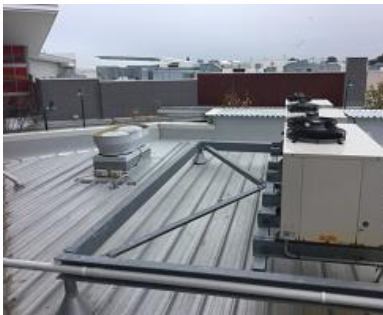
No height safety system installed	Trips, Slips and Falls	Awareness induction	High	Fall arrest anchors to be installed	Low	Client advised	Outstanding	OH&S REGULATIONS 3.55

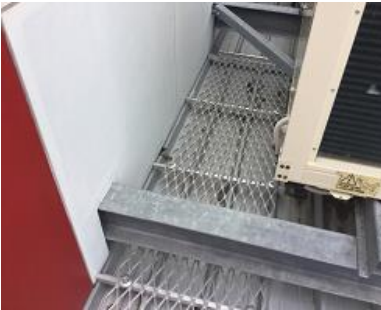
No	Photo of Hazard	Details of Hazard	Details of Risk	Existing/ Immediate Control Measure	Curre nt Risk Level	Proposed Permanent Solution	Resid ual Risk Asse ssme nt	Details of Action Taken	Status	Reference
435	Building: General Stores Location Reference: L185 Task: Access to the A/c unit

Beam protrudes over the walkway path	Trips, Slips and Falls	Awareness induction	Med	Step over to be installed	Low	Client advised	Outstanding	OH&S REGULATIONS 3.7 AS/NZS 1657-2013 3.1.4
436	Building: General Stores Location Reference: L185 Task: Access to the plant deck

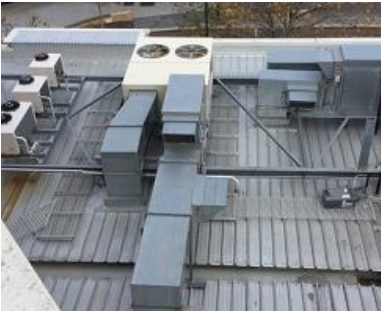
No safe access to the plant deck	Trips, Slips and Falls	Awareness induction	Med	Steps, walkway mesh and handrails to be installed	Low	Client advised	Outstanding	OH&S REGULATIONS 3.7 AS/NZS 1657-2013 3.1.4

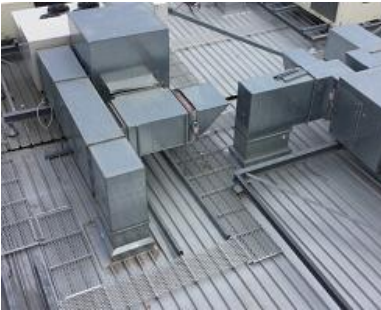
No	Photo of Hazard	Details of Hazard	Details of Risk	Existing/ Immediate Control Measure	Current Risk Level	Proposed Permanent Solution	Residual Risk Assessment	Details of Action Taken	Status	Reference
437	Building: General Stores Location Reference: L185 Task: Access to the A/c unit

Head room is less than required minimum	Trips, Slips and Falls	Awareness induction	High	"Warning-Low Headroom" signs to be installed	Low	Client advised	Outstanding	OH&S REGULATIONS 3.7 AS/NZS 1657-2013 3.1.5
438	Building: General Stores Location Reference: L185 Task: Access to the A/c unit

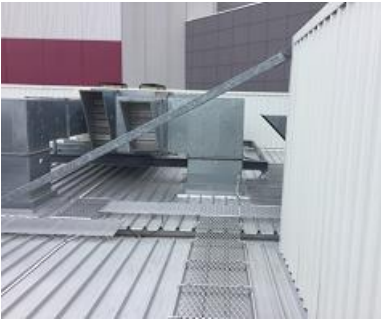
Head room is less than required minimum	Trips, Slips and Falls	Awareness induction	High	"Warning-Low Headroom" signs to be installed	Low	Client advised	Outstanding	OH&S REGULATIONS 3.7 AS/NZS 1657-2013 3.1.5

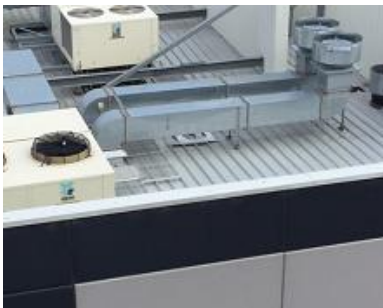
No	Photo of Hazard	Details of Hazard	Details of Risk	Existing/ Immediate Control Measure	Current Risk Level	Proposed Permanent Solution	Residual Risk Assessment	Details of Action Taken	Status	Reference
439	Building: General Stores Location Reference: L185 Task: Access to the A/c unit

Walkway installed under the duct	Trips, Slips and Falls	Awareness induction	Med	Additional walkway section to be installed	Low	Client advised	Outstanding	OH&S REGULATIONS 3.7
440	Building: General Stores Location Reference: L185 Task: Access to the A/c unit

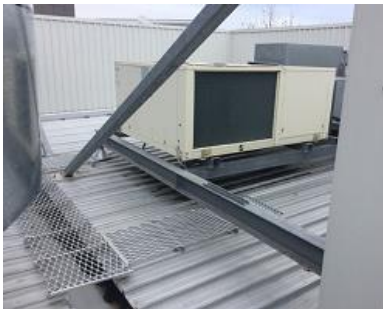
Walkway installed under structural beam and head room is less than required minimum	Trips, Slips and Falls	Awareness induction	High	"Warning-Low Headroom" sign and high visibility safety yellow tape to be installed	Low	Client advised	Outstanding	OH&S REGULATIONS 3.7 AS/NZS 1657-2013 3.1.5

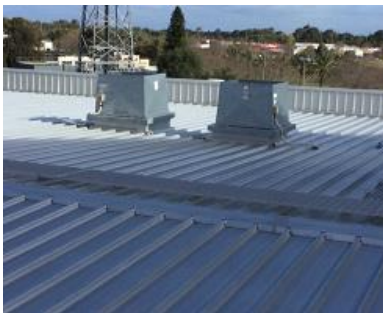
No	Photo of Hazard	Details of Hazard	Details of Risk	Existing/ Immediate Control Measure	Curre nt Risk Level	Proposed Permanent Solution	Resid ual Risk Asse ssme nt	Details of Action Taken	Status	Reference
441	Building: General Stores Location Reference: L186 Task: Access to the A/c unit

No safe access to the A/c unit	Trips, Slips and Falls	N/A	Low	Supply walkway to the A/c unit	Low	Client advised	Outsta nding	-
442	Building: General Stores Location Reference: L186 Task: Access to the A/c unit

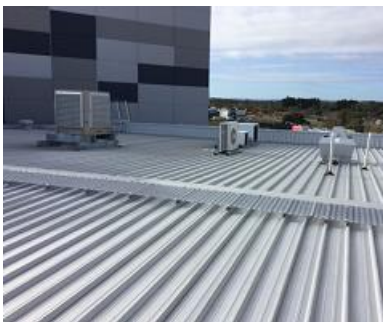
No safe access to the A/c unit	Trips, Slips and Falls	N/A	Low	Supply walkway to the A/c unit	Low	Client advised	Outsta nding	-

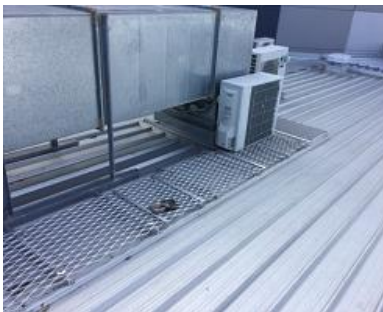
No	Photo of Hazard	Details of Hazard	Details of Risk	Existing/ Immediate Control Measure	Current Risk Level	Proposed Permanent Solution	Residual Risk Assessment	Details of Action Taken	Status	Reference
443	Building: General Stores Location Reference: L186 Task: Access to the A/c unit

A/c unit installed over the walkway	Trips, Slips and Falls	Awareness induction	Med	Additional walkway section to be installed	Low	Client advised	Outstanding	OH&S REGULATIONS 3.7 AS/NZS 1657-2013 5.1.3
444	Building: General Stores Location Reference: L186 Task: Access to the A/c unit

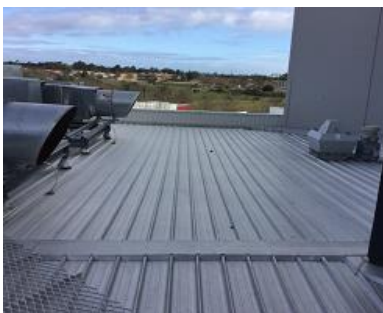
No safe access to the A/c units	Trips, Slips and Falls	N/A	Low	Supply walkway to the A/c units	Low	Client advised	Outstanding	-

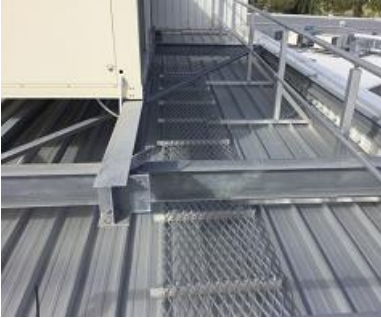
No	Photo of Hazard	Details of Hazard	Details of Risk	Existing/ Immediate Control Measure	Current Risk Level	Proposed Permanent Solution	Residual Risk Assessment	Details of Action Taken	Status	Reference
445	Building: General Stores Location Reference: L188 Task: Access to the A/c unit

Beam and bracing protrudes over the walkway	Trips, Slips and Falls	Awareness induction	Med	Step overs to be installed	Low	Client advised	Outstanding	OH&S REGULATIONS 3.7 AS/NZS 1657-2013 3.1.4
446	Building: General Stores Location Reference: L188 Task: Access to the A/c unit

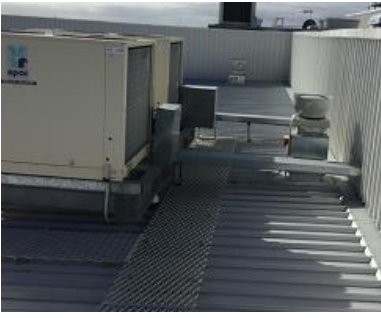
Beam protrudes over the walkway	Trips, Slips and Falls	Awareness induction	Med	Step over to be installed	Low	Client advised	Outstanding	OH&S REGULATIONS 3.7 AS/NZS 1657-2013 3.1.4

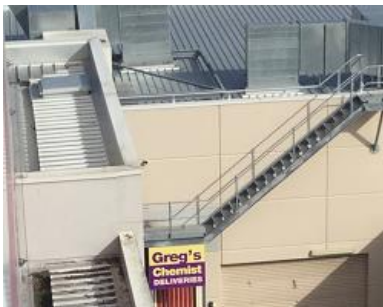
No	Photo of Hazard	Details of Hazard	Details of Risk	Existing/ Immediate Control Measure	Curre nt Risk Level	Proposed Permanent Solution	Resid ual Risk Asse ssme nt	Details of Action Taken	Status	Reference
447	Building: General Stores Location Reference: L189 Task: Access to the roof

Hatch installed too close to the fall edge	Trips, Slips and Falls	Awareness induction	High	Guardrails to be installed	Low	Client advised	Outstanding	OH&S REGULATIONS 3.7 & 3.55
448	Building: General Stores Location Reference: L189 Task: Access to the roof

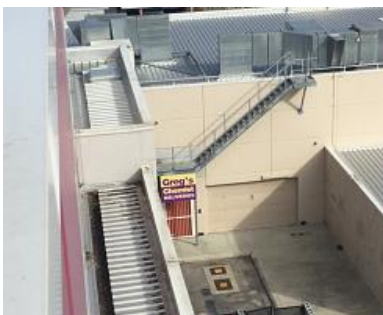
Variation in height between roofs are greater than required maximum	Trips, Slips and Falls	Awareness induction	Med	Access ladder to be installed	Low	Client advised	Outstanding	OH&S REGULATIONS 3.7 AS/NZS 1657-2013 3.1.4

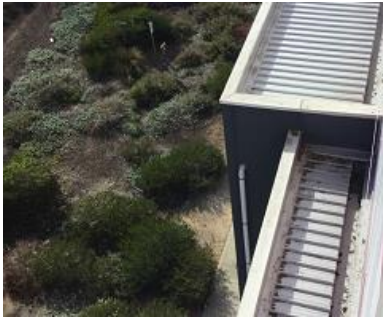
No	Photo of Hazard	Details of Hazard	Details of Risk	Existing/ Immediate Control Measure	Current Risk Level	Proposed Permanent Solution	Residual Risk Assessment	Details of Action Taken	Status	Reference
449	Building: General Stores Location Reference: L189 Task: Access to the roof

Variation in height between roofs are greater than required maximum	Trips, Slips and Falls	Awareness induction	Med	Access ladder to be installed	Low	Client advised	Outstanding	OH&S REGULATIONS 3.7 AS/NZS 1657-2013 3.1.4
450	Building: General Stores Location Reference: L190 Task: Restrict access to the roof

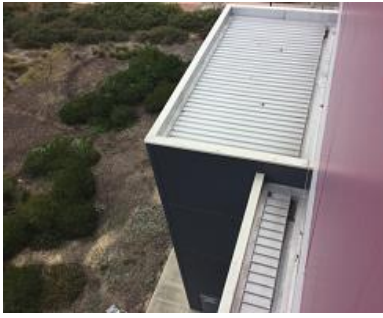
No safe access to the roof	Trips, Slips and Falls	Restrict Access	High	"EWP Access Only" sign to be installed	Low	Client advised	Outstanding	OH&S REGULATIONS 3.55 & 3.11

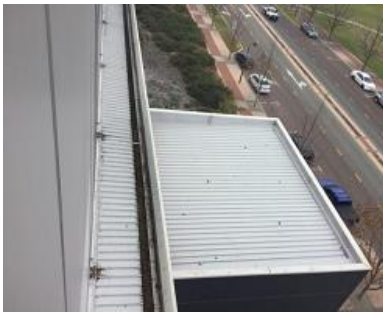
No	Photo of Hazard	Details of Hazard	Details of Risk	Existing/ Immediate Control Measure	Current Risk Level	Proposed Permanent Solution	Residual Risk Assessment	Details of Action Taken	Status	Reference
451	Building: General Stores Location Reference: L191 Task: Restrict access to the roof

No safe access to the roof	Trips, Slips and Falls	Restrict Access	High	"EWP Access Only" signs to be installed	Low	Client advised	Outstanding	OH&S REGULATIONS 3.55 & 3.11
452	Building: General Stores Location Reference: L192 Task: Access to the A/c unit

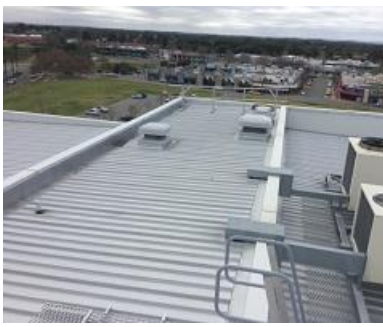
No safe access to the A/c units	Trips, Slips and Falls	N/A	Low	Walkway and handrails to be installed	Low	Client advised	Outstanding	-

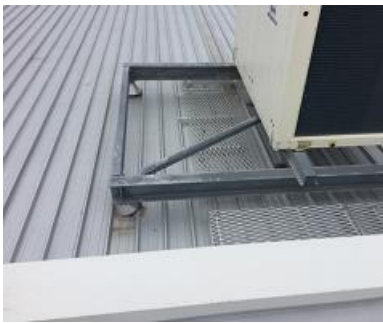
No	Photo of Hazard	Details of Hazard	Details of Risk	Existing/ Immediate Control Measure	Current Risk Level	Proposed Permanent Solution	Residual Risk Assessment	Details of Action Taken	Status	Reference
453	Building: General Stores Location Reference: L192 Task: Access to the plant deck

No safe access to the plant deck	Trips, Slips and Falls	Awareness induction	Med	Steps, walkway mesh and handrails to be installed	Low	Client advised	Outstanding	OH&S REGULATIONS 3.7 AS/NZS 1657-2013 3.1.4
454	Building: General Stores Location Reference: L192 Task: Access to the A/c units

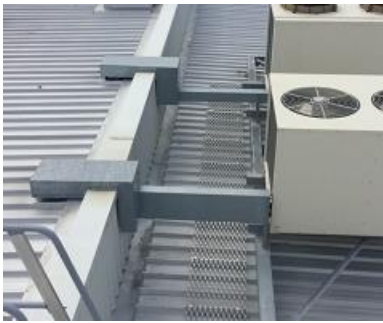
No safe access to the A/c units	Trips, Slips and Falls	Awareness induction	Med	Access ladders to be installed	Low	Client advised	Outstanding	OH&S REGULATIONS 3.7 AS/NZS 1657-2013 3.1.4

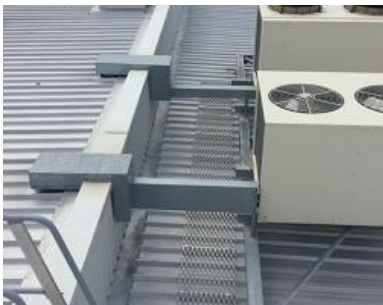
No	Photo of Hazard	Details of Hazard	Details of Risk	Existing/ Immediate Control Measure	Current Risk Level	Proposed Permanent Solution	Residual Risk Assessment	Details of Action Taken	Status	Reference
455	Building: General Stores Location Reference: L193 Task: Access to the roof

Handrail projecting towards the user	Trips, Slips and Falls	Awareness induction	Med	Existing handrail to be removed and new handrails to be installed	Low	Client advised	Outstanding	OH&S REGULATIONS 3.7 AS/NZS 1657-2013 7.4.8.5
456	Building: General Stores Location Reference: L194 Task: Access to the roof

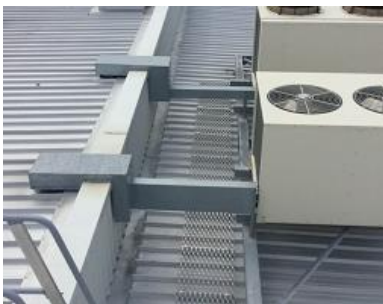
Handrail projecting towards the user	Trips, Slips and Falls	Awareness induction	Med	Existing handrail to be removed and new handrails to be installed	Low	Client advised	Outstanding	OH&S REGULATIONS 3.7 AS/NZS 1657-2013 7.4.8.5

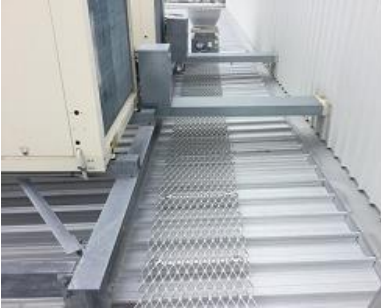
No	Photo of Hazard	Details of Hazard	Details of Risk	Existing/ Immediate Control Measure	Curre nt Risk Level	Proposed Permanent Solution	Resid ual Risk Asse ssme nt	Details of Action Taken	Status	Reference
457	Building: General Stores Location Reference: L194 Task: Access to the A/c units

Cable tray installed over the walkway path	Trips, Slips and Falls	Awareness induction	Med	Steps and additional walkway sections to be installed	Low	Client advised	Outstanding	OH&S REGULATIONS 3.7 AS/NZS 1657-2013 3.1.4
458	Building: General Stores Location Reference: L195 Task: Access to the plant deck

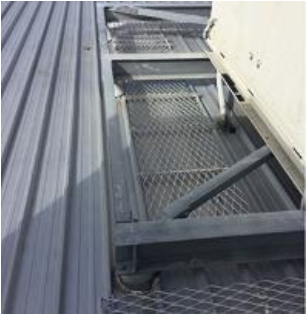
Walkway installed below the structural beams	Trips, Slips and Falls	Awareness induction	Med	Steps, Walkway mesh and handrails to be installed	Low	Client advised	Outstanding	OH&S REGULATIONS 3.7 AS/NZS 1657-2013 3.1.4

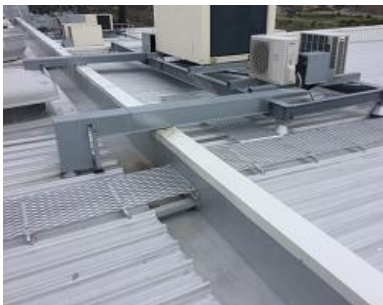
No	Photo of Hazard	Details of Hazard	Details of Risk	Existing/ Immediate Control Measure	Curre nt Risk Level	Proposed Permanent Solution	Resid ual Risk Asse ssme nt	Details of Action Taken	Status	Reference
459	Building: General Stores Location Reference: L196 Task: Access to the A/c units

Variation in height between roofs are greater than required minimum and Cable try installed over the walkway path	Trips, Slips and Falls	Awareness induction	Med	Access ladders to be installed	Low	Client advised	Outstanding	OH&S REGULATIONS 3.7 AS/NZS 1657-2013 3.1.4
460	Building: General Stores Location Reference: L196 Task: Access to the plant deck

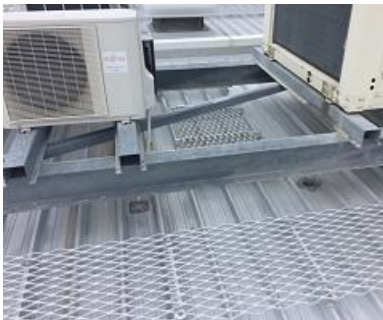
No safe access to the plant deck	Trips, Slips and Falls	Awareness induction	Med	Steps, walkway mesh and handrails to be installed	Low	Client advised	Outstanding	OH&S REGULATIONS 3.7 AS/NZS 1657-2013 3.1.4

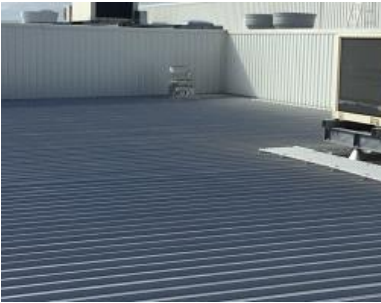
No	Photo of Hazard	Details of Hazard	Details of Risk	Existing/ Immediate Control Measure	Current Risk Level	Proposed Permanent Solution	Residual Risk Assessment	Details of Action Taken	Status	Reference
461	Building: General Stores Location Reference: L196 Task: Access to the A/c unit

No safe access to the A/c unit	Trips, Slips and Falls	N/A	Low	Supply walkway to the A/c unit	Low	Client advised	Outstanding	-
462	Building: General Stores Location Reference: L197 Task: Access to the roof

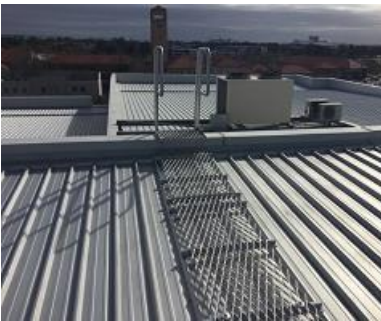
Gap between ladder and structure is less than required minimum, landing is less than required minimum and handrails projecting towards the user	Trips, Slips and Falls	Awareness induction	Med	Existing ladder to be re-installed with new brackets, landing platforms and new handrails	Low	Client advised	Outstanding	OH&S REGULATIONS 3.7 AS/NZS 1657-2013 7.4.5 & 7.3.6 & 7.4.8.5

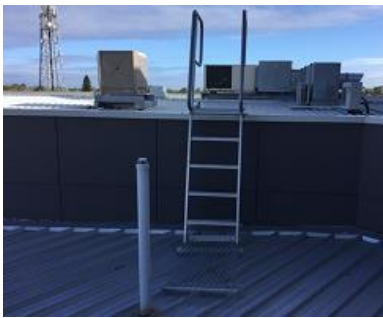
No	Photo of Hazard	Details of Hazard	Details of Risk	Existing/ Immediate Control Measure	Current Risk Level	Proposed Permanent Solution	Residual Risk Assessment	Details of Action Taken	Status	Reference
463	Building: General Stores Location Reference: L198 Task: Access to the roof

Bottom rung height is less than required minimum, handrails projecting towards the user	Trips, Slips and Falls	Awareness induction	Med	Existing ladder to be re-installed with new landing platforms and handrails	Low	Client advised	Outstanding	OH&S REGULATIONS 3.7 AS/NZS 1657-2013 7.4.3.4 & 7.4.8.5
464	Building: General Stores Location Reference: L198 Task: Access to the A/c units

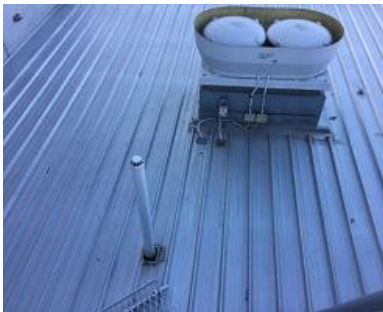
No safe access to the A/c unit	Trips, Slips and Falls	N/A	Low	Supply walkway to the A/c unit	Low	Client advised	Outstanding	-

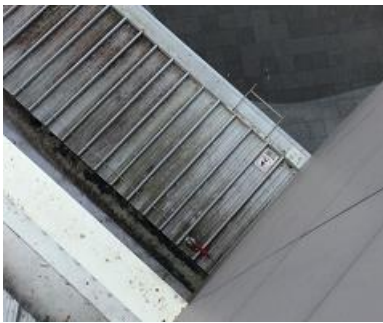
No	Photo of Hazard	Details of Hazard	Details of Risk	Existing/ Immediate Control Measure	Current Risk Level	Proposed Permanent Solution	Residual Risk Assessment	Details of Action Taken	Status	Reference
465	Building: General Stores Location Reference: L199 Task: Access to the roof

Access anchor is missing	Trips, Slips and Falls	Awareness induction	High	Anchor strop to be installed	Low	Client advised	Outstanding	OH&S REGULATIONS 3.55
466	Building: General Stores Location Reference: L199 Task: Access to the roof

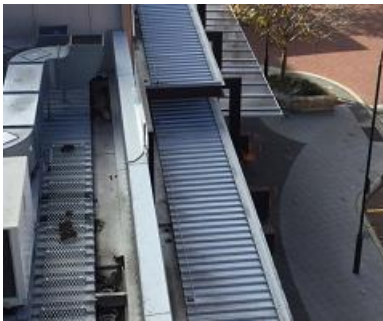
Variation in height between roofs are greater than required maximum	Trips, Slips and Falls	Awareness induction	Med	Access ladder to be installed	Low	Client advised	Outstanding	OH&S REGULATIONS 3.7 AS/NZS 1657-2013 3.1.4

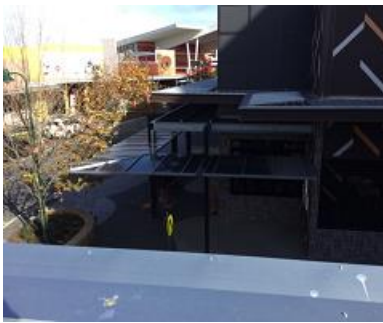
No	Photo of Hazard	Details of Hazard	Details of Risk	Existing/ Immediate Control Measure	Current Risk Level	Proposed Permanent Solution	Residual Risk Assessment	Details of Action Taken	Status	Reference
467	Building: General Stores Location Reference: L201 Task: Restrict access to the roof

Brittle roof (Non-trafficable roof)	Trips, Slips and Falls	Restrict Access	High	"Warning-Keep Off-Brittle and Fragile Roof" signs to be installed	Low	Client advised	Outstanding	OH&S REGULATIONS 3.57
468	Building: General Stores Location Reference: L202 Task: Access to the roof

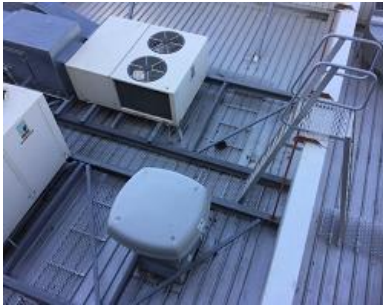
Handrails projecting towards the user	Trips, Slips and Falls	Awareness induction	Med	Existing handrails to be removed and new handrails to be installed	Low	Client advised	Outstanding	OH&S REGULATIONS 3.7 AS/NZS 1657-2013 7.4.8.5

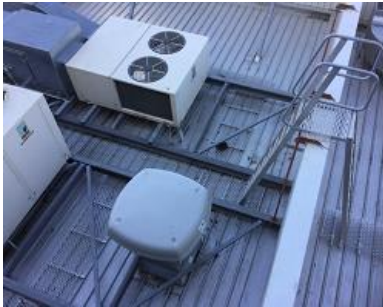
No	Photo of Hazard	Details of Hazard	Details of Risk	Existing/ Immediate Control Measure	Curre nt Risk Level	Proposed Permanent Solution	Resid ual Risk Asse ssme nt	Details of Action Taken	Status	Reference
469	Building: General Stores Location Reference: L202 Task: Access to the plant deck

Walkway installed below plant deck	Trips, Slips and Falls	Awareness induction	Med	Steps, walkway mesh and handrails to be installed	Low	Client advised	Outstanding	OH&S REGULATIONS 3.7 AS/NZS 1657-2013 3.1.4
470	Building: General Stores Location Reference: L202 Task: Access to the A/c units

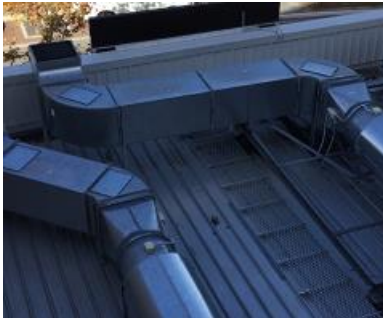
Duct installed over the walkway path	Trips, Slips and Falls	Awareness induction	Med	Access ladder to be installed	Low	Client advised	Outstanding	OH&S REGULATIONS 3.7 AS/NZS 1657-2013 3.1.4

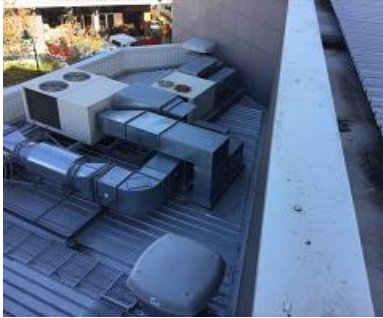
No	Photo of Hazard	Details of Hazard	Details of Risk	Existing/ Immediate Control Measure	Current Risk Level	Proposed Permanent Solution	Residual Risk Assessment	Details of Action Taken	Status	Reference
471	Building: General Stores Location Reference: L202 Task: Access to the A/c units

No safe access to the A/c units	Trips, Slips and Falls	N/A	Low	Supply walkway to the A/c units	Low	Client advised	Outstanding	-
472	Building: General Stores Location Reference: L203 Task: Access to the roof

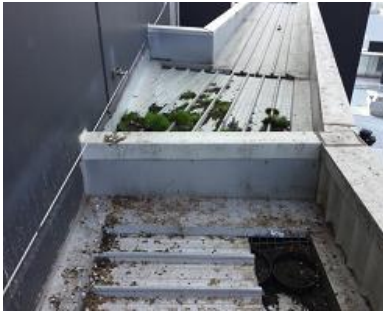
Variation in height between roofs are greater than required maximum	Trips, Slips and Falls	Awareness induction	Med	Single step to be installed	Low	Client advised	Outstanding	OH&S REGULATIONS 3.7 AS/NZS 1657-2013 3.1.4

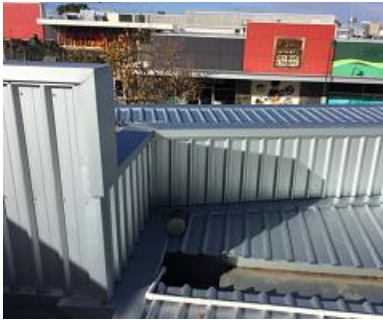
No	Photo of Hazard	Details of Hazard	Details of Risk	Existing/ Immediate Control Measure	Current Risk Level	Proposed Permanent Solution	Residual Risk Assessment	Details of Action Taken	Status	Reference
473	Building: General Stores Location Reference: L205 Task: Access to the roof

Variation in height between roofs are greater than required maximum	Trips, Slips and Falls	Awareness induction	Med	Access ladder to be installed	Low	Client advised	Outstanding	OH&S REGULATIONS 3.7 AS/NZS 1657-2013 3.1.4
474	Building: General Stores Location Reference: L205 Task: Access to the A/c unit

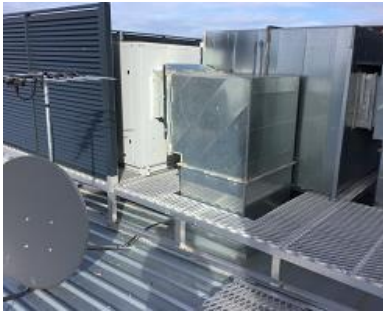
Gap between grating and unit is greater than required maximum	Trips, Slips and Falls	Awareness induction	Med	Gap to be closed with gratings/checker plate	Low	Client advised	Outstanding	OH&S REGULATIONS 3.7 AS/NZS 1657-2013 4.4

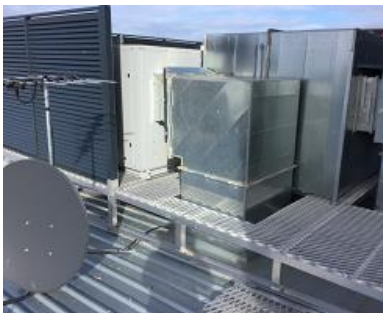
No	Photo of Hazard	Details of Hazard	Details of Risk	Existing/ Immediate Control Measure	Current Risk Level	Proposed Permanent Solution	Residual Risk Assessment	Details of Action Taken	Status	Reference
475	Building: General Stores Location Reference: L205 Task: Access to the A/c unit

Walkway path width is less than required minimum	Trips, Slips and Falls	Awareness induction	Med	Additional walkway section to be installed	Low	Client advised	Outstanding	OH&S REGULATIONS 3.7 AS/NZS 1657-2013 5.1.3
476	Building: General Stores Location Reference: L205 Task: Access to the A/c unit

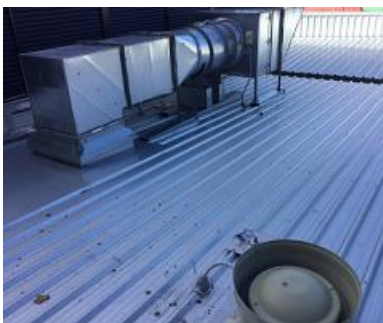
No safe access to the A/c unit	Trips, Slips and Falls	N/A	Low	Supply walkway to the A/c unit	Low	Client advised	Outstanding	-

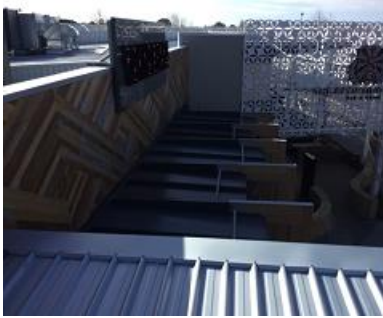
No	Photo of Hazard	Details of Hazard	Details of Risk	Existing/ Immediate Control Measure	Current Risk Level	Proposed Permanent Solution	Residual Risk Assessment	Details of Action Taken	Status	Reference
477	Building: General Stores Location Reference: L206 Task: Restrict access to the roof

Brittle roof (Non-trafficable roof)	Trips, Slips and Falls	Restrict Access	High	"Warning-Keep Off-Brittle and Fragile Roof" sign to be installed	Low	Client advised	Outstanding	OH&S REGULATIONS 3.57
478	Building: General Stores Location Reference: L207 Task: Access to the A/c units

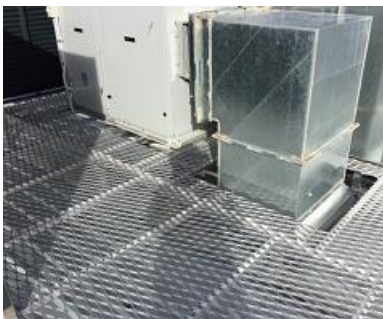
Gap between grating and unit is greater than required maximum	Trips, Slips and Falls	Awareness induction	Med	Gap to be closed with gratings/checker plate	Low	Client advised	Outstanding	OH&S REGULATIONS 3.7 AS/NZS 1657-2013 4.4

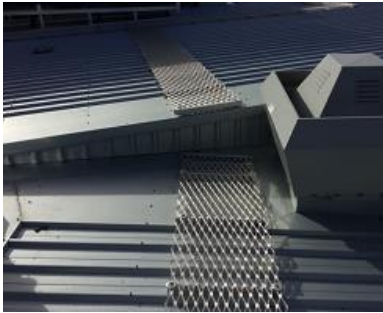
No	Photo of Hazard	Details of Hazard	Details of Risk	Existing/ Immediate Control Measure	Current Risk Level	Proposed Permanent Solution	Residual Risk Assessment	Details of Action Taken	Status	Reference
479	Building: General Stores Location Reference: L207 Task: Access to the roof

Variation in height between walkway panels are greater than required maximum	Trips, Slips and Falls	Awareness induction	Med	Single step to be installed	Low	Client advised	Outstanding	OH&S REGULATIONS 3.7 AS/NZS 1657-2013 3.1.4
480	Building: General Stores Location Reference: L207 Task: Access to the A/c units

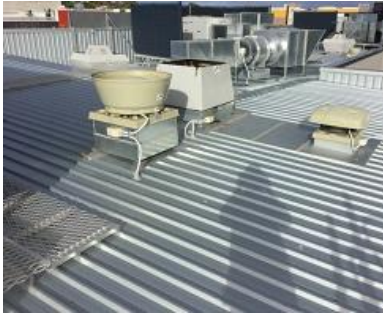
No safe access to the A/c units	Trips, Slips and Falls	N/A	Low	Supply walkway to the A/c units	Low	Client advised	Outstanding	-

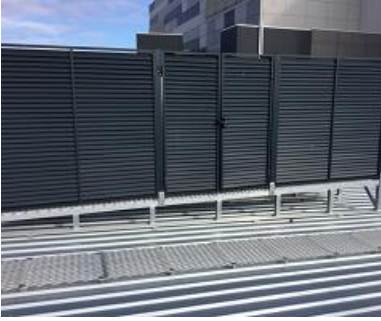
No	Photo of Hazard	Details of Hazard	Details of Risk	Existing/ Immediate Control Measure	Current Risk Level	Proposed Permanent Solution	Residual Risk Assessment	Details of Action Taken	Status	Reference
481	Building: General Stores Location Reference: L209 Task: Access to the A/c unit

No safe access to the plant deck and Variation in height between plant deck and roof is greater than required maximum	Trips, Slips and Falls	Awareness induction	Med	Walkway and step to be installed	Low	Client advised	Outstanding	OH&S REGULATIONS 3.7 AS/NZS 1657-2013 3.1.4
482	Building: General Stores Location Reference: L210 Task: Access to the roof
