Roof Safety Report

Rockingham Centre, WA 6168

Prepared By: Safemaster Safety Products
Date: 10 Aug 2017

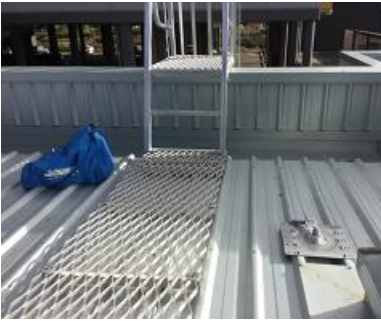
Anchor stop is missing at access point for safe access	Trips, Slips and Falls	Awareness induction	High	Anchor stop to be installed	Low	Client advised	Outstanding	OH&S REGULATIONS 3.55

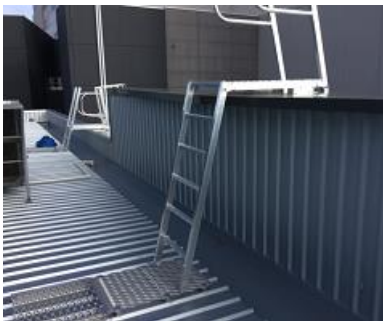
No	Photo of Hazard	Details of Hazard	Details of Risk	Existing/ Immediate Control Measure	Curre nt Risk Level	Proposed Permanent Solution	Resid ual Risk Asse ssme nt	Details of Action Taken	Status	Reference
483	Building: General Stores Location Reference: L211 Task: Access to the roof

Gap between ladder and structure is less than required minimum	Trips, Slips and Falls	Awareness induction	Med	Existing ladder to be re-installed with new landing platform and brackets	Low	Client advised	Outstanding	OH&S REGULATIONS 3.7 AS/NZS 1657-2013 7.4.5
484	Building: General Stores Location Reference: L211 Task: Restrict access to the roof

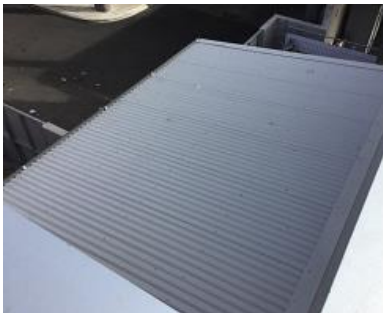
No height safety system installed (No serviceable items on roof)	Trips, Slips and Falls	Restrict Access	High	"EWP Access Only" sign to be installed	Low	Client advised	Outstanding	OH&S REGULATIONS 3.55 & 3.11

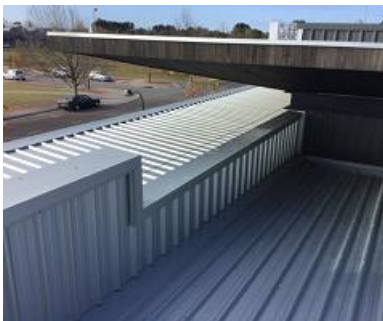
No	Photo of Hazard	Details of Hazard	Details of Risk	Existing/ Immediate Control Measure	Curre nt Risk Level	Proposed Permanent Solution	Resid ual Risk Asse ssme nt	Details of Action Taken	Status	Reference
485	Building: General Stores Location Reference: L212 Task: Access to the roof

Variation in height between roofs are greater than required maximum	Trips, Slips and Falls	Awareness induction	Med	Access ladder to be installed	Low	Client advised	Outstanding	OH&S REGULATIONS 3.7 AS/NZS 1657-2013 3.1.4
486	Building: General Stores Location Reference: L212 Task: Access to the roof

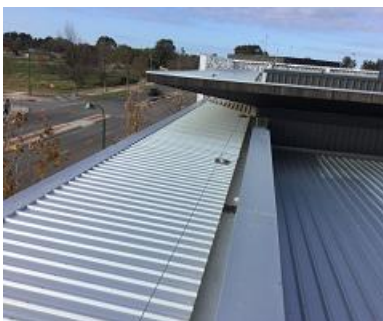
Head room is less than required minimum	Trips, Slips and Falls	Awareness induction	High	"Warning-Low Head room" sign to be installed	Low	Client advised	Outstanding	OH&S REGULATIONS 3.7 & 3.11 AS/NZS 1657-2013 3.1.5

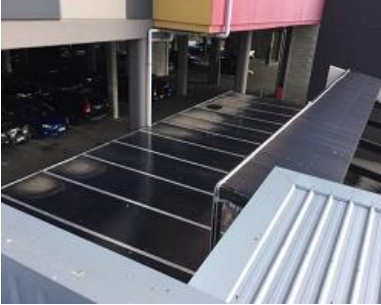
No	Photo of Hazard	Details of Hazard	Details of Risk	Existing/ Immediate Control Measure	Current Risk Level	Proposed Permanent Solution	Residual Risk Assessment	Details of Action Taken	Status	Reference
487	Building: General Stores Location Reference: L213 Task: Restrict access to the roof

Brittle roof (Non-trafficable roof)	Trips, Slips and Falls	Restrict Access	High	"Warning-Keep Off-Brittle and Fragile Roof" signs to be installed	Low	Client advised	Outstanding	OH&S REGULATIONS 3.57
