# Roof Safety Report

**Roxburgh Village, VIC 3064**

Prepared By: Safemaster Safety Products  
Date: 18 June 2018

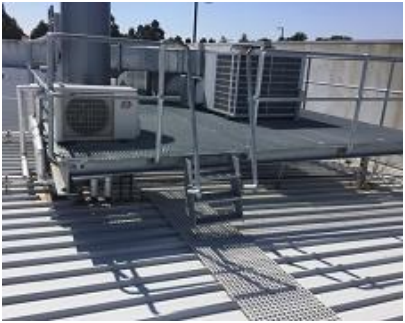
Un-even tread heights are present	Trips, Slips and Falls	Awareness induction	Med	Existing ladder to be removed and new ladder to be installed	Low	Client advised	Outstanding	OH&S REGULATIONS 3.7  AS/NZS 1657-2013 7.3

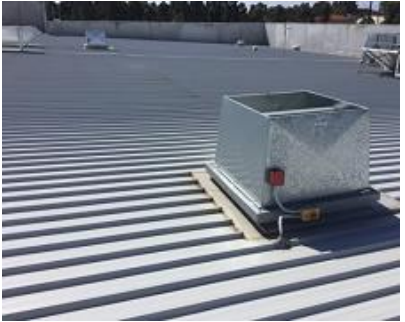
No safe access to the A/c units	Trips, Slips and Falls	N/A	Low	Supply Walkway to the A/c units	Low	Client advised	Outstanding	-

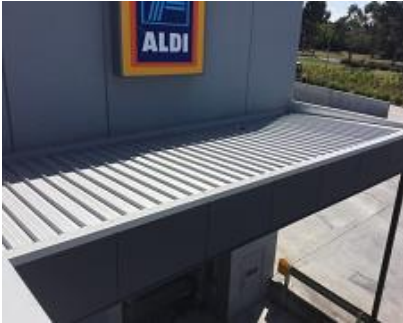
No height safety system installed	Trips, Slips and Falls	Awareness induction	High	Fall arrest anchors to be installed	Low	Client advised	Outstanding	OH&S REGULATIONS 3.55

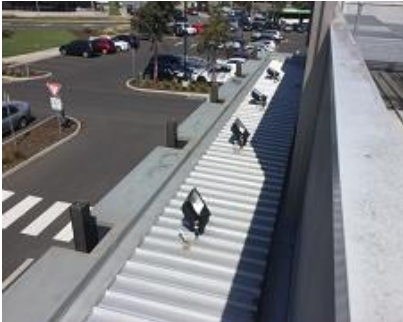
No height safety system installed	Trips, Slips and Falls	Restrict Access	High	"EWP Access Only" signs to be installed	Low	Client advised	Outstanding	OH&S REGULATIONS 3.55 & 3.11

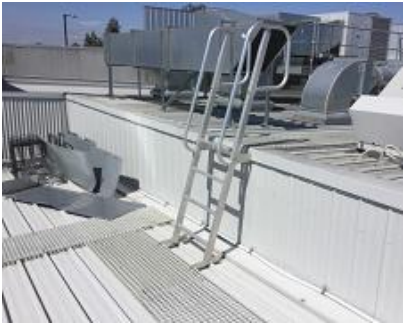
Gap between top rung and landing is greater than required maximum, bottom rung height is less than required minimum and handrail projecting towards the user	Trips, Slips and Falls	Awareness induction	Med	Existing handrail to be removed. Existing ladder to be re-installed with landing platforms and handrails.	Low	Client advised	Outstanding	OH&S REGULATIONS 3.7  AS/NZS 1657-2013 7.4.8.4, 7.4.3.4 & 7.4.8.5

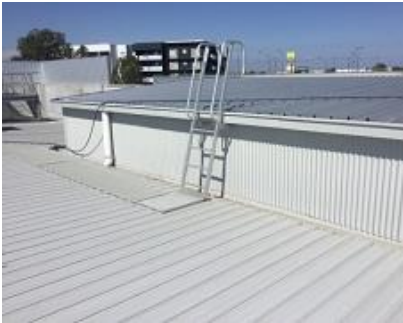
Bottom rung height is less than required minimum and handrail projecting towards the user	Trips, Slips and Falls	Awareness induction	Med	Existing ladder to be re-installed with landing platforms, brackets and handrails	Low	Client advised	Outstanding	OH&S REGULATIONS 3.7  AS/NZS 1657-2013 7.4.3.4 & 7.4.8.5

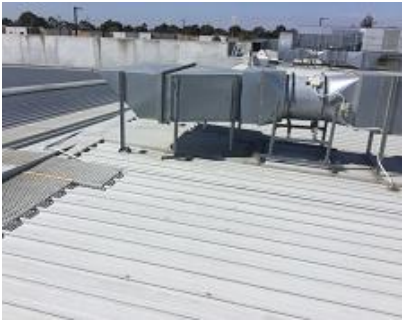
Variation in height between walkway panels are greater than required maximum	Trips, Slips and Falls	Awareness induction	Med	High visibility safety yellow nosing's to be installed	Low	Client advised	Outstanding	OH&S REGULATIONS 3.7  AS/NZS 1657-2013 3.3.4

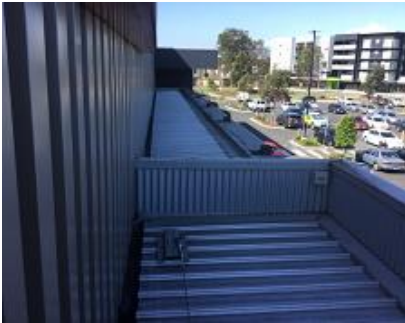
Variation in height between roofs are greater than required maximum	Trips, Slips and Falls	Awareness induction	Med	Access ladder to be installed	Low	Client advised	Outstanding	OH&S REGULATIONS 3.7  AS/NZS 1657-2013 3.1.4

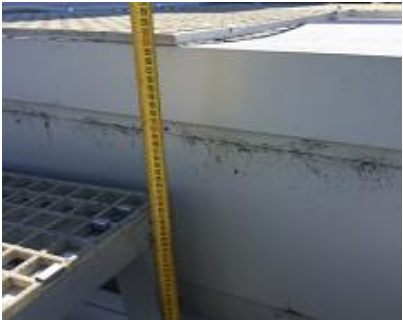
Non-complaint step is present	Trips, Slips and Falls	Awareness induction	Med	Existing step to be removed and new ladder to be installed	Low	Client advised	Outstanding	OH&S REGULATIONS 3.7  AS/NZS 1657-2013 3.1.4

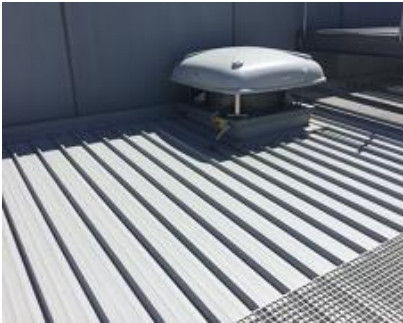
No safe access to the A/c units	Trips, Slips and Falls	N/A	Low	Supply Walkway to the A/c units	Low	Client advised	Outstanding	-

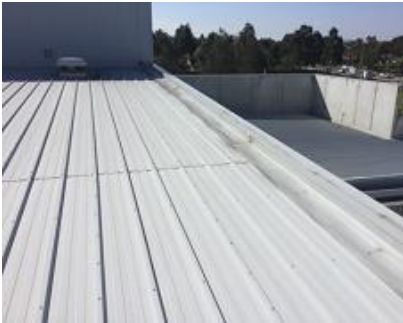
No height safety system installed	Trips, Slips and Falls	Awareness induction	High	Fall arrest anchors to be installed	Low	Client advised	Outstanding	OH&S REGULATIONS 3.55

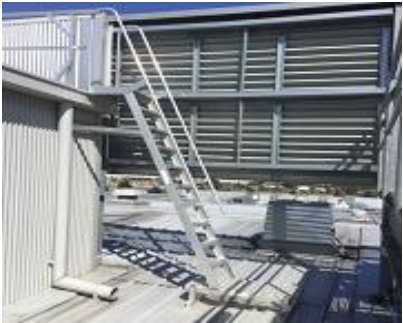
Headroom is less than required minimum	Trips, Slips and Falls	Awareness induction	Med	"Caution-Low headroom" signs to be installed	Low	Client advised	Outstanding	OH&S REGULATIONS 3.7  AS/NZS 1657-2013 3.1.5

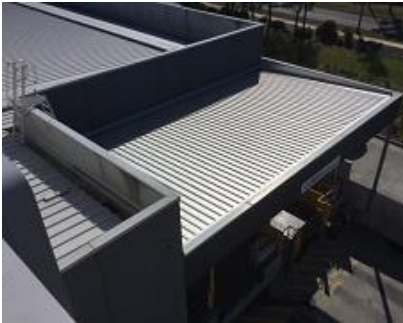
No height safety system installed	Trips, Slips and Falls	Awareness induction	High	Fall arrest anchors to be installed	Low	Client advised	Outstanding	OH&S REGULATIONS 3.55
28	Building: General Stores Location Reference: <a href="#">L19</a> Task: Access to the roof

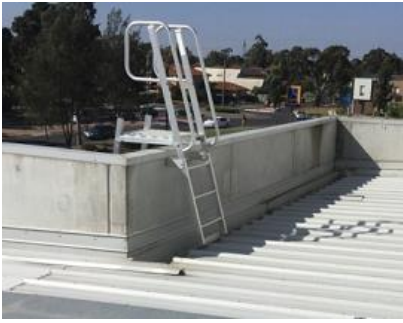
Bottom rung heights are less than required minimum and handrails projecting towards the user	Trips, Slips and Falls	Awareness induction	Med	Existing handrail to be removed. Existing ladder to be re-installed with landing platforms, brackets and handrails	Low	Client advised	Outstanding	OH&S REGULATIONS 3.7  AS/NZS 1657-2013 7.4.3.4 & 7.4.8.5

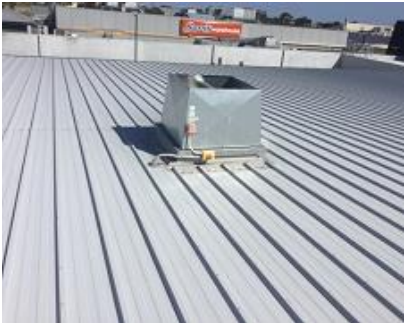
No safe access to the A/c units	Trips, Slips and Falls	N/A	Low	Supply Walkway to the A/c units	Low	Client advised	Outstanding	-

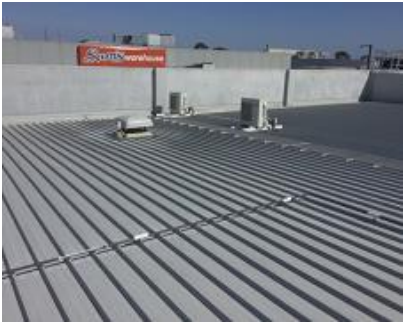
No safe access to the A/c units	Trips, Slips and Falls	N/A	Low	Supply Walkway to the A/c units	Low	Client advised	Outstanding	-

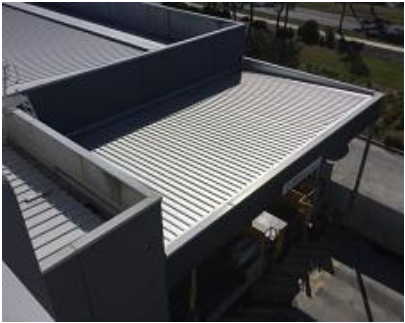
No height safety system installed	Trips, Slips and Falls	Awareness induction	High	Fall arrest anchors to be installed	Low	Client advised	Outstanding	OH&S REGULATIONS 3.55

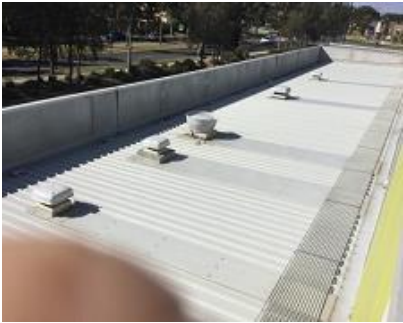
No safe access to the A/c units	Trips, Slips and Falls	N/A	Low	Supply Walkway to the A/c units	Low	Client advised	Outstanding	-

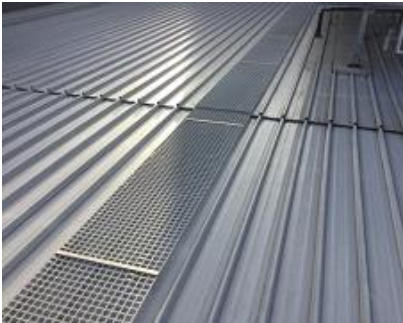
Variation in height between walkway panels are greater than required maximum	Trips, Slips and Falls	Awareness induction	Med	High visibility safety yellow nosing to be installed	Low	Client advised	Outstanding	OH&S REGULATIONS 3.7  AS/NZS 1657-2013 3.3.4

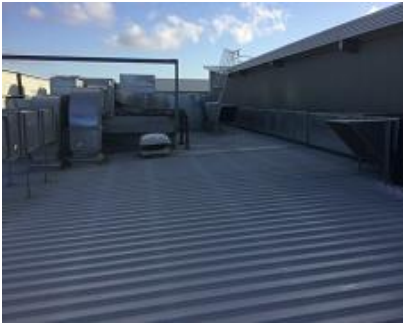
No safe access to the A/c units	Trips, Slips and Falls	N/A	Low	Supply Walkway and access ladder to the A/c units	Low	Client advised	Outstanding	-

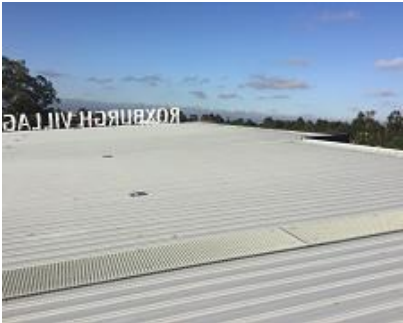
No height safety system installed	Trips, Slips and Falls	Awareness induction	High	Fall arrest anchors to be installed	Low	Client advised	Outstanding	OH&S REGULATIONS 3.55

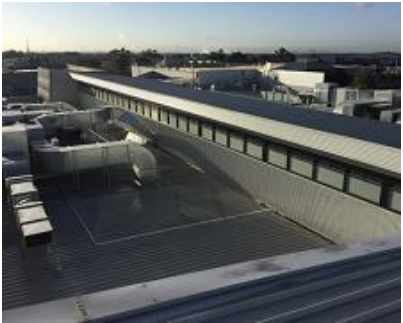
No height safety system installed	Trips, Slips and Falls	Awareness induction	High	Fall arrest anchors to be installed	Low	Client advised	Outstanding	OH&S REGULATIONS 3.55

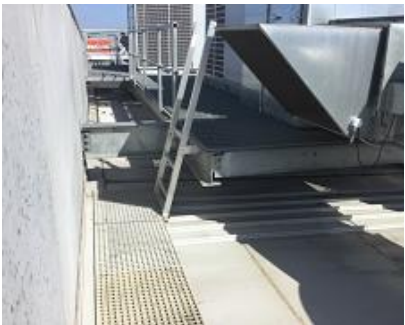
Variation in height between plant deck and roof is greater than required maximum	Trips, Slips and Falls	Awareness induction	Med	Handrail to be installed	Low	Client advised	Outstanding	OH&S REGULATIONS 3.7  AS/NZS 1657-2013 4.4

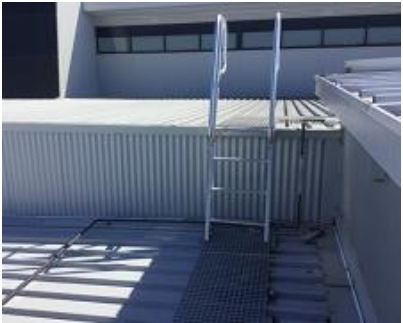
Top rung not levelled with landing, Bottom rung height is greater than required maximum and handrail projecting towards the user	Trips, Slips and Falls	Awareness induction	Med	Existing handrail to be removed. Existing ladder to be re-installed with landing platforms, brackets and handrail	Low	Client advised	Outstanding	OH&S REGULATIONS 3.7  AS/NZS 1657-2013 7.4.3.3, 7.4.3.4 & 7.4.8.5

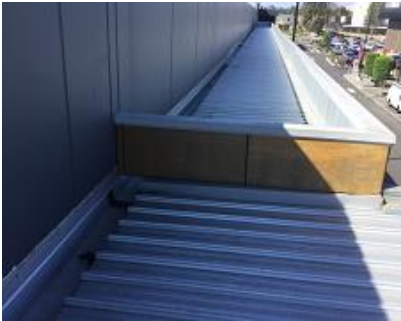
Variation in height between roofs are greater than required maximum	Trips, Slips and Falls	Awareness induction	Med	Access ladder to be installed	Low	Client advised	Outstanding	OH&S REGULATIONS 3.7  AS/NZS 1657-2013 3.1.4
56	Building: General Stores Location Reference: <a href="#">L33</a> Task: Access to the roof

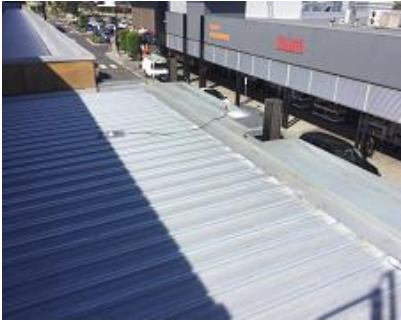
Existing ladder bracket and anchor strop not in service	Trips, Slips and Falls	Awareness induction	Med	Existing ladder bracket and anchor strop to be removed	Low	Client advised	Outstanding	OH&S REGULATIONS 3.55

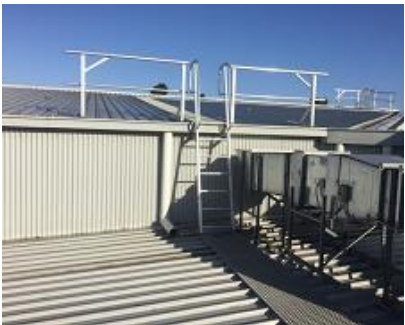
Top rung not levelled with landing, Bottom rung height is greater than required maximum and handrail projecting towards the user	Trips, Slips and Falls	Awareness induction	Med	Existing handrail to be removed. Existing ladder to be re-installed with landing platforms, brackets and handrail	Low	Client advised	Outstanding	OH&S REGULATIONS 3.7  AS/NZS 1657-2013 7.4.3.3, 7.4.3.4 & 7.4.8.5

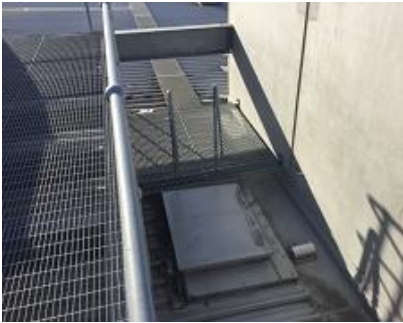
Headroom is less than required minimum	Trips, Slips and Falls	Awareness induction	Med	"Warning-Low Headroom" signs to be installed	Low	Client advised	Outstanding	OH&S REGULATIONS 3.7  AS/NZS 1657-2013 3.1.5

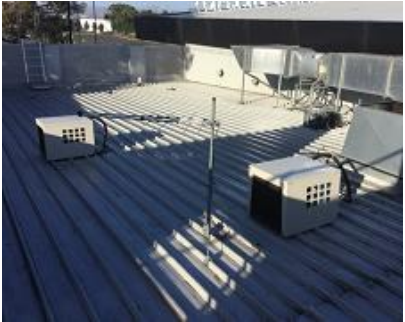
No safe access to the A/c units	Trips, Slips and Falls	N/A	Low	Supply Walkway to the A/c units	Low	Client advised	Outstanding	-

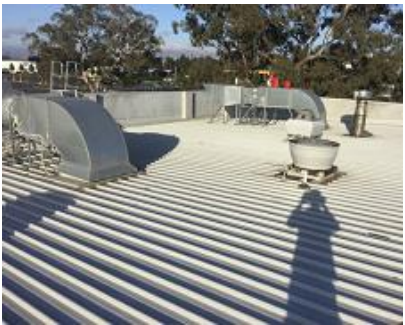
No safe access to the A/c units	Trips, Slips and Falls	N/A	Low	Supply Walkway to the A/c units	Low	Client advised	Outstanding	-

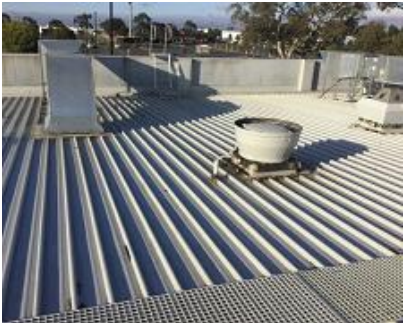
No safe access to the ladder	Trips, Slips and Falls	N/A	Low	Supply Walkway to the ladder	Low	Client advised	Outstanding	-

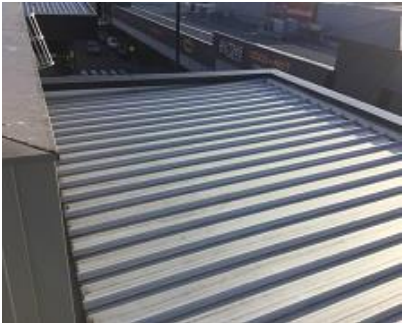
No height safety system installed	Trips, Slips and Falls	Awareness induction	High	Fall arrest anchors to be installed	Low	Client advised	Outstanding	OH&S REGULATIONS 3.55

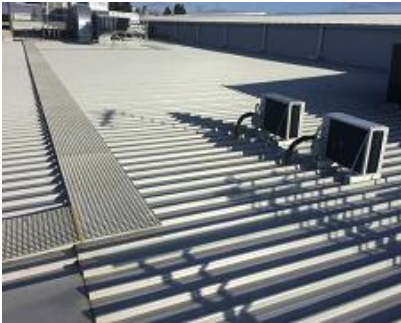
No safe access to the A/c units	Trips, Slips and Falls	N/A	Low	Supply Walkway to the A/c units	Low	Client advised	Outstanding	-
70	Building: General Stores Location Reference: <a href="#">L40</a> Task: Access to the ladder

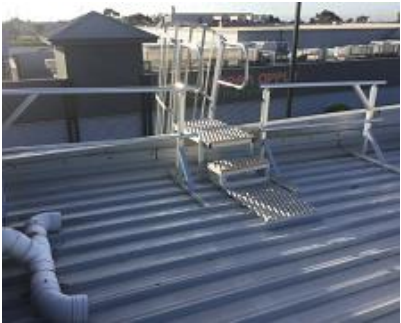
No safe access to the ladder	Trips, Slips and Falls	N/A	Low	Supply Walkway to the ladder	Low	Client advised	Outstanding	-

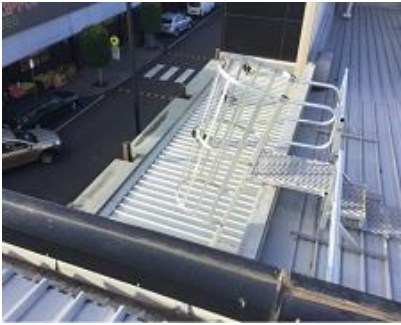
No height safety system installed	Trips, Slips and Falls	Awareness induction	High	Fall arrest anchors to be installed	Low	Client advised	Outstanding	OH&S REGULATIONS 3.55
72	Building: General Stores Location Reference: <a href="#">L41</a> Task: Access to the roof

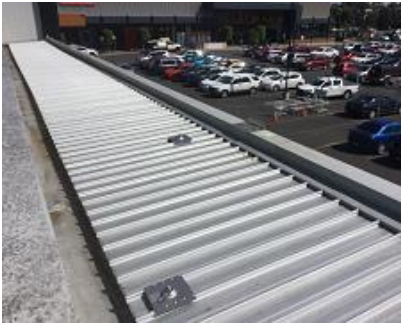
No height safety system installed	Trips, Slips and Falls	Awareness induction	High	Fall arrest anchors and anchor stop to be installed	Low	Client advised	Outstanding	OH&S REGULATIONS 3.55

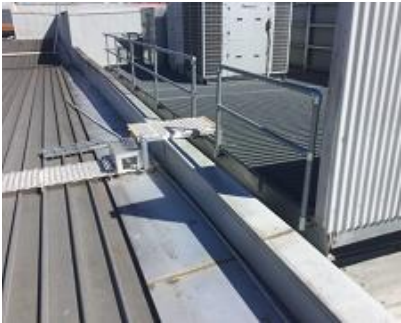
Handrail is missing for steps	Trips, Slips and Falls	Awareness induction	Med	Handrail to be installed	Low	Client advised	Outstanding	OH&S REGULATIONS 3.7  AS/NZS 1657-2013 7.2.6
74	Building: General Stores Location Reference: <a href="#">L43</a> Task: Access to the roof

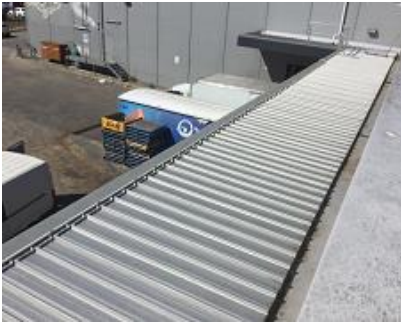
No height safety system installed	Trips, Slips and Falls	Awareness induction	High	Fall arrest anchors to be installed	Low	Client advised	Outstanding	OH&S REGULATIONS 3.55

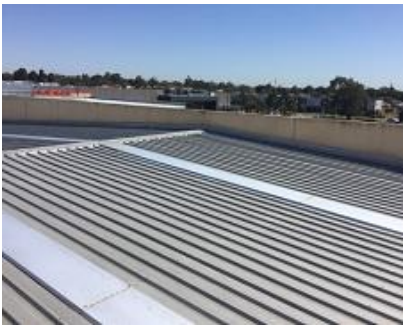
No height safety system installed	Trips, Slips and Falls	Awareness induction	High	Fall arrest anchors to be installed	Low	Client advised	Outstanding	OH&S REGULATIONS 3.55

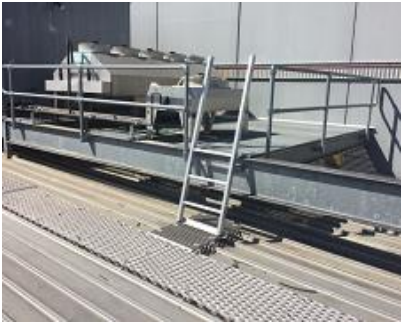
Bottom rung height is less than required minimum	Trips, Slips and Falls	Awareness induction	Med	Landing platform and handrail to be installed	Low	Client advised	Outstanding	OH&S REGULATIONS 3.7  AS/NZS 1657-2013 7.4.3.4

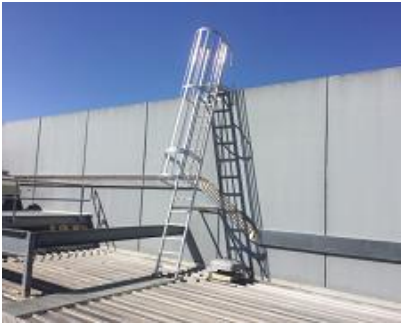
Bottom rung height is less than required minimum and handrail projecting towards the user	Trips, Slips and Falls	Awareness induction	Med	Existing handrail to be removed. Landing platform and handrail to be installed	Low	Client advised	Outstanding	OH&S REGULATIONS 3.7  AS/NZS 1657-2013 7.4.3.4 & 7.4.8.5

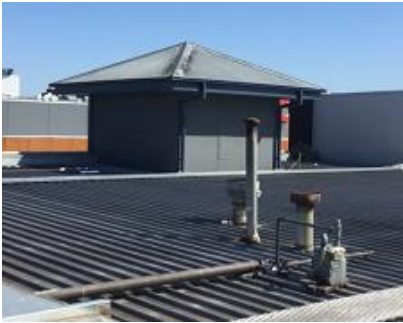
No height safety system installed	Trips, Slips and Falls	Restrict Access	High	"No Access to Roof" sign to be installed	Low	Client advised	Outstanding	OH&S REGULATIONS 3.55 & 3.11

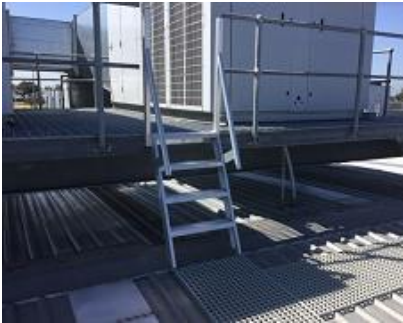
Un-even steps are present	Trips, Slips and Falls	Awareness induction	Med	Existing stair to be removed and new stair to be installed	Low	Client advised	Outstanding	OH&S REGULATIONS 3.7  AS/NZS 1657-2013 7.2

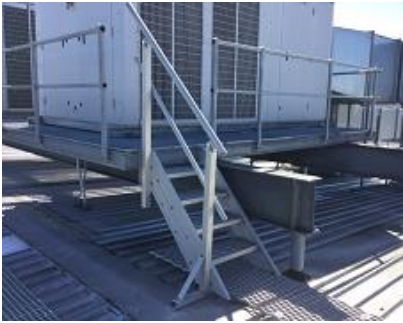
Un-even steps are present	Trips, Slips and Falls	Awareness induction	Med	Existing stair to be removed and new stair to be installed	Low	Client advised	Outstanding	OH&S REGULATIONS 3.7  AS/NZS 1657-2013 7.2
86	Building: General Stores Location Reference: <a href="#">L50</a> Task: Access to the roof

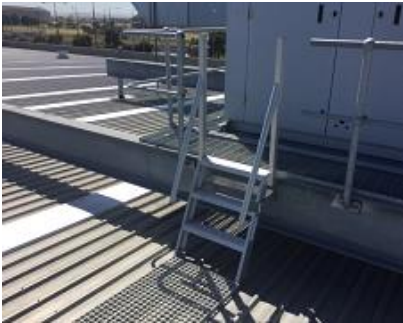
Non-complaint ladder is present	Trips, Slips and Falls	Awareness induction	Med	Existing ladder to be removed and new ladder to be installed	Low	Client advised	Outstanding	OH&S REGULATIONS 3.7  AS/NZS 1657-2013 7.3

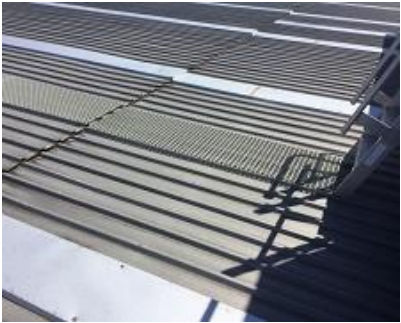
Variation in height between walkway panels are greater than required maximum	Trips, Slips and Falls	Awareness induction	Med	High visibility safety yellow nosing to be installed	Low	Client advised	Outstanding	OH&S REGULATIONS 3.7  AS/NZS 1657-2013 3.3.4
88	Building: General Stores Location Reference: <a href="#">L51</a> Task: Access to the roof

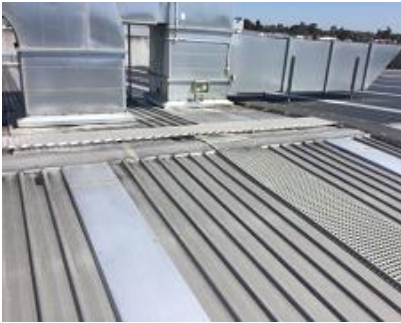
Variation in height between walkway panels are greater than required maximum	Trips, Slips and Falls	Awareness induction	Med	High visibility safety yellow nosing to be installed	Low	Client advised	Outstanding	OH&S REGULATIONS 3.7  AS/NZS 1657-2013 3.3.4

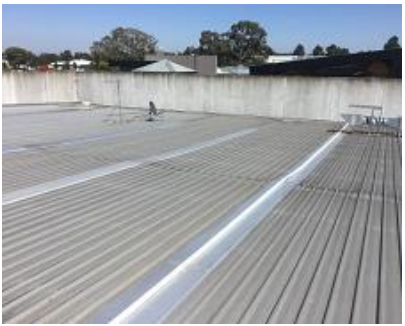
No safe access to the A/c units	Trips, Slips and Falls	N/A	Low	Supply Walkway to the A/c units	Low	Client advised	Outstanding	-

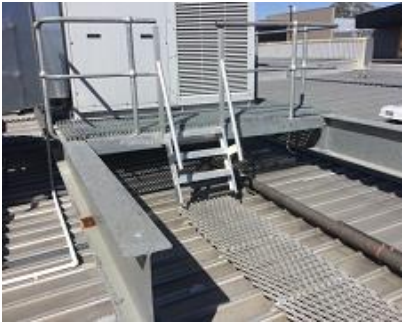
Non-complaint ladder is present	Trips, Slips and Falls	Awareness induction	Med	Existing ladder to be removed and new ladder to be installed	Low	Client advised	Outstanding	OH&S REGULATIONS 3.7  AS/NZS 1657-2013 7.3

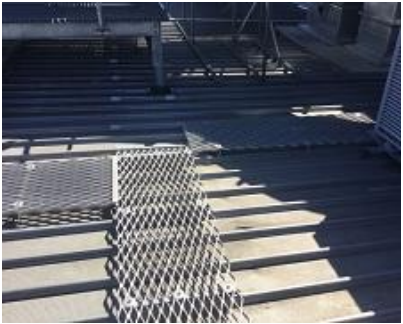
Gap between walkway panels are greater than required maximum	Trips, Slips and Falls	Awareness induction	Med	Additional walkway sections to be installed	Low	Client advised	Outstanding	OH&S REGULATIONS 3.7  AS/NZS 1657-2013 3.2.3.4

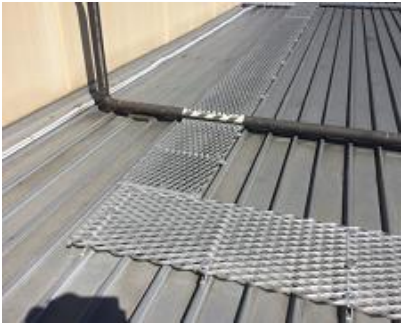
Pipes installed over the walkway path	Trips, Slips and Falls	Awareness induction	Med	Step bridge to be installed	Low	Client advised	Outstanding	OH&S REGULATIONS 3.7  AS/NZS 1657-2013 3.1.4

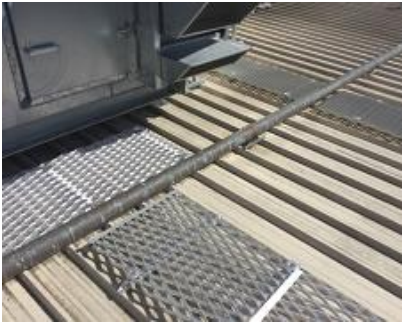
Pipes installed over the walkway path	Trips, Slips and Falls	Awareness induction	Med	Step bridges to be installed	Low	Client advised	Outstanding	OH&S REGULATIONS 3.7  AS/NZS 1657-2013 3.1.4

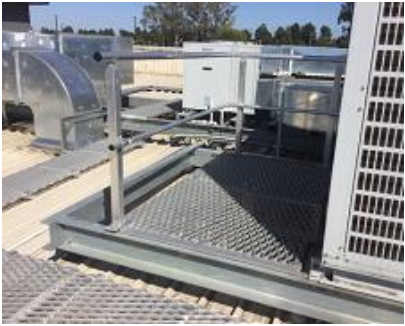
Sharp edges on handrails	Trips, Slips and Falls	Awareness induction	Med	Tek screws to be replaced with rivets	Low	Client advised	Outstanding	OH&S REGULATIONS 3.7  AS/NZS 1657-2013 5.6
104	Building: General Stores Location Reference: <a href="#">L59</a> Task: Access to the roof

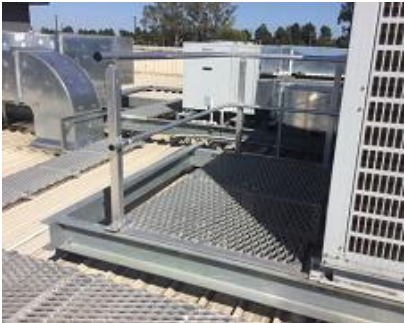
Variation in height between plant deck and roof is greater than required maximum	Trips, Slips and Falls	Awareness induction	Med	Step and handrail to be installed	Low	Client advised	Outstanding	OH&S REGULATIONS 3.7  AS/NZS 1657-2013 3.1.4 & 4.4

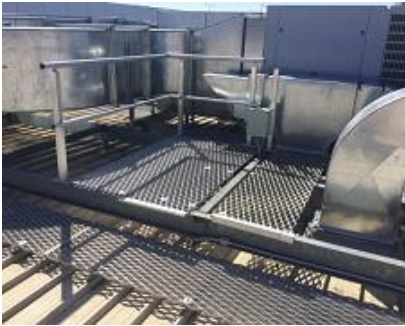
Sharp edges on handrails	Trips, Slips and Falls	Awareness induction	Med	Tek screws to be replaced with rivets	Low	Client advised	Outstanding	OH&S REGULATIONS 3.7  AS/NZS 1657-2013 5.6
106	Building: General Stores Location Reference: <a href="#">L59</a> Task: Access to the roof

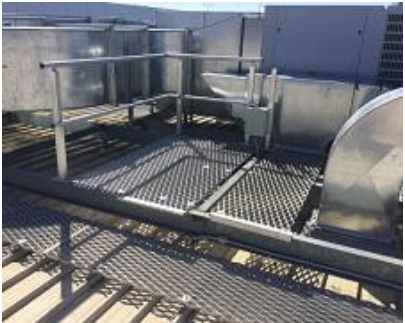
Variation in height between plant deck and roof is greater than required maximum	Trips, Slips and Falls	Awareness induction	Med	Step and handrail to be installed	Low	Client advised	Outstanding	OH&S REGULATIONS 3.7  AS/NZS 1657-2013 3.1.4 & 4.4

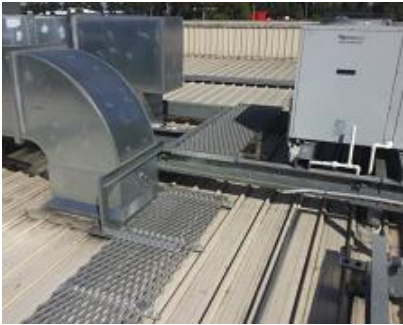
Variation in height between plant deck and roof is greater than required maximum	Trips, Slips and Falls	Awareness induction	Med	Steps and handrail to be installed	Low	Client advised	Outstanding	OH&S REGULATIONS 3.7  AS/NZS 1657-2013 3.1.4 & 4.4
108	Building: General Stores Location Reference: <a href="#">L59</a> Task: Access to the A/c units

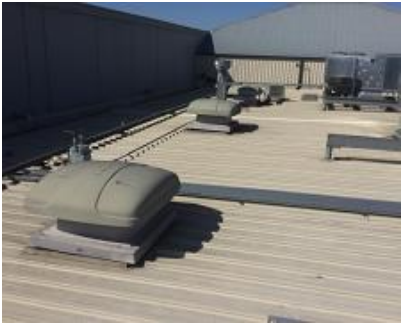
No safe access to the A/c units	Trips, Slips and Falls	N/A	Low	Supply walkway and step overs to the A/c units	Low	Client advised	Outstanding	-

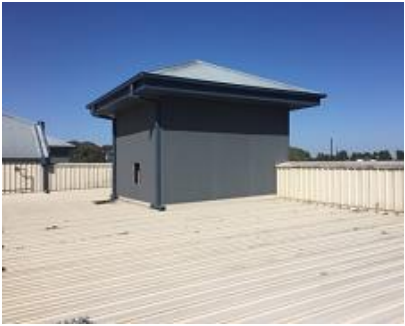
No height safety system installed	Trips, Slips and Falls	Restrict Access	High	"No Access to Roof" sign to be installed	Low	Client advised	Outstanding	OH&S REGULATIONS 3.55 & 3.11
110	Building: General Stores Location Reference: <a href="#">L61</a> Task: Access to the roof

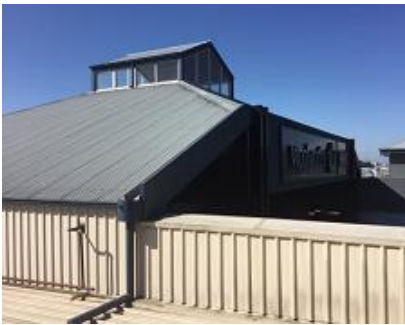
No height safety system installed	Trips, Slips and Falls	Awareness induction	High	Fall arrest anchors, anchor stop and access ladder to be installed	Low	Client advised	Outstanding	OH&S REGULATIONS 3.7 & 3.55  AS/NZS 1657-2013 3.1.4

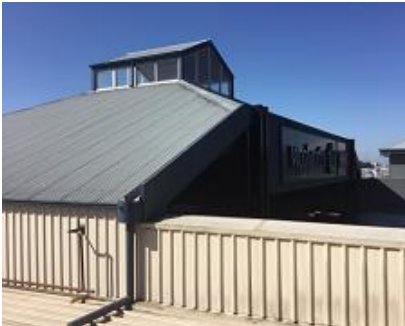
Brittle roof (Non-trafficable roof)	Trips, Slips and Falls	Restrict Access	High	"Warning-Keep Off-Brittle and Fragile Roof" signs to be installed	Low	Client advised	Outstanding	OH&S REGULATIONS 3.57
112	Building: General Stores Location Reference: <a href="#">L62</a> Task: Access to the A/c units

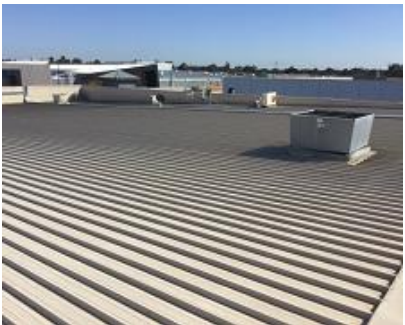
No safe access to the A/c units	Trips, Slips and Falls	N/A	Low	Supply walkway and step overs to the A/c units	Low	Client advised	Outstanding	-

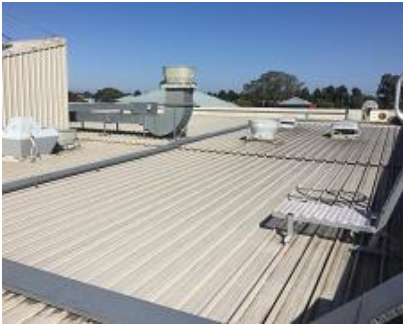
No safe access to the A/c units	Trips, Slips and Falls	N/A	Low	Supply walkway and step overs to the A/c units	Low	Client advised	Outstanding	-
114	Building: General Stores Location Reference: <a href="#">L62</a> Task: Access to the roof

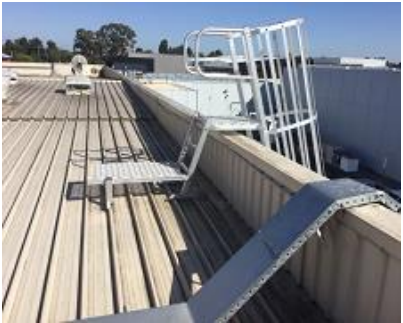
No height safety system installed	Trips, Slips and Falls	Awareness induction	High	Fall arrest anchors to be installed	Low	Client advised	Outstanding	OH&S REGULATIONS 3.55

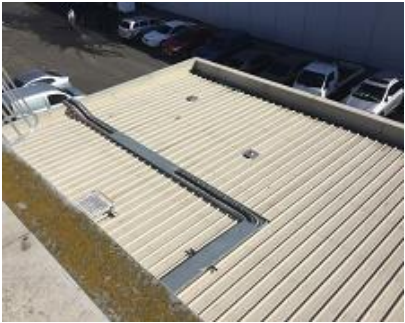
No height safety system installed	Trips, Slips and Falls	Awareness induction	High	Fall arrest anchors to be installed	Low	Client advised	Outstanding	OH&S REGULATIONS 3.55
116	Building: General Stores Location Reference: <a href="#">L64</a> Task: Access to the roof

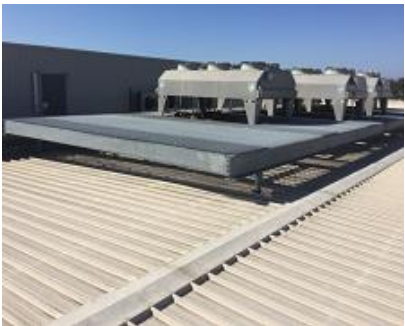
Variation in height between plant deck and roof is greater than required maximum	Trips, Slips and Falls	Awareness induction	Med	Handrail to be installed	Low	Client advised	Outstanding	OH&S REGULATIONS 3.7  AS/NZS 1657-2013 4.4

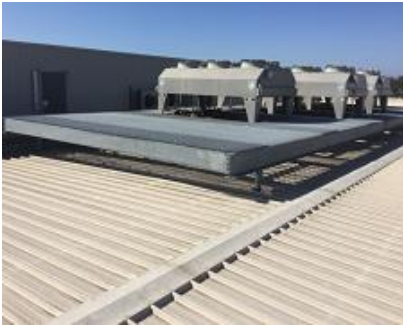
Variation in height between plant deck and unit is greater than required maximum	Trips, Slips and Falls	Awareness induction	Med	Mid rail to be installed	Low	Client advised	Outstanding	OH&S REGULATIONS 3.7  AS/NZS 1657-2013 4.4
118	Building: General Stores Location Reference: <a href="#">L64</a> Task: Access to the roof

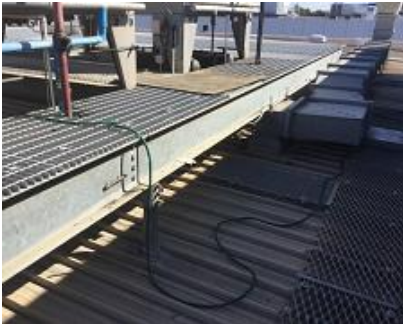
Variation in height between plant deck and roof is greater than required maximum	Trips, Slips and Falls	Awareness induction	Med	Access ladder to be installed	Low	Client advised	Outstanding	OH&S REGULATIONS 3.7  AS/NZS 1657-2013 3.1.4

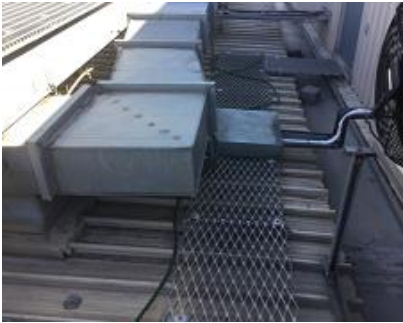
Cable tray installed over the walkway path	Trips, Slips and Falls	Awareness induction	Med	Step bridge to be installed	Low	Client advised	Outstanding	OH&S REGULATIONS 3.7  AS/NZS 1657-2013 3.1.4
120	Building: General Stores Location Reference: <a href="#">L65</a> Task: Access to the ladder

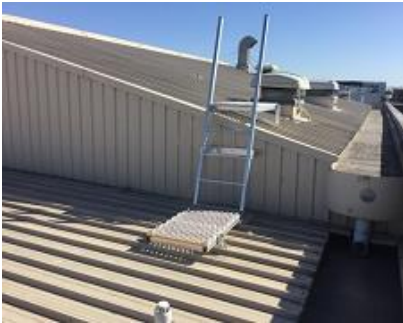
No safe access to the ladder	Trips, Slips and Falls	N/A	Low	Supply walkway to the ladder	Low	Client advised	Outstanding	-

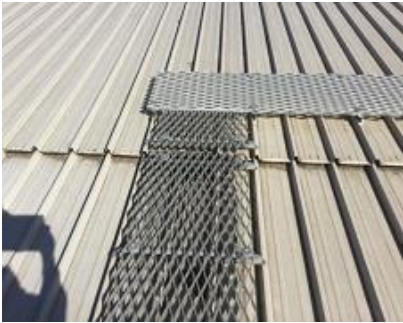
Variation in height between walkway panels are greater than required maximum	Trips, Slips and Falls	Awareness induction	Med	High visibility safety yellow nosing to be installed	Low	Client advised	Outstanding	OH&S REGULATIONS 3.7  AS/NZS 1657-2013 3.3.4
122	Building: General Stores Location Reference: <a href="#">L66</a> Task: Access to the roof

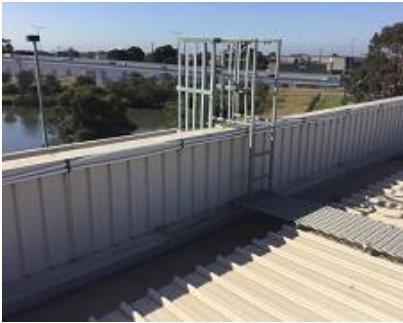
Bottom rung height is less than required minimum, no slip resistance on ladder rungs and no landing platform installed	Trips, Slips and Falls	Awareness induction	Med	Existing ladder to be removed and new ladder to be installed	Low	Client advised	Outstanding	OH&S REGULATIONS 3.7  AS/NZS 1657-2013 7.4.3.4, 7.4.3.1 & 7.3.6

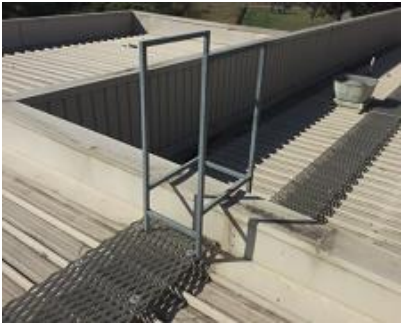
Bottom rung height is less than required minimum, no slip resistance on ladder rungs and no landing platform installed	Trips, Slips and Falls	Awareness induction	Med	Existing ladder to be removed and new ladder to be installed	Low	Client advised	Outstanding	OH&S REGULATIONS 3.7  AS/NZS 1657-2013 7.4.3.4, 7.4.3.1 & 7.3.6
124	Building: General Stores Location Reference: <a href="#">L67</a> Task: Access to the roof

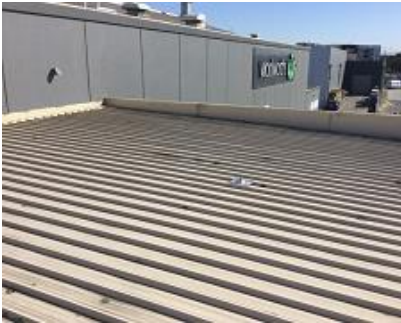
No height safety system installed	Trips, Slips and Falls	Awareness induction	High	Fall arrest anchors to be installed	Low	Client advised	Outstanding	OH&S REGULATIONS 3.55

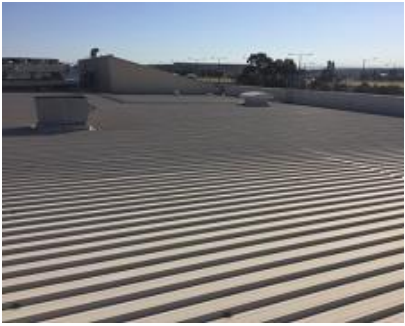
No safe access to the A/c units	Trips, Slips and Falls	N/A	Low	Supply walkway to the A/c units	Low	Client advised	Outstanding	-
126	Building: General Stores Location Reference: <a href="#">L68</a> Task: Access to the A/c units

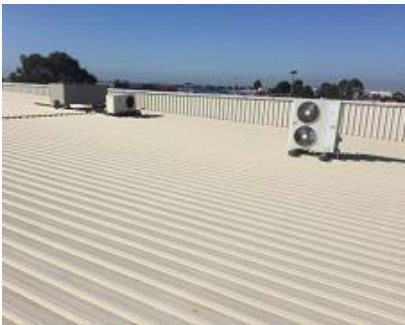
No safe access to the A/c units	Trips, Slips and Falls	N/A	Low	Supply walkway to the A/c units	Low	Client advised	Outstanding	-

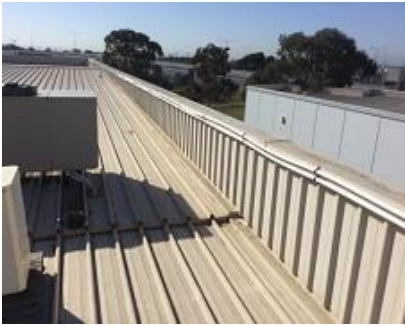
No	Photo of Hazard	Details of Hazard	Details of Risk	Existing/ Immediate Control Measure	Curre nt Risk Level	Proposed Permanent Solution	Resid ual Risk Asse sme nt	Details of Action Taken	Status	Reference
127	Building: General Stores Location Reference: <a href="#">L68</a> Task: Access to the roof

No height safety system installed	Trips, Slips and Falls	Awareness induction	High	Fall arrest anchors to be installed	Low	Client advised	Outstanding	OH&S REGULATIONS 3.55
128	Building: General Stores Location Reference: <a href="#">L69</a> Task: Access to the roof

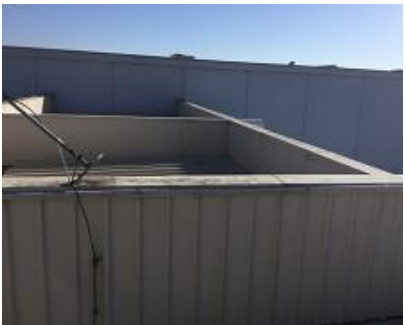
No height safety system installed	Trips, Slips and Falls	Awareness induction	High	Fall arrest anchors to be installed	Low	Client advised	Outstanding	OH&S REGULATIONS 3.55

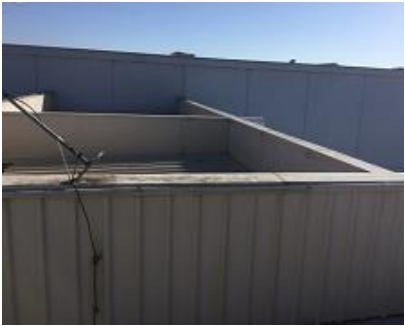
No	Photo of Hazard	Details of Hazard	Details of Risk	Existing/ Immediate Control Measure	Curre nt Risk Level	Proposed Permanent Solution	Resid ual Risk Asse sme nt	Details of Action Taken	Status	Reference
129	Building: General Stores Location Reference: <a href="#">L69</a> Task: Access to the roof

Variation in height between roofs are greater than required maximum	Trips, Slips and Falls	Awareness induction	Med	Access ladders to be installed	Low	Client advised	Outstanding	OH&S REGULATIONS 3.7  AS/NZS 1657-2013 3.1.4
130	Building: General Stores Location Reference: <a href="#">L70</a> Task: Restrict access to the roof

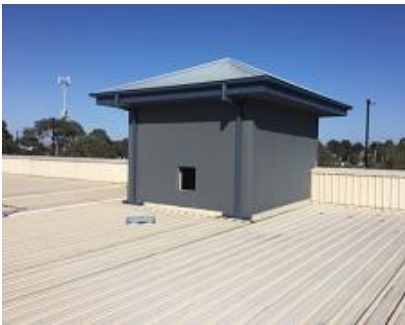
No height safety system installed	Trips, Slips and Falls	Restrict Access	High	"No Access to Roof" sign to be installed	Low	Client advised	Outstanding	OH&S REGULATIONS 3.55 & 3.11

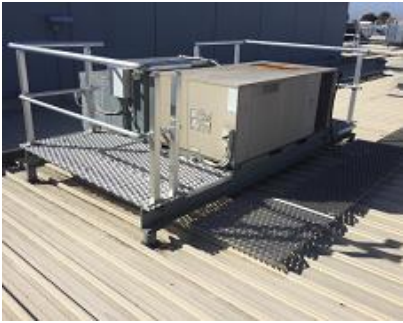
No	Photo of Hazard	Details of Hazard	Details of Risk	Existing/ Immediate Control Measure	Curre nt Risk Level	Proposed Permanent Solution	Resid ual Risk Asse sme nt	Details of Action Taken	Status	Reference
131	Building: General Stores Location Reference: <a href="#">L71</a> Task: Access to the roof

Sharp edges on handrails	Trips, Slips and Falls	Awareness induction	Med	Tek screws to be replaced with rivets	Low	Client advised	Outstanding	OH&S REGULATIONS 3.7  AS/NZS 1657-2013 5.6
132	Building: General Stores Location Reference: <a href="#">L72</a> Task: Access to the roof

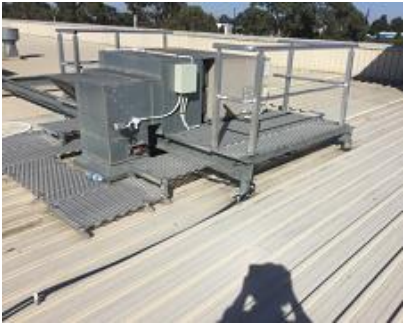
Sharp edges on handrails	Trips, Slips and Falls	Awareness induction	Med	Tek screws to be replaced with rivets	Low	Client advised	Outstanding	OH&S REGULATIONS 3.7  AS/NZS 1657-2013 5.6

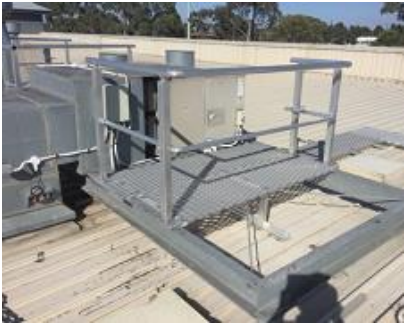
No	Photo of Hazard	Details of Hazard	Details of Risk	Existing/ Immediate Control Measure	Curre nt Risk Level	Proposed Permanent Solution	Resid ual Risk Asse sme nt	Details of Action Taken	Status	Reference
133	Building: General Stores Location Reference: <a href="#">L73</a> Task: Access to the roof

Sharp edges on handrails	Trips, Slips and Falls	Awareness induction	Med	Tek screws to be replaced with rivets	Low	Client advised	Outstanding	OH&S REGULATIONS 3.7  AS/NZS 1657-2013 5.6
134	Building: General Stores Location Reference: <a href="#">L74</a> Task: Access to the roof

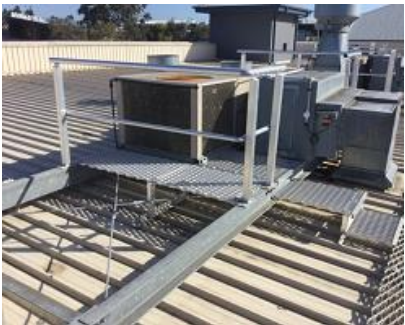
Sharp edges on handrails	Trips, Slips and Falls	Awareness induction	Med	Tek screws to be replaced with rivets	Low	Client advised	Outstanding	OH&S REGULATIONS 3.7  AS/NZS 1657-2013 5.6

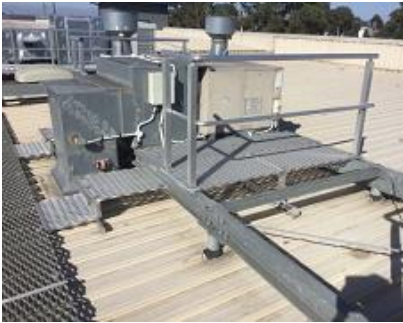
No	Photo of Hazard	Details of Hazard	Details of Risk	Existing/ Immediate Control Measure	Curre nt Risk Level	Proposed Permanent Solution	Resid ual Risk Asse sme nt	Details of Action Taken	Status	Reference
135	Building: General Stores Location Reference: <a href="#">L75</a> Task: Access to the roof

Sharp edges on handrails	Trips, Slips and Falls	Awareness induction	Med	Tek screws to be replaced with rivets	Low	Client advised	Outstanding	OH&S REGULATIONS 3.7  AS/NZS 1657-2013 5.6
136	Building: General Stores Location Reference: <a href="#">L76</a> Task: Access to the roof

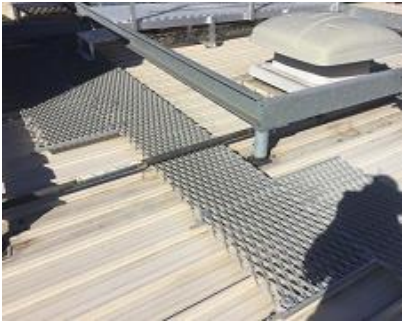
Pipe installed over the walkway path	Trips, Slips and Falls	Awareness induction	Med	Step bridge to be installed	Low	Client advised	Outstanding	OH&S REGULATIONS 3.7  AS/NZS 1657-2013 3.1.4

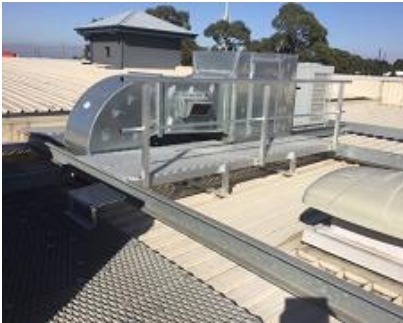
No	Photo of Hazard	Details of Hazard	Details of Risk	Existing/ Immediate Control Measure	Curre nt Risk Level	Proposed Permanent Solution	Resid ual Risk Asse sme nt	Details of Action Taken	Status	Reference
137	Building: General Stores Location Reference: <a href="#">L76</a> Task: Access to the roof

Sharp edges on handrails	Trips, Slips and Falls	Awareness induction	Med	Tek screws to be replaced with rivets	Low	Client advised	Outstanding	OH&S REGULATIONS 3.7  AS/NZS 1657-2013 5.6
138	Building: General Stores Location Reference: <a href="#">L76</a> Task: Access to the roof

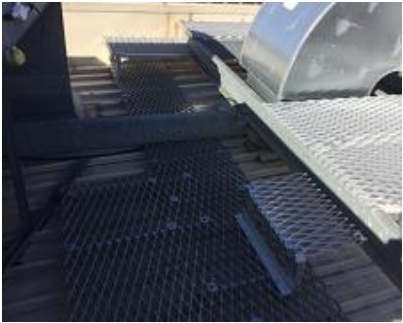
Bracings protruding over the walkway path	Trips, Slips and Falls	Awareness induction	Med	Step bridge to be installed	Low	Client advised	Outstanding	OH&S REGULATIONS 3.7  AS/NZS 1657-2013 3.1.4

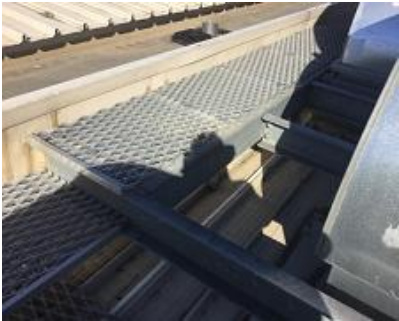
No	Photo of Hazard	Details of Hazard	Details of Risk	Existing/ Immediate Control Measure	Curre nt Risk Level	Proposed Permanent Solution	Resid ual Risk Asse sme nt	Details of Action Taken	Status	Reference
139	Building: General Stores Location Reference: <a href="#">L76</a> Task: Access to the roof

Variation in height between plant deck and roof is greater than required maximum	Trips, Slips and Falls	Awareness induction	Med	Handrail to be installed	Low	Client advised	Outstanding	OH&S REGULATIONS 3.7  AS/NZS 1657-2013 4.4
140	Building: General Stores Location Reference: <a href="#">L78</a> Task: Access to the roof

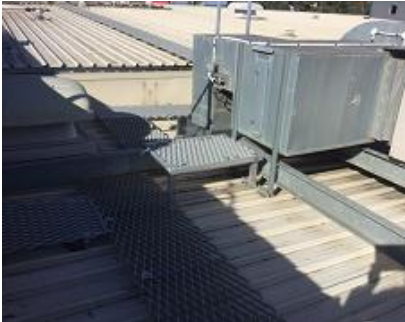
Handrail is missing for steps	Trips, Slips and Falls	Awareness induction	Med	Handrail to be installed	Low	Client advised	Outstanding	OH&S REGULATIONS 3.7  AS/NZS 1657-2013 4.4

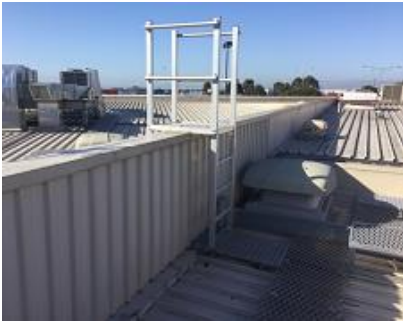
No	Photo of Hazard	Details of Hazard	Details of Risk	Existing/ Immediate Control Measure	Curre nt Risk Level	Proposed Permanent Solution	Resid ual Risk Asse sme nt	Details of Action Taken	Status	Reference
141	Building: General Stores Location Reference: <a href="#">L78</a> Task: Access to the roof

Bottom rung height is less than required minimum	Trips, Slips and Falls	Awareness induction	Med	Landing platform to be installed	Low	Client advised	Outstanding	OH&S REGULATIONS 3.7  AS/NZS 1657-2013 7.4.3.4
142	Building: General Stores Location Reference: <a href="#">L79</a> Task: Access to the roof

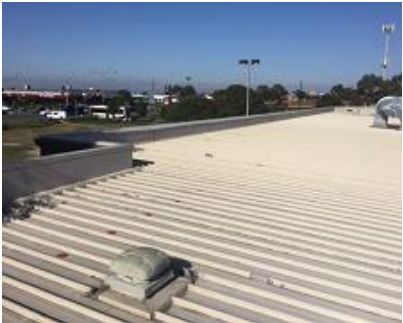
No height safety system installed	Trips, Slips and Falls	Awareness induction	High	Fall arrest anchors to be installed	Low	Client advised	Outstanding	OH&S REGULATIONS 3.55

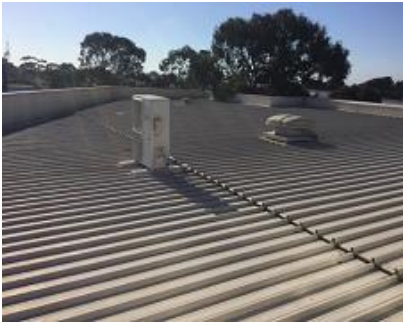
No safe access to the A/c units	Trips, Slips and Falls	N/A	Low	Supply walkway to the A/c units	Low	Client advised	Outstanding	-
144	Building: General Stores Location Reference: <a href="#">L80</a> Task: Access to the roof

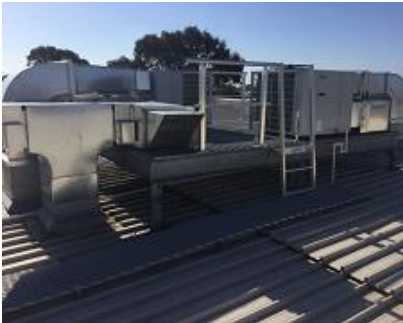
Top rung not levelled with landing and Bottom rung height is less than required minimum	Trips, Slips and Falls	Awareness induction	Med	Existing ladder to be re-installed with landing platforms and handrails	Low	Client advised	Outstanding	OH&S REGULATIONS 3.7  AS/NZS 1657-2013 7.4.3.3 & 7.4.3.4

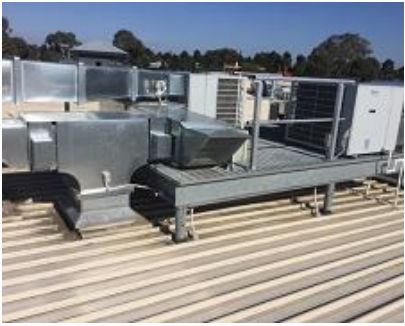
No	Photo of Hazard	Details of Hazard	Details of Risk	Existing/ Immediate Control Measure	Curre nt Risk Level	Proposed Permanent Solution	Resid ual Risk Asse sme nt	Details of Action Taken	Status	Reference
145	Building: General Stores Location Reference: <a href="#">L80</a> Task: Access to the roof

Variation in height between plant deck and roof is greater than required maximum	Trips, Slips and Falls	Awareness induction	Med	Handrail to be installed	Low	Client advised	Outstanding	OH&S REGULATIONS 3.7  AS/NZS 1657-2013 4.4
146	Building: General Stores Location Reference: <a href="#">L81</a> Task: Access to the roof

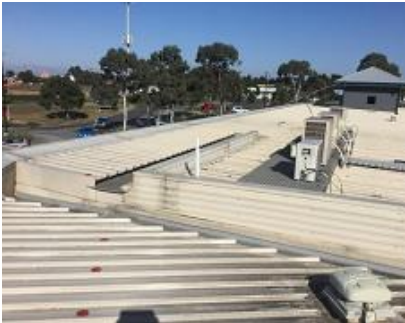
No height safety system installed	Trips, Slips and Falls	Awareness induction	High	Fall arrest anchors to be installed	Low	Client advised	Outstanding	OH&S REGULATIONS 3.55

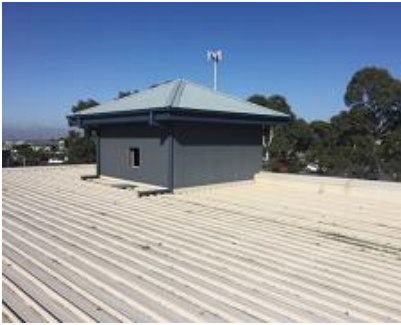
No height safety system installed	Trips, Slips and Falls	Restrict Access	High	"No Access to Roof" sign to be installed	Low	Client advised	Outstanding	OH&S REGULATIONS 3.55 & 3.11
148	Building: General Stores Location Reference: <a href="#">L83</a> Task: Access to the roof

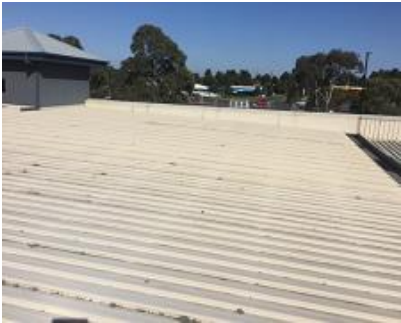
No height safety system installed	Trips, Slips and Falls	Awareness induction	High	Fall arrest anchors to be installed	Low	Client advised	Outstanding	OH&S REGULATIONS 3.55
