Roof Safety Report

**Runaway Bay Centre,
QLD 4216**

Prepared By: Safemaster Safety Products
Date: 10 Aug 2017

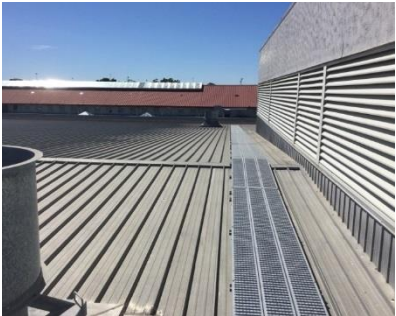
No safe access to the roof	Trips, Slips and Falls	Awareness induction	Med	Access ladder including handrails to be installed	Low	Client advised	Outstanding	OH&S REGULATIONS 3.7 AS/NZS 1657-2013 3.1.4

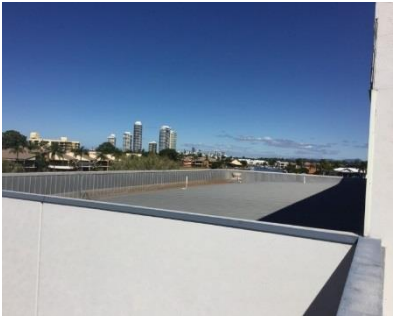
No safe access to the roof	Trips, Slips and Falls	Awareness induction	Med	Access ladder including handrails to be installed	Low	Client advised	Outstanding	OH&S REGULATIONS 3.7 AS/NZS 1657-2013 3.1.4

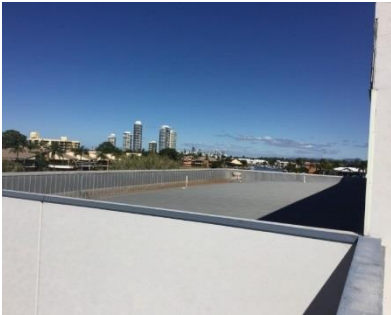
No height safety system installed	Trips, Slips and Falls	Awareness induction	High	Fall restraint anchors to be installed	Low	Client advised	Outstanding	OH&S REGULATIONS 3.55
06	Building: Target Location Reference: L7 Task: Access to the A/c units

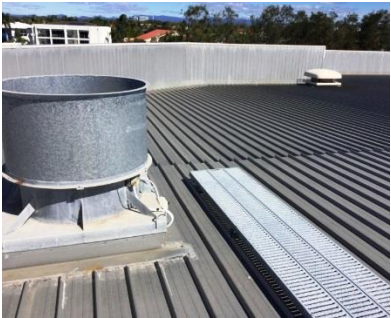
No safe access to the A/c units	Trips, Slips and Falls	N/A	Low	Supply walkway to the A/c units	Low	Client advised	Outstanding	-

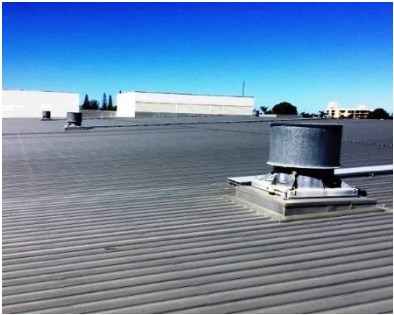
No safe access to the A/c units	Trips, Slips and Falls	N/A	Low	Supply walkway to the A/c units	Low	Client advised	Outstanding	-

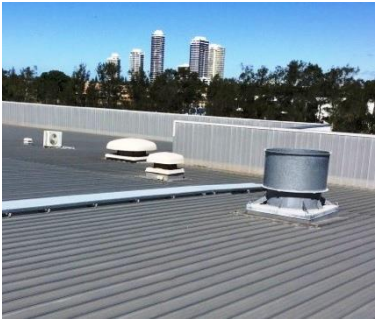
No safe access to the A/c units	Trips, Slips and Falls	N/A	Low	Supply walkway to the A/c units	Low	Client advised	Outstanding	-
10	Building: Target Location Reference: L11 Task: Access to the roof

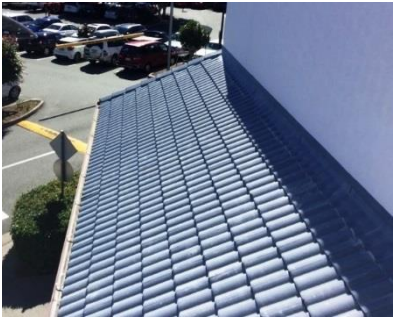
No height safety system installed (No serviceable items on roof)	Trips, Slips and Falls	Awareness induction	High	"EWP ACCESS ONLY" sign to be installed	Low	Client advised	Outstanding	OH&S REGULATIONS 3.55 & 3.11

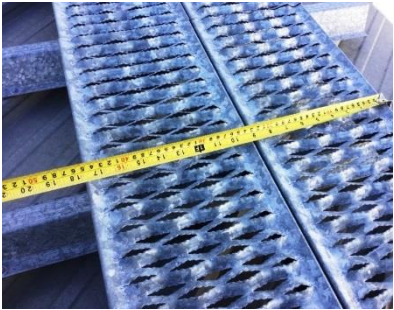
Roof walkway width is less than required minimum	Trips, Slips and Falls	Awareness induction	Med	Existing walkway to be removed and new 600mm wide walkway to be installed	Low	Client advised	Outstanding	OH&S REGULATIONS 3.7 AS/NZS 1657-2013 5.1.3

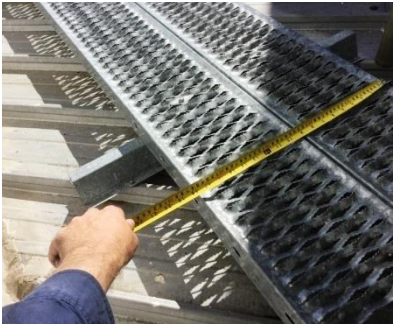
Roof walkway width is less than required minimum	Trips, Slips and Falls	Awareness induction	Med	Existing walkway to be removed and new 600mm wide walkway to be installed	Low	Client advised	Outstanding	OH&S REGULATIONS 3.7 AS/NZS 1657-2013 5.1.3

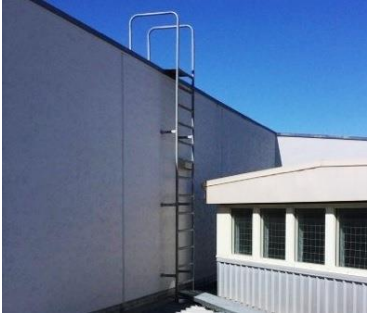
No slip resistance on ladder rungs, fall arrest static line is missing and bottom rung height is less than required minimum	Trips, Slips and Falls	Awareness induction	Med	Existing ladder to be removed and New ladder including landing platform to be installed	Low	Client advised	Outstanding	OH&S REGULATIONS 3.7 AS/NZS 1657-2013 7.4.3.1 & 7.4.3.4
16	Building: Target Location Reference: L16 Task: Access to the roof

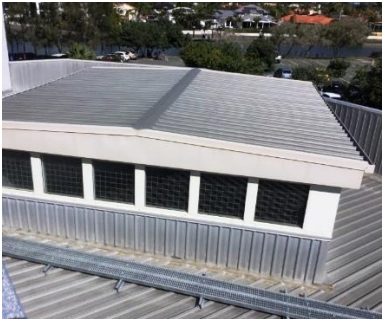
No height safety system installed	Trips, Slips and Falls	Awareness induction	High	Fall restraint anchors, anchor stop and ladder access bracket to be installed	Low	Client advised	Outstanding	OH&S REGULATIONS 3.55 & 3.7

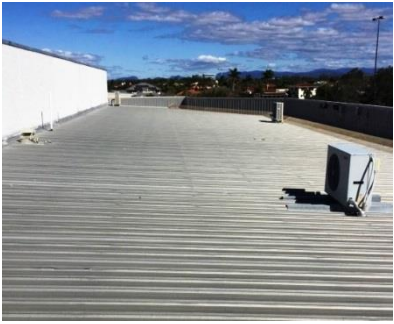
No safe access to the A/c units	Trips, Slips and Falls	N/A	Low	Supply walkway to the A/c units	Low	Client advised	Outstanding	-

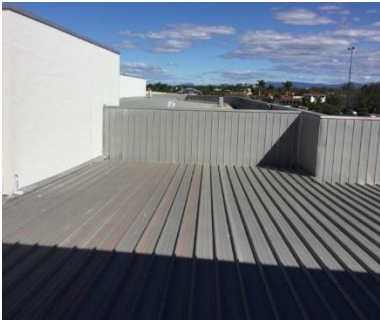
No safe access to the roof	Trips, Slips and Falls	Awareness induction	Med	Access ladder including handrails to be installed	Low	Client advised	Outstanding	OH&S REGULATIONS 3.7 AS/NZS 1657-2013 3.1.4
20	Building: General Stores Location Reference: L20 Task: Access to the roof

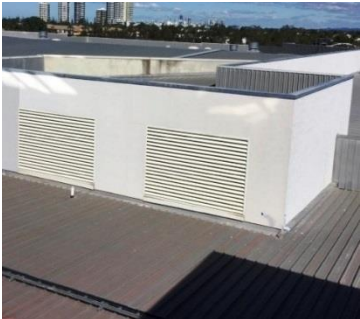
No safe access to the roof	Trips, Slips and Falls	Awareness induction	Med	Access ladder including handrails to be installed	Low	Client advised	Outstanding	OH&S REGULATIONS 3.7 AS/NZS 1657-2013 3.1.4

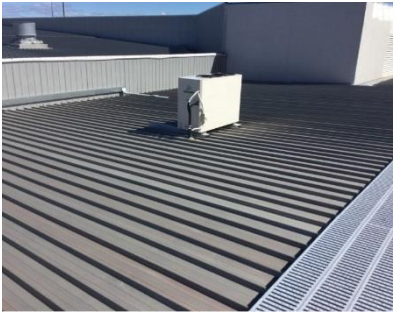
No safe access to the A/c unit	Trips, Slips and Falls	N/A	Low	Supply walkway to the A/c unit	Low	Client advised	Outstanding	-
22	Building: General Stores Location Reference: L22 Task: Access to the A/c unit

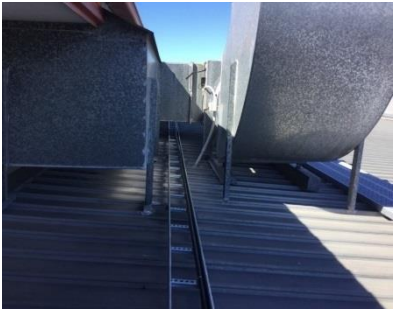
No safe access to the A/c unit	Trips, Slips and Falls	N/A	Low	Supply walkway to the A/c unit	Low	Client advised	Outstanding	-

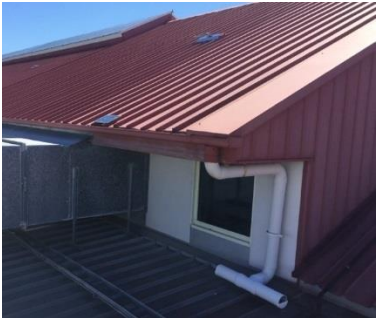
No safe access to the roof	Trips, Slips and Falls	Awareness induction	Med	Access ladder including handrails to be installed	Low	Client advised	Outstanding	OH&S REGULATIONS 3.7 AS/NZS 1657-2013 3.1.4

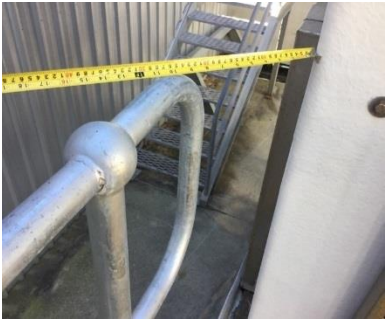
Handrail section is missing	Trips, Slips and Falls	Awareness induction	Med	Handrail section to be installed to close the gap	Low	Client advised	Outstanding	OH&S REGULATIONS 3.7 AS/NZS 1657-2013 4.4
30	Building: General Stores Location Reference: L29 Task: Access to the plant deck

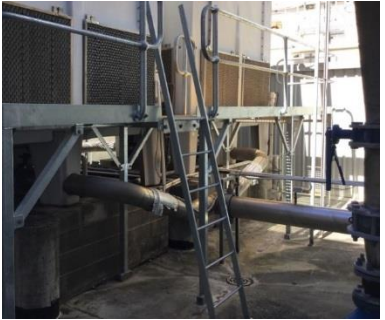
No slip resistance on ladder rungs	Trips, Slips and Falls	Awareness induction	Med	Non-slip rung caps to be installed on existing ladder	Low	Client advised	Outstanding	OH&S REGULATIONS 3.7 AS/NZS 1657-2013 7.4.3.1

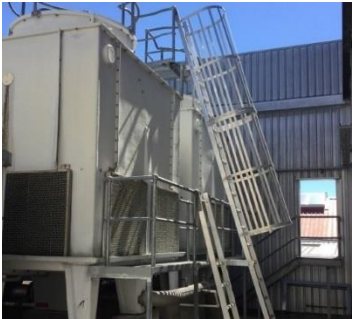
Bottom rung height is less than required minimum	Trips, Slips and Falls	Awareness induction	Med	Landing platform to existing ladder to be installed	Low	Client advised	Outstanding	OH&S REGULATIONS 3.7 AS/NZS 1657-2013 7.4.3.4

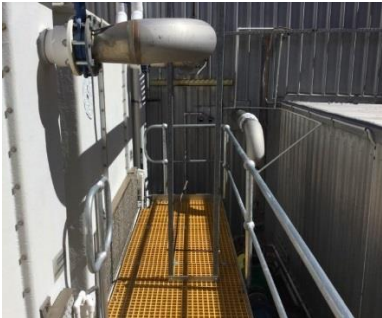
Headroom is less than required minimum	Head Injury	Awareness induction	Med	"Low-Headroom" sign and high visibility safety yellow tape to be installed	Low	Client advised	Outstanding	OH&S REGULATIONS 3.7 AS/NZS 1657-2013 3.1.5

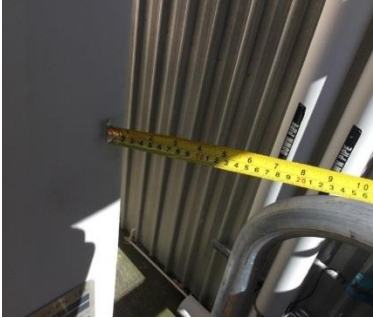
Handrail section is missing	Trips, Slips and Falls	Awareness induction	Med	Handrail section to be installed to close the gap	Low	Client advised	Outstanding	OH&S REGULATIONS 3.7 AS/NZS 1657-2013 4.4
36	Building: General Stores Location Reference: L30 Task: Access to the plant deck

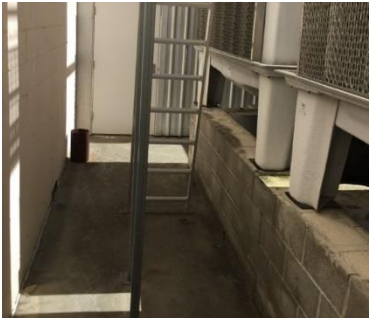
Bottom rung height is less than required minimum and gap between top rung and landing is greater than required maximum	Trips, Slips and Falls	Awareness induction	Med	Landing platform at base and additional walkway section at top to be installed	Low	Client advised	Outstanding	OH&S REGULATIONS 3.7 AS/NZS 1657-2013 7.4.3.4 & 7.4.8.4

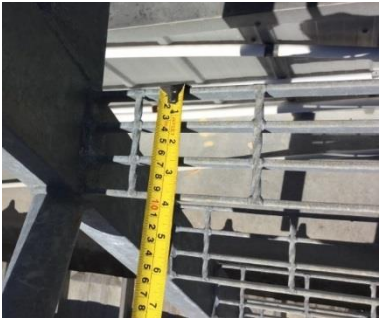
Tread width is less than required minimum	Trips, Slips and Falls	Awareness induction	Med	Existing non-complaint ladder to be removed and new ladder to be installed	Low	Client advised	Outstanding	OH&S REGULATIONS 3.7 AS/NZS 1657-2013 7.3.3.1
38	Building: General Stores Location Reference: L31 Task: Access to the plant deck

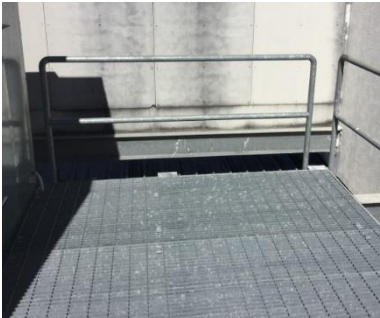
Gap between the handrail sections is greater than required maximum	Trips, Slips and Falls	Awareness induction	Med	Gap to be filled with additional post/handrail section to be installed	Low	Client advised	Outstanding	OH&S REGULATIONS 3.7 AS/NZS 1657-2013 4.4

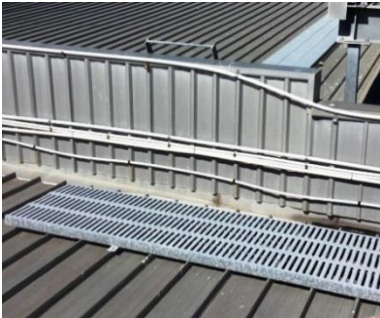
No safe access to the roof	Trips, Slips and Falls	Awareness induction	Med	Access ladder including handrails to be installed	Low	Client advised	Outstanding	OH&S REGULATIONS 3.7 AS/NZS 1657-2013 3.1.4

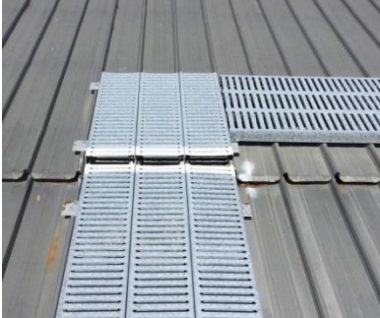
Variation in height between walkway panels is greater than required maximum	Trips, Slips and Falls	Awareness induction	Med	High visibility safety yellow nosing's to be installed	Low	Client advised	Outstanding	OH&S REGULATIONS 3.7 AS/NZS 1657-2013 3.3.4
42	Building: General Stores Location Reference: L33 Task: Access to the A/c unit

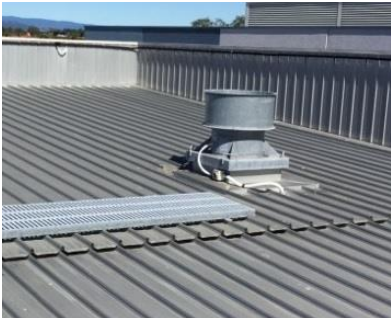
No safe access to the A/c unit	Trips, Slips and Falls	N/A	Low	Supply walkway to the A/c unit	Low	Client advised	Outstanding	-

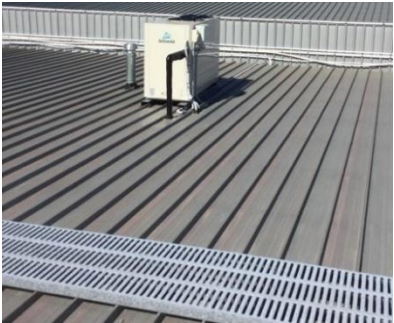
No safe access to the A/c unit	Trips, Slips and Falls	N/A	Low	Supply walkway to the A/c unit	Low	Client advised	Outstanding	-

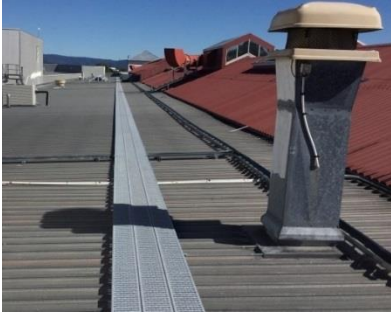
No safe access to the A/c unit	Trips, Slips and Falls	N/A	Low	Supply walkway to the A/c unit	Low	Client advised	Outstanding	-
46	Building: General Stores Location Reference: L37 Task: Access to the stair

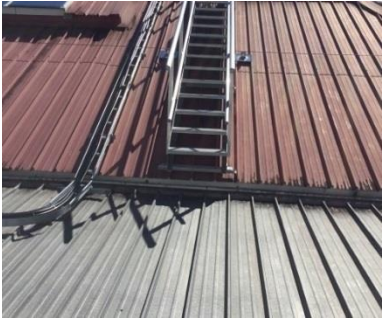
No safe access to the A/c unit	Trips, Slips and Falls	N/A	Low	Supply walkway to the A/c unit	Low	Client advised	Outstanding	-

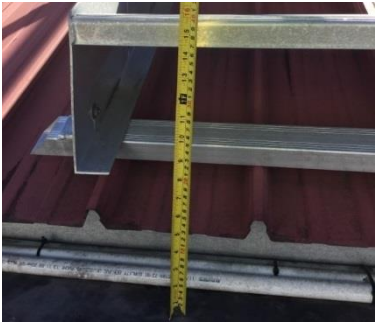
No landing platform at base of stair	Trips, Slips and Falls	Awareness induction	Med	Landing platform and step to be installed if required	Low	Client advised	Outstanding	OH&S REGULATIONS 3.7 AS/NZS 1657-2013 7.3.6
48	Building: General Stores Location Reference: L38 Task: Restrict access to the roof

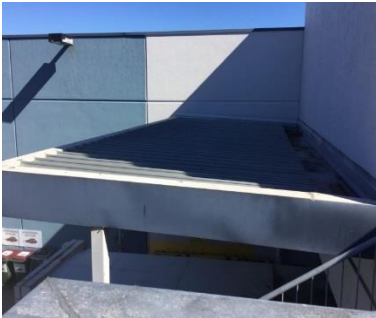
No height safety system installed (No serviceable items)	Trips, Slips and Falls	Awareness induction	High	"EWP Access Only" sign to be installed	Low	Client advised	Outstanding	OH&S REGULATIONS 3.55 & 3.11

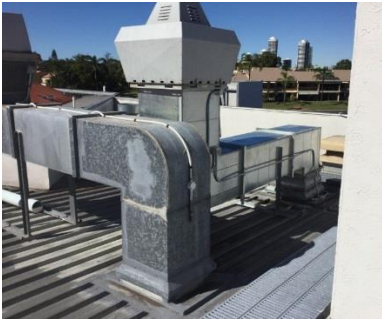
No safe access to the A/c units	Trips, Slips and Falls	N/A	Low	Supply walkway to the A/c units	Low	Client advised	Outstanding	-
50	Building: General Stores Location Reference: L40 Task: Access to the A/c units

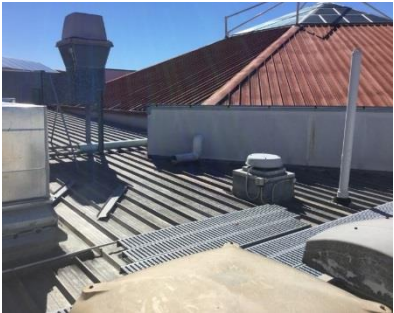
No safe access to the A/c units	Trips, Slips and Falls	N/A	Low	Supply walkway to the A/c units	Low	Client advised	Outstanding	-

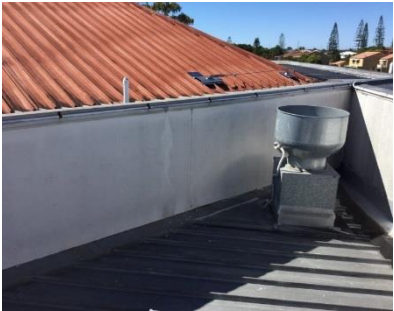
No safe access to the roof	Trips, Slips and Falls	Awareness induction	Med	Access ladder including handrails to be installed	Low	Client advised	Outstanding	OH&S REGULATIONS 3.7 AS/NZS 1657-2013 3.1.4

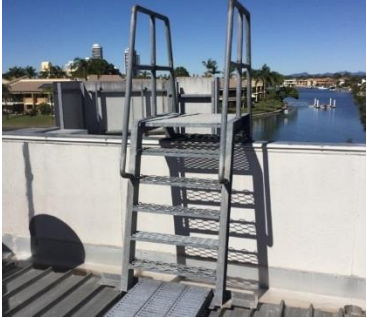
Ladder slope is greater than required maximum	Trips, Slips and Falls	Awareness induction	Med	Existing ladder to be removed and new ladder to be installed	Low	Client advised	Outstanding	OH&S REGULATIONS 3.7 AS/NZS 1657-2013 7.3.2
54	Building: General Stores Location Reference: L43 Task: Access to the plant deck

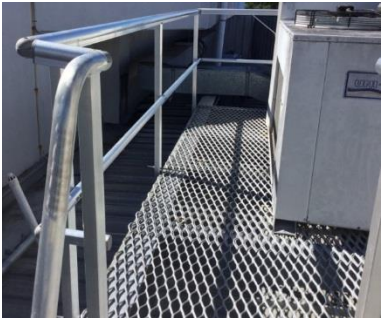
Sharp edges on handrails	Hand injury	Awareness induction	Med	Tek screws to be replaced with rivets	Low	Client advised	Outstanding	OH&S REGULATIONS 3.7 AS/NZS 1657-2013 5.6

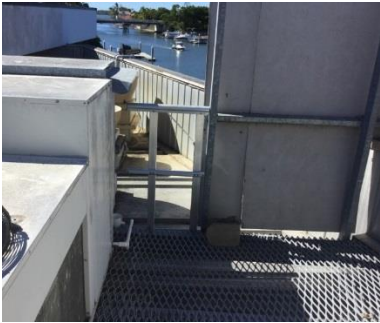
No safe access to the A/c units	Trips, Slips and Falls	Awareness induction	Med	Existing handrail section to be removed. New steps and walkway to the A/c units to be installed	Low	Client advised	Outstanding	OH&S REGULATIONS 3.7 AS/NZS 1657-2013 3.1.4
56	Building: General Stores Location Reference: L44 Task: Restrict access to the roof

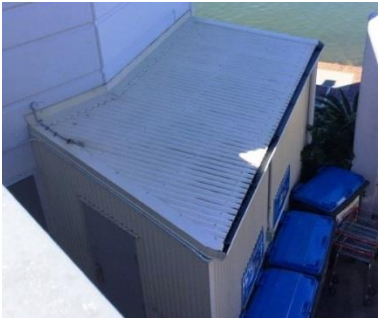
No height safety system installed (No serviceable items)	Trips, Slips and Falls	Awareness induction	High	"EWP Access Only" sign to be installed	Low	Client advised	Outstanding	OH&S REGULATIONS 3.55 & 3.11

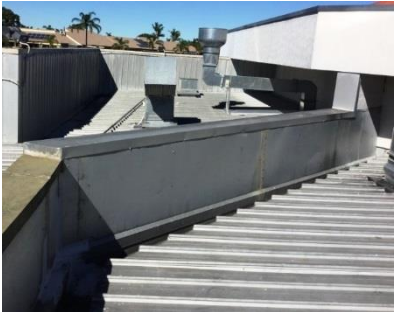
No safe access to the A/c units	Trips, Slips and Falls	N/A	Low	Supply walkway to the A/c units	Low	Client advised	Outstanding	-

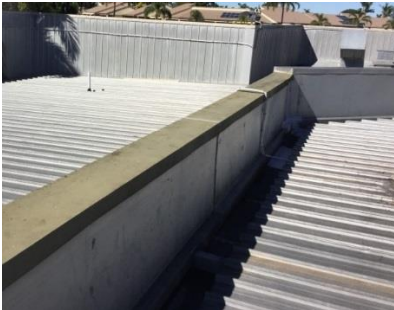
No safe access to the roof	Trips, Slips and Falls	Awareness induction	Med	Access ladder including handrails to be installed	Low	Client advised	Outstanding	OH&S REGULATIONS 3.7 AS/NZS 1657-2013 3.1.4

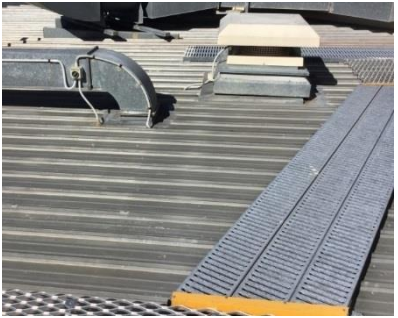
No safe access to the A/c units	Trips, Slips and Falls	N/A	Low	Supply walkway to the A/c units	Low	Client advised	Outstanding	-

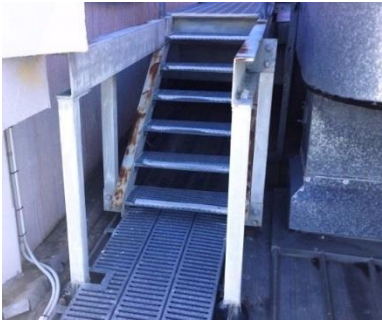
Bottom tread height is less than required minimum	Trips, Slips and Falls	Awareness induction	Med	Landing platform at base to be installed	Low	Client advised	Outstanding	OH&S REGULATIONS 3.7 AS/NZS 1657-2013 7.2.3.2
64	Building: General Stores Location Reference: L53 Task: Access to the A/c unit

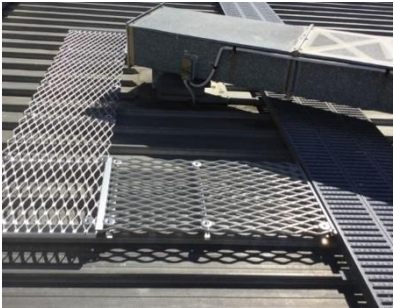
No safe access to the A/c unit	Trips, Slips and Falls	N/A	Low	Supply walkway to the A/c unit	Low	Client advised	Outstanding	-

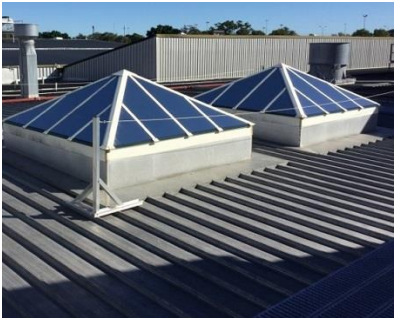
Brittle roof (Non-trafficable roof)	Trips, Slips and Falls	Awareness induction	High	"WARNING-KEEP OFF-BRITTLE AND FRAGILE ROOF" signs to be installed	Low	Client advised	Outstanding	OH&S REGULATIONS 3.57

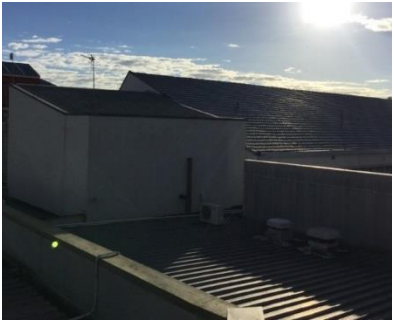
No height safety system installed	Trips, Slips and Falls	Awareness induction	High	Fall arrest anchors, anchor stop and ladder access bracket to be installed	Low	Client advised	Outstanding	OH&S REGULATIONS 3.55

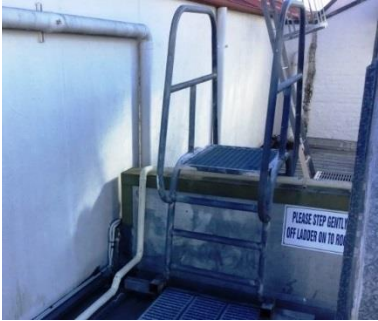
Un even rung heights and handrail projecting towards user	Trips, Slips and Falls	Awareness induction	Med	Existing ladder to be removed and new ladder including handrails to be installed	Low	Client advised	Outstanding	OH&S REGULATIONS 3.7 AS/NZS 1657-2013 7.4.3.2
70	Building: General Stores Location Reference: L59 Task: Access to the A/c unit

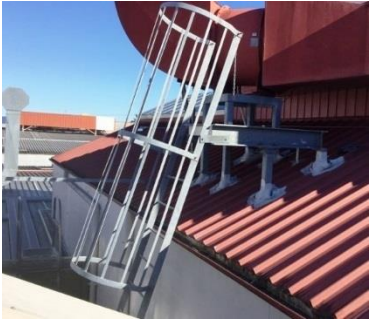
Non complaint ladder	Trips, Slips and Falls	Awareness induction	Med	Existing ladder to be removed and New ladder including landing platform and handrails to be installed	Low	Client advised	Outstanding	OH&S REGULATIONS 3.7 AS/NZS 1657-2013 7.4.3.1 & 7.4.3.2

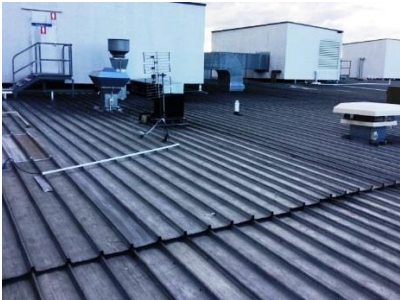
No safe access to the A/c units	Trips, Slips and Falls	N/A	Low	Supply walkway to the A/c units	Low	Client advised	Outstanding	-
74	Building: General Stores Location Reference: L65 Task: Access to the A/c unit

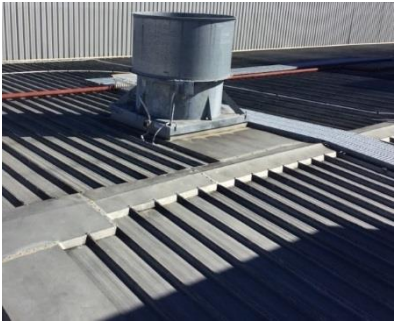
No safe access to the A/c unit	Trips, Slips and Falls	N/A	Low	Supply walkway to the A/c unit	Low	Client advised	Outstanding	-

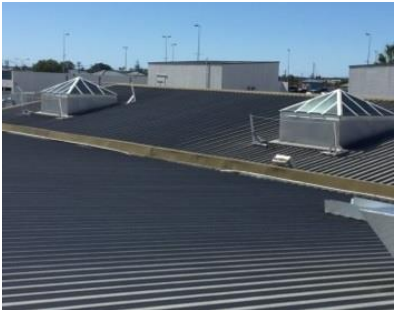
Brittle roof (Non-Trafficable Roof)	Fall hazard	Awareness induction	High	"WARNING-KEEP OFF-BRITTLE AND FRAGILE ROOF" signs to be installed	Low	Client advised	Outstanding	OH&S REGULATIONS 3.57
76	Building: General Stores Location Reference: L70 Task: Access to the A/c unit

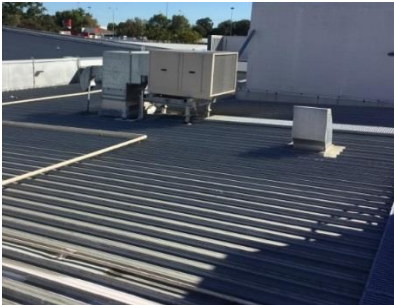
No safe access to the A/c unit	Trips, Slips and Falls	N/A	Low	Supply walkway to A/c unit	Low	Client advised	Outstanding	-

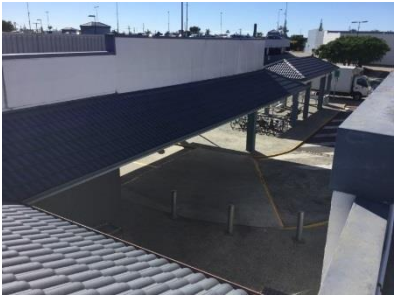
No height safety system installed (No serviceable items)	Trips, Slips and Falls	Awareness induction	High	"EWP Access Only" sign to be installed	Low	Client advised	Outstanding	OH&S REGULATIONS 3.55 & 3.11
78	Building: General Stores Location Reference: L72 Task: Restrict access to the roof

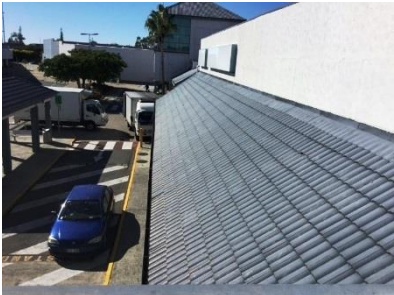
No height safety system installed (No serviceable items)	Trips, Slips and Falls	Awareness induction	High	"EWP Access Only" sign to be installed	Low	Client advised	Outstanding	OH&S REGULATIONS 3.55 & 3.11

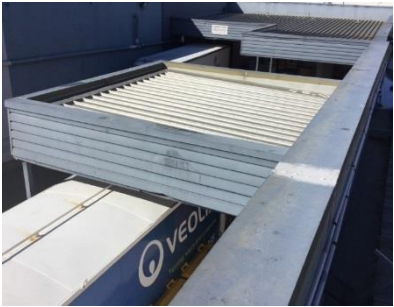
No height safety system installed (No serviceable items)	Trips, Slips and Falls	Awareness induction	High	"EWP Access Only" sign to be installed	Low	Client advised	Outstanding	OH&S REGULATIONS 3.55 & 3.11

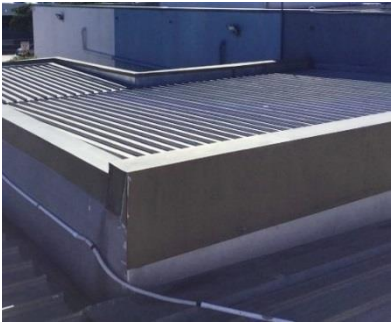
No safe access to the roof	Trips, Slips and Falls	Awareness induction	Med	Access ladder including handrails to be installed	Low	Client advised	Outstanding	OH&S REGULATIONS 3.7 AS/NZS 1657-2013 3.1.4

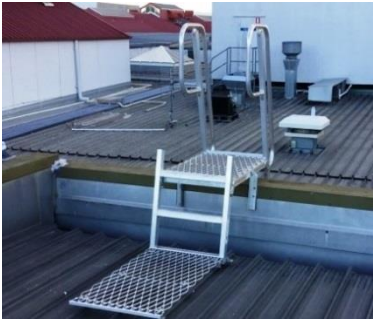
Handrail projects toward the user	Trips, Slips and Falls	Awareness induction	Med	Existing handrails to be removed and new handrails to be installed	Low	Client advised	Outstanding	OH&S REGULATIONS 3.7 AS/NZS 1657-2013 7.4.8.5
84	Building: General Stores Location Reference: L78 Task: Access to the A/c units

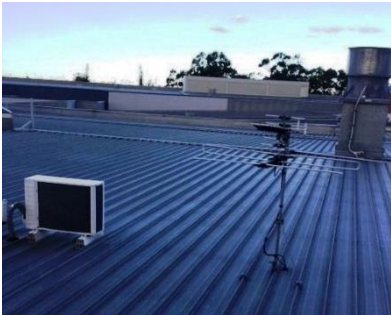
No safe access to the A/c units	Trips, Slips and Falls	N/A	Low	Supply walkway to the A/c units	Low	Client advised	Outstanding	-

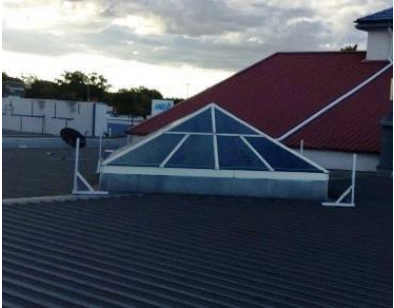
Brittle roof (Non-trafficable roof)	Fall hazard	Awareness induction	High	"WARNING-KEEP OFF-BRITTLE AND FRAGILE ROOF" signs to be installed	Low	Client advised	Outstanding	OH&S REGULATIONS 3.57
86	Building: General Stores Location Reference: L80 Task: Access to the A/c units

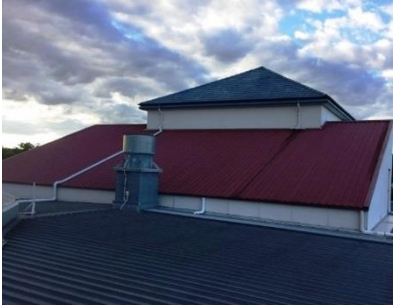
Roof is too steep (No serviceable items)	Trips, Slips and Falls	Awareness induction	High	"No Access" sign to be installed	Low	Client advised	Outstanding	OH&S REGULATIONS 3.55 & 3.11
88	Building: General Stores Location Reference: L82 Task: Restrict access to the roof

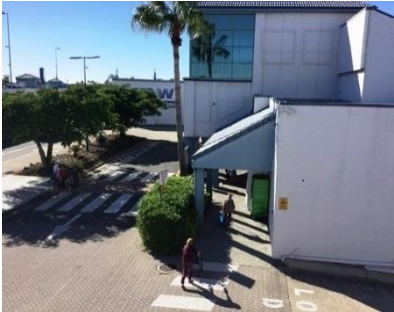
No height safety system installed (No serviceable items)	Trips, Slips and Falls	Awareness induction	High	"EWP Access Only" signs to be installed	Low	Client advised	Outstanding	OH&S REGULATIONS 3.55 & 3.11

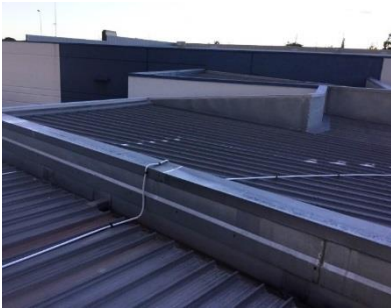
No safe access to the roof	Trips, Slips and Falls	Awareness induction	High	Fall arrest anchors to be installed	Low	Client advised	Outstanding	OH&S REGULATIONS 3.55

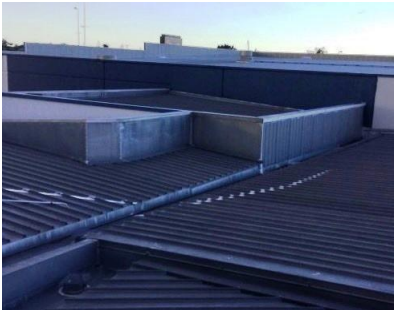
No safe access to the roof	Trips, Slips and Falls	Awareness induction	Med	Access ladder including handrails to be installed	Low	Client advised	Outstanding	OH&S REGULATIONS 3.7 AS/NZS 1657-2013 3.1.4
92	Building: General Stores Location Reference: L86, L87 & L88 Task: Restrict access to the roof

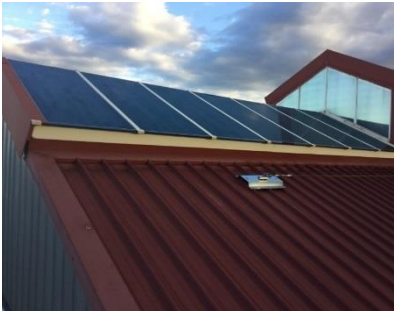
Brittle roof (Non-Trafficable Roof)	Trips, Slips and Falls	Awareness induction	High	"WARNING-KEEP OFF-BRITTLE AND FRAGILE ROOF" signs to be installed	Low	Client advised	Outstanding	OH&S REGULATIONS 3.57

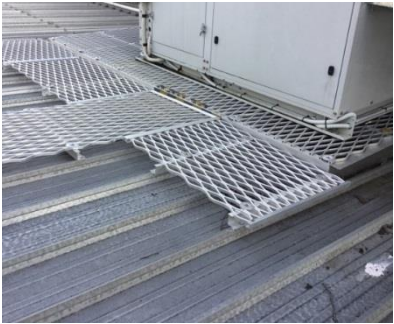
Variation in height between two panels is greater than required maximum	Trips, Slips and Falls	Awareness induction	Med	High visibility safety yellow nosing's to be installed	Low	Client advised	Outstanding	OH&S REGULATIONS 3.7 AS/NZS 1657-2013 3.3.4

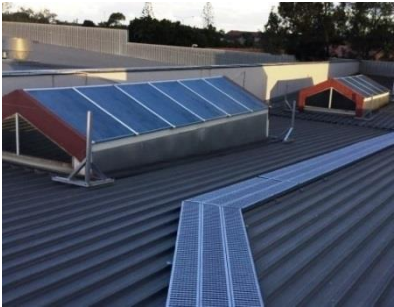
Brittle roof (Non-Trafficable Roof)	Fall hazard	Awareness induction	High	"WARNING-KEEP OFF-BRITTLE AND FRAGILE ROOF" signs to be installed	Low	Client advised	Outstanding	OH&S REGULATIONS 3.57

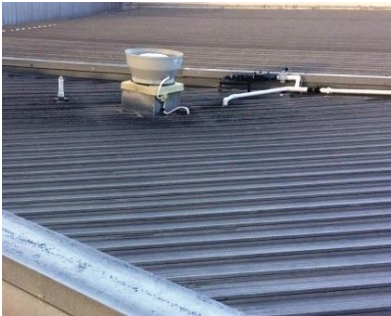
No safe access to the A/c unit	Trips, Slips and Falls	N/A	Low	Supply walkway to the A/c unit	Low	Client advised	Outstanding	-

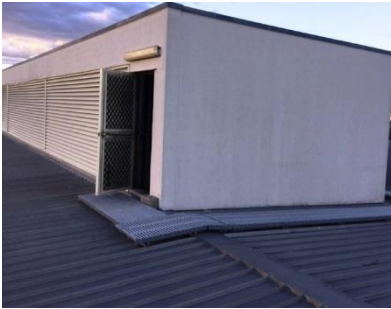
No height safety system installed	Trips, Slips and Falls	Awareness induction	High	Fall arrest anchors, anchor stop and ladder access bracket to be installed	Low	Client advised	Outstanding	OH&S REGULATIONS 3.55
104	Building: BIG W Location Reference: L101 Task: Access to the roof

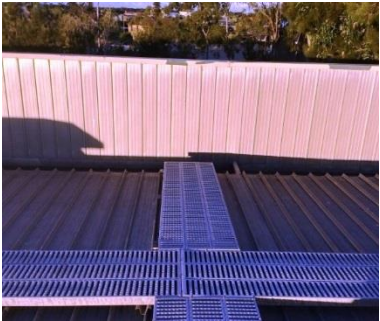
No safe access to the roof	Trips, Slips and Falls	Awareness induction	Med	Access ladder including handrails to be installed	Low	Client advised	Outstanding	OH&S REGULATIONS 3.7 AS/NZS 1657-2013 3.1.4

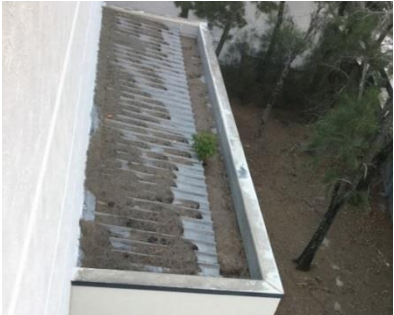
No height safety system installed (No serviceable items on roof)	Trips, Slips and Falls	Awareness induction	High	"EWP ACCESS ONLY" sign to be installed	Low	Client advised	Outstanding	OH&S REGULATIONS 3.55 & 3.11

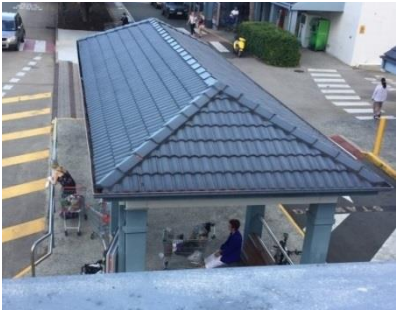
No height safety system installed (No serviceable items on roof)	Trips, Slips and Falls	Awareness induction	High	"EWP ACCESS ONLY" sign to be installed	Low	Client advised	Outstanding	OH&S REGULATIONS 3.55 & 3.11
108	Building: General Stores Location Reference: L105 Task: Access to the roof

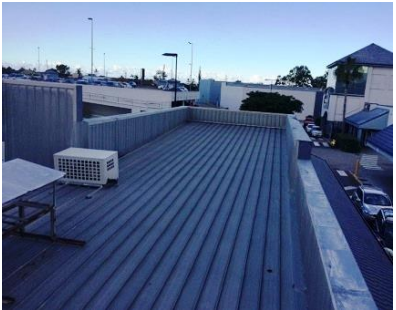
No height safety system Installed	Trips, Slips and Falls	Awareness induction	High	Fall arrest anchors to be installed	Low	Client advised	Outstanding	OH&S REGULATIONS 3.55

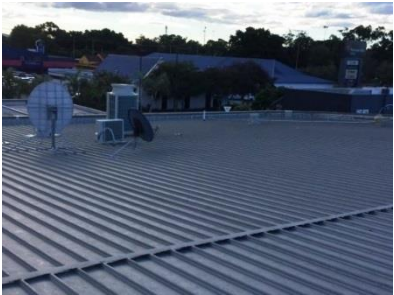
No safe access to the A/c units	Trips, Slips and Falls	N/A	Low	Supply walkway to the A/c units	Low	Client advised	Outstanding	-

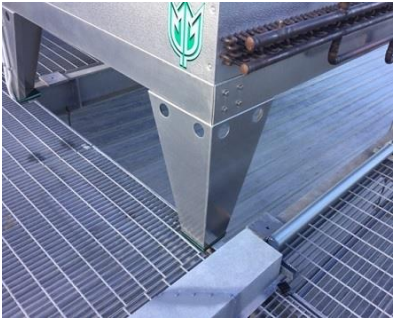
Gap between grating and unit is greater than required maximum	Trips, Slips and Falls	Awareness induction	Med	Midrail to be installed	Low	Client advised	Outstanding	OH&S REGULATIONS 3.6 AS/NZS 1657-2013 4.4

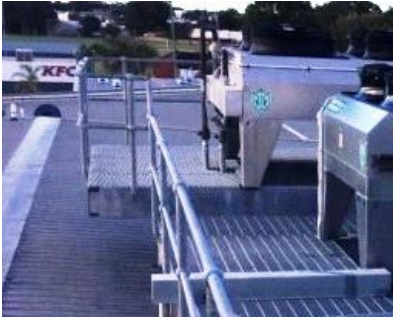
Variation in height between two panels are greater than required maximum	Trips, Slips and Falls	Awareness induction	Med	High visibility safety yellow nosing's to be installed	Low	Client advised	Outstanding	OH&S REGULATIONS 3.6 AS/NZS 1657-2013 3.3.4

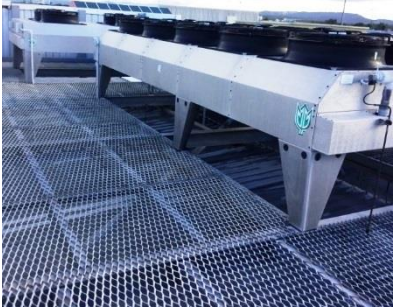
Gap between grating and unit is greater than required maximum	Trips, Slips and Falls	Awareness induction	Med	Midrail to be installed	Low	Client advised	Outstanding	OH&S REGULATIONS 3.6 AS/NZS 1657-2013 4.4
116	Building: Woolworths Location Reference: L112 Task: Access to the roof

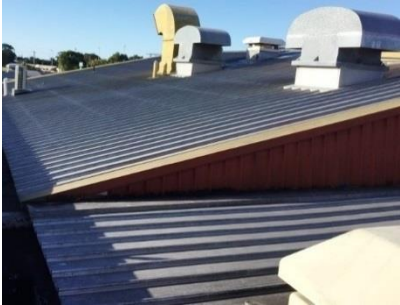
No safe access to the A/c units	Trips, Slips and Falls	N/A	Low	Supply walkway, Handrails and steps to the A/c units	Low	Client advised	Outstanding	-
118	Building: Woolworths Location Reference: L113 Task: Access to the roof

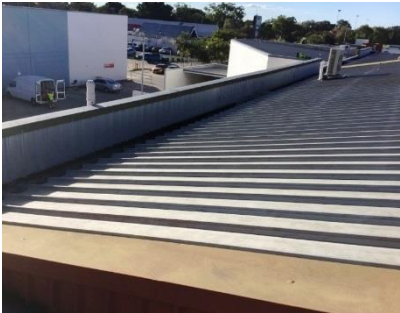
No height safety system is installed	Trips, Slips and Falls	Awareness induction	High	Fall arrest anchors to be installed	Low	Client advised	Outstanding	OH&S REGULATIONS 3.55

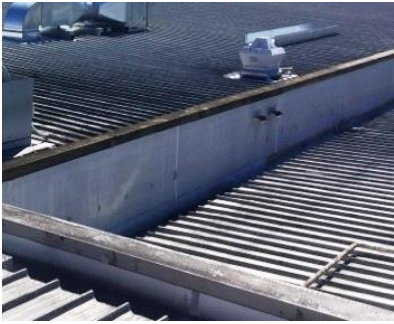
No safe access to the roof	Trips, Slips and Falls	Awareness induction	Med	Access ladder including handrails to be installed	Low	Client advised	Outstanding	OH&S REGULATIONS 3.7 AS/NZS 1657-2013 3.1.4

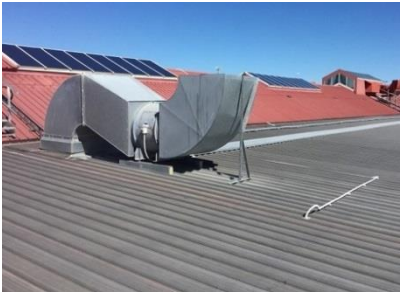
Brittle roof (Non-trafficable roof)	Fall hazard	Awareness induction	High	"Warning- Keep Off - Brittle and Fragile roof" signs to be installed	Low	Client advised	Outstanding	OH&S REGULATIONS 3.57

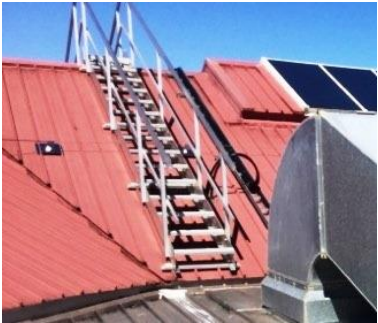
Bottom tread heights is greater than required maximum and no landing platforms at base	Trips, Slips and Falls	Awareness induction	Med	Landing platforms and steps to be installed	Low	Client advised	Outstanding	OH&S REGULATIONS 3.7 AS/NZS 1657-2013 7.2.4 & 7.3.6

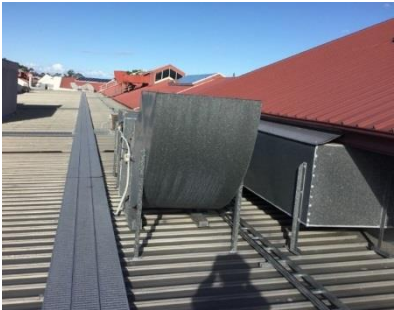
No safe access to the roof	Trips, Slips and Falls	Awareness induction	Med	Access ladder including handrails to be installed	Low	Client advised	Outstanding	OH&S REGULATIONS 3.7 AS/NZS 1657-2013 3.1.4
132	Building: General Stores Location Reference: L137 Task: Restrict access to the roof

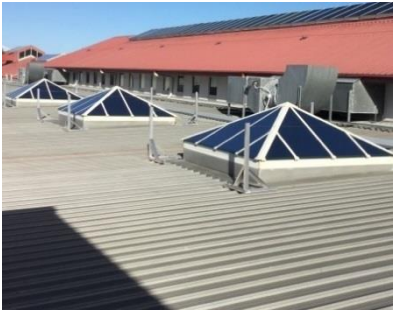
Brittle roof (Non-Trafficable roof)	Fall Hazard	Awareness induction	High	"Warning-Keep Off-Brittle and Fragile Roof" signs to be installed	Low	Client advised	Outstanding	OH&S REGULATIONS 3.57

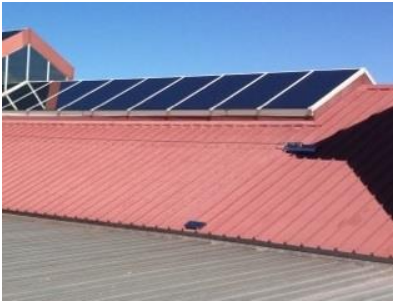
Brittle roof (Non-Trafficable roof)	Fall Hazard	Awareness induction	High	"Warning-Keep Off-Brittle and Fragile Roof" signs to be installed	Low	Client advised	Outstanding	OH&S REGULATIONS 3.57
134	Building: General Stores Location Reference: L142 Task: Access to the A/c unit

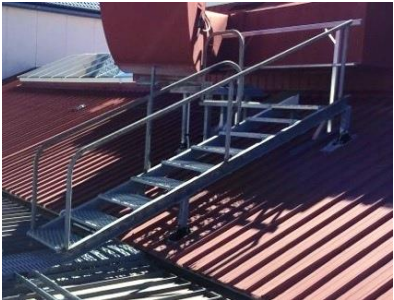
Going is greater than required maximum, Midrail is missing and sharp edges on handrails	Trips, Slips and Falls	Awareness induction	Med	Existing stair to be removed and New access ladder including landing platforms and handrails to be installed	Low	Client advised	Outstanding	OH&S REGULATIONS 3.7 AS/NZS 1657-2013 7.2.4 & 4.4 & 5.6

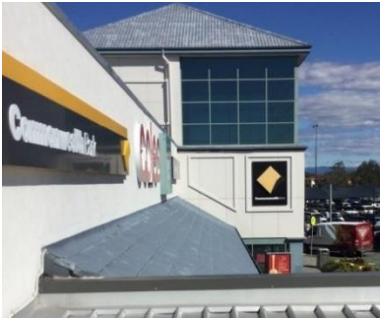
No height safety system installed (No serviceable items)	Trips, Slips and Falls	Awareness induction	High	"EWP Access Only" signs to be installed	Low	Client advised	Outstanding	OH&S REGULATIONS 3.55 & 3.11
136	Building: General Stores Location Reference: L144 Task: Access to the A/c unit

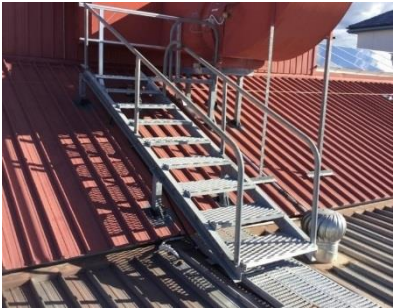
Going is greater than required maximum, Midrail is missing and sharp edges on handrails	Trips, Slips and Falls	Awareness induction	Med	Existing stair to be removed and New access ladder including landing platforms and handrails to be installed	Low	Client advised	Outstanding	OH&S REGULATIONS 3.7 AS/NZS 1657-2013 7.2.4 & 4.4 & 5.6

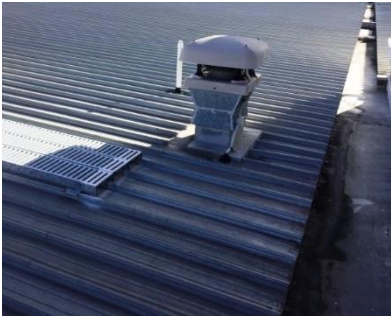
No safe access to the A/c unit	Trips, Slips and Falls	N/A	Low	Supply walkway to the A/c units	Low	Client advised	Outstanding	-

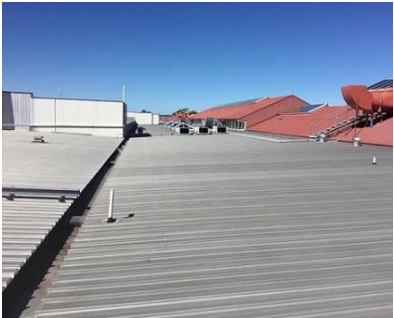
No safe access to the A/c units	Trips, Slips and Falls	N/A	Low	Supply walkway to the A/c units	Low	Client advised	Outstanding	-

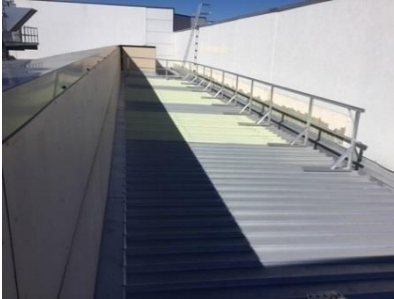
Sharp edges on handrails	Hand Injury	Awareness induction	Med	Tek screws to be replaced with rivets and Additional handrail section to be installed	Low	Client advised	Outstanding	OH&S REGULATIONS 3.6 AS/NZS 1657-2013 5.6
142	Building: ALDI Location Reference: L150 Task: Access to the A/c unit

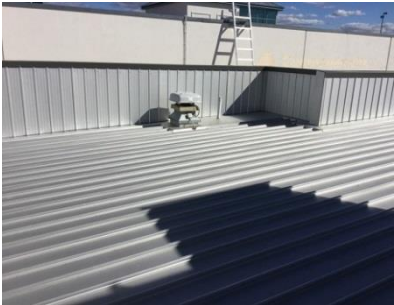
No safe access to the A/c unit	Trips, Slips and Falls	N/A	Low	Supply walkway to the A/c unit	Low	Client advised	Outstanding	-

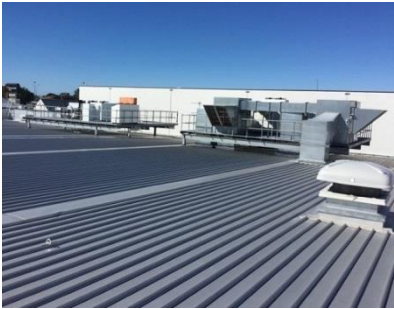
No safe access to the A/c units	Trips, Slips and Falls	N/A	Low	Supply walkway to the A/c units	Low	Client advised	Outstanding	-
144	Building: ALDI Location Reference: L152 Task: Access to the roof

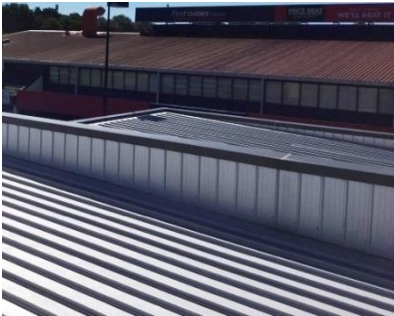
No safe access to the roof	Trips, Slips and Falls	Awareness induction	Med	Access ladder including handrails to be installed	Low	Client advised	Outstanding	OH&S REGULATIONS 3.7 AS/NZS 1657-2013 3.1.4

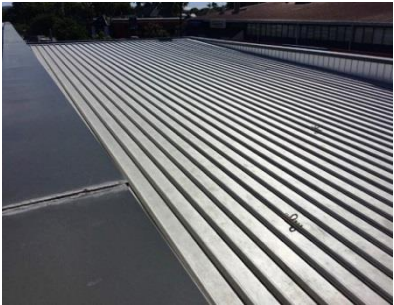
No height safety system installed	Trips, Slips and Falls	Awareness induction	High	Fall arrest anchors to be installed	Low	Client advised	Outstanding	OH&S REGULATIONS 3.55
146	Building: ALDI Location Reference: L153 Task: Access to the roof

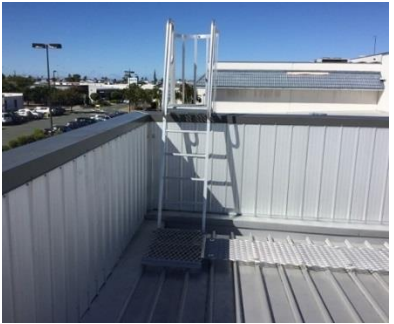
Bottom rung height is less than required minimum and handrail projecting towards the user	Trips, Slips and Falls	Awareness induction	Med	Existing handrail to be removed. Landing platform and handrails to be installed	Low	Client advised	Outstanding	OH&S REGULATIONS 3.7 AS/NZS 1657-2013 7.4.3.4 & 7.4.8.5

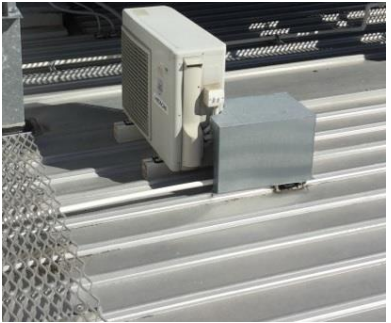
No safe access to the A/c unit	Trips, Slips and Falls	N/A	Low	Supply walkway to the A/c unit	Low	Client advised	Outstanding	-

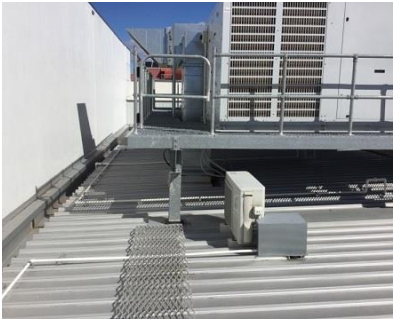
No safe access to the plant deck	Trips, Slips and Falls	Awareness induction	Med	Access ladder including landing platforms and handrails to be installed	Low	Client advised	Outstanding	OH&S REGULATIONS 3.7 AS/NZS 1657-2013 3.1.4
150	Building: ALDI Location Reference: L155 Task: Access to the plant deck

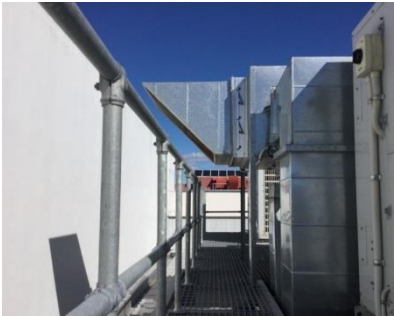
Headroom is less than required minimum	Trips, Slips and Falls	Awareness induction	Med	Low headroom signs and high visibility safety yellow tape to be installed	Low	Client advised	Outstanding	OH&S REGULATIONS 3.6 AS/NZS 1657-2013 3.1.5

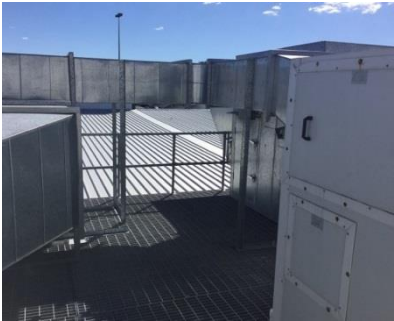
Headroom is less than required minimum	Trips, Slips and Falls	Awareness induction	Med	Low headroom signs and high visibility safety yellow tape to be installed	Low	Client advised	Outstanding	OH&S REGULATIONS 3.6 AS/NZS 1657-2013 3.1.5
152	Building: ALDI Location Reference: L156 Task: Restrict access to the roof

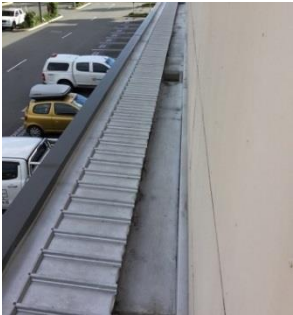
No height safety system installed (No serviceable items)	Trips, Slips and Falls	Awareness induction	High	"EWP Access Only" signs to be installed	Low	Client advised	Outstanding	OH&S REGULATIONS 3.55 & 3.11

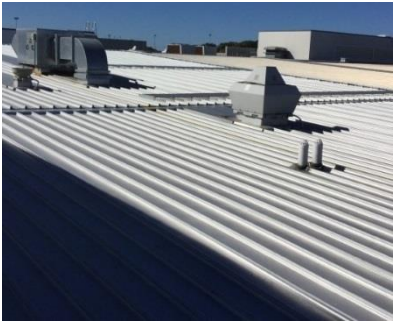
No safe access to the A/c units	Trips, Slips and Falls	N/A	Low	Supply walkway to the A/c units	Low	Client advised	Outstanding	-
154	Building: Coles Location Reference: L158 Task: Access to the A/c unit

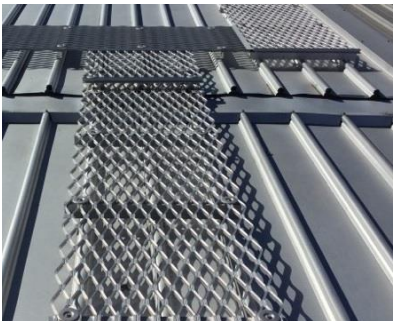
Variation in height between two panels are greater than required maximum	Trips, Slips and Falls	Awareness induction	Med	High visibility safety yellow nosing to be installed	Low	Client advised	Outstanding	OH&S REGULATIONS 3.6 AS/NZS 1657-2013 3.3.4

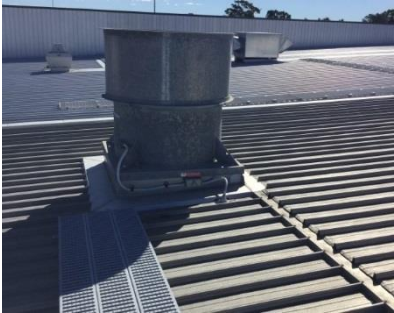
No safe access to the A/c unit	Trips, Slips and Falls	N/A	Low	Supply walkway to the A/c unit	Low	Client advised	Outstanding	-
156	Building: Coles Location Reference: L159 Task: Access to the A/c unit

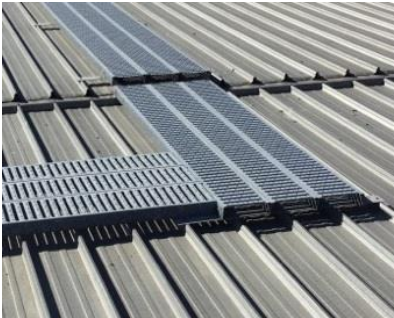
Variation in height between two panels are greater than required maximum	Trips, Slips and Falls	Awareness induction	Med	High visibility safety yellow nosing to be installed	Low	Client advised	Outstanding	OH&S REGULATIONS 3.6 AS/NZS 1657-2013 3.3.4

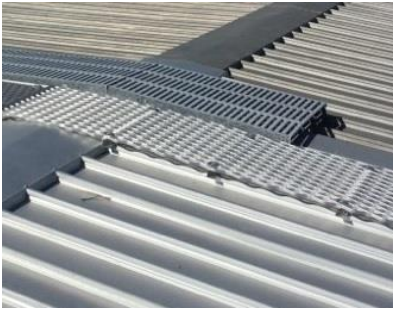
Variation in height between two panels are greater than required maximum	Trips, Slips and Falls	Awareness induction	Med	High visibility safety yellow nosing to be installed	Low	Client advised	Outstanding	OH&S REGULATIONS 3.6 AS/NZS 1657-2013 3.3.4
158	Building: Coles Location Reference: L160 Task: Access to the A/c unit

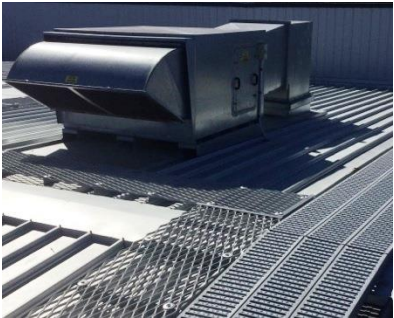
No safe access to the A/c unit	Trips, Slips and Falls	N/A	Low	Supply walkway to the A/c unit	Low	Client advised	Outstanding	-

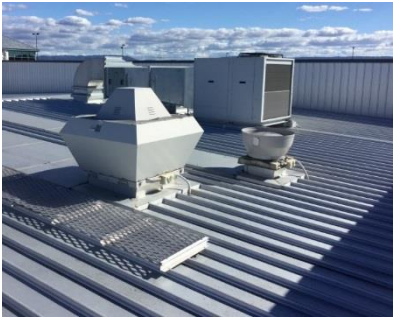
No safe access to the A/c units	Trips, Slips and Falls	N/A	Low	Supply walkway to the A/c units	Low	Client advised	Outstanding	-
160	Building: Coles Location Reference: L162 Task: Access to the A/c units

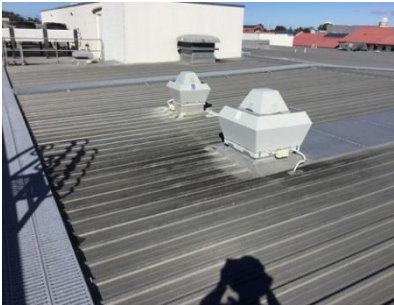
No safe access to the A/c units	Trips, Slips and Falls	N/A	Low	Supply walkway to the A/c units	Low	Client advised	Outstanding	-

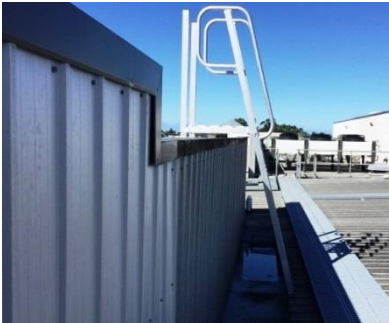
Bottom rung height is less than required minimum, handrails projecting towards the user and static line is missing	Trips, Slips and Falls	Awareness induction	Med	Existing handrails to be removed. Landing platforms, preformed handrails and static line to be installed	Low	Client advised	Outstanding	OH&S REGULATIONS 3.7 AS/NZS 1657-2013 7.4.3.4 & 7.4.8.5
162	Building: Coles Location Reference: L164 Task: Access to the roof

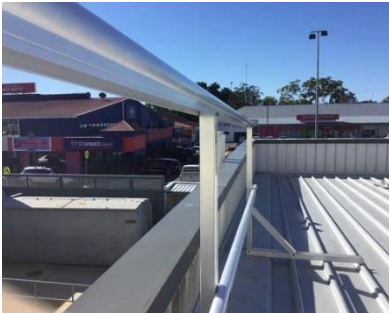
Sharp edges on handrails	Hand Injury	Awareness induction	Med	Tek screws to be replaced with rivets	Low	Client advised	Outstanding	OH&S REGULATIONS 3.6 AS/NZS 1657-2013 5.6

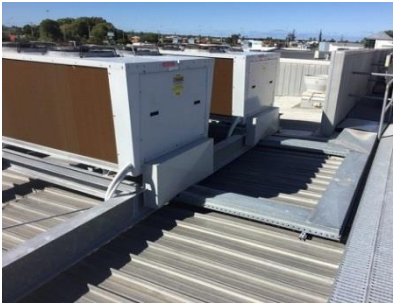
No safe access to the A/c units	Trips, Slips and Falls	N/A	Low	Supply walkway to the A/c units	Low	Client advised	Outstanding	-
164	Building: Coles Location Reference: L166 Task: Access to the A/c unit

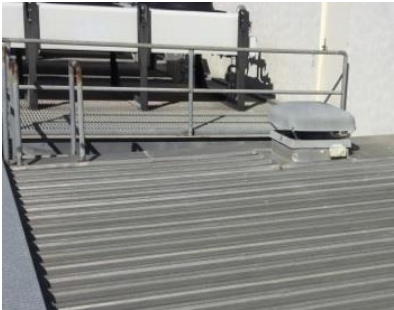
No safe access to the A/c unit	Trips, Slips and Falls	N/A	Low	Supply walkway to the A/c unit	Low	Client advised	Outstanding	-

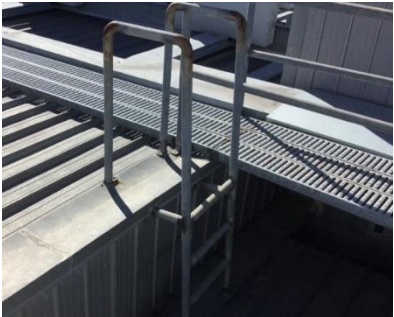
Non-compliant ladder (Not required)	Trips, Slips and Falls	Awareness induction	Med	Existing ladder to be removed	Low	Client advised	Outstanding	OH&S REGULATIONS 3.7 AS/NZS 1657-2013 3.1.4
166	Building: Coles Location Reference: L167 Task: Access to the roof

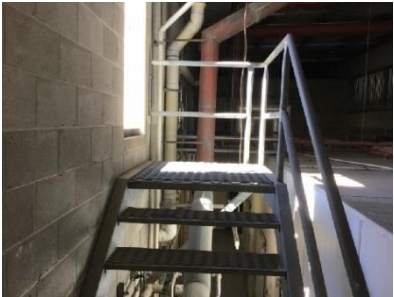
Toe board is missing at landing	Trips, Slips and Falls	Awareness induction	Med	Toe board to be installed	Low	Client advised	Outstanding	OH&S REGULATIONS 3.7 AS/NZS 1657-2013 4.6

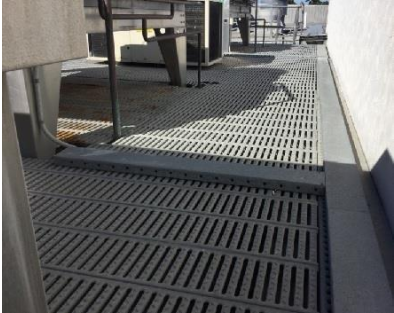
Cable covers over the walkway path	Trips, Slips and Falls	Awareness induction	Med	High visibility safety yellow tape to be installed	Low	Client advised	Outstanding	OH&S REGULATIONS 3.6
168	Building: Coles Location Reference: L168 Task: Restrict access to the roof

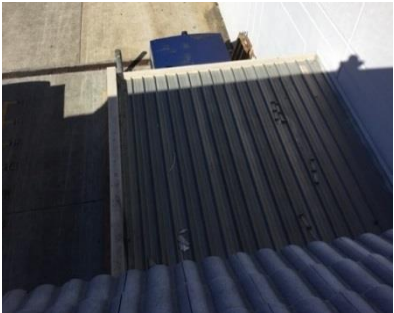
No height safety system is installed (No serviceable items)	Trips, Slips and Falls	Awareness induction	High	"EWP Access Only" sign to be installed	Low	Client advised	Outstanding	OH&S REGULATIONS 3.55 & 3.11

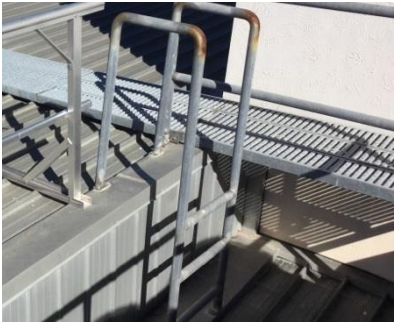
No	Photo of Hazard	Details of Hazard	Details of Risk	Existing/ Immediate Control Measure	Current Risk Level	Proposed Permanent Solution	Residual Risk Assessment	Details of Action Taken	Status	Reference
169	Building: Coles Location Reference: L169 Task: Access to the roof

Non-compliant ladder	Trips, Slips and Falls	Awareness induction	Med	Existing ladder to be removed and New ladder to be installed	Low	Client advised	Outstanding	OH&S REGULATIONS 3.7 AS/NZS 1657-2013 3.1.4
170	Building: Coles Location Reference: L169 Task: Access to the A/c units

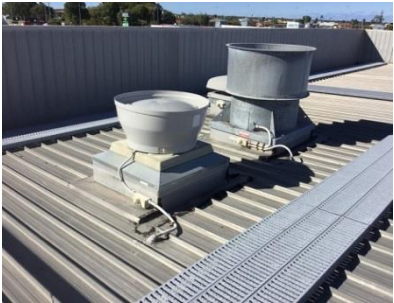
No safe access to the A/c units	Trips, Slips and Falls	N/A	Low	Supply walkway to the A/c units	Low	Client advised	Outstanding	-

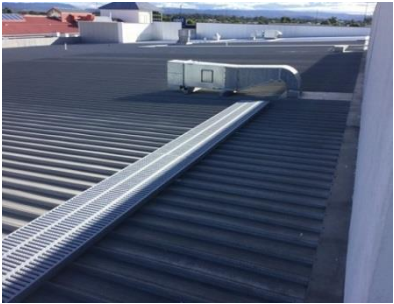
No	Photo of Hazard	Details of Hazard	Details of Risk	Existing/ Immediate Control Measure	Current Risk Level	Proposed Permanent Solution	Residual Risk Assessment	Details of Action Taken	Status	Reference
171	Building: Coles Location Reference: L170 Task: Access to the A/c unit

No safe access to the A/c unit	Trips, Slips and Falls	N/A	Low	Supply walkway to the A/c unit	Low	Client advised	Outstanding	-
172	Building: Coles Location Reference: L171 Task: Access to the roof

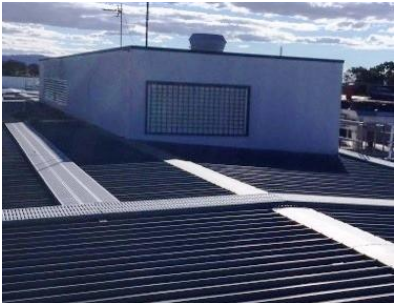
No safe access to the roof	Trips, Slips and Falls	Awareness induction	Med	Access ladder including handrails to be installed	Low	Client advised	Outstanding	OH&S REGULATIONS 3.7 AS/NZS 1657-2013 3.1.4
