Roof Safety Report

**Runaway Bay Centre,
QLD 4216**

Prepared By: Safemaster Safety Products
Date: 10 Aug 2017

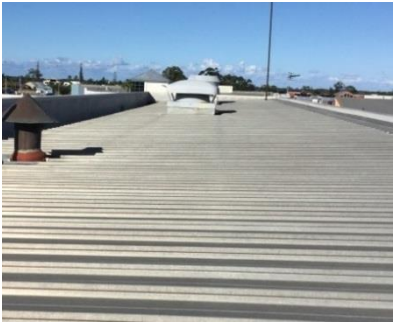
No	Photo of Hazard	Details of Hazard	Details of Risk	Existing/ Immediate Control Measure	Curre nt Risk Level	Proposed Permanent Solution	Resid ual Risk Asse ssme nt	Details of Action Taken	Status	Reference
173	Building: Coles Location Reference: L171 Task: Access to the A/c units

No safe access to the A/c units	Trips, Slips and Falls	N/A	Low	Supply walkway to the A/c units	Low	Client advised	Outstanding	-
174	Building: Coles Location Reference: L172 Task: Access to the A/c unit

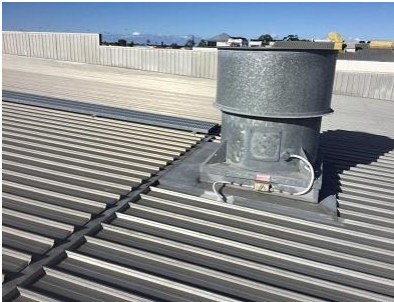
No safe access to the A/c unit	Trips, Slips and Falls	N/A	Low	Supply walkway to the A/c unit	Low	Client advised	Outstanding	-

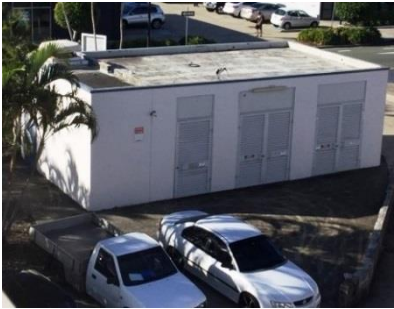
No	Photo of Hazard	Details of Hazard	Details of Risk	Existing/ Immediate Control Measure	Current Risk Level	Proposed Permanent Solution	Residual Risk Assessment	Details of Action Taken	Status	Reference
175	Building: General Stores Location Reference: L173 Task: Restrict access to the roof

No height safety system installed (No serviceable items)	Trips, Slips and Falls	Awareness induction	High	"EWP Access only" sign to be installed	Low	Client advised	Outstanding	OH&S REGULATIONS 3.55 & 3.11
176	Building: Pet Stock Location Reference: L174 Task: Access to the roof

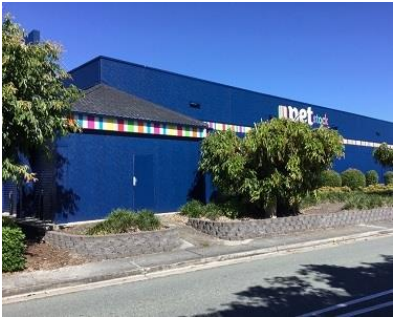
No height safety system installed and no safe access provided	Trips, Slips and Falls	Awareness induction	High	Roof access ladder, Fall arrest anchors, anchor strop and signage to be installed	Low	Client advised	Outstanding	OH&S REGULATIONS 3.55 & 3.7 AS/NZS 1657-2013 3.1.4

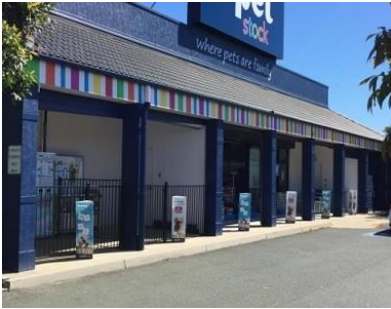
No	Photo of Hazard	Details of Hazard	Details of Risk	Existing/ Immediate Control Measure	Current Risk Level	Proposed Permanent Solution	Residual Risk Assessment	Details of Action Taken	Status	Reference
177	Building: Pet Stock Location Reference: L175 Task: Restrict access to the roof

No height safety system installed (No serviceable items on roof)	Trips, Slips and Falls	Awareness induction	High	"EWP Access Only" signs to be installed	Low	Client advised	Outstanding	OH&S REGULATIONS 3.55 & 3.11
178	Building: General Stores Location Reference: L176 Task: Restrict access to the roof

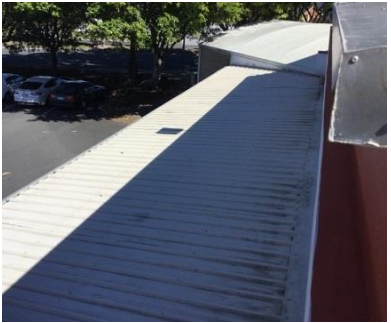
No height safety system installed (No serviceable items on roof)	Trips, Slips and Falls	Awareness induction	High	"EWP Access Only" signs to be installed	Low	Client advised	Outstanding	OH&S REGULATIONS 3.55 & 3.11

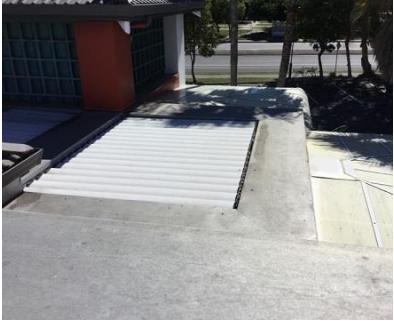
No	Photo of Hazard	Details of Hazard	Details of Risk	Existing/ Immediate Control Measure	Curre nt Risk Level	Proposed Permanent Solution	Resid ual Risk Asse ssme nt	Details of Action Taken	Status	Reference
179	Building: General Stores Location Reference: L177 Task: Restrict access to the roof

No height safety system installed (No serviceable items on roof)	Trips, Slips and Falls	Awareness induction	High	"EWP Access Only" signs to be installed	Low	Client advised	Outstanding	OH&S REGULATIONS 3.55 & 3.11
180	Building: General Stores Location Reference: L178 Task: Access to the A/c unit

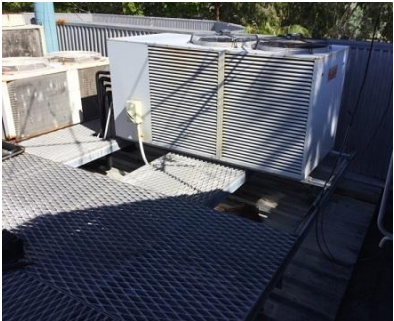
No safe access to the A/c unit	Trips, Slips and Falls	Awareness induction	Med	Gap to be filled with gratings	Low	Client advised	Outstanding	OH&S REGULATIONS 3.7

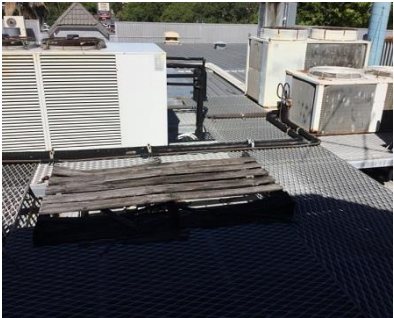
No	Photo of Hazard	Details of Hazard	Details of Risk	Existing/ Immediate Control Measure	Current Risk Level	Proposed Permanent Solution	Residual Risk Assessment	Details of Action Taken	Status	Reference
181	Building: General Stores Location Reference: L178 Task: Access to the A/c unit

No safe access to the A/c unit	Trips, Slips and Falls	Awareness induction	Med	Gap to be filled with gratings	Low	Client advised	Outstanding	OH&S REGULATIONS 3.7
182	Building: General Stores Location Reference: L178 Task: Access to the A/c unit

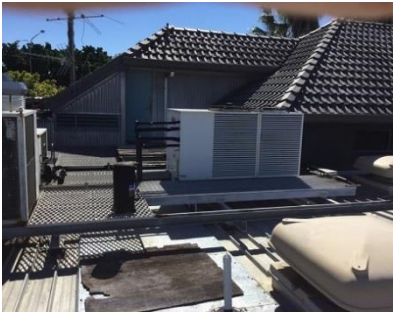
No safe access to the A/c unit	Trips, Slips and Falls	Awareness induction	Med	Gap to be filled with gratings	Low	Client advised	Outstanding	OH&S REGULATIONS 3.7

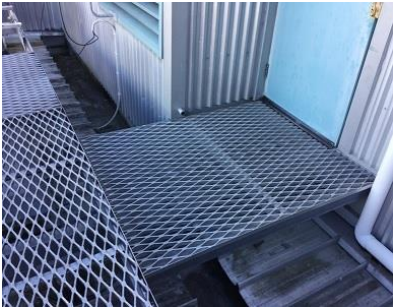
No	Photo of Hazard	Details of Hazard	Details of Risk	Existing/ Immediate Control Measure	Current Risk Level	Proposed Permanent Solution	Residual Risk Assessment	Details of Action Taken	Status	Reference
183	Building: General Stores Location Reference: L178 Task: Access to the plant deck

Variation in height between plantdeck and roof is greater than required maximum	Trips, Slips and Falls	Awareness induction	Med	Aluminium guardrail around plant deck including nitrile separation to be installed	Low	Client advised	Outstanding	OH&S REGULATIONS 3.6 AS/NZS 1657-2013 4.4
184	Building: General Stores Location Reference: L178 Task: Access to the roof

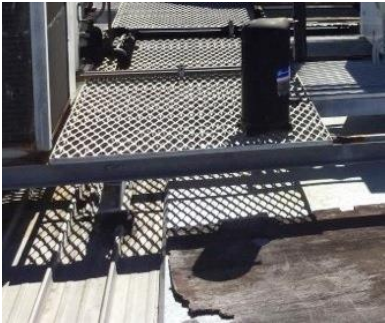
Variation in height between plantdeck and roof is greater than required maximum	Trips, Slips and Falls	Awareness induction	Med	Aluminium step up to be installed	Low	Client advised	Outstanding	OH&S REGULATIONS 3.7 AS/NZS 1657-2013 3.1.4

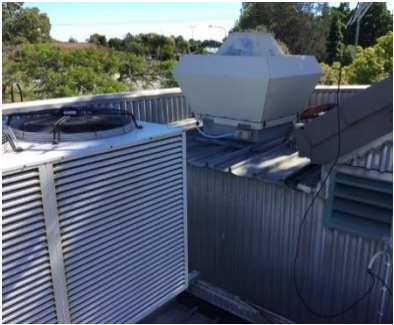
No	Photo of Hazard	Details of Hazard	Details of Risk	Existing/ Immediate Control Measure	Current Risk Level	Proposed Permanent Solution	Residual Risk Assessment	Details of Action Taken	Status	Reference
185	Building: General Stores Location Reference: L178 Task: Access to the A/c unit

Variation in height between two roofs are greater than required minimum	Trips, Slips and Falls	Awareness induction	Med	Access ladder including handrails to be installed	Low	Client advised	Outstanding	OH&S REGULATIONS 3.7 AS/NZS 1657-2013 3.1.4
186	Building: General Stores Location Reference: L178 Task: Access to the roof

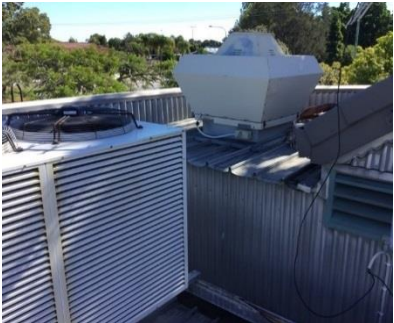
No safe access to the roof	Trips, Slips and Falls	Awareness induction	High	Fall arrest anchor to be installed	Low	Client advised	Outstanding	OH&S REGULATIONS 3.55

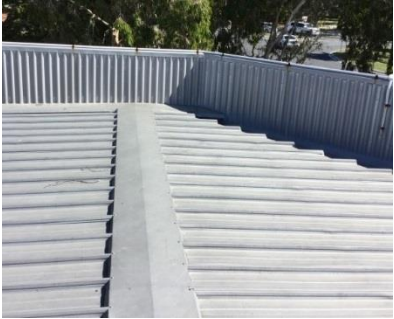
No height safety system installed	Trips, Slips and Falls	Awareness induction	High	Fall arrest anchors to be installed	Low	Client advised	Outstanding	OH&S REGULATIONS 3.55
188	Building: General Stores Location Reference: L185 Task: Access to the A/c units

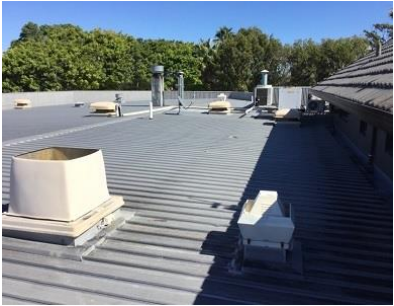
No safe access to the A/c units	Trips, Slips and Falls	N/A	Low	Supply walkway to the A/c units	Low	Client advised	Outstanding	-

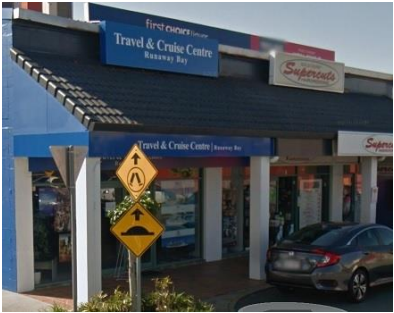
No	Photo of Hazard	Details of Hazard	Details of Risk	Existing/ Immediate Control Measure	Current Risk Level	Proposed Permanent Solution	Residual Risk Assessment	Details of Action Taken	Status	Reference
189	Building: General Stores Location Reference: L186 & 187 Task: Restrict access to the roof

No height safety system installed (No serviceable items)	Trips, Slips and Falls	Awareness induction	High	"EWP Access only" signs to be installed	Low	Client advised	Outstanding	OH&S REGULATIONS 3.55 & 3.11
190	Building: General Stores Location Reference: L188 Task: Access to the roof

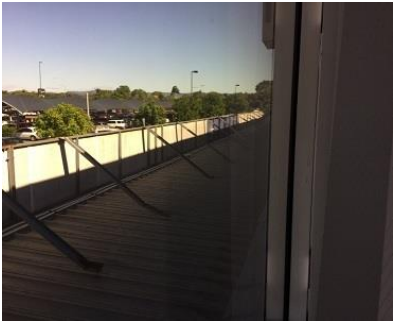
No height safety system installed	Trips, Slips and Falls	Awareness induction	High	Fall arrest anchors to be installed	Low	Client advised	Outstanding	OH&S REGULATIONS 3.55

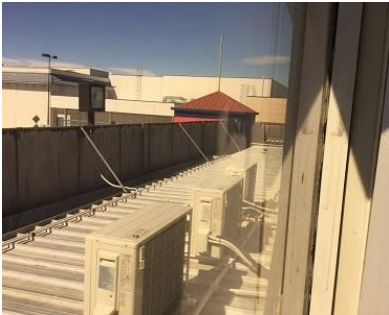
No	Photo of Hazard	Details of Hazard	Details of Risk	Existing/ Immediate Control Measure	Current Risk Level	Proposed Permanent Solution	Residual Risk Assessment	Details of Action Taken	Status	Reference
191	Building: General Stores Location Reference: L189 Task: Access to the A/c units

No safe access to the A/c units	Trips, Slips and Falls	N/A	Low	Supply walkway to the A/c units	Low	Client advised	Outstanding	-
192	Building: General Stores Location Reference: L190 Task: Access to the roof

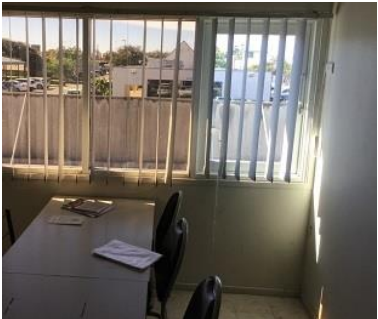
Roof access window not able to use and headroom is less than required minimum	Trips, Slips and Falls	Awareness induction	Med	"No Access" sign to be installed	Low	Client advised	Outstanding	OH&S REGULATIONS 3.7 AS/NZS 1657-2013 3.1.5

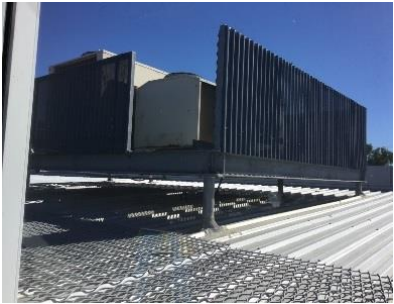
No	Photo of Hazard	Details of Hazard	Details of Risk	Existing/ Immediate Control Measure	Current Risk Level	Proposed Permanent Solution	Residual Risk Assessment	Details of Action Taken	Status	Reference
193	Building: General Stores Location Reference: L191 Task: Access to the plant deck

Variation in height between plant deck and roof is greater than required maximum	Trips, Slips and Falls	Awareness induction	Med	Aluminium single step up to be installed	Low	Client advised	Outstanding	OH&S REGULATIONS 3.7 AS/NZS 1657-2013 3.1.4
194	Building: General Stores Location Reference: L192 Task: Restrict access to the roof

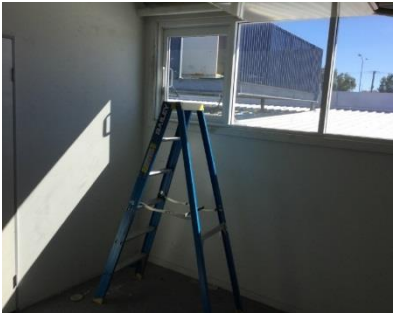
Roof access window not able to use and headroom is less than required minimum	Trips, Slips and Falls	Awareness induction	Med	"No Access" sign to be installed	Low	Client advised	Outstanding	OH&S REGULATIONS 3.7 AS/NZS 1657-2013 3.1.5

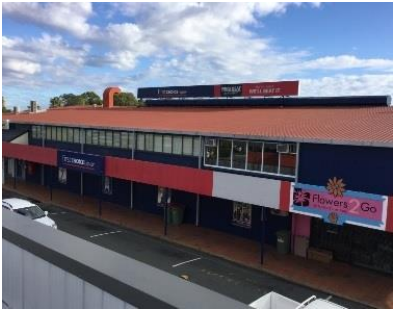
No	Photo of Hazard	Details of Hazard	Details of Risk	Existing/ Immediate Control Measure	Current Risk Level	Proposed Permanent Solution	Residual Risk Assessment	Details of Action Taken	Status	Reference
195	Building: General Stores Location Reference: L193 Task: Access to the roof

No safe access to the roof and no height safety system installed	Trips, Slips and Falls	Awareness induction	High	Ladder access bracket, Signage, permanent ladders, fall arrest anchors to be installed	Low	Client advised	Outstanding	OH&S REGULATIONS 3.7 & 3.55 AS/NZS 1657-2013 3.1.4
196	Building: General Stores Location Reference: L194 Task: Access to the roof

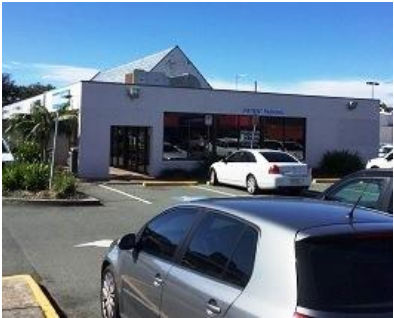
No safe access to the roof and no height safety system installed	Trips, Slips and Falls	Awareness induction	High	Ladder access bracket, Signage, anchor strop, fall arrest anchors to be installed	Low	Client advised	Outstanding	OH&S REGULATIONS 3.55

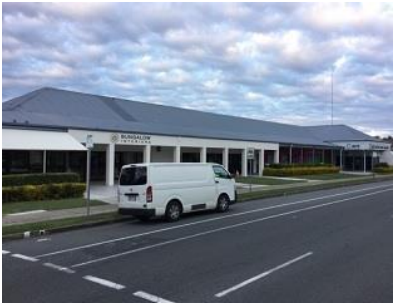
No	Photo of Hazard	Details of Hazard	Details of Risk	Existing/ Immediate Control Measure	Current Risk Level	Proposed Permanent Solution	Residual Risk Assessment	Details of Action Taken	Status	Reference
197	Building: General Stores Location Reference: L195 Task: Access to the roof

No safe access to the roof and no height safety system installed	Trips, Slips and Falls	Awareness induction	High	Ladder access bracket, Signage, anchor strop, fall arrest anchors to be installed	Low	Client advised	Outstanding	OH&S REGULATIONS 3.55
198	Building: General Stores Location Reference: L196 Task: Access to the roof

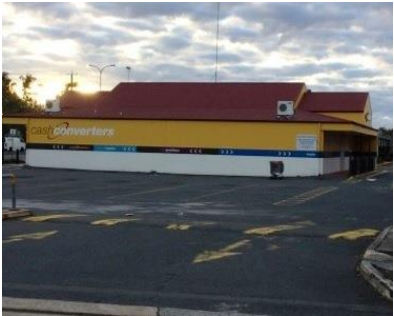
No safe access to the roof and no height safety system installed	Trips, Slips and Falls	Awareness induction	High	Ladder access bracket, Signage, anchor strop, fall arrest anchors to be installed	Low	Client advised	Outstanding	OH&S REGULATIONS 3.55

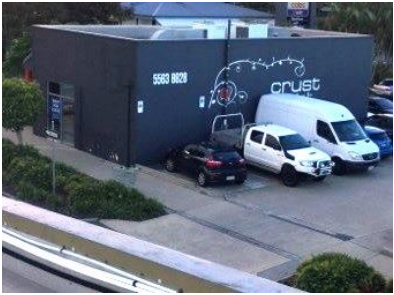
No	Photo of Hazard	Details of Hazard	Details of Risk	Existing/ Immediate Control Measure	Curre nt Risk Level	Proposed Permanent Solution	Resid ual Risk Asse ssme nt	Details of Action Taken	Status	Reference
199	Building: General Stores Location Reference: L197 Task: Access to the roof

No safe access to the roof and no height safety system installed	Trips, Slips and Falls	Awareness induction	High	Ladder access bracket, Signage, anchor strop, access ladder, fall arrest anchors to be installed	Low	Client advised	Outstanding	OH&S REGULATIONS 3.55
200	Building: General Stores Location Reference: L198 Task: Access to the roof

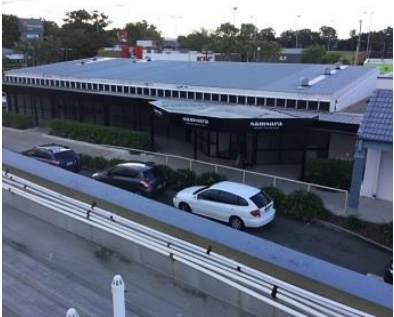
No safe access to the roof and no height safety system installed	Trips, Slips and Falls	Awareness induction	High	Ladder access bracket, Signage, anchor strop, access ladders, fall arrest anchors to be installed	Low	Client advised	Outstanding	OH&S REGULATIONS 3.55

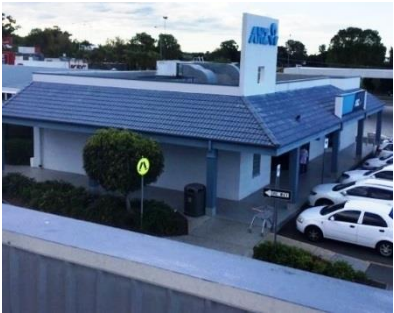
No	Photo of Hazard	Details of Hazard	Details of Risk	Existing/ Immediate Control Measure	Current Risk Level	Proposed Permanent Solution	Residual Risk Assessment	Details of Action Taken	Status	Reference
201	Building: General Stores Location Reference: L199 Task: Restrict access to the roof

No height safety system installed (No serviceable items)	Trips, Slips and Falls	Awareness induction	High	"EWP Access only" signs to be installed	Low	Client advised	Outstanding	OH&S REGULATIONS 3.55 & 3.11
202	Building: General Stores Location Reference: L200 Task: Access to the roof

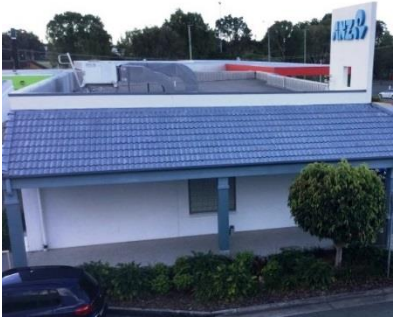
No height safety system installed	Trips, Slips and Falls	Awareness induction	High	Anchor strop and Fall arrest anchors to be installed	Low	Client advised	Outstanding	OH&S REGULATIONS 3.55

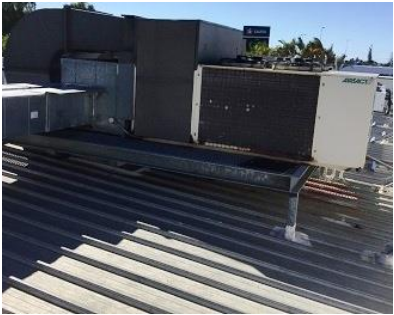
No	Photo of Hazard	Details of Hazard	Details of Risk	Existing/ Immediate Control Measure	Current Risk Level	Proposed Permanent Solution	Residual Risk Assessment	Details of Action Taken	Status	Reference
203	Building: General Stores Location Reference: L201 Task: Access to the plant deck

No safe access to the A/c unit on plant deck	Trips, Slips and Falls	Awareness induction	Med	Access ladder, handrails and grating to be installed to fill the gap	Low	Client advised	Outstanding	OH&S REGULATIONS 3.7 AS/NZS 1657-2013 3.1.4 & 4.4
204	Building: General Stores Location Reference: L202 Task: Access to the plant deck

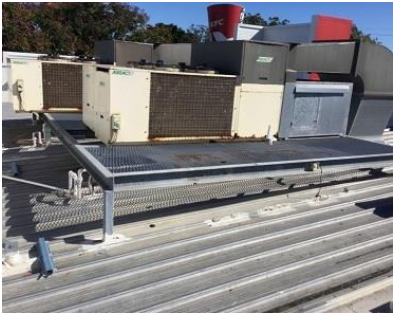
No safe access to the A/c unit on plant deck	Trips, Slips and Falls	Awareness induction	Med	Access ladder, handrails and grating to be installed to fill the gap	Low	Client advised	Outstanding	OH&S REGULATIONS 3.7 AS/NZS 1657-2013 3.1.4 & 4.4

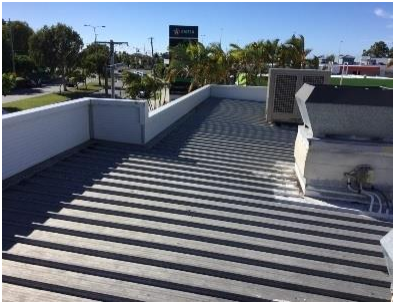
No	Photo of Hazard	Details of Hazard	Details of Risk	Existing/ Immediate Control Measure	Current Risk Level	Proposed Permanent Solution	Residual Risk Assessment	Details of Action Taken	Status	Reference
205	Building: General Stores Location Reference: L203 Task: Access to the roof

No height safety system installed	Trips, Slips and Falls	Awareness induction	High	Fall arrest anchors to be installed	Low	Client advised	Outstanding	OH&S REGULATIONS 3.55
206	Building: General Stores Location Reference: L206 Task: Access to the plant deck

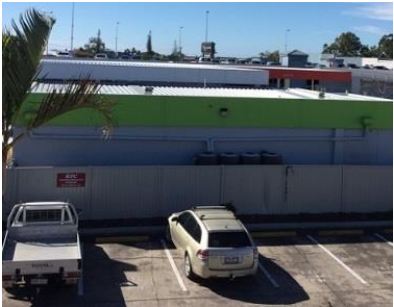
No height safety system installed	Trips, Slips and Falls	Awareness induction	High	Anchor strop, permanent ladder and Fall arrest anchors to be installed	Low	Client advised	Outstanding	OH&S REGULATIONS 3.55 & 3.7 AS/NZS 1657-2013 3.1.4

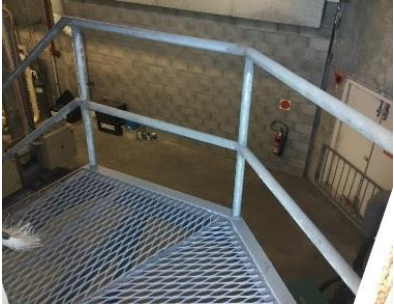
207	Building: Target Location Reference: L207 Task: Access to the roof

Toe board is missing at landing	Head Injury	Awareness induction	Med	Toe board including nitrile separation to be installed	Low	Client advised	Outstanding	OH&S REGULATIONS 3.7 AS/NZS 1657-2013 4.6
