# Roof Safety Report

Runaway Bay Centre,

Prepared By: Safemaster Safety Products  
Date: 03-09-2020

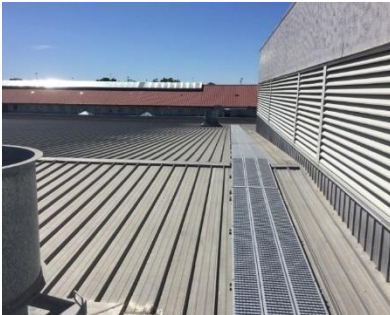
No safe access to the roof	Trips, Slips and Falls	Awareness induction	Med	Access ladder including handrails to be installed	Low	Client advised	Outstanding	OH&S REGULATIONS 3.7  AS/NZS 1657-2013 3.1.4

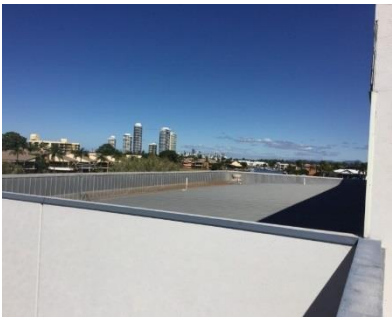
No safe access to the roof	Trips, Slips and Falls	Awareness induction	Med	Access ladder including handrails to be installed	Low	Client advised	Outsta nding	OH&S REGULATIONS 3.7  AS/NZS 1657-2013 3.1.4

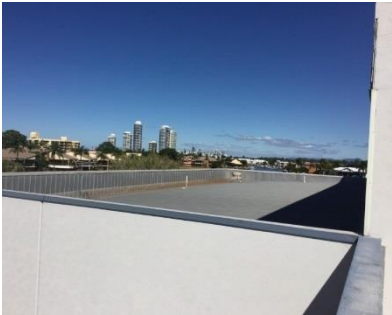
No height safety system installed	Trips, Slips and Falls	Awareness induction	High	Fall restraint anchors to be installed	Low	Client advised	Outsta nding	OH&S REGULATIONS 3.55
06	Building: Target Location Reference: <a href="#">L7</a> Task: Access to the A/c units

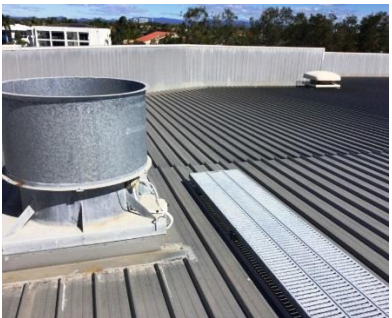
No safe access to the A/c units	Trips, Slips and Falls	N/A	Low	Supply walkway to the A/c units	Low	Client advised	Outsta nding	-

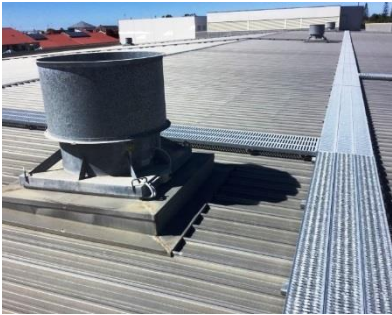
No safe access to the A/c units	Trips, Slips and Falls	N/A	Low	Supply walkway to the A/c units	Low	Client advised	Outstanding	-
08	Building: Target Location Reference: <a href="#">L9</a> Task: Access to the A/c units

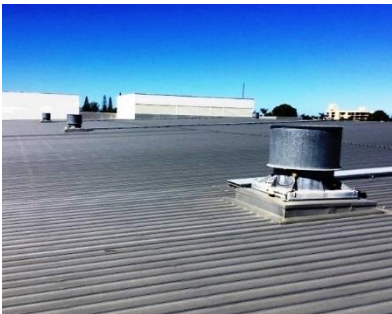
No safe access to the A/c units	Trips, Slips and Falls	N/A	Low	Supply walkway to the A/c units	Low	Client advised	Outstanding	-

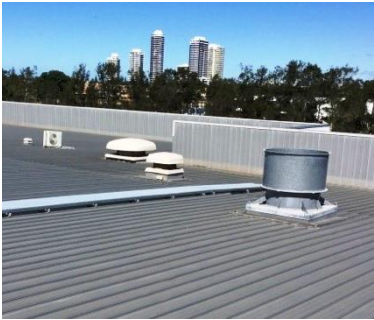
No safe access to the A/c units	Trips, Slips and Falls	N/A	Low	Supply walkway to the A/c units	Low	Client advised	Outstanding	-
10	Building: Target Location Reference: <a href="#">L11</a> Task: Access to the roof

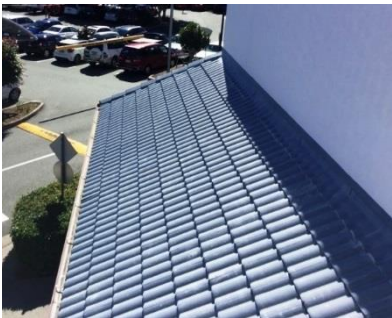
No height safety system installed (No serviceable items on roof)	Trips, Slips and Falls	Awareness induction	High	"EWP ACCESS ONLY" sign to be installed	Low	Client advised	Outstanding	OH&S REGULATIONS 3.55 & 3.11

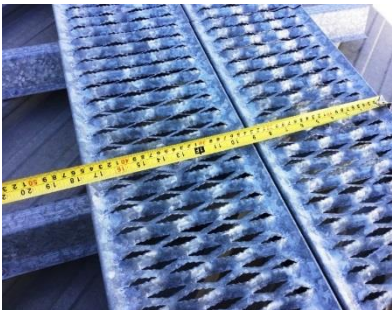
Roof walkway width is less than required minimum	Trips, Slips and Falls	Awareness induction	Med	Existing walkway to be removed and new 600mm wide walkway to be installed	Low	Client advised	Outstanding	OH&S REGULATIONS 3.7  AS/NZS 1657-2013 5.1.3

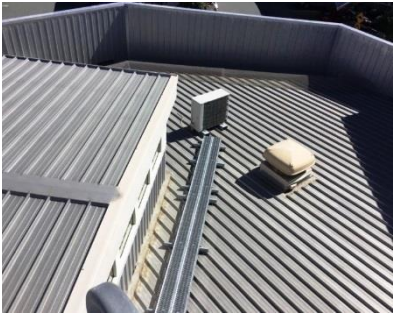
No safe access to the A/c units	Trips, Slips and Falls	N/A	Low	Supply walkway to the A/c units	Low	Client advised	Outstanding	-
14	Building: Target Location Reference: <a href="#">L15</a> Task: Access to the A/c units

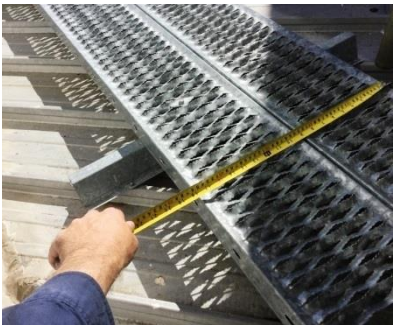
Roof walkway width is less than required minimum	Trips, Slips and Falls	Awareness induction	Med	Existing walkway to be removed and new 600mm wide walkway to be installed	Low	Client advised	Outstanding	OH&S REGULATIONS 3.7  AS/NZS 1657-2013 5.1.3

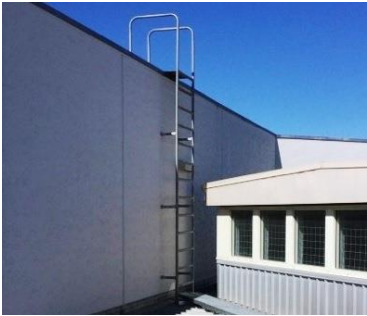
No slip resistance on ladder rungs, fall arrest static line is missing and bottom rung height is less than required minimum	Trips, Slips and Falls	Awareness induction	Med	Existing ladder to be removed and New ladder including landing platform to be installed	Low	Client advised	Outstanding	OH&S REGULATIONS 3.7  AS/NZS 1657-2013 7.4.3.1 & 7.4.3.4
16	Building: Target Location Reference: <a href="#">L16</a> Task: Access to the roof

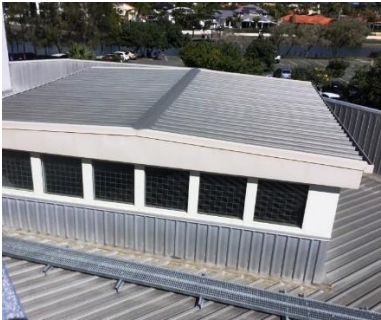
No height safety system installed	Trips, Slips and Falls	Awareness induction	High	Fall restraint anchors, anchor stop and ladder access bracket to be installed	Low	Client advised	Outstanding	OH&S REGULATIONS 3.55 & 3.7

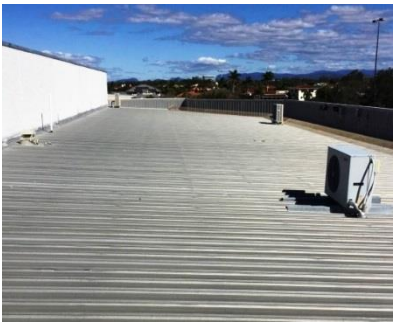
No safe access to the A/c units	Trips, Slips and Falls	N/A	Low	Supply walkway to the A/c units	Low	Client advised	Outstanding	-

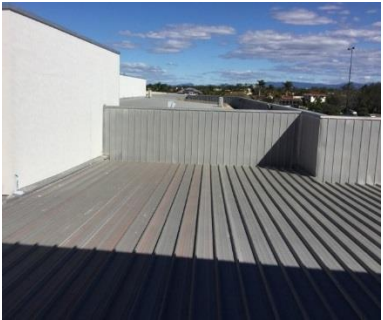
No safe access to the roof	Trips, Slips and Falls	Awareness induction	Med	Access ladder including handrails to be installed	Low	Client advised	Outstanding	OH&S REGULATIONS 3.7  AS/NZS 1657-2013 3.1.4
20	Building: General Stores Location Reference: <a href="#">L20</a> Task: Access to the roof

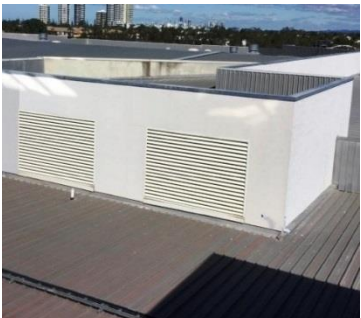
No safe access to the roof	Trips, Slips and Falls	Awareness induction	Med	Access ladder including handrails to be installed	Low	Client advised	Outstanding	OH&S REGULATIONS 3.7  AS/NZS 1657-2013 3.1.4

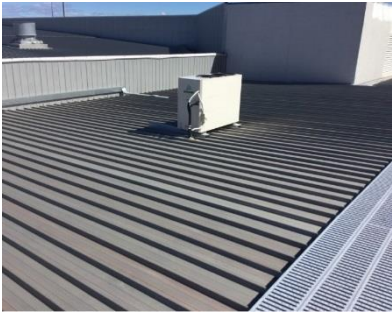
No safe access to the A/c unit	Trips, Slips and Falls	N/A	Low	Supply walkway to the A/c unit	Low	Client advised	Outsta nding	-
22	Building: General Stores Location Reference: <a href="#">L22</a> Task: Access to the A/c unit

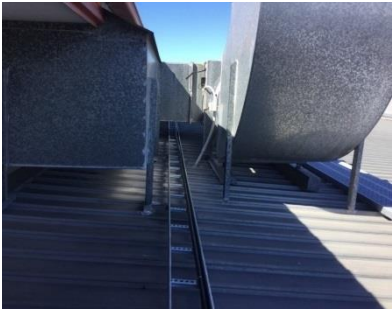
No safe access to the A/c unit	Trips, Slips and Falls	N/A	Low	Supply walkway to the A/c unit	Low	Client advised	Outsta nding	-

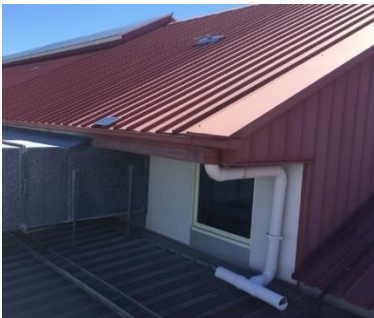
No safe access to the roof	Trips, Slips and Falls	Awareness induction	Med	Access ladder including handrails to be installed	Low	Client advised	Outstanding	OH&S REGULATIONS 3.7  AS/NZS 1657-2013 3.1.4

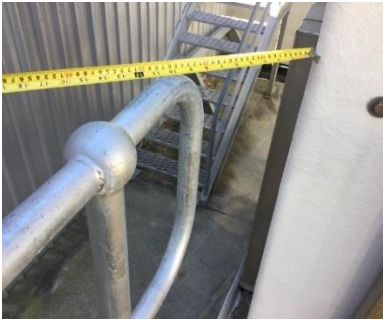
Handrail section is missing	Trips, Slips and Falls	Awareness induction	Med	Handrail section to be installed to close the gap	Low	Client advised	Outstanding	OH&S REGULATIONS 3.7  AS/NZS 1657-2013 4.4
30	Building: General Stores Location Reference: <a href="#">L29</a> Task: Access to the plant deck

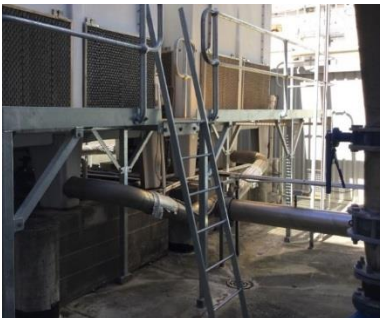
No slip resistance on ladder rungs	Trips, Slips and Falls	Awareness induction	Med	Non-slip rung caps to be installed on existing ladder	Low	Client advised	Outstanding	OH&S REGULATIONS 3.7  AS/NZS 1657-2013 7.4.3.1

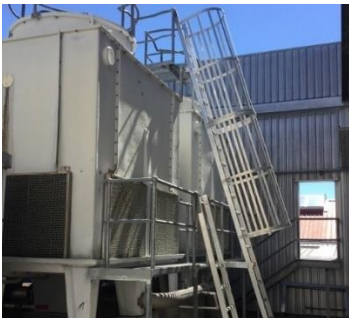
Bottom rung height is less than required minimum	Trips, Slips and Falls	Awareness induction	Med	Landing platform to existing ladder to be installed	Low	Client advised	Outstanding	OH&S REGULATIONS 3.7  AS/NZS 1657-2013 7.4.3.4

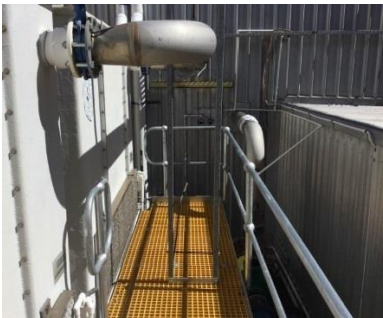
Headroom is less than required minimum	Head Injury	Awareness induction	Med	"Low-Headroom" sign and high visibility safety yellow tape to be installed	Low	Client advised	Outstanding	OH&S REGULATIONS 3.7  AS/NZS 1657-2013 3.1.5

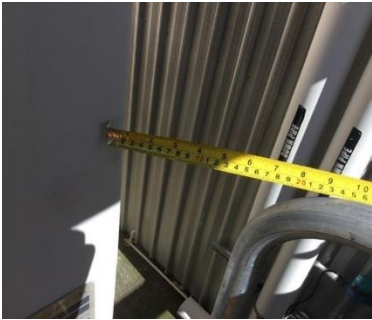
Handrail section is missing	Trips, Slips and Falls	Awareness induction	Med	Handrail section to be installed to close the gap	Low	Client advised	Outstanding	OH&S REGULATIONS 3.7  AS/NZS 1657-2013 4.4
36	Building: General Stores Location Reference: <a href="#">L30</a> Task: Access to the plant deck

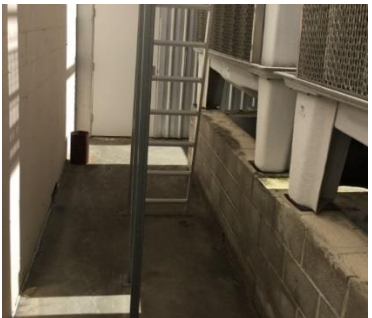
Bottom rung height is less than required minimum and gap between top rung and landing is greater than required maximum	Trips, Slips and Falls	Awareness induction	Med	Landing platform at base and additional walkway section at top to be installed	Low	Client advised	Outstanding	OH&S REGULATIONS 3.7  AS/NZS 1657-2013 7.4.3.4 & 7.4.8.4

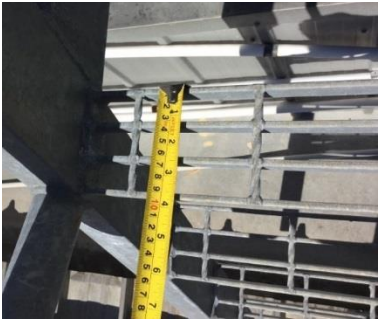
Tread width is less than required minimum	Trips, Slips and Falls	Awareness induction	Med	Existing non-complaint ladder to be removed and new ladder to be installed	Low	Client advised	Outstanding	OH&S REGULATIONS 3.7  AS/NZS 1657-2013 7.3.3.1
38	Building: General Stores Location Reference: <a href="#">L31</a> Task: Access to the plant deck

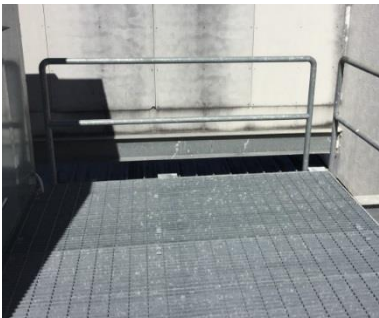
Gap between the handrail sections is greater than required maximum	Trips, Slips and Falls	Awareness induction	Med	Gap to be filled with additional post/handrail section to be installed	Low	Client advised	Outstanding	OH&S REGULATIONS 3.7  AS/NZS 1657-2013 4.4

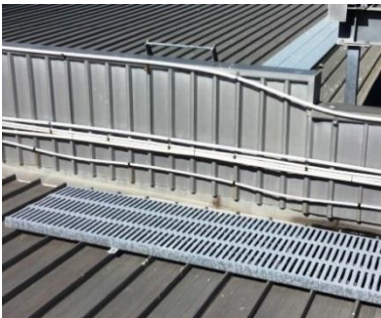
No safe access to the roof	Trips, Slips and Falls	Awareness induction	Med	Access ladder including handrails to be installed	Low	Client advised	Outstanding	OH&S REGULATIONS 3.7  AS/NZS 1657-2013 3.1.4

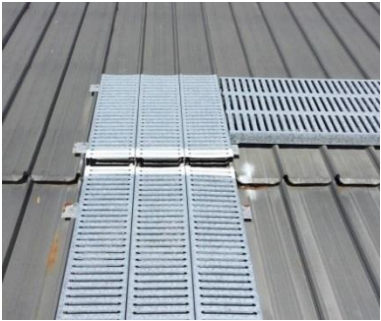
Variation in height between walkway panels is greater than required maximum	Trips, Slips and Falls	Awareness induction	Med	High visibility safety yellow nosing's to be installed	Low	Client advised	Outstanding	OH&S REGULATIONS 3.7  AS/NZS 1657-2013 3.3.4
42	Building: General Stores Location Reference: <a href="#">L33</a> Task: Access to the A/c unit

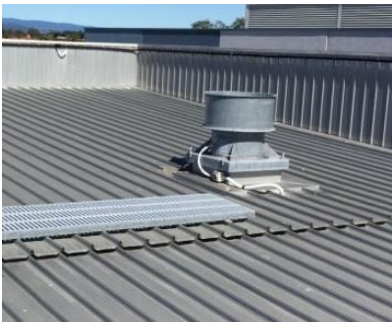
No safe access to the A/c unit	Trips, Slips and Falls	N/A	Low	Supply walkway to the A/c unit	Low	Client advised	Outstanding	-

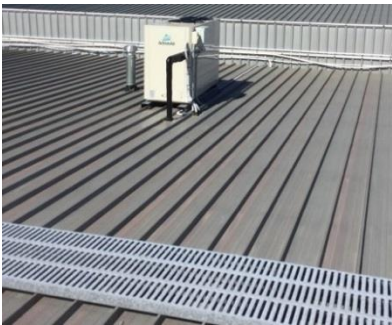
No safe access to the A/c unit	Trips, Slips and Falls	N/A	Low	Supply walkway to the A/c unit	Low	Client advised	Outstanding	-

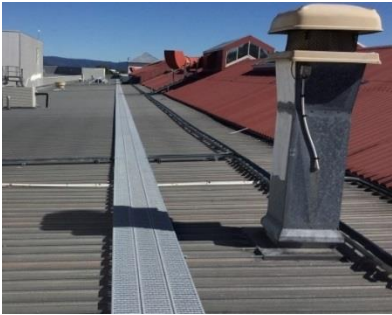
No safe access to the A/c unit	Trips, Slips and Falls	N/A	Low	Supply walkway to the A/c unit	Low	Client advised	Outsta nding	-
46	Building: General Stores Location Reference: <a href="#">L37</a> Task: Access to the stair

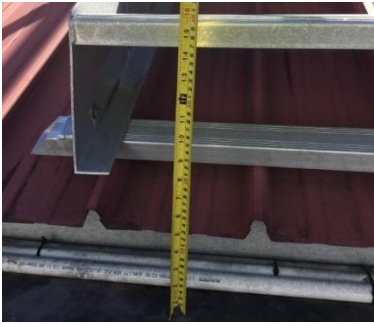
No landing platform at base of stair	Trips, Slips and Falls	Awareness induction	Med	Landing platform and step to be installed if required	Low	Client advised	Outstanding	OH&S REGULATIONS 3.7  AS/NZS 1657-2013 7.3.6
48	Building: General Stores Location Reference: <a href="#">L38</a> Task: Restrict access to the roof

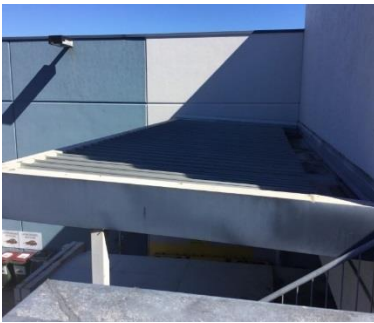
No height safety system installed (No serviceable items)	Trips, Slips and Falls	Awareness induction	High	"EWP Access Only" sign to be installed	Low	Client advised	Outstanding	OH&S REGULATIONS 3.55 & 3.11

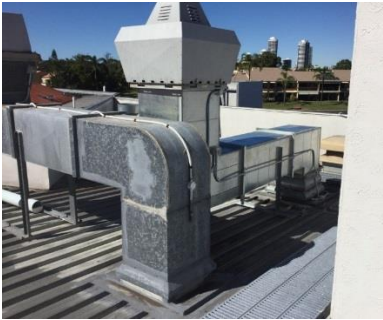
No safe access to the A/c units	Trips, Slips and Falls	N/A	Low	Supply walkway to the A/c units	Low	Client advised	Outstanding	-
50	Building: General Stores Location Reference: <a href="#">L40</a> Task: Access to the A/c units

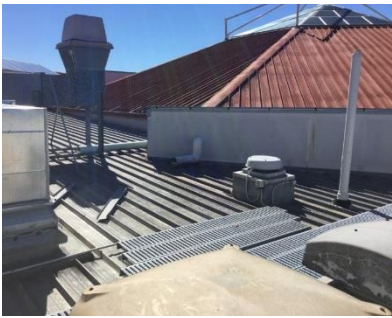
No safe access to the A/c units	Trips, Slips and Falls	N/A	Low	Supply walkway to the A/c units	Low	Client advised	Outstanding	-

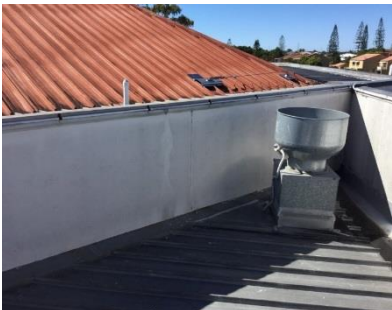
No safe access to the roof	Trips, Slips and Falls	Awareness induction	Med	Access ladder including handrails to be installed	Low	Client advised	Outstanding	OH&S REGULATIONS 3.7  AS/NZS 1657-2013 3.1.4

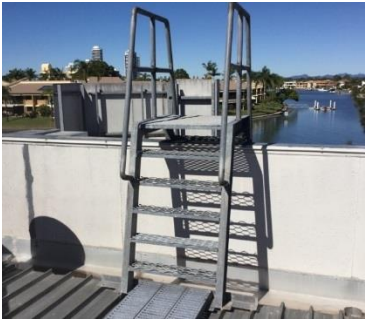
Ladder slope is greater than required maximum	Trips, Slips and Falls	Awareness induction	Med	Existing ladder to be removed and new ladder to be installed	Low	Client advised	Outstanding	OH&S REGULATIONS 3.7  AS/NZS 1657-2013 7.3.2
54	Building: General Stores Location Reference: <a href="#">L43</a> Task: Access to the plant deck

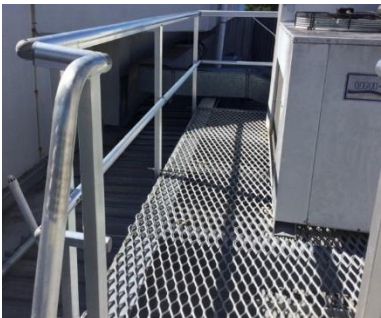
Sharp edges on handrails	Hand injury	Awareness induction	Med	Tek screws to be replaced with rivets	Low	Client advised	Outstanding	OH&S REGULATIONS 3.7  AS/NZS 1657-2013 5.6

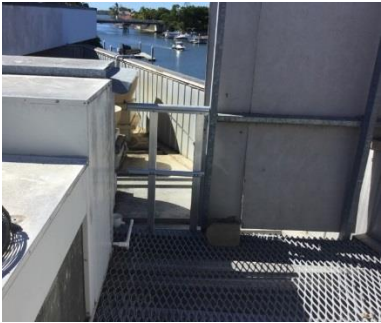
No safe access to the A/c units	Trips, Slips and Falls	Awareness induction	Med	Existing handrail section to be removed. New steps and walkway to the A/c units to be installed	Low	Client advised	Outstanding	OH&S REGULATIONS 3.7  AS/NZS 1657-2013 3.1.4
56	Building: General Stores Location Reference: <a href="#">L44</a> Task: Restrict access to the roof

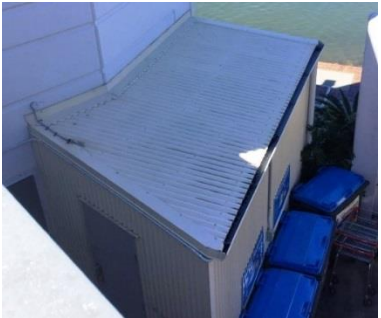
No height safety system installed (No serviceable items)	Trips, Slips and Falls	Awareness induction	High	"EWP Access Only" sign to be installed	Low	Client advised	Outstanding	OH&S REGULATIONS 3.55 & 3.11

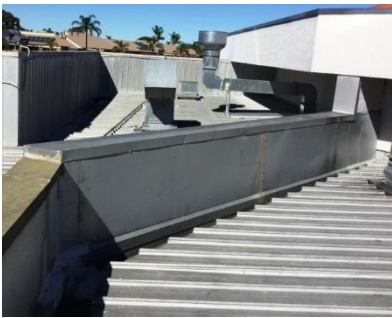
No safe access to the A/c units	Trips, Slips and Falls	N/A	Low	Supply walkway to the A/c units	Low	Client advised	Outstanding	-

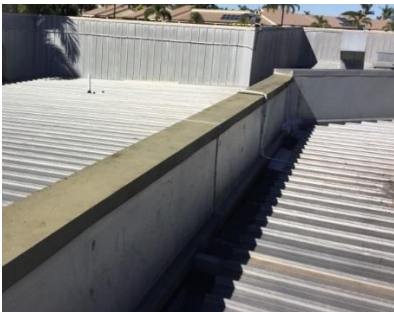
No safe access to the roof	Trips, Slips and Falls	Awareness induction	Med	Access ladder including handrails to be installed	Low	Client advised	Outstanding	OH&S REGULATIONS 3.7  AS/NZS 1657-2013 3.1.4

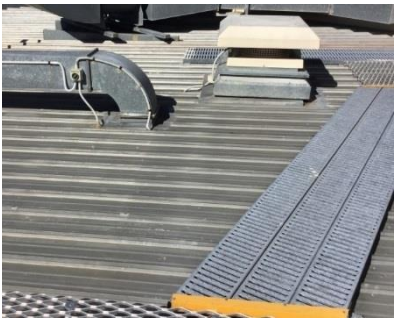
No safe access to the A/c units	Trips, Slips and Falls	N/A	Low	Supply walkway to the A/c units	Low	Client advised	Outsta nding	-

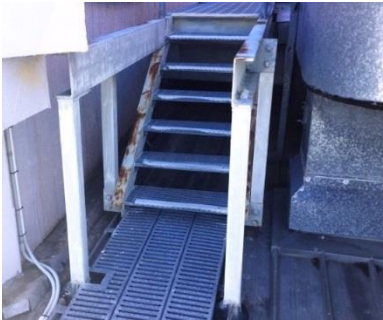
Bottom tread height is less than required minimum	Trips, Slips and Falls	Awareness induction	Med	Landing platform at base to be installed	Low	Client advised	Outstanding	OH&S REGULATIONS 3.7  AS/NZS 1657-2013 7.2.3.2
64	Building: General Stores Location Reference: <a href="#">L53</a> Task: Access to the A/c unit

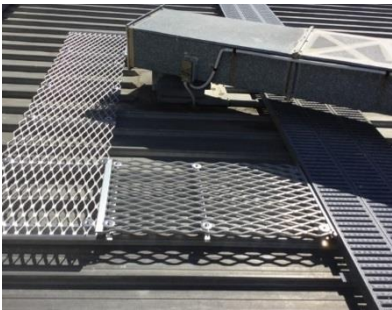
No safe access to the A/c unit	Trips, Slips and Falls	N/A	Low	Supply walkway to the A/c unit	Low	Client advised	Outstanding	-

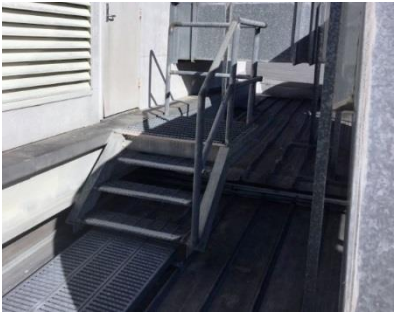
Un even tread risers	Trips, Slips and Falls	Awareness induction	Med	Existing stair to be removed and New access ladder including handrails to be installed	Low	Client advised	Outsta nding	OH&S REGULATIONS 3.7  AS/NZS 1657- 2013 7.2.3.2
66	Building: General Stores Location Reference: <a href="#">L55</a> Task: Restrict access to the roof

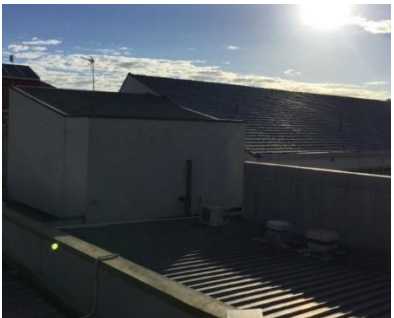
No height safety system installed	Trips, Slips and Falls	Awareness induction	High	Fall arrest anchors, anchor stop and ladder access bracket to be installed	Low	Client advised	Outstanding	OH&S REGULATIONS 3.55

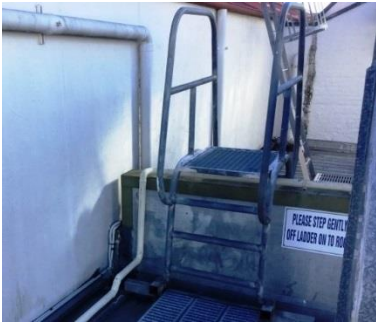
Un even rung heights and handrail projecting towards user	Trips, Slips and Falls	Awareness induction	Med	Existing ladder to be removed and new ladder including handrails to be installed	Low	Client advised	Outstanding	OH&S REGULATIONS 3.7  AS/NZS 1657-2013 7.4.3.2
70	Building: General Stores Location Reference: <a href="#">L59</a> Task: Access to the A/c unit

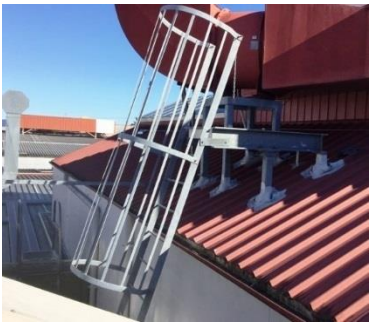
Non complaint ladder	Trips, Slips and Falls	Awareness induction	Med	Existing ladder to be removed and New ladder including landing platform and handrails to be installed	Low	Client advised	Outstanding	OH&S REGULATIONS 3.7  AS/NZS 1657-2013 7.4.3.1 & 7.4.3.2

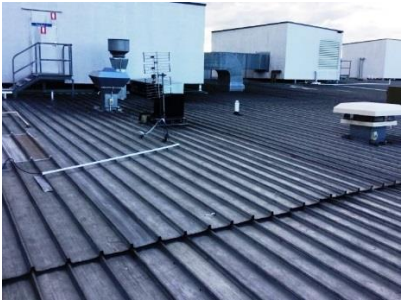
No safe access to the A/c units	Trips, Slips and Falls	N/A	Low	Supply walkway to the A/c units	Low	Client advised	Outstanding	-
74	Building: General Stores Location Reference: <a href="#">L65</a> Task: Access to the A/c unit

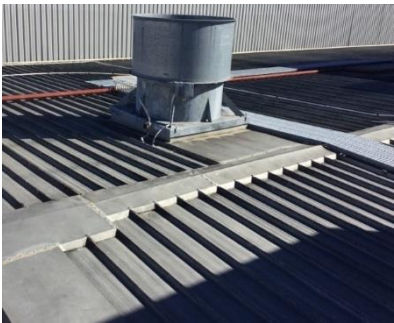
No safe access to the A/c unit	Trips, Slips and Falls	N/A	Low	Supply walkway to the A/c unit	Low	Client advised	Outstanding	-

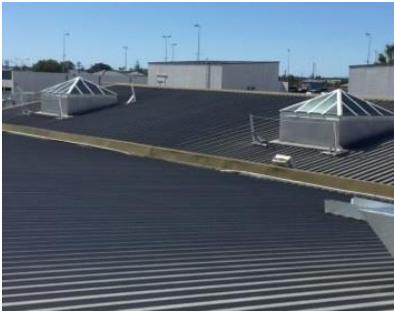
Brittle roof (Non-Trafficable Roof)	Fall hazard	Awareness induction	High	"WARNING-KEEP OFF-BRITTLE AND FRAGILE ROOF" signs to be installed	Low	Client advised	Outsta nding	OH&S REGULATIONS 3.57
76	Building: General Stores Location Reference: <a href="#">L70</a> Task: Access to the A/c unit

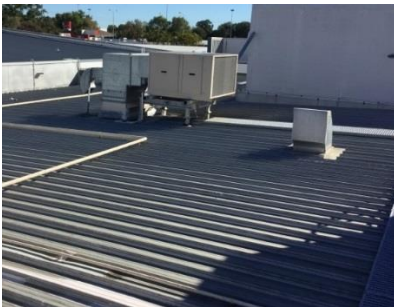
No safe access to the A/c unit	Trips, Slips and Falls	N/A	Low	Supply walkway to A/c unit	Low	Client advised	Outsta nding	-

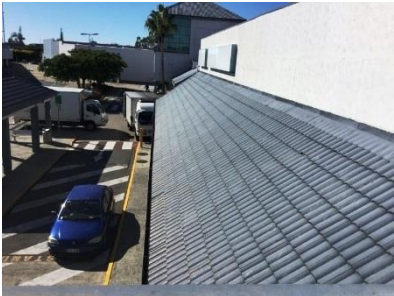
No height safety system installed (No serviceable items)	Trips, Slips and Falls	Awareness induction	High	"EWP Access Only" sign to be installed	Low	Client advised	Outstanding	OH&S REGULATIONS 3.55 & 3.11

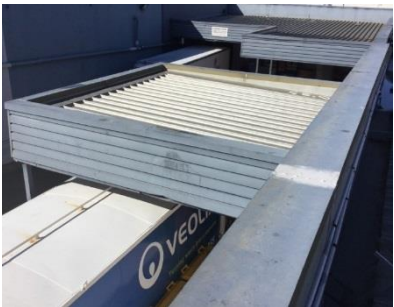
No height safety system installed (No serviceable items)	Trips, Slips and Falls	Awareness induction	High	"EWP Access Only" sign to be installed	Low	Client advised	Outstanding	OH&S REGULATIONS 3.55 & 3.11

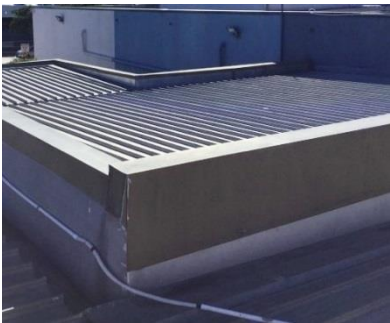
No safe access to the roof	Trips, Slips and Falls	Awareness induction	Med	Access ladder including handrails to be installed	Low	Client advised	Outstanding	OH&S REGULATIONS 3.7  AS/NZS 1657-2013 3.1.4

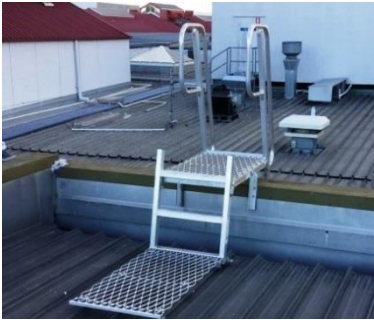
Handrail projects toward the user	Trips, Slips and Falls	Awareness induction	Med	Existing handrails to be removed and new handrails to be installed	Low	Client advised	Outsta nding	OH&S REGULATIONS 3.7  AS/NZS 1657- 2013 7.4.8.5
84	Building: General Stores Location Reference: <a href="#">L78</a> Task: Access to the A/c units

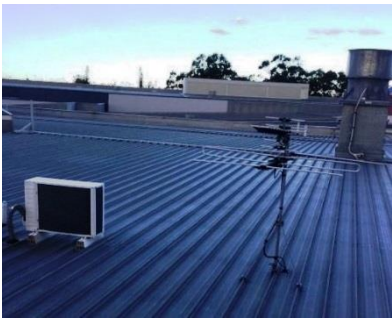
No safe access to the A/c units	Trips, Slips and Falls	N/A	Low	Supply walkway to the A/c units	Low	Client advised	Outsta nding	-

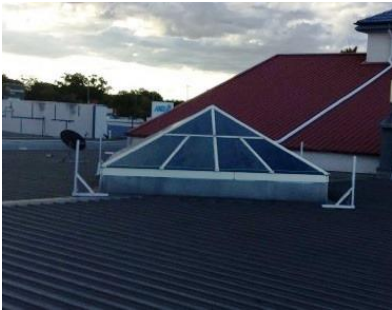
Brittle roof (Non-trafficable roof)	Fall hazard	Awareness induction	High	"WARNING-KEEP OFF-BRITTLE AND FRAGILE ROOF" signs to be installed	Low	Client advised	Outstanding	OH&S REGULATIONS 3.57
86	Building: General Stores Location Reference: <a href="#">L80</a> Task: Access to the A/c units

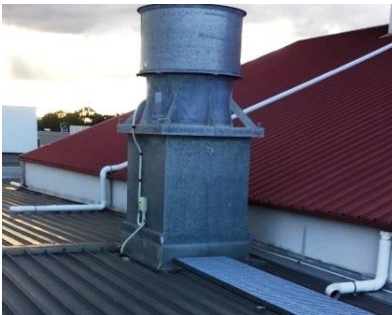
No safe access to the A/c units	Trips, Slips and Falls	N/A	Low	Supply walkway to the A/c units	Low	Client advised	Outstanding	-

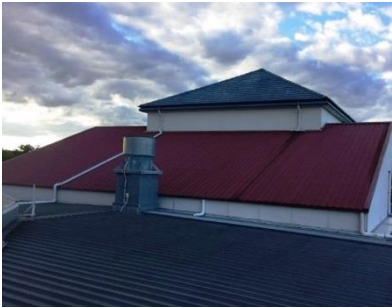
Roof is too steep (No serviceable items)	Trips, Slips and Falls	Awareness induction	High	"No Access" sign to be installed	Low	Client advised	Outstanding	OH&S REGULATIONS 3.55 & 3.11
88	Building: General Stores Location Reference: <a href="#">L82</a> Task: Restrict access to the roof

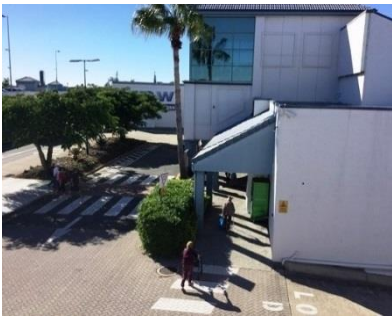
No height safety system installed (No serviceable items)	Trips, Slips and Falls	Awareness induction	High	"EWP Access Only" signs to be installed	Low	Client advised	Outstanding	OH&S REGULATIONS 3.55 & 3.11

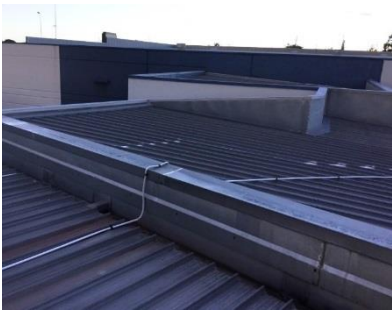
No safe access to the roof	Trips, Slips and Falls	Awareness induction	High	Fall arrest anchors to be installed	Low	Client advised	Outstanding	OH&S REGULATIONS 3.55

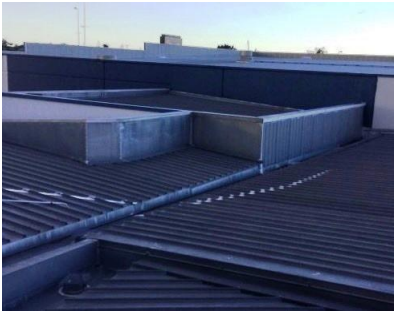
No safe access to the roof	Trips, Slips and Falls	Awareness induction	Med	Access ladder including handrails to be installed	Low	Client advised	Outsta nding	OH&S REGULATIONS 3.7  AS/NZS 1657- 2013 3.1.4
92	Building: General Stores Location Reference: <a href="#">L86</a> , <a href="#">L87</a> & <a href="#">L88</a> Task: Restrict access to the roof

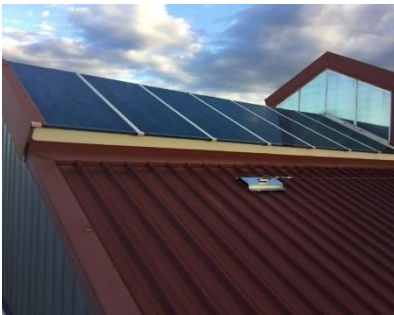
Brittle roof (Non-Trafficable Roof)	Trips, Slips and Falls	Awareness induction	High	"WARNING-KEEP OFF-BRITTLE AND FRAGILE ROOF" signs to be installed	Low	Client advised	Outsta nding	OH&S REGULATIONS 3.57

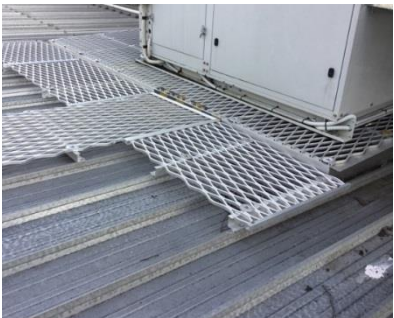
Variation in height between two panels is greater than required maximum	Trips, Slips and Falls	Awareness induction	Med	High visibility safety yellow nosing's to be installed	Low	Client advised	Outstanding	OH&S REGULATIONS 3.7  AS/NZS 1657-2013 3.3.4

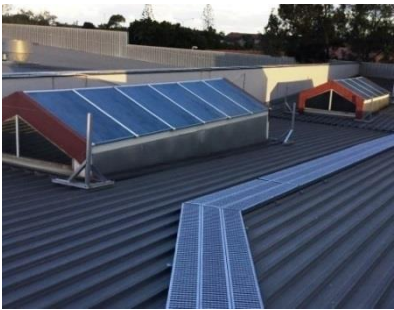
Brittle roof (Non-Trafficable Roof)	Fall hazard	Awareness induction	High	"WARNING-KEEP OFF-BRITTLE AND FRAGILE ROOF" signs to be installed	Low	Client advised	Outsta nding	OH&S REGULATIONS 3.57

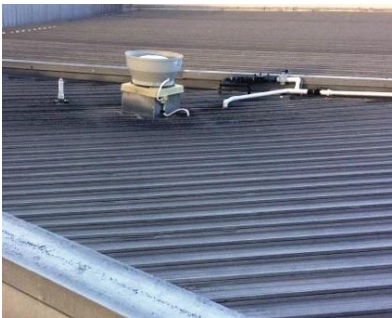
No safe access to the A/c unit	Trips, Slips and Falls	N/A	Low	Supply walkway to the A/c unit	Low	Client advised	Outsta nding	-

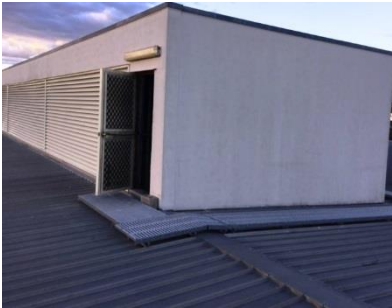
No height safety system installed	Trips, Slips and Falls	Awareness induction	High	Fall arrest anchors, anchor strop and ladder access bracket to be installed	Low	Client advised	Outsta nding	OH&S REGULATIONS 3.55
104	Building: BIG W Location Reference: <a href="#">L101</a> Task: Access to the roof

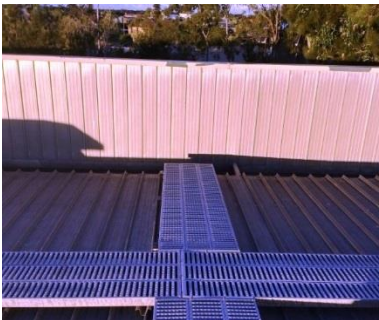
No safe access to the roof	Trips, Slips and Falls	Awareness induction	Med	Access ladder including handrails to be installed	Low	Client advised	Outsta nding	OH&S REGULATIONS 3.7  AS/NZS 1657-2013 3.1.4

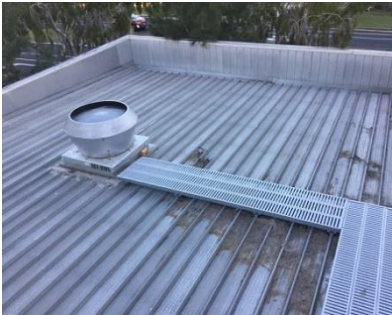
No height safety system installed	Trips, Slips and Falls	Awareness induction	High	Fall arrest anchors to be installed	Low	Client advised	Outsta nding	OH&S REGULATIONS 3.55
106	Building: BIG W Location Reference: <a href="#">L103</a> Task: Restrict access to the roof

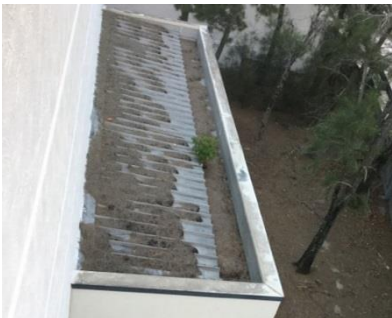
No height safety system installed (No serviceable items on roof)	Trips, Slips and Falls	Awareness induction	High	"EWP ACCESS ONLY" sign to be installed	Low	Client advised	Outsta nding	OH&S REGULATIONS 3.55 & 3.11

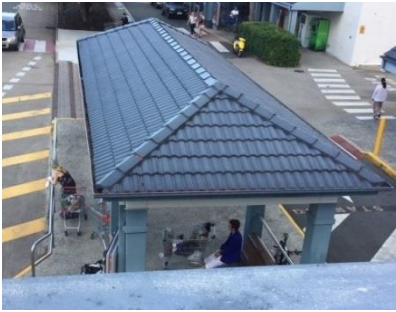
No height safety system installed (No serviceable items on roof)	Trips, Slips and Falls	Awareness induction	High	"EWP ACCESS ONLY" sign to be installed	Low	Client advised	Outstanding	OH&S REGULATIONS 3.55 & 3.11
108	Building: General Stores Location Reference: <a href="#">L105</a> Task: Access to the roof

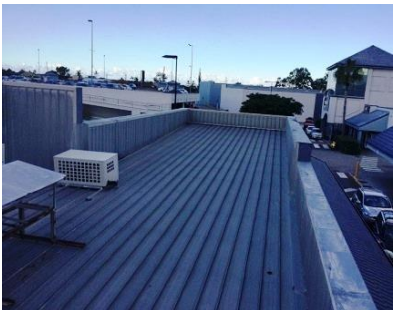
No height safety system Installed	Trips, Slips and Falls	Awareness induction	High	Fall arrest anchors to be installed	Low	Client advised	Outstanding	OH&S REGULATIONS 3.55

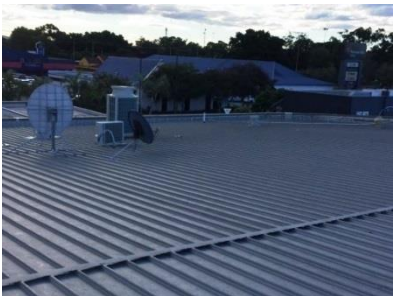
No safe access to the A/c units	Trips, Slips and Falls	N/A	Low	Supply walkway to the A/c units	Low	Client advised	Outstanding	-

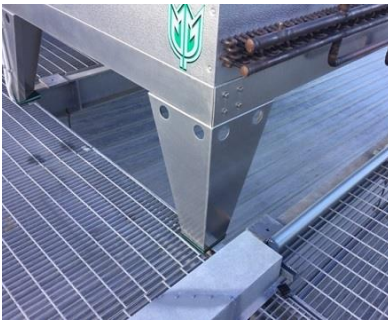
Gap between grating and unit is greater than required maximum	Trips, Slips and Falls	Awareness induction	Med	Midrail to be installed	Low	Client advised	Outstanding	OH&S REGULATIONS 3.6  AS/NZS 1657-2013 4.4

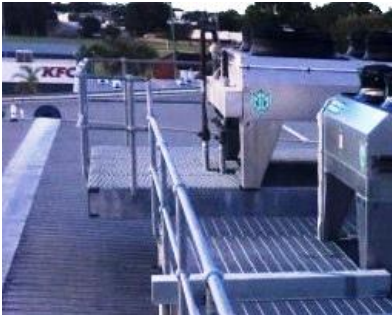
Variation in height between two panels are greater than required maximum	Trips, Slips and Falls	Awareness induction	Med	High visibility safety yellow nosing's to be installed	Low	Client advised	Outstanding	OH&S REGULATIONS 3.6  AS/NZS 1657-2013 3.3.4

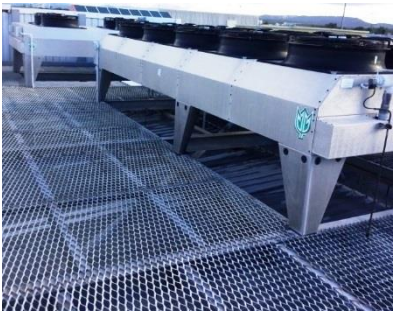
Gap between grating and unit is greater than required maximum	Trips, Slips and Falls	Awareness induction	Med	Midrail to be installed	Low	Client advised	Outstanding	OH&S REGULATIONS 3.6  AS/NZS 1657-2013 4.4
116	Building: Woolworths Location Reference: <a href="#">L112</a> Task: Access to the roof

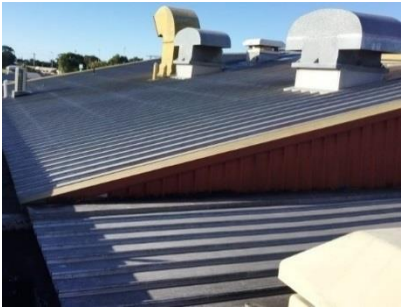
No safe access to the A/c units	Trips, Slips and Falls	N/A	Low	Supply walkway, Handrails and steps to the A/c units	Low	Client advised	Outstanding	-
118	Building: Woolworths Location Reference: <a href="#">L113</a> Task: Access to the roof

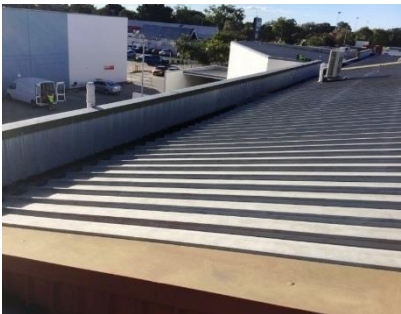
No height safety system is installed	Trips, Slips and Falls	Awareness induction	High	Fall arrest anchors to be installed	Low	Client advised	Outstanding	OH&S REGULATIONS 3.55

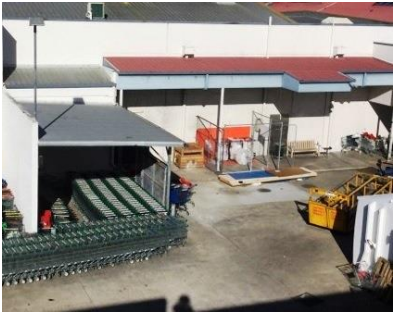
No height safety system installed (No serviceable items)	Trips, Slips and Falls	Awareness induction	High	"EWP Access Only" signs to be installed	Low	Client advised	Outstanding	OH&S REGULATIONS 3.55 & 3.11
120	Building: Woolworths Location Reference: <a href="#">L115</a> Task: Access to the roof

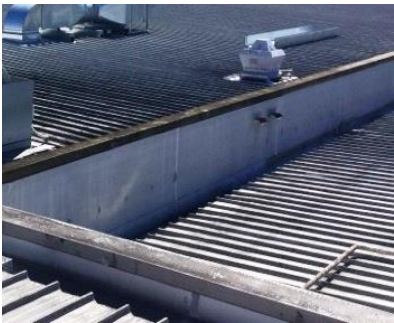
No safe access to the roof	Trips, Slips and Falls	Awareness induction	Med	Access ladder including handrails to be installed	Low	Client advised	Outstanding	OH&S REGULATIONS 3.7  AS/NZS 1657-2013 3.1.4

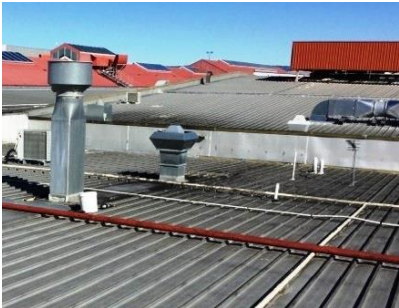
No safe access to the A/c units	Trips, Slips and Falls	N/A	Low	Supply walkway to the A/c units	Low	Client advised	Outstanding	-
122	Building: General Stores Location Reference: <a href="#">L116,117,118,119,120 &amp; 121</a> Task: Restrict access to the roof

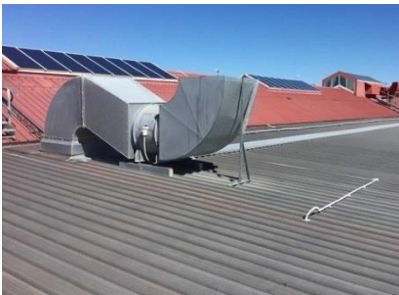
Brittle roof (Non-trafficable roof)	Fall hazard	Awareness induction	High	"Warning- Keep Off - Brittle and Fragile roof" signs to be installed	Low	Client advised	Outstanding	OH&S REGULATIONS 3.57

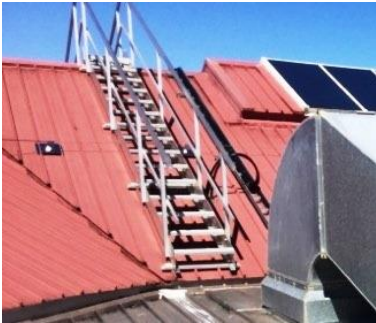
Bottom tread heights is greater than required maximum and no landing platforms at base	Trips, Slips and Falls	Awareness induction	Med	Landing platforms and steps to be installed	Low	Client advised	Outstanding	OH&S REGULATIONS 3.7  AS/NZS 1657-2013 7.2.4 & 7.3.6

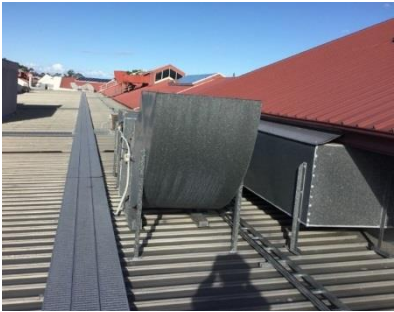
No safe access to the roof	Trips, Slips and Falls	Awareness induction	Med	Access ladder including handrails to be installed	Low	Client advised	Outstanding	OH&S REGULATIONS 3.7  AS/NZS 1657-2013 3.1.4
132	Building: General Stores Location Reference: <a href="#">L137</a> Task: Restrict access to the roof

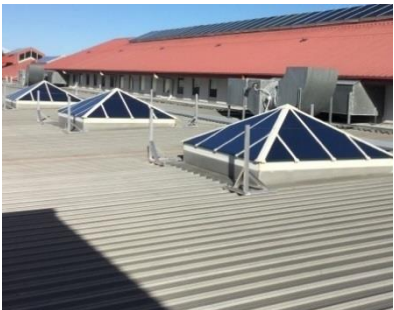
Brittle roof (Non-Trafficable roof)	Fall Hazard	Awareness induction	High	"Warning-Keep Off-Brittle and Fragile Roof" signs to be installed	Low	Client advised	Outstanding	OH&S REGULATIONS 3.57

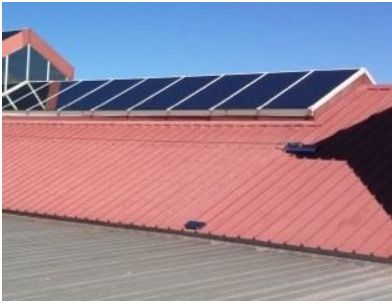
Brittle roof (Non-Trafficable roof)	Fall Hazard	Awareness induction	High	"Warning-Keep Off-Brittle and Fragile Roof" signs to be installed	Low	Client advised	Outstanding	OH&S REGULATIONS 3.57
134	Building: General Stores Location Reference: <a href="#">L142</a> Task: Access to the A/c unit

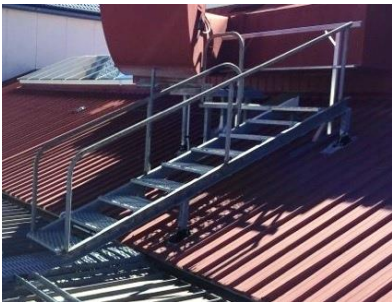
Going is greater than required maximum, Midrail is missing and sharp edges on handrails	Trips, Slips and Falls	Awareness induction	Med	Existing stair to be removed and New access ladder including landing platforms and handrails to be installed	Low	Client advised	Outstanding	OH&S REGULATIONS 3.7  AS/NZS 1657-2013 7.2.4 & 4.4 & 5.6

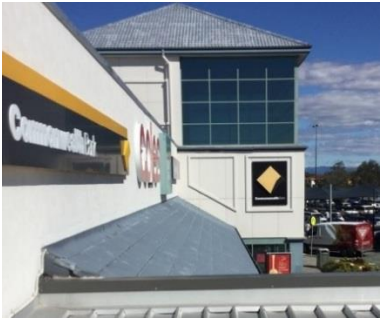
No height safety system installed (No serviceable items)	Trips, Slips and Falls	Awareness induction	High	"EWP Access Only" signs to be installed	Low	Client advised	Outstanding	OH&S REGULATIONS 3.55 & 3.11
136	Building: General Stores Location Reference: <a href="#">L144</a> Task: Access to the A/c unit

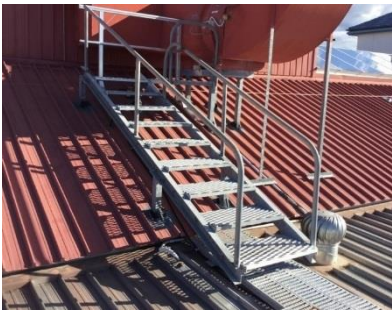
Going is greater than required maximum, Midrail is missing and sharp edges on handrails	Trips, Slips and Falls	Awareness induction	Med	Existing stair to be removed and New access ladder including landing platforms and handrails to be installed	Low	Client advised	Outstanding	OH&S REGULATIONS 3.7  AS/NZS 1657-2013 7.2.4 & 4.4 & 5.6

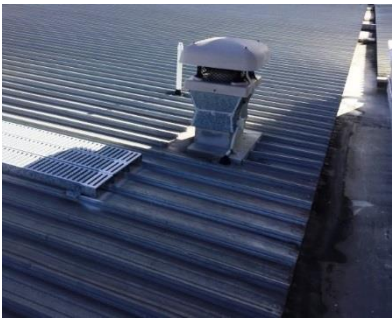
No safe access to the A/c unit	Trips, Slips and Falls	N/A	Low	Supply walkway to the A/c units	Low	Client advised	Outstanding	-

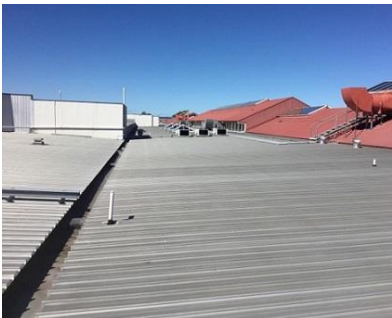
No safe access to the A/c units	Trips, Slips and Falls	N/A	Low	Supply walkway to the A/c units	Low	Client advised	Outstanding	-

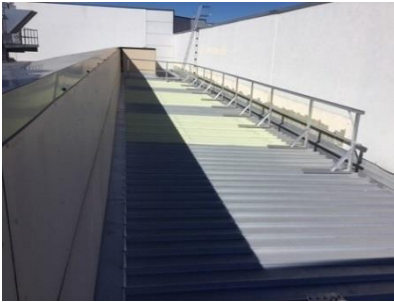
Sharp edges on handrails	Hand Injury	Awareness induction	Med	Tek screws to be replaced with rivets and Additional handrail section to be installed	Low	Client advised	Outstanding	OH&S REGULATIONS 3.6  AS/NZS 1657-2013 5.6
142	Building: ALDI Location Reference: <a href="#">L150</a> Task: Access to the A/c unit

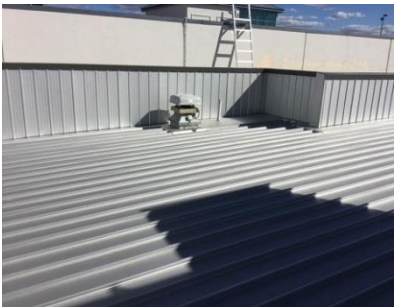
No safe access to the A/c unit	Trips, Slips and Falls	N/A	Low	Supply walkway to the A/c unit	Low	Client advised	Outstanding	-

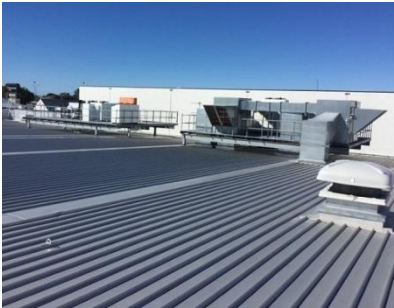
No safe access to the A/c units	Trips, Slips and Falls	N/A	Low	Supply walkway to the A/c units	Low	Client advised	Outstanding	-
144	Building: ALDI Location Reference: <a href="#">L152</a> Task: Access to the roof

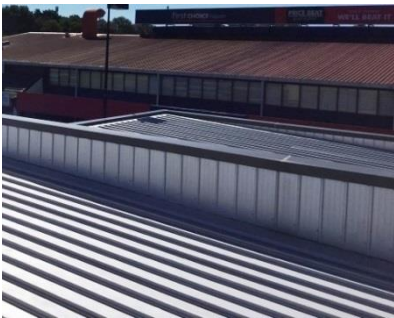
No safe access to the roof	Trips, Slips and Falls	Awareness induction	Med	Access ladder including handrails to be installed	Low	Client advised	Outstanding	OH&S REGULATIONS 3.7  AS/NZS 1657-2013 3.1.4

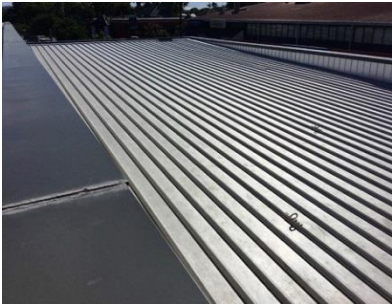
No height safety system installed	Trips, Slips and Falls	Awareness induction	High	Fall arrest anchors to be installed	Low	Client advised	Outsta nding	OH&S REGULATIONS 3.55
146	Building: ALDI Location Reference: <a href="#">L153</a> Task: Access to the roof

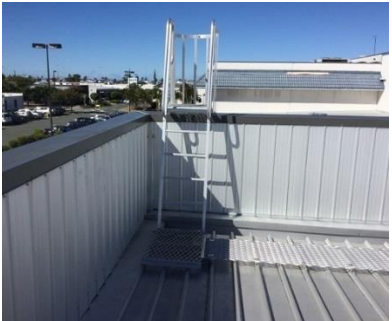
Bottom rung height is less than required minimum and handrail projecting towards the user	Trips, Slips and Falls	Awareness induction	Med	Existing handrail to be removed. Landing platform and handrails to be installed	Low	Client advised	Outsta nding	OH&S REGULATIONS 3.7  AS/NZS 1657-2013 7.4.3.4 & 7.4.8.5

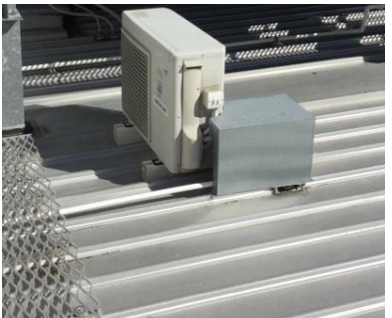
No safe access to the A/c unit	Trips, Slips and Falls	N/A	Low	Supply walkway to the A/c unit	Low	Client advised	Outstanding	-

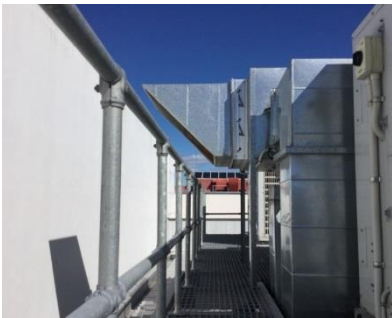
Headroom is less than required minimum	Trips, Slips and Falls	Awareness induction	Med	Low headroom signs and high visibility safety yellow tape to be installed	Low	Client advised	Outstanding	OH&S REGULATIONS 3.6  AS/NZS 1657-2013 3.1.5

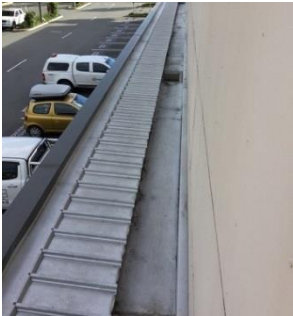
No height safety system installed (No serviceable items)	Trips, Slips and Falls	Awareness induction	High	"EWP Access Only" signs to be installed	Low	Client advised	Outstanding	OH&S REGULATIONS 3.55 & 3.11

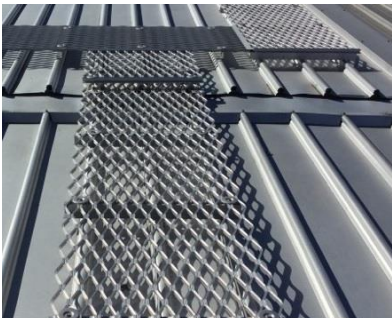
Variation in height between two panels are greater than required maximum	Trips, Slips and Falls	Awareness induction	Med	High visibility safety yellow nosing to be installed	Low	Client advised	Outstanding	OH&S REGULATIONS 3.6  AS/NZS 1657-2013 3.3.4

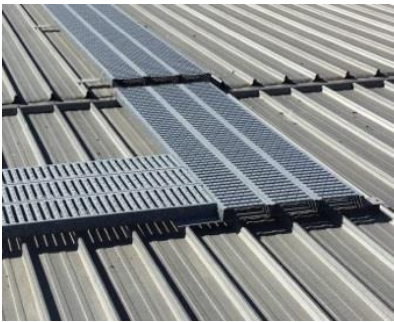
Variation in height between two panels are greater than required maximum	Trips, Slips and Falls	Awareness induction	Med	High visibility safety yellow nosing to be installed	Low	Client advised	Outsta nding	OH&S REGULATIONS 3.6  AS/NZS 1657-2013 3.3.4

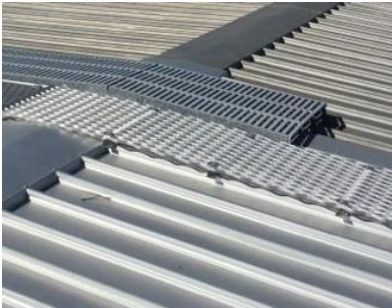
Variation in height between two panels are greater than required maximum	Trips, Slips and Falls	Awareness induction	Med	High visibility safety yellow nosing to be installed	Low	Client advised	Outstanding	OH&S REGULATIONS 3.6  AS/NZS 1657-2013 3.3.4
158	Building: Coles Location Reference: <a href="#">L160</a> Task: Access to the A/c unit

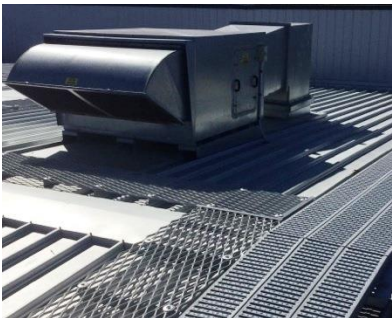
No safe access to the A/c unit	Trips, Slips and Falls	N/A	Low	Supply walkway to the A/c unit	Low	Client advised	Outstanding	-

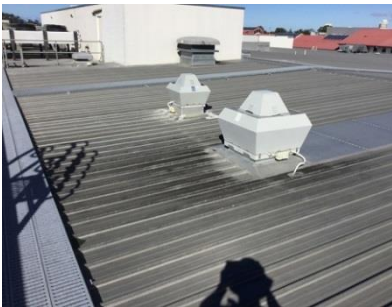
No safe access to the A/c units	Trips, Slips and Falls	N/A	Low	Supply walkway to the A/c units	Low	Client advised	Outstanding	-

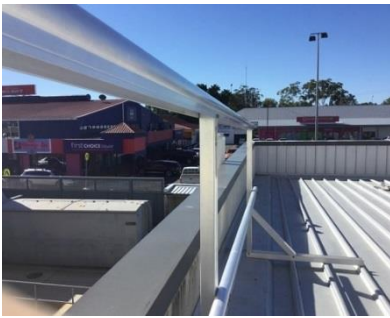
Sharp edges on handrails	Hand Injury	Awareness induction	Med	Tek screws to be replaced with rivets	Low	Client advised	Outstanding	OH&S REGULATIONS 3.6  AS/NZS 1657-2013 5.6

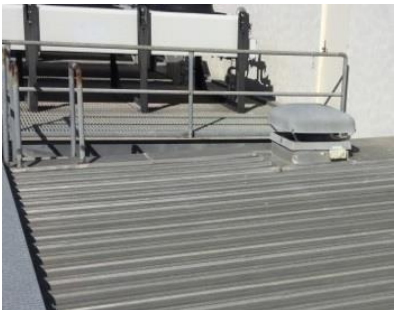
No safe access to the A/c unit	Trips, Slips and Falls	N/A	Low	Supply walkway to the A/c unit	Low	Client advised	Outstanding	-

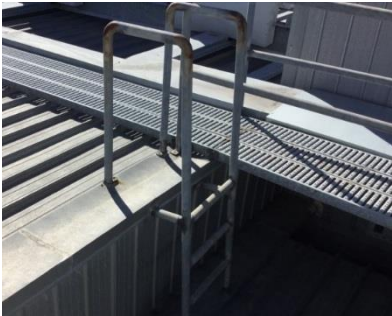
No	Photo of Hazard	Details of Hazard	Details of Risk	Existing/ Immediate Control Measure	Curren t Risk Level	Proposed Permanent Solution	Residu al Risk Assess ment	Details of Action Taken	Status	Reference
165	Building: Coles Location Reference: <a href="#">L166</a> Task: Access to the roof

Non-compliant ladder (Not required)	Trips, Slips and Falls	Awareness induction	Med	Existing ladder to be removed	Low	Client advised	Outsta nding	OH&S REGULATIONS 3.7  AS/NZS 1657- 2013 3.1.4
166	Building: Coles Location Reference: <a href="#">L167</a> Task: Access to the roof

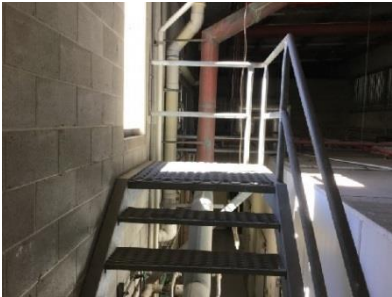
Toe board is missing at landing	Trips, Slips and Falls	Awareness induction	Med	Toe board to be installed	Low	Client advised	Outsta nding	OH&S REGULATIONS 3.7  AS/NZS 1657-2013 4.6

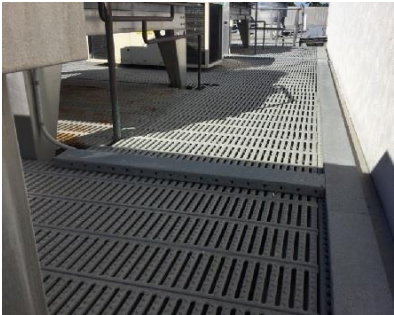
No	Photo of Hazard	Details of Hazard	Details of Risk	Existing/ Immediate Control Measure	Curren t Risk Level	Proposed Permanent Solution	Residu al Risk Assess ment	Details of Action Taken	Status	Reference
167	Building: Coles Location Reference: <a href="#">L167</a> Task: Access to the plant deck

Cable covers over the walkway path	Trips, Slips and Falls	Awareness induction	Med	High visibility safety yellow tape to be installed	Low	Client advised	Outstanding	OH&S REGULATIONS 3.6
168	Building: Coles Location Reference: <a href="#">L168</a> Task: Restrict access to the roof

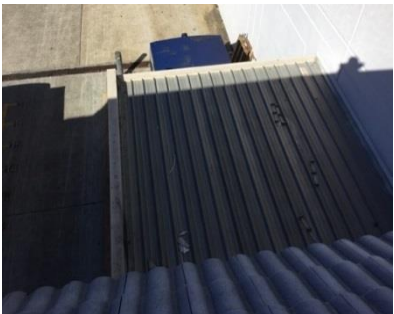
No height safety system is installed (No serviceable items)	Trips, Slips and Falls	Awareness induction	High	"EWP Access Only" sign to be installed	Low	Client advised	Outstanding	OH&S REGULATIONS 3.55 & 3.11

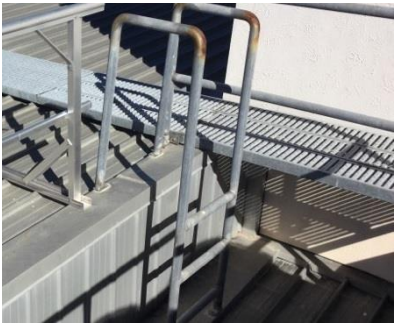
No	Photo of Hazard	Details of Hazard	Details of Risk	Existing/ Immediate Control Measure	Curren t Risk Level	Proposed Permanent Solution	Residu al Risk Assess ment	Details of Action Taken	Status	Reference
169	Building: Coles Location Reference: <a href="#">L169</a> Task: Access to the roof

Non-compliant ladder	Trips, Slips and Falls	Awareness induction	Med	Existing ladder to be removed and New ladder to be installed	Low	Client advised	Outsta nding	OH&S REGULATIONS 3.7  AS/NZS 1657- 2013 3.1.4
170	Building: Coles Location Reference: <a href="#">L169</a> Task: Access to the A/c units

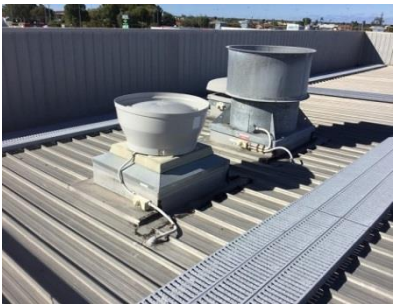
No safe access to the A/c units	Trips, Slips and Falls	N/A	Low	Supply walkway to the A/c units	Low	Client advised	Outsta nding	-

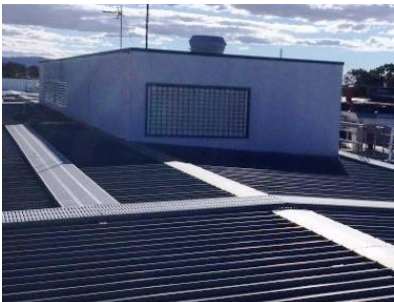
No safe access to the roof	Trips, Slips and Falls	Awareness induction	Med	Access ladder including handrails to be installed	Low	Client advised	Outstanding	OH&S REGULATIONS 3.7  AS/NZS 1657-2013 3.1.4

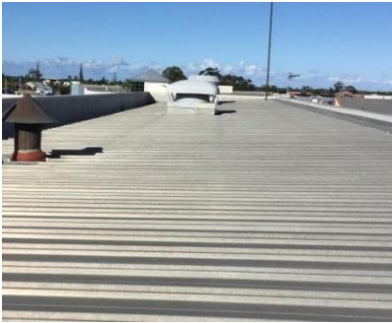
No	Photo of Hazard	Details of Hazard	Details of Risk	Existing/ Immediate Control Measure	Curren t Risk Level	Proposed Permanent Solution	Residu al Risk Assess ment	Details of Action Taken	Status	Reference
173	Building: Coles Location Reference: <a href="#">L171</a> Task: Access to the A/c units

No safe access to the A/c units	Trips, Slips and Falls	N/A	Low	Supply walkway to the A/c units	Low	Client advised	Outstanding	-
174	Building: Coles Location Reference: <a href="#">L172</a> Task: Access to the A/c unit

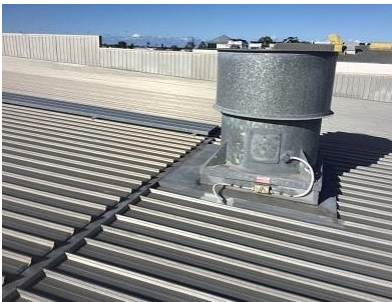
No safe access to the A/c unit	Trips, Slips and Falls	N/A	Low	Supply walkway to the A/c unit	Low	Client advised	Outstanding	-
